Albia Municipal Airport

PAVEMENT MANAGEMENT REPORT

JULY 2022

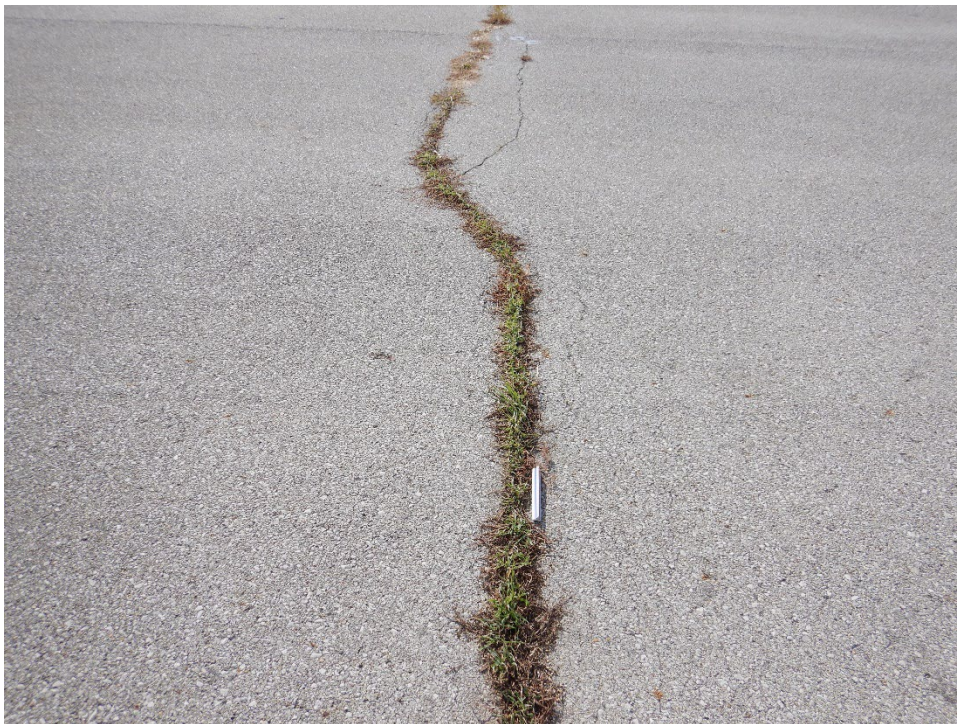
A01AL-01. L&T Cracking (Sample Unit No. 02).

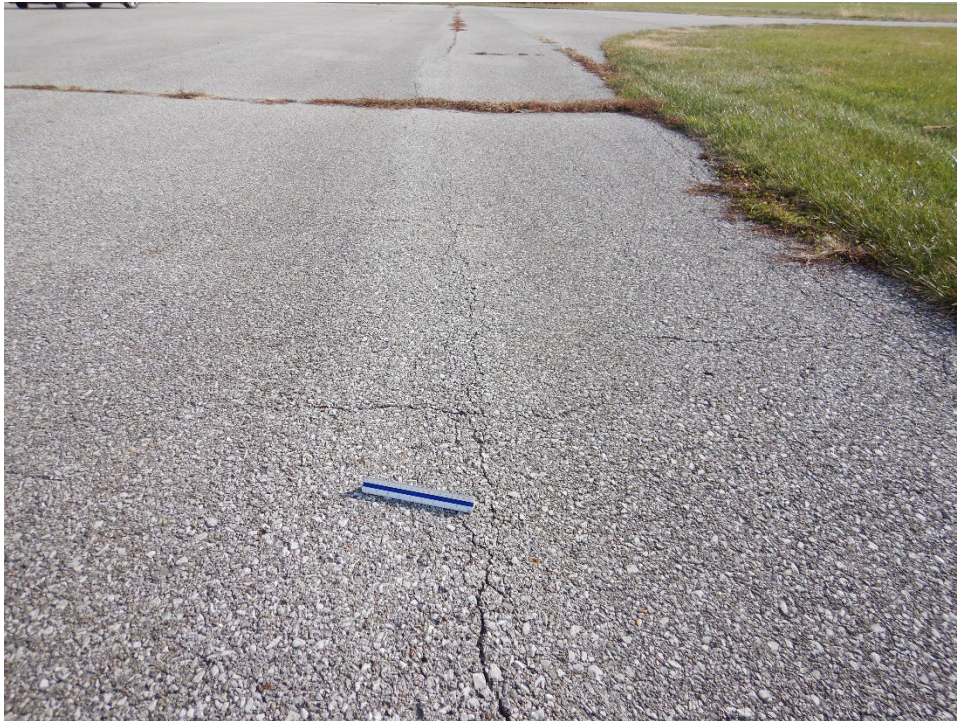
A01AL-01. Swelling (Sample Unit No. 04).

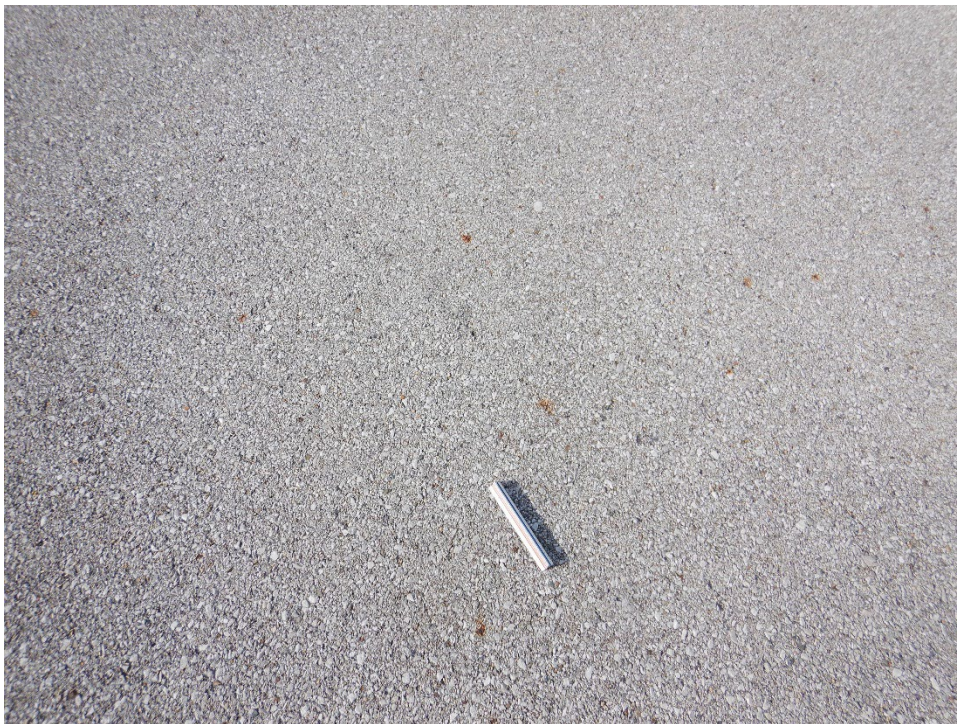
A01AL-01. Weathering (Sample Unit No. 02).

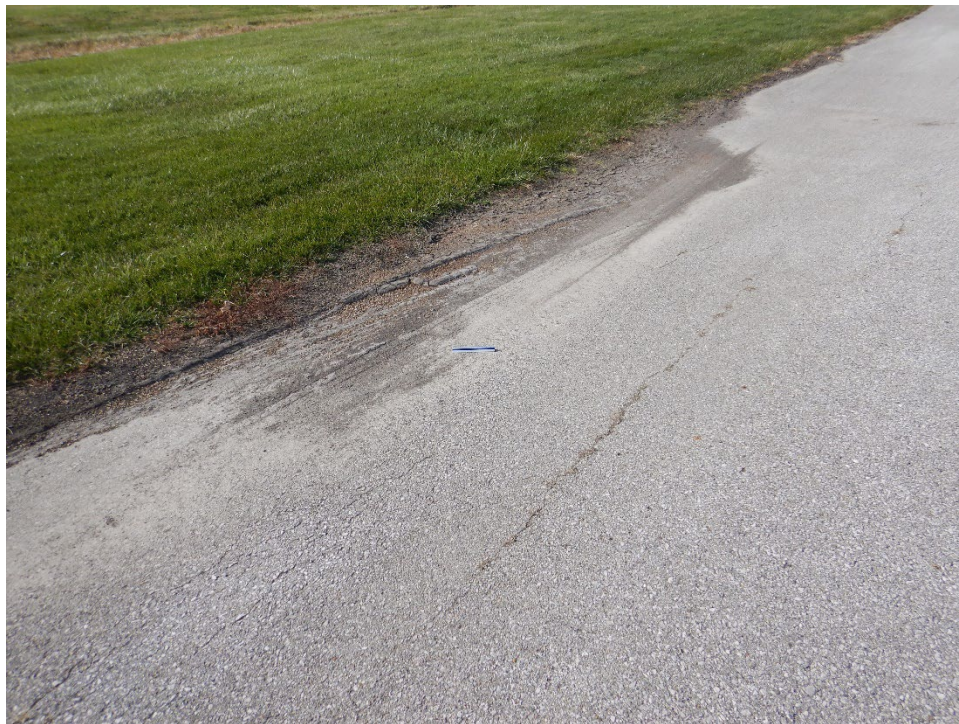
A01AL-02. Depression (Sample Unit No. 01).

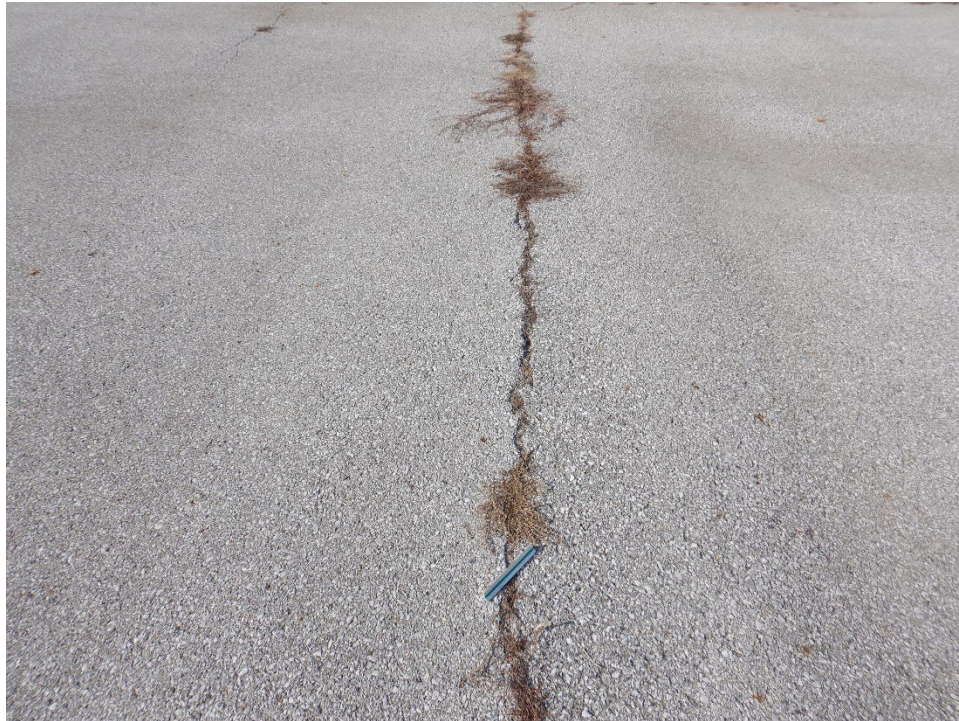
A01AL-02. L&T Cracking (Sample Unit No. 01).

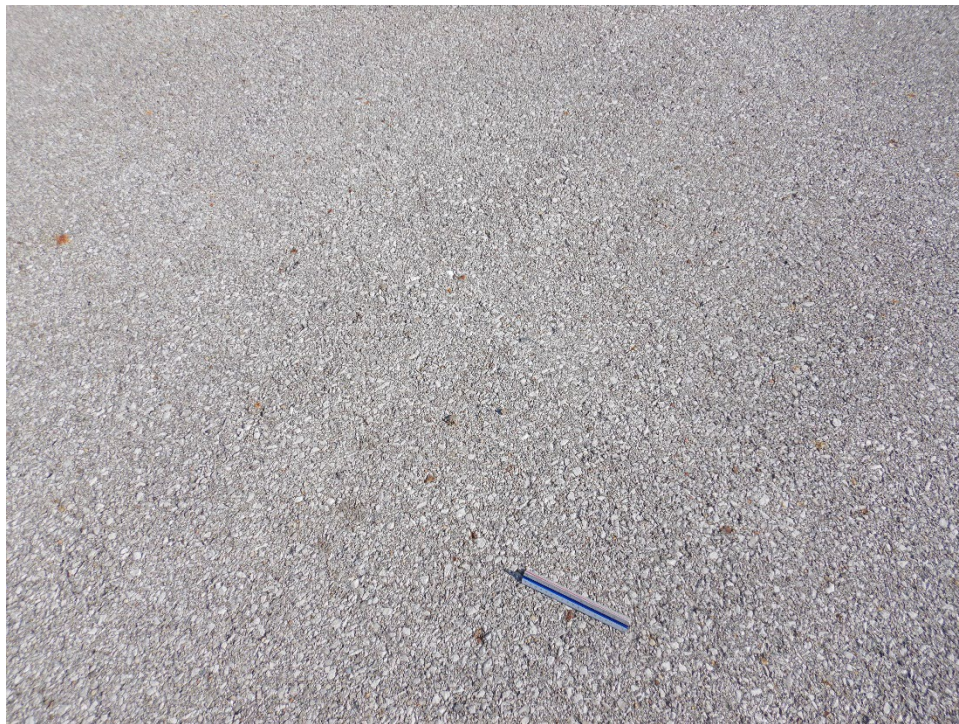
A01AL-02. Weathering (Sample Unit No. 01).

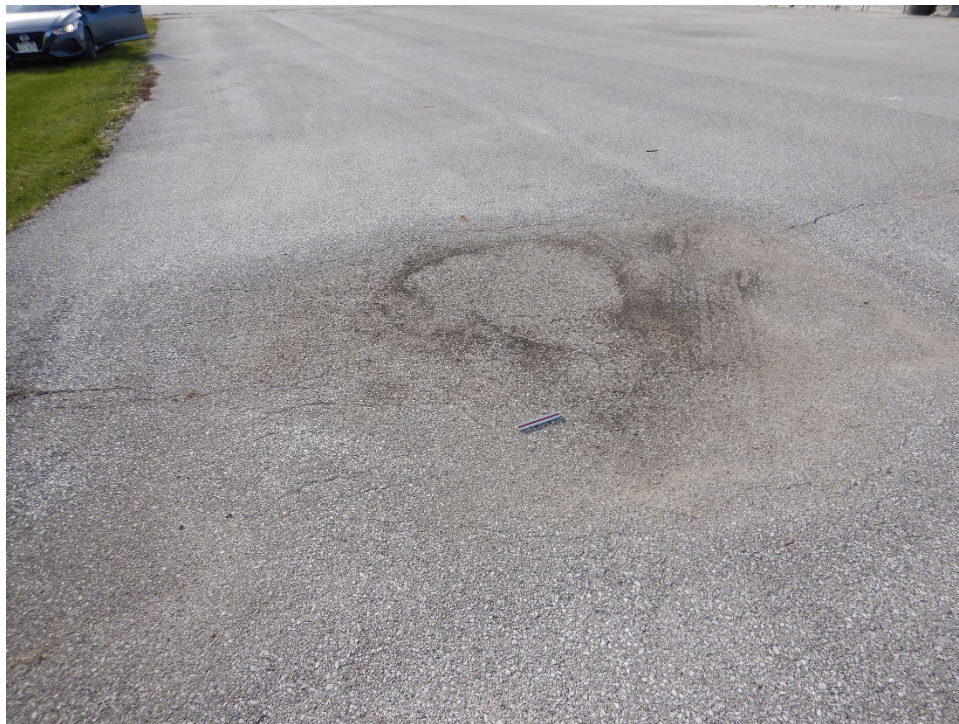
A01AL-03. Depression (Sample Unit No. 02).

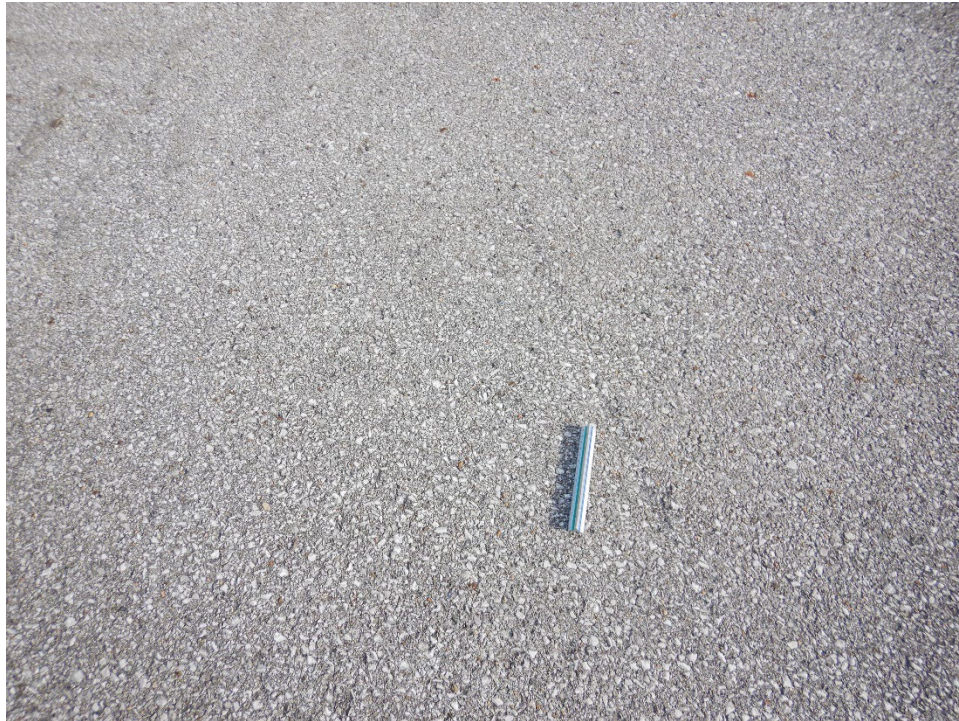
A01AL-03. Weathering (Sample Unit No. 02).

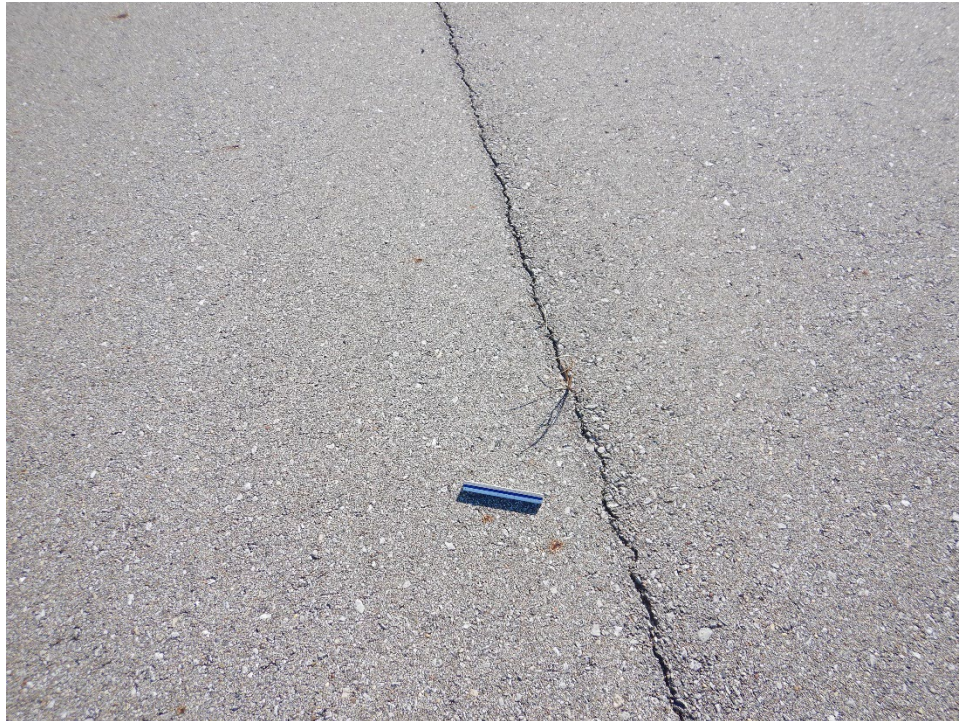
R13AL-01. L&T Cracking (Sample Unit No. 04).

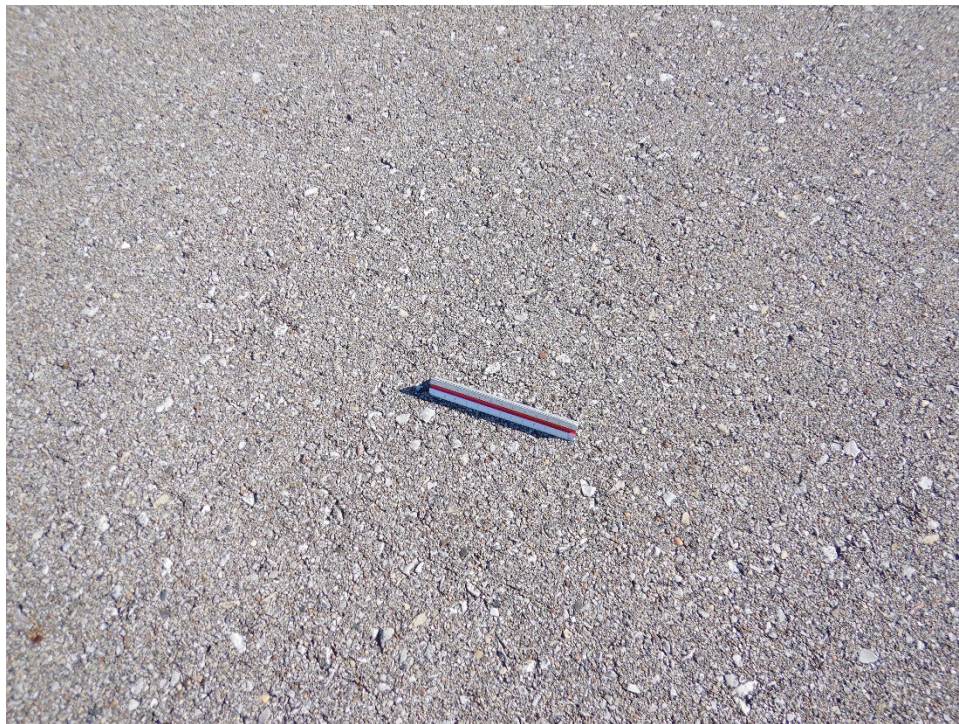
R13AL-01. Weathering (Sample Unit No. 04).

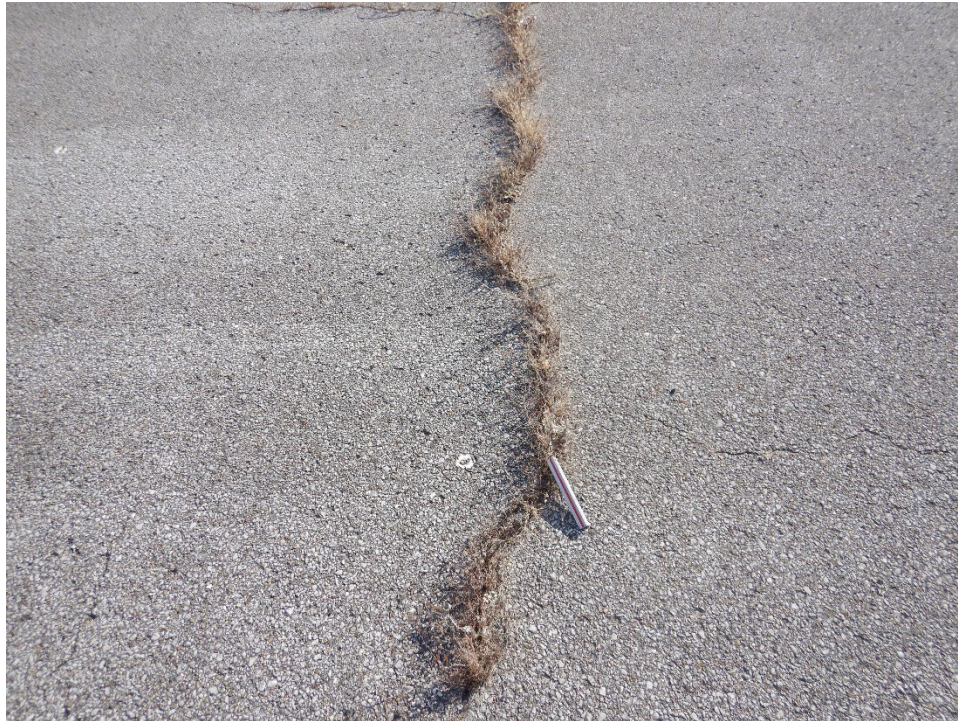
R13AL-02. L&T Cracking (Sample Unit No. 01).

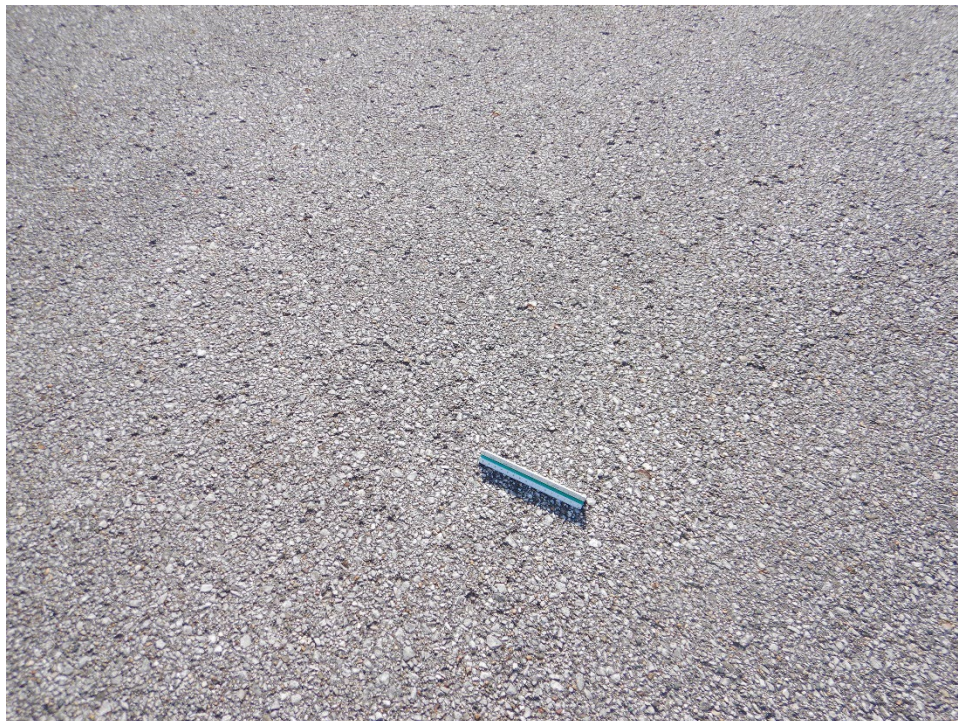
R13AL-02. Raveling (Sample Unit No. 01).

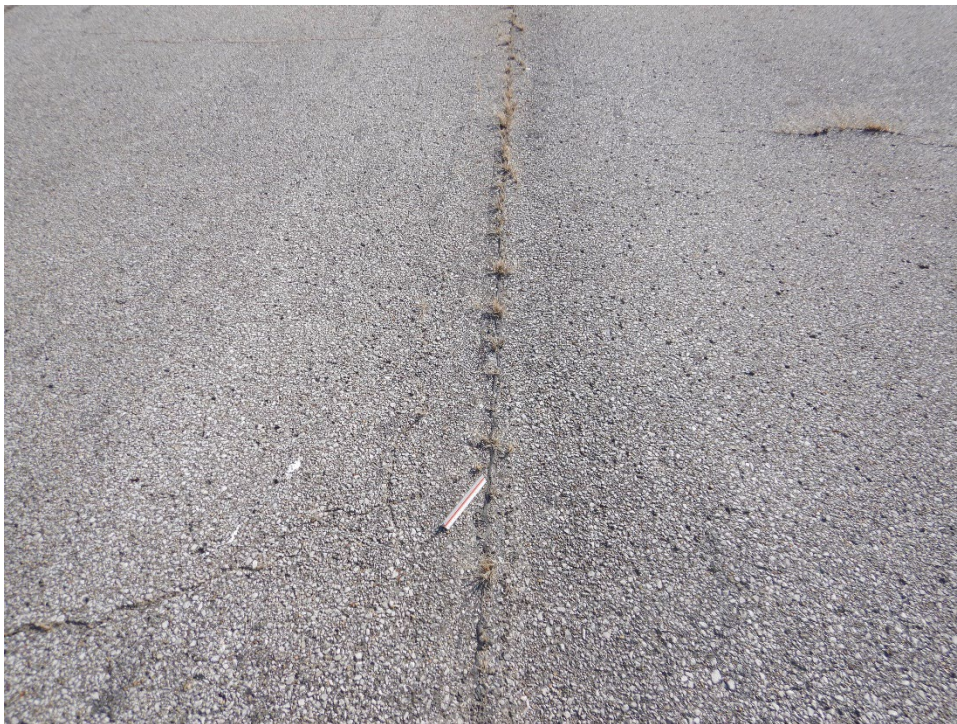
R13AL-03. L&T Cracking (Sample Unit No. 01).

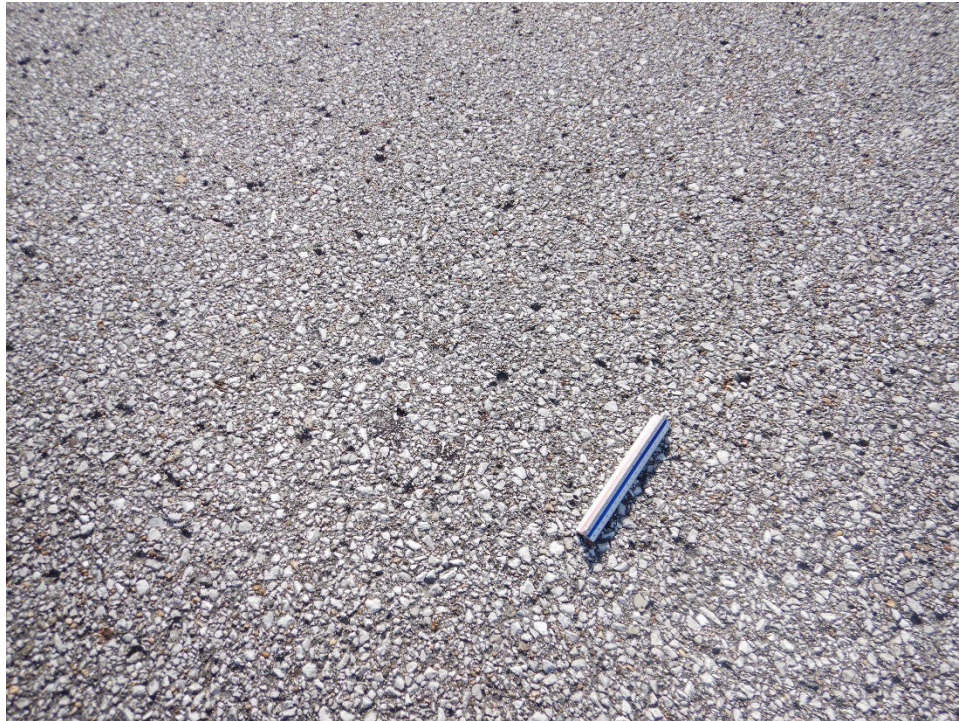
R13AL-03. Raveling (Sample Unit No. 01).

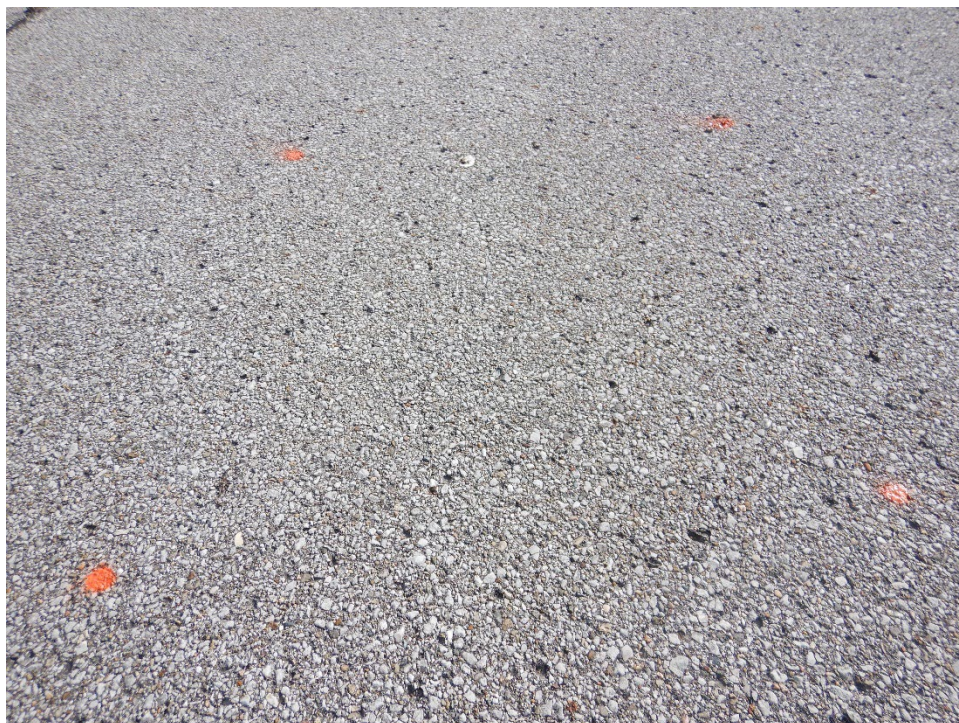
R13AL-03. Raveling (Sample Unit No. 03).

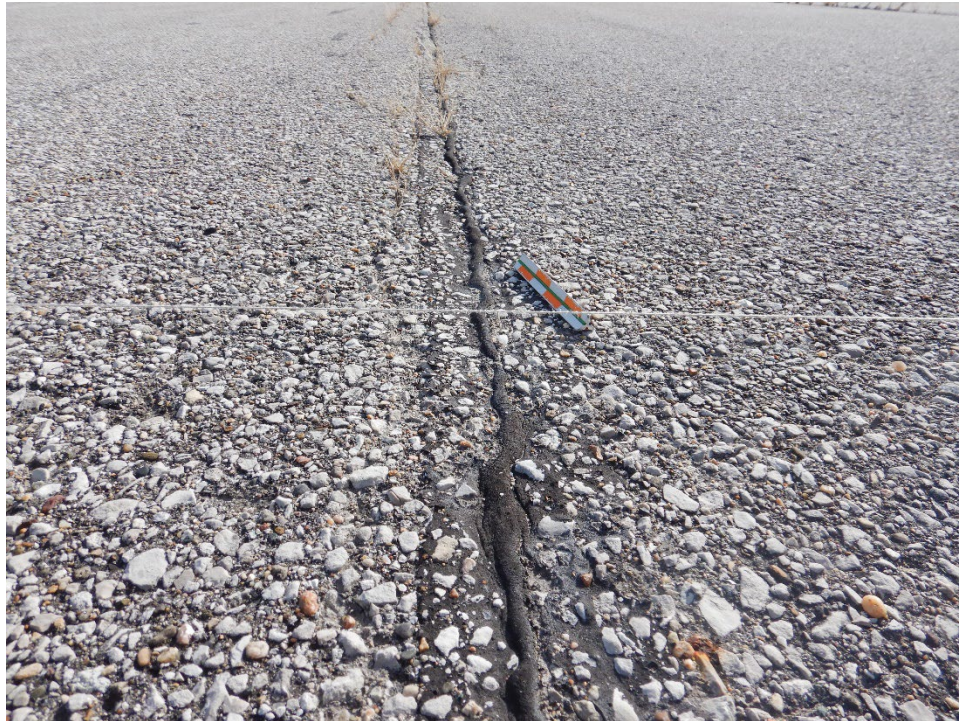
R13AL-03. Rutting (Sample Unit No. 03).

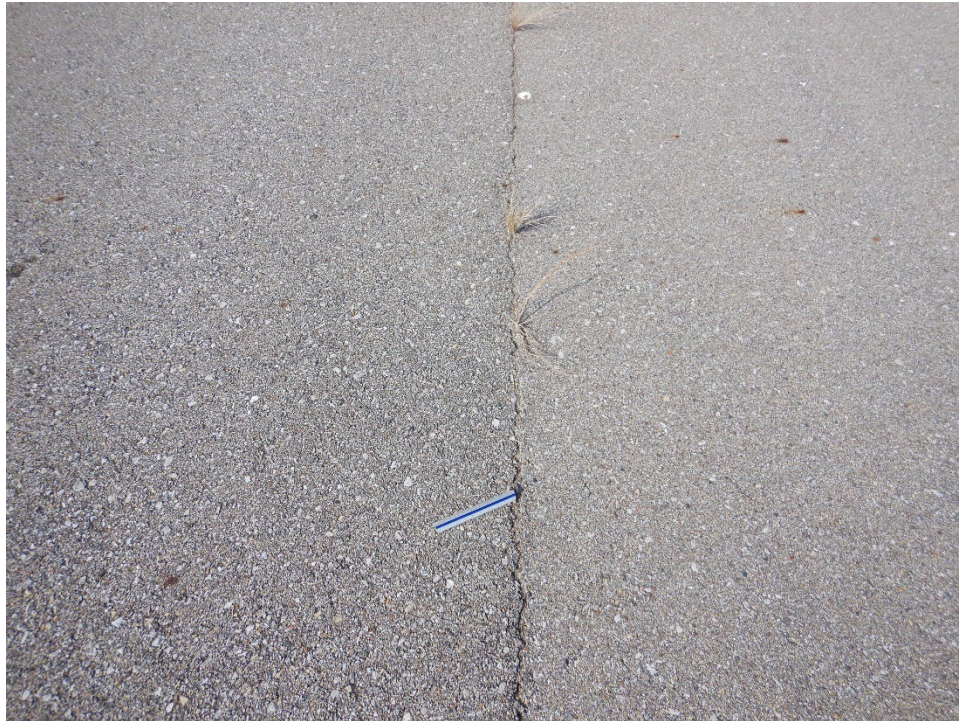
R13AL-04. L&T Cracking (Sample Unit No. 04).

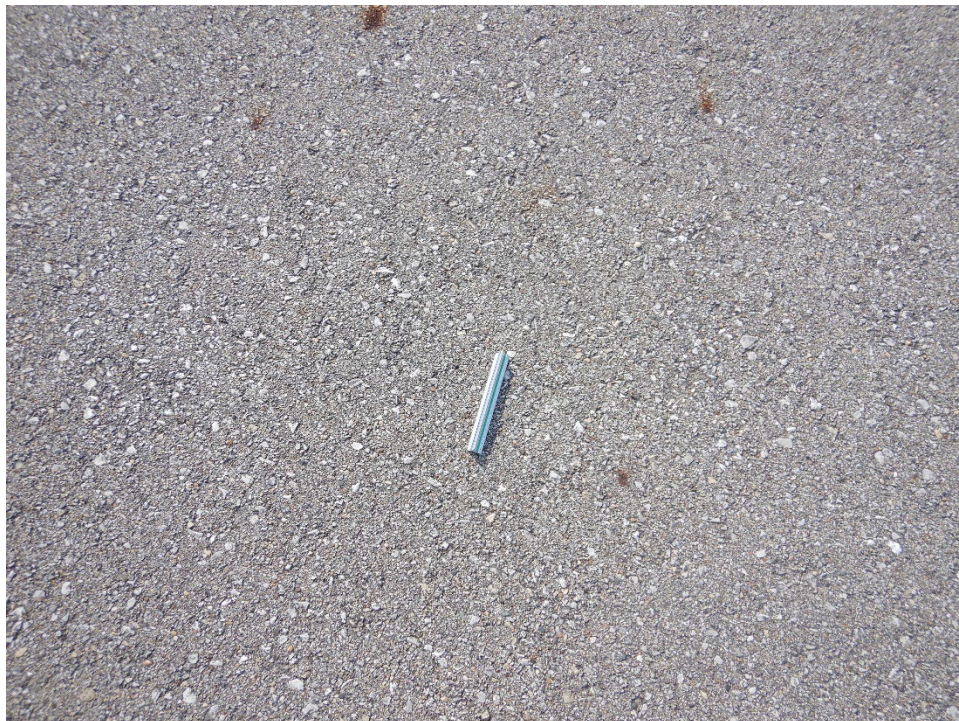
R13AL-04. Weathering (Sample Unit No. 04).

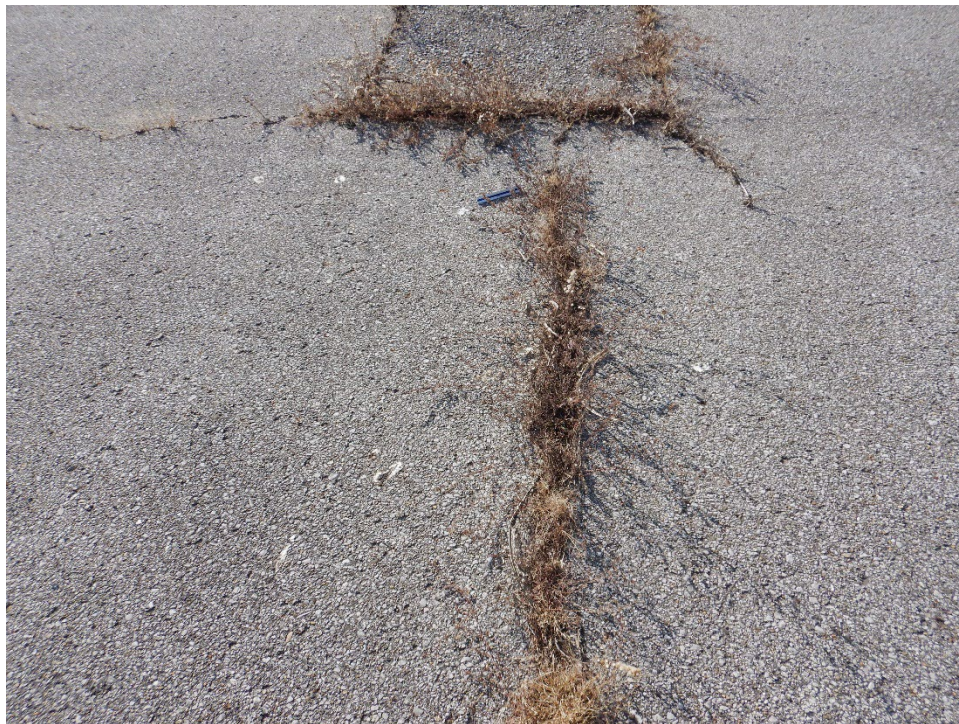
R13AL-05. L&T Cracking (Sample Unit No. 01).

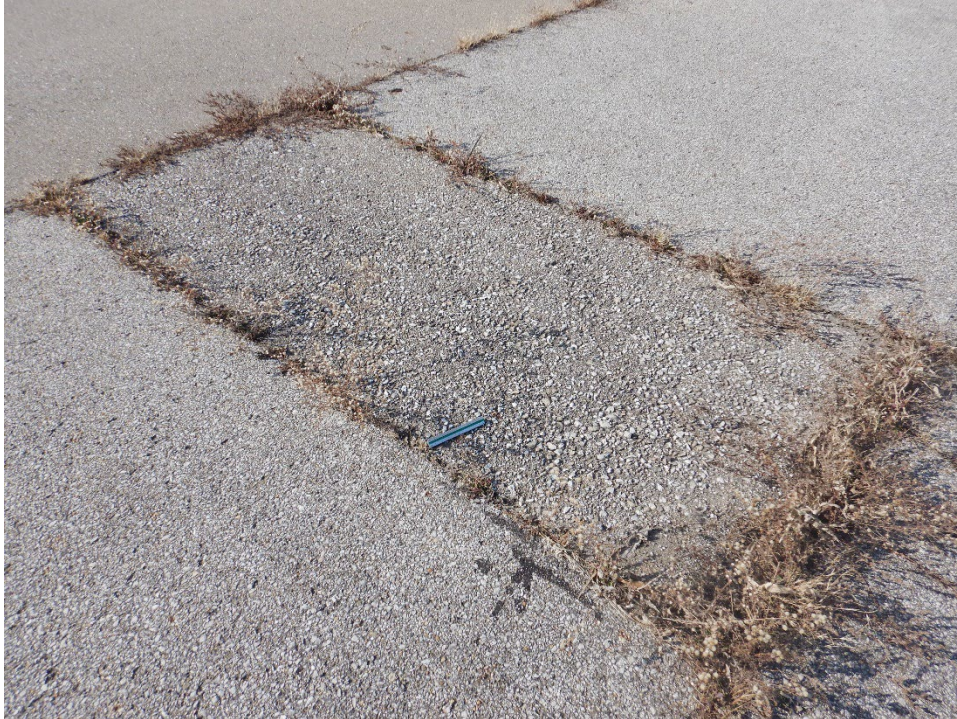
R13AL-05. Patching (Sample Unit No. 01).

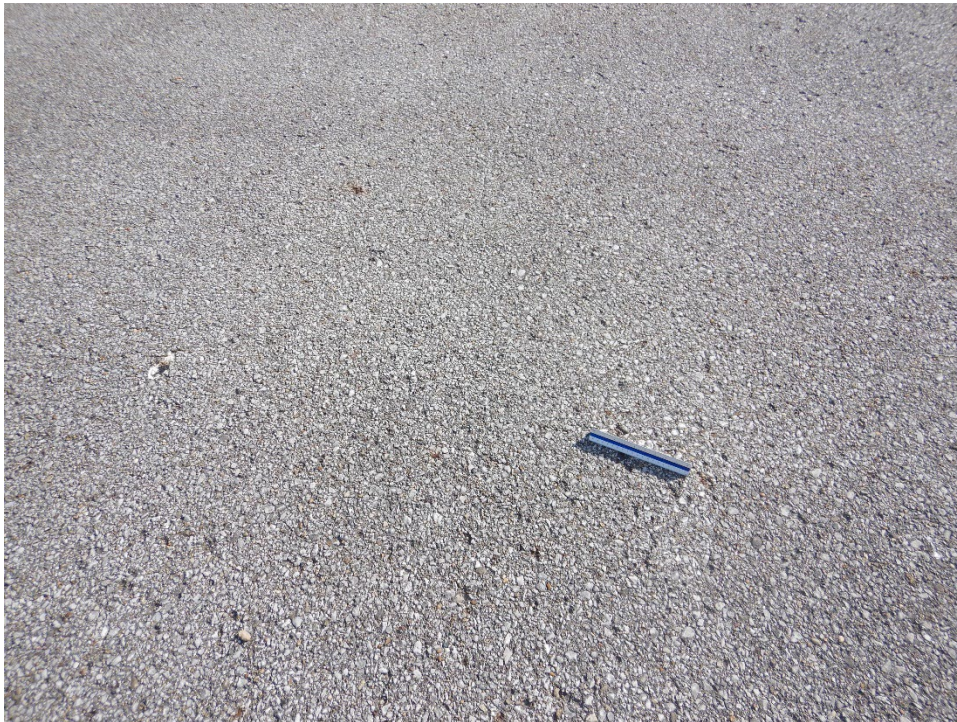
R13AL-05. Raveling (Sample Unit No. 01).

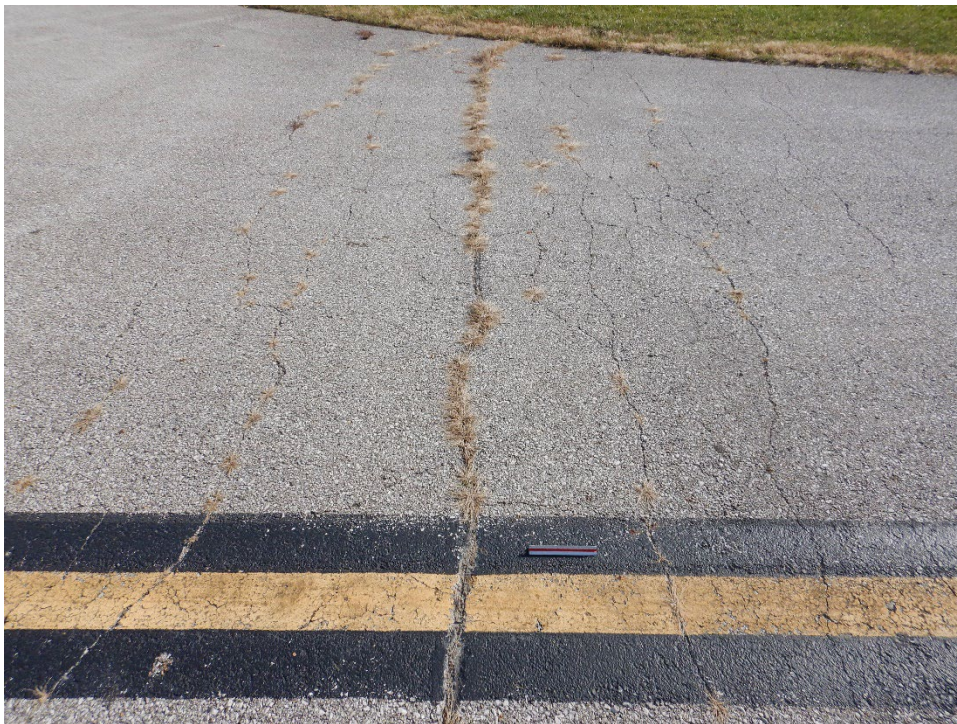
T01AL-01. Alligator Cracking (Sample Unit No. 01).

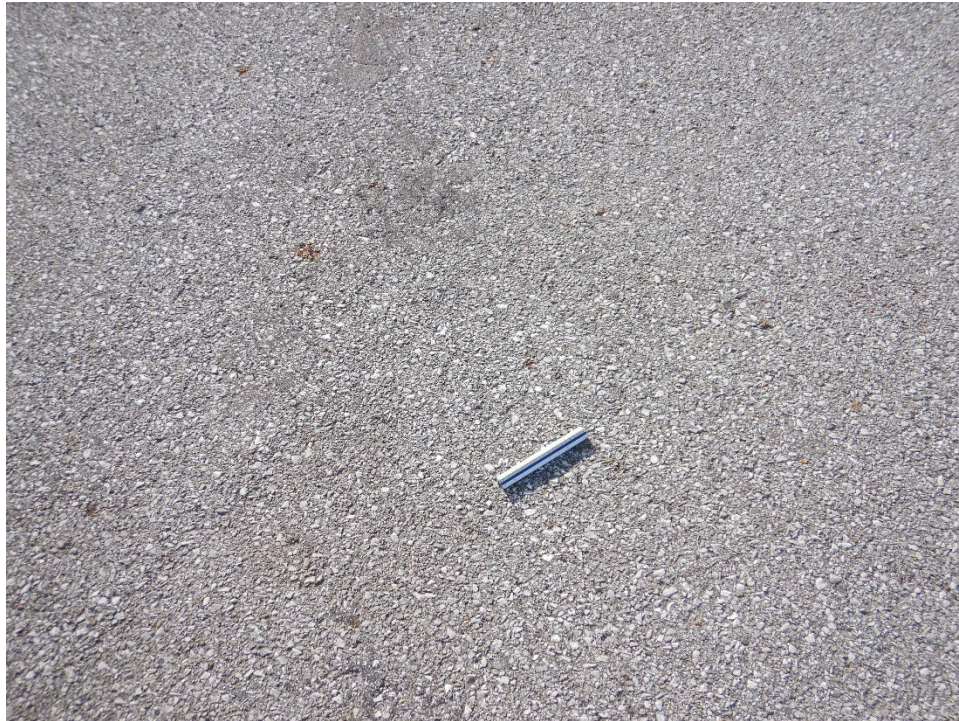
T01AL-01. Weathering (Sample Unit No. 01).

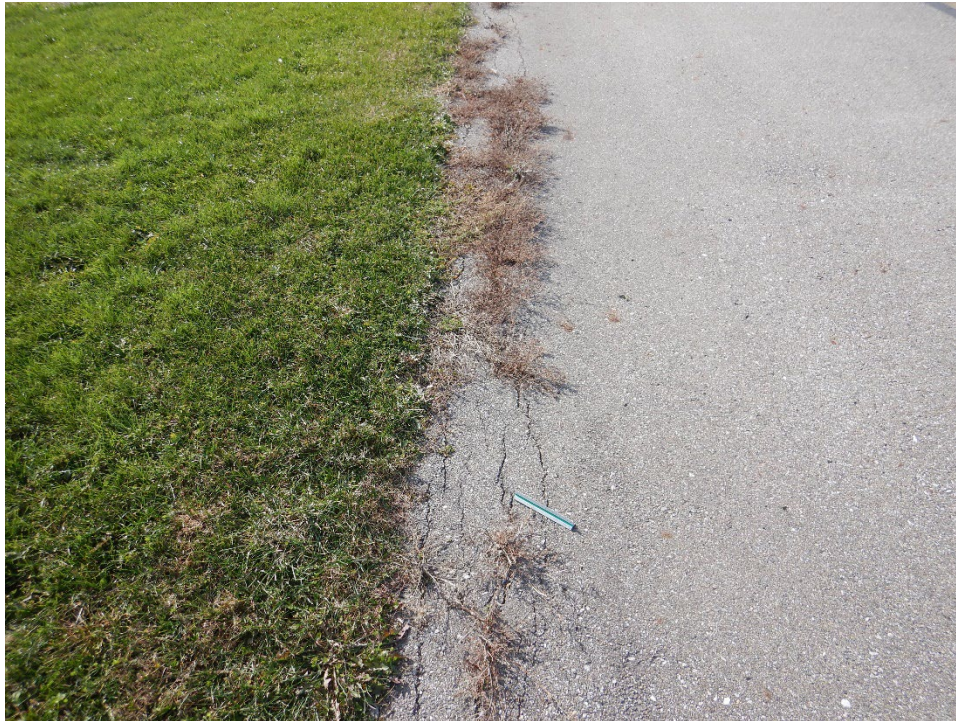
T02AL-01. Alligator Cracking (Sample Unit No. 01).

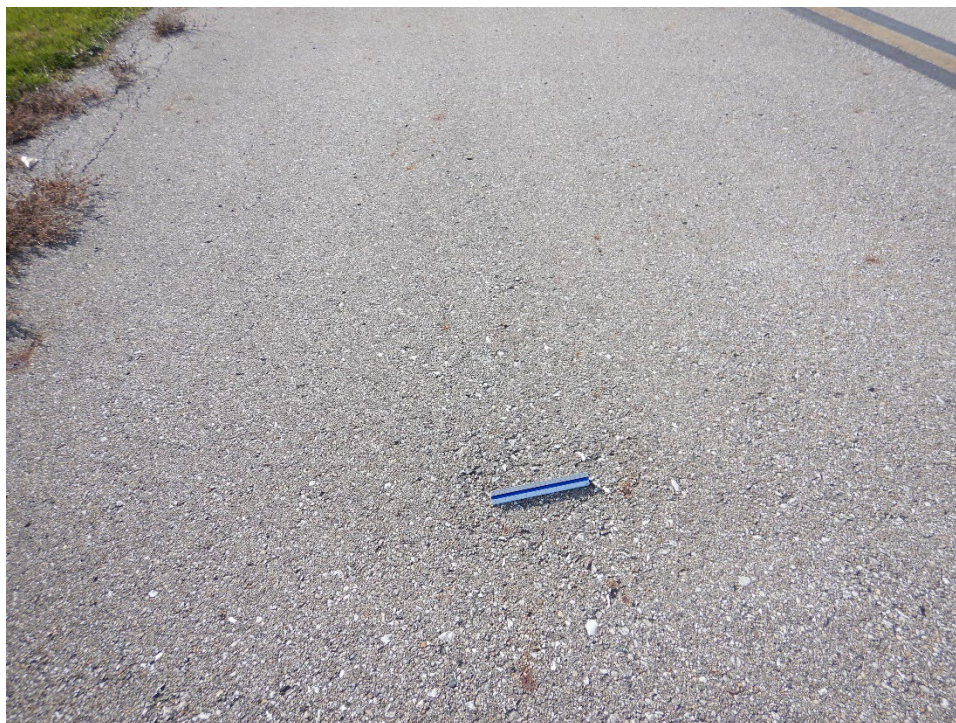
T02AL-01. Weathering (Sample Unit No. 01).

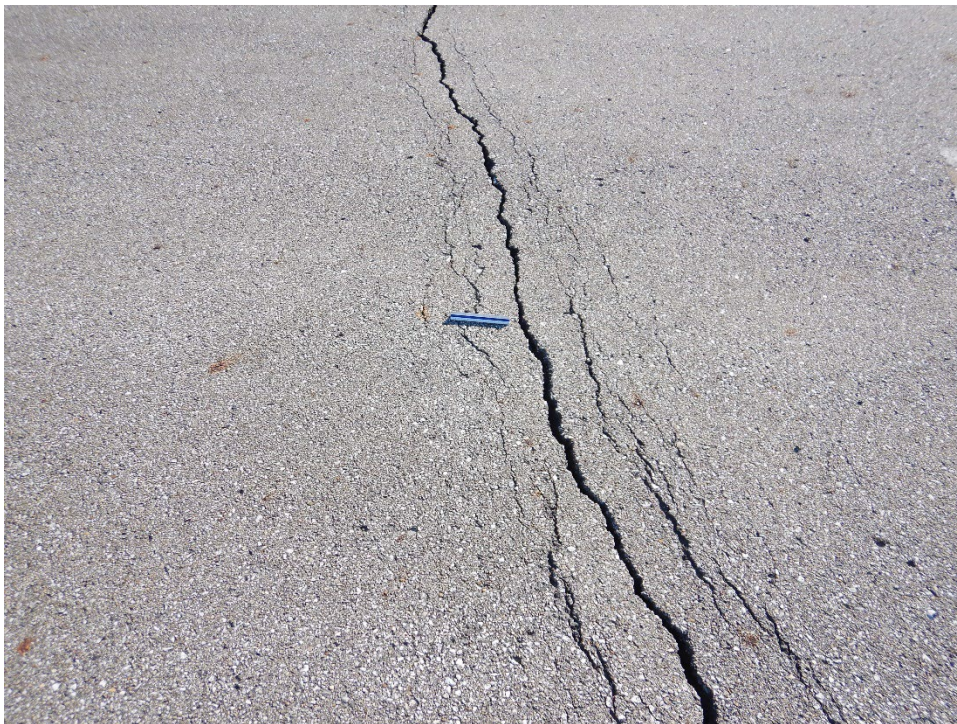
T03AL-01. L&T Cracking (Sample Unit No. 01).

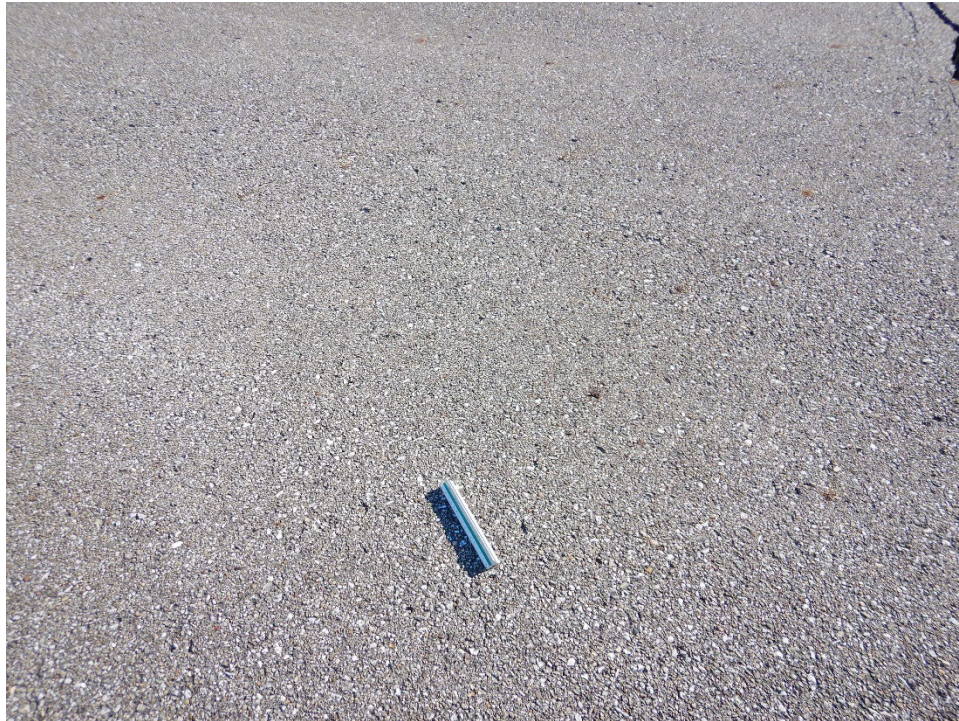
T03AL-01. Raveling (Sample Unit No. 01).

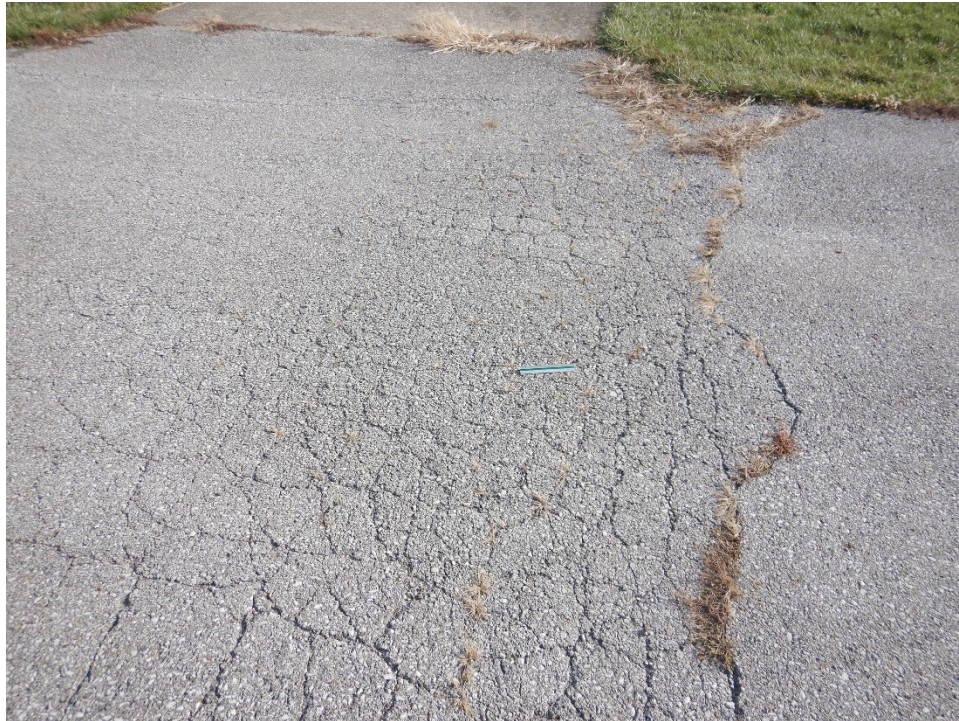
TH01AL-01. Alligator Cracking (Sample Unit No. 01).

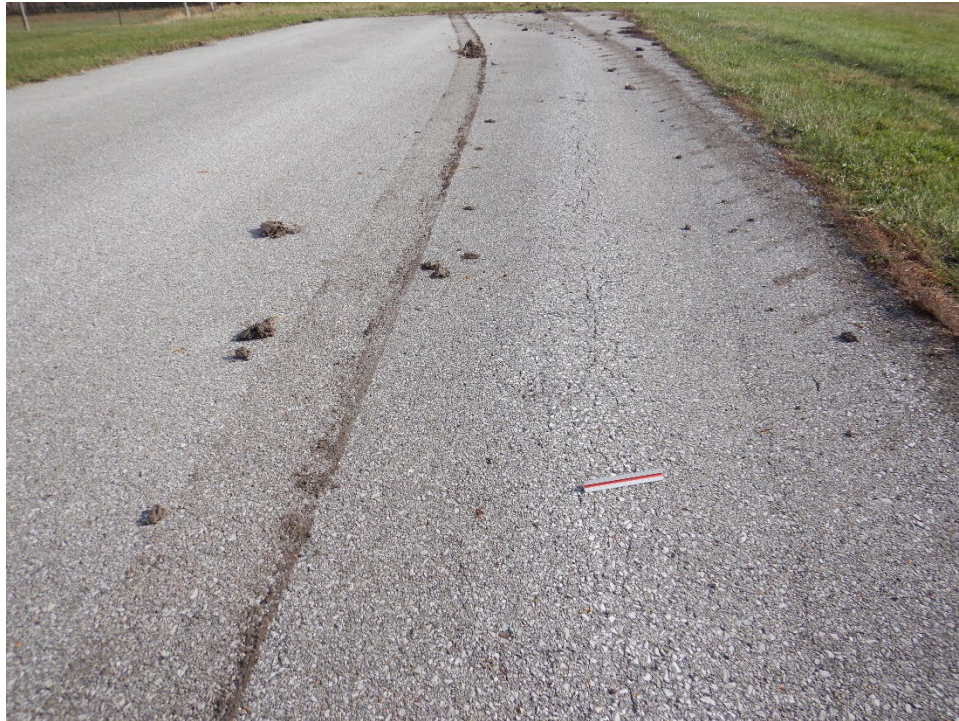
TH01AL-02. Swelling (Sample Unit No. 01).
