Ankeny Regional Airport

PAVEMENT MANAGEMENT REPORT

JULY 2022

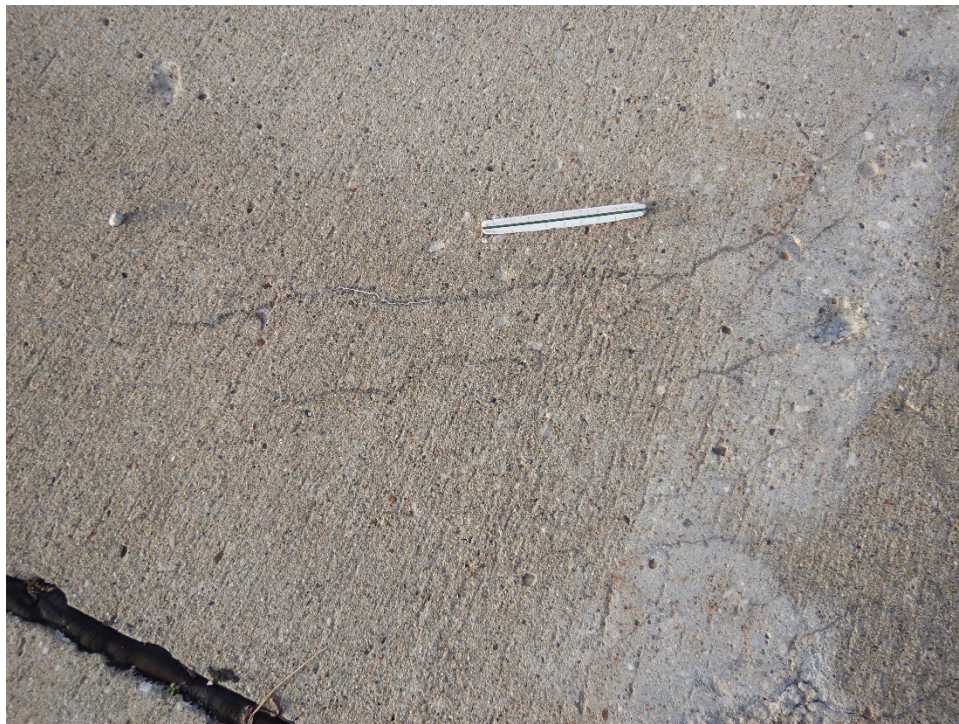
A01AN-01. ASR (Sample Unit No. 11).

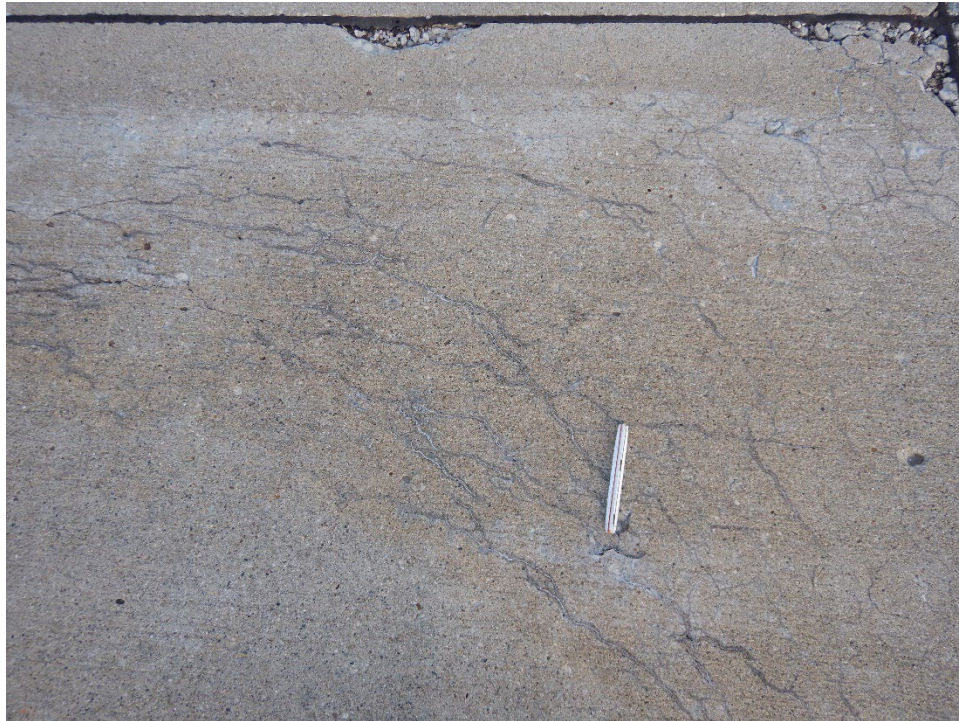
A01AN-01. ASR (Sample Unit No. 15).

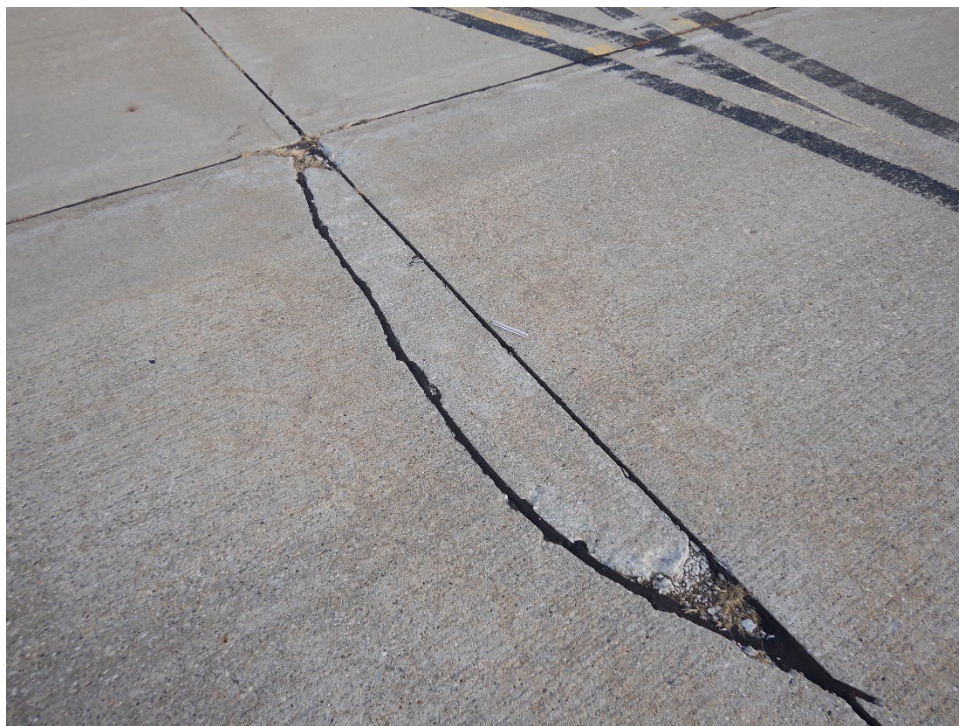
A01AN-01. Joint Spalling (Sample Unit No. 30).

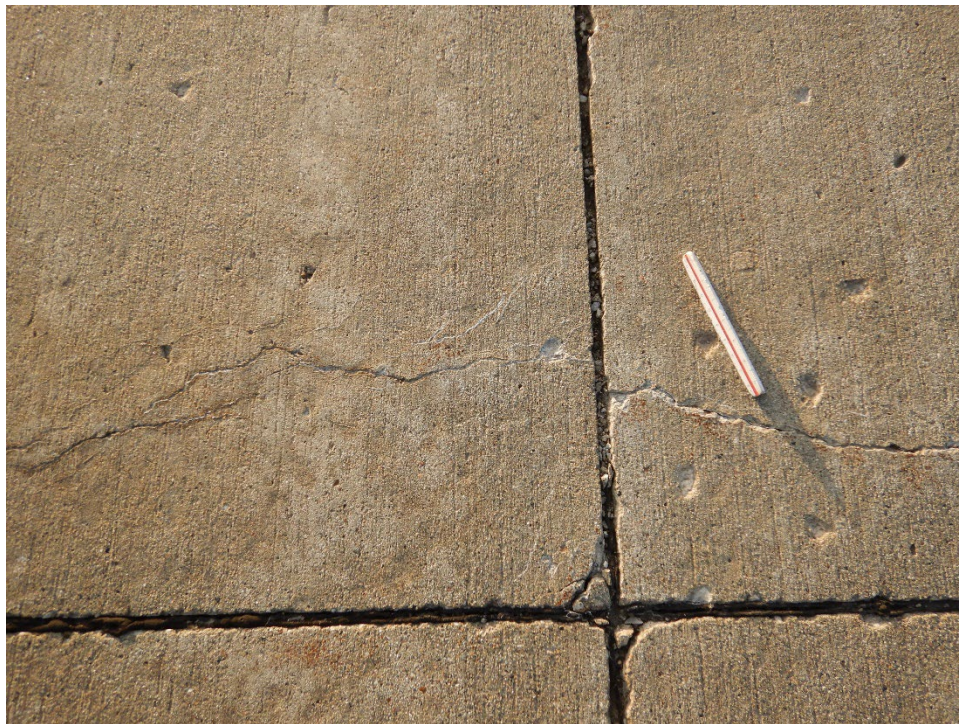
A01AN-02. ASR (Sample Unit No. 07).

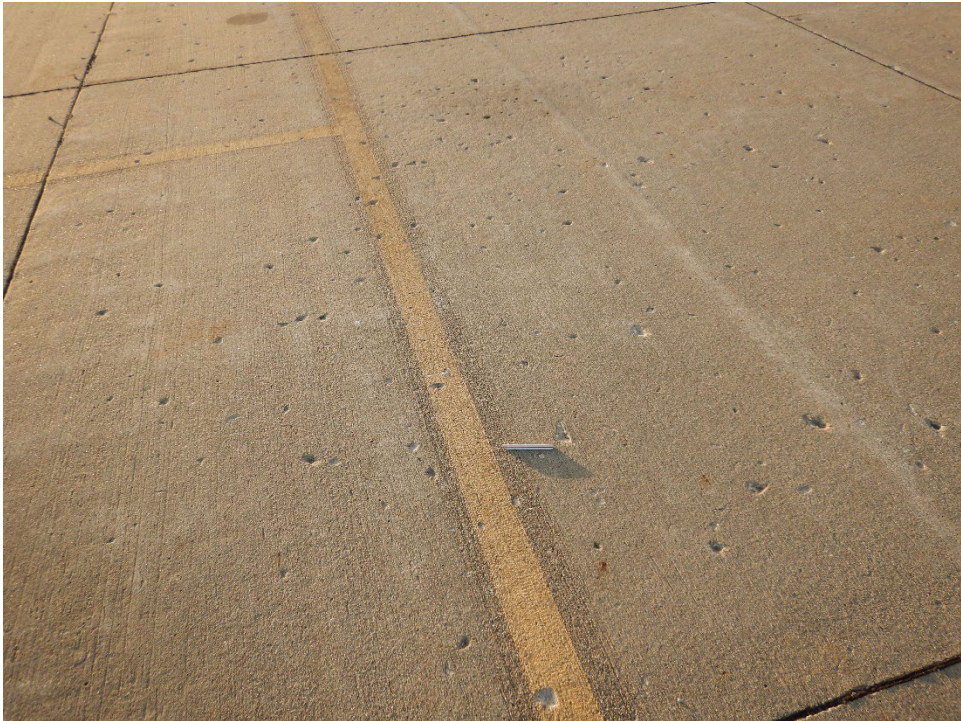
A01AN-02. Popouts (Sample Unit No. 12).

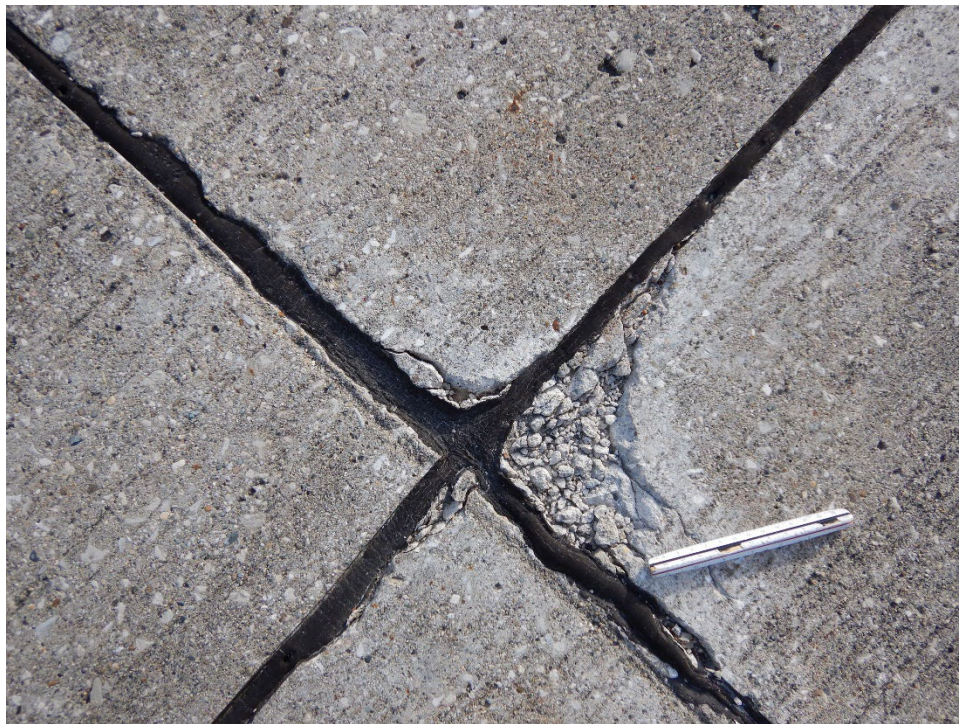
R04AN-01. Corner Spalling (Sample Unit No. 01).

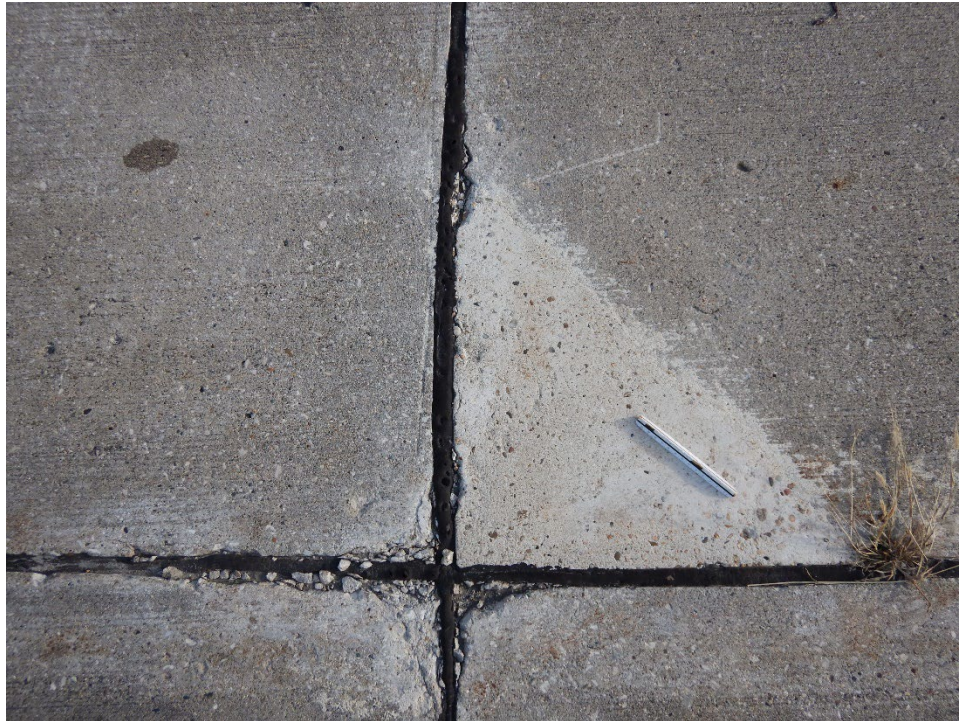
R04AN-01. Small Patching (Sample Unit No. 01).

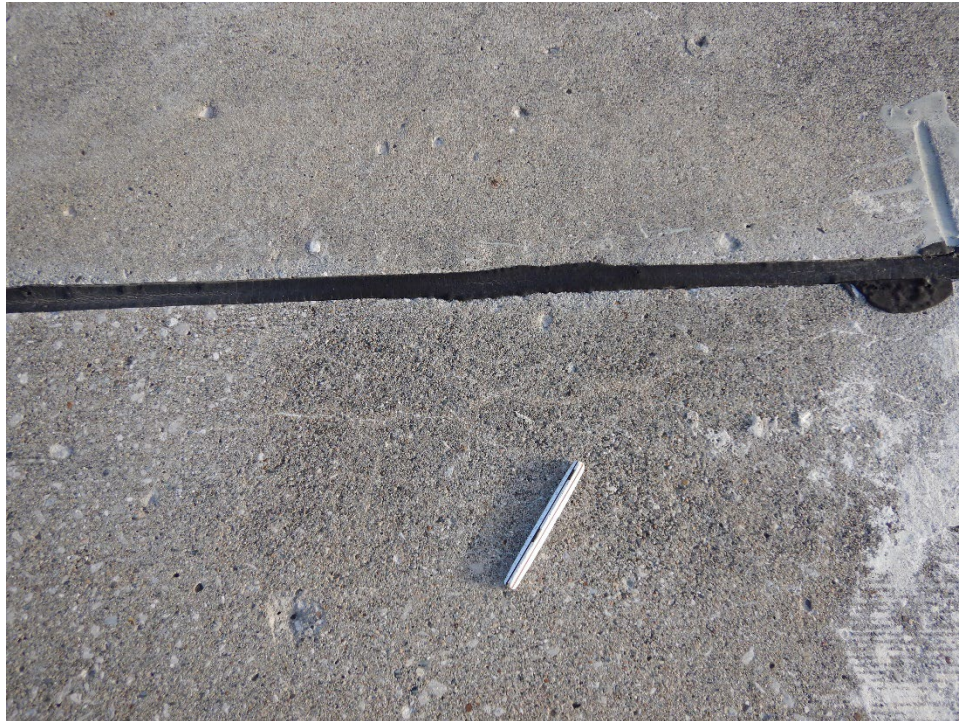
R04AN-02. ASR (Sample Unit No. 02).

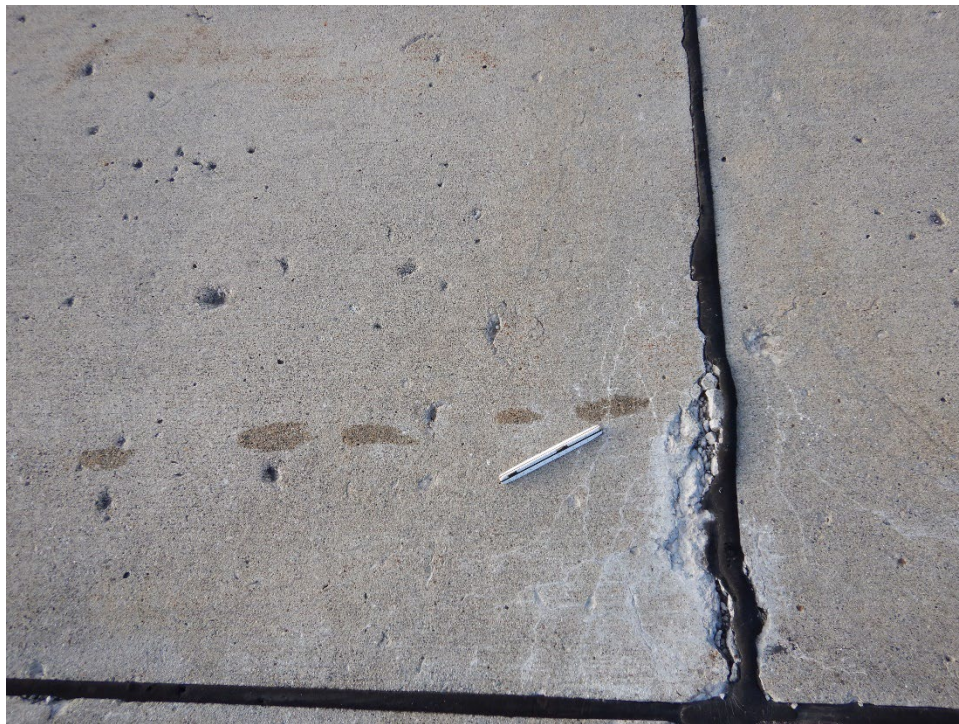
R04AN-02. ASR (Sample Unit No. 04).

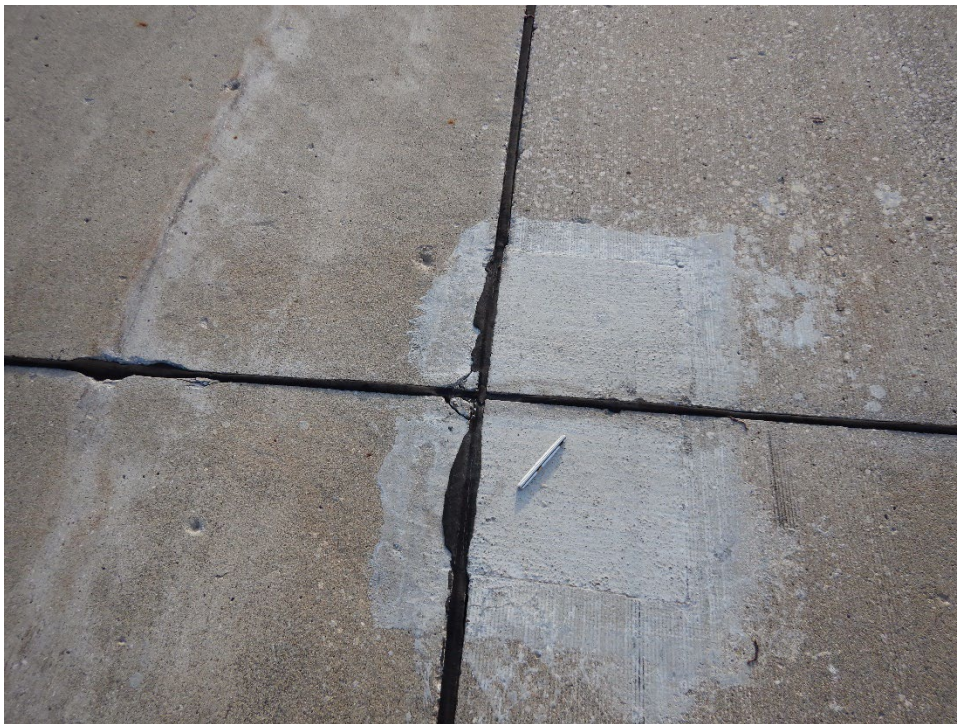
R04AN-02. Small Patching (Sample Unit No. 02).

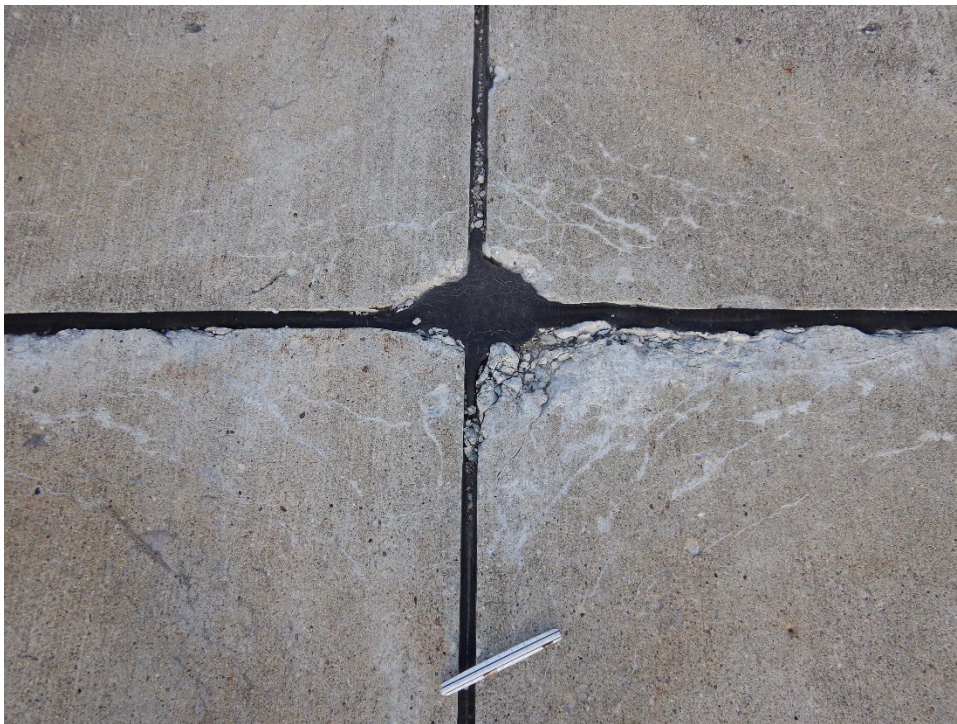
R04AN-03. ASR (Sample Unit No. 06).

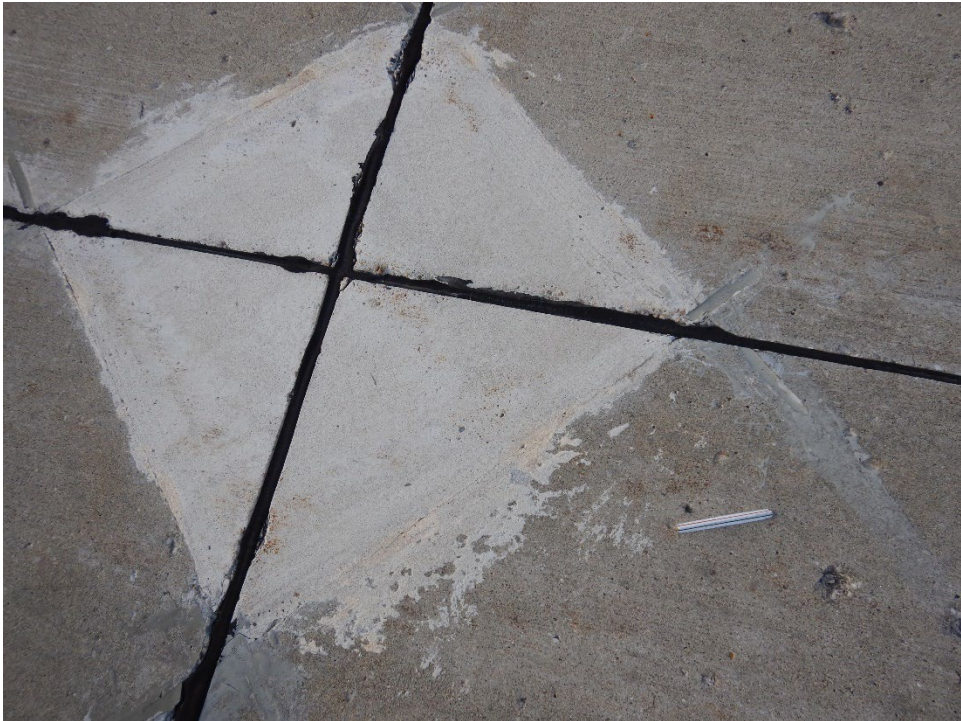
R04AN-03. Small Patching (Sample Unit No. 06).

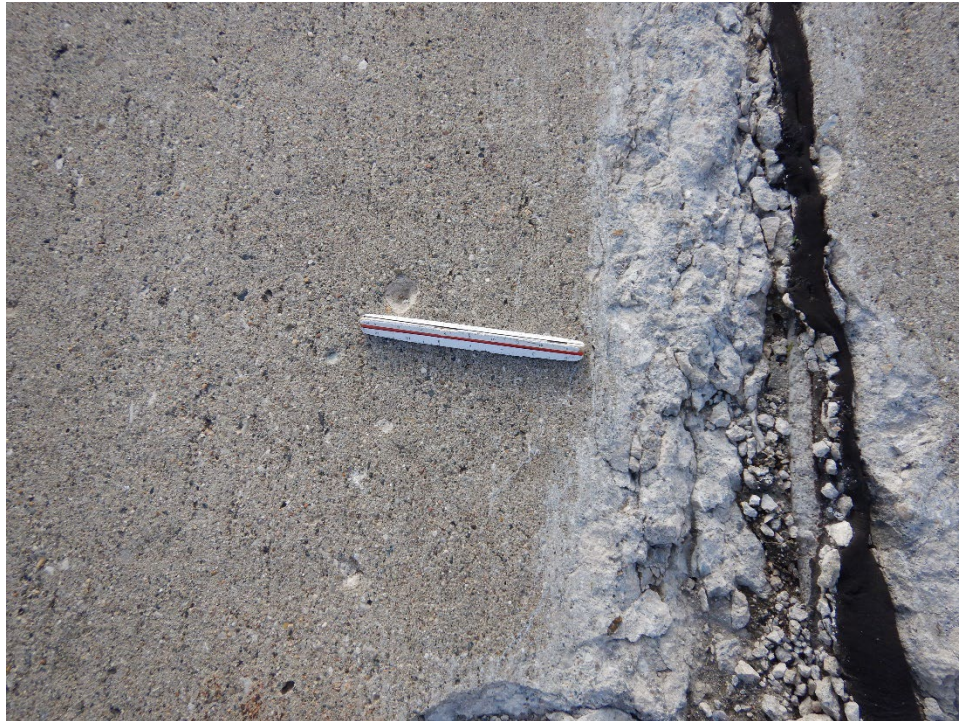
R04AN-04. ASR (Sample Unit No. 43).

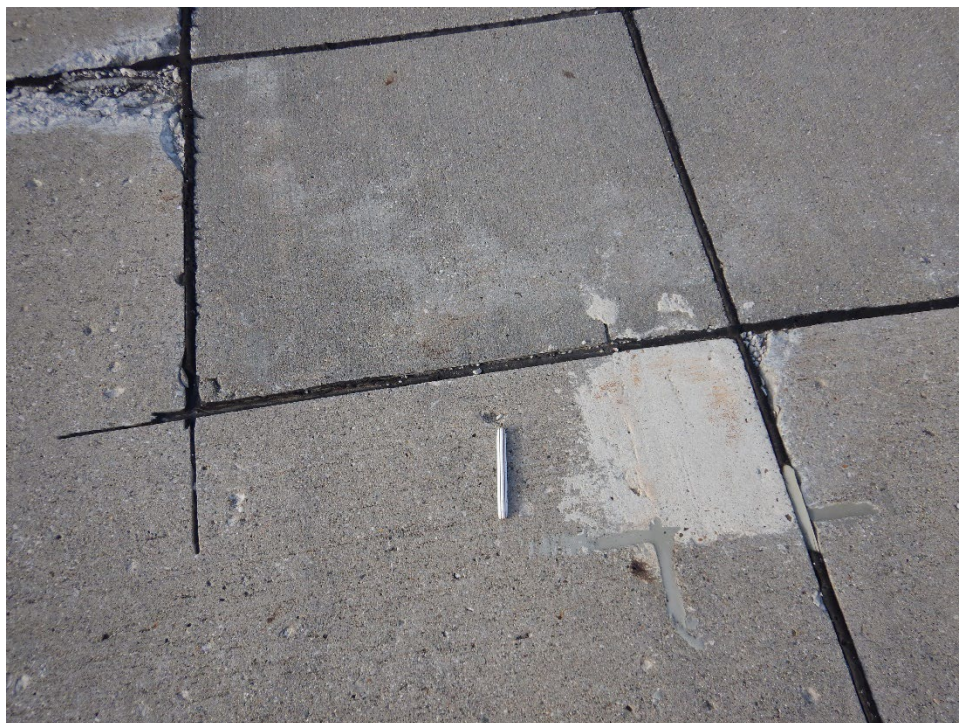
R04AN-04. Small Patching (Sample Unit No. 43).

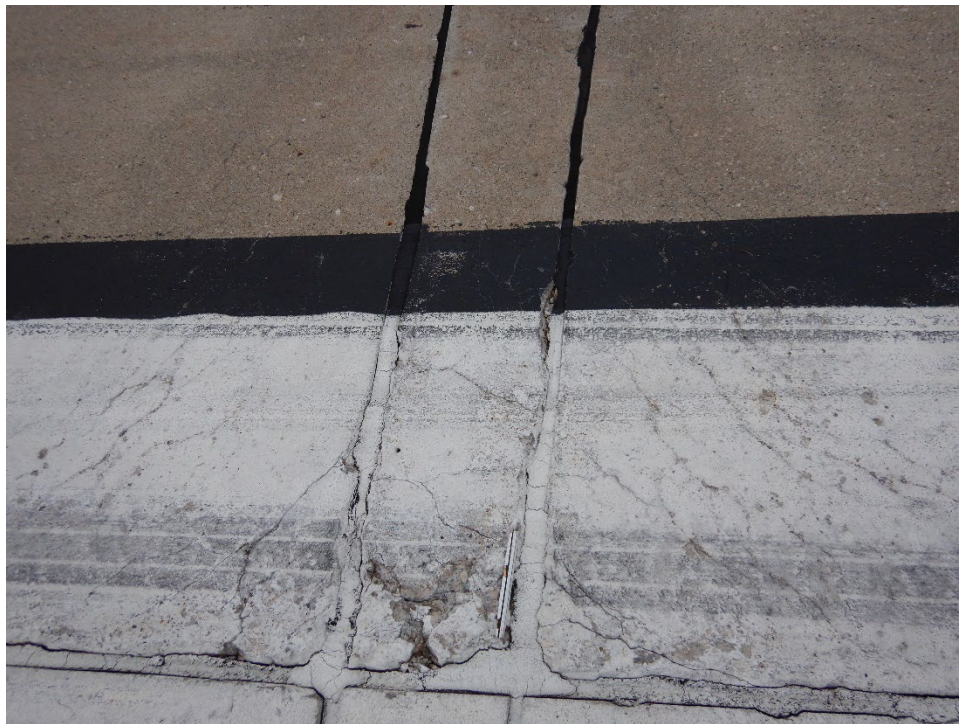
R18AN-01. ASR (Sample Unit No. 09).

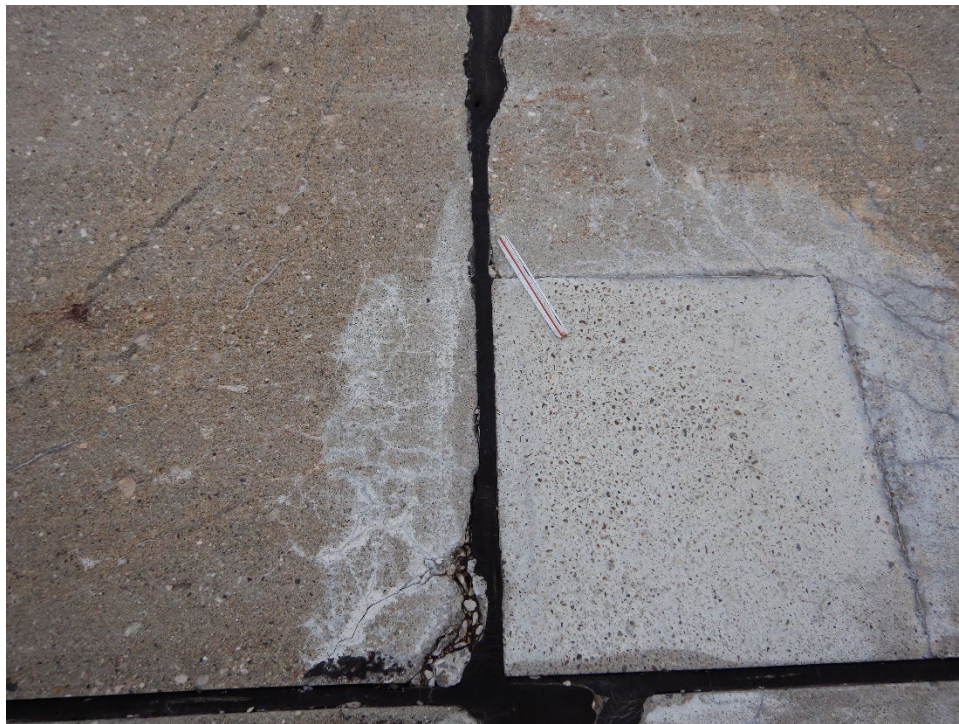
R18AN-01. ASR (Sample Unit No. 36).

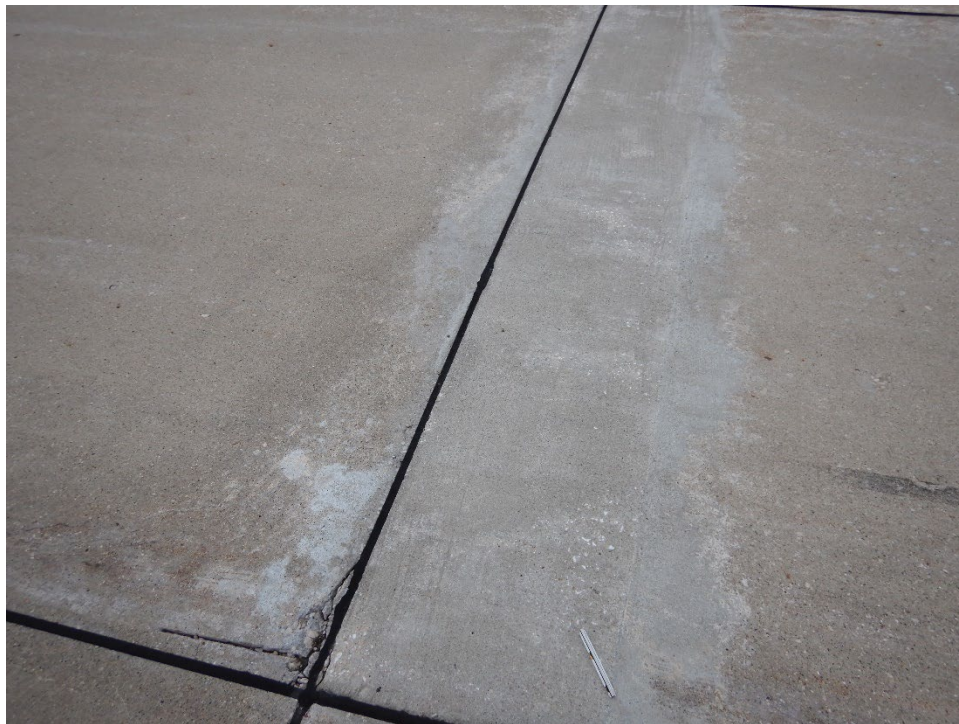
R18AN-01. Large Patching (Sample Unit No. 09).

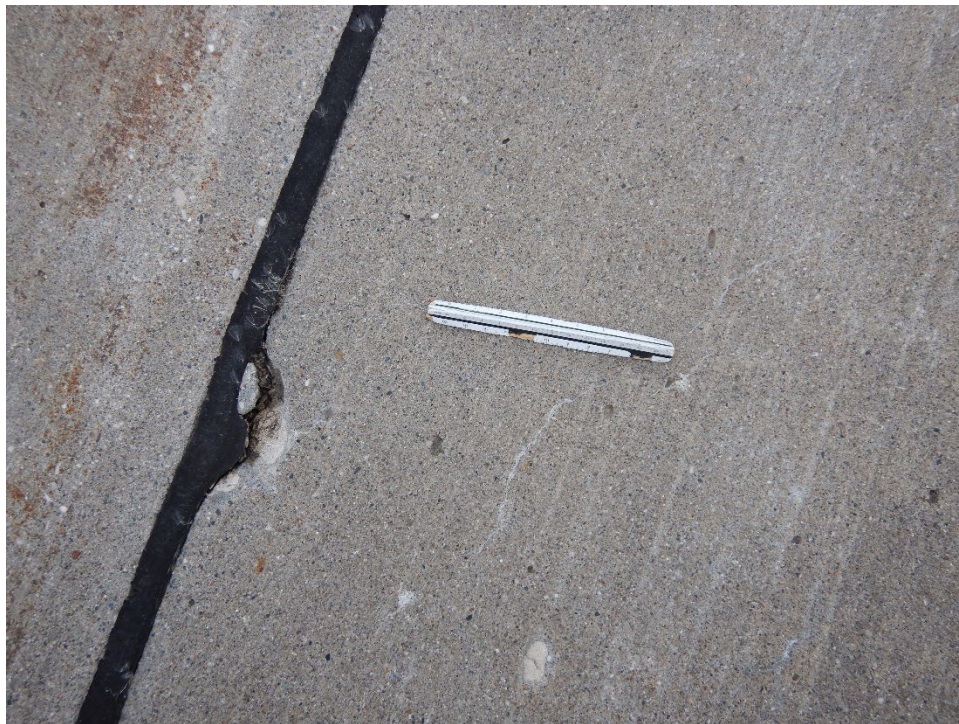
R18AN-02. ASR (Sample Unit No. 06).

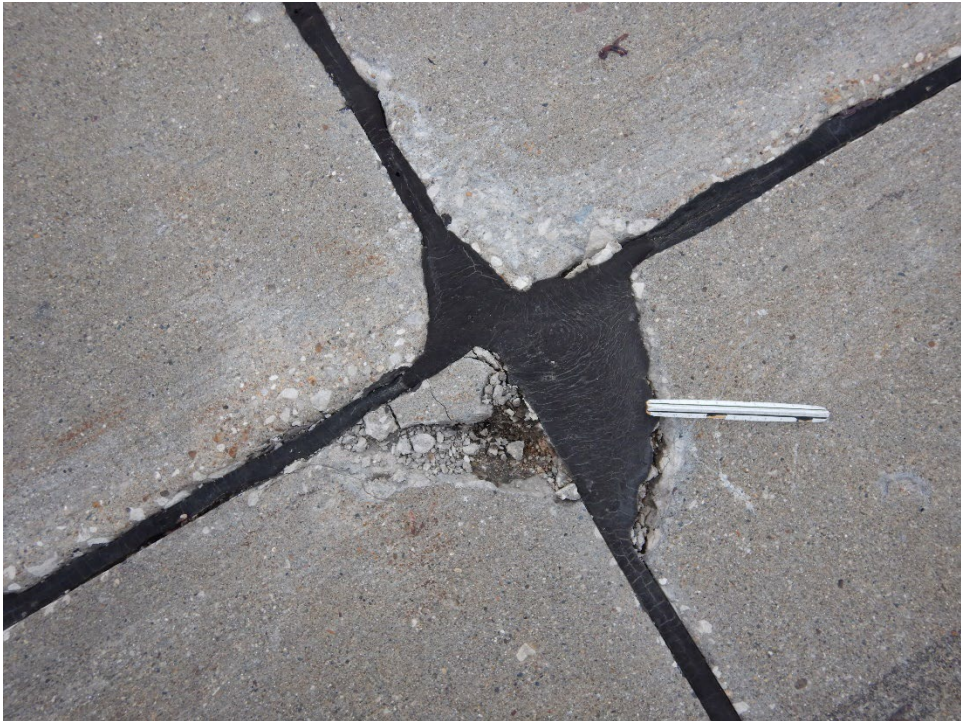
R18AN-02. Corner Spalling (Sample Unit No. 06).

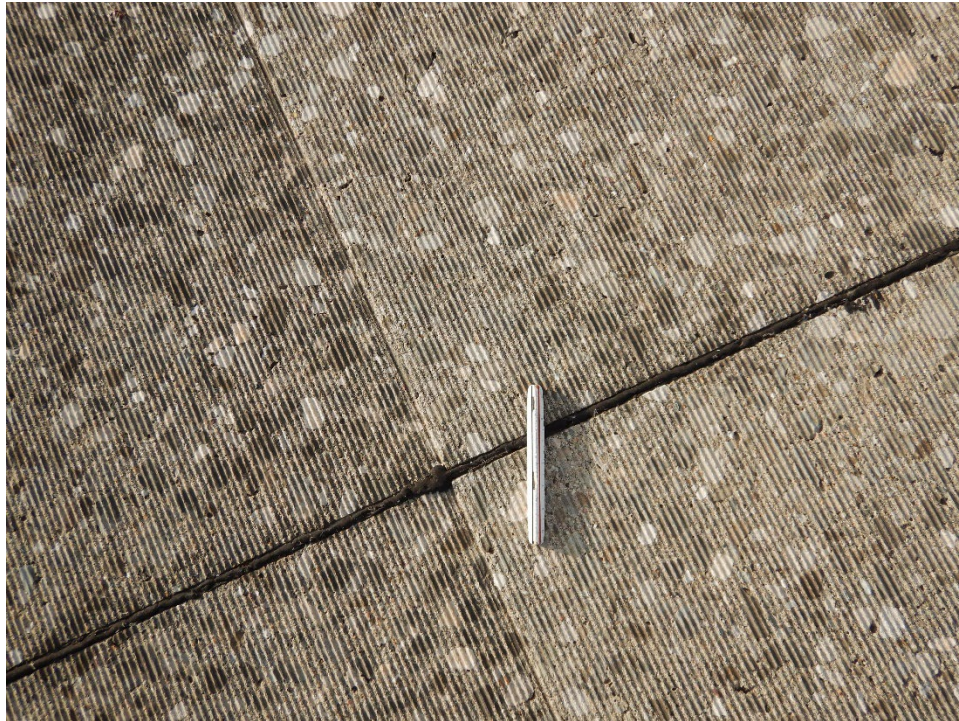
T01AN-02. Joint Seal Damage (Sample Unit No. 12).

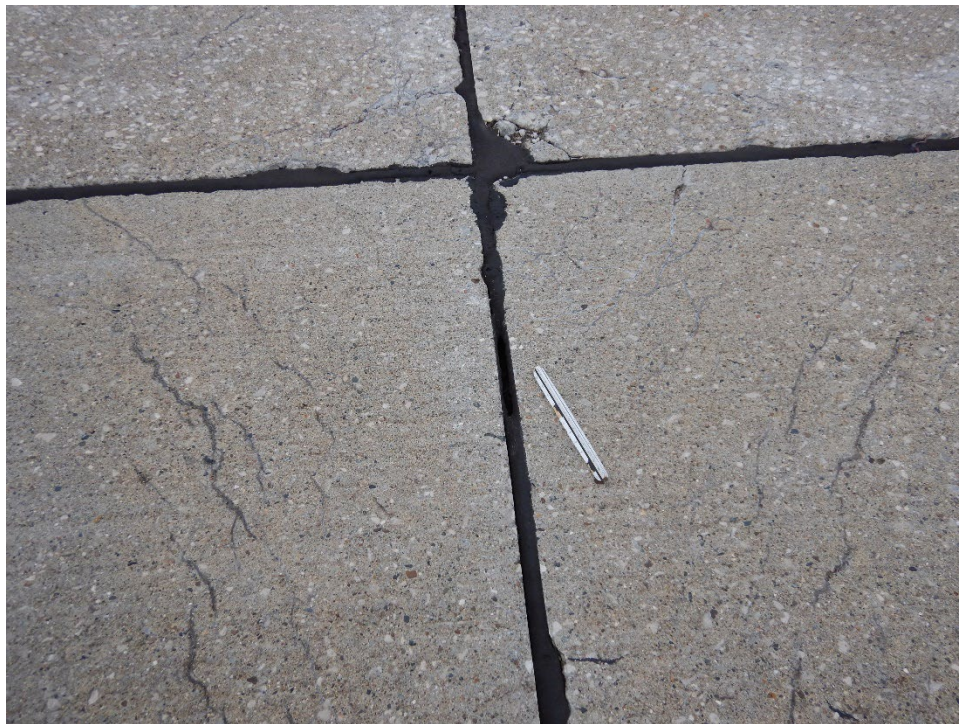
T02AN-01. ASR (Sample Unit No. 03) (2).

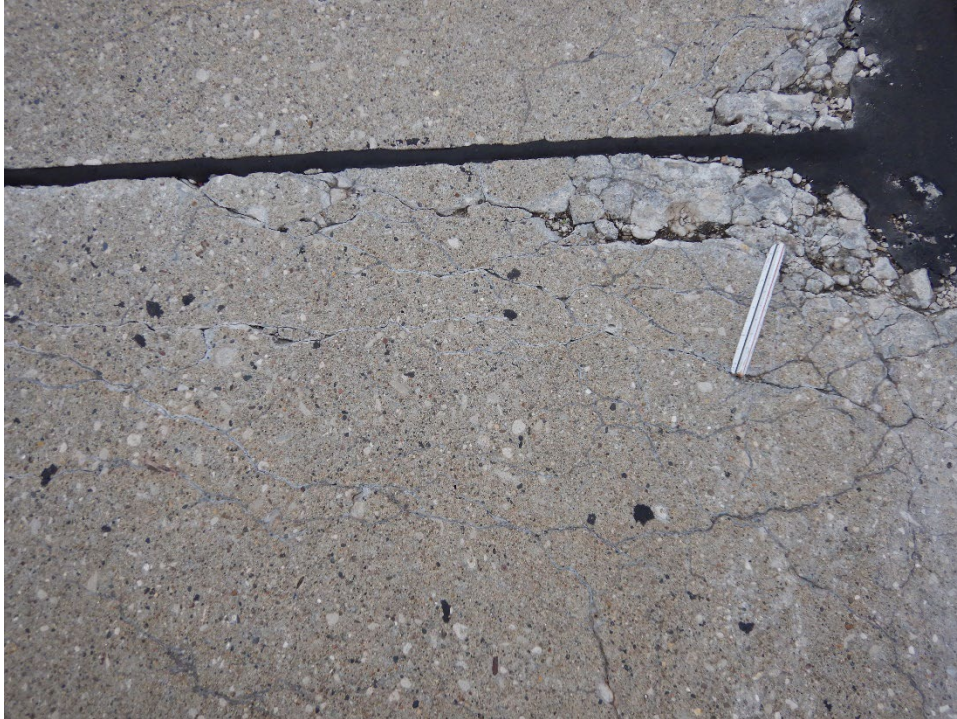
T02AN-01. ASR (Sample Unit No. 03) (3).

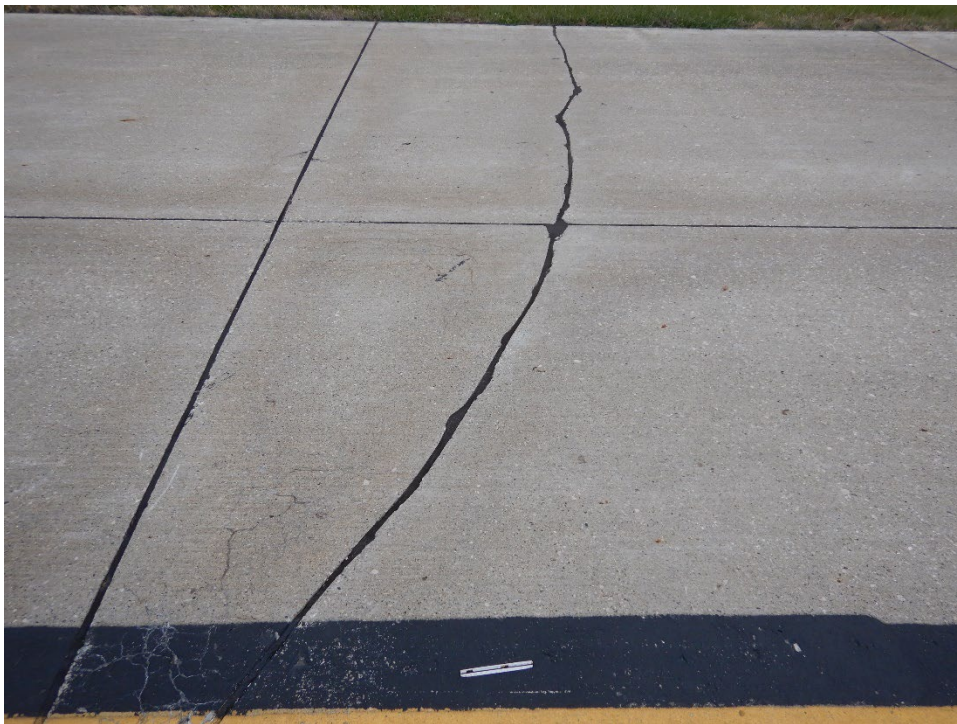
T02AN-01. LTD Cracking (Sample Unit No. 03).

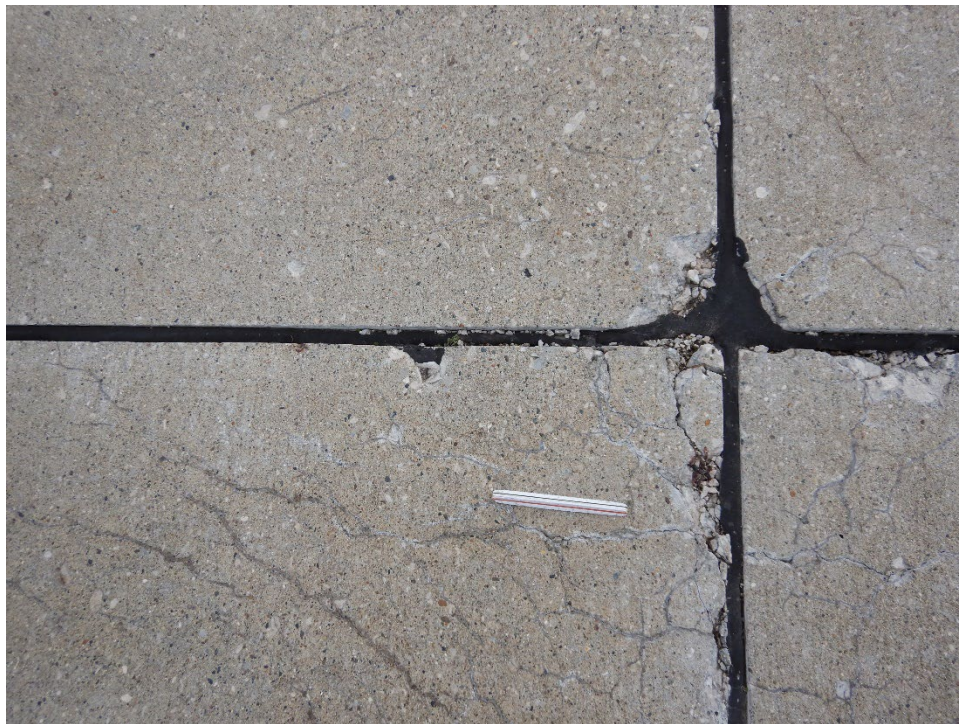
T03AN-01. ASR (Sample Unit No. 02).

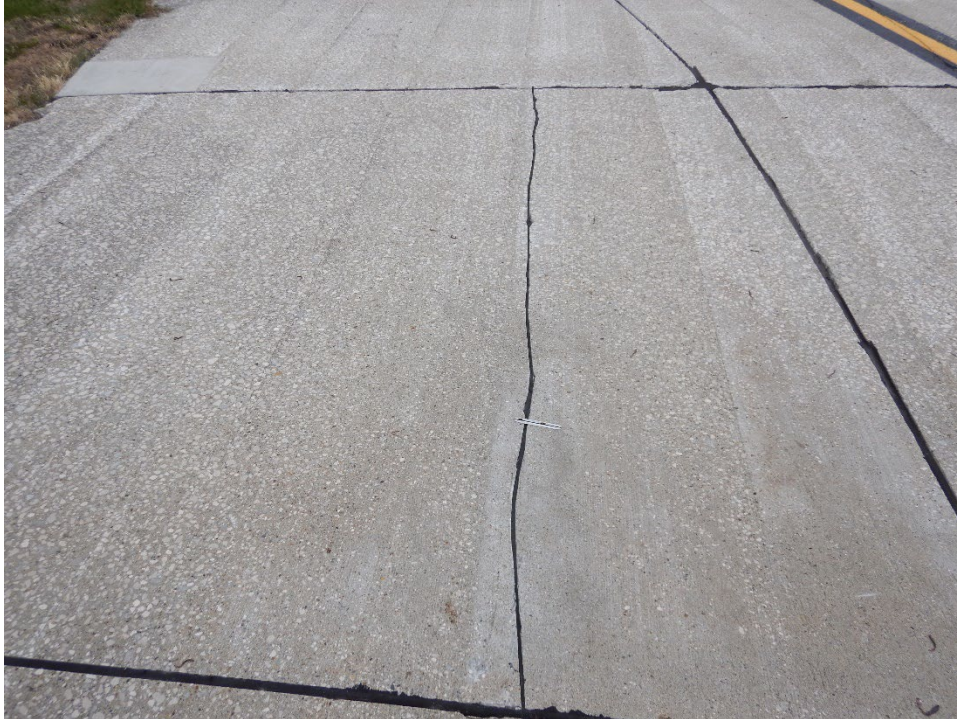
T03AN-01. LTD Cracking (Sample Unit No. 02).

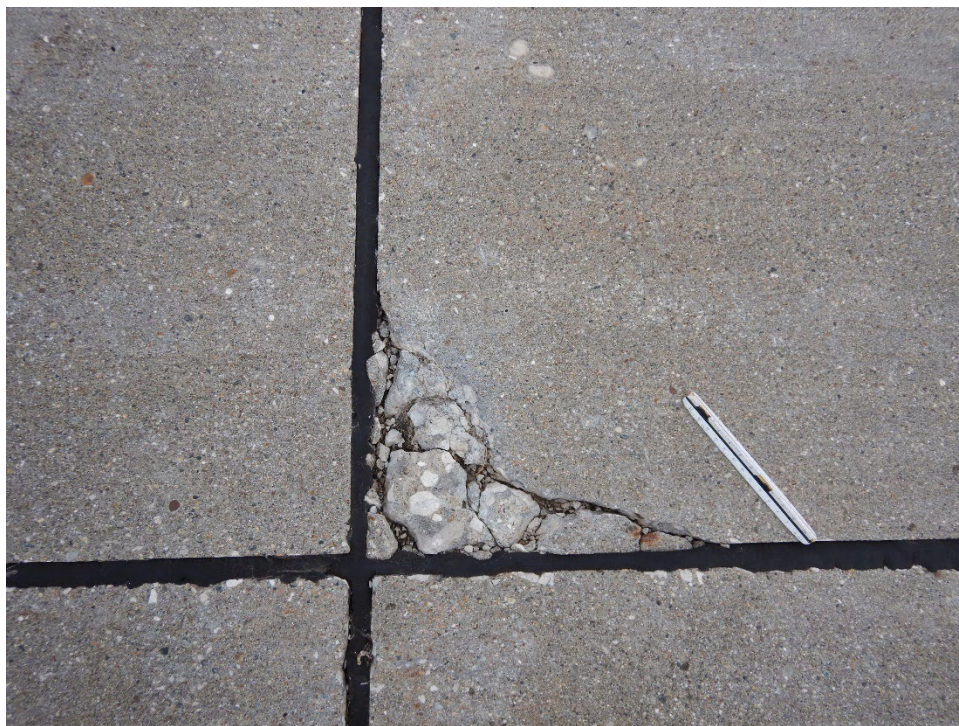
T04AN-01. Corner Spalling (Sample Unit No. 08).

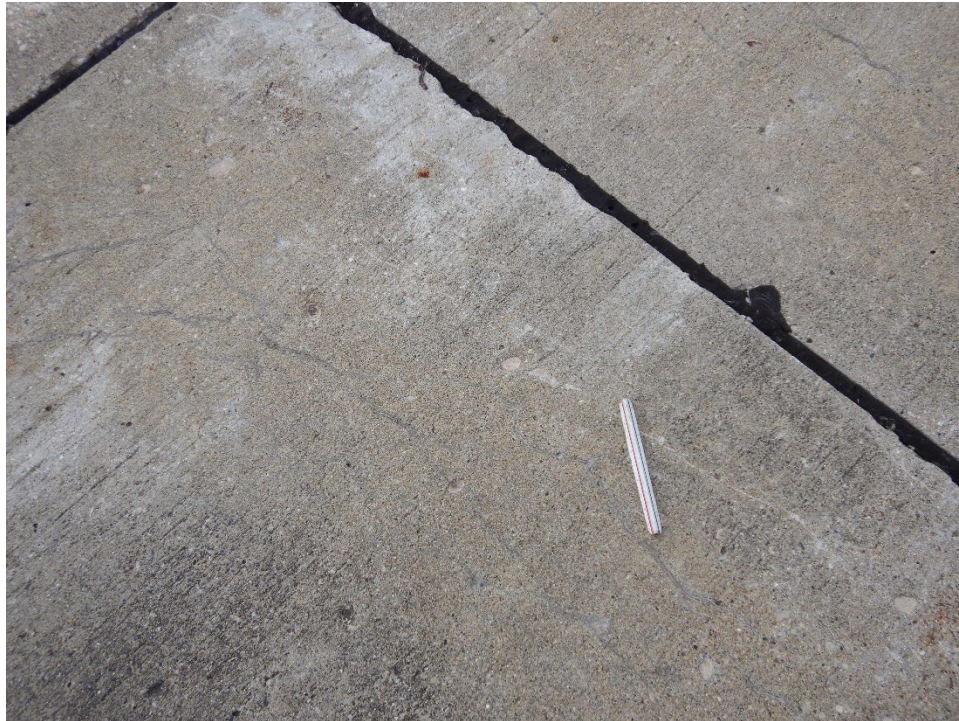
T05AN-01. ASR (Sample Unit No. 05).

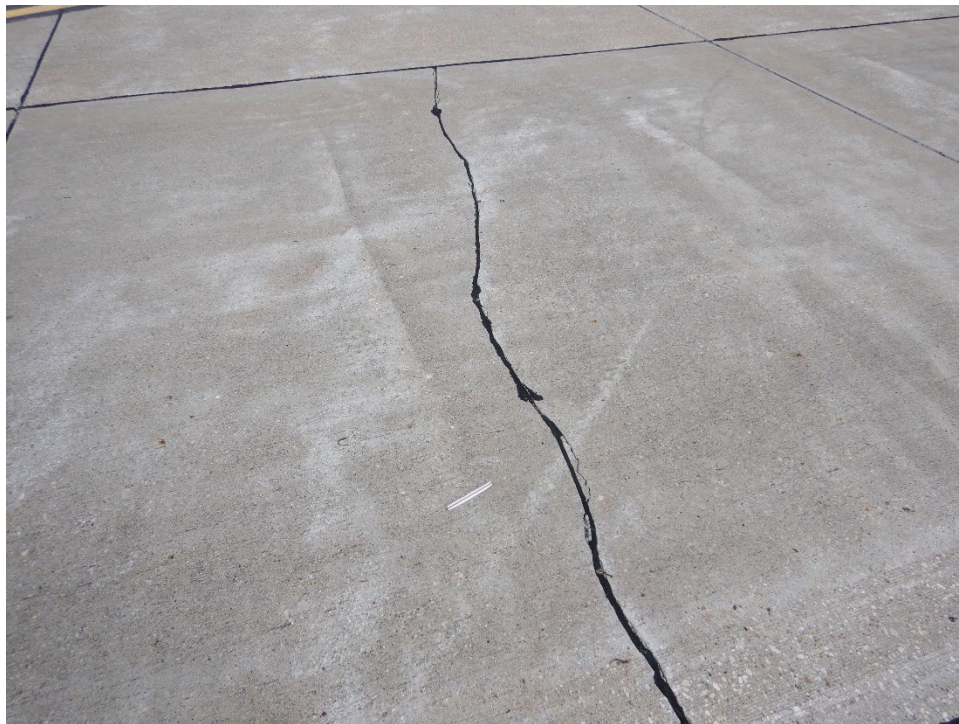
T05AN-01. LTD Cracking (Sample Unit No. 05).

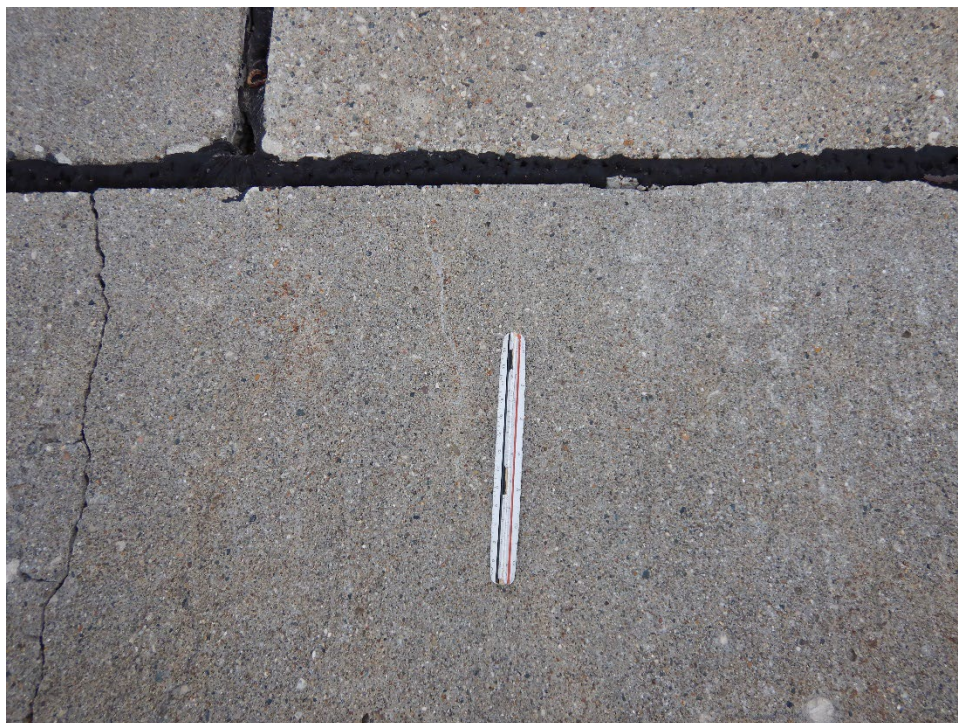
T06AN-01. ASR (Sample Unit No. 15).

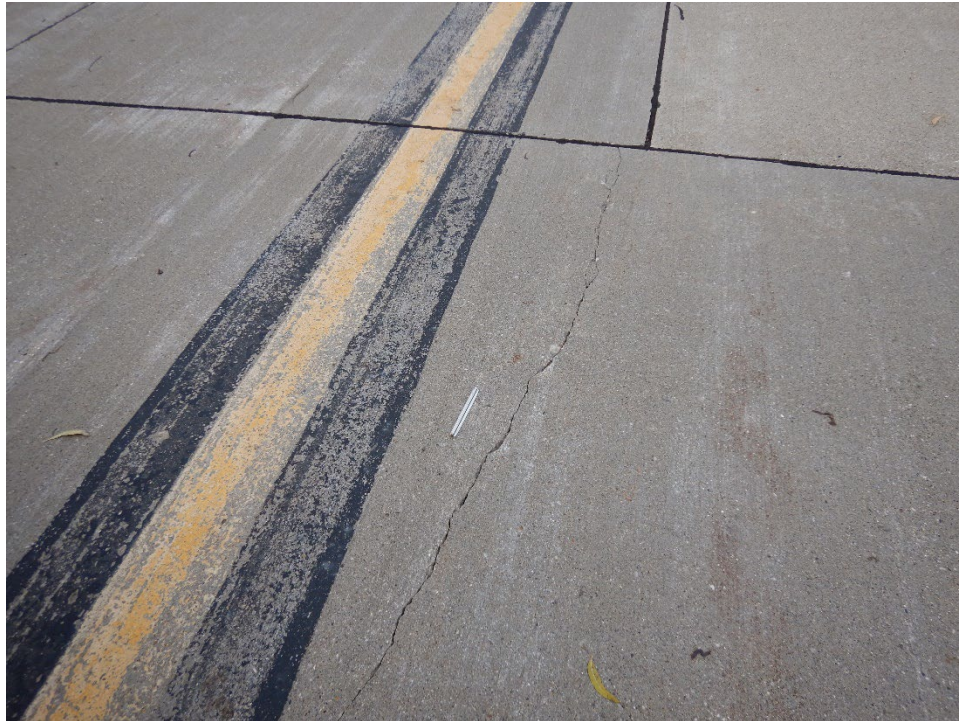
T06AN-01. LTD Cracking (Sample Unit No. 15).

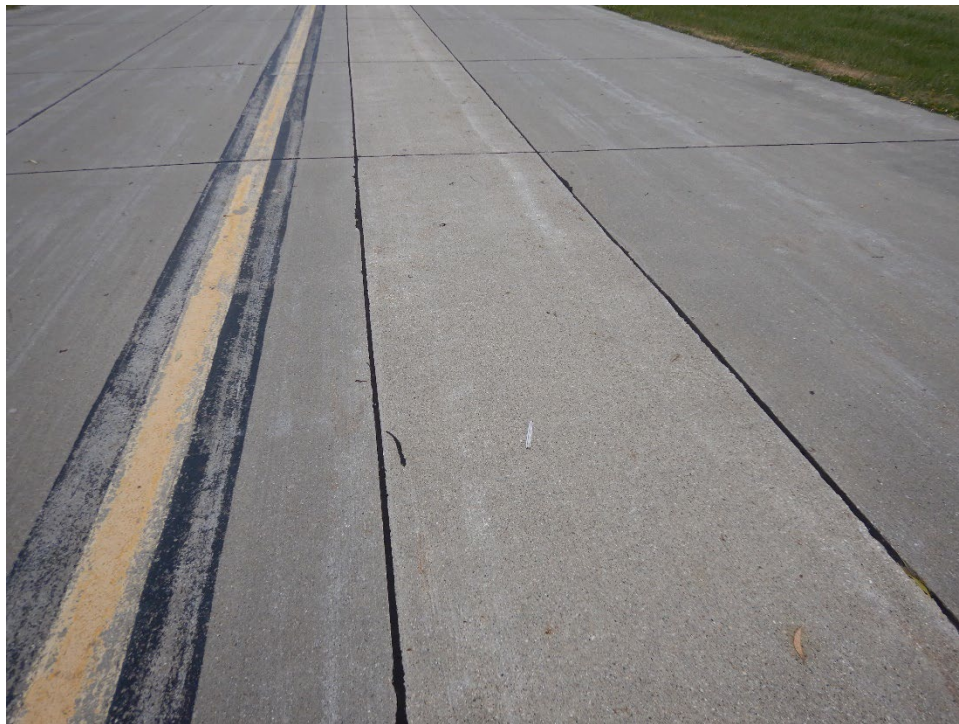
T06AN-01. Large Patching (Sample Unit No. 15).

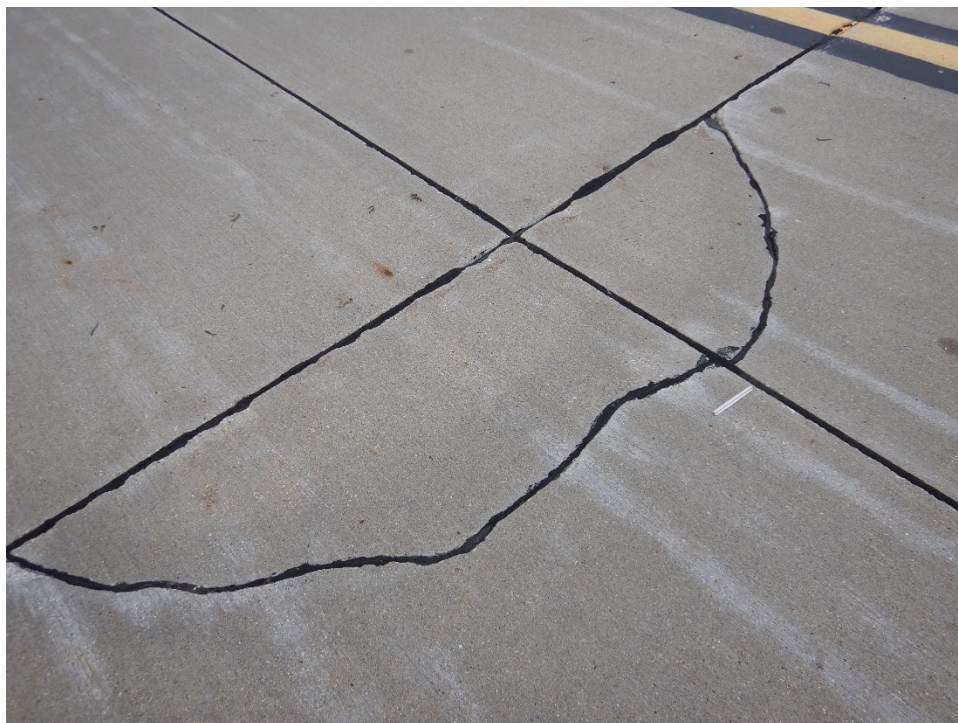
T07AN-01. Corner Break (Sample Unit No. 04).

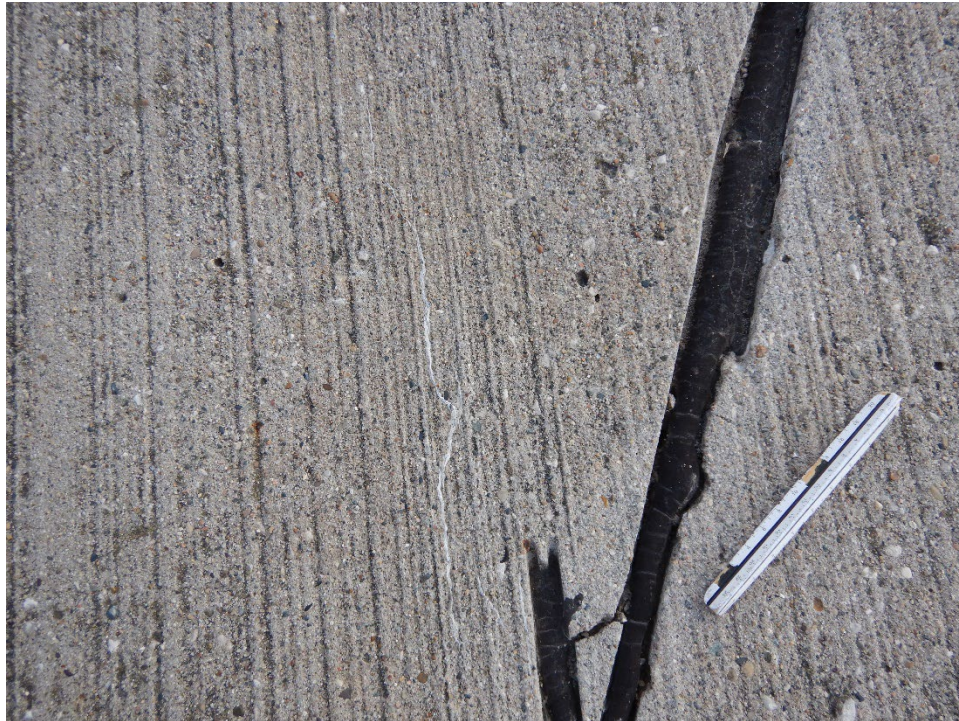
T08AN-01. ASR (Sample Unit No. 04).
