Ankeny Regional Airport

PAVEMENT MANAGEMENT REPORT

JULY 2022

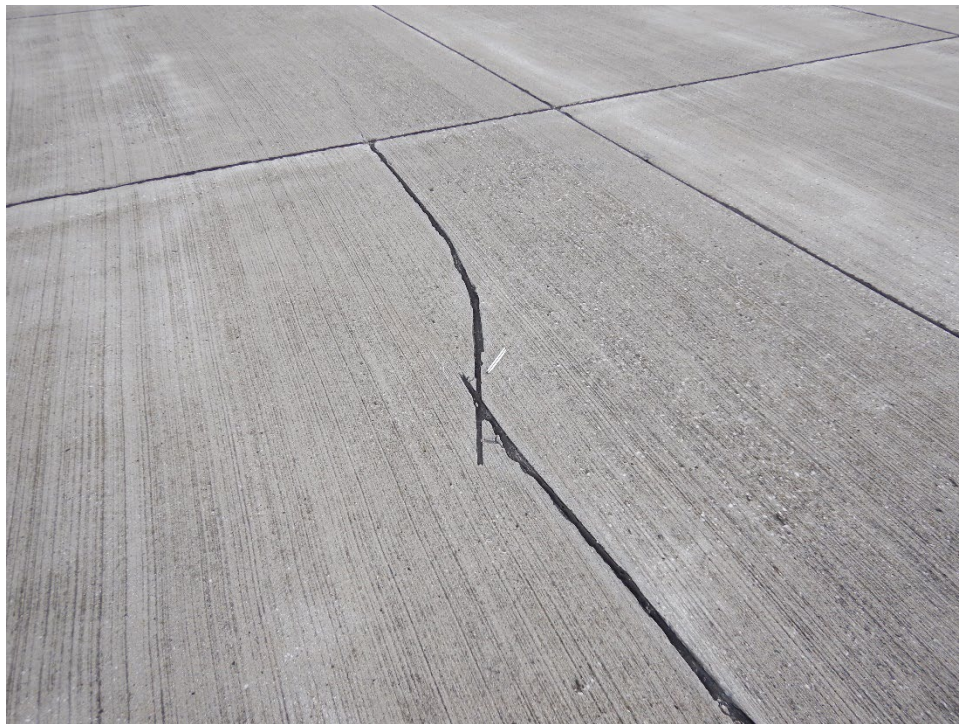
T08AN-01. LTD Cracking (Sample Unit No. 04).

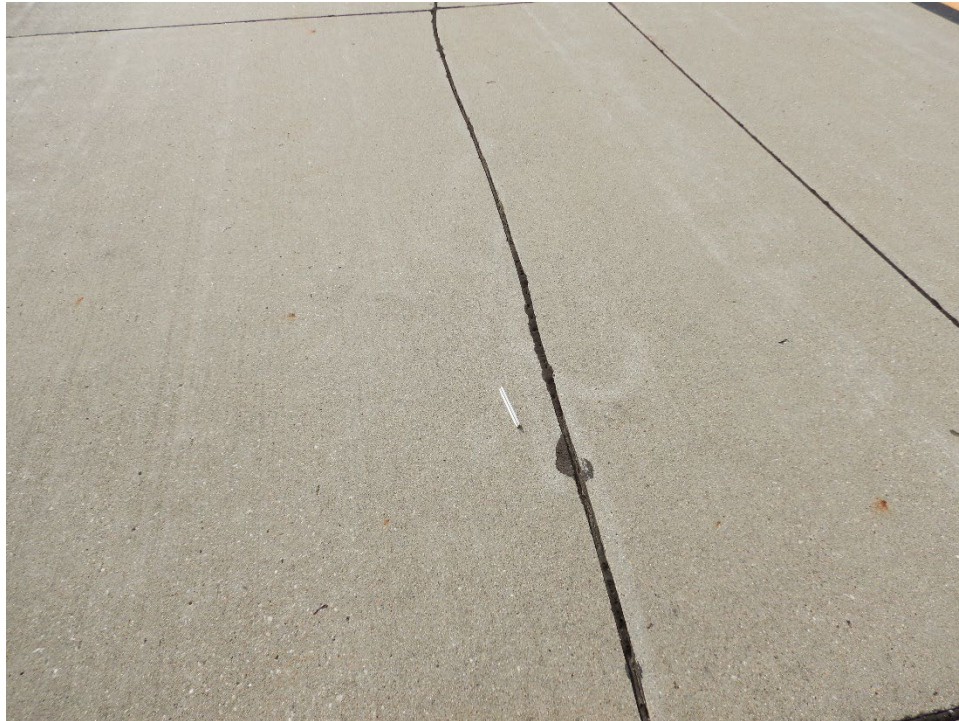
T12AN-01. LTD Cracking (Sample Unit No. 06).

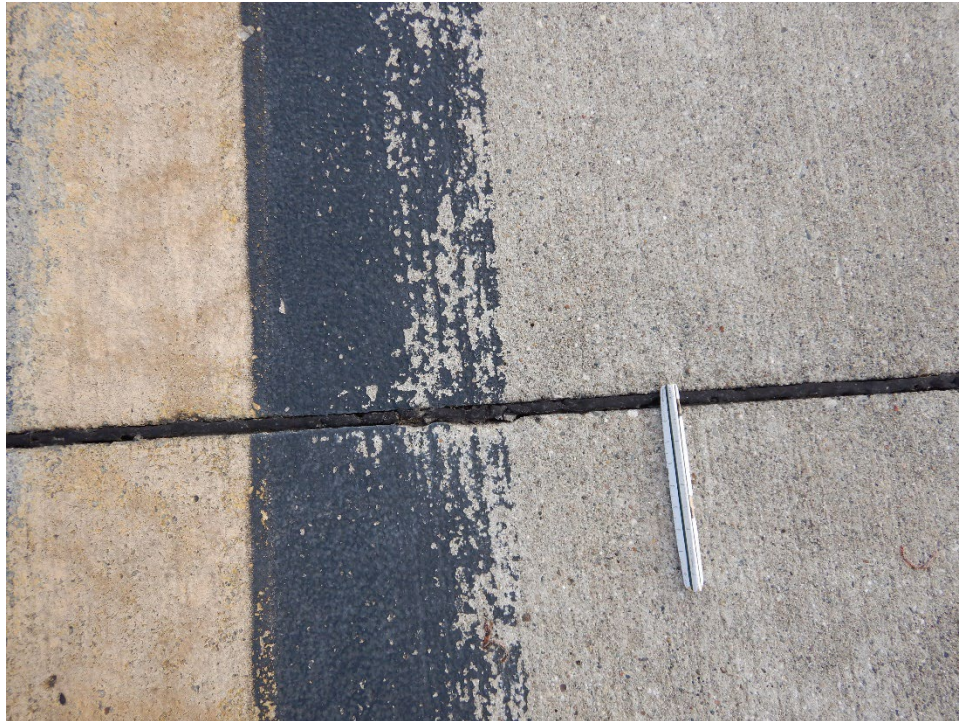
T13AN-01. Joint Seal Damage (Sample Unit No. 13).

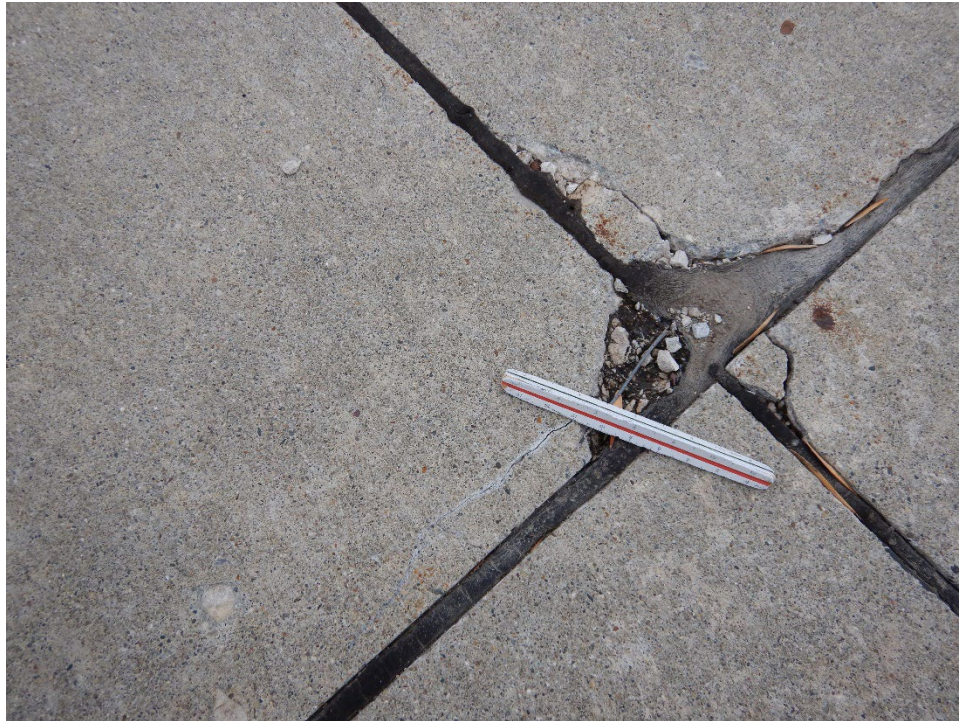
TH01AN-01. ASR (Sample Unit No. 04).

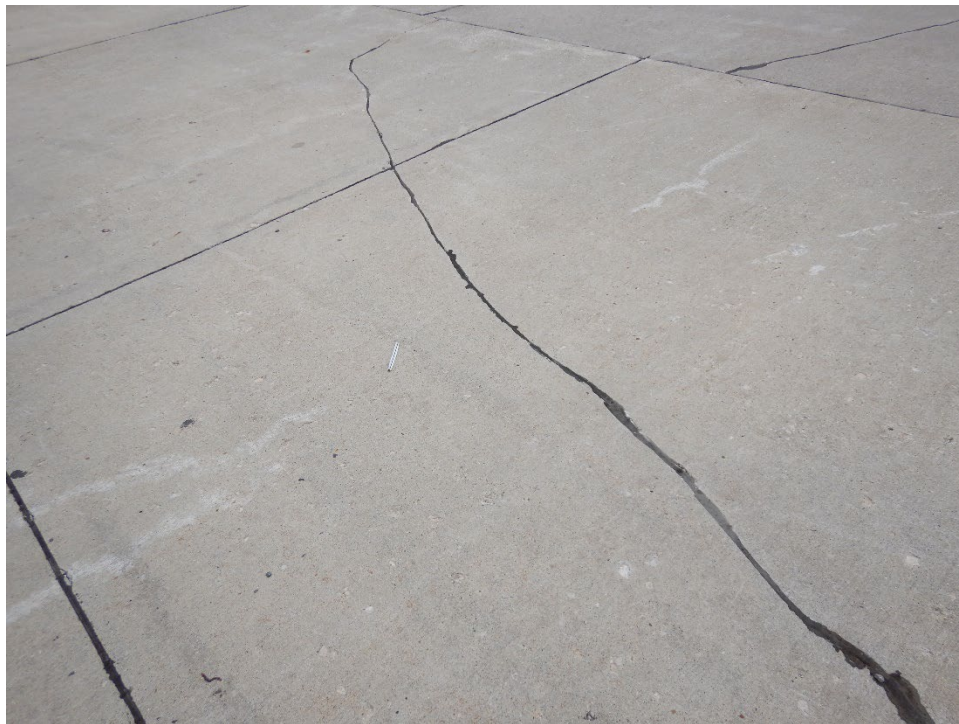
TH01AN-01. LTD Cracking (Sample Unit No. 09).

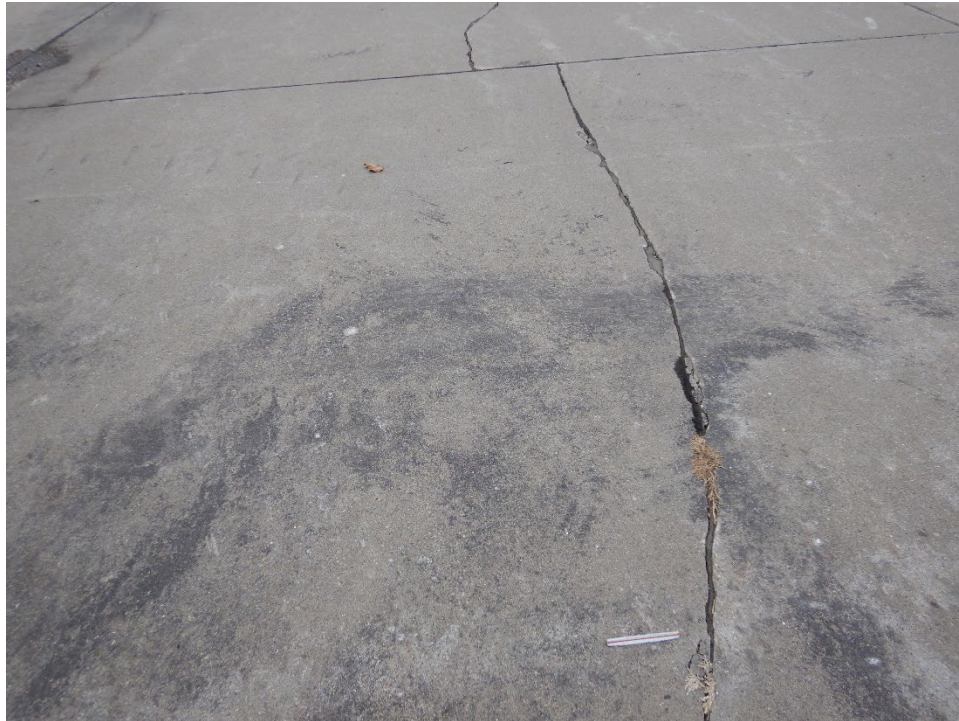
TH01AN-02. LTD Cracking (Sample Unit No. 18).

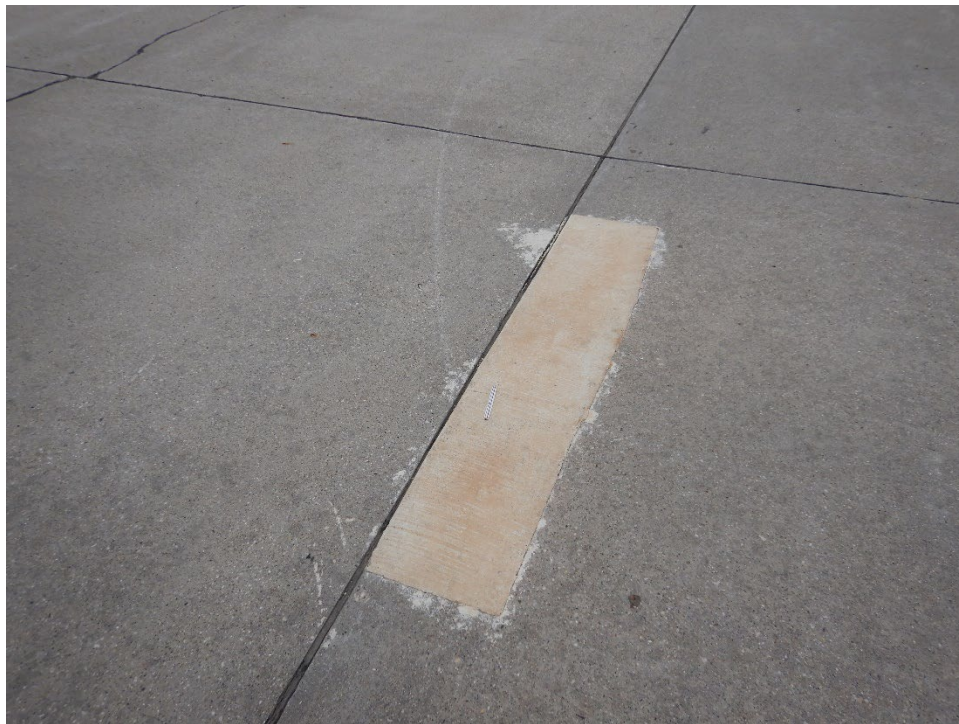
TH01AN-02. Large Patching (Sample Unit No. 18).
