Audubon County Airport

Pavement Management Report

JULY 2024

AUDUBON COUNTY AIRPORT PAVEMENT MANAGEMENT REPORT

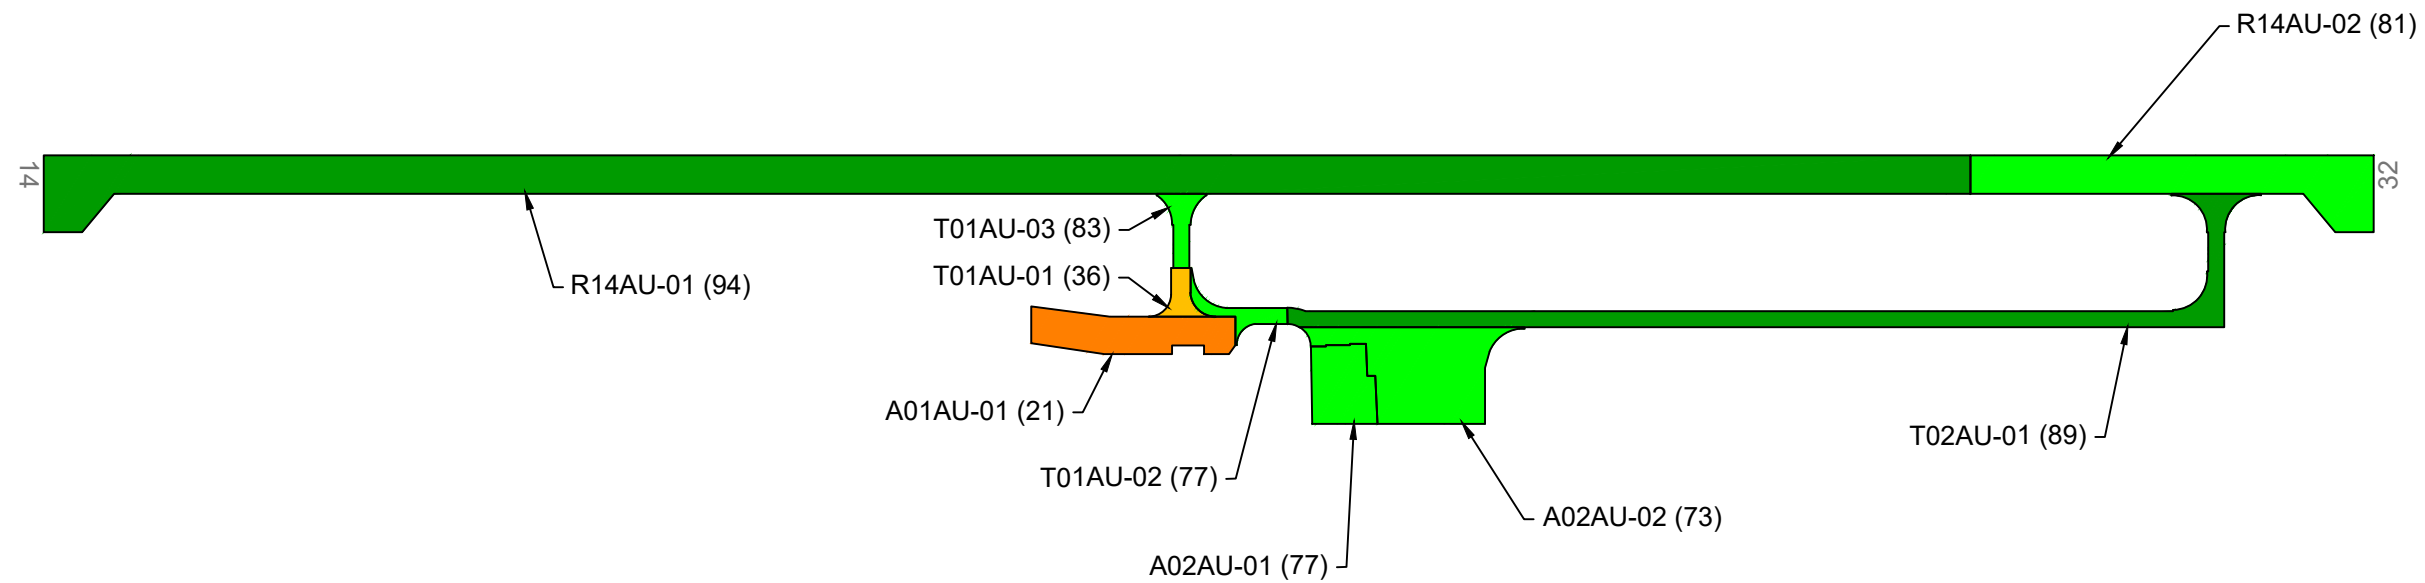
FIGURE 8. PCI MAP.

The pavements at Audubon County Airport were inspected in November 2023. The 2023 area-weighted condition of Audubon County Airport is 85, with conditions ranging from 21 to 94 (on a scale of 0 [failed] to 100 [excellent]). During the previous pavement inspection in 2020, the area-weighted PCI of the airport was 89.

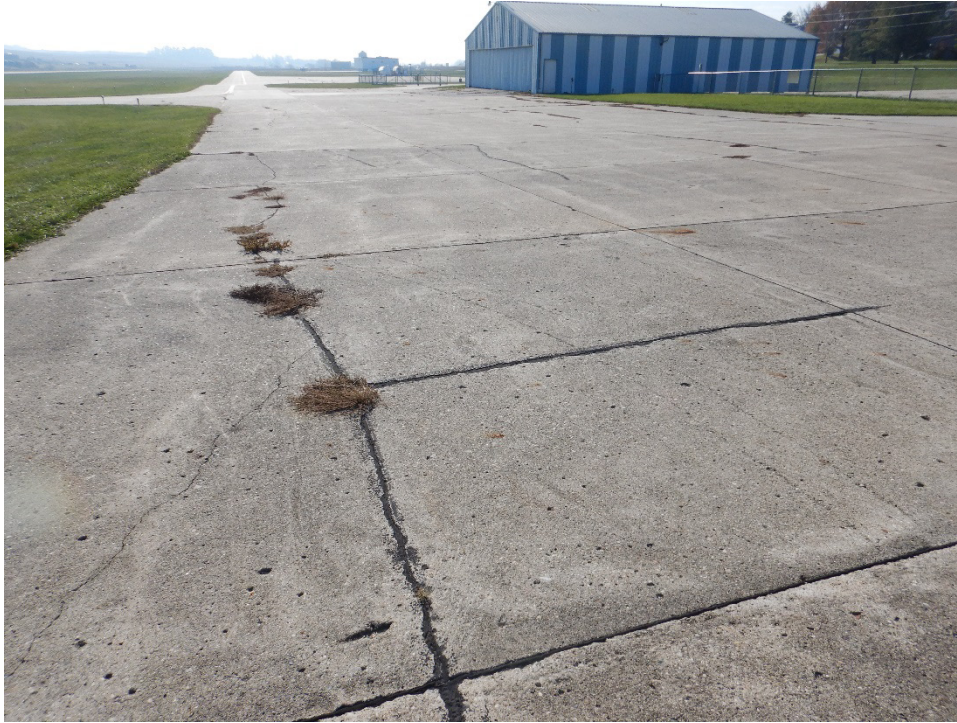
Apron 01 was defined by one section. Section 01 was in poor condition with low-severity corner spalling, large patching, and scaling; low- and medium-severity joint spalling and LTD cracking; medium-severity faulting and joint seal damage; all severities of shattered slab; shrinkage cracking; and popouts recorded throughout.

A01AU-01. Overview.

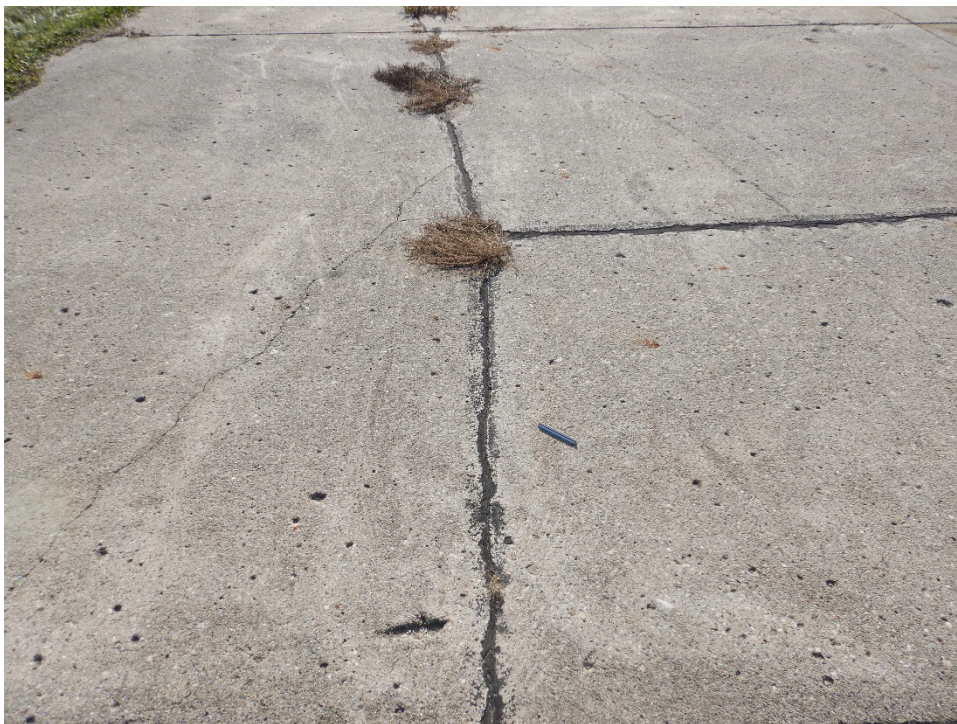
A01AU-01. Shattered Slab (Sample Unit No. 02).

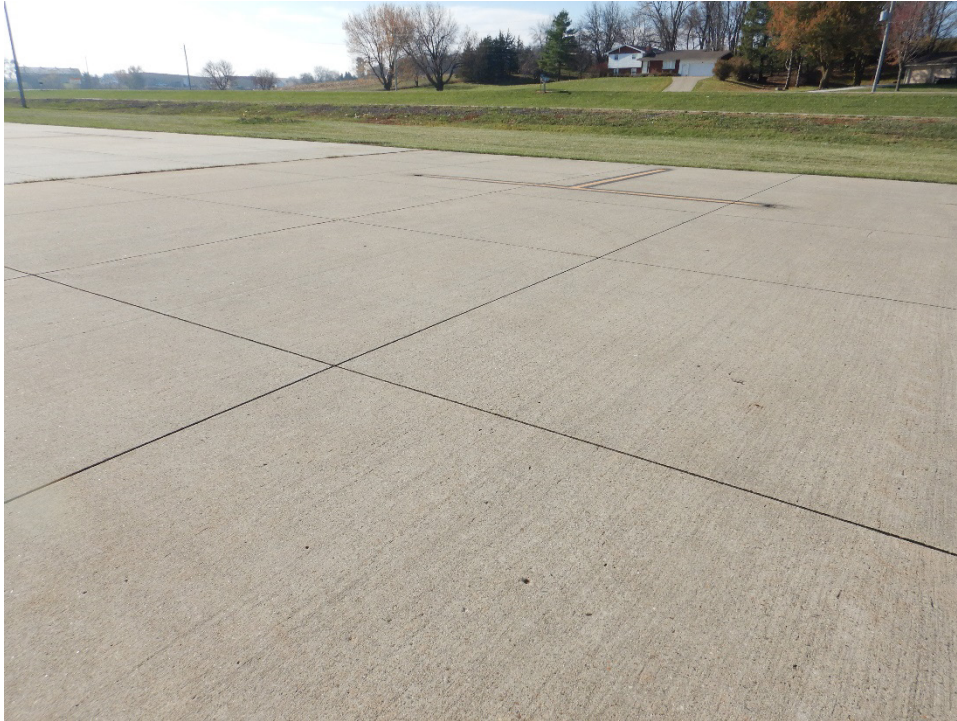
A02AU-01. Overview.

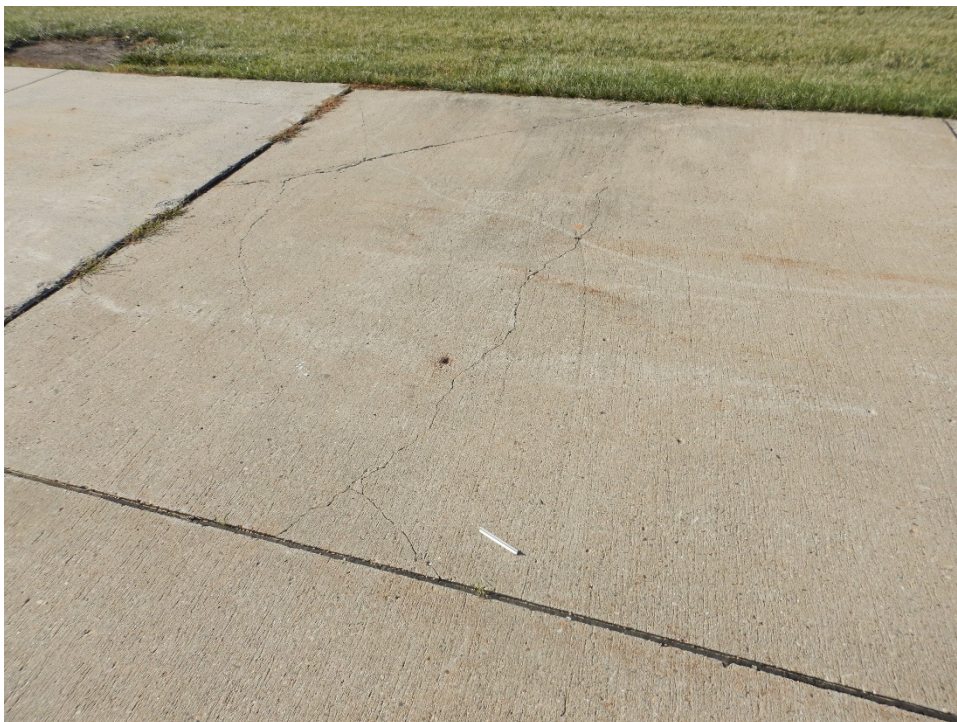
Apron 02 contained two sections. Section 01 had low-severity faulting, medium-severity joint spalling and shattered slab, and high-severity joint seal damage and small patching identified during the inspection. Areas of low-severity faulting; low- and medium-severity corner spalling; medium-severity corner break, joint spalling, and LTD cracking; and high-severity joint seal damage were observed in Section 02.

A02AU-01. Shattered Slab (Sample Unit No. 03).

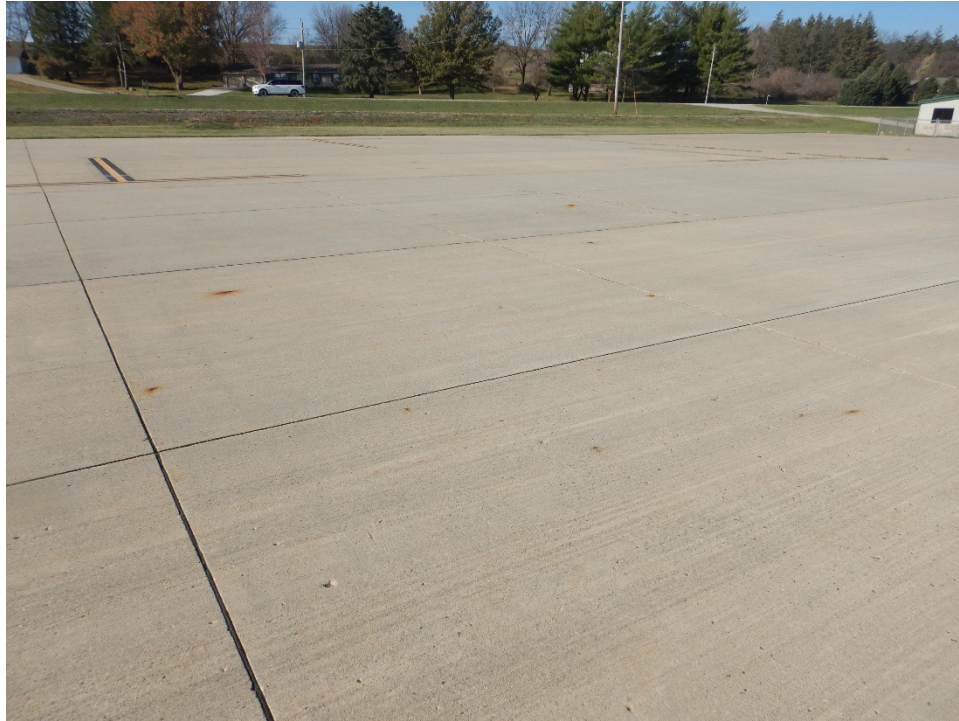
A02AU-02. Overview.

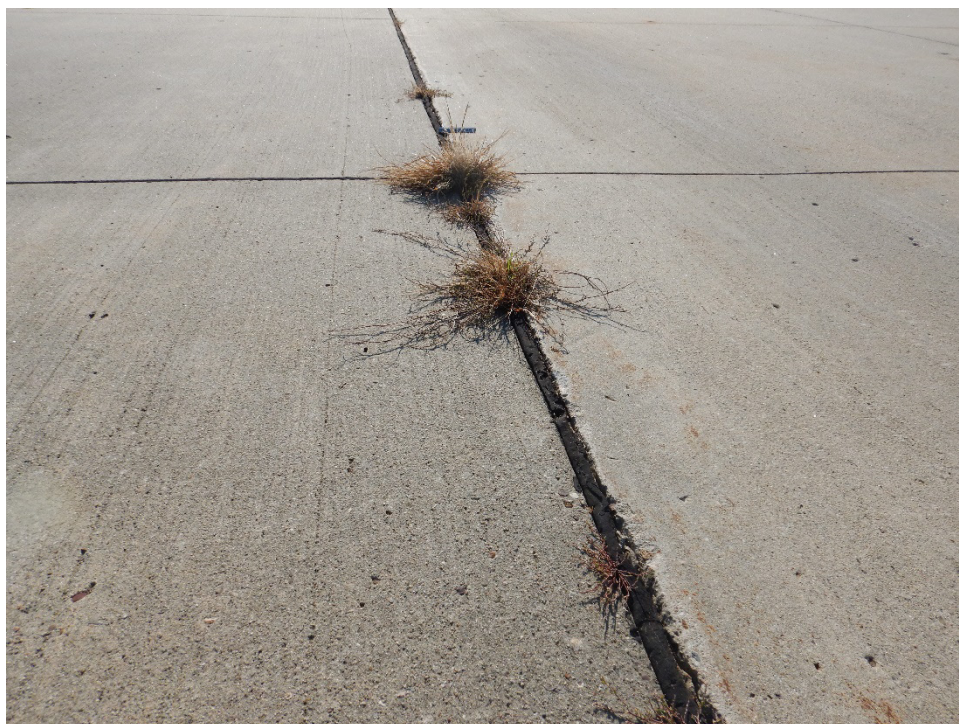
A02AU-02. Faulting (Sample Unit No. 03).

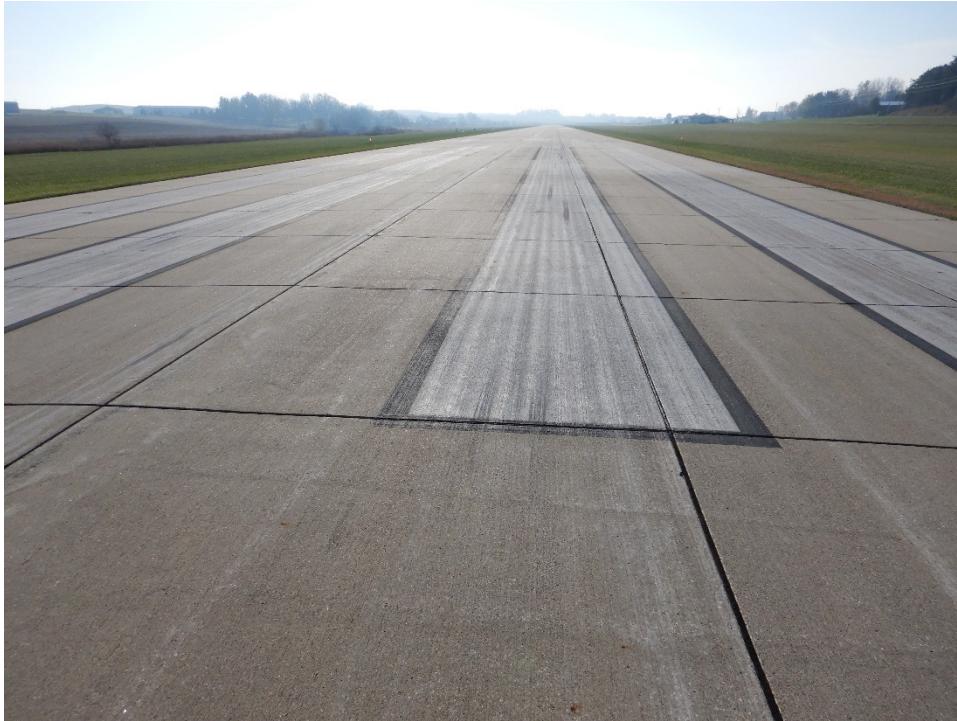
R14AU-01. Overview.

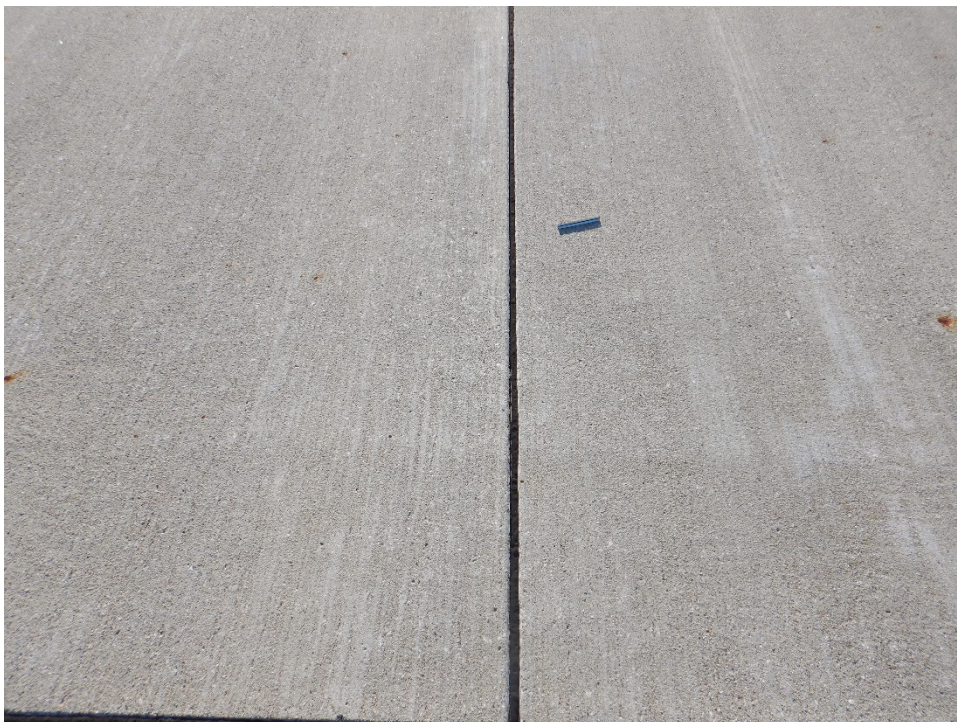
Runway 14/32 was defined by two sections. Section 01 was located at the Runway 14 approach. Areas of low-severity corner break and joint spalling and all severities of joint seal damage were recorded in Section 01. Section 02 was located at the Runway 32 approach and had low-severity corner break, faulting, and joint spalling; low- and medium-severity longitudinal, transverse, and diagonal (LTD) cracking; high-severity joint seal damage; and shrinkage cracking identified at the time of the inspection.

R14AU-01. Joint Seal Damage (Sample Unit No. 55).

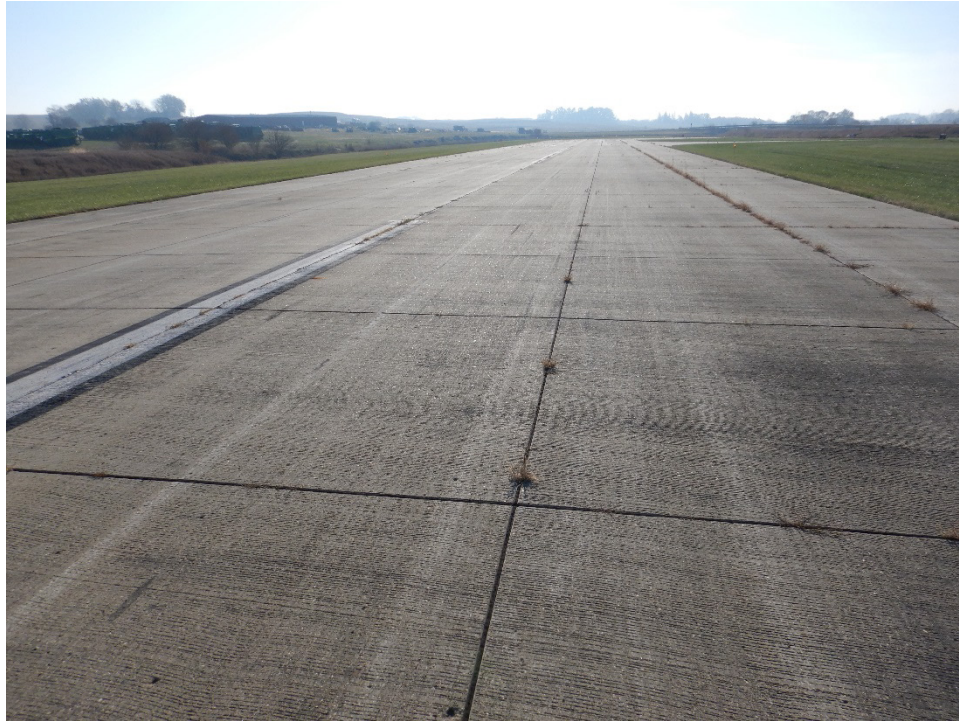
R14AU-02. Overview.

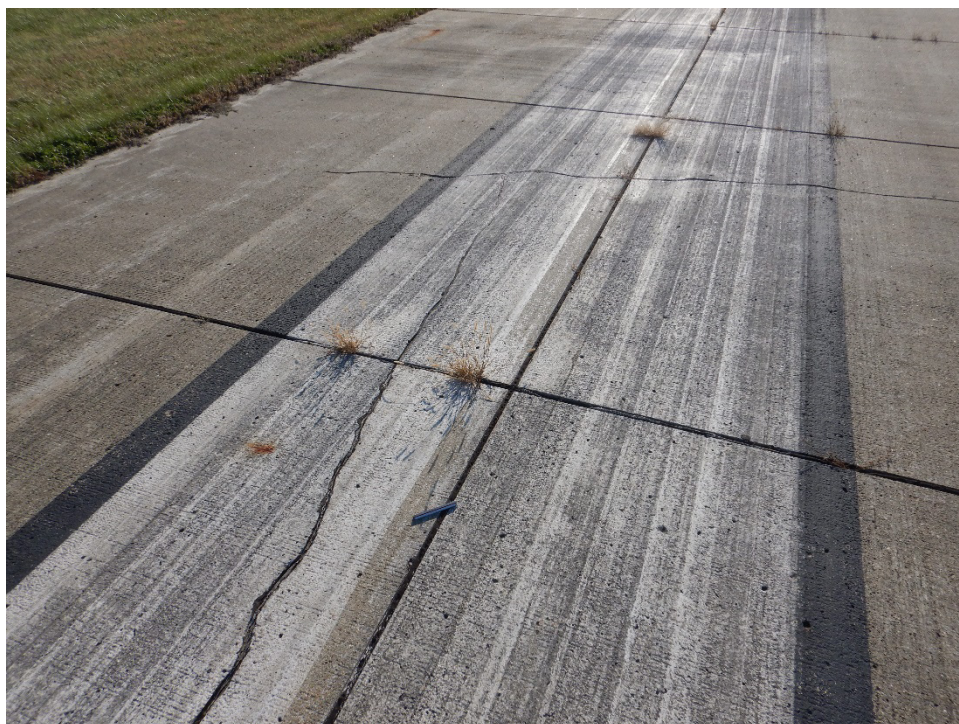
R14AU-02. LTD Cracking (Sample Unit No. 14).

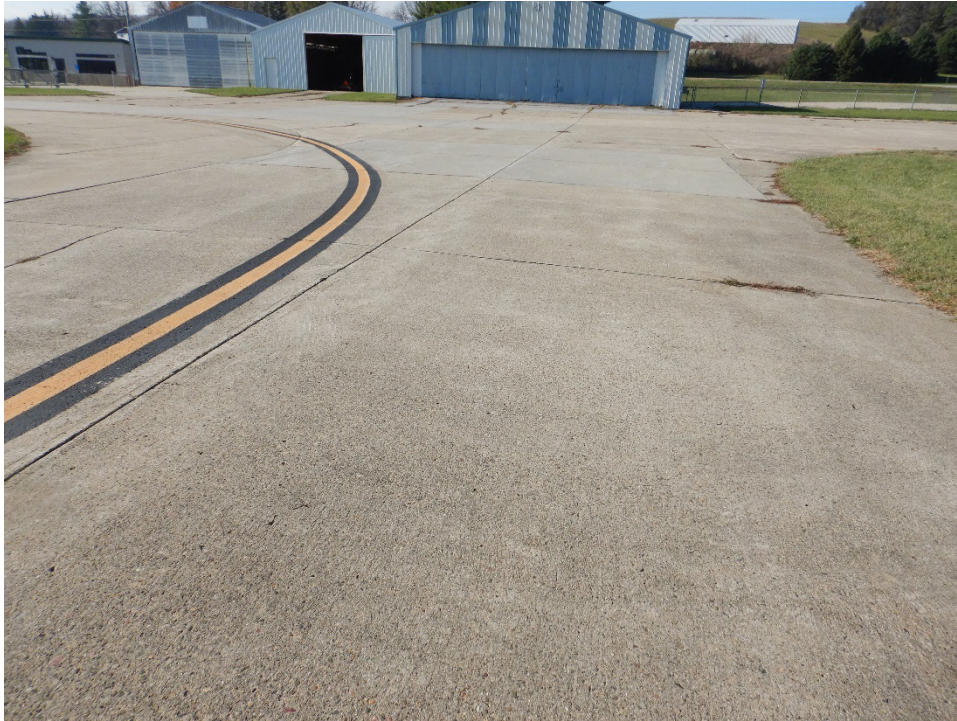
T01AU-01. Overview.

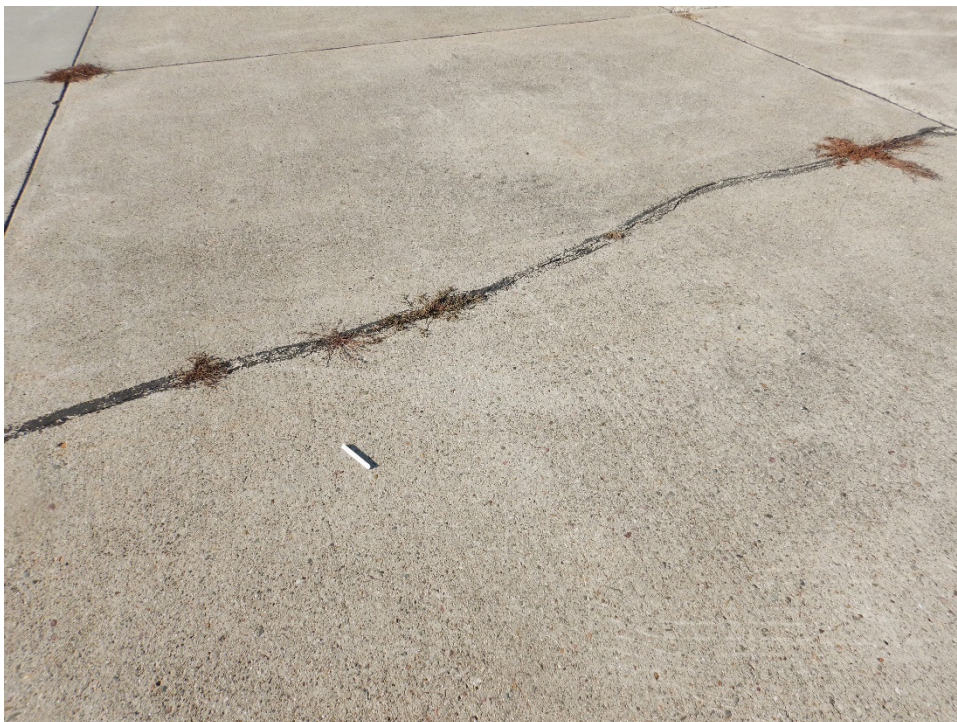
Taxiway 01 consisted of three sections. Section 01 was in poor condition with low-severity faulting; low- and medium-severity LTD cracking; and medium-severity corner spalling, joint spalling, and joint seal damage recorded. Low-severity joint spalling, low- and medium-severity LTD cracking, medium-severity corner spalling, and medium- and high-severity joint seal damage were observed in Section 02. Areas of medium-severity joint seal damage and low-severity corner break and faulting were identified in Section 03.

T01AU-01. LTD Cracking (Sample Unit No. 01).

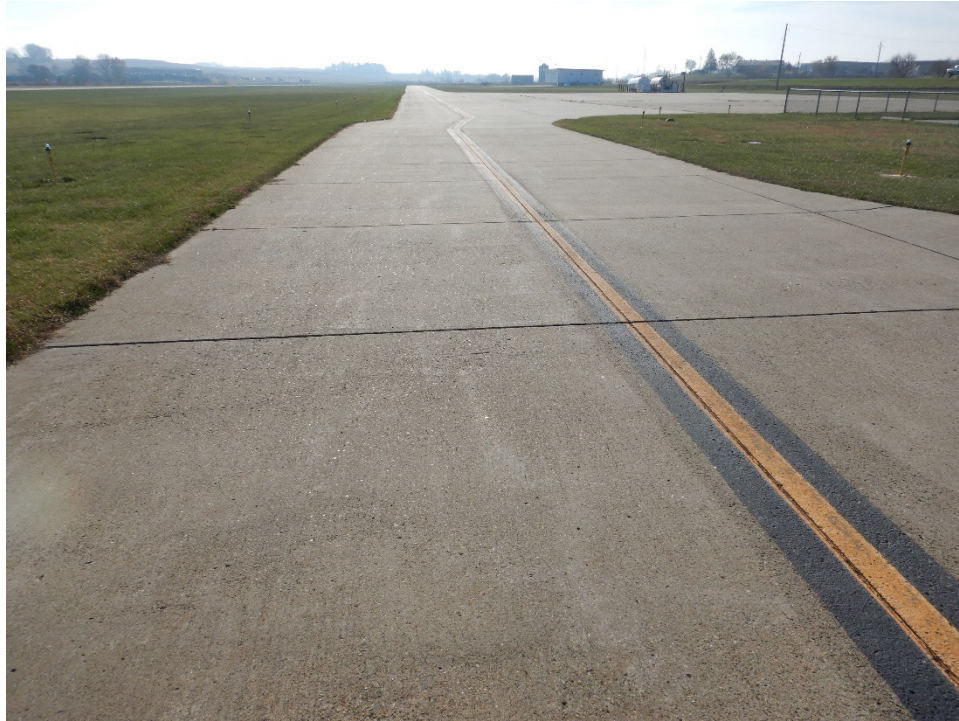
T01AU-02. Overview.

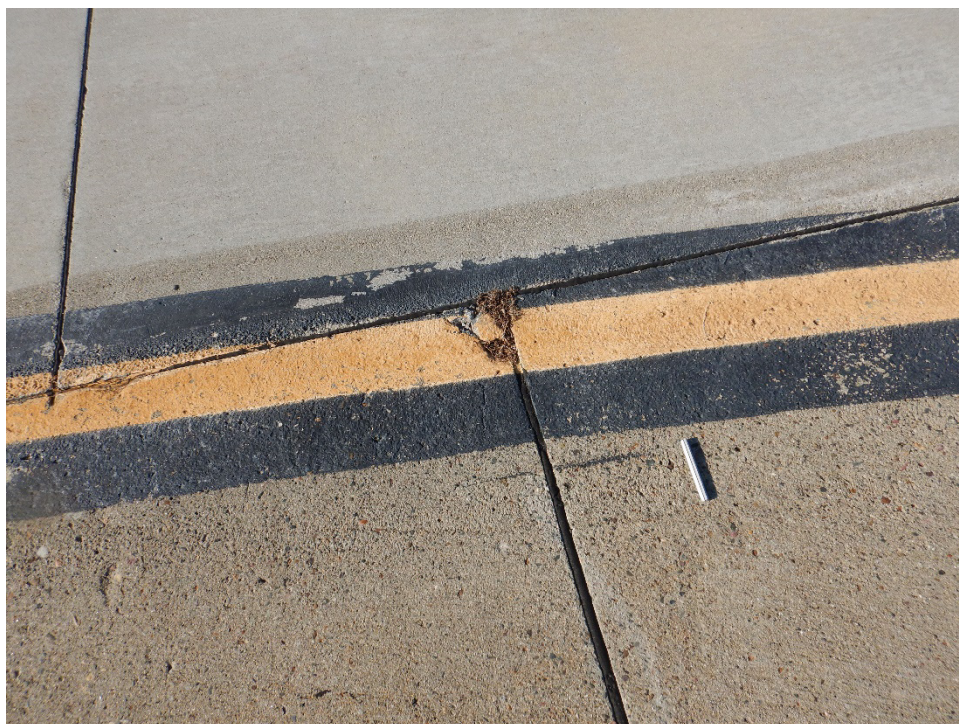
T01AU-02. Corner Spalling (Sample Unit No. 01).

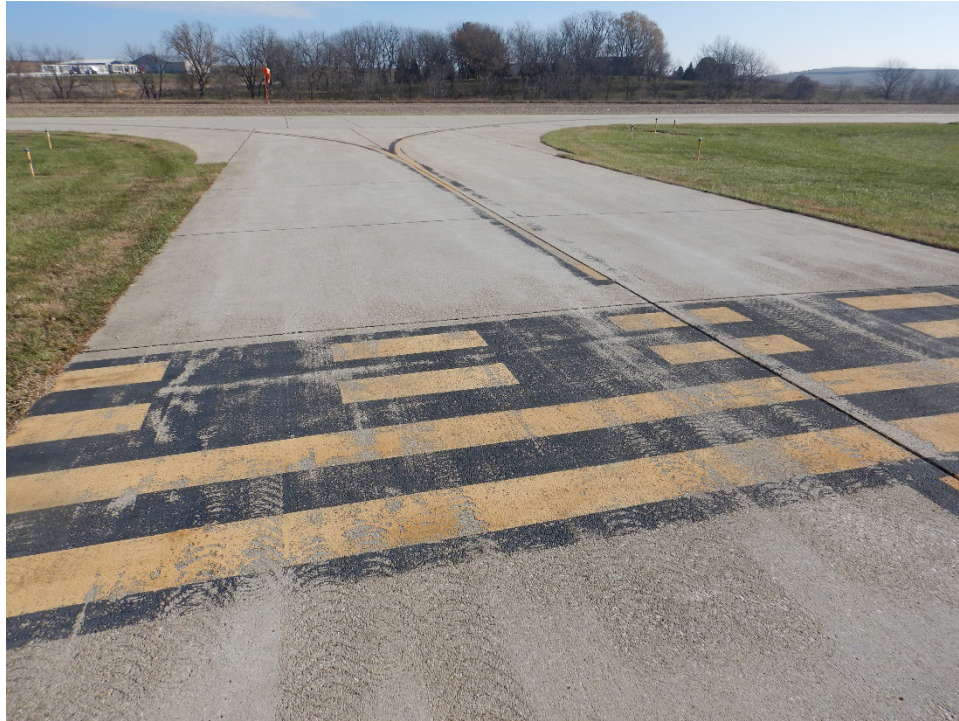
T01AU-03. Overview.

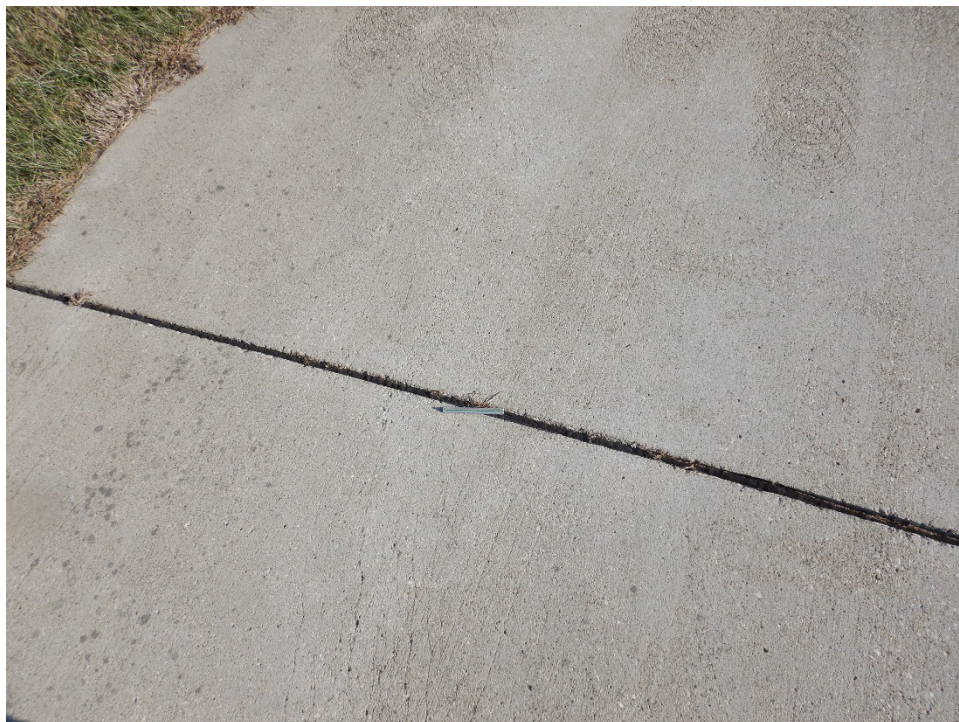
T01AU-03. Joint Seal Damage (Sample Unit No. 01).

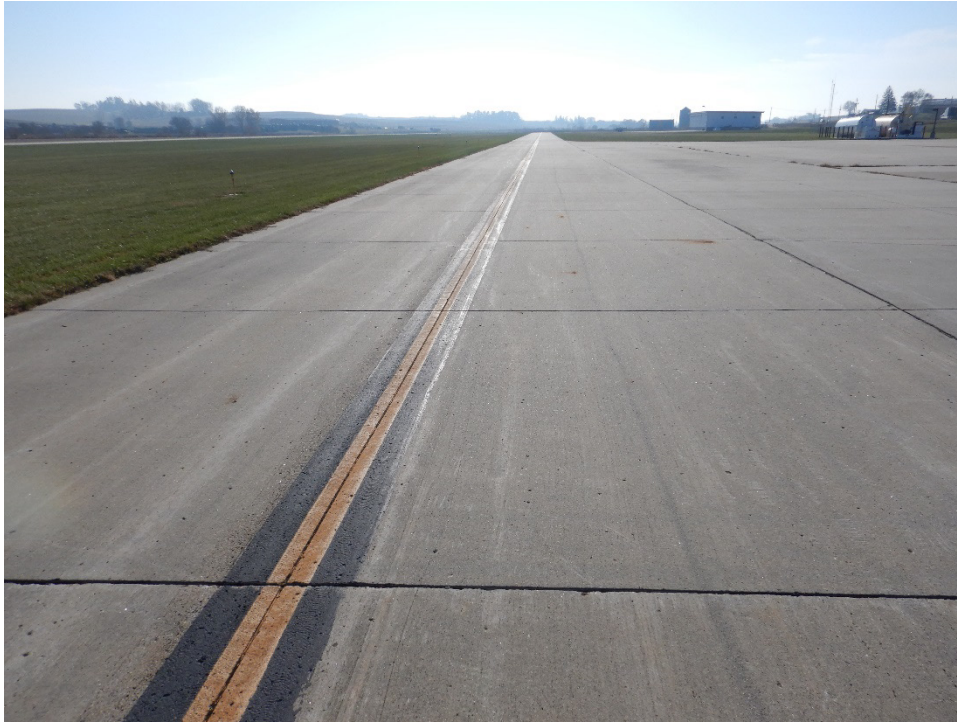
T02AU-01. Overview.

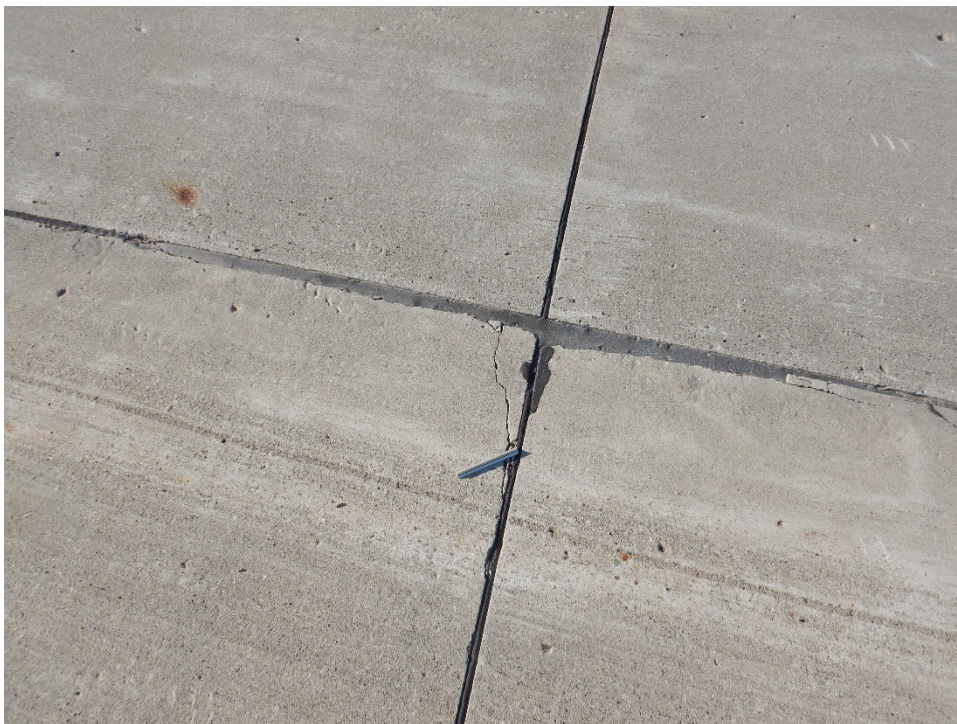
Taxiway 02 contained one section. Areas of low-severity corner spalling, joint spalling, and large patching; medium-severity joint seal damage and LTD cracking; and shrinkage cracking were recorded in Section 01 at the time of the inspection.

T02AU-01. Joint Spalling (Sample Unit No. 02).
