# Belle Plaine Municipal Airport

## PAVEMENT MANAGEMENT REPORT

**JULY 2022**

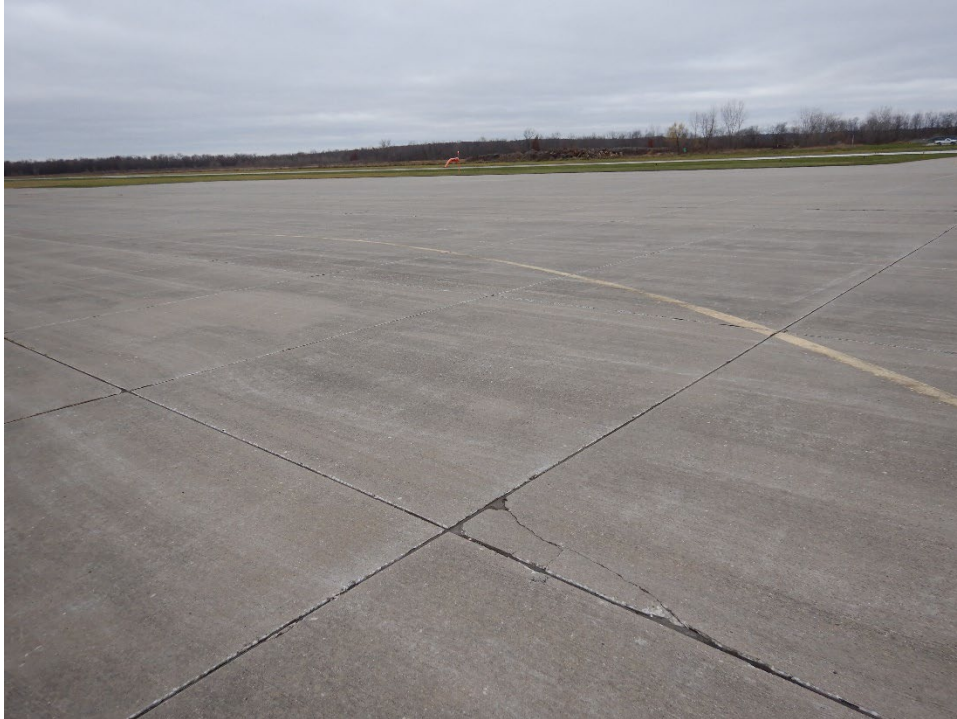
A01BP-01. Overview.

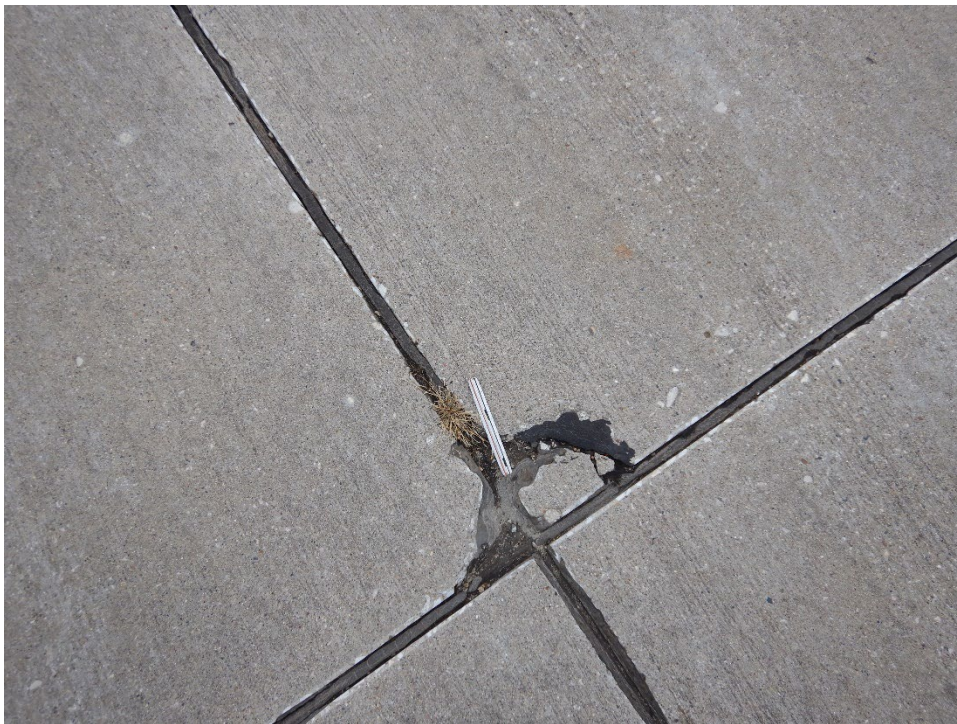
A01BP-01. Corner Spalling (Sample Unit No. 04).

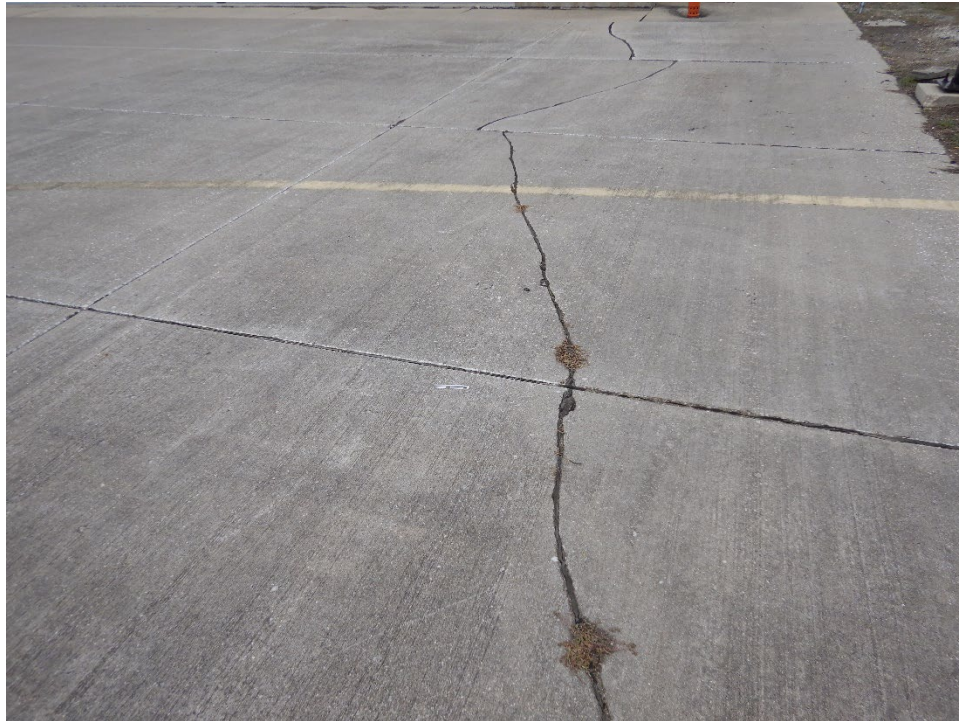
A01BP-01. LTD Cracking (Sample Unit No. 04).

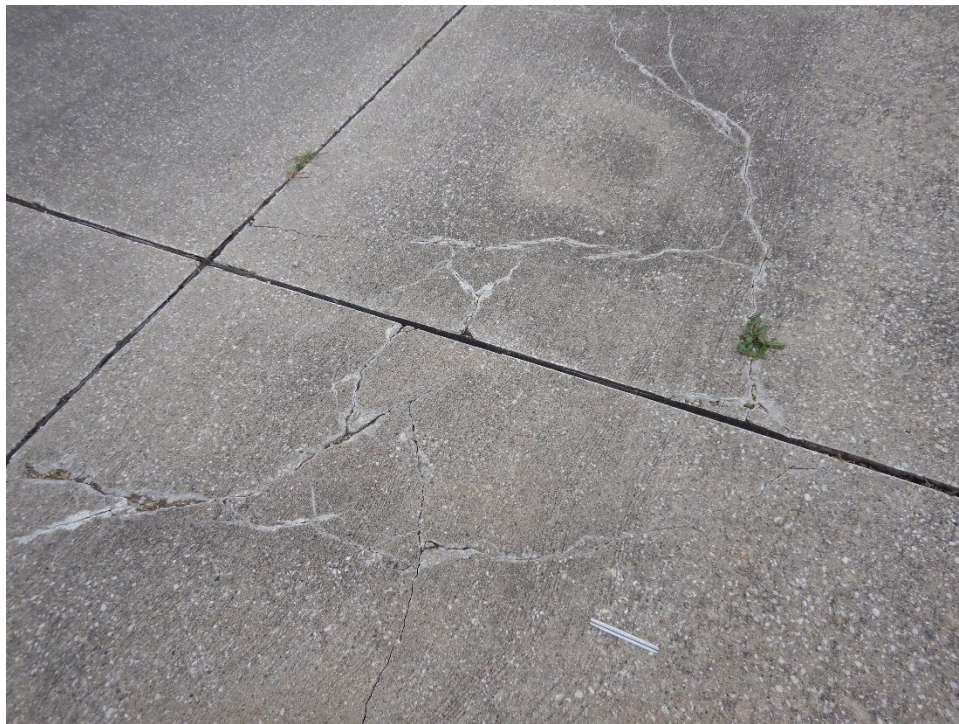
A01BP-01. Shattered Slab (Sample Unit No. 14).

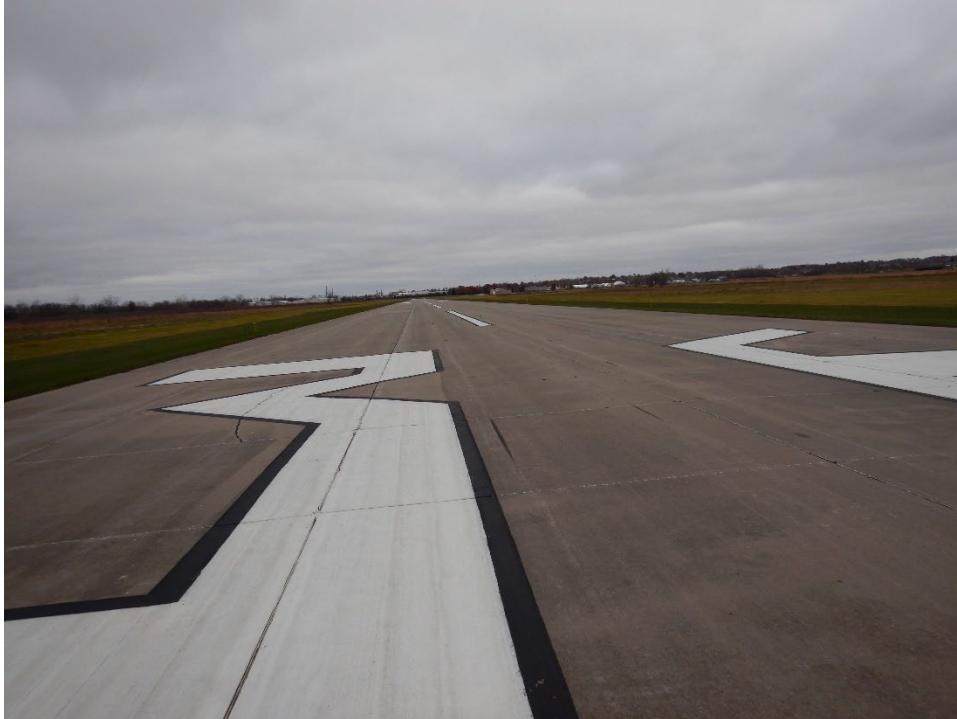
Runway 18/36 consisted of one section. Low- and medium-severity ASR, corner spalling, joint spalling, shattered slab, and longitudinal, transverse, and diagonal (LTD) cracking and low-severity large patching, small patching, joint seal damage, faulting, and corner break were observed in Section 01.

R18BP-01. Overview.

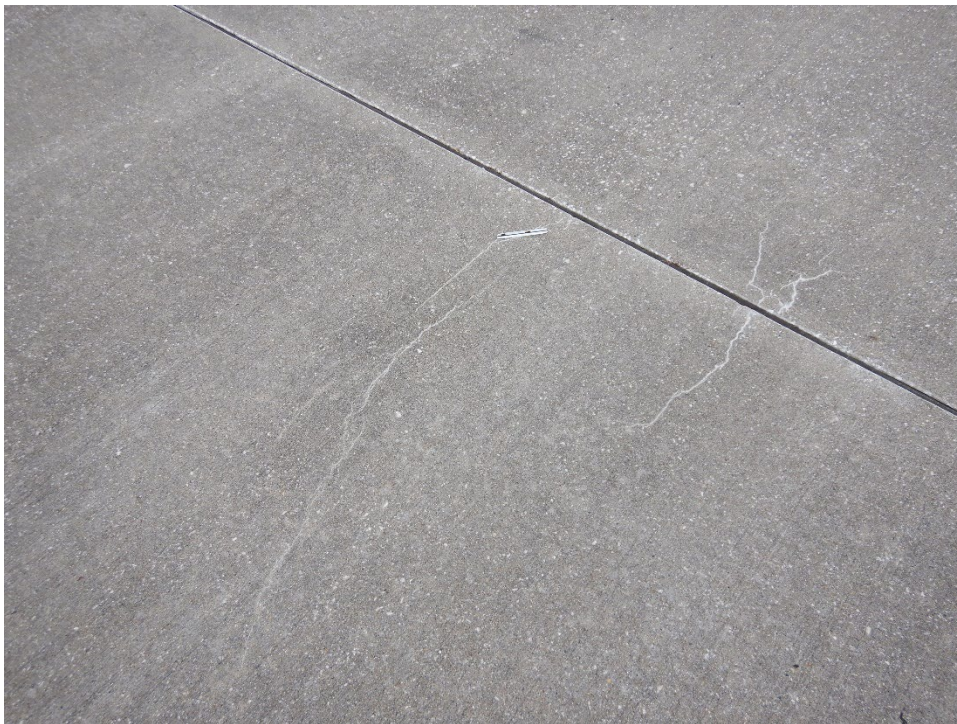
R18BP-01. ASR (Sample Unit No. 55).

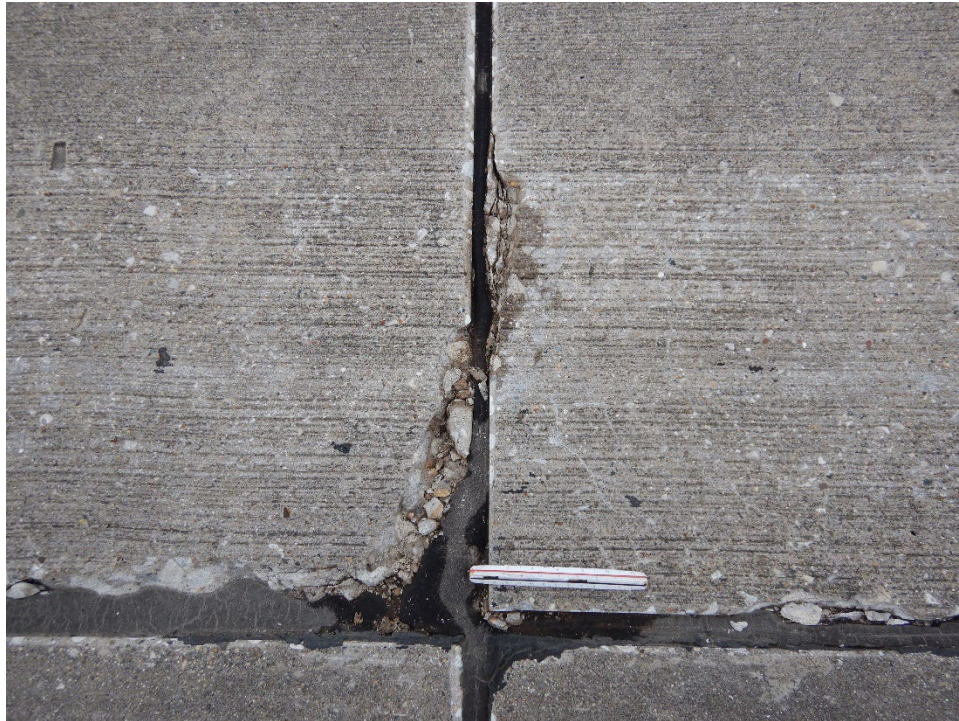
R18BP-01. ASR (Sample Unit No. 75).

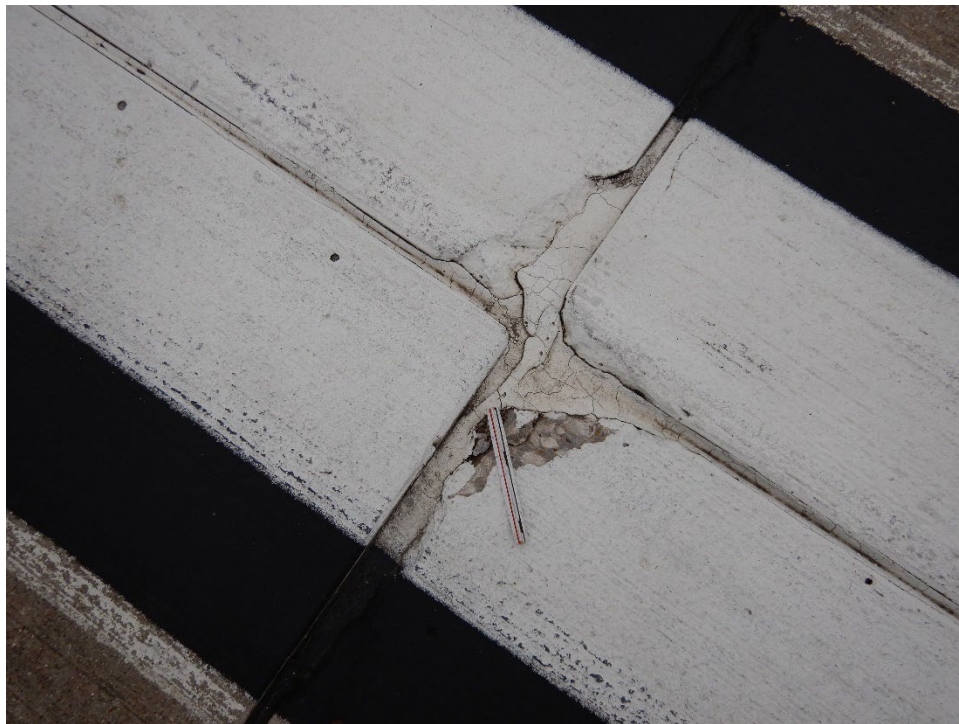
R18BP-01. Corner Spalling (Sample Unit No. 55).

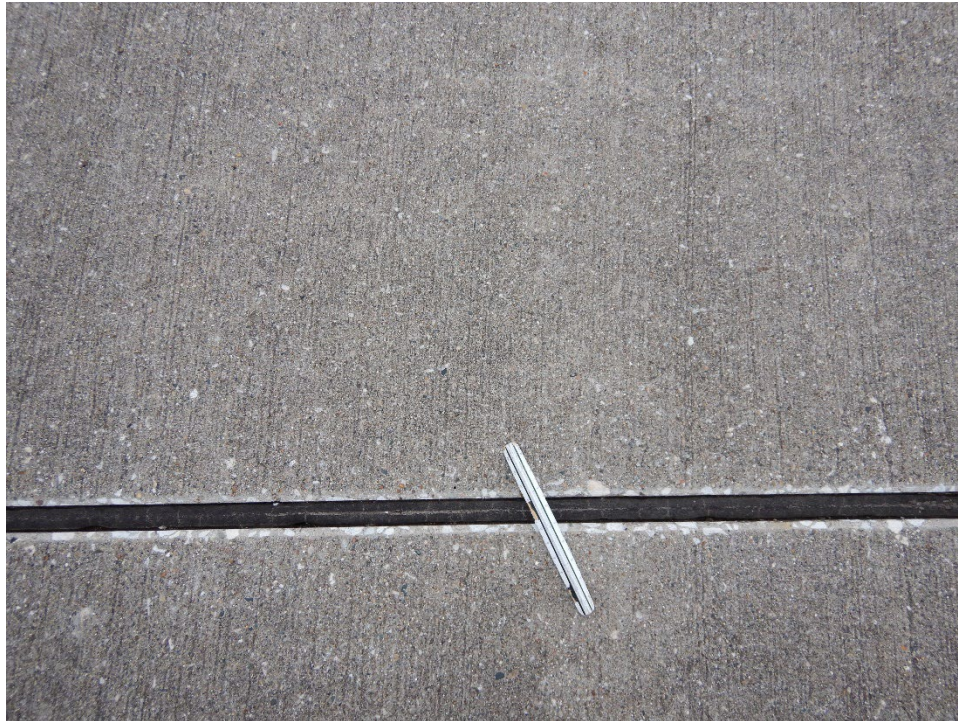
R18BP-01. Joint Seal Damage (Sample Unit No. 95).

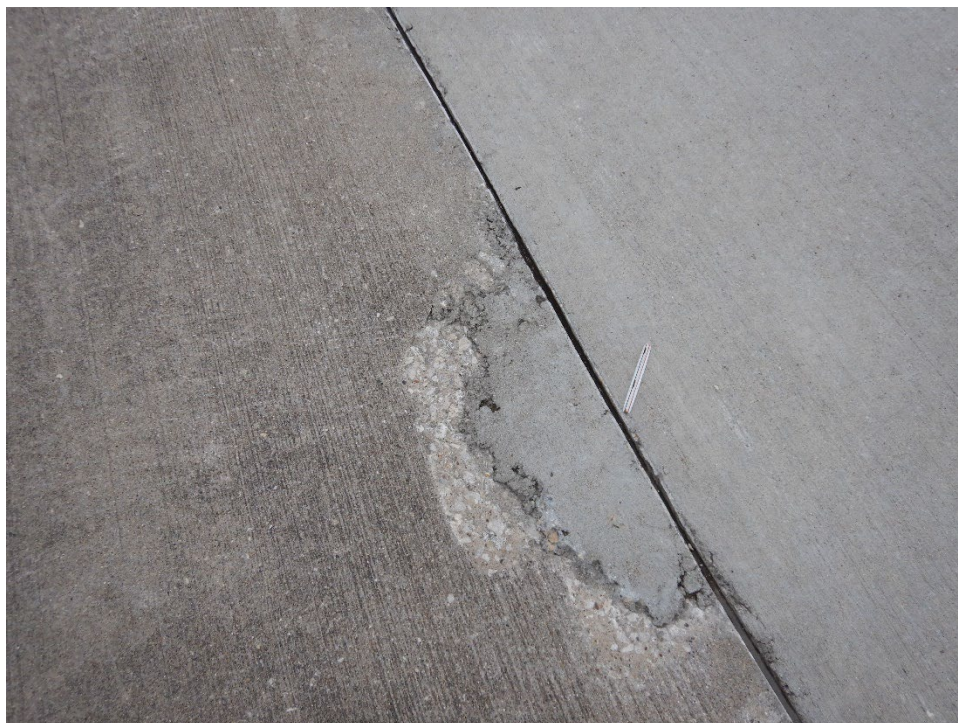
R18BP-01. Joint Spalling (Sample Unit No. 55).

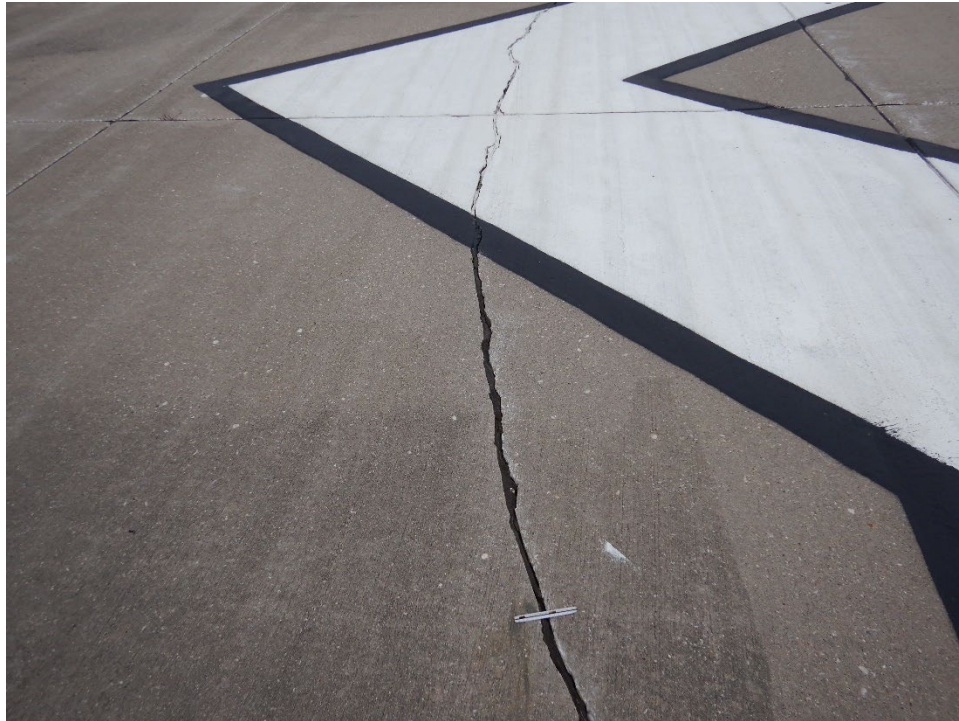
R18BP-01. LTD Cracking (Sample Unit No. 95).

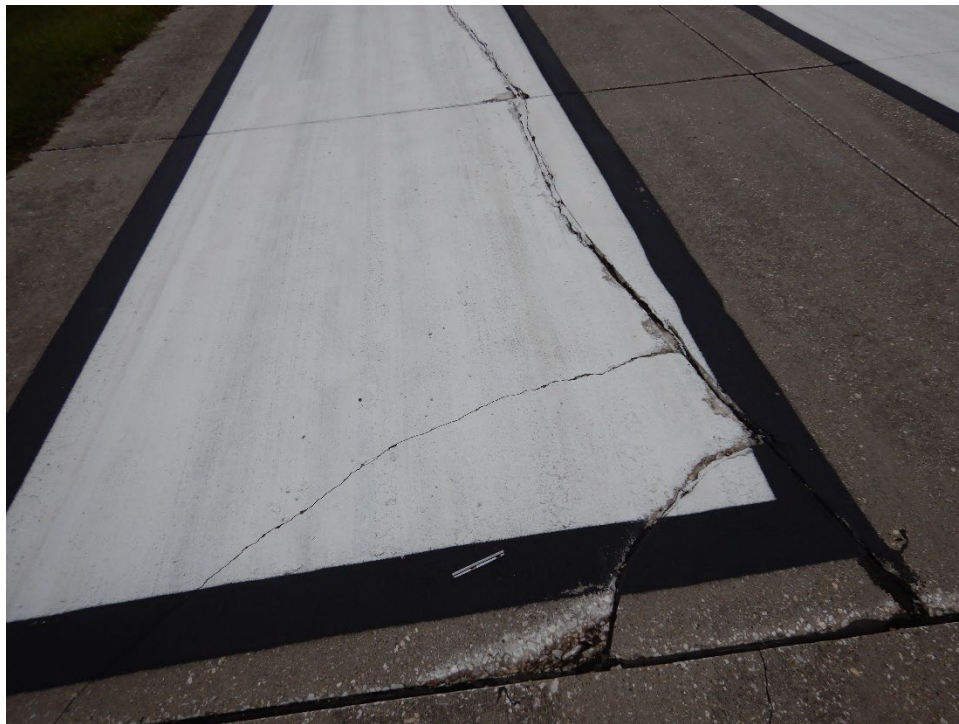
R18BP-01. Shattered Slab (Sample Unit No. 05).

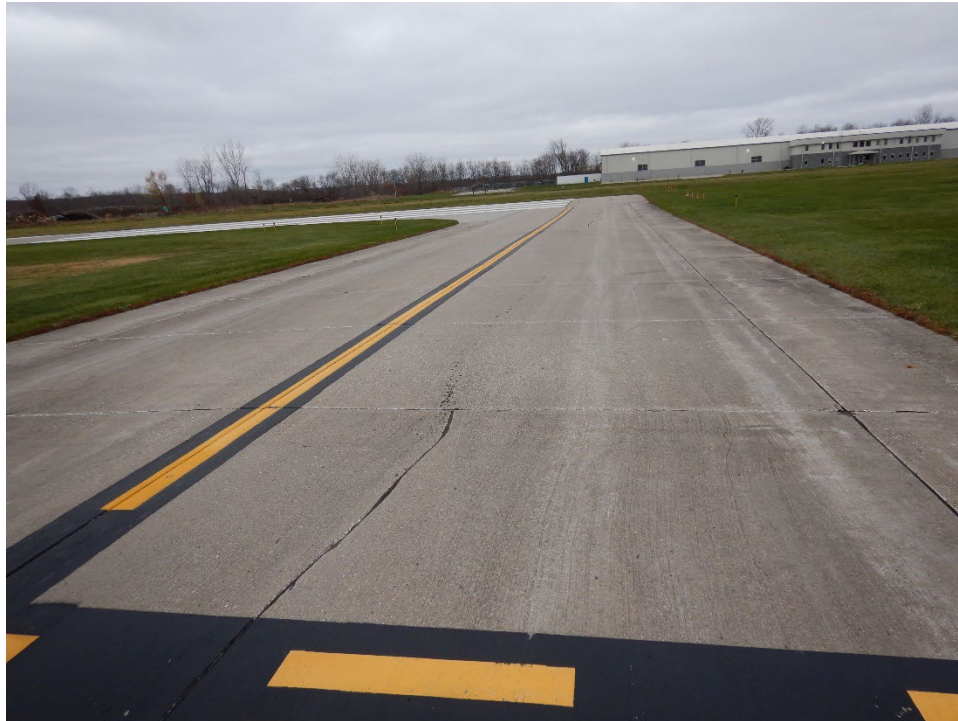
The taxiway connected the apron area to the Runway 18 approach and contained one section with low- and medium-severity LTD cracking and low-severity corner break, corner spalling, joint seal damage, joint spalling, and shattered slab recorded during the inspection.

T01BP-01. Overview.

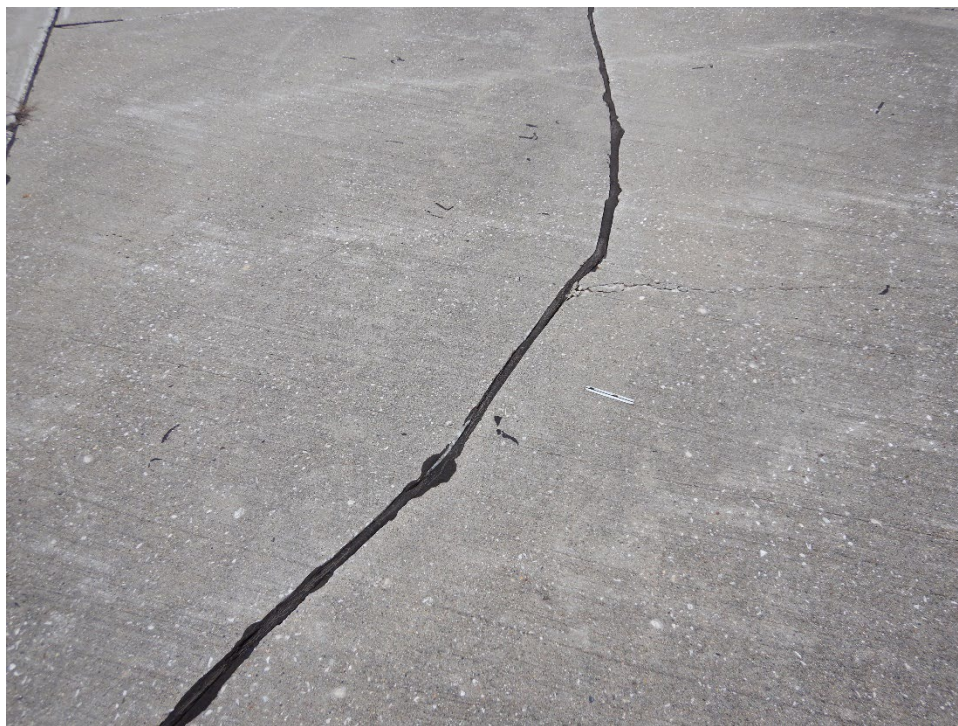
T01BP-01. LTD Cracking (Sample Unit No. 01).

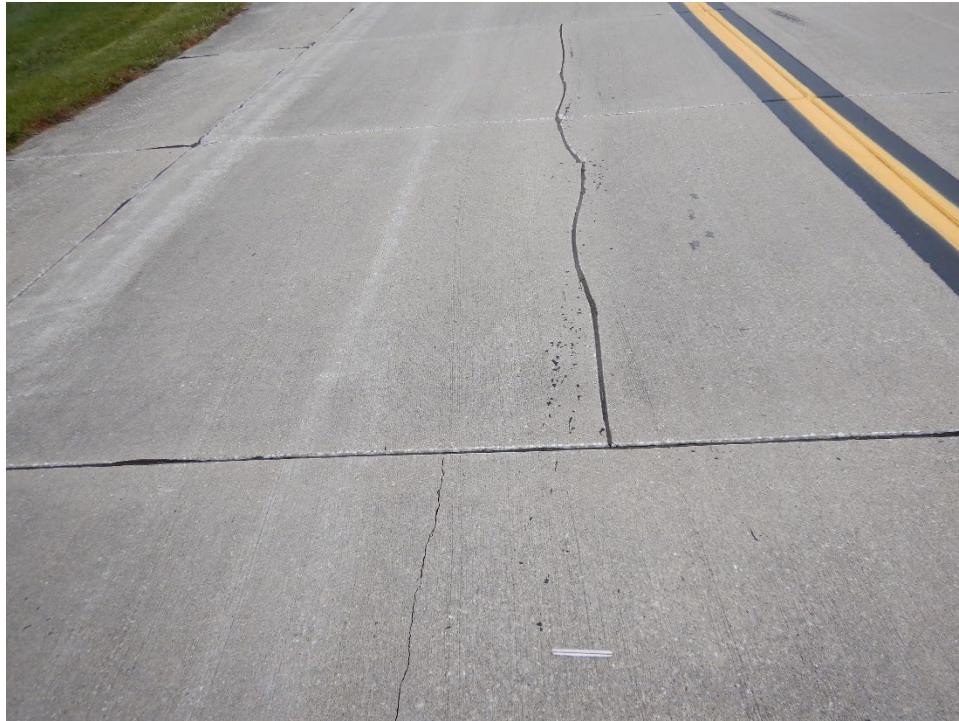
T01BP-01. LTD Cracking (Sample Unit No. 02).

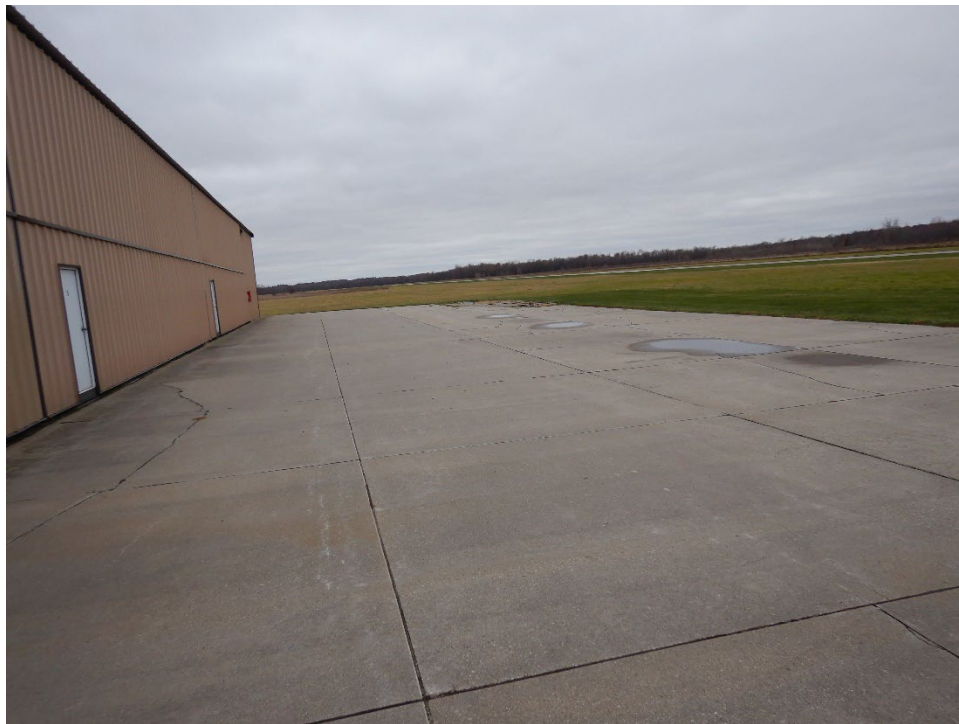
The T-hangar area consisted of two sections. Section 01 was in poor condition with medium-severity joint seal damage recorded throughout, along with areas of all severities of ASR and low- and medium-severity corner break, corner spalling, LTD cracking, and shattered slab. In Section 02, areas of low-severity corner break, faulting, and joint seal damage; medium-severity LTD cracking; and shrinkage cracking were observed.

TH01BP-01. Overview.

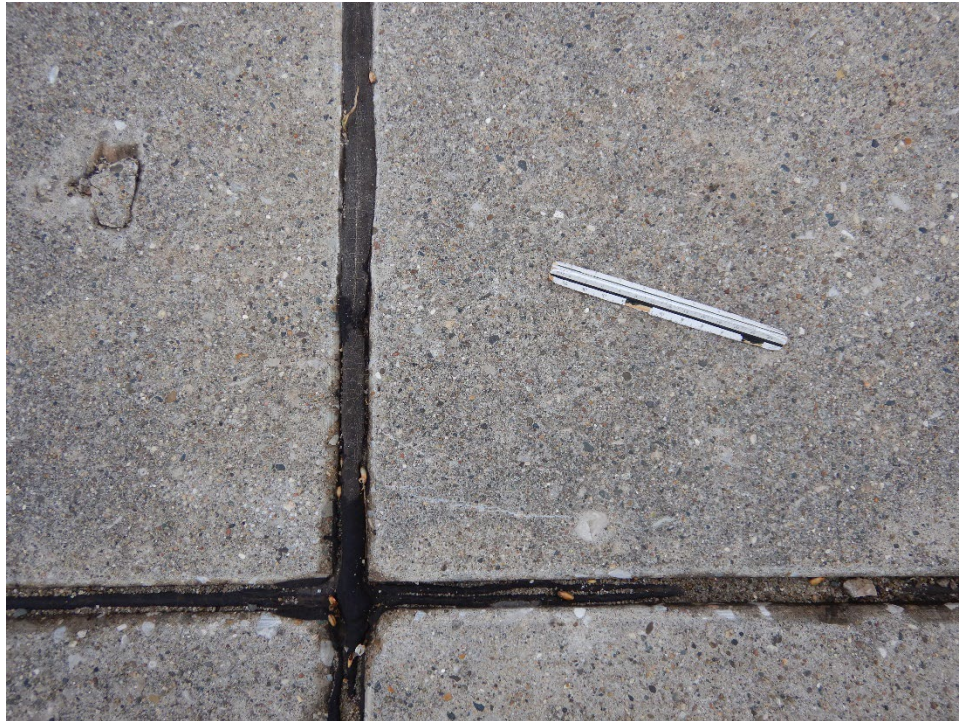
TH01BP-01. ASR (Sample Unit No. 01) (1).

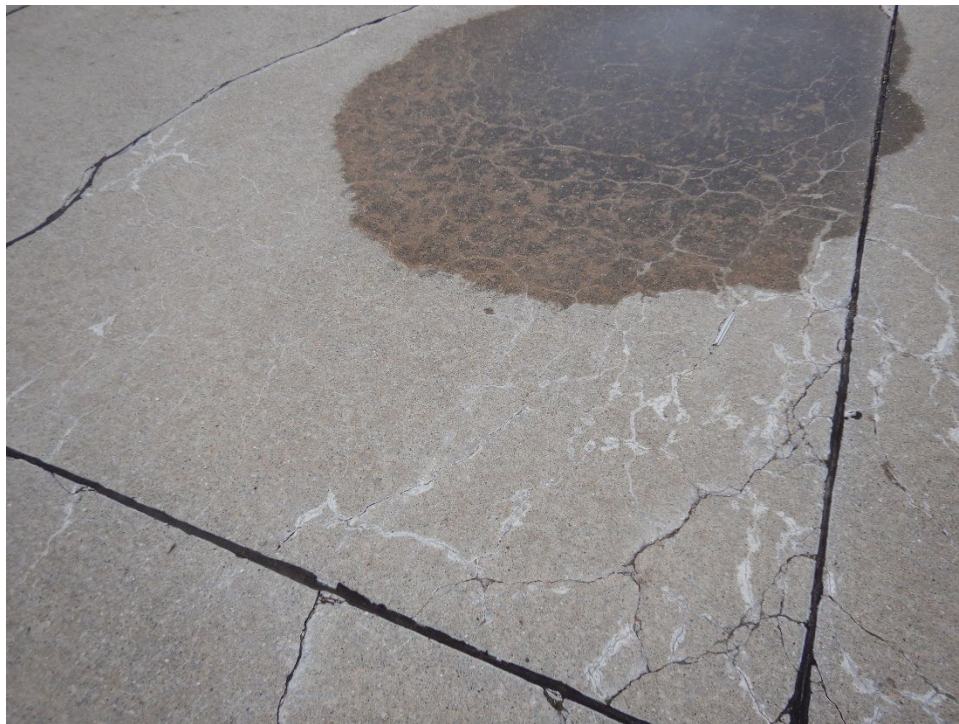
TH01BP-01. ASR (Sample Unit No. 01) (2).

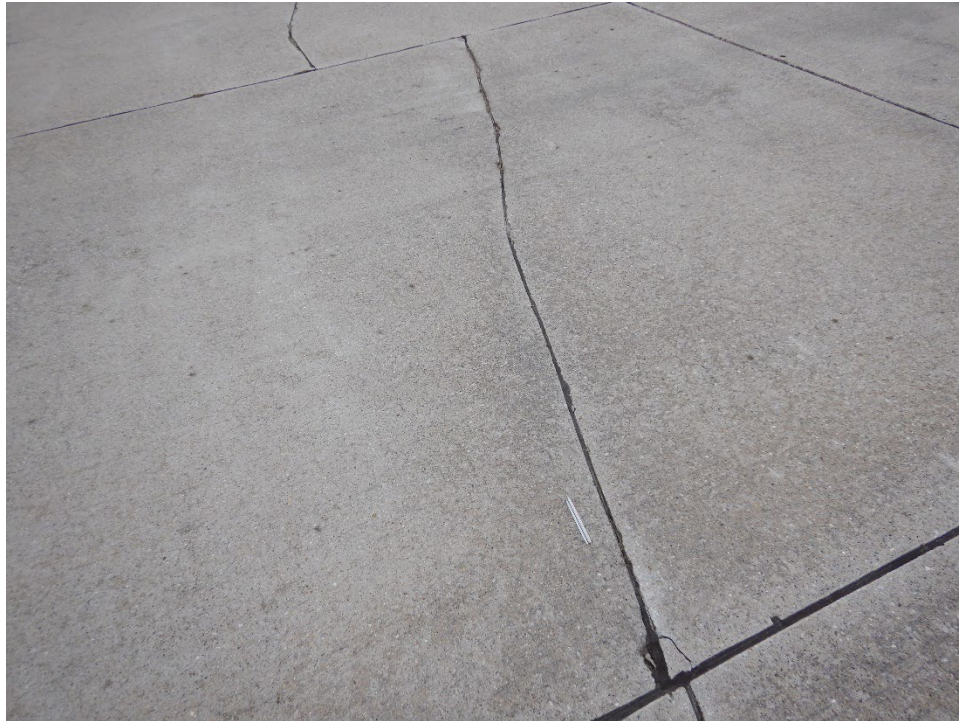
TH01BP-01. LTD Cracking (Sample Unit No. 01).

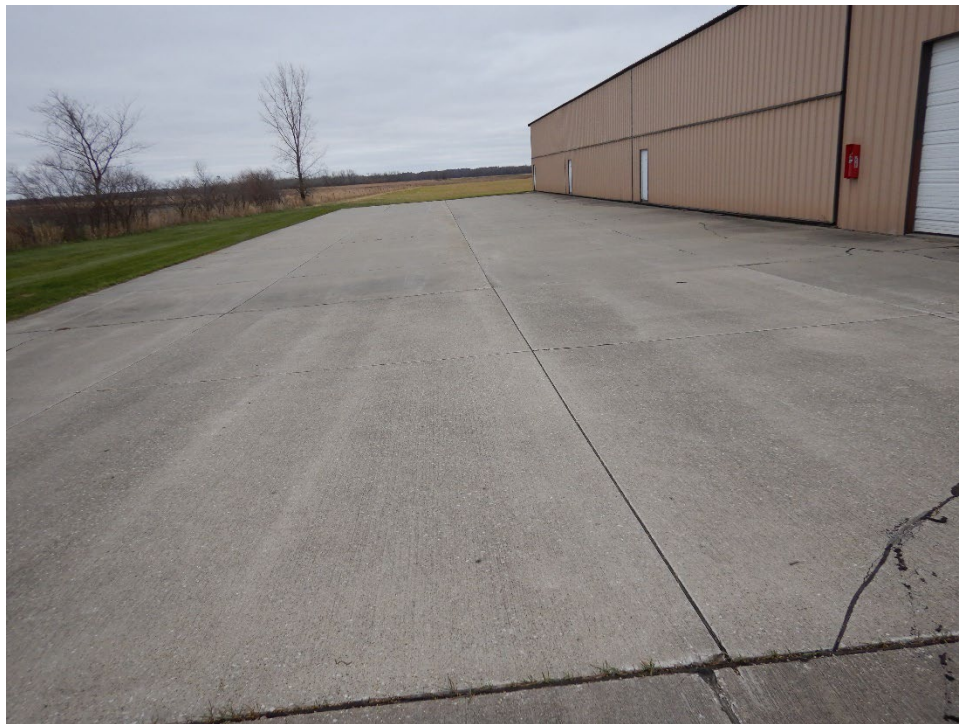
TH01BP-02. Overview.

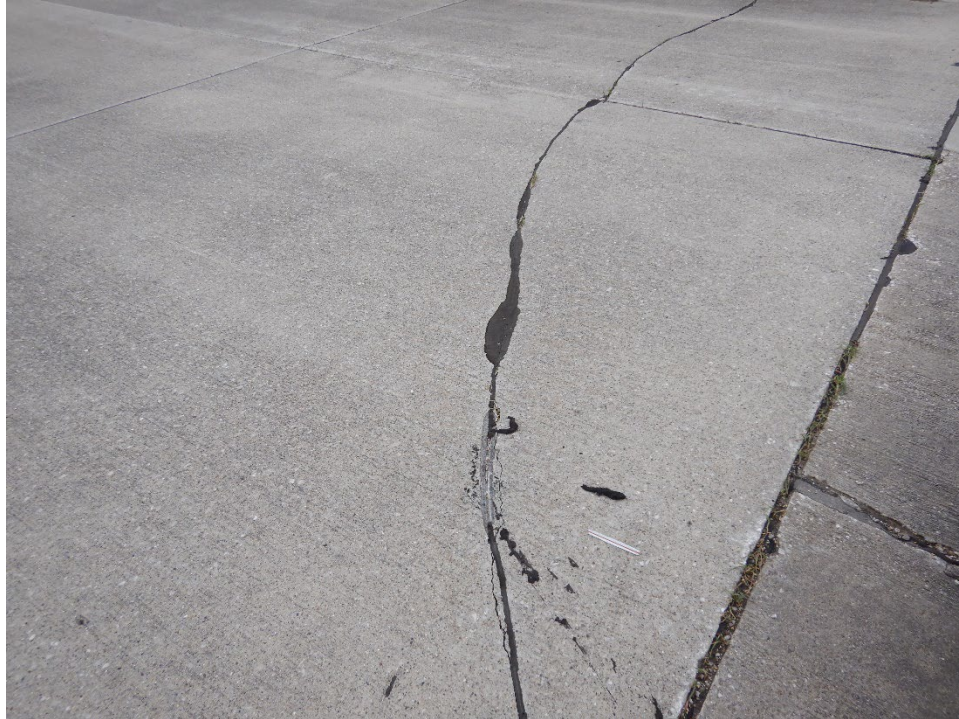
TH01BP-02. LTD Cracking (Sample Unit No. 01).
