Boone Municipal Airport

Pavement Management Report

JULY 2024

BOONE MUNICIPAL AIRPORT PAVEMENT MANAGEMENT REPORT

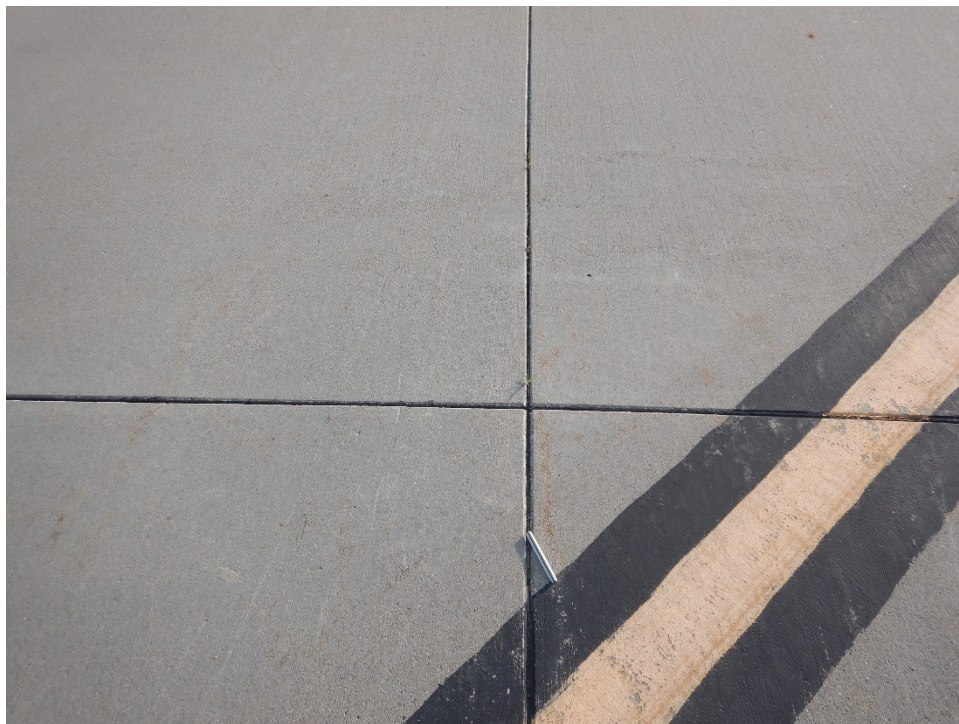
A01BO-01. Joint Seal Damage (Sample Unit No. 08).

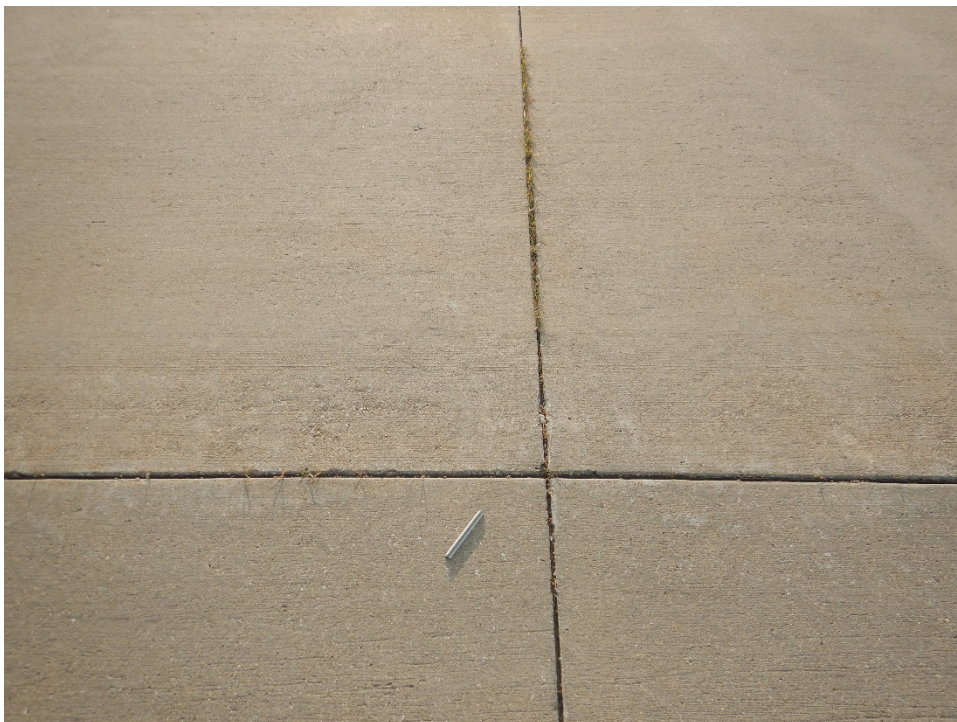
A01BO-02. Joint Seal Damage (Sample Unit No. 29).

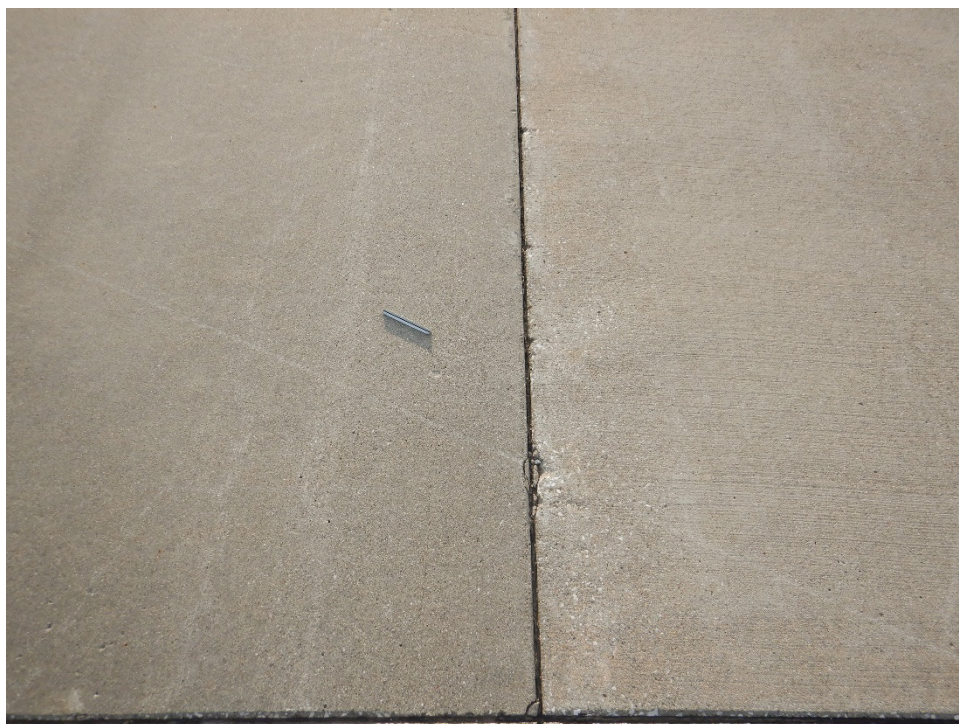
A01BO-03. Joint Seal Damage (Sample Unit No. 03).

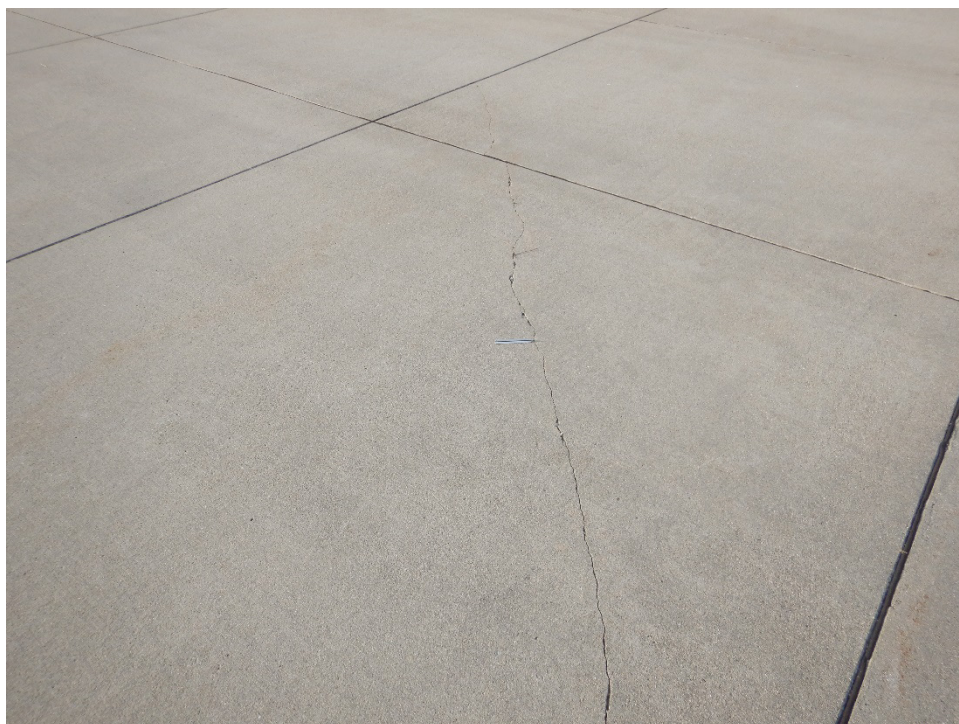
A01BO-04. LTD Cracking (Additional Sample Unit No. 07).

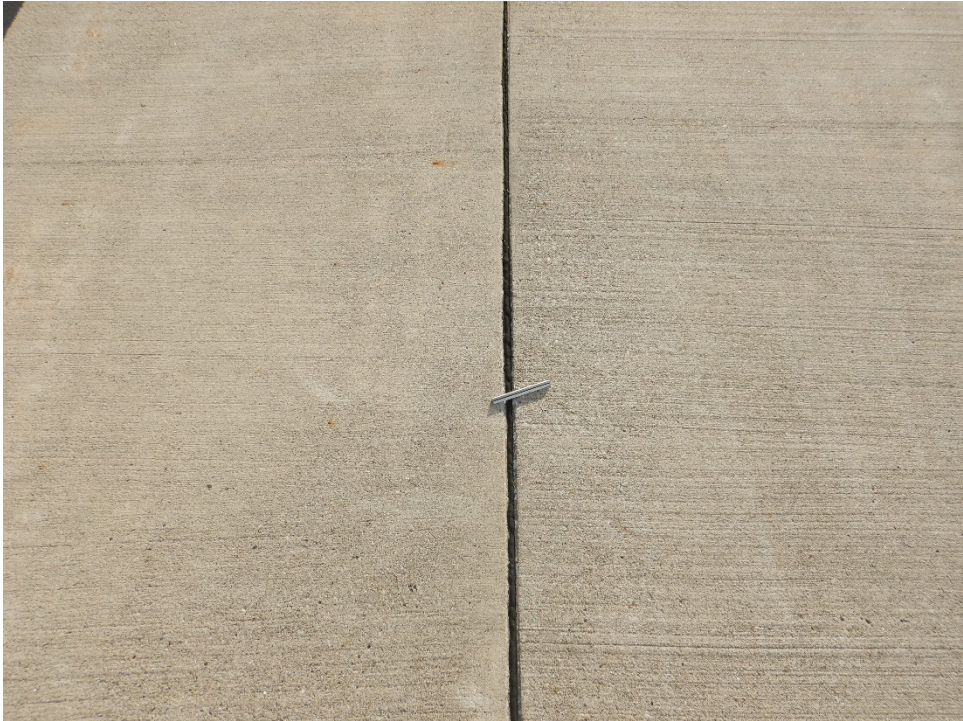
Runway 02/20 contained one section. Medium-severity joint seal damage was recorded throughout Section 01.

R02BO-01. Joint Seal Damage (Sample Unit No. 02).

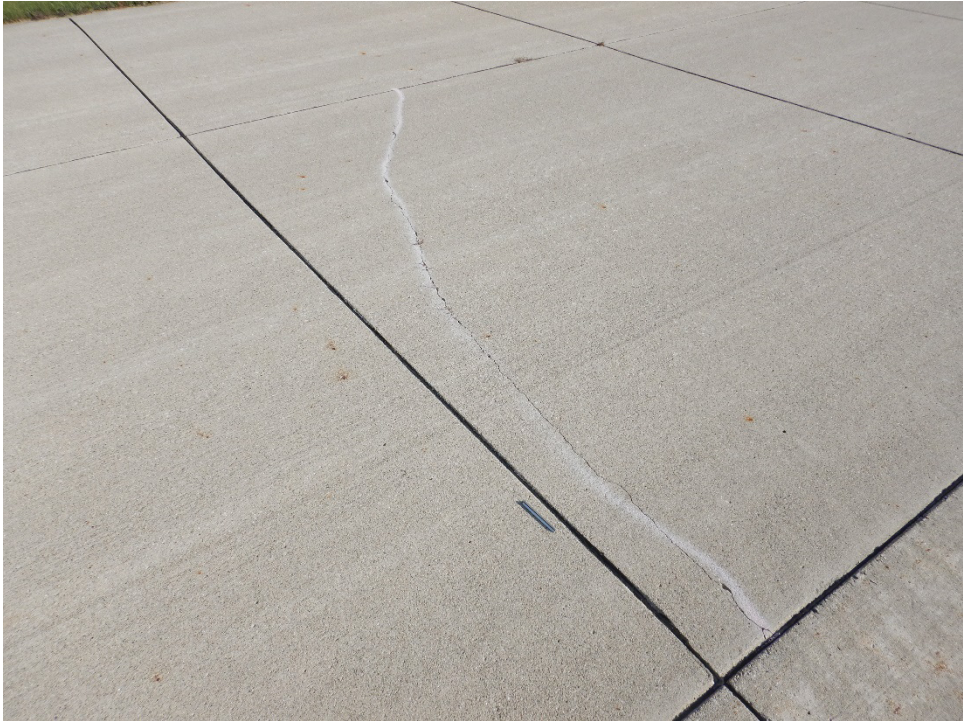
Runway 15/33 was defined by two sections. Section 01 had areas of low-severity faulting and joint spalling; medium-severity corner spalling and longitudinal, transverse, and diagonal (LTD) cracking; and high-severity joint seal damage identified during the inspection. Section 02 was in excellent condition with only low-severity small patching observed.

R15BO-01. LTD Cracking (Sample Unit No. 59).

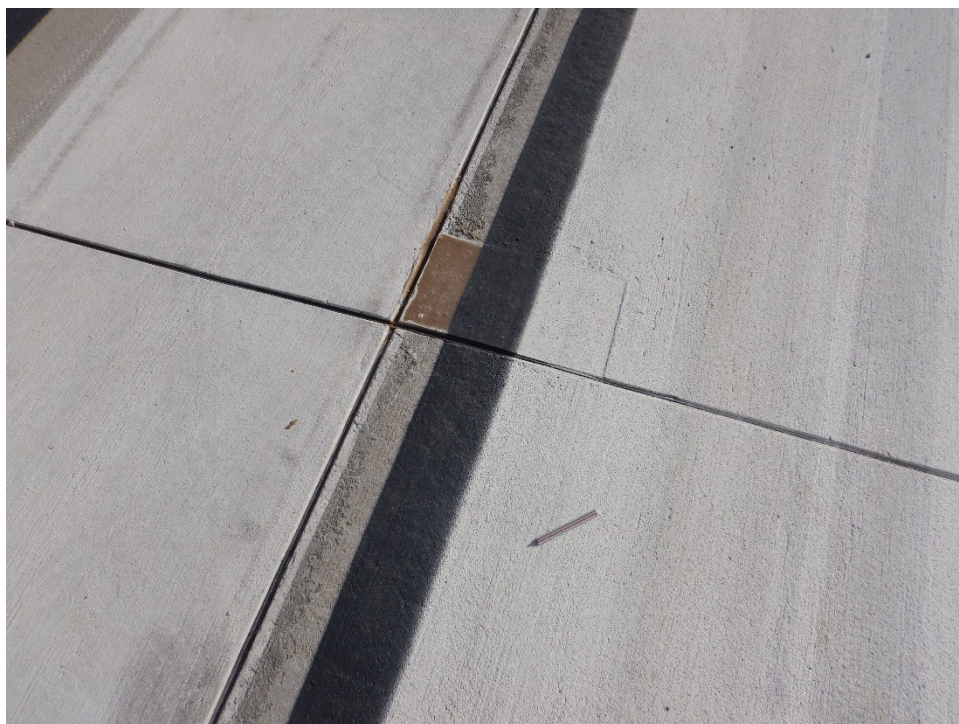
R15BO-02. Small Patching (Sample Unit No. 37).

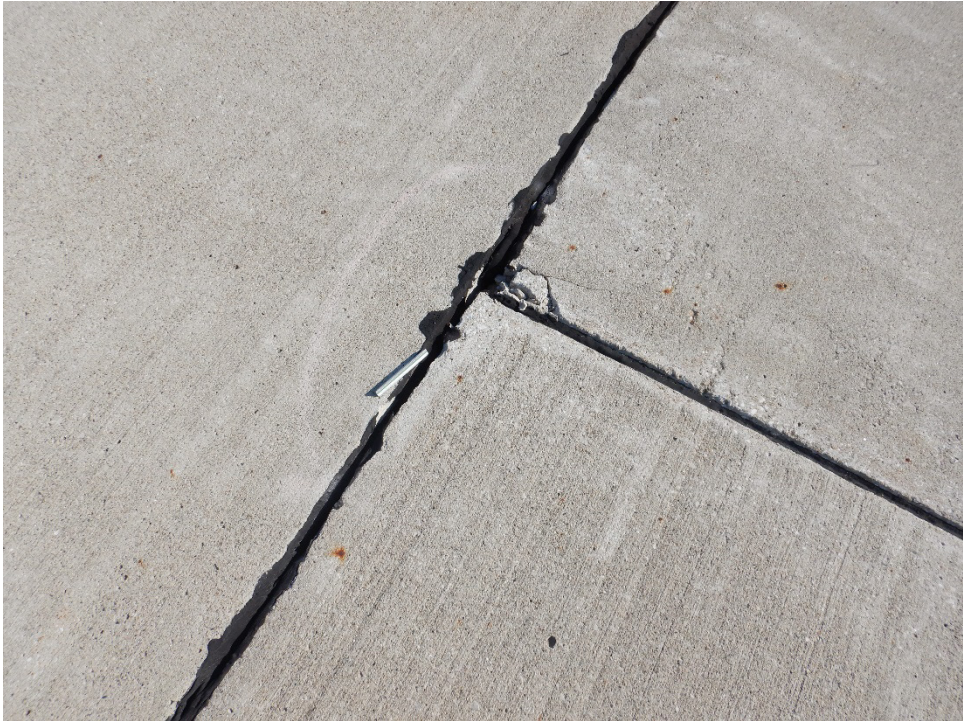
Taxiway A1 was defined by one section. Areas of medium-severity corner spalling and medium- and high-severity joint seal damage were recorded in Section 01.

TA1BO-01. Corner Spalling (Sample Unit No. 01).

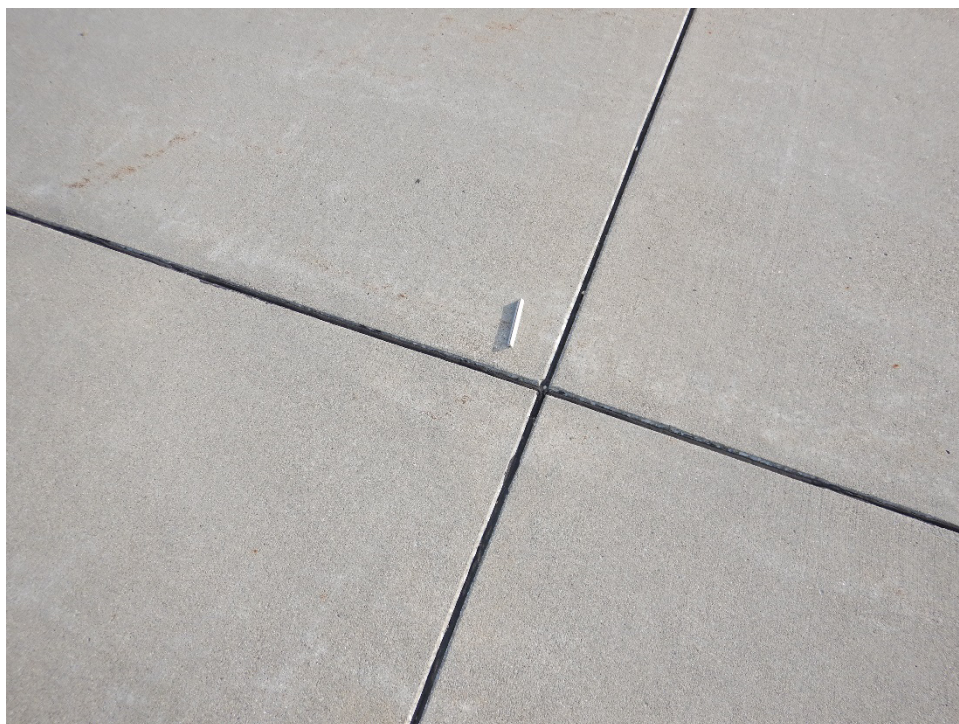
TA2BO-01. Joint Seal Damage (Sample Unit No. 02).

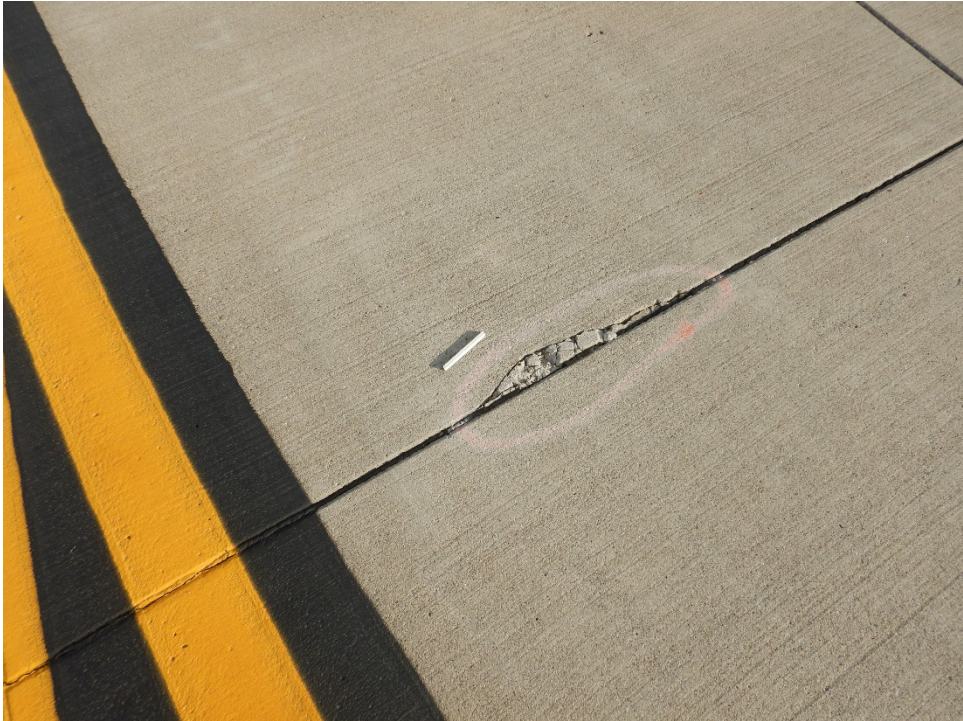
TA2BO-02. Joint Spalling (Sample Unit No. 04).

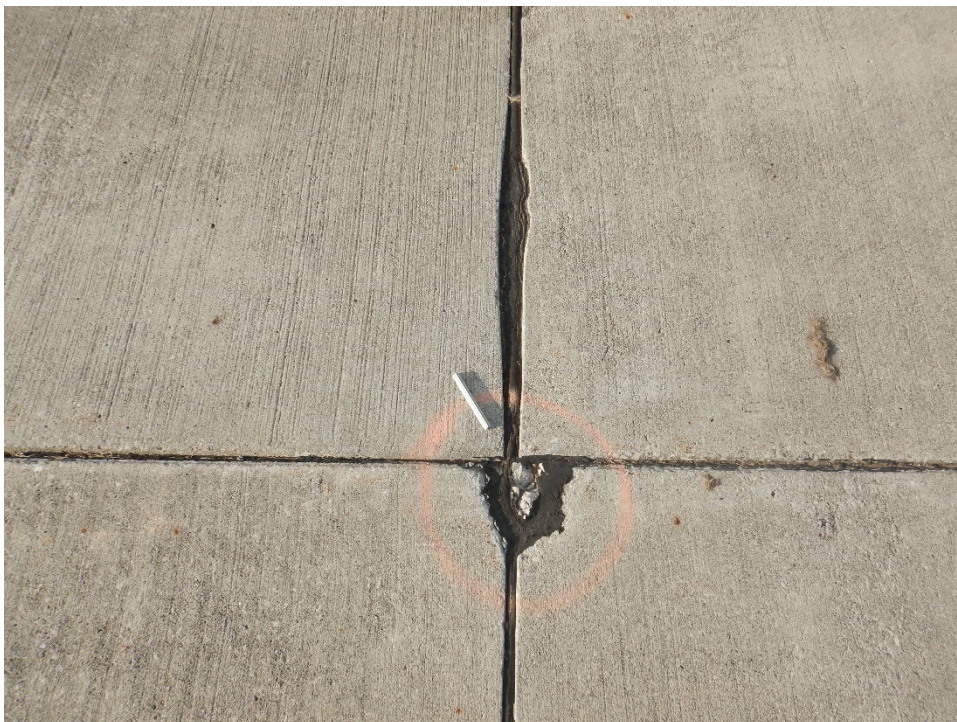
Taxiway A3 contained one section. Areas of low-severity faulting, medium-severity corner spalling and LTD cracking, and medium- and high-severity joint seal damage were identified in Section 01.

TA3BO-01. Corner Spalling (Sample Unit No. 02).

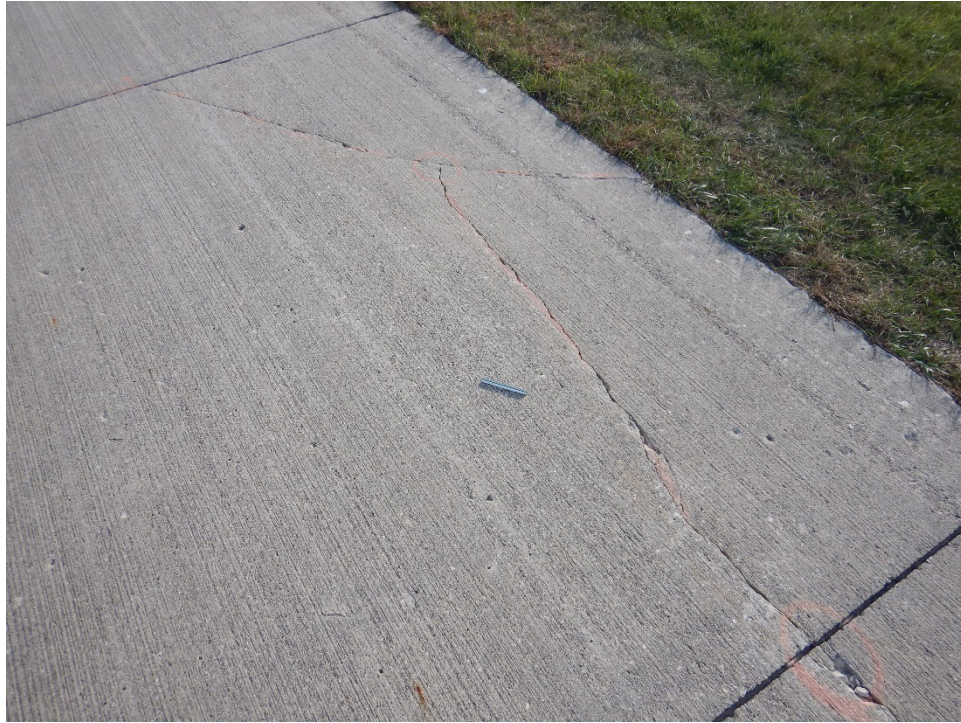
Taxiway A consisted of one section. Low-severity corner break, faulting, and joint spalling; low- and medium-severity alkali-silica reaction (ASR) and corner spalling; low- and high-severity joint seal damage; medium-severity LTD cracking and shattered slab; and high-severity large patching were observed in Section 01. The suspected ASR was recorded in accordance with ASTM D5340. It should be noted that laboratory testing in the form of petrographic analysis is the only definitive way to validate the presence of ASR; however, the formation of a precipitate is evidence of a reaction consistent with this type of materials-related distress.

TABO-01. LTD Cracking (Sample Unit No. 33).

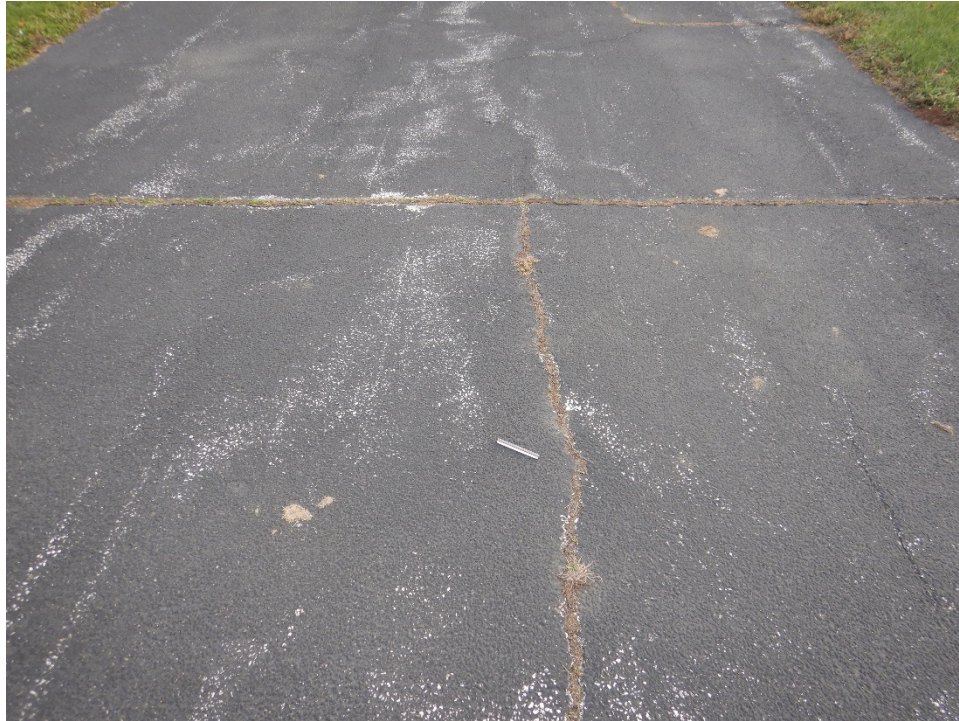
TH01BO-01. L&T Cracking (Sample Unit No. 02).

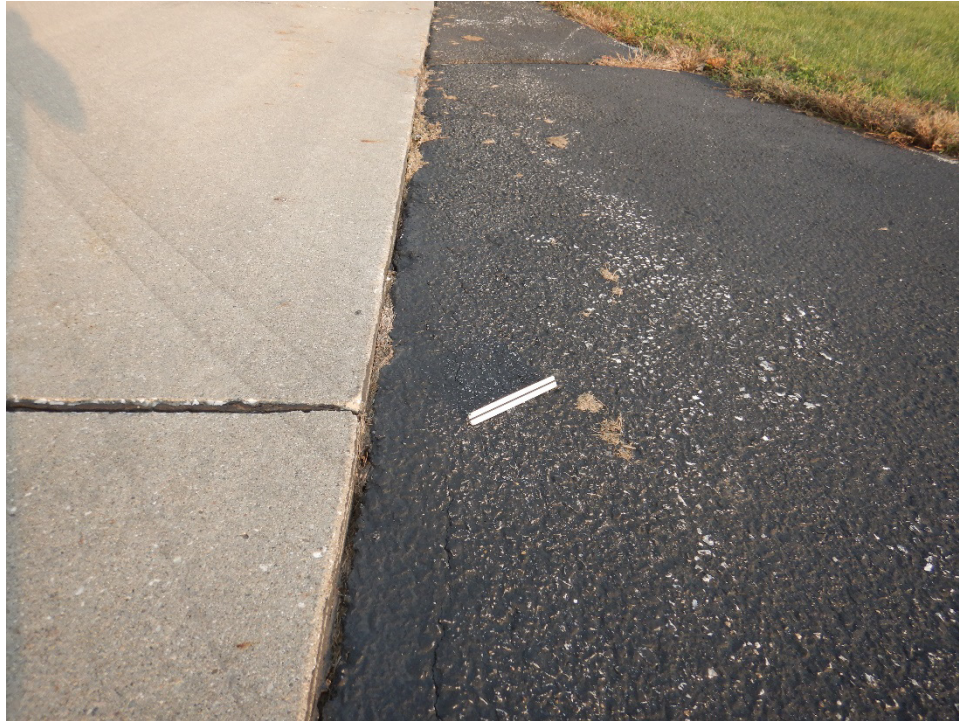
TH01BO-02. Depression (Sample Unit No. 01).

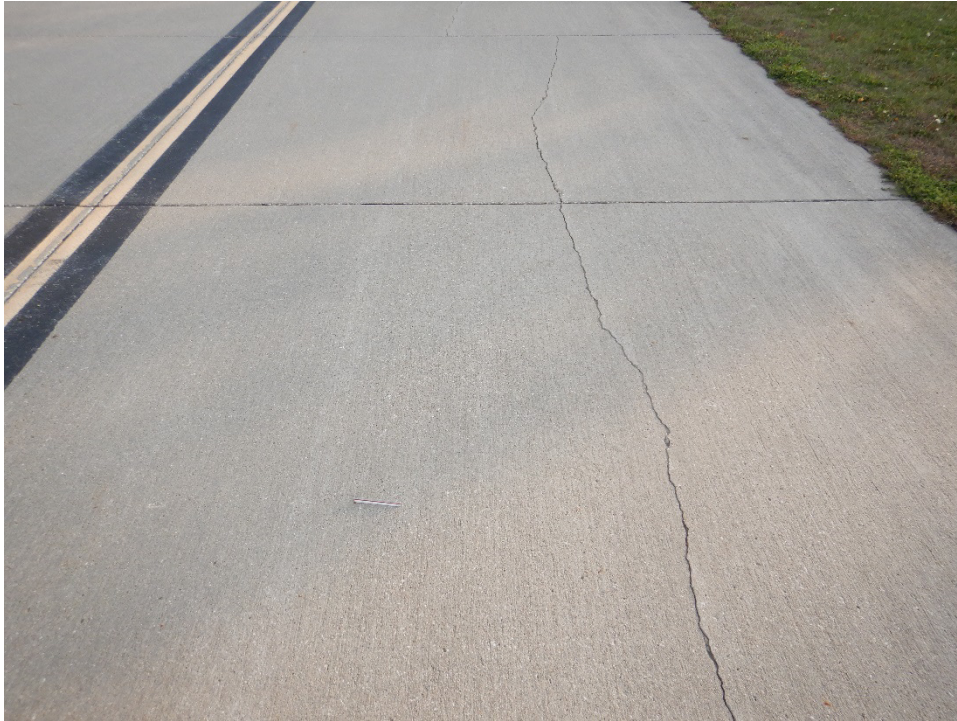
TH01BO-03. LTD Cracking (Sample Unit No. 10).

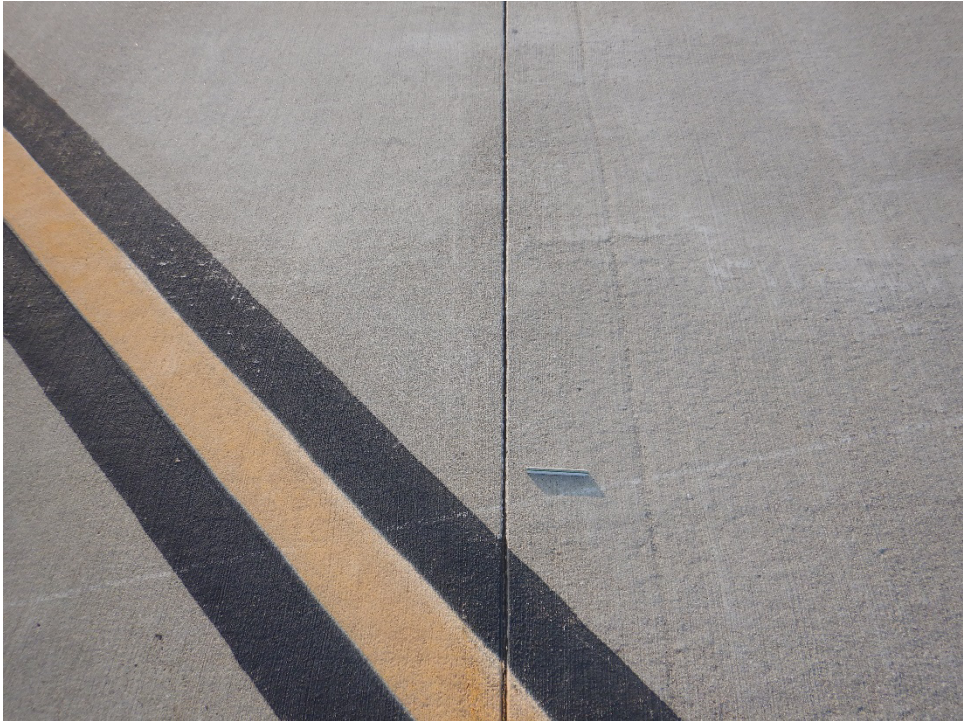
TH02BO-01. Joint Seal Damage (Sample Unit No. 03).

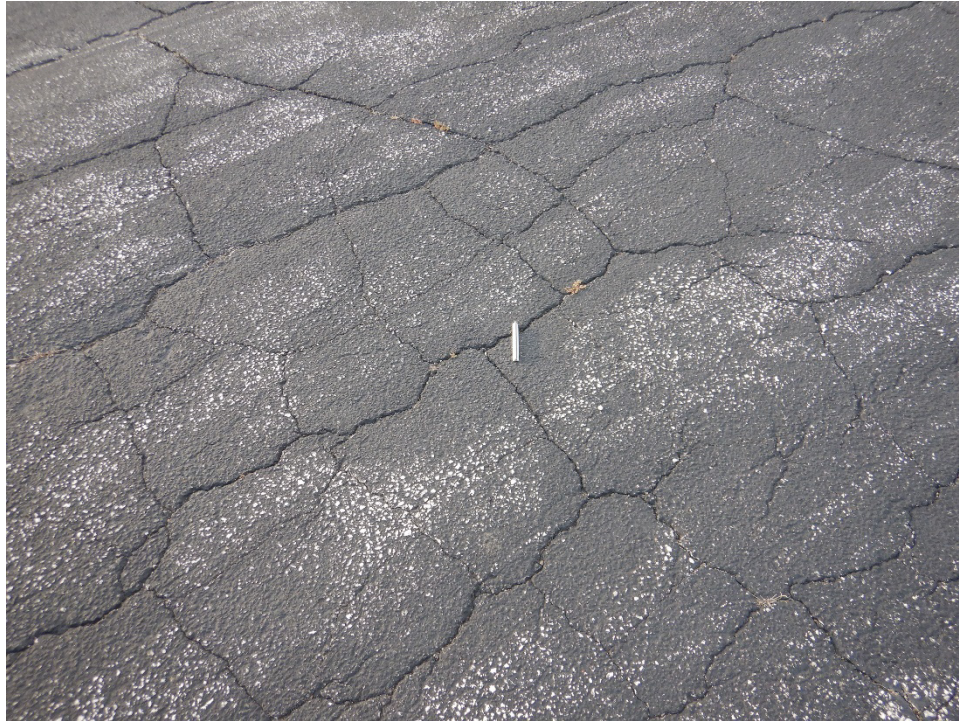
TH02BO-02. Alligator Cracking (Sample Unit No. 01).

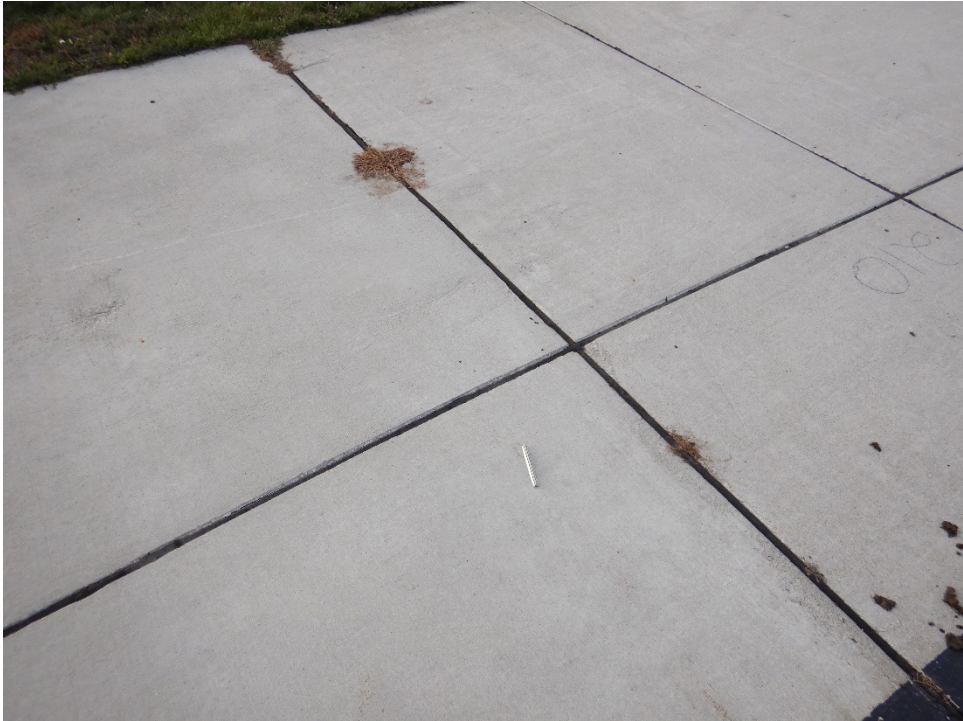
TH02BO-03. Joint Seal Damage (Sample Unit No. 05).

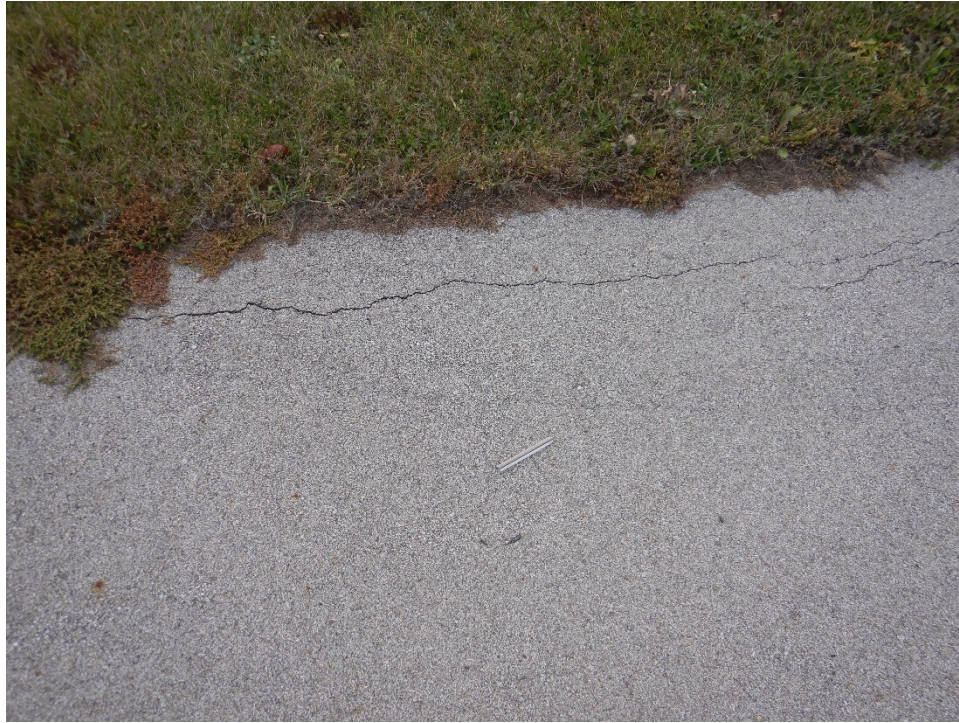
TH02BO-04. L&T Cracking (Sample Unit No. 02).
