Cherokee County Regional Airport

Pavement Management Report

JULY 2023

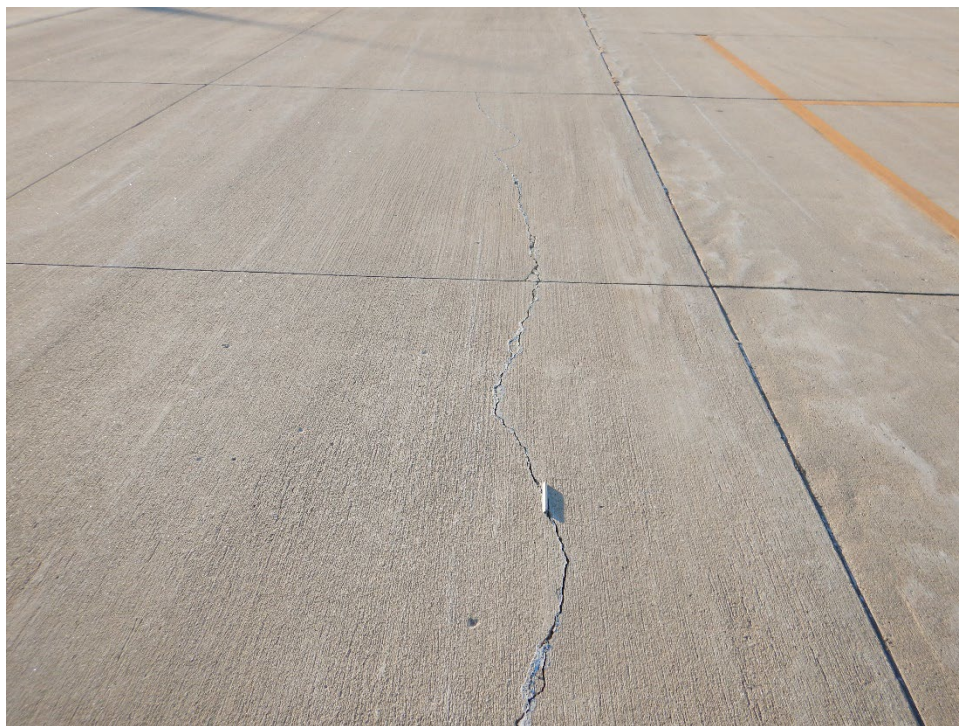
The apron area was defined by one section. Section 01 contained low- and medium-severity corner spalling and joint seal damage, low-severity faulting and joint spalling, and medium-severity longitudinal, transverse, and diagonal (LTD) cracking.

A01CK-01. LTD Cracking (Sample Unit No. 05).

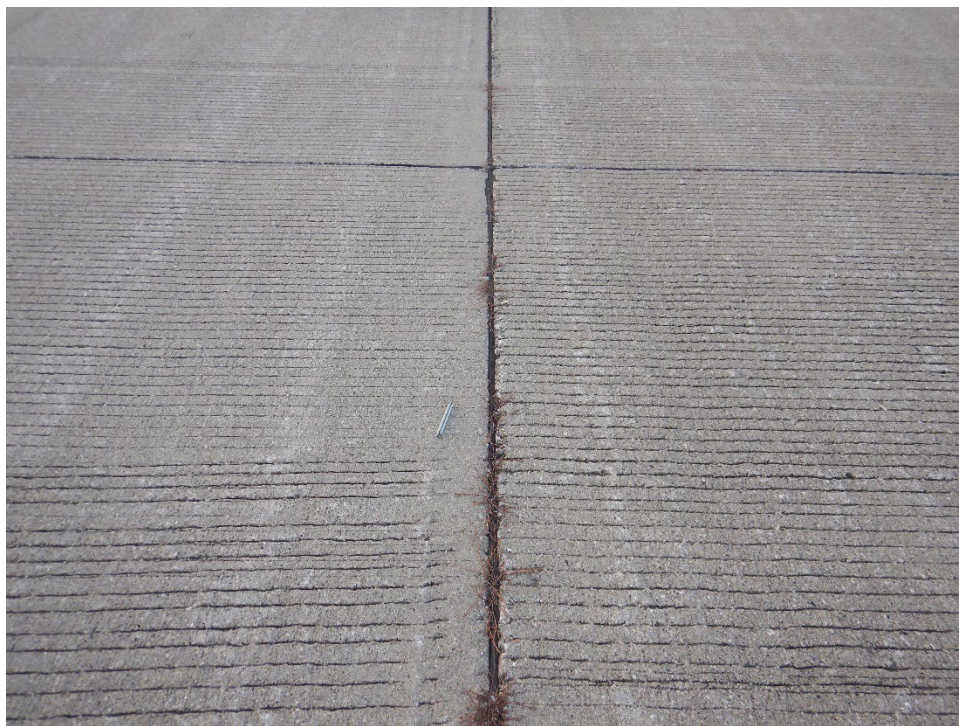
Runway 18/36 was defined by one section. Areas of low-severity joint spalling, small patching, and faulting; medium-severity corner spalling; and medium- and high-severity joint seal damage were identified in Section 01.

R18CK-01. Joint Seal Damage (Sample Unit No. 38).

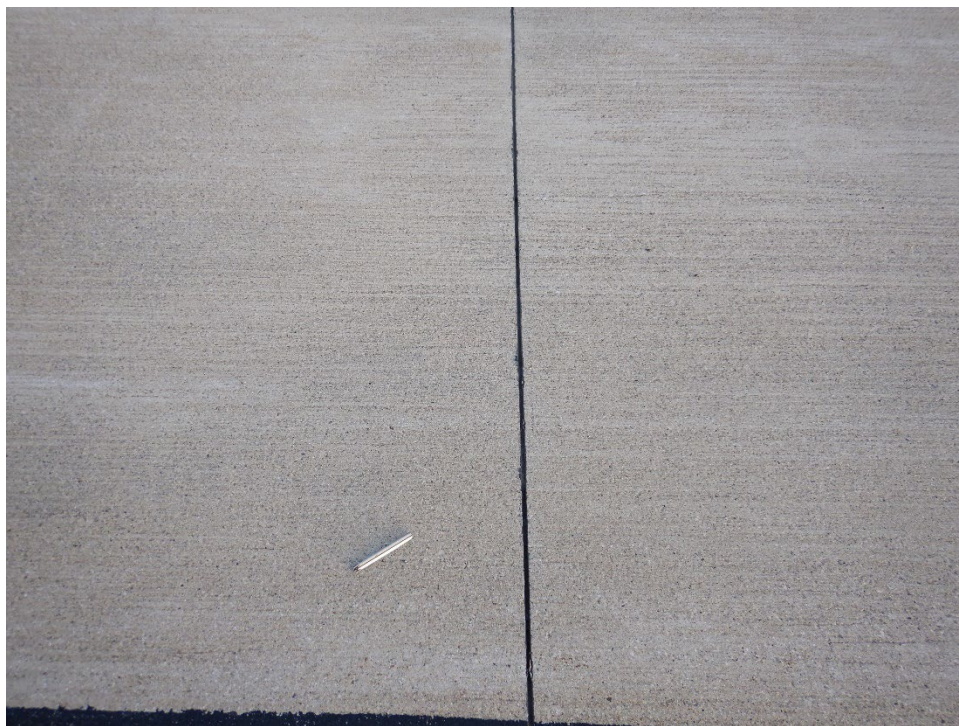
Taxiway 01, which connected Runway 18/36 to the apron area, contained one section. Section 01 was in excellent condition with shrinkage cracking and low-severity joint seal damage and small patching noted at the time of inspection.

T01CK-01. Joint Seal Damage (Sample Unit No. 03).

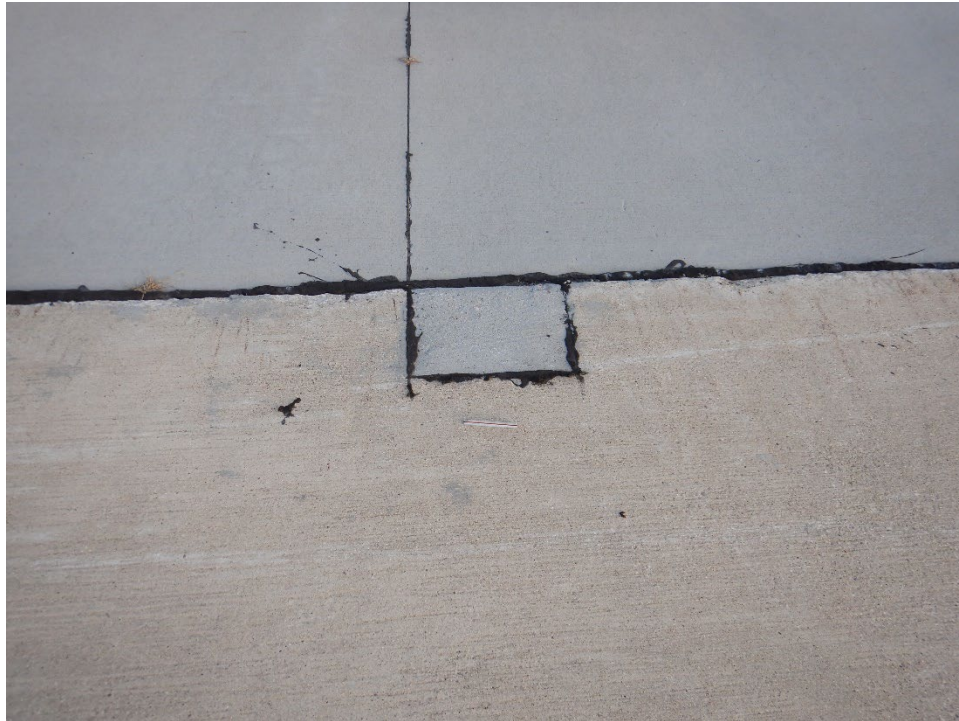
T01CK-01. Small Patching (Sample Unit No. 05).

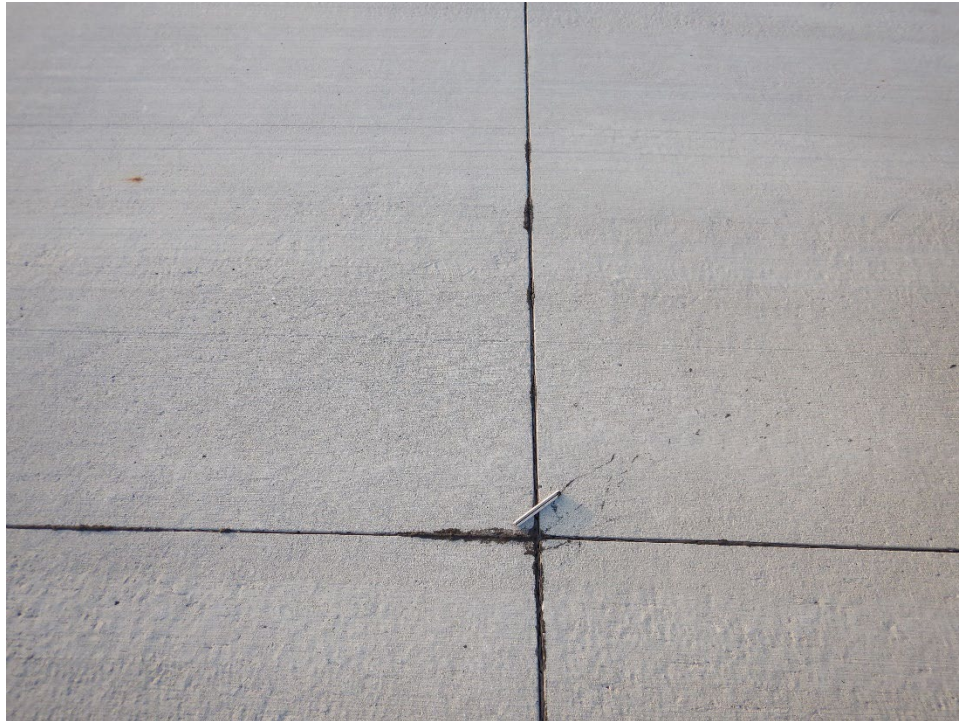
Taxiway 02, which connected Taxiway 01 to Runway 18 approach, consisted of one section. Section 01 was in excellent condition with low- and medium-severity joint seal damage identified throughout, along with an isolated amount of low-severity small patching.

T02CK-01. Joint Seal Damage (Sample Unit No. 03).

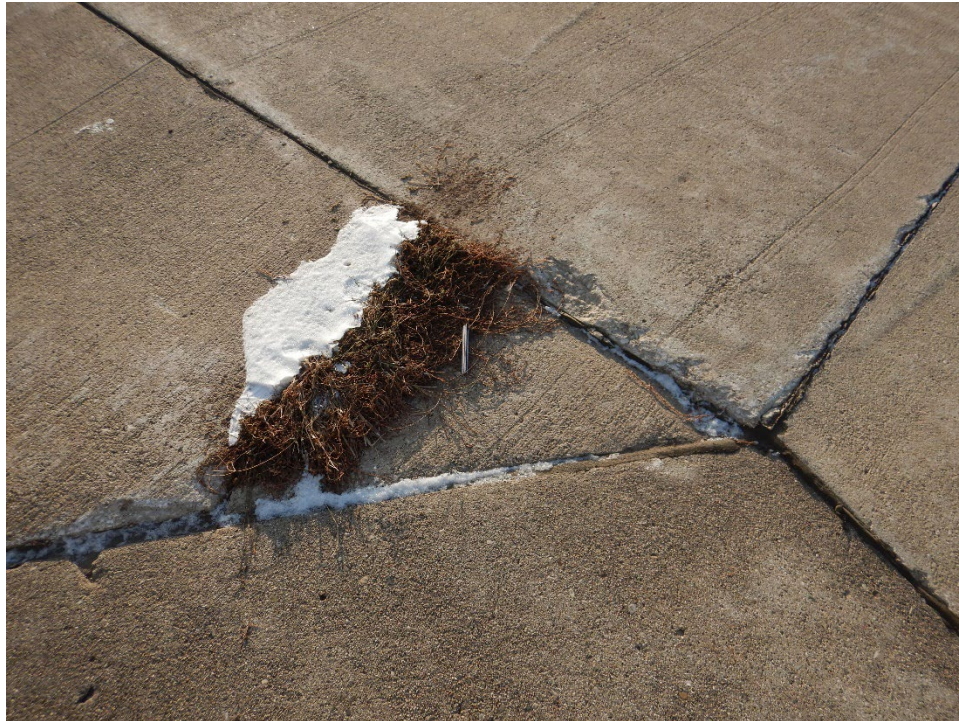
TH01CK-01. Corner Break (Sample Unit No. 03).

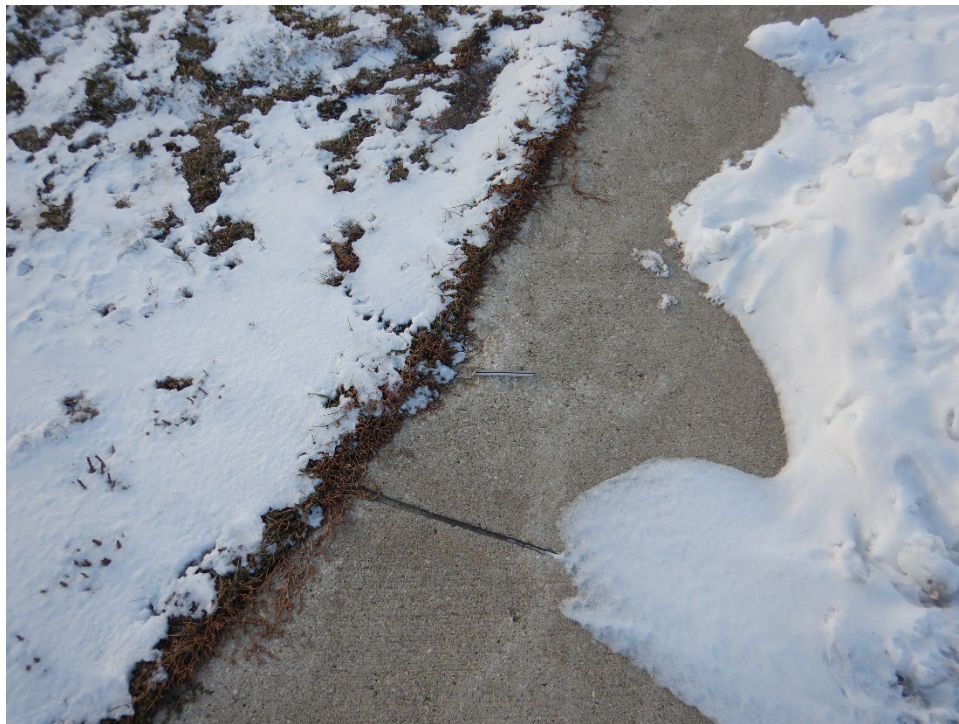
TH01CK-01. Joint Spalling (Sample Unit No. 02).

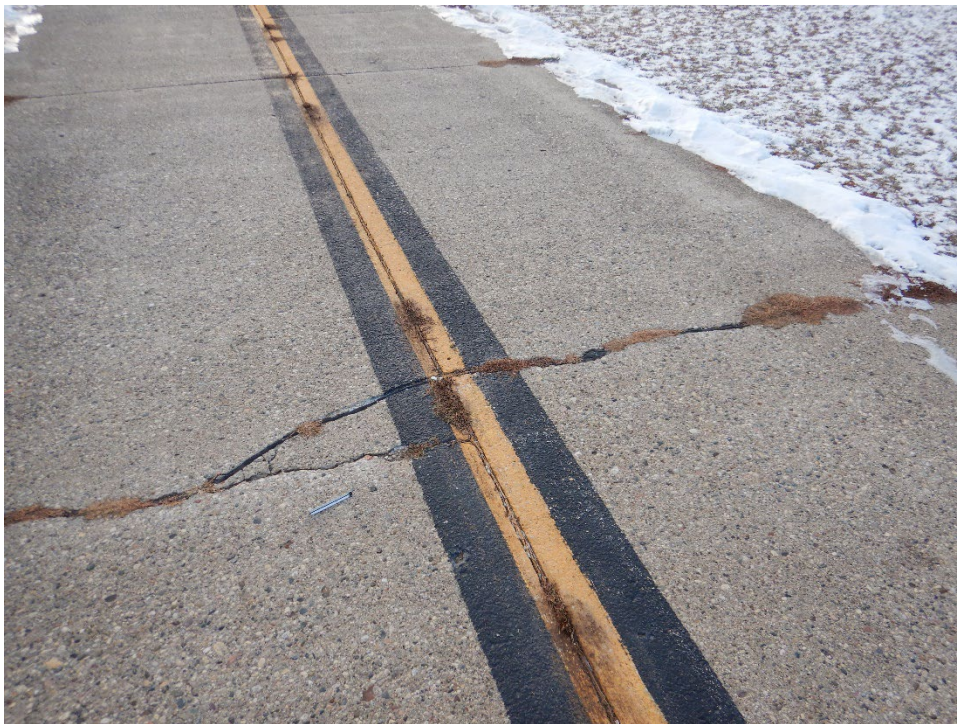
TH01CK-02. LTD Cracking (Sample Unit No. 01).

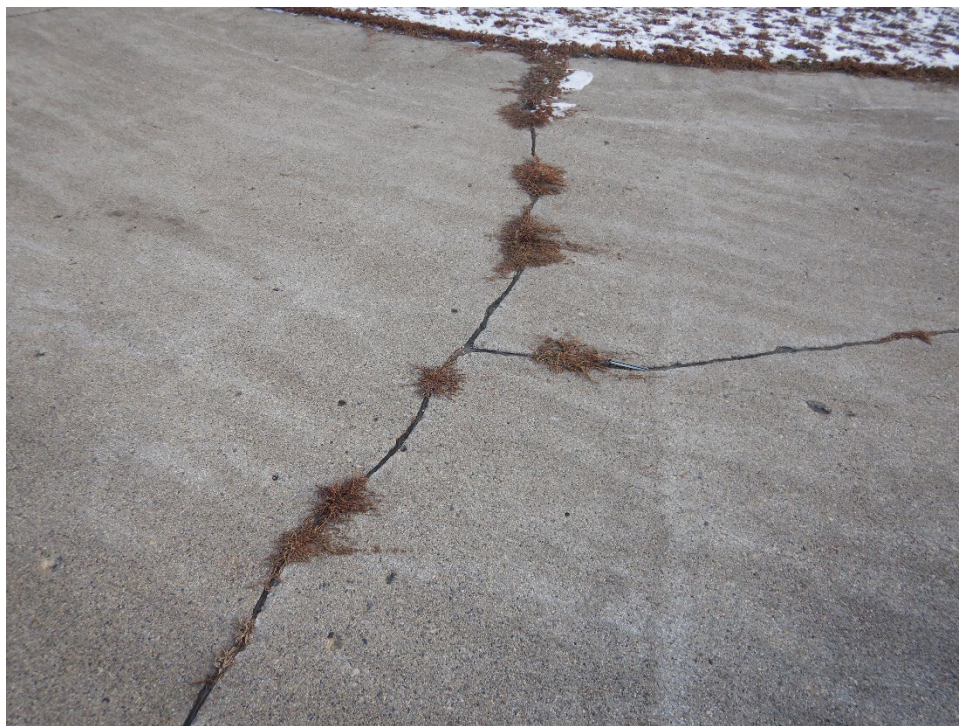
TH01CK-03. LTD Cracking (Sample Unit No. 04).

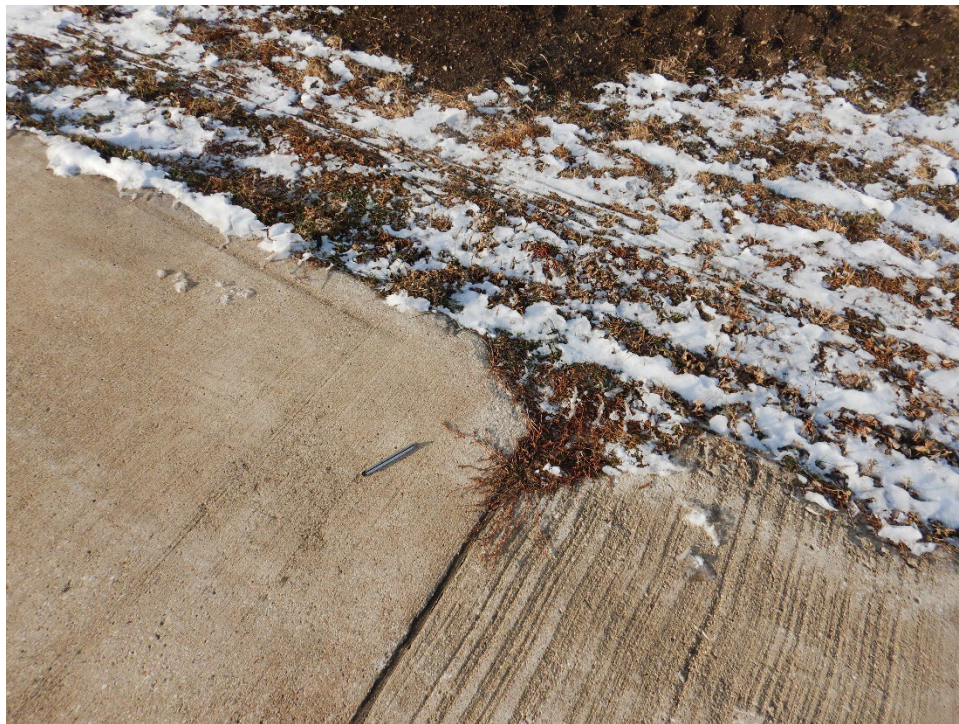
TH02CK-01. Corner Spalling (Sample Unit No. 01).

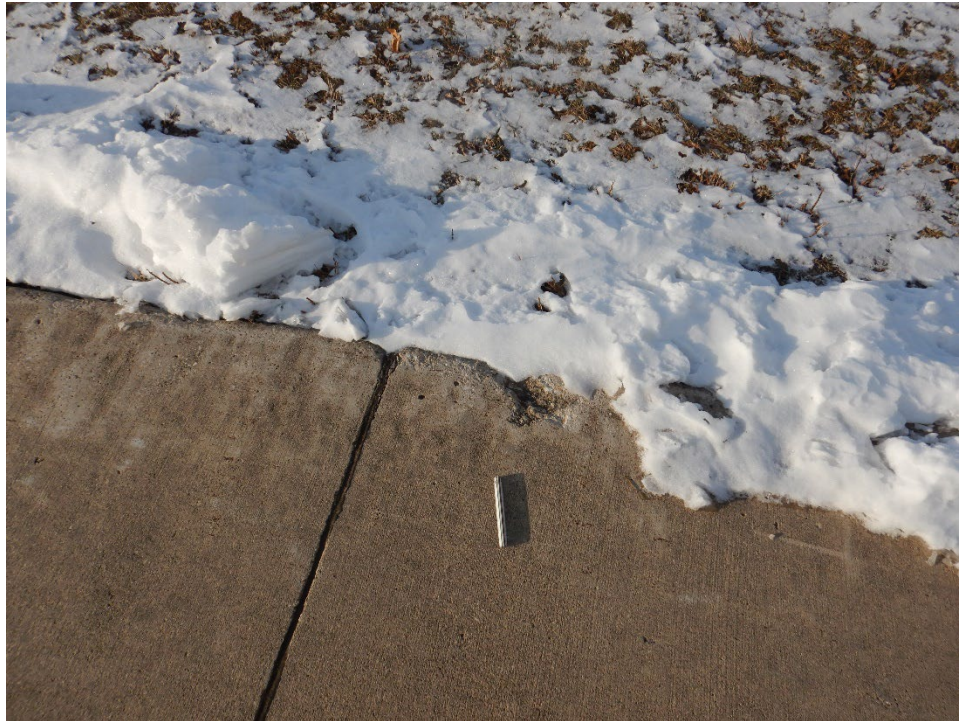
TH02CK-01. Joint Spalling (Sample Unit No. 01).

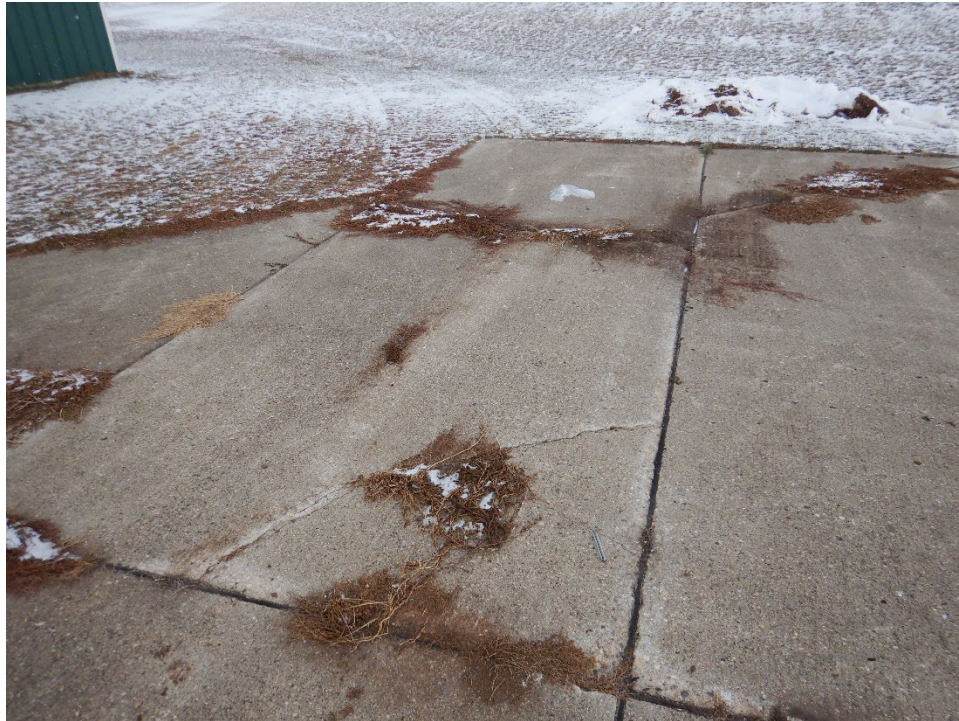
TH02CK-02. Shattered Slab (Sample Unit No. 03).

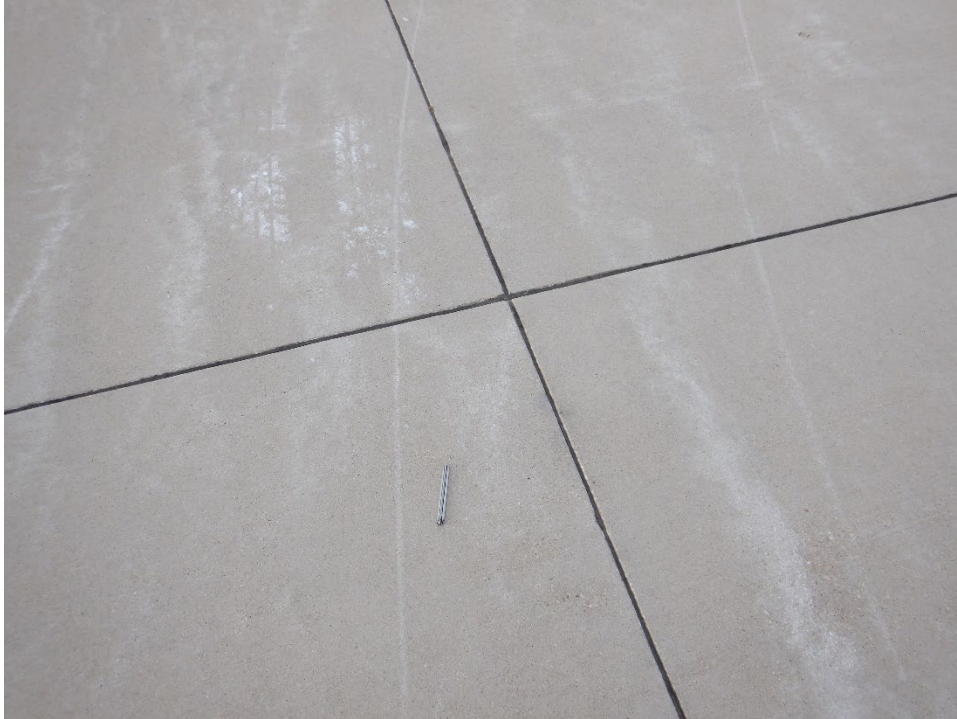
TH02CK-03. Joint Seal Damage (Sample Unit No. 01).

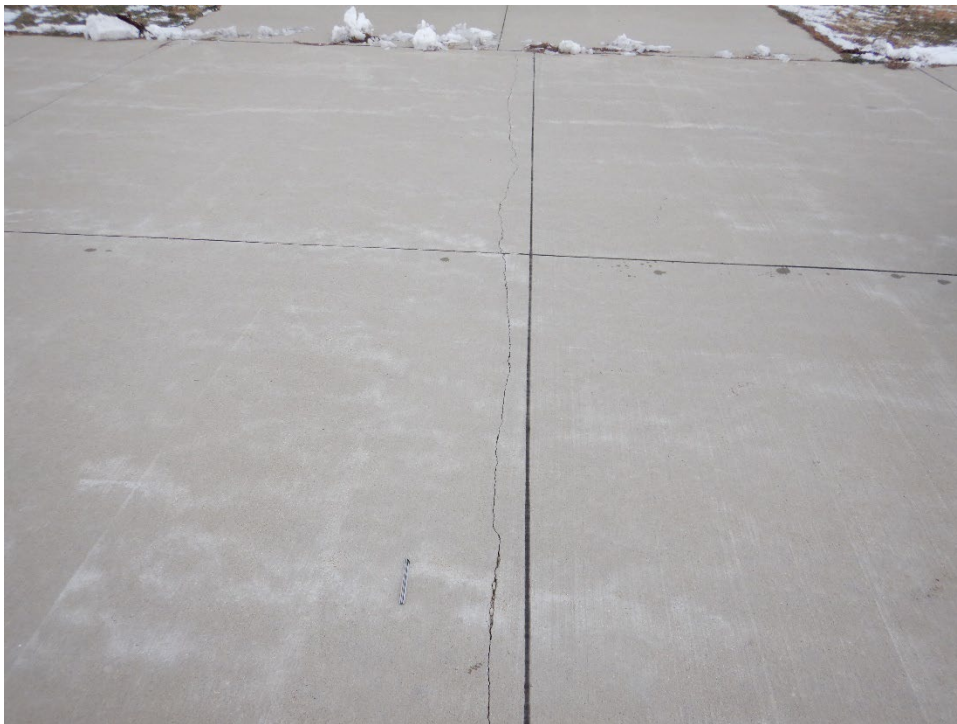
TH02CK-03. LTD Cracking (Sample Unit No. 02).
