Clarinda-Schenck Field Airport

PAVEMENT MANAGEMENT REPORT

JULY 2022

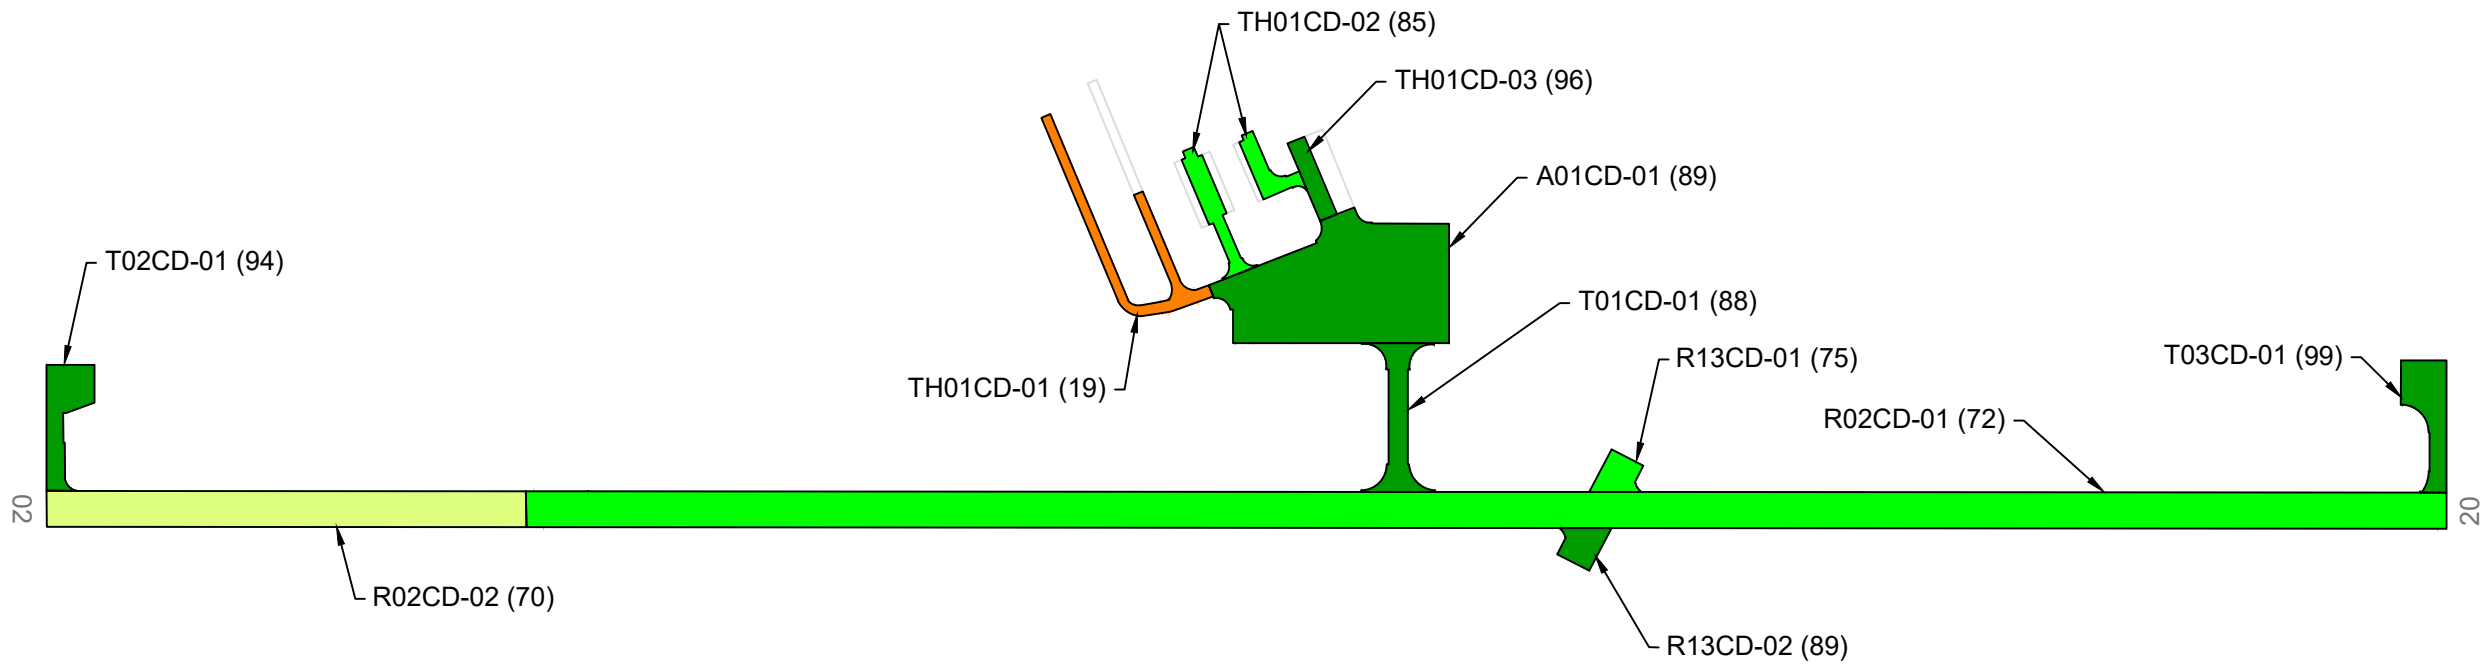
FIGURE 8. PCI MAP.

The pavements at Clarinda-Schenck Field Airport were inspected in November 2021. The 2021 area-weighted condition of Clarinda-Schenck Field Airport is 76, with conditions ranging from 19 to 99 (on a scale of 0 [failed] to 100 [excellent]). During the previous pavement inspection in 2018, the area-weighted PCI of the airport was 74.

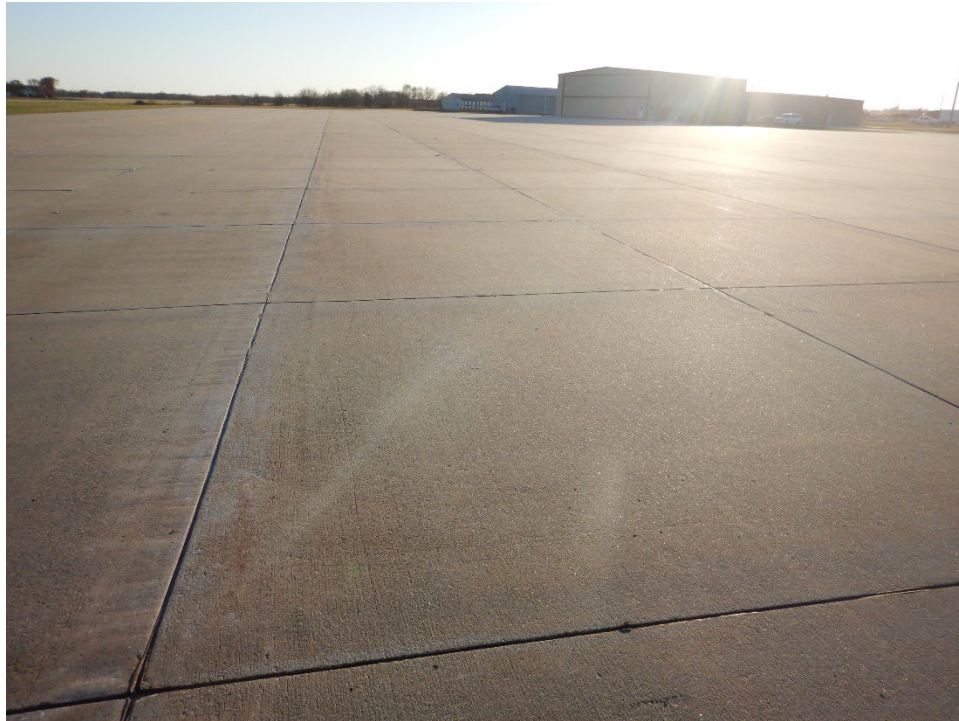
A01CD-01. Overview.

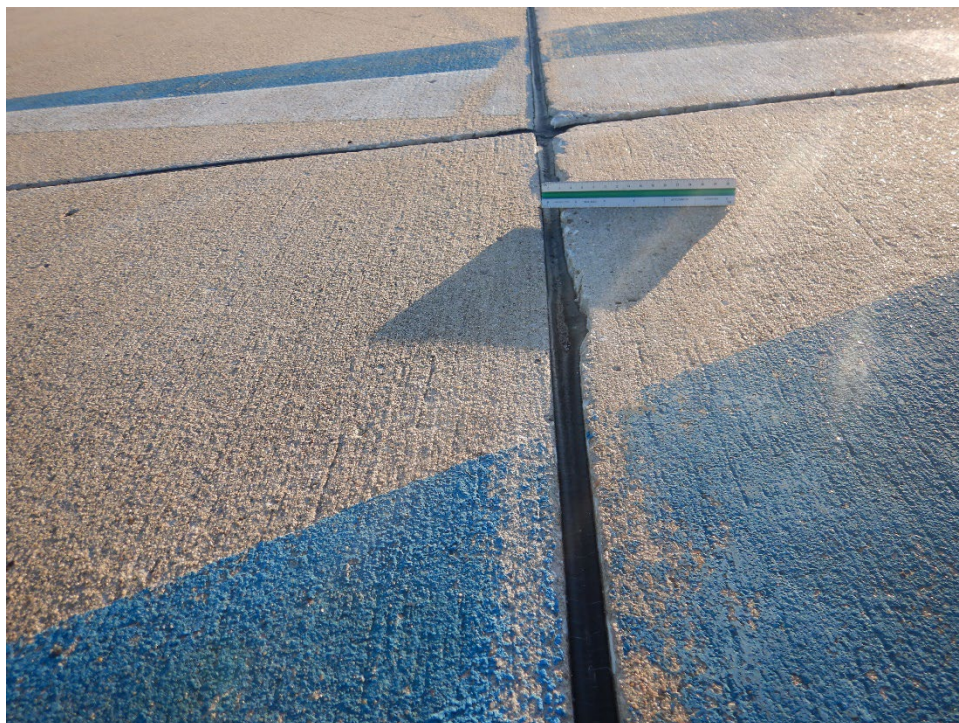
A01CD-01. Faulting (Sample Unit No. 13).

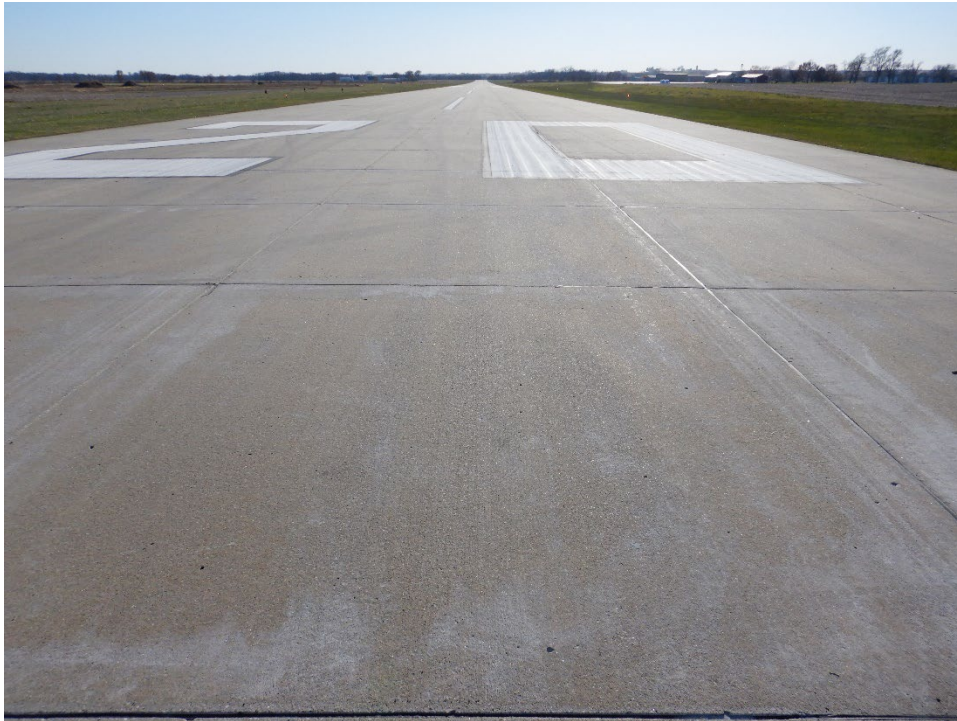
Runway 02/20 consisted of two sections. Section 01 contained medium-severity corner spalling and joint spalling, as well as low-severity ASR, faulting, large patching, small patching, and longitudinal, transverse, and diagonal (LTD) cracking. Low-severity ASR, faulting, LTD cracking, and small patching; low- and medium-severity corner spalling; and medium-severity joint spalling were recorded in Section 02.

R02CD-01. Overview.

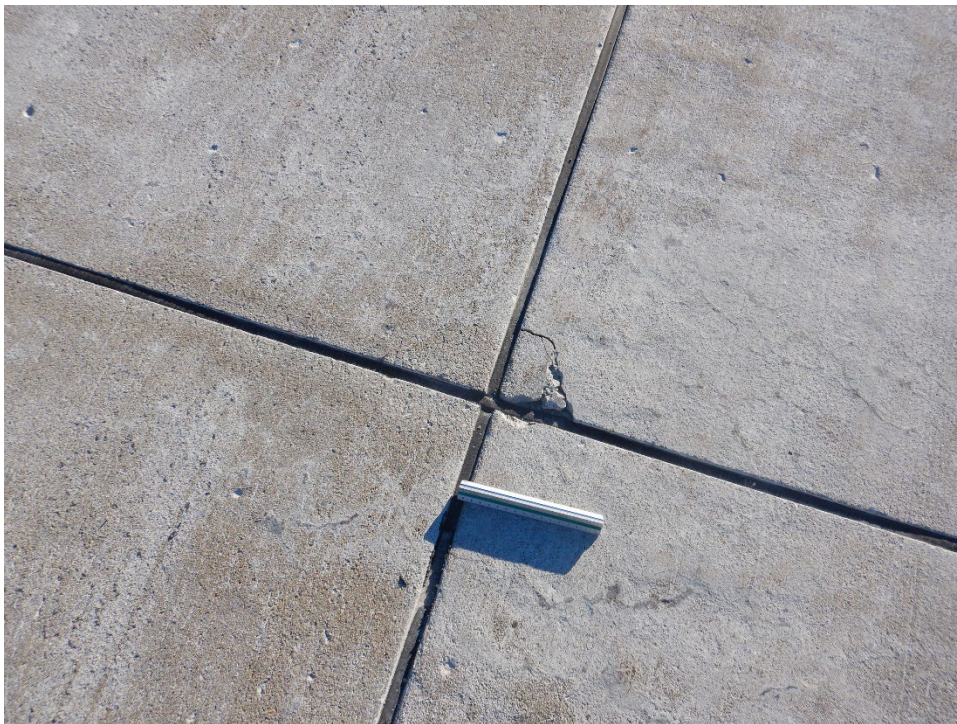
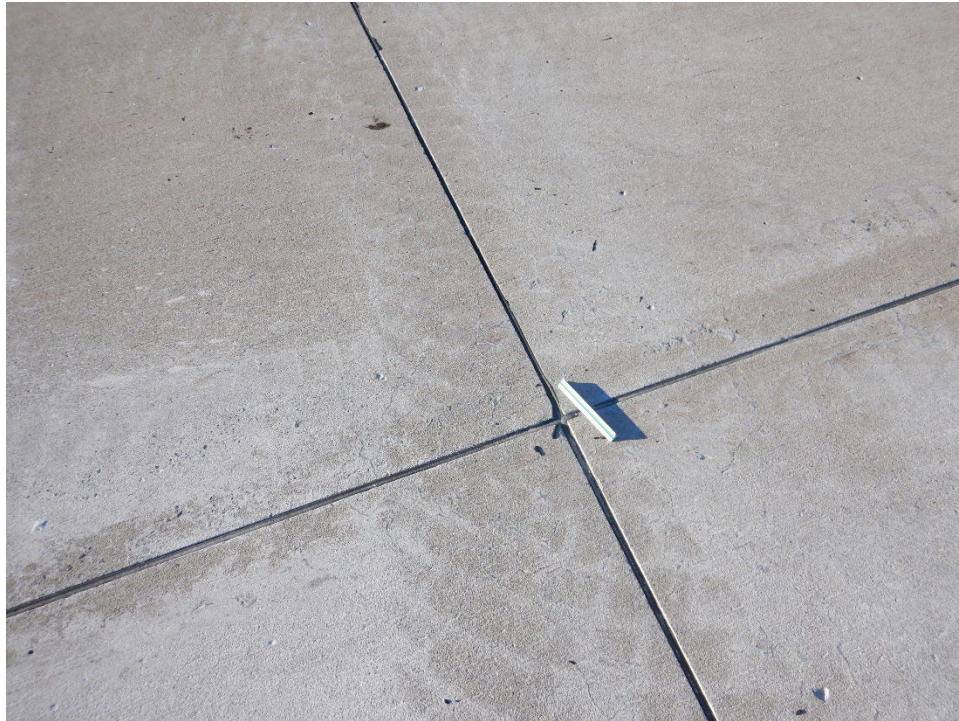
R02CD-01. ASR (Sample Unit No. 43) (1).

R02CD-01. ASR (Sample Unit No. 43) (2).

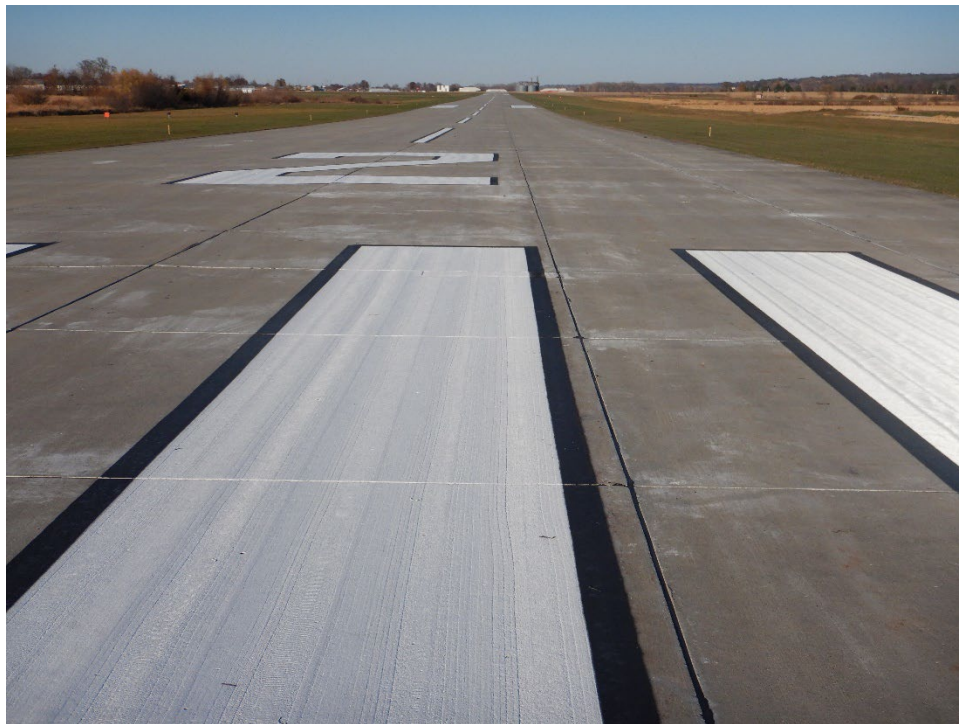
R02CD-02. Overview.

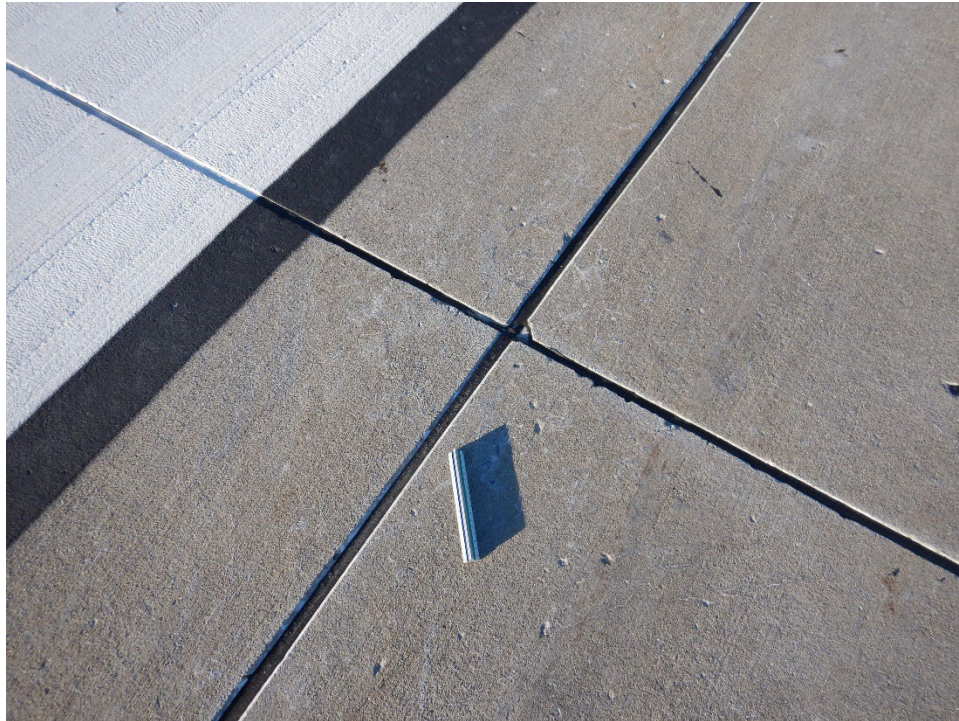
R02CD-02. ASR (Sample Unit No. 02).

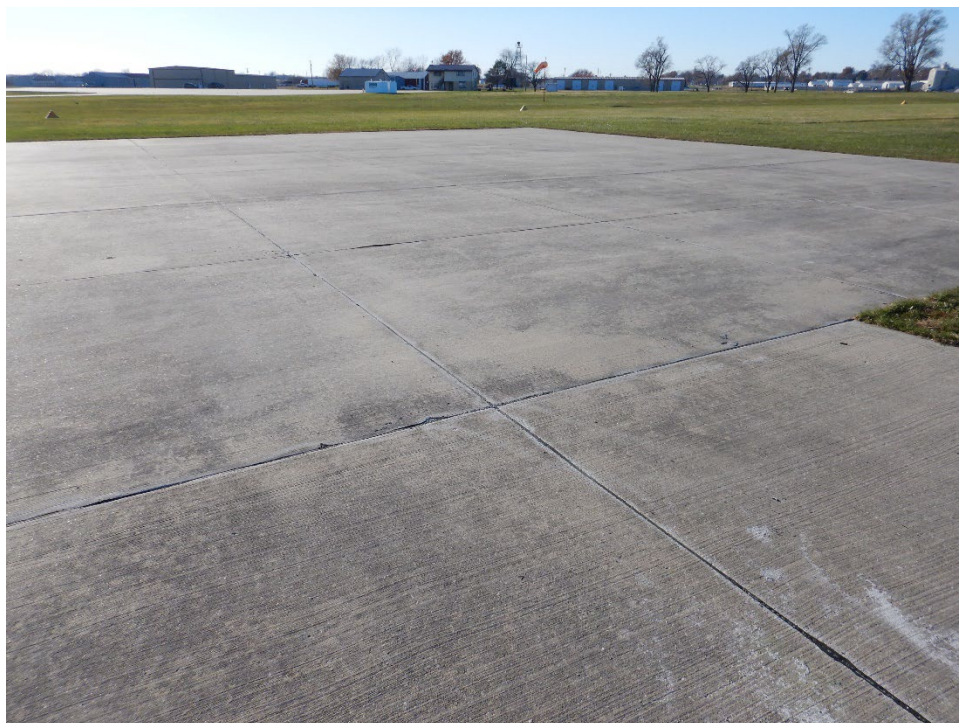
Runway 13/31 was divided into two sections. Areas of low-severity corner spalling, low- and medium-severity faulting, and low-severity LTD cracking were observed in Section 01. Section 02 had areas of low-severity faulting and LTD cracking.

R13CD-01. Overview.

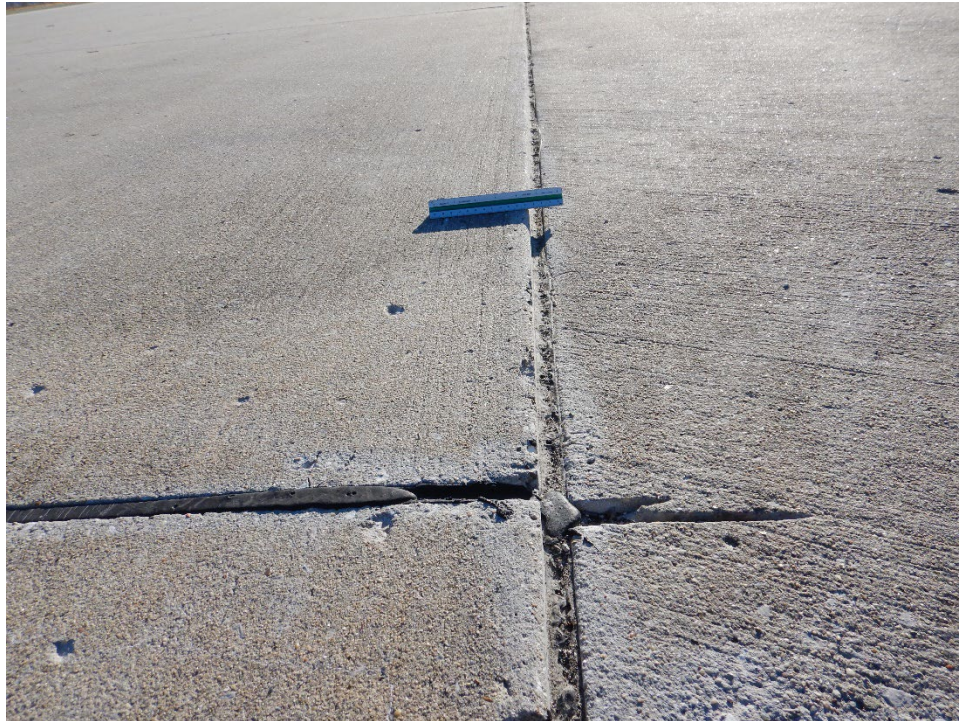
R13CD-01. Faulting (Sample Unit No. 01).

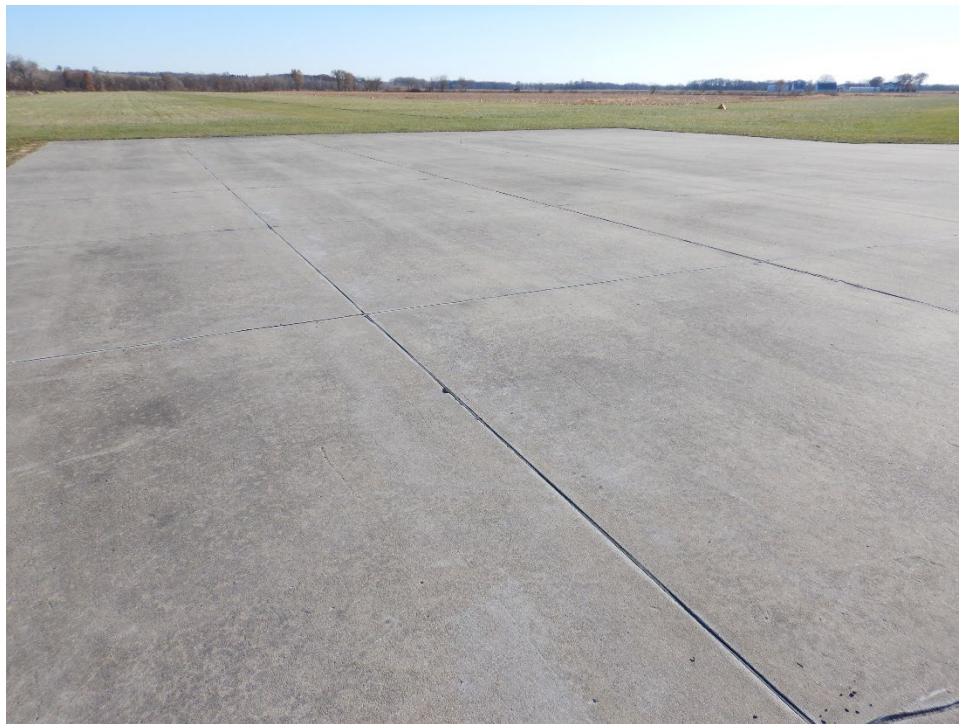
R13CD-02. Overview.

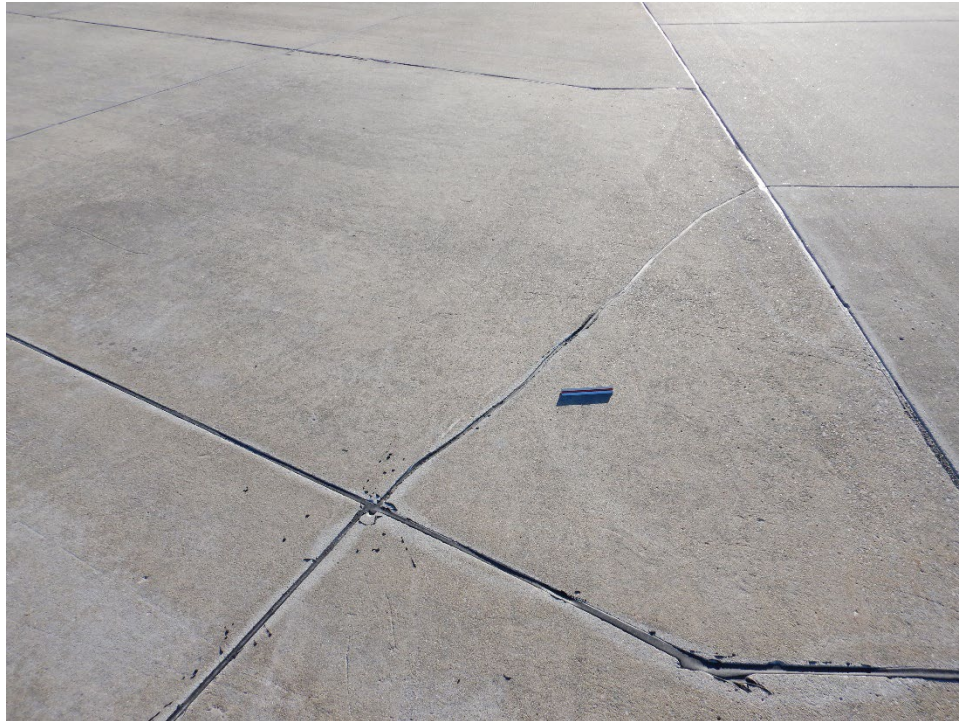
R13CD-02. LTD Cracking (Sample Unit No. 01).

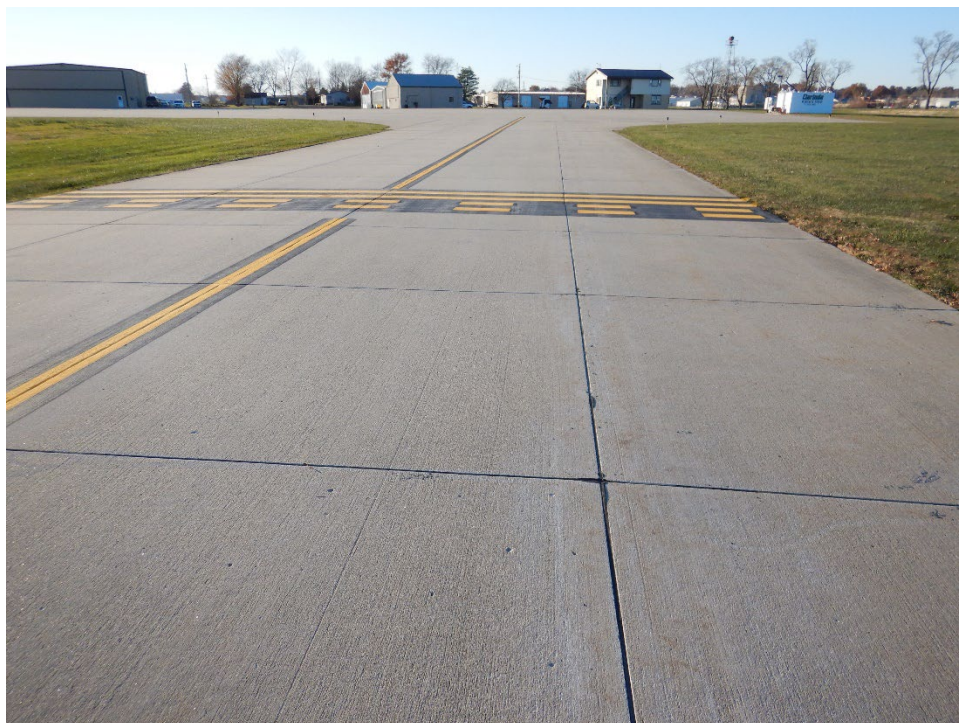
Taxiway 01 connected Runway 13/31 with the apron area and consisted of one section. Medium-severity joint spalling and low-severity ASR, faulting, and LTD cracking were recorded in Section 01.

T01CD-01. Overview.

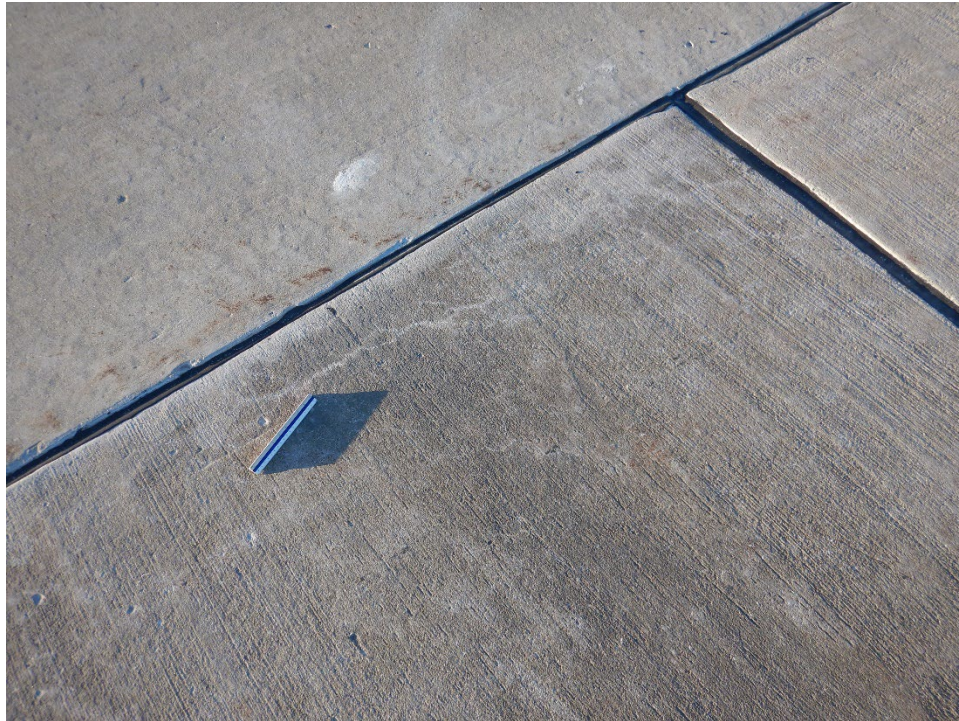
T01CD-01. ASR (Sample Unit No. 07).

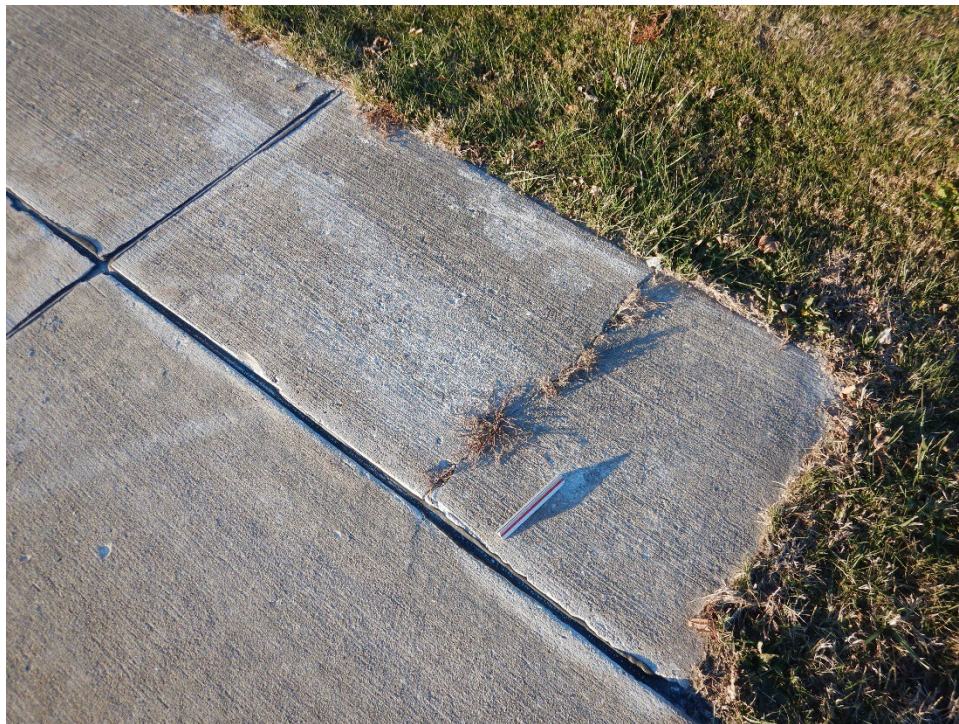
T01CD-01. LTD Cracking (Sample Unit No. 07).

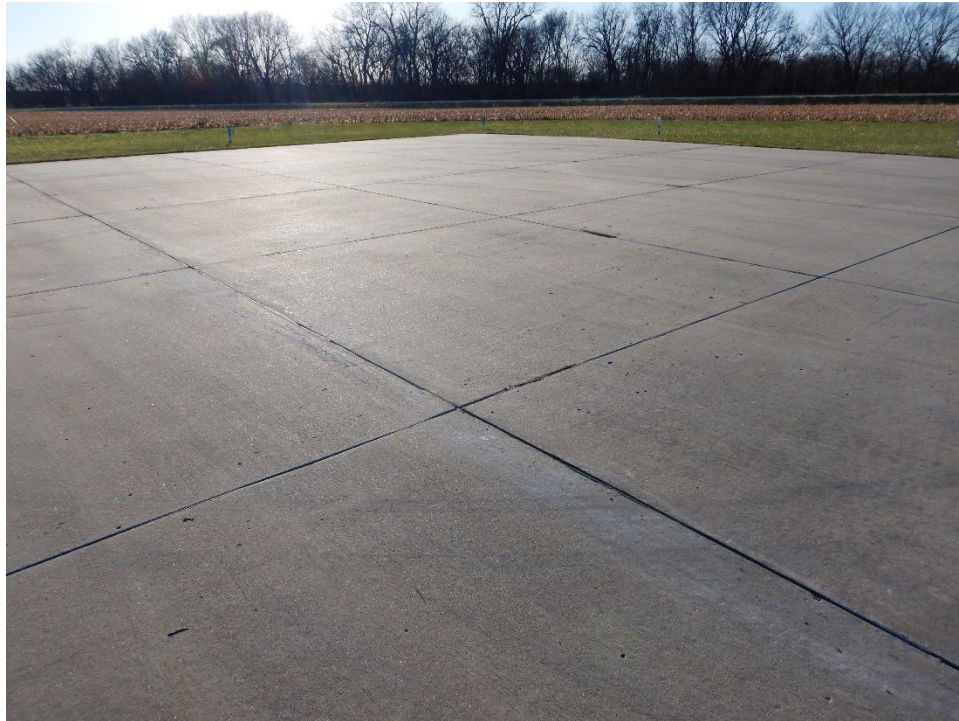
Taxiway 02, a turnaround located at the Runway 02 approach, was defined by one section. Only low-severity ASR and faulting were noted in Section 01 at the time of inspection.

T02CD-01. Overview.

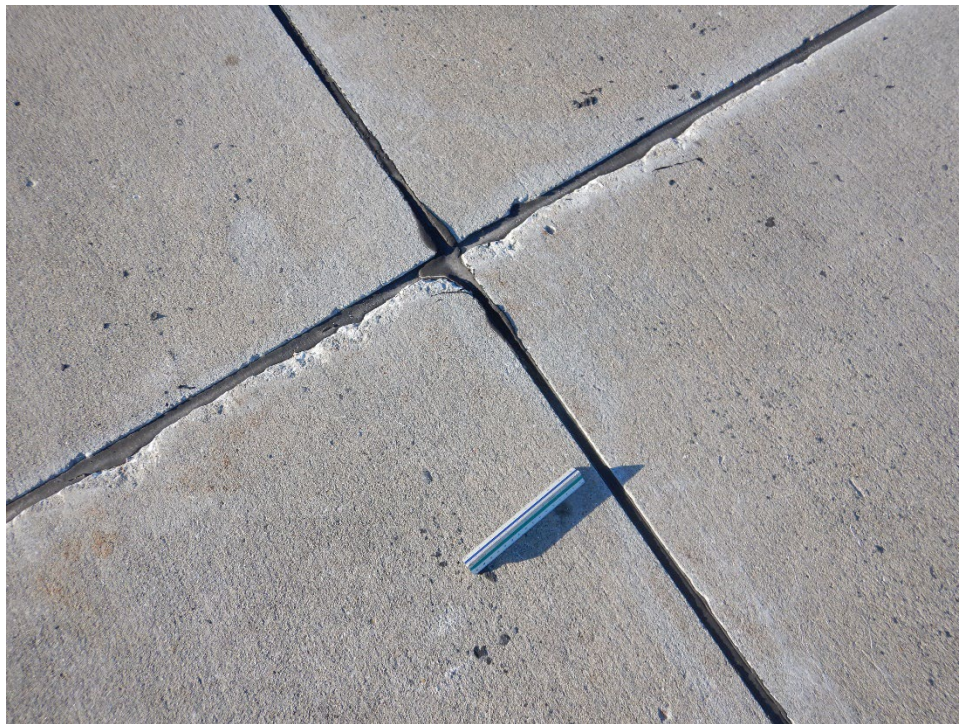
T02CD-01. ASR (Additional Sample Unit No. 02).

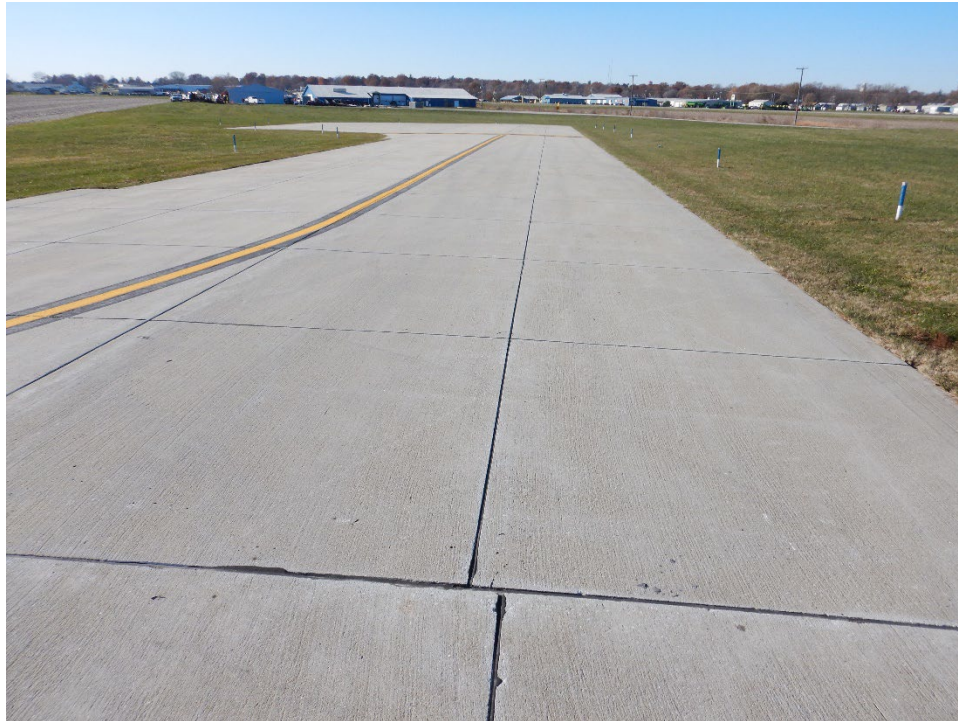
Taxiway 03 was a turnaround located at the Runway 20 approach that contained one section in was in excellent condition. Only medium-severity corner spalling was observed.

T03CD-01. Overview.

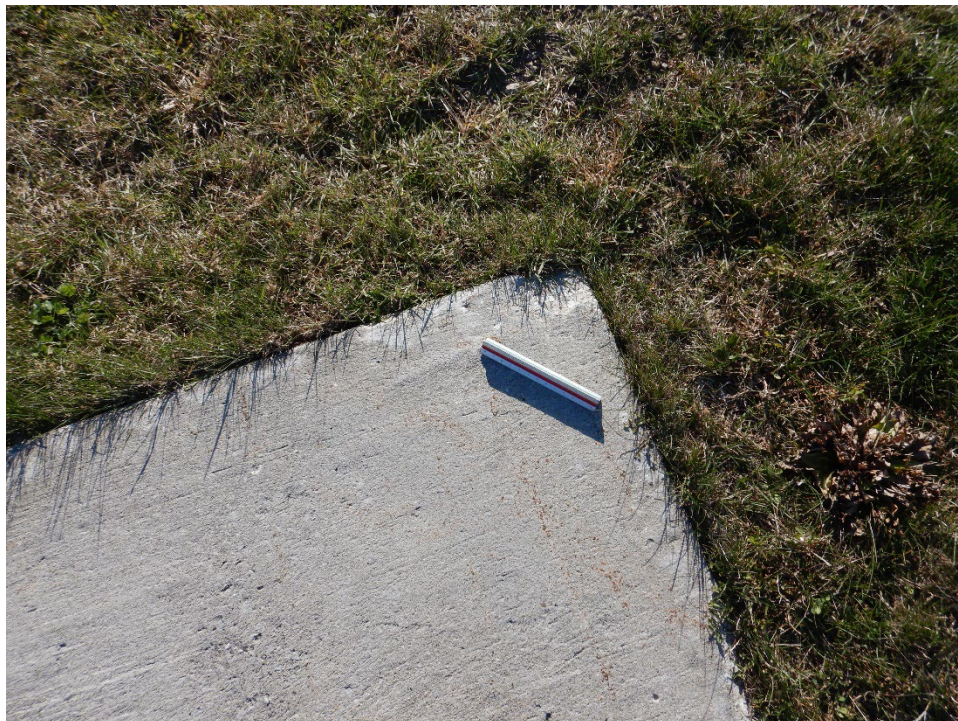
T03CD-01. Corner Spalling (Sample Unit No. 06).

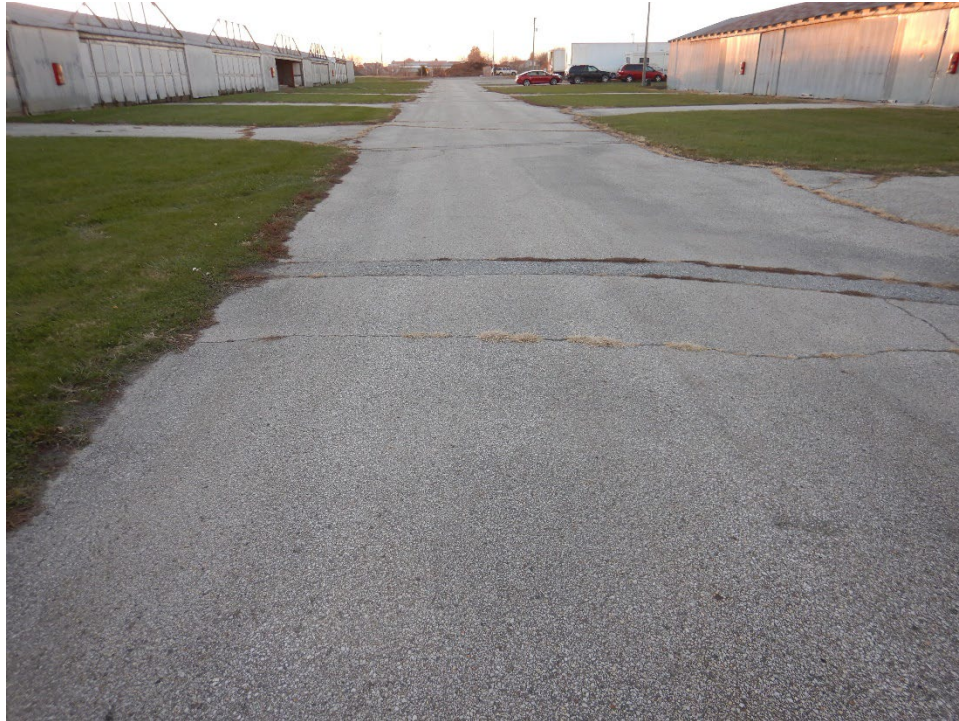
The T-hangar area contained three sections. Section 01 was in poor condition with areas of medium-severity alligator cracking and shoving, medium- and high-severity longitudinal and transverse (L&T) cracking and patching, high-severity raveling and weathering, and low-severity rutting. Low- and medium-severity corner spalling, medium- and high-severity joint seal damage, medium-severity joint spalling, low-severity LTD cracking, and shrinkage cracking were recorded in Section 02. Section 03 contained low- and medium-severity joint seal damage.

TH01CD-01. Overview.

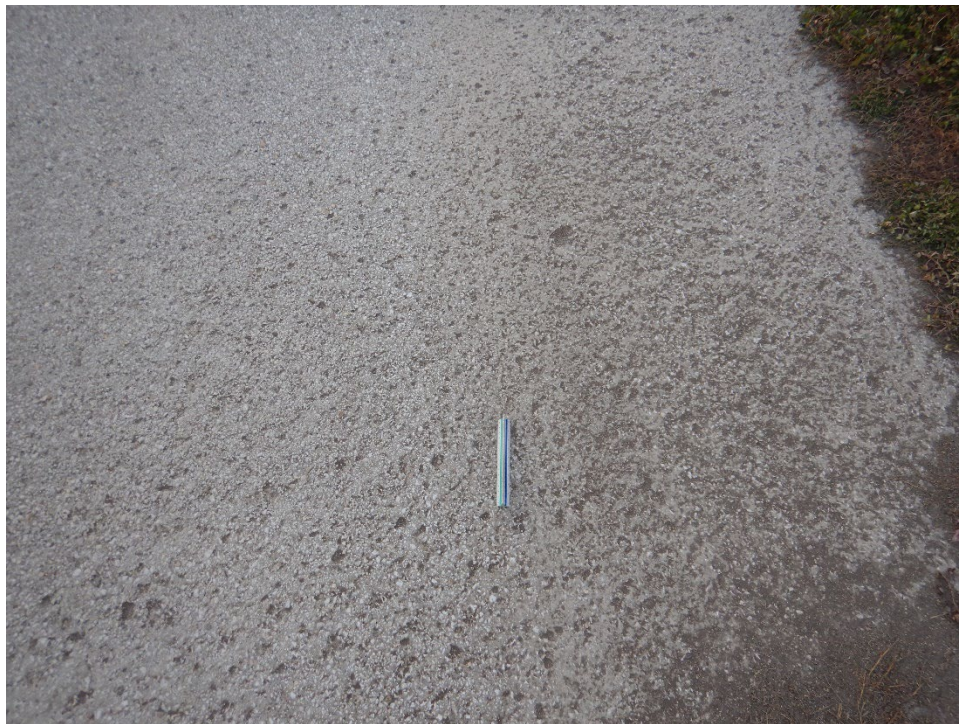
TH01CD-01. Raveling (Sample Unit No. 04).

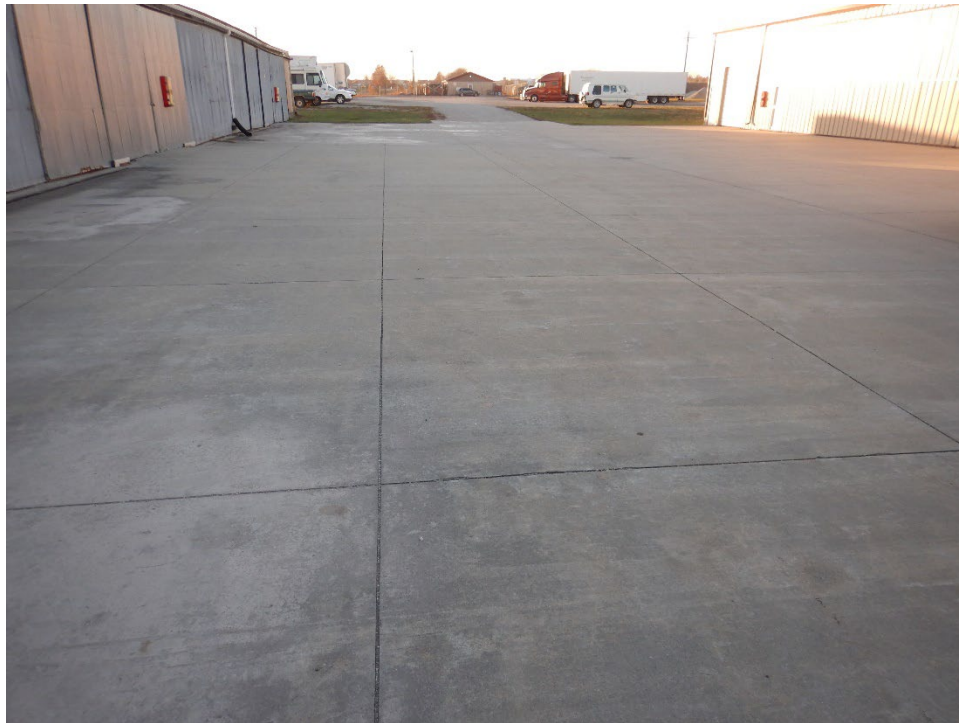
TH01CD-02. Overview.

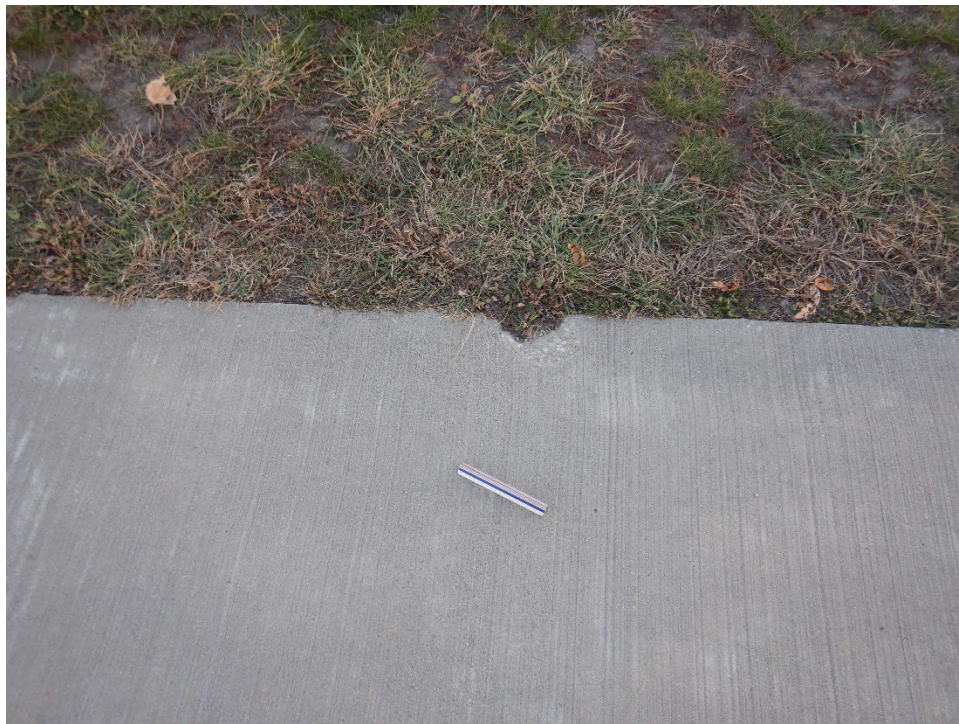
TH01CD-02. Joint Spalling (Sample Unit No. 05).

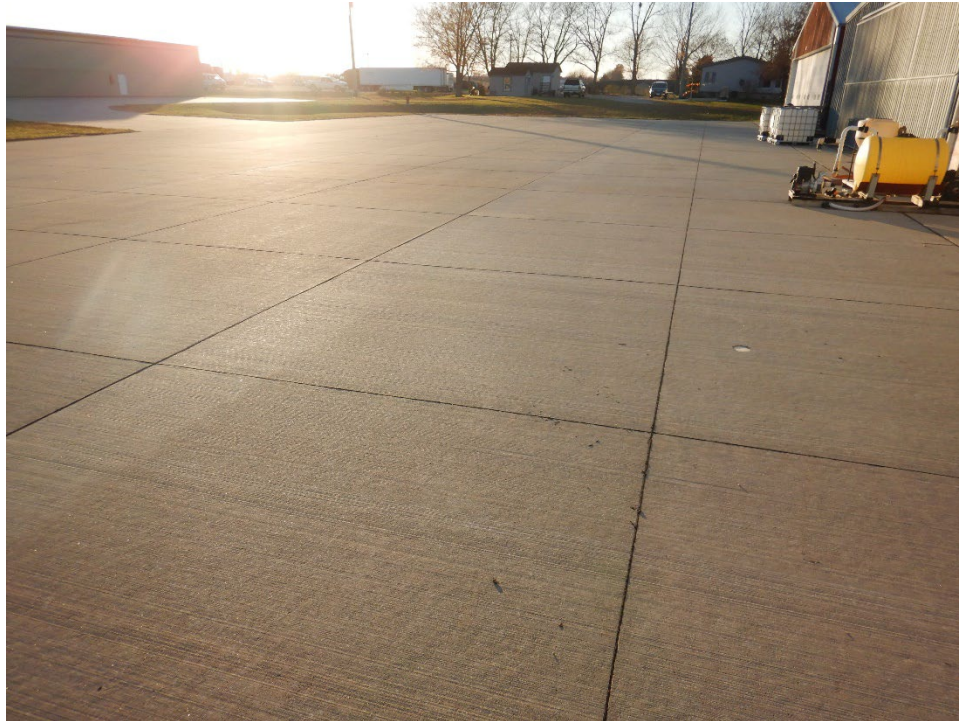
TH01CD-03. Overview.

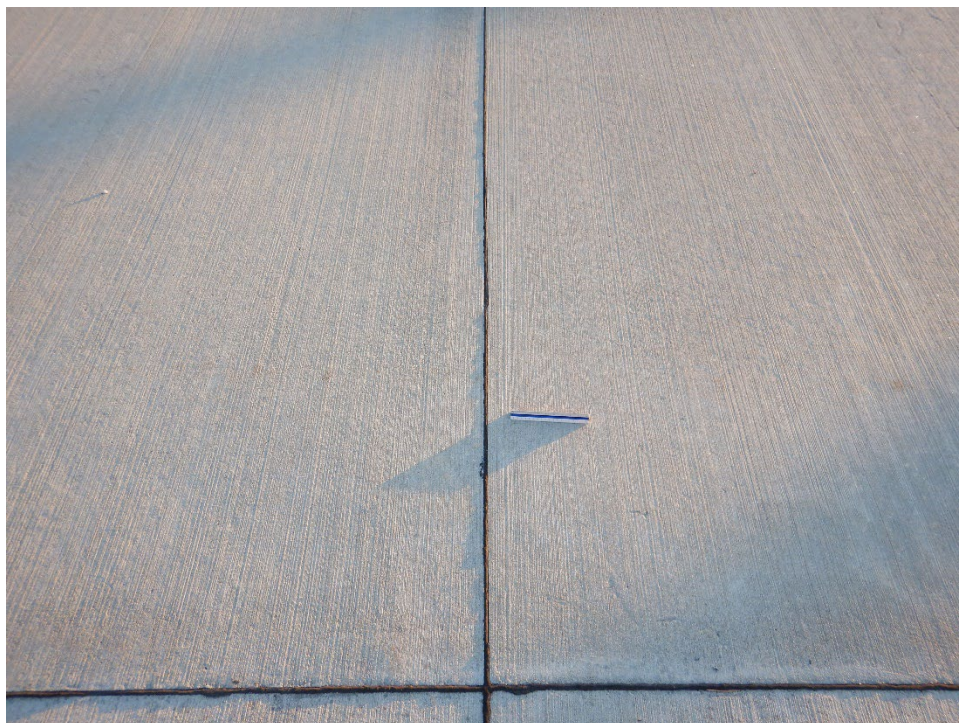
TH01CD-03. Joint Seal Damage (Sample Unit No. 01).
