Corning Municipal Airport

PAVEMENT MANAGEMENT REPORT

AUGUST 2019

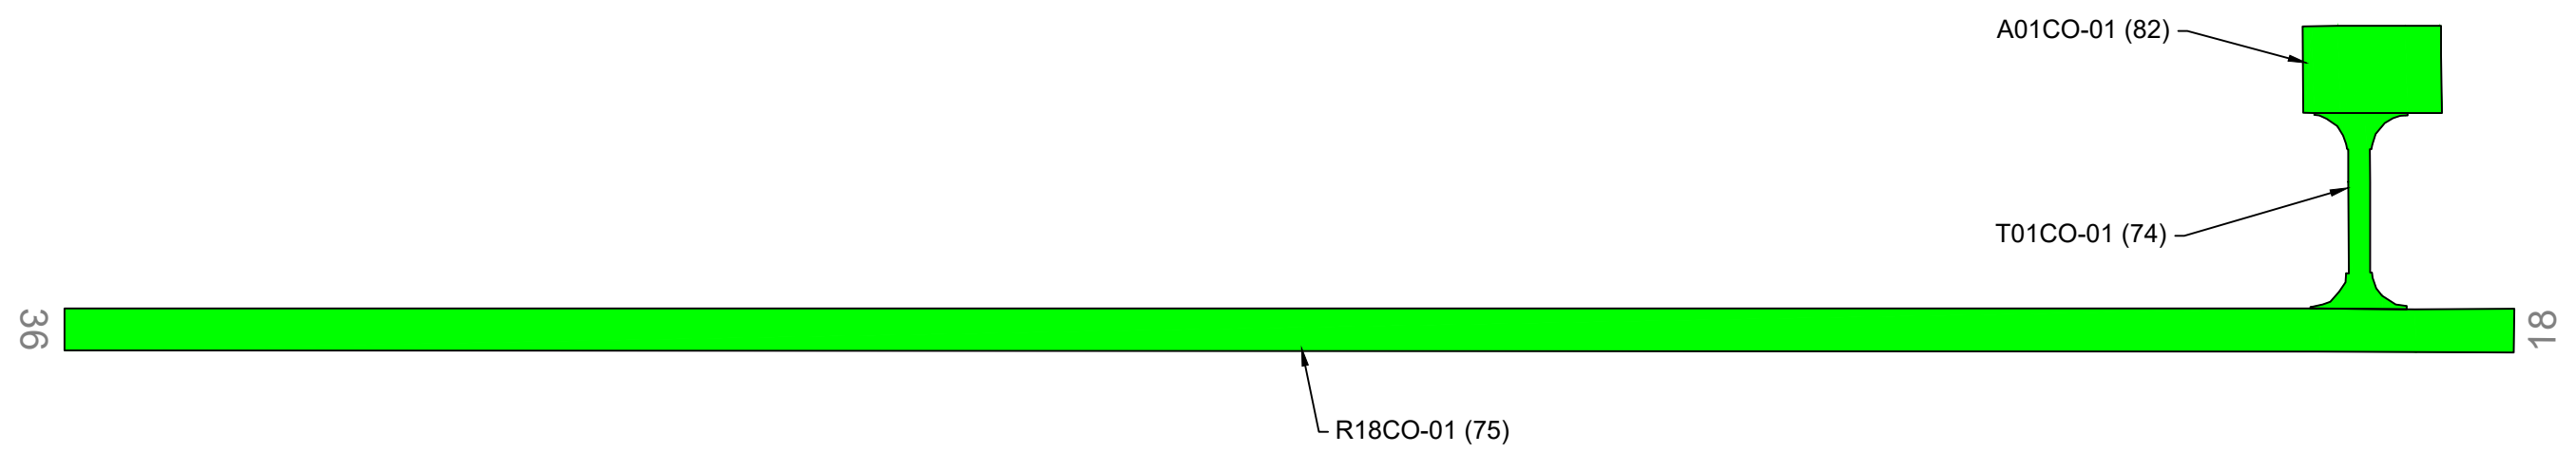
FIGURE 8. PCI MAP.

The pavements at Corning Municipal Airport were inspected on December 1, 2018. The 2018 area-weighted condition of Corning Municipal Airport is 76, with conditions ranging from 74 to 82 (on a scale of 0 [failed] to 100 [excellent]). During the previous pavement inspection in 2012, the area-weighted PCI of the airport was 95.

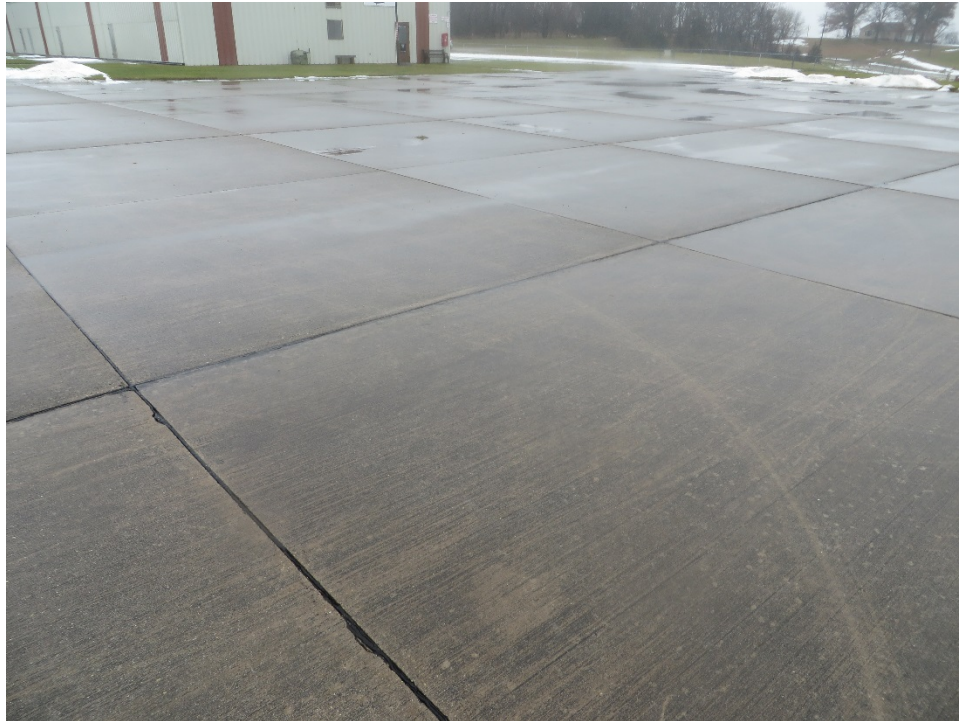
The apron area consisted of one section and areas of high-severity joint seal damage and low-severity LTD cracking and ASR identified throughout. An atypical area with medium-severity shattered slabs was observed and inspected as an additional sample unit according to ASTM D5340-12.

A01CO-01. Overview.

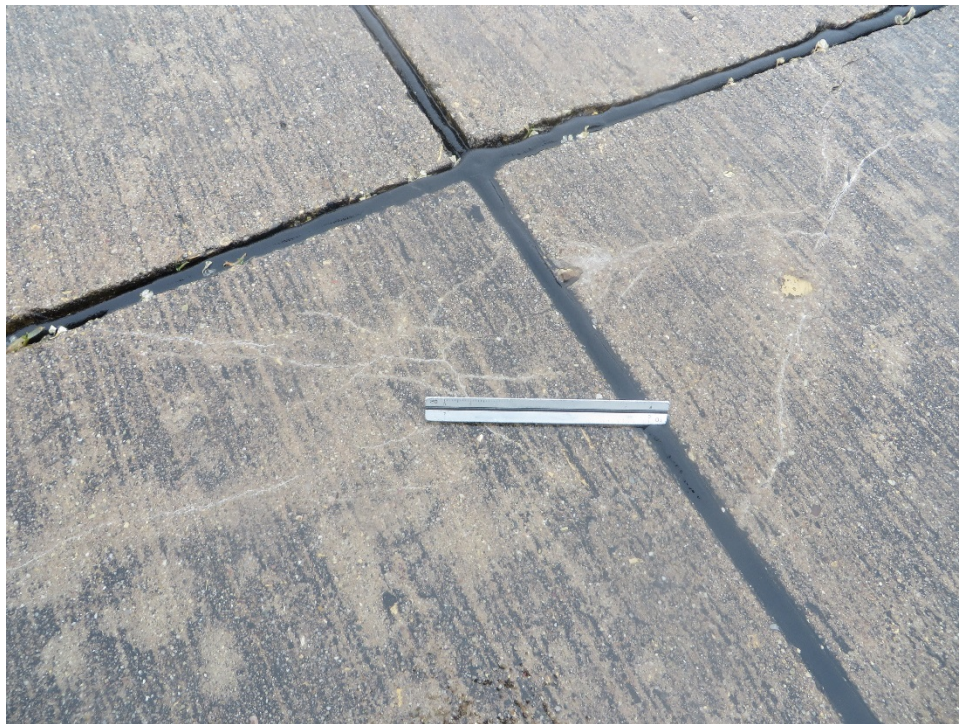
A01CO-01. ASR (Sample Unit No. 05).

Sample Number: 005 Type: R Area: 16.00Slabs PCI = 83
Sample Comments:
76 ASR L 2.00 Slabs Comments:
65 JOINT SEAL DAMAGE H 16.00 Slabs Comments:

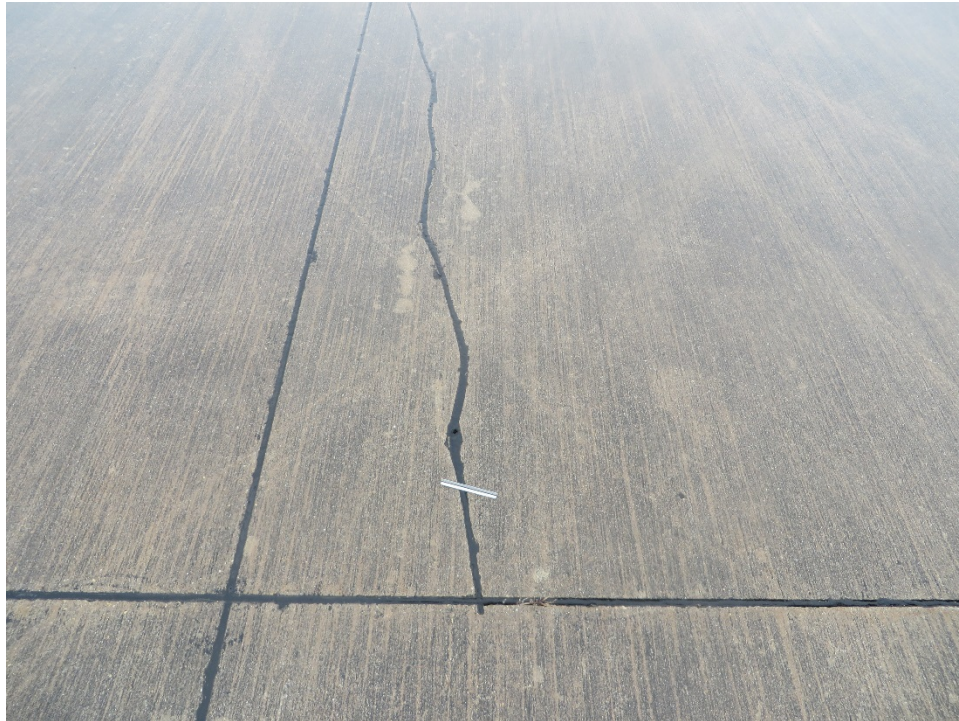
A01CO-01. LTD Cracking (Sample Unit No. 03).

Sample Number: 003 Type: R Area: 20.00Slabs PCI = 83
Sample Comments:
63 LINEAR CRACKING L 1.00 Slabs Comments:
65 JOINT SEAL DAMAGE H 20.00 Slabs Comments:

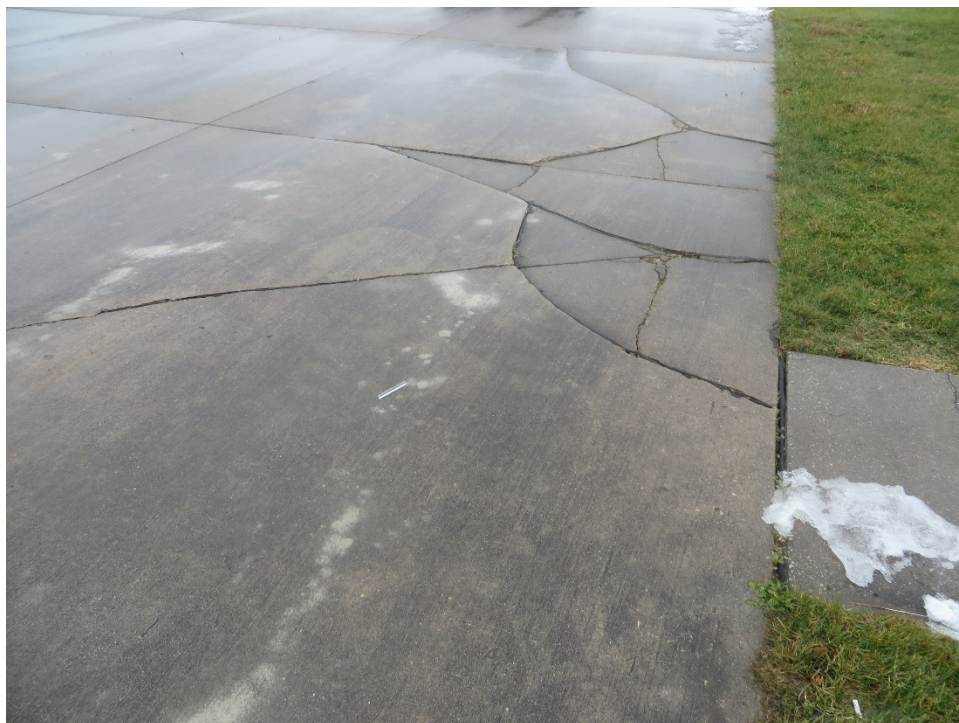
A01CO-01. Shattered Slab (Additional Sample Unit No. 04).

Sample Number: 004 Type: A Area: 16.00Slabs PCI = 64
Sample Comments:
72 SHATTERED SLAB M 2.00 Slabs Comments:
65 JOINT SEAL DAMAGE H 16.00 Slabs Comments:

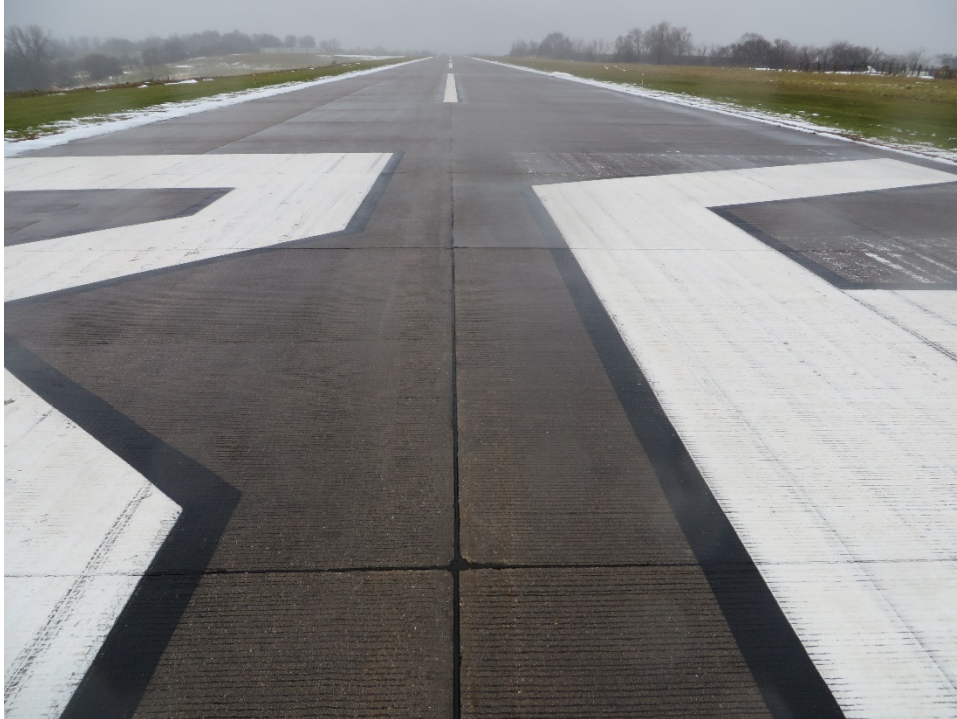
Runway 18/36 consisted of one section. Low-severity ASR, low- and medium-severity corner spalling, high-severity joint seal damage, low-severity joint spalling and small patching, and medium-severity longitudinal, transverse, and diagonal (LTD) cracking were recorded in Section 01. An atypical area of low-severity faulting located along an LTD crack was noted and recorded as an additional sample unit according to ASTM D5340-12.

R18CO-01. Overview.

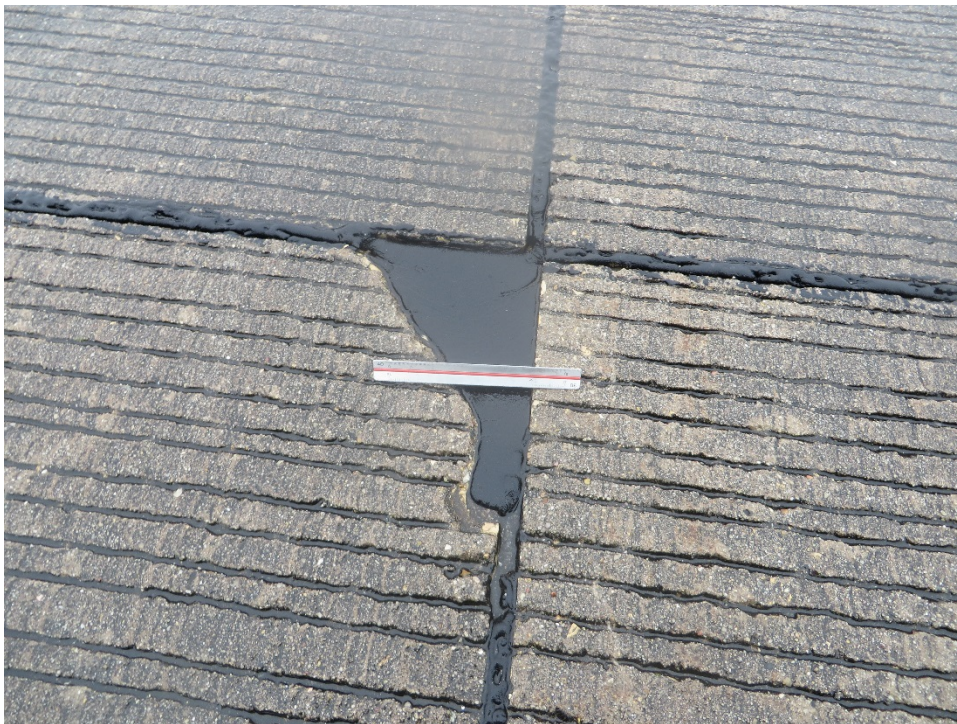
R18CO-01. Corner Spalling (Additional Sample Unit No. 17).

Sample Number: 017 Type: A Area: 20.00Slabs PCI = 55
 Sample Comments:
 63 LINEAR CRACKING M 3.00 Slabs Comments:
 71 FAULTING L 2.00 Slabs Comments:@63
 75 CORNER SPALLING L 2.00 Slabs Comments:
 76 ASR L 5.00 Slabs Comments:
 75 CORNER SPALLING L 3.00 Slabs Comments:SEALANT
 65 JOINT SEAL DAMAGE H 20.00 Slabs Comments:

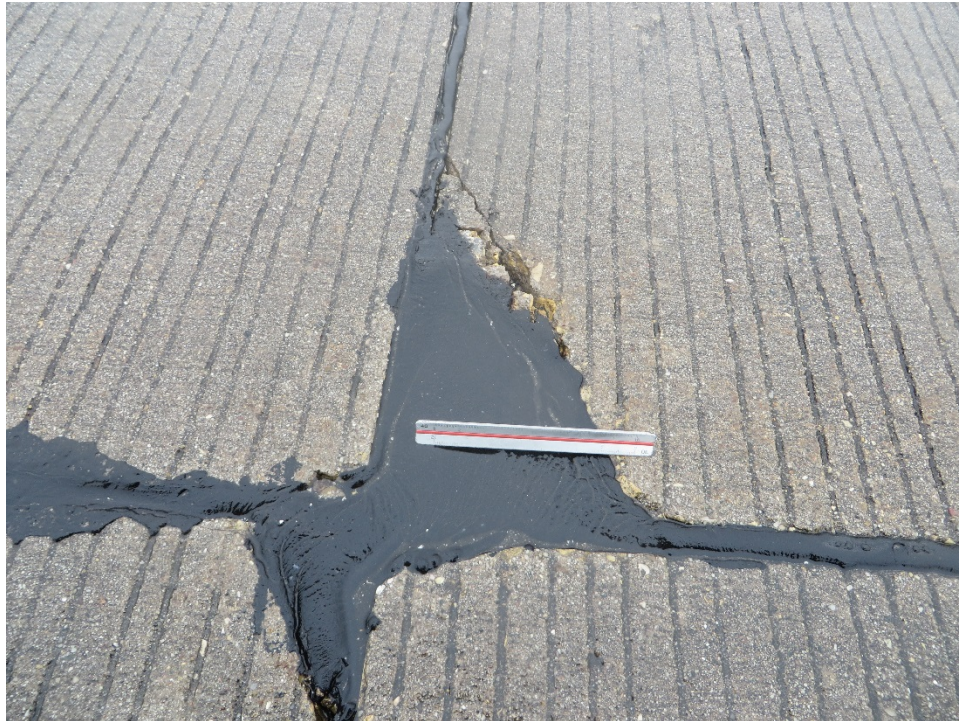
R18CO-01. Corner Spalling (Sample Unit No. 40).

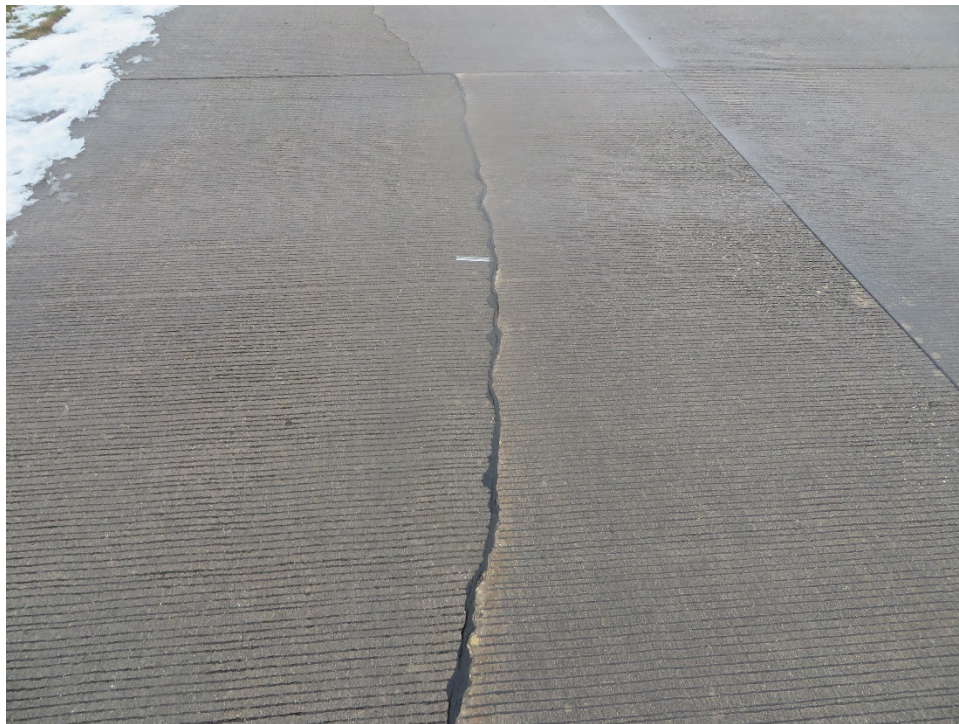
R18CO-01. LTD Cracking (Additional Sample Unit No. 17).

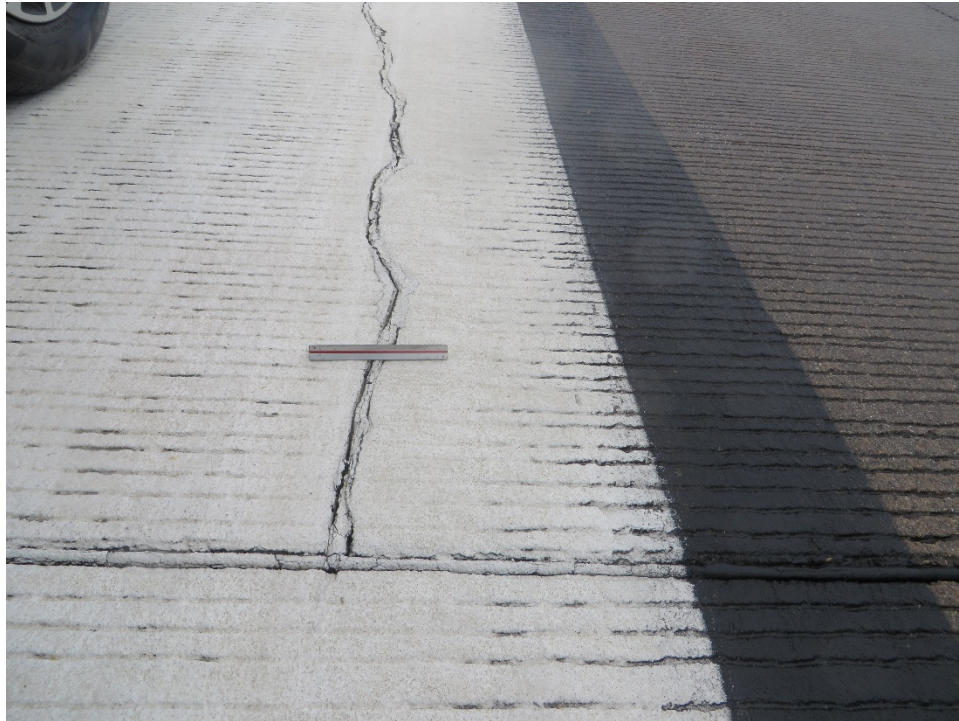
R18CO-01. LTD Cracking (Sample Unit No. 40).

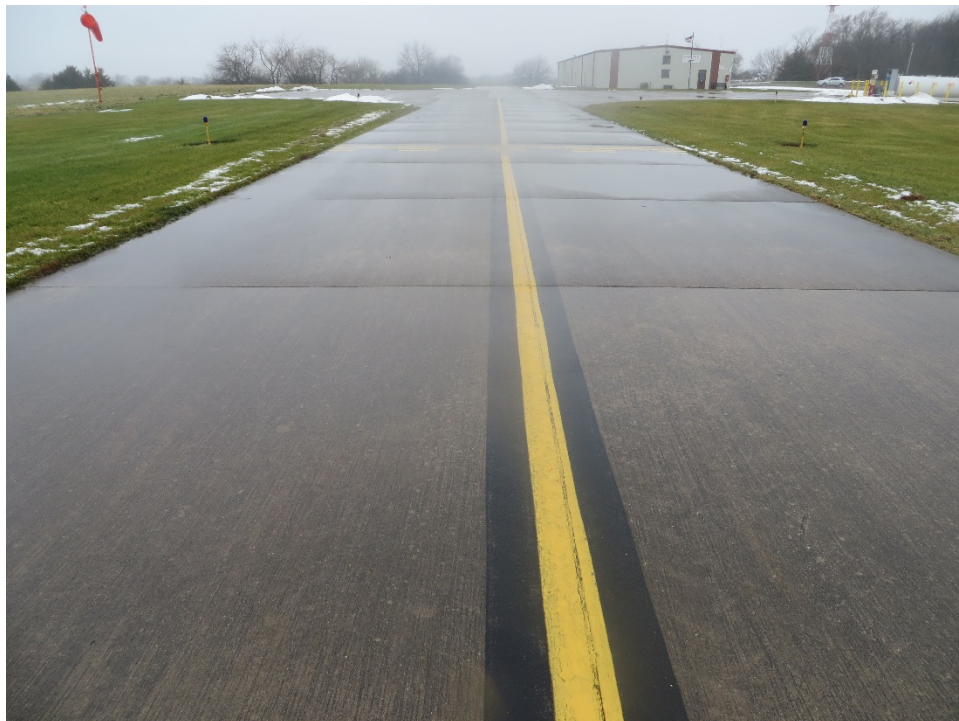
Taxiway 01, located between the apron area and the Runway 18 approach, was defined by one section. Low- and medium-severity corner spalling, medium-severity faulting and joint spalling, high-severity joint seal damage, and low-severity LTD cracking and small patching were observed in Section 01.

T01CO-01. Overview.

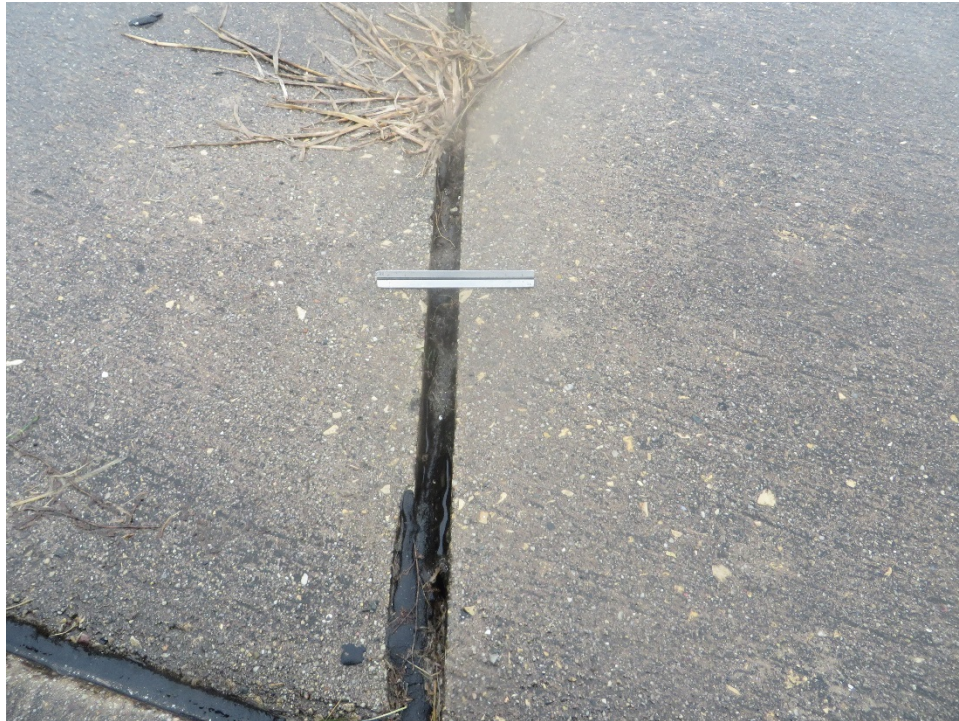
T01CO-01. Joint Seal Damage (Sample Unit No. 03).

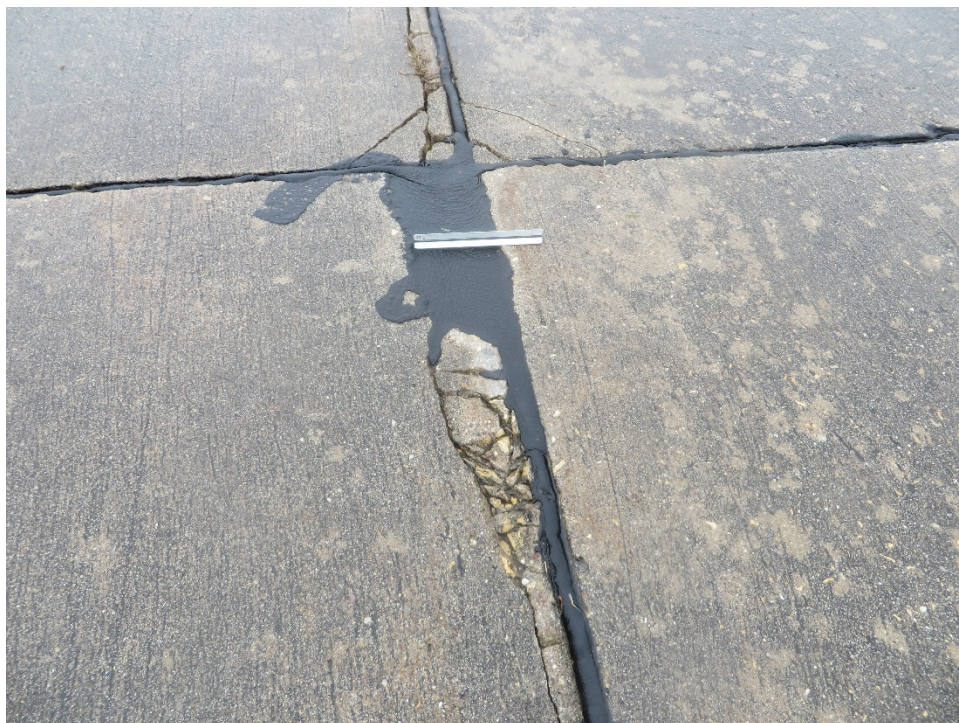
T01CO-01. Joint Spalling (Sample Unit No. 01).
