# Council Bluffs Municipal Airport

## Pavement Management Report

**JULY 2023**

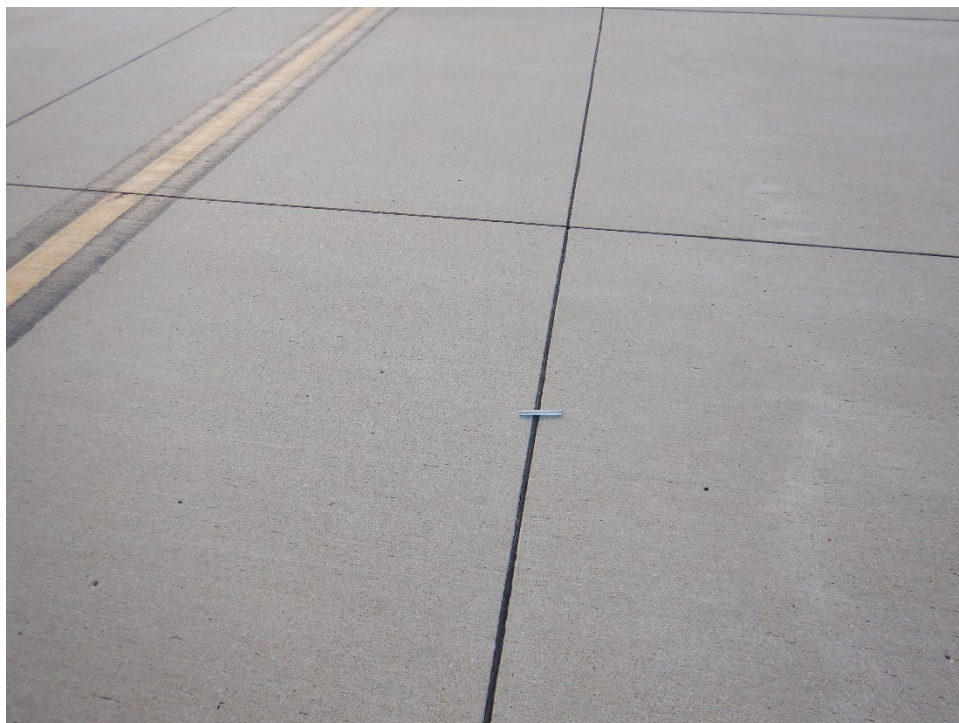
A01CB-01. Joint Seal Damage (Sample Unit No. 23).

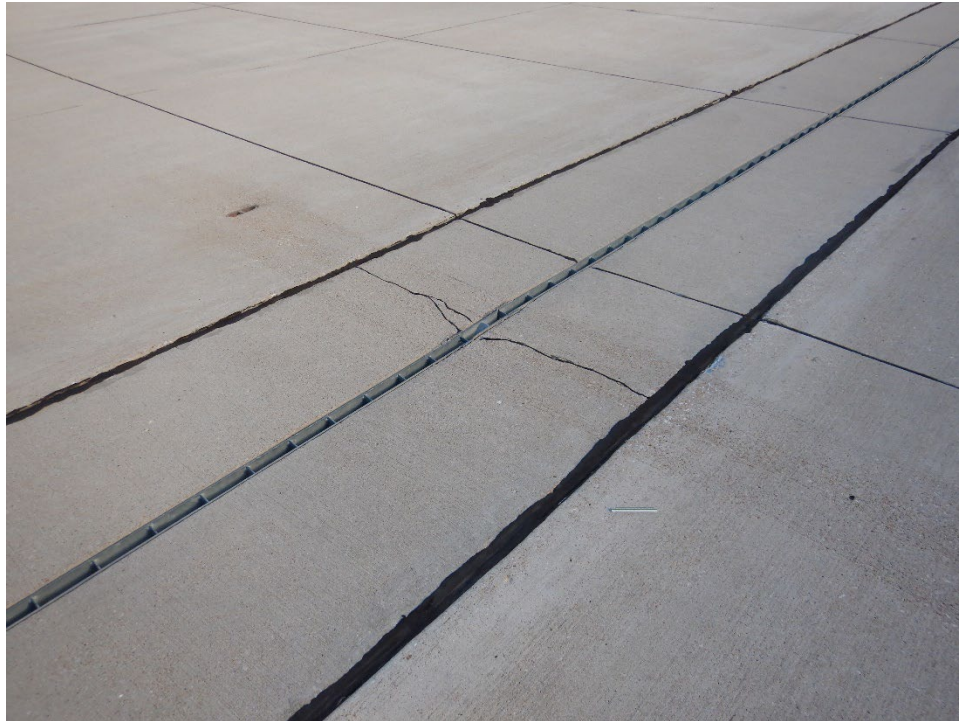
A01CB-01. LTD Cracking (Sample Unit No. 61).

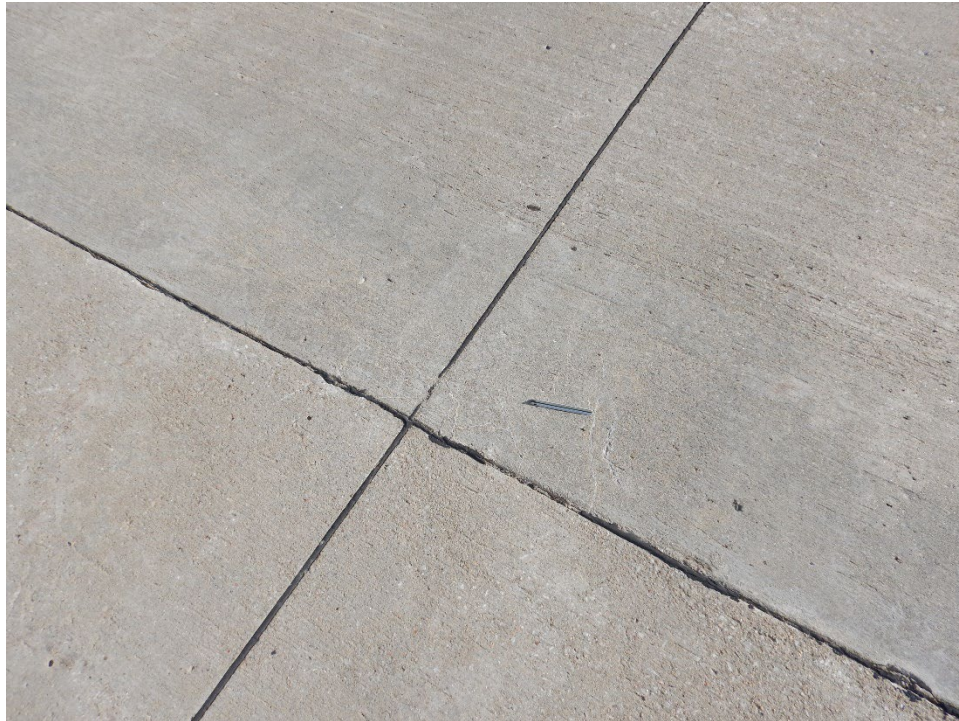
A02CB-01. ASR (Sample Unit No. 22).

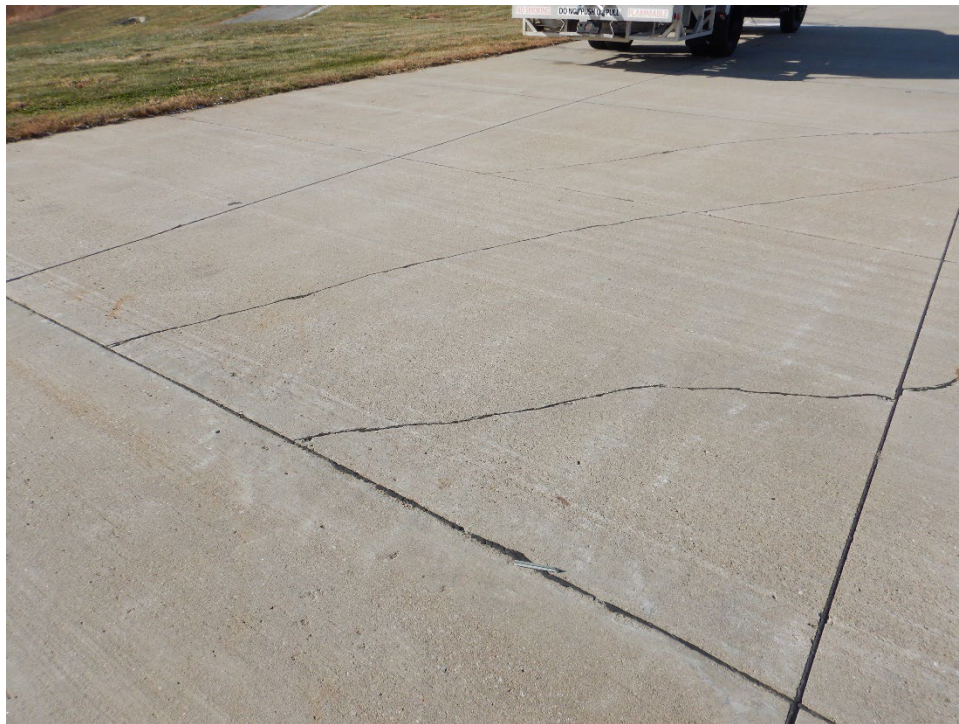
A02CB-01. LTD Cracking (Sample Unit No. 25).

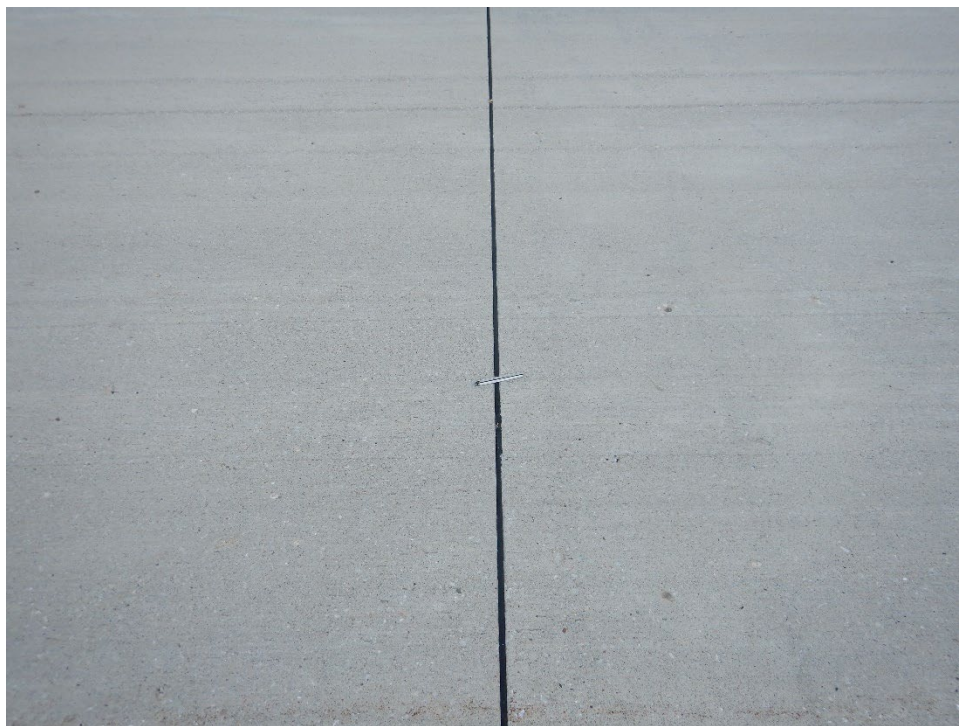
R14CB-01. Joint Seal Damage (Sample Unit No. 27).

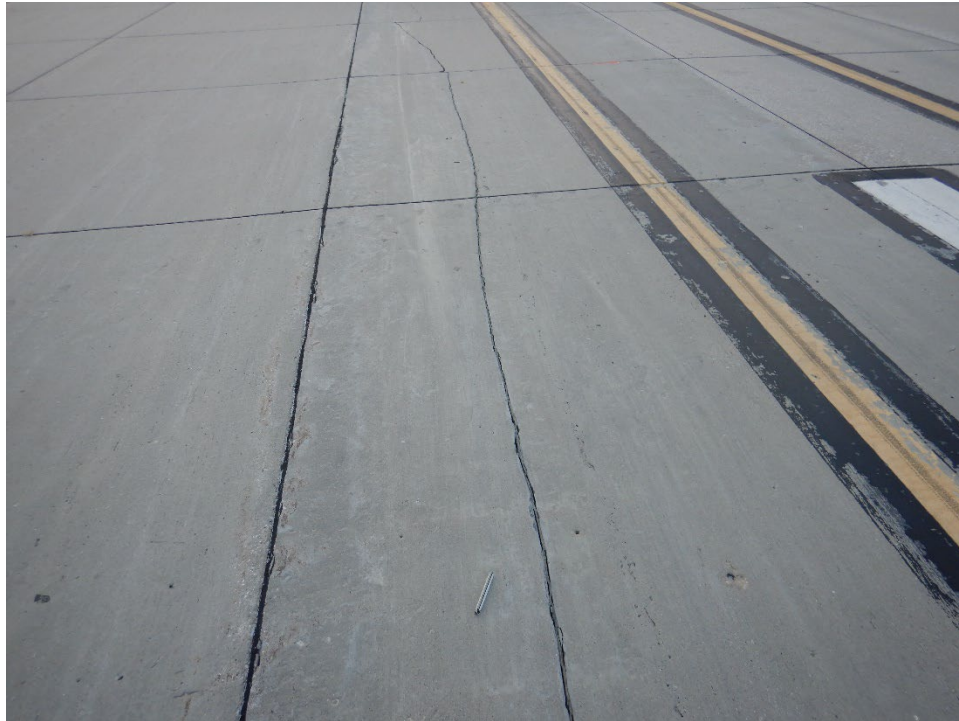
R14CB-01. LTD Cracking (Sample Unit No. 36).

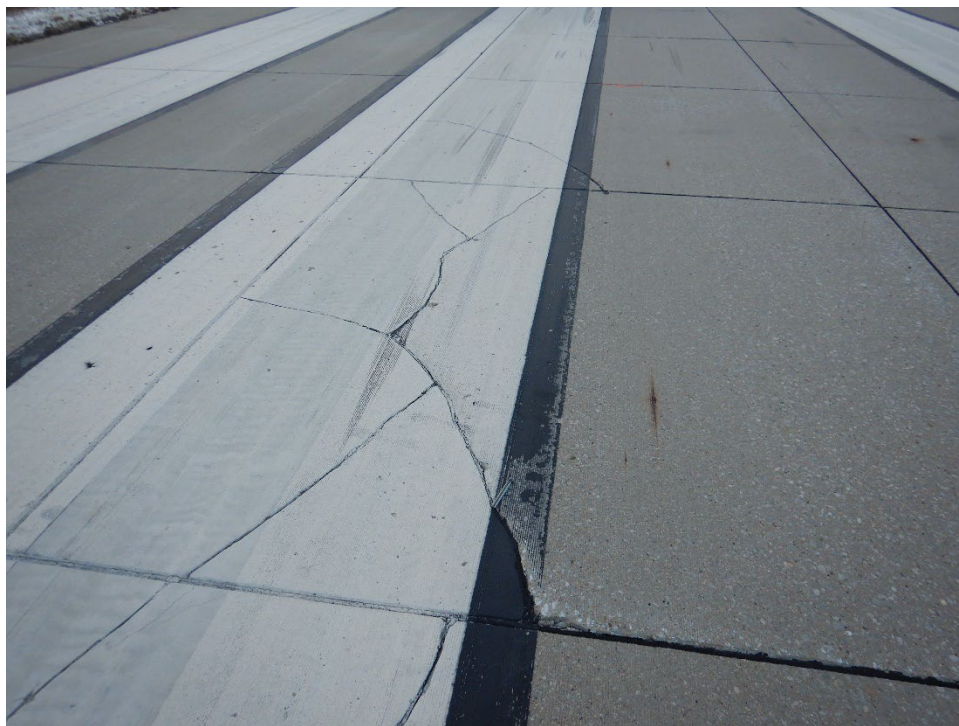
R14CB-01. Shattered Slab (Additional Sample Unit No. 03).

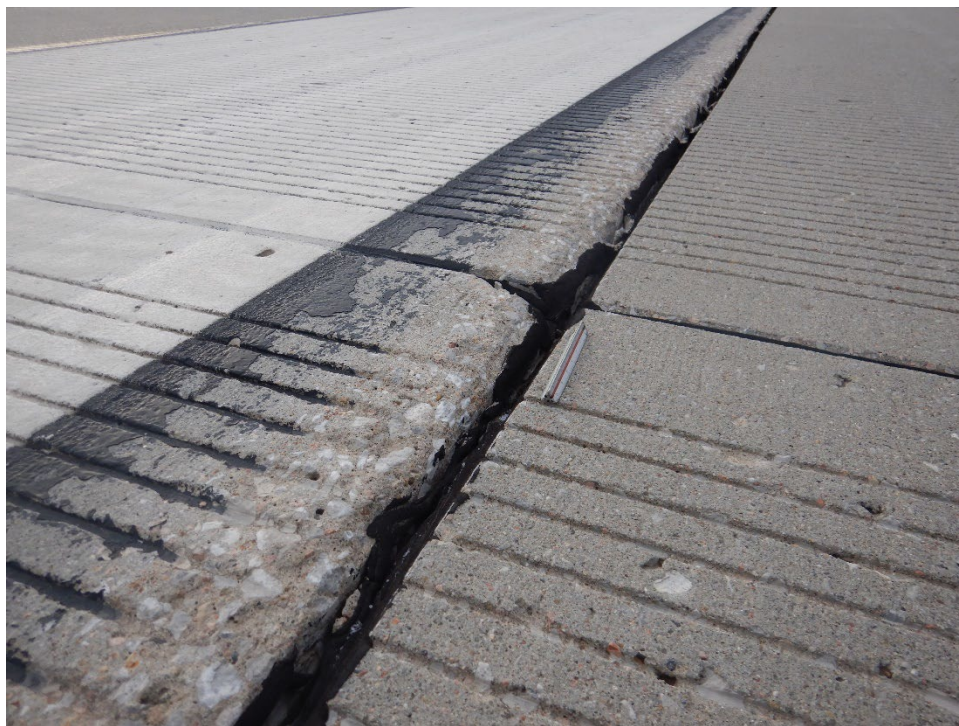
R14CB-02. Faulting (Sample Unit No. 15).

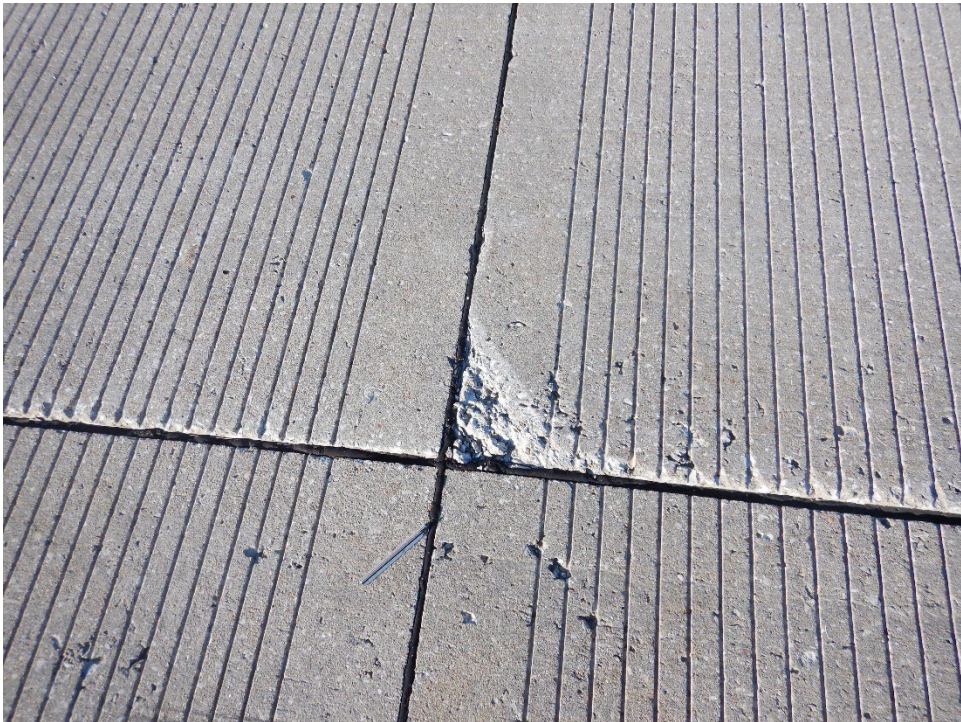
R18CB-01. Corner Spalling (Sample Unit No. 119).

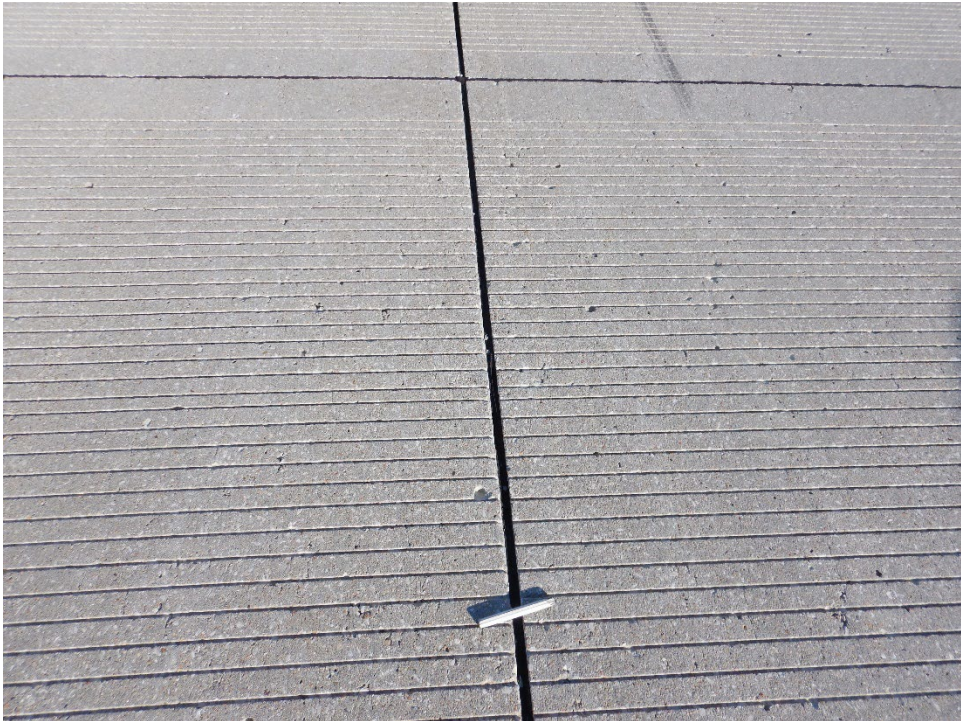
R18CB-01. Joint Seal Damage (Sample Unit No. 99).

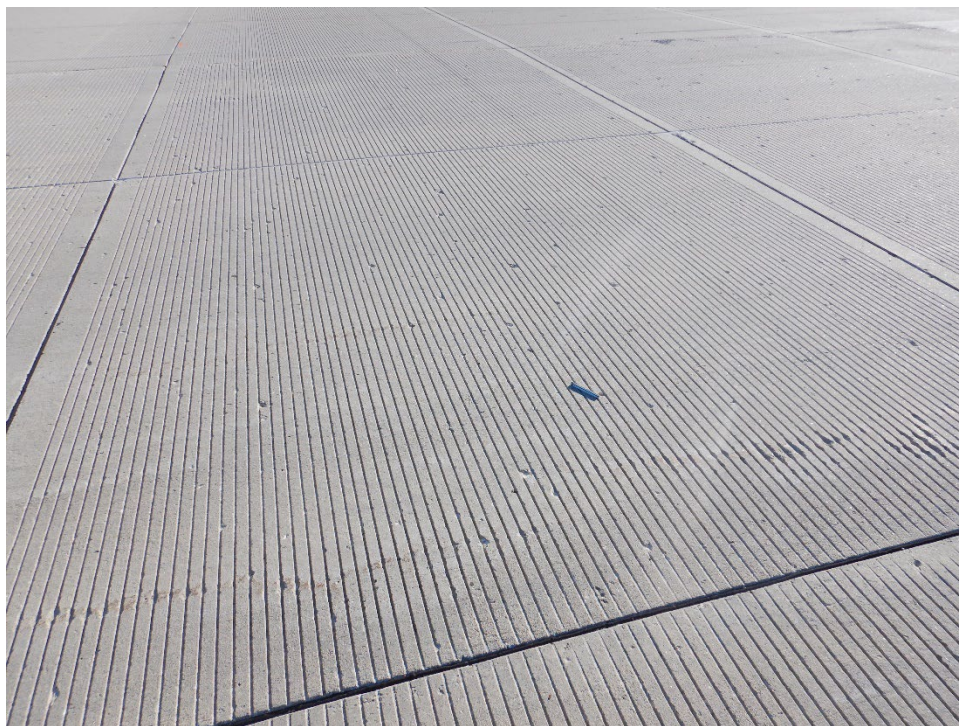
R18CB-02. Popouts (Sample Unit No. 47).

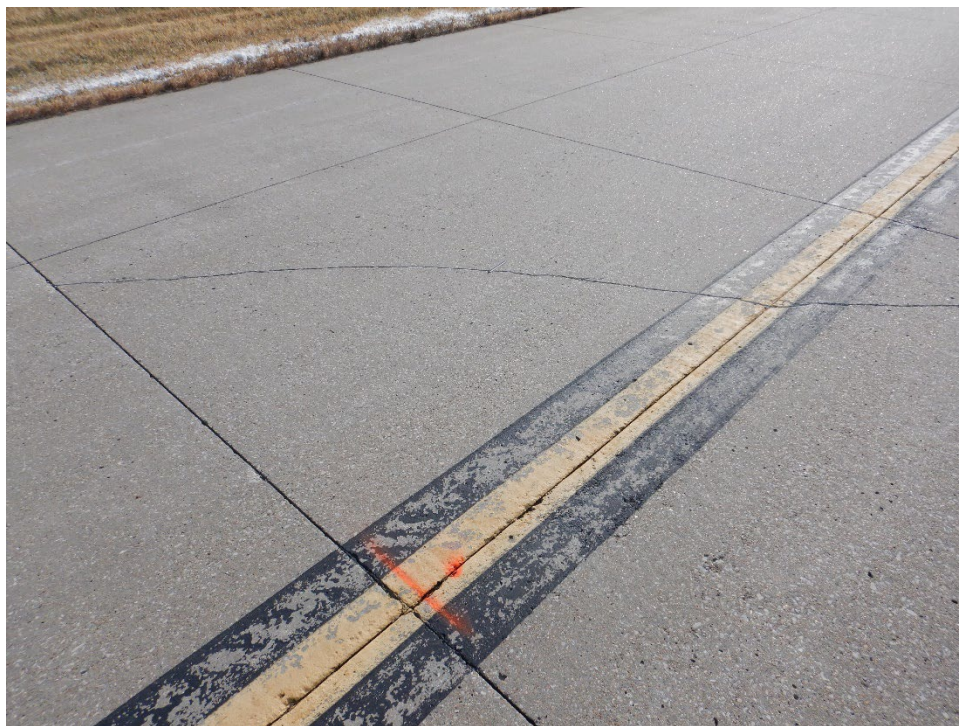
T01CB-01. LTD Cracking (Sample Unit No. 55).

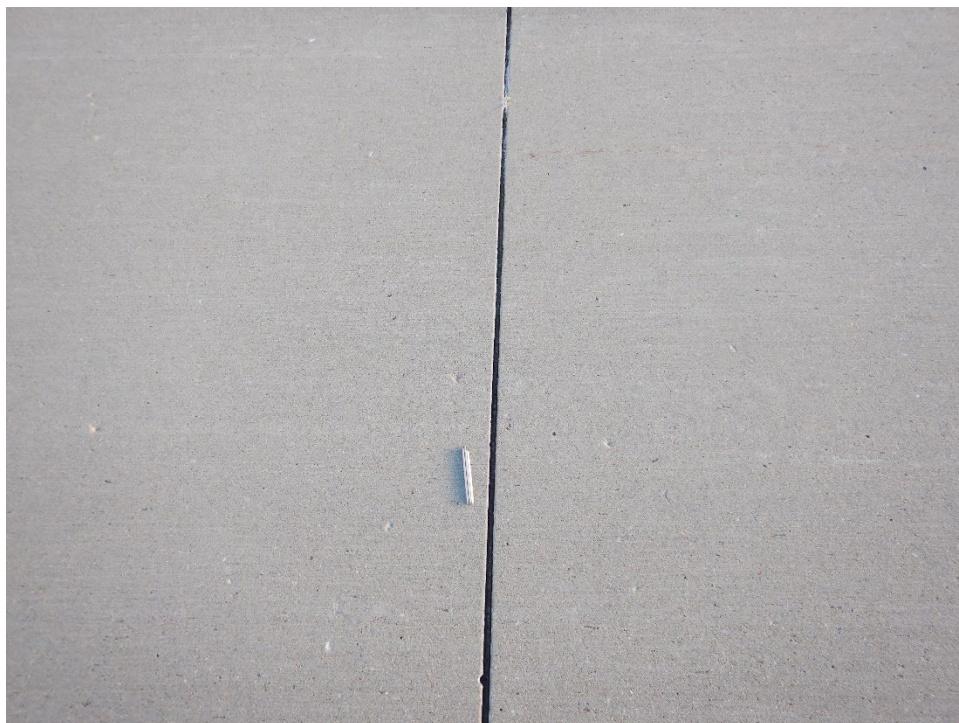
T02CB-01. Joint Seal Damage (Sample Unit No. 24).

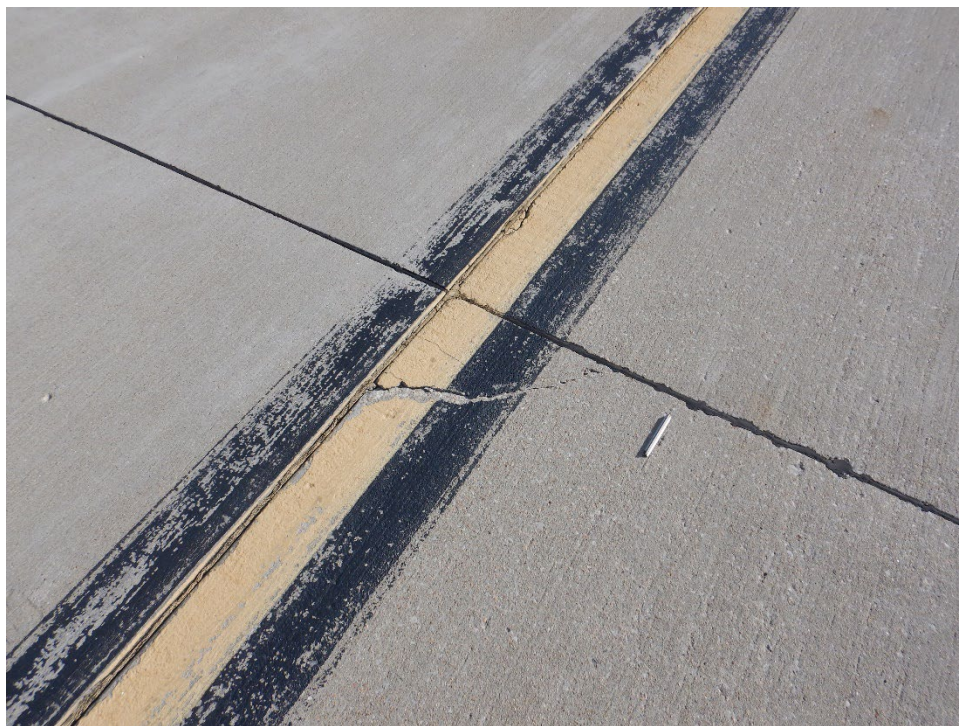
T02CB-02. Corner Spalling (Sample Unit No. 09).

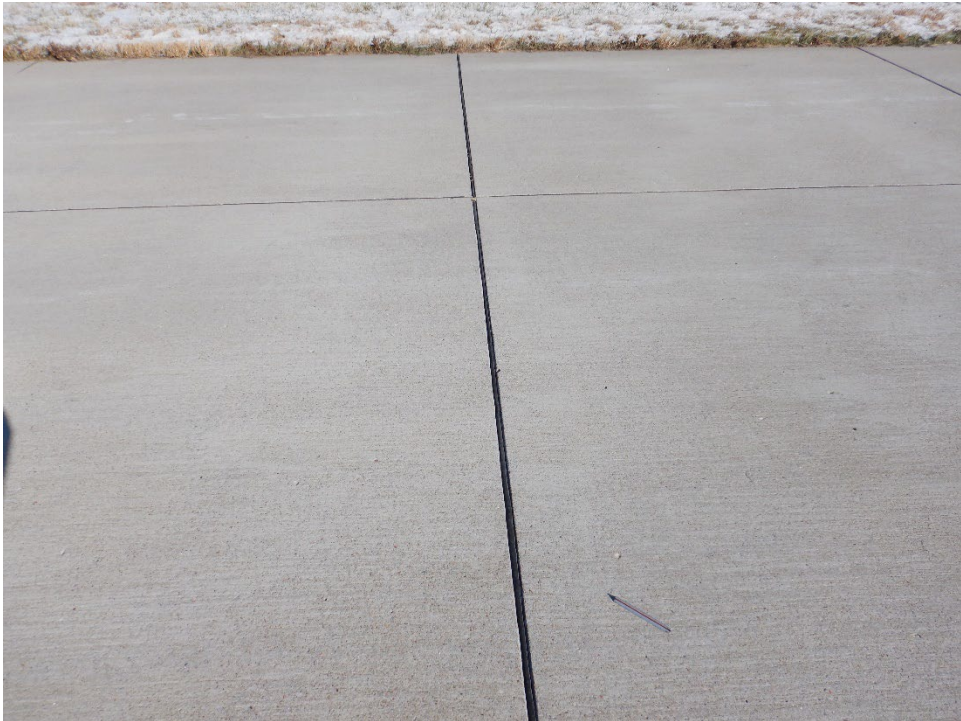
T02CB-02. Joint Seal Damage (Sample Unit No. 02).

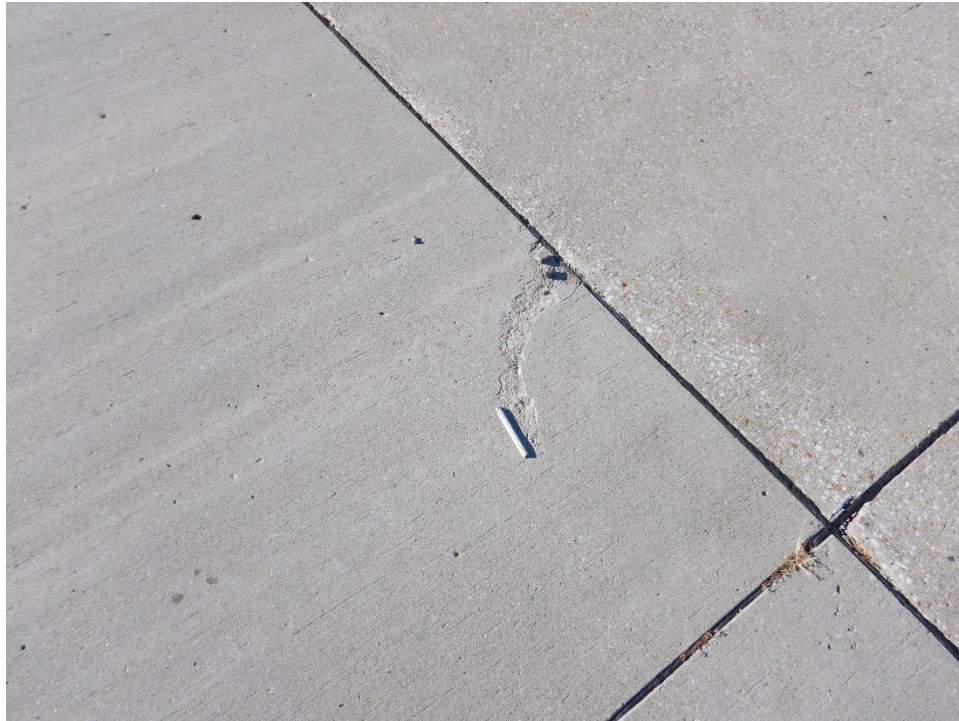
T02CB-03. Joint Spalling (Sample Unit No. 05).

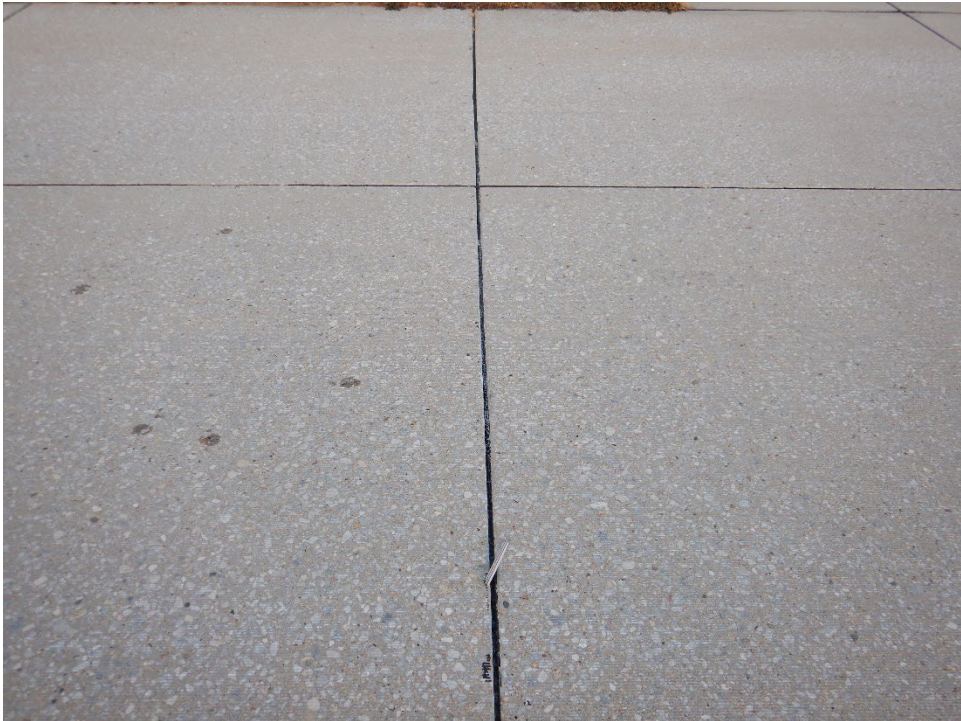
T03CB-01. Joint Seal Damage (Sample Unit No. 03).

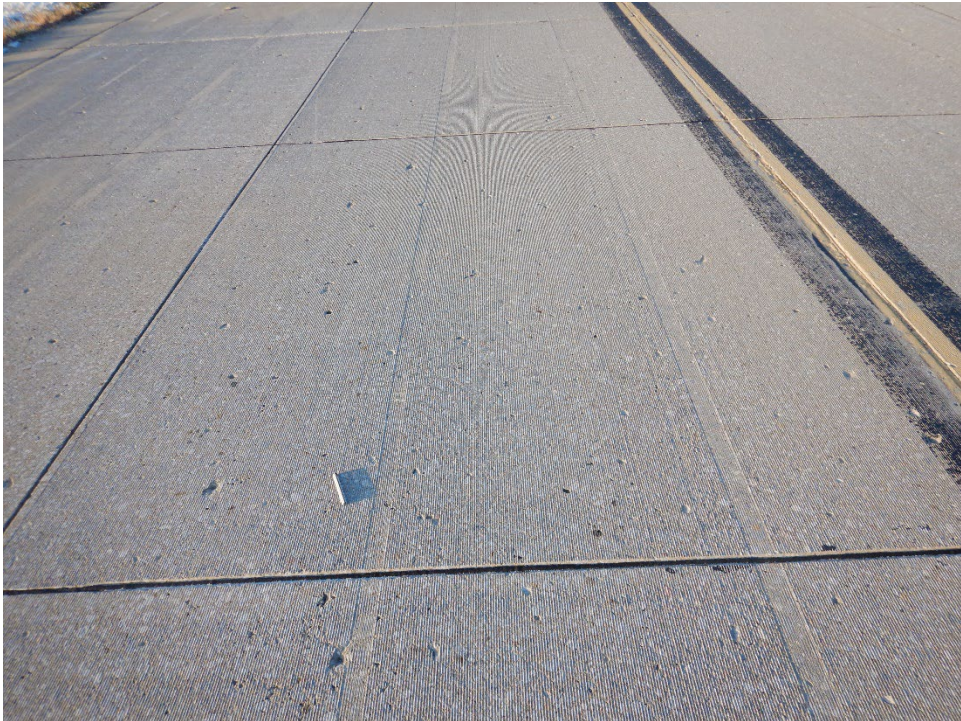
T03CB-02. Popouts (Sample Unit No. 17).

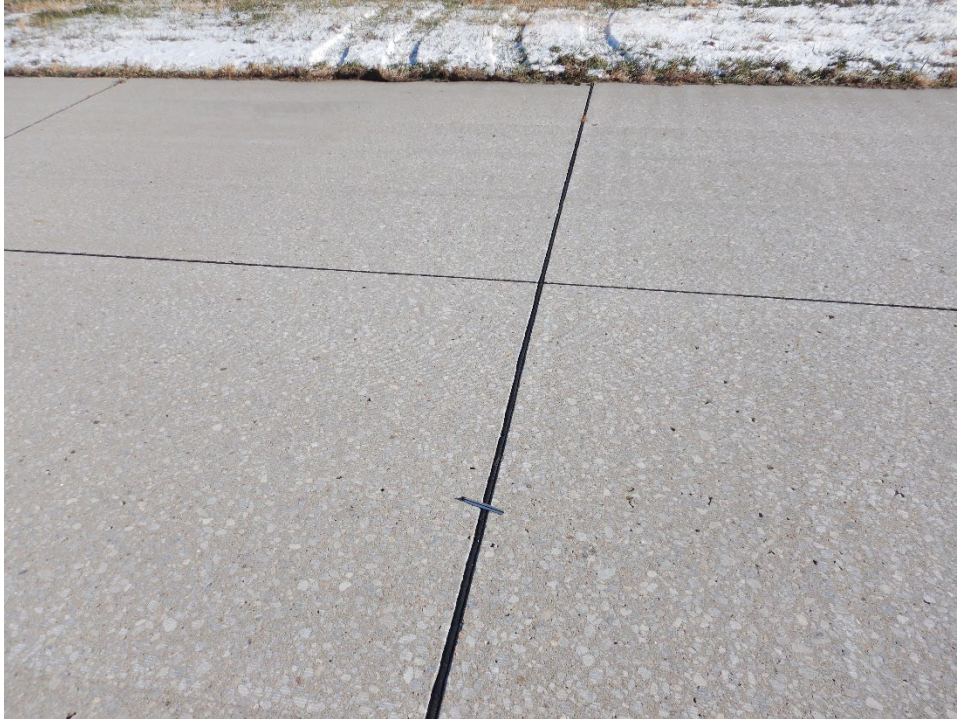
T04CB-01. Joint Seal Damage (Sample Unit No. 09).

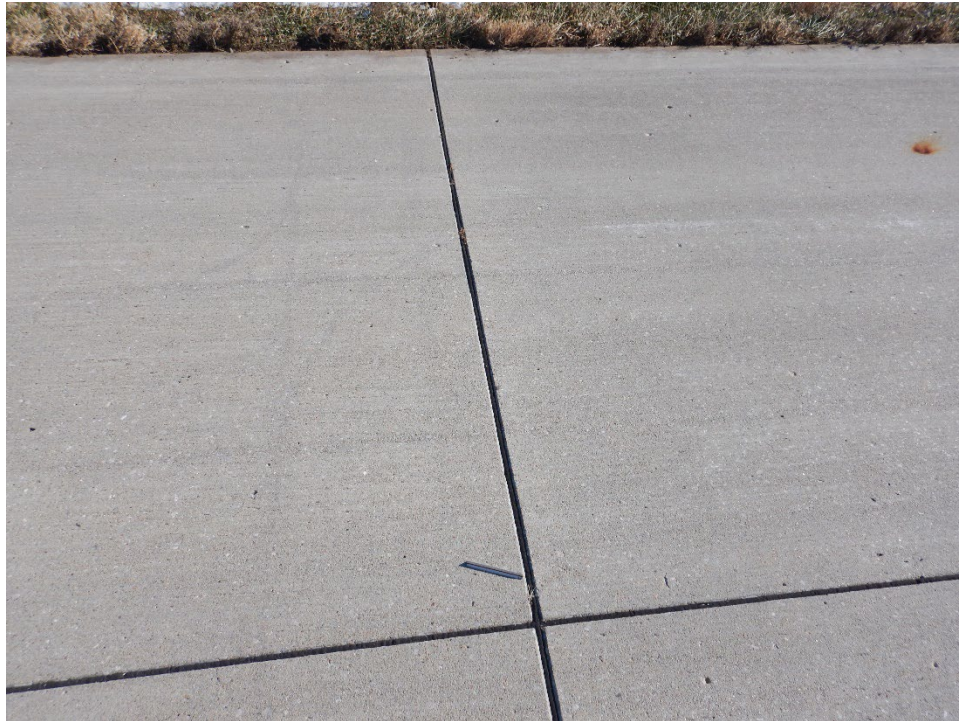
T04CB-02. Joint Seal Damage (Sample Unit No. 08).

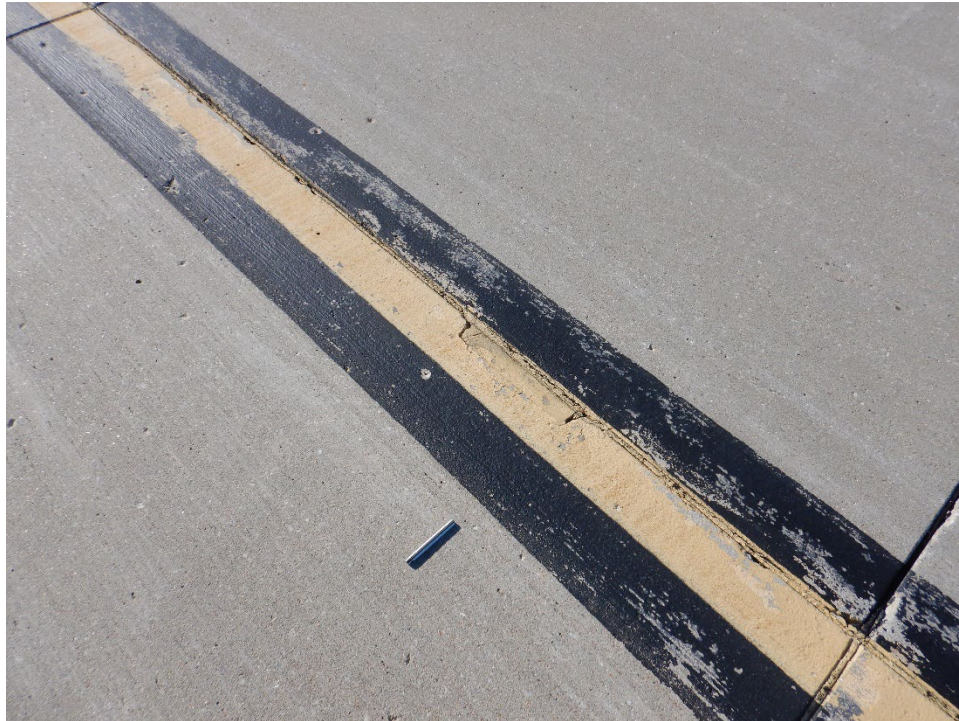
T04CB-03. Small Patching (Sample Unit No. 11).

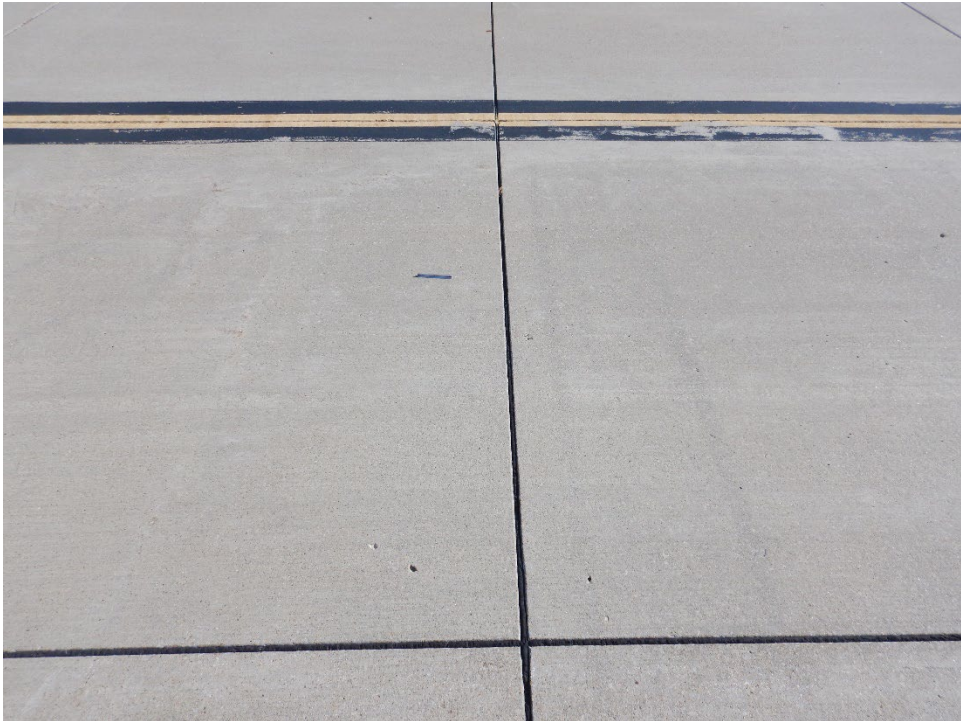
T05CB-01. Joint Seal Damage (Sample Unit No. 12).

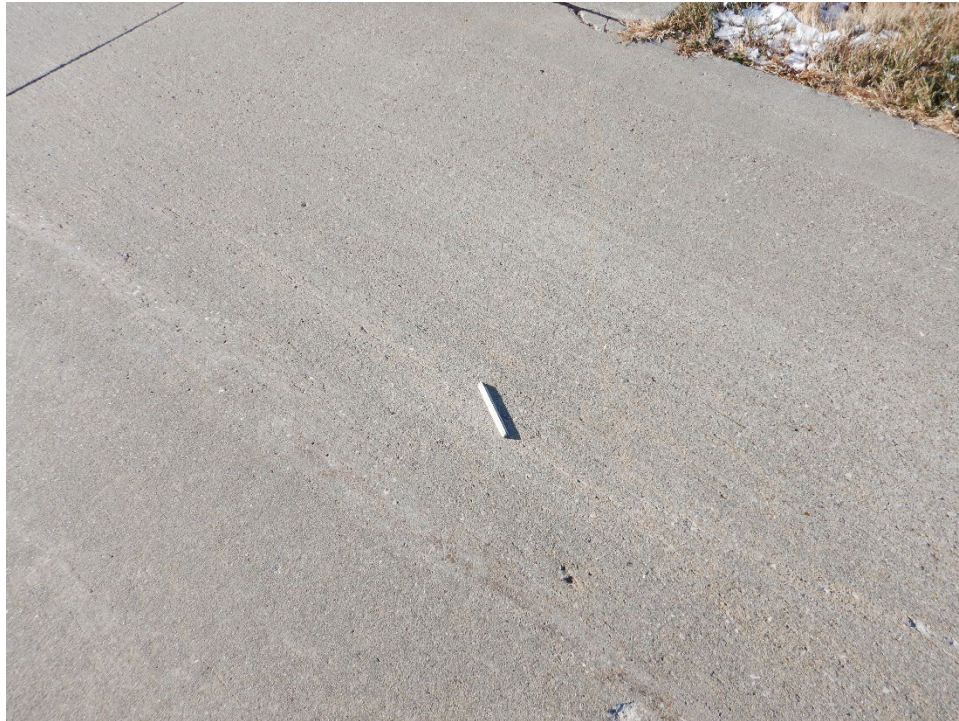
TH01CB-01. ASR (Sample Unit No. 03).

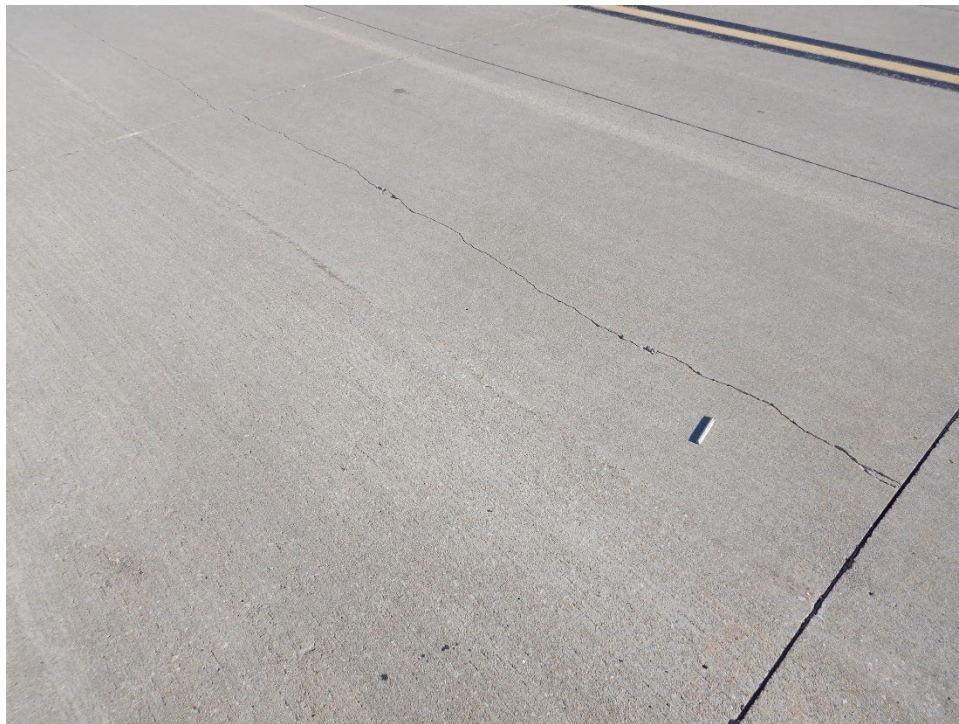
TH01CB-01. LTD Cracking (Sample Unit No. 03).

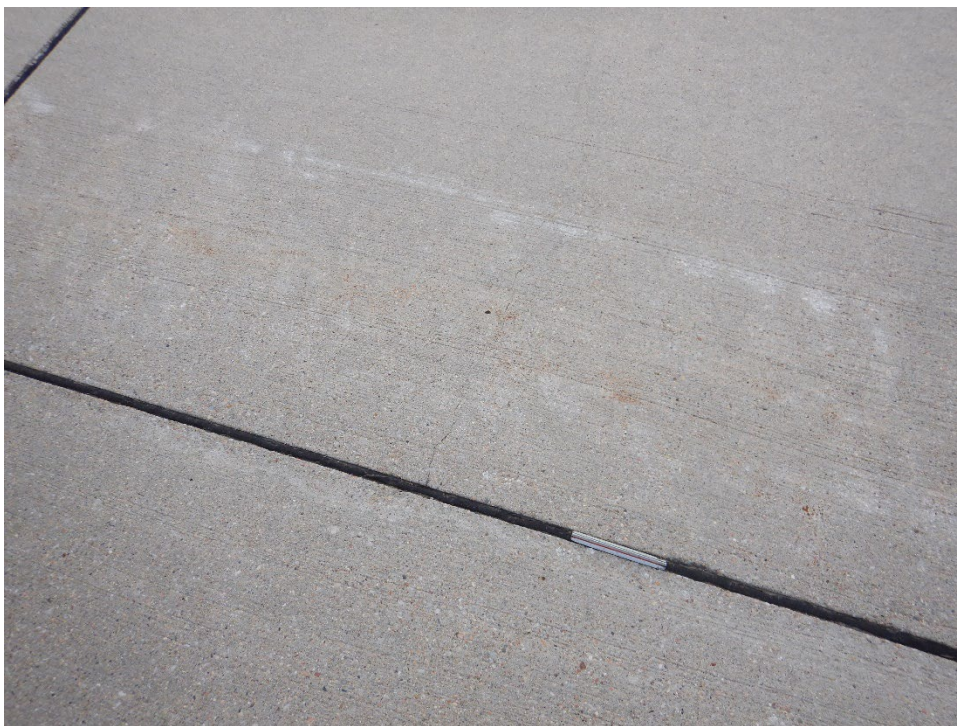
TH01CB-02. Shrinkage Cracking (Sample Unit No. 13).

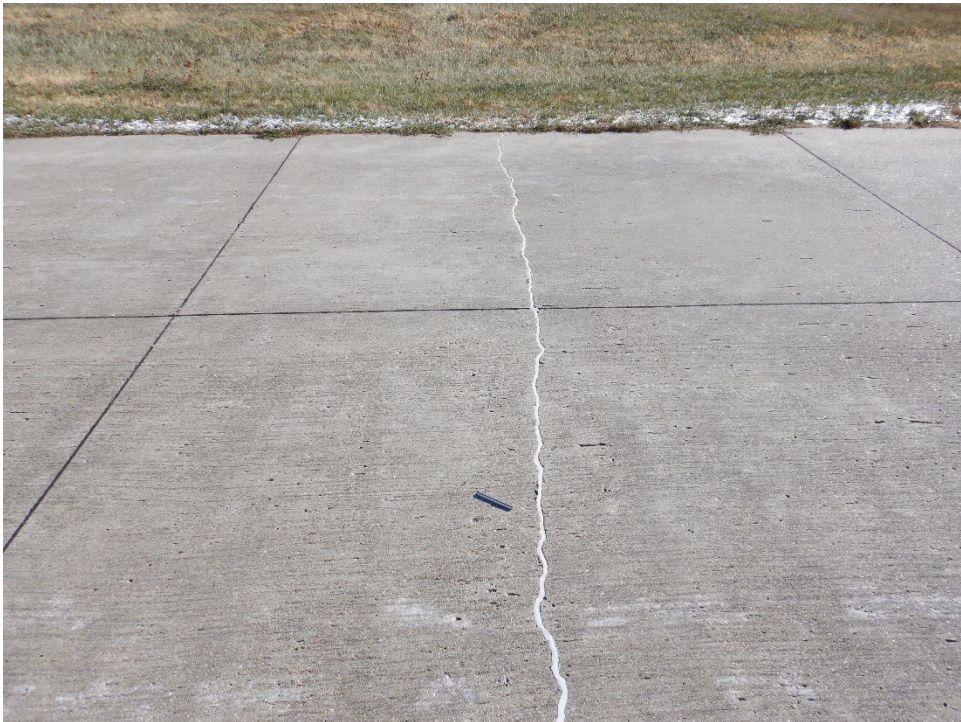
TH01CB-03. LTD Cracking (Sample Unit No. 03).
