Creston Municipal Airport

PAVEMENT MANAGEMENT REPORT

JULY 2022

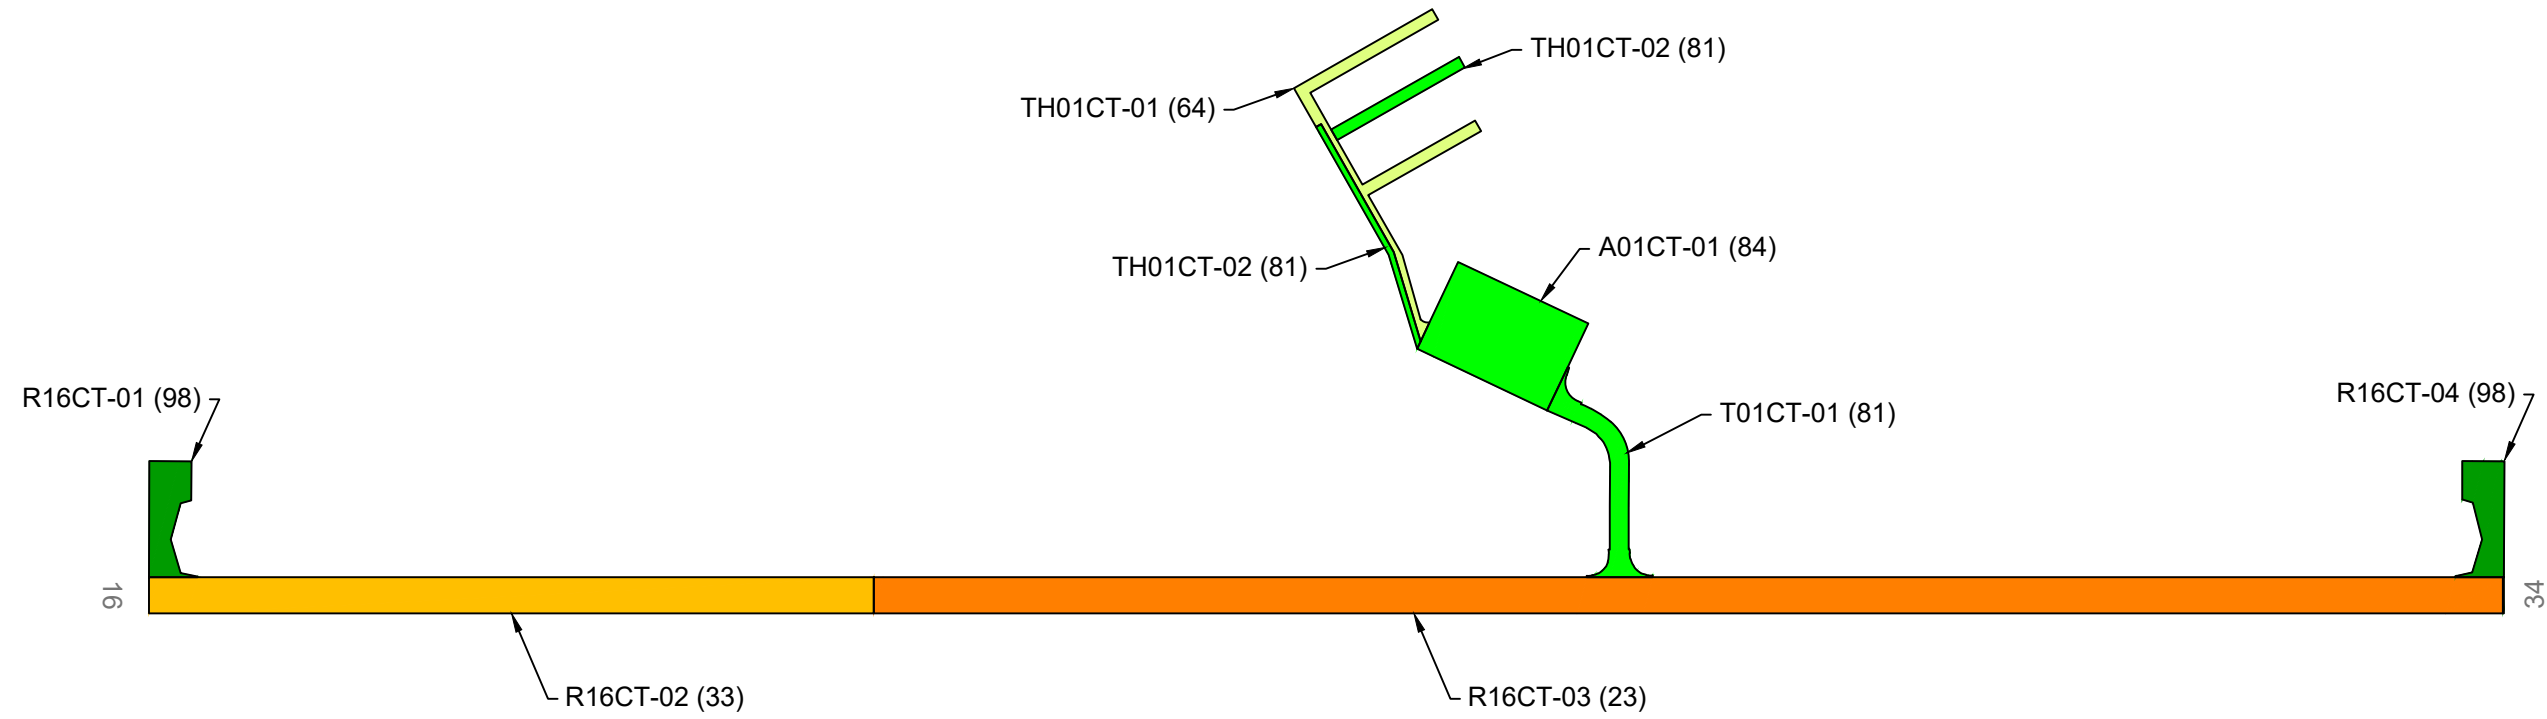
FIGURE 8. PCI MAP.

The pavements at Creston Municipal Airport were inspected in November 2021. The 2021 area-weighted condition of Creston Municipal Airport is 43, with conditions ranging from 23 to 98 (on a scale of 0 [failed] to 100 [excellent]). During the previous pavement inspection in 2018, the area-weighted PCI of the airport was 62.

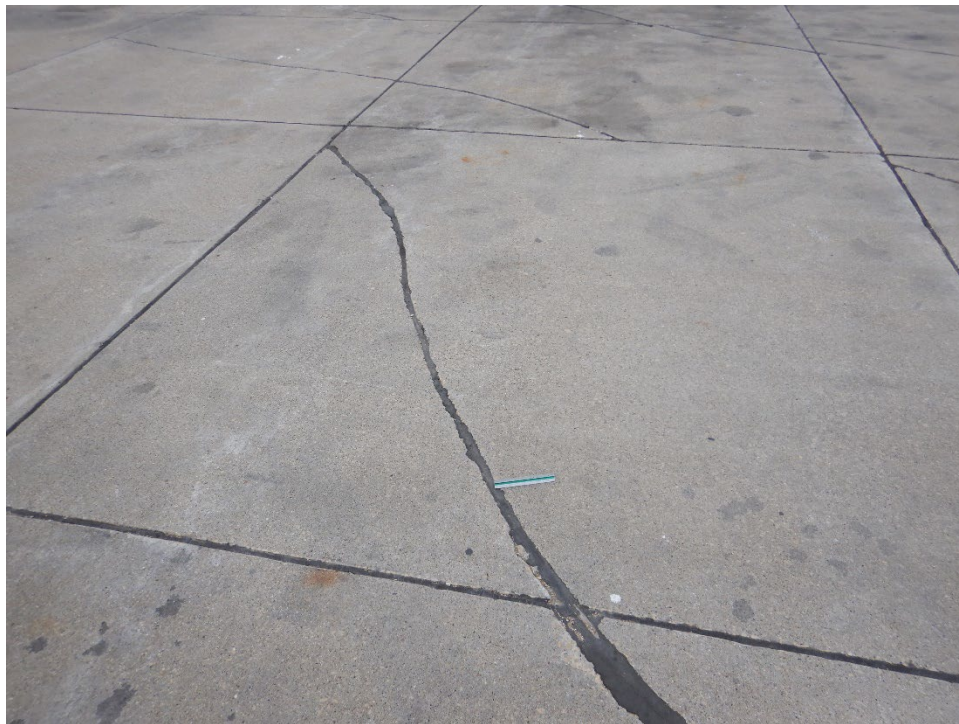
A01CT-01. LTD Cracking (Sample Unit No. 12).

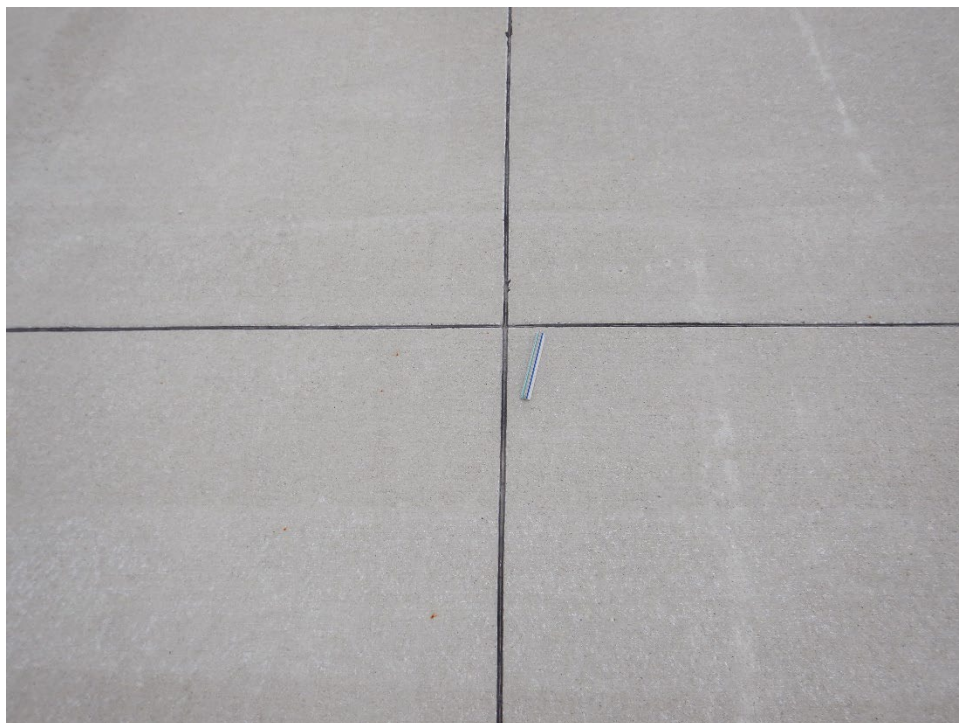
R16CT-01. Joint Seal Damage (Sample Unit No. 01).

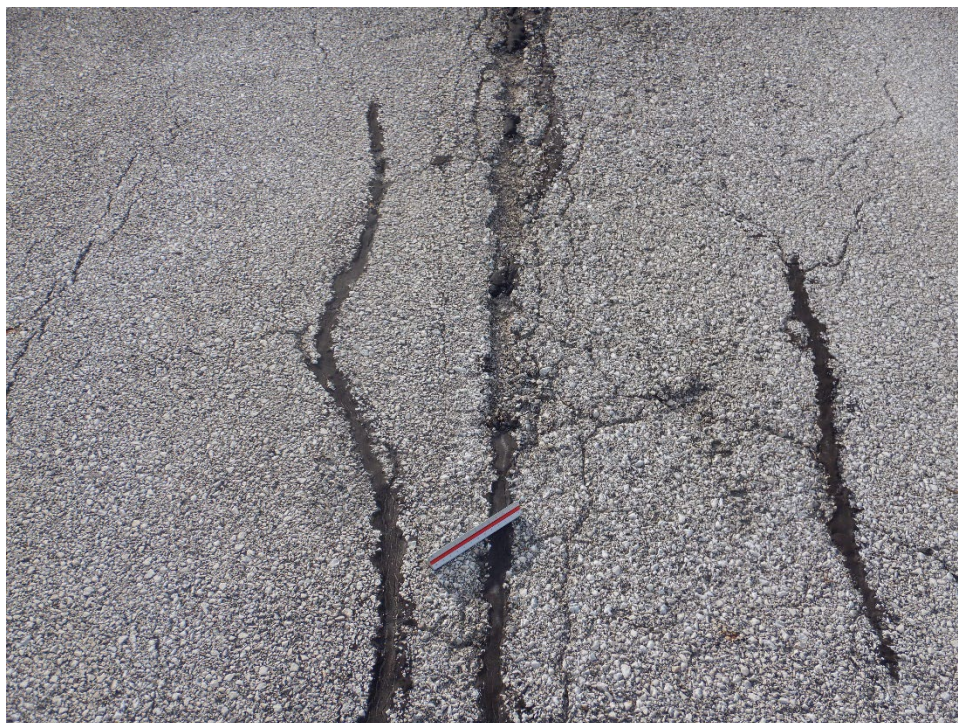
R16CT-02. L&T Cracking (Sample Unit No. 20).

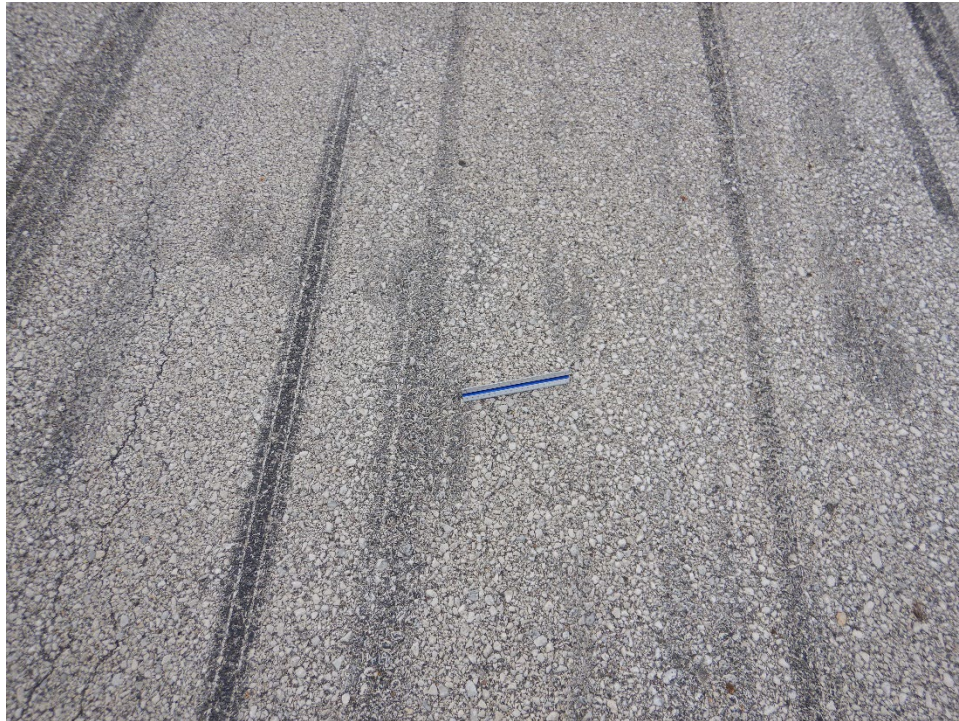
R16CT-02. Weathering (Sample Unit No. 11).

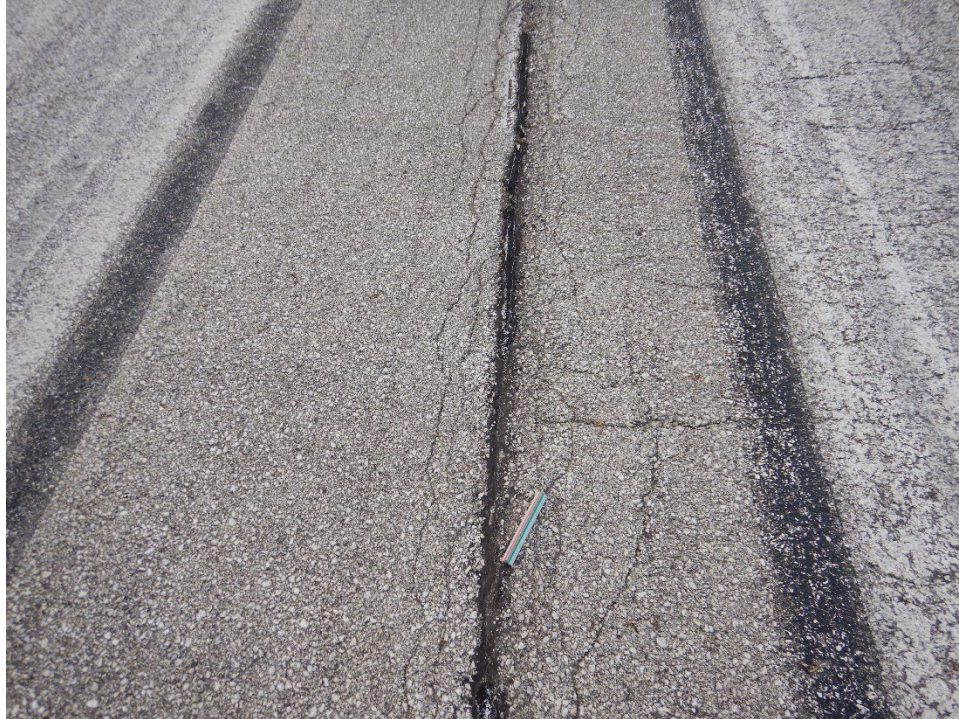
R16CT-03. L&T Cracking (Sample Unit No. 44).

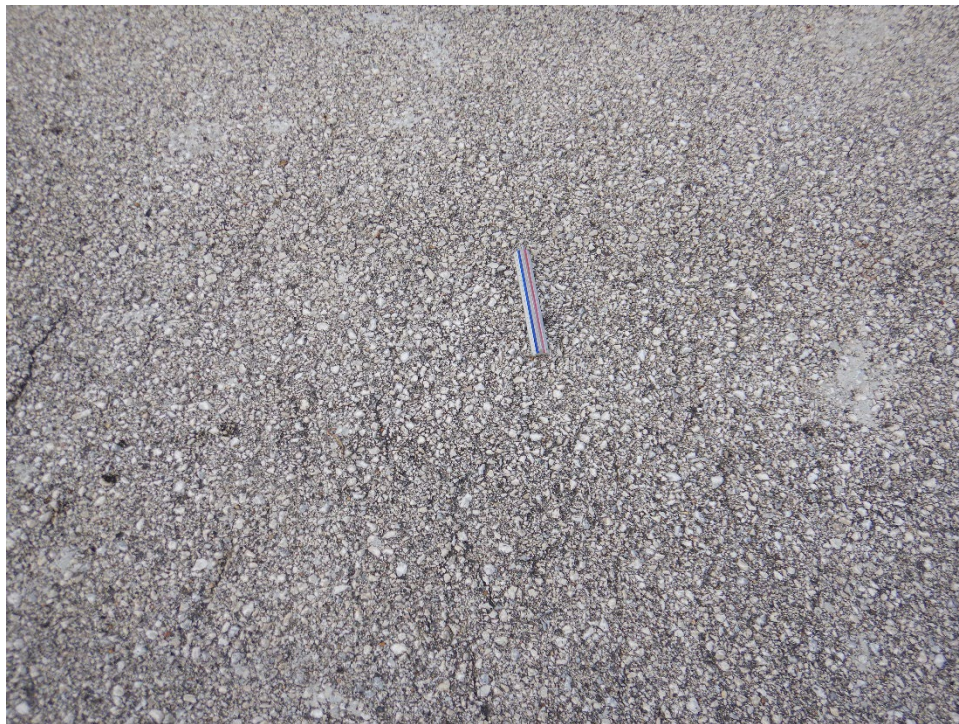
R16CT-03. Raveling (Sample Unit No. 44).

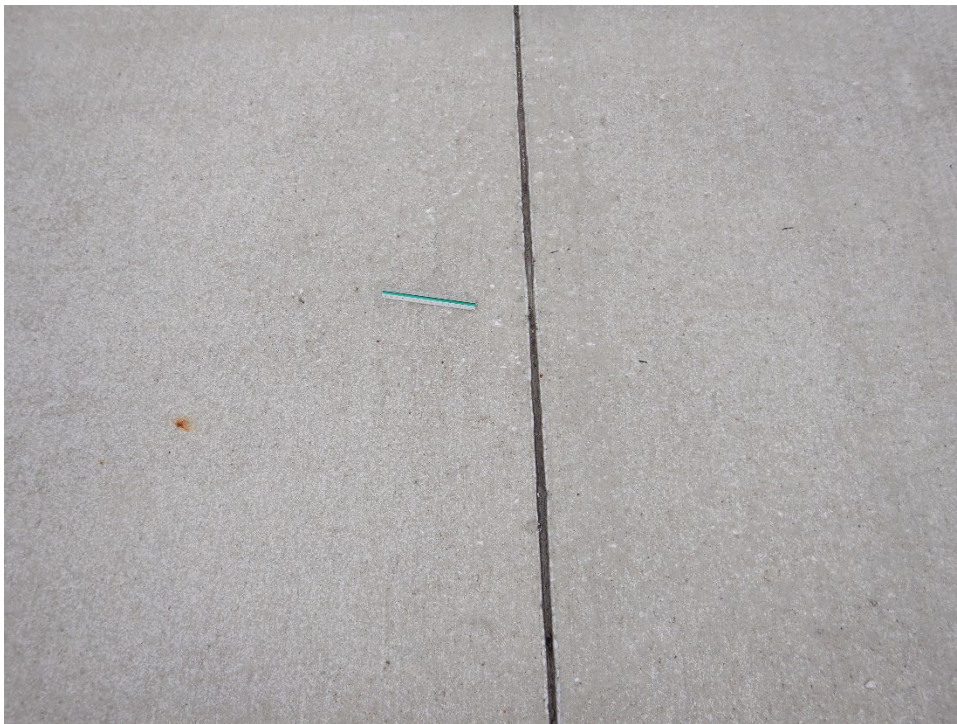
R16CT-04. Joint Seal Damage (Sample Unit No. 04).

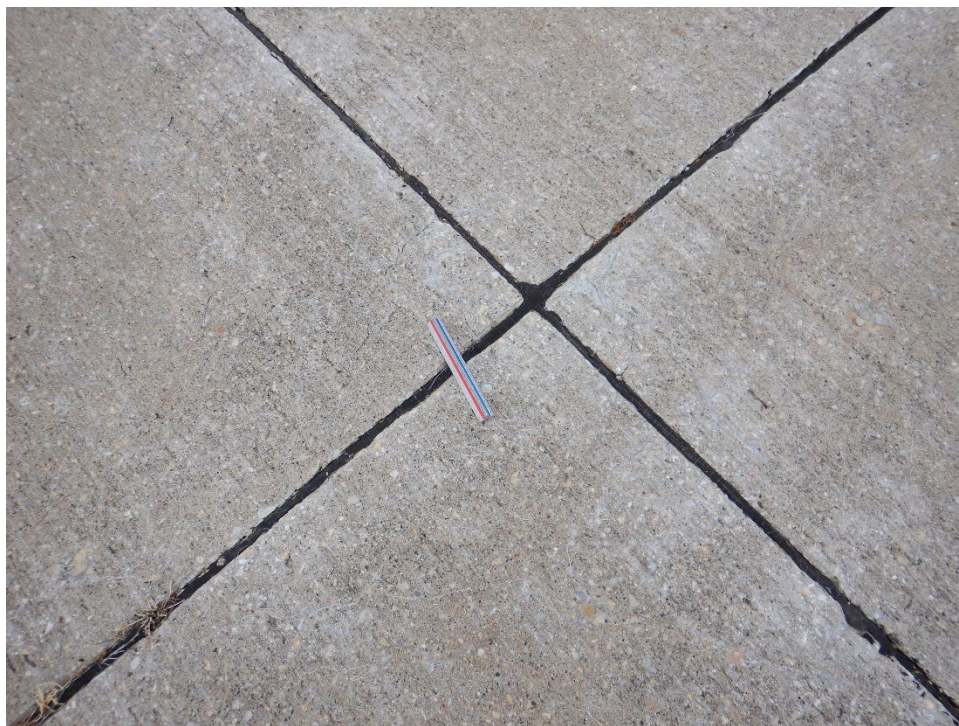
Taxiway 01 connected Runway 16/34 with the apron area and consisted of one section. Areas of medium-severity corner break; medium- and high-severity corner spalling and joint seal damage; and low-severity ASR, faulting, and longitudinal, transverse, and diagonal (LTD) cracking were noted in Section 01.

T01CT-01. ASR (Sample Unit No. 03).

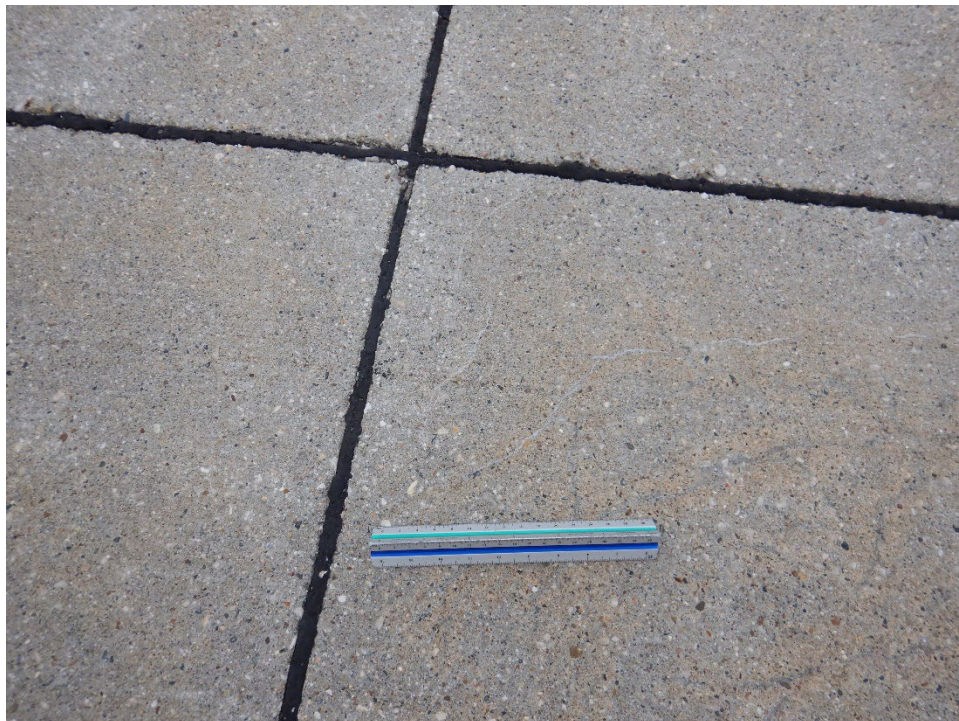
TH01CT-01. ASR (Sample Unit No. 04).

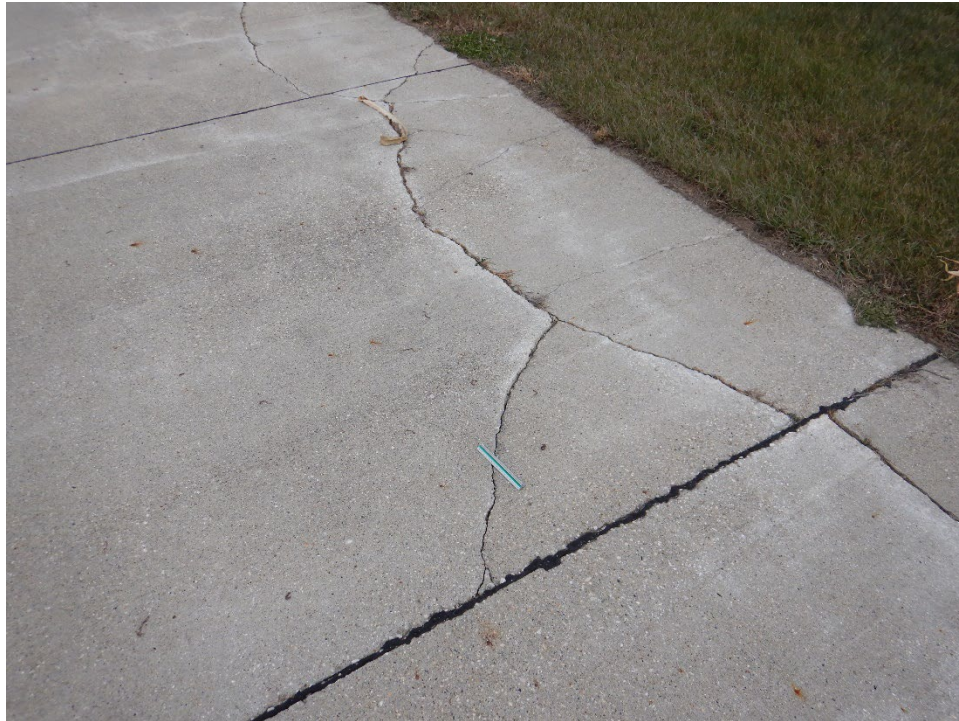
TH01CT-01. Shattered Slab (Sample Unit No. 03).

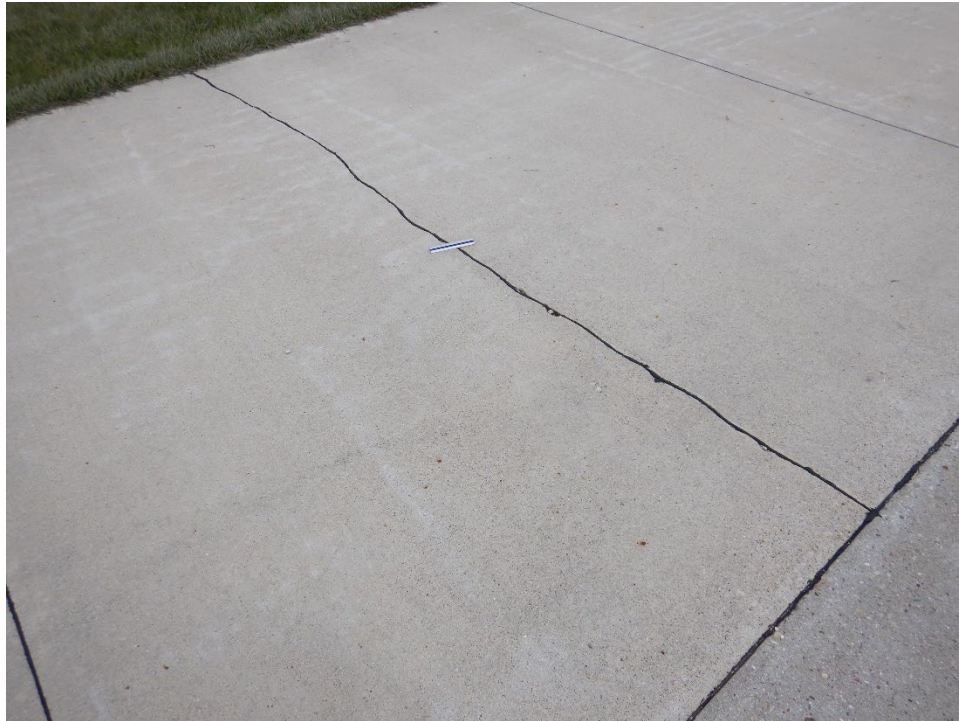
TH01CT-02. LTD Cracking (Sample Unit No. 04).
