# Decorah Municipal Airport

## Pavement Management Report

# DECORAH MUNICIPAL AIRPORT PAVEMENT MANAGEMENT REPORT

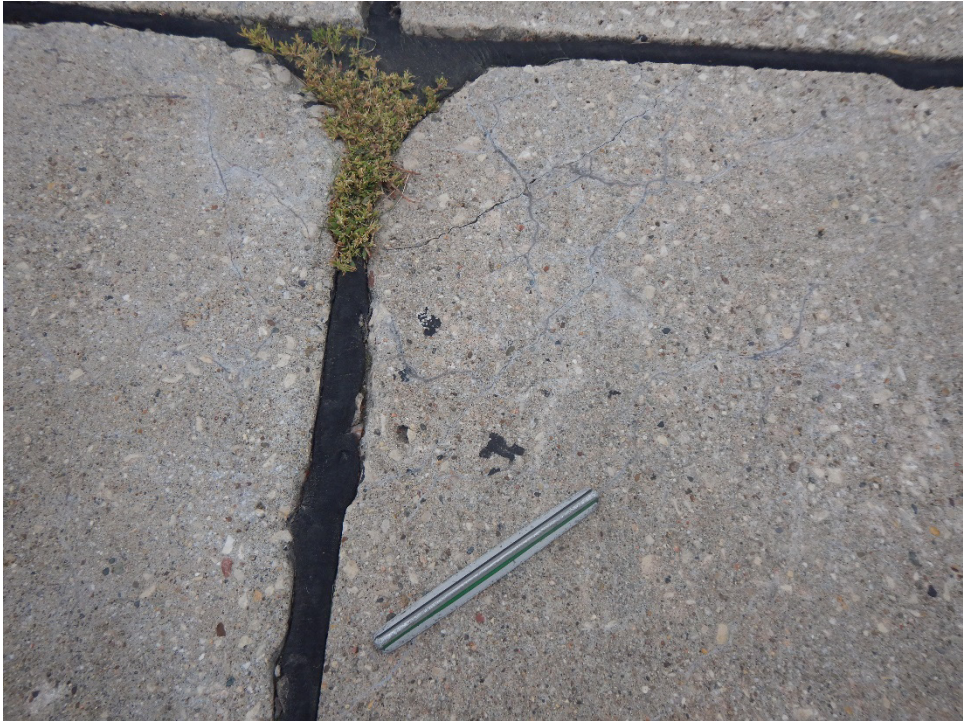
A01DE-01. ASR (Sample Unit No. 01).

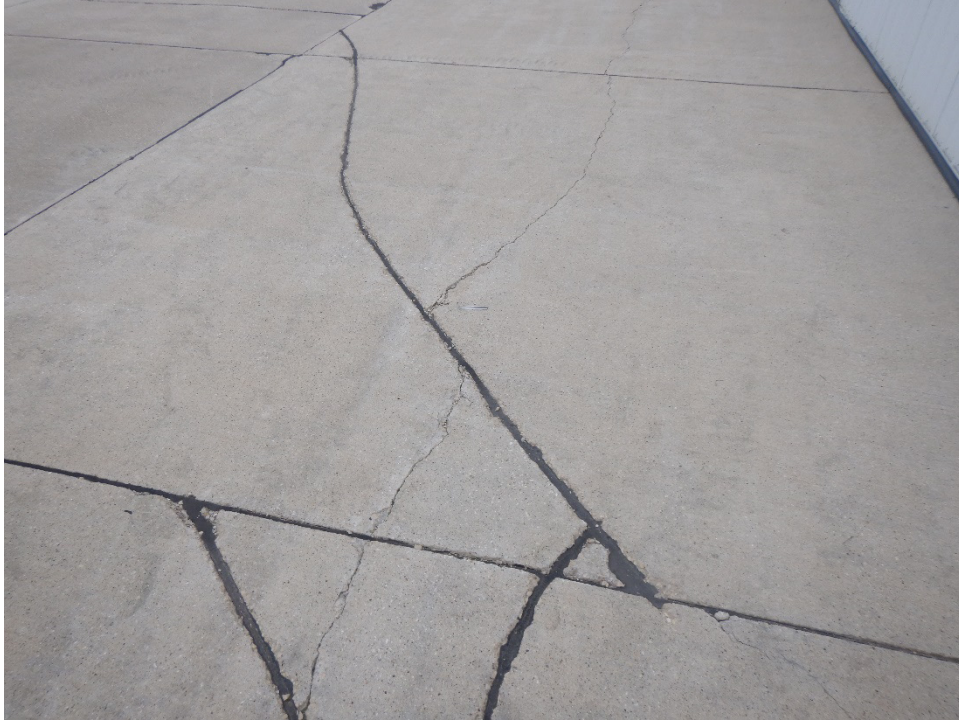
A01DE-01. Shattered Slab (Sample Unit No. 01).

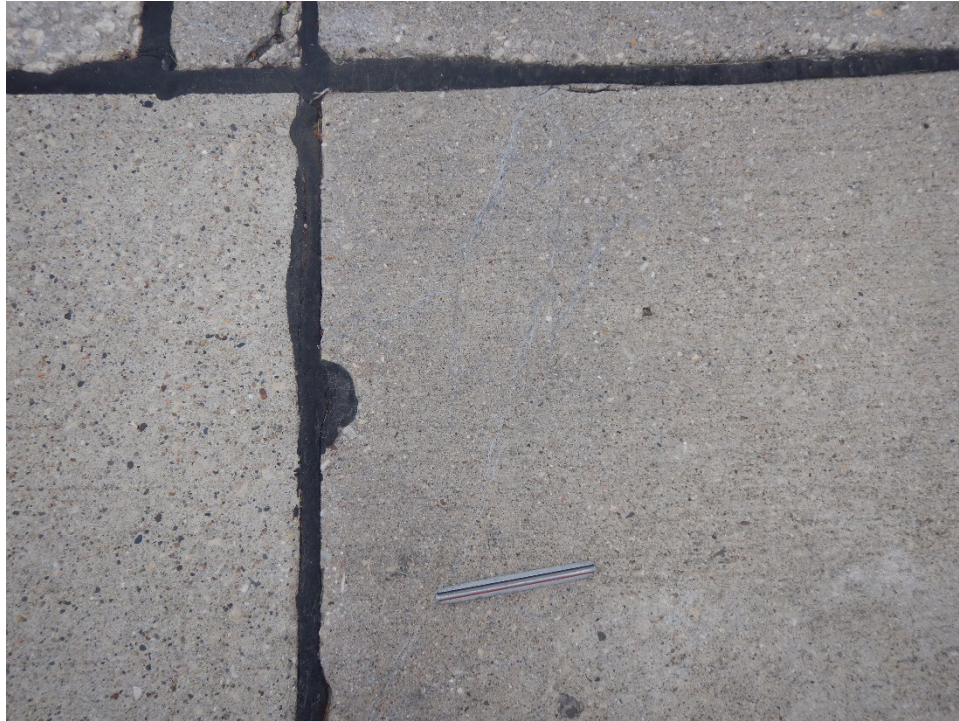
A01DE-02. ASR (Sample Unit No. 01).

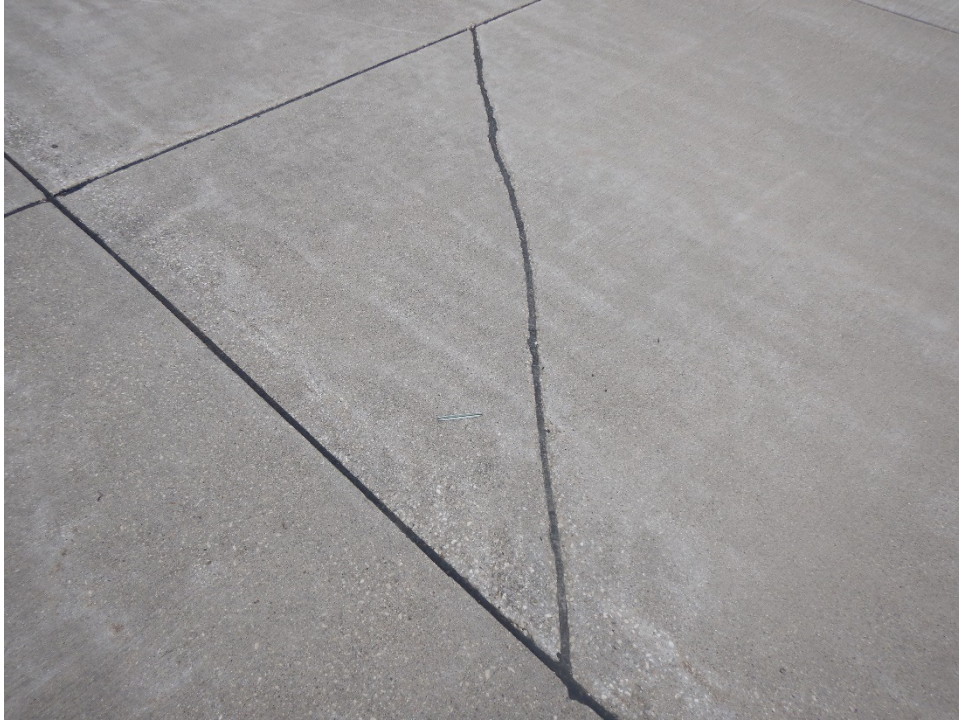
A01DE-03. LTD Cracking (Sample Unit No. 04).

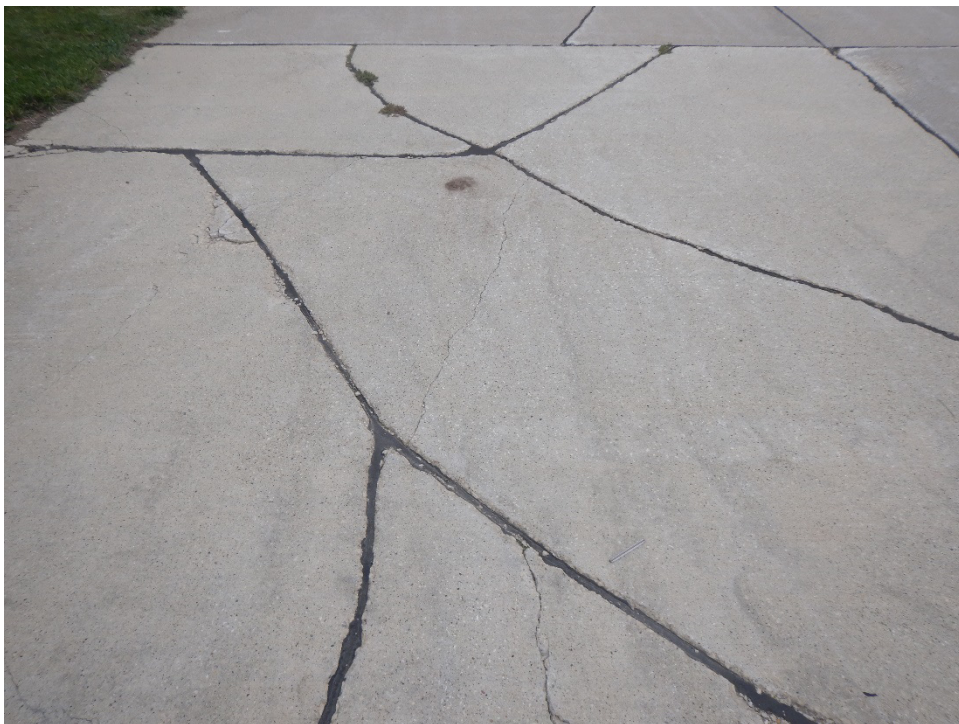
A01DE-03. Shattered Slab (Sample Unit No. 01).

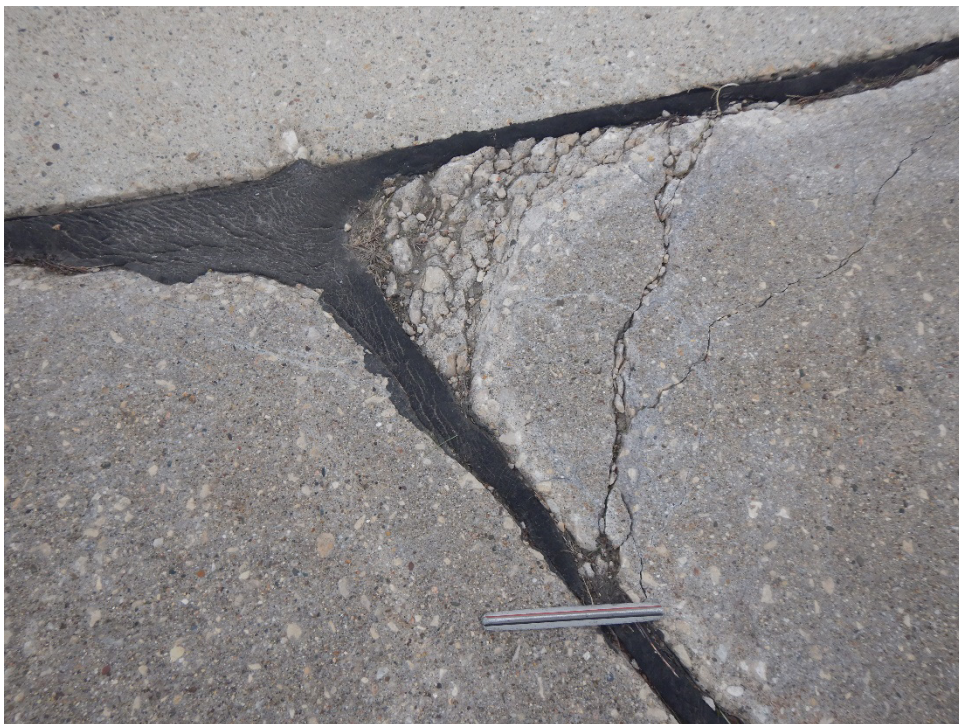
A01DE-04. ASR (Sample Unit No. 02).

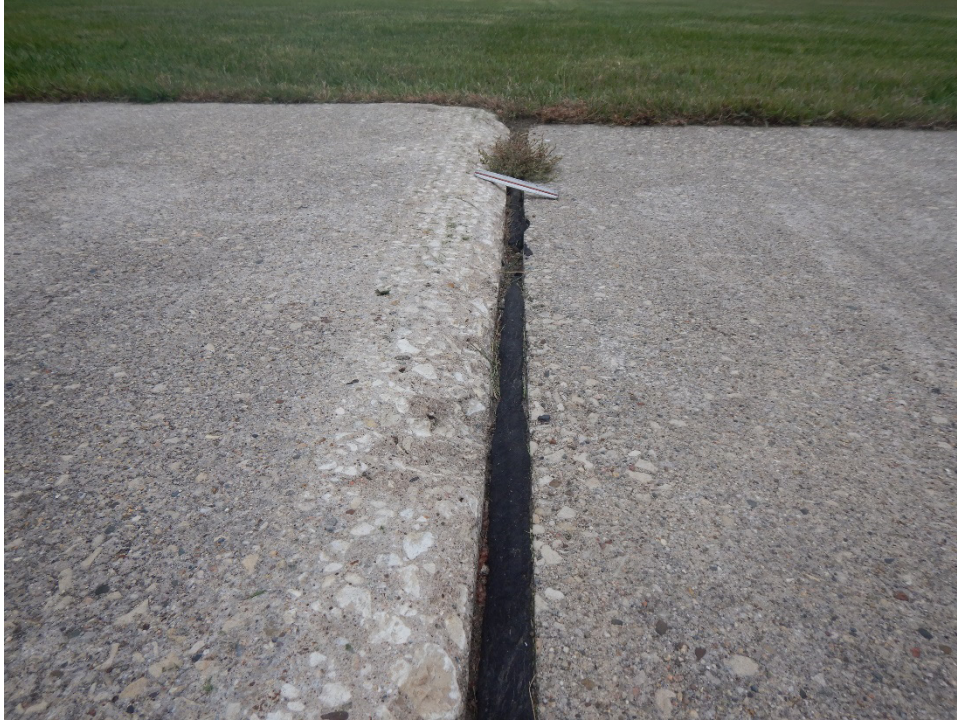
A01DE-04. Faulting (Sample Unit No. 03).

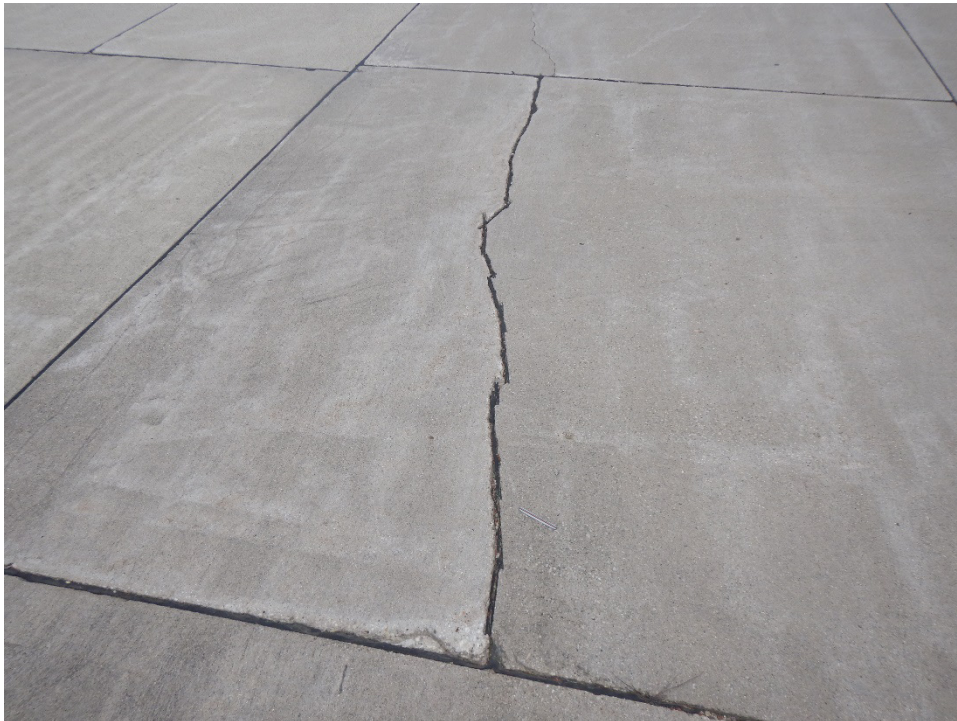
A01DE-04. LTD Cracking (Sample Unit No. 02).

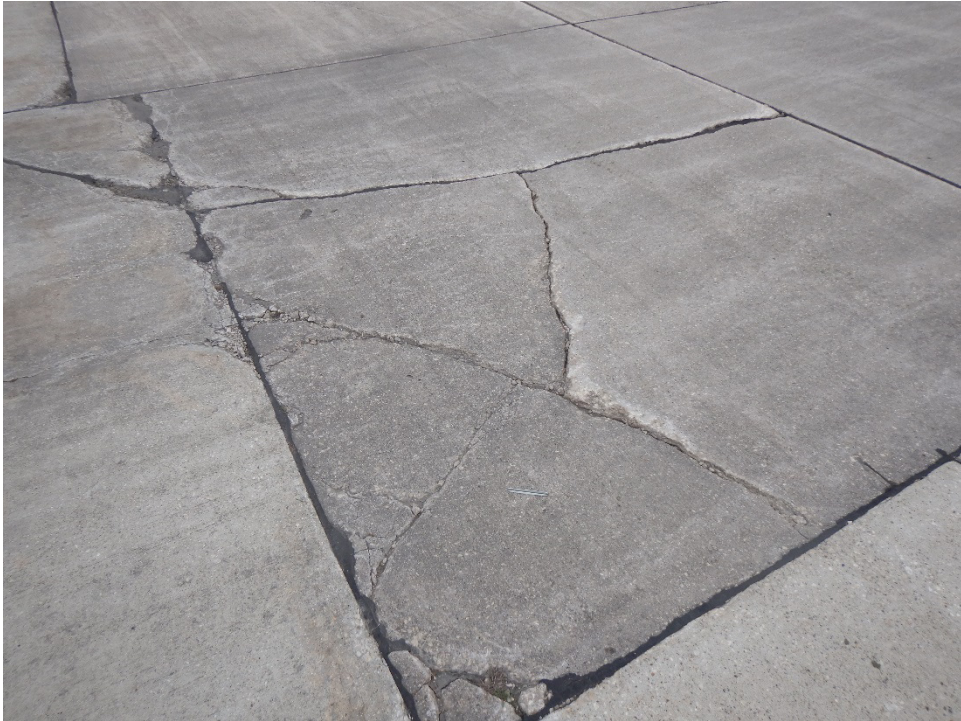
A01DE-04. Shattered Slab (Sample Unit No. 03).

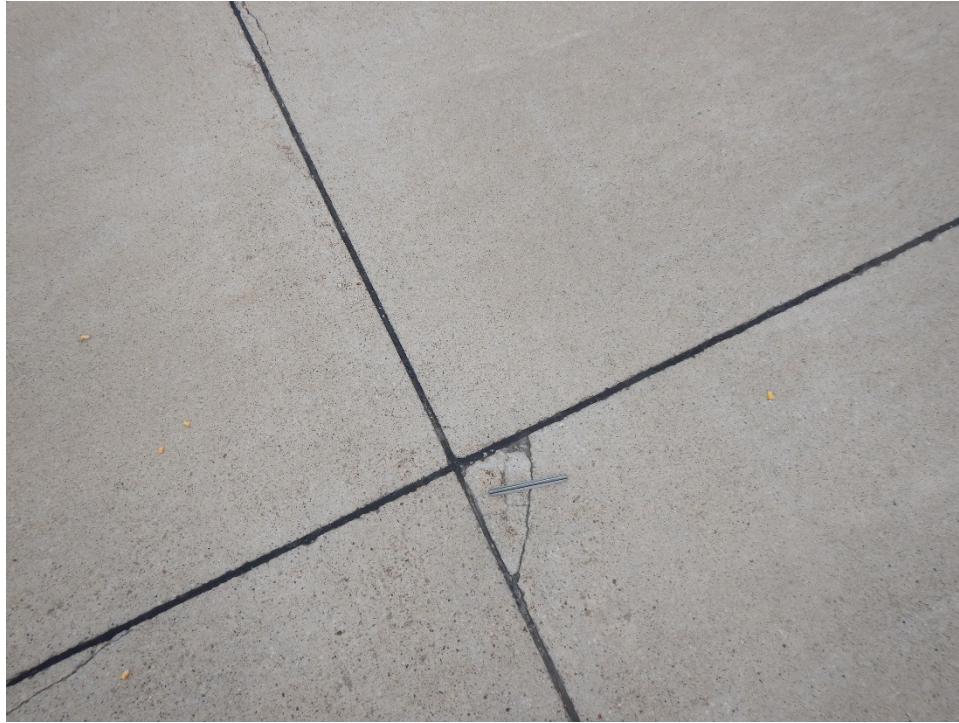
A01DE-05. Corner Spalling (Sample Unit No. 06).

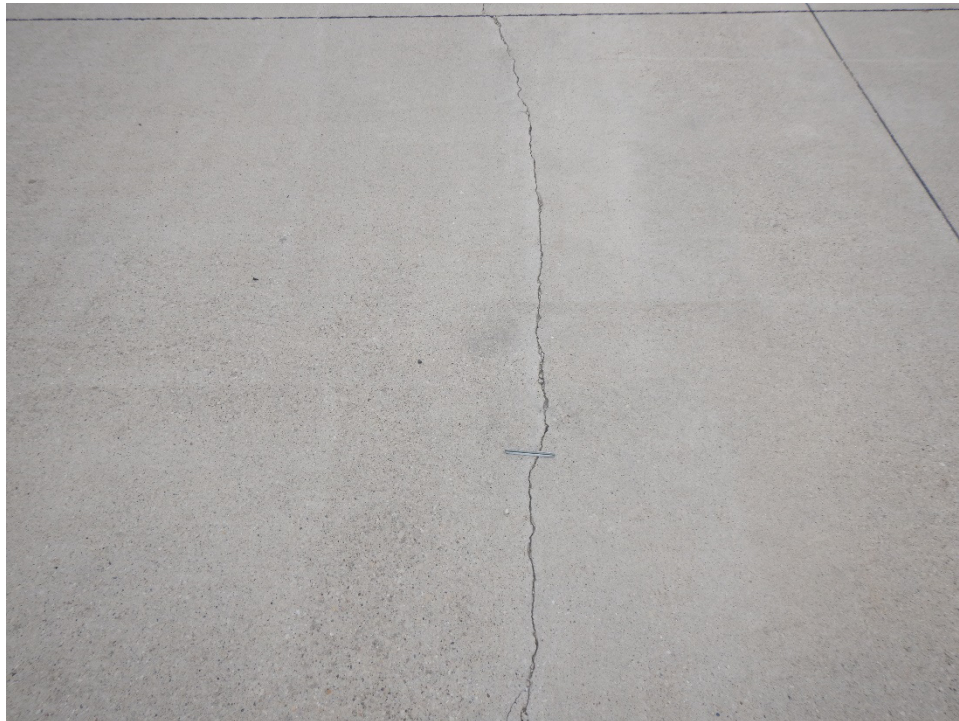
A01DE-05. LTD Cracking (Sample Unit No. 04).

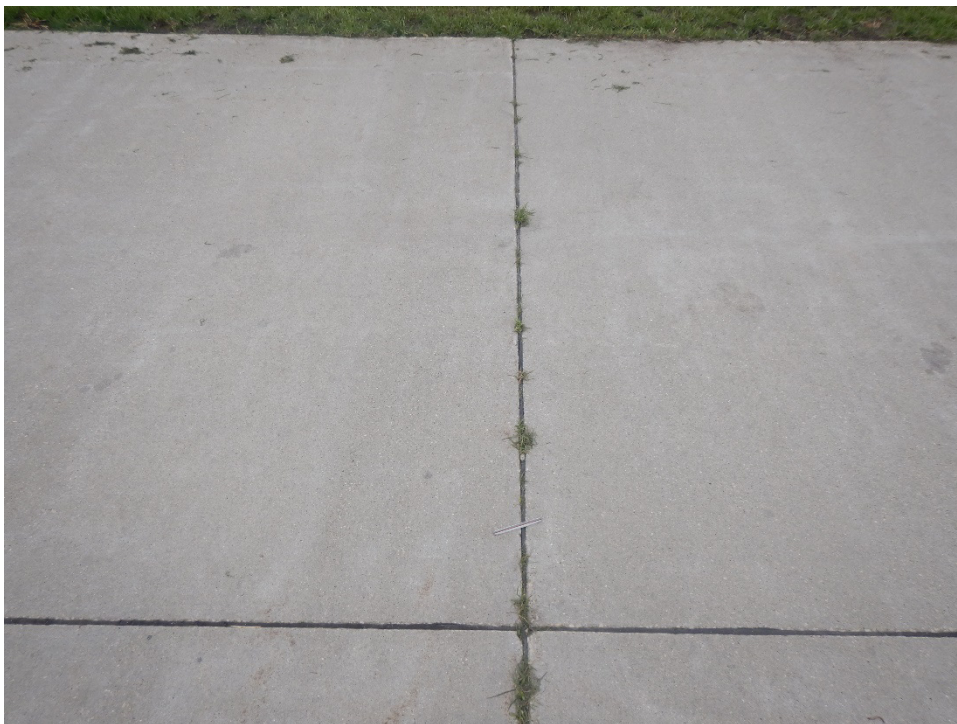
A01DE-06. Joint Seal Damage (Sample Unit No. 09).

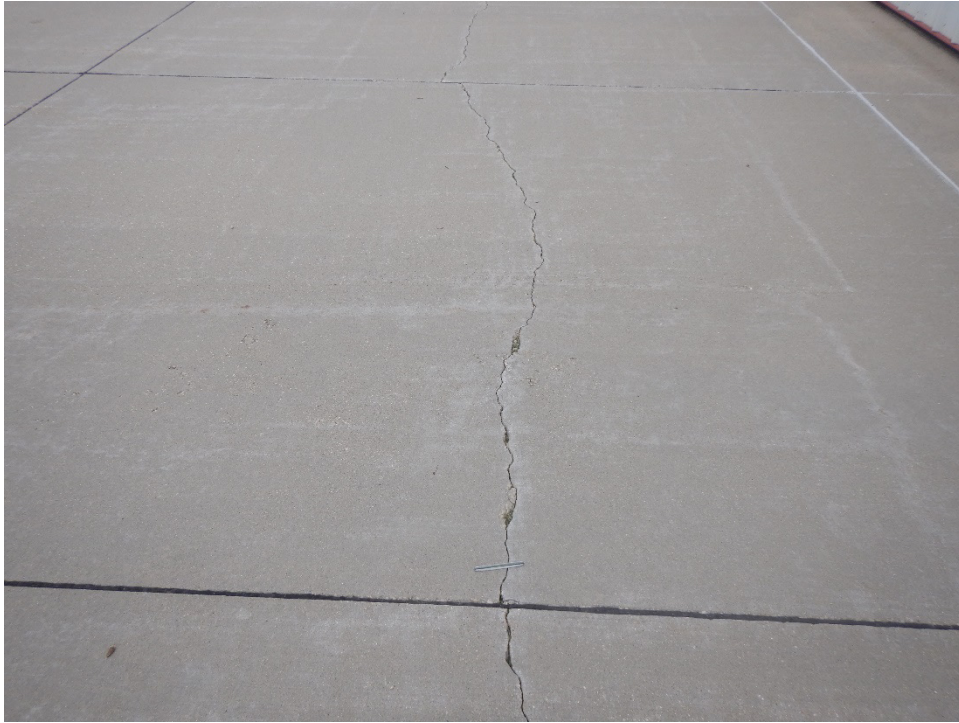
A01DE-06. LTD Cracking (Sample Unit No. 05).

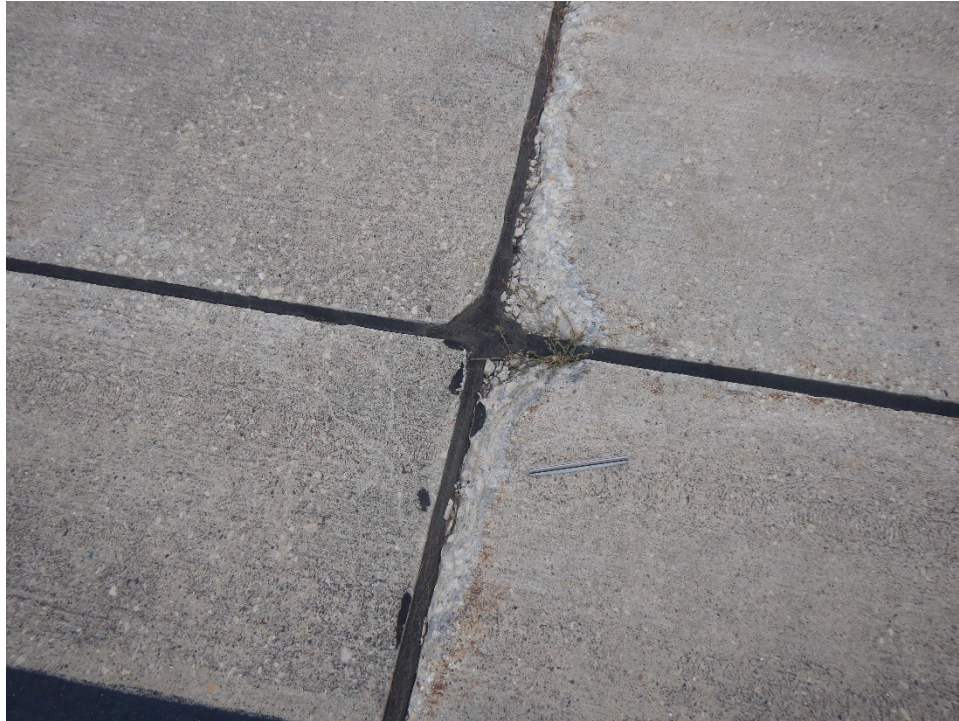
R11DE-01. ASR (Sample Unit No. 05).

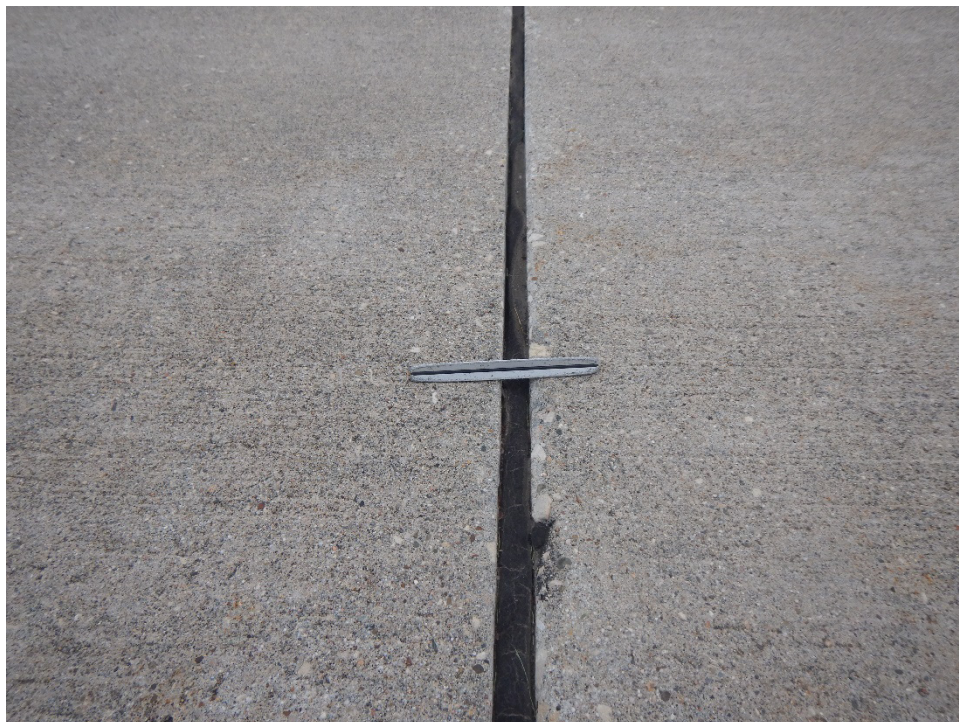
R11DE-01. Joint Seal Damage (Sample Unit No. 12).

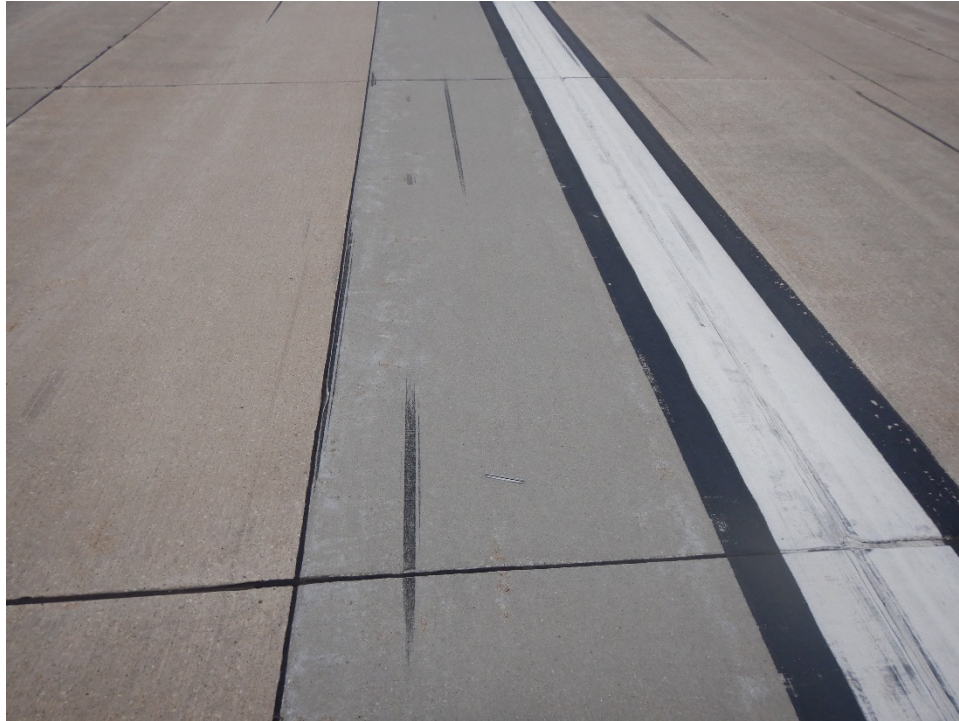
R11DE-01. Large Patching (Sample Unit No. 08).

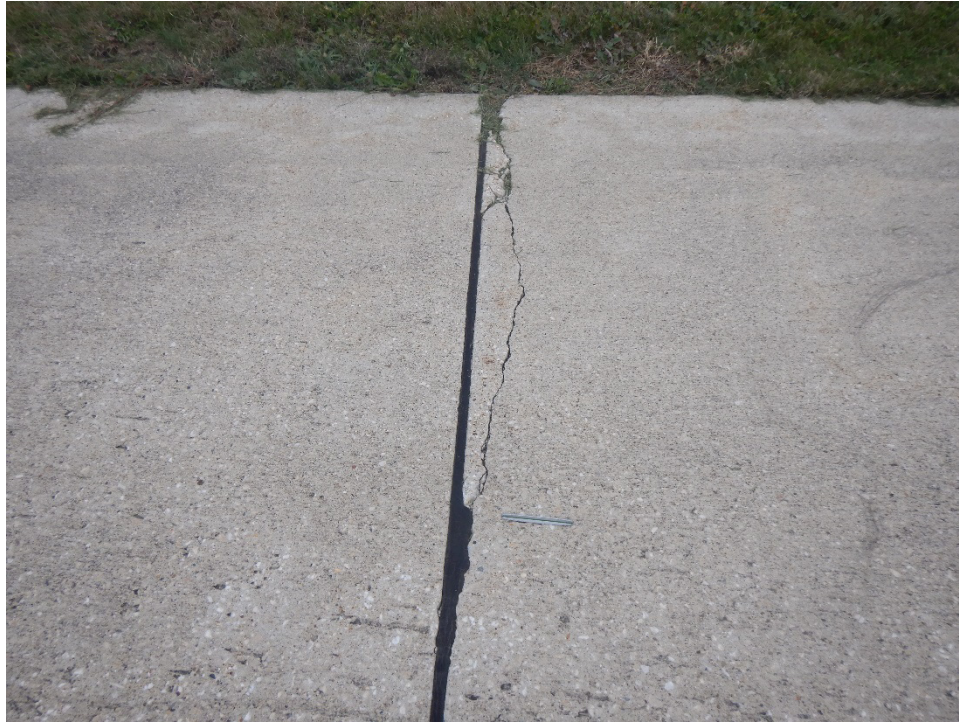
R11DE-02. Joint Spalling (Sample Unit No. 49).

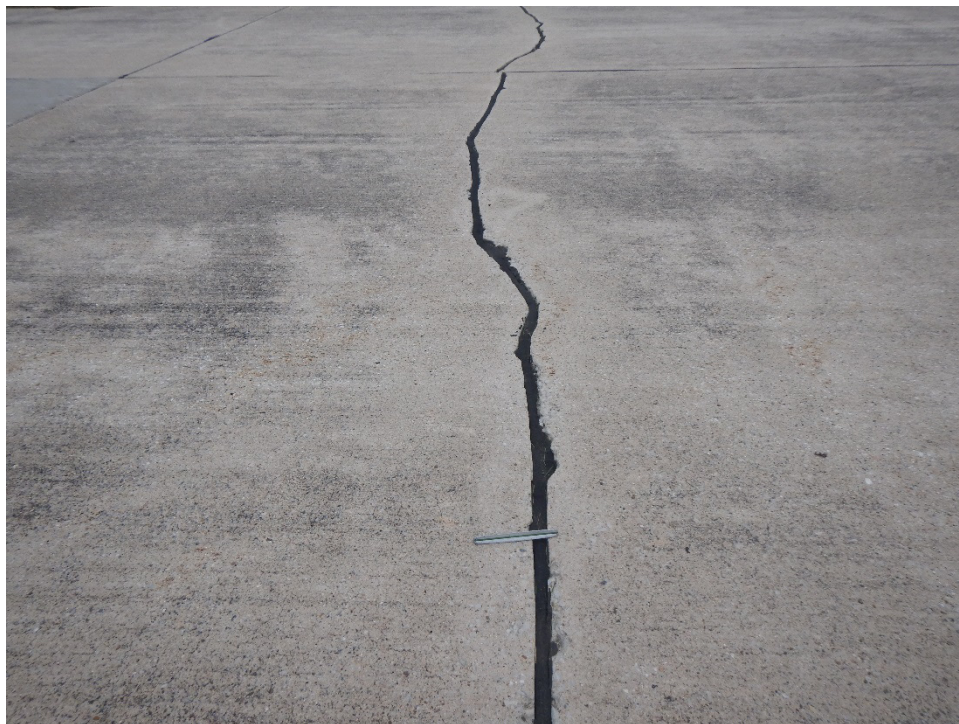
R11DE-02. LTD Cracking (Sample Unit No. 02).

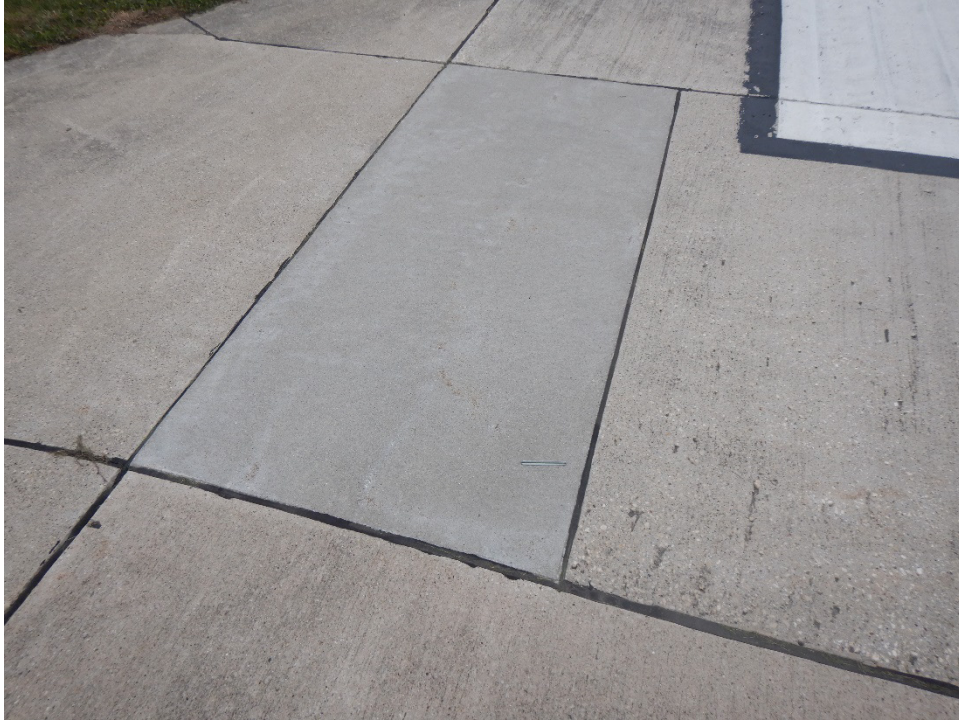
R11DE-02. Large Patching (Sample Unit No. 08).

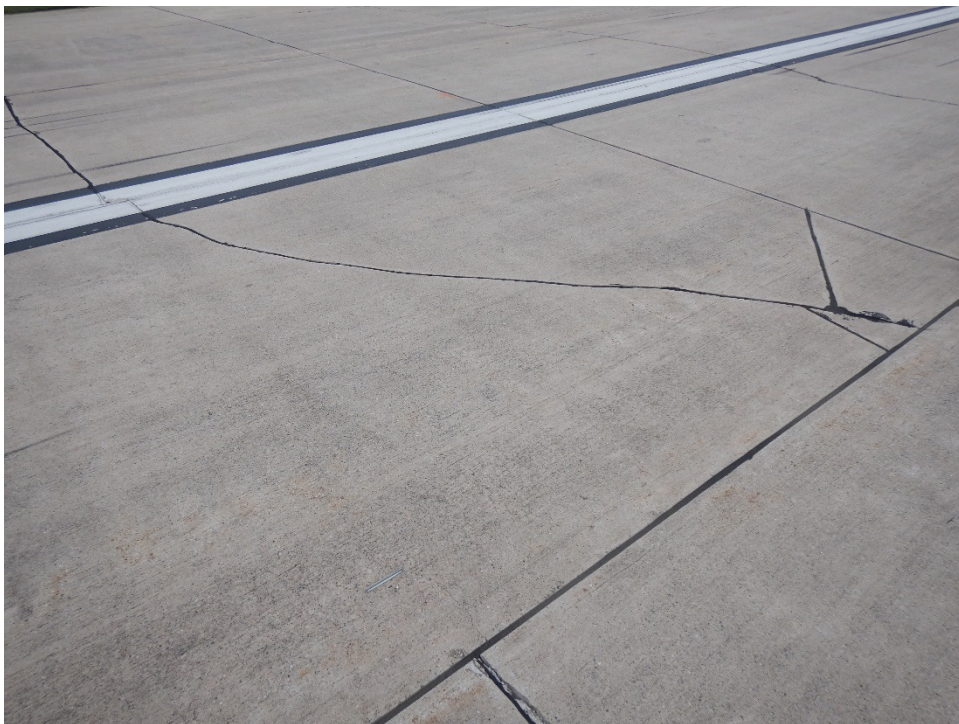
R11DE-02. Shattered Slab (Sample Unit No. 65).

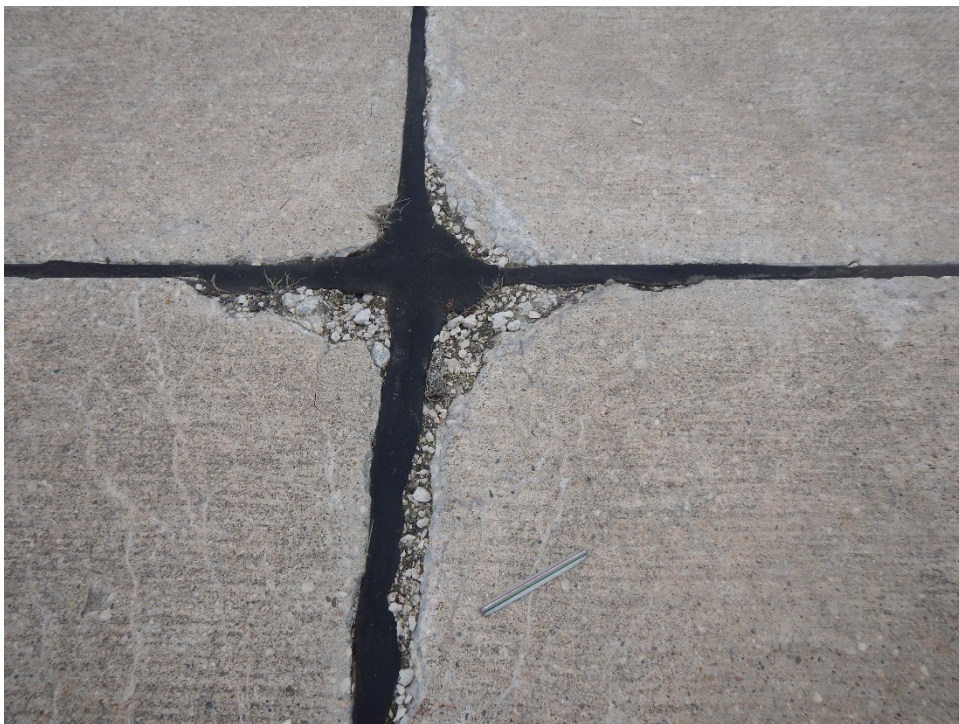
R11DE-03. ASR (Sample Unit No. 06).

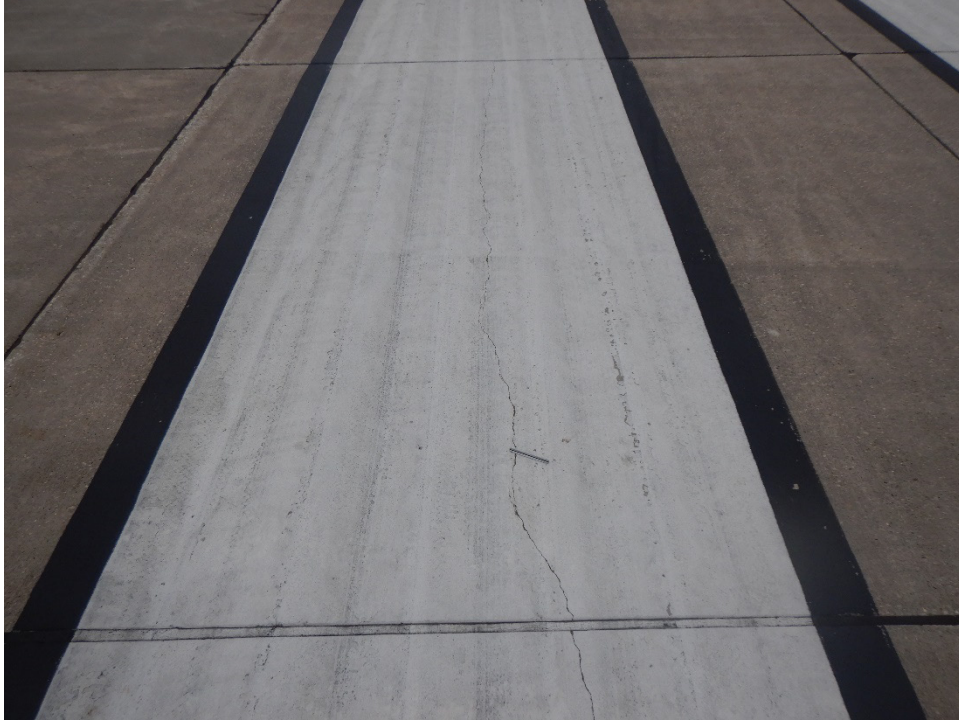
R11DE-03. LTD Cracking (Sample Unit No. 09).

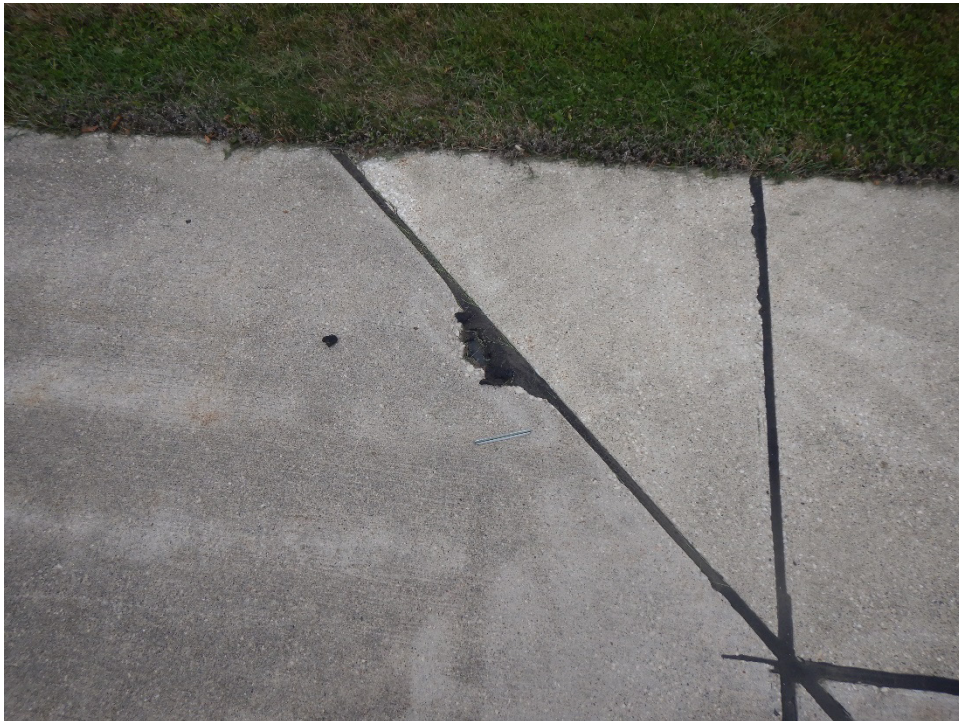
R11DE-03. Small Patching (Sample Unit No. 04).

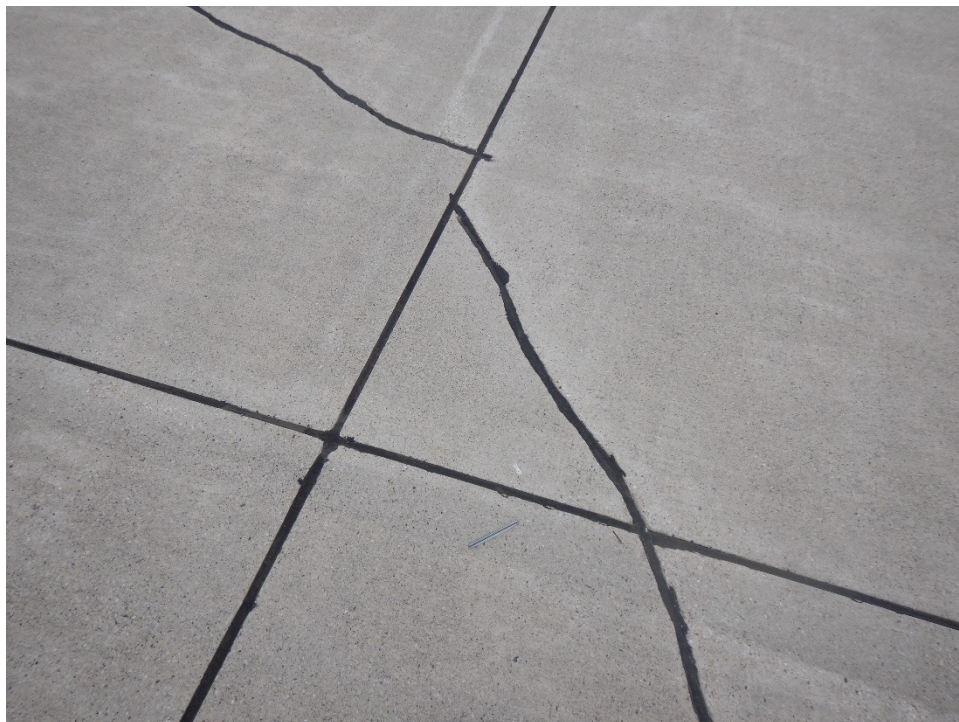
R11DE-04. Corner Break (Sample Unit No. 01).

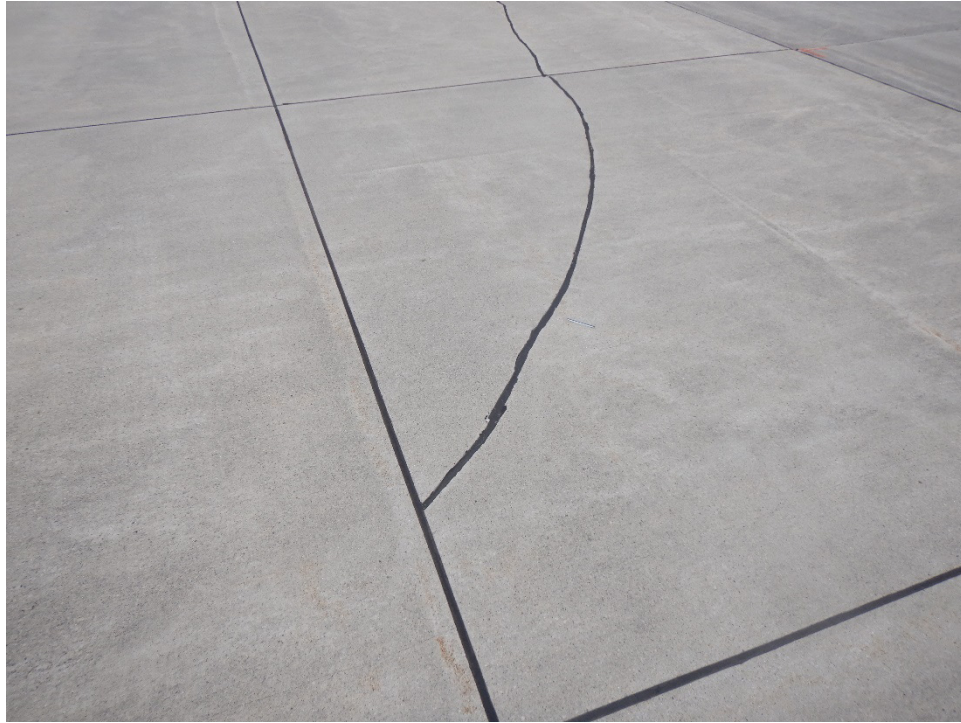
R11DE-04. LTD Cracking (Sample Unit No. 02).

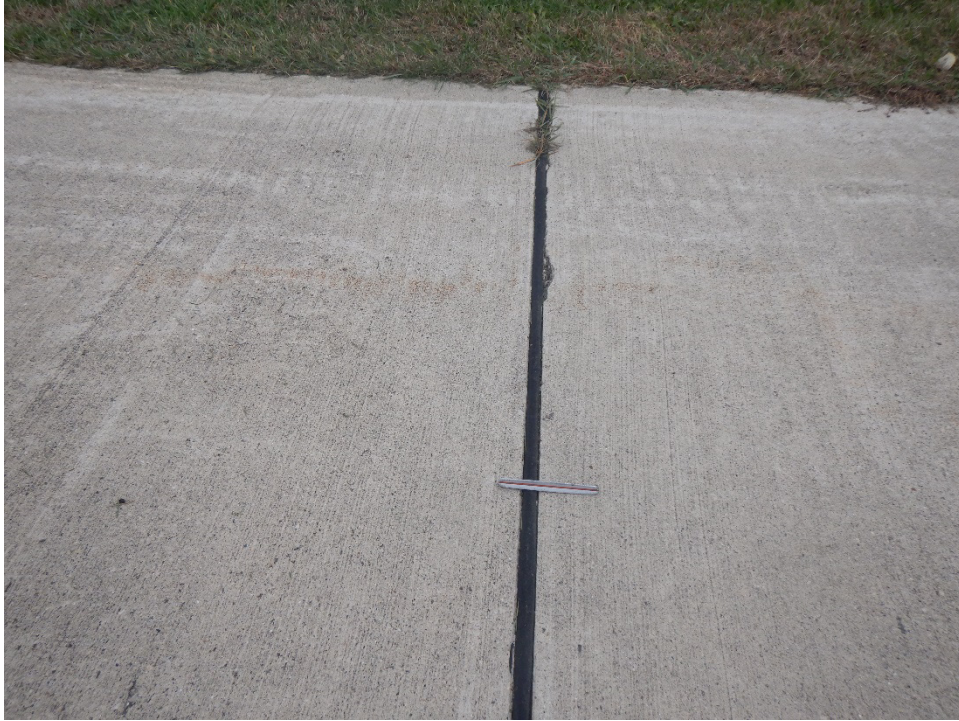
R11DE-05. Joint Seal Damage (Sample Unit No. 02).

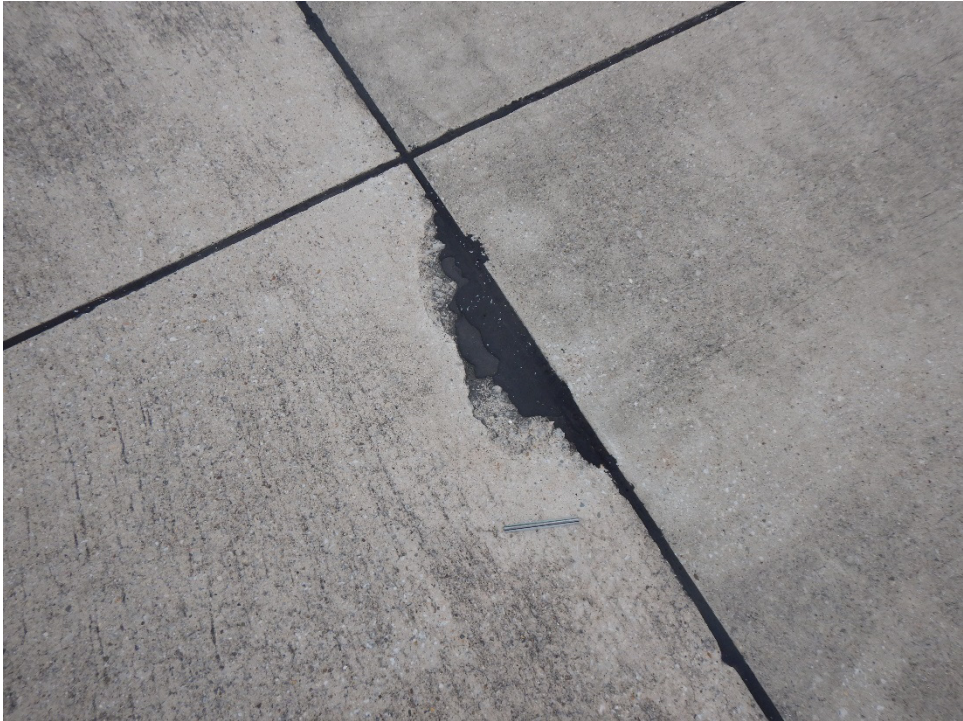
T01DE-01. Joint Spalling (Sample Unit No. 01).

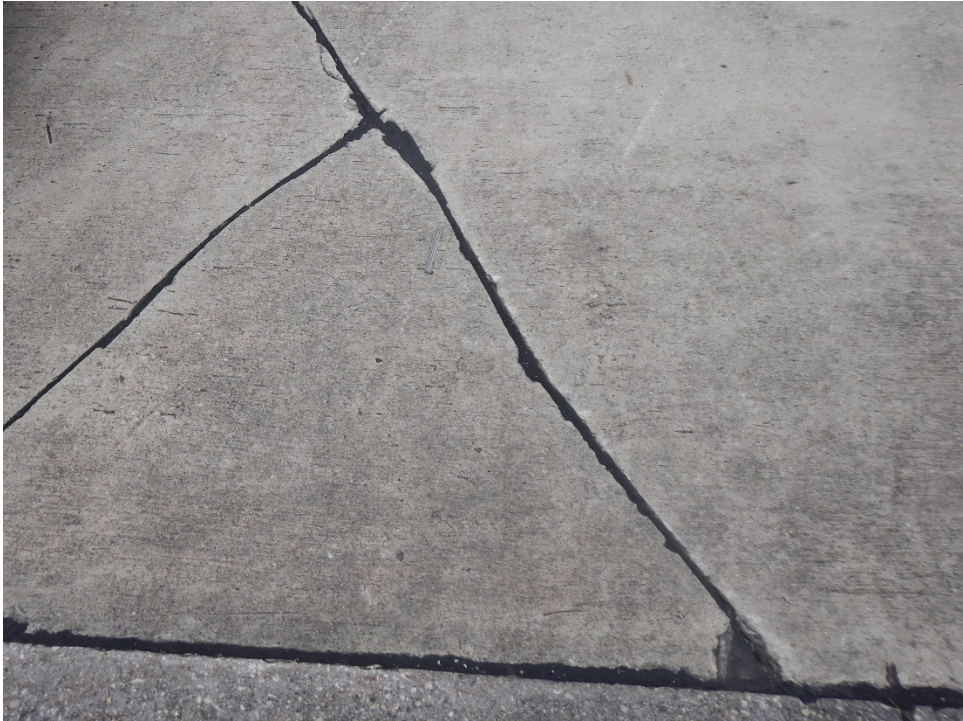
T01DE-01. LTD Cracking (Sample Unit No. 02).

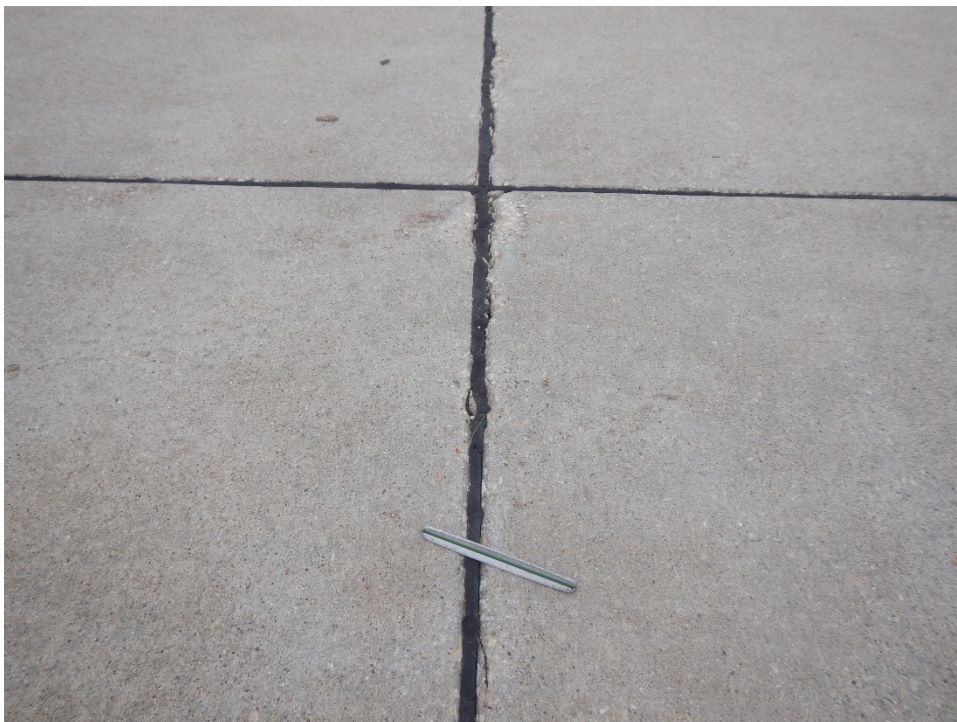
T02DE-01. Joint Seal Damage (Sample Unit No. 05).

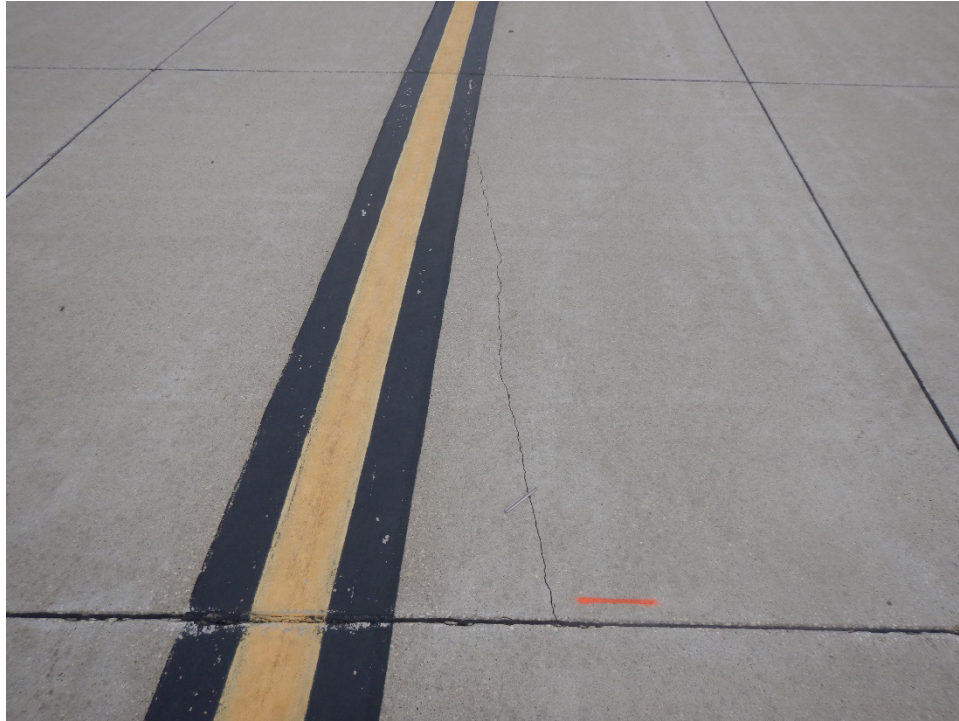
T02DE-01. LTD Cracking (Sample Unit No. 03).

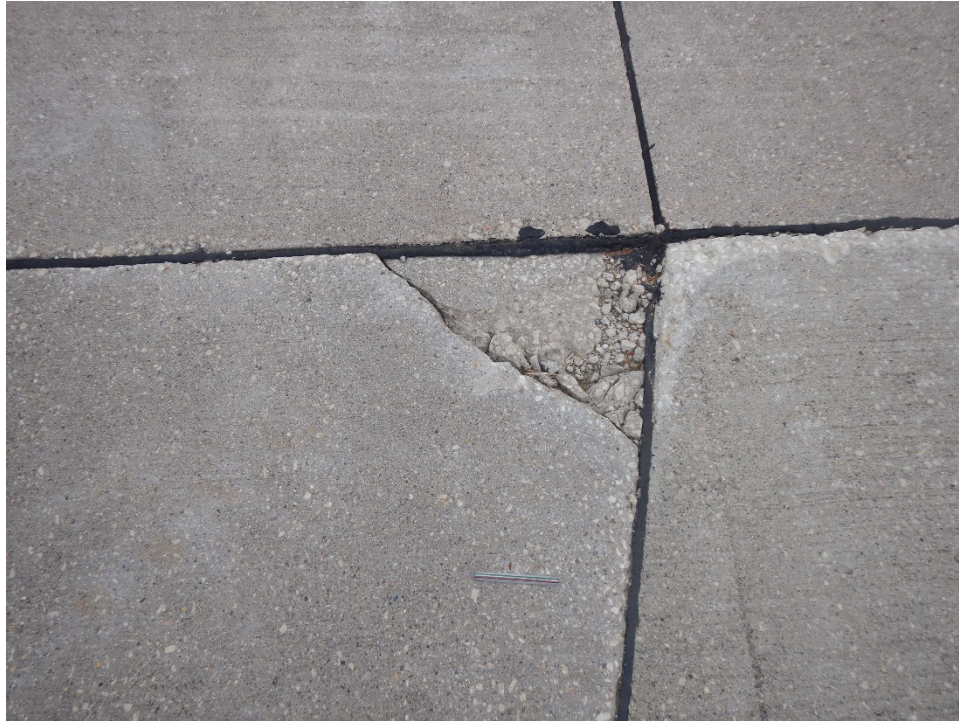
TH01DE-01. Corner Break (Sample Unit No. 04).

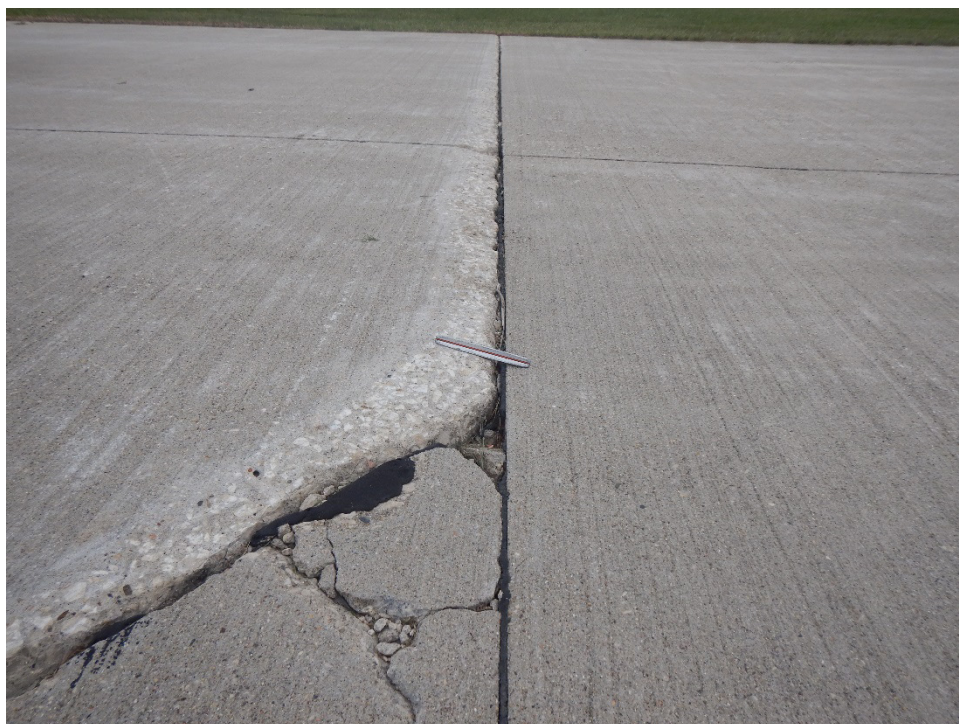
TH01DE-01. Faulting (Sample Unit No. 03).

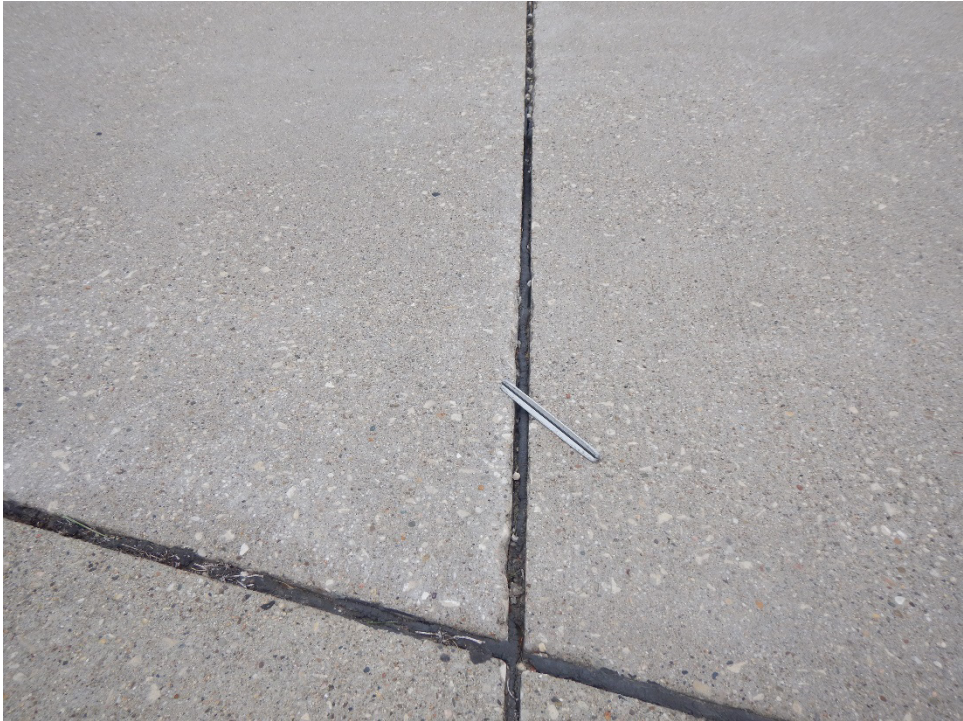
TH01DE-01. Joint Seal Damage (Sample Unit No. 04).
