# Decorah Municipal Airport

## Pavement Management Report

# DECORAH MUNICIPAL AIRPORT PAVEMENT MANAGEMENT REPORT

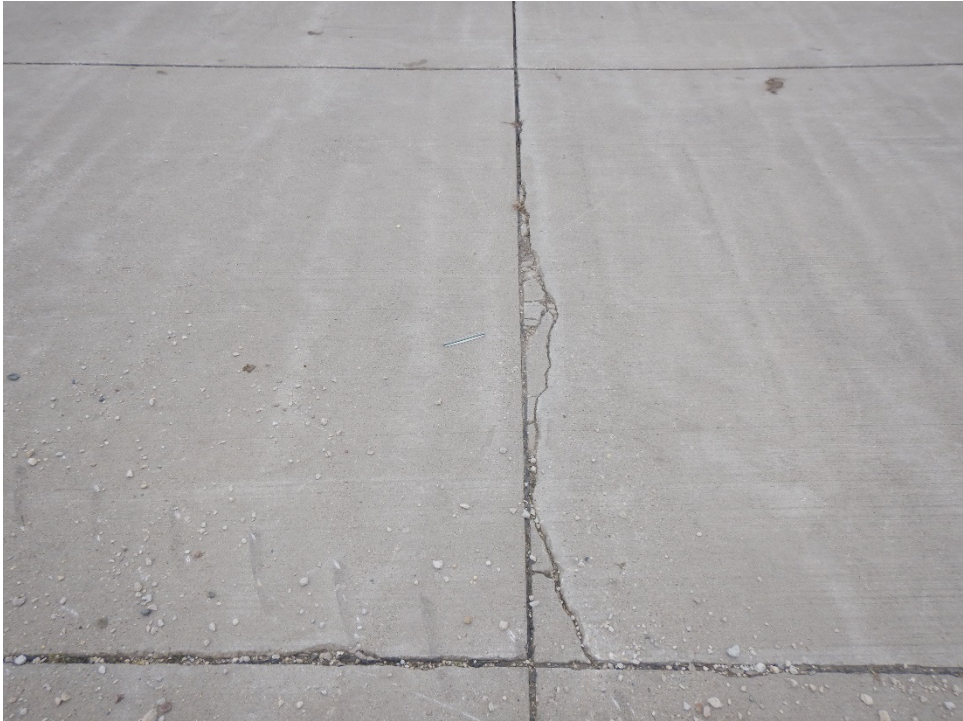
TH01DE-01. Joint Spalling (Sample Unit No. 01).

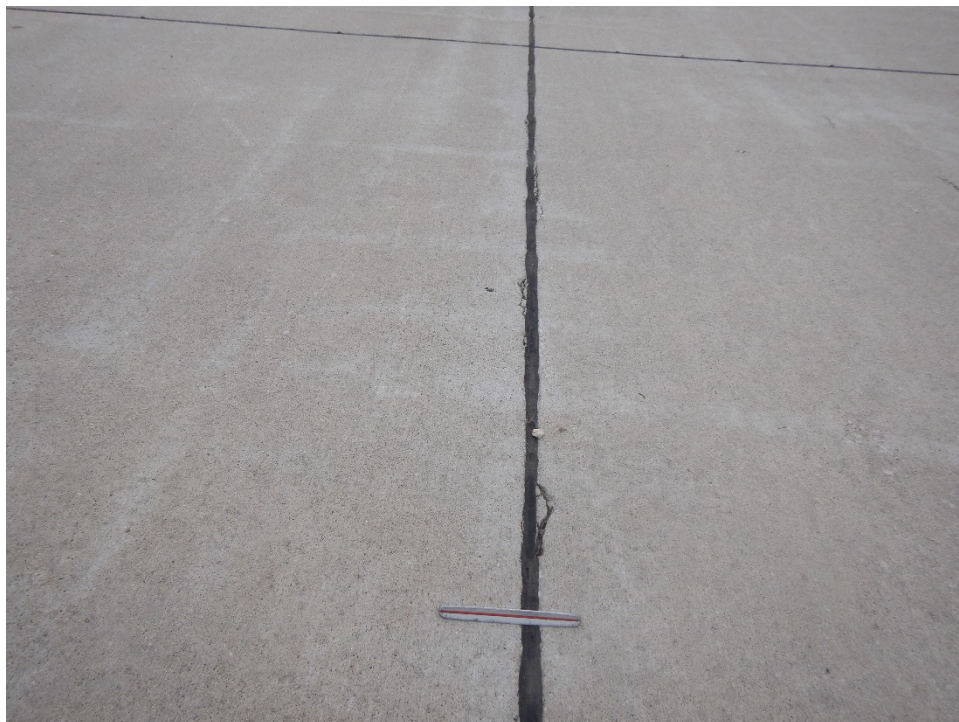
TH01DE-02. Joint Seal Damage (Sample Unit No. 08).

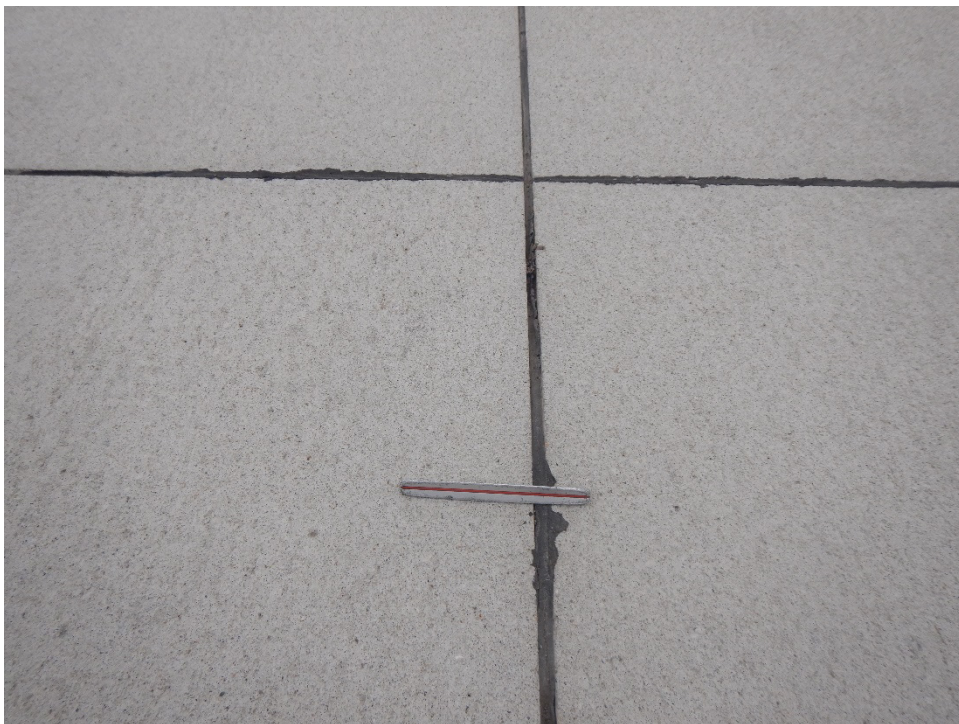
TH02DE-01. Joint Seal Damage (Sample Unit No. 05).
