Denison Municipal Airport

PAVEMENT MANAGEMENT REPORT

JULY 2022

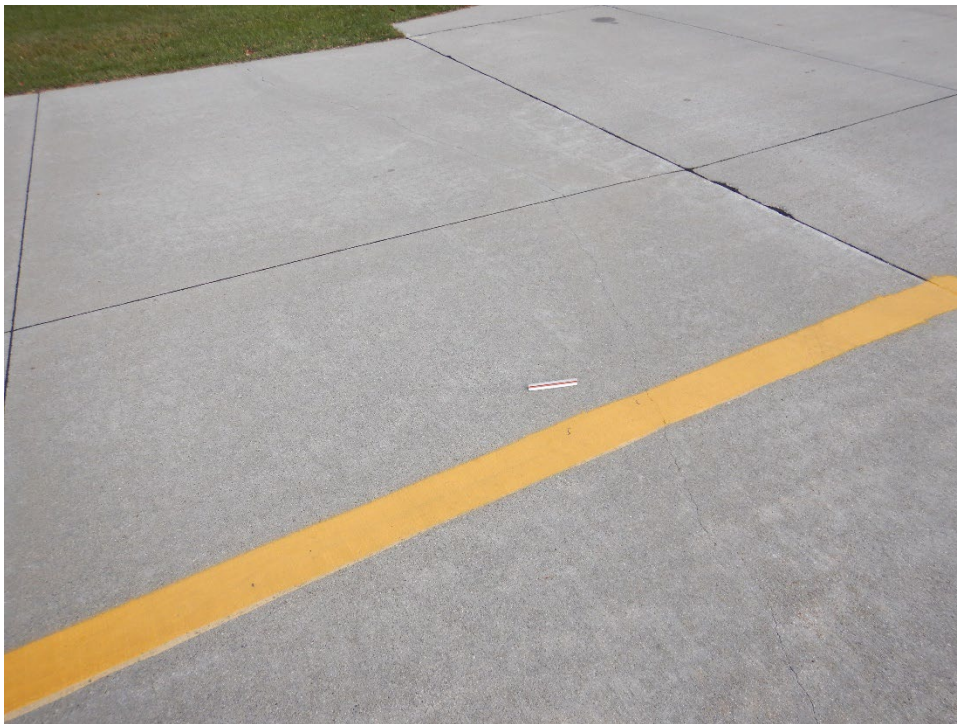
A01DN-01. LTD Cracking (Sample Unit No. 01).

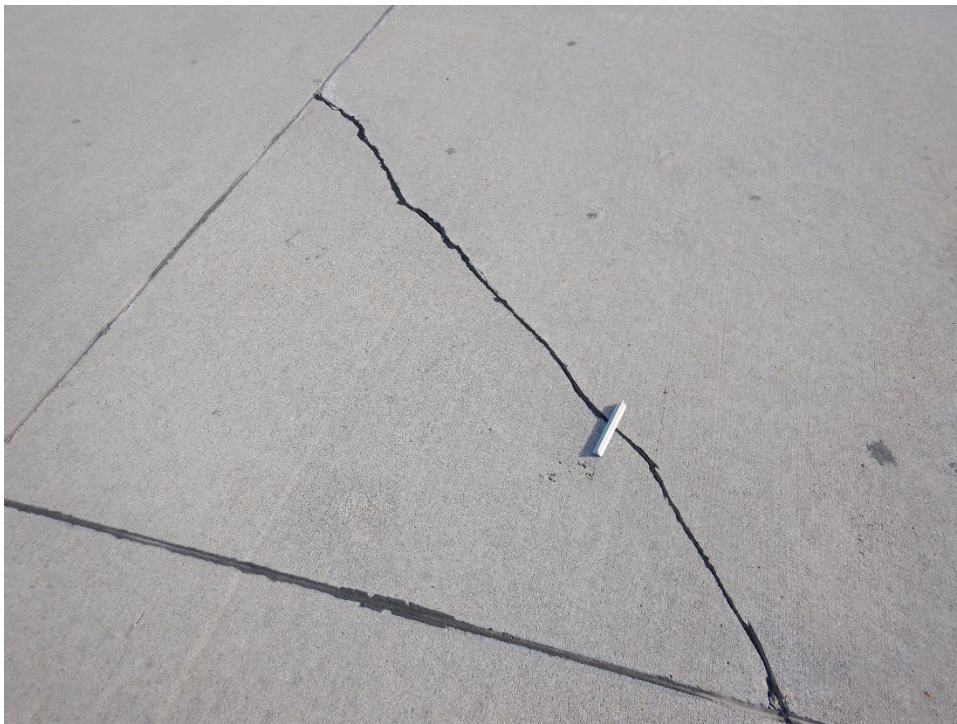
A01DN-02. Corner Break (Sample Unit No. 06).

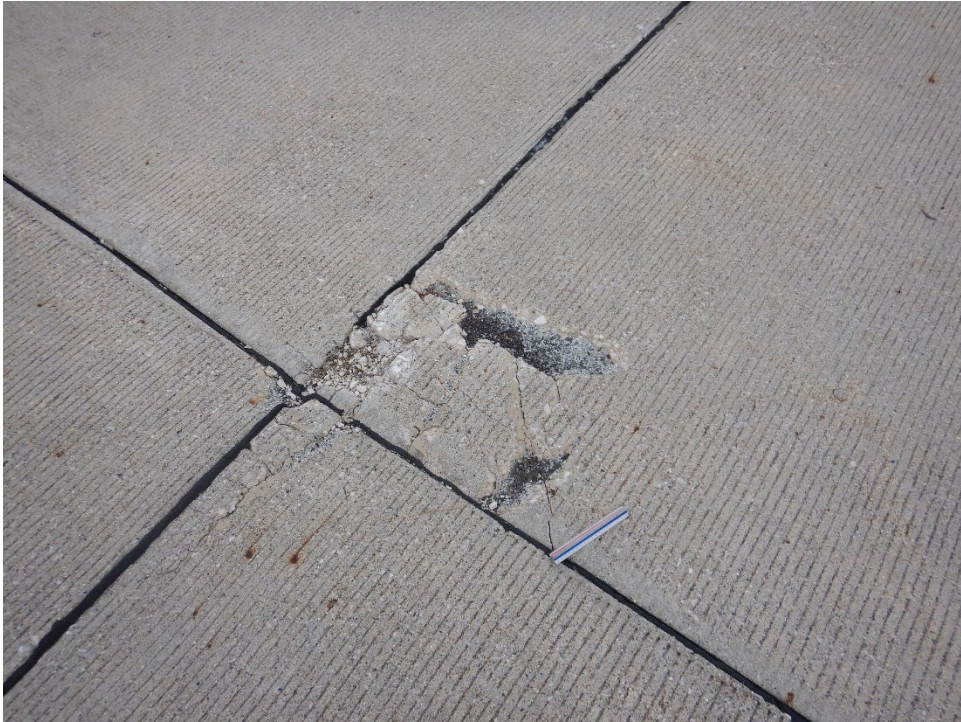
R12DN-01. Corner Spalling (Additional Sample Unit No. 36).

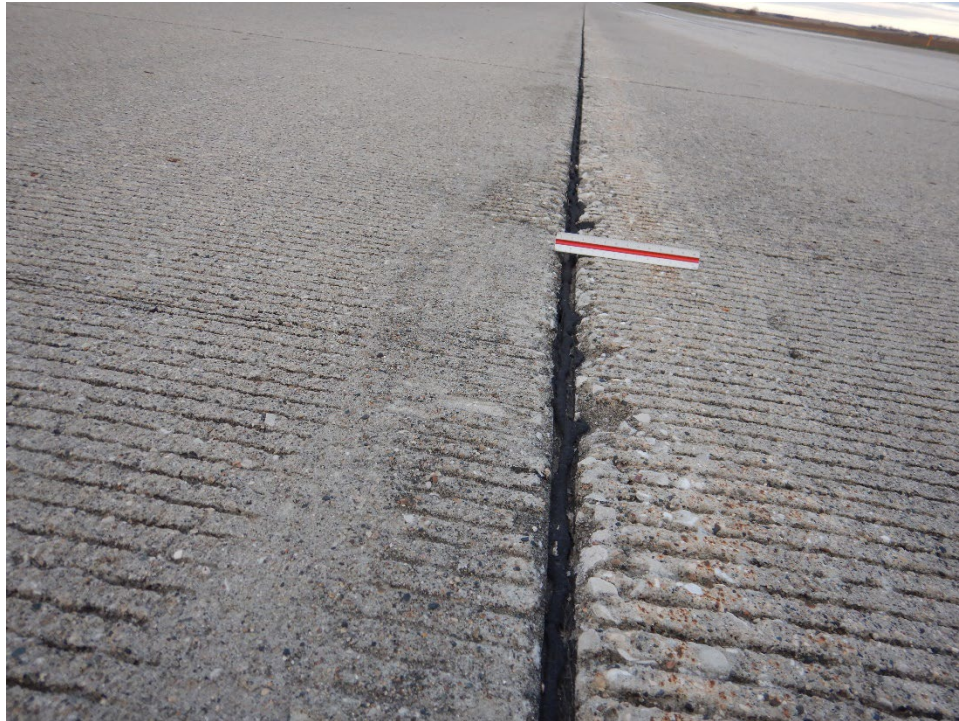
R12DN-01. Faulting (Sample Unit No. 22).

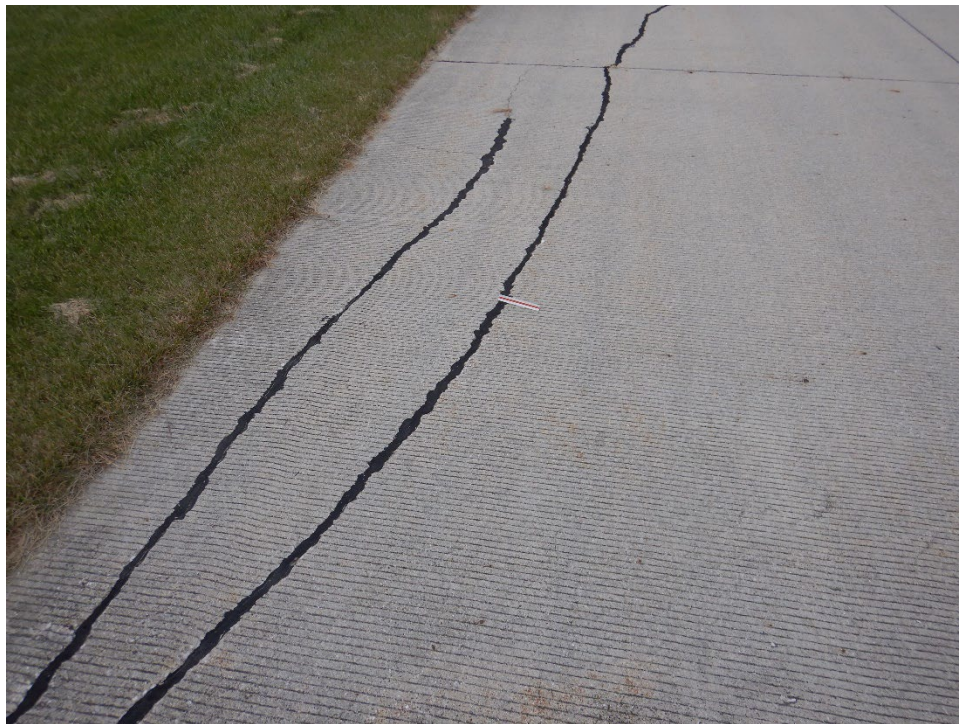
R12DN-01. Shattered Slab (Sample Unit No. 35).

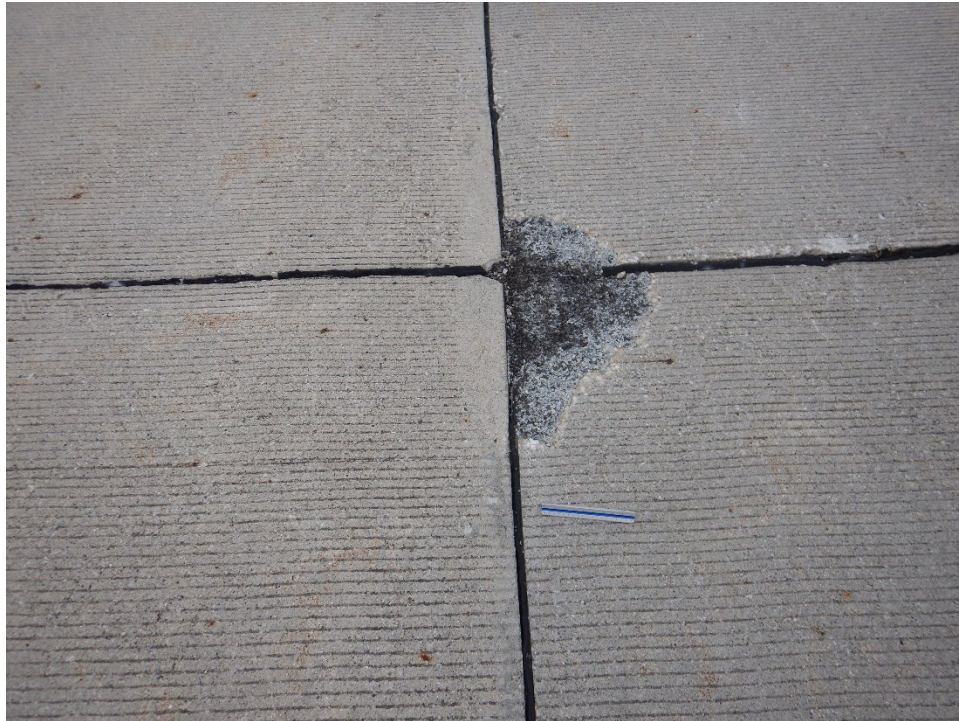
R12DN-01. Small Patching (Additional Sample Unit No. 36).

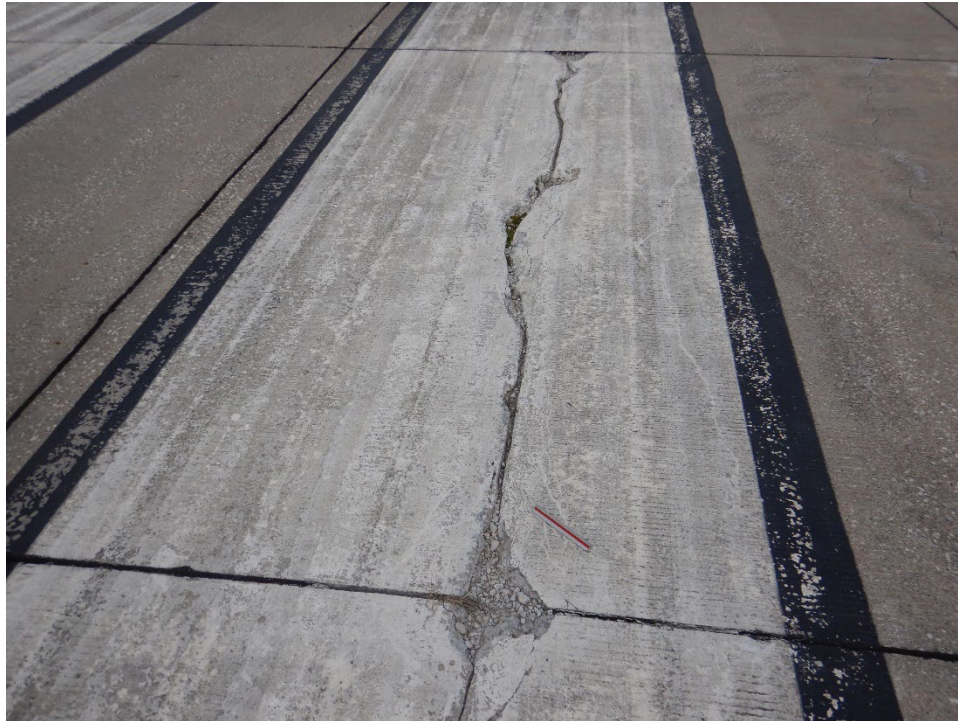
Denison Municipal Airport was inspected on November 17, 2021. There were eighteen pavement sections defined during the inspection. Suspected alkali-silica reaction (ASR) was recorded at this airport in accordance with ASTM D5340-20. It should be noted that laboratory testing in the form of petrographic analysis is the only definitive way to validate the presence of ASR; however, the formation of a precipitate is evidence of a reaction consistent with this type of materials-related distress.

R12DN-02. ASR (Additional Sample Unit No. 15).

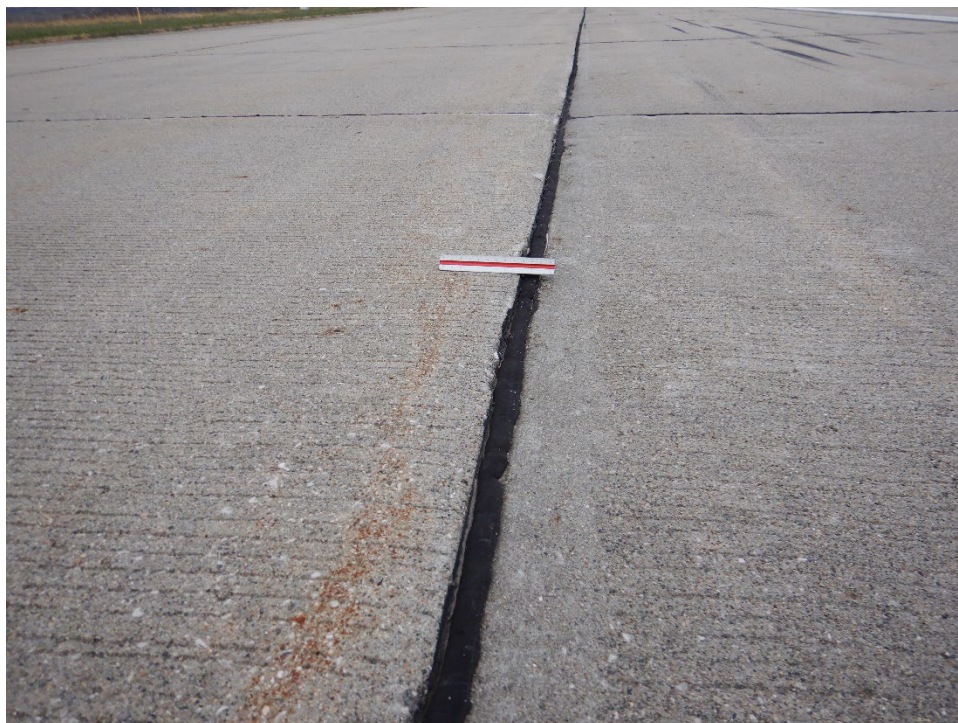
R12DN-02. Faulting (Sample Unit No. 02).

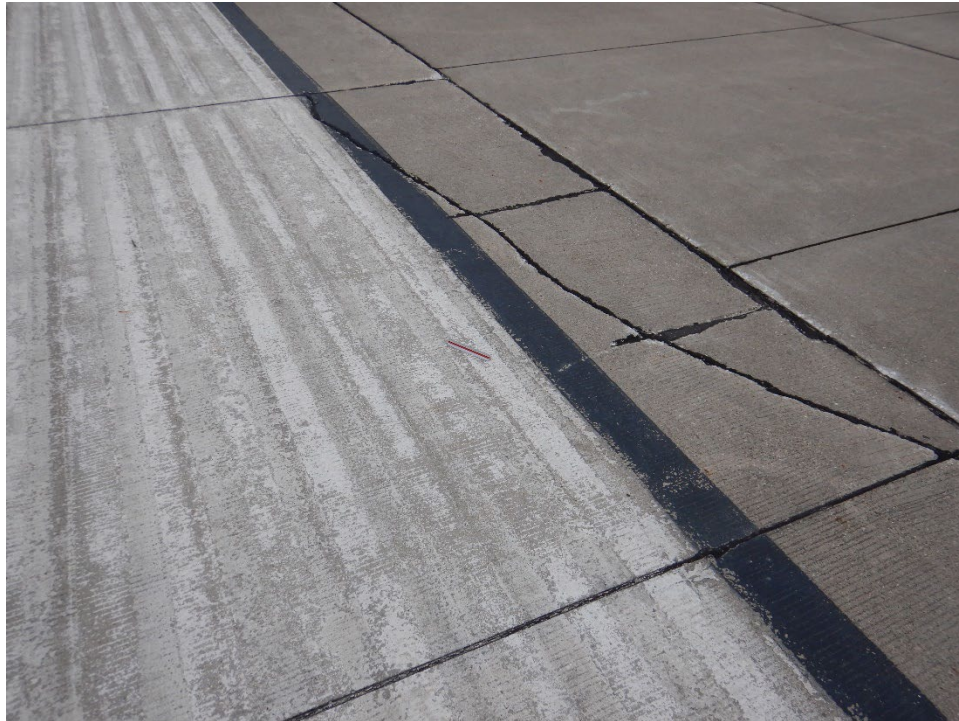
R12DN-02. Shattered Slab (Sample Unit No. 16).

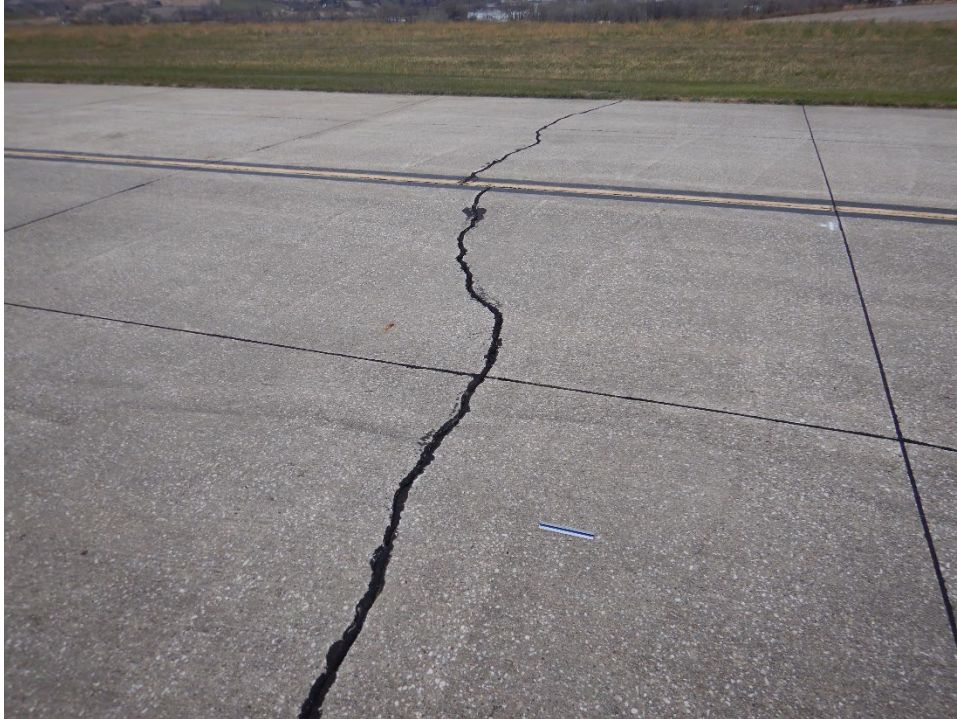
R12DN-03. LTD Cracking (Sample Unit No. 03).

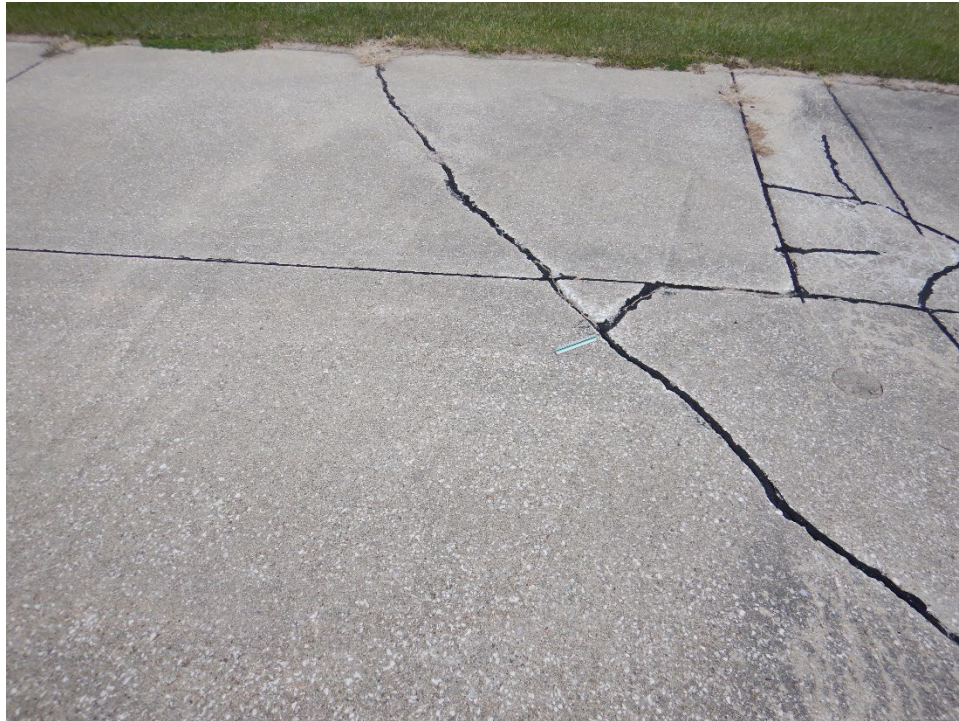
R12DN-04. LTD Cracking (Sample Unit No. 02).

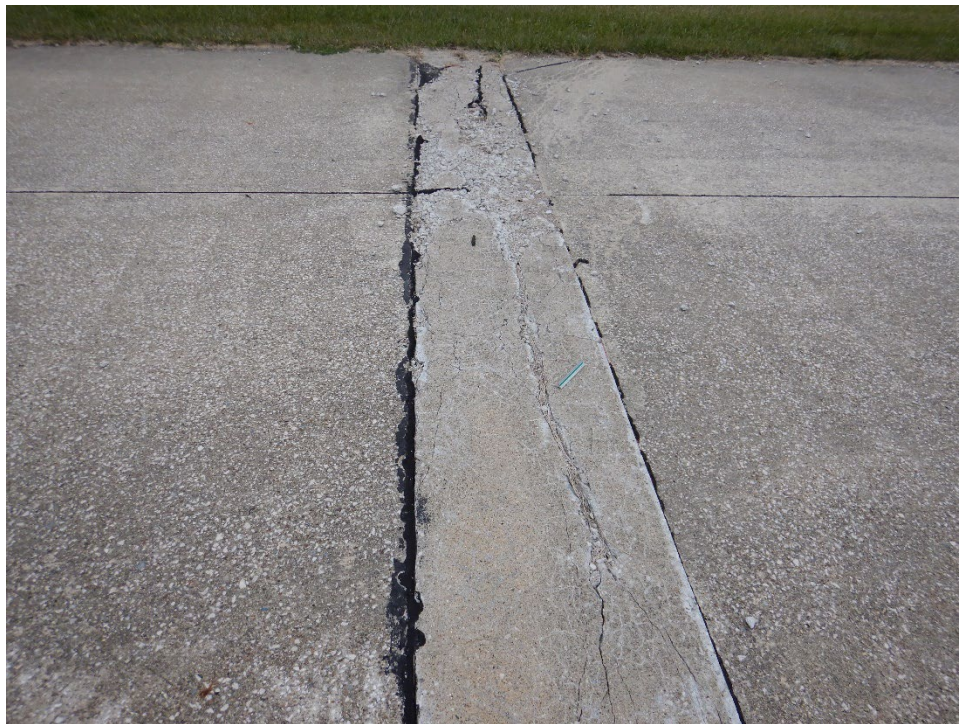
R12DN-04. Large Patching (Additional Sample Unit No. 03).

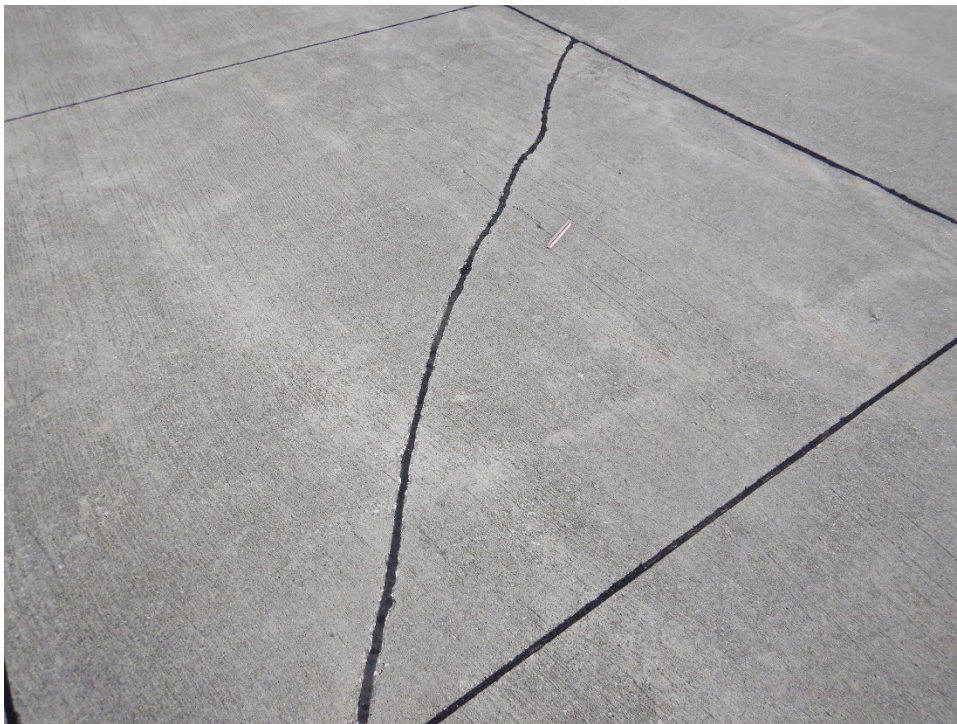
R12DN-05. LTD Cracking (Sample Unit No. 04).

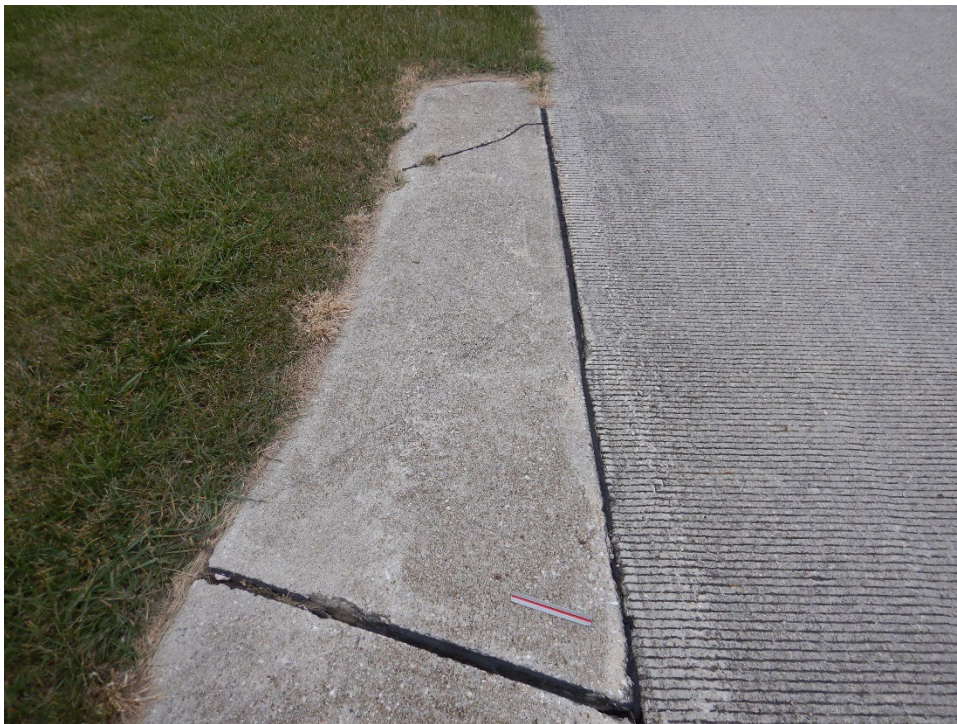
R12DN-06. LTD Cracking (Sample Unit No. 02).

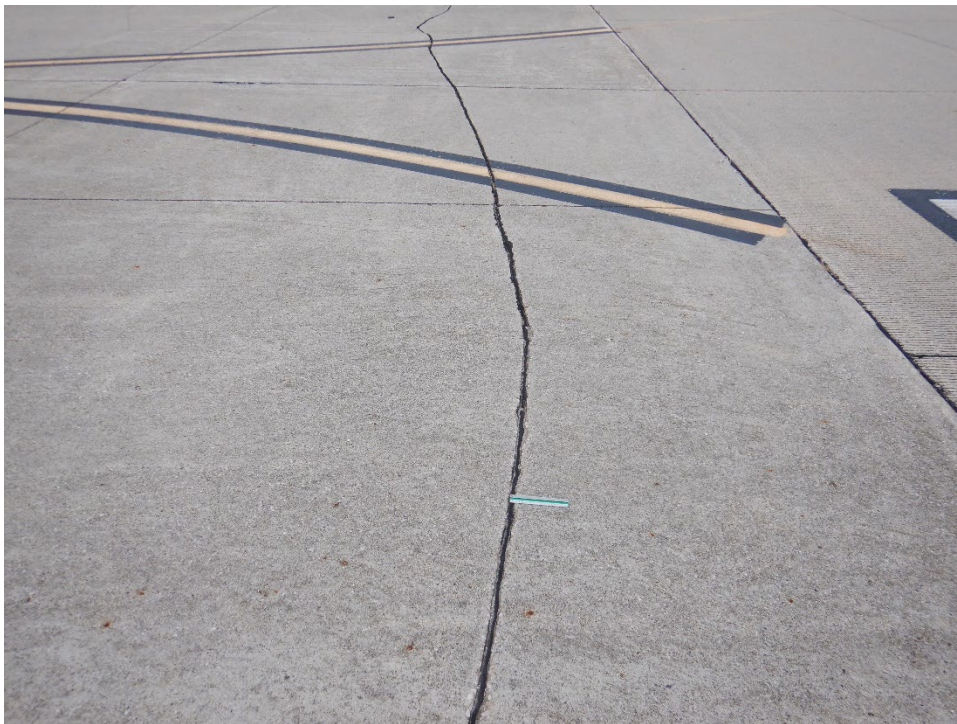
R12DN-07. LTD Cracking (Sample Unit No. 01).

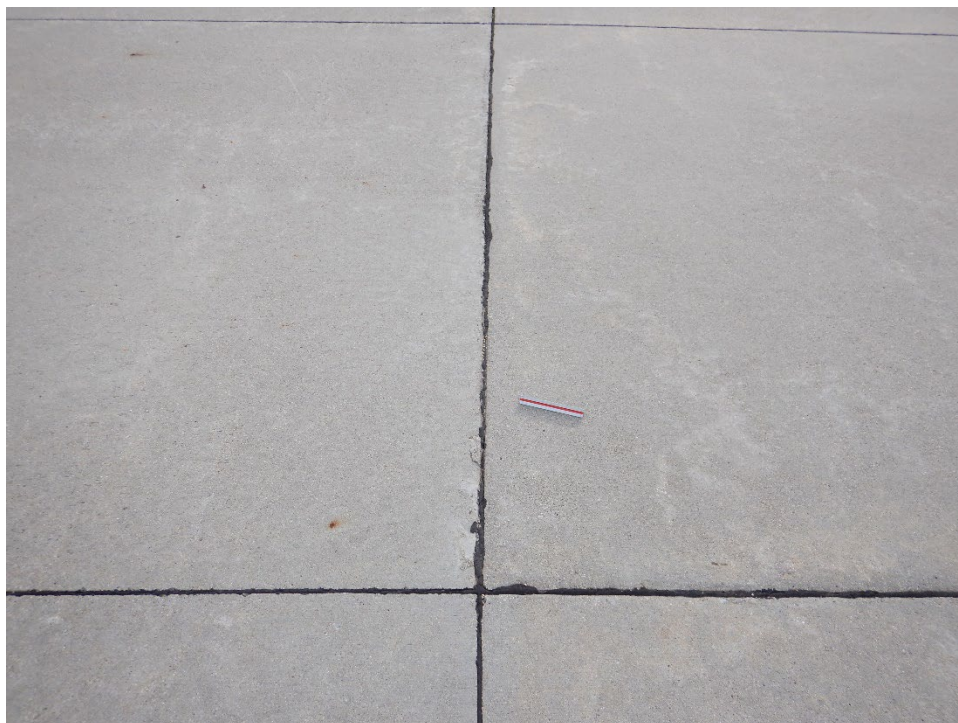
T01DN-01. Joint Seal Damage (Sample Unit No. 01).

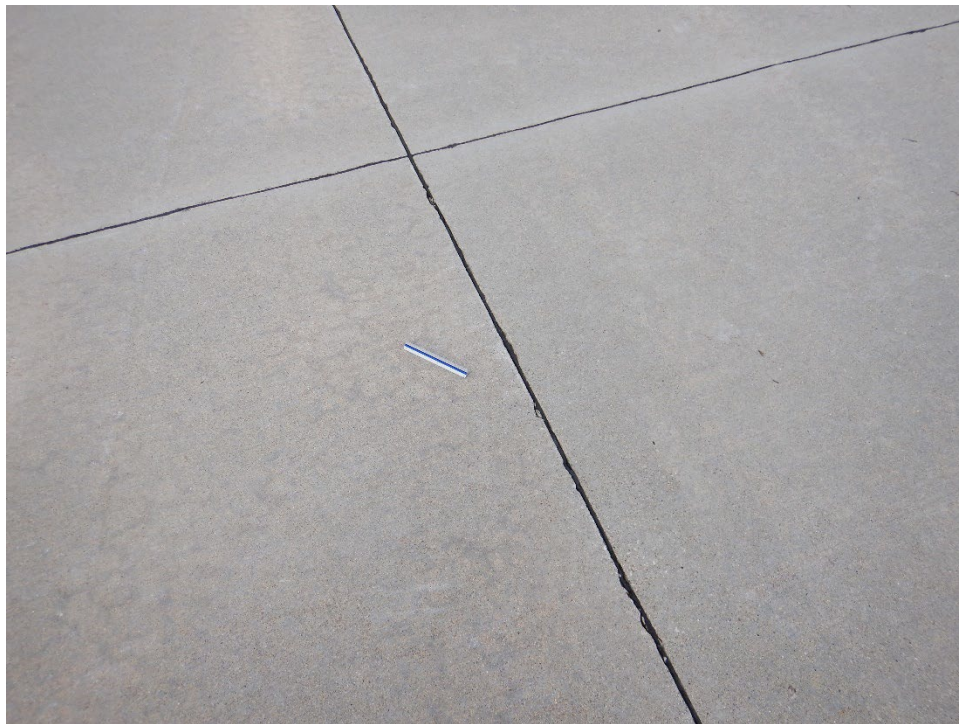
T01DN-02. Joint Seal Damage (Sample Unit No. 01).

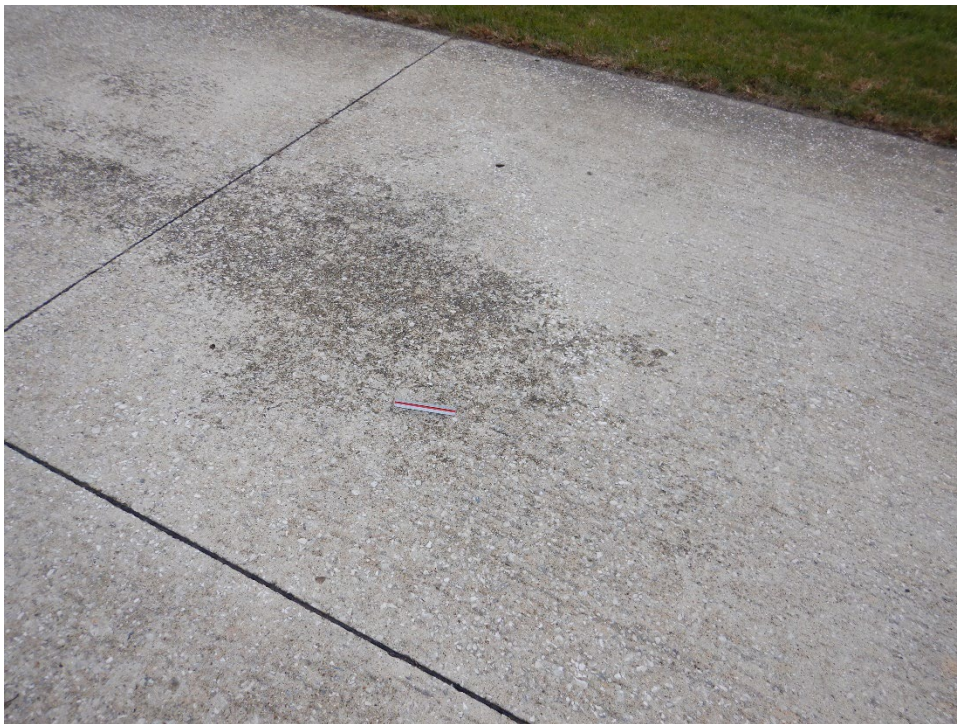
T01DN-03. Scaling (Sample Unit No. 02).

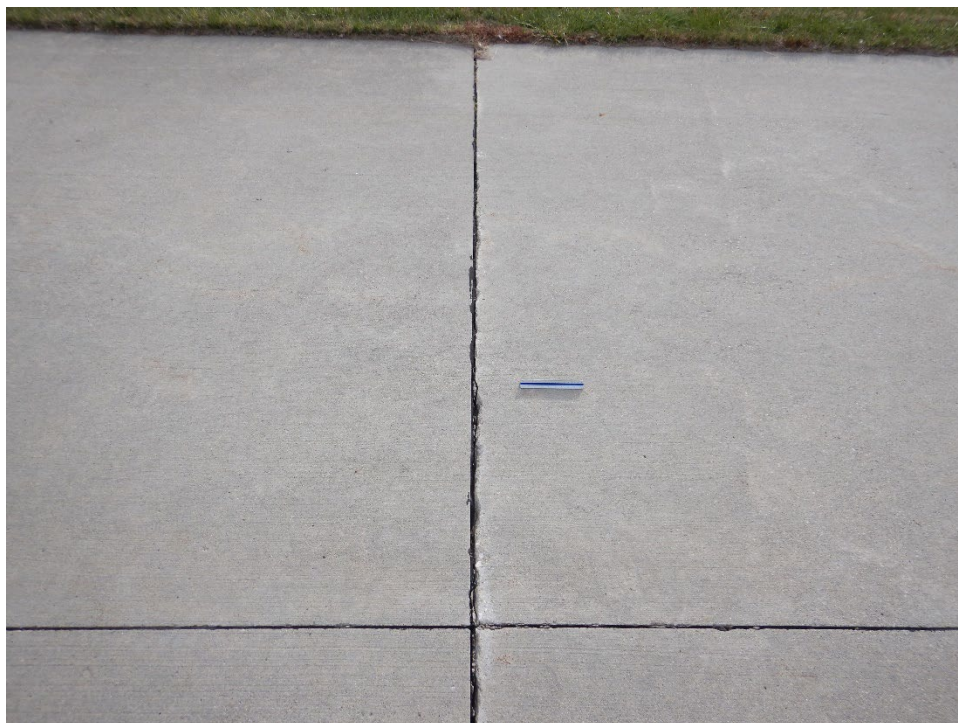
T01DN-04. Joint Seal Damage (Sample Unit No. 01).

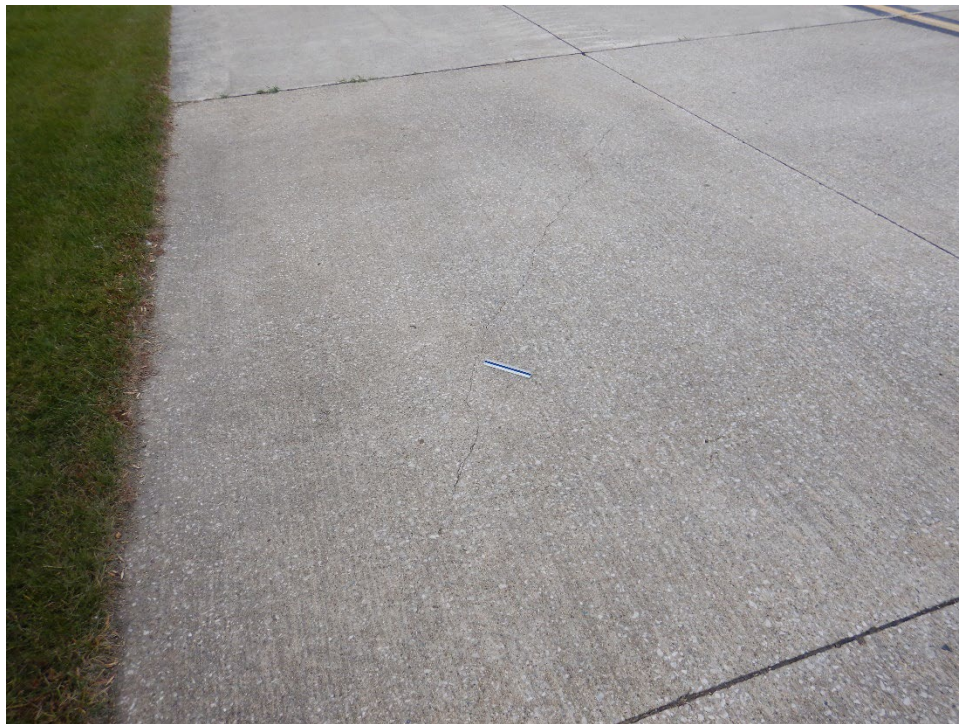
T01DN-05. LTD Cracking (Sample Unit No. 01).

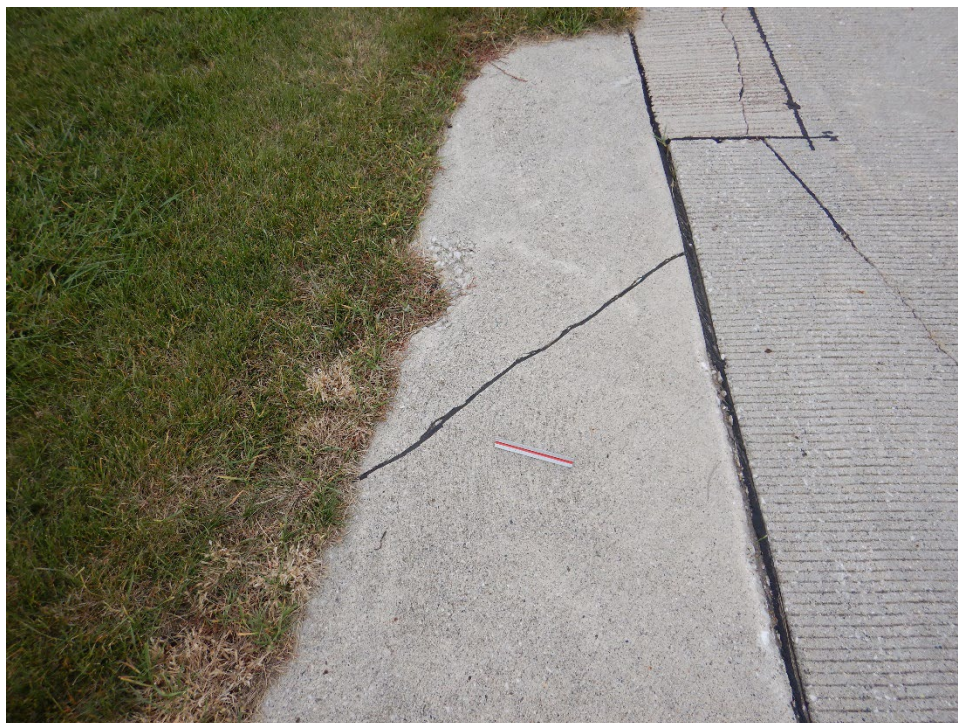
T01DN-06. LTD Cracking (Sample Unit No. 01).

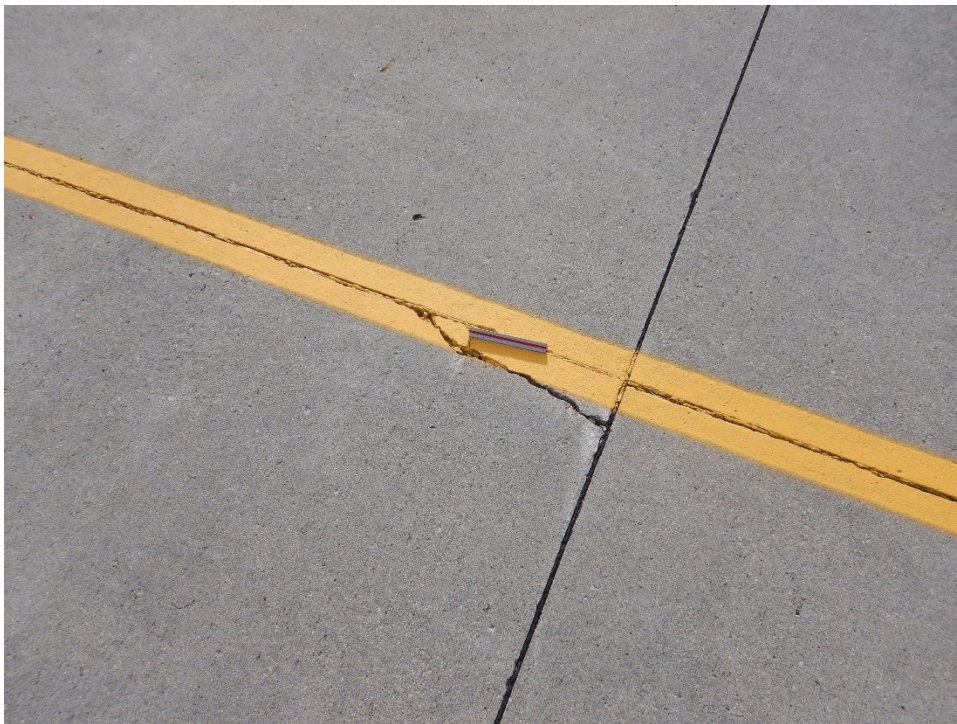
TH01DN-01. Joint Spalling (Sample Unit No. 03).

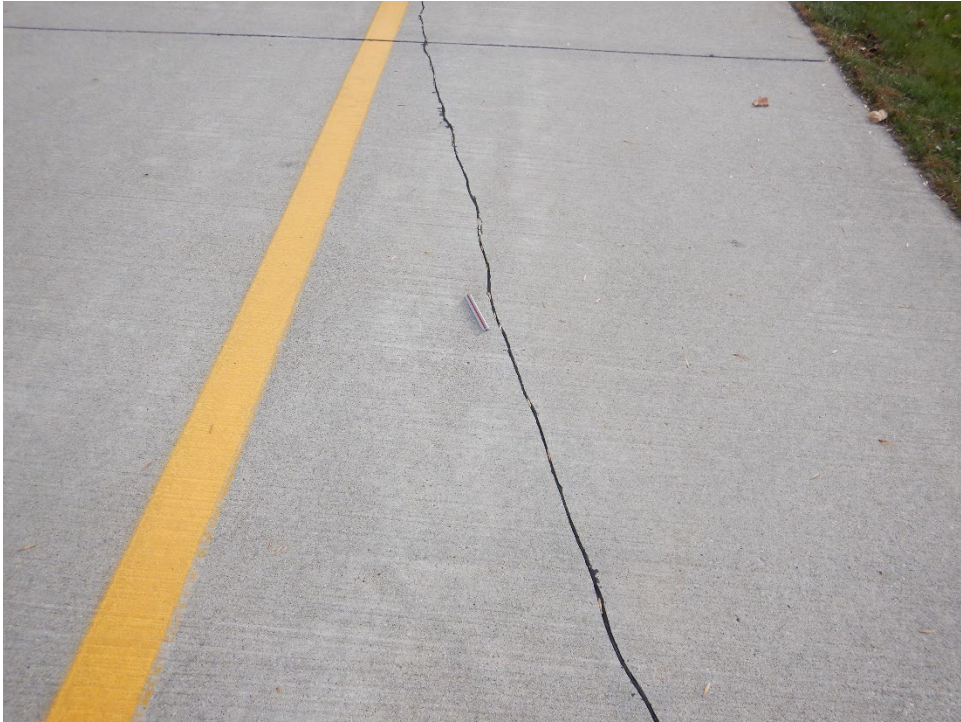
TH01DN-02. LTD Cracking (Sample Unit No. 01).

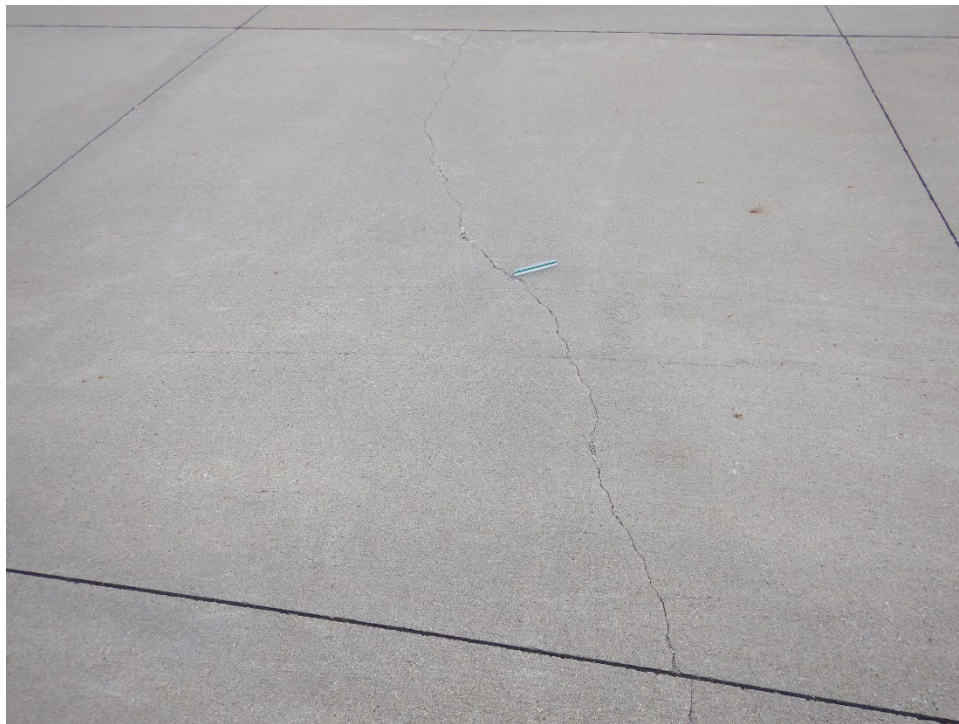
TH01DN-03. LTD Cracking (Sample Unit No. 01).
