Fairfield Municipal Airport

Pavement Management Report

JULY 2024

FAIRFIELD MUNICIPAL AIRPORT PAVEMENT MANAGEMENT REPORT

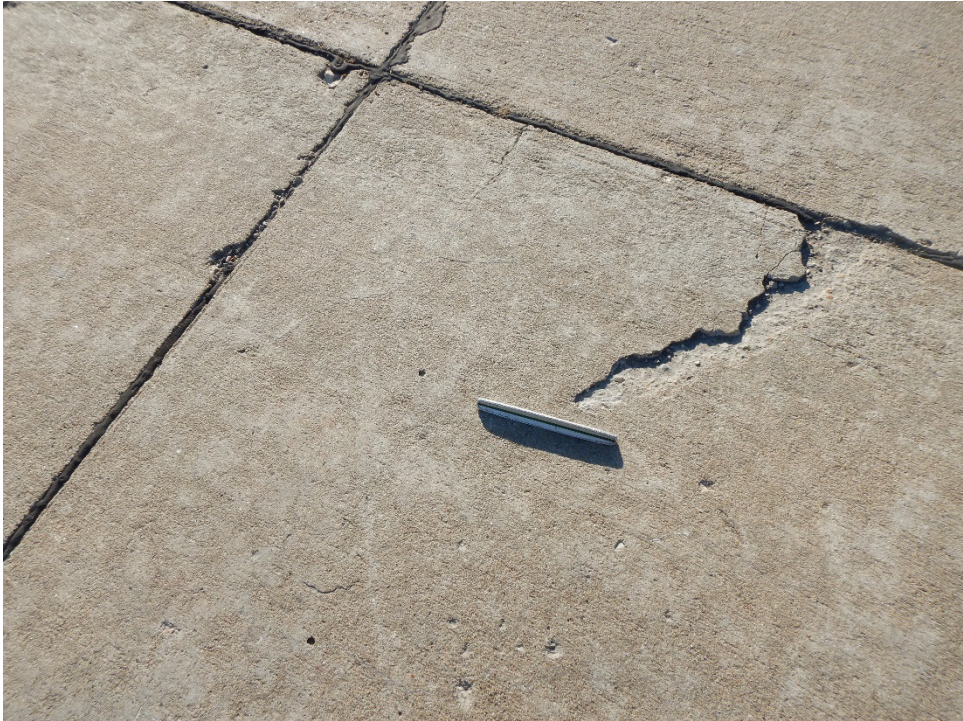
A01FA-01. ASR (Sample Unit No. 05).

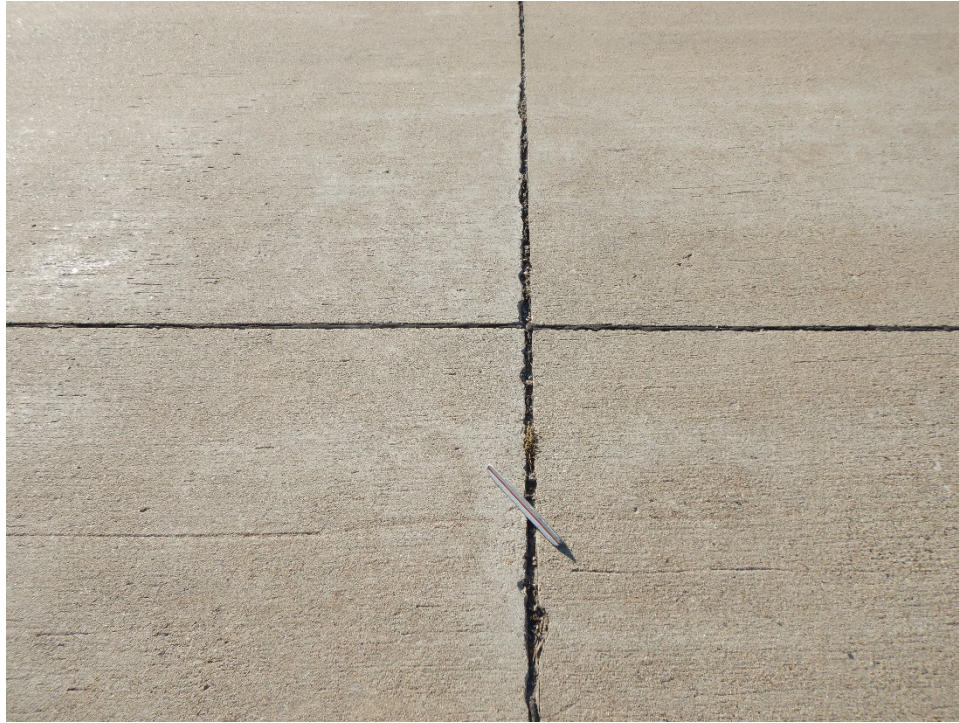
A01FA-01. Joint Seal Damage (Sample Unit No. 02).

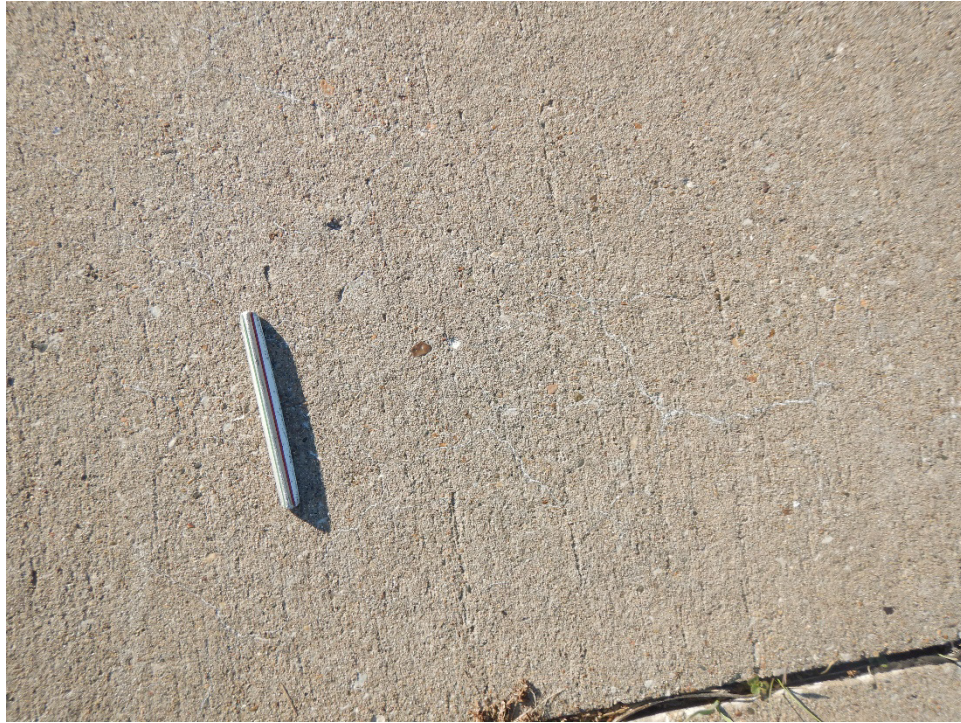
A01FA-02. ASR (Sample Unit No. 26).

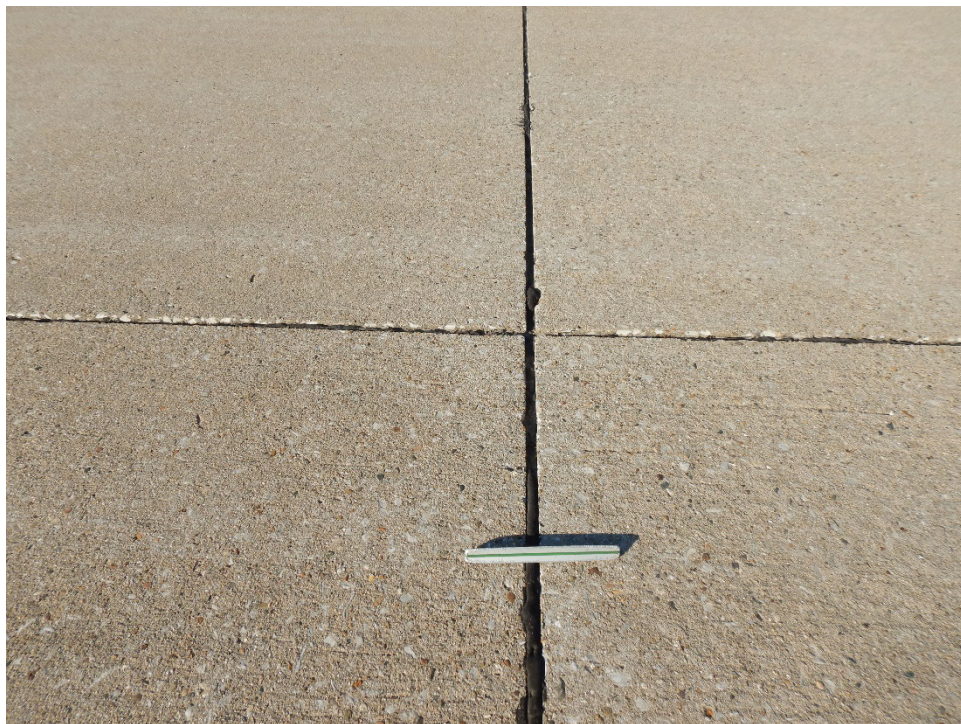
A01FA-02. Joint Seal Damage (Sample Unit No. 19).

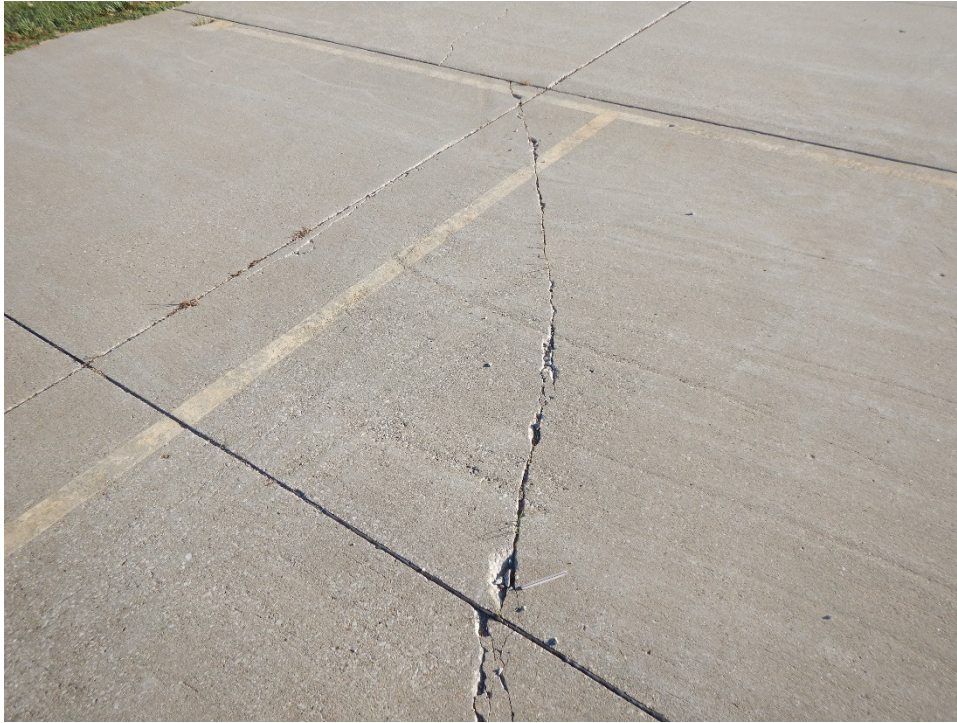
A01FA-02. LTD Cracking (Sample Unit No. 26).

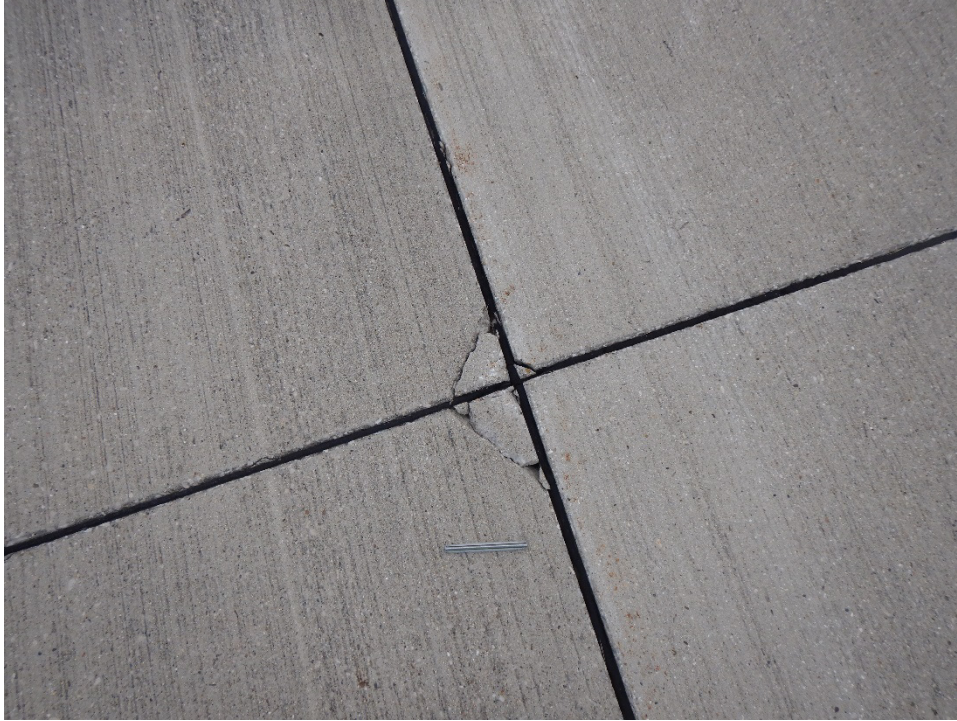
Runway 18/36 was defined by one section. Section 01 contained low-severity corner break and faulting, low- and medium-severity corner spalling, medium-severity joint spalling, and high-severity joint seal damage. An isolated area of high-severity small patching was identified and recorded as an additional sample unit, in accordance with ASTM D5340.

R18FA-01. Corner Spalling (Sample Unit No. 73).

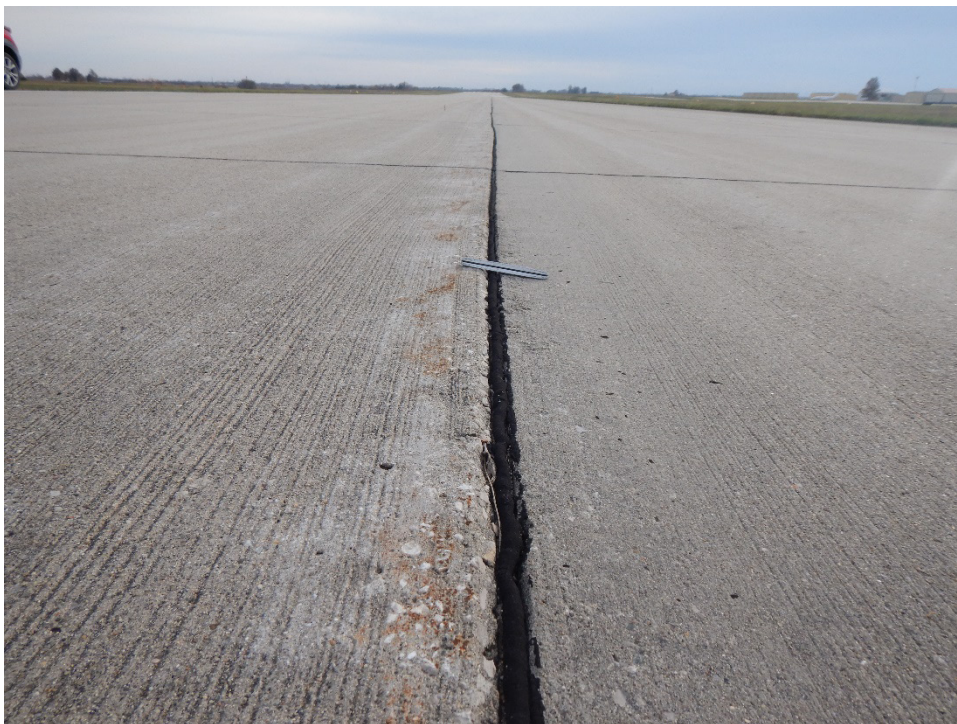
R18FA-01. Faulting (Sample Unit No. 113).

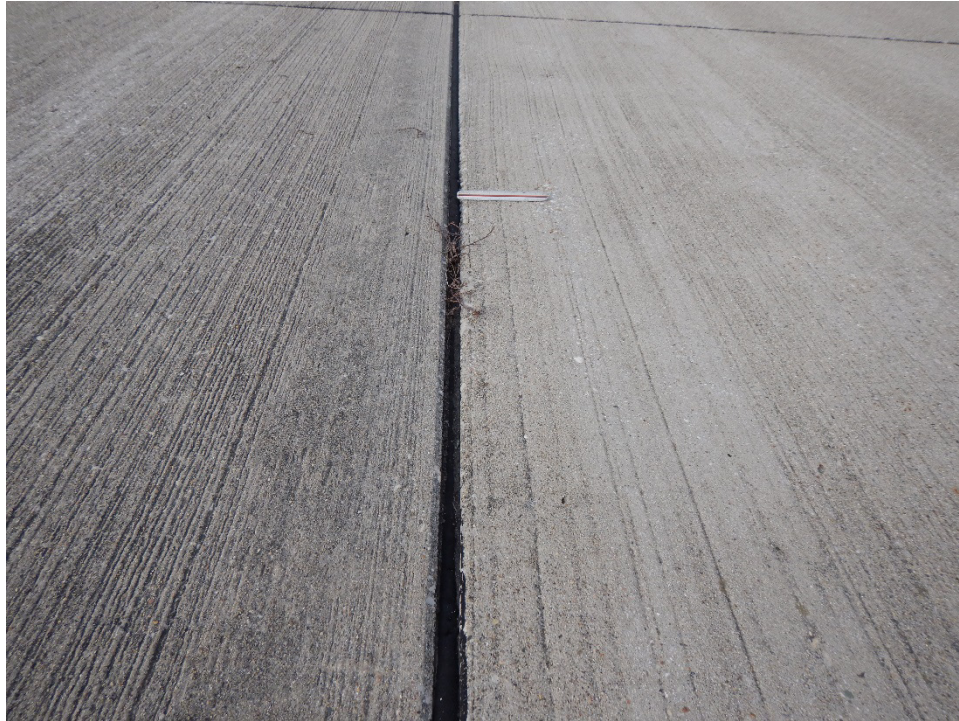
R18FA-01. Joint Seal Damage (Sample Unit No. 103).

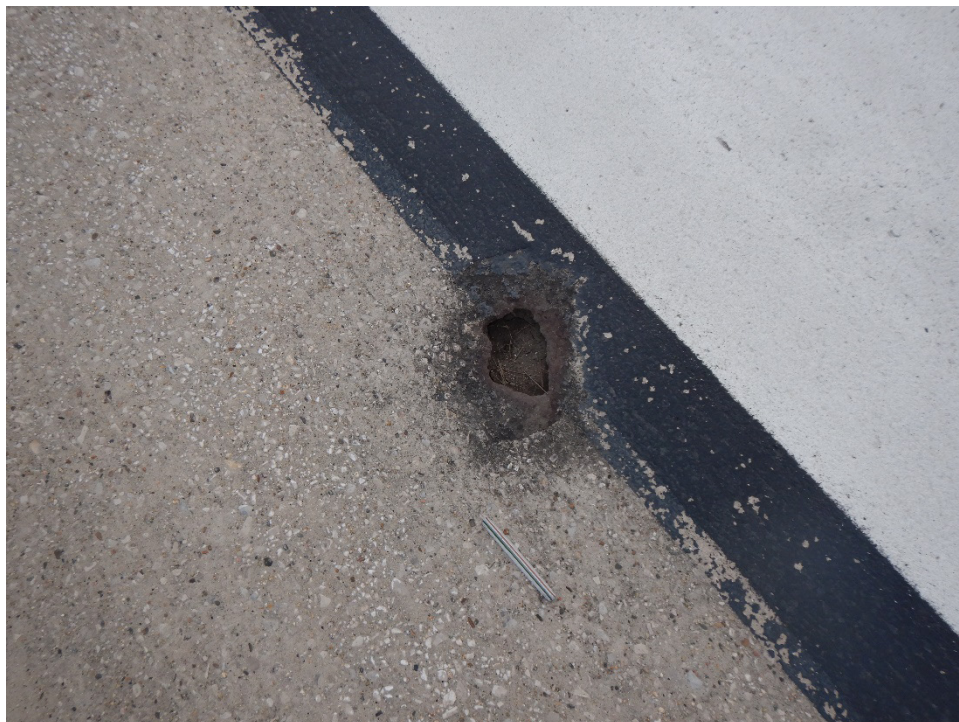
R18FA-01. Small Patching (Additional Sample Unit No. 173).

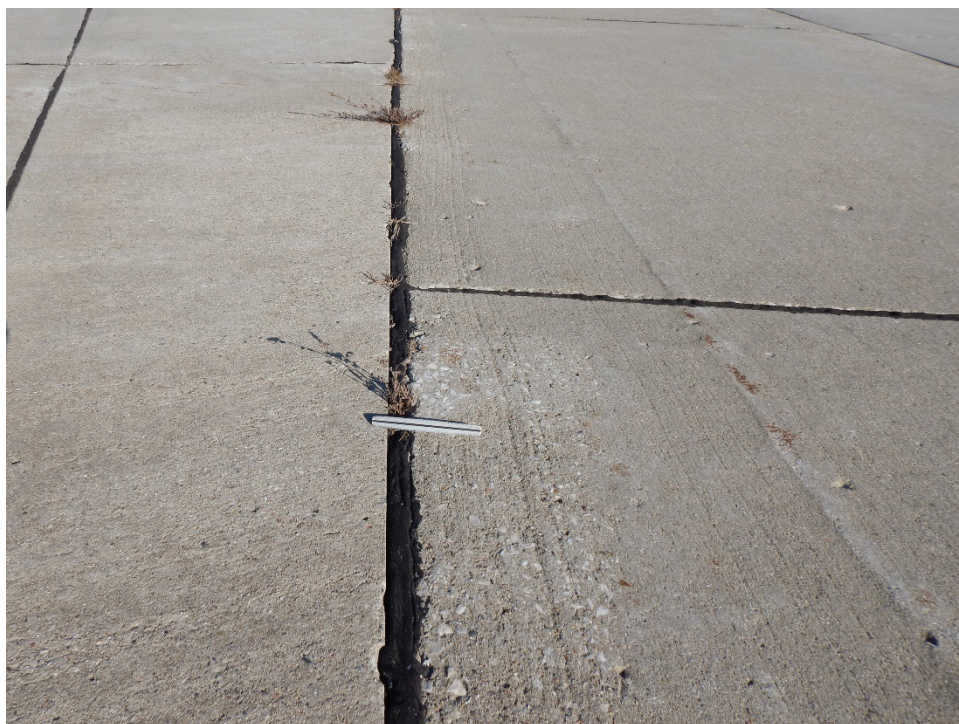
Taxiway 02 contained one section that connected Taxiway A to the T-hangar area. It only contained high-severity joint seal damage.

T02FA-01. Joint Seal Damage (Sample Unit No. 05).

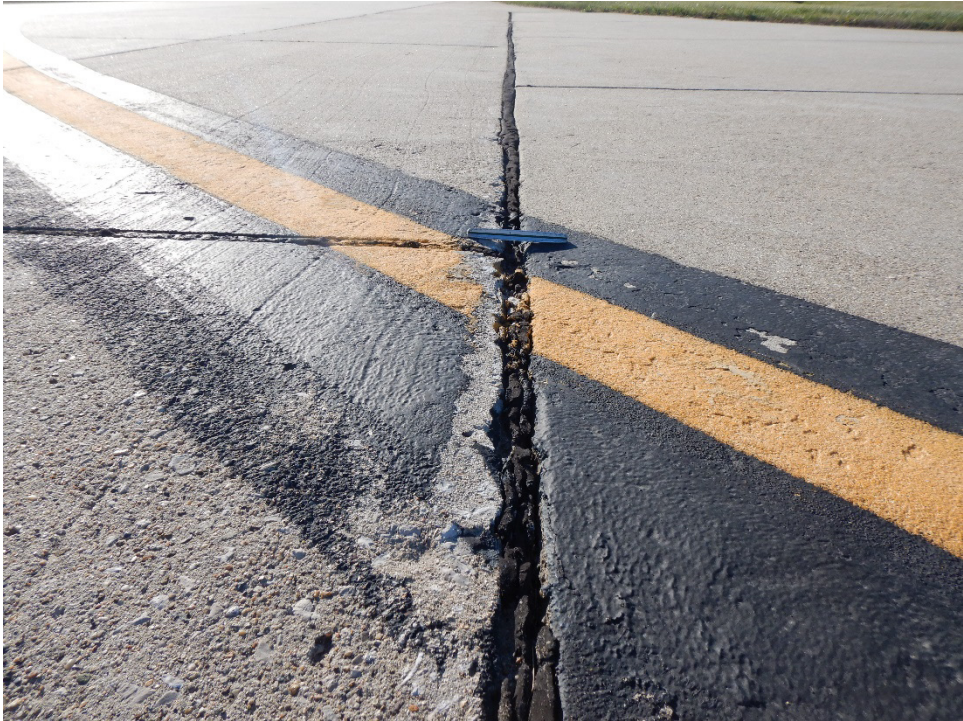
T03FA-01. Faulting (Sample Unit No. 05).

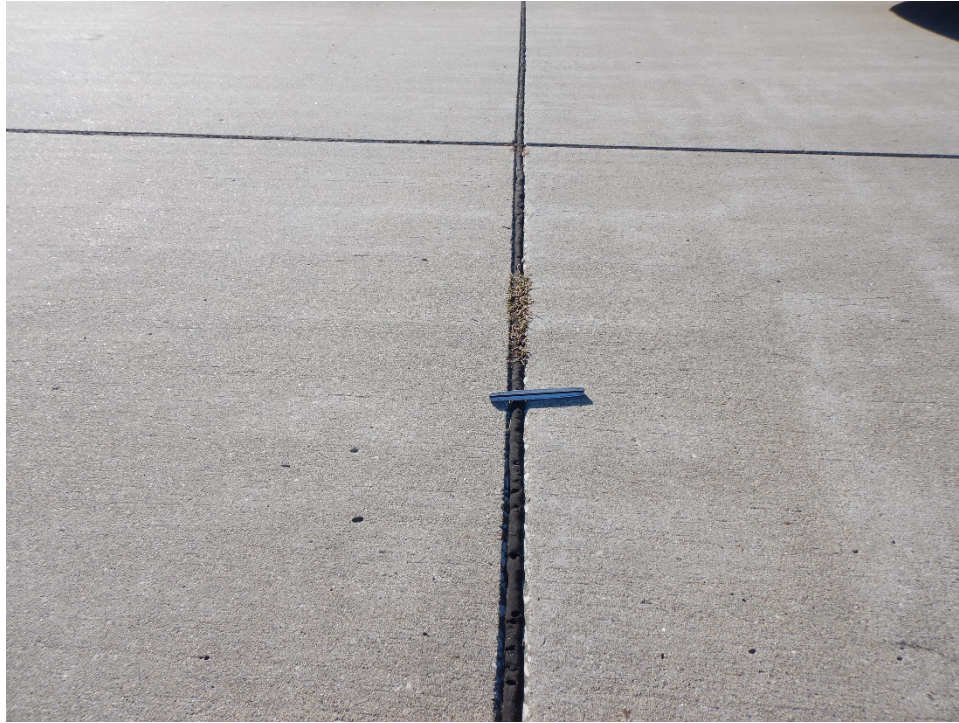
T03FA-01. Joint Seal Damage (Sample Unit No. 03).

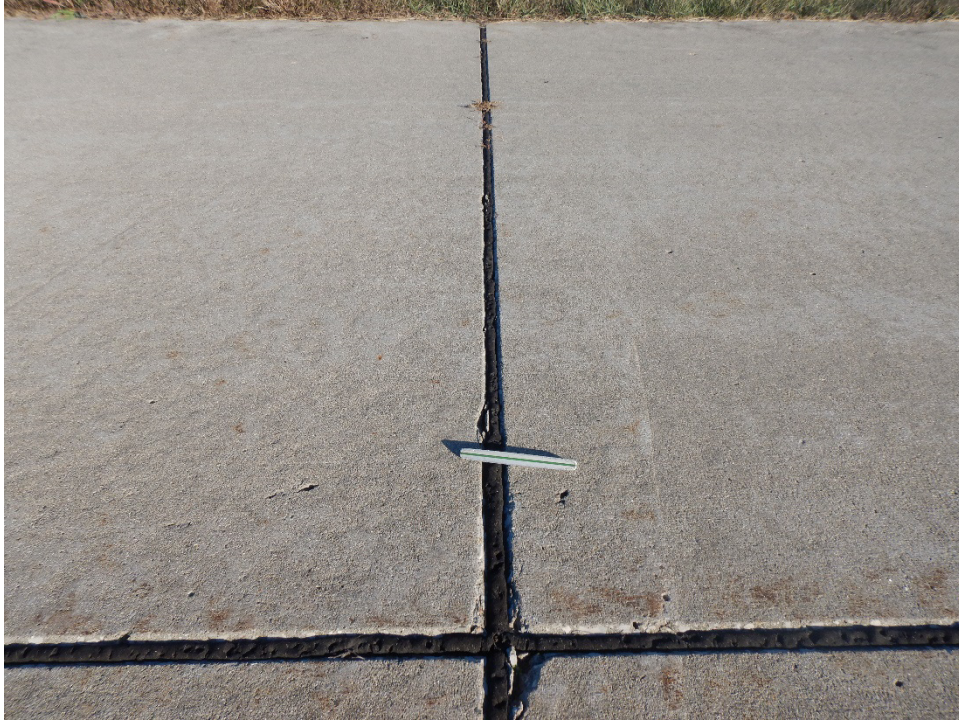
Taxiway 04 consisted of one section that connected Taxiway A to the apron area. High-severity joint seal damage was the only distress observed in Section 01.

T04FA-01. Joint Seal Damage (Sample Unit No. 04).

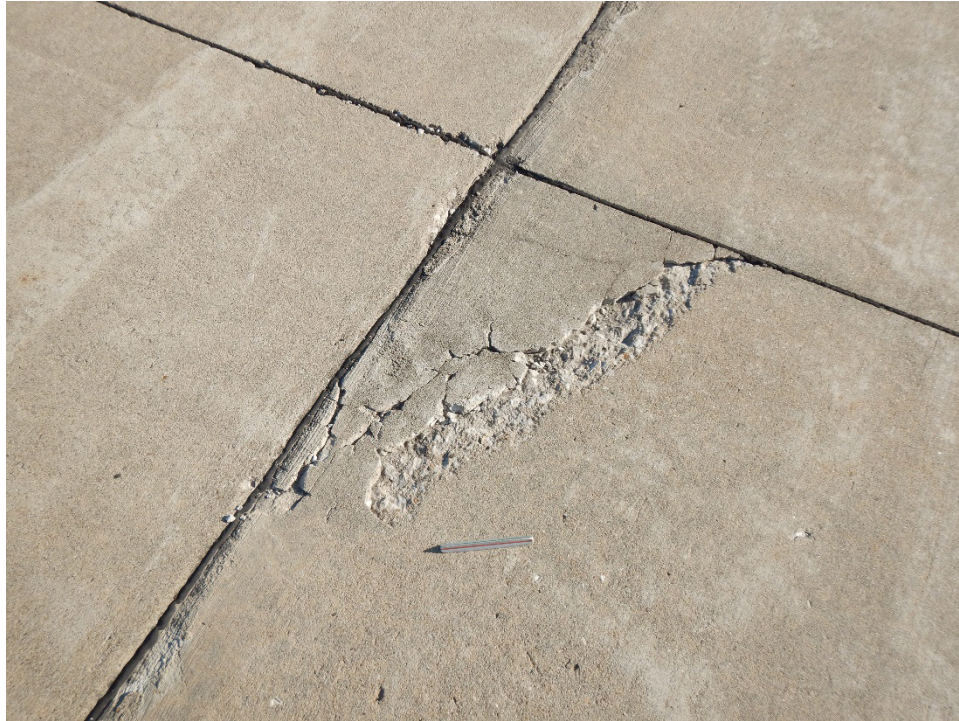
T07FA-01. Corner Spalling (Sample Unit No. 04).

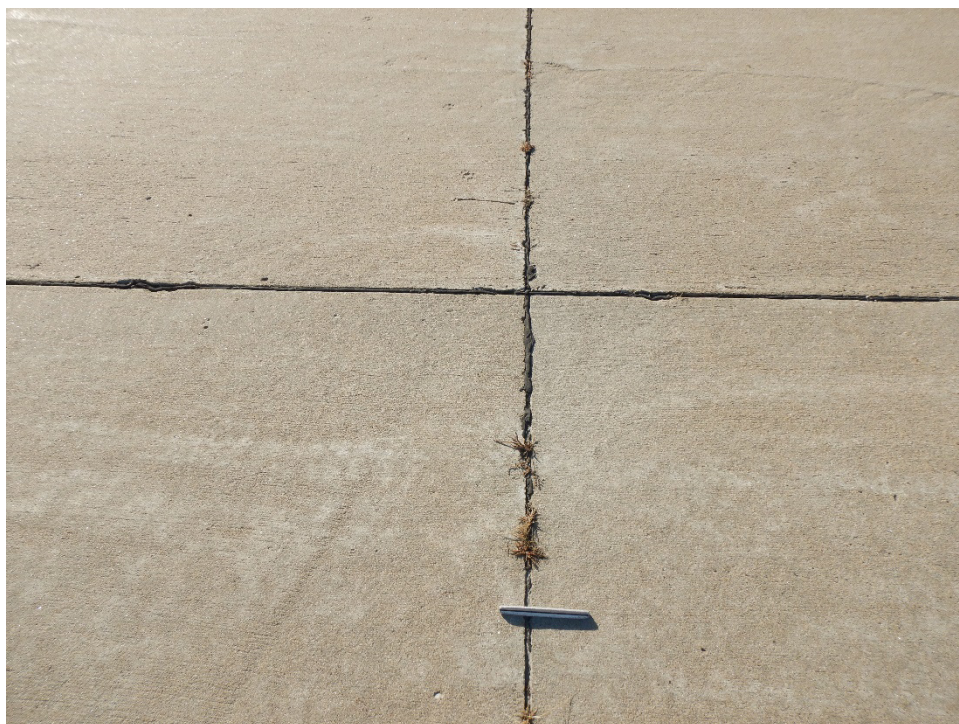
T07FA-01. Joint Seal Damage (Sample Unit No. 02).

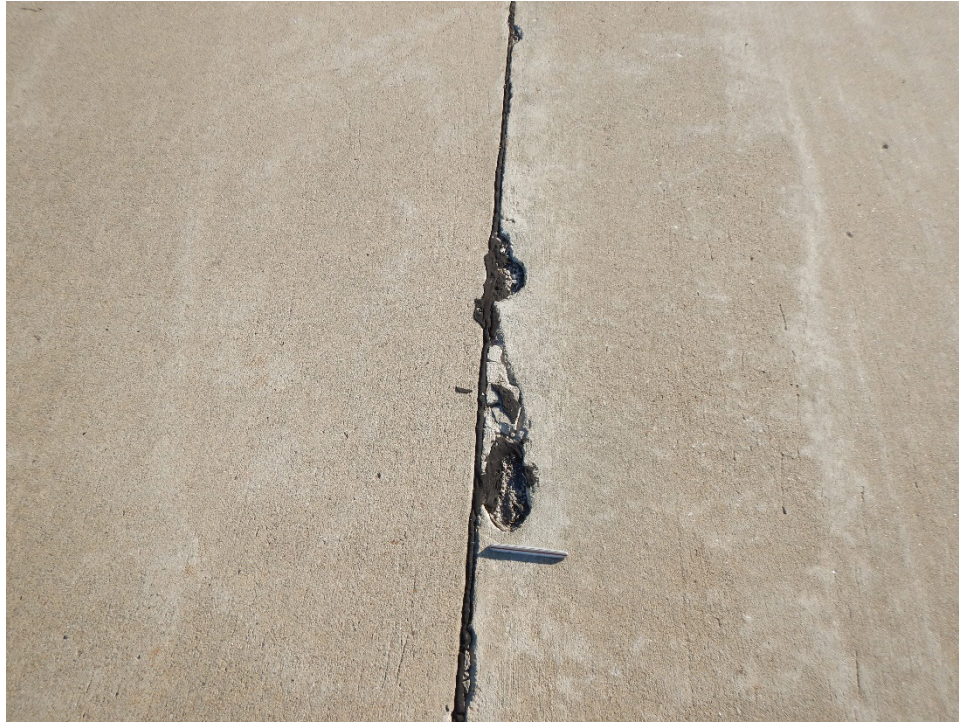
T07FA-01. Joint Spalling (Sample Unit No. 03).

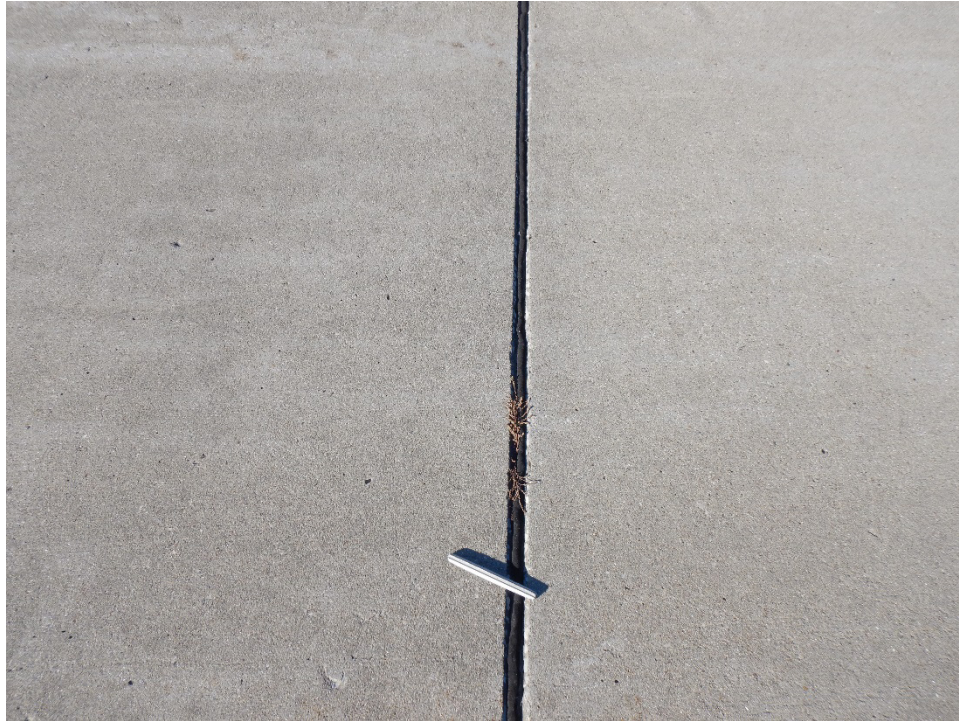
T07FA-02. Joint Seal Damage (Sample Unit No. 02).

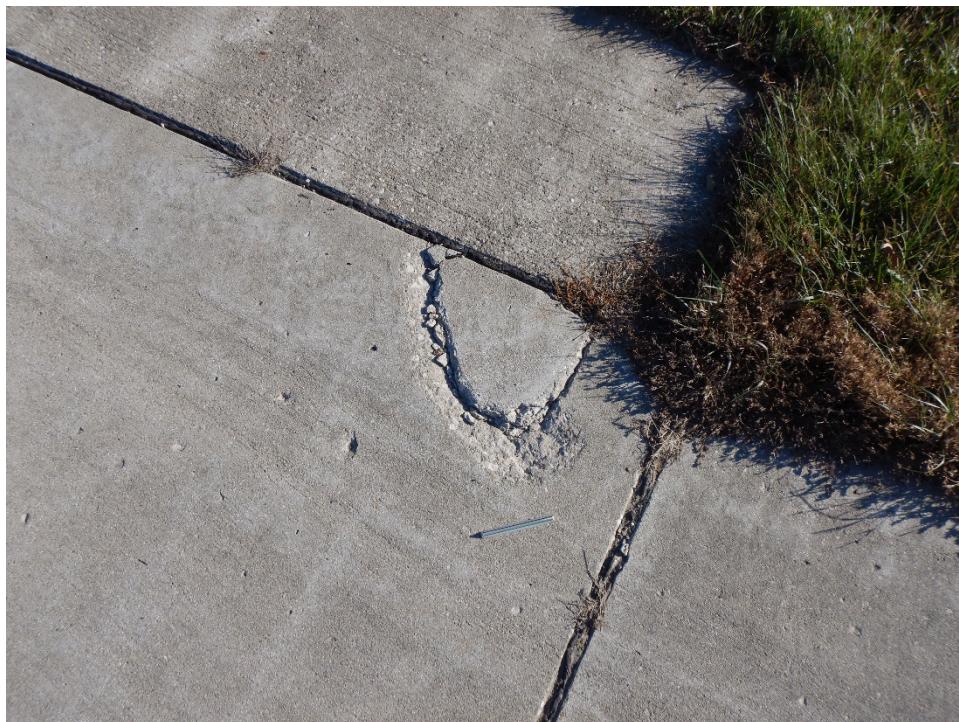
T07FA-02. Joint Spalling (Sample Unit No. 05).

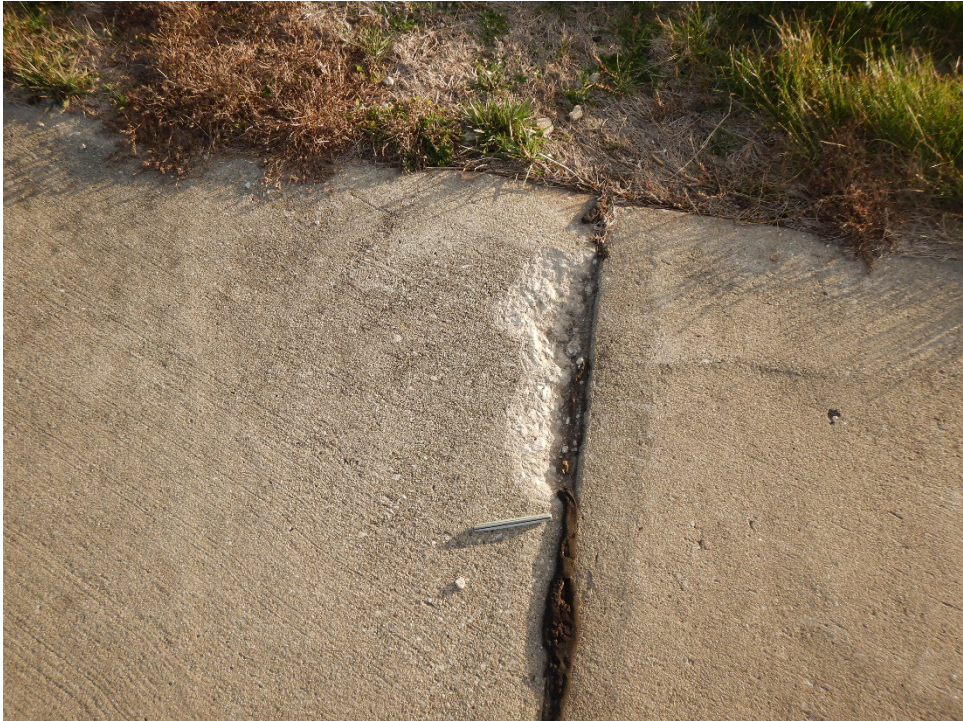
TA1FA-01. Joint Spalling (Sample Unit No. 01).

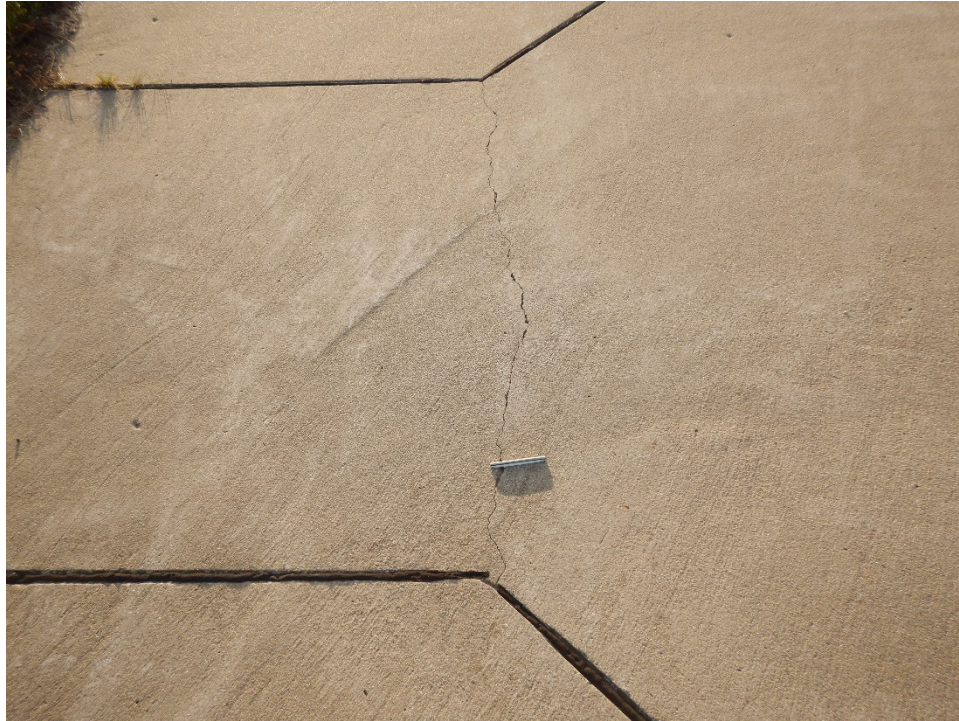
TA1FA-01. LTD Cracking (Sample Unit No. 01).

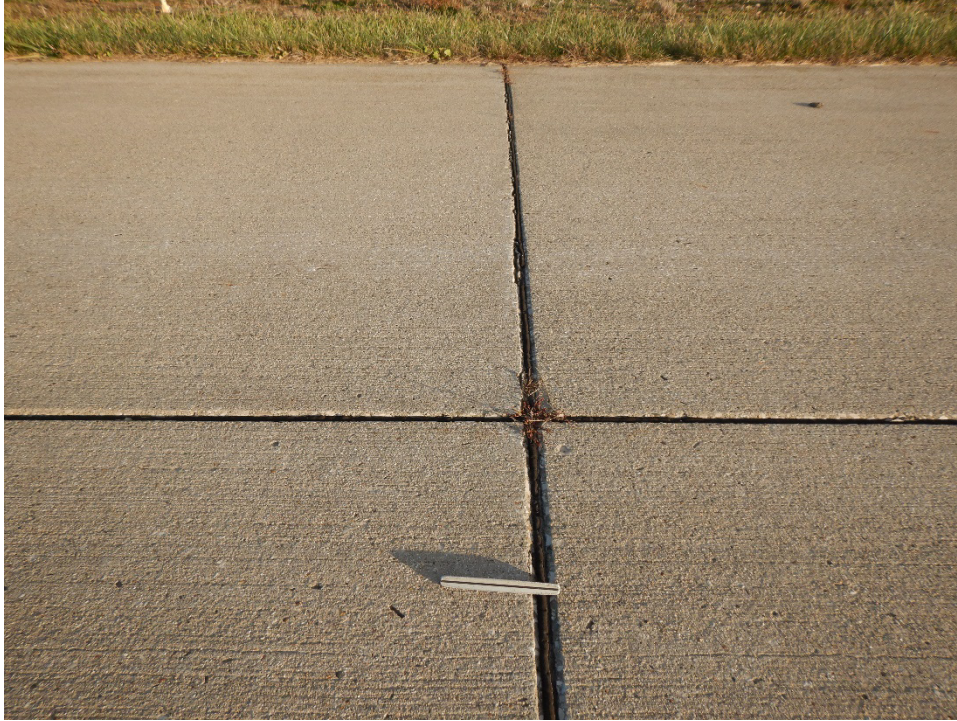
TA1FA-02. Joint Seal Damage (Sample Unit No. 03).

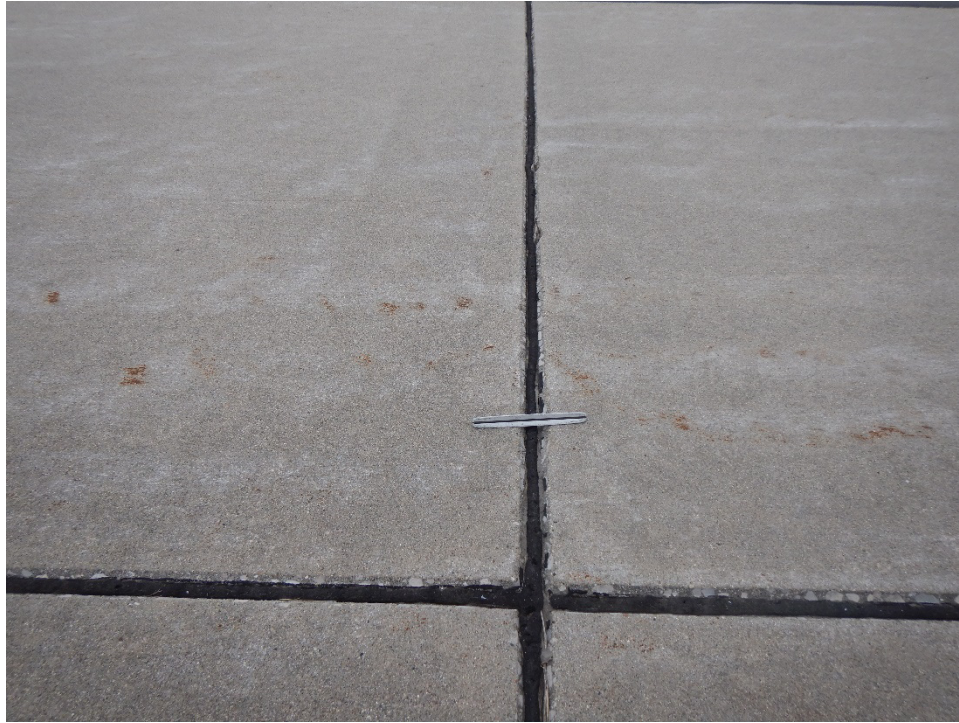
TA2FA-01. Joint Seal Damage (Sample Unit No. 04).

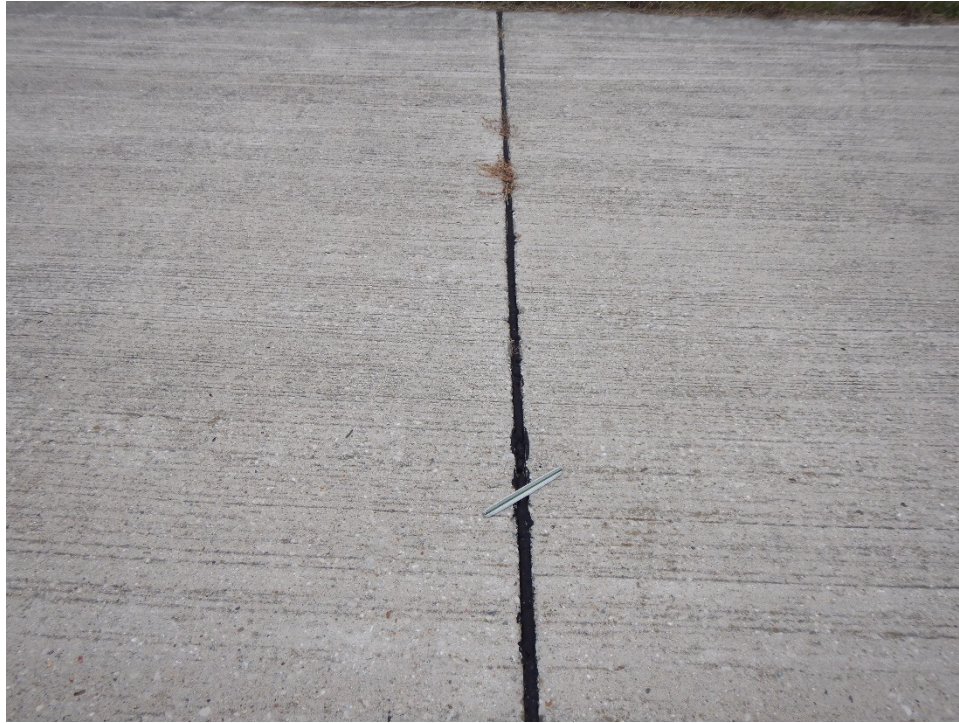
TA2FA-02. Joint Seal Damage (Sample Unit No. 02).

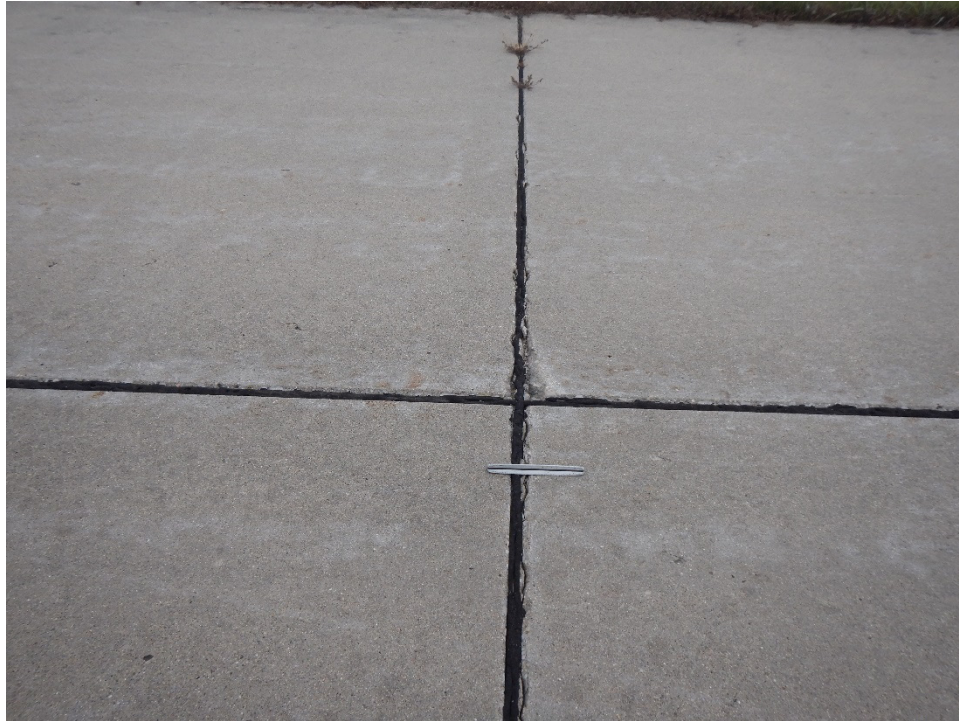
TA3FA-01. Joint Seal Damage (Sample Unit No. 03).

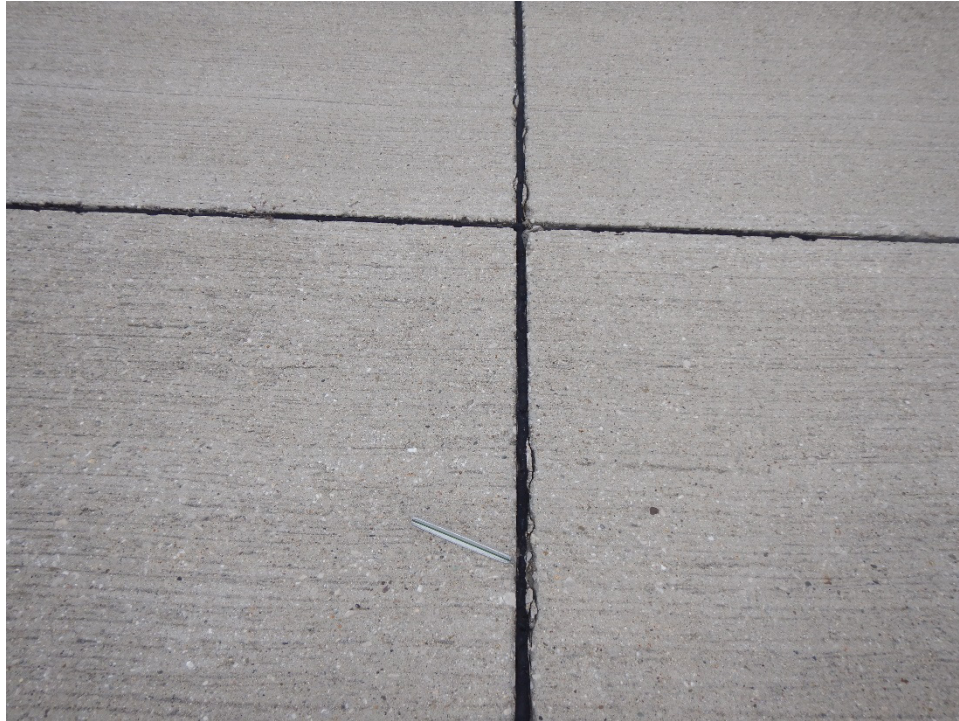
TA3FA-02. Joint Seal Damage (Sample Unit No. 03).

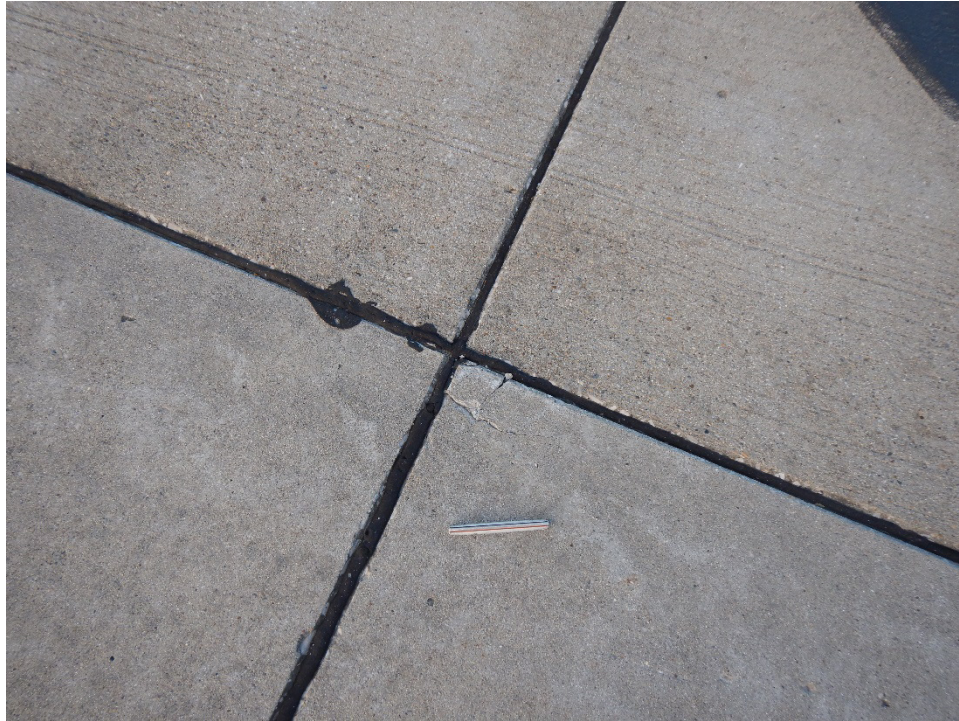
TAF A-01. Corner Spalling (Sample Unit No. 07).

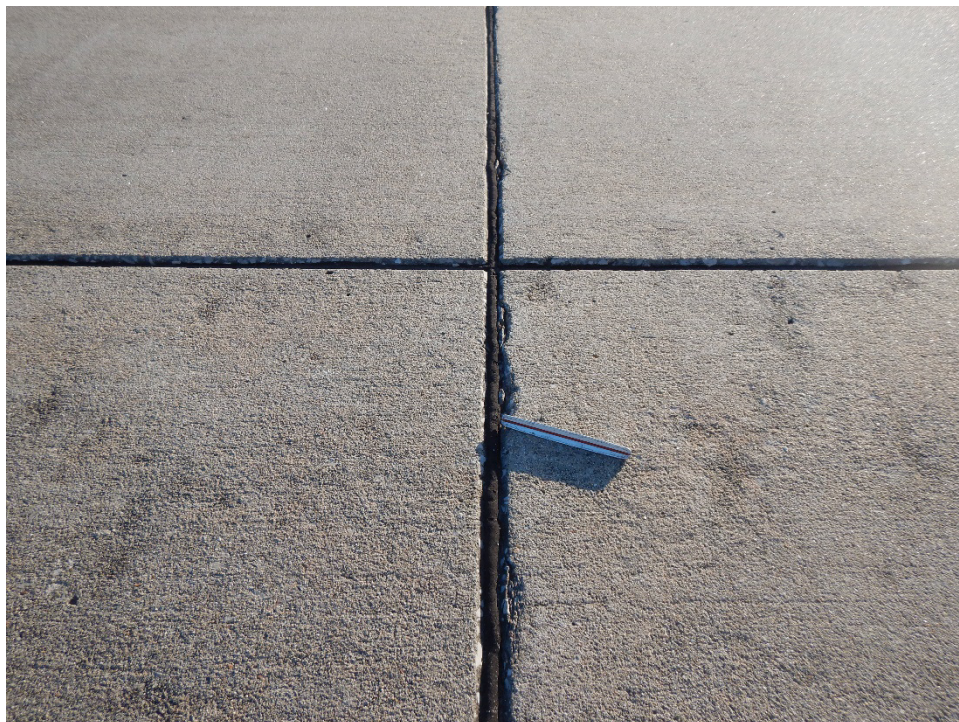
TAF A-01. Joint Seal Damage (Sample Unit No. 57).

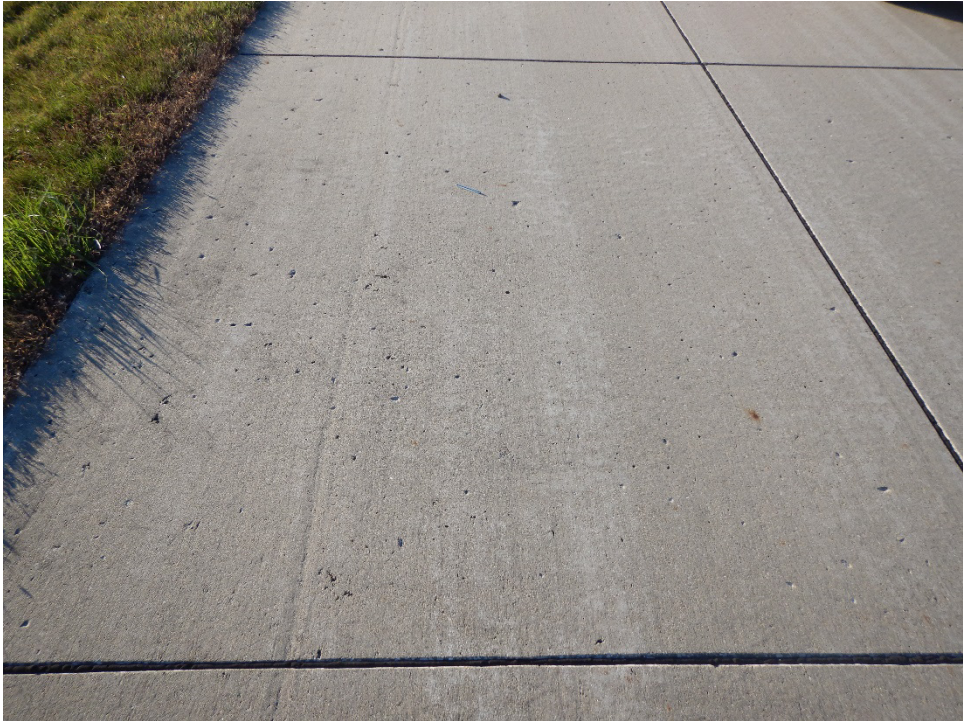
TAF A-01. Popouts (Sample Unit No. 48).

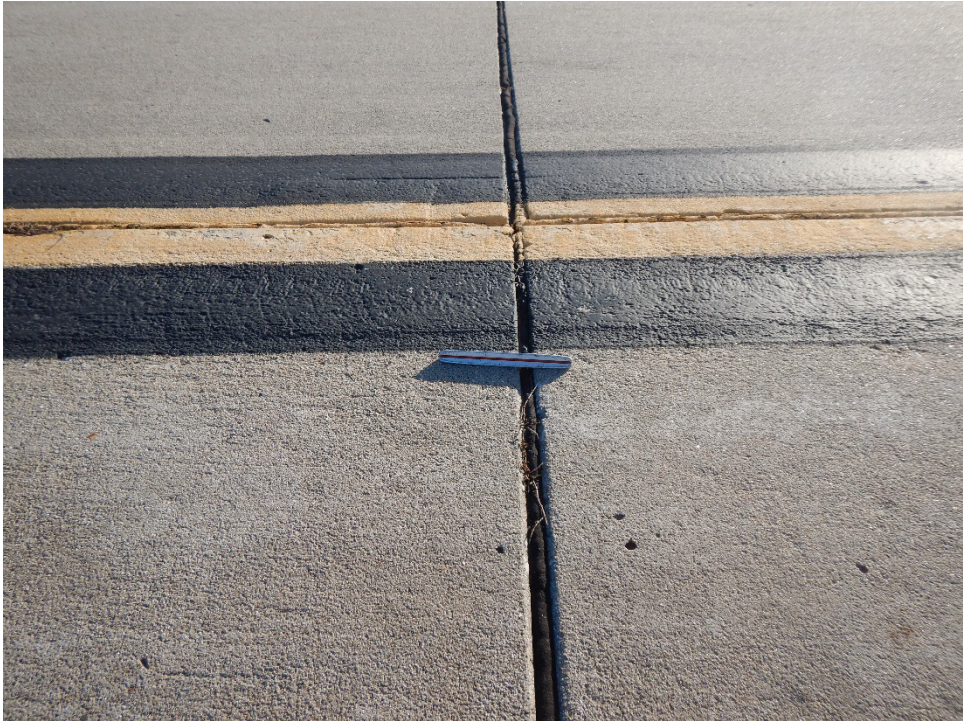
TAF A-02. Joint Seal Damage (Sample Unit No. 10).

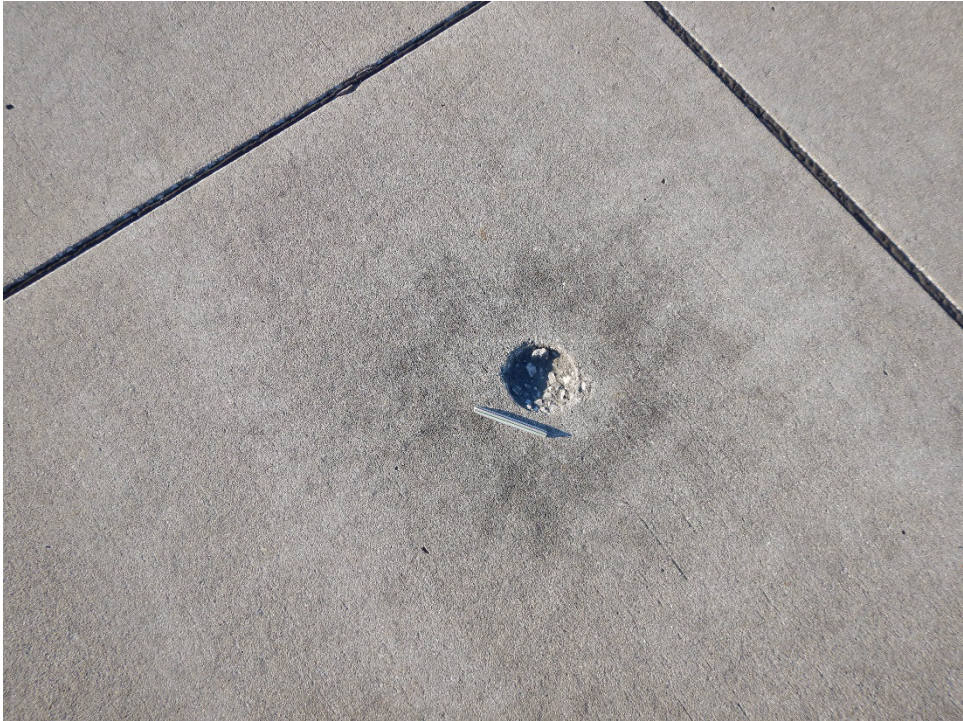
TAF A-02. Small Patching (Sample Unit No. 02).

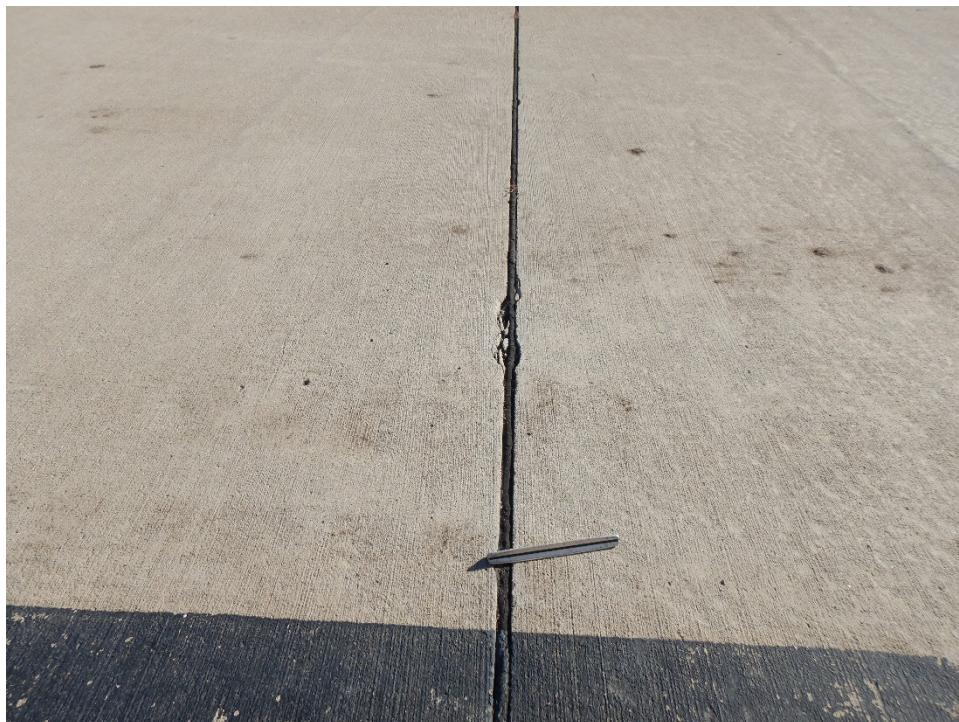
TH01FA-01. Joint Seal Damage (Sample Unit No. 05).

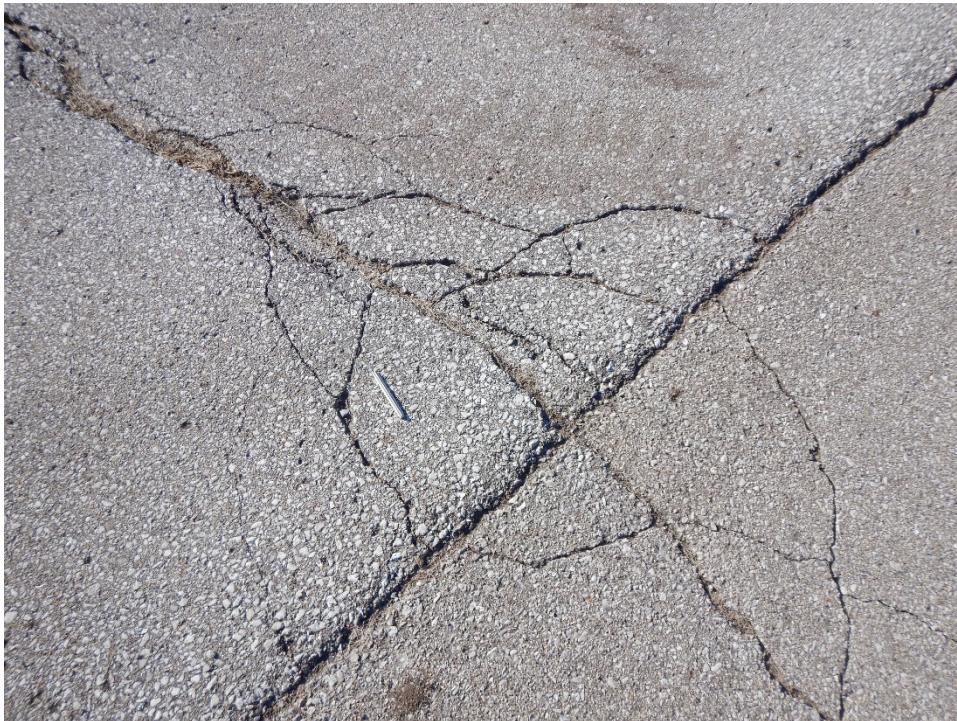
TH01FA-02. Alligator Cracking (Sample Unit No. 01).
