Fairfield Municipal Airport

Pavement Management Report

JULY 2024

FAIRFIELD MUNICIPAL AIRPORT PAVEMENT MANAGEMENT REPORT

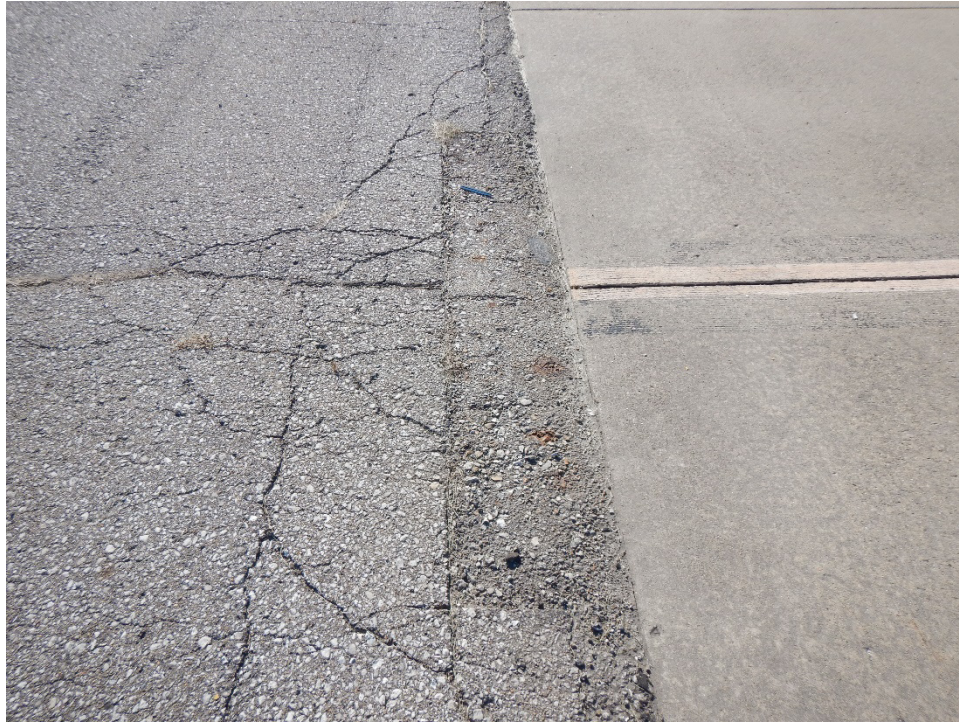
TH01FA-02. Patching (Sample Unit No. 02).

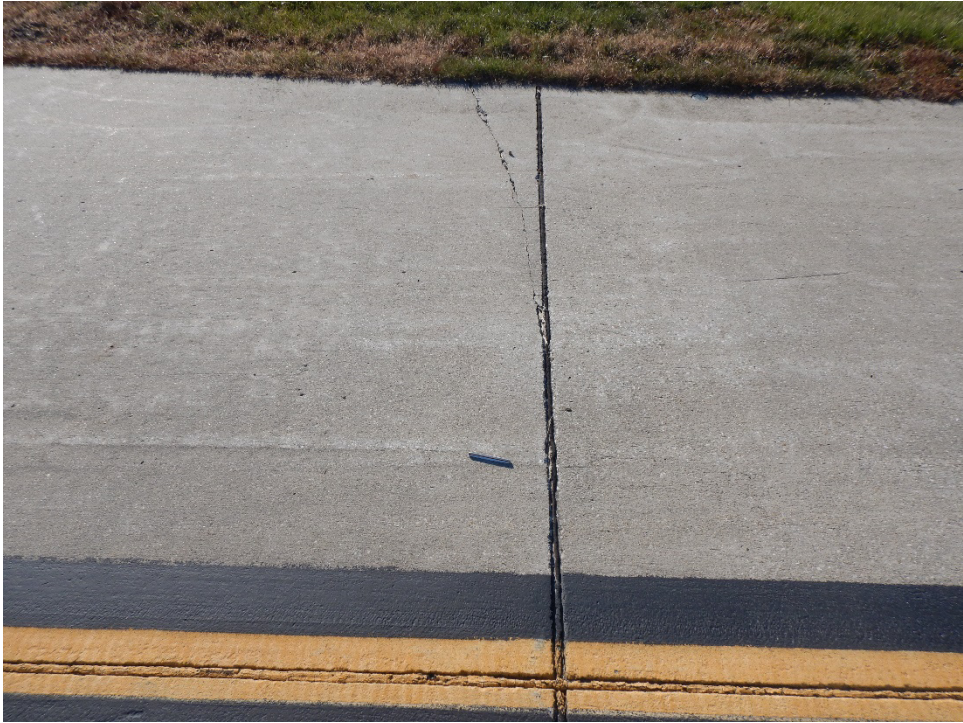
TH01FA-03. LTD Cracking (Sample Unit No. 01).

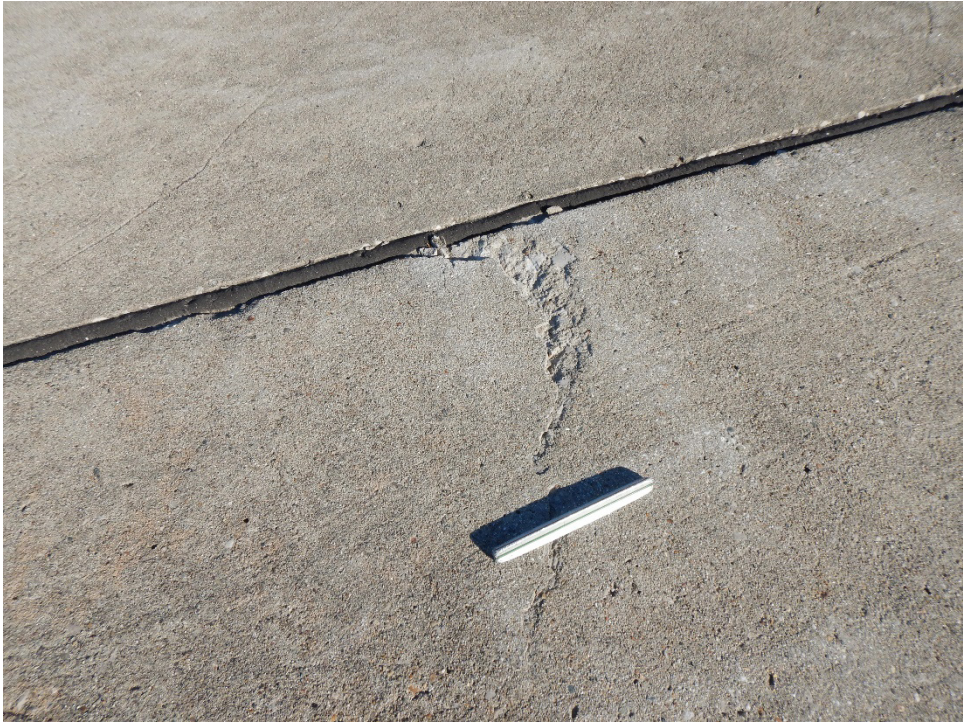
TH01FA-03. Scaling (Sample Unit No. 01).
