# Forest City Municipal Airport

## Pavement Management Report

**JULY 2023**

# FOREST CITY MUNICIPAL AIRPORT PAVEMENT MANAGEMENT REPORT

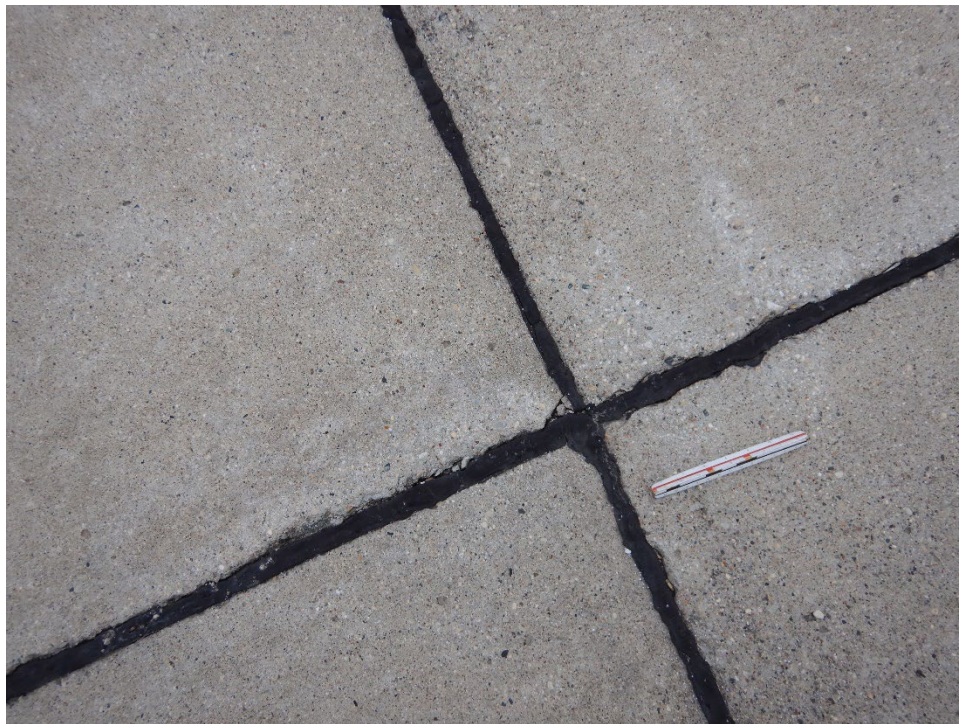
The apron area consisted of two sections. Section 01 contained areas of low-severity corner spalling, medium-severity joint seal damage, and shrinkage cracking. Low-severity corner break and longitudinal, transverse, and diagonal (LTD) cracking; medium-severity joint seal damage; and low- and medium-severity joint spalling were recorded in Section 02.

A01FC-01. Joint Seal Damage (Sample Unit No. 05).

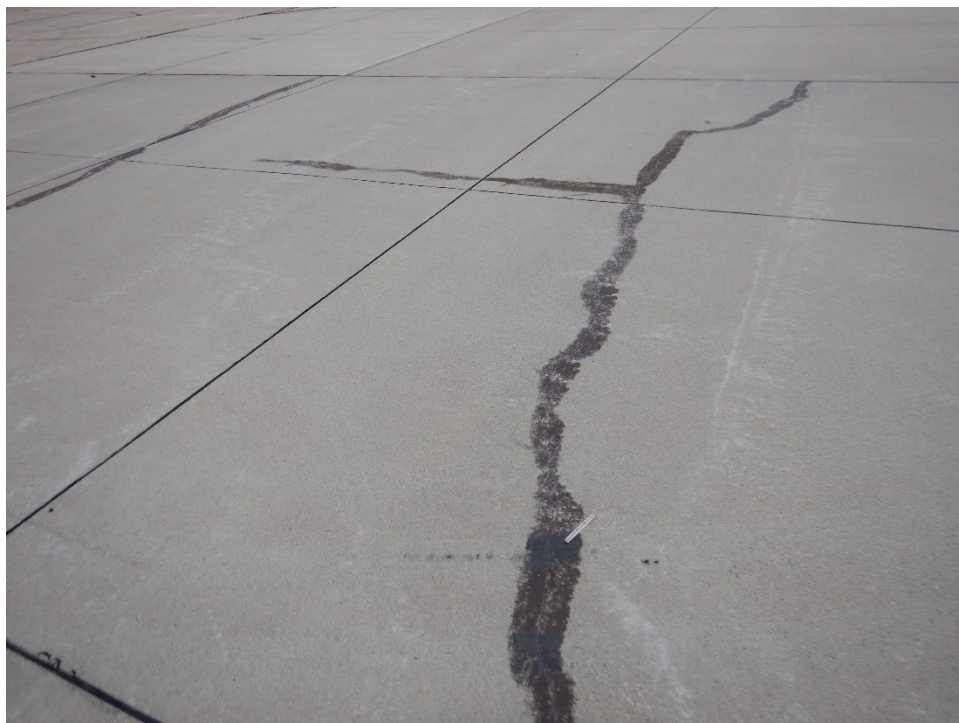
A01FC-02. LTD Cracking (Sample Unit No. 06).

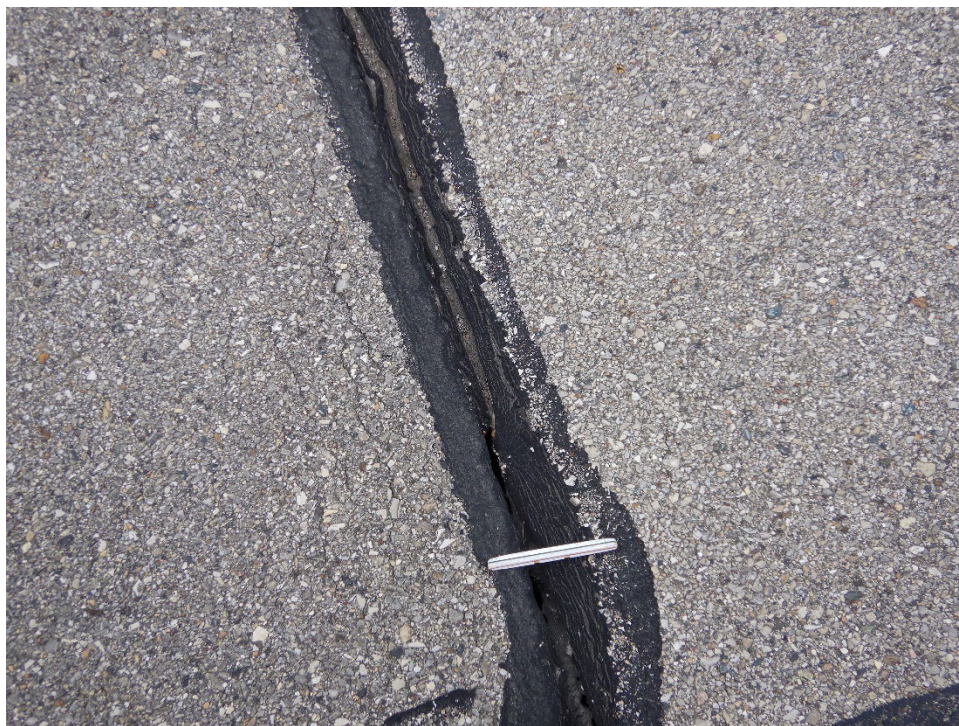
Runway 09/27 was defined by four sections. All severities of longitudinal and transverse (L&T) cracking as well as low-severity raveling and weathering were observed in Section 01. Section 02 contained low-severity weathering and alligator cracking and all severities of L&T cracking. Areas of all severities of L&T cracking and low-severity weathering were identified in Section 03. Medium- and high-severity L&T cracking and low-severity patching, raveling, and weathering were recorded in Section 04. The low-severity L&T cracking in Sections 01, 02, and 03 was unsealed, and the medium-severity L&T cracking in all sections was due to either unsatisfactory crack sealant or unsealed crack widths that exceeded  $\frac{1}{4}$  in.

R09FC-01. L&T Cracking (Sample Unit No. 01).

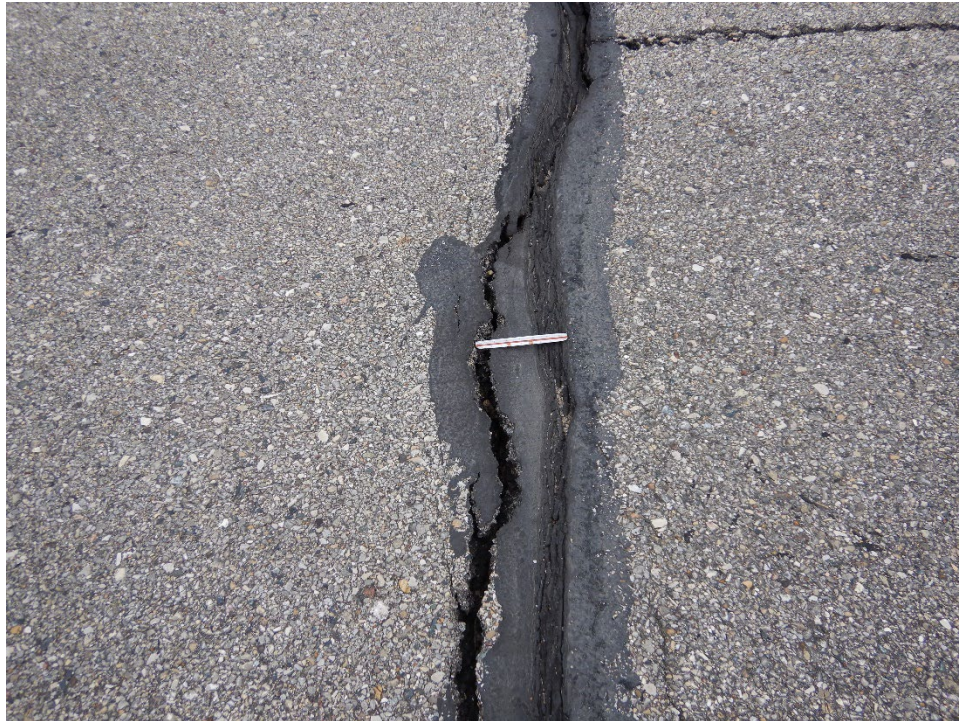
R09FC-01. L&T Cracking (Sample Unit No. 09).

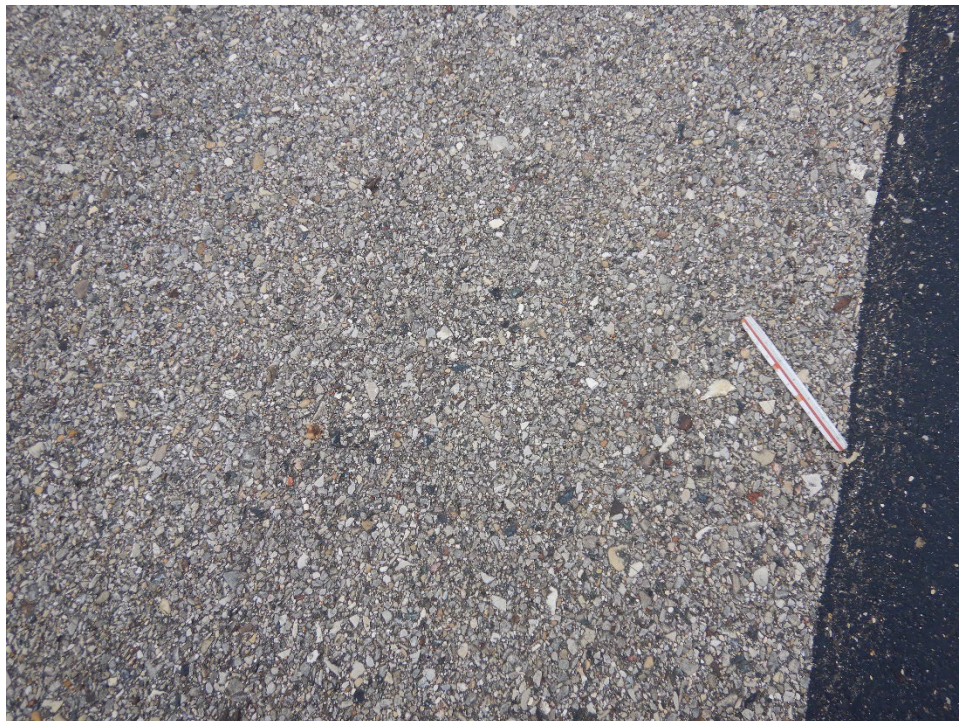
R09FC-01. Weathering (Sample Unit No. 01).

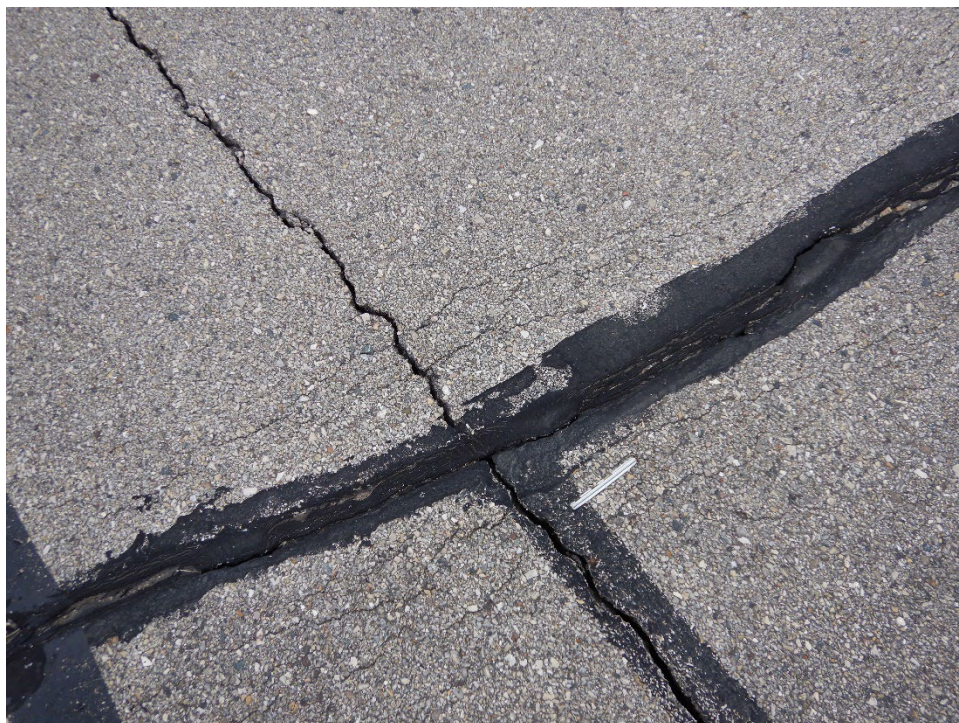
R09FC-02. L&T Cracking (Sample Unit No. 01) (1).

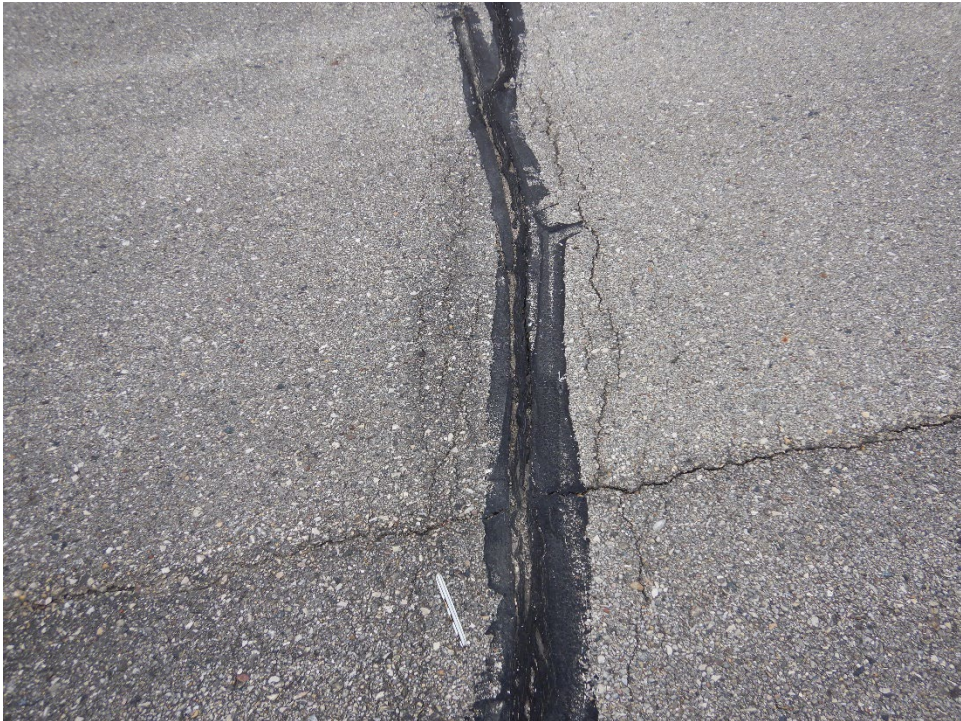
R09FC-02. L&T Cracking (Sample Unit No. 01) (2).

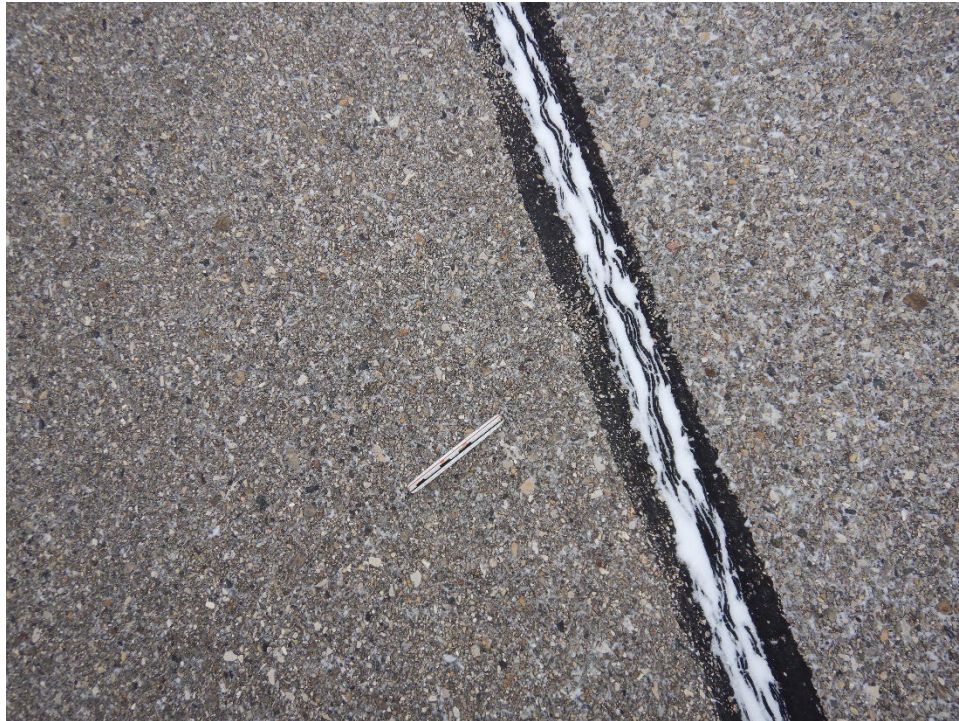
R09FC-03. L&T Cracking (Sample Unit No. 03) (1).

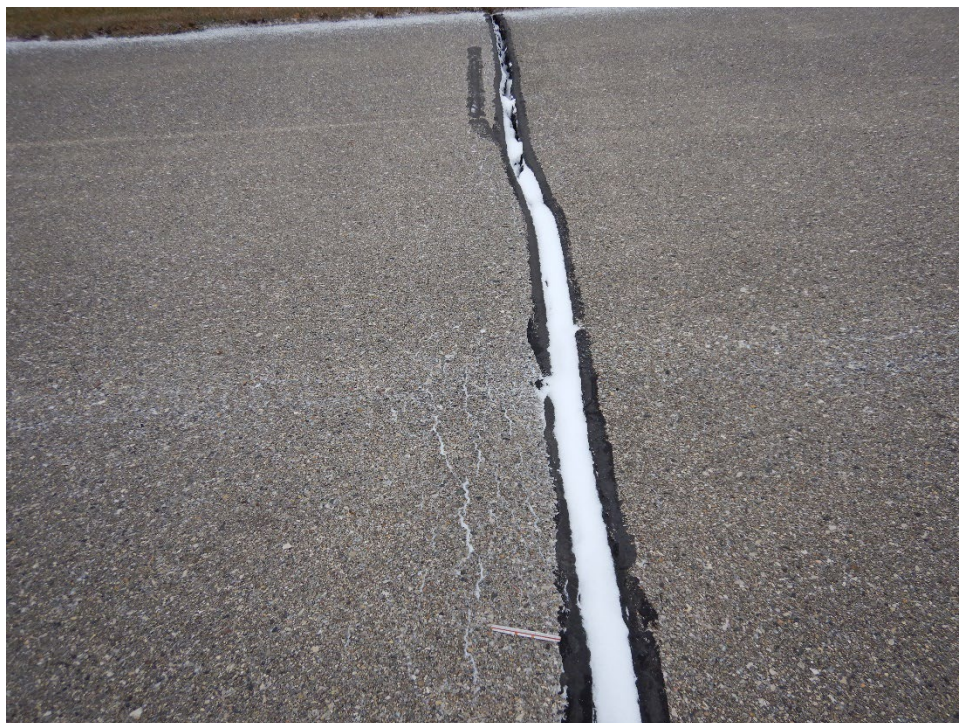
R09FC-03. L&T Cracking (Sample Unit No. 03) (2).

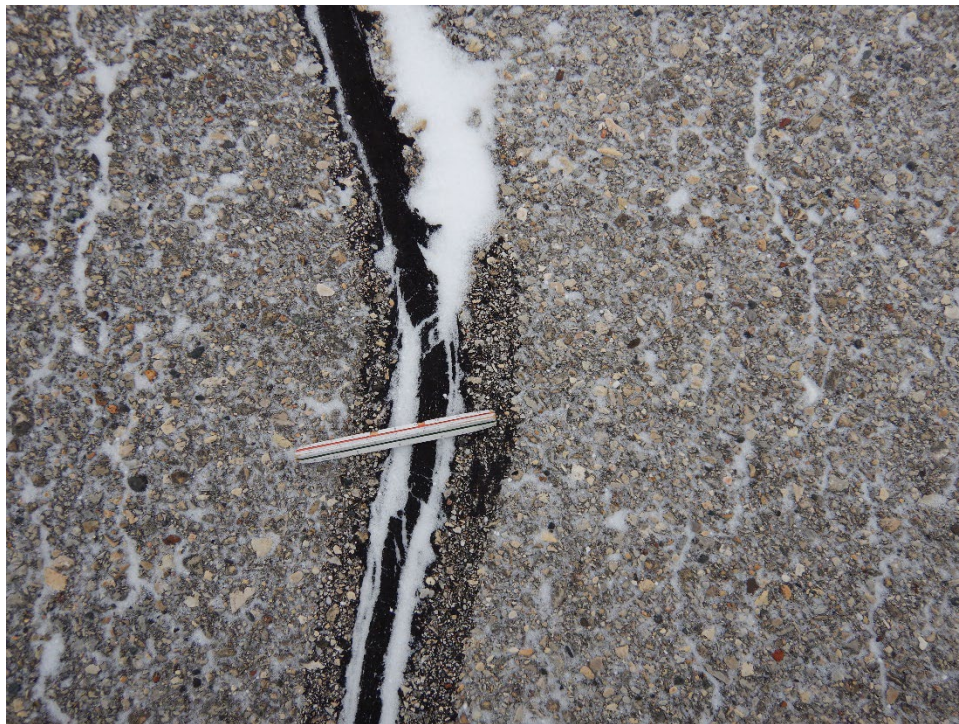
R09FC-04. L&T Cracking (Sample Unit No. 04).

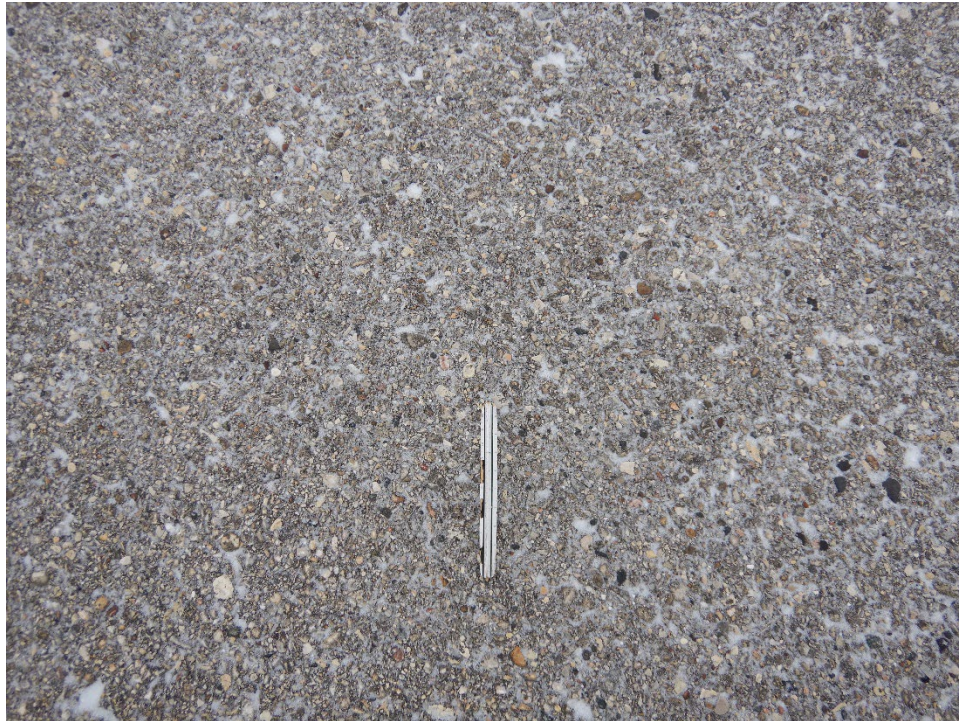
R09FC-04. Weathering (Sample Unit No. 04).

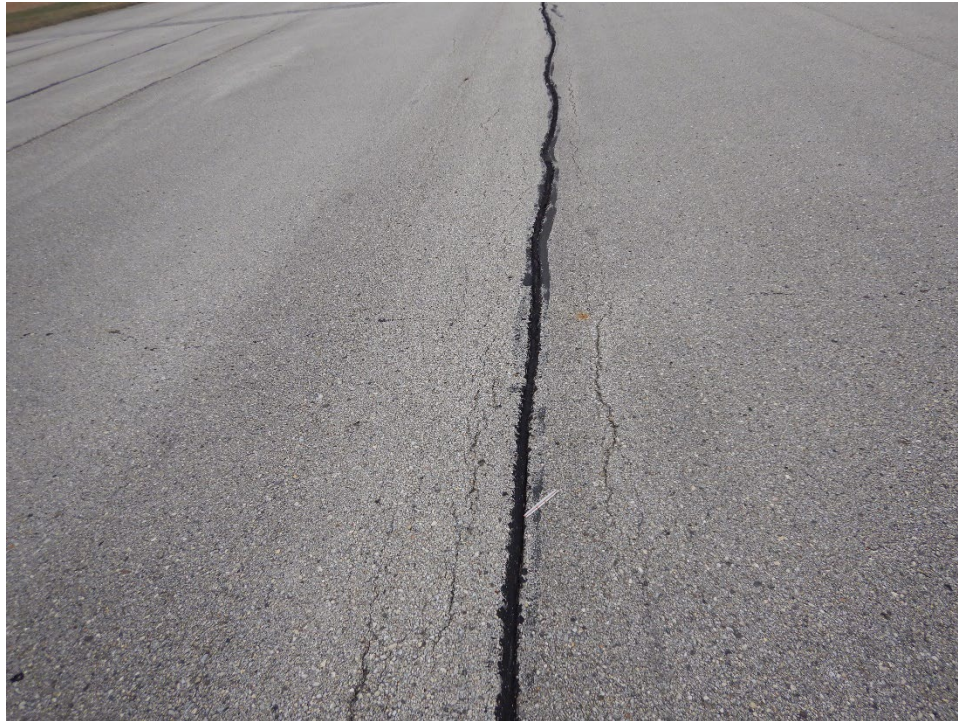
Runway 15/33 contained two sections. Areas of low-severity raveling, weathering, and alligator cracking and low- and medium-severity L&T cracking and patching were observed in Section 01. Low- and medium-severity L&T cracking and low-severity raveling, weathering, alligator cracking, and patching were recorded in Section 02. The low-severity L&T cracking in both sections was unsealed, and the medium-severity L&T cracking was due to either unsatisfactory crack sealant or unsealed crack widths greater than  $\frac{1}{4}$  in.

R15FC-01. Alligator Cracking (Sample Unit No. 41).

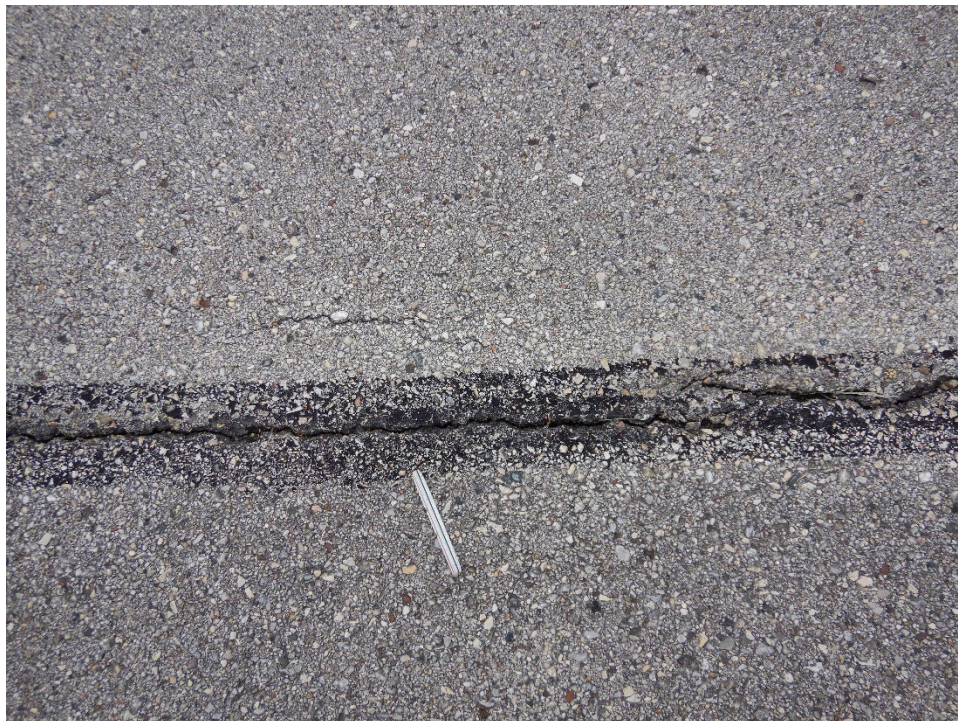
R15FC-01. L&T Cracking (Sample Unit No. 05).

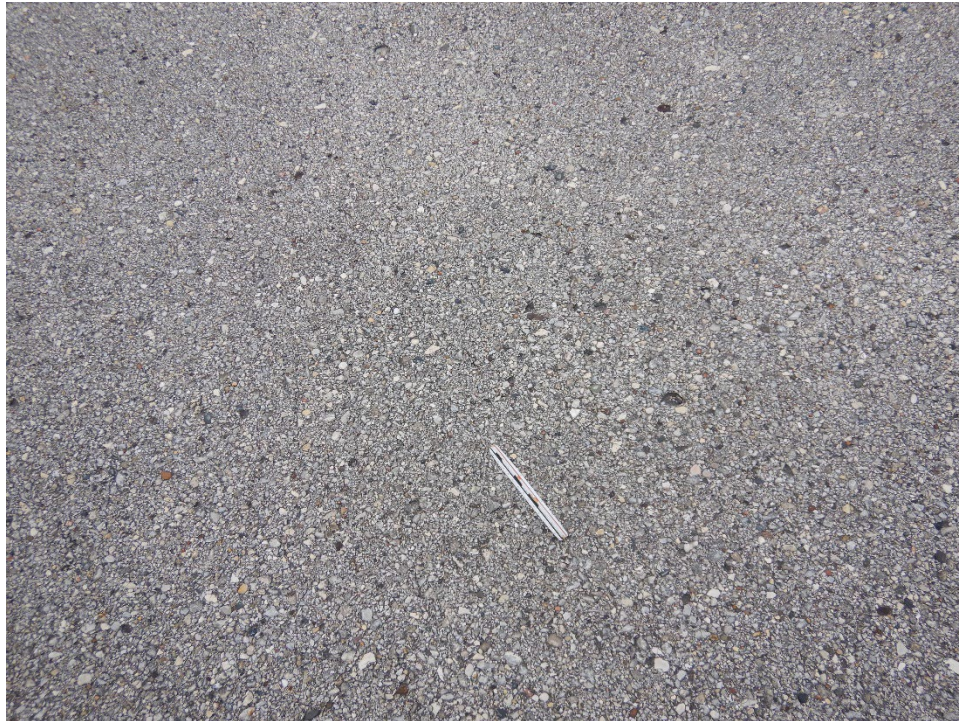
R15FC-01. Raveling (Sample Unit No. 05).

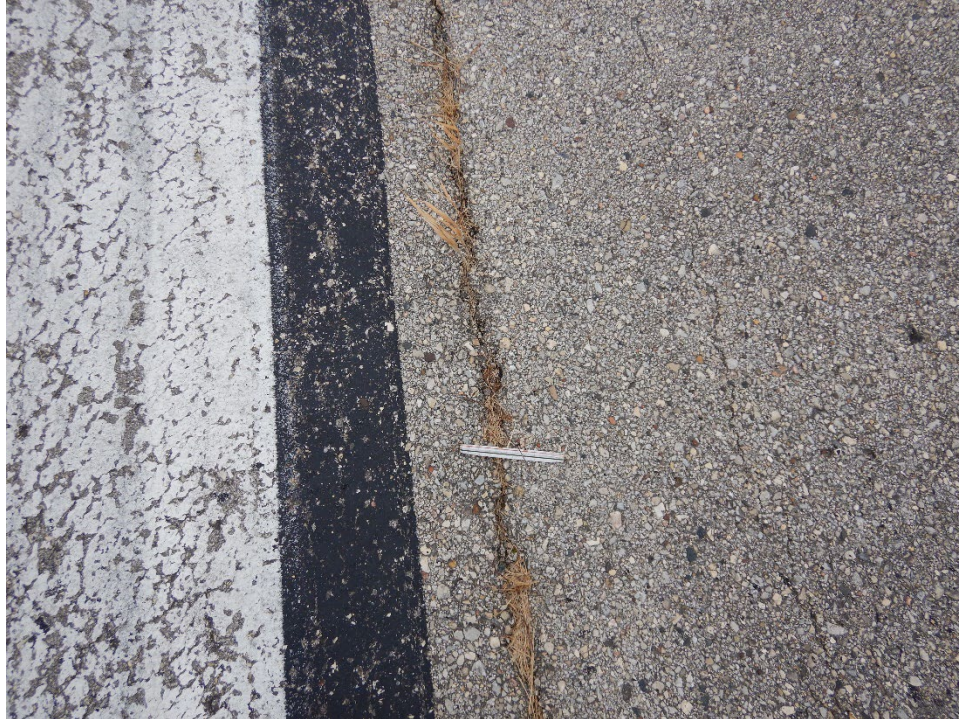
R15FC-02. L&T Cracking (Sample Unit No. 49).

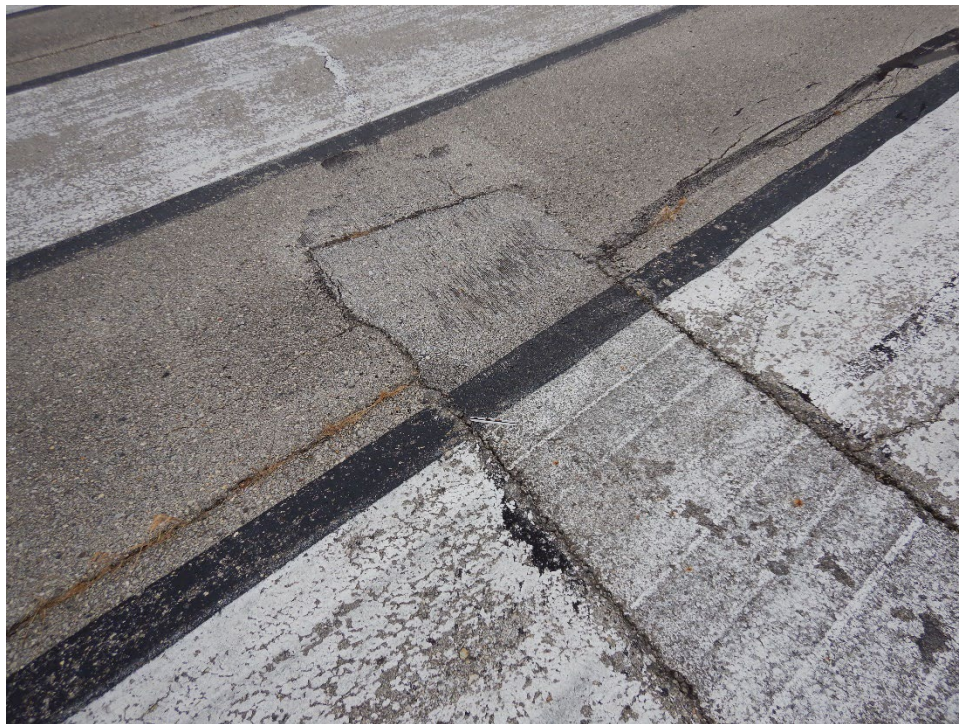
R15FC-02. Patching (Sample Unit No. 49).

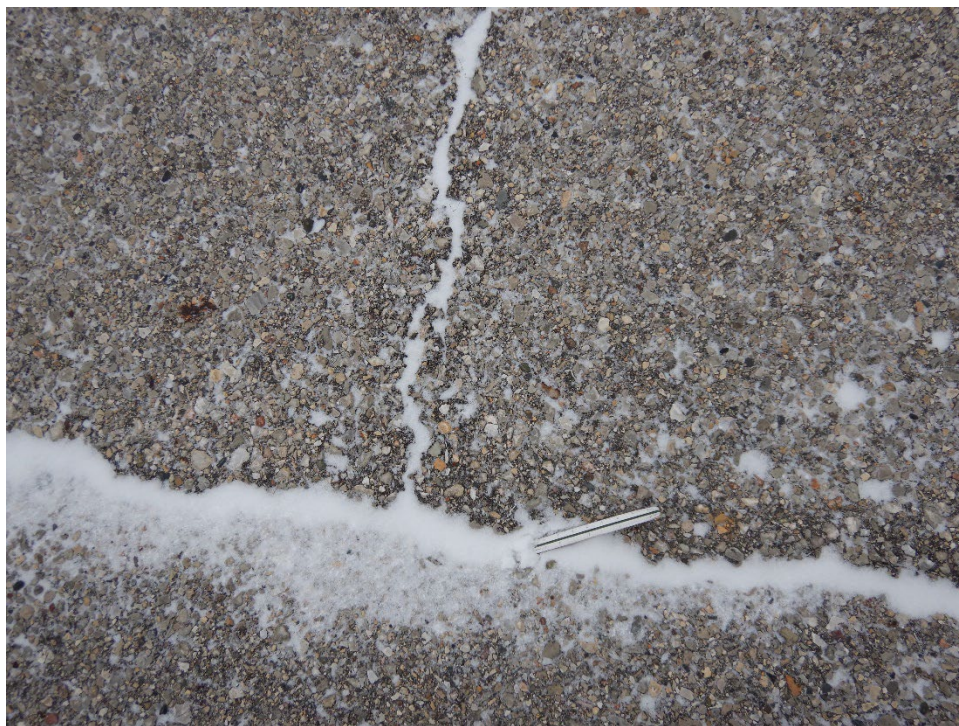
Taxiway 01 consisted of two sections. Section 01 contained areas of low-severity raveling and low- and medium-severity weathering and L&T cracking. Medium-severity alligator cracking and weathering; low-severity depression and patching; all severities of L&T cracking; and low- and high-severity raveling were noted in Section 02. The low-severity L&T cracking in both sections was unsealed, and the medium-severity L&T cracking was due to either the development of secondary cracking or unsealed crack widths that exceeded  $\frac{1}{4}$  in.

T01FC-01. L&T Cracking (Sample Unit No. 02).

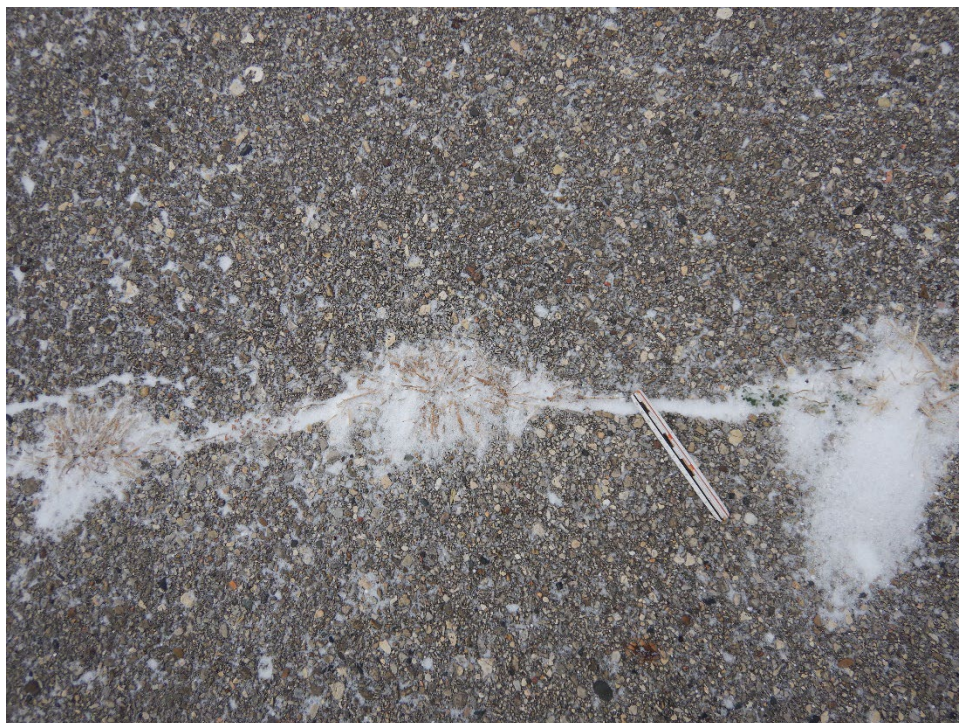
T01FC-02. L&T Cracking (Sample Unit No. 02).

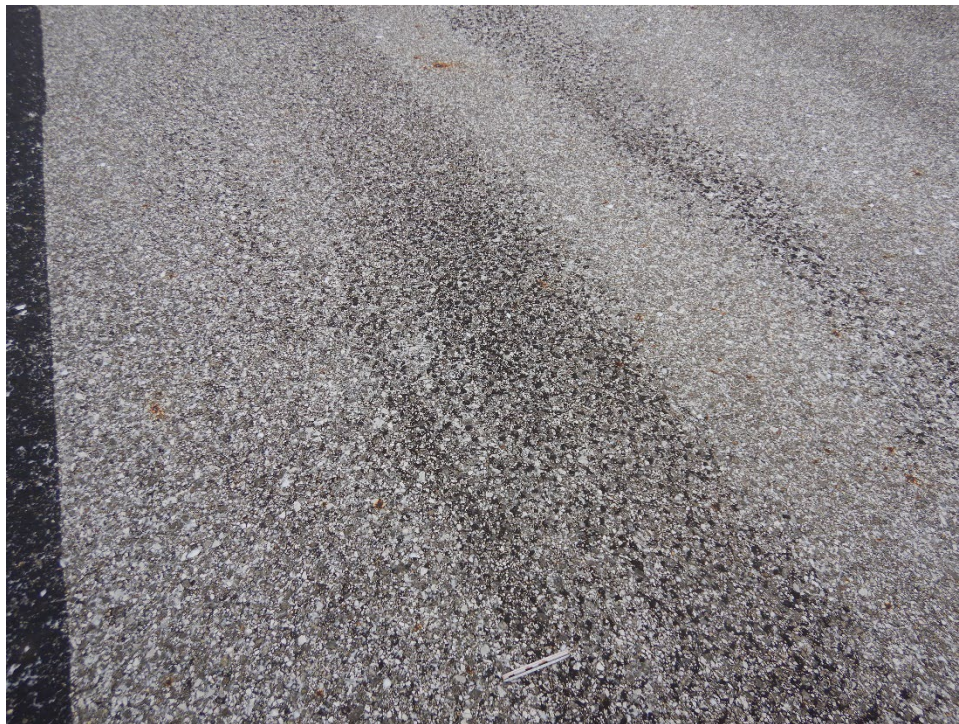
Taxiway 02 was defined by three sections. Areas of low-severity patching, raveling, and weathering; medium-severity alligator cracking; bleeding; and all severities of L&T cracking were observed in Section 01. Section 02 contained areas of low-severity raveling and weathering and low- and medium-severity L&T cracking. The low-severity L&T cracking in Sections 01 and 02 was unsealed, and the medium-severity L&T cracking was due to either the development of secondary cracking or unsealed crack widths that exceeded  $\frac{1}{4}$  in in Section 01 and to unsealed crack widths greater than  $\frac{1}{4}$  in in Section 02. Low- and medium-severity L&T cracking and low-severity raveling and weathering were recorded in Section 03. The low-severity L&T cracking in Section 03 was unsealed, and the medium-severity L&T cracking was due to either the unsatisfactory crack sealant or unsealed crack widths that exceeded  $\frac{1}{4}$  in.

T02FC-01. Bleeding (Sample Unit No. 02).

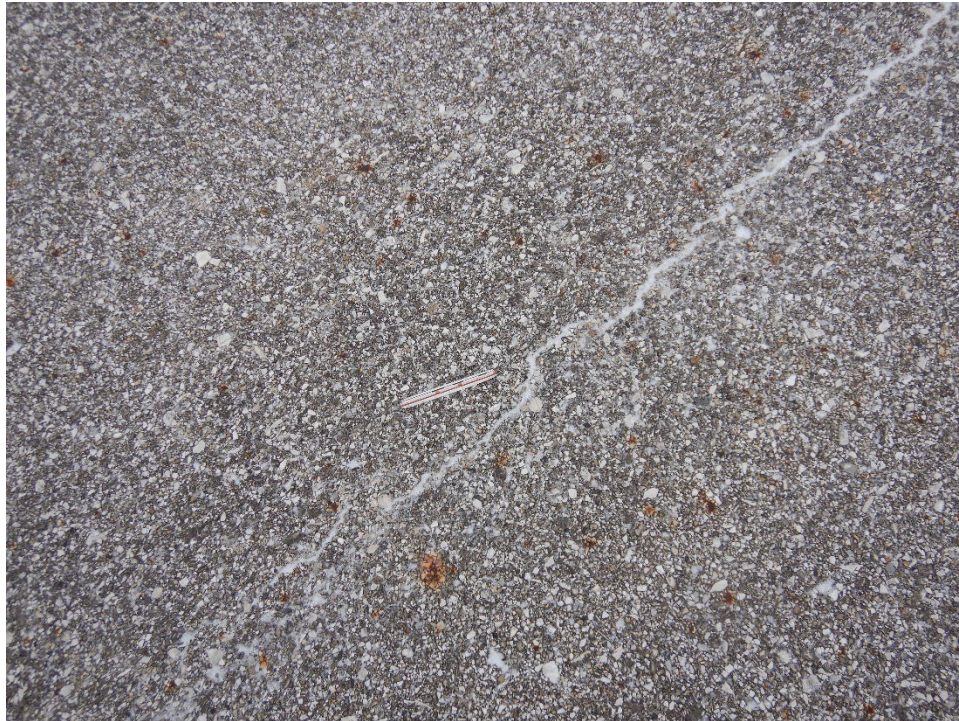
T02FC-01. L&T Cracking (Sample Unit No. 02).

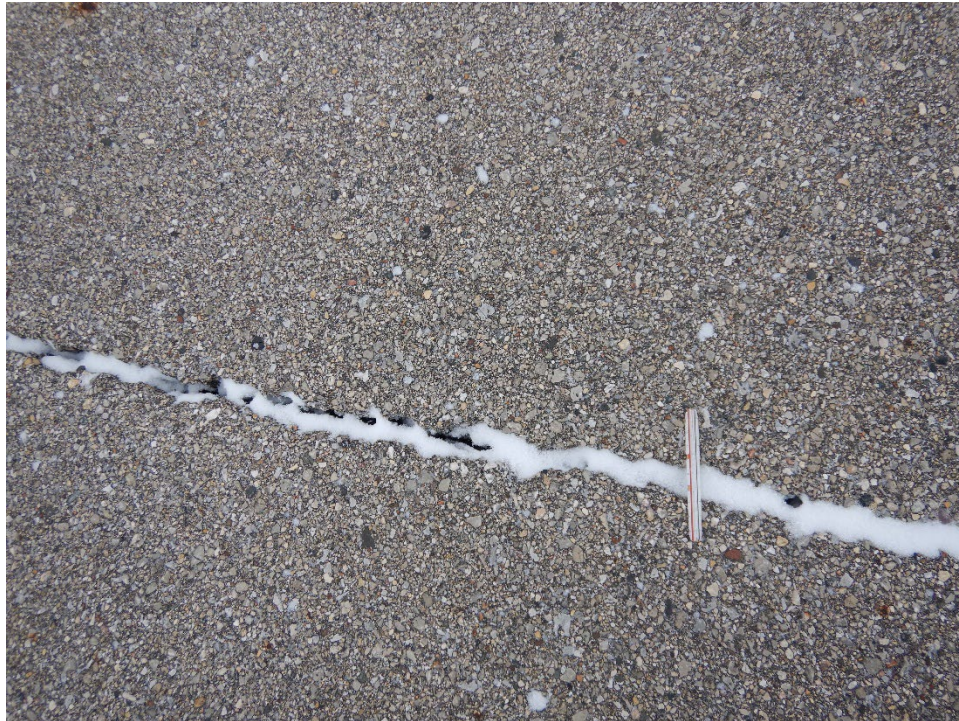
T02FC-02. L&T Cracking (Sample Unit No. 01).

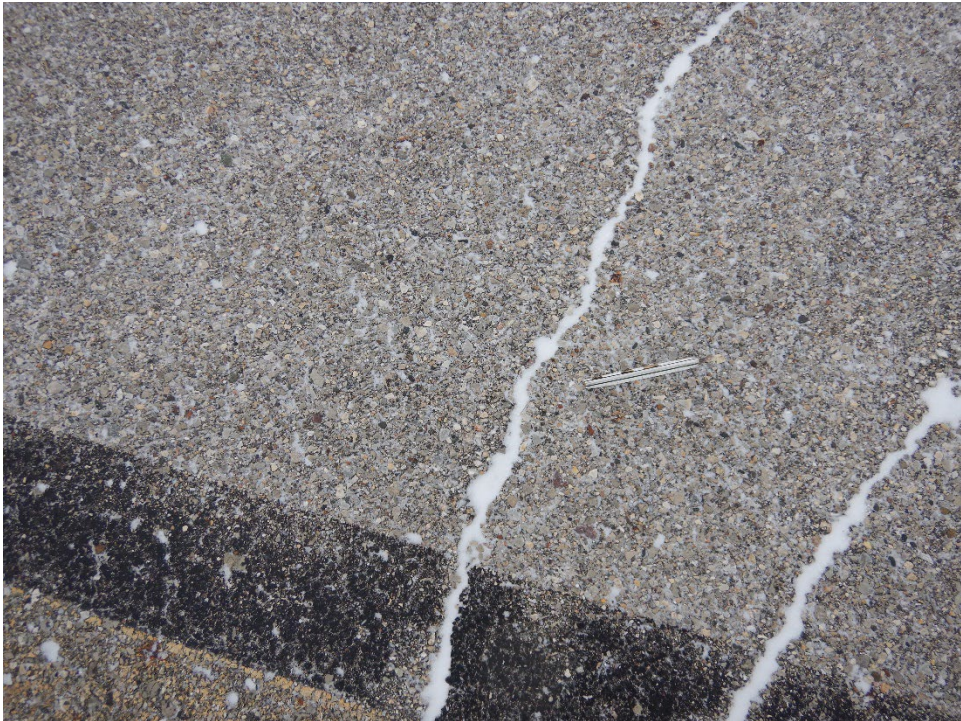
T02FC-03. L&T Cracking (Sample Unit No. 01).

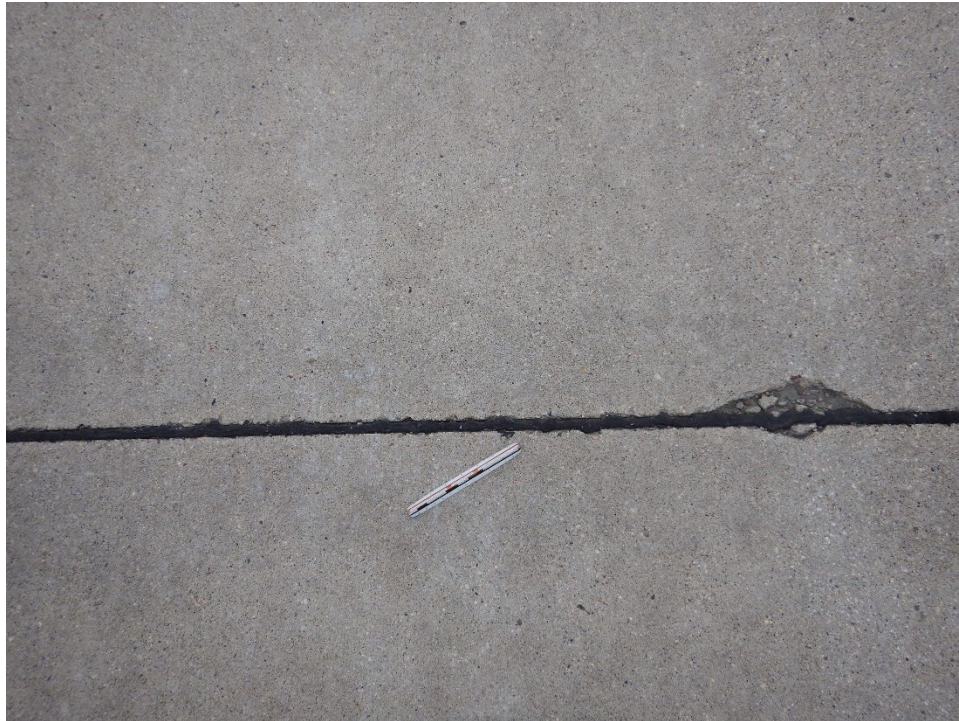
The T-hangar area was defined by four sections. Medium-severity joint seal damage was observed throughout Section 01. Section 02 was in poor condition with areas of medium-severity joint spalling and corner break; high-severity joint seal damage; low- and medium-severity LTD cracking and shattered slab; low-severity scaling; and shrinkage cracking were noted during the inspection. Areas of medium-severity weathering and alligator cracking; all severities of L&T cracking; and low- and high-severity raveling were observed in Section 03. Section 04 contained low- and medium-severity L&T cracking, low-severity raveling, and medium-severity weathering. The low-severity L&T cracking in Sections 03 and 04 was unsealed, and the medium-severity L&T cracking was due to either the development of secondary cracking, unsatisfactory crack sealant, or unsealed crack widths that exceeded ¼ in.

TH01FC-01. Joint Seal Damage (Sample Unit No. 03).

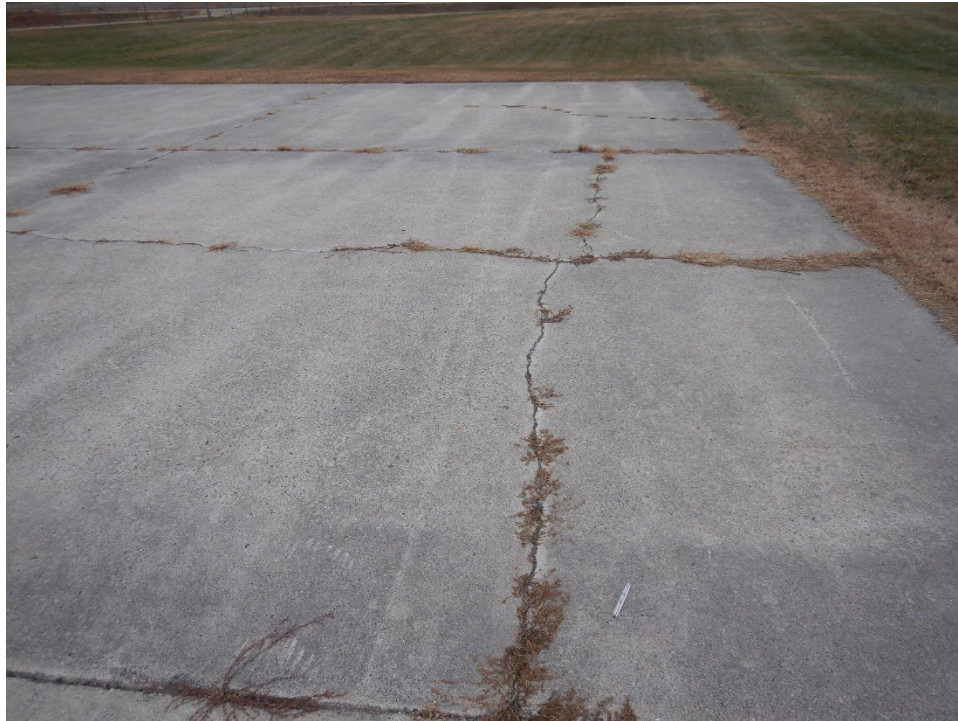
TH01FC-02. Shattered Slab (Sample Unit No. 01).

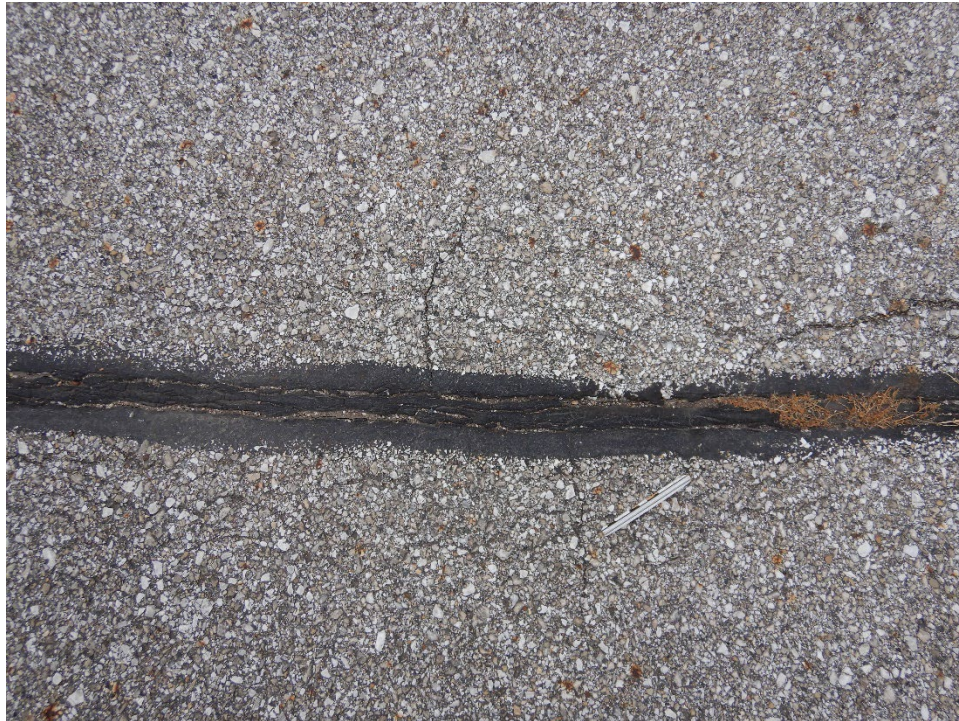
TH01FC-03. L&T Cracking (Sample Unit No. 03).

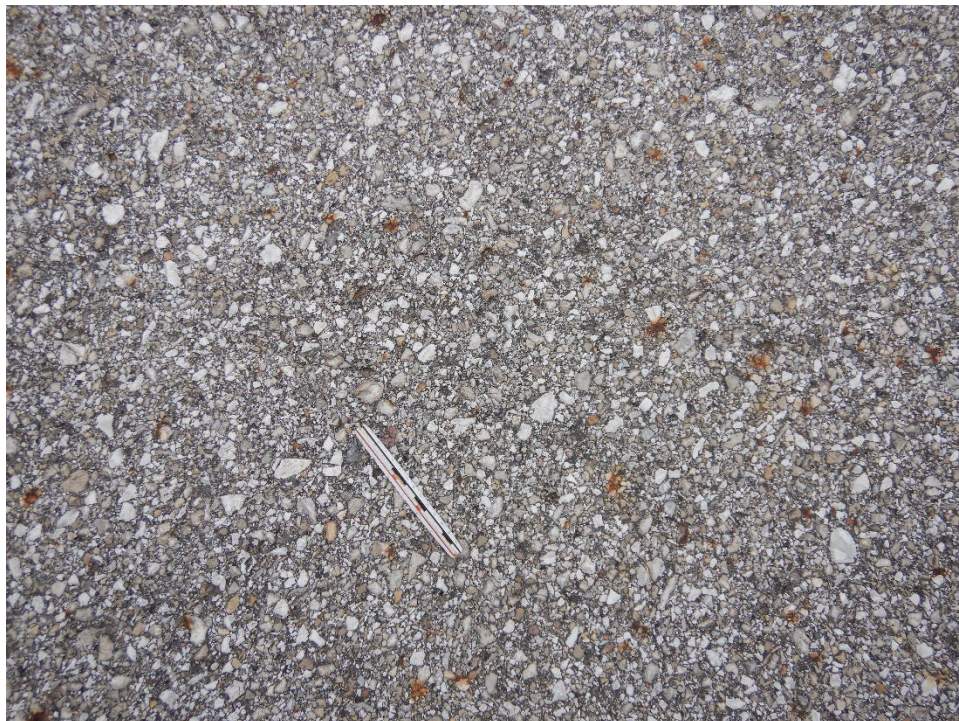
TH01FC-03. Weathering (Sample Unit No. 03).

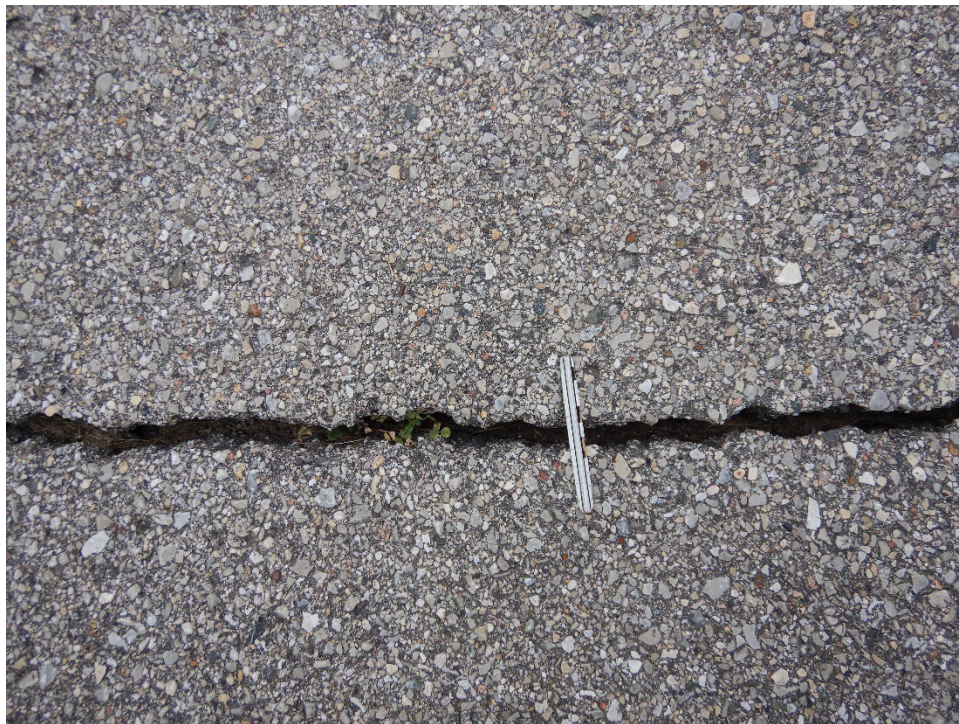
TH01FC-04. L&T Cracking (Sample Unit No. 01).
