Grinnell Regional Airport

PAVEMENT MANAGEMENT REPORT

JULY 2022

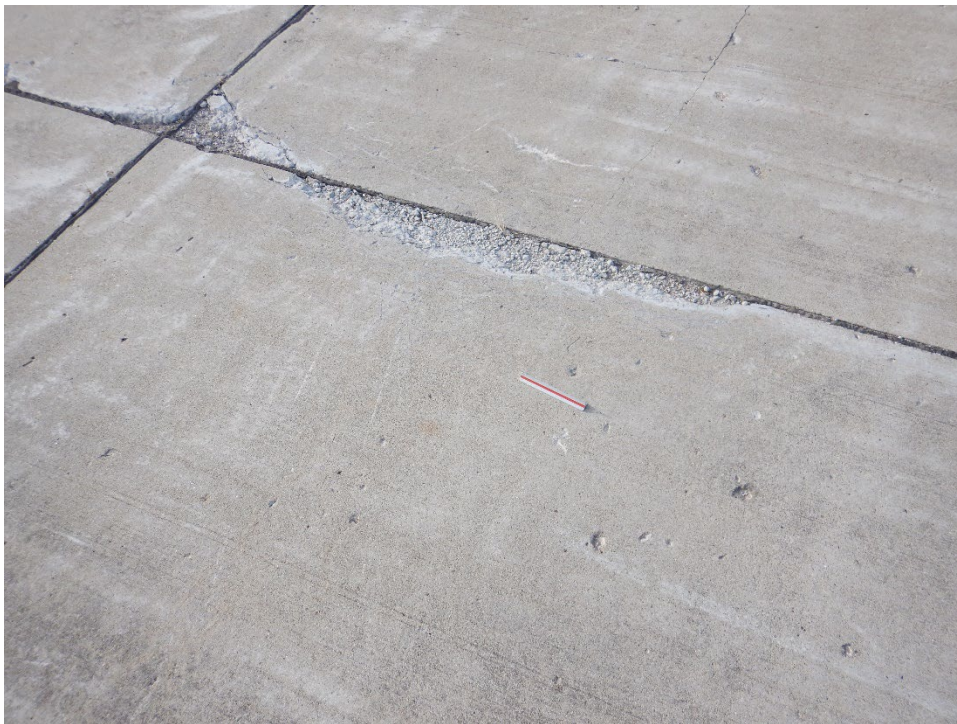
A01GL-01. ASR (Sample Unit No. 09).

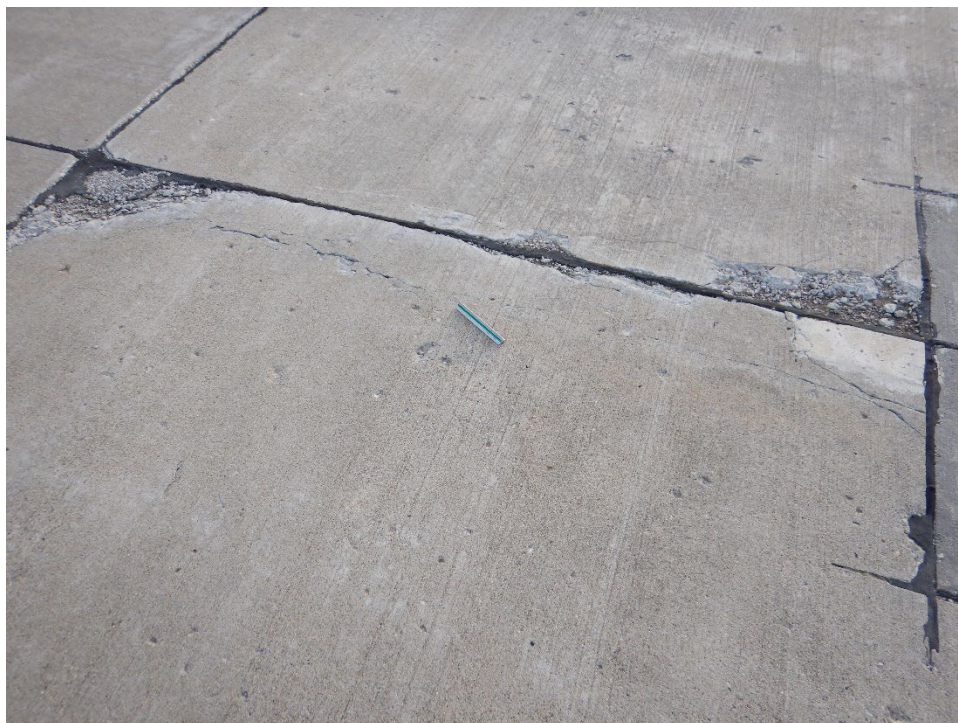
A01GL-02. ASR (Sample Unit No. 01).

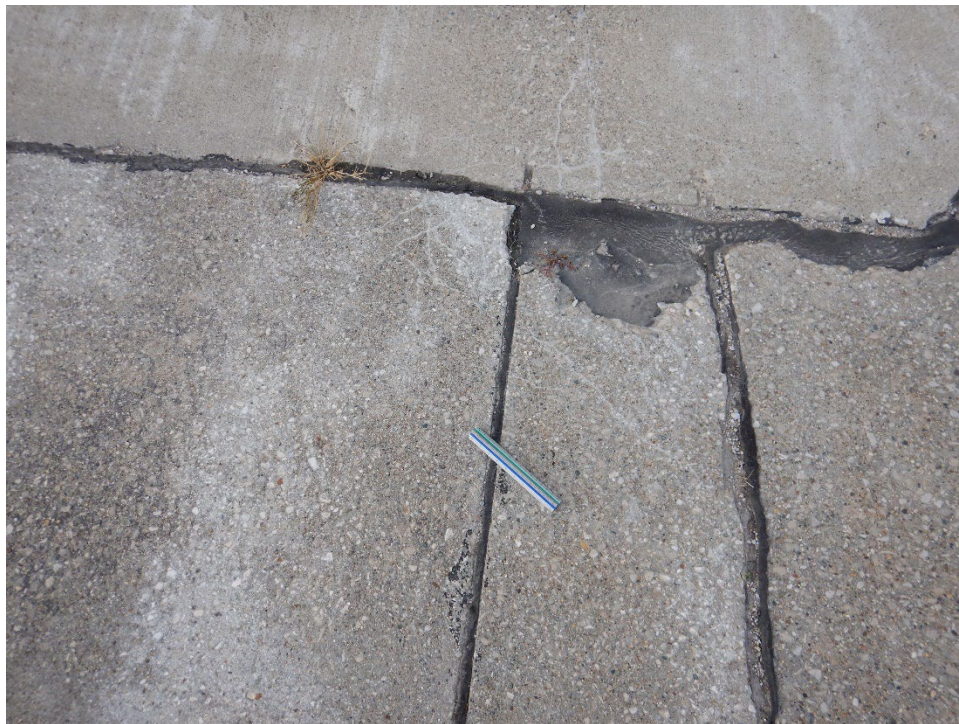
A01GL-03. ASR (Sample Unit No. 10).

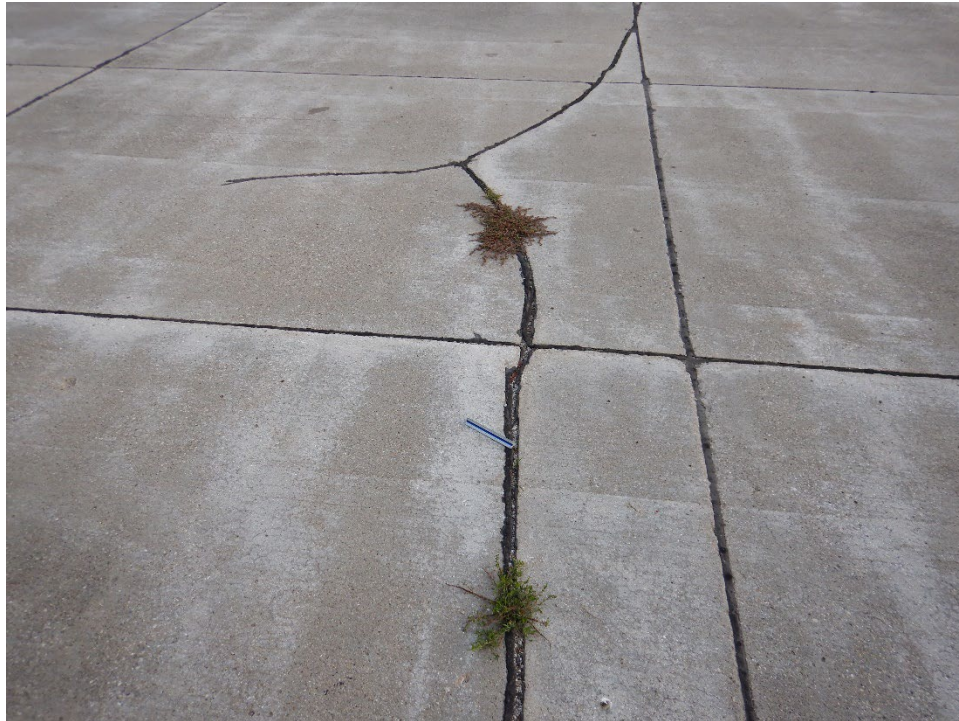
A01GL-03. LTD Cracking (Sample Unit No. 10).

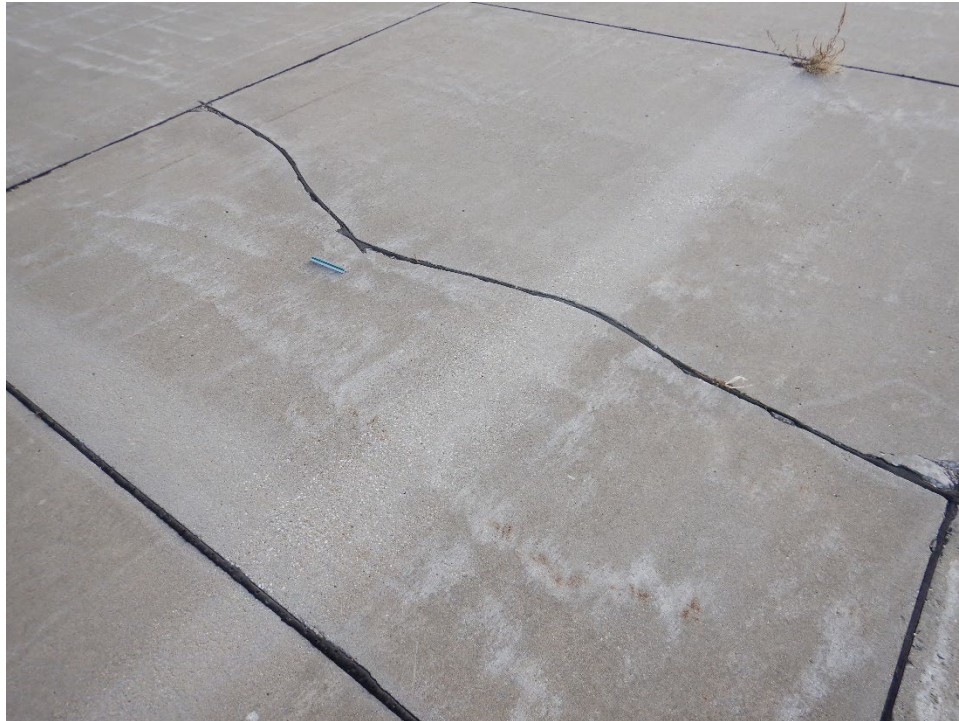
A01GL-04. LTD Cracking (Sample Unit No. 01).

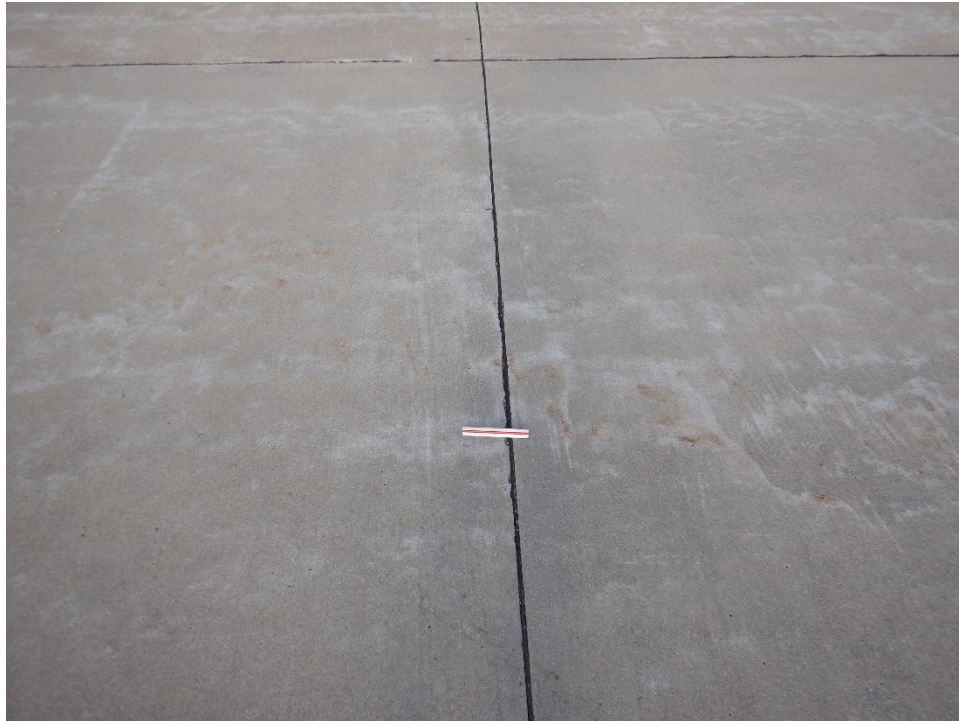
A01GL-05. Joint Seal Damage (Sample Unit No. 03).

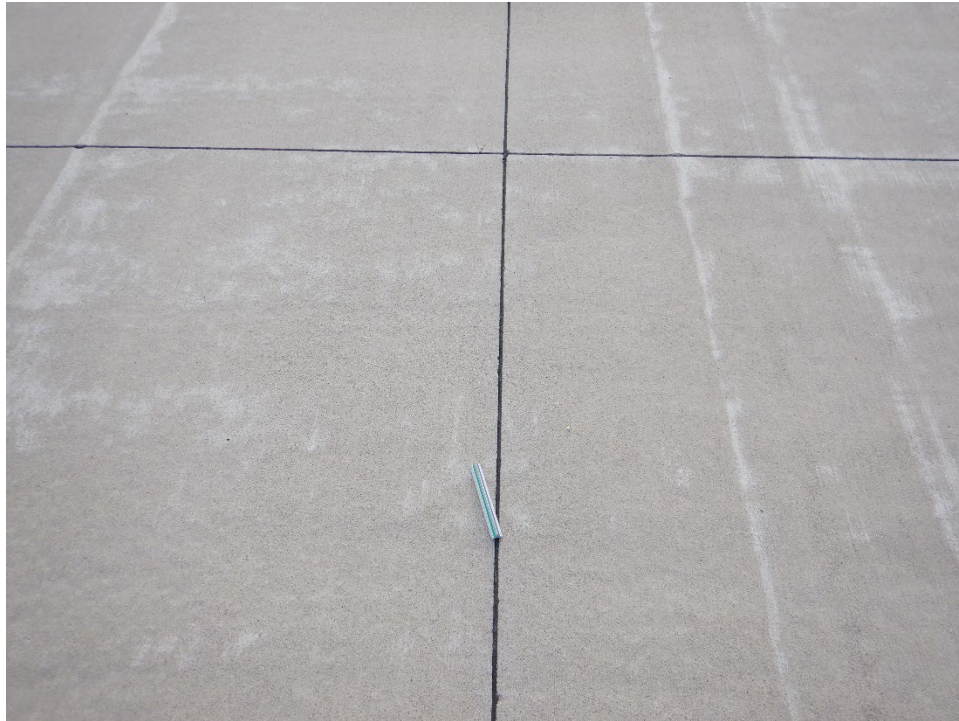
A01GL-06. Joint Seal Damage (Sample Unit No. 01).

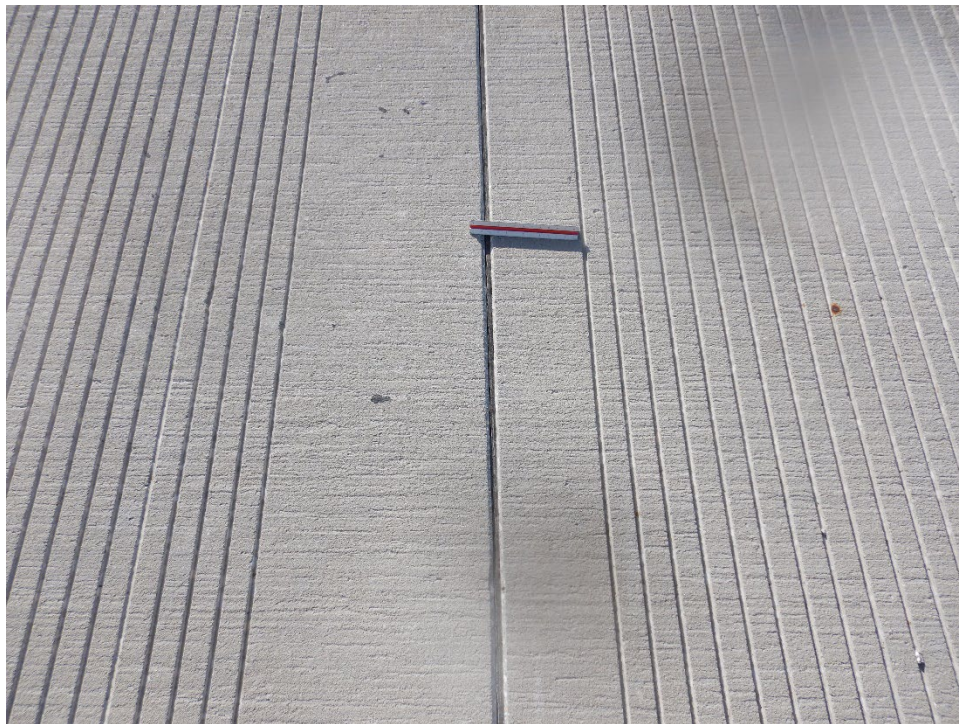
R13GL-01. Joint Seal Damage (Sample Unit No. 95).

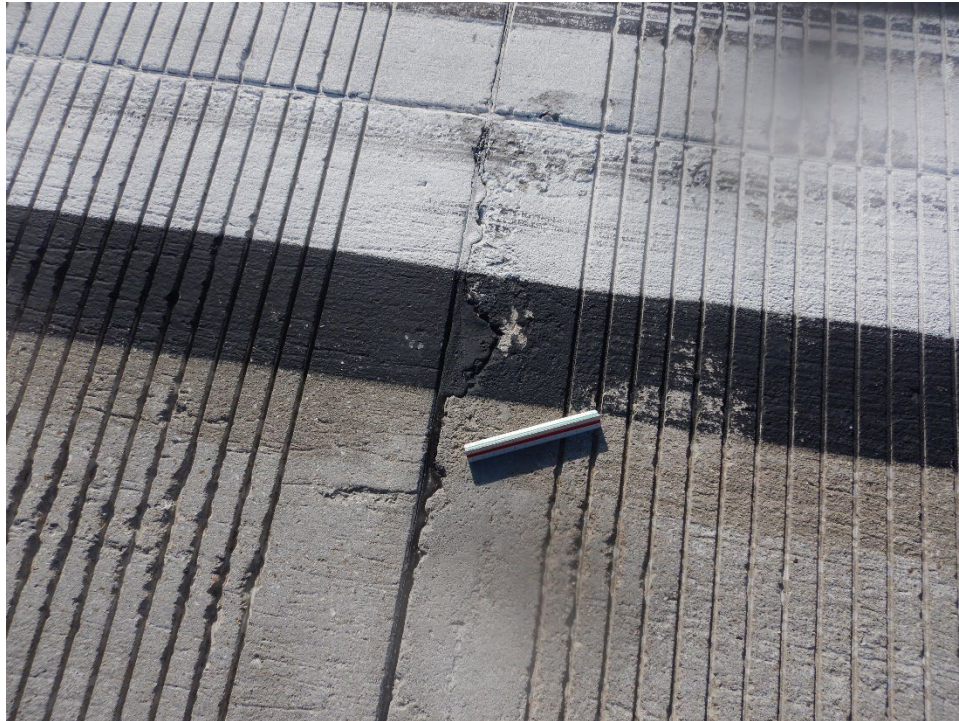
R13GL-01. Joint Spalling (Sample Unit No. 45).

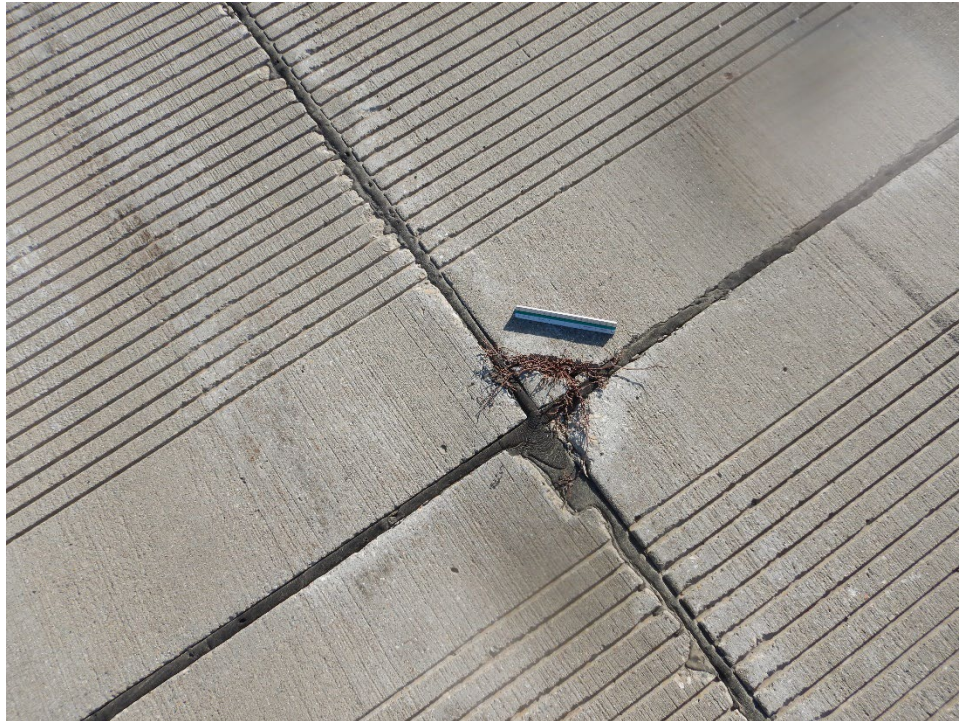
R13GL-02. Corner Spalling (Sample Unit No. 20).

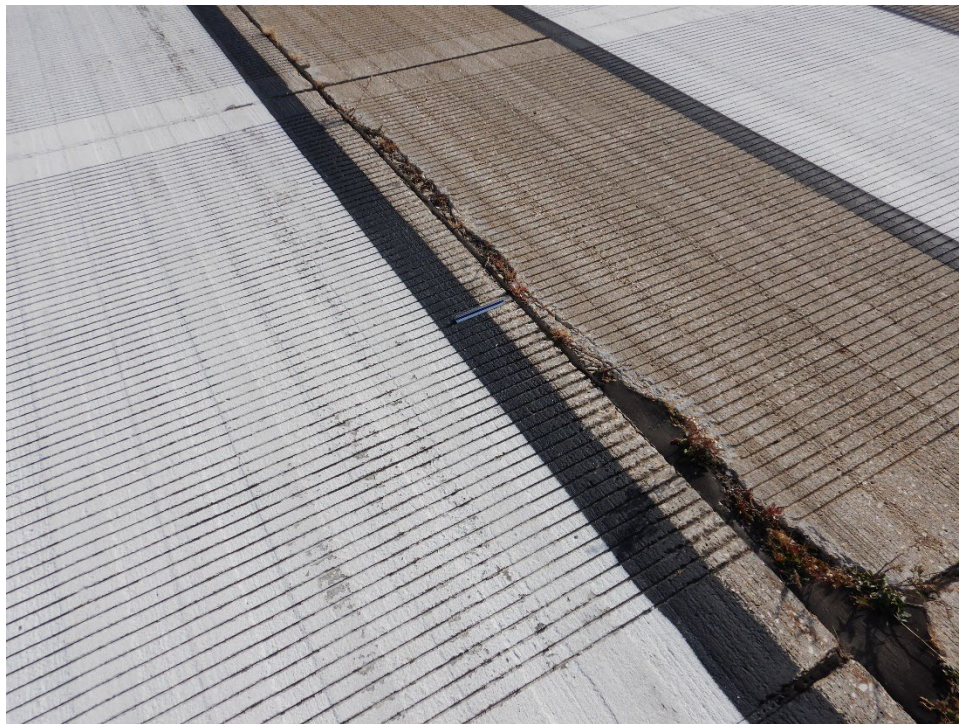
R13GL-02. Joint Spalling (Sample Unit No. 02).

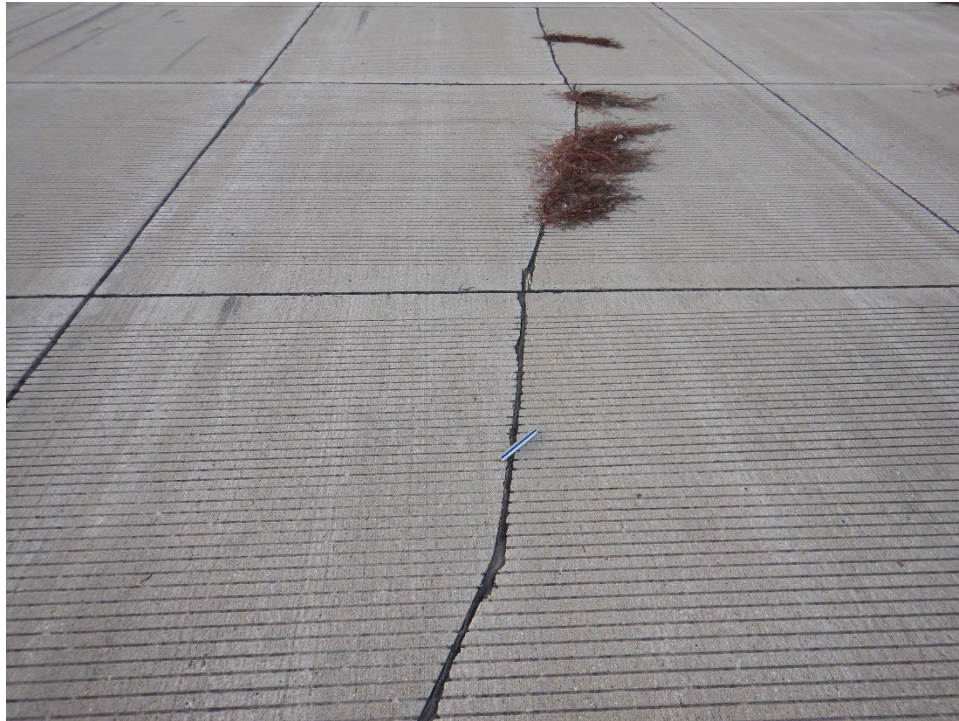
R13GL-02. LTD Cracking (Additional Sample Unit No. 16).

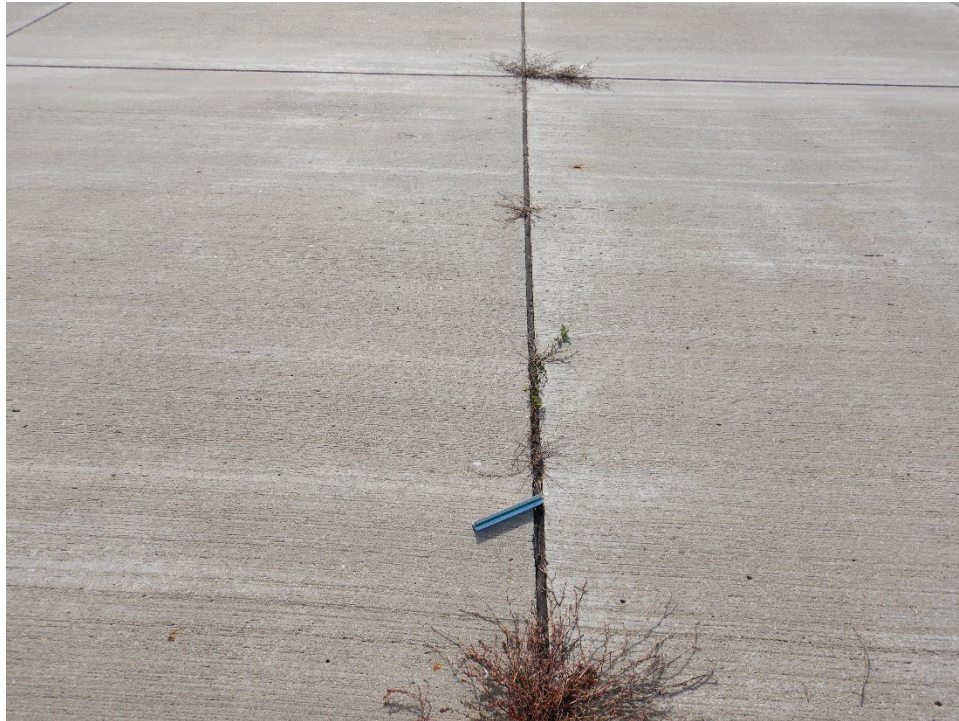
R13GL-03. Joint Seal Damage (Sample Unit No. 02).

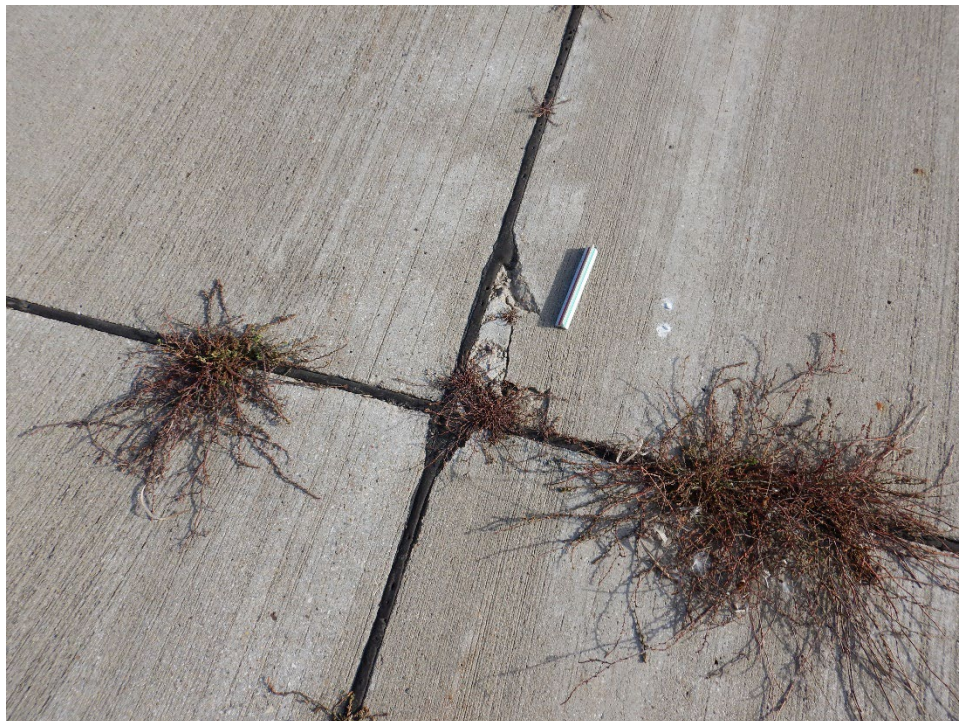
R13GL-03. Joint Spalling (Sample Unit No. 02).

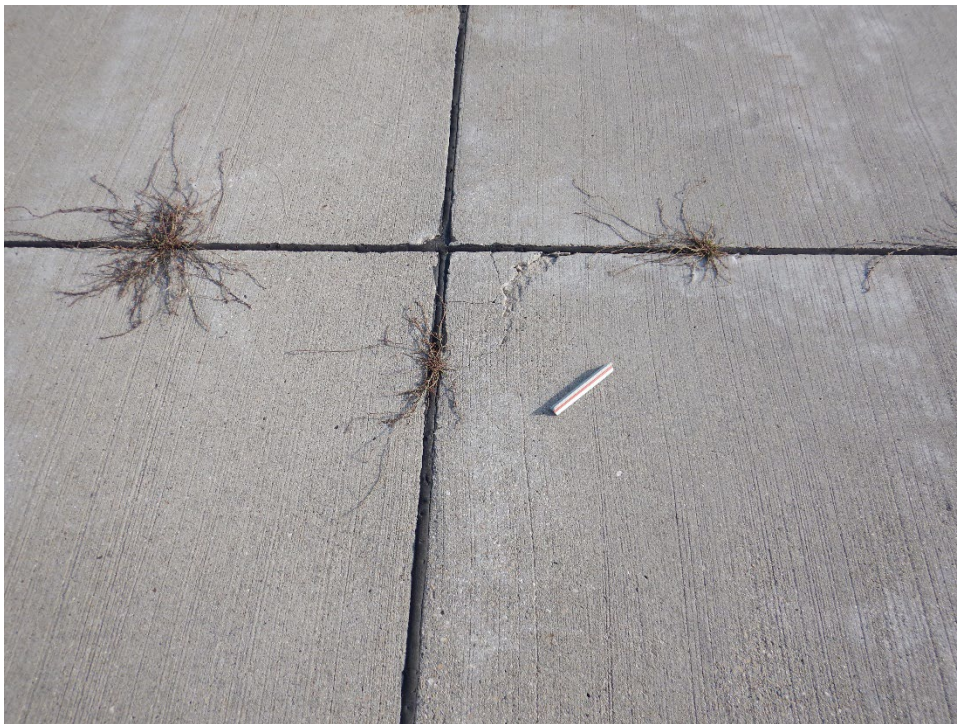
R13GL-04. Corner Spalling (Sample Unit No. 01).

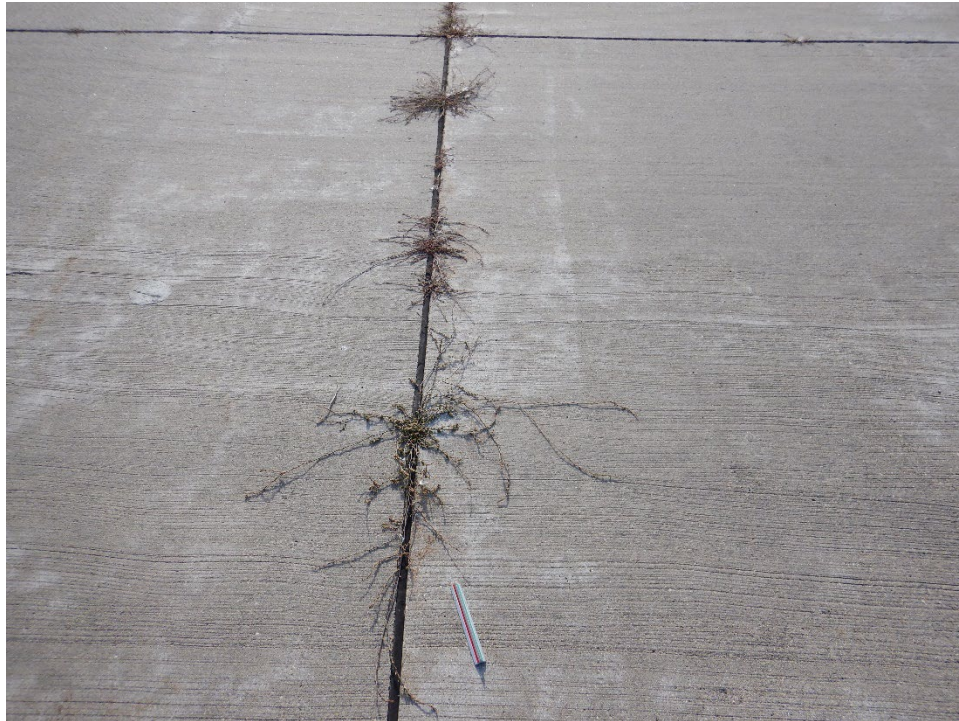
R13GL-04. Joint Seal Damage (Sample Unit No. 01).

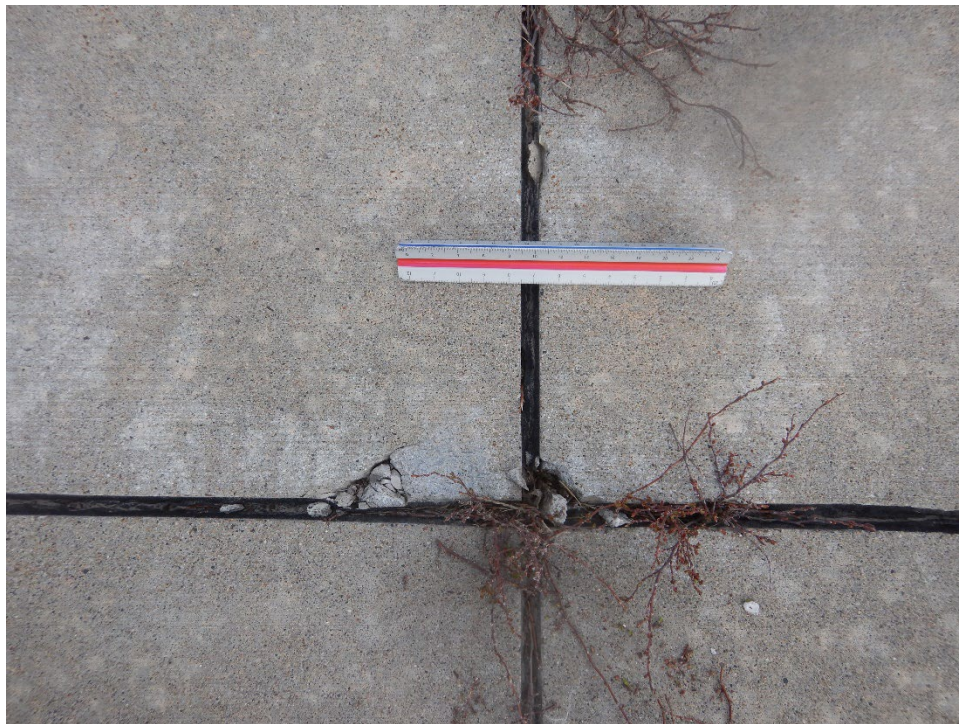
R13GL-05. ASR (Sample Unit No. 01).

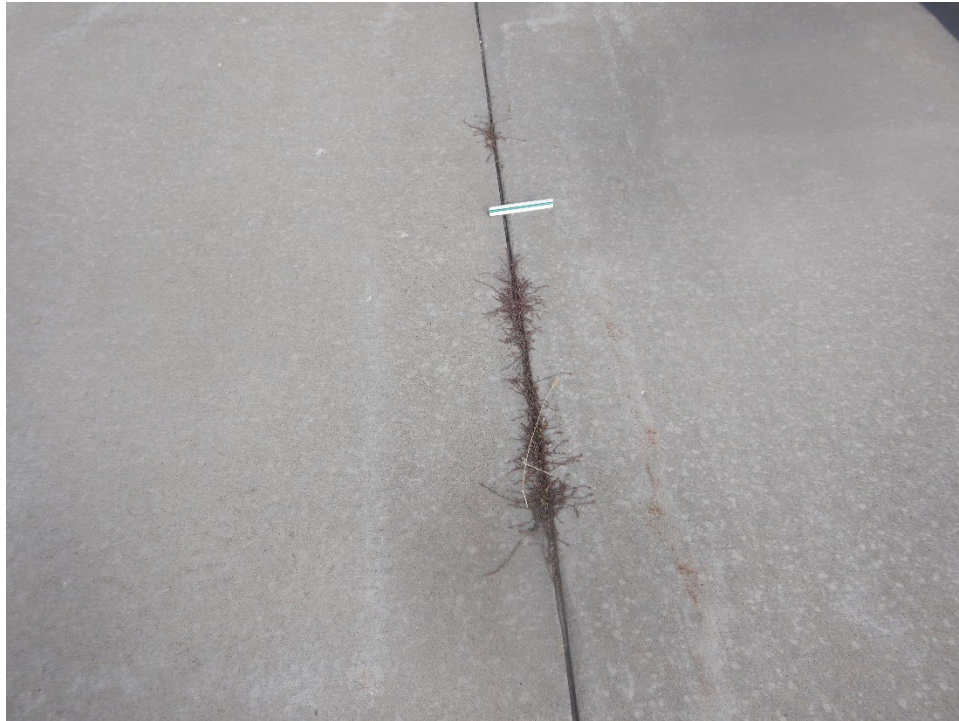
R13GL-05. Joint Seal Damage (Sample Unit No. 05).

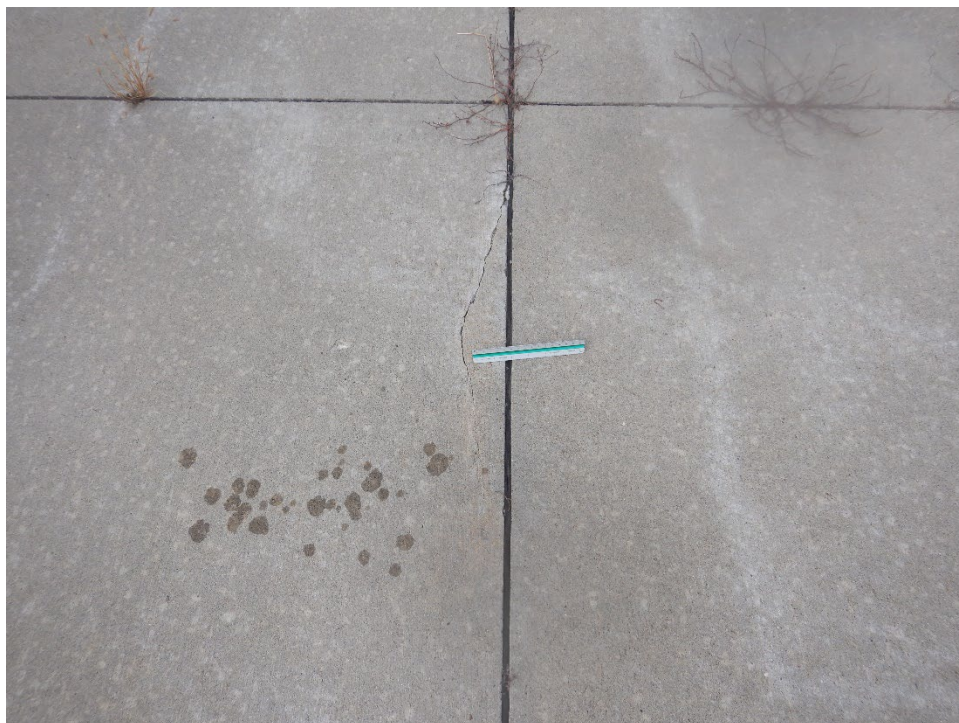
R13GL-05. Joint Spalling (Sample Unit No. 03).

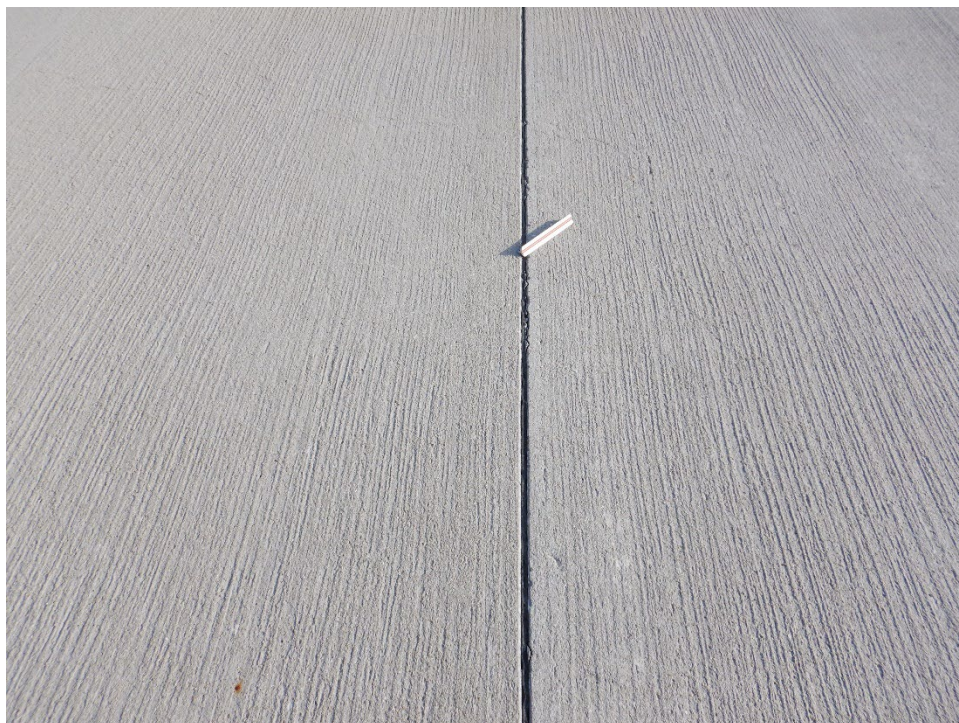
T01GL-01. Joint Seal Damage (Sample Unit No. 02).

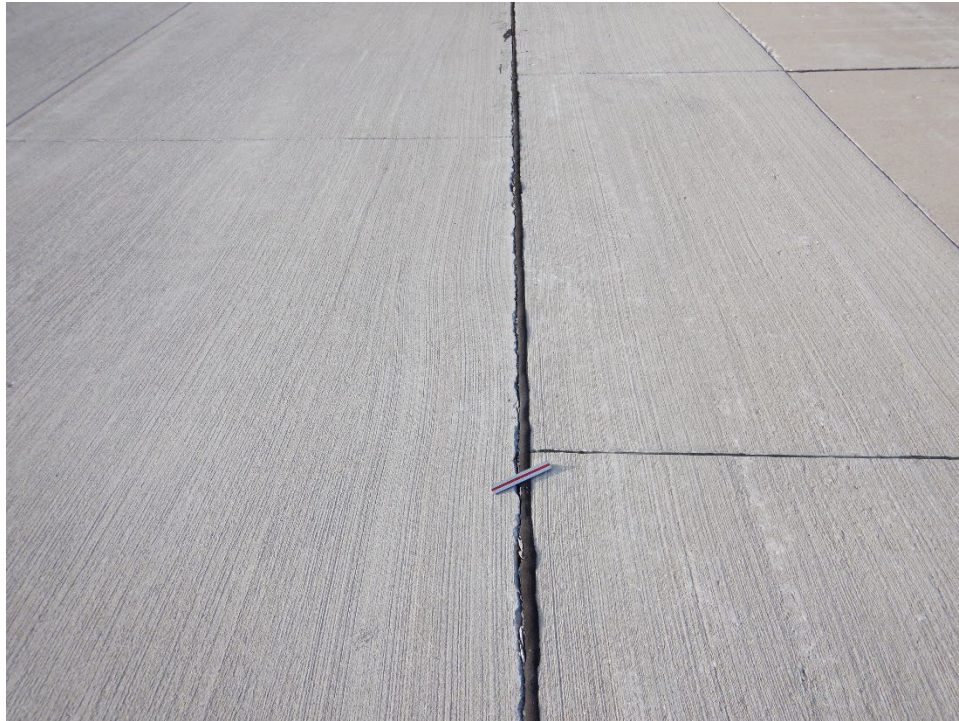
T01GL-01. Joint Seal Damage (Sample Unit No. 20).

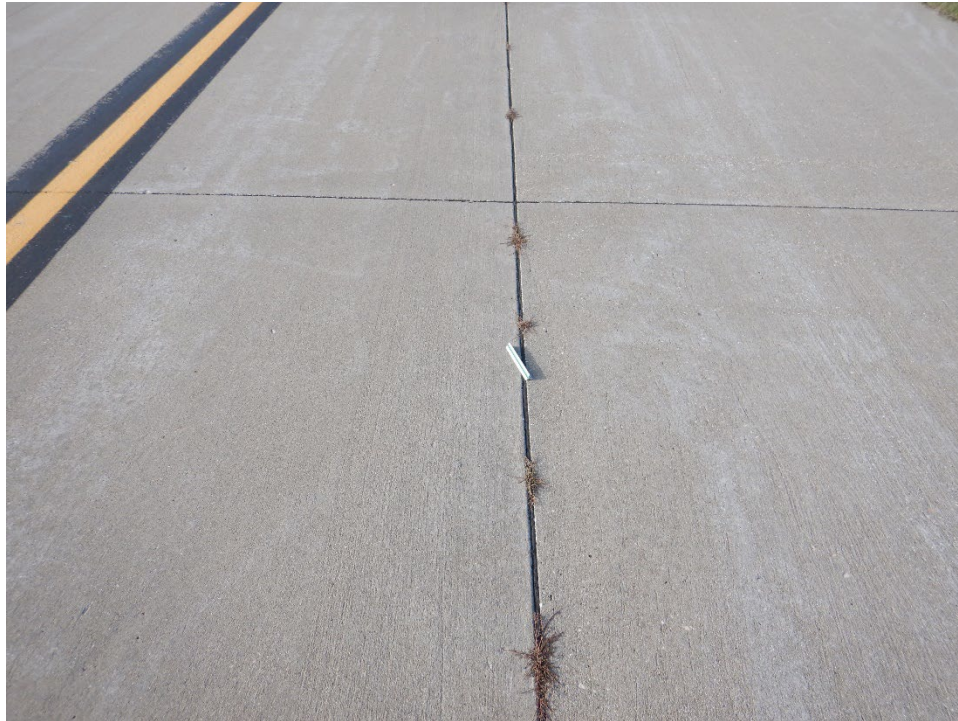
T02GL-01. Joint Seal Damage (Sample Unit No. 01).

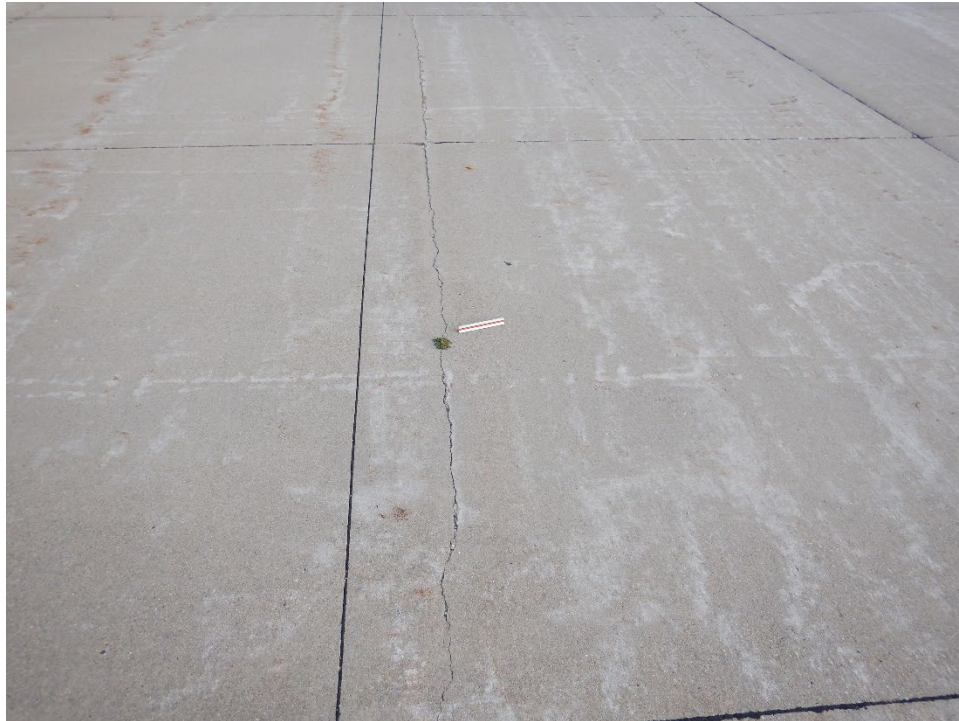
TH01GL-01. LTD Cracking (Sample Unit No. 05).

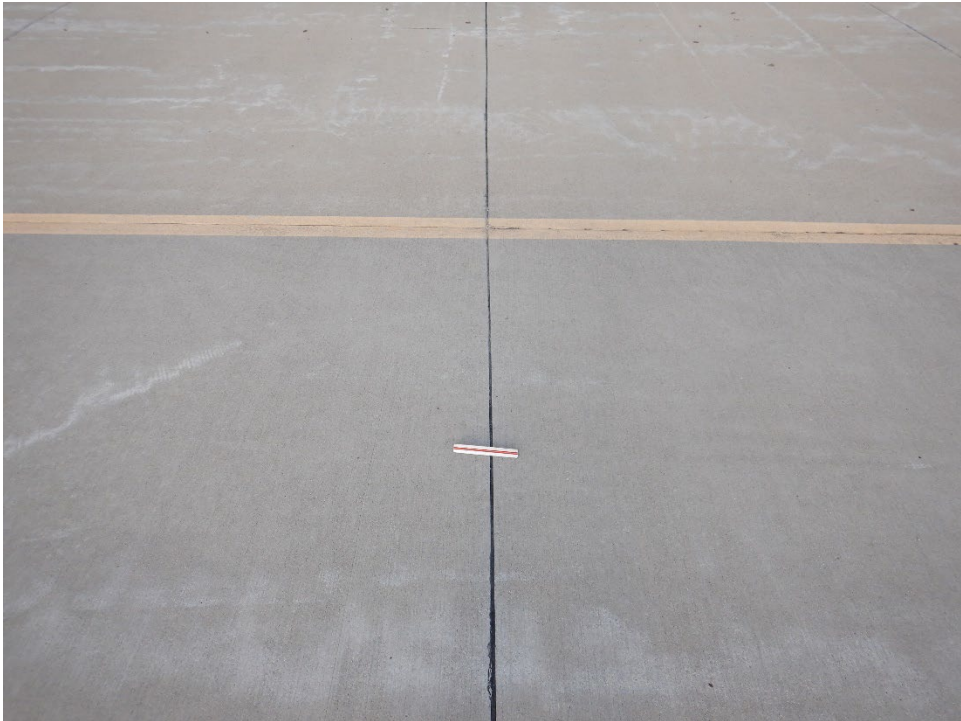
TH01GL-02. Joint Seal Damage (Sample Unit No. 01).
