Ida Grove Municipal Airport

PAVEMENT MANAGEMENT REPORT

AUGUST 2019

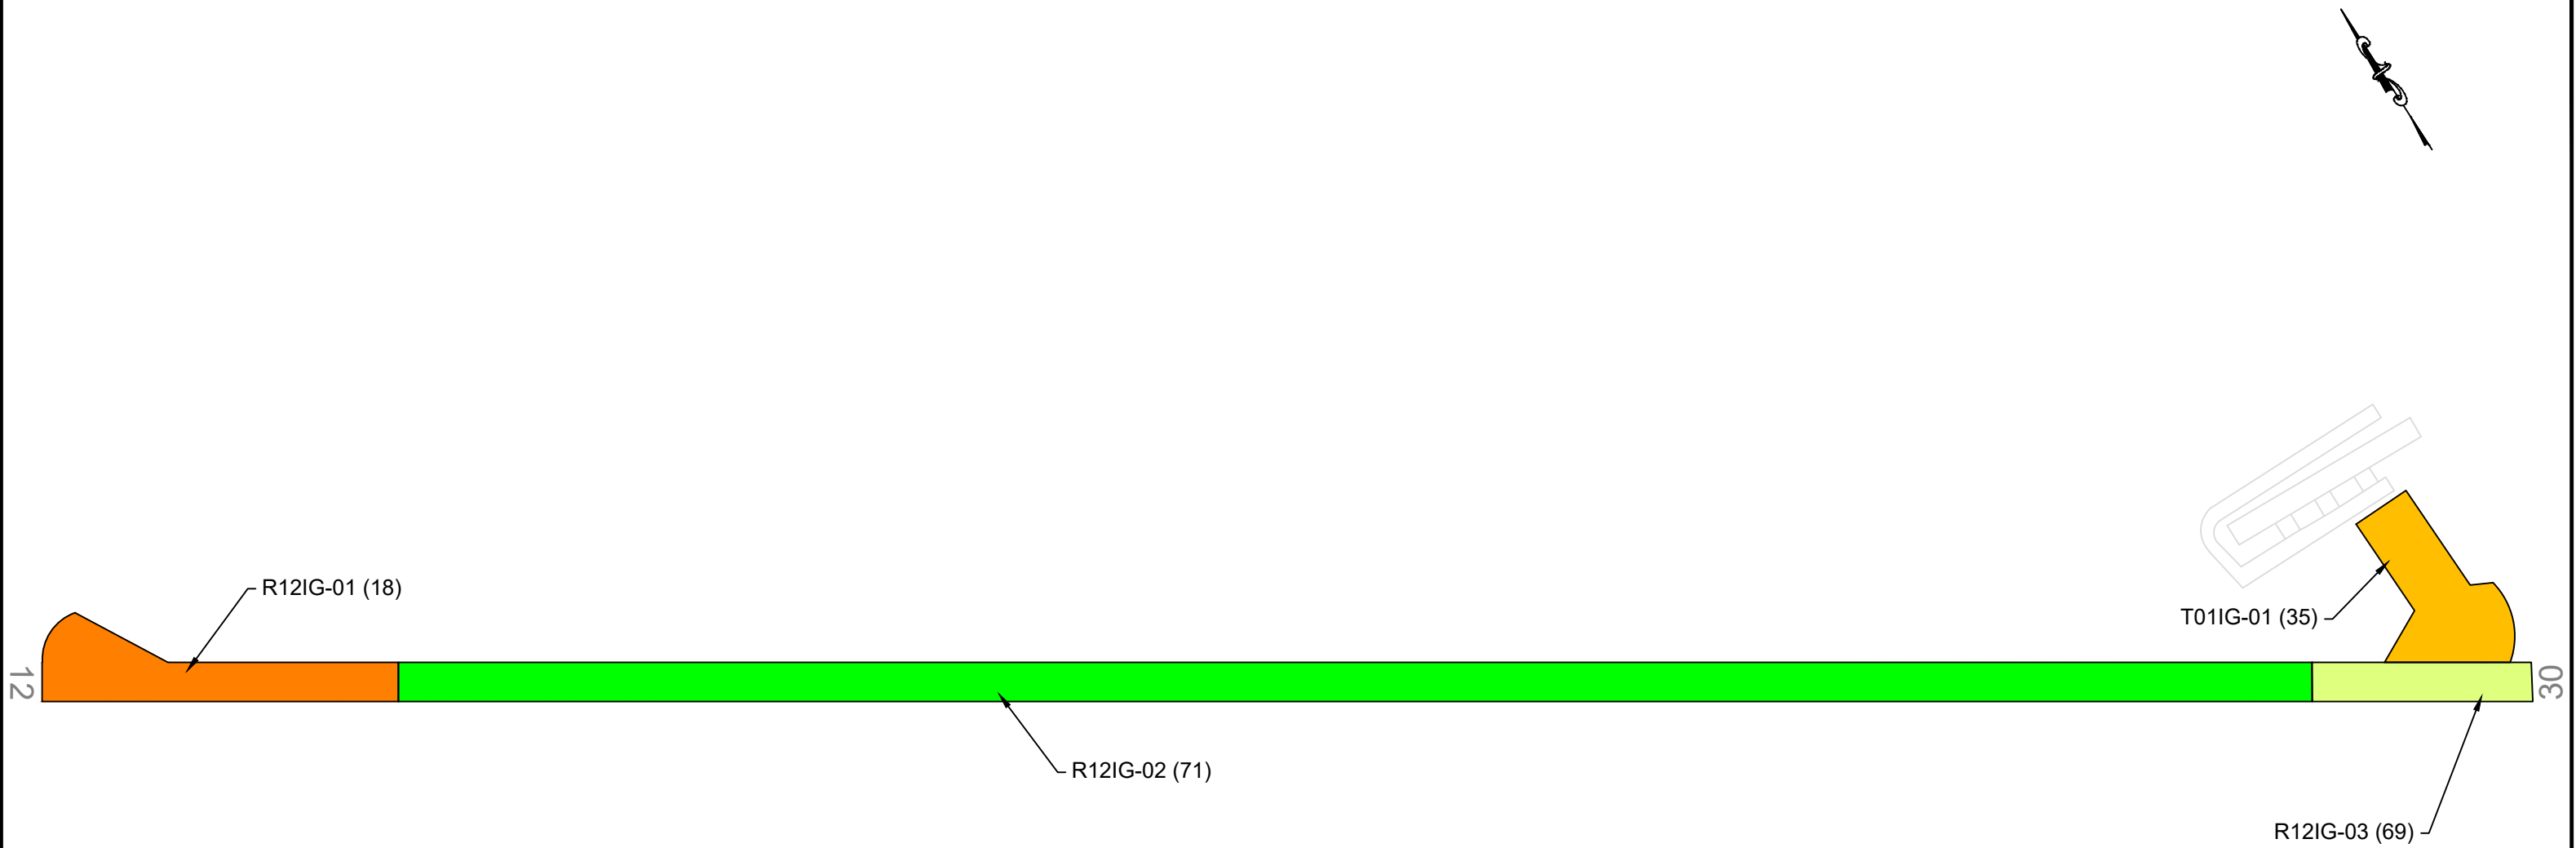
FIGURE 8. PCI MAP.

The pavements at Ida Grove Municipal Airport were inspected on November 18, 2018. The 2018 area-weighted condition of Ida Grove Municipal Airport is 58, with conditions ranging from 18 to 71 (on a scale of 0 [failed] to 100 [excellent]). During the previous pavement inspection in 2010, the area-weighted PCI of the airport was 86.

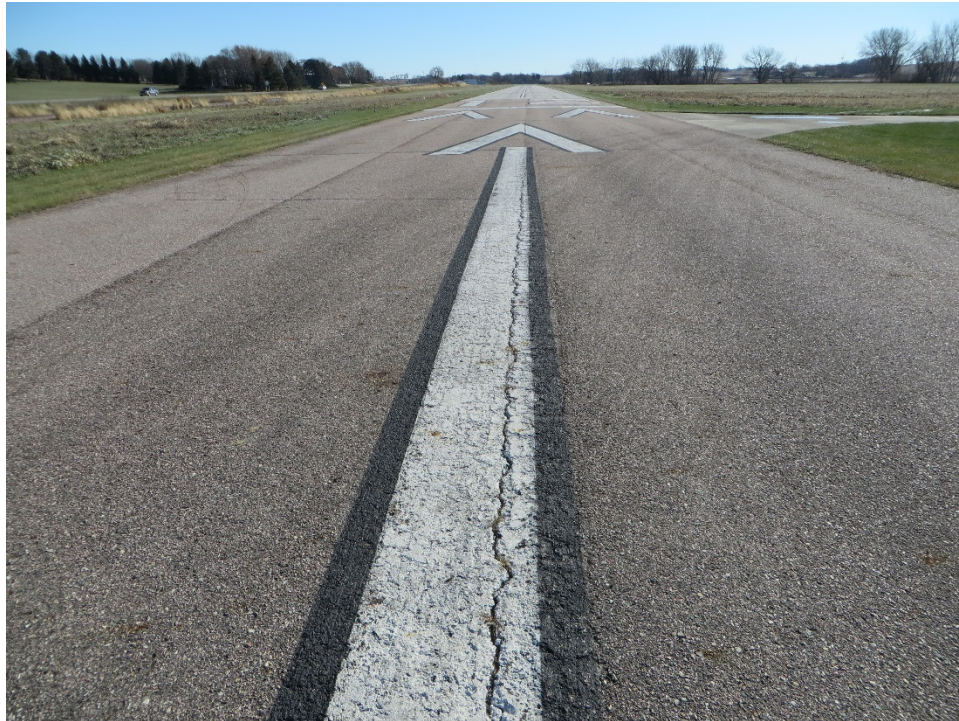
Runway 12/30 consisted of three sections. Section 01, located at the Runway 12 approach, was in poor condition with all severities of alligator cracking and longitudinal and transverse (L&T) cracking, medium- and high-severity raveling, low-severity swelling, and high-severity weathering recorded. The low-severity L&T cracking was unsealed, the medium-severity L&T cracking was due to either unsealed crack widths greater than 1/4 in or the development of secondary cracking, and the alligator cracking was noted in areas where the development of pattern cracking was greater than 1 ft wide. Section 02, the majority of the runway, was observed with low-severity L&T cracking in both the sealed and unsealed conditions, medium-severity L&T cracking due to either the development of secondary cracking or unsatisfactory crack sealant, low- and medium-severity patching and weathering, and high-severity raveling where mechanical damage was noted. Section 03, located at the Runway 30 approach, was recorded with low-severity L&T cracking in either the sealed or unsealed condition, medium-severity L&T cracking where crack sealant was no longer performing satisfactorily, low-severity patching, and medium-severity weathering.

R12IG-01. Overview.

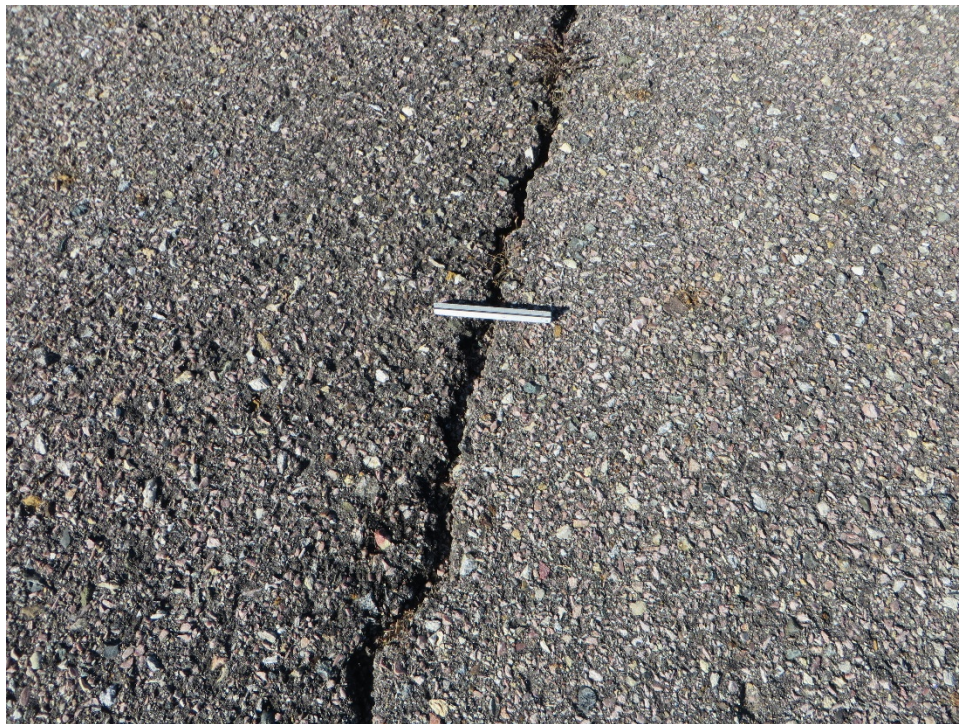
R12IG-01. L&T Cracking (Sample Unit No. 03).

Sample Number: 03 Type: R Area: 4,000.00SqFt PCI = 24
Sample Comments:
48 LONGITUDINAL/TRANSVERSE CRACKING M 215.00 Ft Comments:with 2nd
41 ALLIGATOR CRACKING L 30.00 SqFt Comments:1ft
41 ALLIGATOR CRACKING M 15.00 SqFt Comments:1ft
56 SWELLING L 15.00 SqFt Comments:
48 LONGITUDINAL/TRANSVERSE CRACKING L 13.00 Ft Comments:u
52 RAVELING M 250.00 SqFt Comments:
57 WEATHERING H 3,750.00 SqFt Comments:

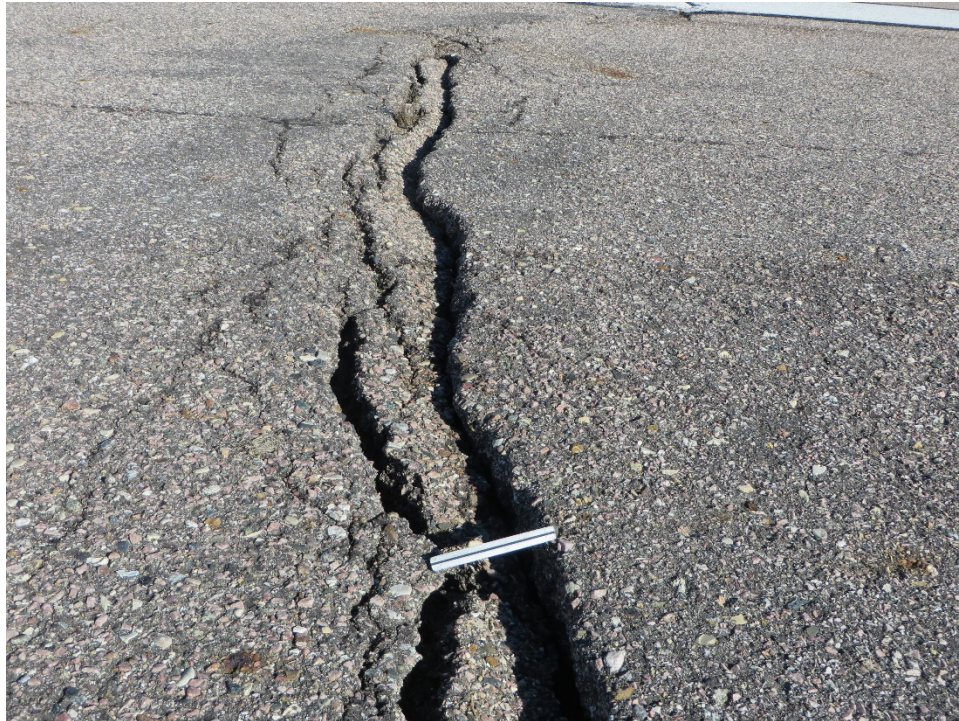
R12IG-01. L&T Cracking (Sample Unit No. 06).

Sample Number: 06 Type: R Area: 5,000.00SqFt PCI = 13
Sample Comments:
41 ALLIGATOR CRACKING M 150.00 SqFt Comments:1ft
41 ALLIGATOR CRACKING H 25.00 SqFt Comments:1ft
48 LONGITUDINAL/TRANSVERSE CRACKING L 50.00 Ft Comments:u
48 LONGITUDINAL/TRANSVERSE CRACKING M 305.00 Ft Comments:width 2nd
48 LONGITUDINAL/TRANSVERSE CRACKING H 25.00 Ft Comments:
52 RAVELING M 180.00 SqFt Comments:
52 RAVELING H 250.00 SqFt Comments:
57 WEATHERING H 4,570.00 SqFt Comments:

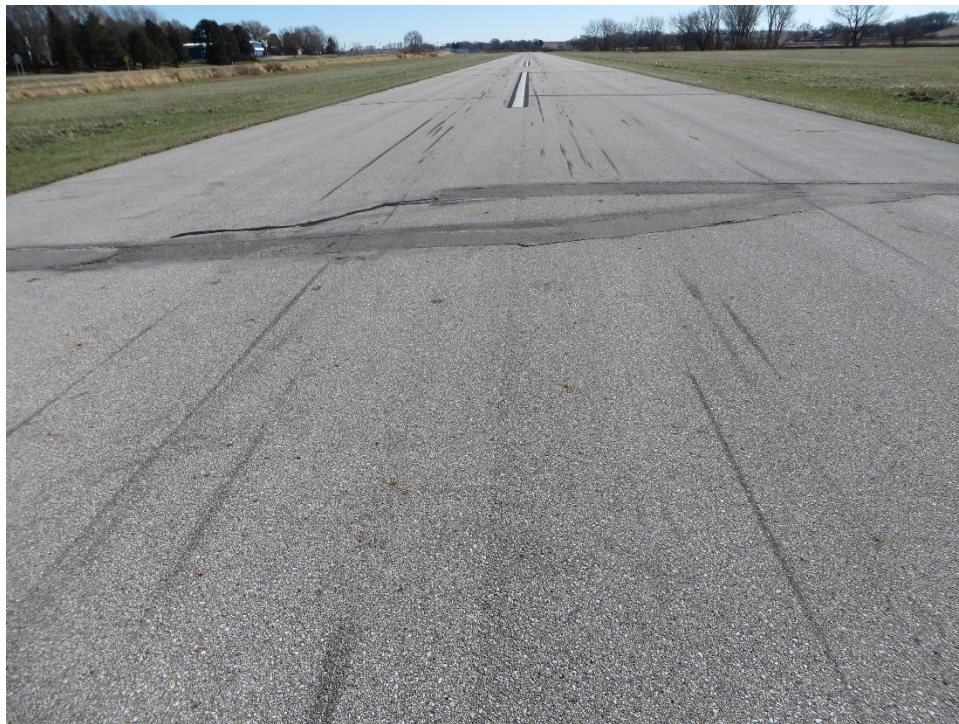
R12IG-02. Overview.

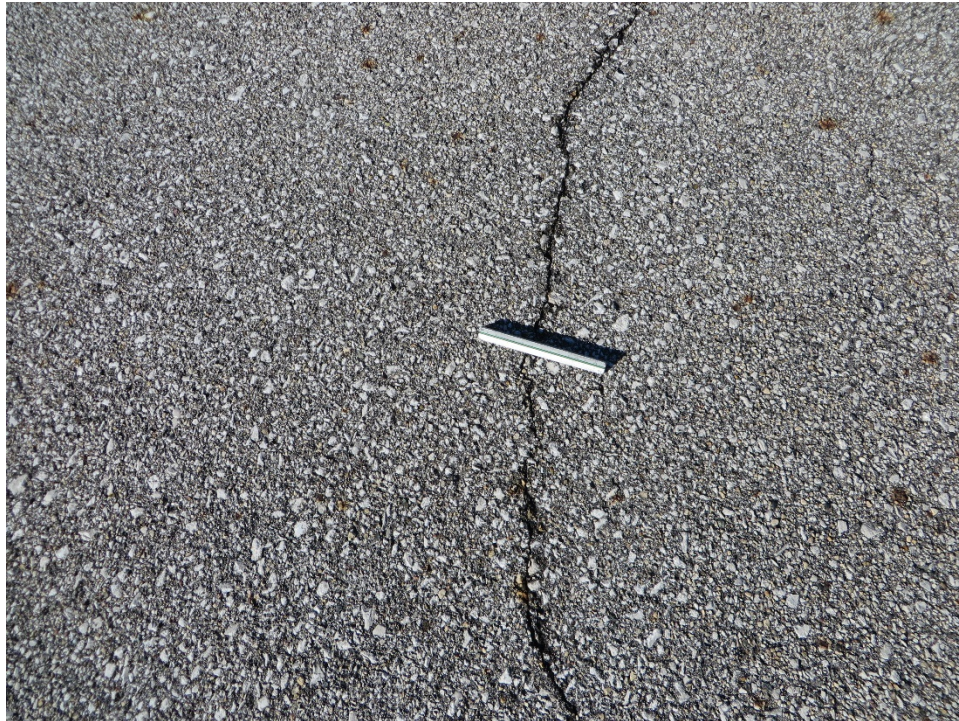
R12IG-02. L&T Cracking (Sample Unit No. 01).

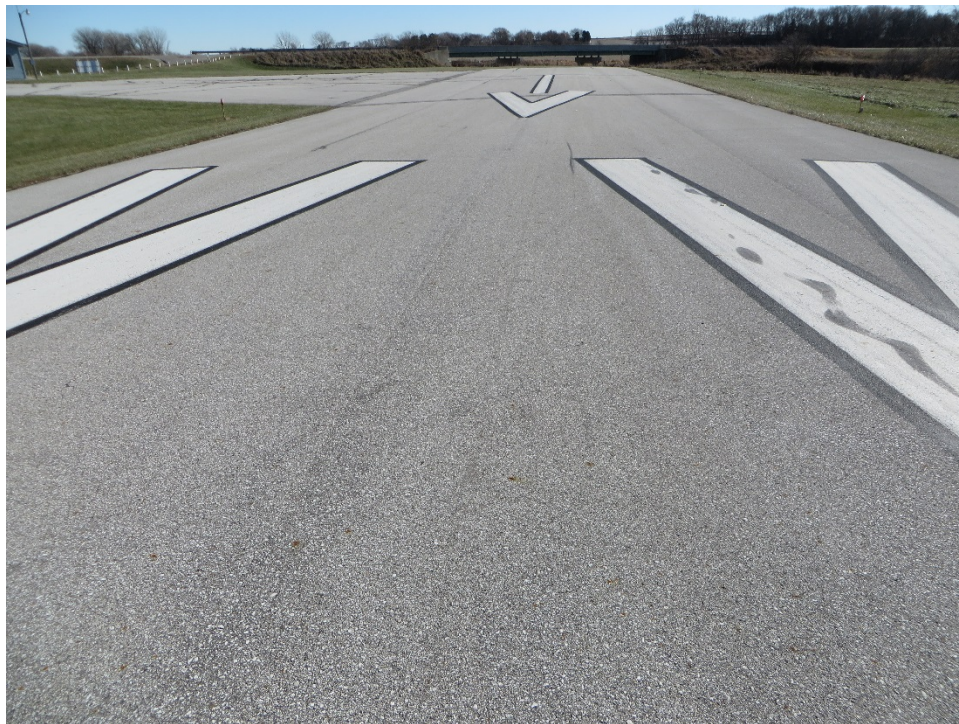
R12IG-03. Overview.

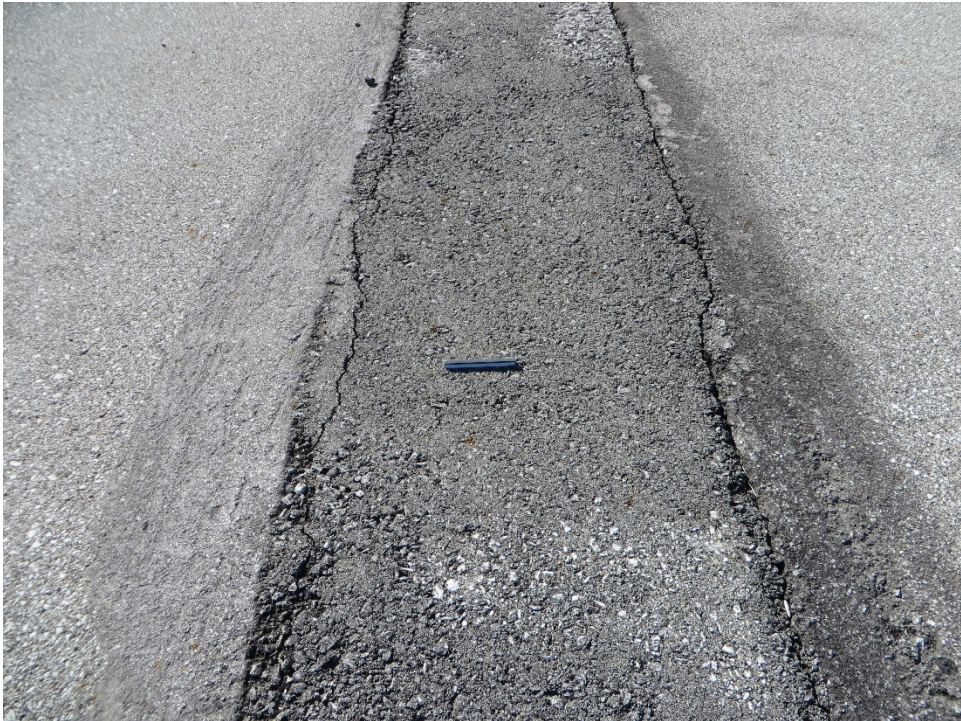
R12IG-03. Patching (Sample Unit No. 01).

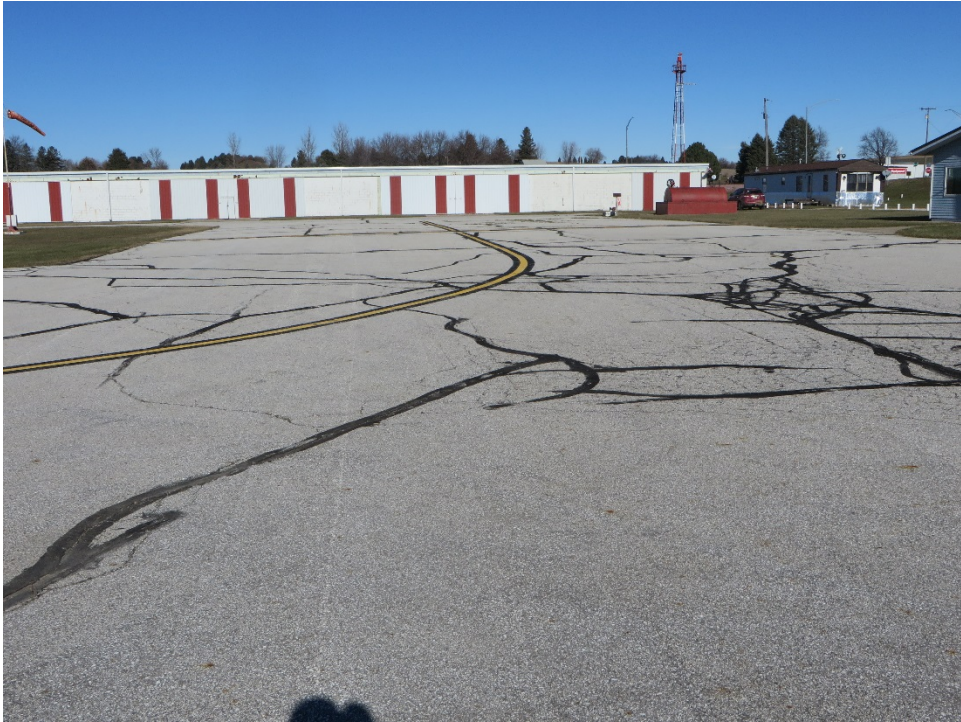
Taxiway 01, located adjacent to the Runway 30 approach, was defined by one section in poor condition. Low- and medium-severity alligator cracking, all severities of L&T cracking, low-severity patching and rutting, and medium-severity weathering were observed. The low-severity L&T cracking was unsealed, the medium-severity L&T cracking was noted where either the crack sealant was no longer performing satisfactorily or where unsealed crack widths exceeded 1/4 in, and the high-severity L&T cracking was due to crack widths greater than 3 in.

T01IG-01. Overview.

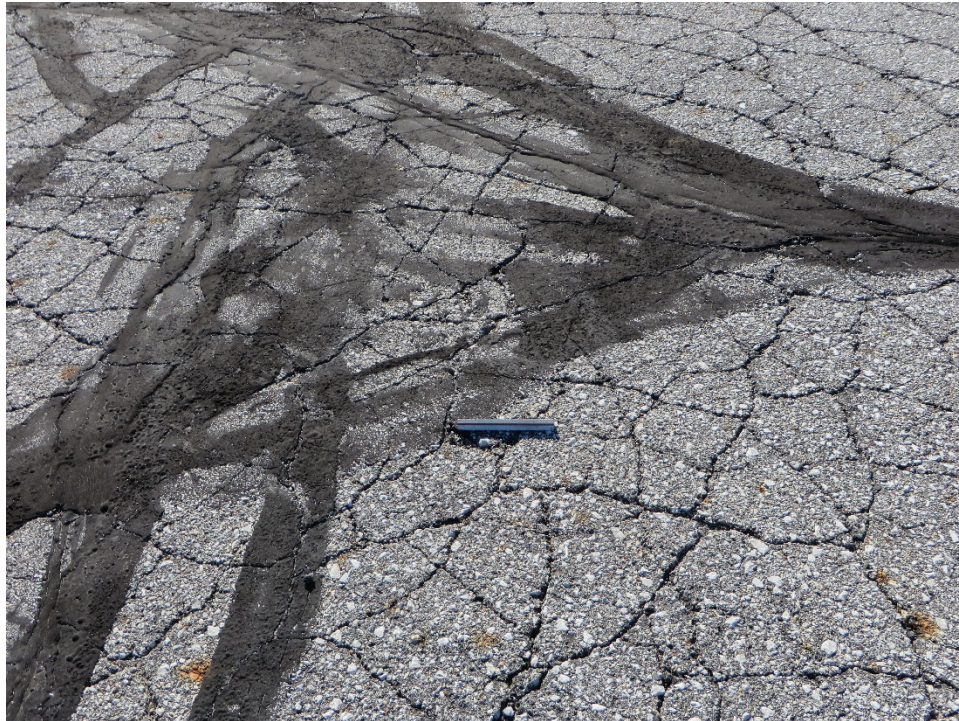
T01IG-01. Alligator Cracking (Sample Unit No. 03).

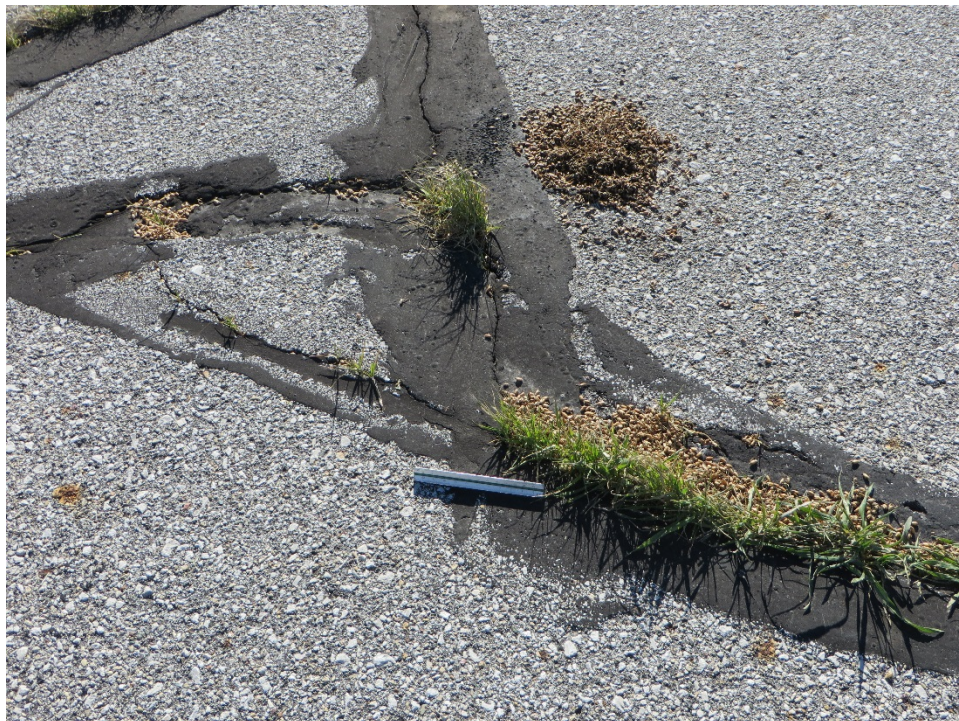
T01IG-01. L&T Cracking (Sample Unit No. 03).
