### Iowa City Municipal Airport

**PAVEMENT MANAGEMENT REPORT**

**JULY 2022**

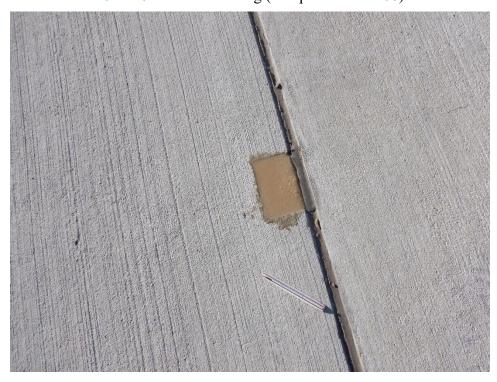
Apron 01 was defined by one section in excellent condition, with only low-severity small patching recorded.

A01IC-01. Small Patching (Sample Unit No. 06).

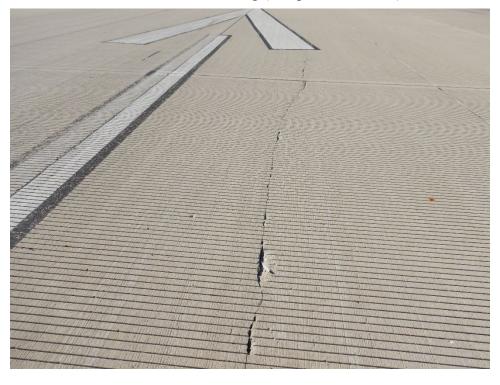
Runway 07/25 was defined by three sections. Section 01 contained low-severity faulting; low-and medium-severity joint seal damage and small patching; and medium-severity longitudinal, transverse, and diagonal (LTD) cracking. Section 02 was in excellent condition with areas of low- and medium-severity joint seal damage and low-severity small patching observed during the inspection. Section 03 was also in excellent condition with low- and medium-severity joint seal damage and low-severity LTD cracking noted at the time of inspection.

R07IC-01. LTD Cracking (Sample Unit No. 53).

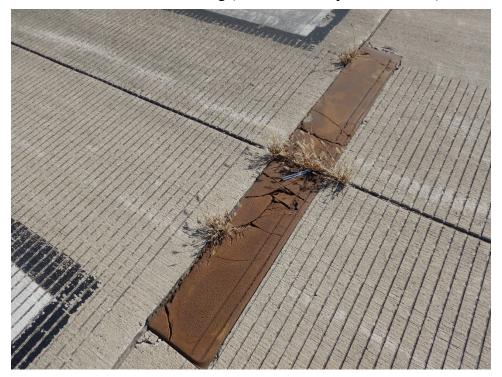
R07IC-01. Small Patching (Additional Sample Unit No. 36).

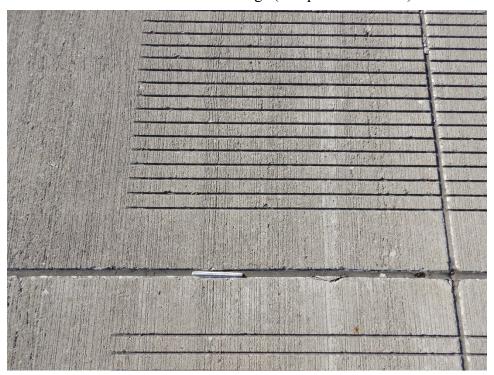
R07IC-02. Joint Seal Damage (Sample Unit No. 48).

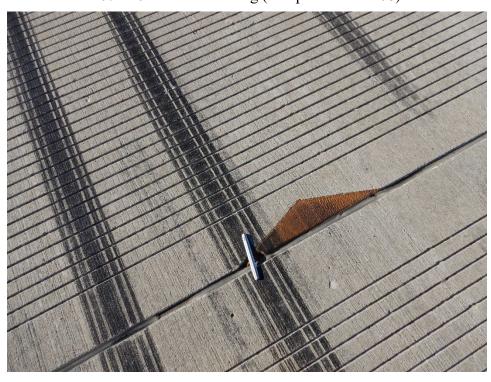
R07IC-02. Small Patching (Sample Unit No. 08).

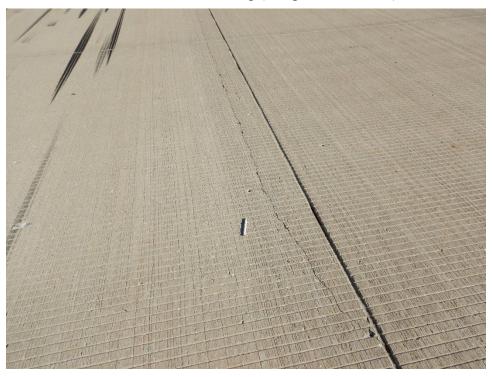
R07IC-03. LTD Cracking (Sample Unit No. 16).

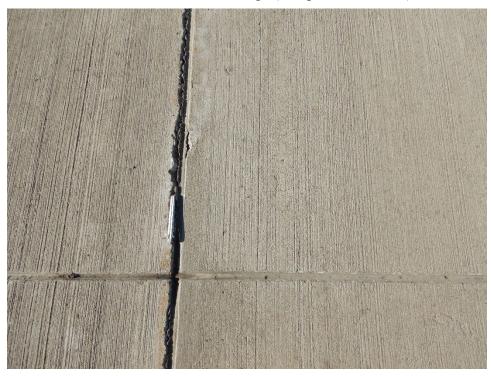
Runway 12/30 consisted of one section in excellent condition. Low- and medium-severity joint seal damage, medium-severity joint spalling, and shrinkage cracking were recorded in Section 01.

R12IC-01. Joint Seal Damage (Sample Unit No. 11).

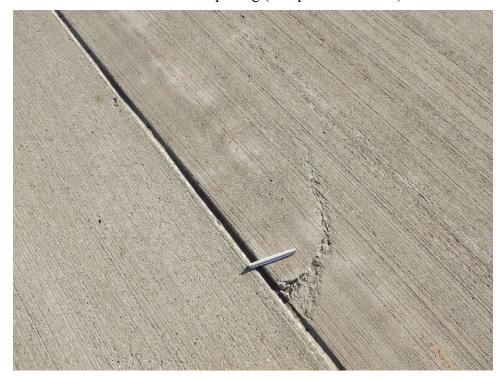
R12IC-01. Joint Spalling (Sample Unit No. 35).

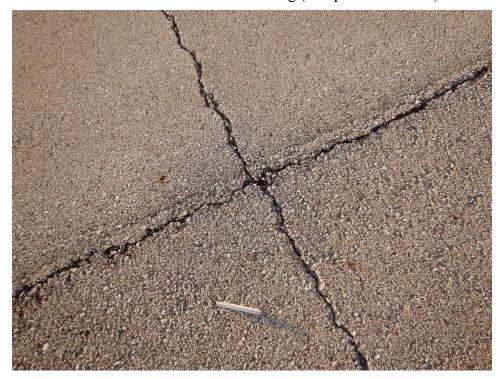
Taxiway 01 connected Runway 07/25 and Runway 12/30 to the apron area and contained five sections. Section 01 had areas of low- and medium-severity joint reflection cracking and low-severity longitudinal and transverse (L&T) cracking, raveling, and weathering. All cracking was unsealed. Section 02 was in excellent condition with no distress identified at the time of inspection. Low- and medium-severity joint reflection cracking and weathering and low-severity L&T cracking and patching were recorded in Section 04. The joint reflection cracking and the L&T cracking were unsealed. Section 05 was in excellent condition and contained only low-severity joint seal damage. Areas of medium-severity alkali-silica reaction (ASR), low- and high-severity corner spalling, and low-severity joint seal damage were observed in Section 06. The suspected ASR was recorded in accordance with ASTM D5340-20. It should be noted that laboratory testing in the form of petrographic analysis is the only definitive way to validate the presence of ASR; however, the formation of a precipitate is evidence of a reaction consistent with this type of materials-related distress.

T01IC-01. Joint Reflection Cracking (Sample Unit No. 06).

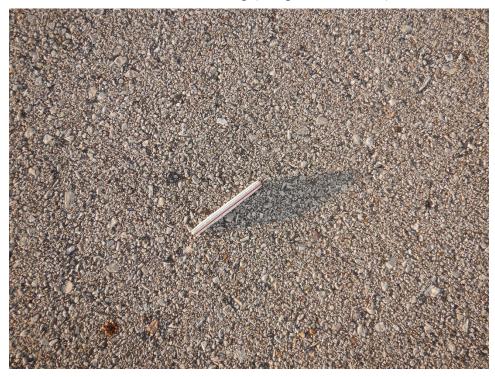
T01IC-01. Weathering (Sample Unit No. 06).

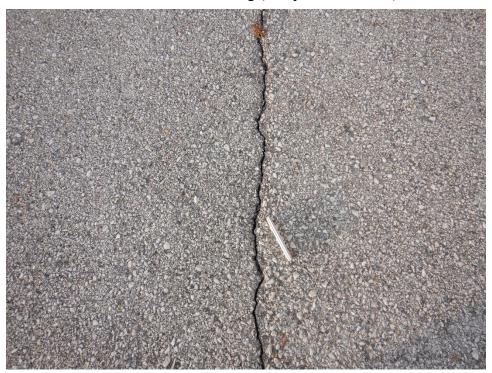
T01IC-04. L&T Cracking (Sample Unit No. 02).

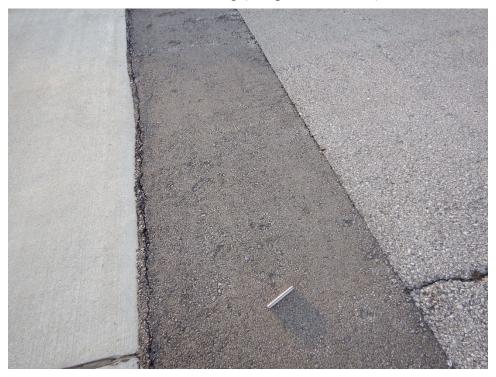
T01IC-04. Patching (Sample Unit No. 02).

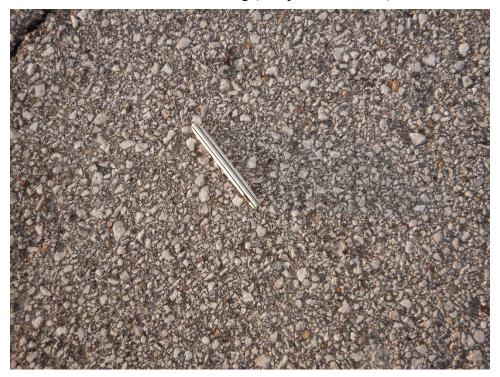
T01IC-04. Weathering (Sample Unit No. 02).

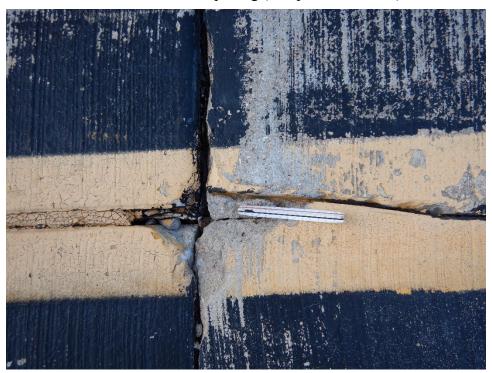
Shattered Slab	Load repetition.	
Shrinkage Cracking	Setting and curing of the concrete.	
Spalling (Joint and Corner)	Excessive stresses at the joint caused by infiltration of incompressible materials or traffic loads; weak concrete at the joint combined with traffic loads.

T01IC-06. Corner Spalling (Sample Unit No. 01).

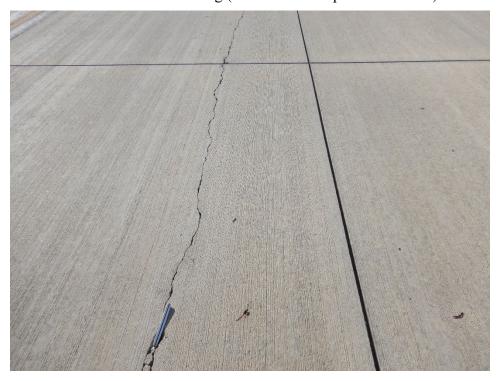
Taxiway 02 served as the parallel taxiway for Runway 07/25 and consisted of two sections that were both in excellent condition. Section 01 contained only areas of low-severity joint seal damage. Low-severity small patching was observed in Section 02. In addition, an atypical area of low- and medium-severity LTD cracking was identified and recorded as an additional sample unit, according to ASTM D5340-20.

T02IC-02. LTD Cracking (Additional Sample Unit No. 89).

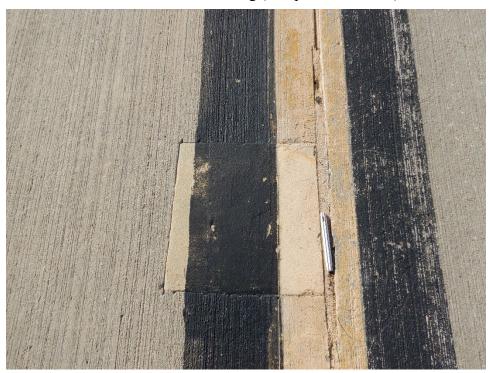
T02IC-02. Small Patching (Sample Unit No. 25).

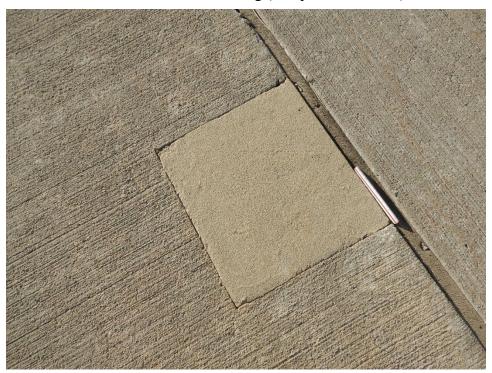
T-hangar 01 contained four sections. Section 01 was in excellent condition with low-severity joint seal damage and small patching noted at the time of inspection. Section 02 contained low-and medium-severity alligator cracking, weathering, and L&T cracking; low-severity depression;

TH01IC-01. Small Patching (Sample Unit No. 04).

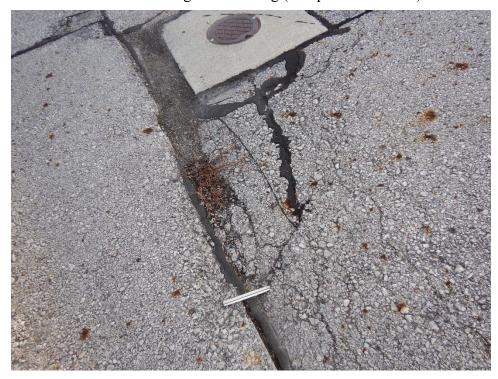
medium-severity joint reflection cracking; and all severities of raveling. The low-severity cracking was unsealed, and the medium-severity cracking was due to either unsealed crack widths that exceeded ¼ in, unsatisfactory crack sealant, or the development of secondary cracking. Section 03 was in poor condition with areas of high-severity corner break and joint seal damage, medium-severity corner spalling, low- and medium-severity LTD cracking, and medium- and high-severity scaling and shattered slab noted. Section 04 contained medium-severity alligator cracking, raveling, and weathering; low- and medium-severity L&T cracking and rutting; and low-severity patching. The low-severity L&T cracking was unsealed and the medium-severity L&T cracking was due to unsatisfactory crack sealant.

TH01IC-02. Alligator Cracking (Sample Unit No. 02).

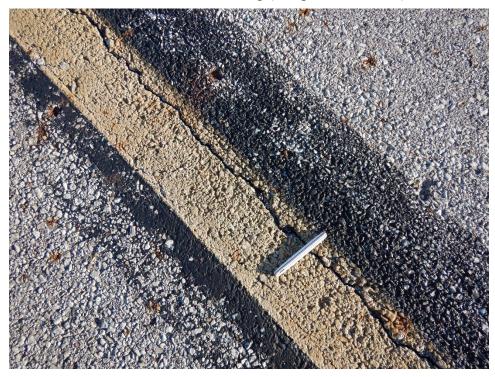
TH01IC-02. L&T Cracking (Sample Unit No. 01).

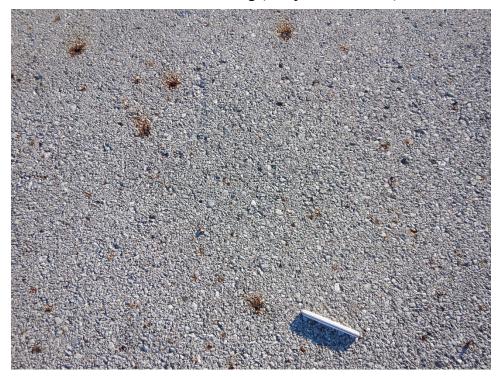
TH01IC-02. Weathering (Sample Unit No. 01).

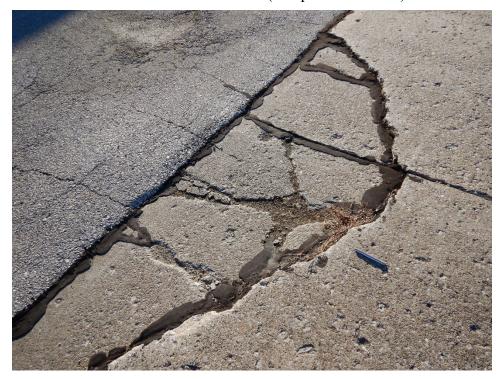
TH01IC-03. Corner Break (Sample Unit No. 02).

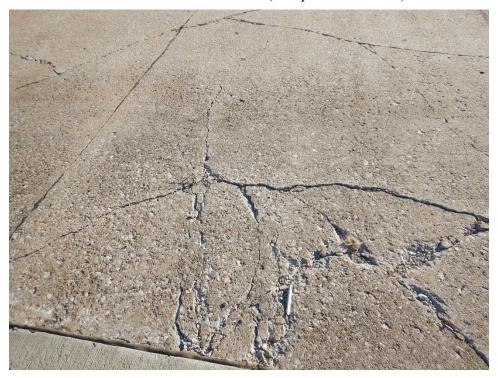
TH01IC-03. Shattered Slab (Sample Unit No. 02).

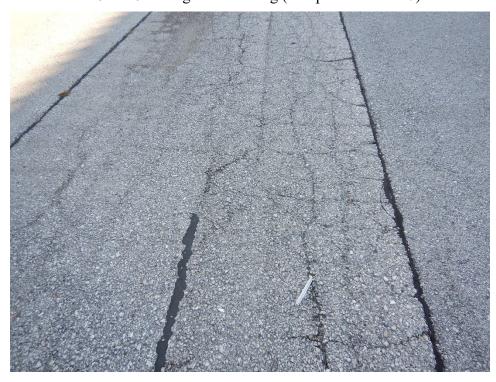
TH01IC-04. Alligator Cracking (Sample Unit No. 17).

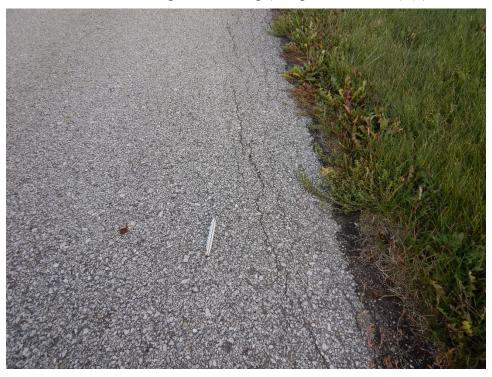
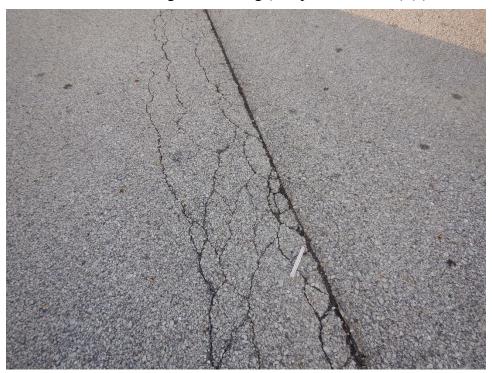
T-hangar 02 consisted of five sections. Section 01 contained areas of low- and medium-severity alligator cracking, patching, and L&T cracking; low-severity depression and raveling; and medium-severity weathering. The low-severity L&T cracking was unsealed, while the medium-severity L&T cracking was due to either unsealed cracking with widths greater than ¼ in or to the development of secondary cracking. All severities of corner break; low- and medium-severity corner spalling, LTD cracking, and shattered slab; medium- and high-severity joint seal damage and joint spalling; medium-severity scaling; low-severity large patching; and shrinkage cracking were noted in Section 02. Section 03 was in excellent condition with low-severity joint seal damage was recorded throughout. Section 04 contained medium-severity faulting and joint seal damage. Section 05 was in excellent condition with no distress noted at the time of inspection.

TH02IC-01. Alligator Cracking (Sample Unit No. 03) (1).

TH02IC-01. Alligator Cracking (Sample Unit No. 03) (2).

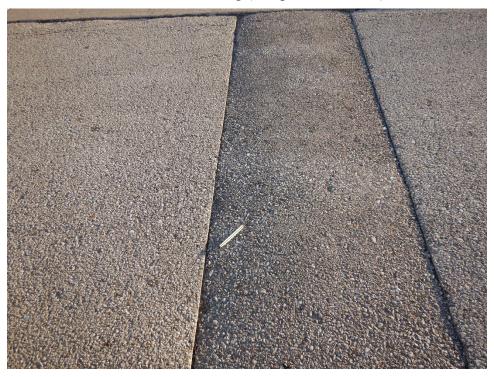
TH02IC-01. Patching (Sample Unit No. 02).

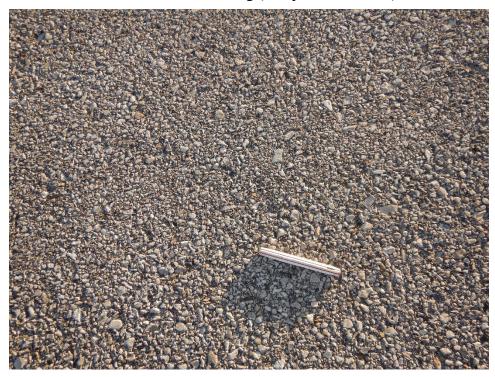
TH02IC-01. Weathering (Sample Unit No. 03).

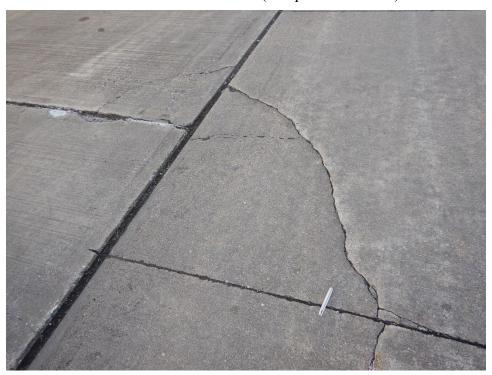
TH02IC-02. Corner Break (Sample Unit No. 13).

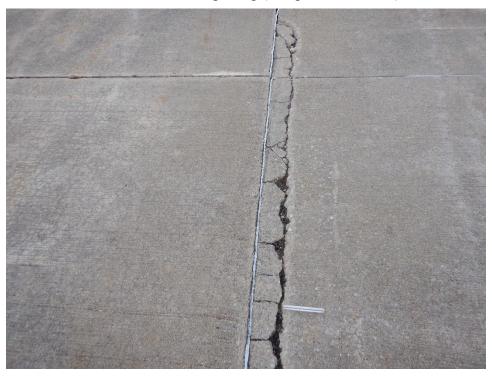
TH02IC-02. Joint Spalling (Sample Unit No. 17).

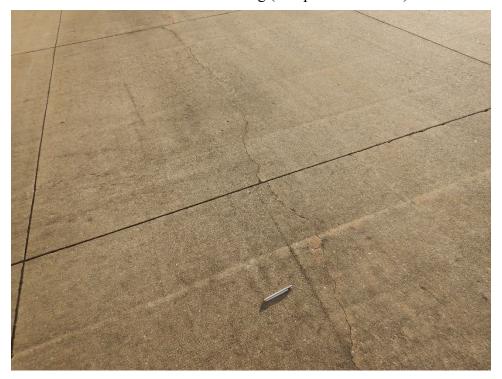
TH02IC-02. LTD Cracking (Sample Unit No. 02).

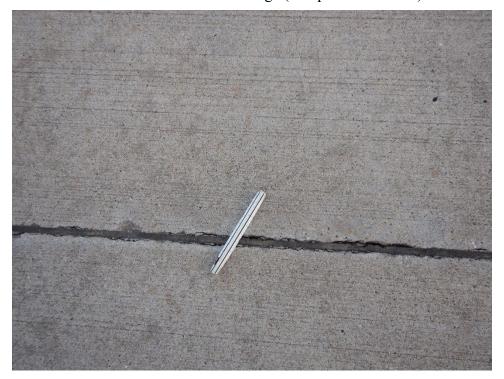
TH02IC-03. Joint Seal Damage (Sample Unit No. 01).
