# Jefferson Municipal Airport

## PAVEMENT MANAGEMENT REPORT

**JULY 2022**

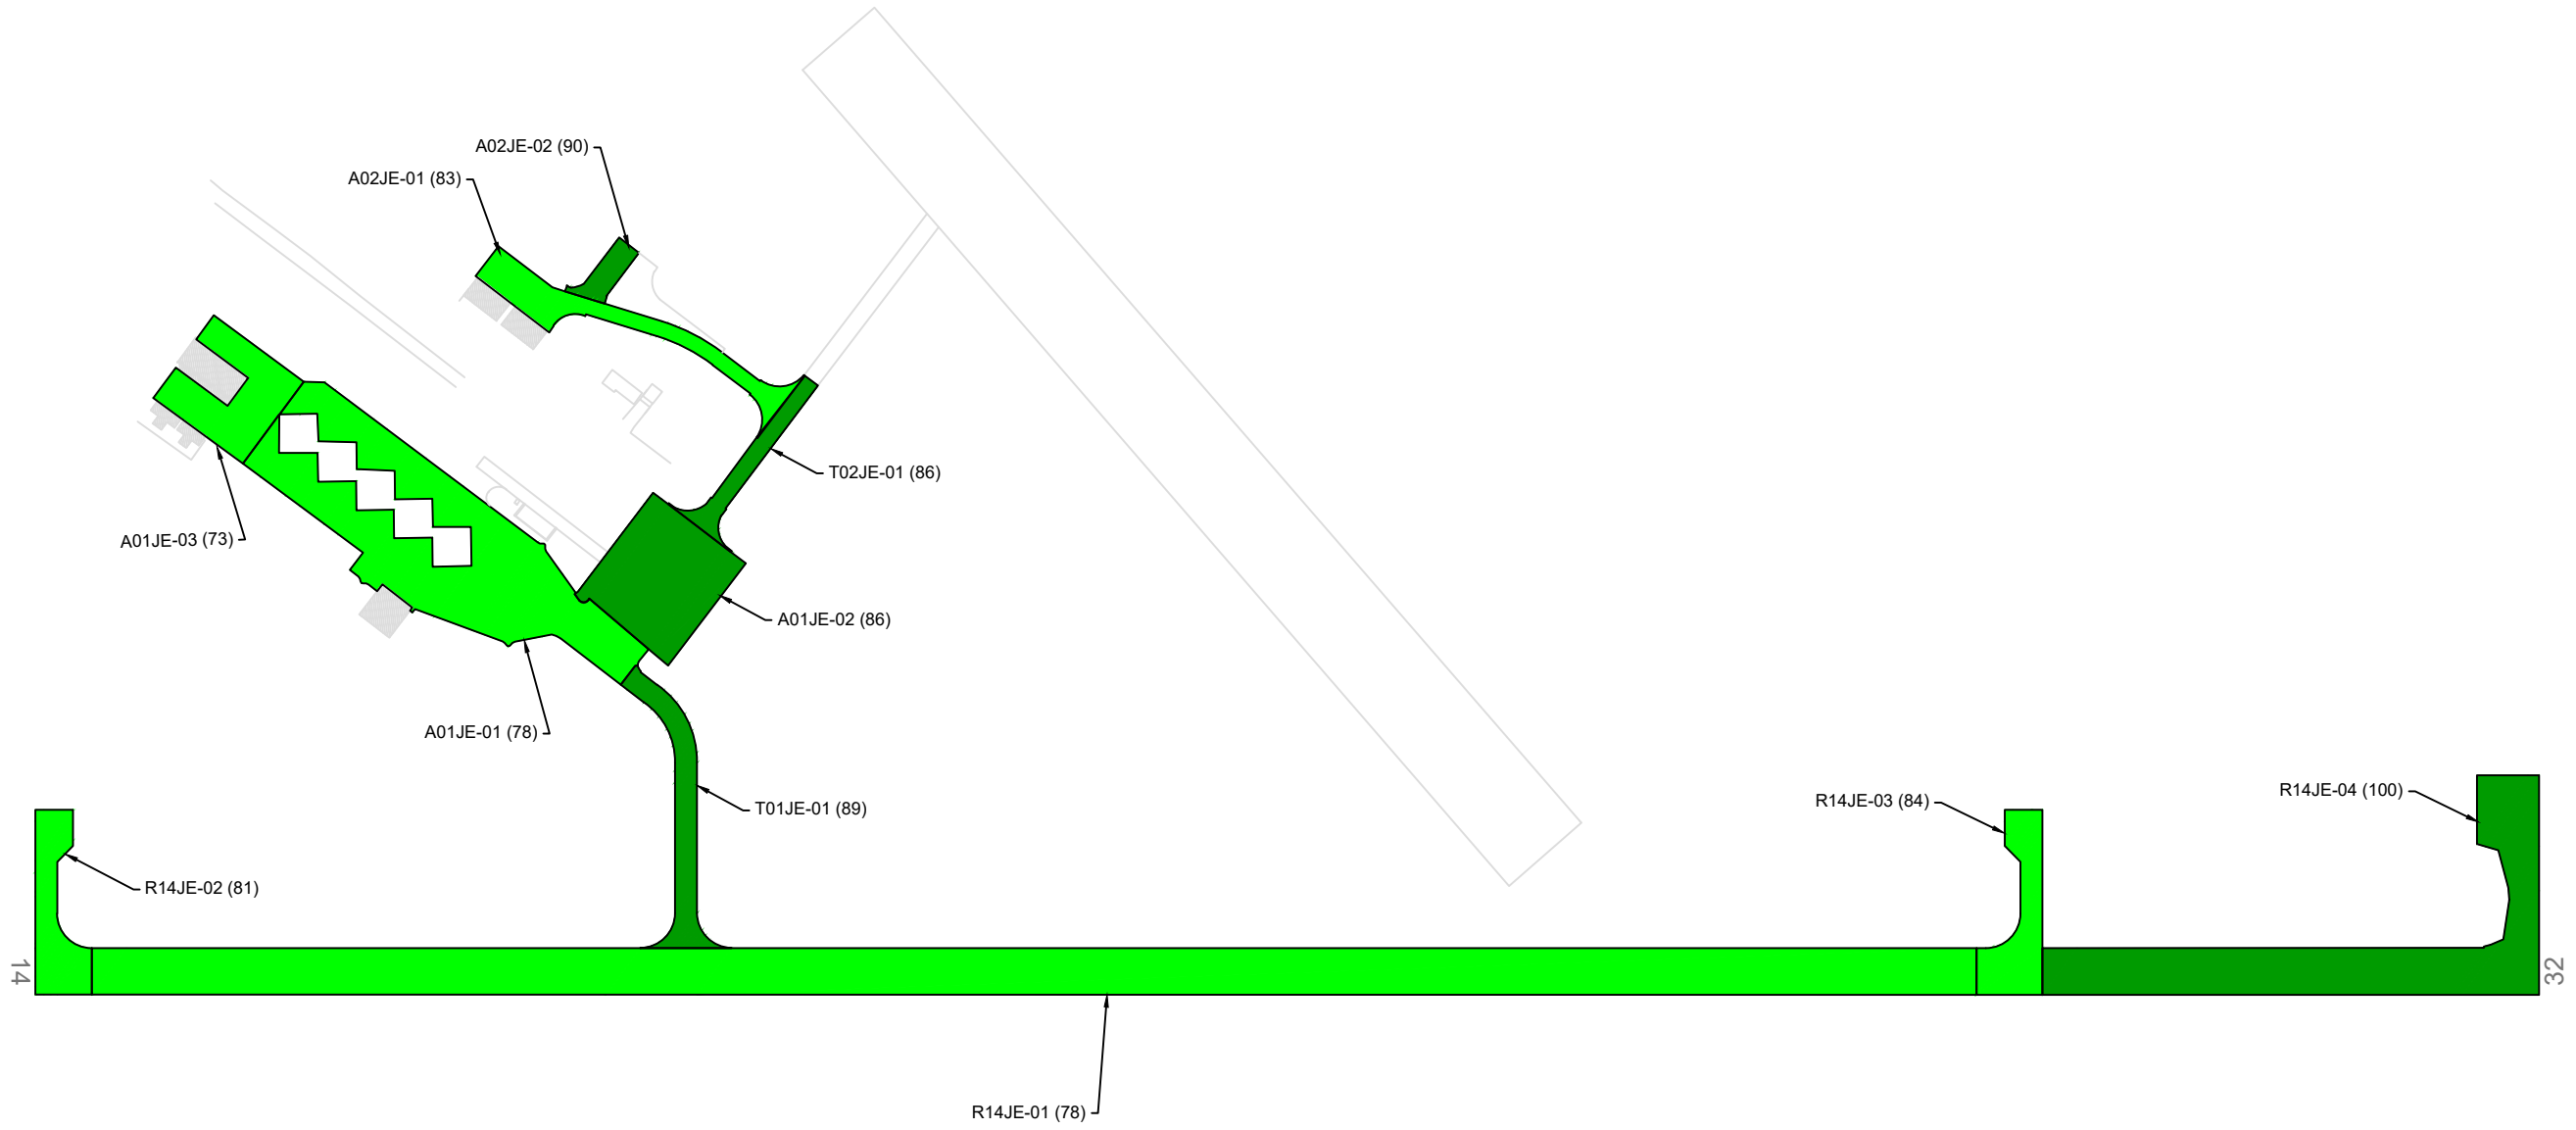
FIGURE 8. PCI MAP.

The pavements at Jefferson Municipal Airport were inspected in November 2021. The 2021 area-weighted condition of Jefferson Municipal Airport is 83, with conditions ranging from 73 to 100 (on a scale of 0 [failed] to 100 [excellent]). During the previous pavement inspection in 2018, the area-weighted PCI of the airport was 76.

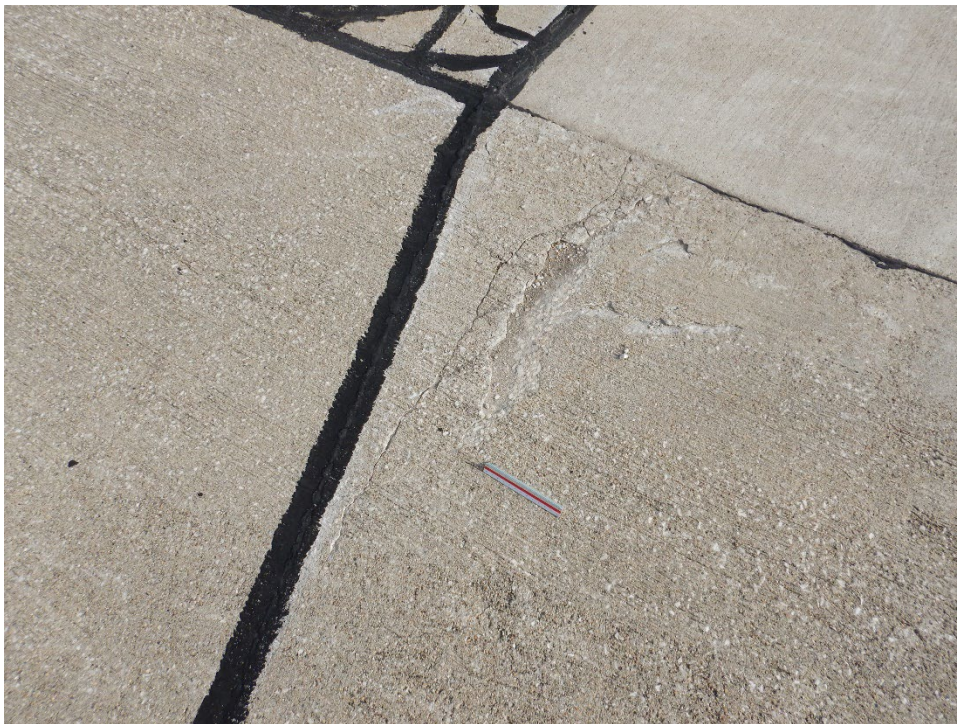
A01JE-01. ASR (Additional Sample Unit No. 12).

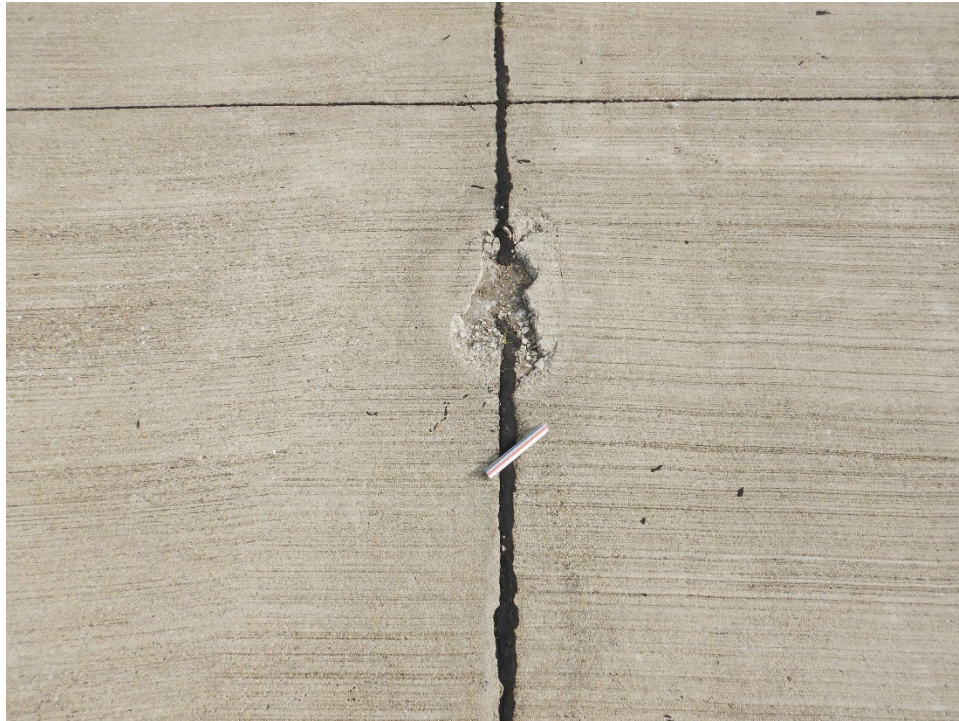
A01JE-01. Joint Spalling (Additional Sample Unit No. 12).

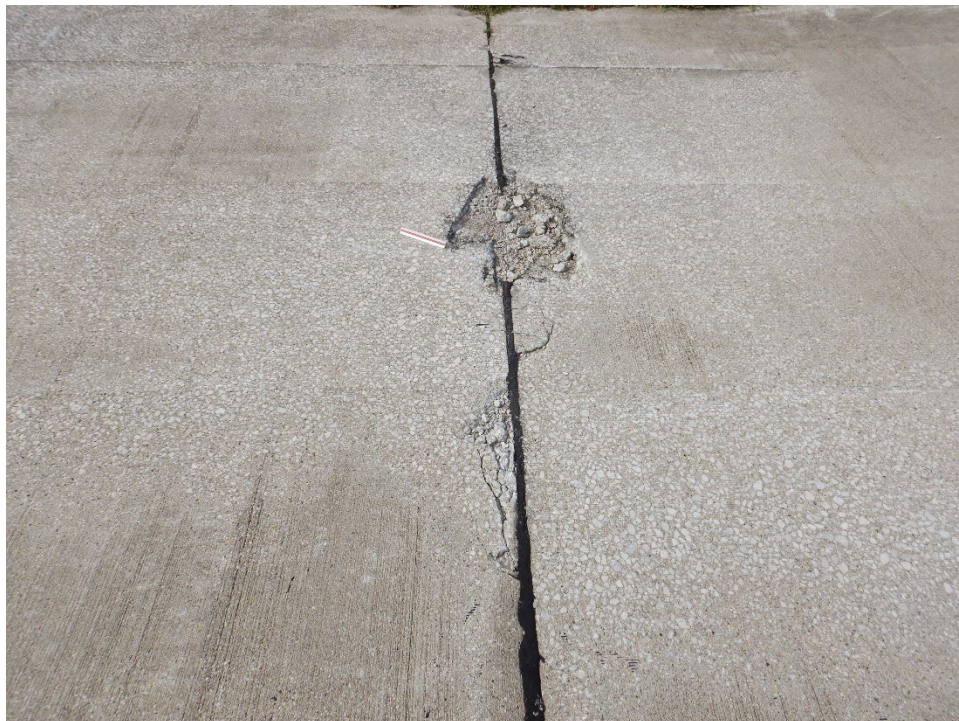
A01JE-01. Joint Spalling (Additional Sample Unit No. 18).

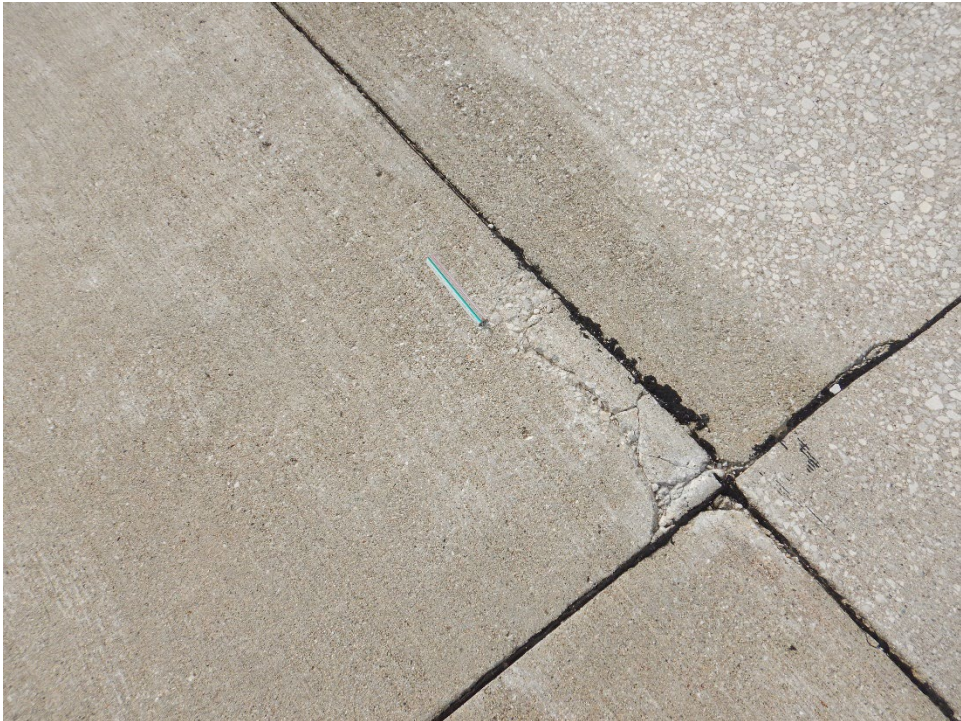
A01JE-01. Joint Spalling (Sample Unit No. 13).

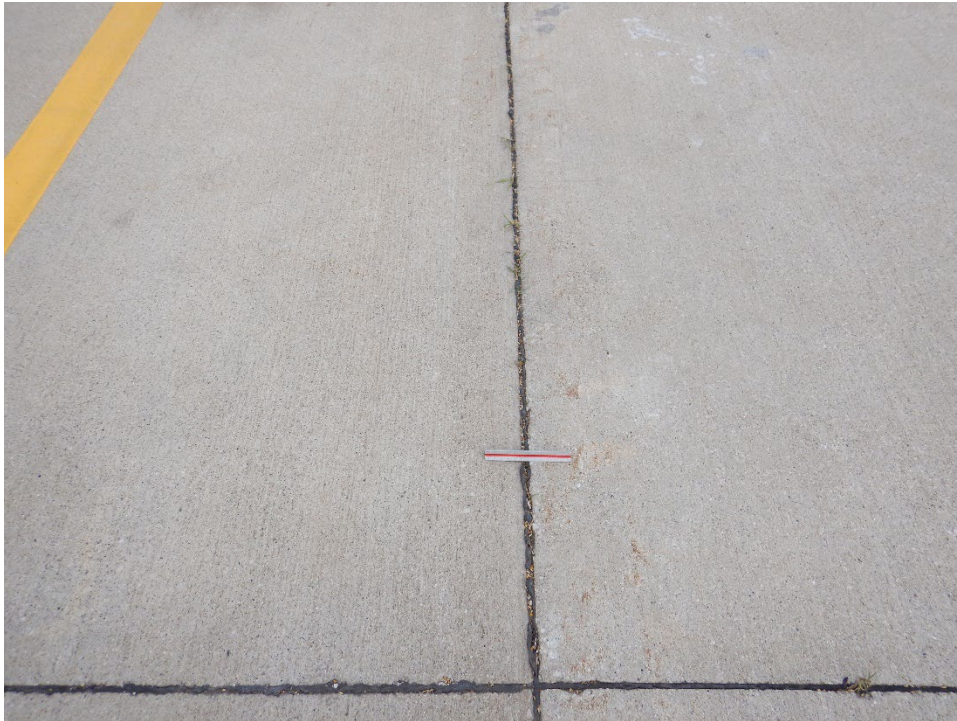
A01JE-02. Joint Seal Damage (Sample Unit No. 04).

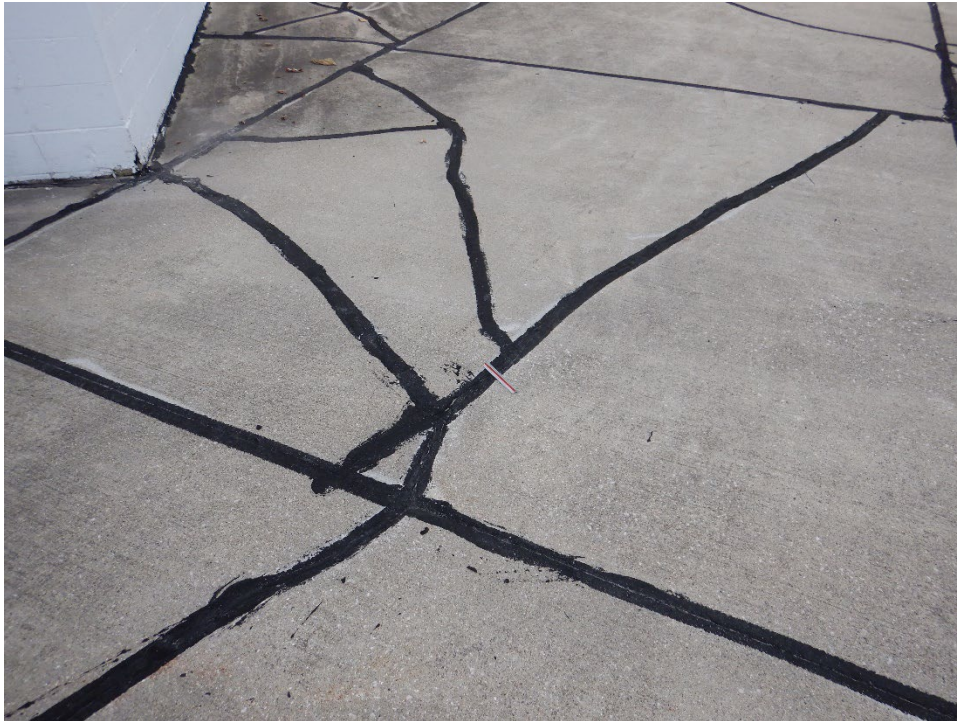
A01JE-03. Shattered Slab (Sample Unit No. 04).

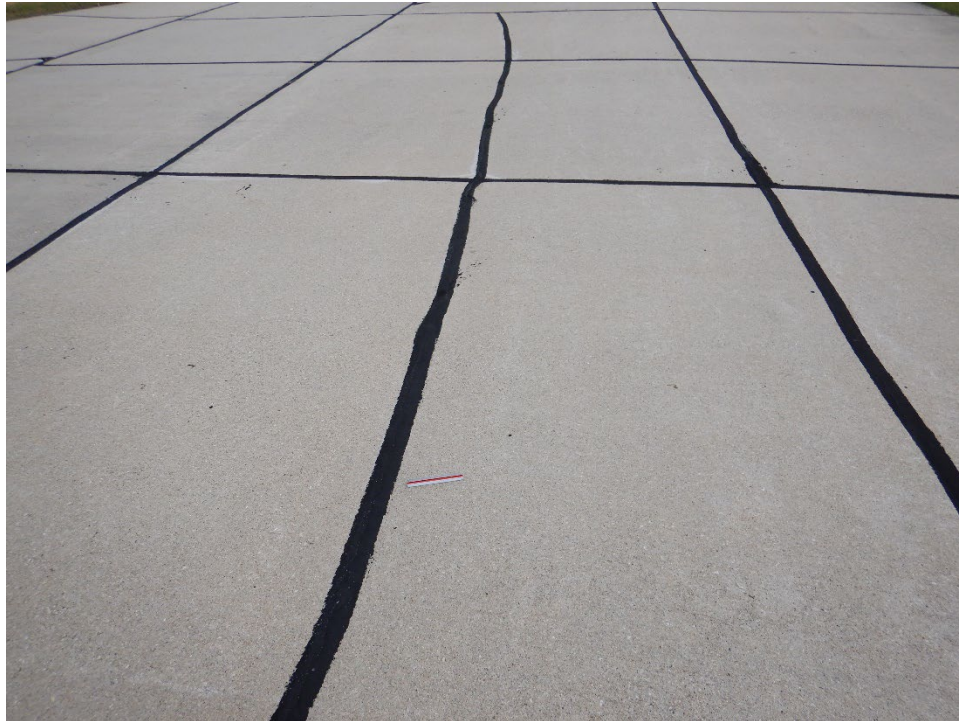
A02JE-01. LTD Cracking (Sample Unit No. 06).

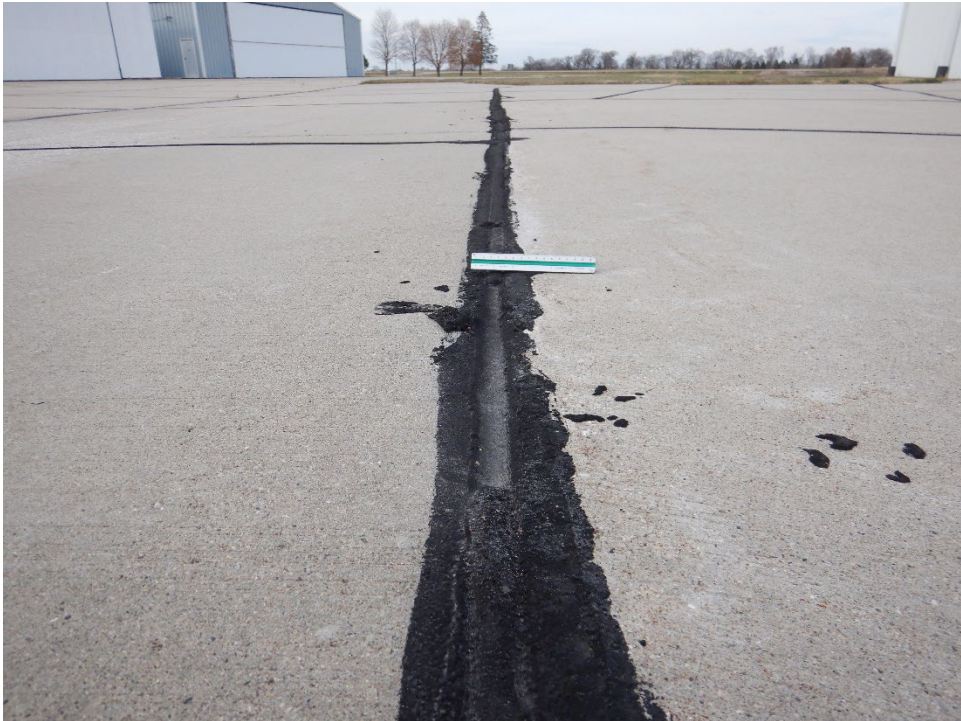
A02JE-02. Faulting (Sample Unit No. 02).

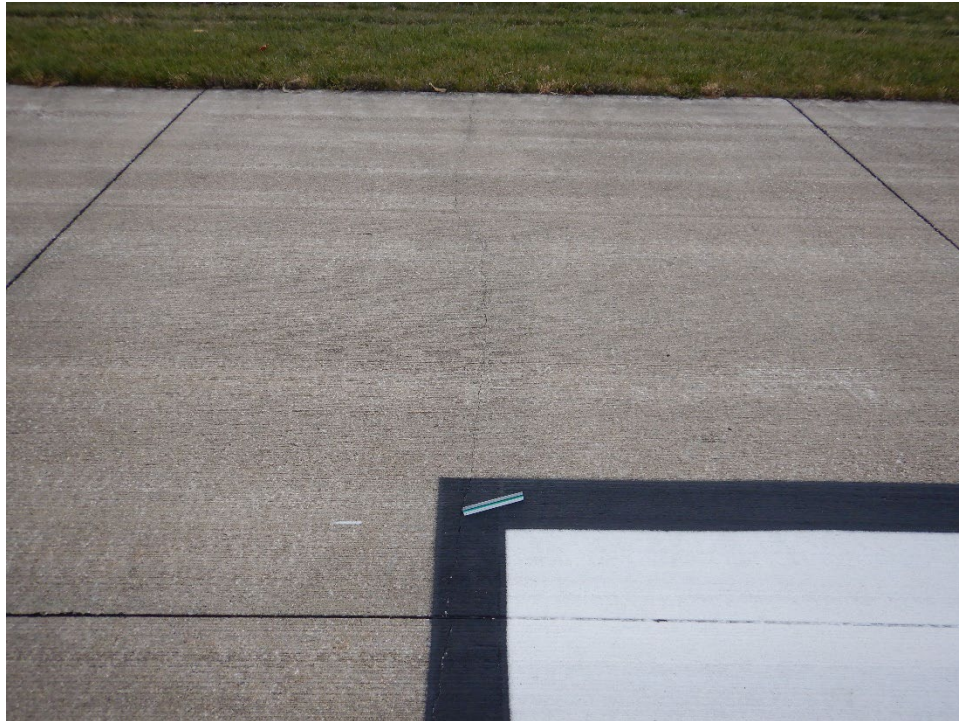
R14JE-01. LTD Cracking (Sample Unit No. 05).

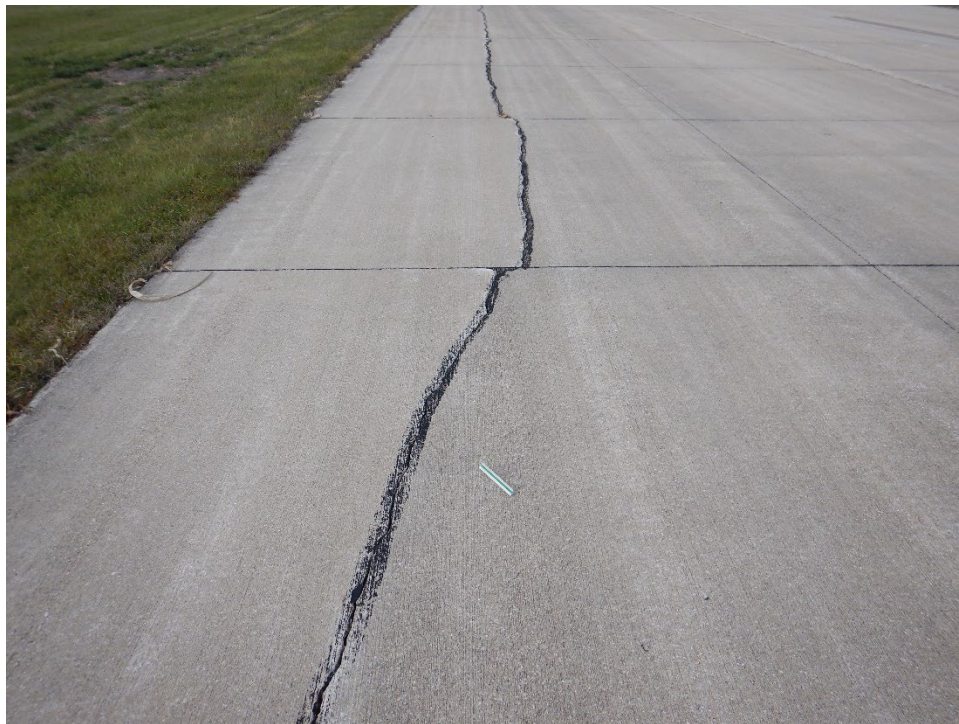
R14JE-01. LTD Cracking (Sample Unit No. 15).

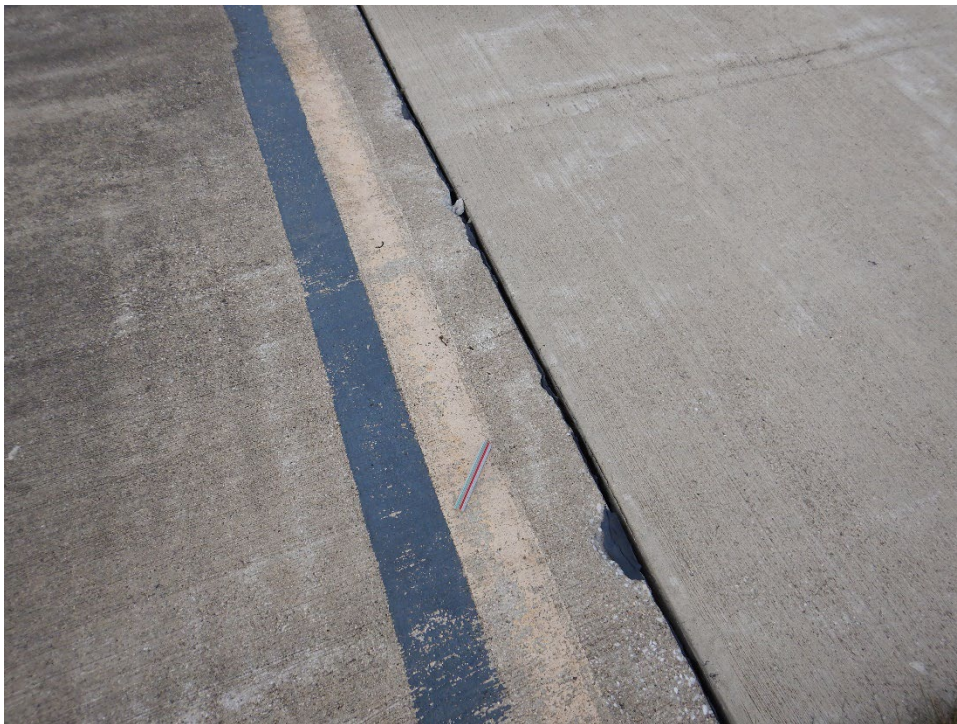
R14JE-02. Joint Spalling (Sample Unit No. 01).

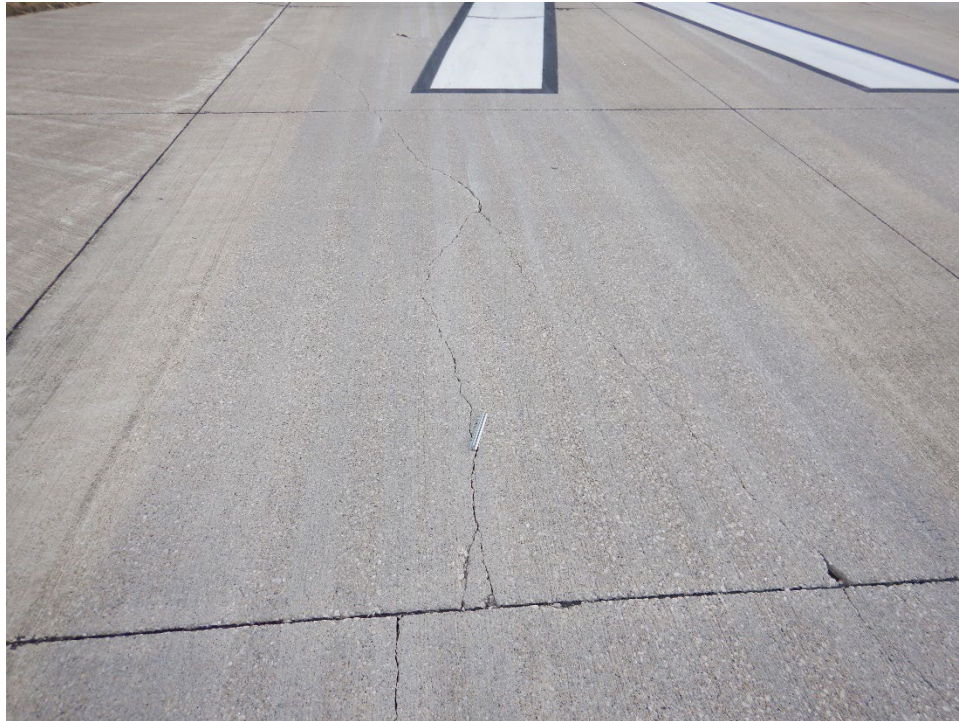
R14JE-02. Shattered Slab (Sample Unit No. 05).

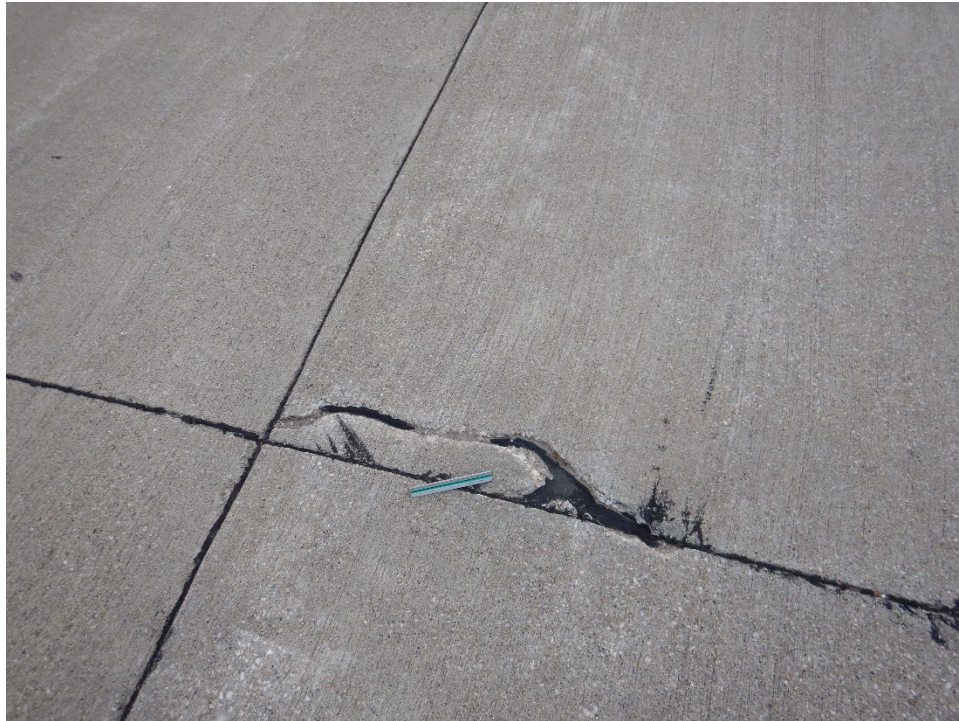
R14JE-03. Joint Spalling (Sample Unit No. 04).

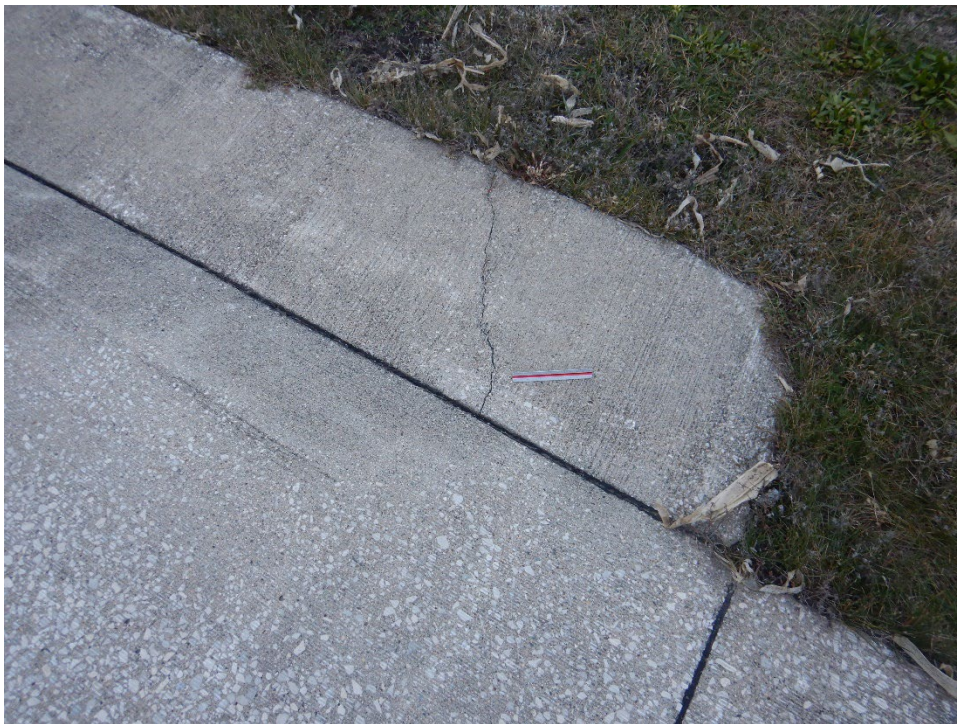
Taxiway 01 connected Runway 14/32 to the apron area and was defined by one section. Medium-severity corner break and joint seal damage and low-severity faulting and LTD cracking were identified in Section 01.

T01JE-01. LTD Cracking (Sample Unit No. 05).

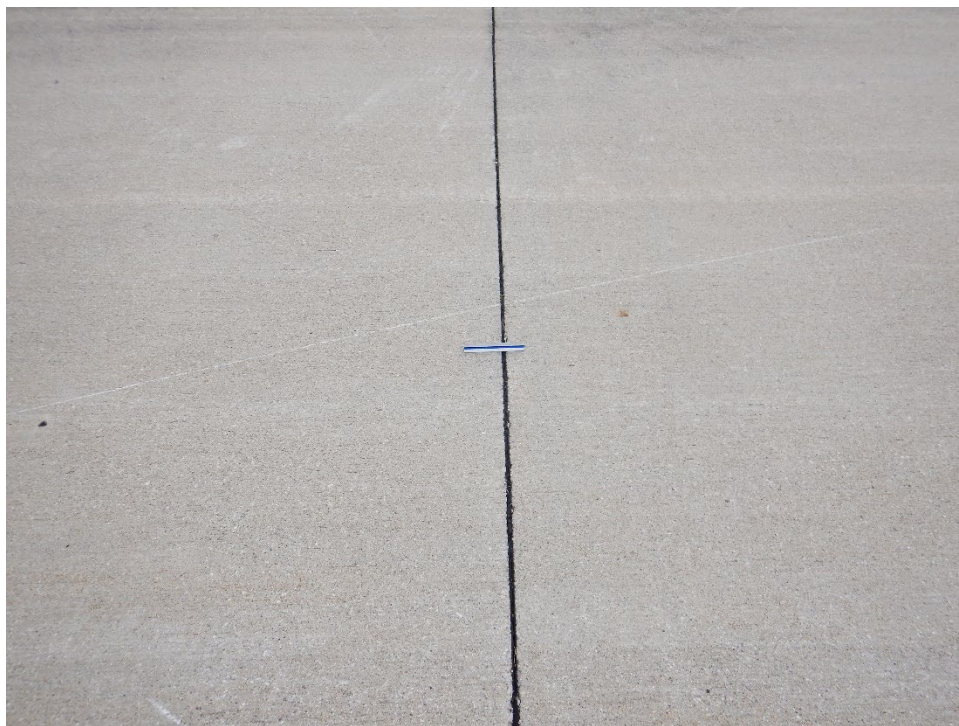
Taxiway 02 connected Apron 01 with Apron 02 and contained one section. Areas of high-severity joint seal damage and low-severity joint spalling and LTD cracking were noted in Section 01.

T02JE-01. Joint Seal Damage (Sample Unit No. 01).
