# Marshalltown Municipal Airport

## PAVEMENT MANAGEMENT REPORT

**JULY 2022**

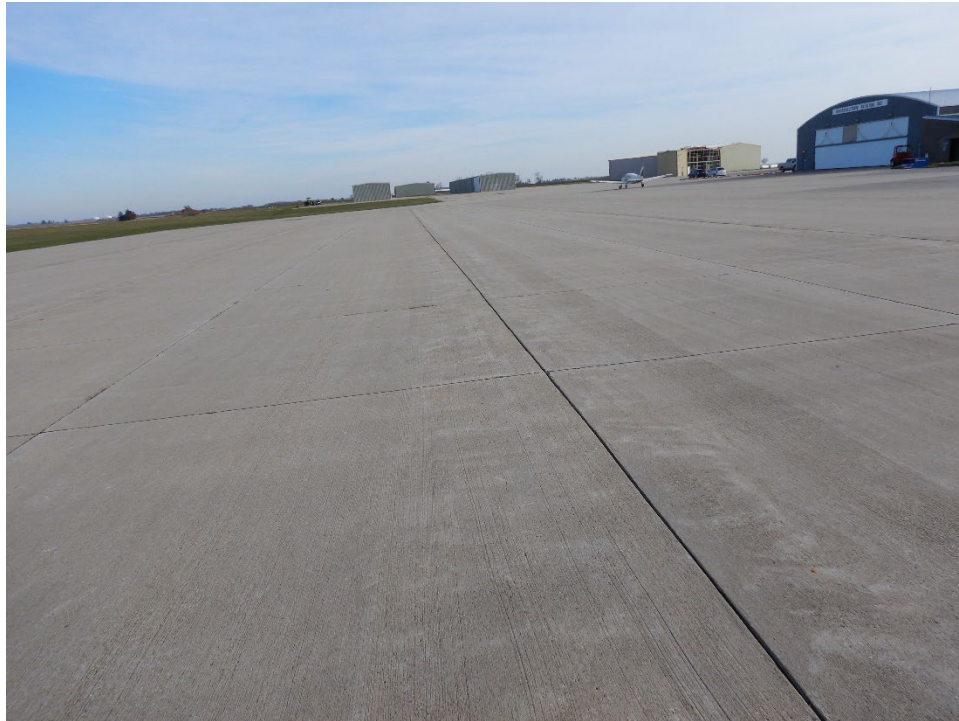
A01MT-01. Overview.

Apron 01 was defined by one section that contained low-severity faulting; low- and medium-severity corner spalling and joint spalling; high-severity joint seal damage; and medium-severity alkali-silica reaction (ASR) and longitudinal, transverse, and diagonal (LTD) cracking. The suspected ASR was recorded in accordance with ASTM D5340-20. It should be noted that laboratory testing in the form of petrographic analysis is the only definitive way to validate the presence of ASR; however, the formation of a precipitate is evidence of a reaction consistent with this type of materials-related distress. Additionally, an atypical area with medium- and high-severity shattered slab was identified and recorded as an additional sample unit, in accordance with ASTM D5340-20.

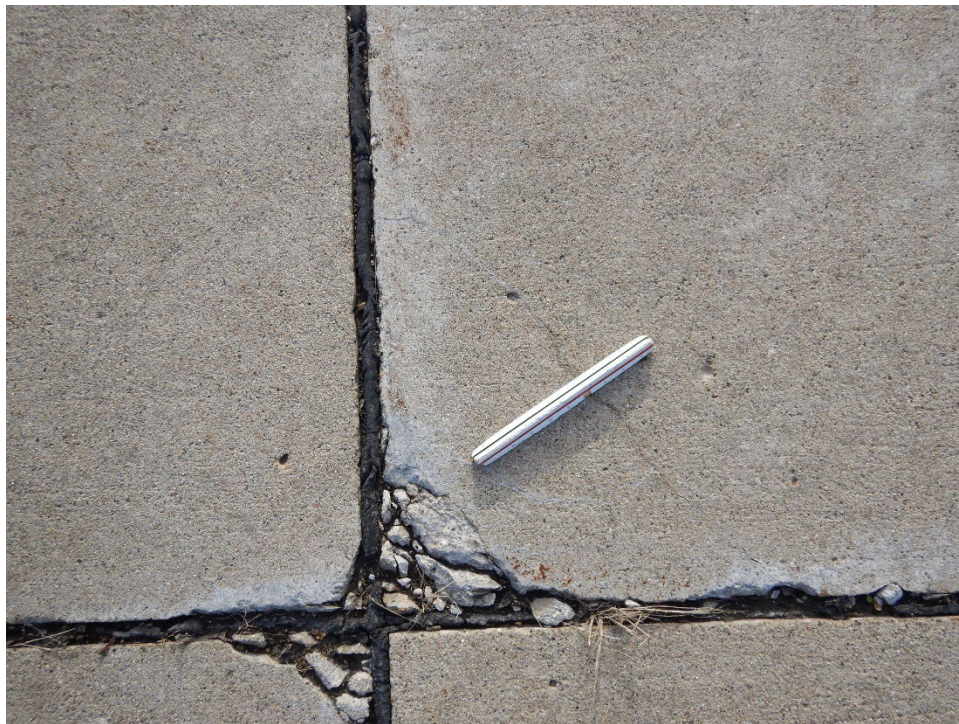
A01MT-01. ASR (Sample Unit No. 11).

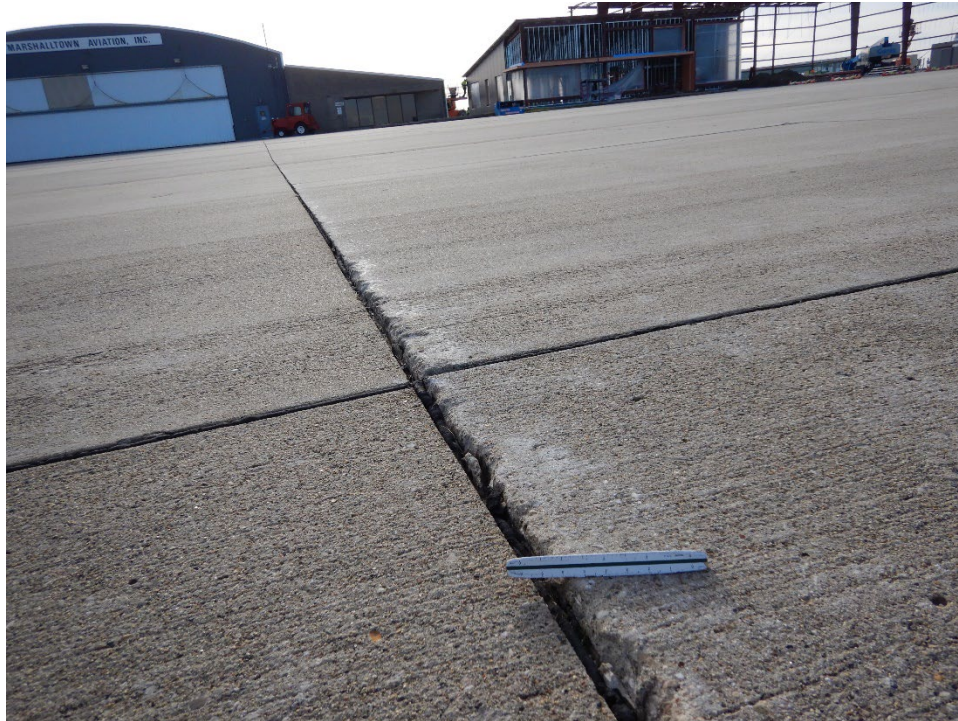
A01MT-01. Faulting (Sample Unit No. 06).

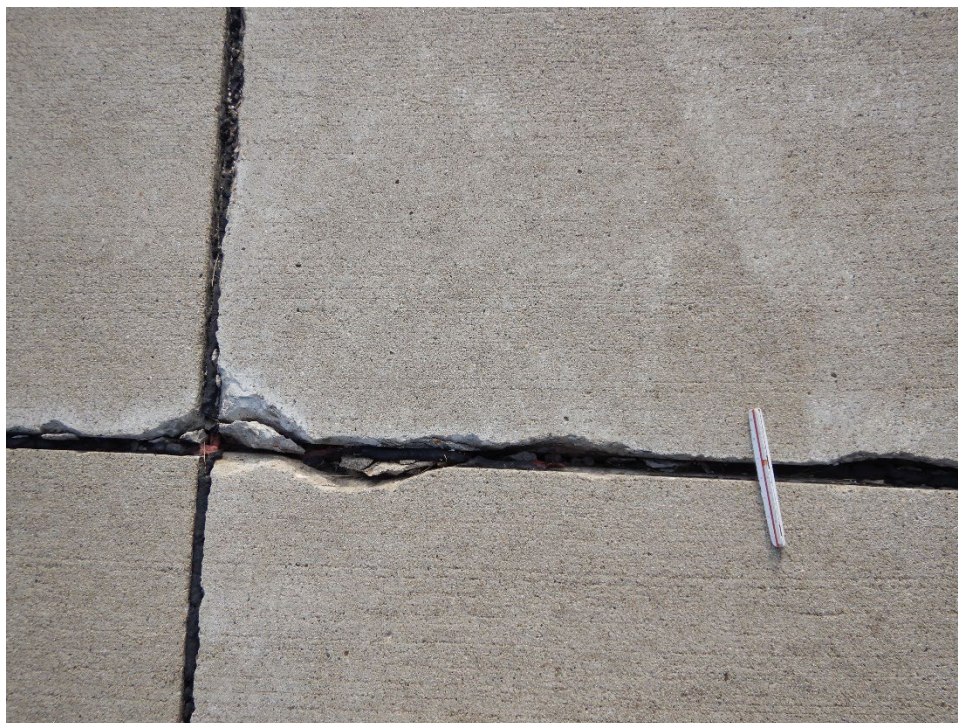
A01MT-01. Joint Seal Damage (Sample Unit No. 11).

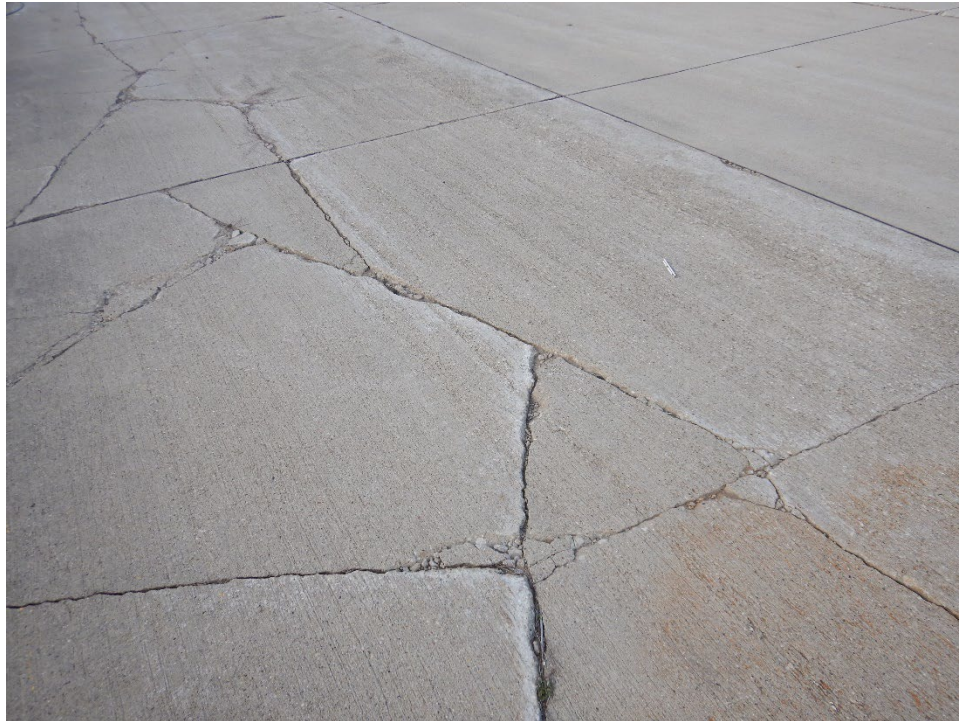
A01MT-01. Shattered Slab (Additional Sample Unit No. 23).

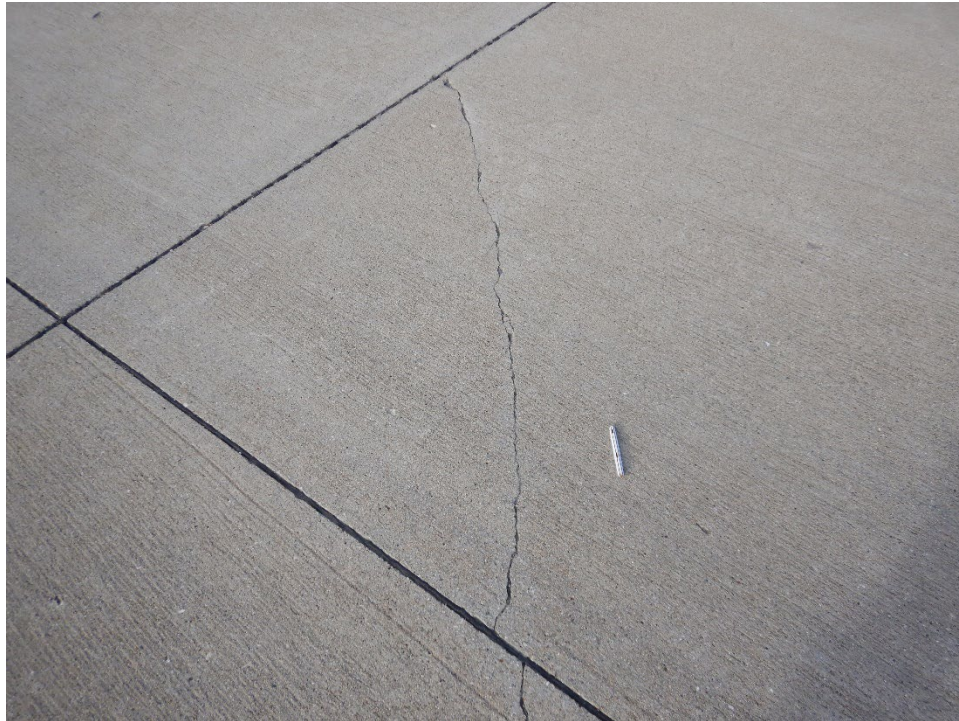
Apron 02 contained two sections. Medium-severity corner break and LTD cracking, high-severity corner spalling and joint seal damage, and low-severity faulting were recorded in Section 01. Section 02 was in poor condition with medium-severity block cracking, raveling, and weathering and low-severity depression and patching identified at the time of inspection.

A02MT-01. Corner Break (Sample Unit No. 10).

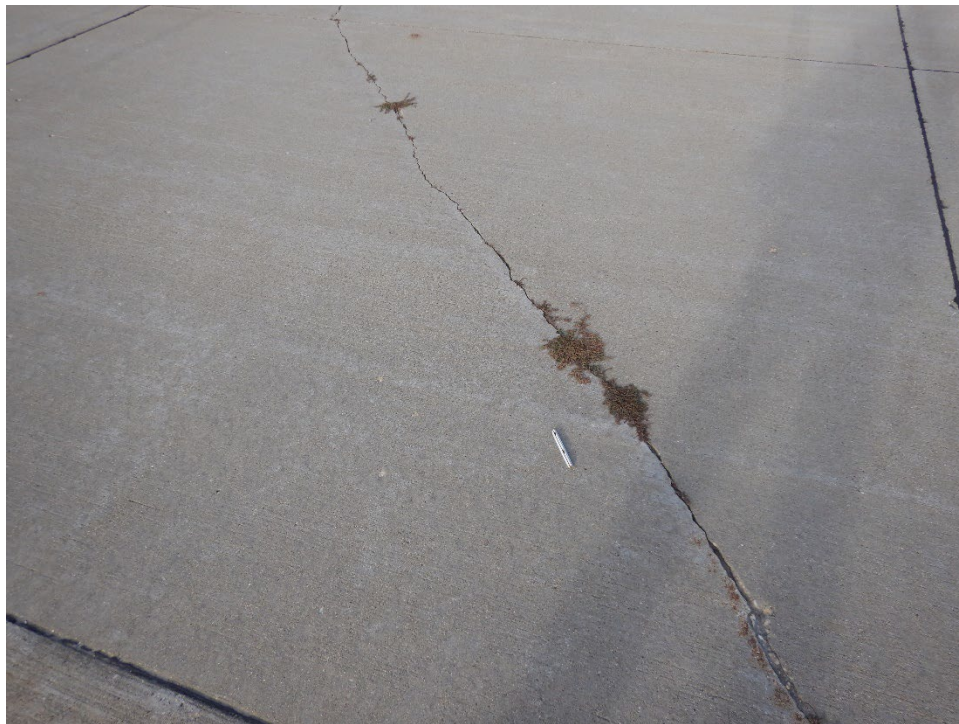
A02MT-01. LTD Cracking (Sample Unit No. 10).

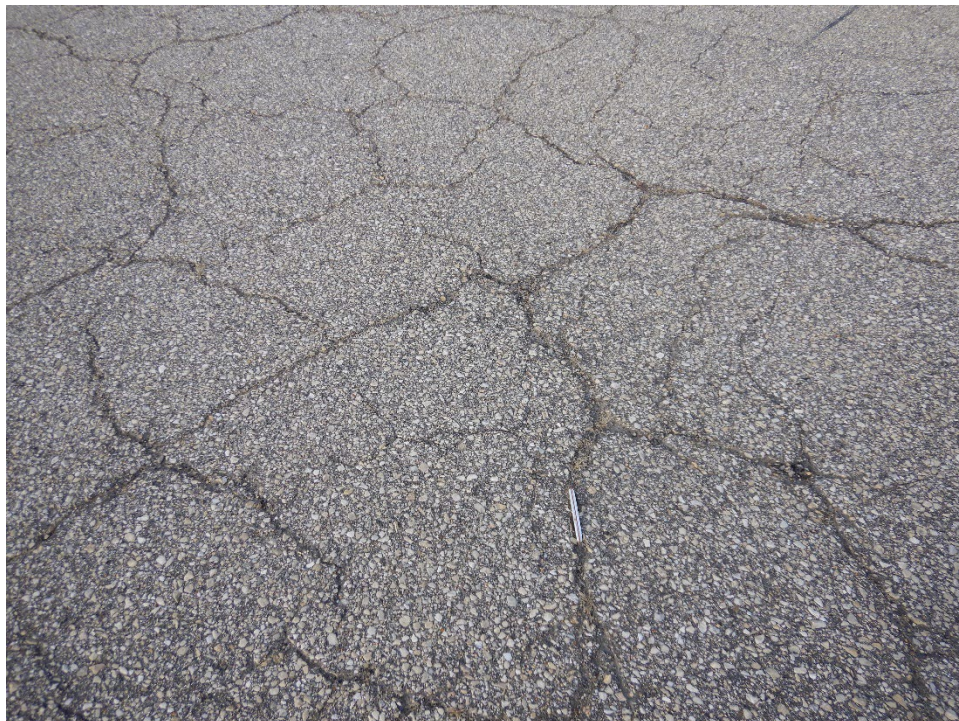
A02MT-02. Block Cracking (Sample Unit No. 02).

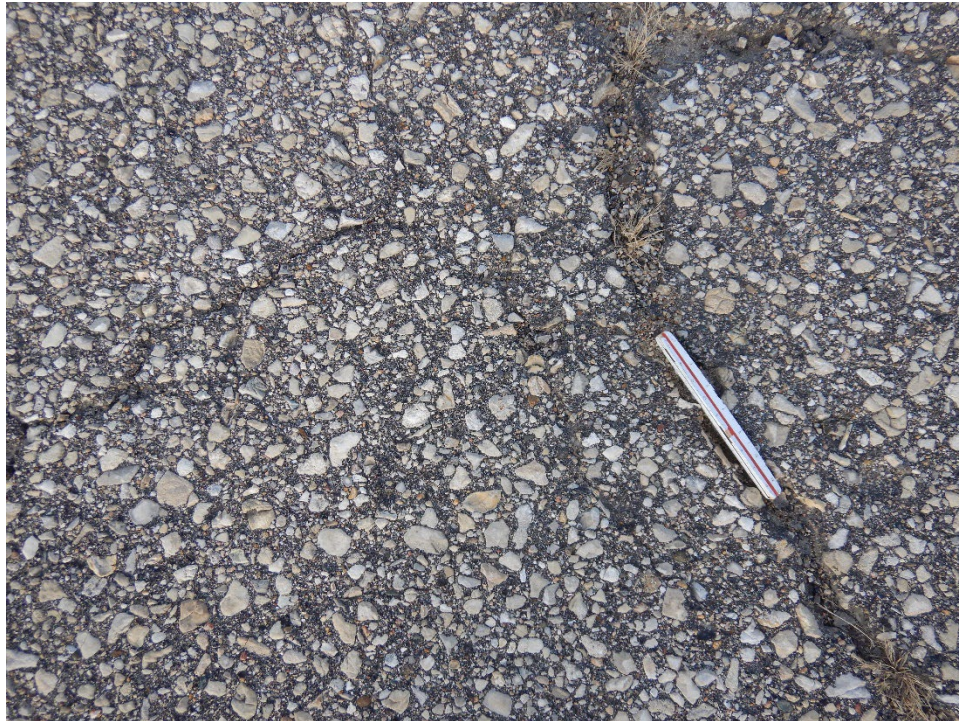
A02MT-02. Weathering (Sample Unit No. 02).

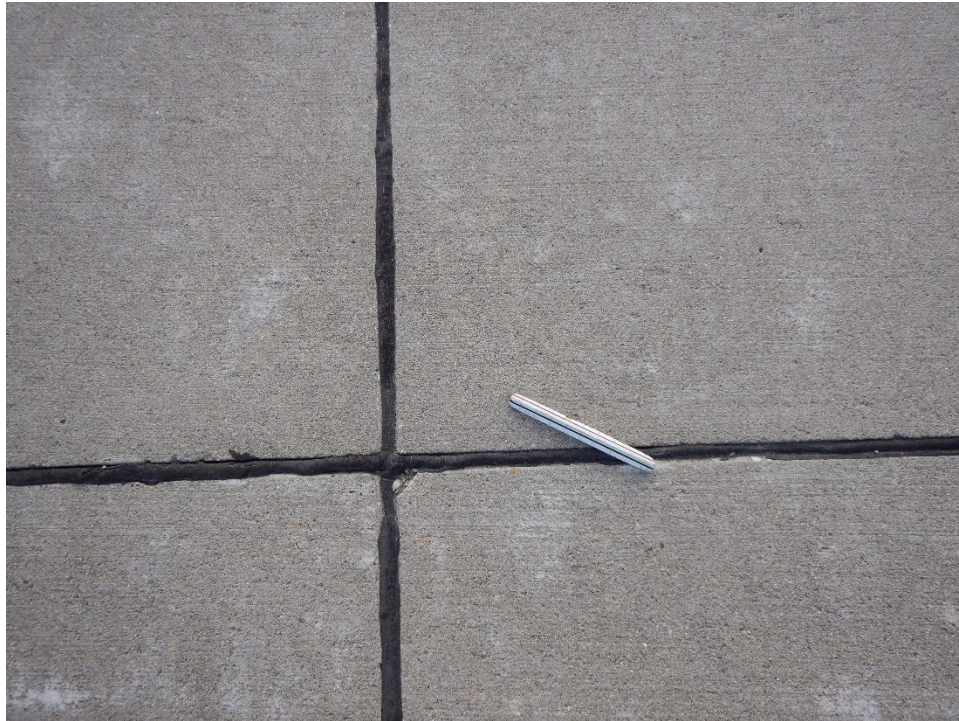
Apron 03 consisted of one section with medium-severity joint seal damage observed throughout.

A03MT-01. Joint Seal Damage (Sample Unit No. 02).

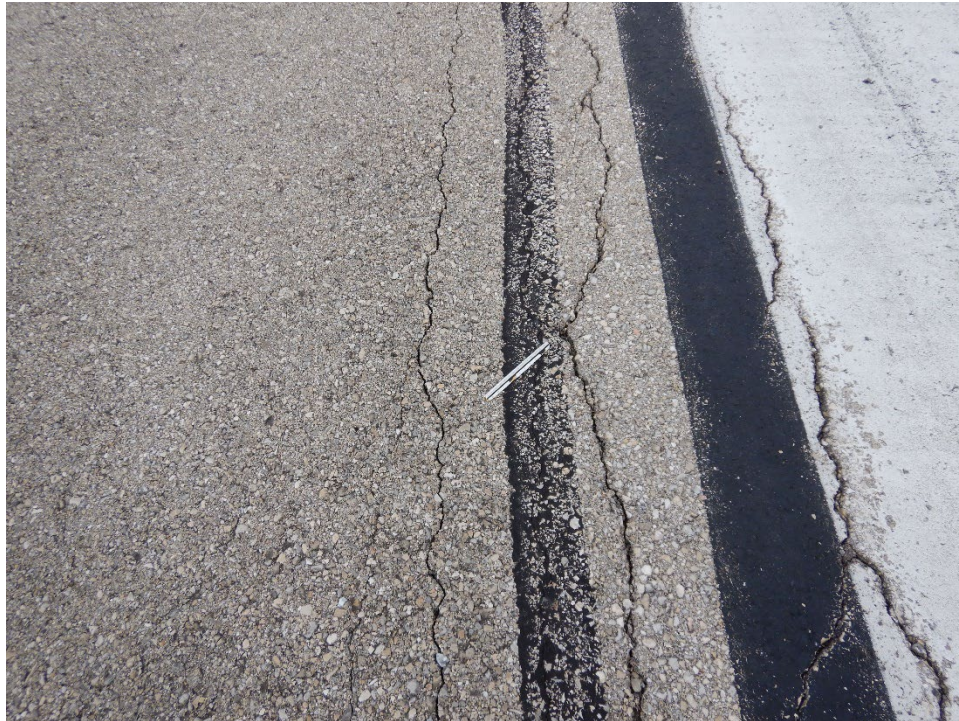
Runway 13/31 was defined by four sections. Section 01 contained low- and medium-severity longitudinal and transverse (L&T) cracking and low-severity raveling, alligator cracking, and weathering. Low- and medium-severity alligator cracking, all severities of L&T cracking and raveling, and low-severity weathering were recorded in Section 02. Areas of all severities of L&T cracking, low-severity raveling, and low- and medium-severity weathering were observed in Section 03. Section 04 contained low- and medium-severity L&T cracking, raveling, and weathering. In all four sections, the low-severity L&T cracking was unsealed and the medium-severity L&T cracking was noted where either the crack sealant was unsatisfactory, unsealed crack widths exceeded  $\frac{1}{4}$  in, or secondary cracking had developed. High-severity L&T cracking was recorded where secondary cracking was greater than 1 ft in width.

R13MT-01. Alligator Cracking (Sample Unit No. 03).

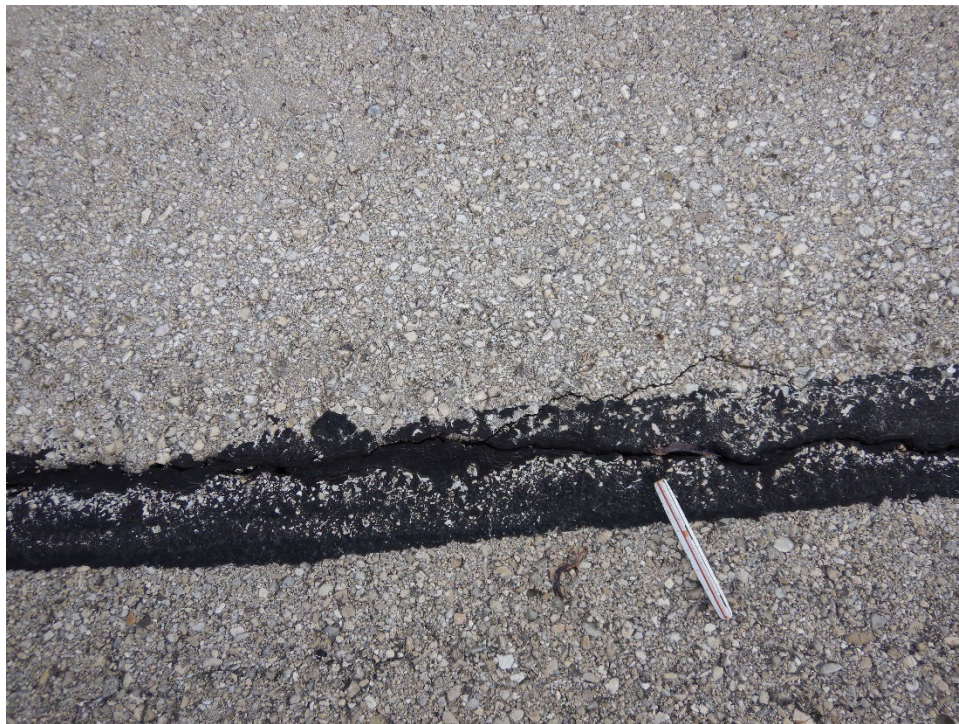
R13MT-01. L&T Cracking (Sample Unit No. 16).

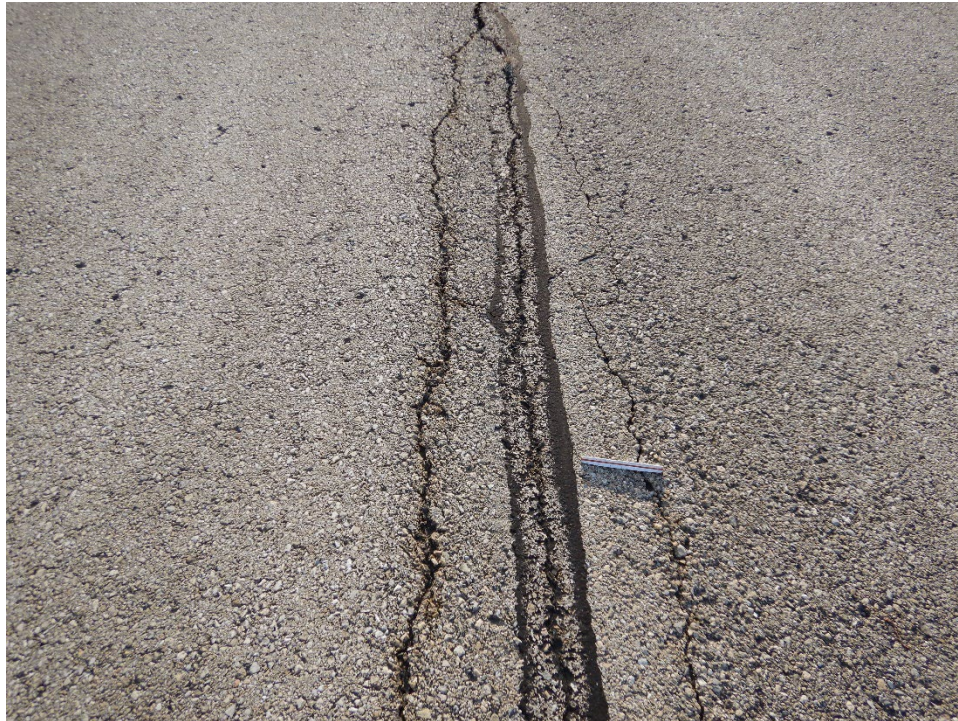
R13MT-02. Alligator Cracking (Sample Unit No. 75).

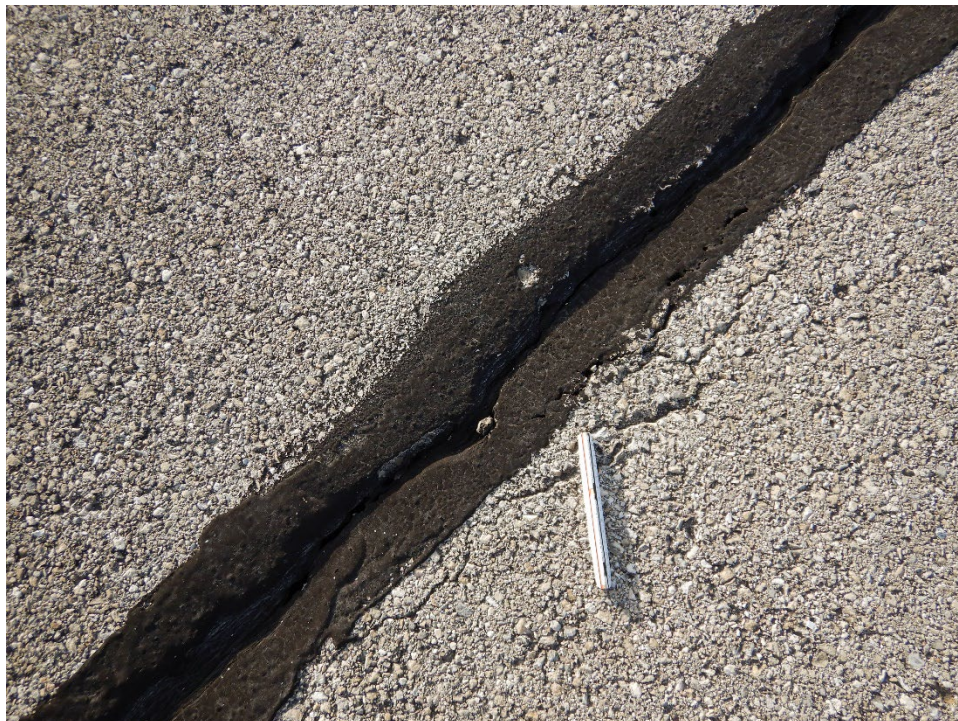
R13MT-02. L&T Cracking (Sample Unit No. 75).

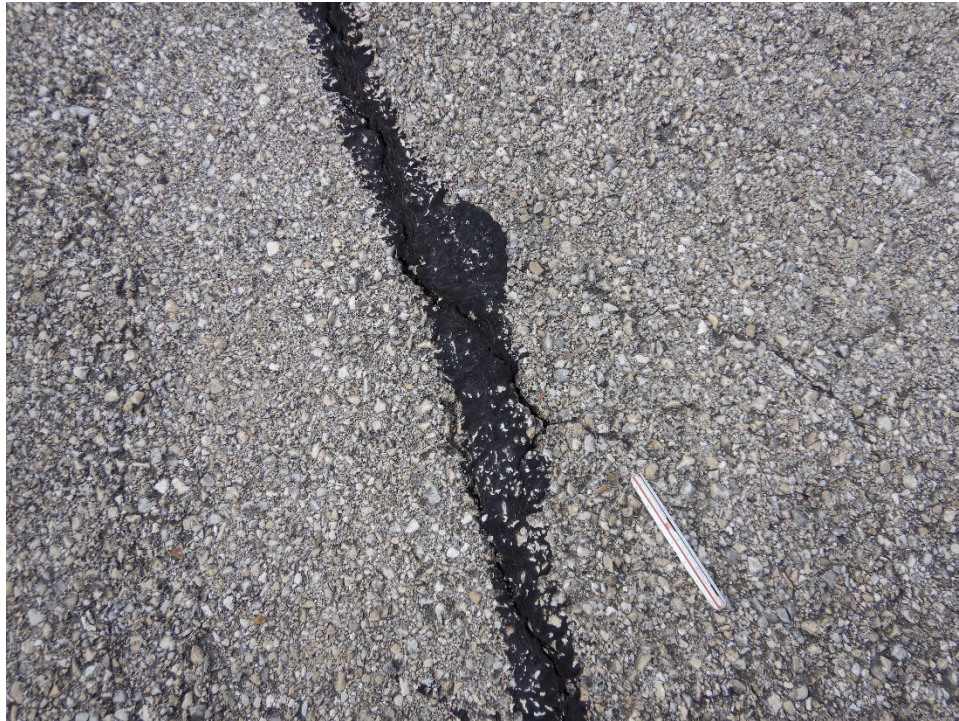
R13MT-03. L&T Cracking (Sample Unit No. 02).

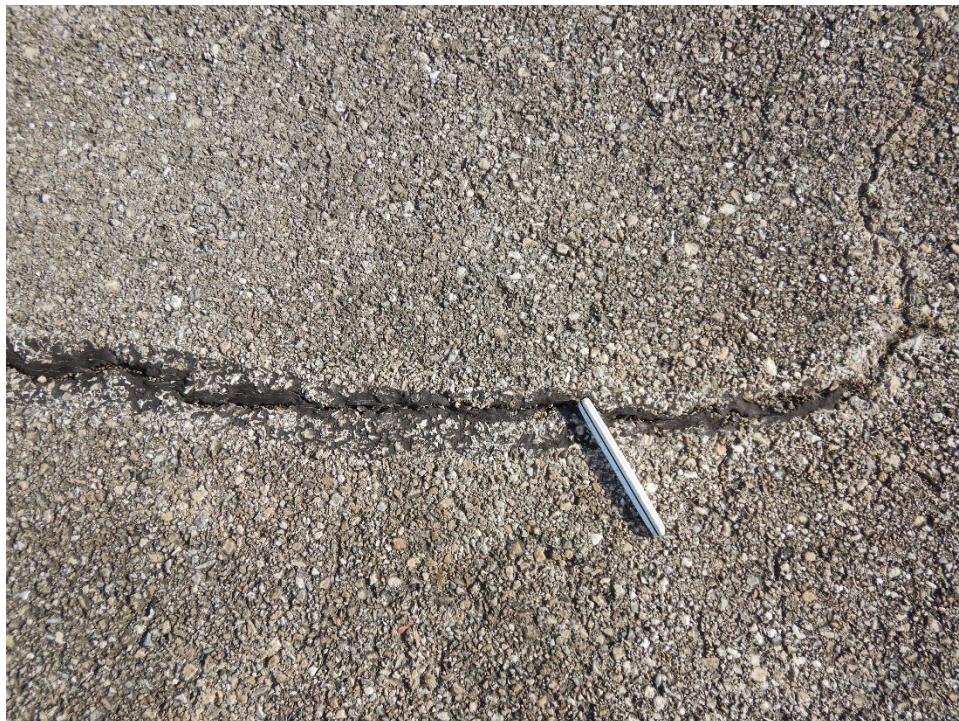
R13MT-04. L&T Cracking (Sample Unit No. 01).

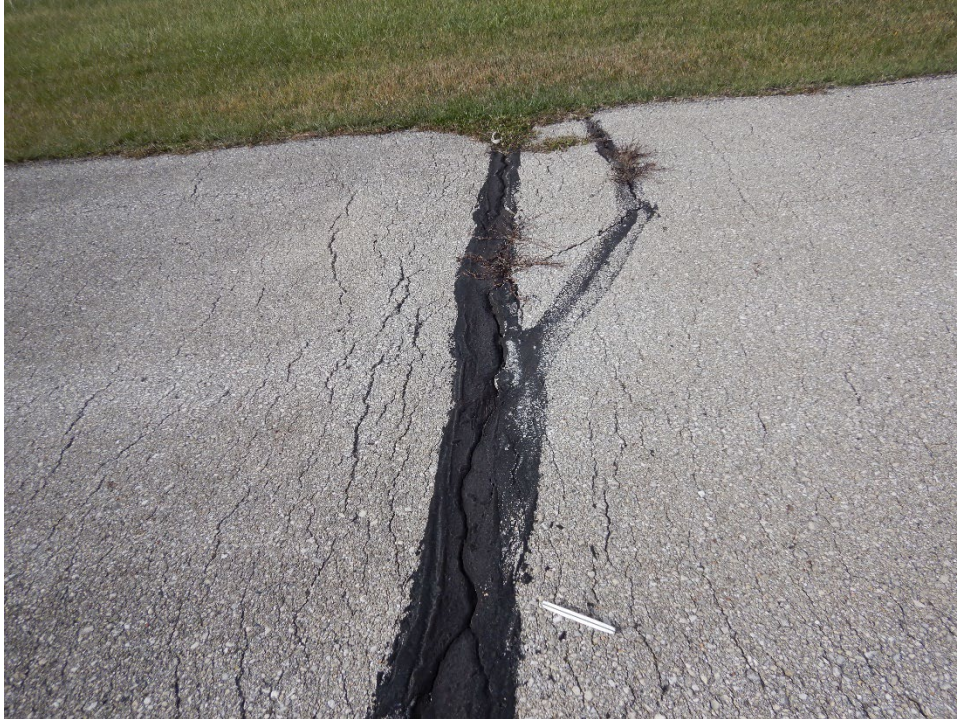
Runway 18/36 was divided into four sections. All severities of L&T cracking, low-severity raveling, and low- and medium-severity weathering were identified in Section 01. Section 02 contained low- and medium-severity alligator cracking and L&T cracking, as well as low-severity patching, raveling, and weathering. Low- and medium-severity L&T cracking, low-severity raveling, and all severities of weathering were observed in Section 03. Section 04 contained low- and medium-severity L&T cracking and weathering and low-severity patching, raveling, and alligator cracking. The low-severity L&T cracking on this runway was primarily unsealed, and the medium-severity L&T cracking was due to either unsealed crack widths greater than  $\frac{1}{4}$  in, crack sealant that had failed, or to the development of secondary cracking.

R18MT-01. L&T Cracking (Sample Unit No. 02) (1).

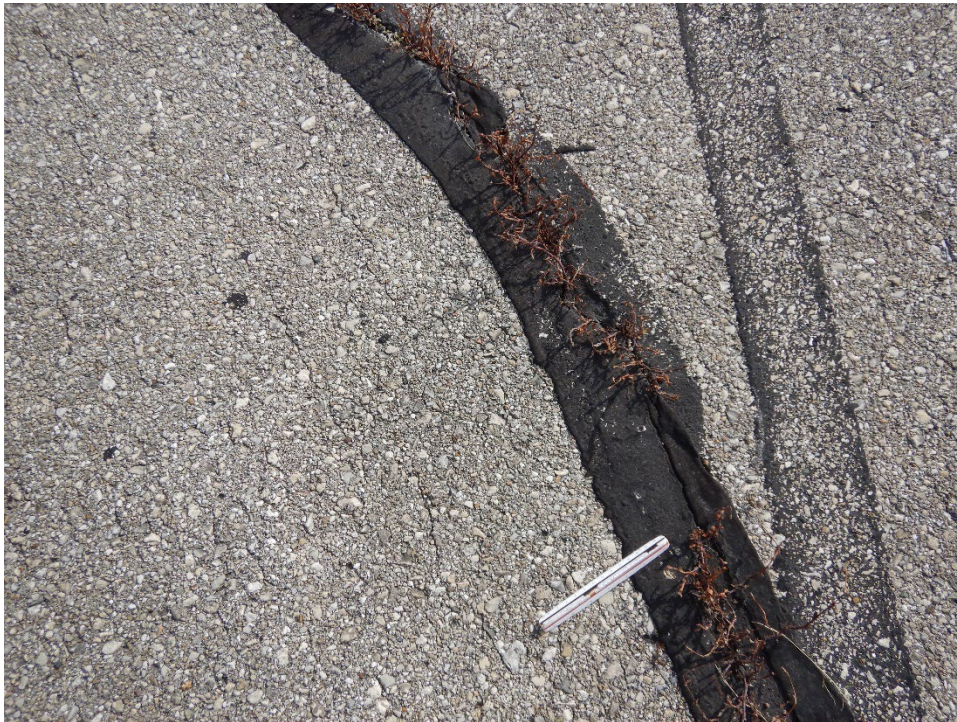
R18MT-01. L&T Cracking (Sample Unit No. 02) (2).

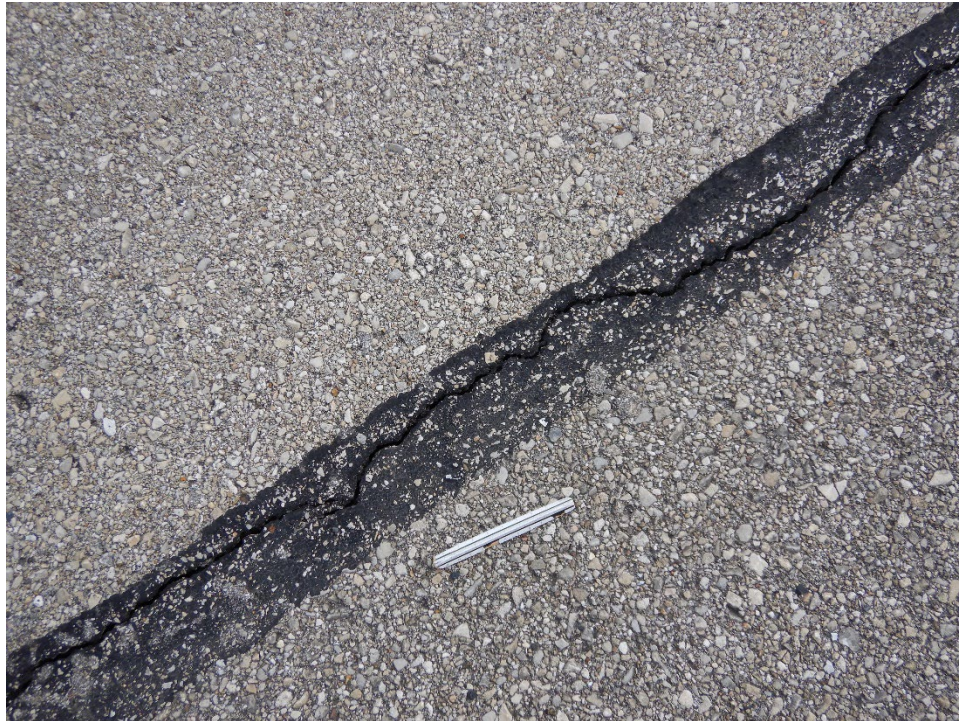
R18MT-02. L&T Cracking (Sample Unit No. 03).

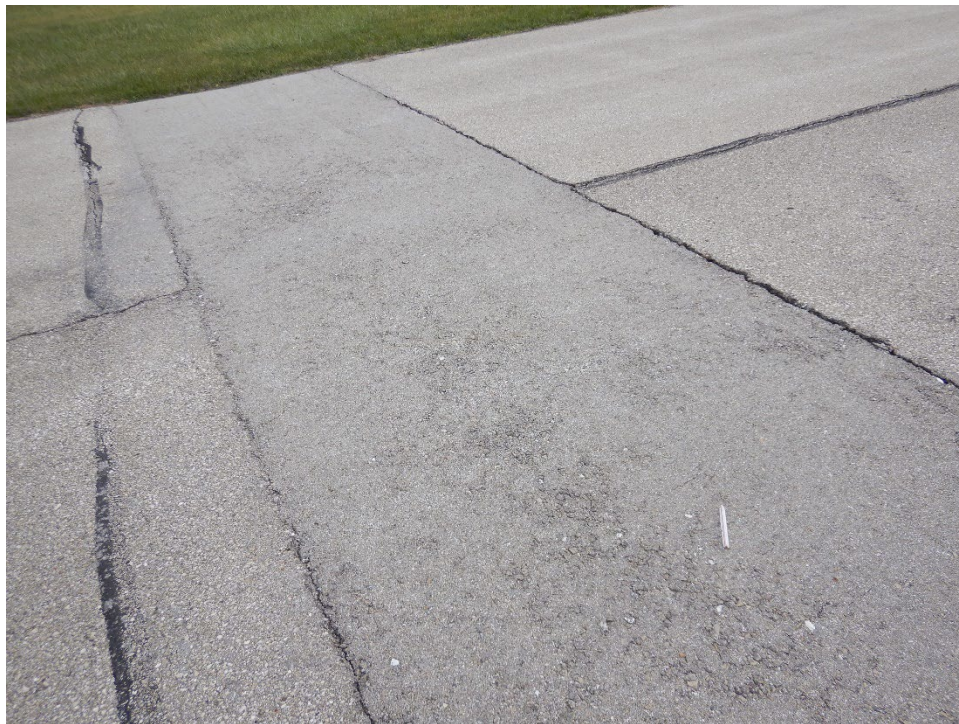
R18MT-02. Patching (Sample Unit No. 03).

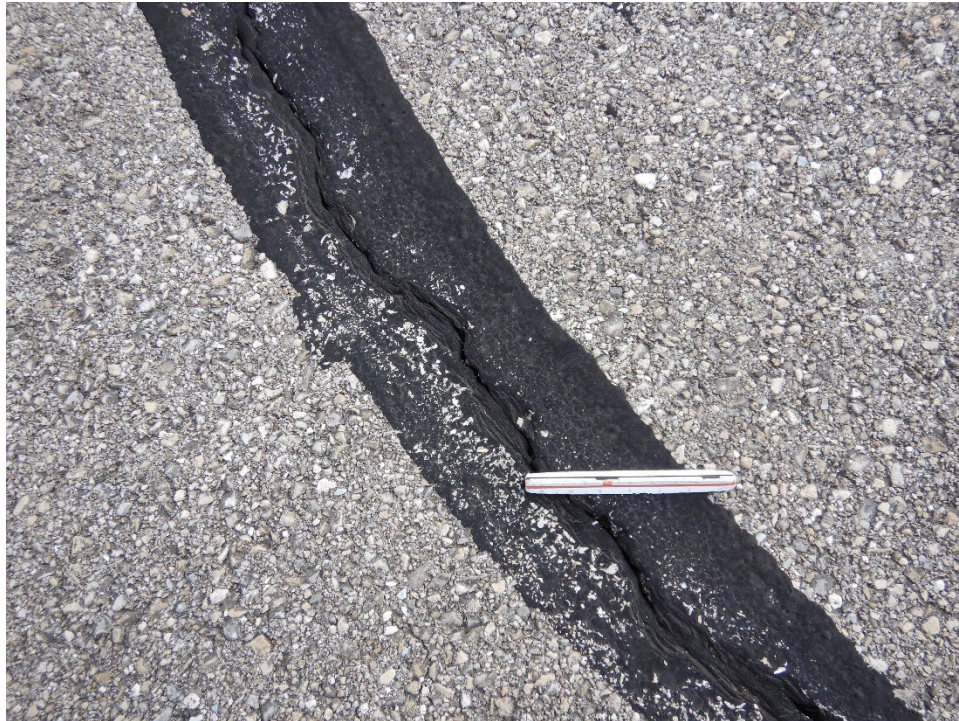
R18MT-03. L&T Cracking (Sample Unit No. 01).

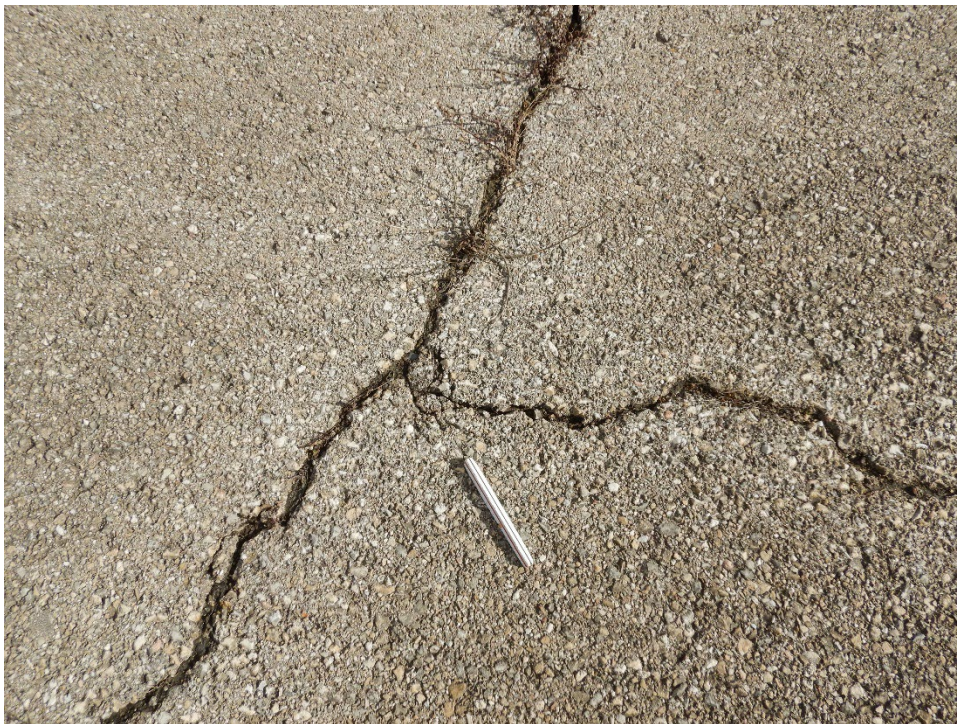
R18MT-04. L&T Cracking (Sample Unit No. 01).

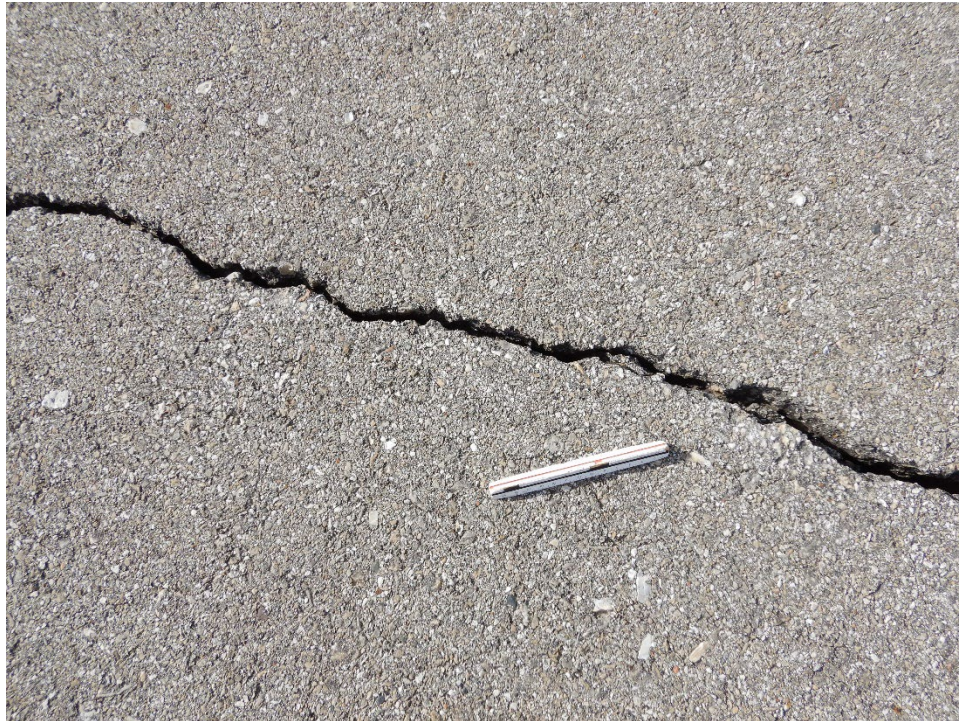
Taxiway 01 connected the Runway 36 approach with the apron area and consisted of one section that had low- and medium-severity L&T cracking and low-severity weathering noted during the inspection. The low-severity L&T cracking in Section 01 was unsealed and the medium-severity L&T cracking was recorded where unsealed crack widths exceeded  $\frac{1}{4}$  in.

T01MT-01. L&T Cracking (Sample Unit No. 02).

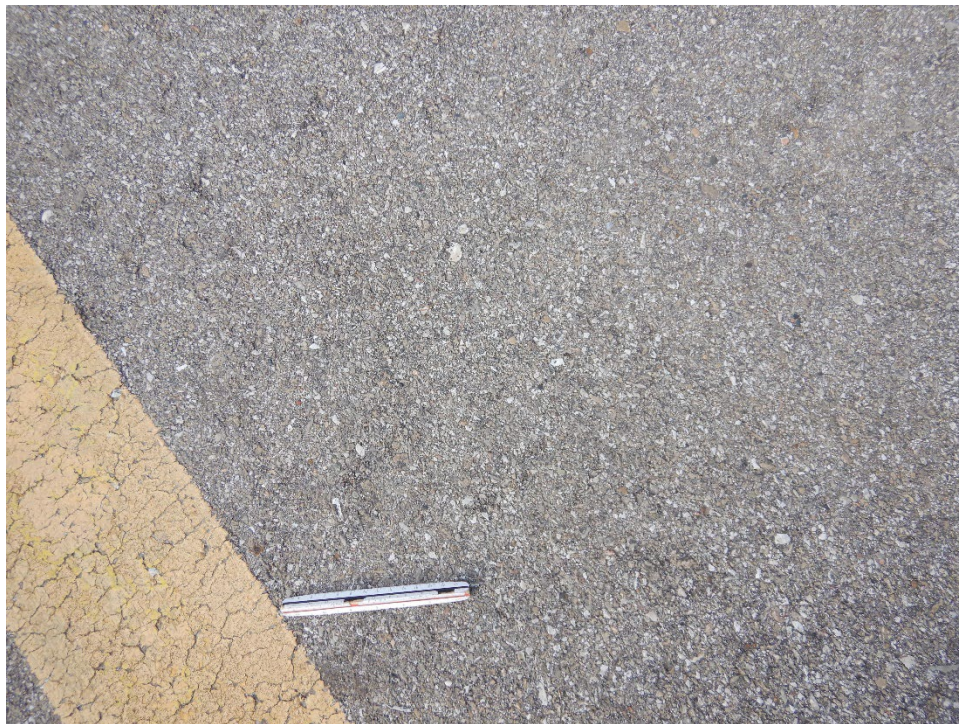
T01MT-01. Weathering (Sample Unit No. 02).

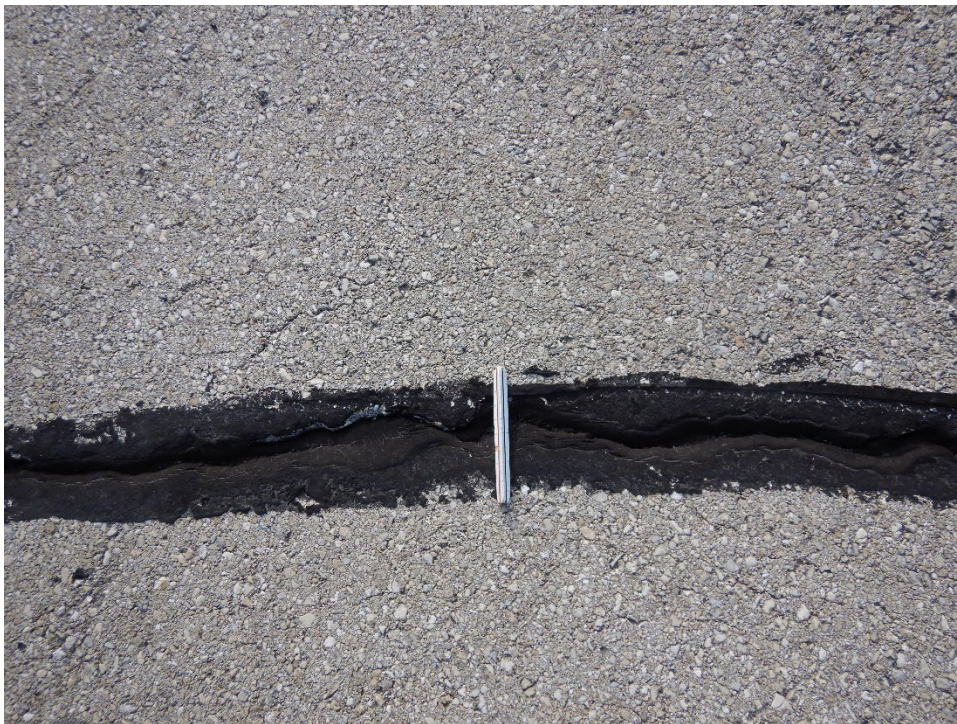
Taxiway 02 was defined by two sections that connected Runway 13/31 and with the apron area. Section 01 contained low-severity raveling and low- and medium-severity L&T cracking and weathering. The low-severity L&T cracking was unsealed, and the medium-severity L&T cracking was recorded where either secondary cracking had developed, crack sealant had failed, or unsealed crack widths were greater than  $\frac{1}{4}$  in. Medium-severity L&T cracking, low-severity raveling, and low- and medium-severity weathering were observed in Section 02. The medium-severity L&T cracking was noted where crack sealant was unsatisfactory.

T02MT-01. L&T Cracking (Sample Unit No. 05).

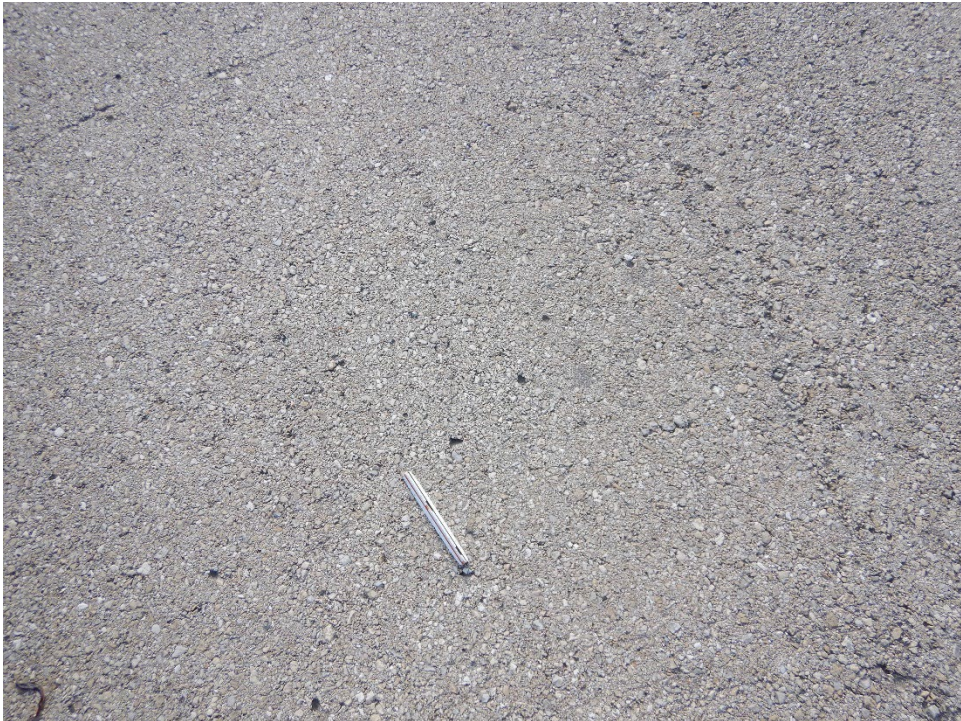
T02MT-01. Weathering (Sample Unit No. 05).

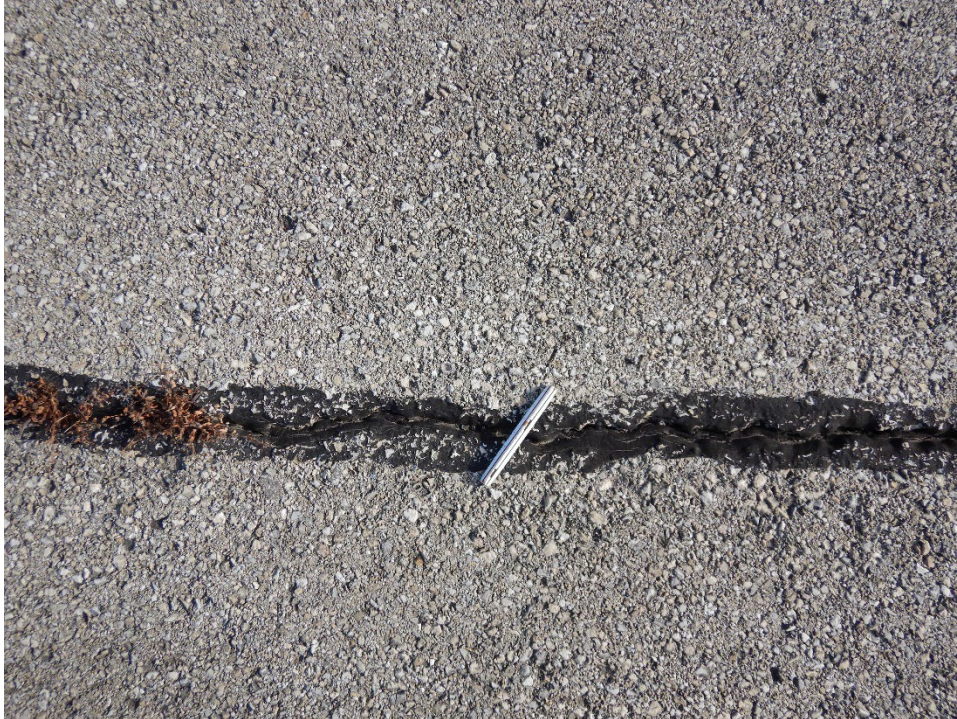
T02MT-02. L&T Cracking (Sample Unit No. 01).

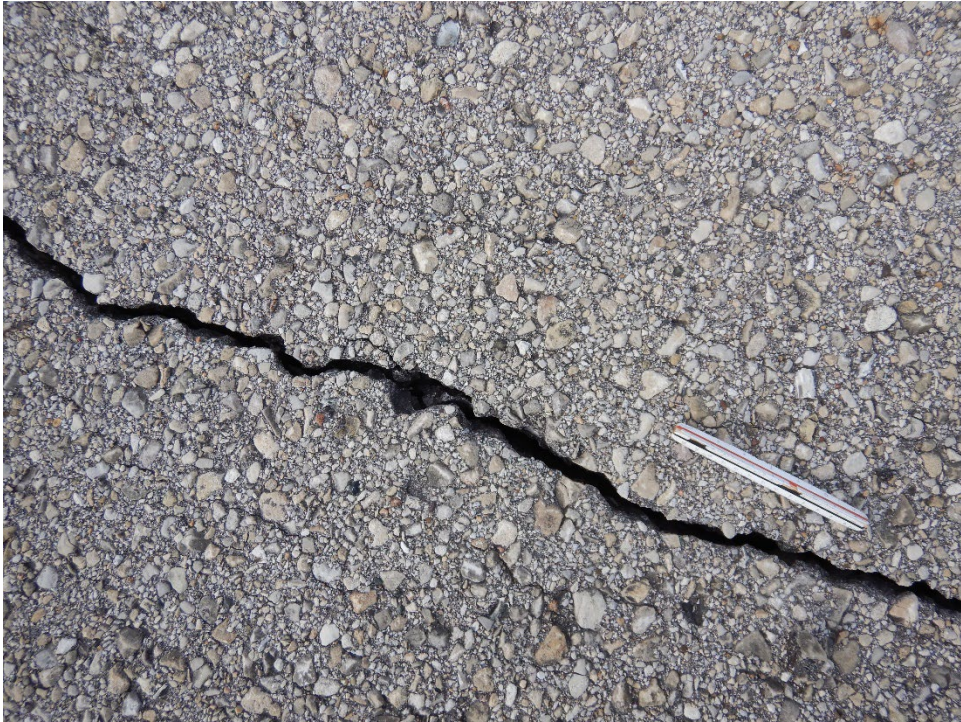
Taxiway 03, the parallel taxiway for Runway 13/31, consisted of three sections. Section 01 contained all severities of L&T cracking; low- and medium-severity raveling; and low-severity alligator cracking, patching, and weathering. Low- and medium-severity L&T cracking, low-severity patching and raveling, and medium-severity weathering were recorded in Section 02. Section 03 contained all severities of L&T cracking; medium-severity raveling; low-severity alligator cracking, depression, rutting, and swelling; and low- and medium-severity weathering. The low-severity L&T cracking on this taxiway was both sealed and unsealed, while the

T03MT-01. L&T Cracking (Sample Unit No. 03).

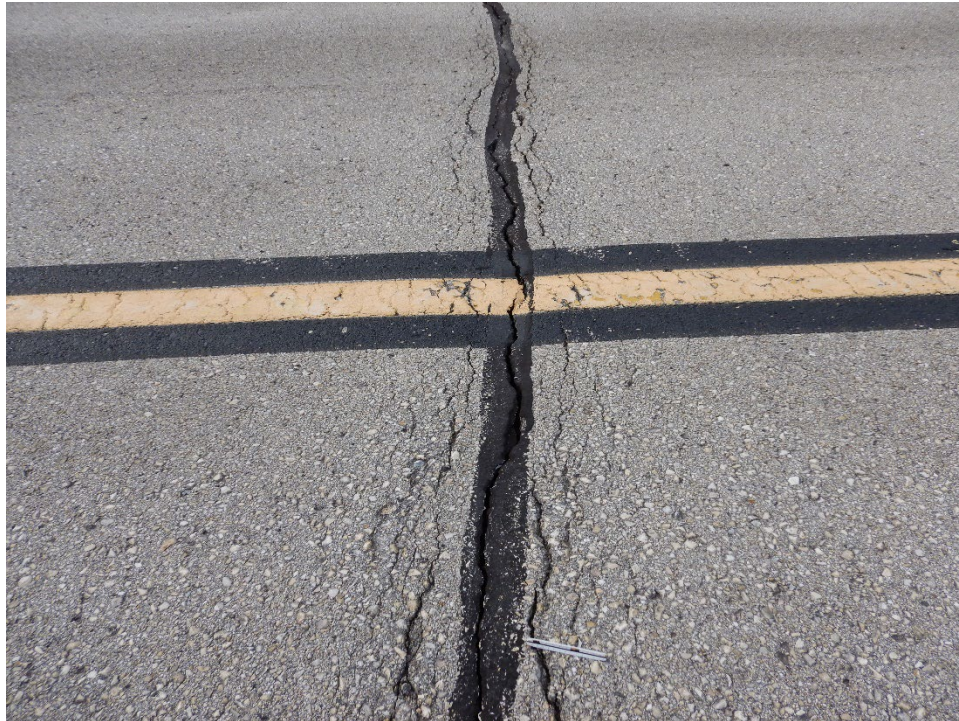
T03MT-01. L&T Cracking (Sample Unit No. 08).

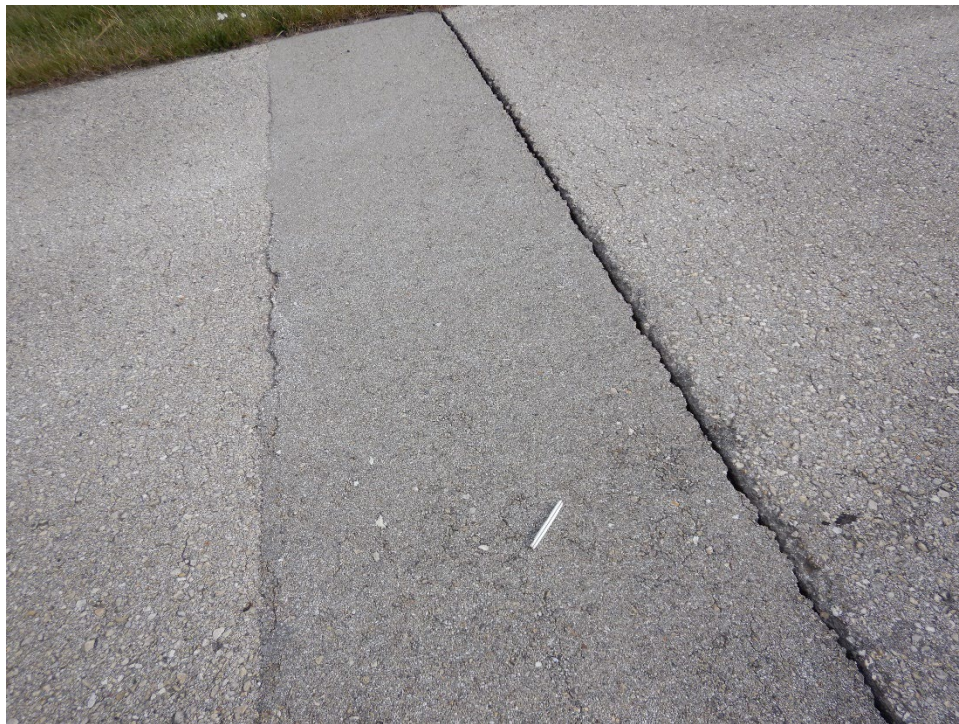
T03MT-01. Patching (Sample Unit No. 03).

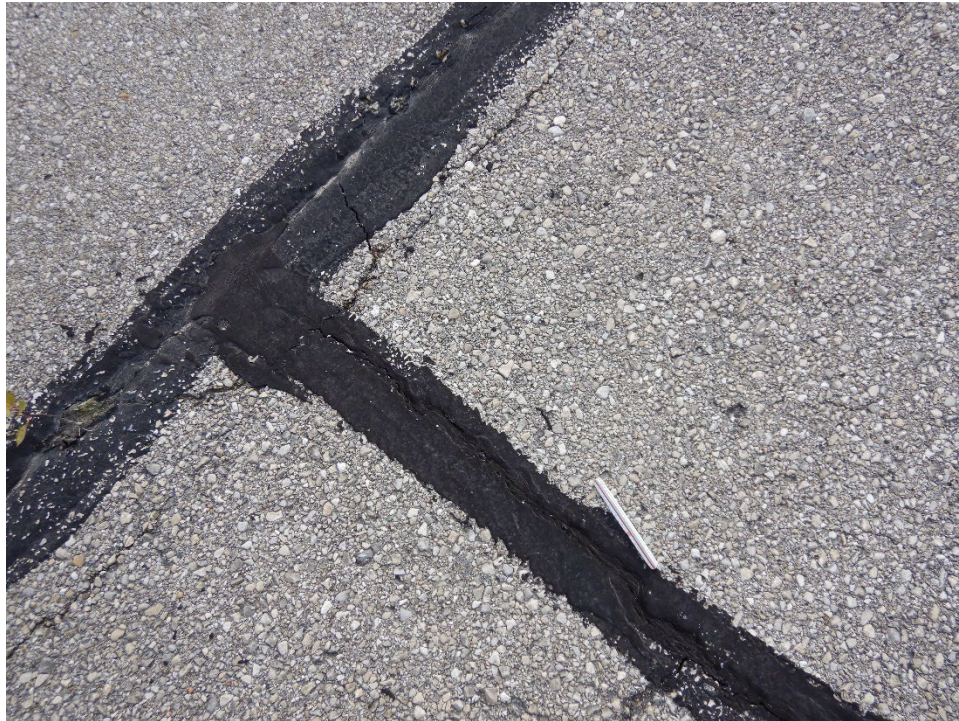
T03MT-02. L&T Cracking (Sample Unit No. 01).
