# Marshalltown Municipal Airport

## PAVEMENT MANAGEMENT REPORT

**JULY 2022**

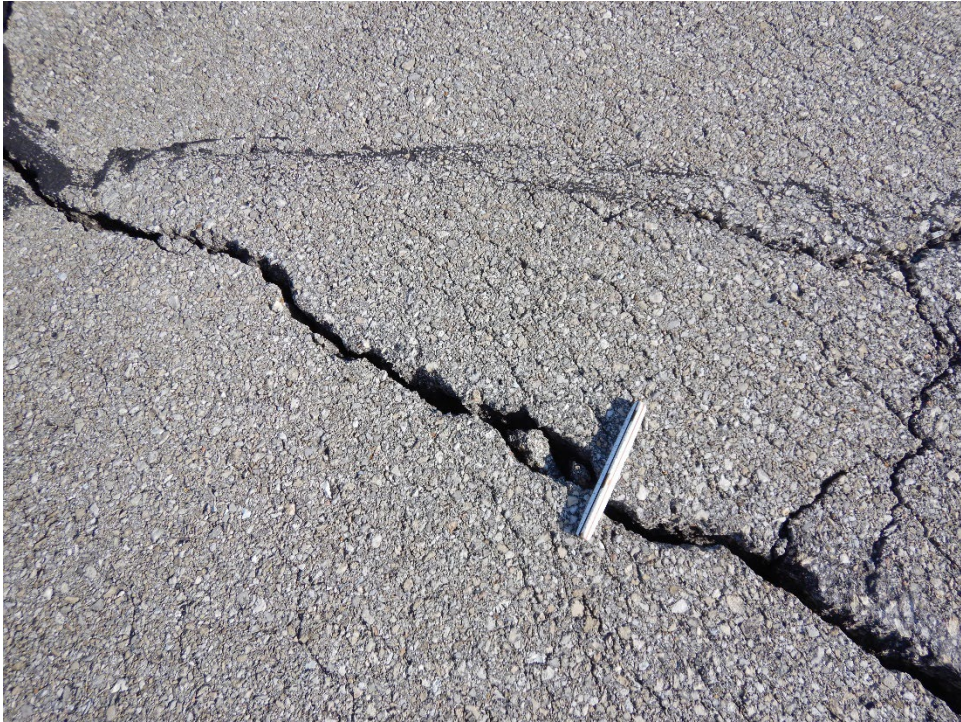
T03MT-03. L&T Cracking (Sample Unit No. 06).

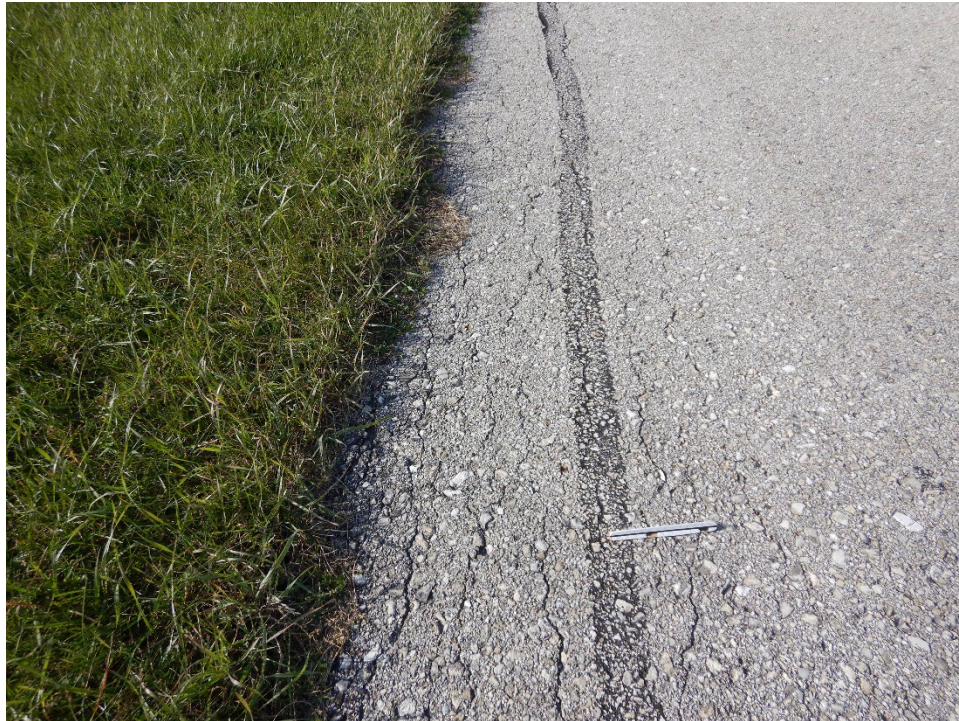
Taxiway 04 contained one section that had areas of low- and medium-severity L&T cracking and weathering, as well as low-severity patching, raveling, alligator cracking, and rutting. The low-severity L&T cracking was unsealed. The medium-severity L&T cracking was recorded where either secondary cracking had developed, unsealed crack widths were greater than  $\frac{1}{4}$  in, or the crack sealant had failed.

T04MT-01. Alligator Cracking (Sample Unit No. 03).

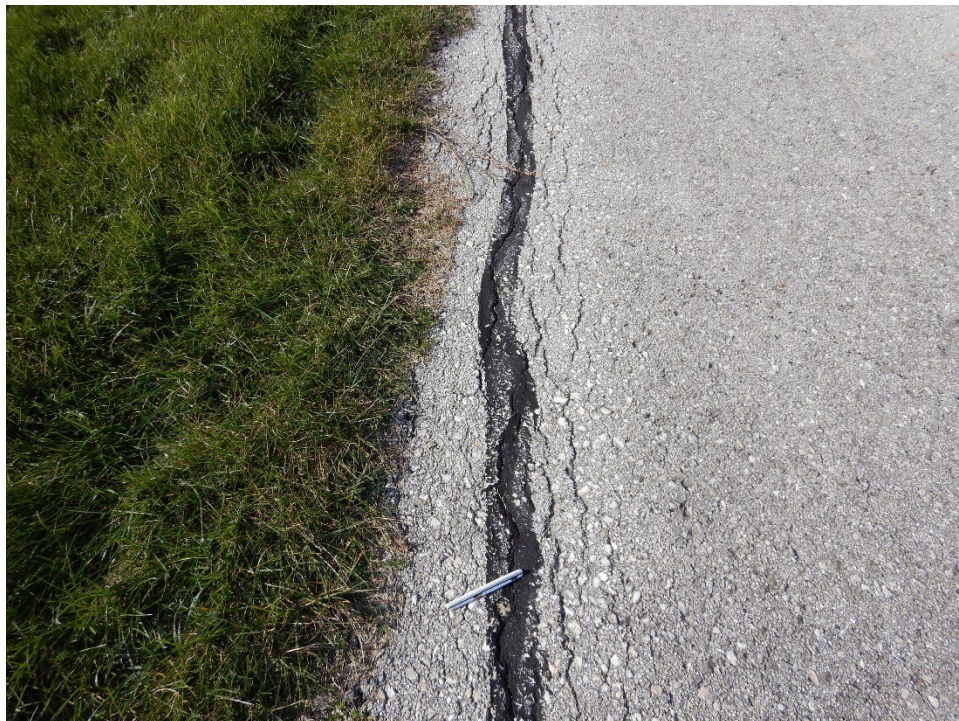
T04MT-01. Alligator Cracking (Sample Unit No. 11).

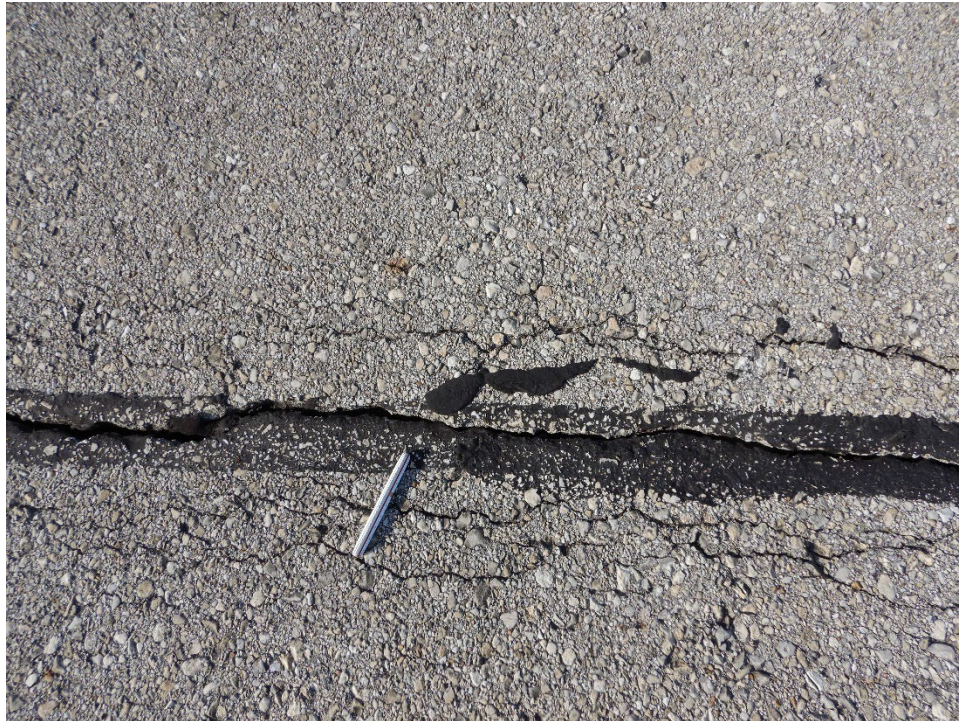
T04MT-01. L&T Cracking (Sample Unit No. 11).

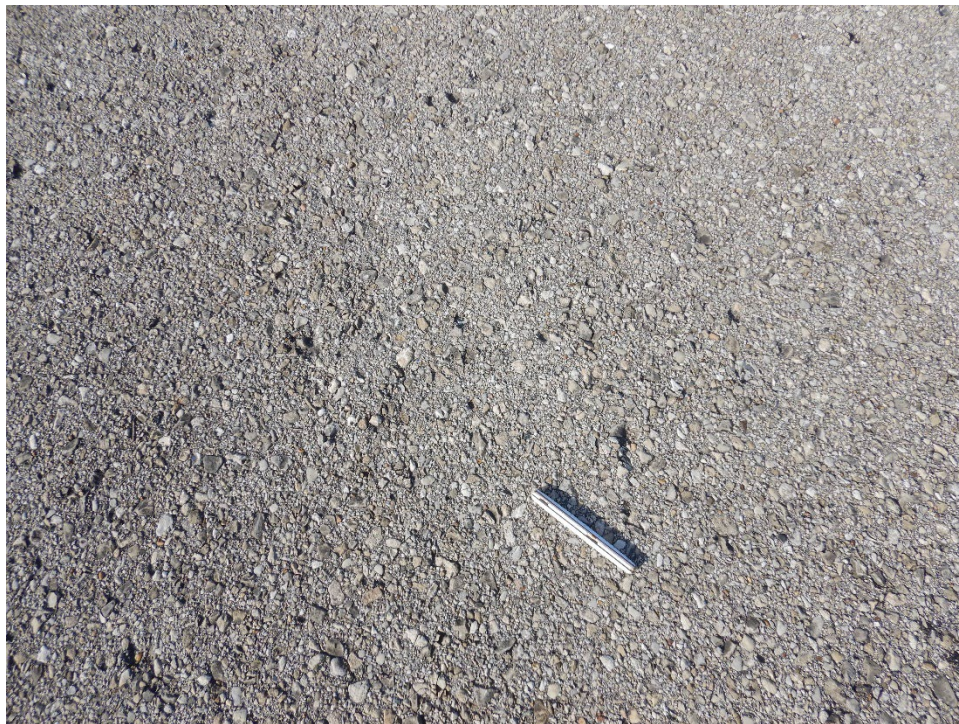
T04MT-01. Weathering (Sample Unit No. 11).

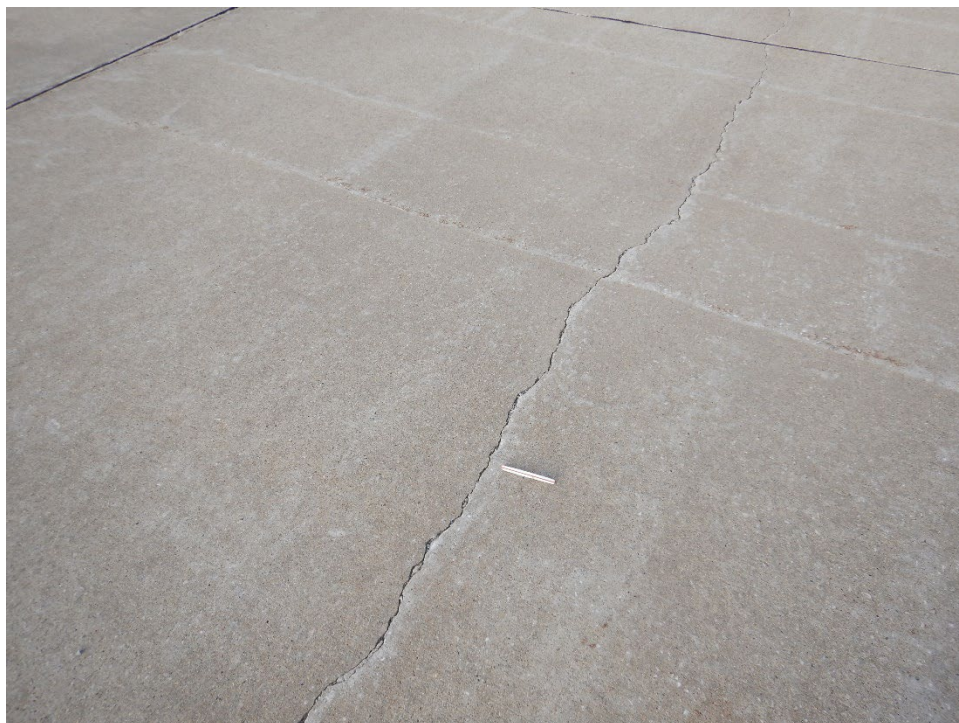
T-hangar 01 was divided into two sections. Section 01 contained low-severity joint seal damage and medium-severity corner spalling, LTD cracking, and small patching. An atypical area with low- and high-severity large patching was noted and recorded as an additional sample unit, according to ASTM D5340-20. Low- and medium-severity LTD cracking and low-severity faulting, joint seal damage, and small patching were identified in Section 02.

TH01MT-01. LTD Cracking (Additional Sample Unit No. 07).

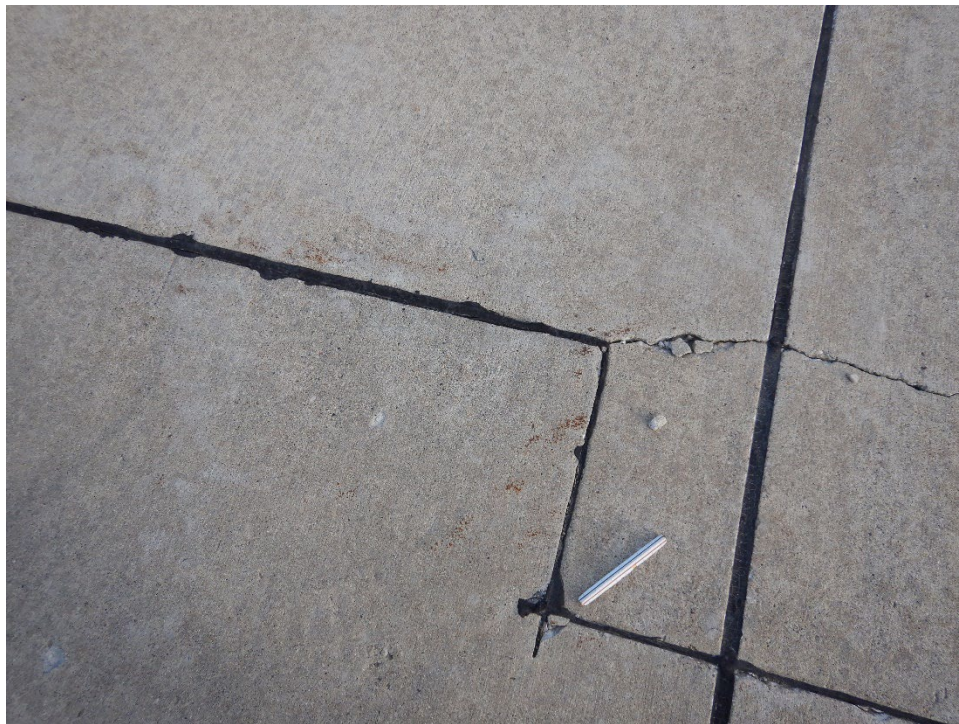
TH01MT-01. Small Patching (Sample Unit No. 11).

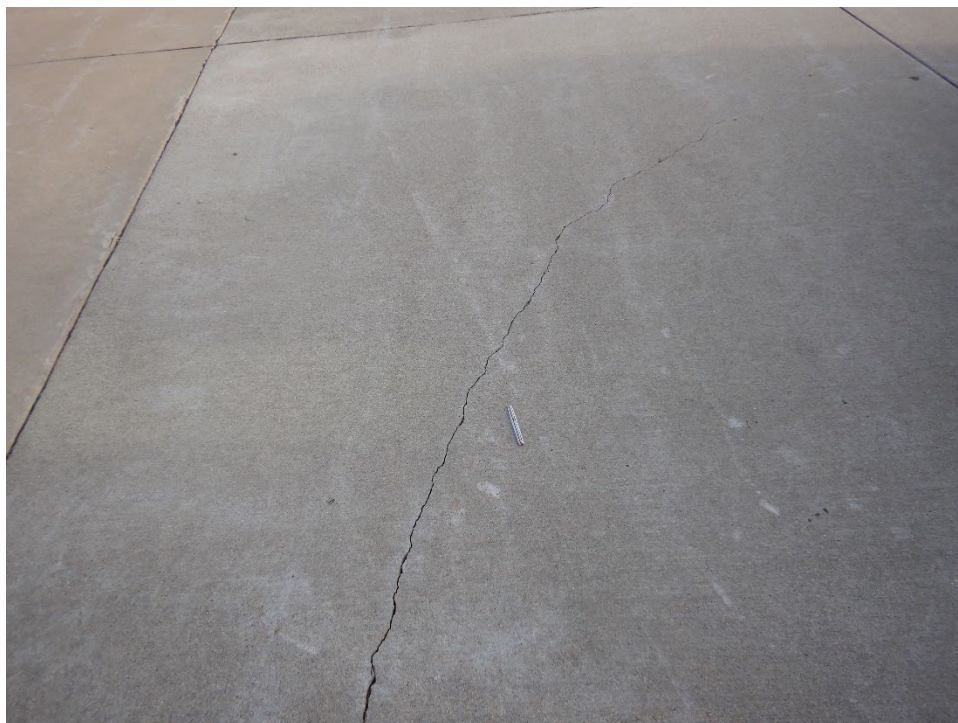
TH01MT-02. LTD Cracking (Sample Unit No. 05).

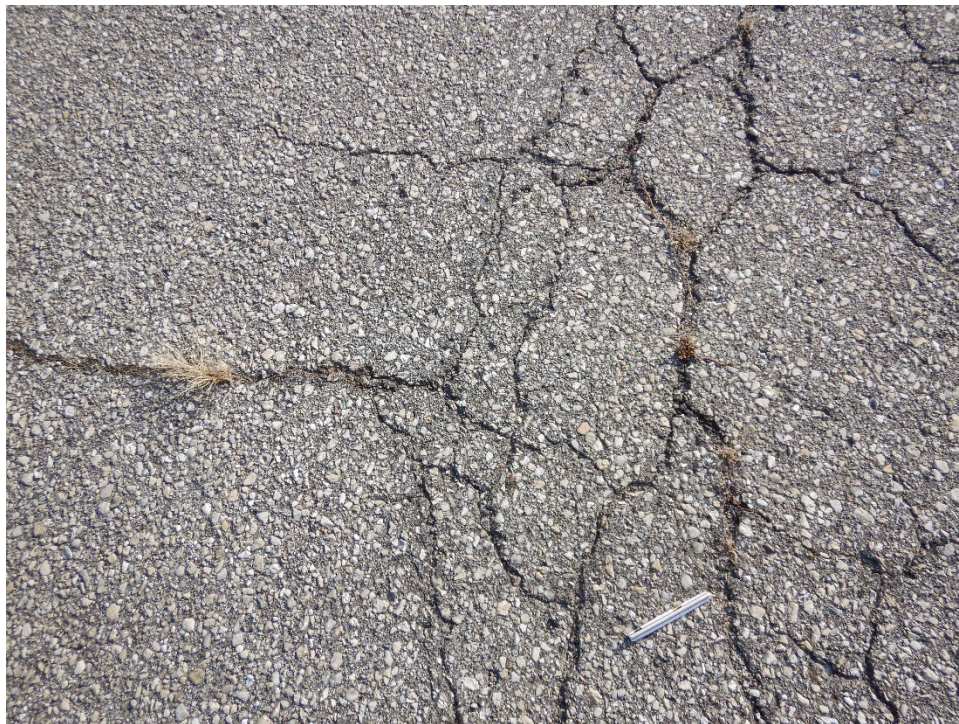
T-hangar 02, which was located adjacent to Taxiway 01, consisted of one section in poor condition. Medium-severity alligator cracking, block cracking, weathering, and patching; all severities of L&T cracking; and low-severity raveling were recorded in Section 01. All cracking was unsealed.

TH02MT-01. Alligator Cracking (Sample Unit No. 03).

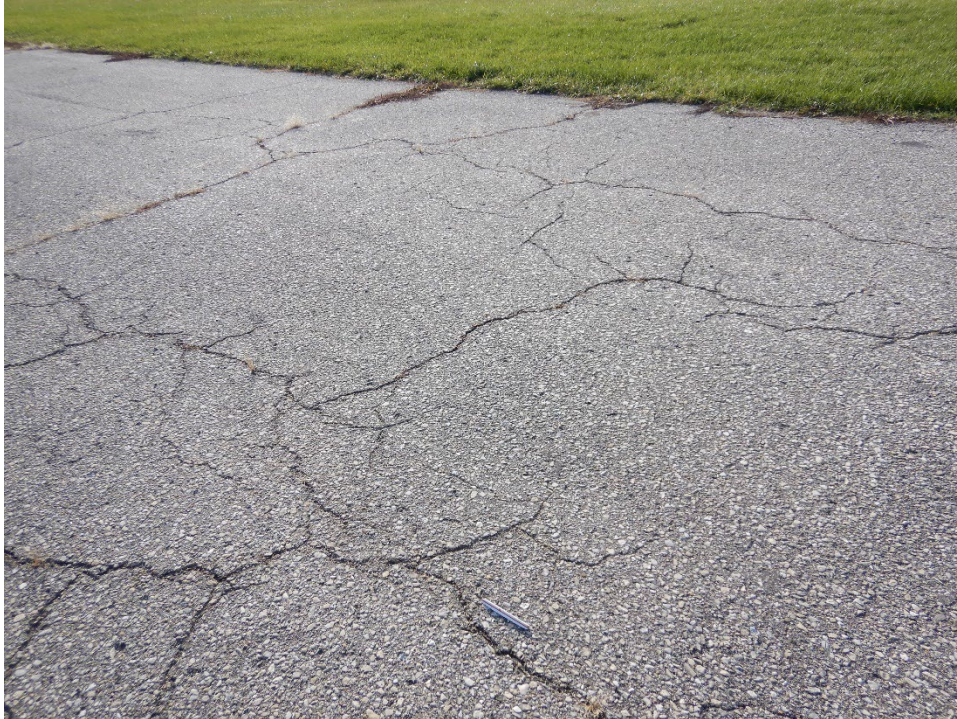
TH02MT-01. Block Cracking (Sample Unit No. 03).
