Milford-Fuller Airport

PAVEMENT MANAGEMENT REPORT

AUGUST 2019

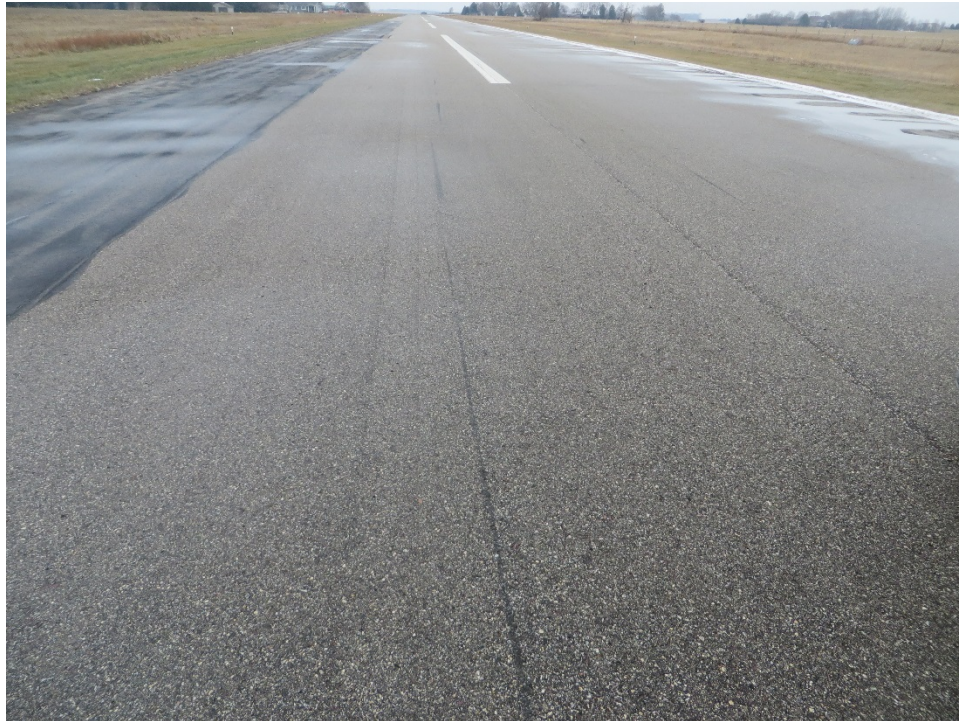
R09MD-01. Overview.

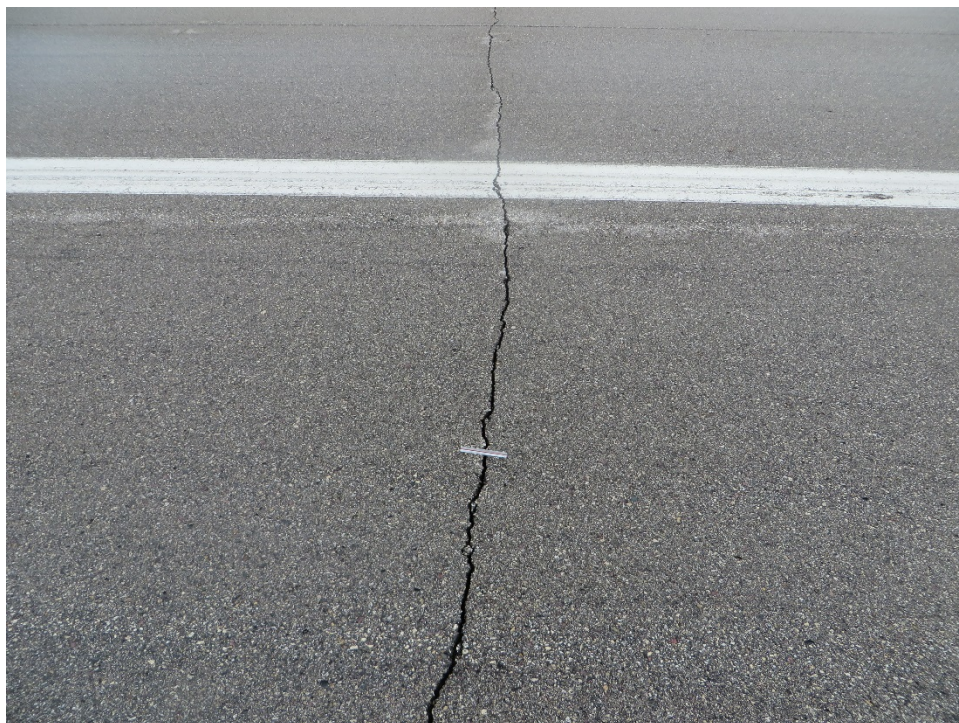
R09MD-01. L&T Cracking (Sample Unit No. 07).

50 PATCHING L 26.00 SqFt Comments:
48 LONGITUDINAL/TRANSVERSE CRACKING L 10.00 Ft Comments:LU
57 WEATHERING L 4,000.00 SqFt Comments:

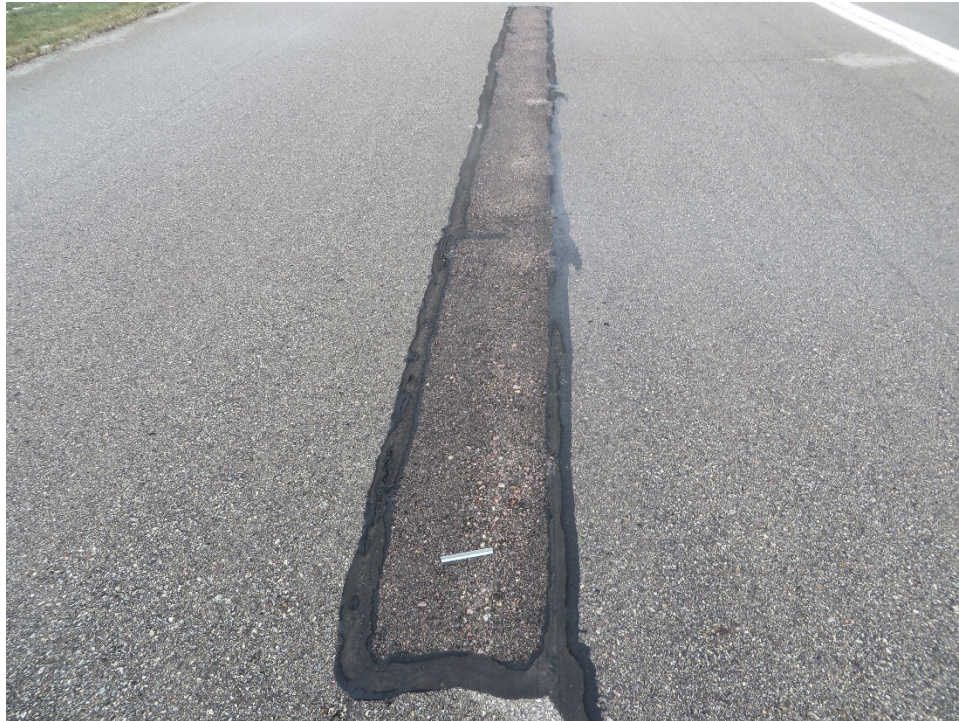
R09MD-01. Patching (Sample Unit No. 07).

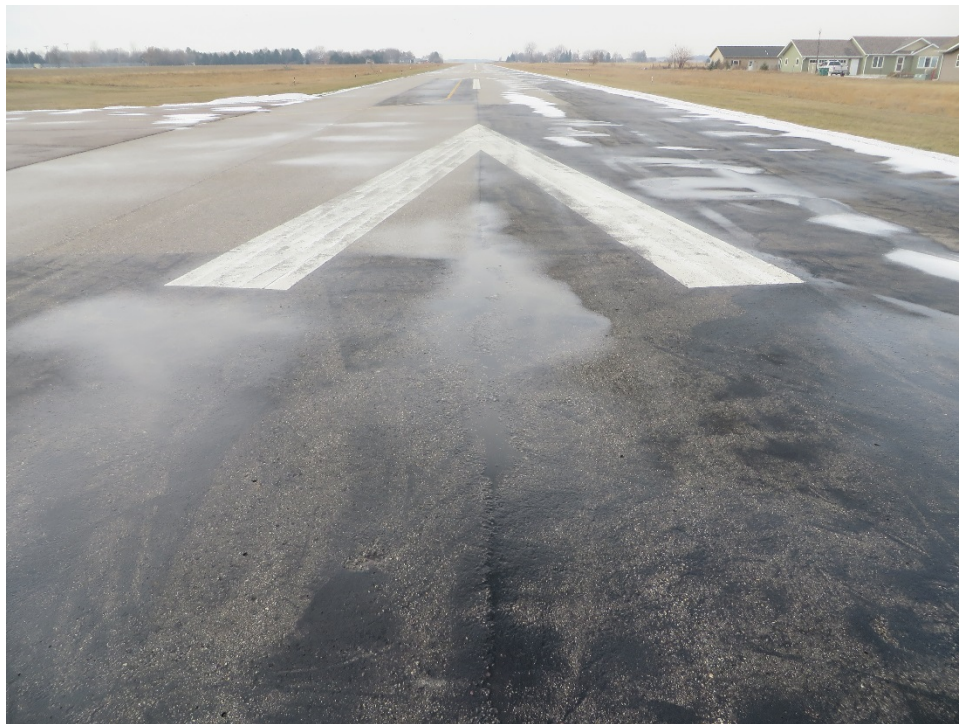
R09MD-02. Overview.

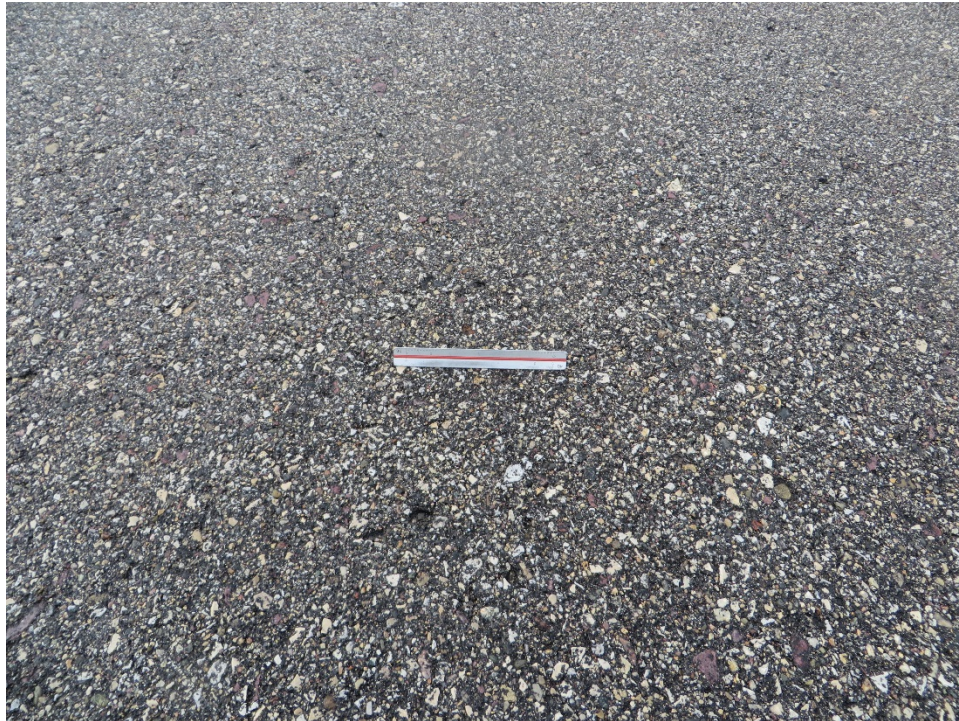
R09MD-02. Raveling (Sample Unit No. 03).

Sample Number: 03 Type: R Area: 5,000.00SqFt PCI = 80
Sample Comments:
57 WEATHERING L 4,000.00 SqFt Comments:
48 LONGITUDINAL/TRANSVERSE CRACKING M 17.00 Ft Comments:W 2NDY
52 RAVELING L 500.00 SqFt Comments:

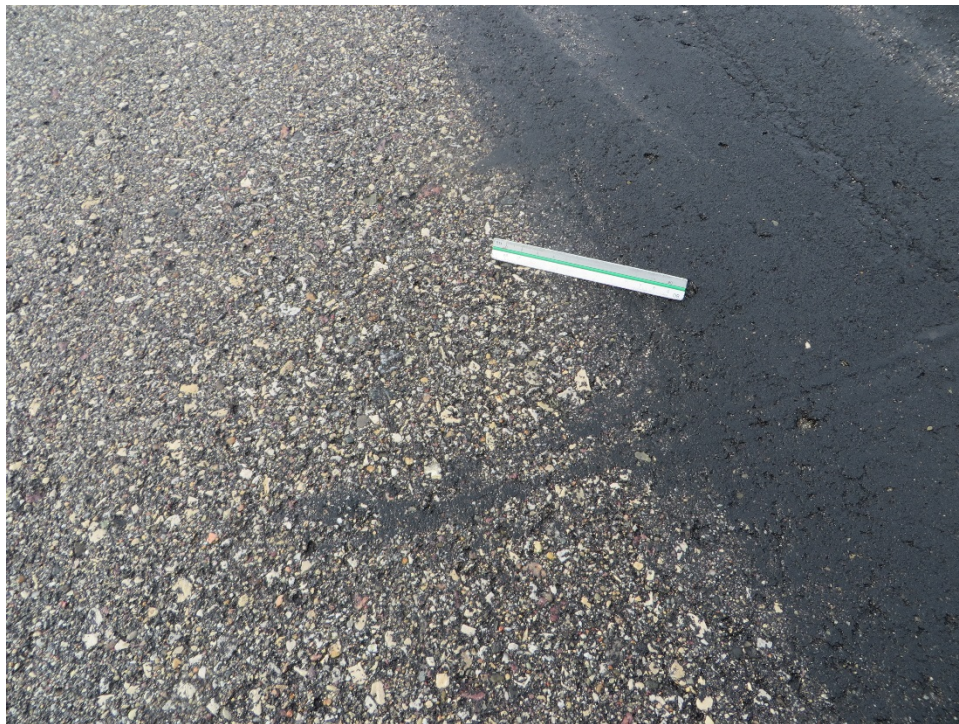
R09MD-02. Weathering (Sample Unit No. 03).

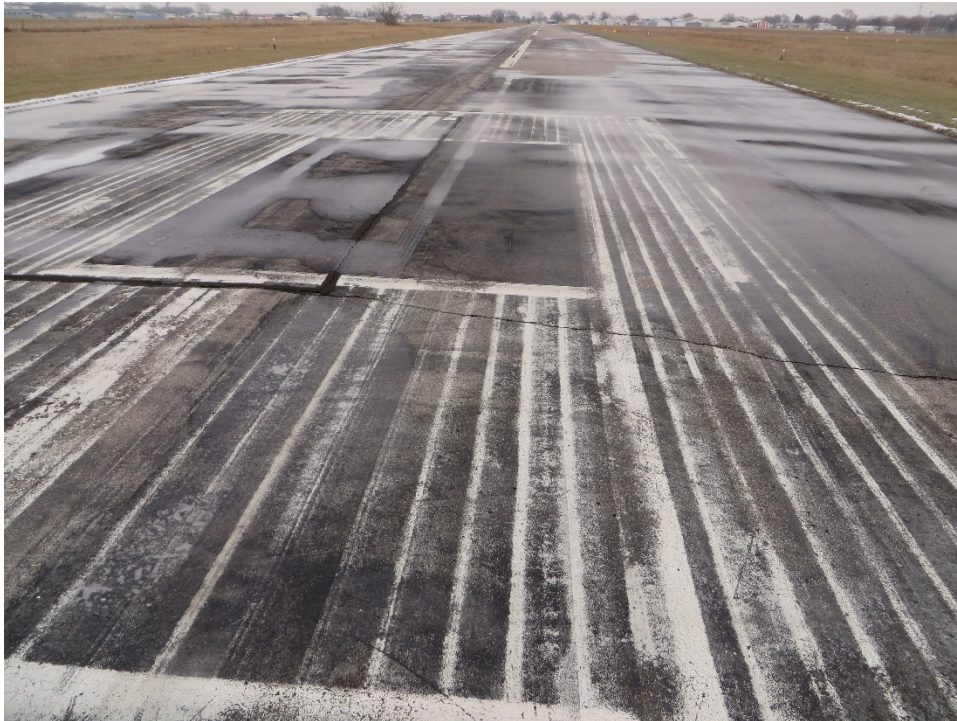
R09MD-03. Overview.

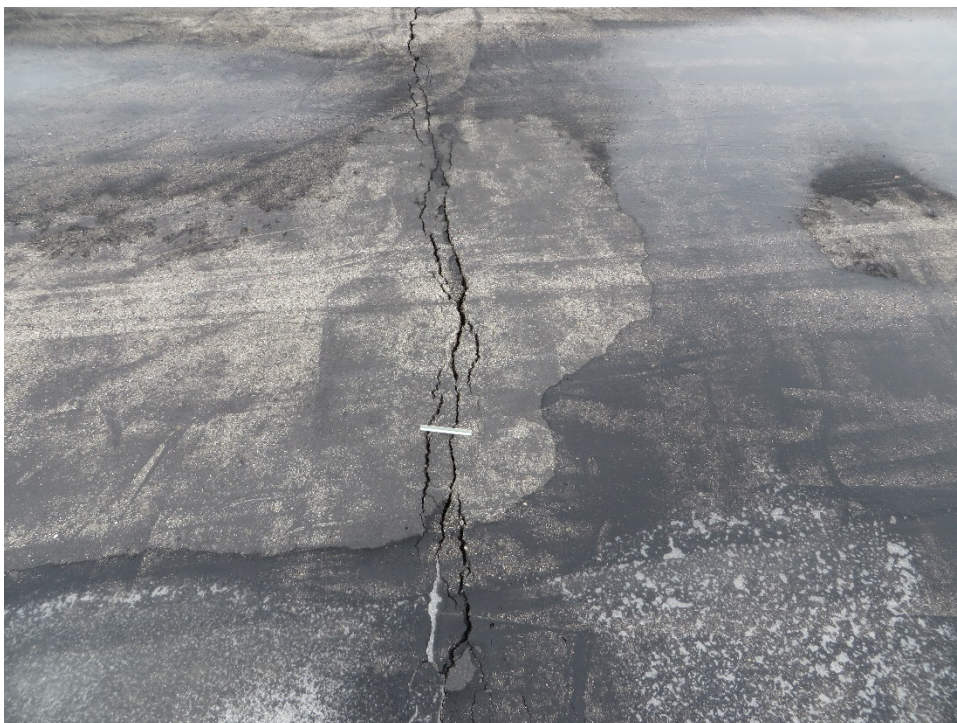
R09MD-03. L&T Cracking (Sample Unit No. 03).

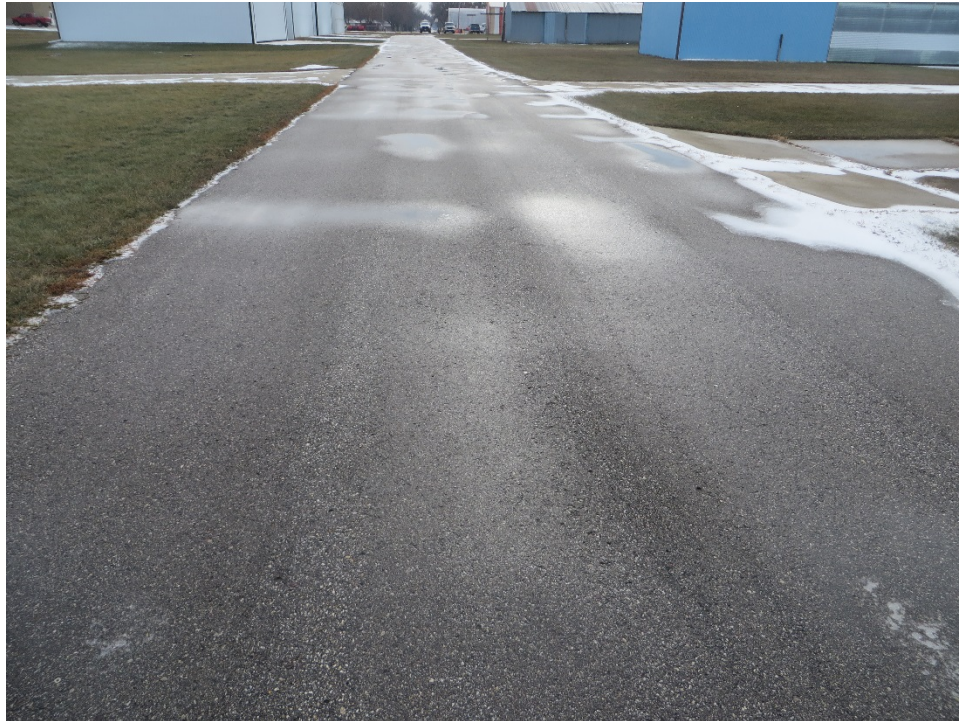
T01MD-01. Overview.

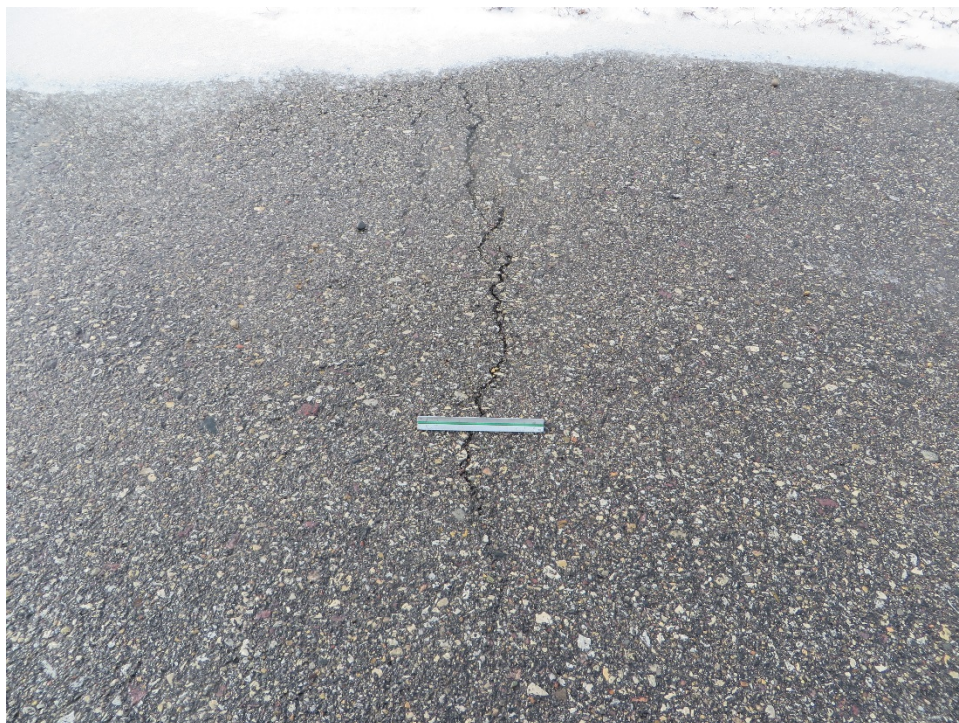
T01MD-01. L&T Cracking (Sample Unit No. 02).

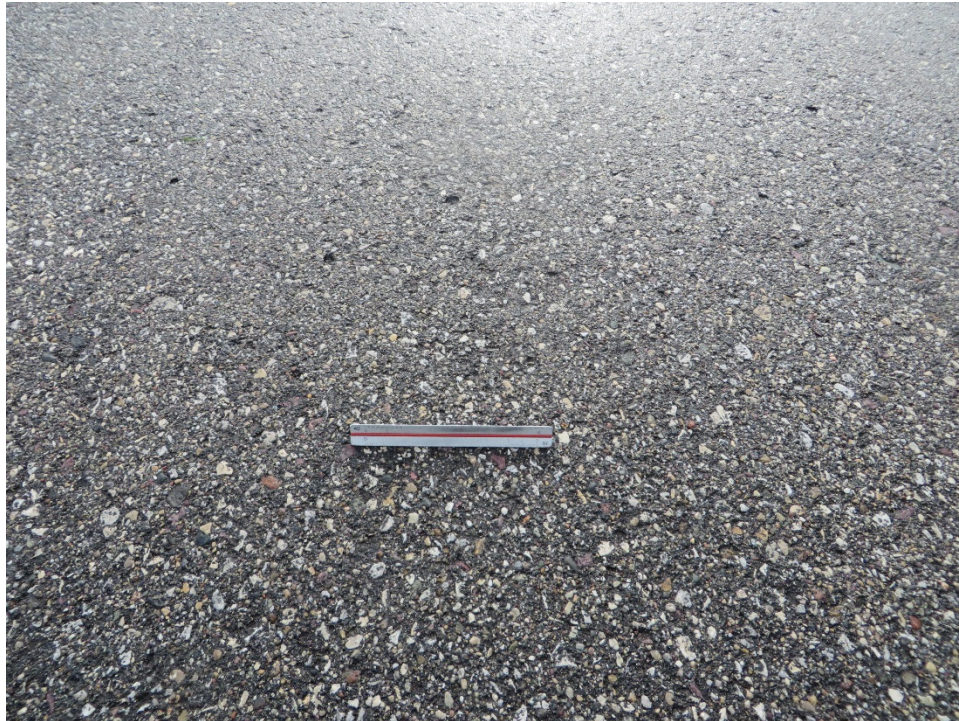
T01MD-01. Weathering (Sample Unit No. 02).

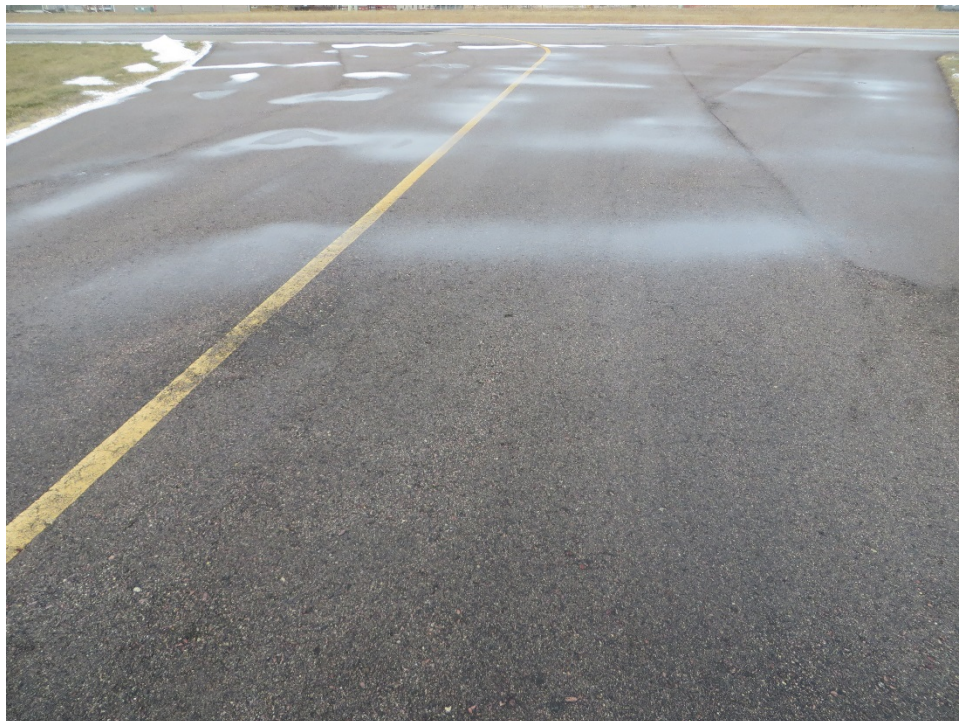
T01MD-02. Overview.

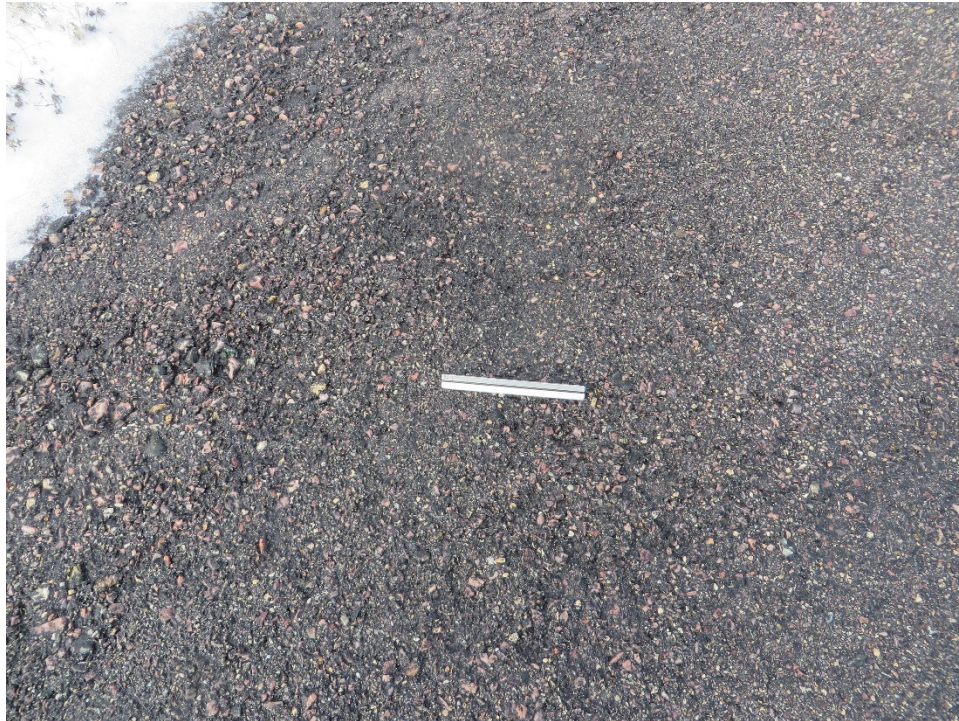
Taxiway was defined by two sections that extended from the Runway 27 approach. Low-severity, unsealed L&T cracking, medium-severity L&T cracking where unsealed crack widths exceeded 1/4 in, and low-severity weathering were recorded in Sections 01 and 02. Areas of low-severity raveling in Section 01 and medium-severity raveling in Section 02 were also observed.

T01MD-02. Raveling (Sample Unit No. 01).
