# Muscatine Municipal Airport

## Pavement Management Report

**JULY 2024**

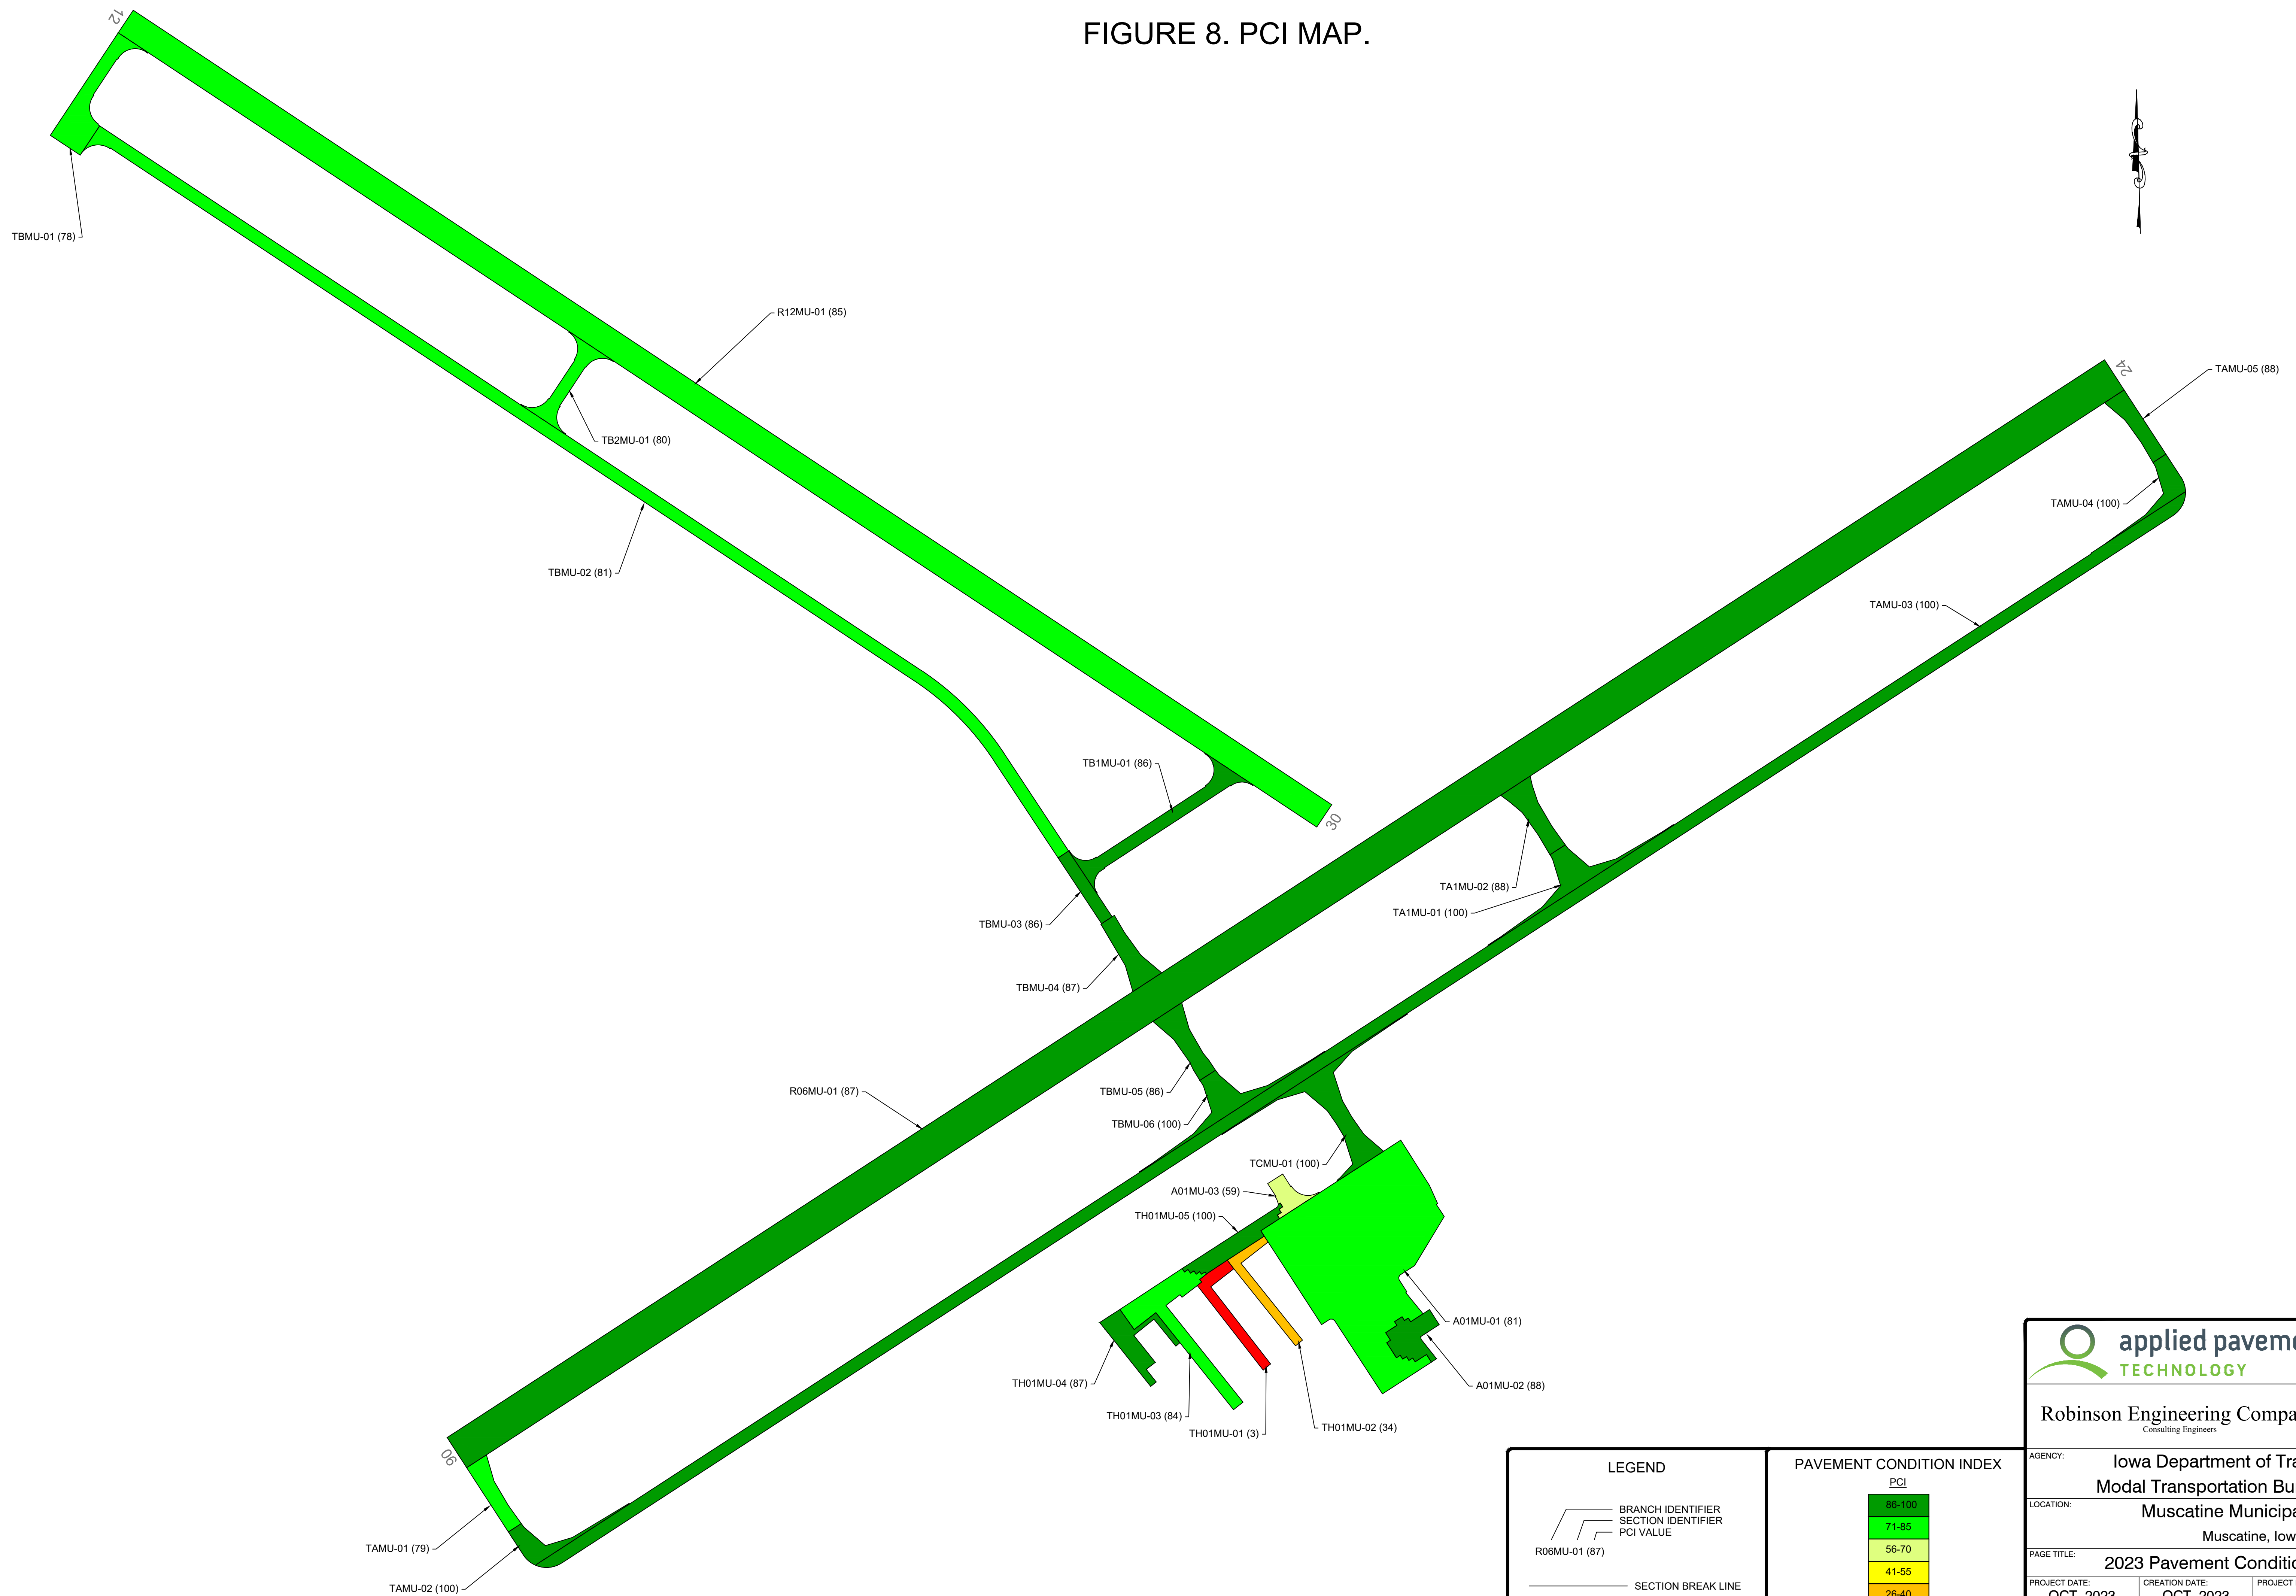
FIGURE 8. PCI MAP.

The pavements at Muscatine Municipal Airport were inspected in November 2023. The 2023 area-weighted condition of Muscatine Municipal Airport is 86, with conditions ranging from 3 to 100 (on a scale of 0 [failed] to 100 [excellent]). During the previous pavement inspection in 2020, the area-weighted PCI of the airport was 83.

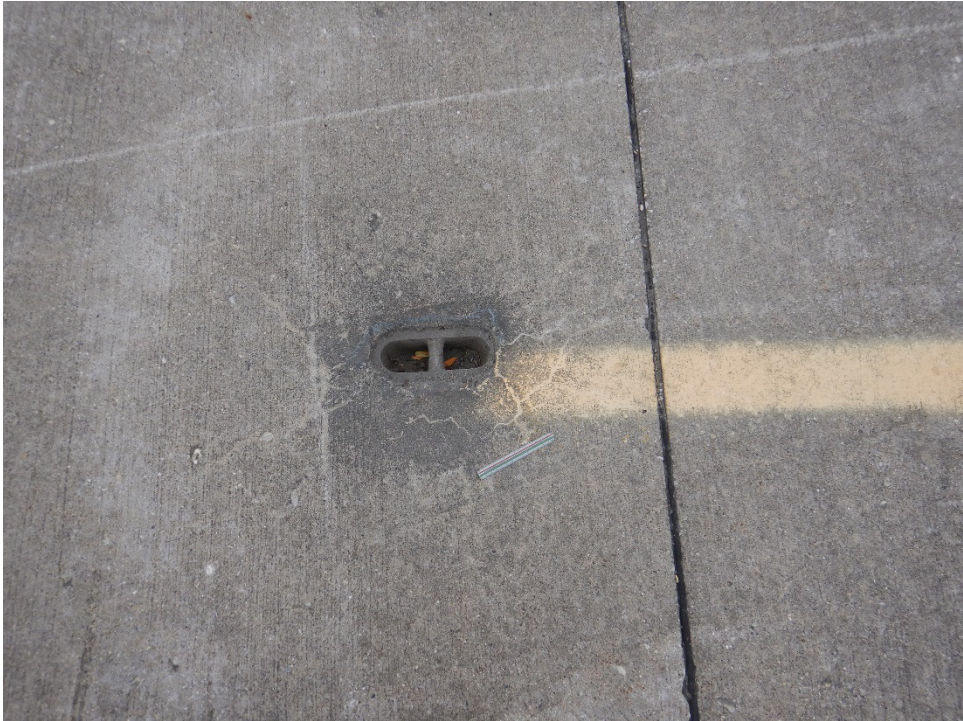
A01MU-01. ASR (Sample Unit No. 47).

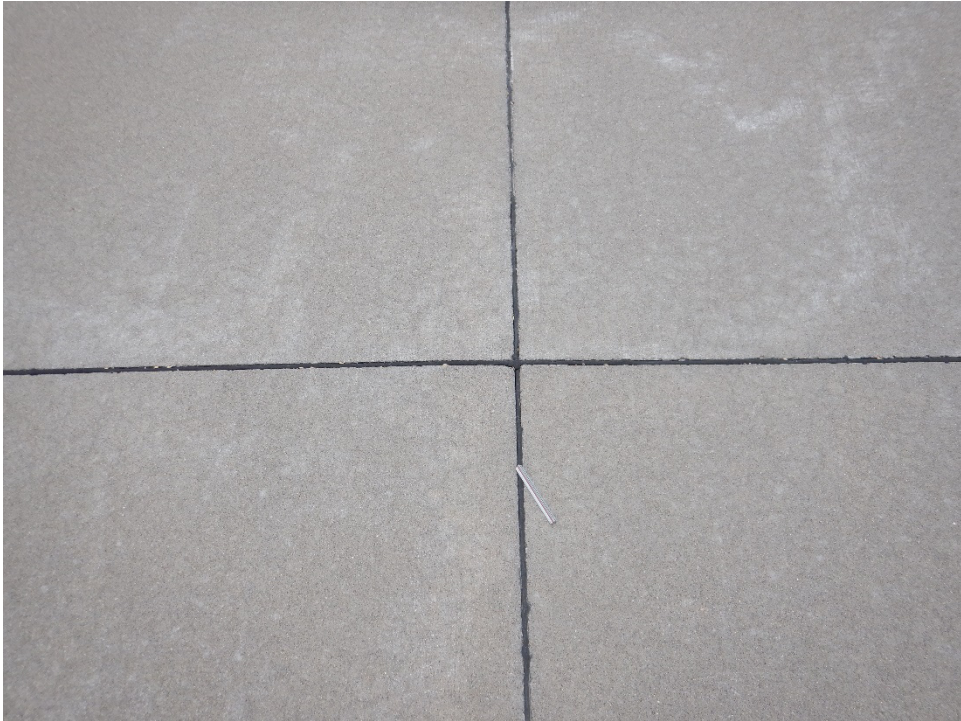
A01MU-02. Joint Seal Damage (Sample Unit No. 02).

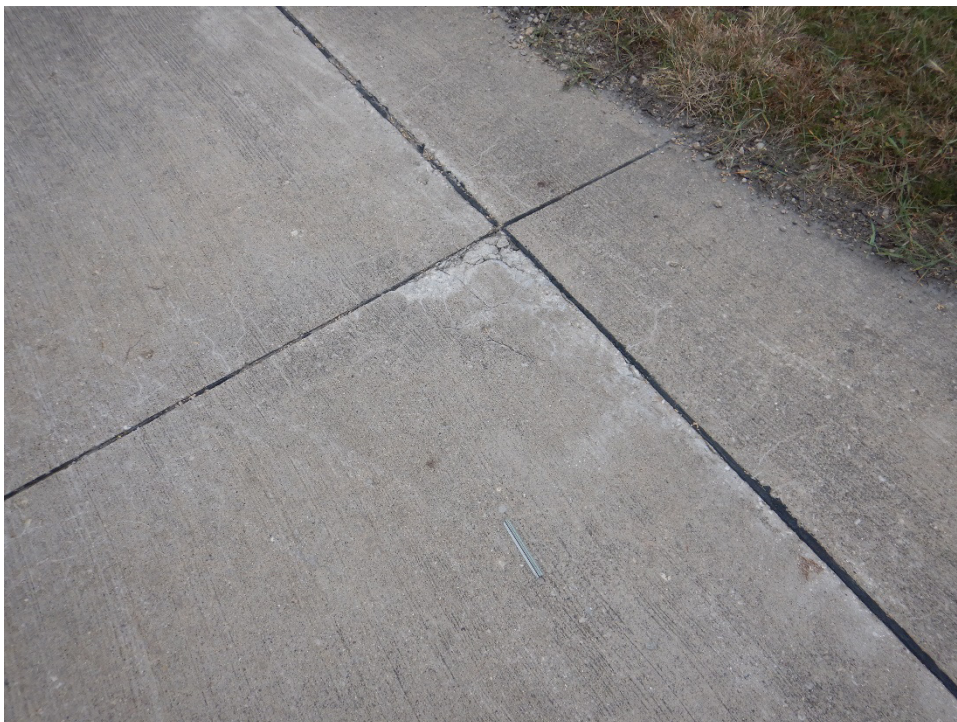
A01MU-03. ASR (Sample Unit No. 02).

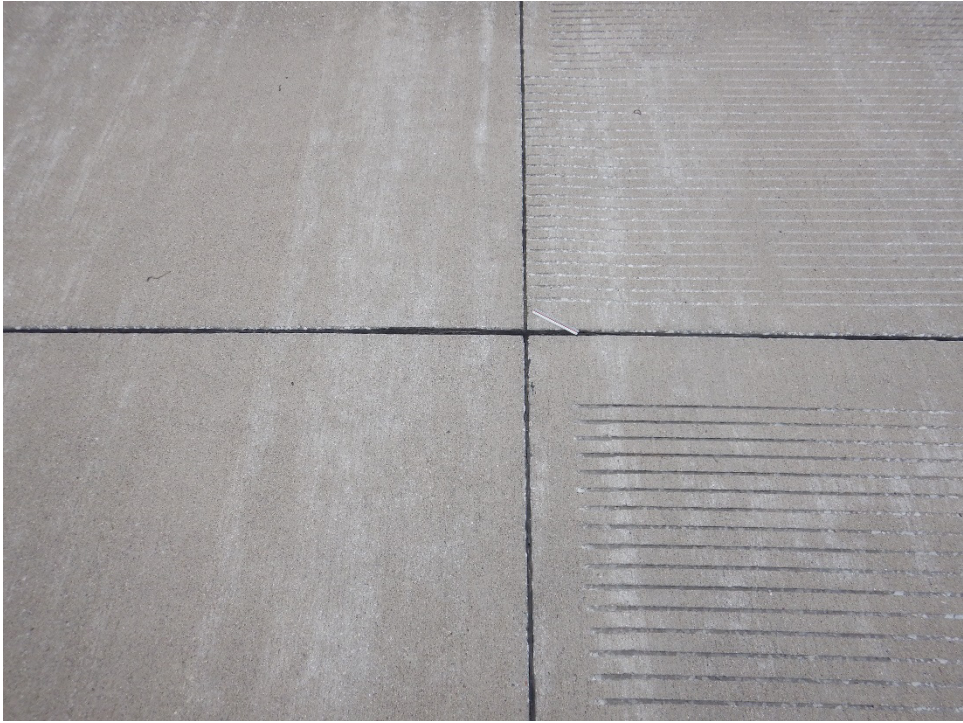
Runway 06/24 was defined by one section. Low-severity faulting and joint spalling, medium-severity corner spalling, and high-severity joint seal damage were recorded in Section 01. An atypical area of low-severity large patching was observed and recorded as an additional sample unit in accordance with ASTM D5340.

R06MU-01. Joint Seal Damage (Sample Unit No. 142).

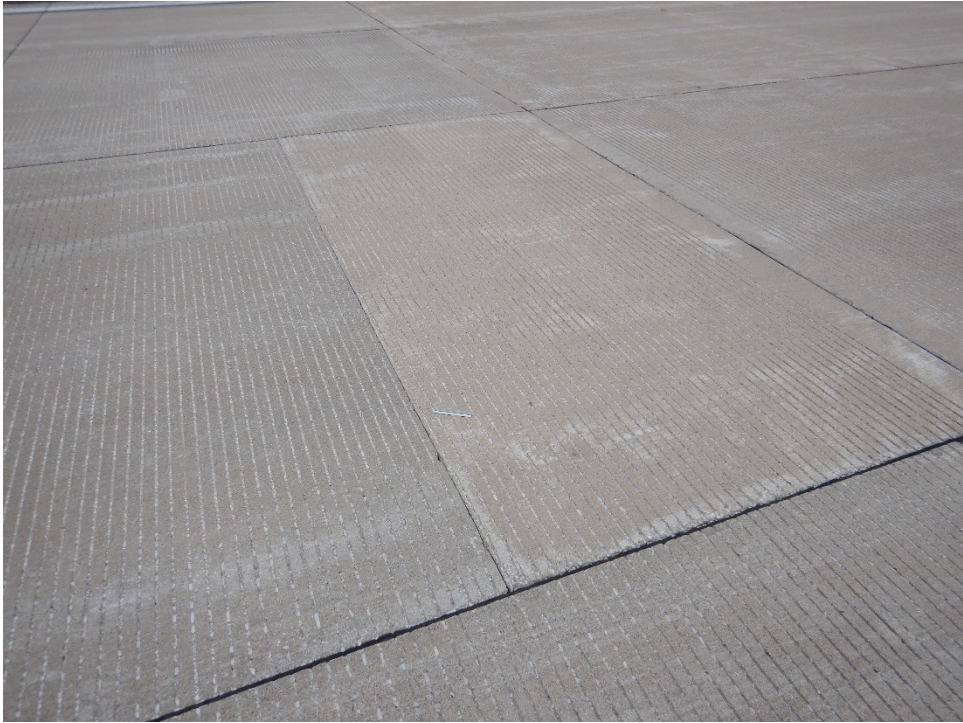
R06MU-01. Large Patching (Additional Sample Unit No. 063).

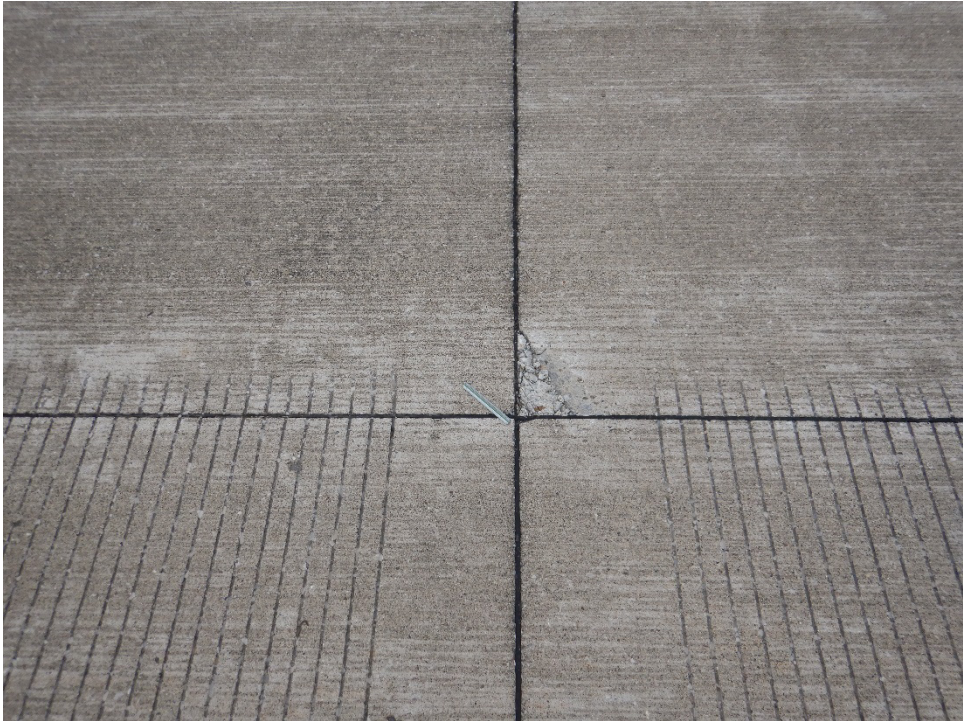
Runway 12/30 contained one section. Areas of low-severity faulting and joint spalling, low- and medium-severity small patching, medium-severity corner spalling, and high-severity joint seal damage were identified in Section 01 during the inspection.

R12MU-01. Corner Spalling (Sample Unit No. 29).

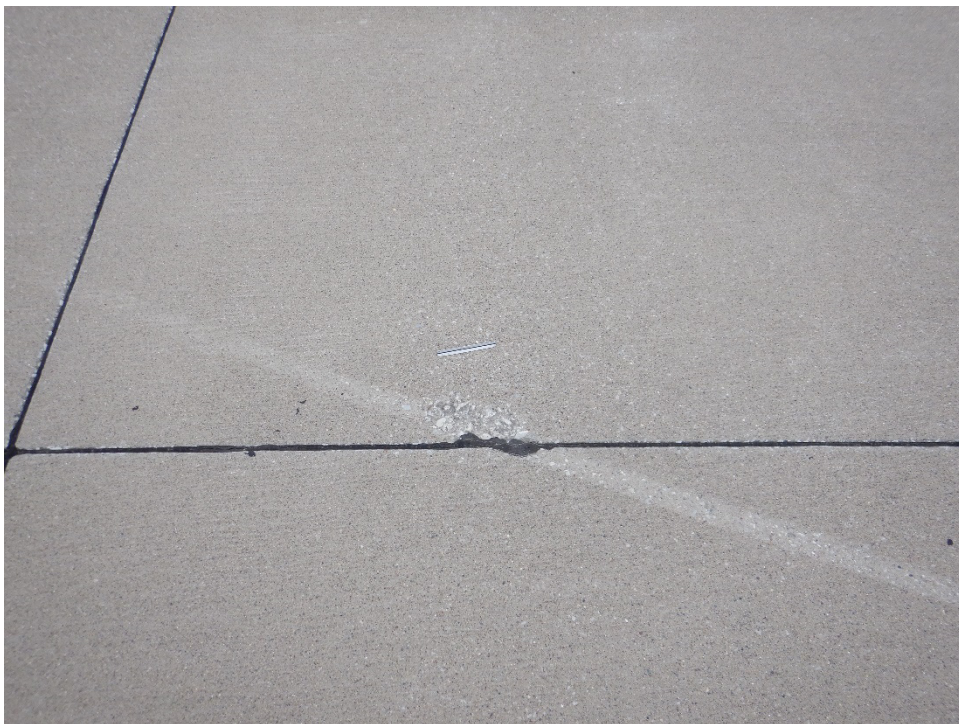
Taxiway A1 was defined by two sections. Section 01 was in excellent condition with no distress noted at the time of the inspection. Section 02 was recorded with low-severity joint spalling and high-severity joint seal damage.

TA1MU-02. Joint Spalling (Sample Unit No. 04).

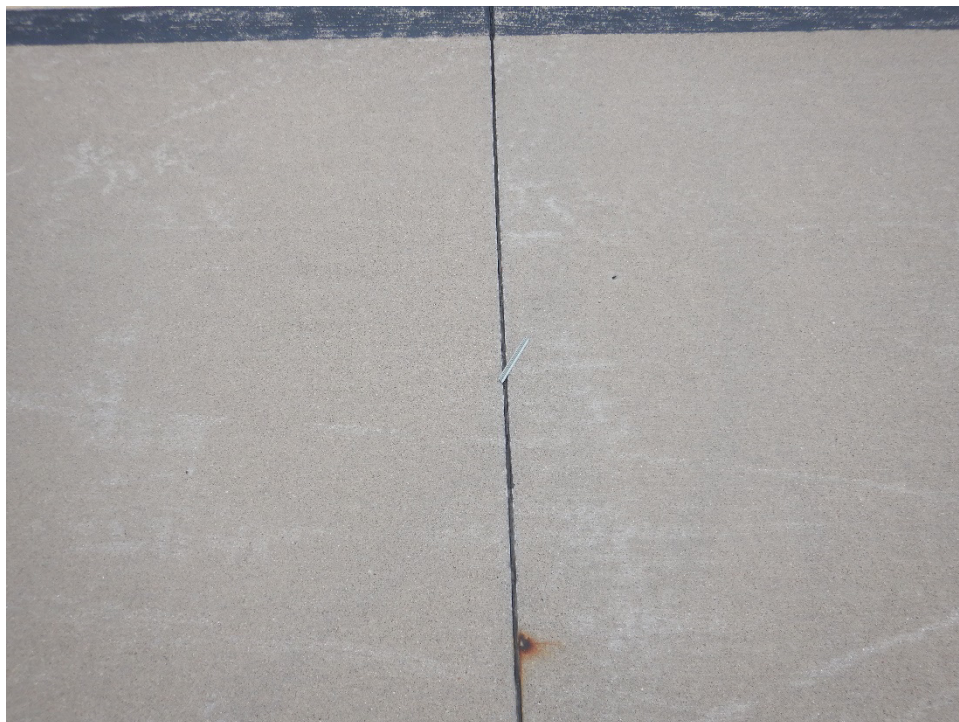
Taxiway A consisted of five sections. Low-severity faulting, low- and medium-severity joint spalling, medium-severity scaling, and all severities of joint seal damage were recorded in Section 01. Sections 02, 03, and 04 were in excellent condition with no distress observed at the time of the inspection. High-severity joint seal damage was identified throughout Section 05.

TAMU-01. Joint Seal Damage (Sample Unit No. 04).

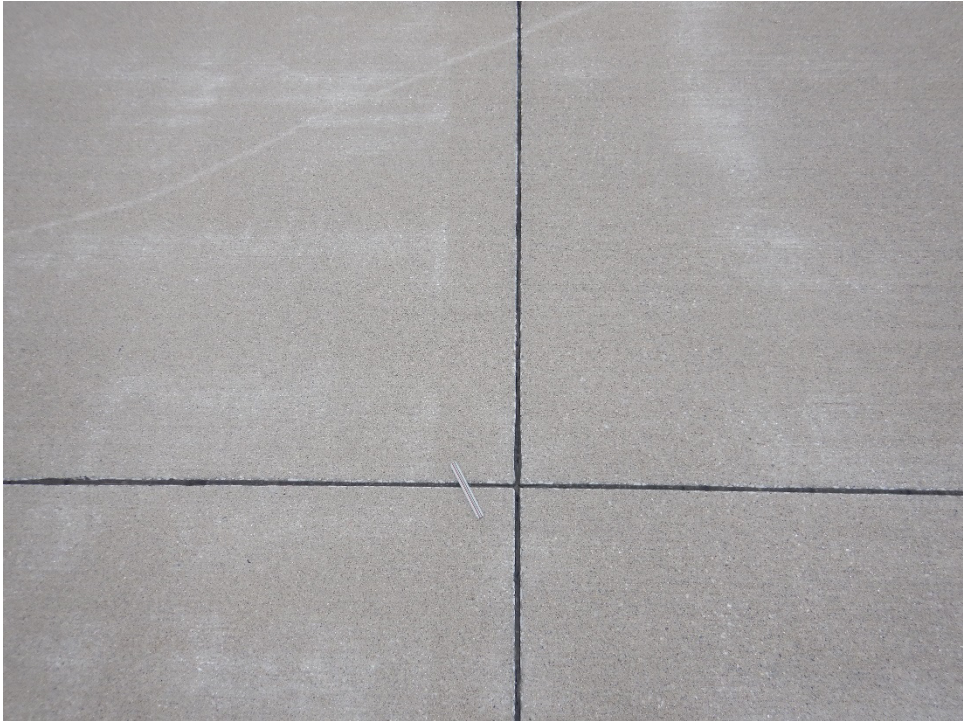
TAMU-05. Joint Seal Damage (Sample Unit No. 04).

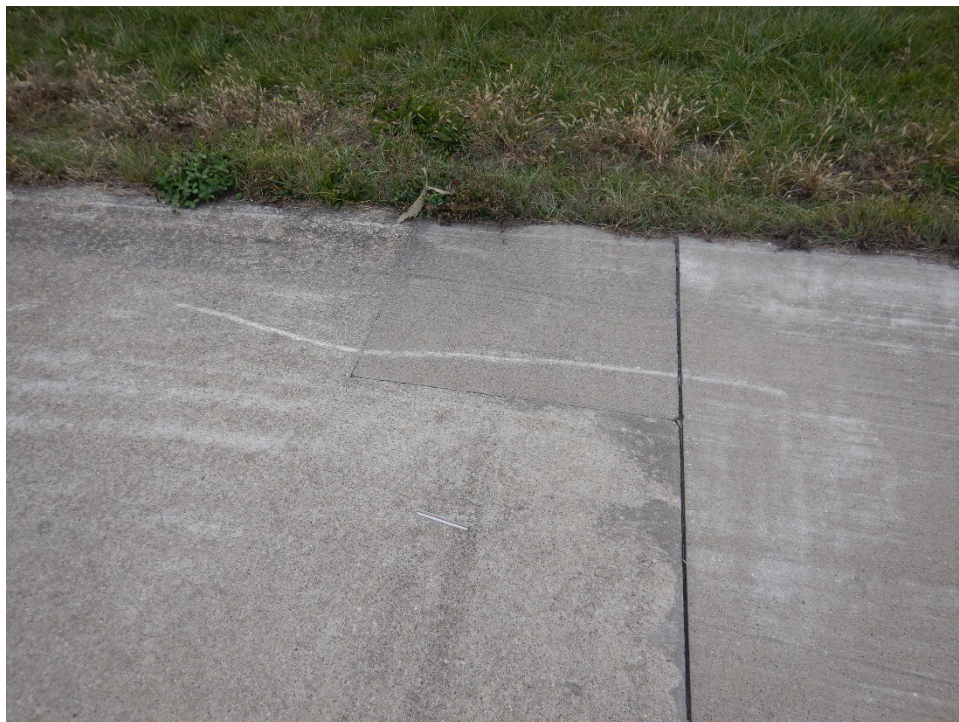
Taxiway B1 was defined by one section. High-severity joint seal damage was identified throughout Section 01, along with areas of low-severity corner spalling, faulting, joint spalling, and large patching.

TB1MU-01. Large Patching (Sample Unit No. 04).

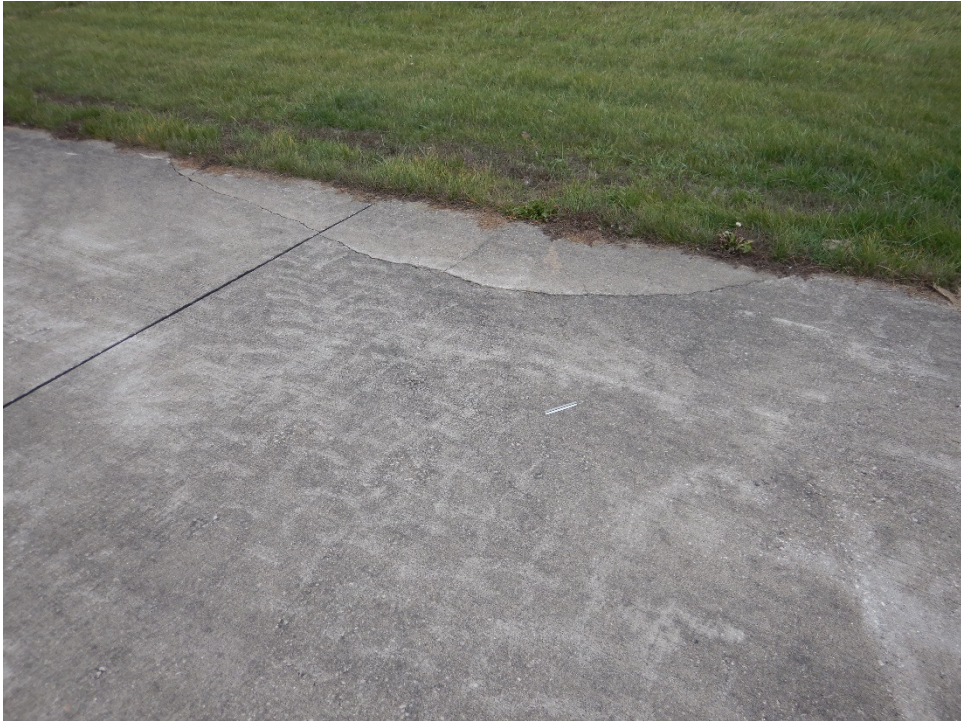
Taxiway B2 contained one section. Low-severity faulting, scaling, and small patching; medium-severity corner break, corner spalling, joint spalling, and LTD cracking; and medium- and high-severity joint seal damage were observed in Section 01.

TB2MU-01. Corner Break (Sample Unit No. 02).

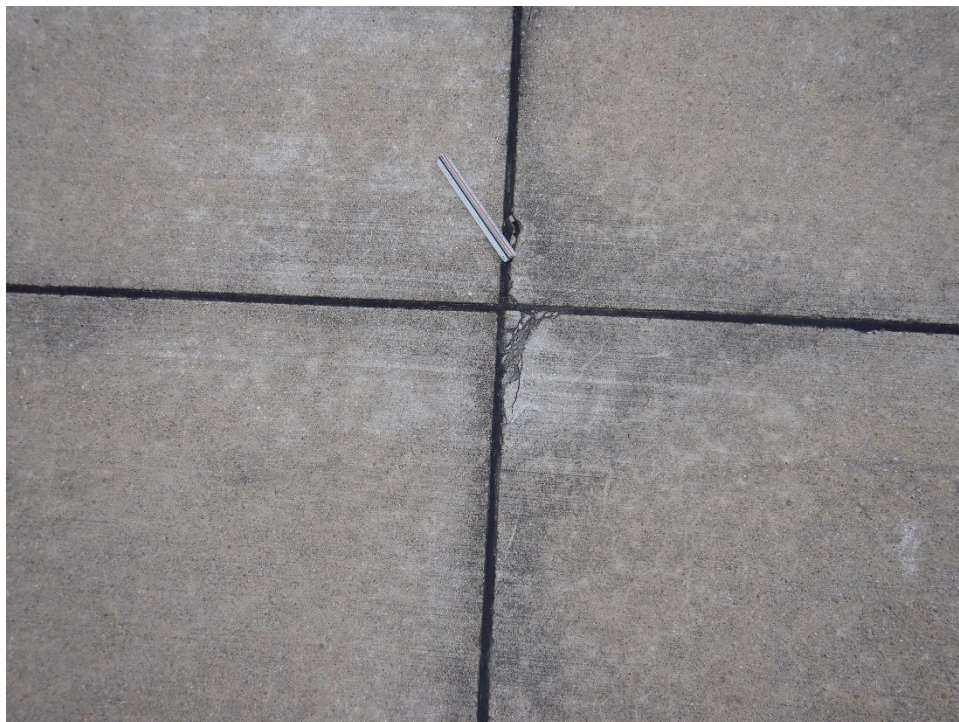
Taxiway B contained six sections. Section 01 had areas of low-severity ASR, faulting, and small patching and medium- and high-severity joint seal damage. Areas of low- and medium-severity longitudinal, transverse, and diagonal (LTD) cracking; medium-severity joint spalling; and high-severity joint seal damage were recorded in Section 02. Sections 03, 04, and 05 were in similar condition with low-severity faulting and high-severity joint seal damage observed in all three sections. Section 06 was in excellent condition with no distress recorded during the inspection.

TBMU-01. ASR (Sample Unit No. 01).

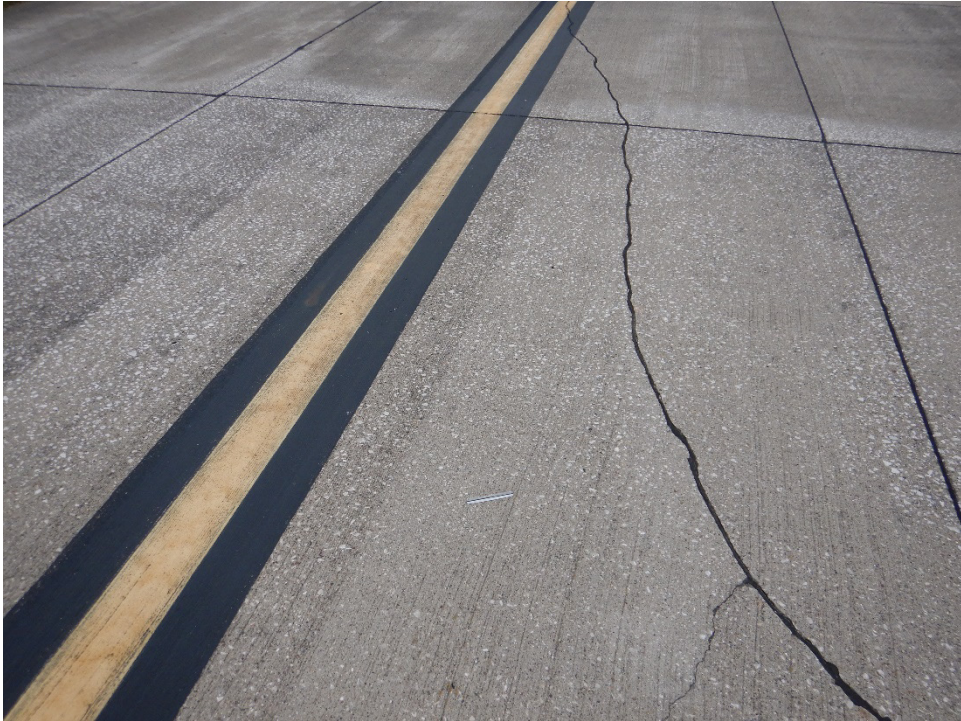
TBMU-02. LTD Cracking (Sample Unit No. 31).

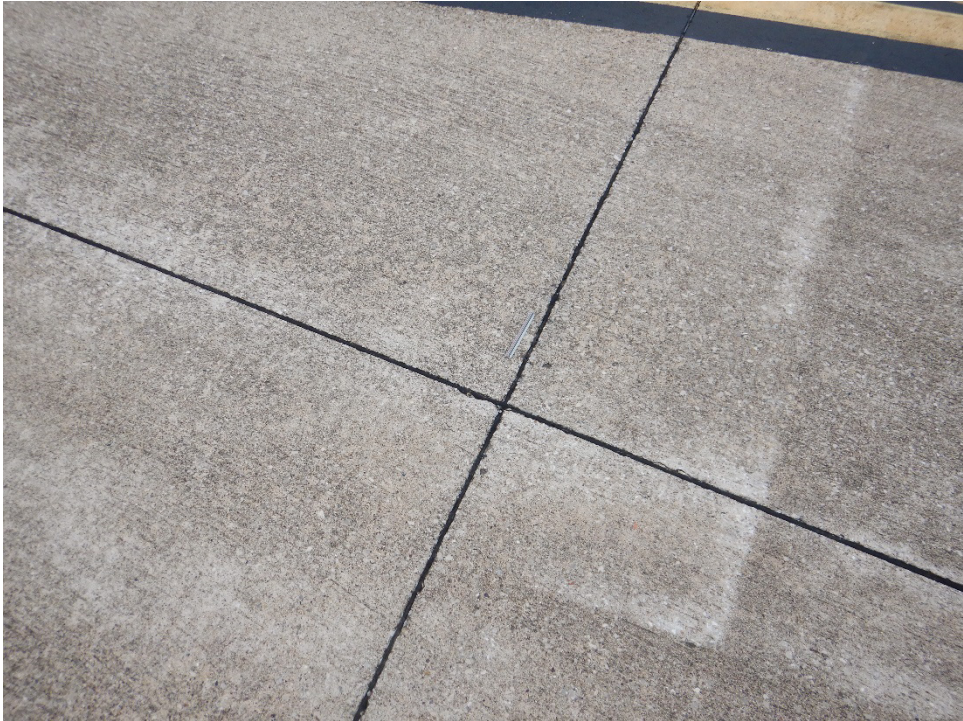
TBMU-03. Joint Seal Damage (Sample Unit No. 03).

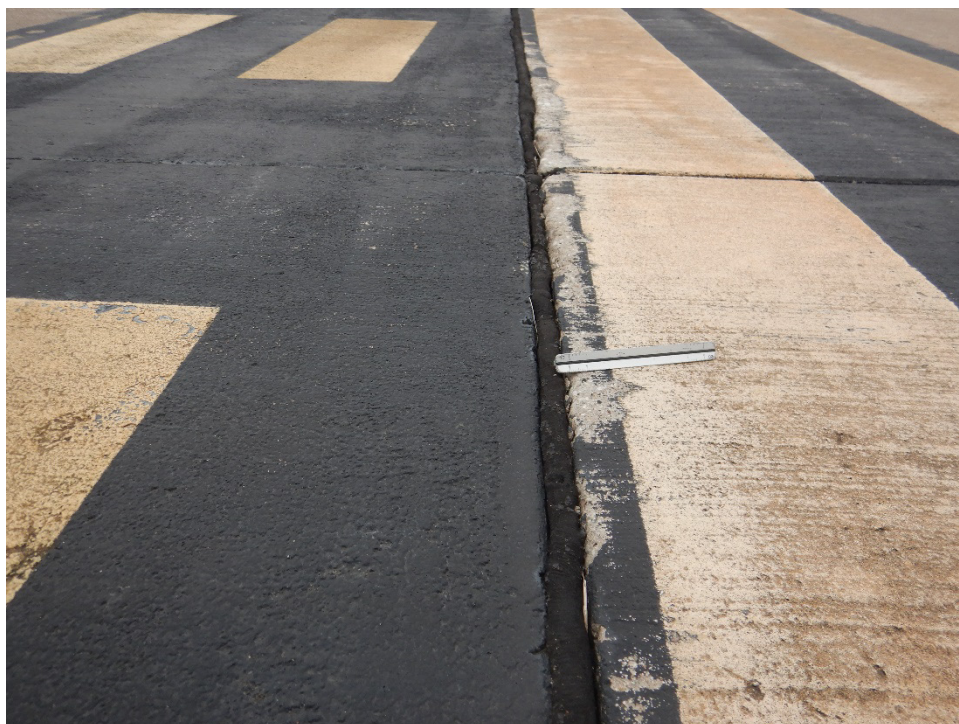
TBMU-04. Faulting (Sample Unit No. 06).

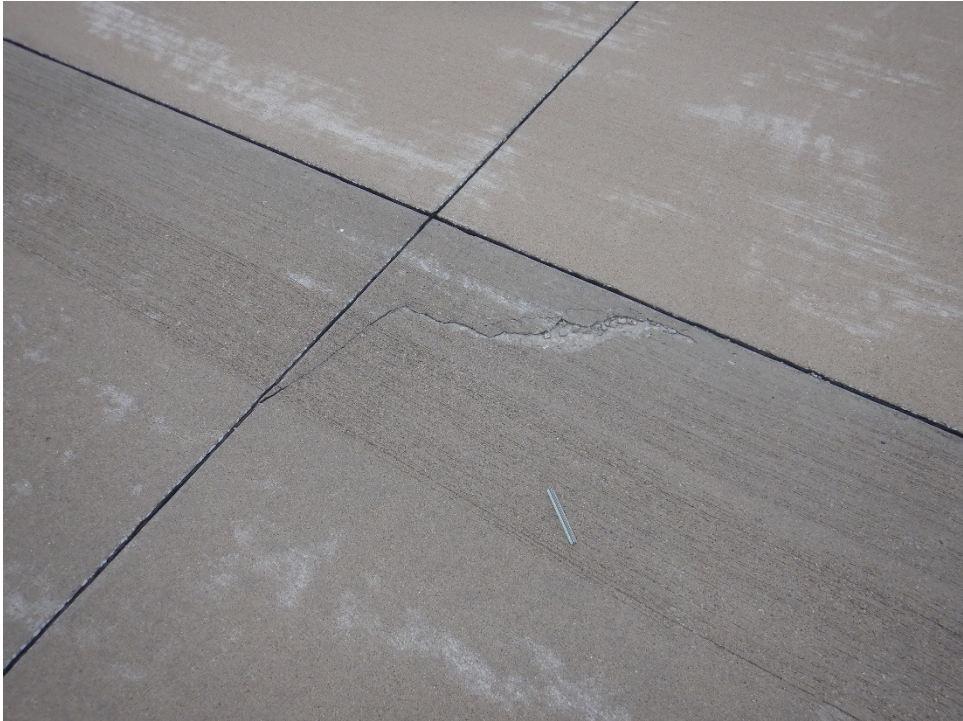
Taxiway C was defined by one section. Section 01 was in excellent condition with only an isolated amount of low-severity joint spalling noted.

TCMU-01. Joint Spalling (Sample Unit No. 04).

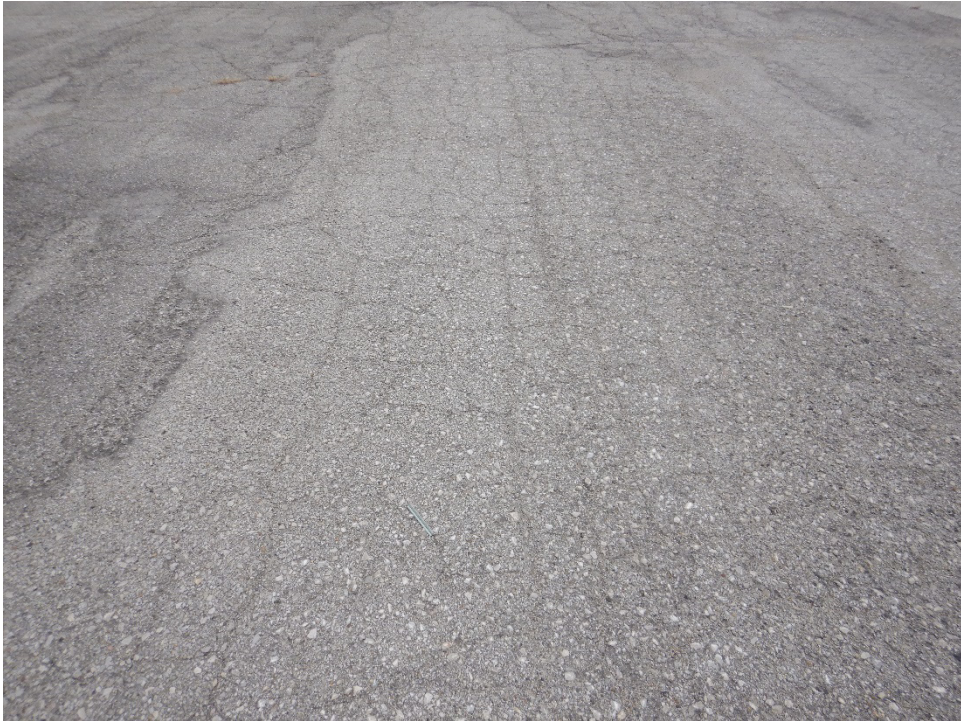
The T-hangar area was defined by five sections. Section 01 was in poor condition with areas of low-severity rutting, medium-severity alligator cracking and block cracking, and high-severity raveling. Section 02 was also in poor condition. Areas of low-severity rutting, low- and medium-severity longitudinal and transverse (L&T) cracking, and medium-severity alligator cracking and weathering were recorded in the section. The low-severity L&T cracking was unsealed while the medium-severity L&T cracking was due to unsealed crack widths that exceeded 1/4 inch. Section 03 contained areas of medium-severity LTD cracking and joint spalling and high-severity joint seal damage. Low-severity corner spalling, faulting, and LTD cracking; low- and medium-severity joint spalling; medium-severity joint seal damage; and shrinkage cracking were identified in Section 04. Section 05 was in excellent condition with no distress recorded at the time of the inspection.

TH01MU-01. Alligator Cracking (Sample Unit No. 01).

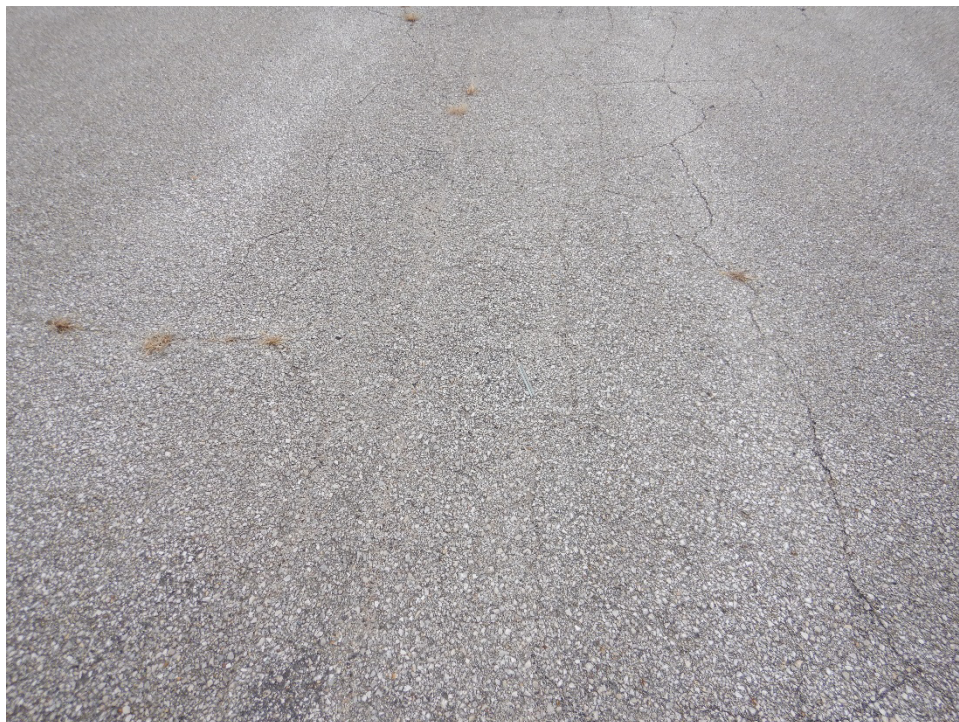
TH01MU-02. Alligator Cracking (Sample Unit No. 02).

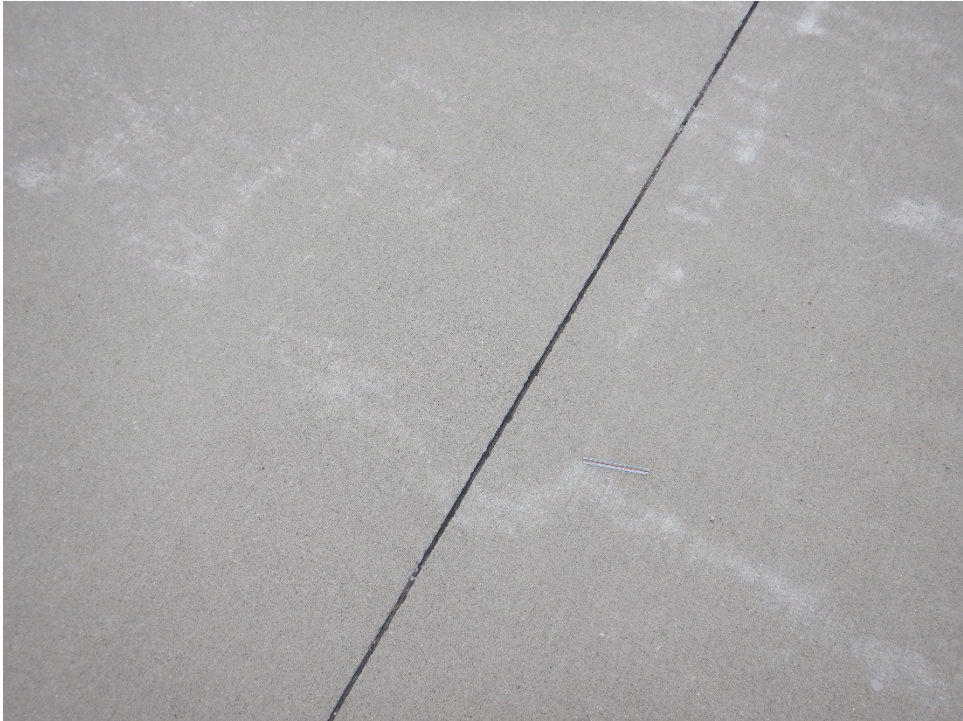
TH01MU-03. Joint Seal Damage (Sample Unit No. 08).

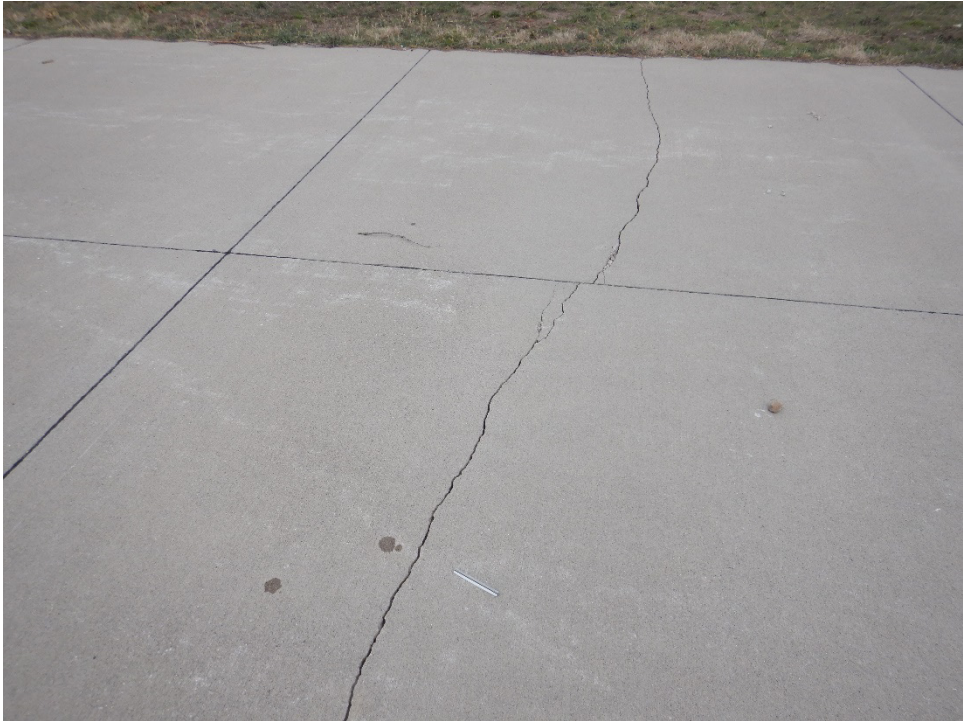
TH01MU-03. LTD Cracking (Sample Unit No. 10).

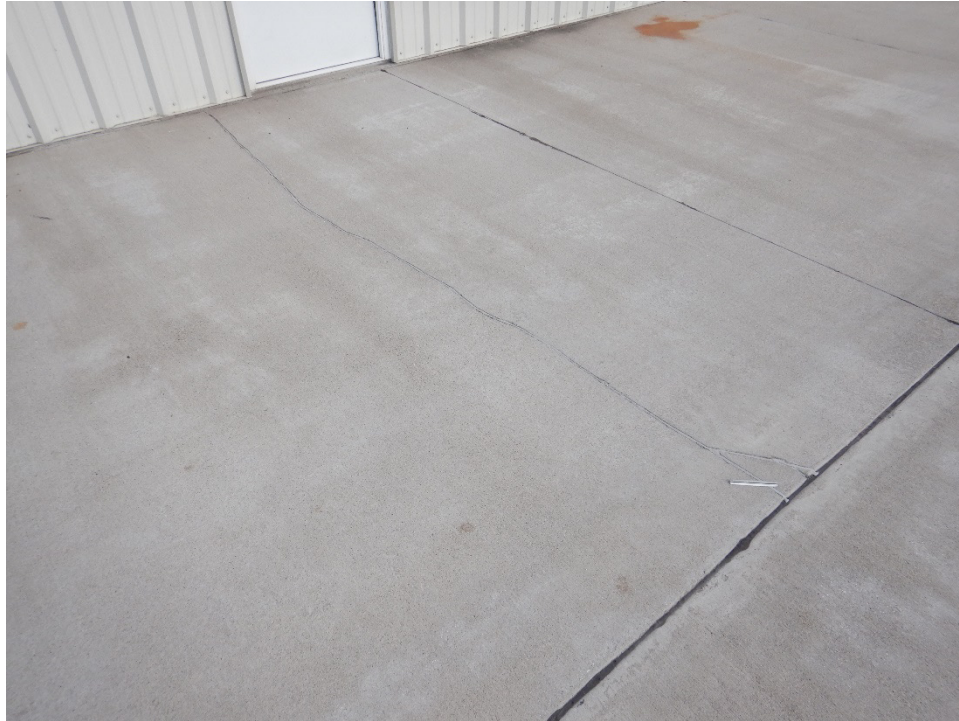
TH01MU-04. LTD Cracking (Sample Unit No. 04).
