# New Hampton Municipal Airport

**PAVEMENT MANAGEMENT REPORT**

**AUGUST 2019**

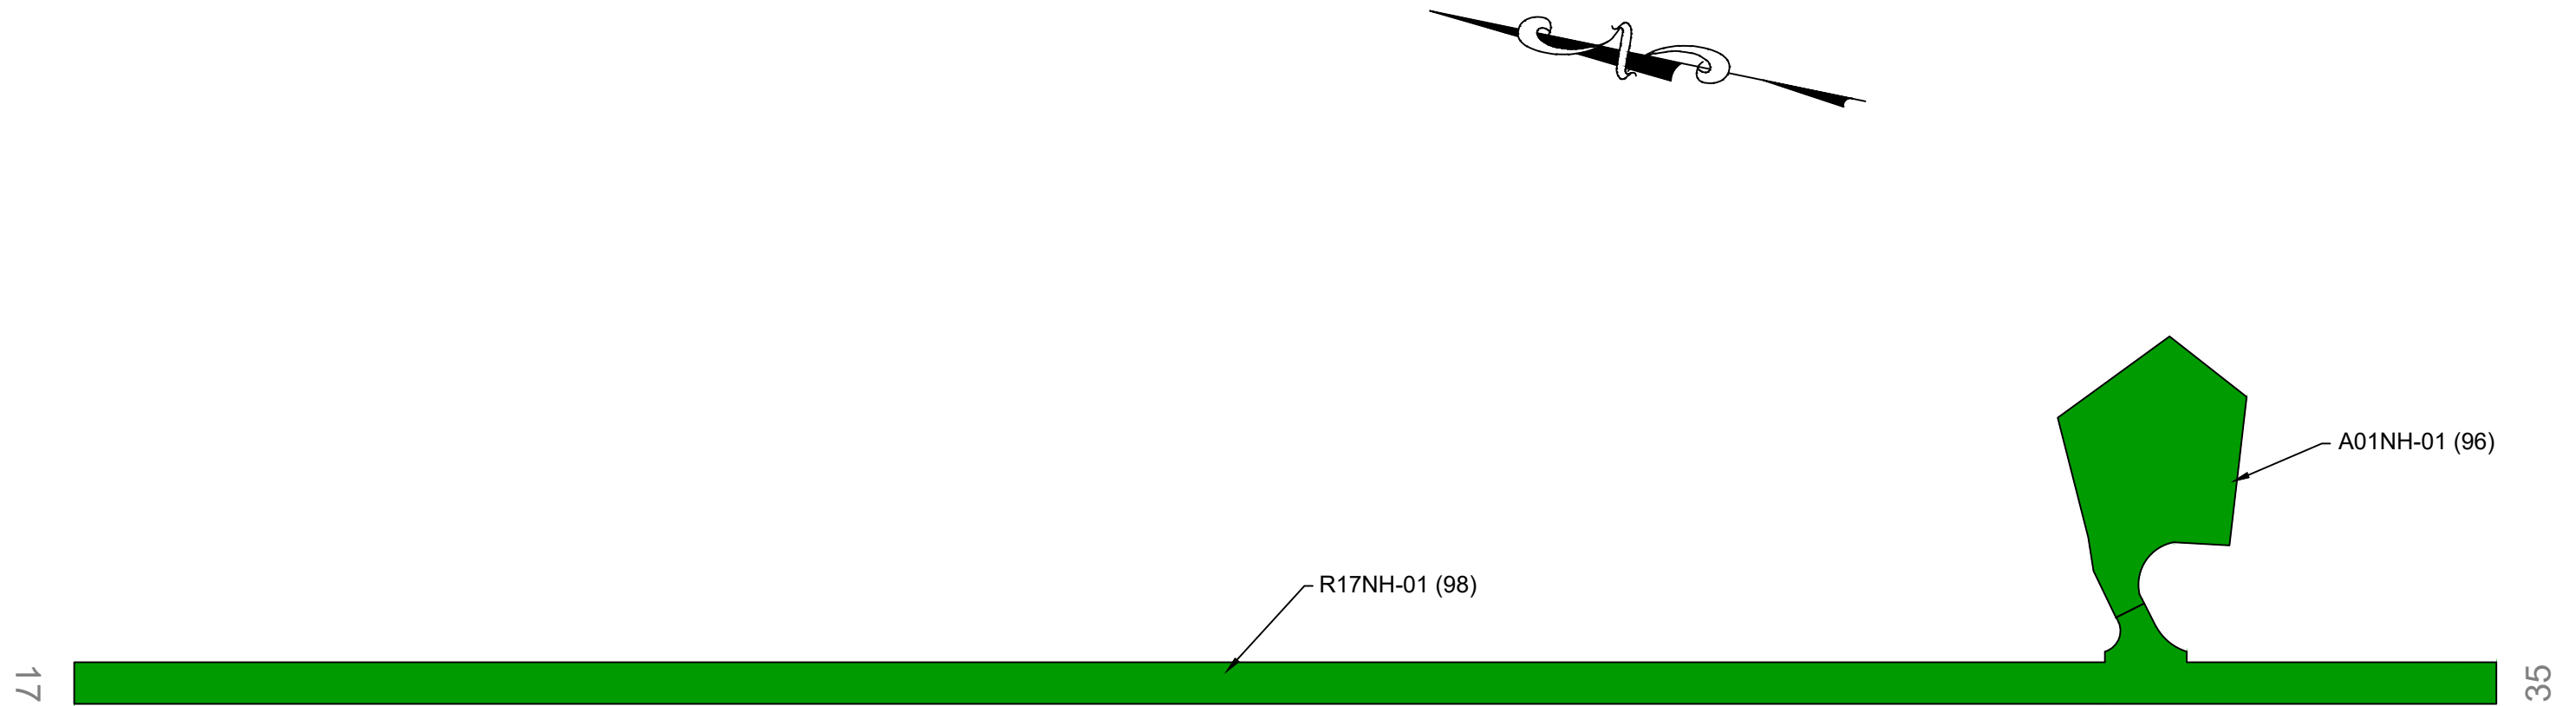
FIGURE 8. PCI MAP.

The pavements at New Hampton Municipal Airport were inspected on November 14, 2018. The 2018 area-weighted condition of New Hampton Municipal Airport is 98, with conditions ranging from 96 to 98 (on a scale of 0 [failed] to 100 [excellent]). During the previous pavement inspection in 2012, the area-weighted PCI of the airport was 44.

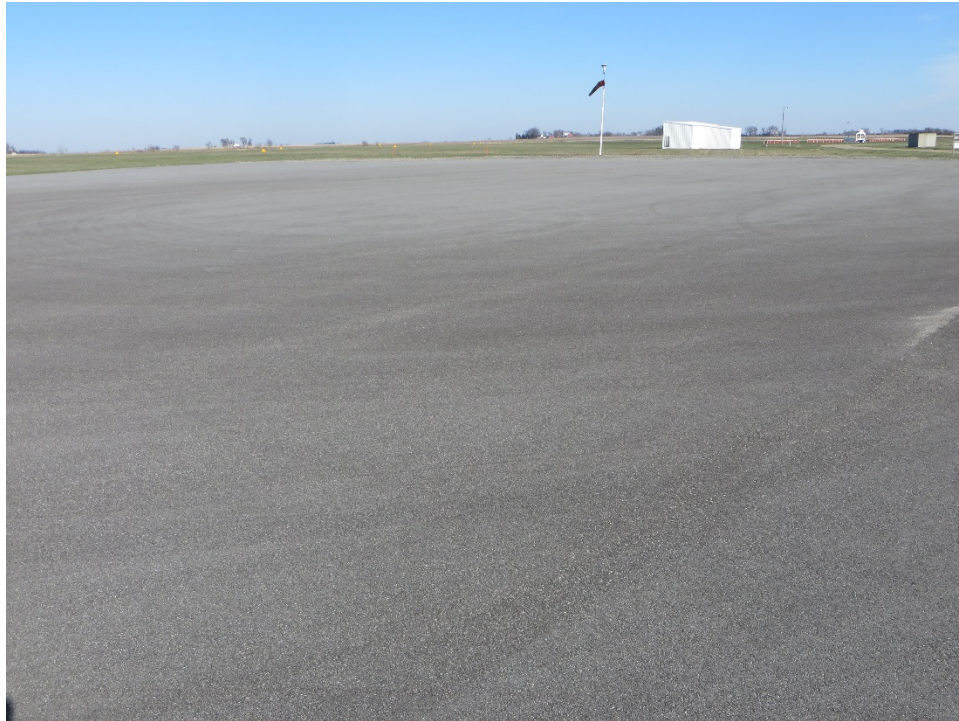
The apron area consisted of one recently rehabilitated section. Section 01 was in excellent condition with only small amounts of low-severity, unsealed longitudinal and transverse (L&T) cracking and high-severity raveling due to mechanical damage identified.

A01NH-01. Overview.

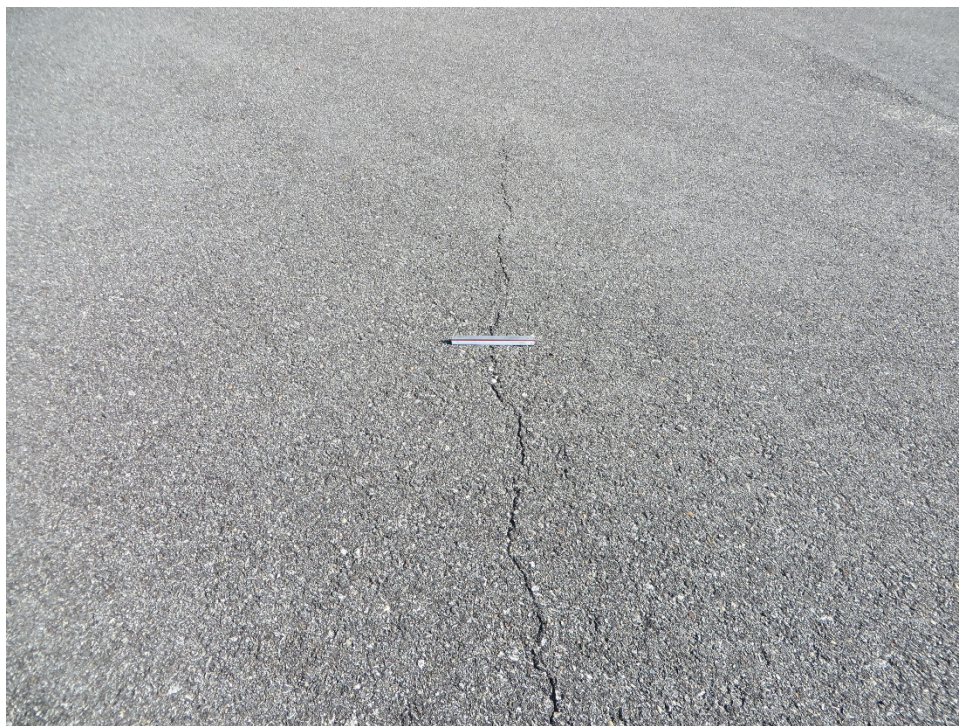
A01NH-01. L&T Cracking (Sample Unit No. 09).

Sample Number: 009 Type: R Area: 5,009.00SqFt PCI = 96  
Sample Comments: 48 LONGITUDINAL/TRANSVERSE CRACKING L 16.00 Ft Comments:

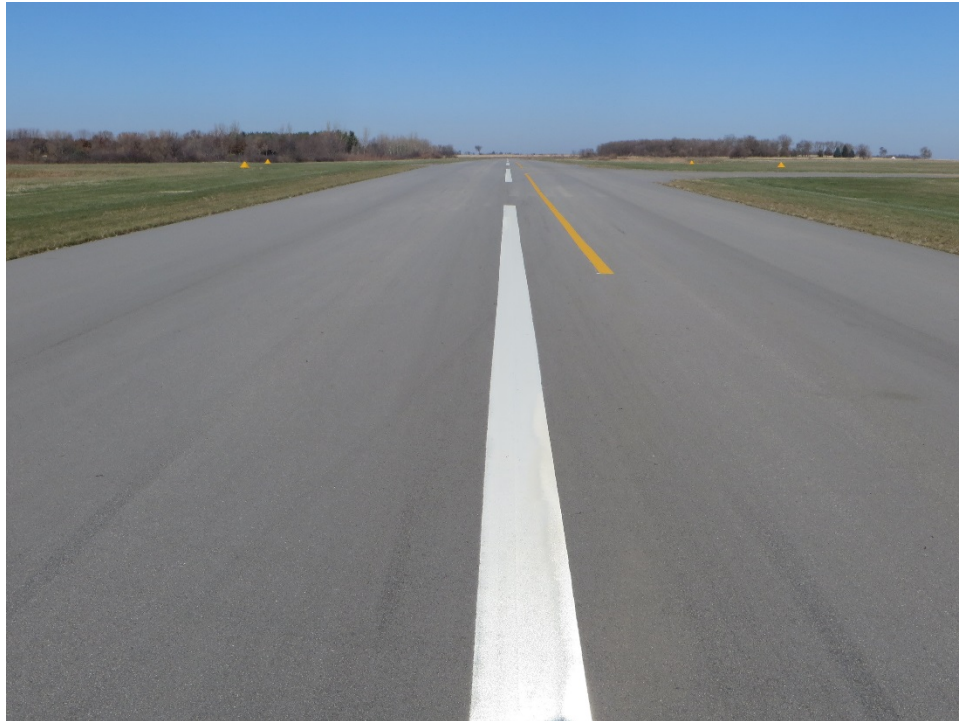
Runway 17/35 was defined by one recently rehabilitated section that was in excellent condition. Only isolated areas of high-severity raveling were recorded where mechanical damage was observed at the time of inspection.

R17NH-01. Overview.

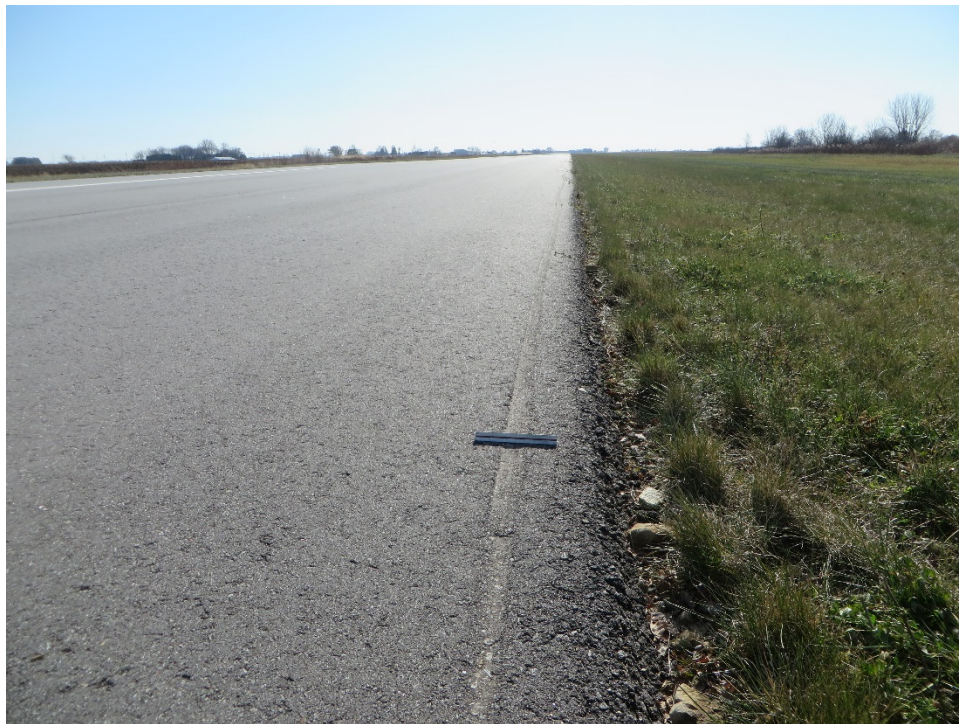
R17NH-01. Raveling (Sample Unit No. 06).

Sample Number: 006 Type: R Area: 5,000.00SqFt PCI = 93  
Sample Comments: 52 RAVELING H 6.00 SqFt Comments:md
