Osage Municipal Airport

PAVEMENT MANAGEMENT REPORT

AUGUST 2019

**IOWA DEPARTMENT OF TRANSPORTATION
AVIATION BUREAU**

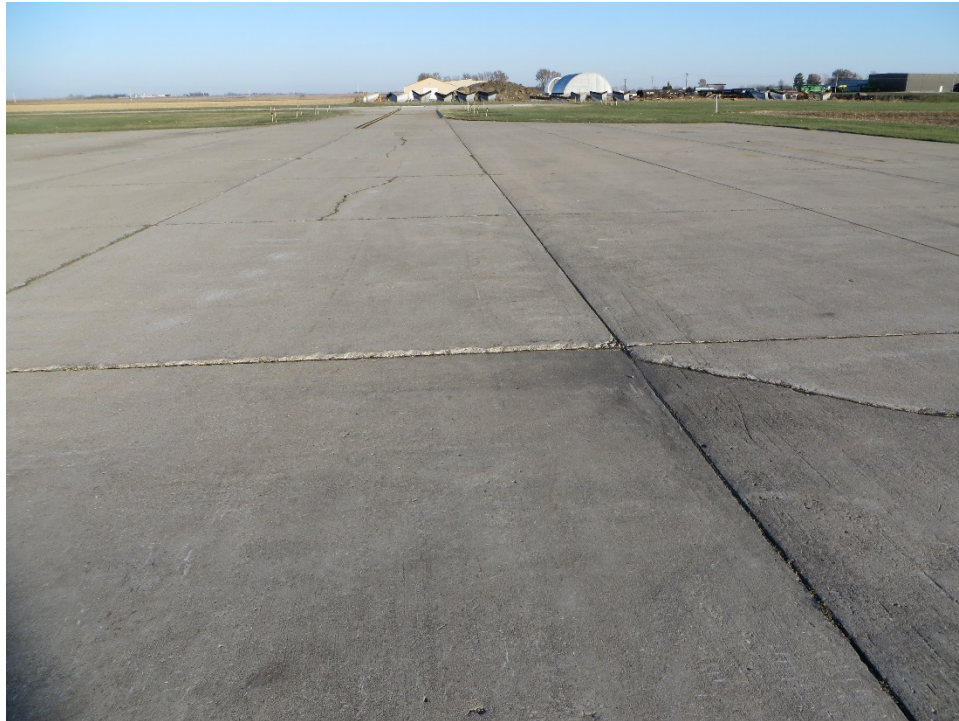
The apron area consisted of two sections. Section 01 was in poor condition with low-severity ASR; medium-severity corner break; low- and medium-severity corner spalling, faulting, joint spalling, and LTD cracking; high-severity joint seal damage; and shrinkage cracking observed. Section 02 had high-severity joint seal damage identified throughout along with smaller areas of low-severity corner spalling and low- and medium-severity corner break, LTD cracking, and shattered slab.

A01OS-01. Overview.

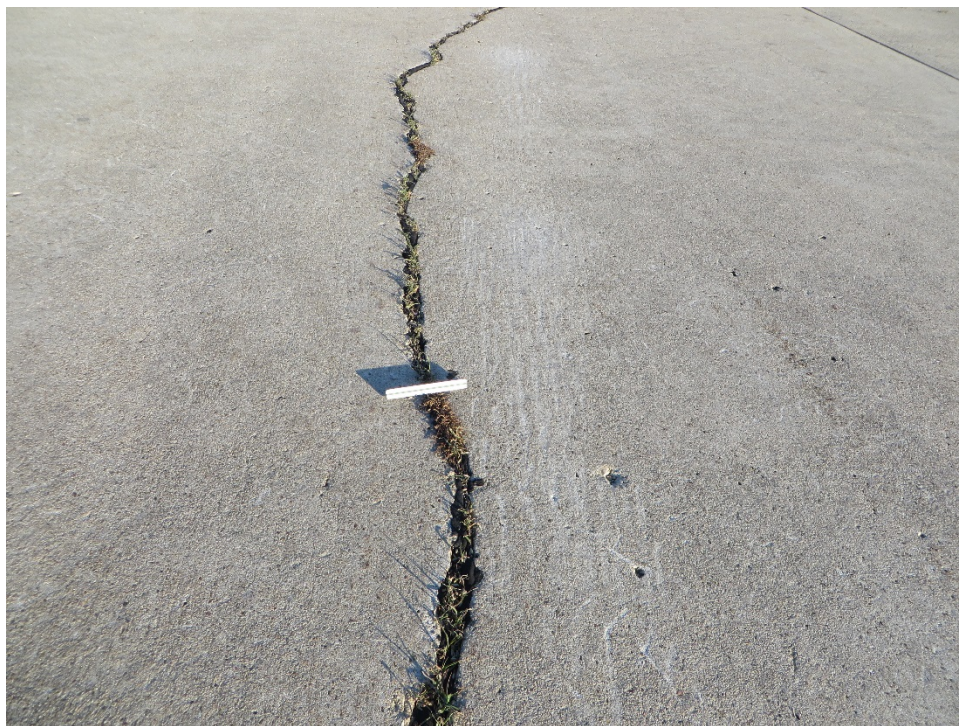
A01OS-01. LTD Cracking (Sample Unit No. 03).

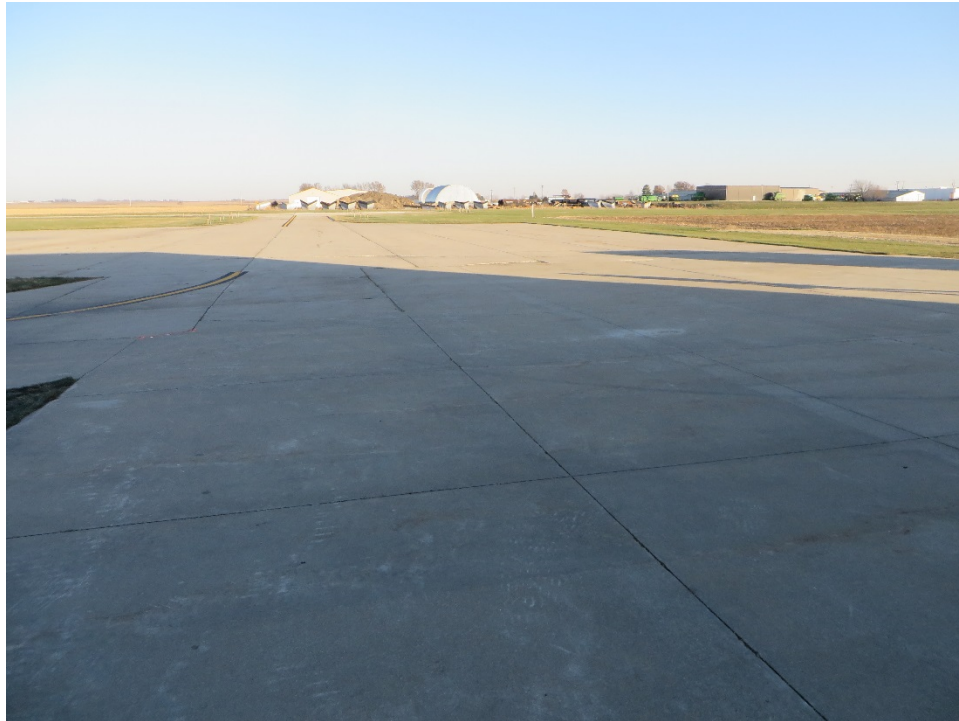
A01OS-02. Overview.

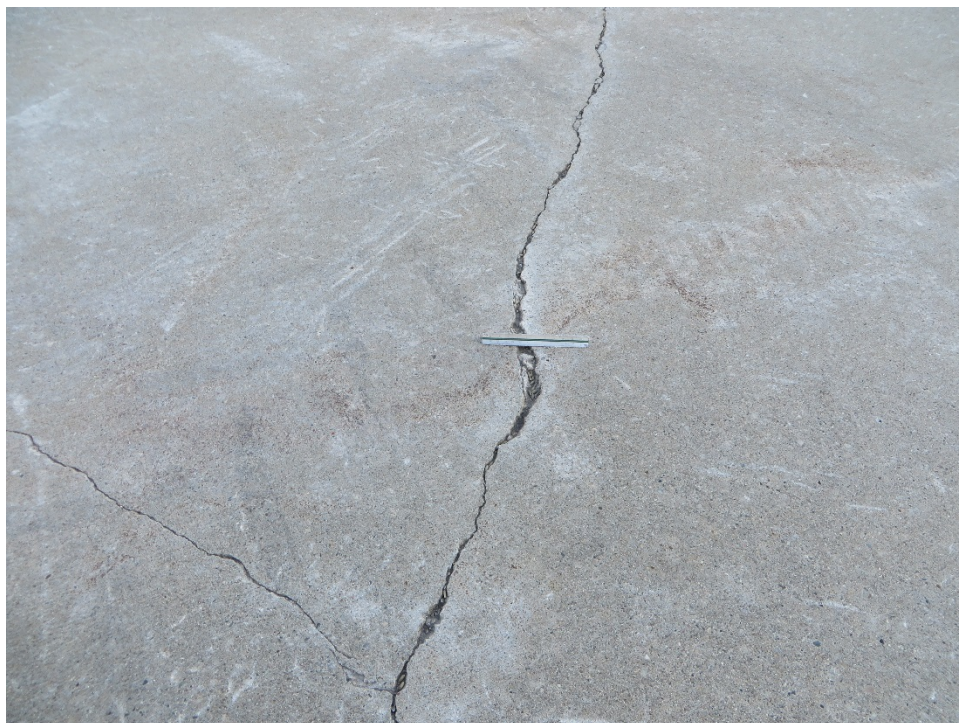
A01OS-02. LTD Cracking (Sample Unit No. 02).

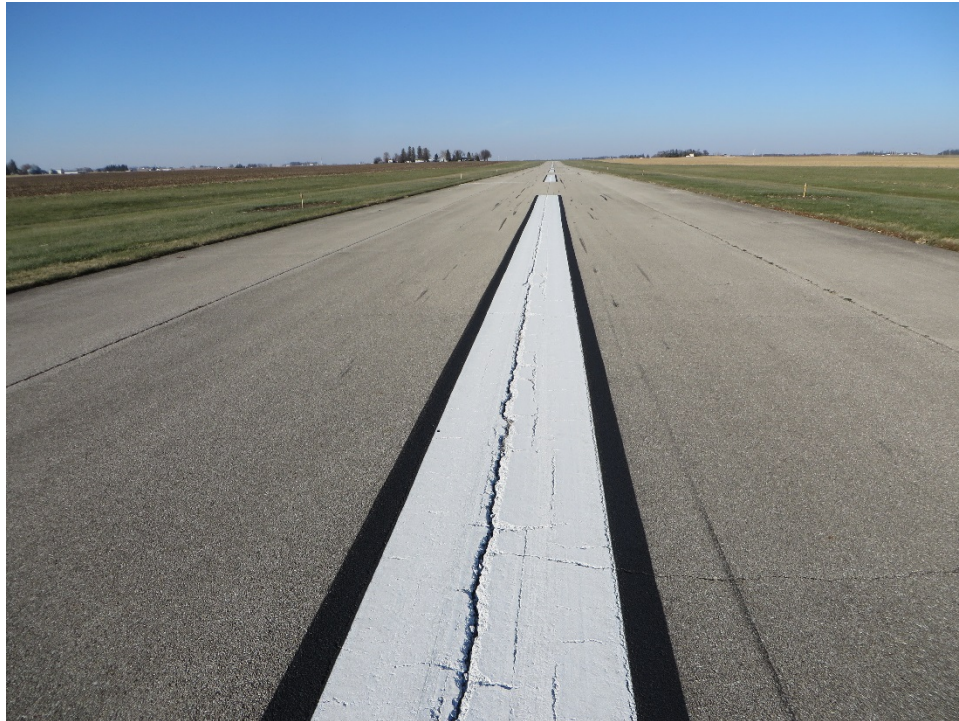
Runway 17/35 consisted of two sections. Low- and medium-severity joint reflection cracking, longitudinal and transverse (L&T) cracking, swelling, and weathering; low-severity patching; and all severities of raveling were recorded in Section 01. The low-severity cracking was in either the sealed or unsealed condition, while the medium-severity cracking was due to either crack sealant that had failed, the development of secondary cracking, or unsealed crack widths that exceeded 1/4 in. Section 02 had low- and medium-severity joint reflection cracking, L&T cracking, and swelling and medium-severity raveling and weathering observed at the time of inspection. The low-severity cracking was unsealed, and the medium-severity cracking was due to either unsealed crack widths greater than 1/4 in, the development of secondary cracking, or failed crack sealant.

R17OS-01. Overview.

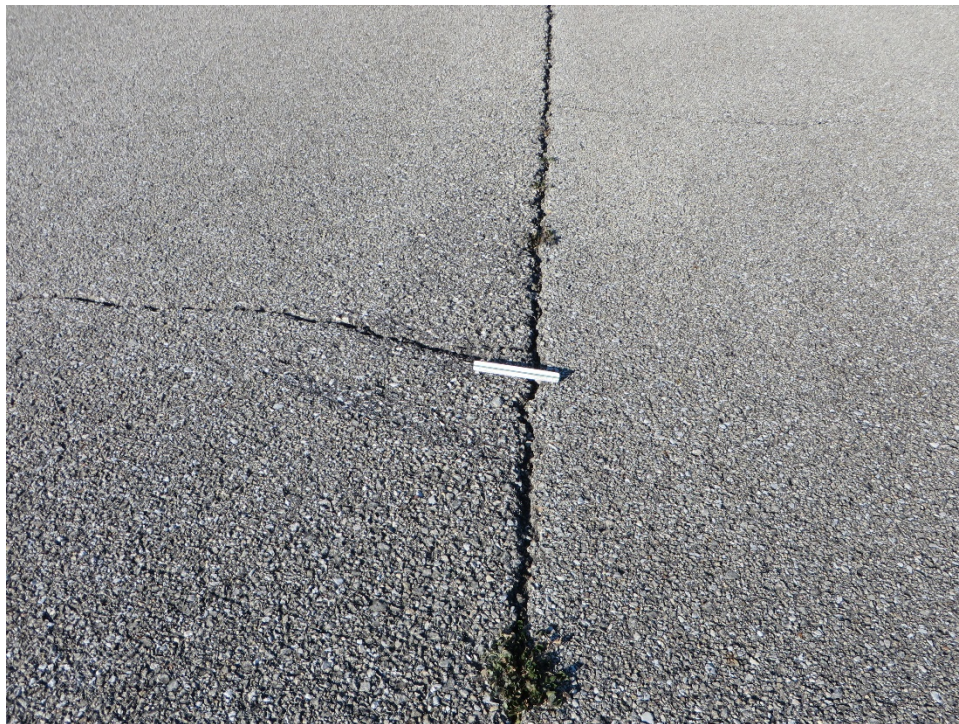
R17OS-01. L&T Cracking (Sample Unit No. 28).

Sample Number:	028	Type: R	Area:	5,000.00SqFt	PCI = 40
Sample Comments:					
48	LONGITUDINAL/TRANSVERSE CRACKING		L	202.00 Ft	Comments:u
48	LONGITUDINAL/TRANSVERSE CRACKING		M	310.00 Ft	Comments:w fs
50	PATCHING		L	140.00 SqFt	Comments:
56	SWELLING		L	28.00 SqFt	Comments:
56	SWELLING		M	9.00 SqFt	Comments:
47	JOINT REFLECTION CRACKING		M	38.00 Ft	Comments:w fs
52	RAVELING		M	400.00 SqFt	Comments:
57	WEATHERING		M	4,460.00 SqFt	Comments:

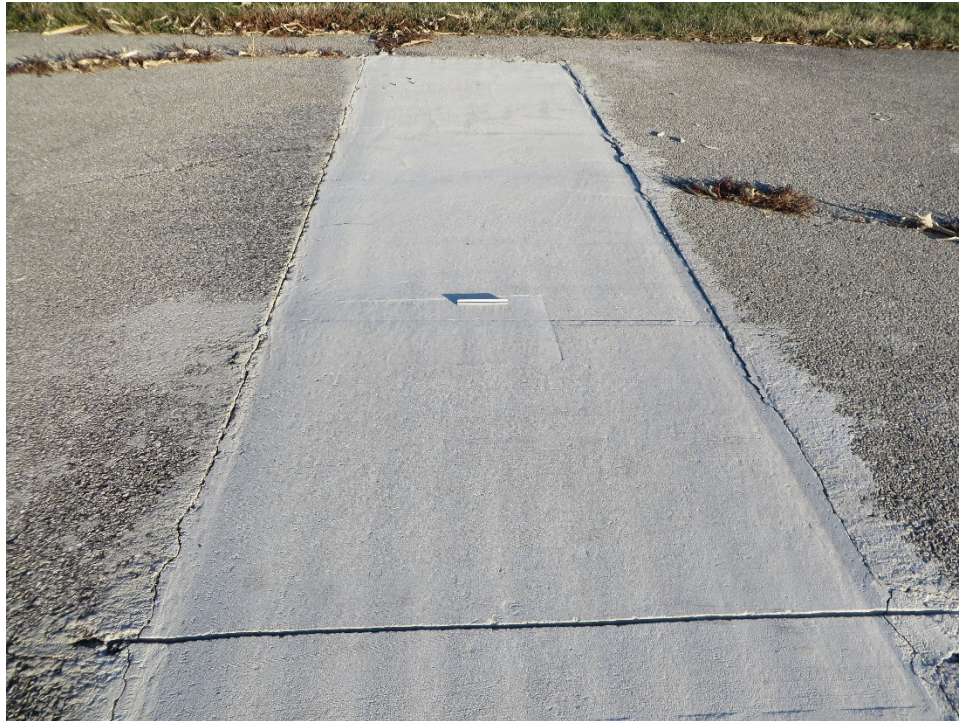
R17OS-01. Patching (Sample Unit No. 08).

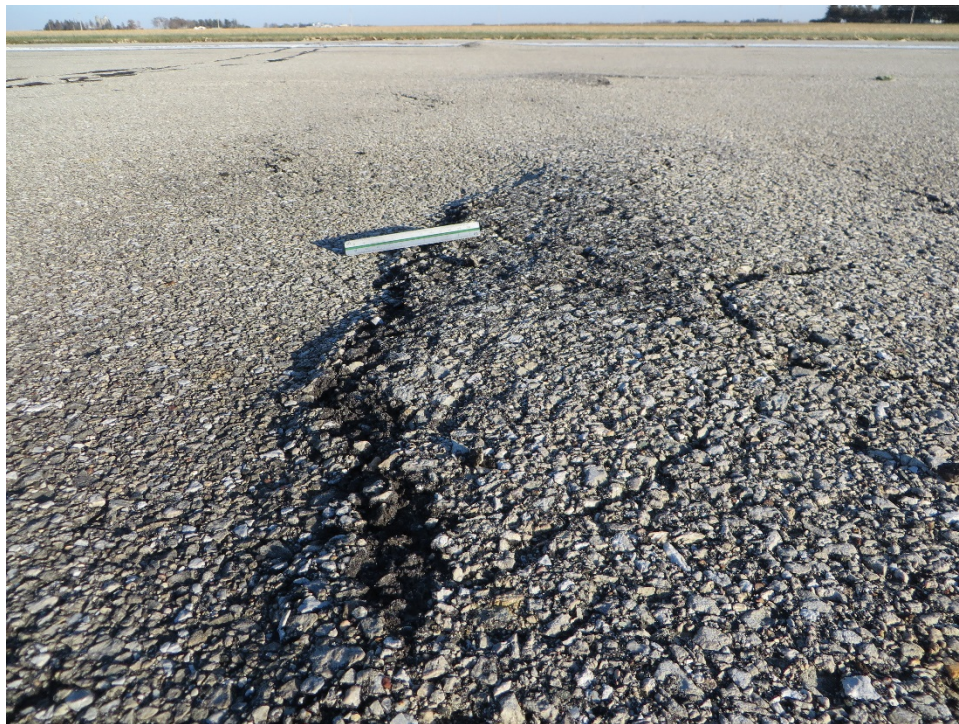
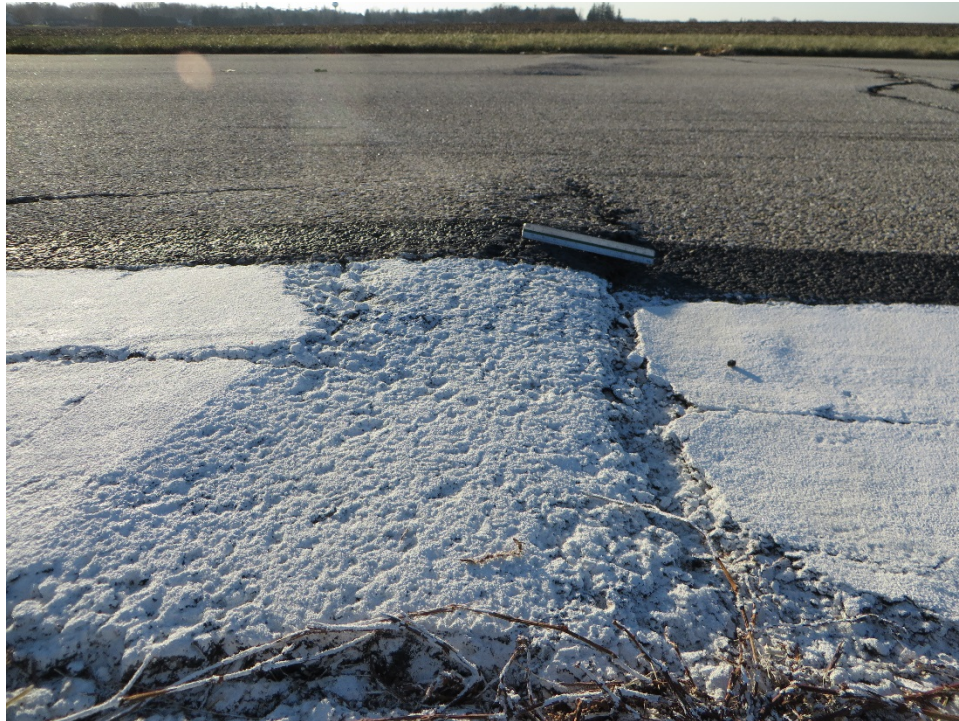
R17OS-01. Swelling (Sample Unit No. 08) (1).

R17OS-01. Swelling (Sample Unit No. 08) (2).

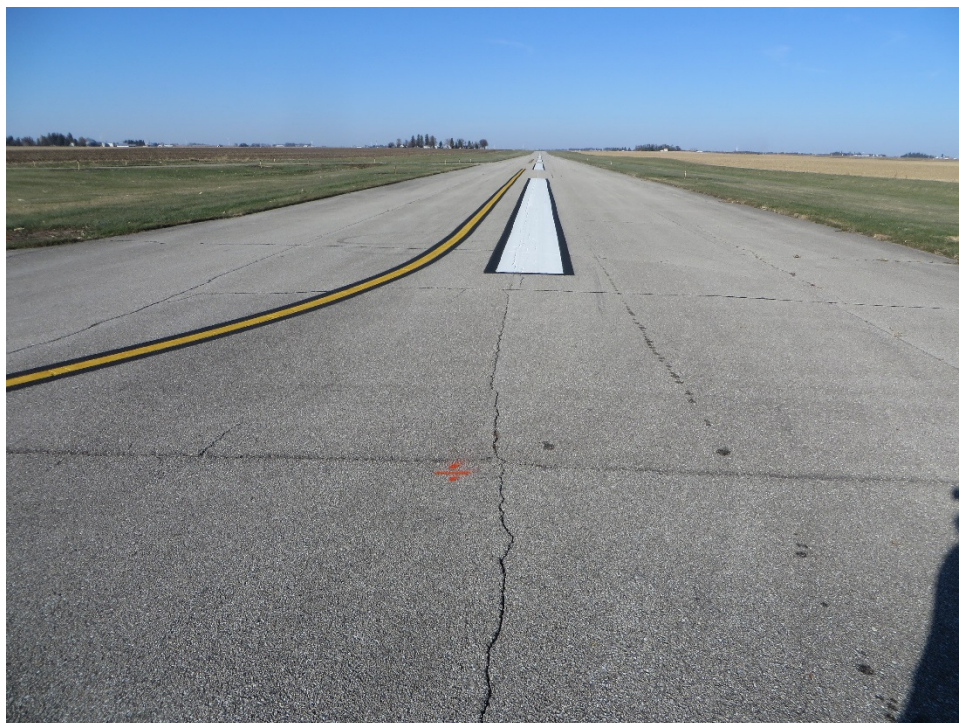
R17OS-02. Overview.

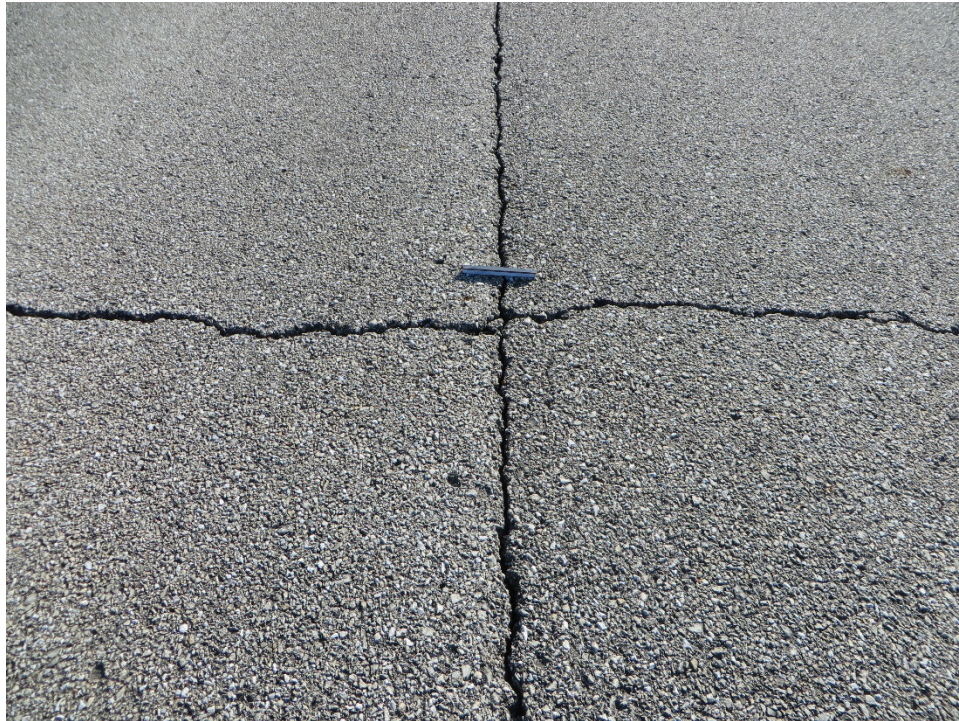
R17OS-02. Joint Reflection Cracking (Sample Unit No. 03).

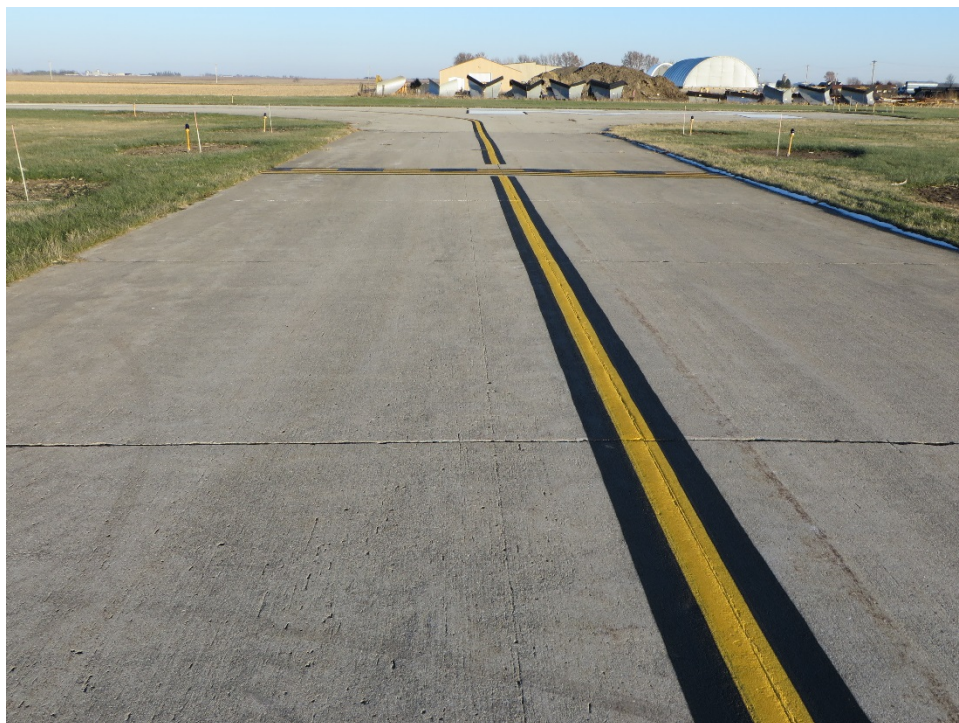
Taxiway 01 was defined by one section that was located between Apron 01 and the Runway 35 approach. Medium-severity ASR and corner break, high-severity joint seal damage, low-severity joint spalling, and low- and medium-severity longitudinal, transverse, and diagonal (LTD) cracking were recorded in Section 01.

T01OS-01. Overview.

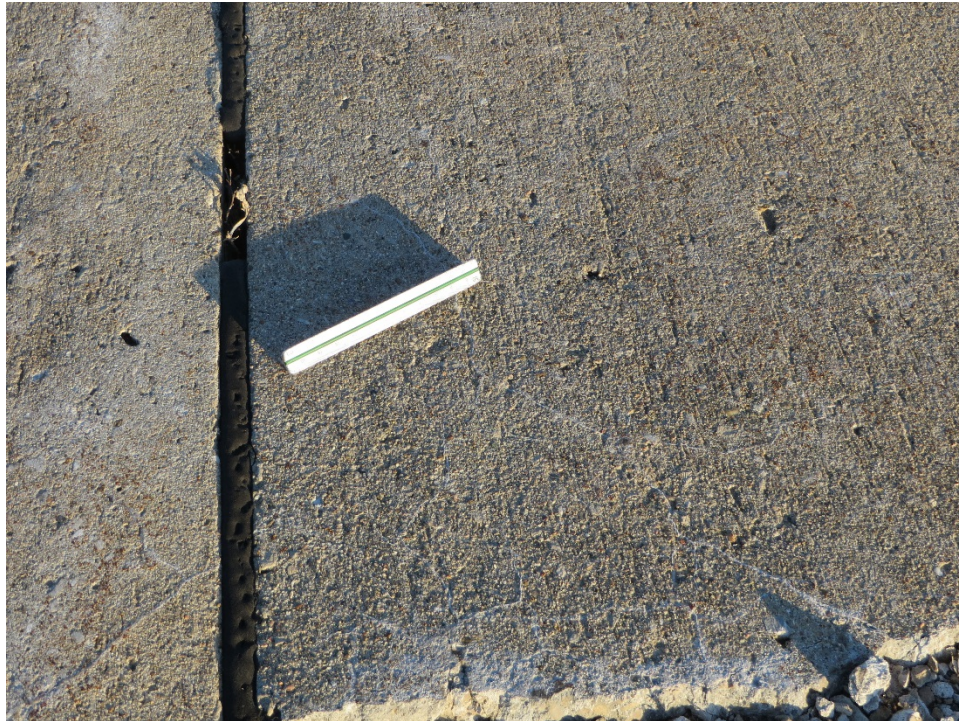
T01OS-01. ASR (Sample Unit No. 01).

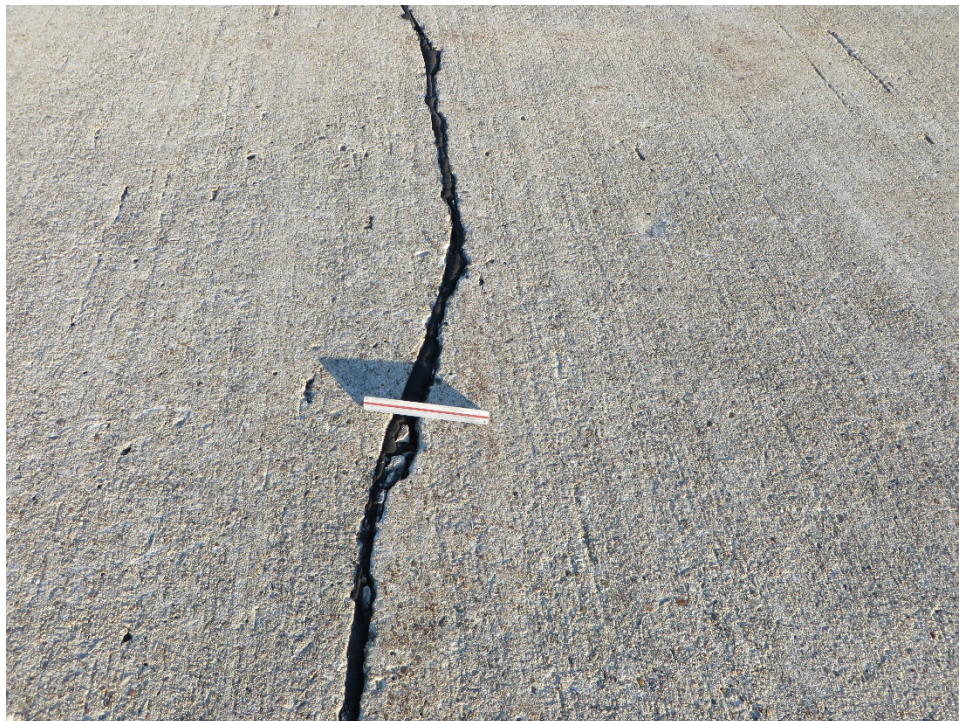
T01OS-01. LTD Cracking (Sample Unit No. 01).

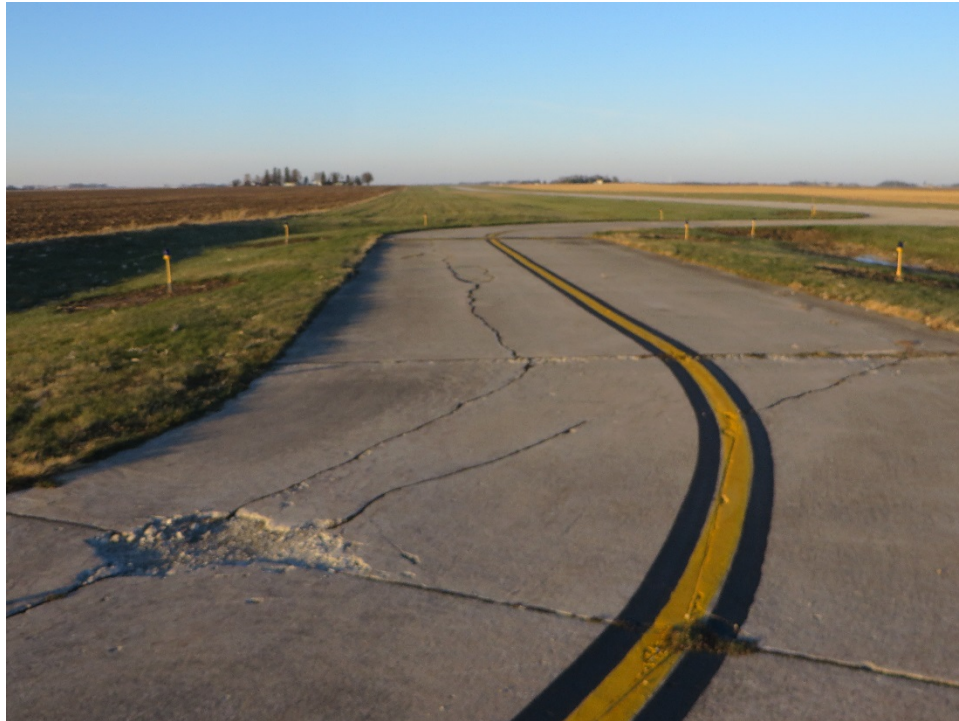
Taxiway 02 contained two sections. Section 01 was in poor condition with low- and high-severity ASR, high-severity joint seal damage, medium-severity LTD cracking, and medium- and high-severity shattered slab observed at the time of inspection. Medium-severity corner break, low-severity corner spalling and joint spalling, low- and medium-severity faulting and LTD cracking, and high-severity joint seal damage were identified in Section 02. The high-severity joint seal damage was recorded where the joint sealant had deteriorated or where visible gaps between the sealant and slab edge were observed.

T02OS-01. Overview.

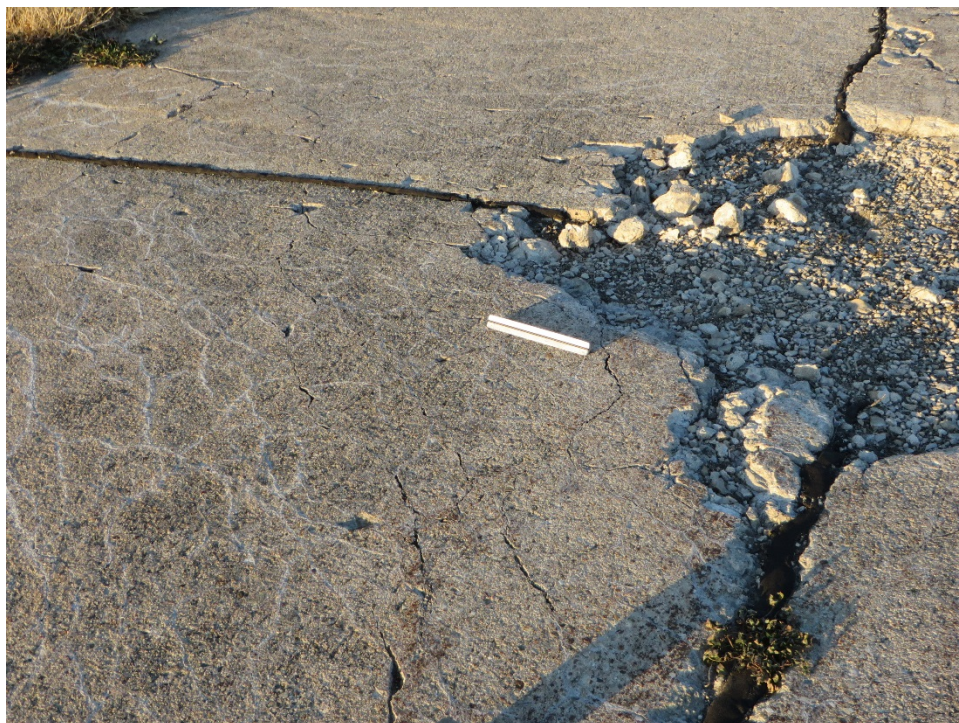
T02OS-01. ASR (Sample Unit No. 01).

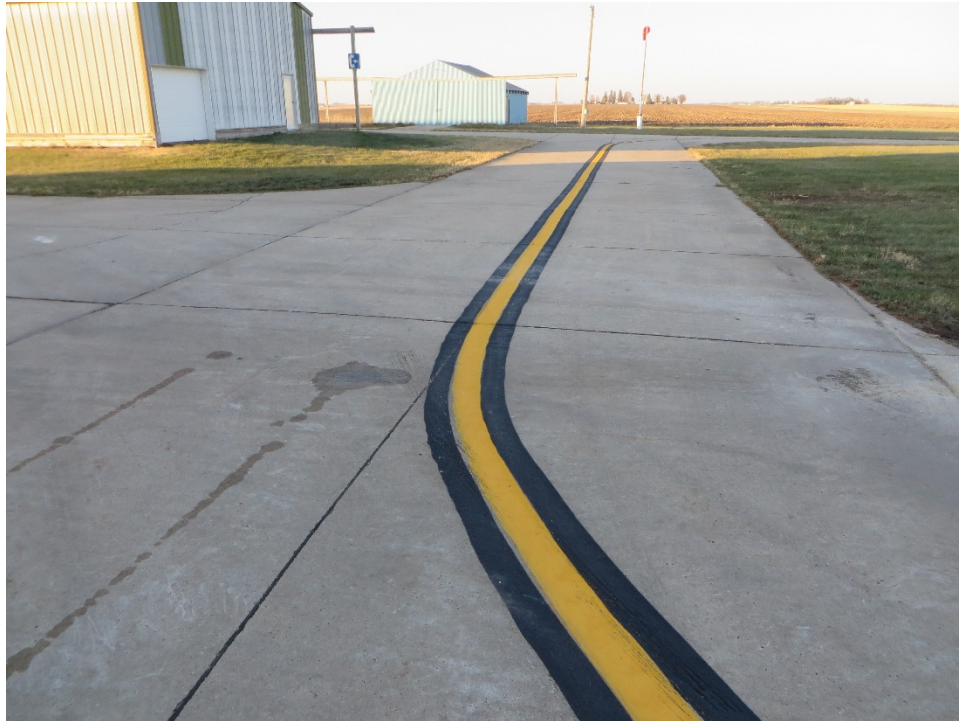
T02OS-02. Overview.

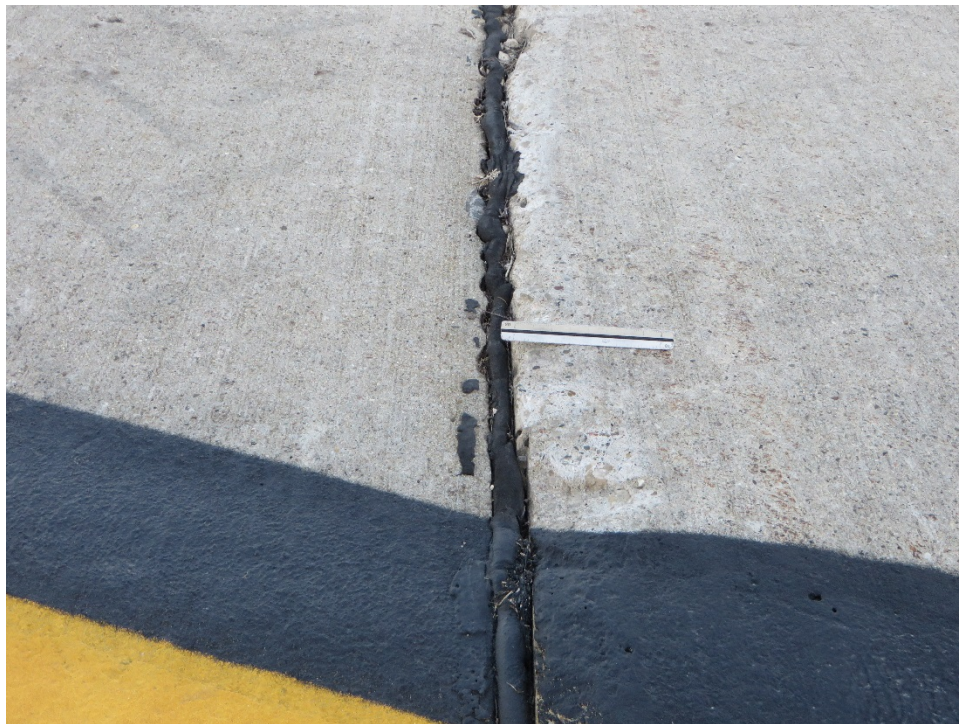
T02OS-02. Faulting (Sample Unit No. 03).

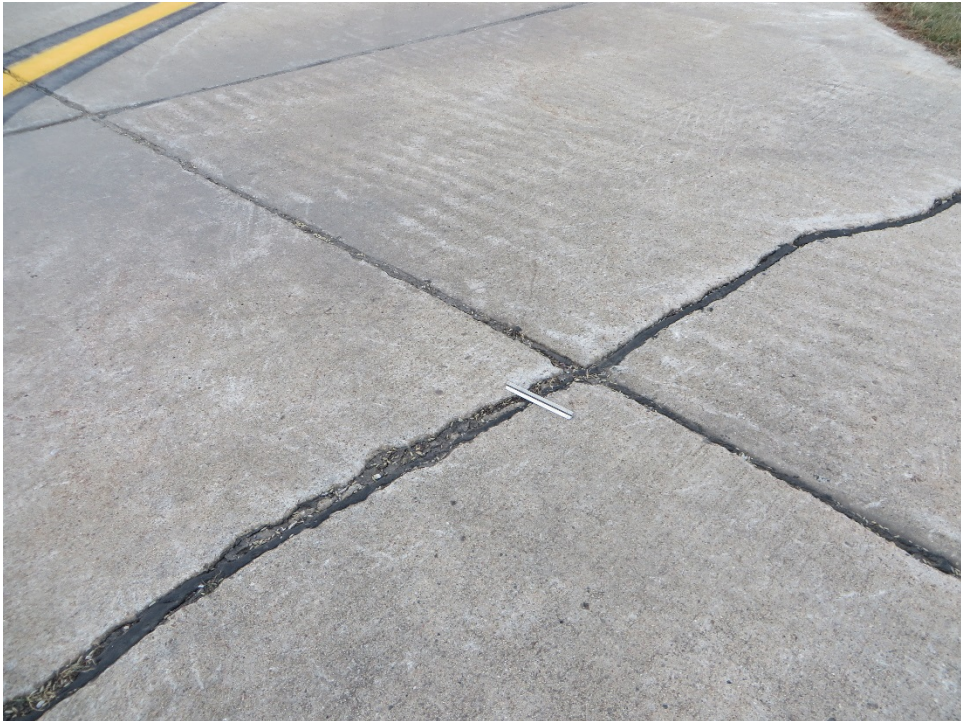
T02OS-02. LTD Cracking (Sample Unit No. 03).
