Ottumwa Regional Airport

Pavement Management Report

JULY 2023

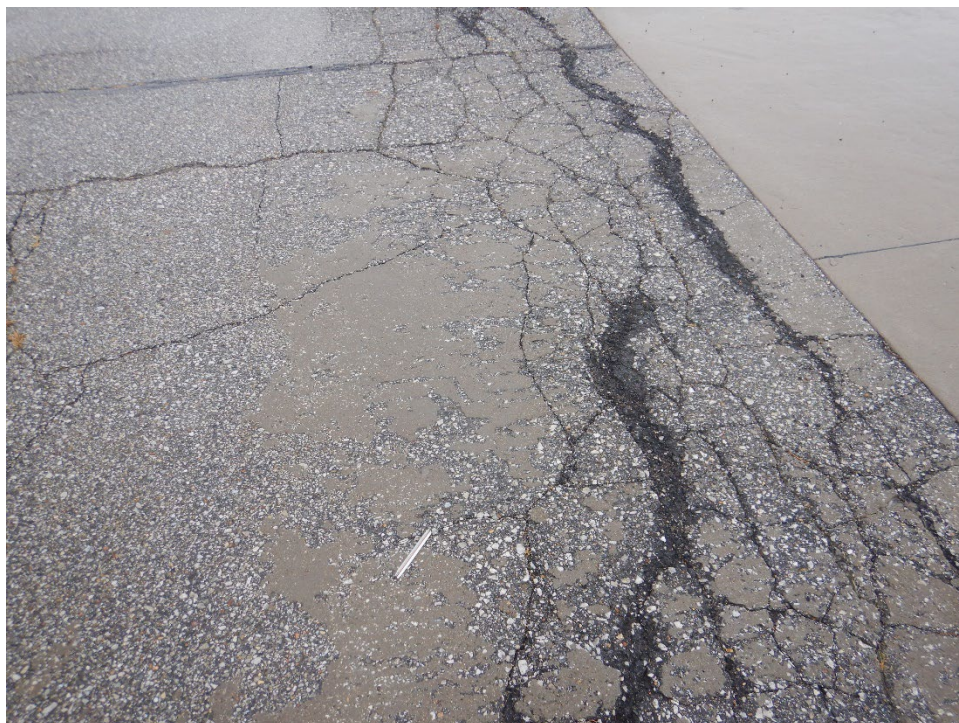
A01OT-01. Alligator Cracking (Sample Unit No. 02).

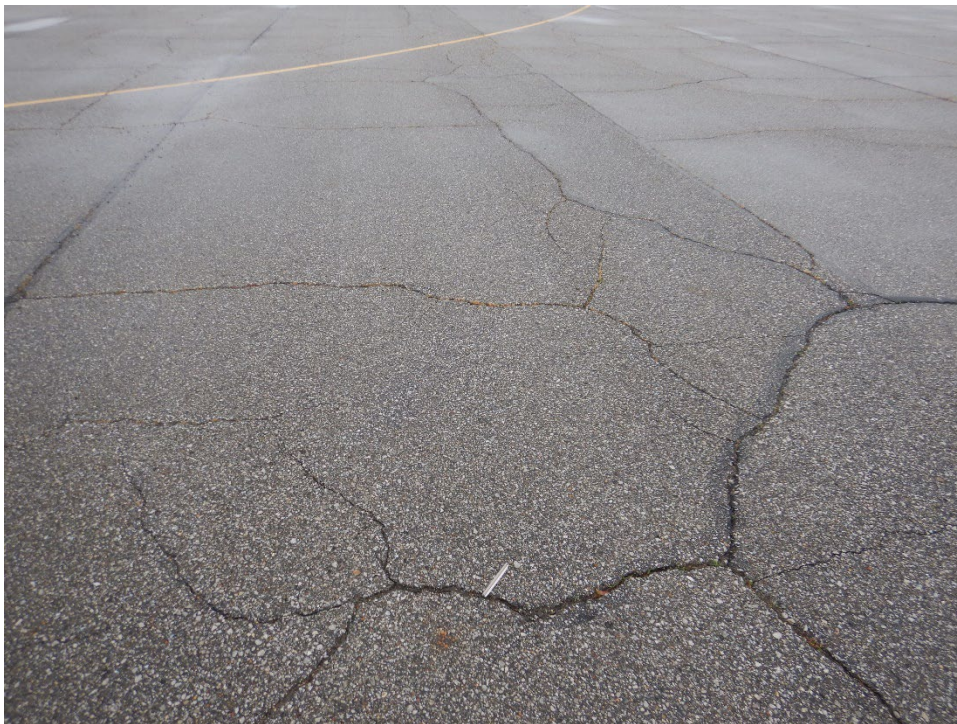
A01OT-02. Block Cracking (Sample Unit No. 06).

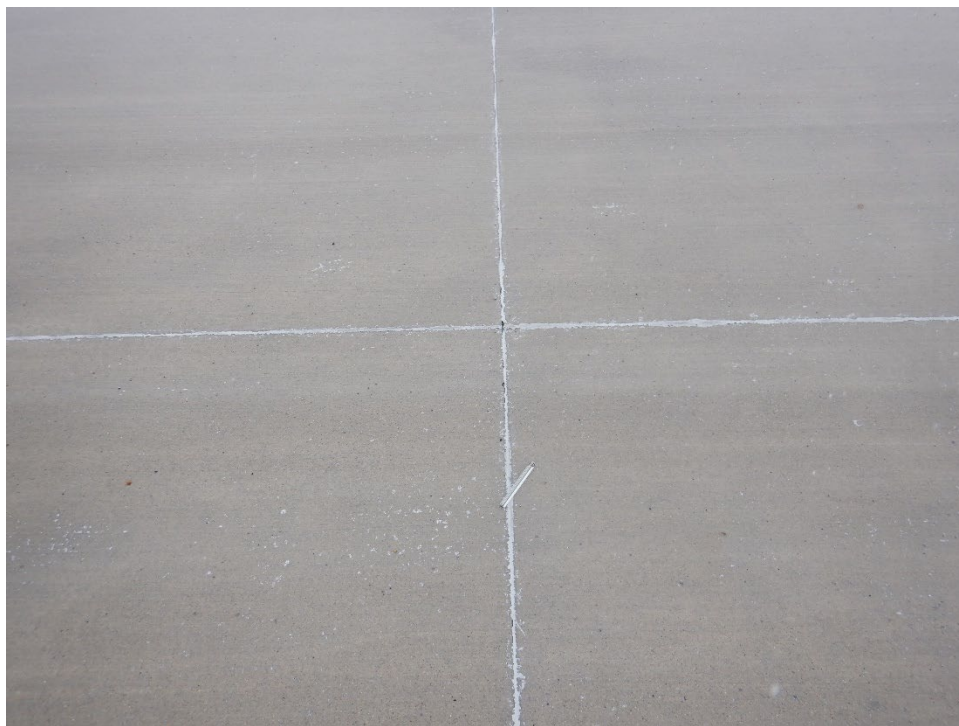
A01OT-03. Joint Seal Damage (Sample Unit No. 10).

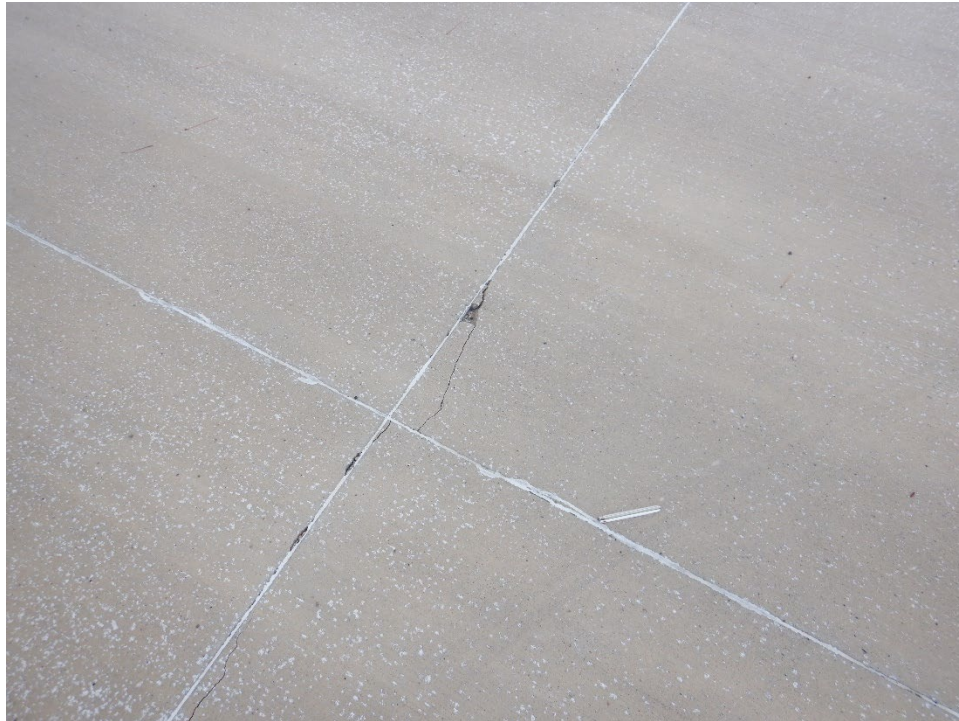
A01OT-03. Joint Spalling (Sample Unit No. 05).

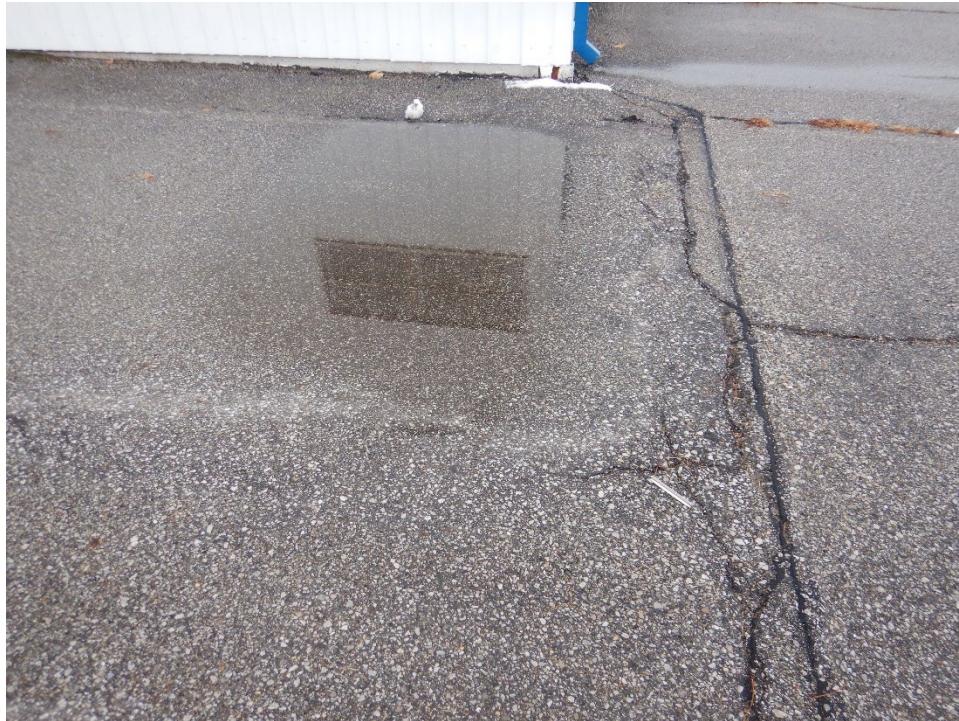
A01OT-04. Swelling (Sample Unit No. 01).

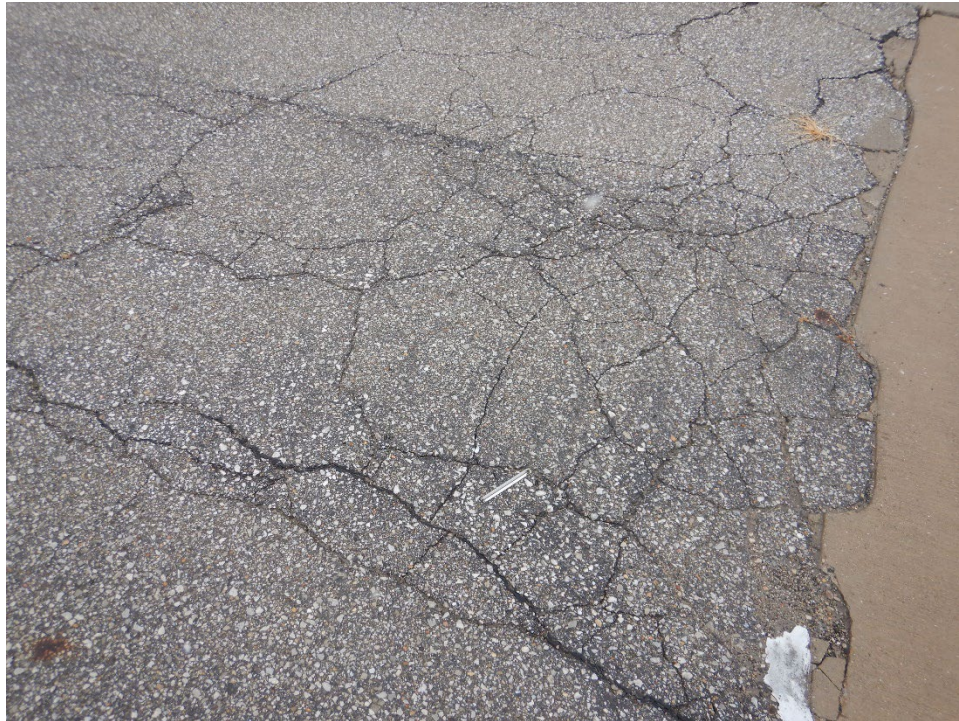
A01OT-05. Alligator Cracking (Sample Unit No. 01).

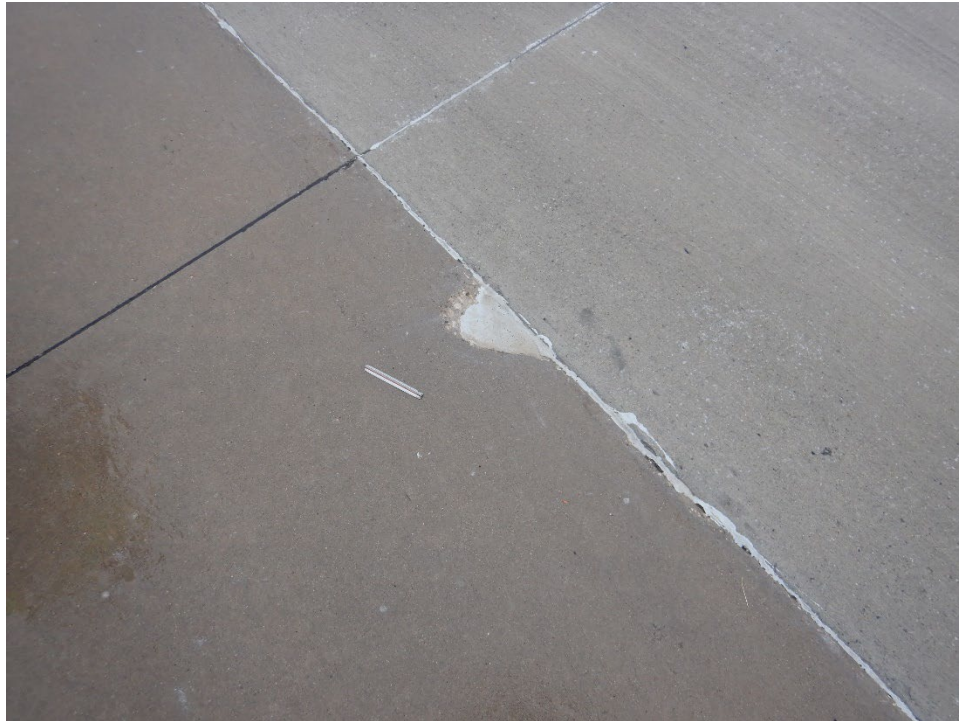
A01OT-07. Joint Spalling (Sample Unit No. 04).

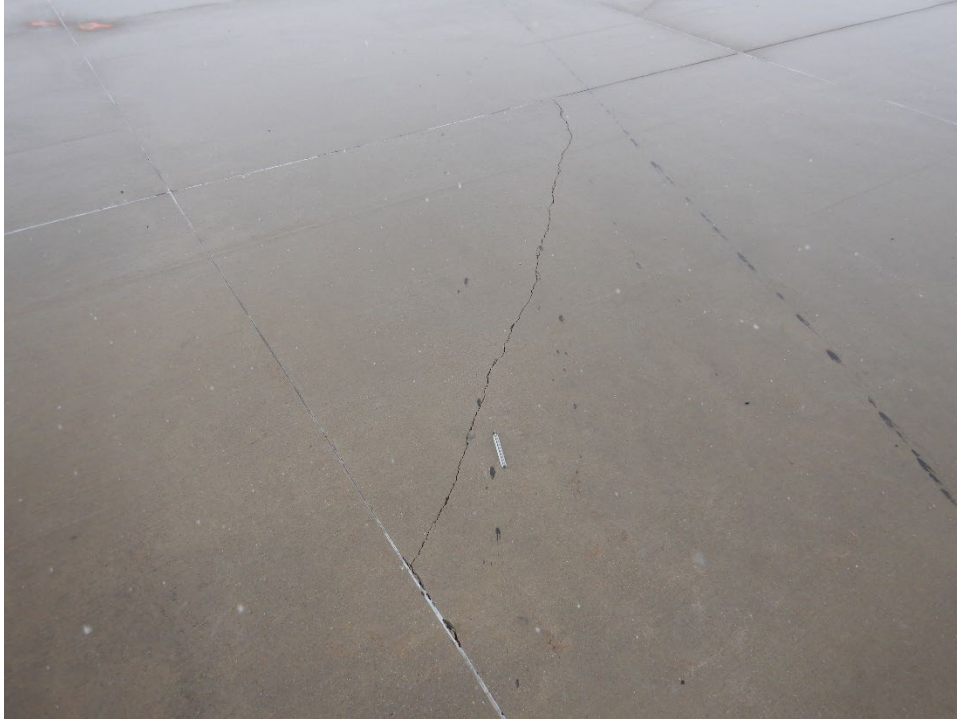
A01OT-08. Corner Break (Sample Unit No. 12).

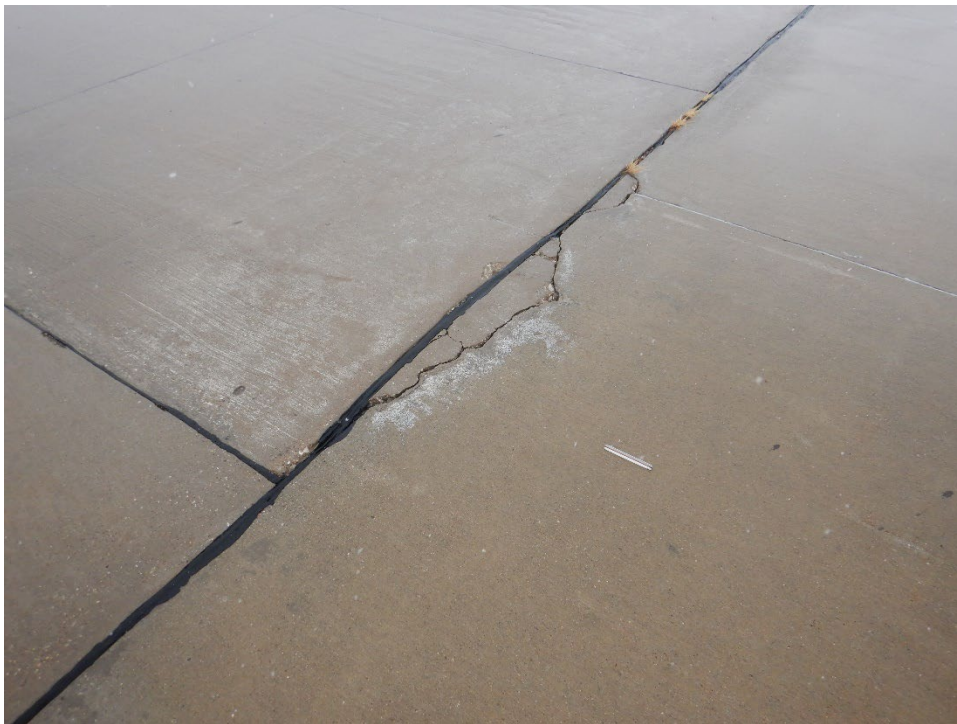
A01OT-08. Joint Spalling (Additional Sample Unit No. 13).

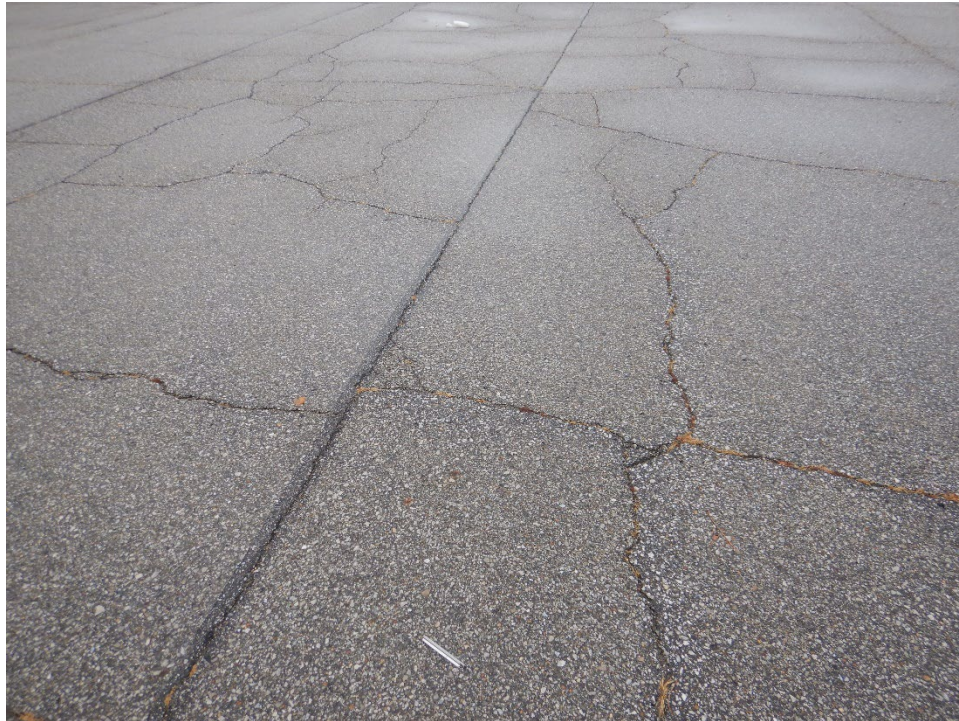
A02OT-01. Block Cracking (Sample Unit No. 09).

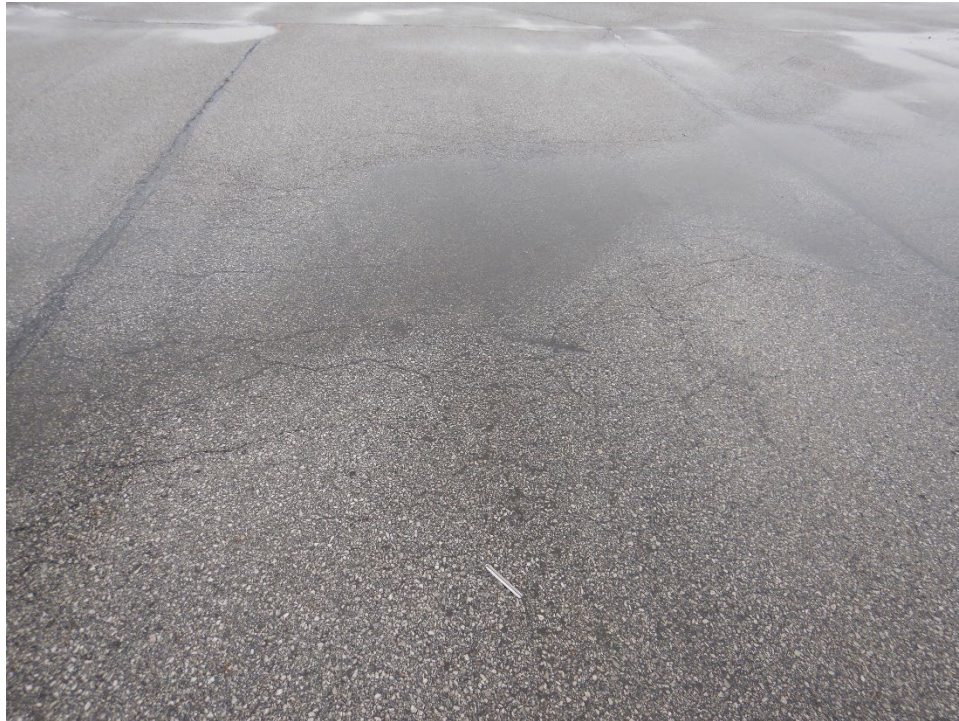
A02OT-02. Alligator Cracking (Sample Unit No. 04).

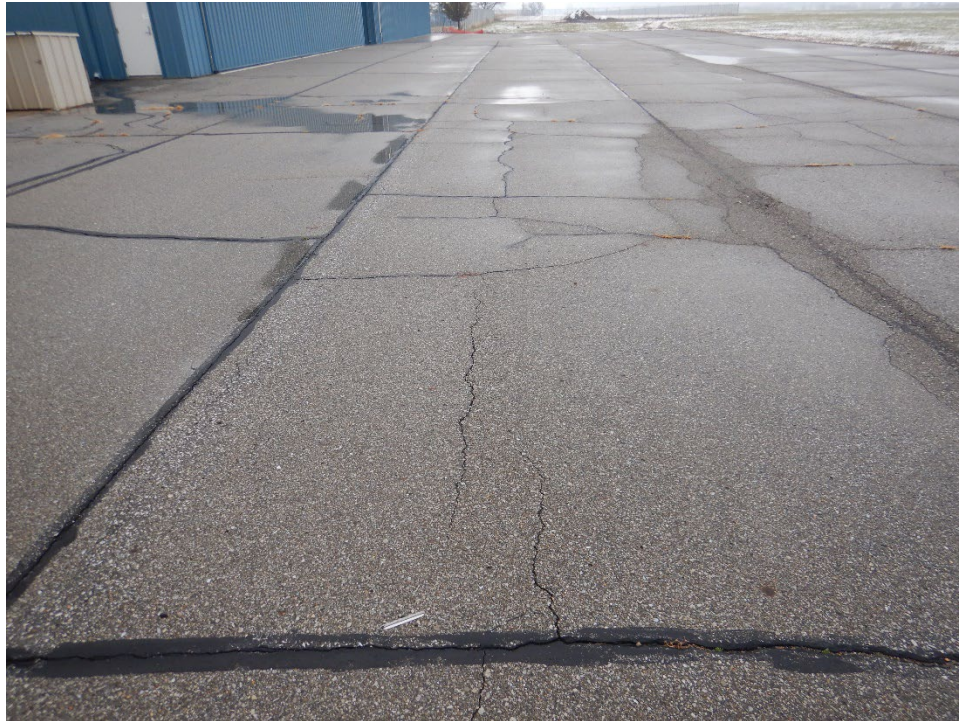
A02OT-03. L&T Cracking (Sample Unit No. 01).

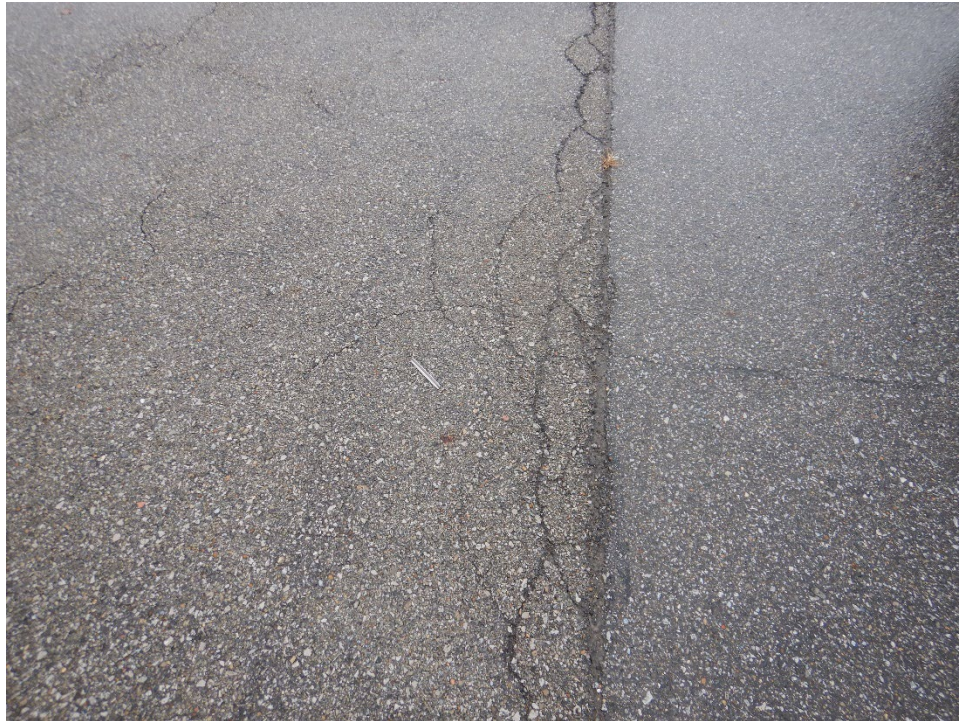
A02OT-04. Alligator Cracking (Sample Unit No. 01).

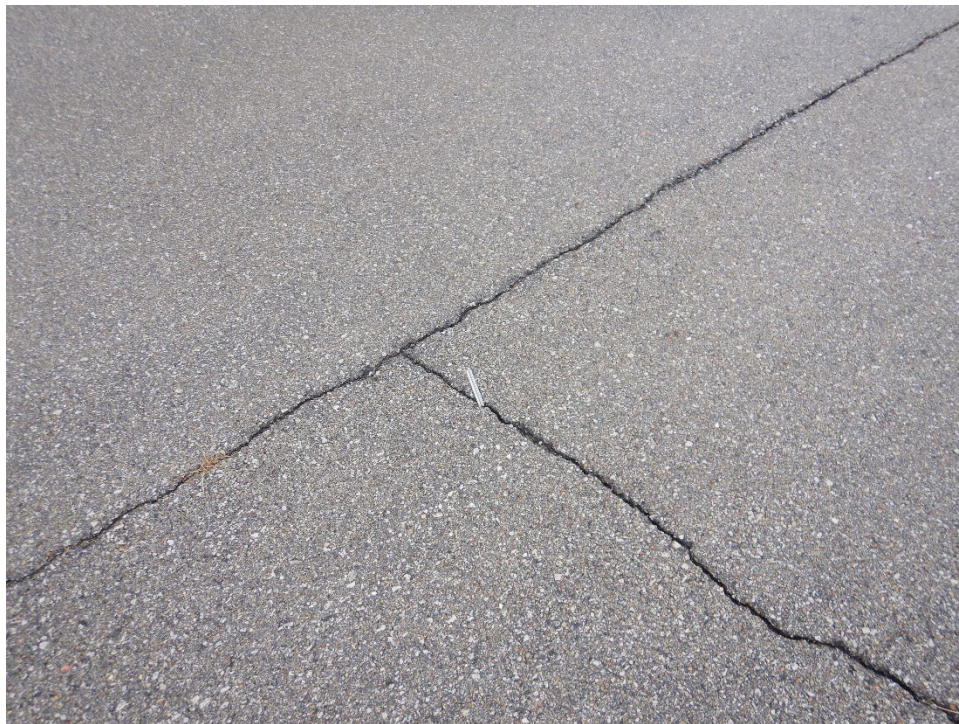
A02OT-04. L&T Cracking (Sample Unit No. 01).

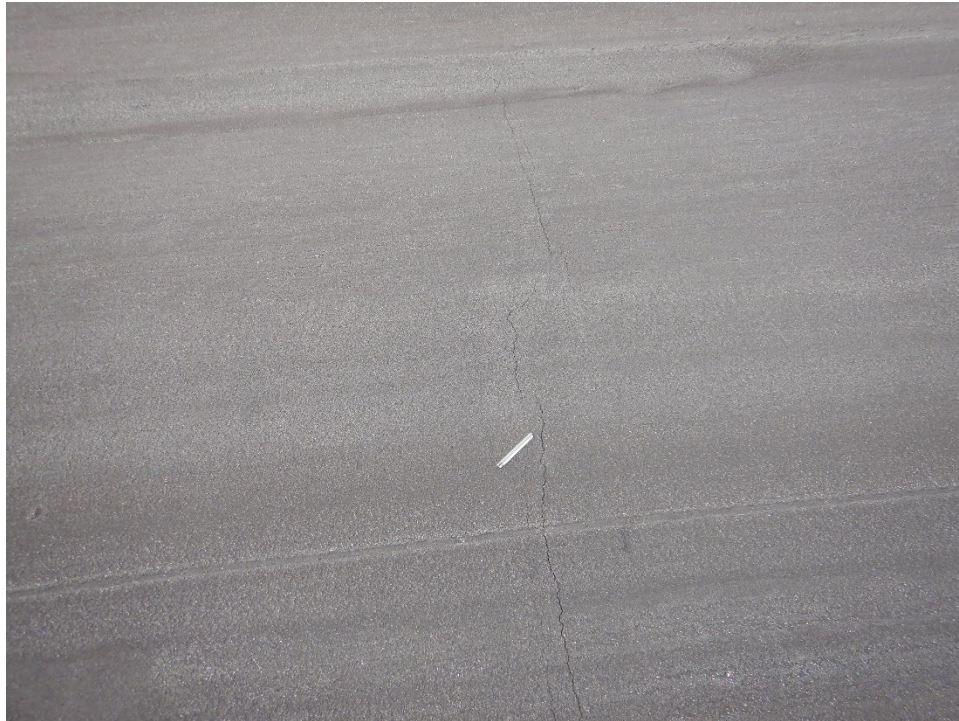
R04OT-02. Joint Reflection Cracking (Sample Unit No. 65).

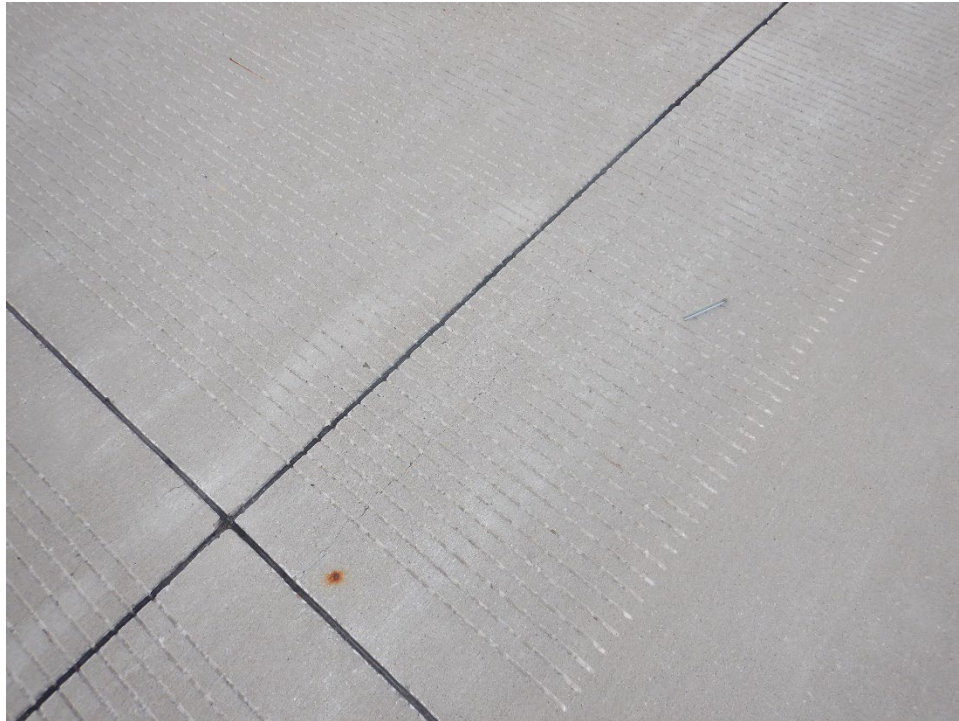
R13OT-01. Joint Spalling (Sample Unit No. 183).

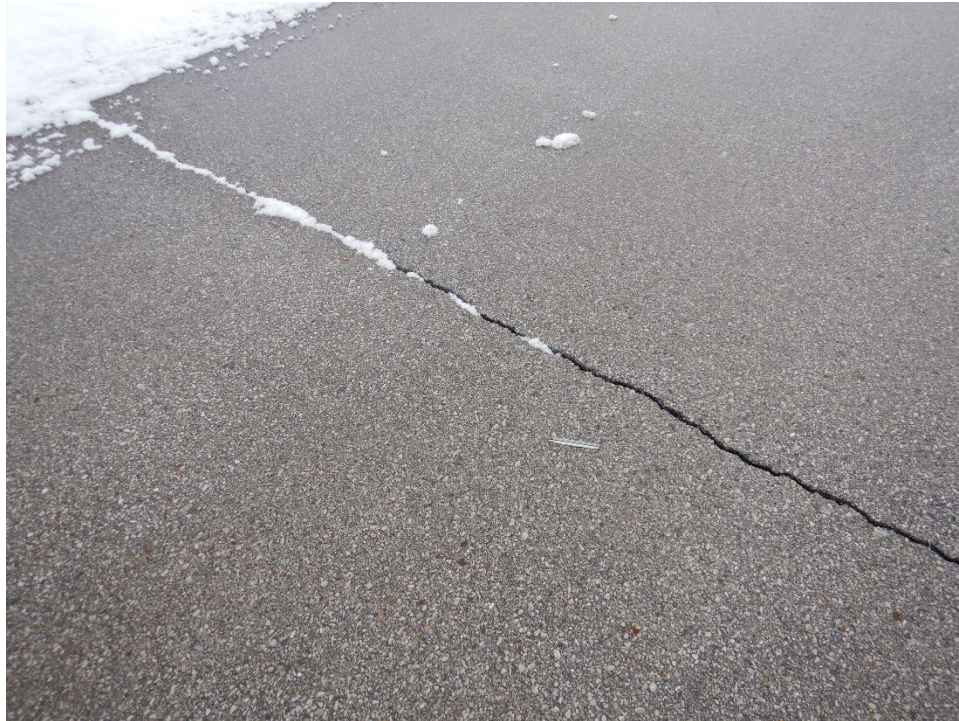
TAOT-01. L&T Cracking (Sample Unit No. 04).

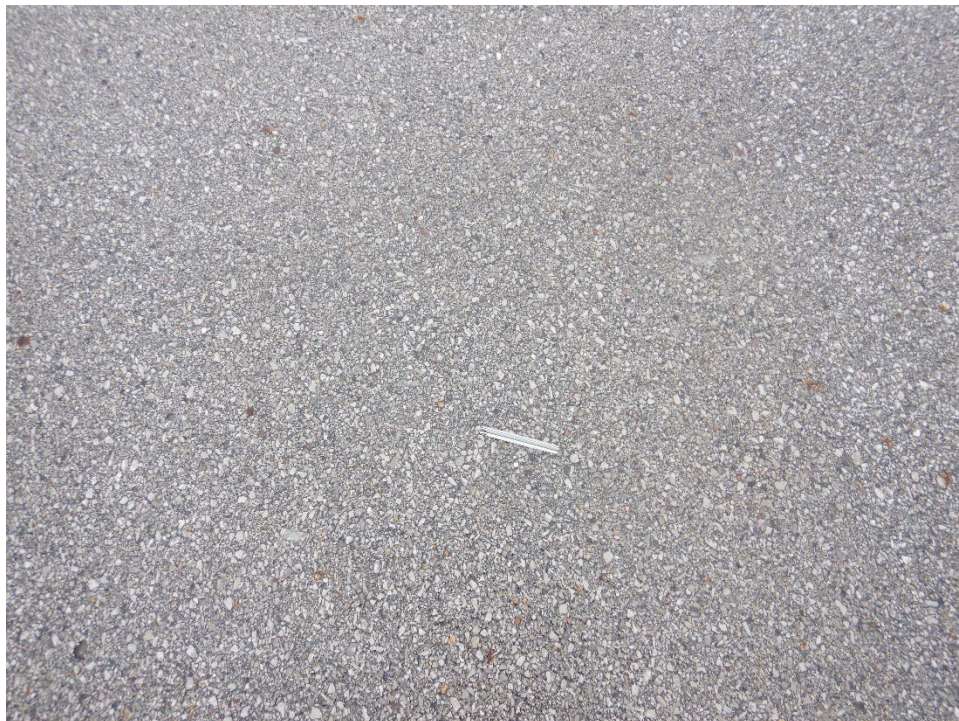
TAOT-01. Weathering (Sample Unit No. 04).

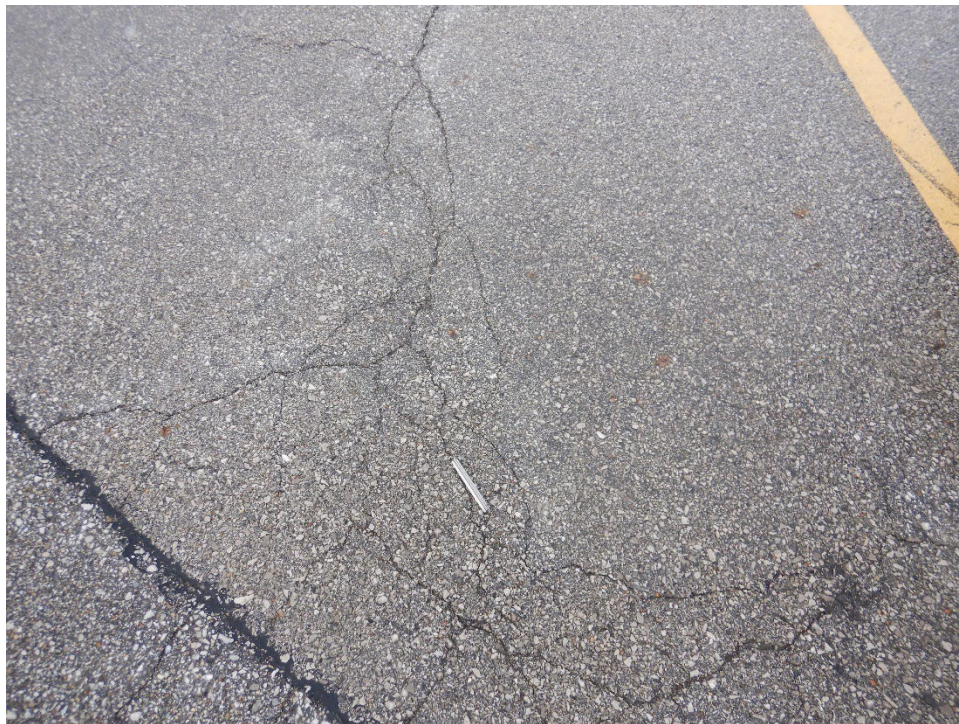
TAOT-02. Alligator Cracking (Sample Unit No. 01).

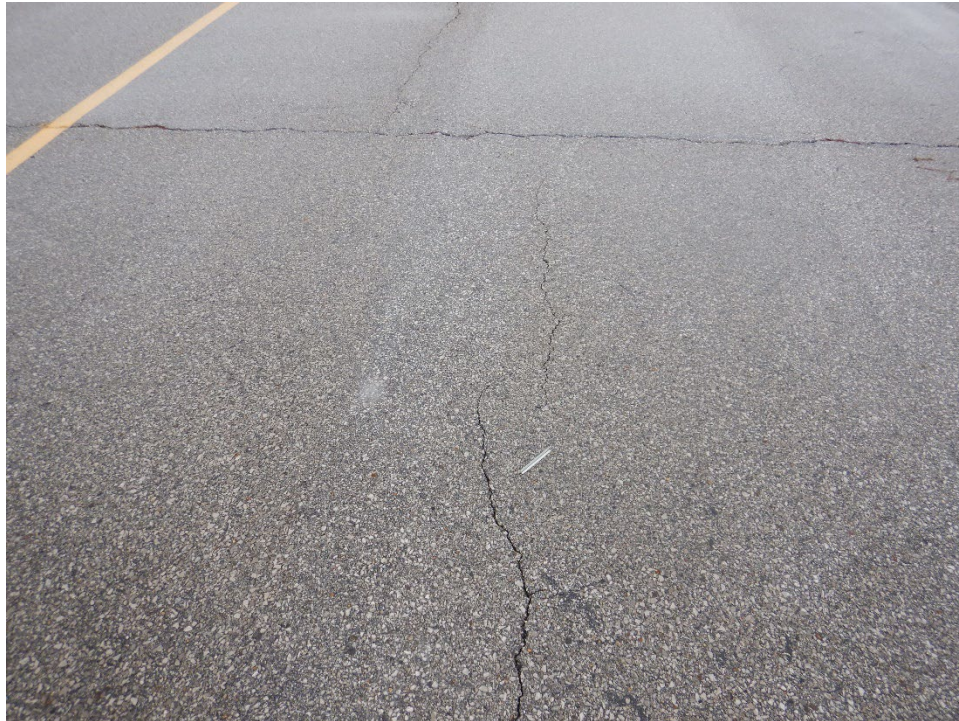
TAOT-02. L&T Cracking (Sample Unit No. 01).

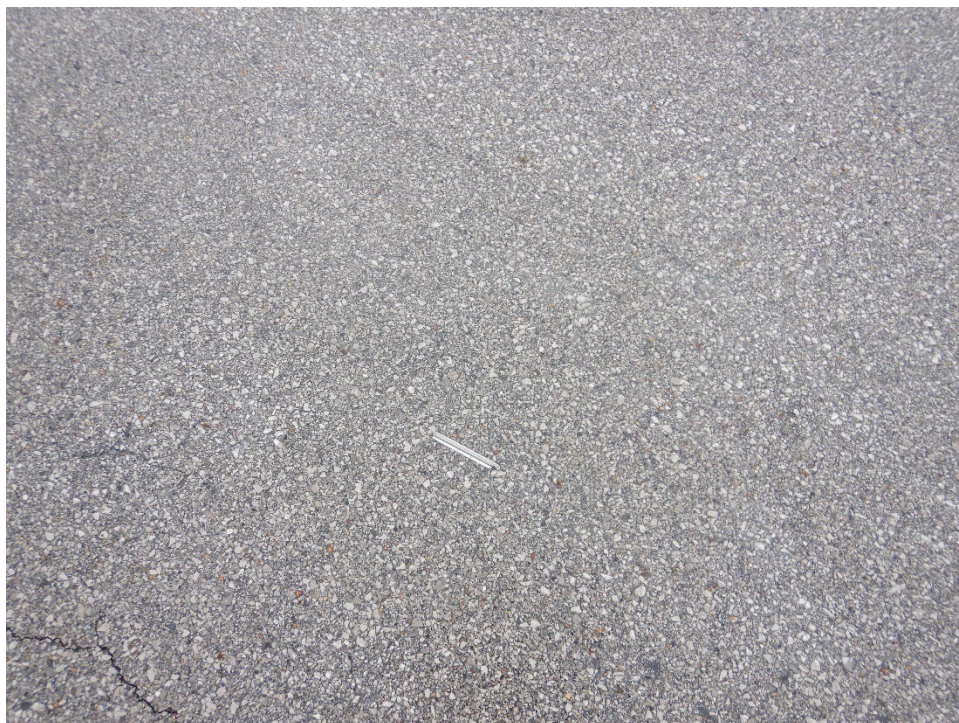
TAOT-02. Weathering (Sample Unit No. 01).

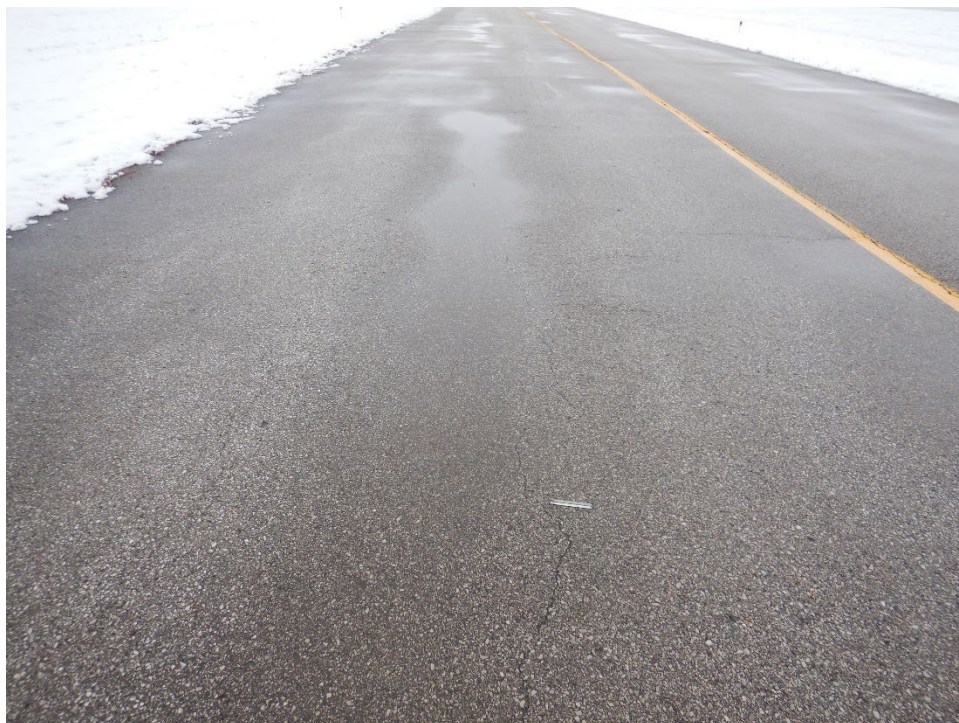
TAOT-03. Rutting (Sample Unit No. 11).

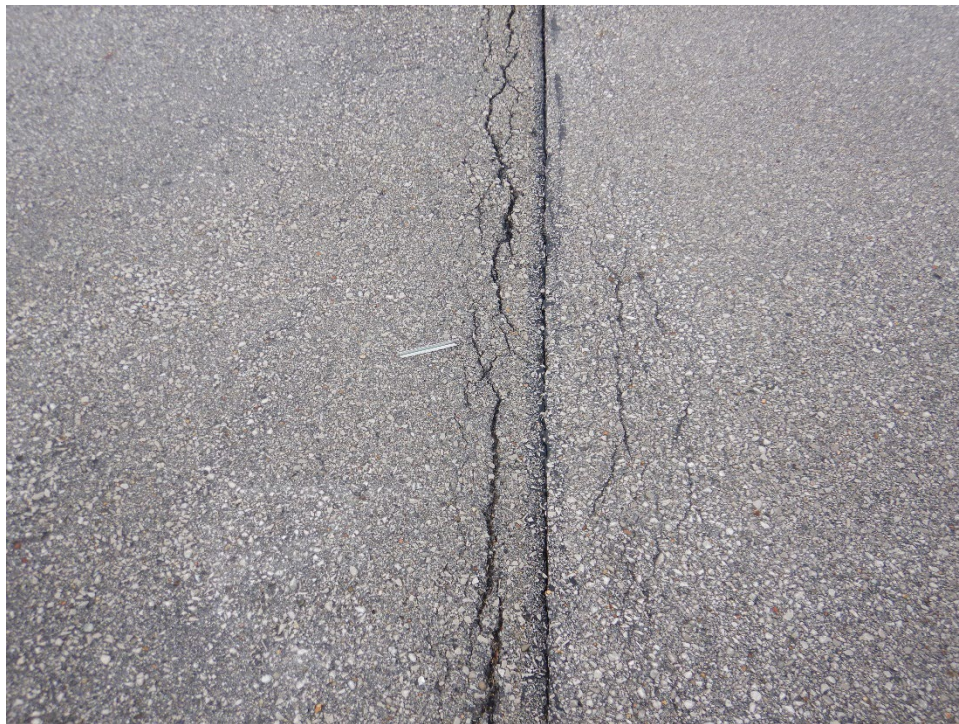
TAOT-04. L&T Cracking (Sample Unit No. 01).

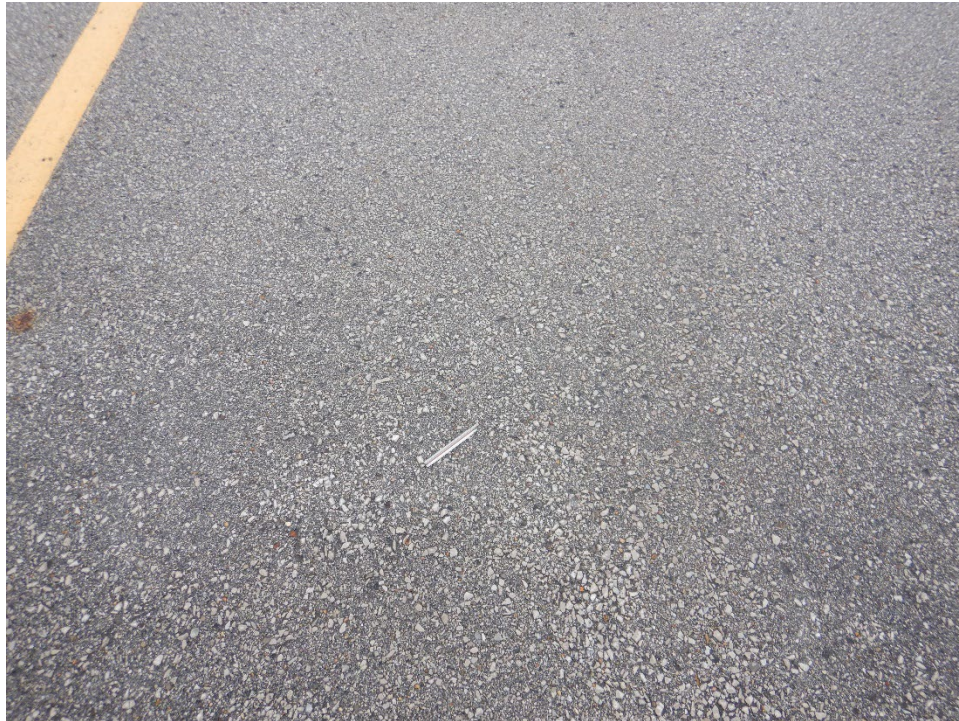
TAOT-04. Weathering (Sample Unit No. 01).

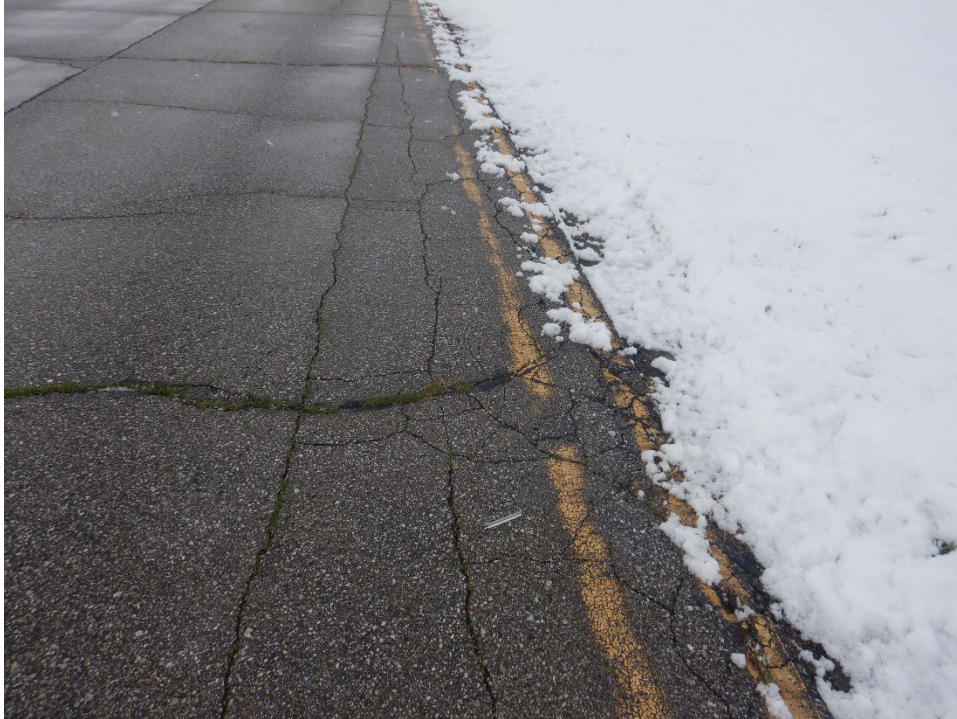
TAOT-06. Alligator Cracking (Sample Unit No. 14).

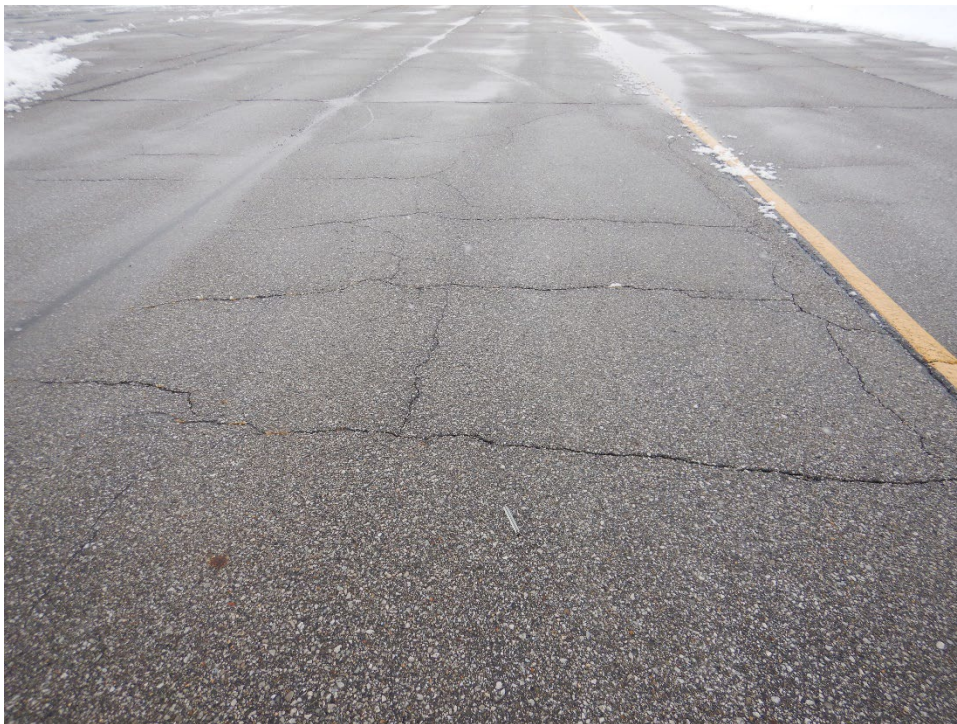
TAOT-06. Block Cracking (Sample Unit No. 06).

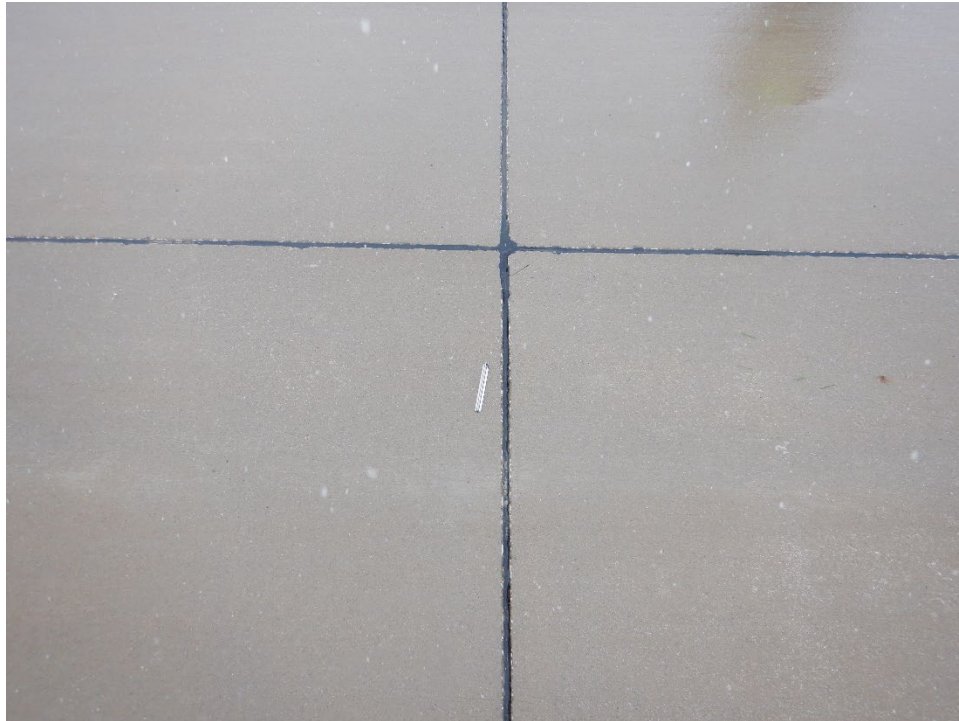
TAOT-07. Joint Seal Damage (Sample Unit No. 16).

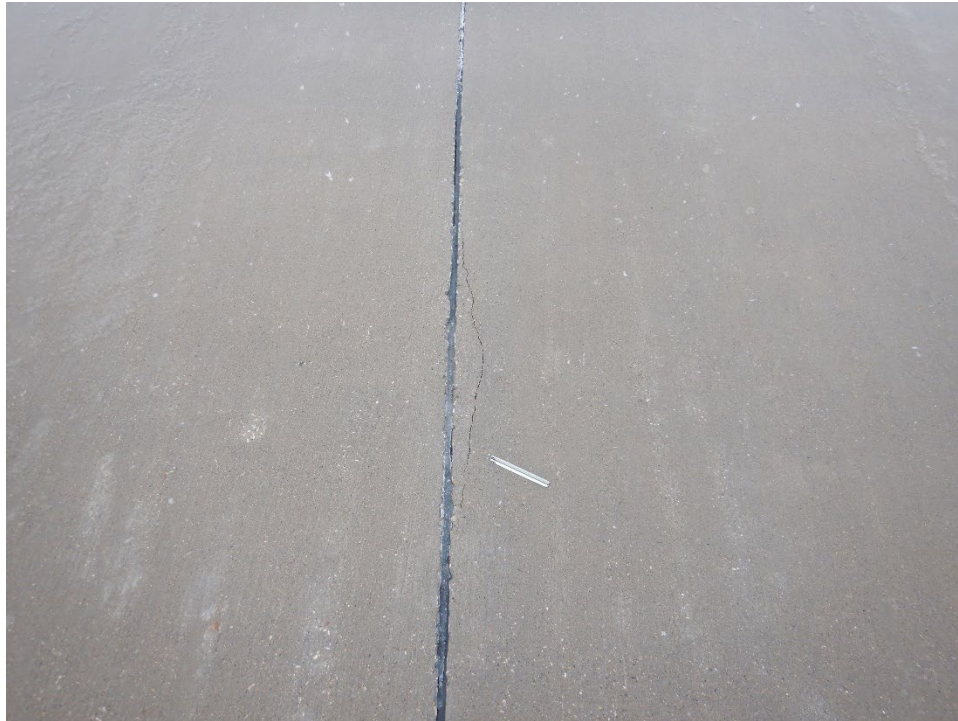
TAOT-08. Joint Spalling (Sample Unit No. 02).

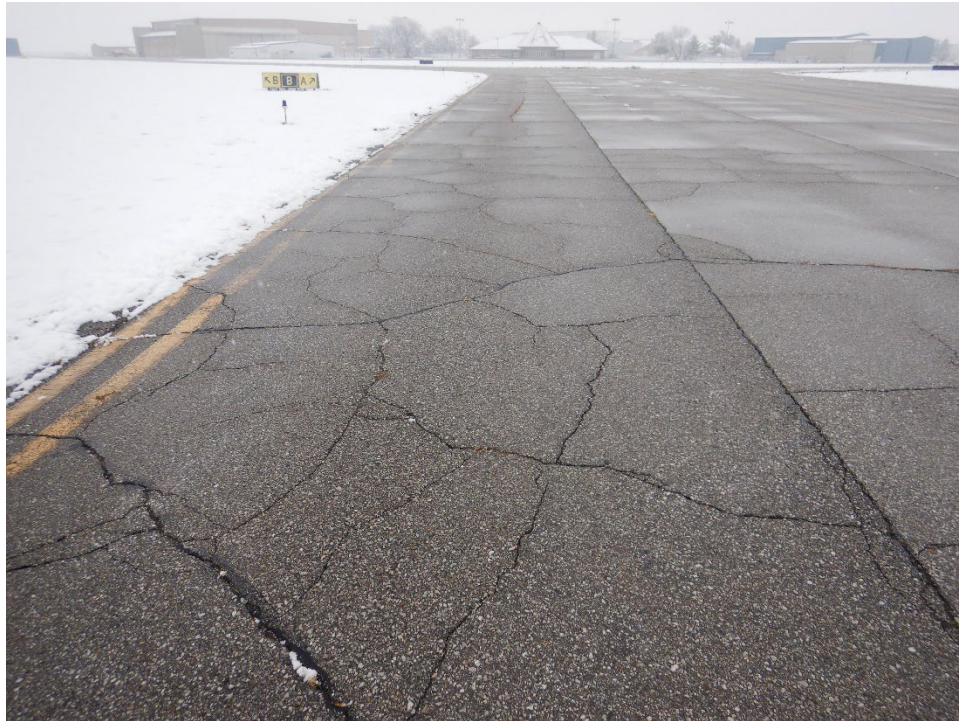
TBOT-01. Block Cracking (Sample Unit No. 02).

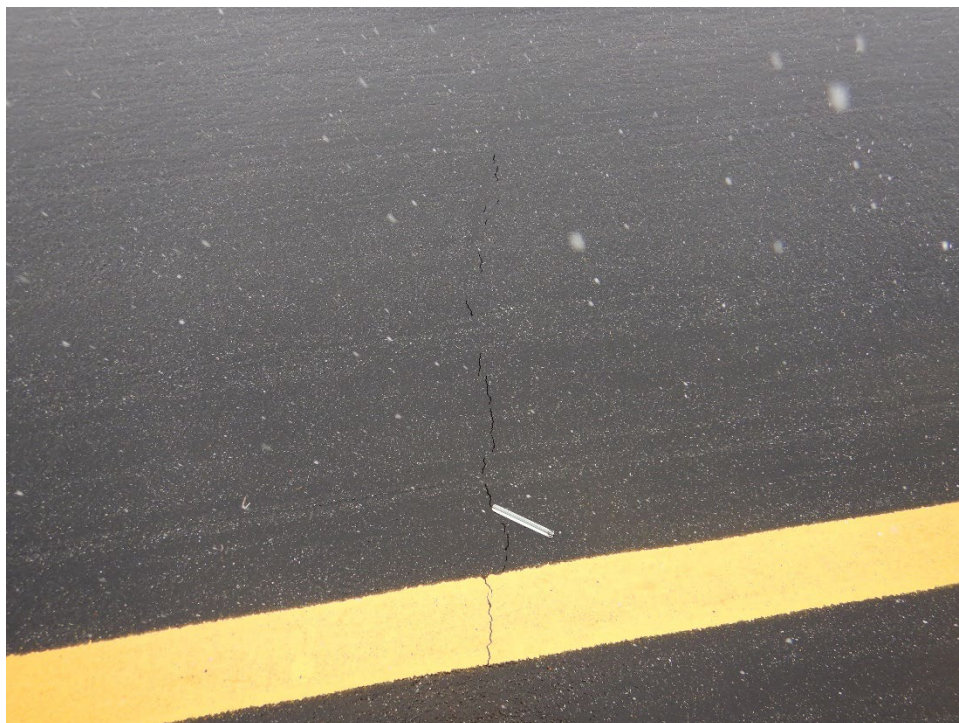
TBOT-04. L&T Cracking (Sample Unit No. 05).

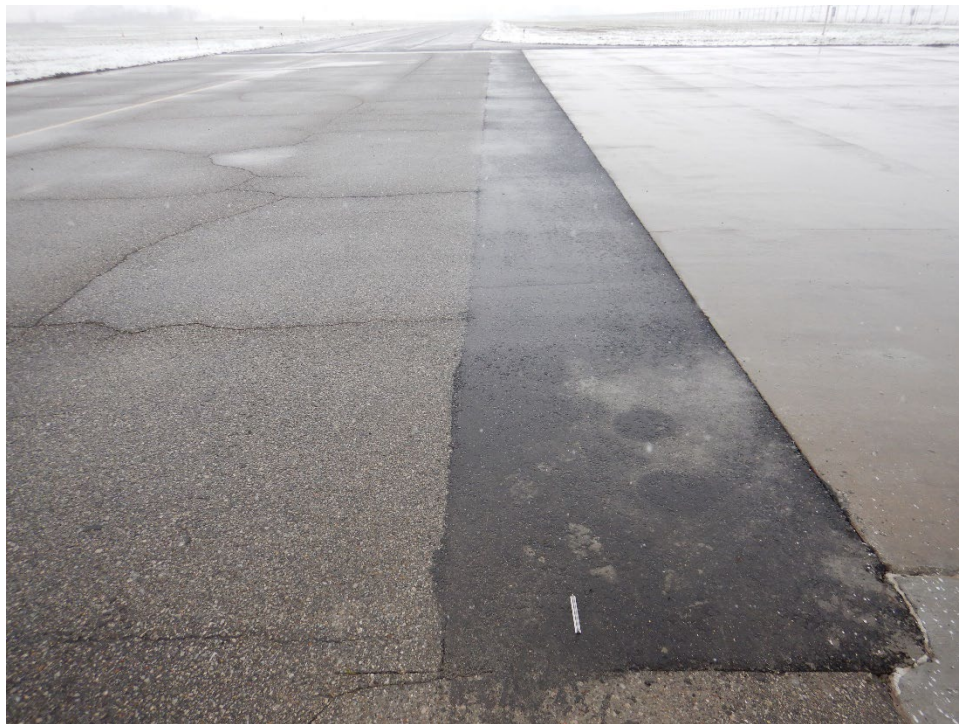
TBOT-06. Patching (Additional Sample Unit No. 01).
