# Perry Municipal Airport

## Pavement Management Report

**JULY 2024**

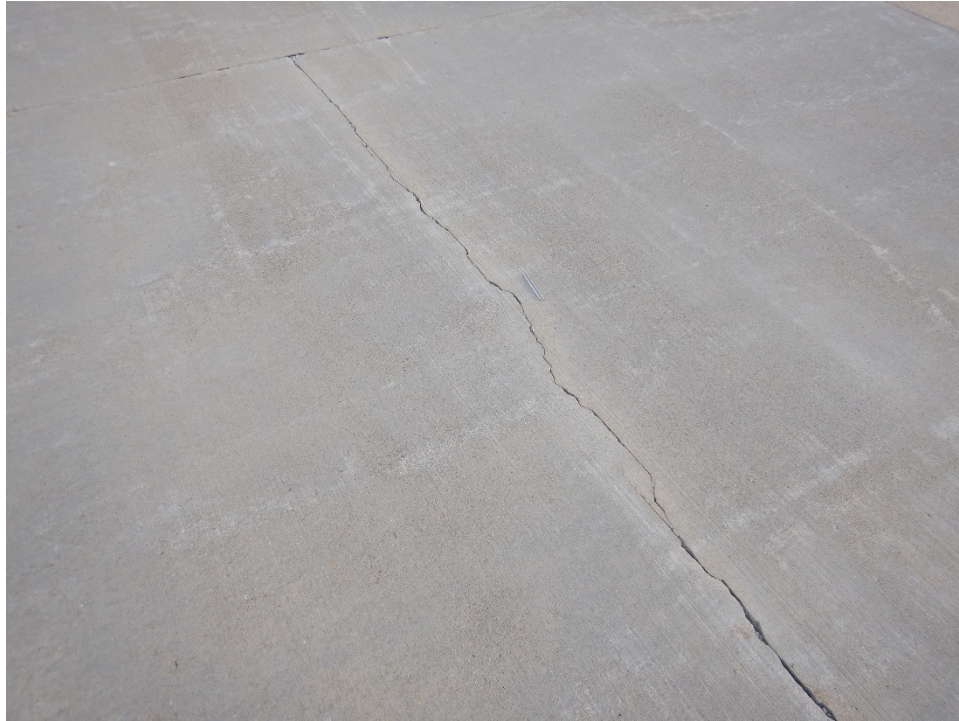
A01PR-01. LTD Cracking (Sample Unit No. 05).

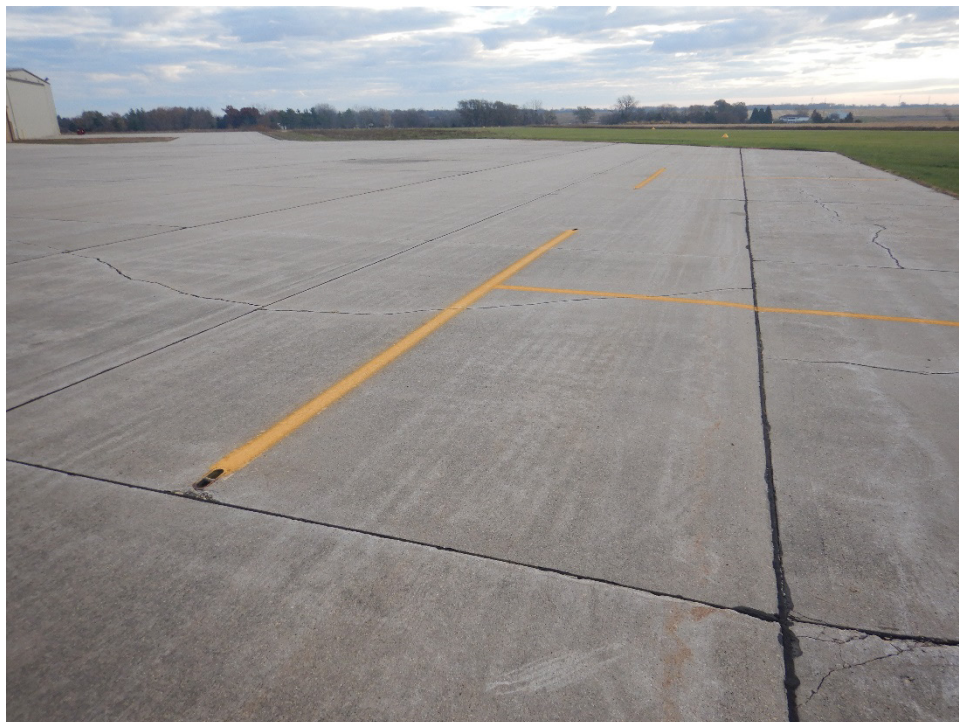
A01PR-03. Overview.

The apron area was defined by two sections. Medium-severity LTD cracking and joint seal damage were observed in Section 01. Section 03 was in poor condition with areas of low-severity corner break and small patching, low- and medium-severity corner spalling, medium-severity joint seal damage and shattered slab, medium- and high-severity joint spalling, and all severities of ASR and LTD cracking.

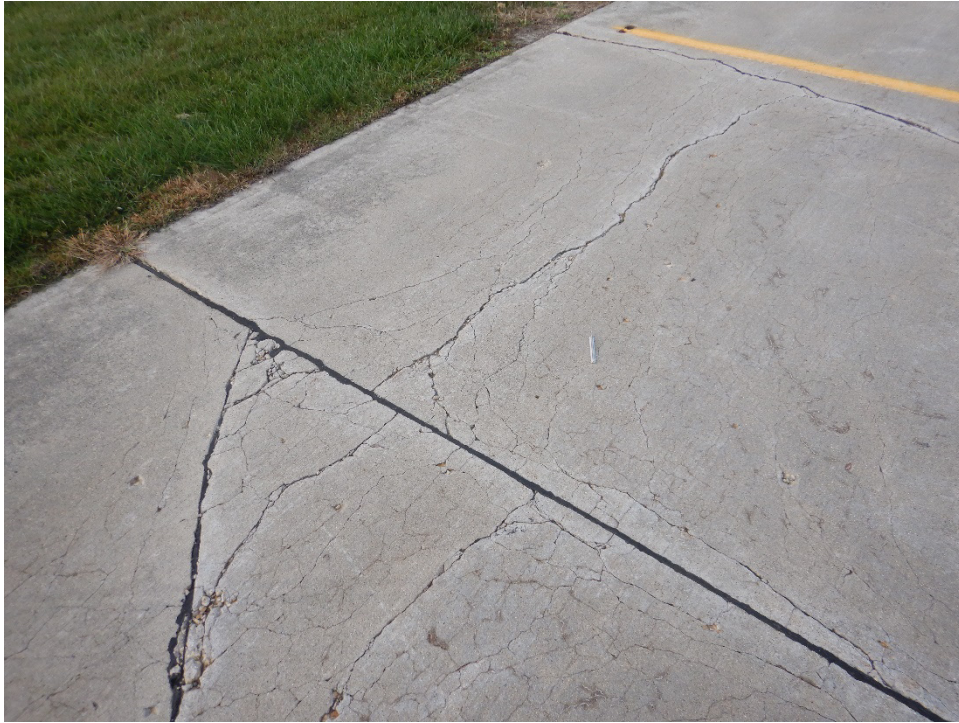
A01PR-03. ASR (Sample Unit No. 02).

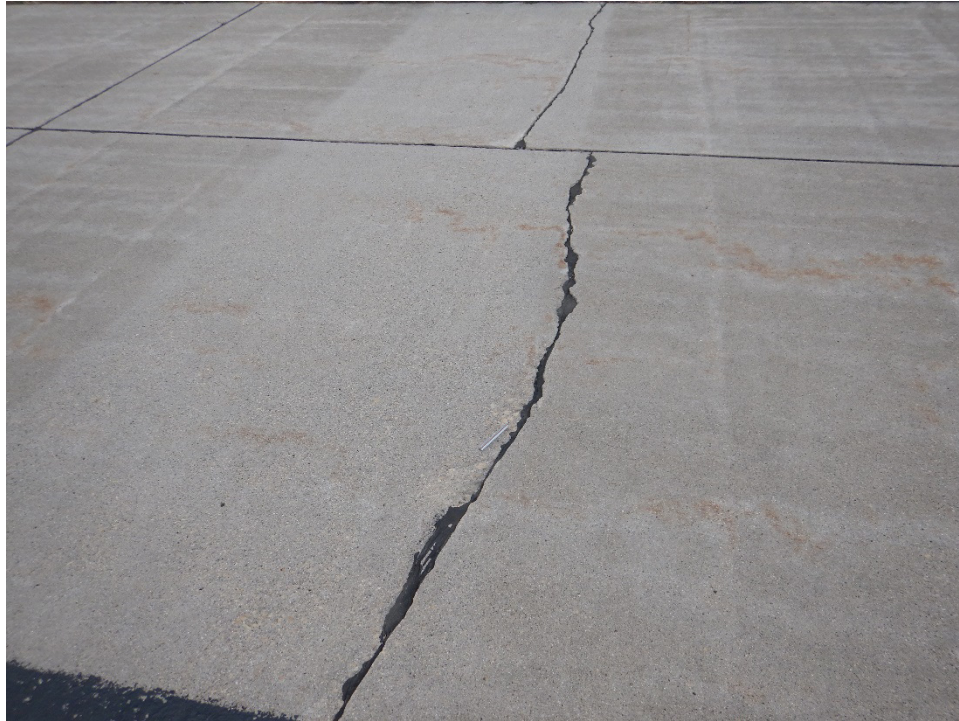
T01PR-01. LTD Cracking (Sample Unit No. 01).

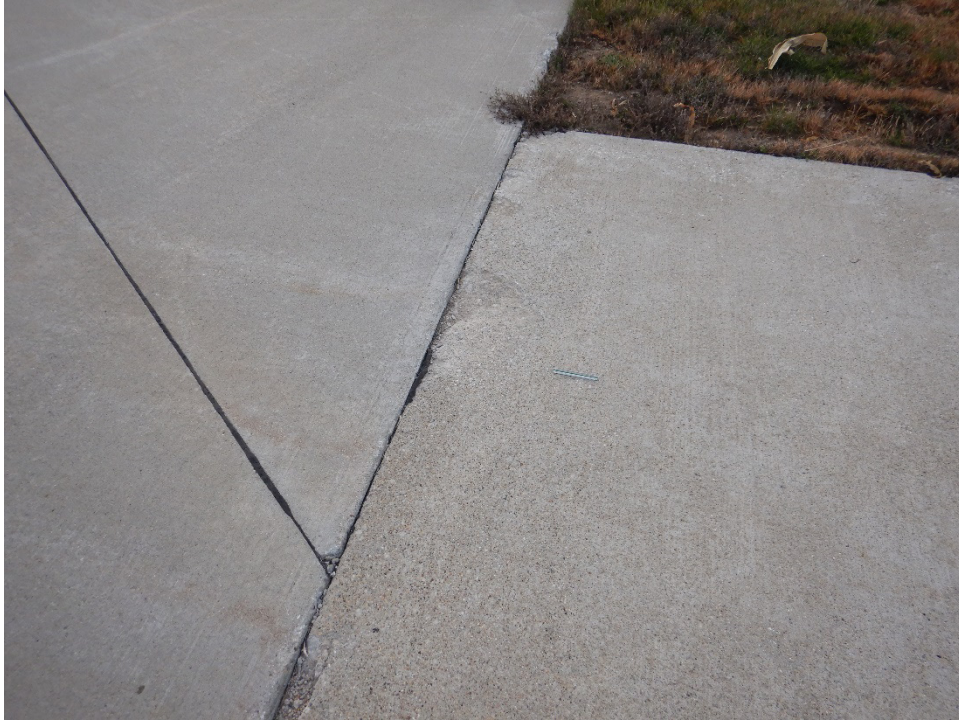
T01PR-02. Joint Spalling (Sample Unit No. 03).

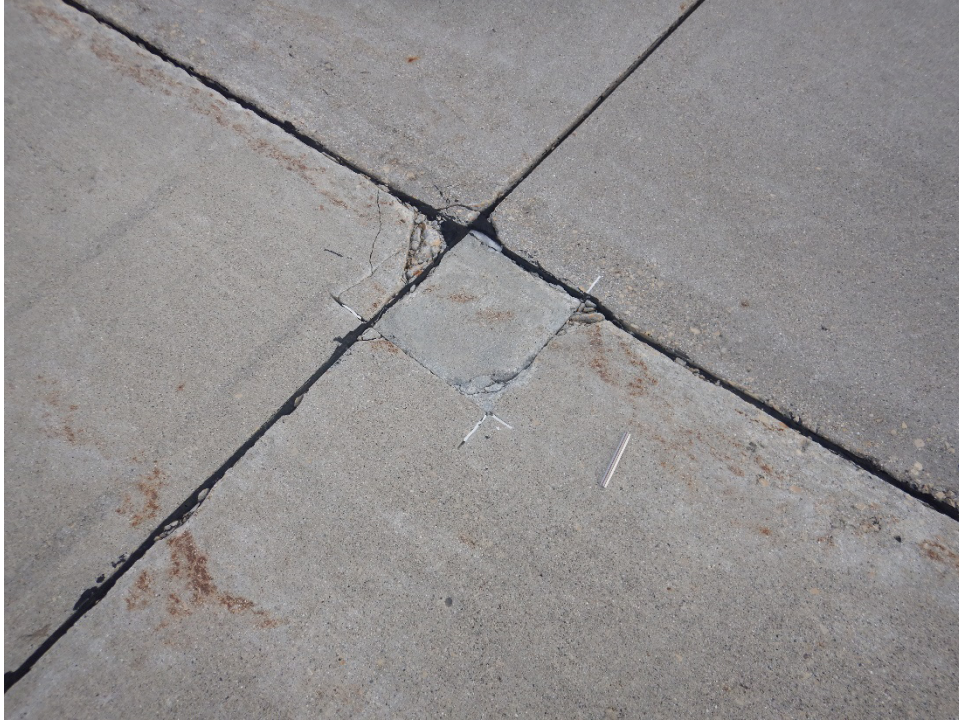
T02PR-01. Small Patching (Sample Unit No. 28).

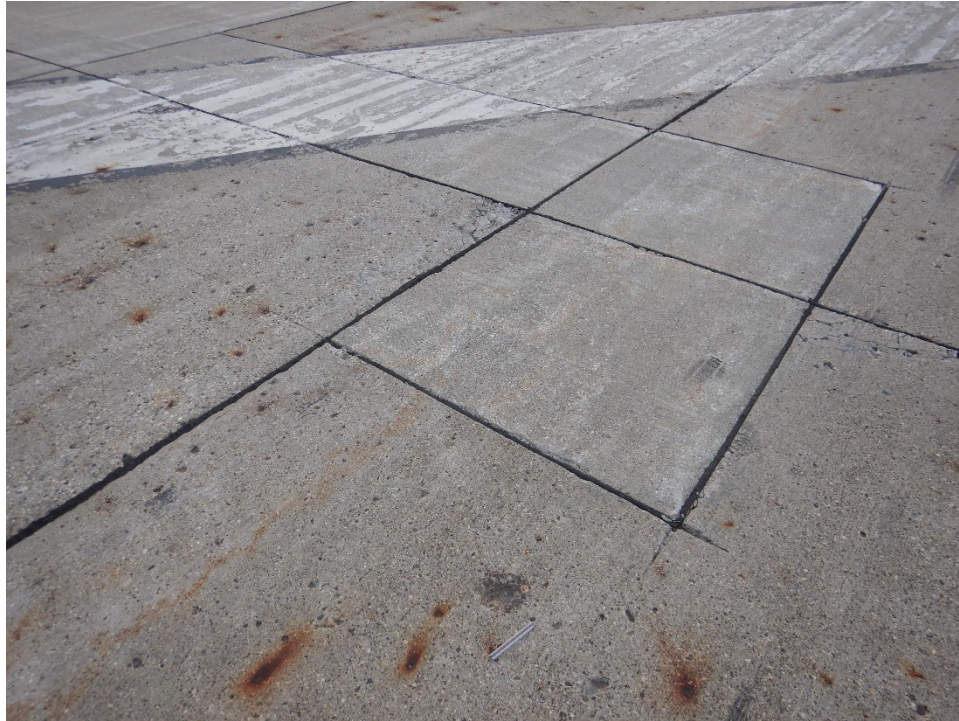
T02PR-02. Large Patching (Sample Unit No. 20).

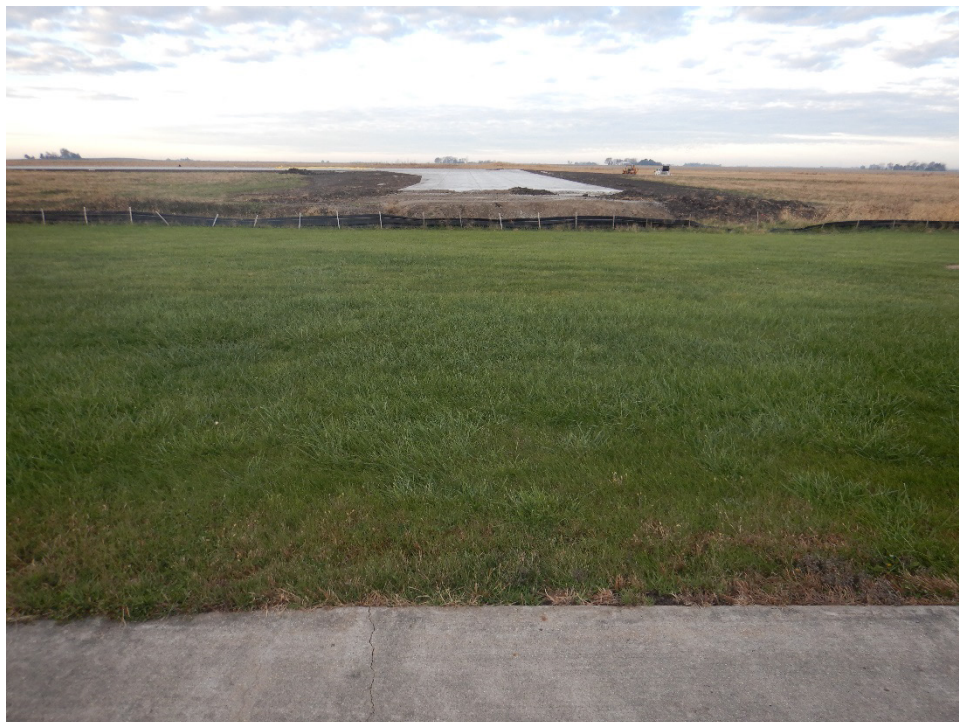
TA1PR-01. Overview (Under Construction).

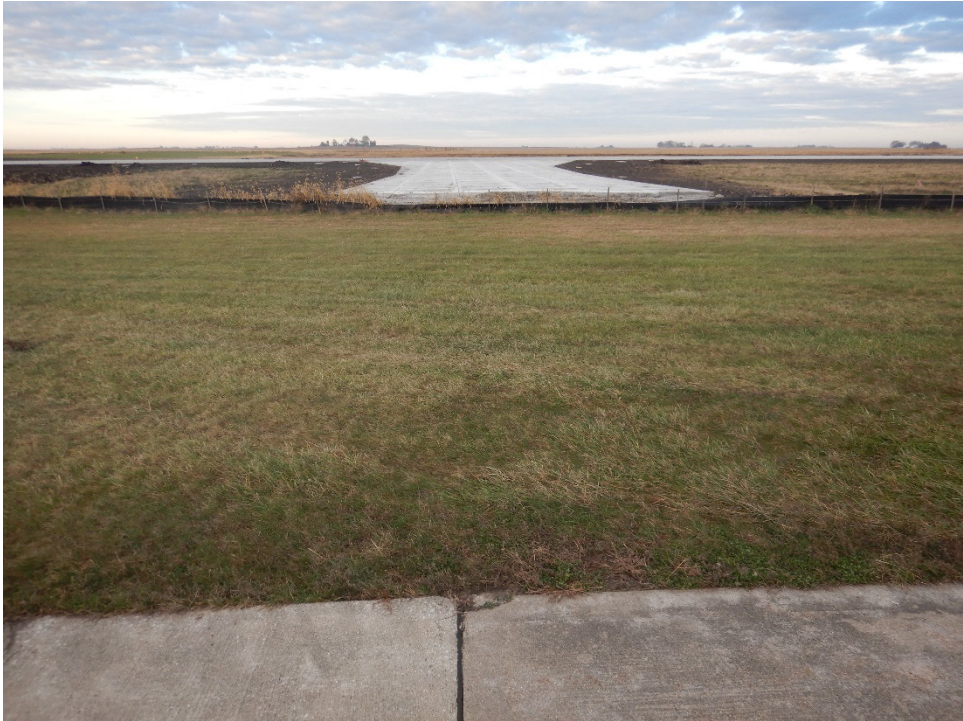
TA2PR-01. Overview (Under Construction).

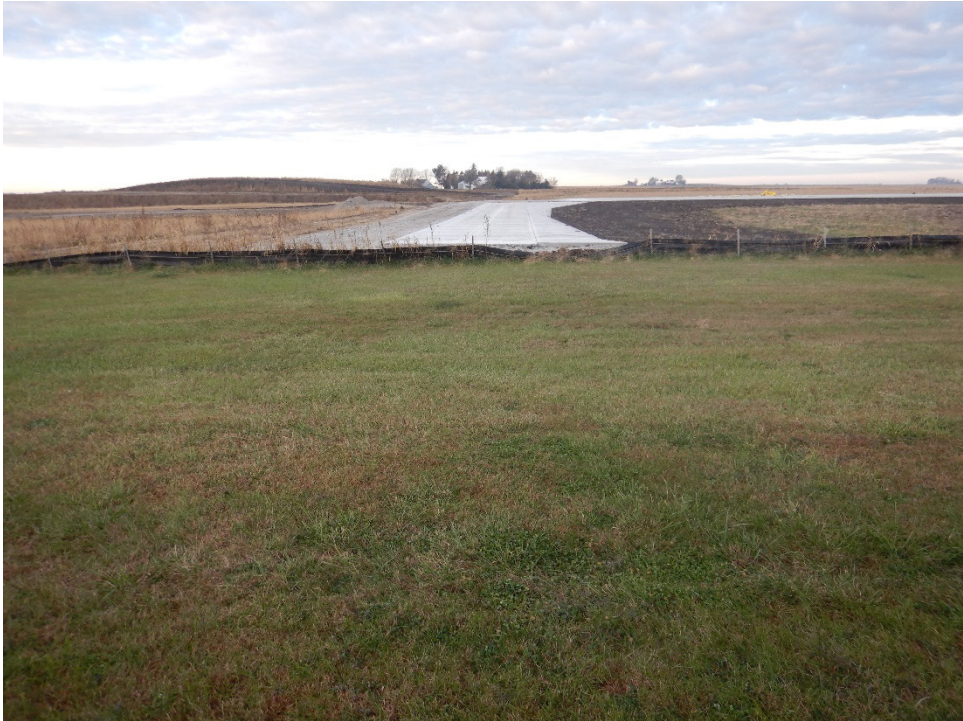
TA3PR-01. Overview (Under Construction).

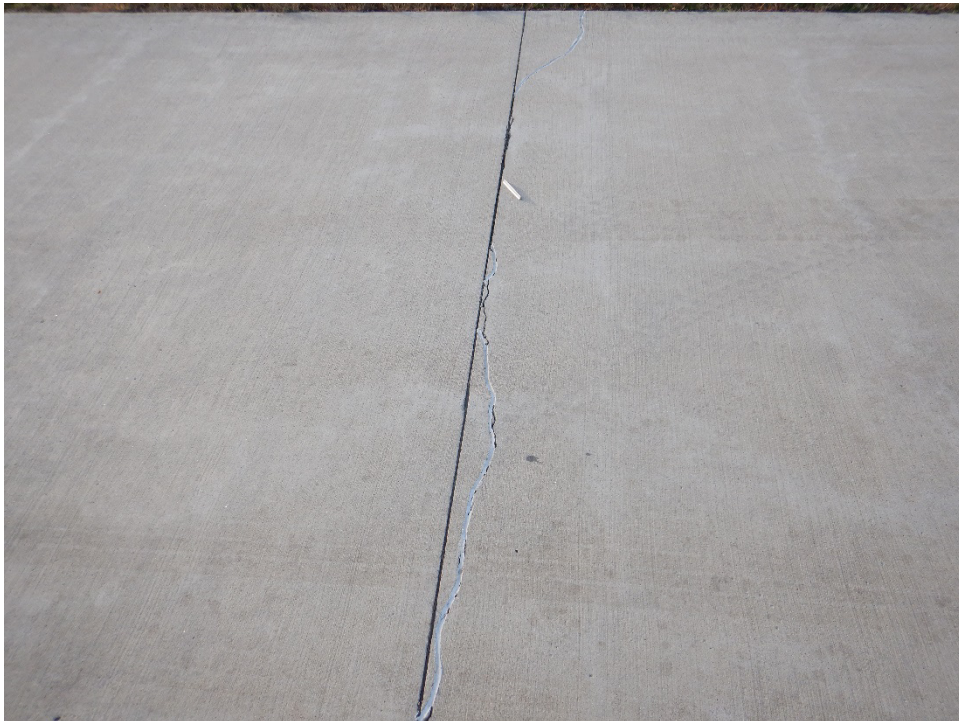
TH01PR-01. Joint Spalling (Sample Unit No. 04).

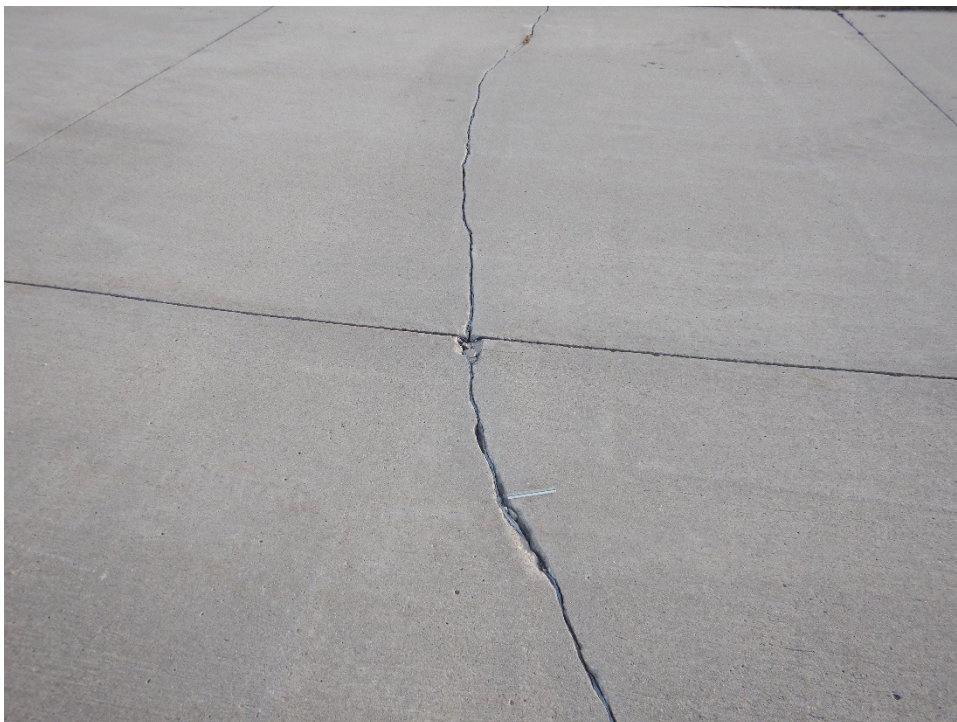
TH01PR-02. LTD Cracking (Sample Unit No. 01).

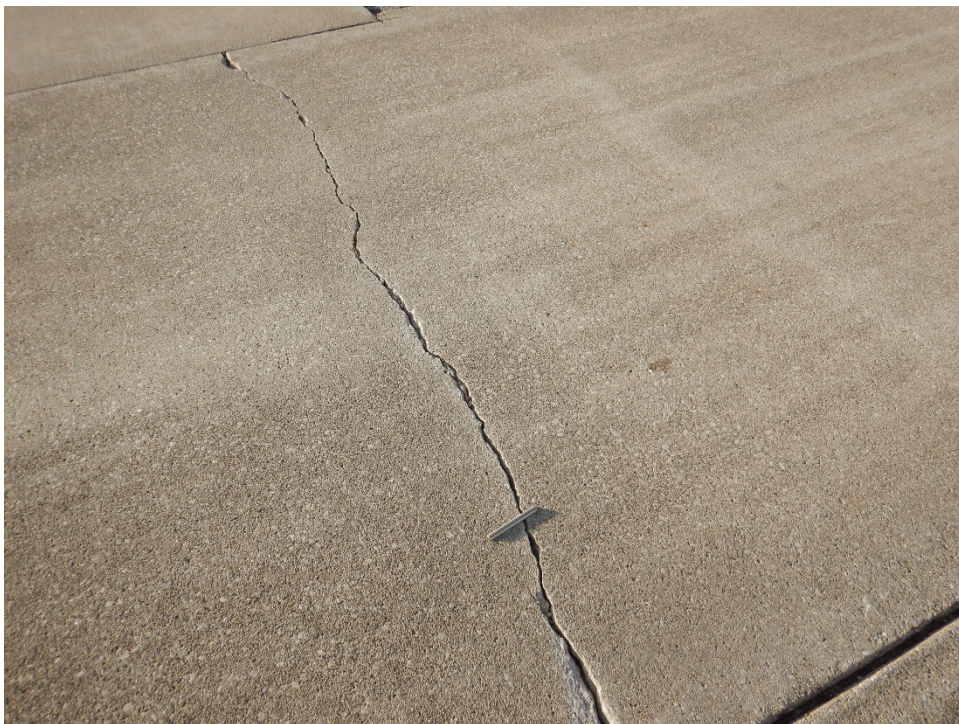
TH02PR-01. LTD Cracking (Sample Unit No. 01).

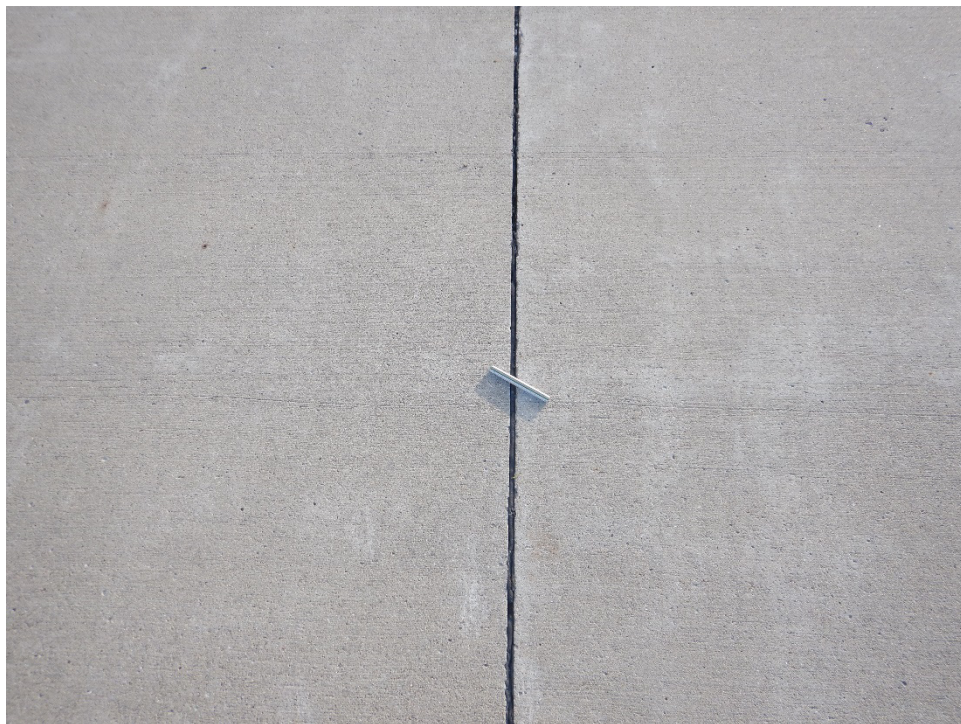
TH02PR-02. Joint Seal Damage (Sample Unit No. 01).

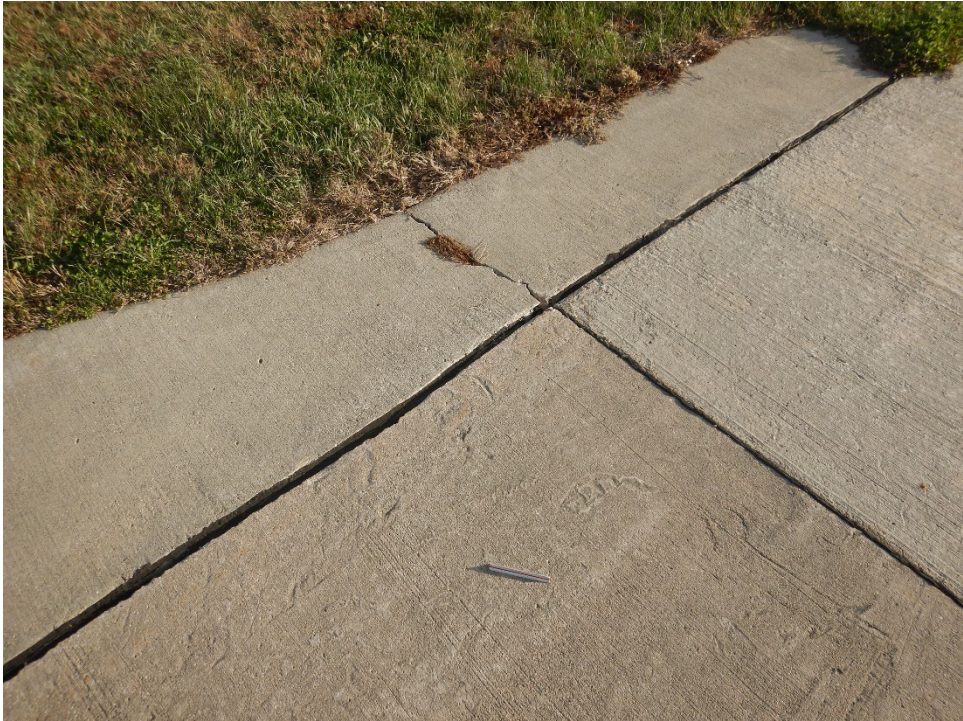
TH02PR-03. LTD Cracking (Sample Unit No. 01).
