Rock Rapids Municipal Airport

PAVEMENT MANAGEMENT REPORT

AUGUST 2019

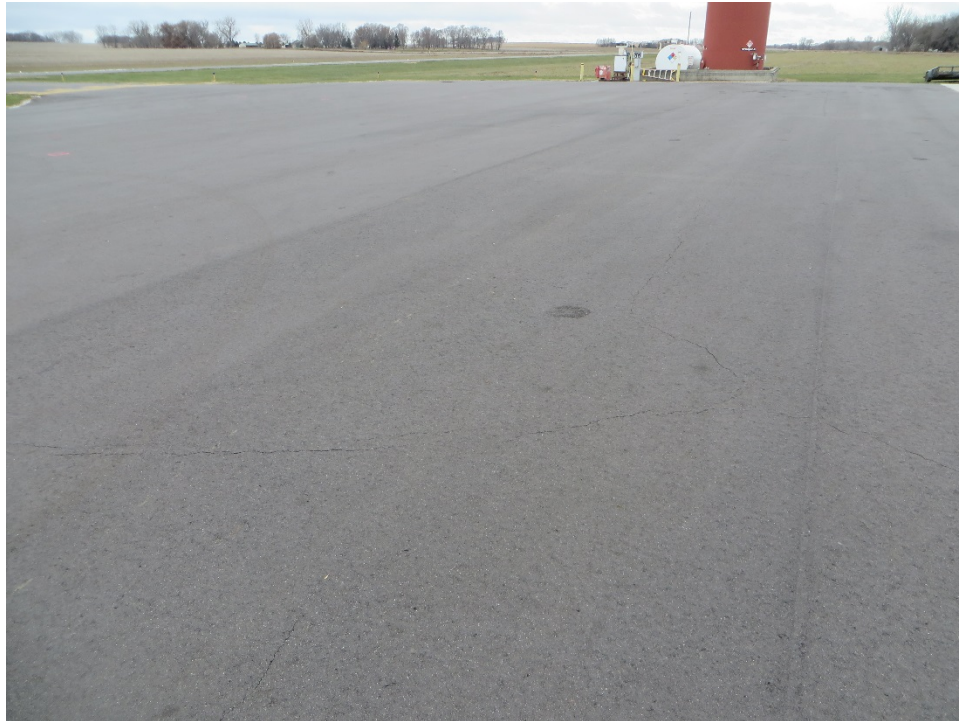
A01RR-01. Overview.

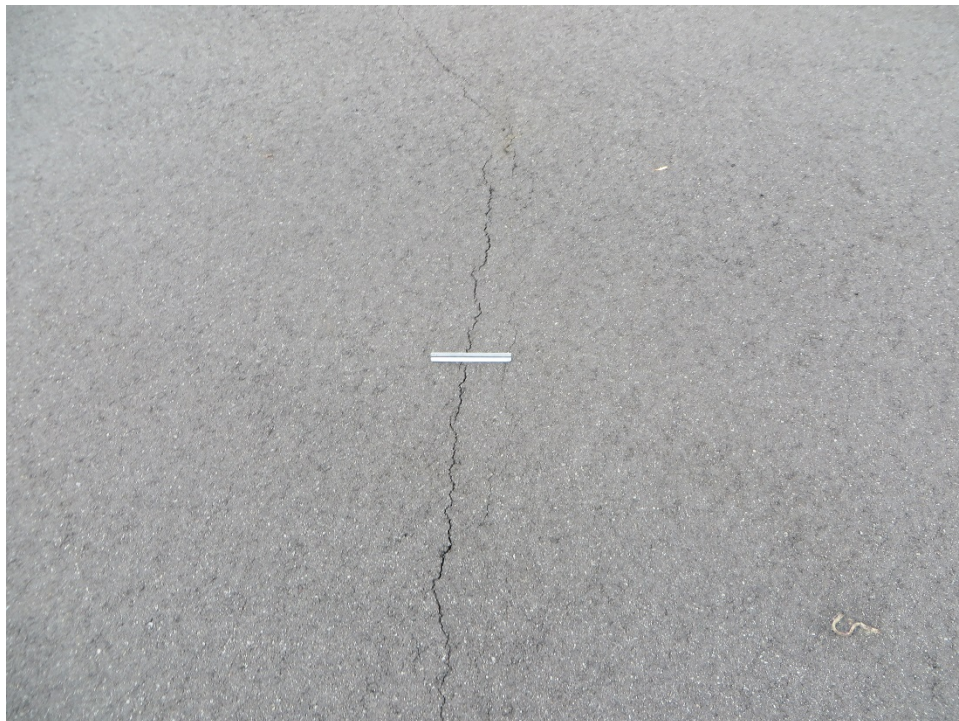
A01RR-01. L&T Cracking (Sample Unit No. 01).

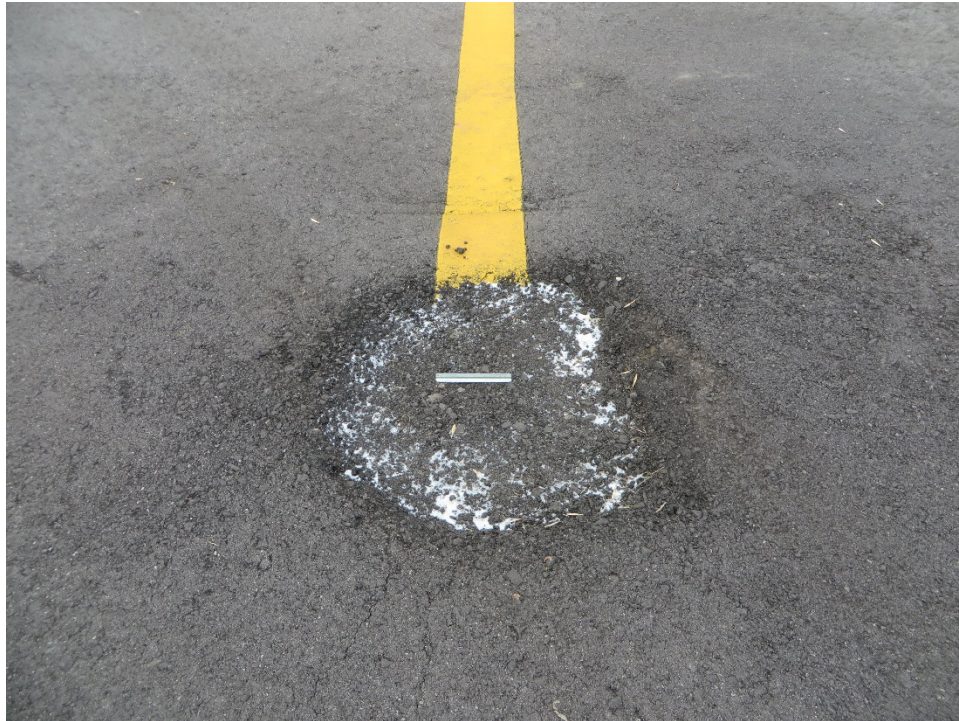
The apron area consisted of three sections. Low-severity, unsealed L&T cracking was observed throughout Section 01 along with small amounts of high-severity raveling, where mechanical damage was noted, and low-severity rutting. Section 02 was in excellent condition with shrinkage cracking and low-severity corner spalling and joint seal damage observed. Low-severity corner spalling and faulting and low- and medium-severity joint seal damage were identified in Section 03.

A01RR-01. Raveling (Sample Unit No. 03).

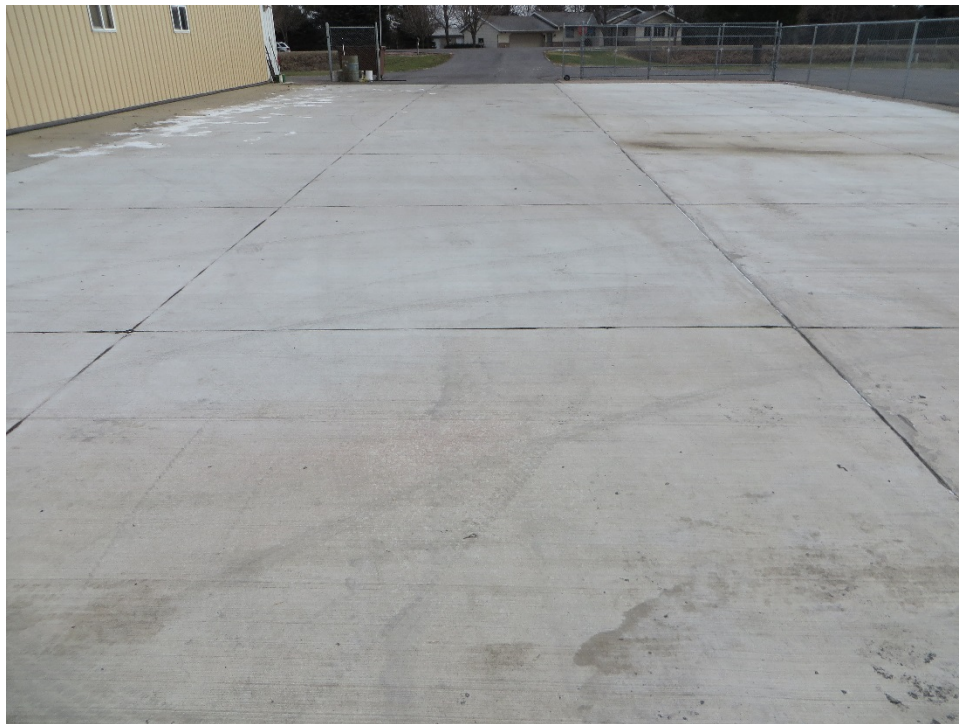
A01RR-02. Overview.

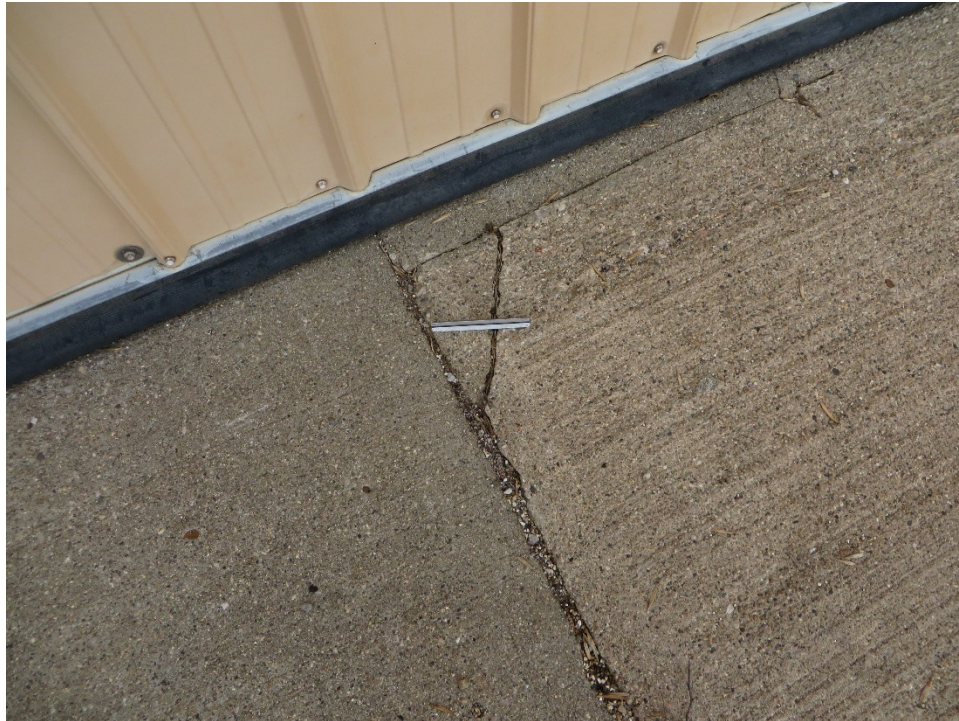
A01RR-02. Corner Spalling (Sample Unit No. 02).

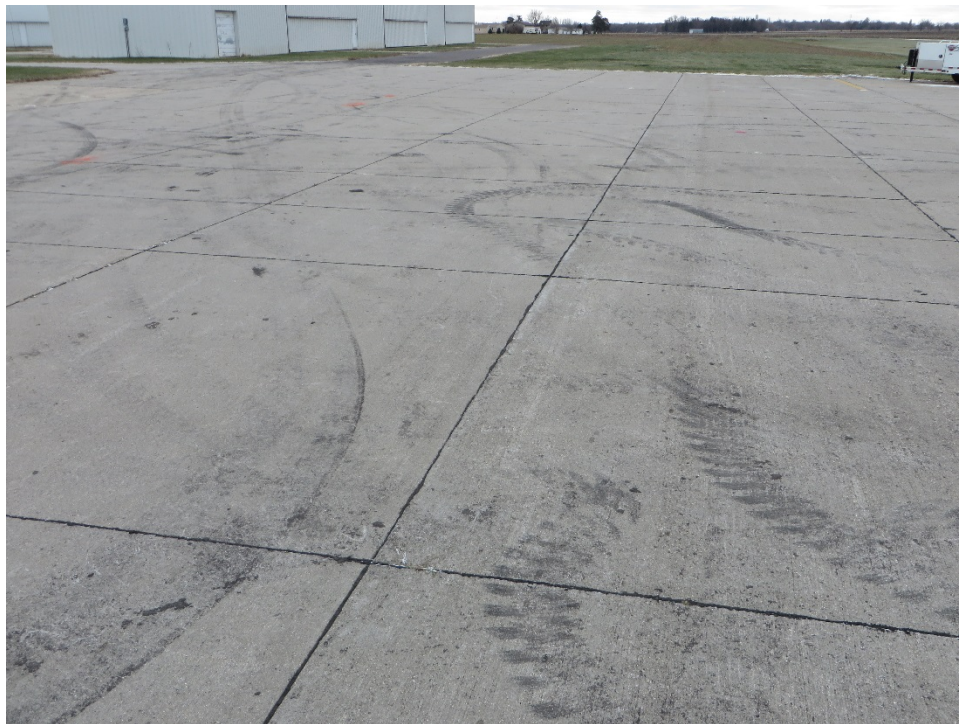
A01RR-03. Overview.

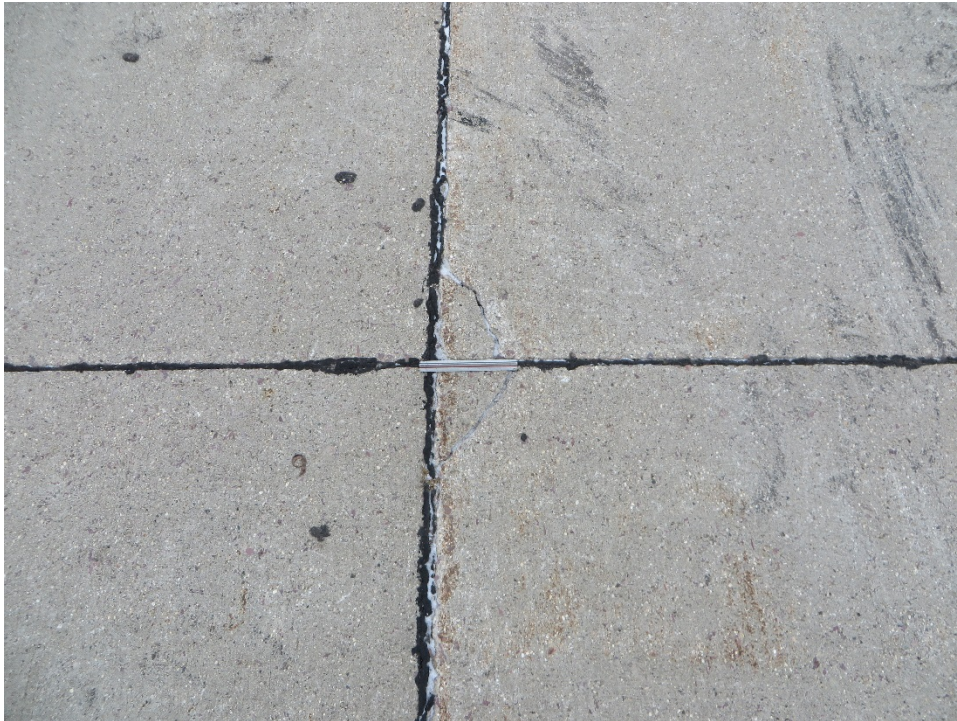
A01RR-03. Corner Spalling (Sample Unit No. 05).

Sample Number: 005 Type: R Area: 24.00Slabs PCI = 90
Sample Comments:
75 CORNER SPALLING L 2.00 Slabs Comments:
65 JOINT SEAL DAMAGE M 24.00 Slabs Comments:

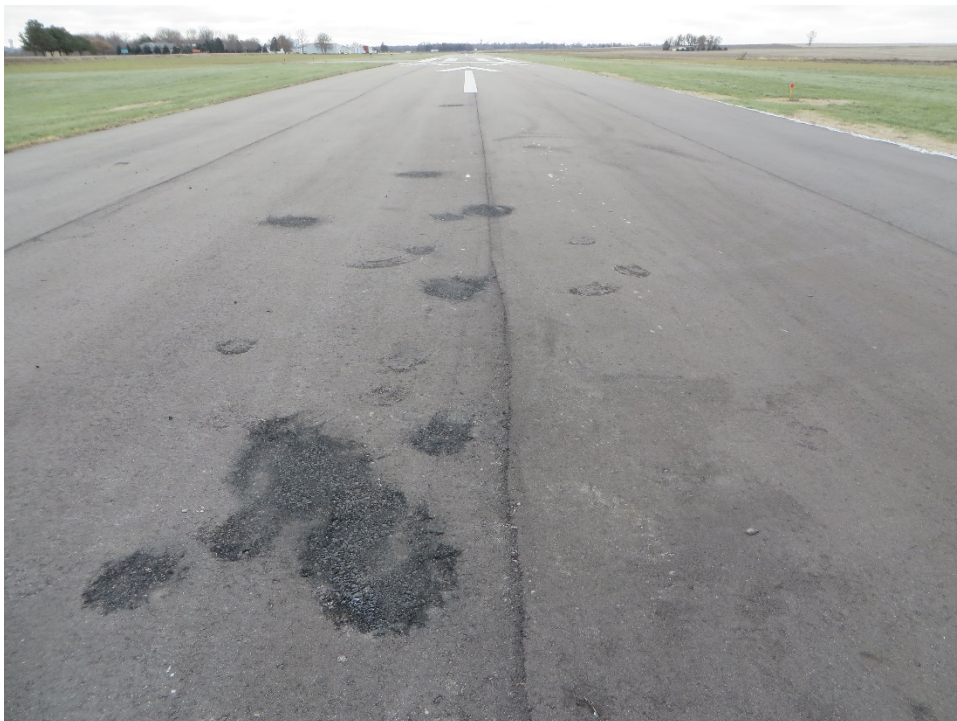
R16RR-01. Overview.

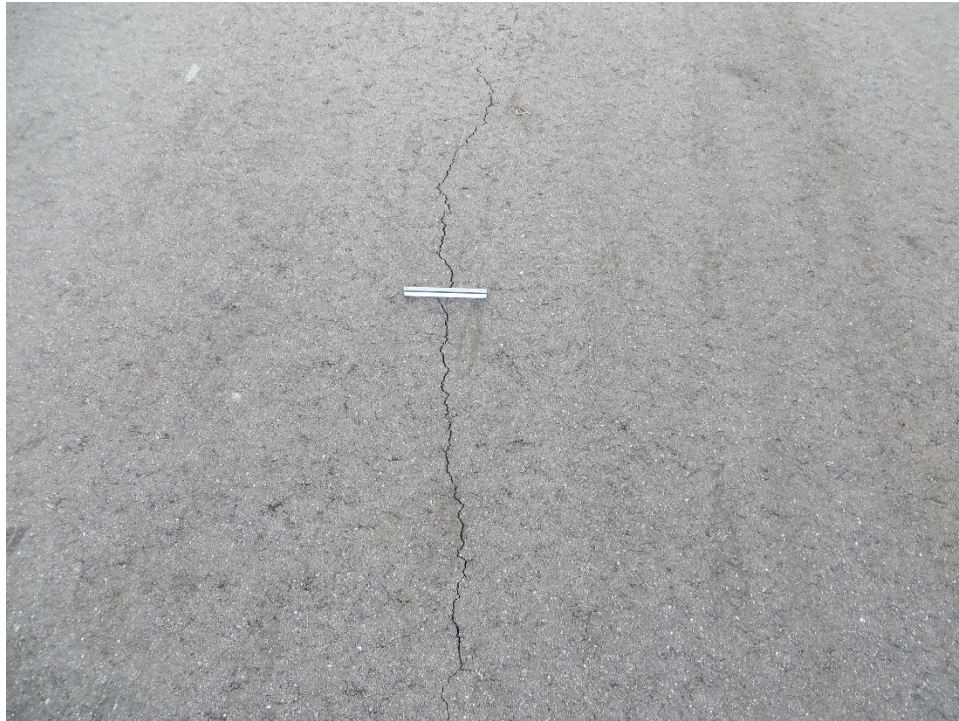
R16RR-01. L&T Cracking (Sample Unit No. 01).

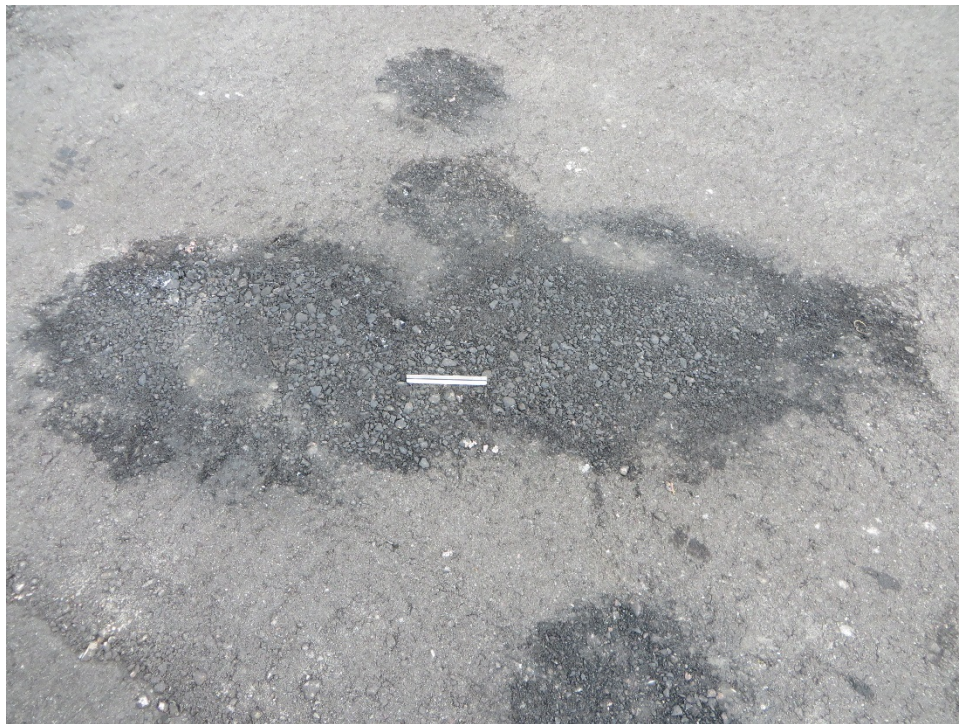
R16RR-01. Raveling (Sample Unit No. 01).

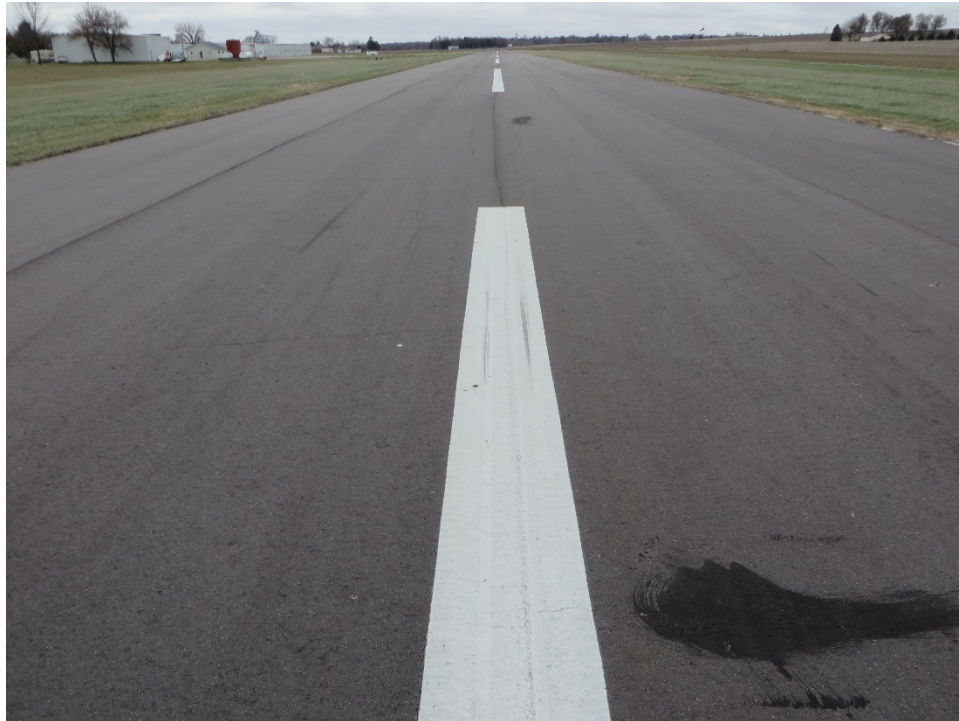
R16RR-02. Overview.

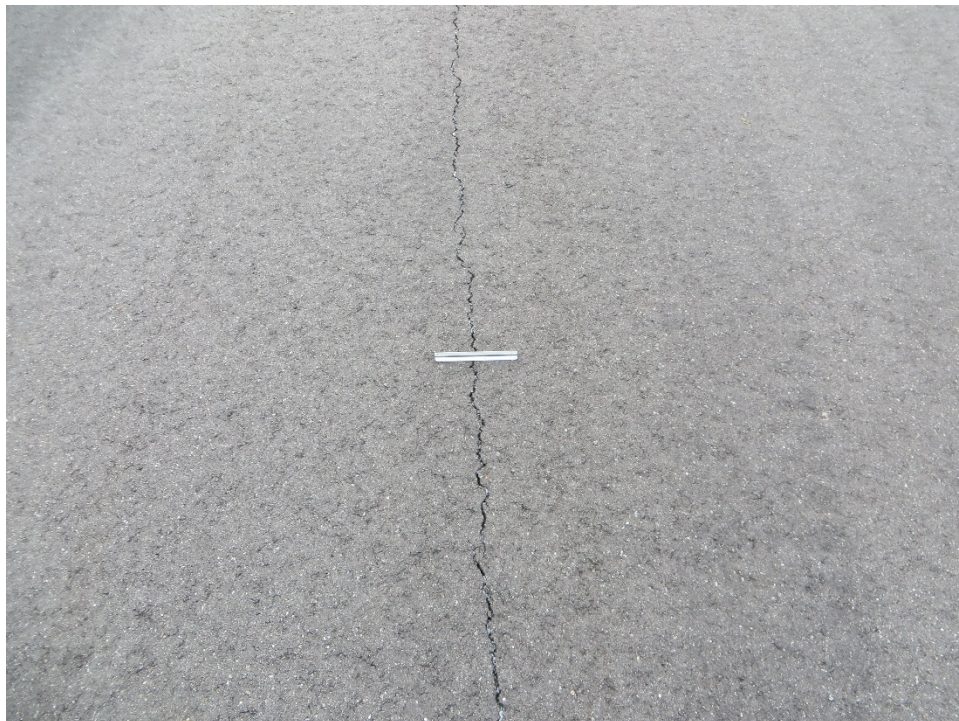
R16RR-02. L&T Cracking (Sample Unit No. 12).

Sample Number: 012 Type: R Area: 5,000.00SqFt PCI = 81
Sample Comments:
48 LONGITUDINAL/TRANSVERSE CRACKING L 234.00 Ft Comments:lu
52 RAVELING H 20.00 SqFt Comments:md

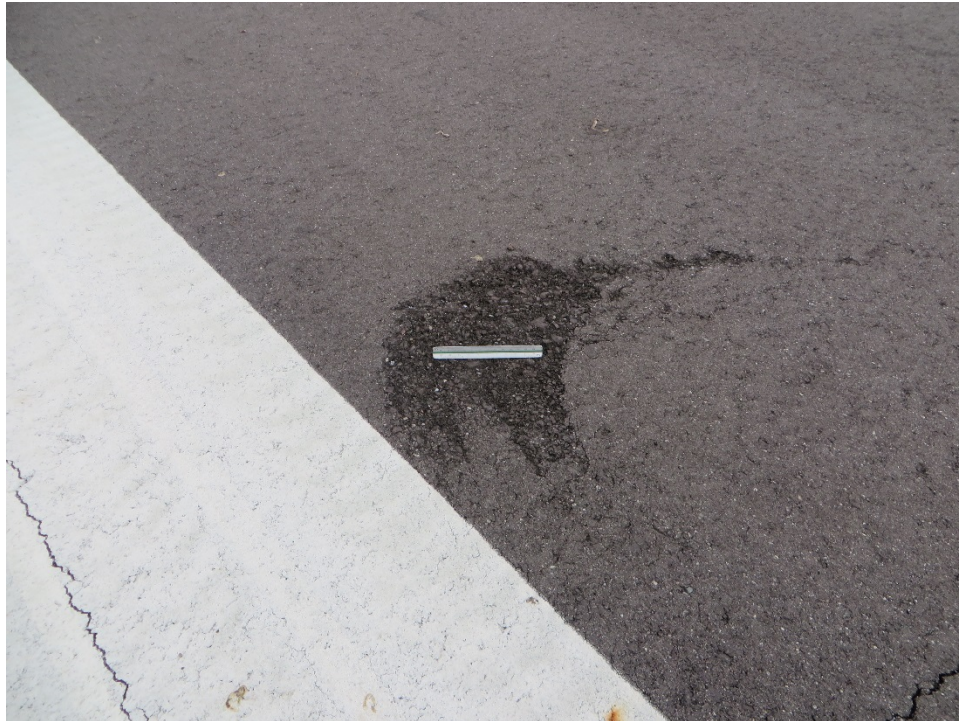
R16RR-02. Raveling (Sample Unit No. 07).

Sample Number: 007 Type: R Area: 5,000.00SqFt PCI = 80
Sample Comments:
52 RAVELING H 2.00 SqFt Comments:md
48 LONGITUDINAL/TRANSVERSE CRACKING L 252.00 Ft Comments:lu

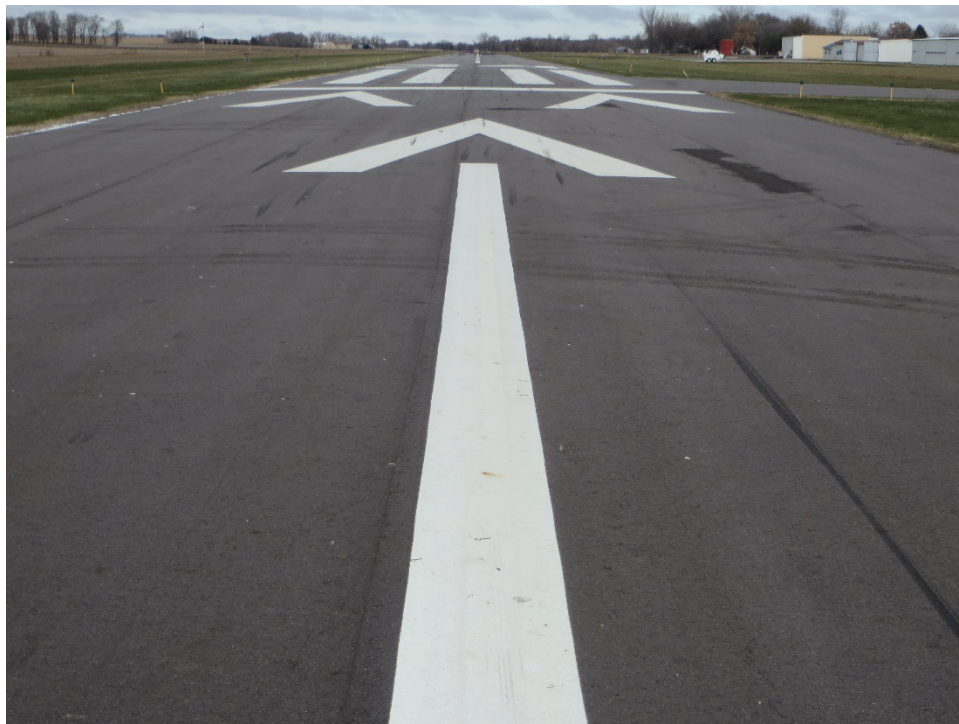
R16RR-03. Overview.

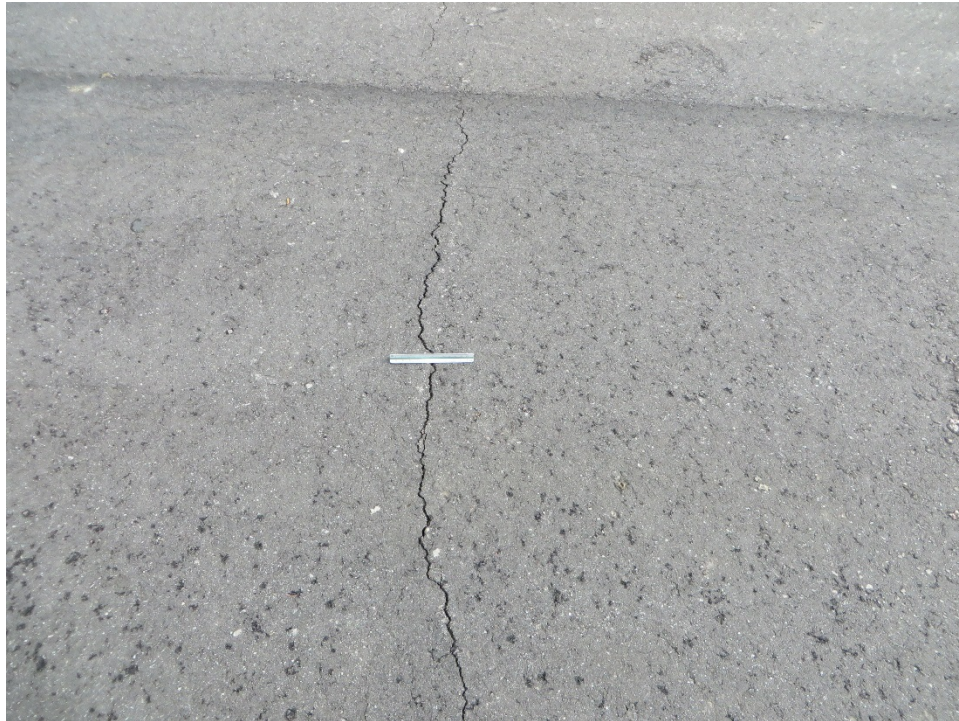
R16RR-03. L&T Cracking (Sample Unit No. 01).

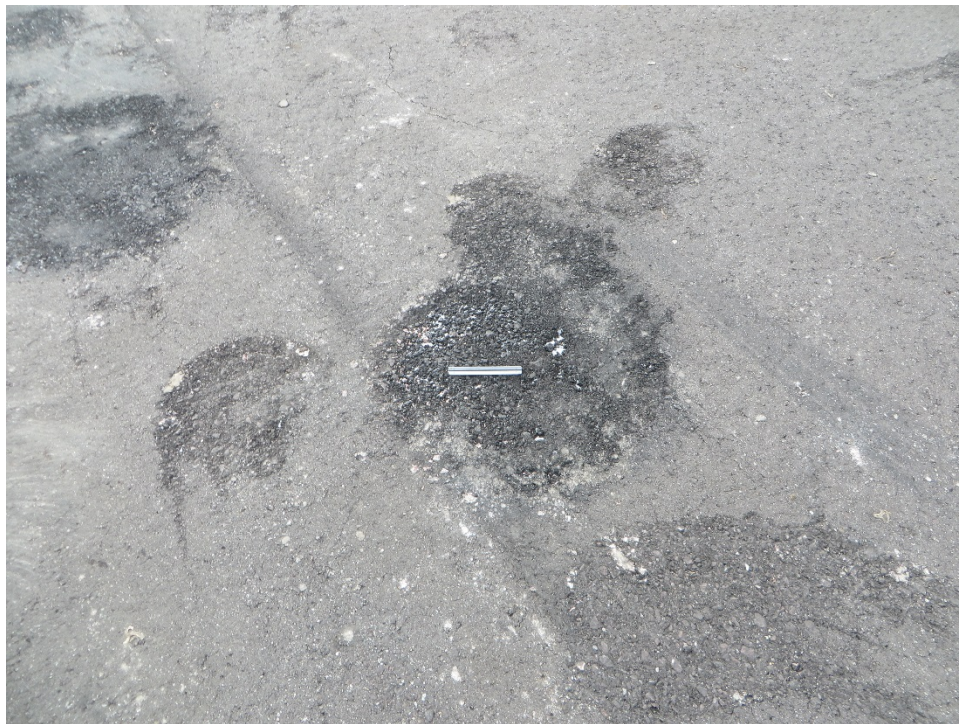
R16RR-03. Raveling (Sample Unit No. 03).

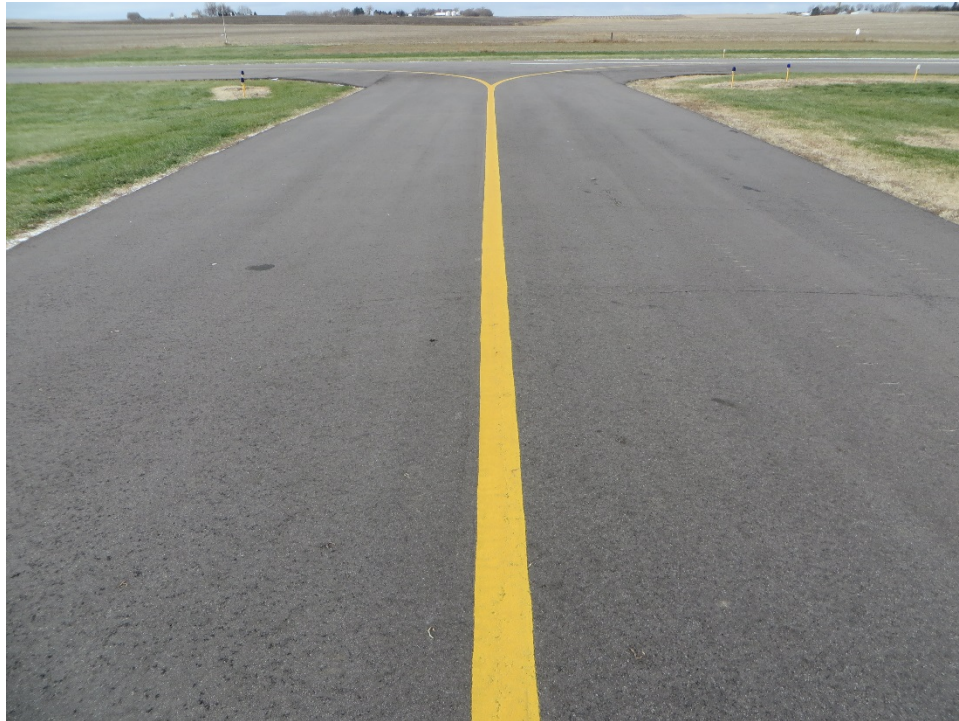
Taxiway 01 was located between the apron area and Runway 16/34 and contained one section. Only low-severity, unsealed L&T cracking was identified in Section 01.

T01RR-01. Overview.

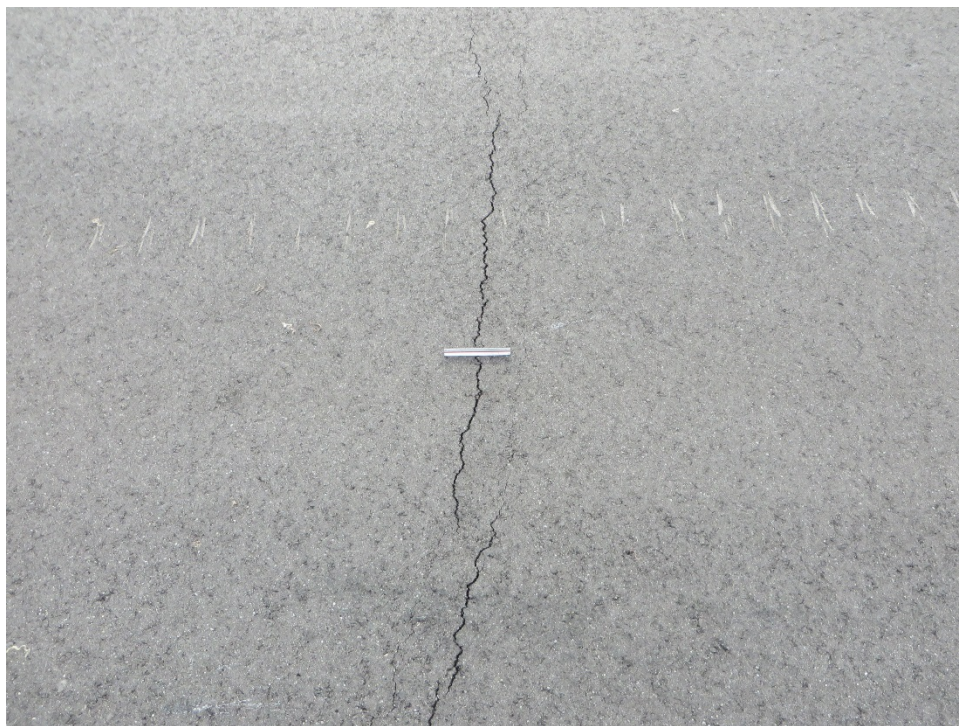
T01RR-01. L&T Cracking (Sample Unit No. 01).
