Shenandoah Municipal Airport

Pavement Management Report

JULY 2024

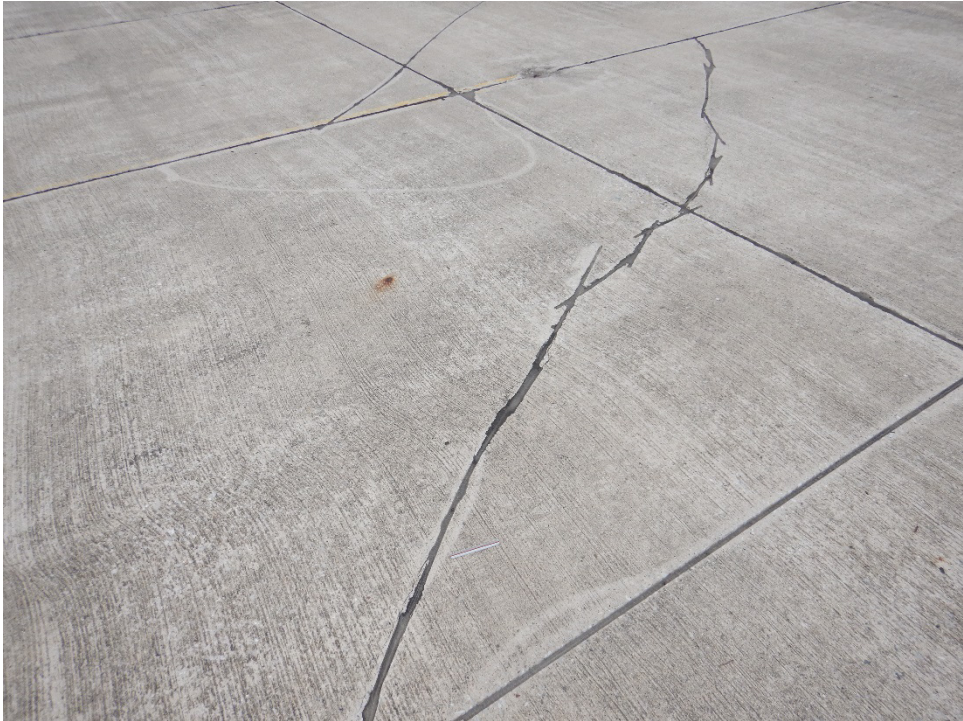
A02SH-01. LTD Cracking (Sample Unit No. 03).

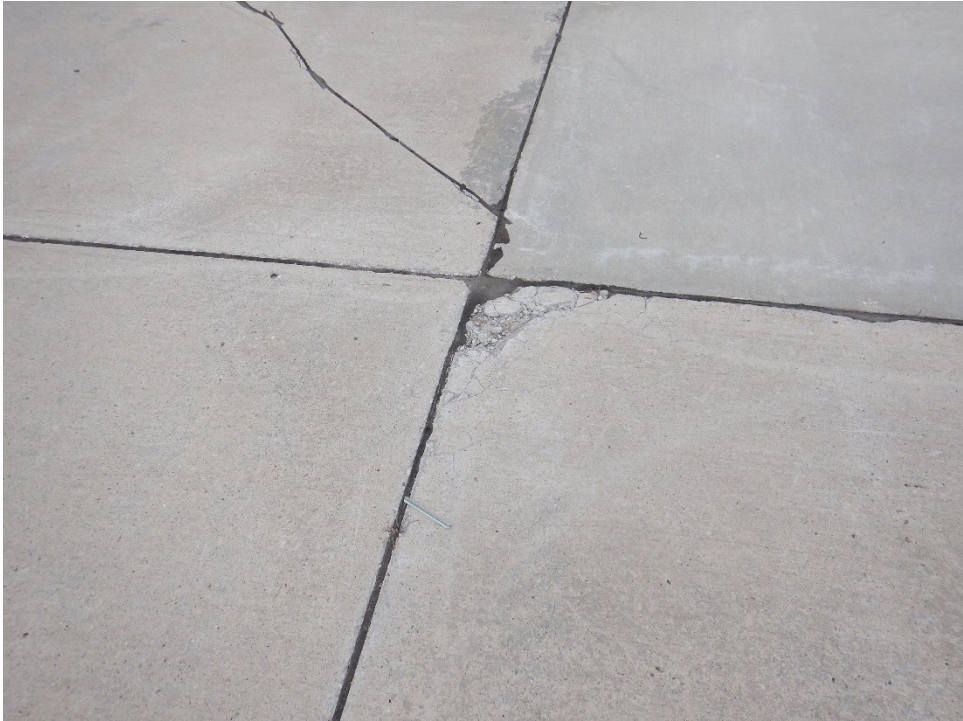
A02SH-02. ASR (Sample Unit No. 09).

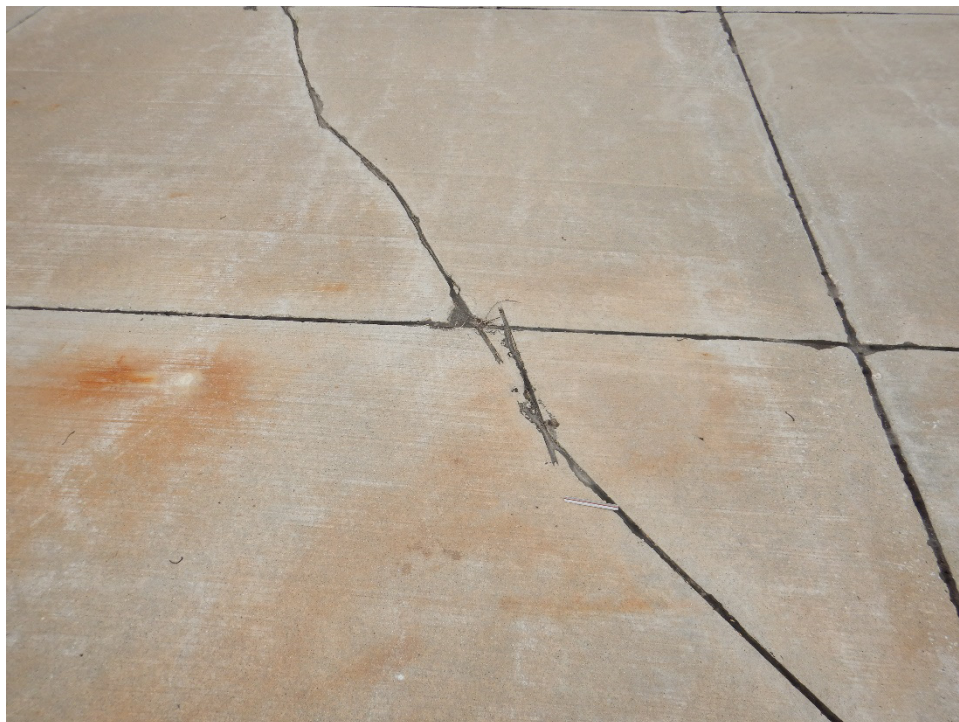
A02SH-03. LTD Cracking (Sample Unit No. 10).

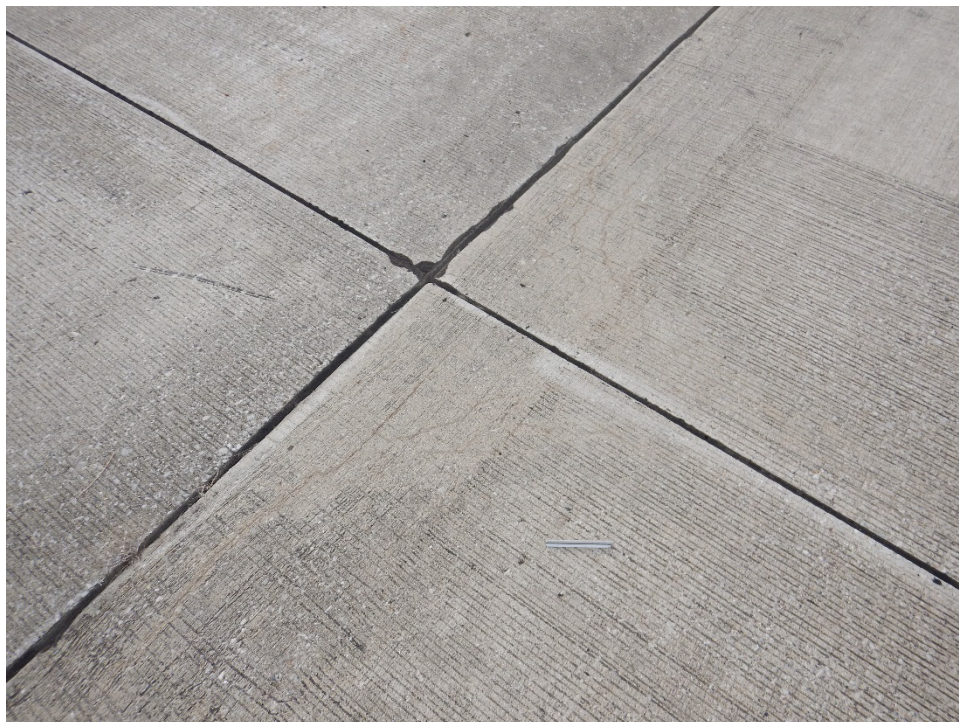
R04SH-01. ASR (Sample Unit No. 34).

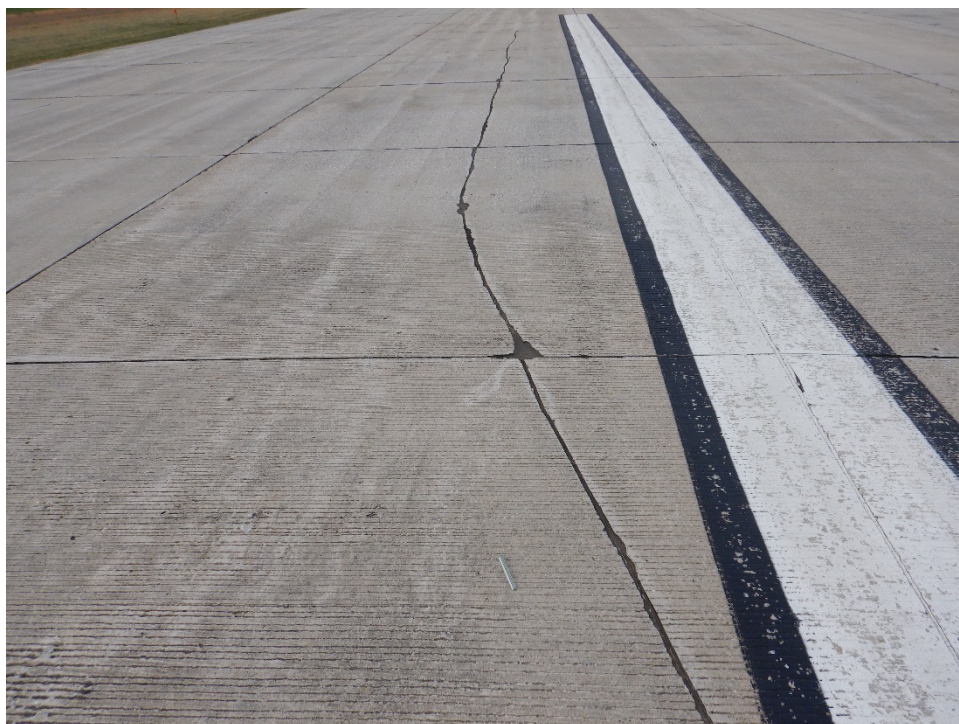
R04SH-02. LTD Cracking (Sample Unit No. 11).

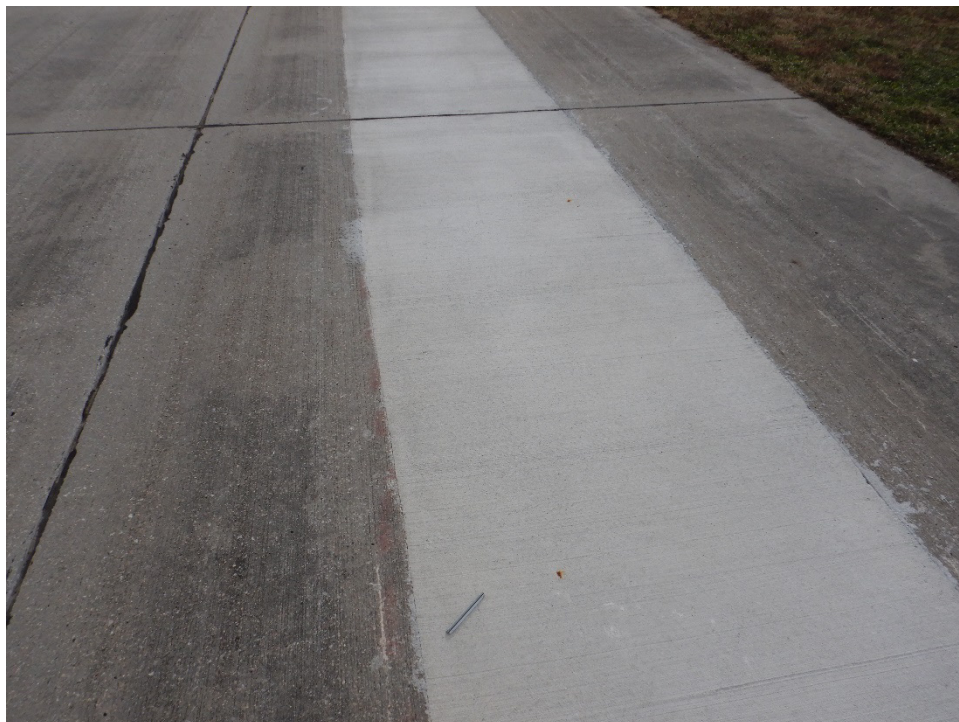
R12SH-01. Large Patching (Sample Unit No. 15).

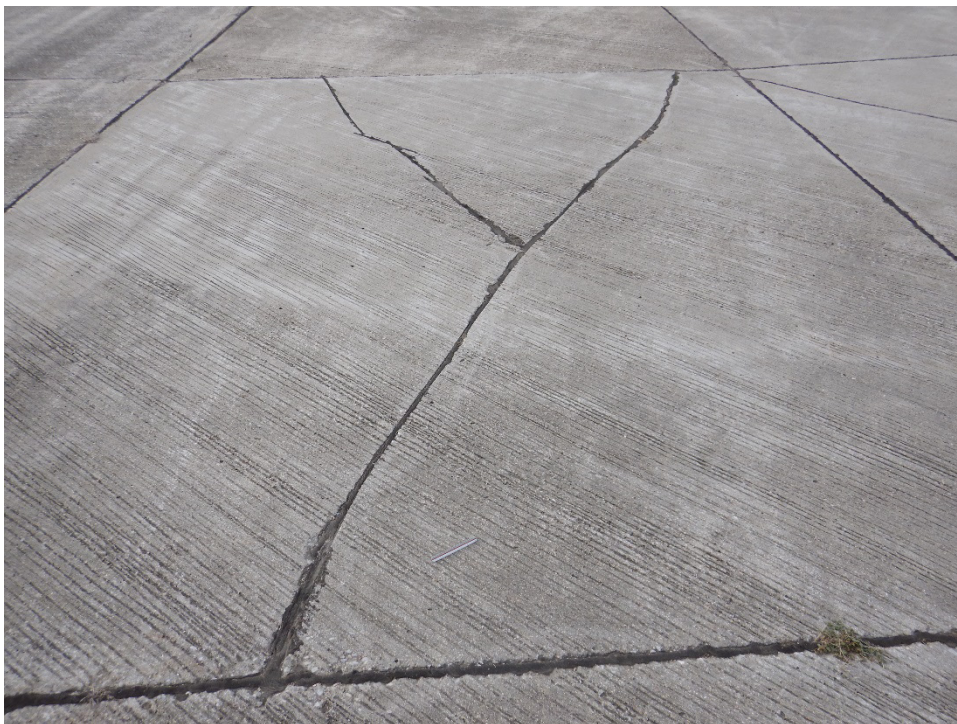
R12SH-02. LTD Cracking (Sample Unit No. 03).

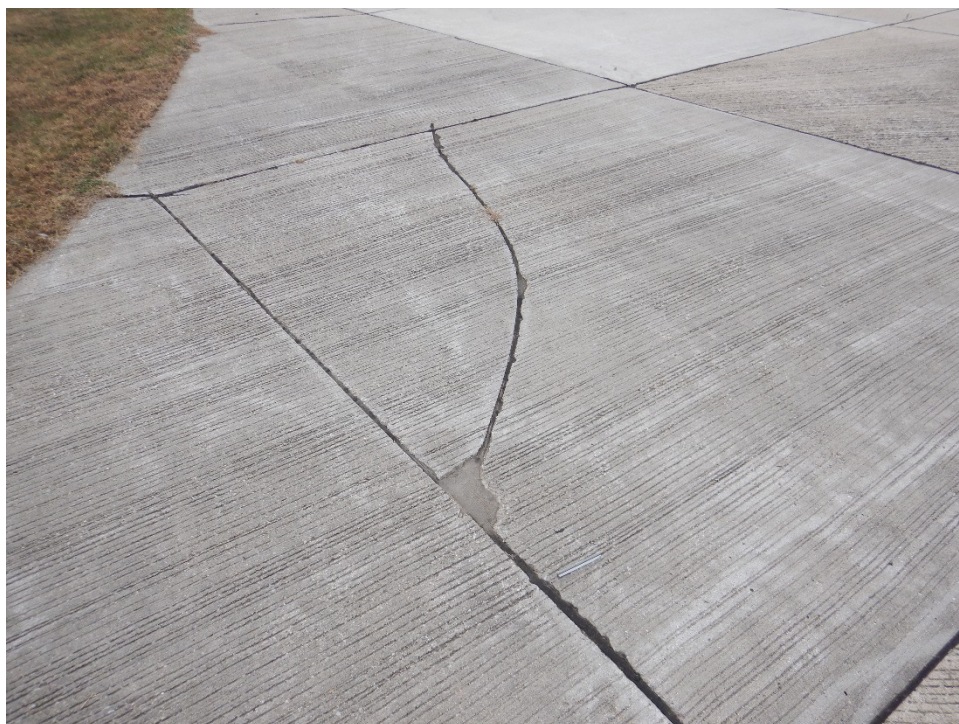
R12SH-03. LTD Cracking (Sample Unit No. 05).

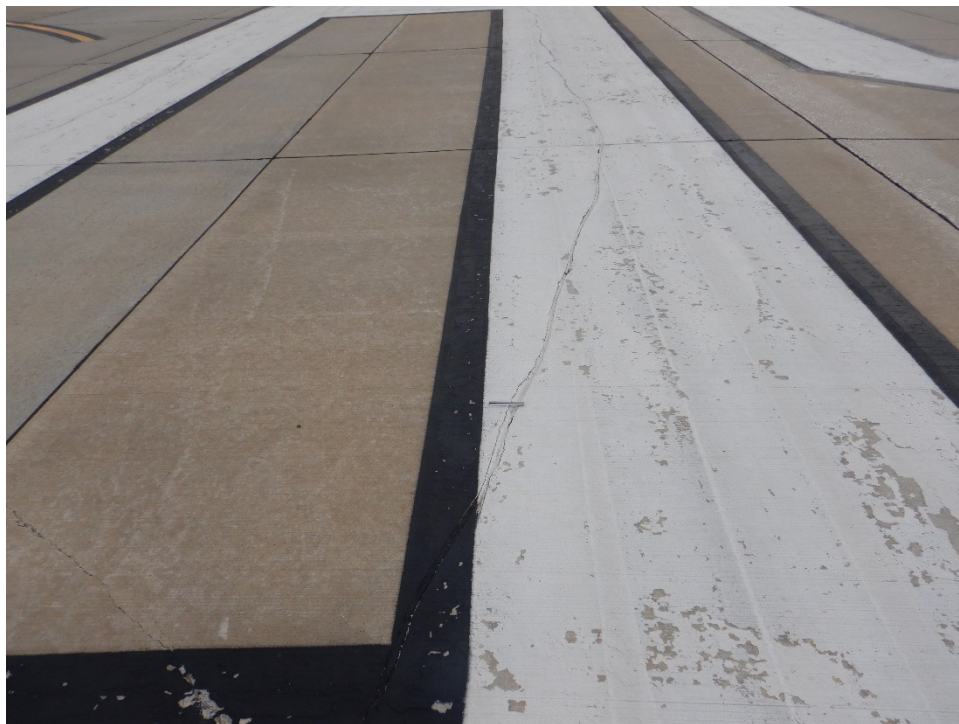
R12SH-04. LTD Cracking (Sample Unit No. 03).

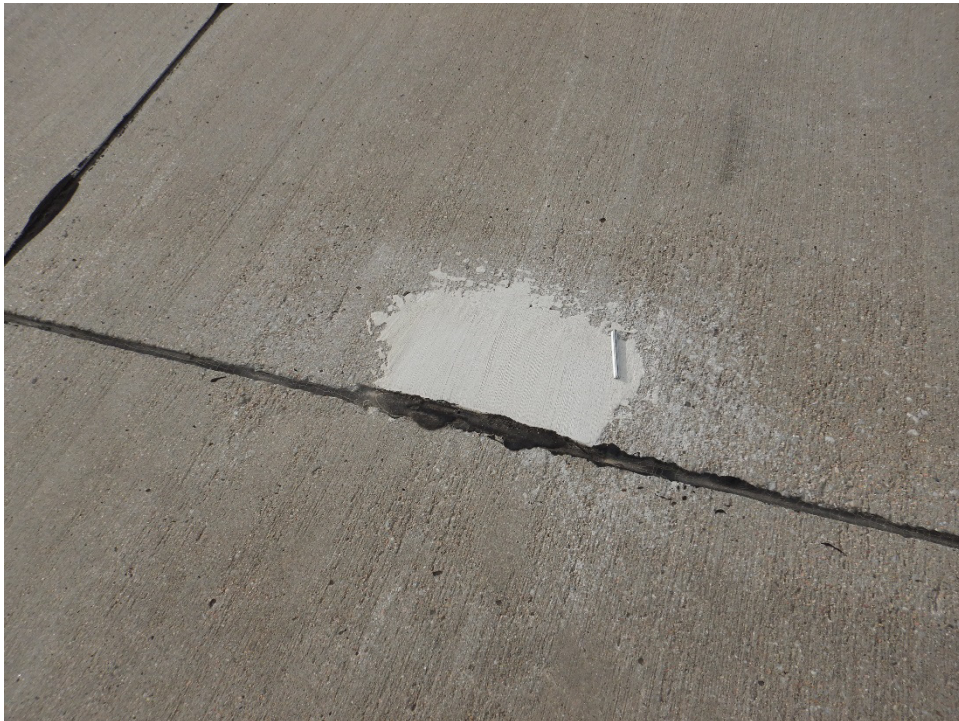
Taxiway 01 contained one section in excellent condition. Low-severity small patching and joint spalling were identified in Section 01.

T01SH-01. Small Patching (Sample Unit No. 05).

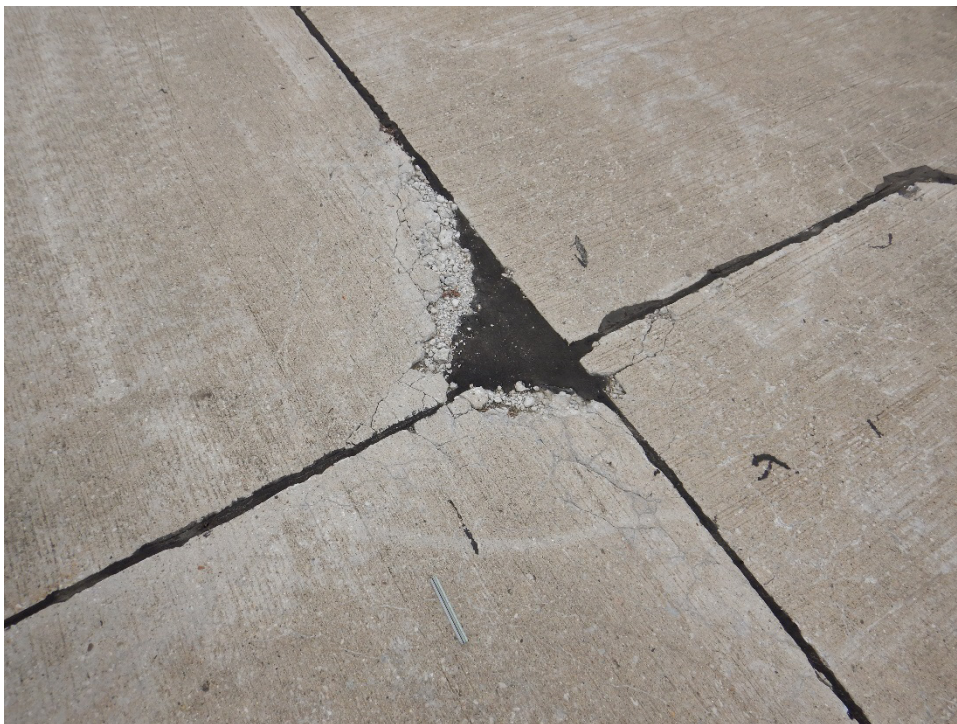
Taxiway 02 consisted of one section that connected the apron area to Runway 04/22. All severities of ASR and low-severity corner spalling, joint spalling, faulting, joint seal damage, scaling, and small patching were recorded in Section 01.

T02SH-01. ASR (Sample Unit No. 03).

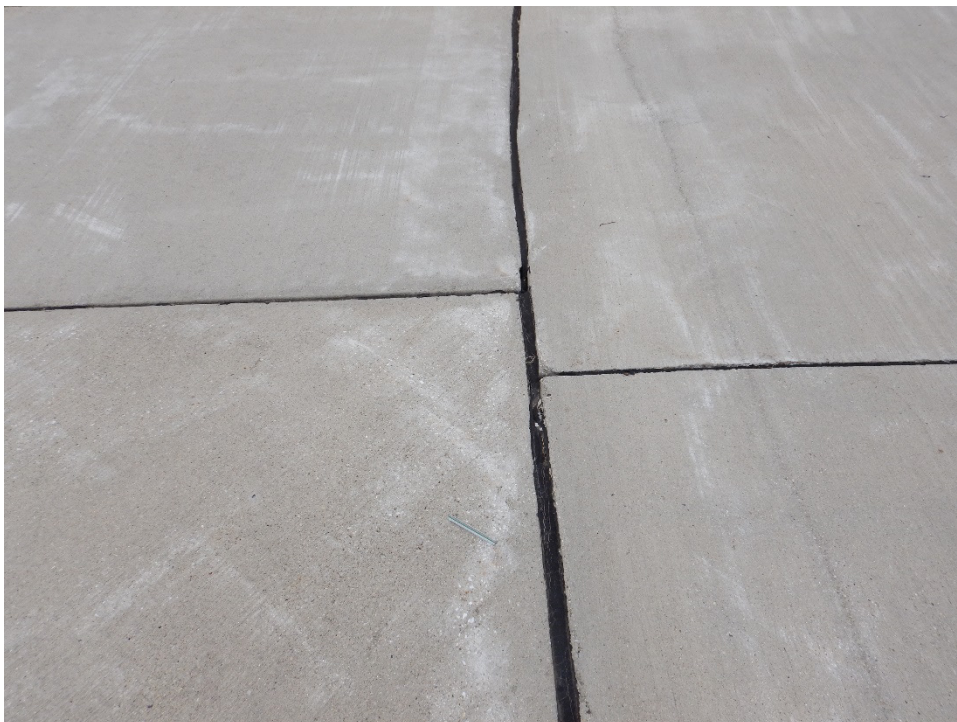
T03SH-01. Joint Seal Damage (Sample Unit No. 16).

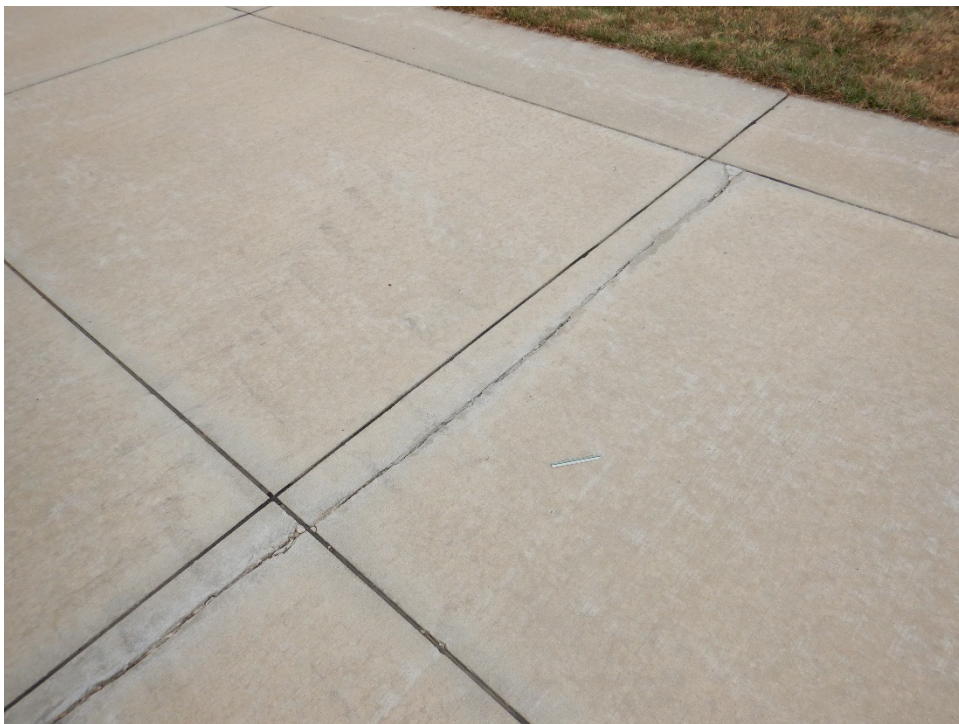
T03SH-02. Joint Spalling (Sample Unit No. 26).

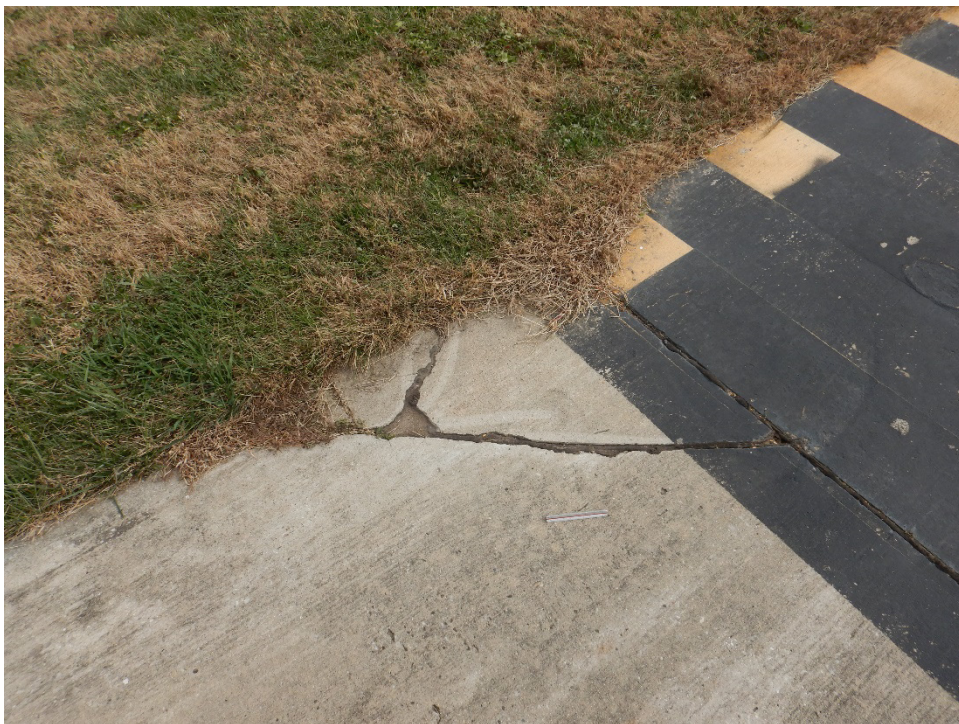
T03SH-03. Corner Break (Sample Unit No. 02).

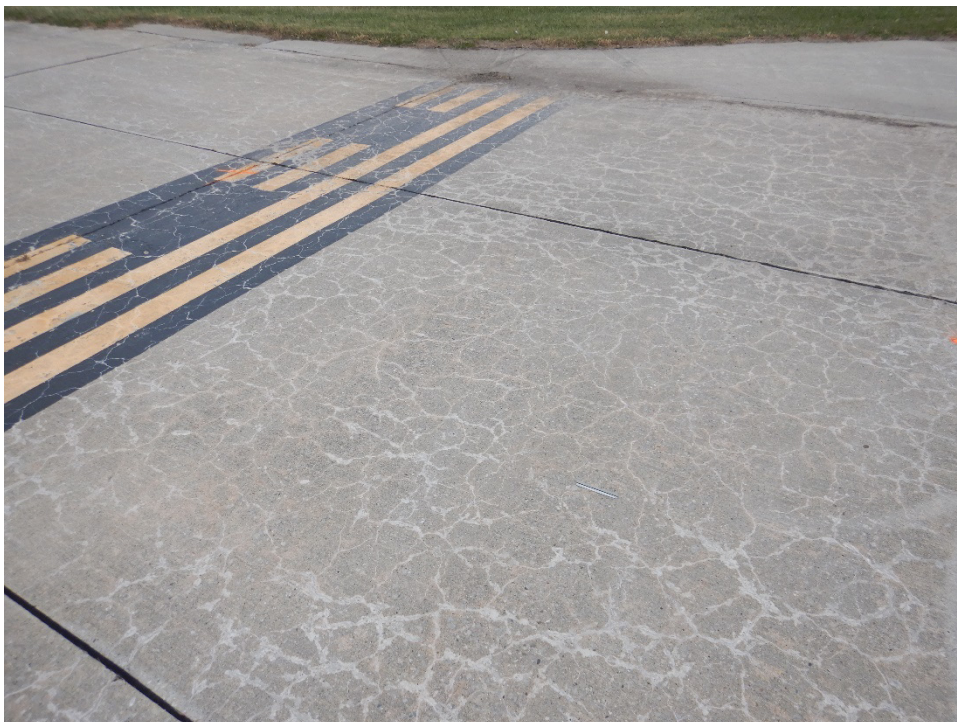
Taxiway 04 contained one section located at the Runway 04 approach. Areas of low-severity ASR, corner break, faulting, and joint seal damage; low- and medium-severity corner spalling and LTD cracking; low- and high-severity small patching; medium-severity shattered slab; high-severity large patching; and shrinkage cracking were identified in Section 01.

T04SH-01. ASR (Sample Unit No. 03).

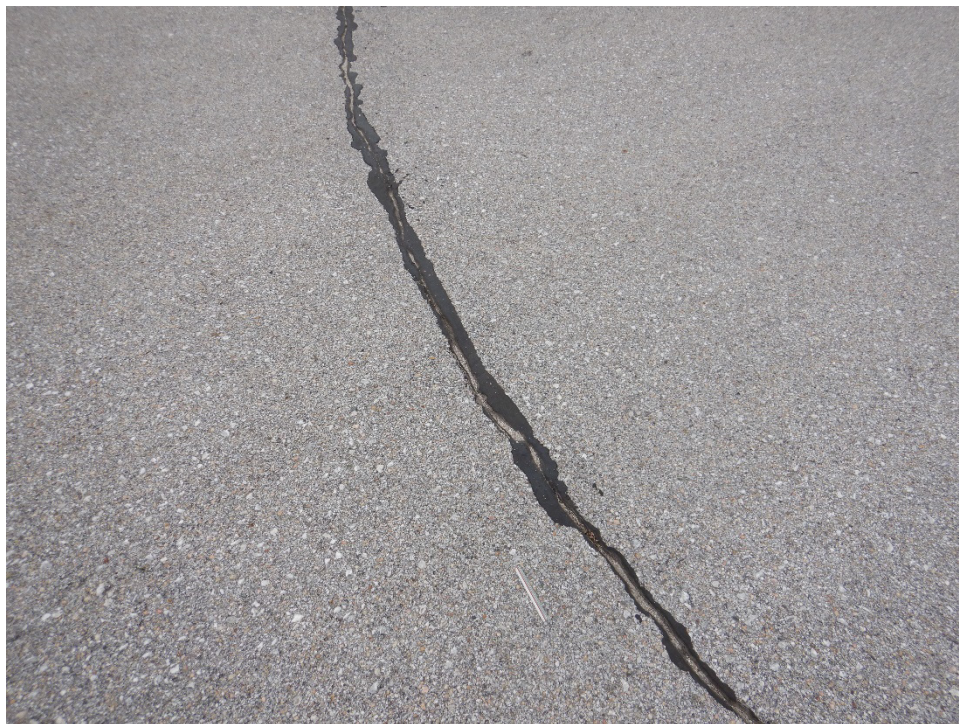
TH01SH-01. L&T Cracking (Sample Unit No. 01).

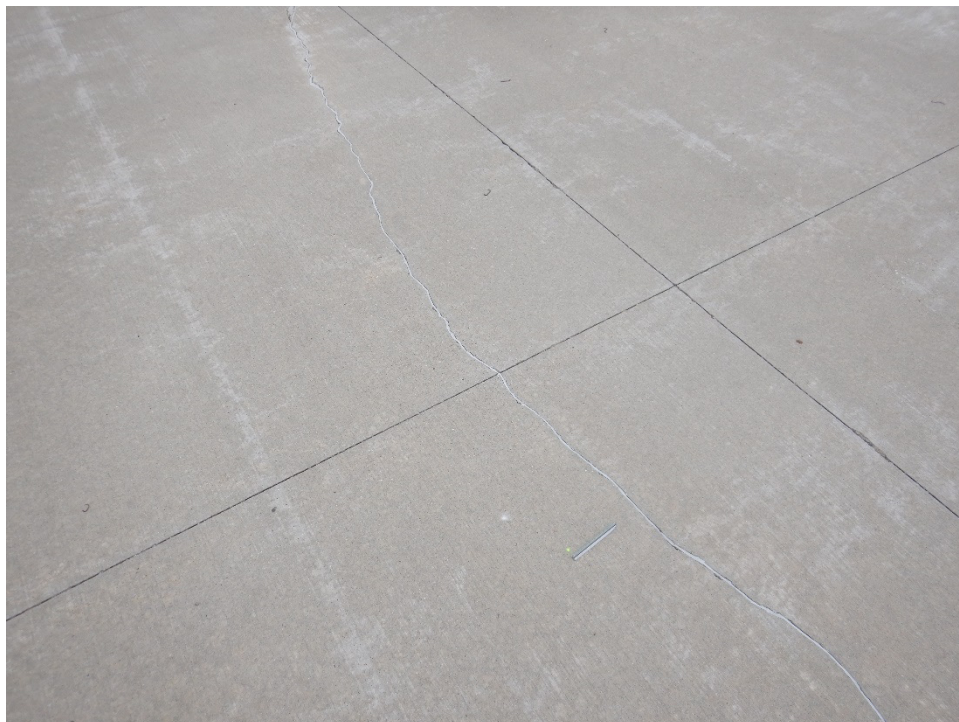
TH01SH-02. LTD Cracking (Sample Unit No. 02).

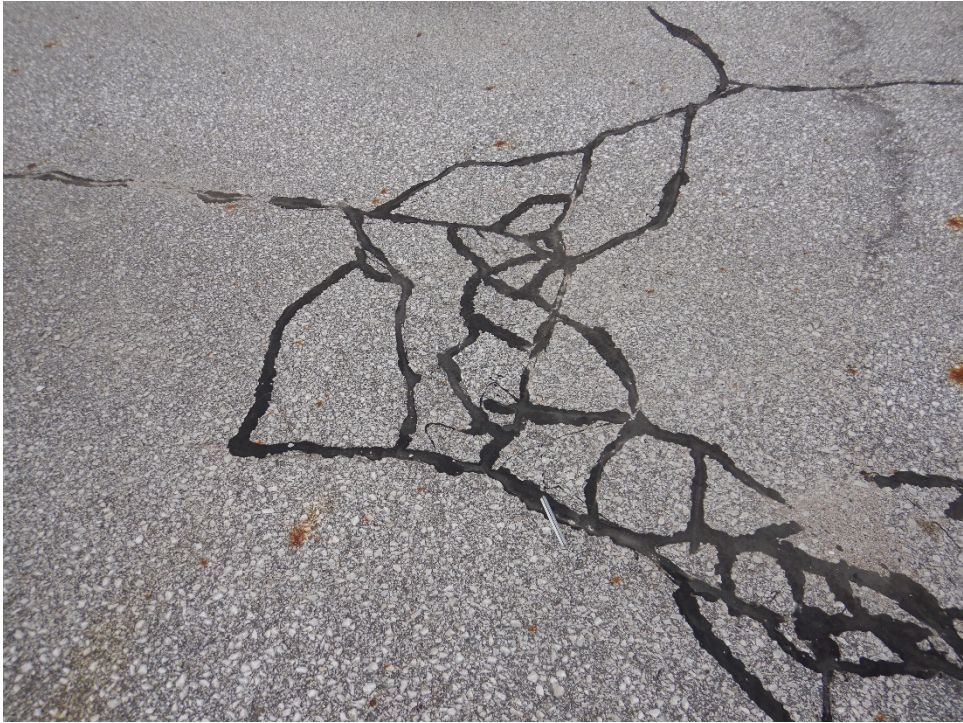
TH01SH-03. Alligator Cracking (Sample Unit No. 01).

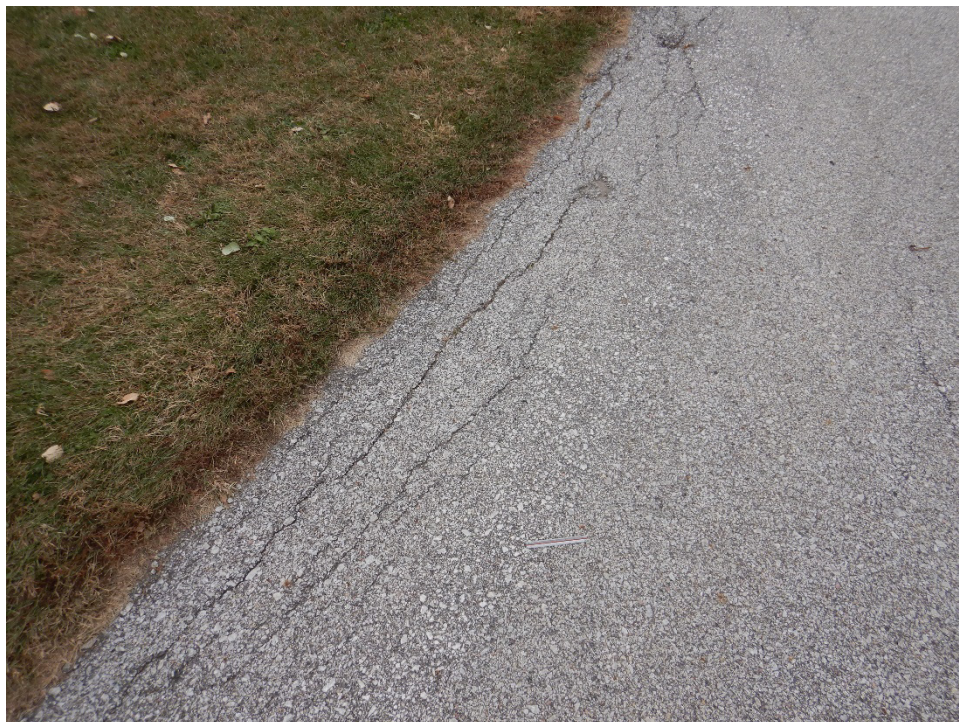
TH01SH-04. Alligator Cracking (Sample Unit No. 01).

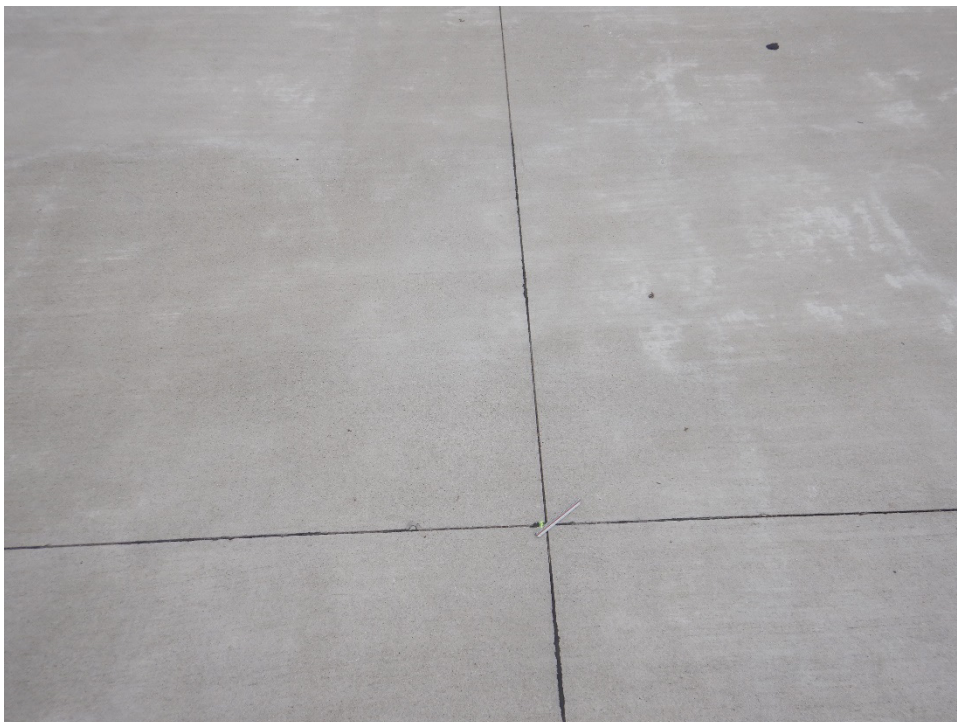
TH01SH-05. Joint Seal Damage (Sample Unit No. 01).
