Sioux County Regional Airport

Pavement Management Report

JULY 2023

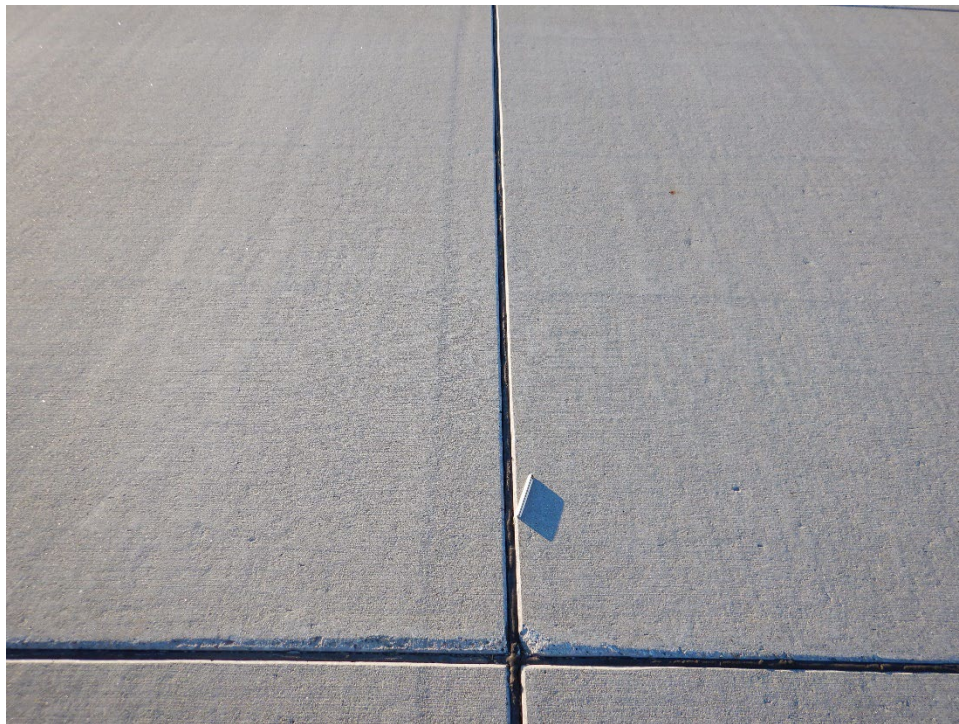
A01SX-01. Joint Seal Damage (Sample Unit No. 23).

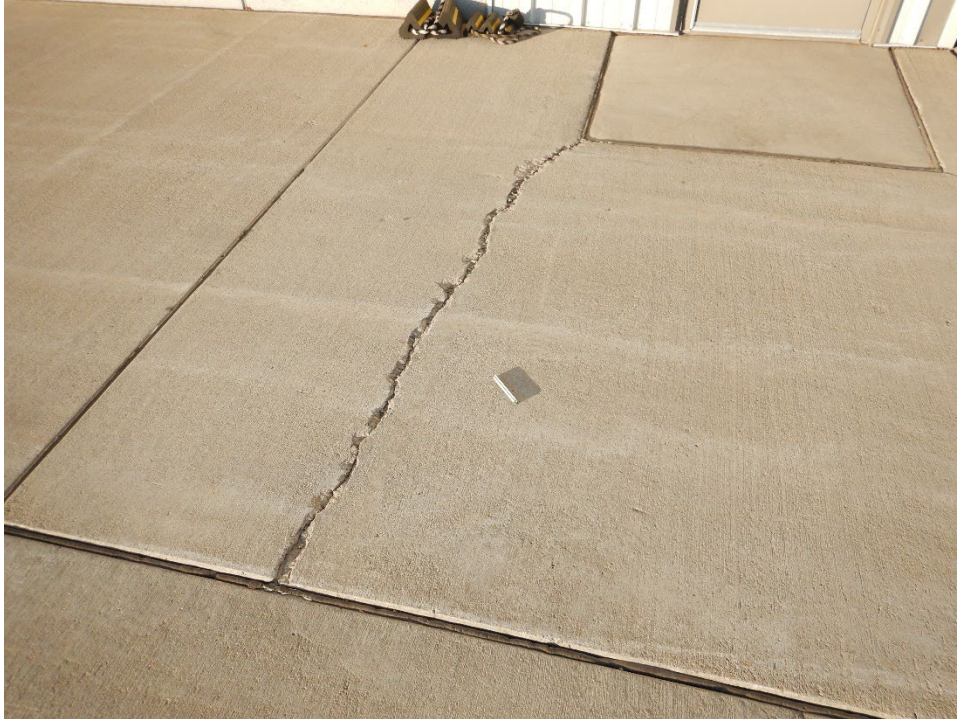
A01SX-01. LTD Cracking (Sample Unit No. 56).

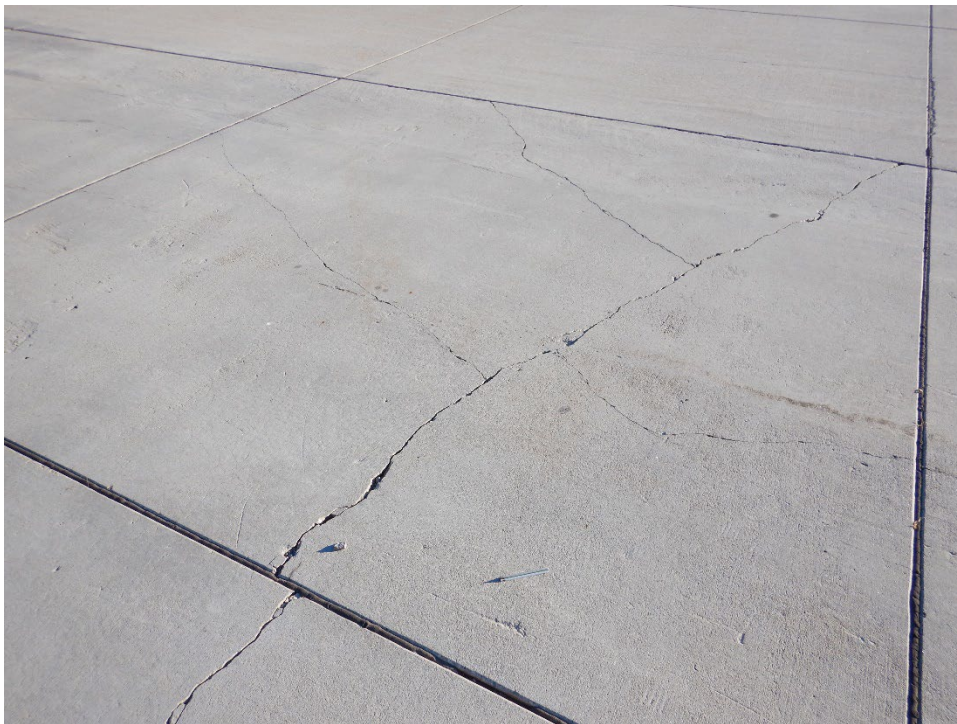
A01SX-01. Shattered Slab (Additional Sample Unit No. 41).

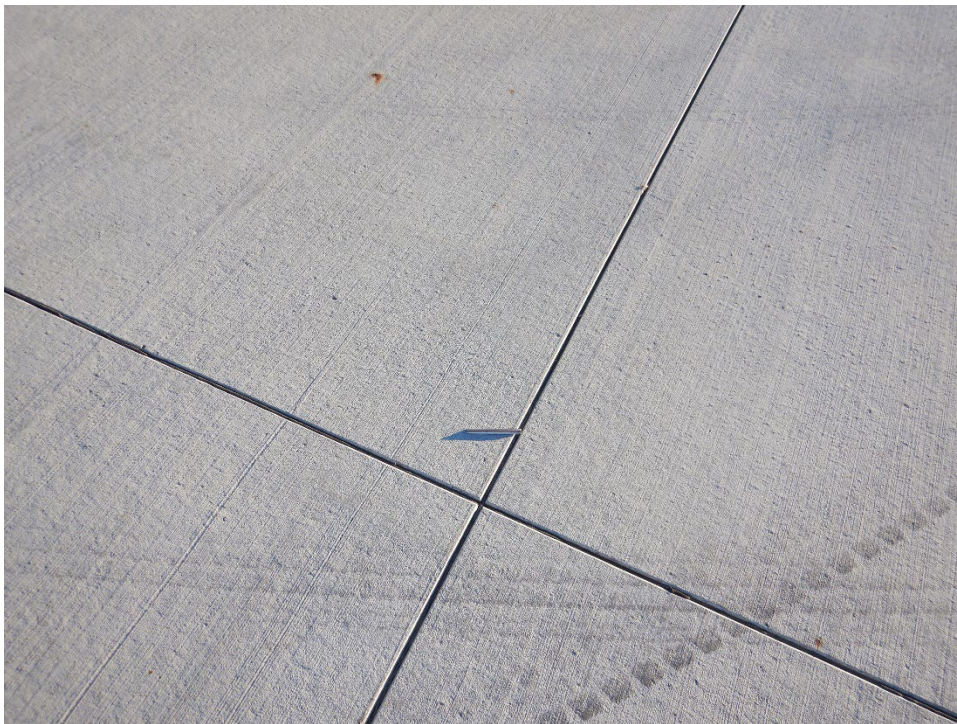
A01SX-02. Joint Seal Damage (Sample Unit No. 05).

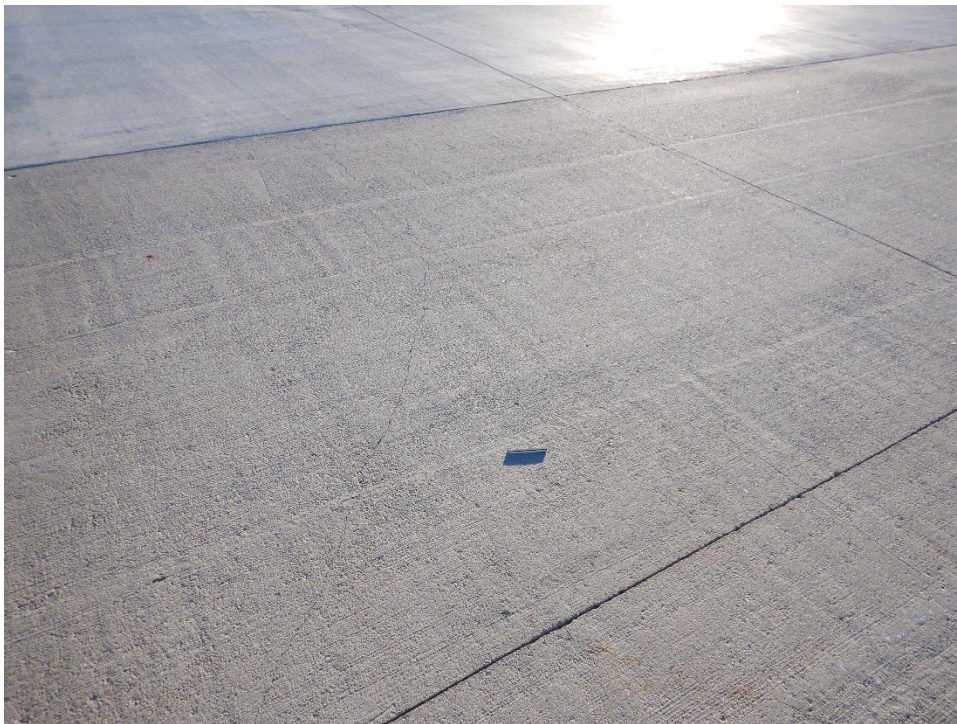
A01SX-03. Shattered Slab (Sample Unit No. 01).

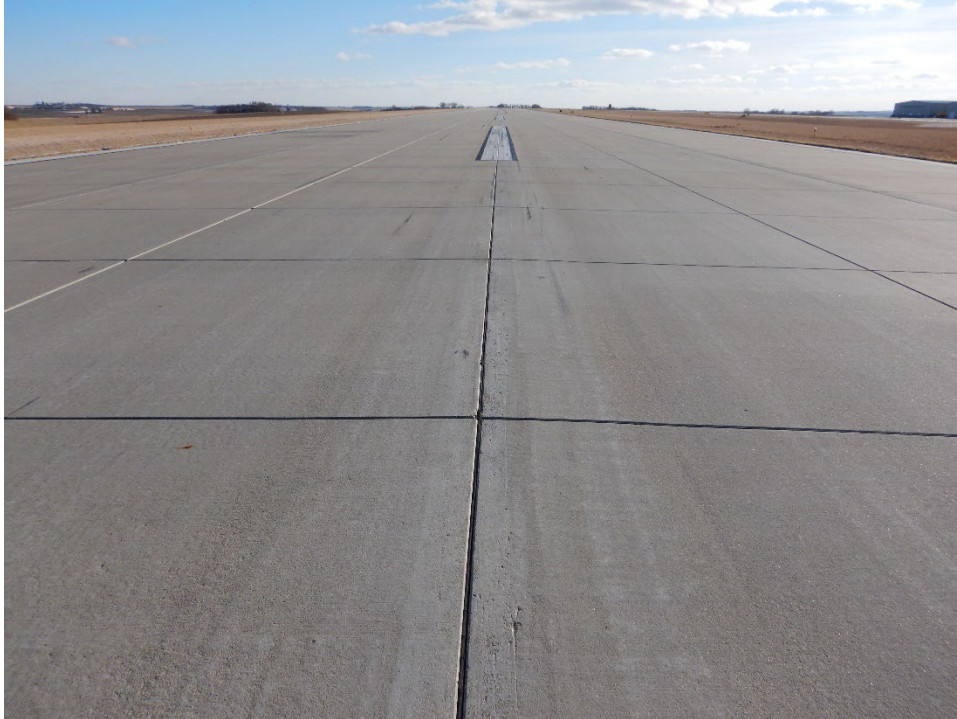
R17SX-01. Overview.

Runway 17/35 was defined by two sections. Section 01 was in excellent condition with low-severity faulting and joint seal damage recorded at the time of inspection. Medium-severity corner spalling and low-severity faulting, joint seal damage, and longitudinal, transverse, and diagonal (LTD) cracking were observed in Section 02.

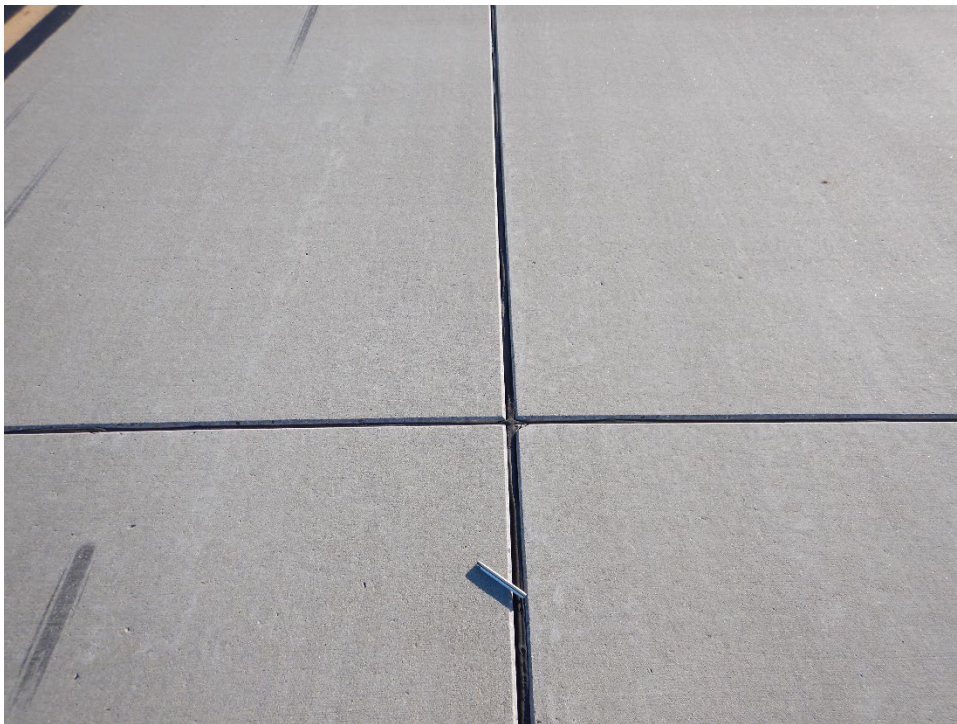
R17SX-01. Faulting (Sample Unit No. 27).

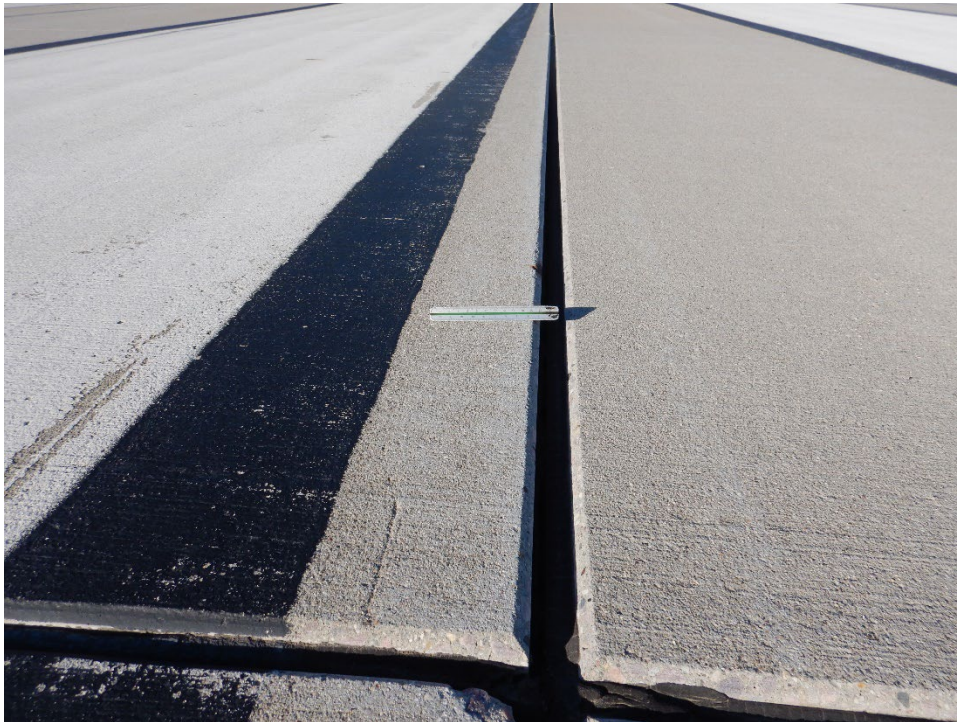
R17SX-02. Faulting (Sample Unit No. 03).

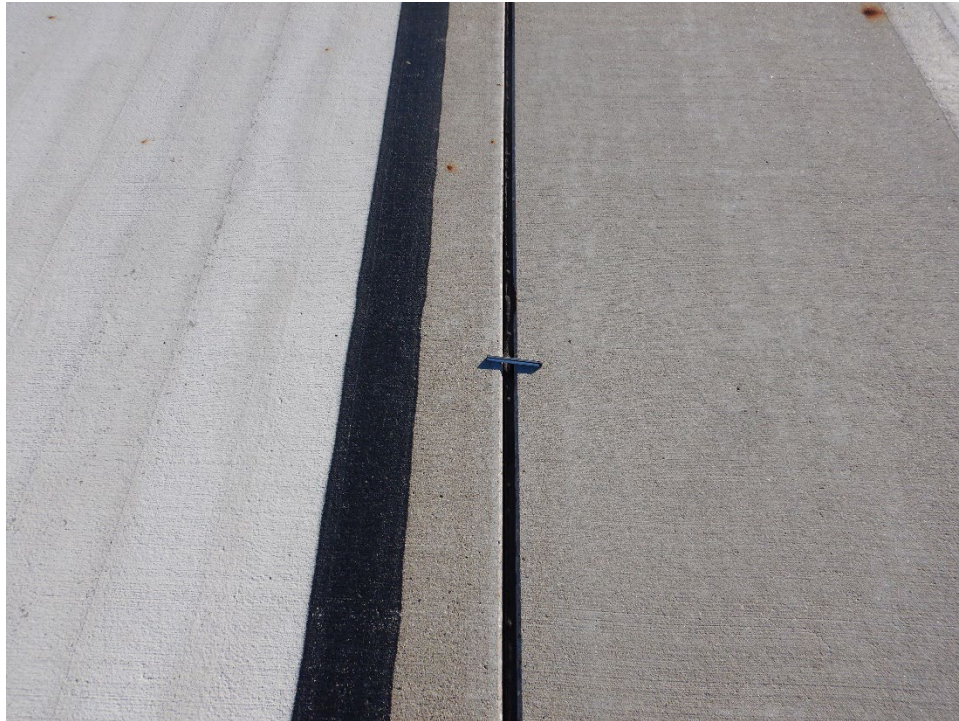
R17SX-02. Joint Seal Damage (Sample Unit No. 06).

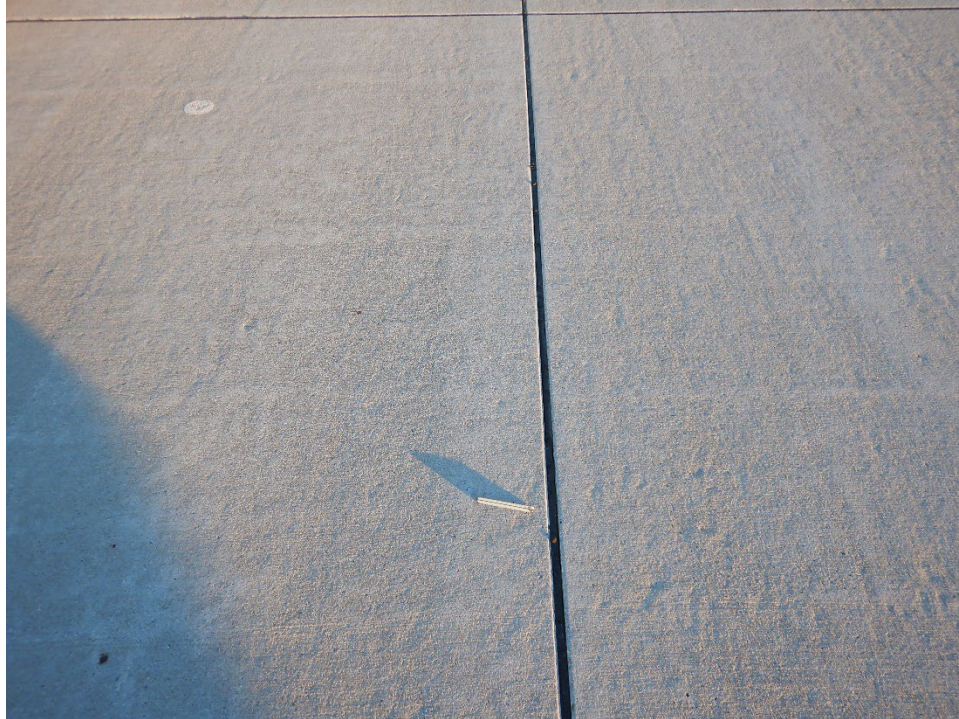
T01SX-01. Joint Seal Damage (Sample Unit No. 06).

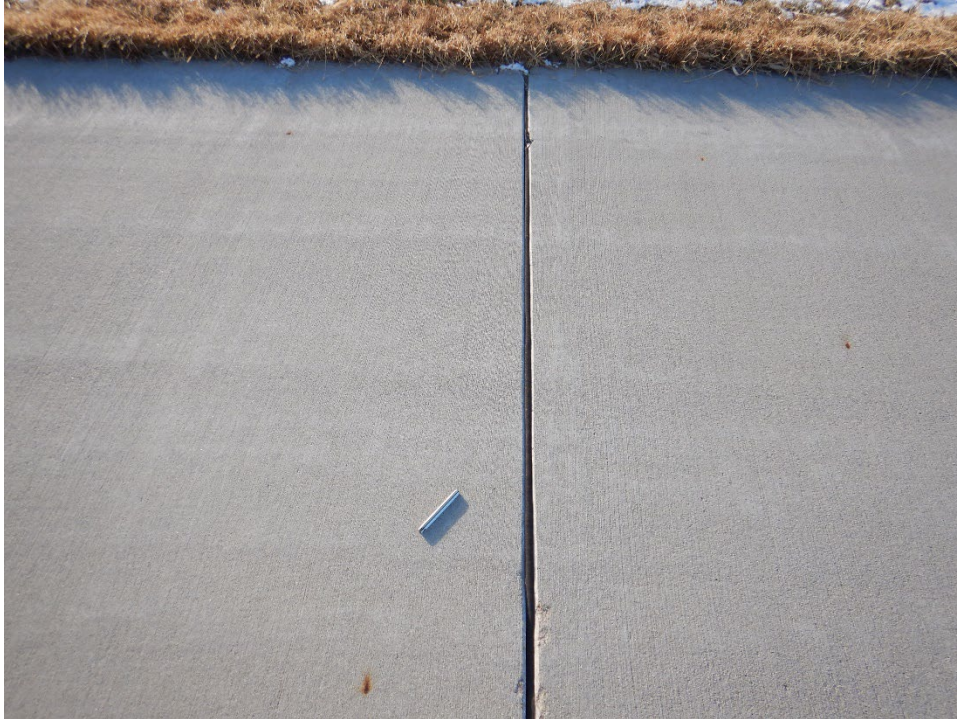
T01SX-02. Joint Seal Damage (Sample Unit No. 02).

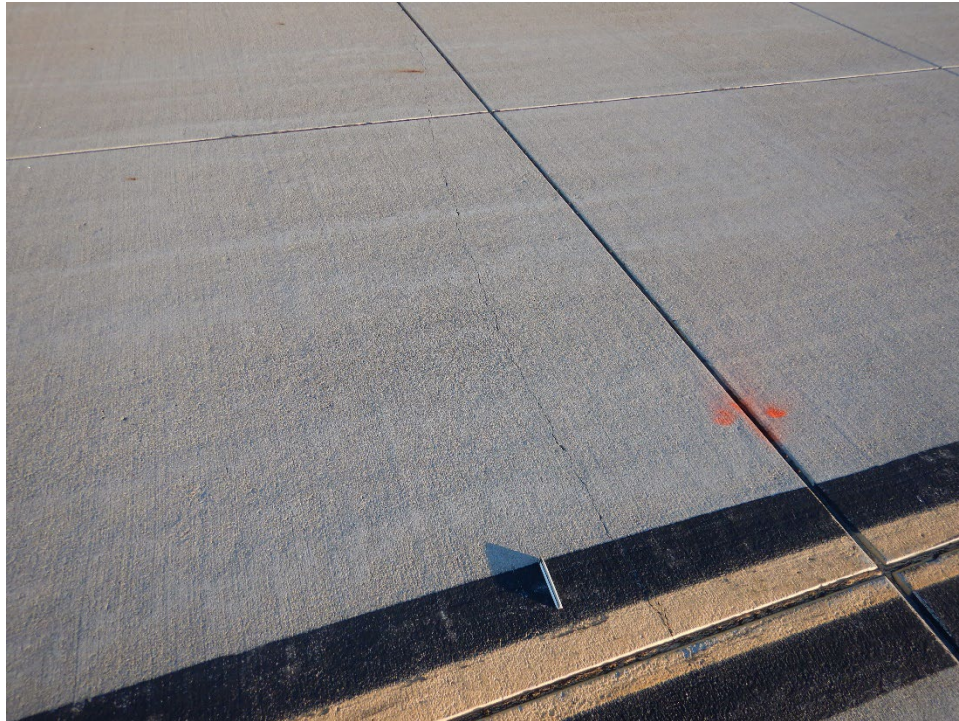
T02SX-01. LTD Cracking (Sample Unit No. 02).

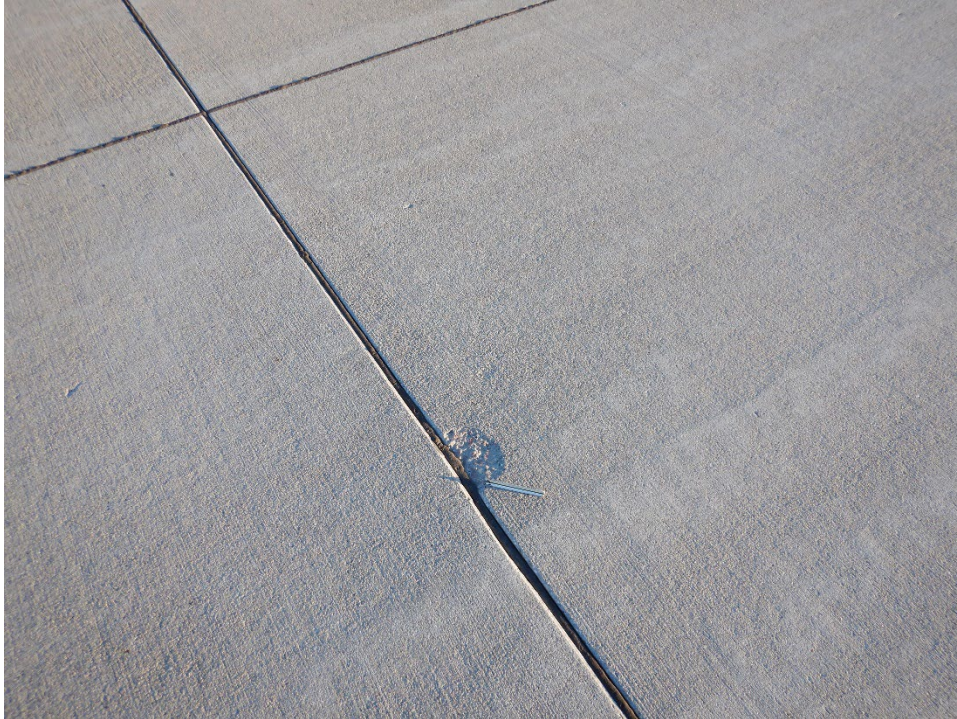
T02SX-02. Joint Spalling (Sample Unit No. 02).

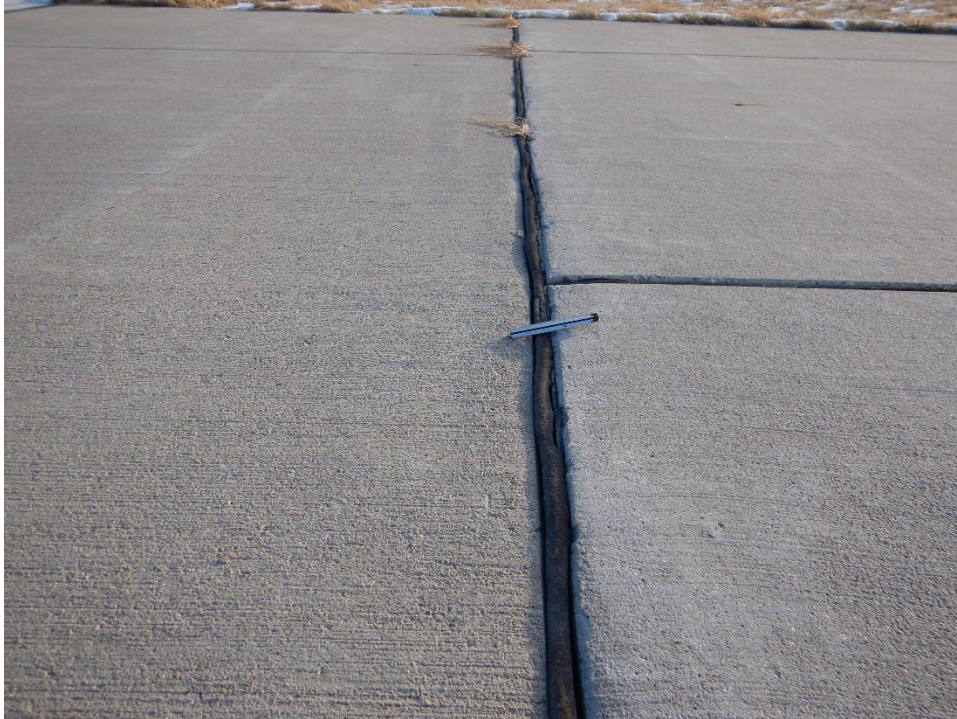
T02SX-03. Faulting (Sample Unit No. 01).

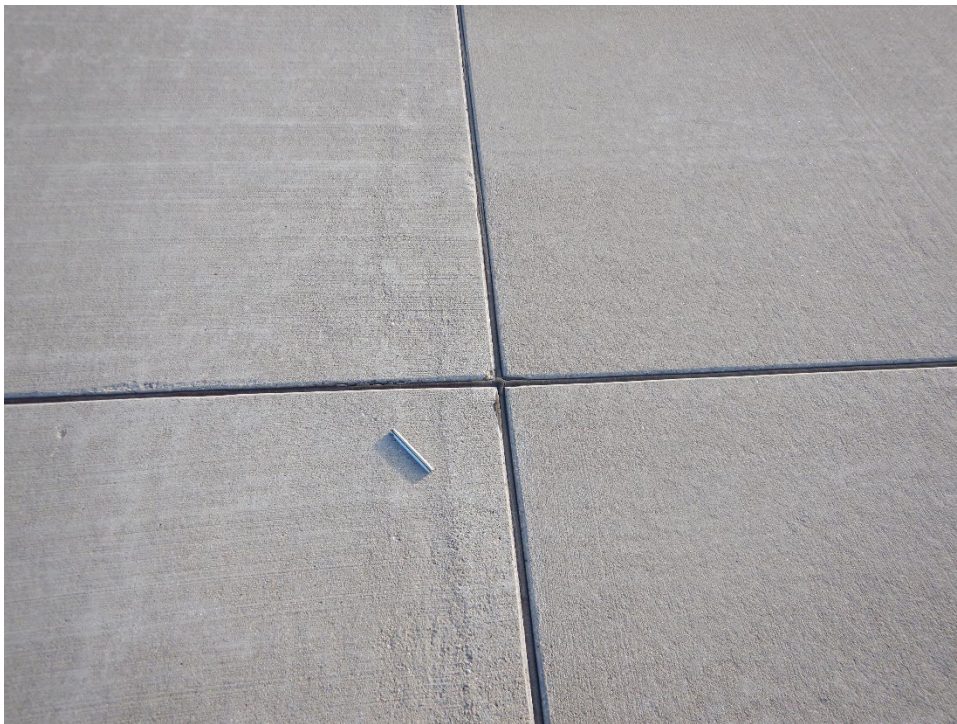
T02SX-03. Joint Seal Damage (Sample Unit No. 01).

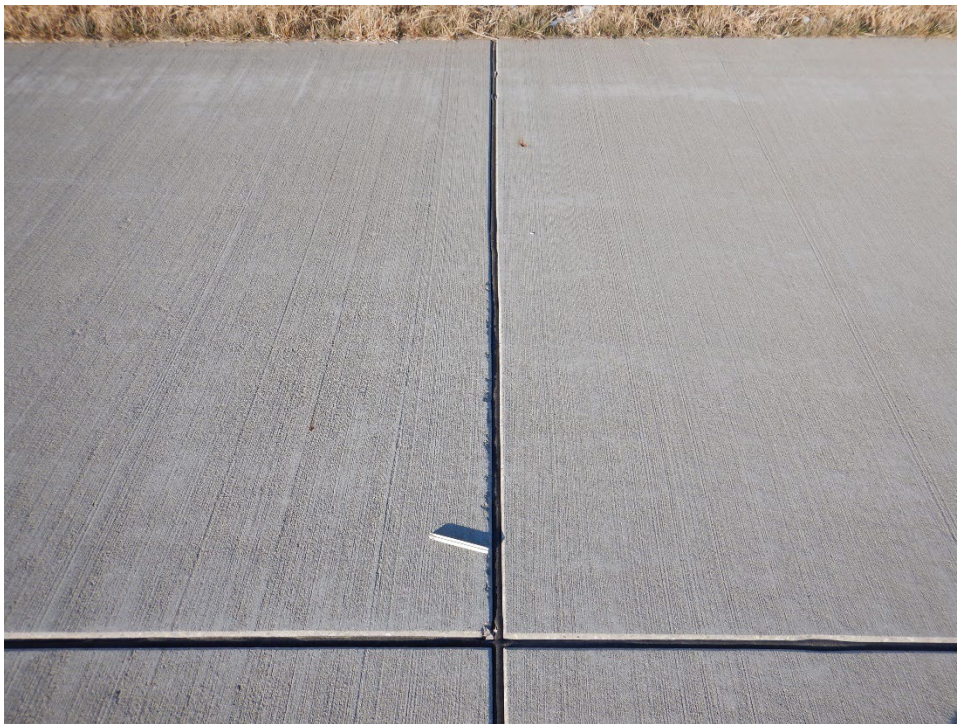
T02SX-04. Joint Seal Damage (Sample Unit No. 01).

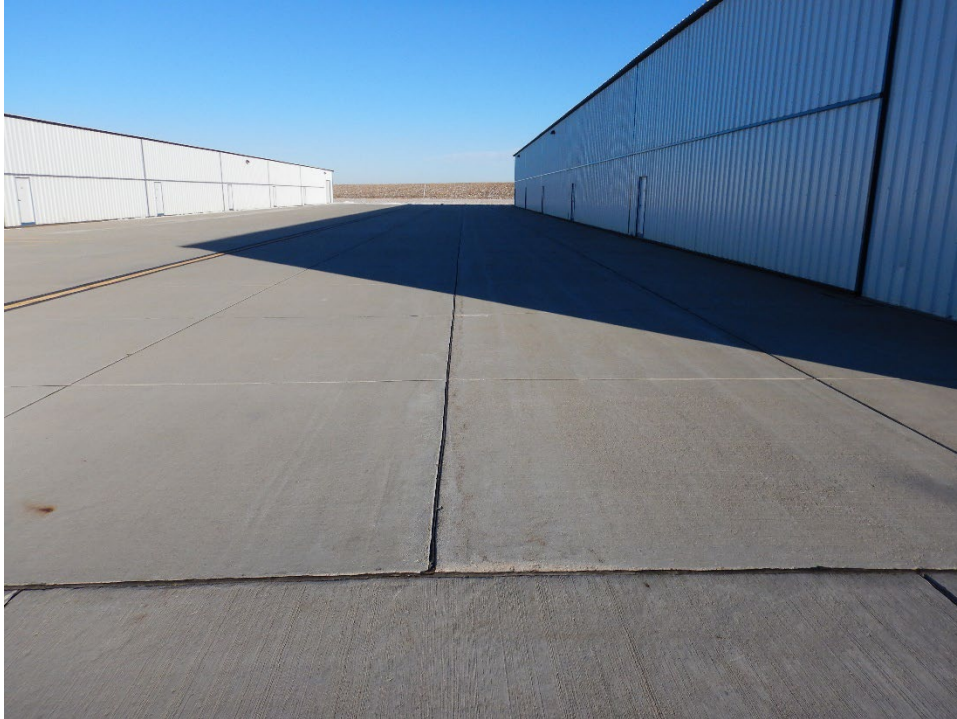
TH01SX-01. Overview.

The T-hangar area consisted of one section. Section 01 contained areas of low-severity faulting, medium- and high-severity joint seal damage, medium-severity joint spalling, and low- and medium-severity small patching.

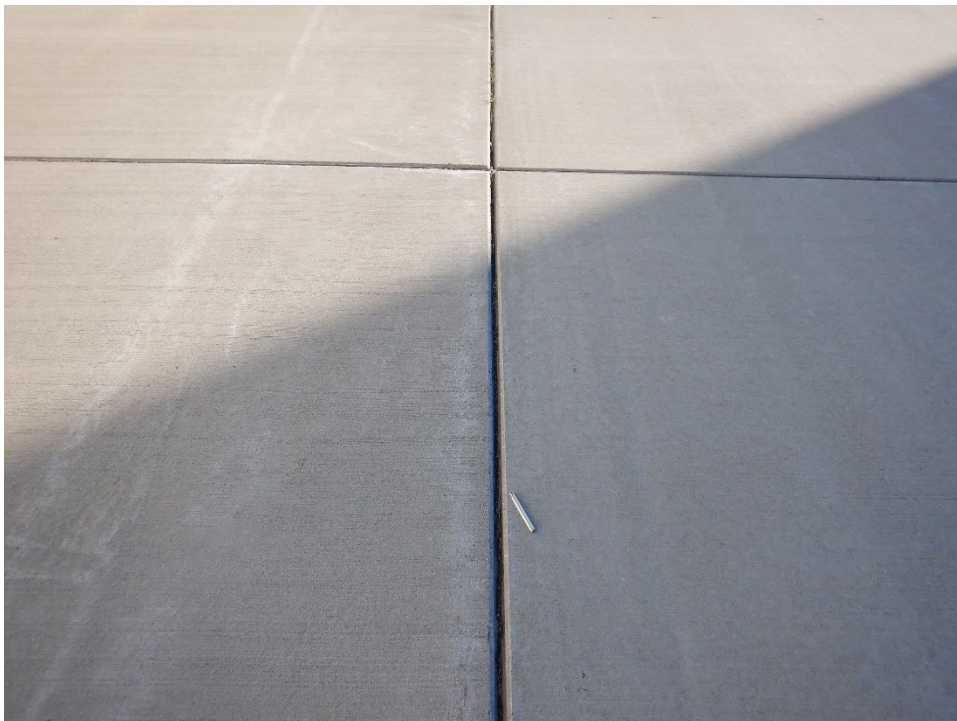
TH01SX-01. Joint Seal Damage (Sample Unit No. 07).
