# Spencer Municipal Airport

## Pavement Management Report

**JULY 2023**

# SPENCER MUNICIPAL AIRPORT PAVEMENT MANAGEMENT REPORT

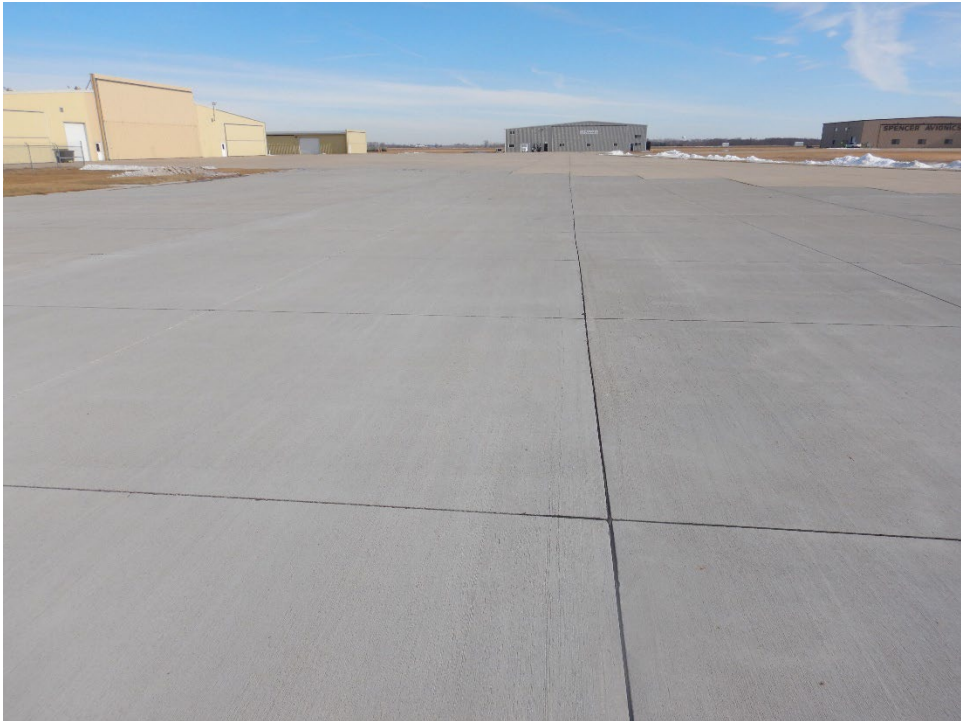
A01SP-01. Overview.

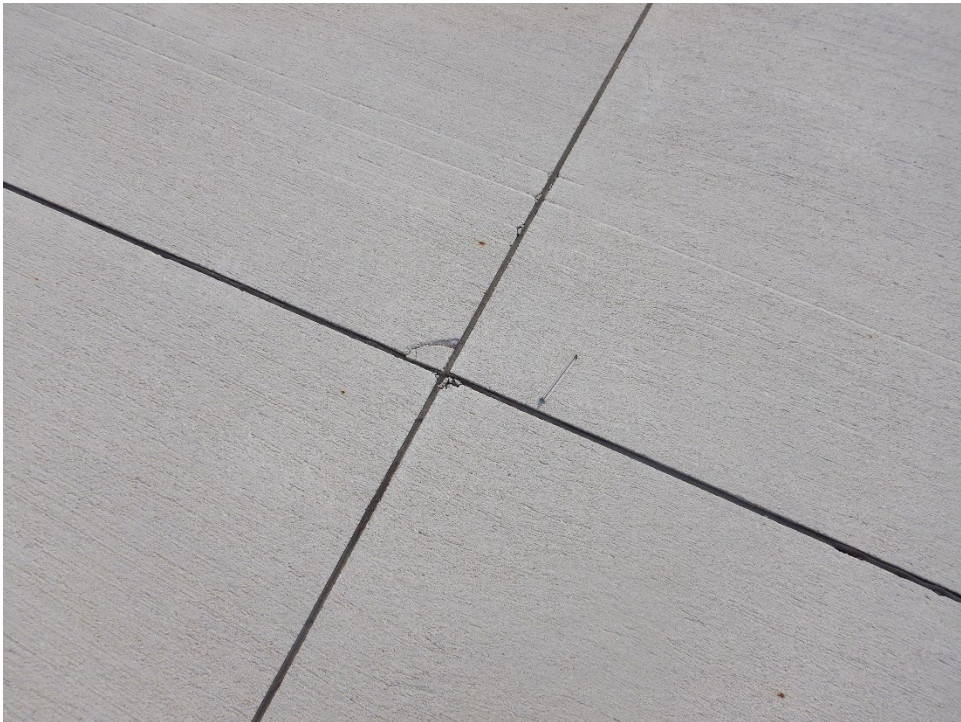
A01SP-01. Corner Spalling (Sample Unit No. 05).

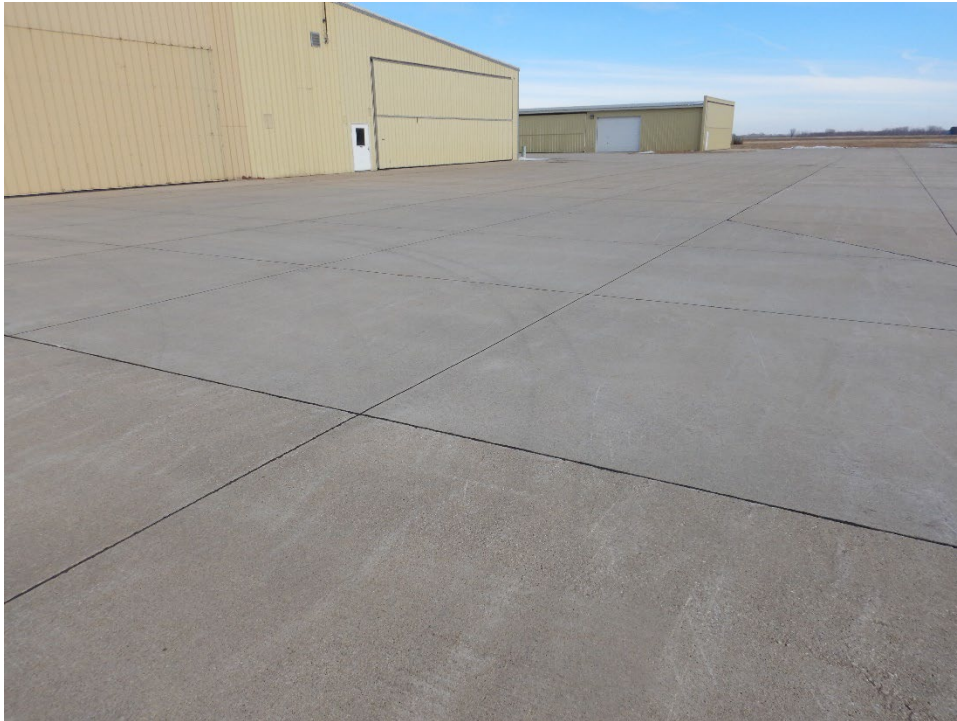
A01SP-02. Overview.

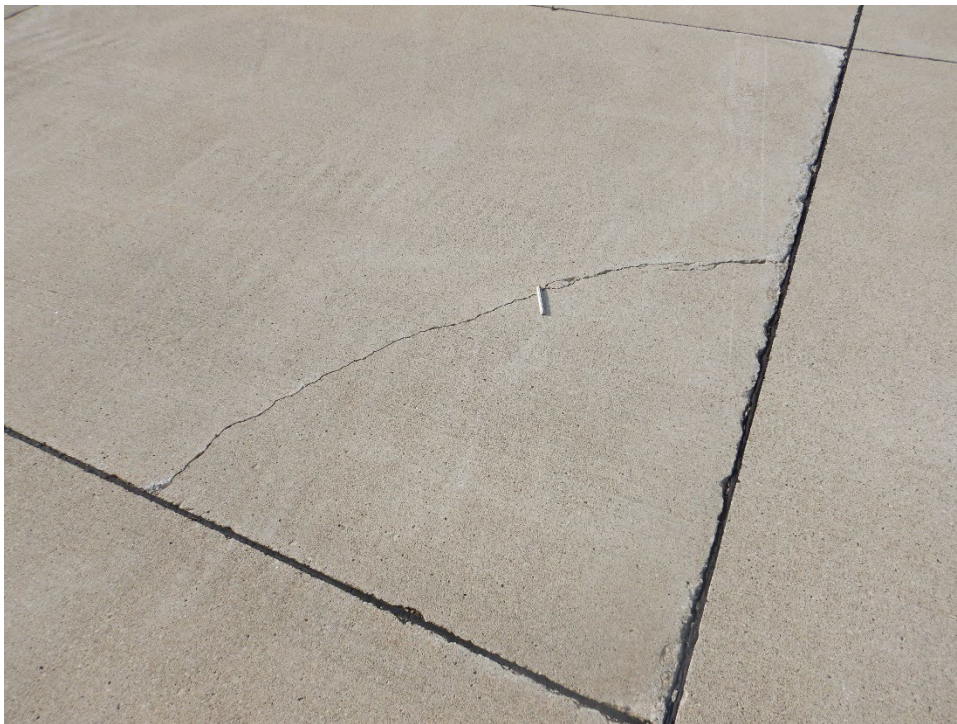
A01SP-02. Corner Break (Sample Unit No. 02).

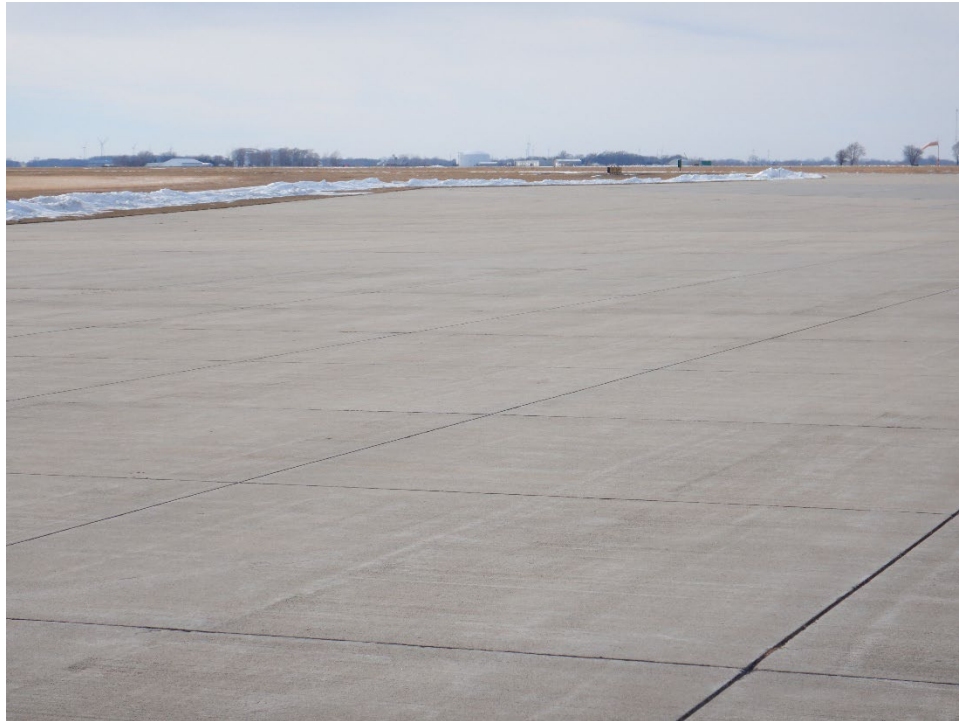
A01SP-03. Overview.

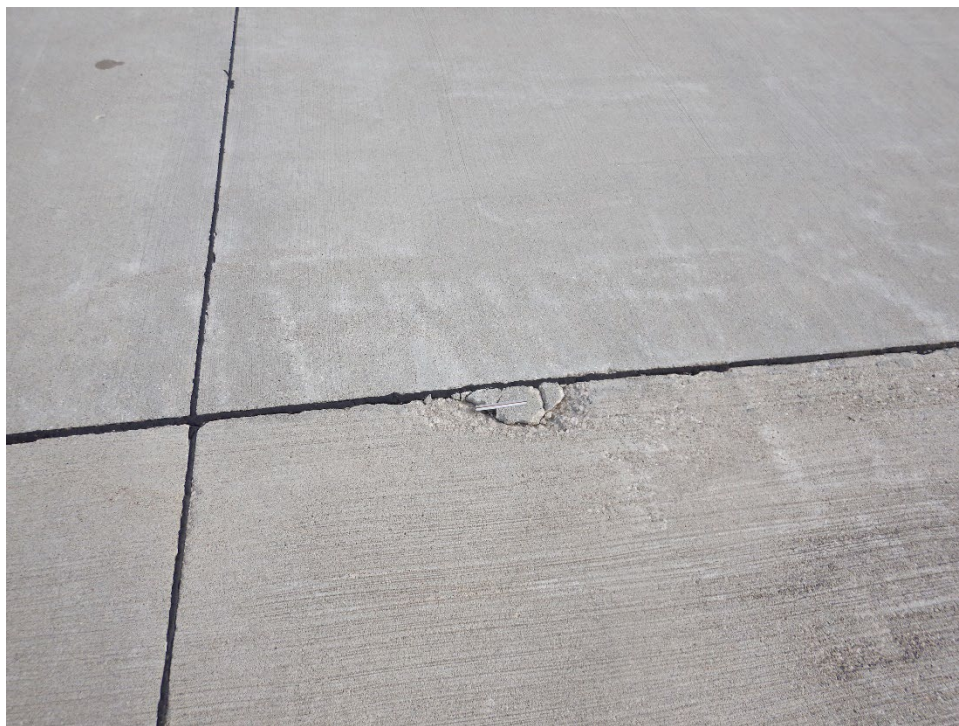
A01SP-03. Joint Spalling (Sample Unit No. 05).

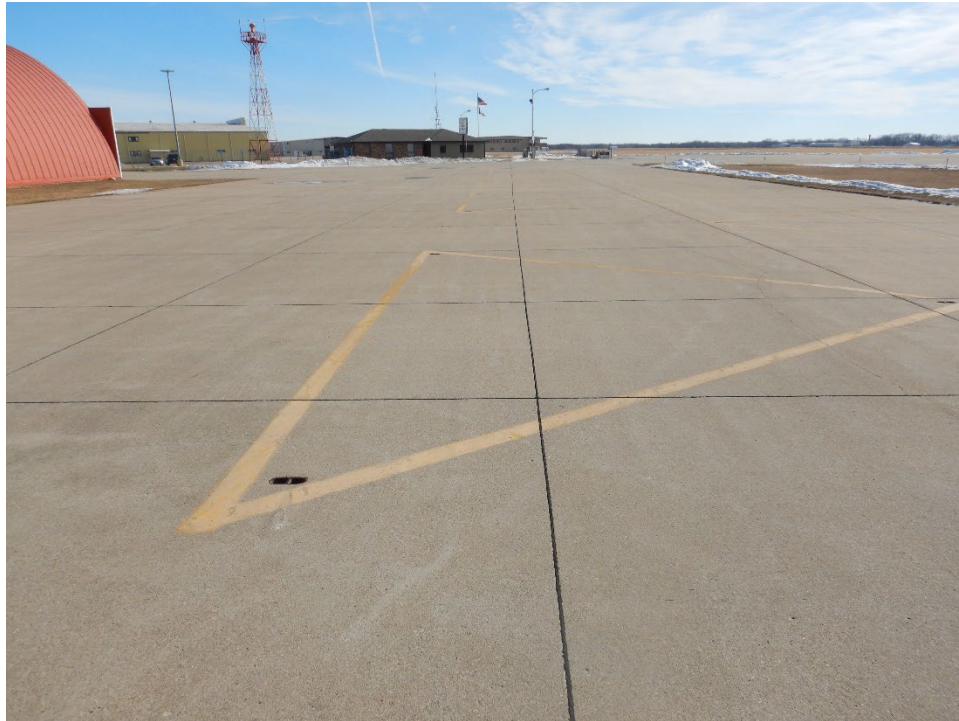
A01SP-04. Overview.

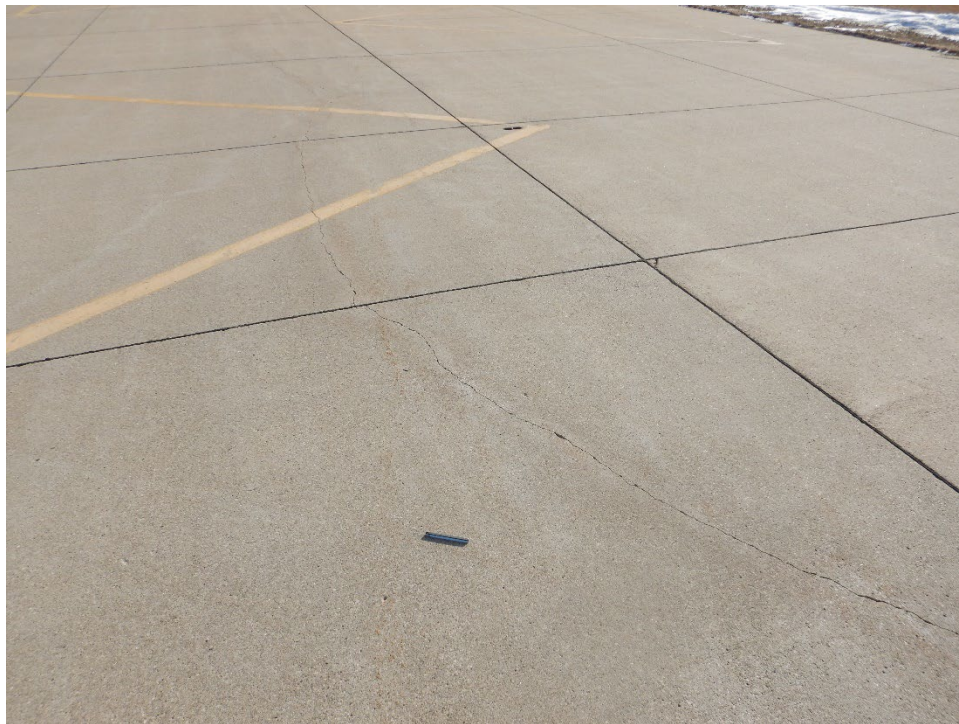
A01SP-04. LTD Cracking (Sample Unit No. 04).

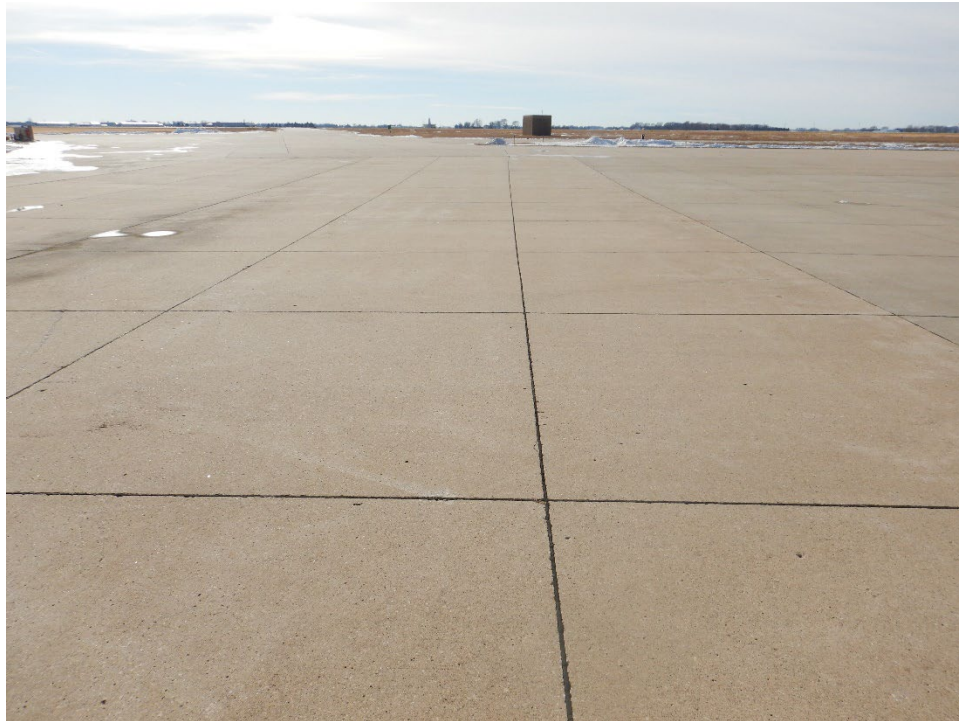
A01SP-05. Overview.

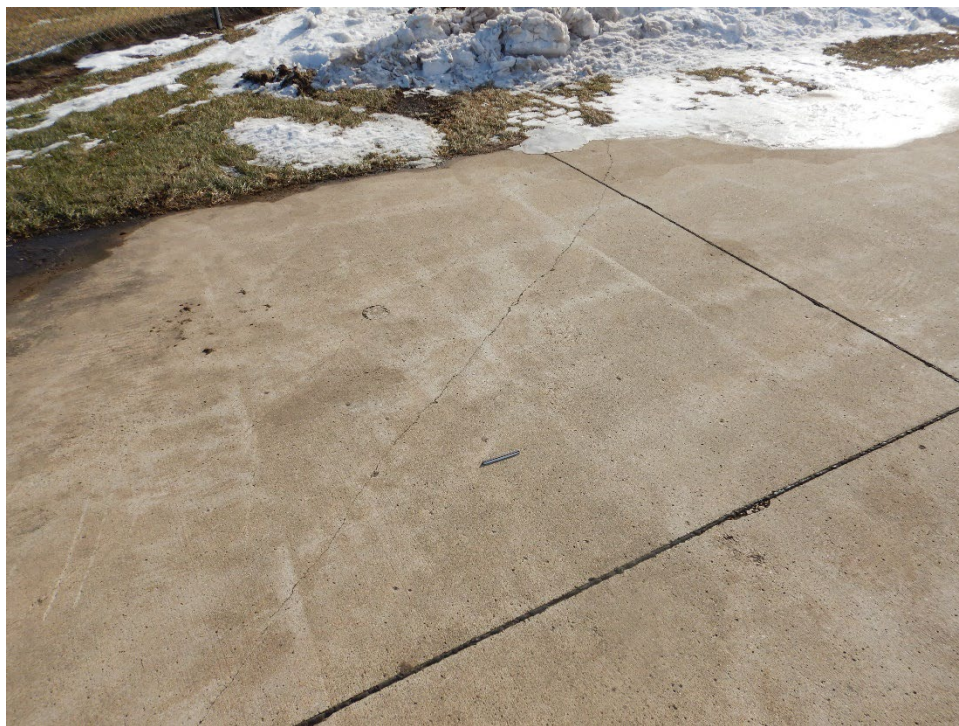
A01SP-05. LTD Cracking (Sample Unit No. 05).

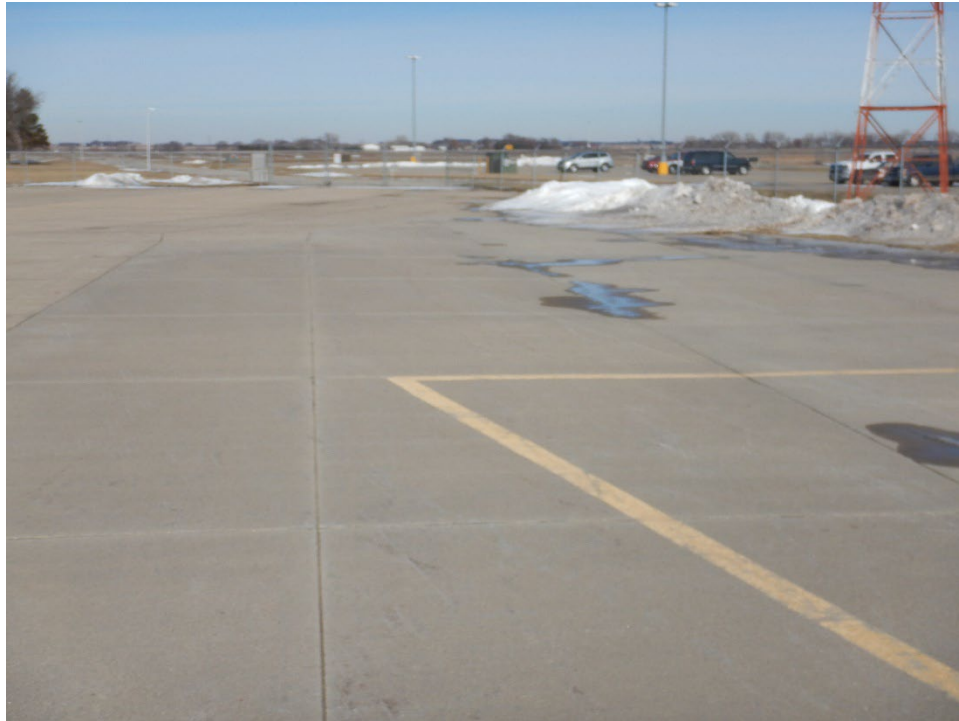
A01SP-06. Overview.

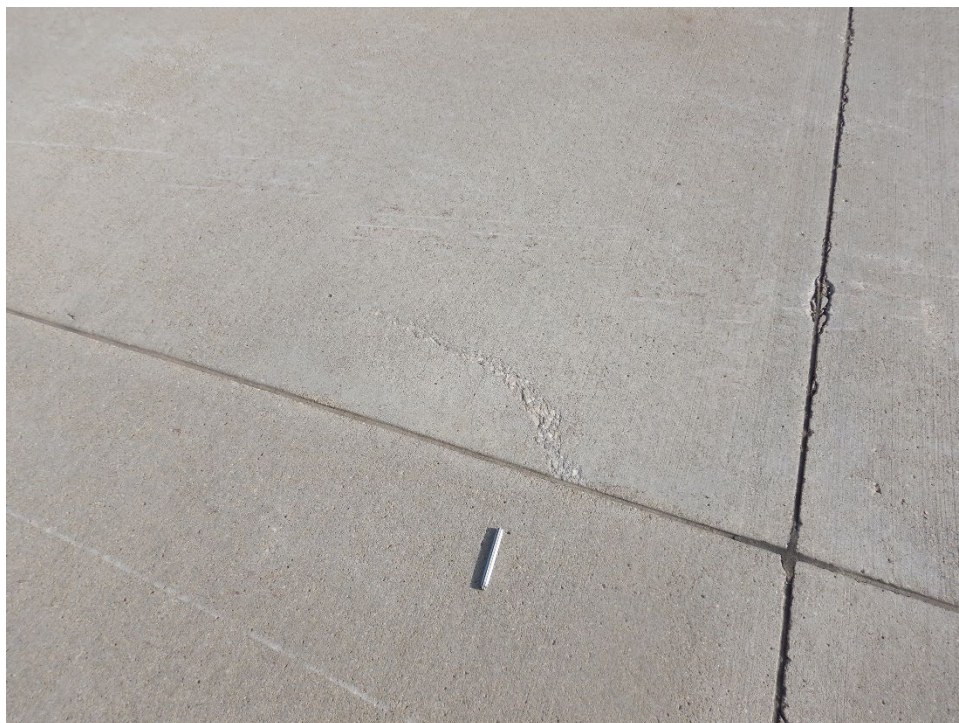
A01SP-06. Joint Spalling (Sample Unit No. 02).

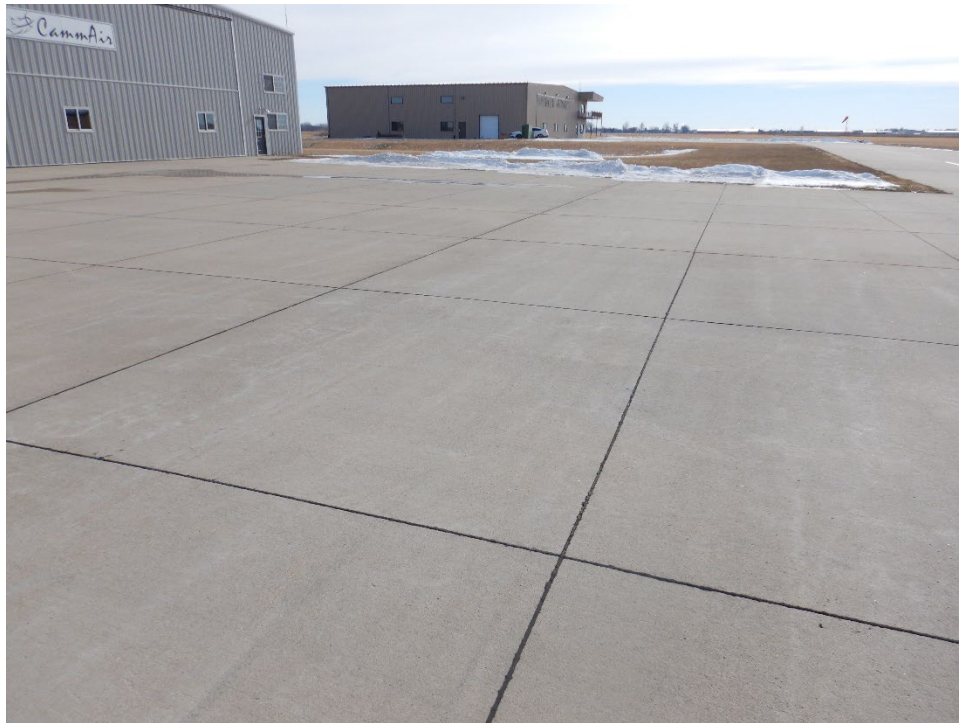
A01SP-07. Overview.

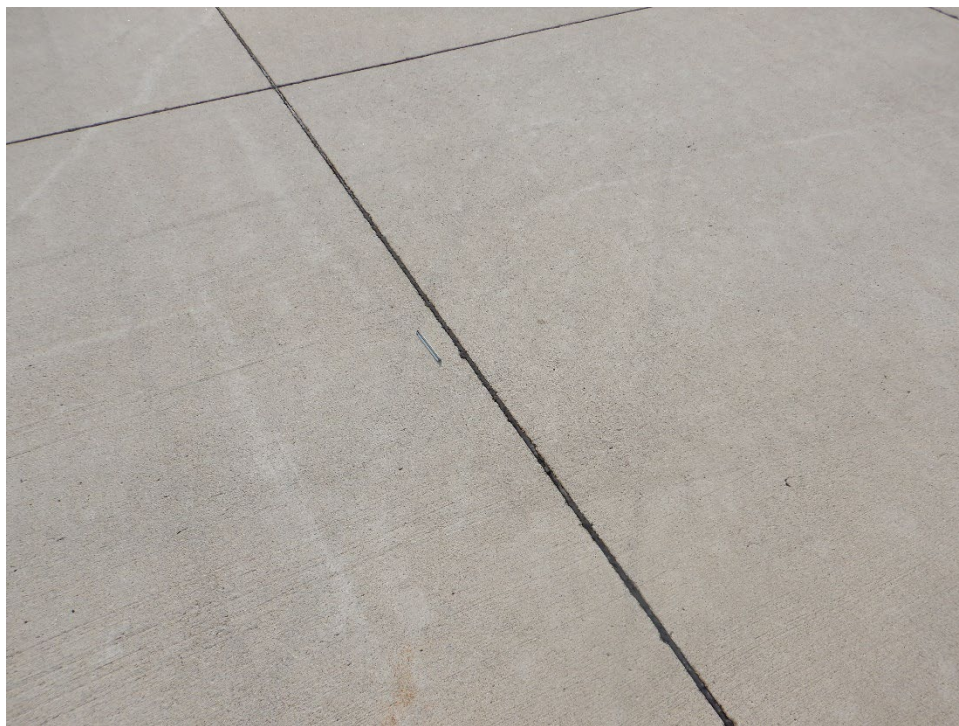
A01SP-07. Joint Seal Damage (Sample Unit No. 01).

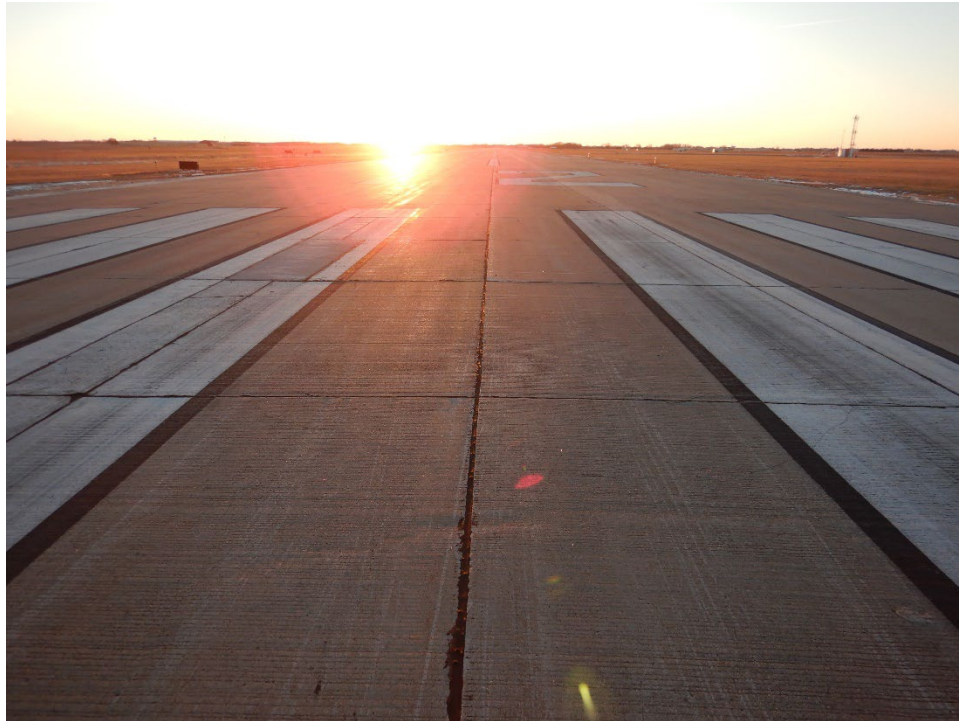
Runway 12/30 was defined by one section. Section 01 contained areas of low- and medium-severity corner spalling and joint spalling and low-severity large patching, small patching, faulting, corner break, and longitudinal, transverse, and diagonal (LTD) cracking.

R12SP-01. Overview.

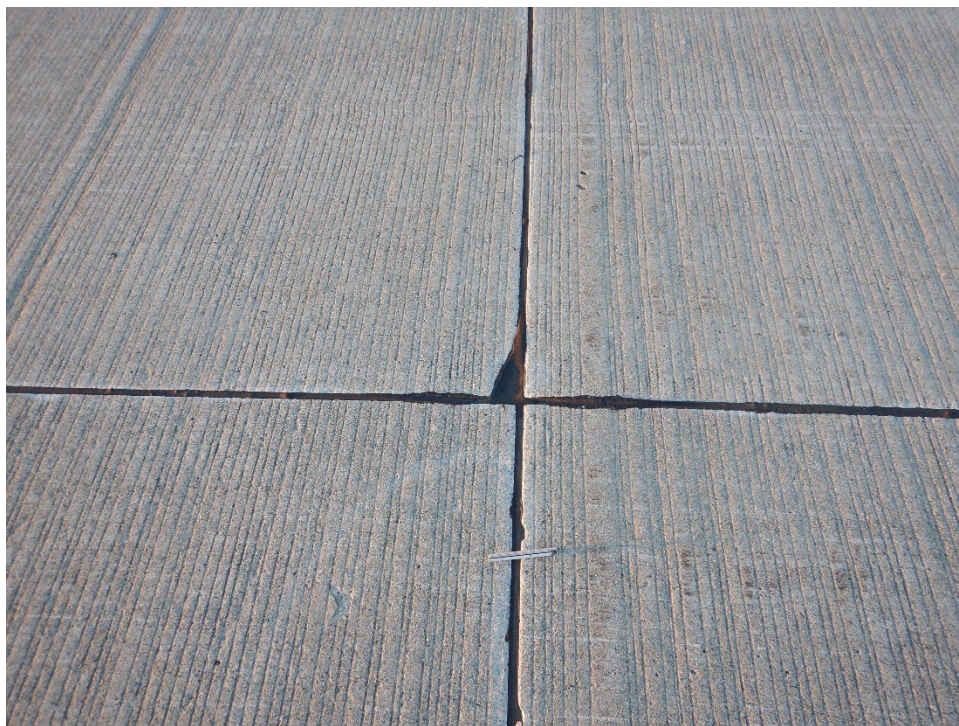
R12SP-01. Corner Spalling (Sample Unit No. 23).

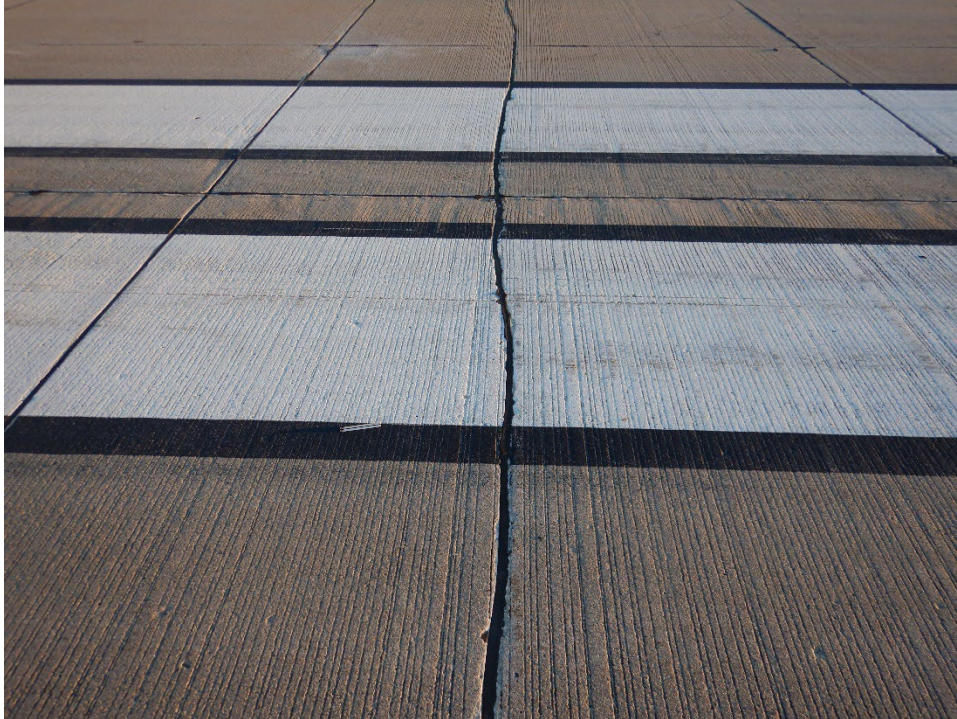
R12SP-01. LTD Cracking (Sample Unit No. 83).

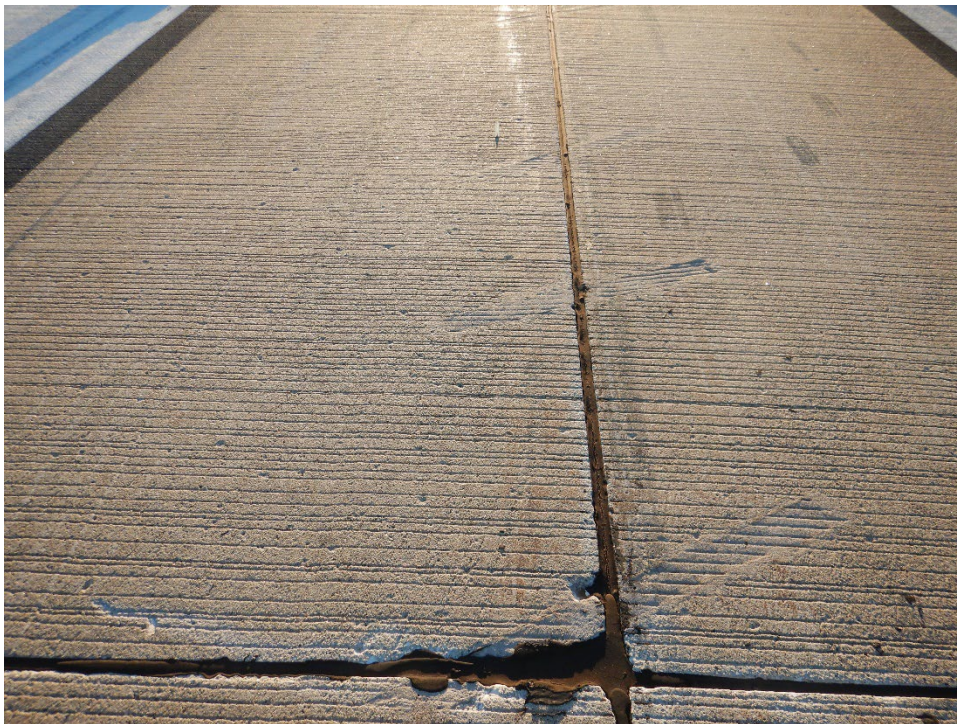
R12SP-01. Small Patching (Sample Unit No. 223).

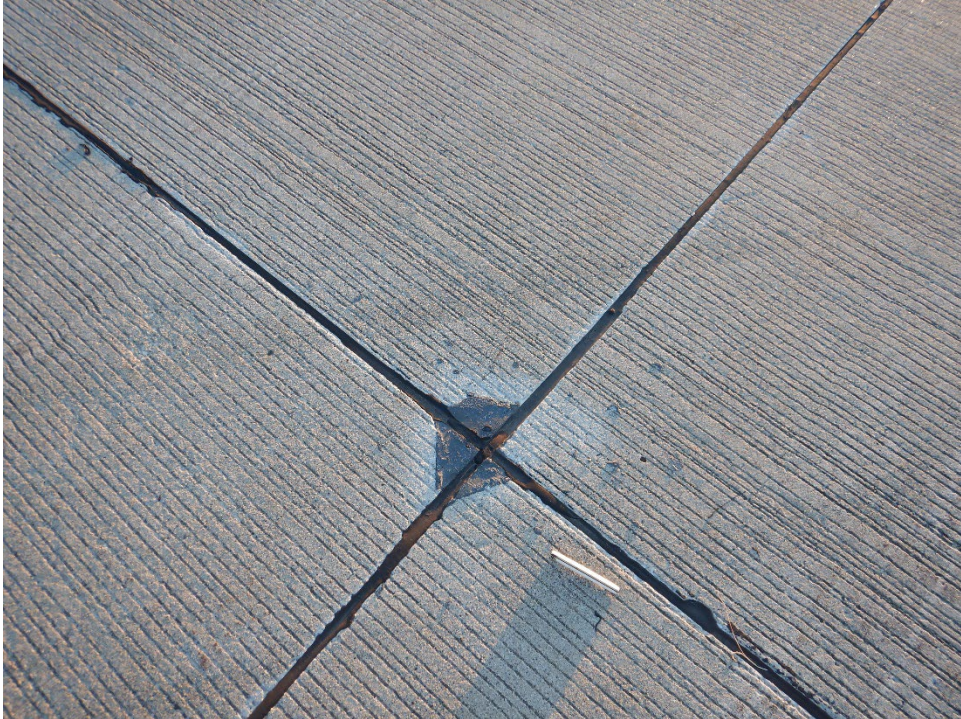
R12SP-01. Small Patching (Sample Unit No. 43).

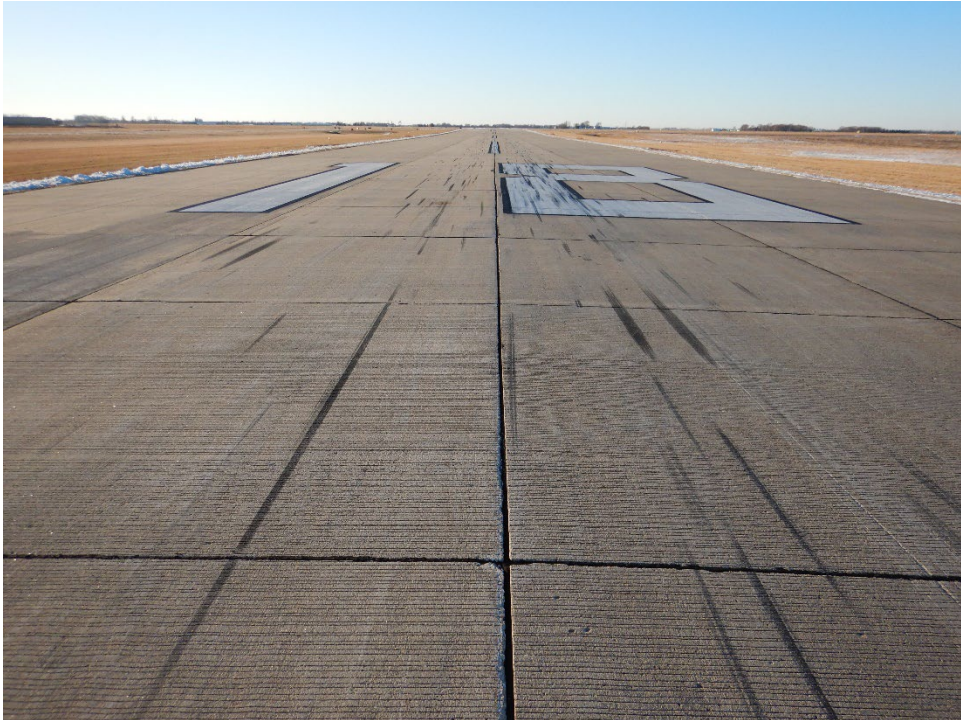
Runway 18/36 contained one section that was in excellent condition. Low- and medium-severity joint spalling and corner spalling and low-severity joint seal damage were recorded in Section 01. An atypical area of low-severity LTD cracking was observed and recorded as an additional sample unit in accordance with ASTM D5340-20.

R18SP-01. Overview.

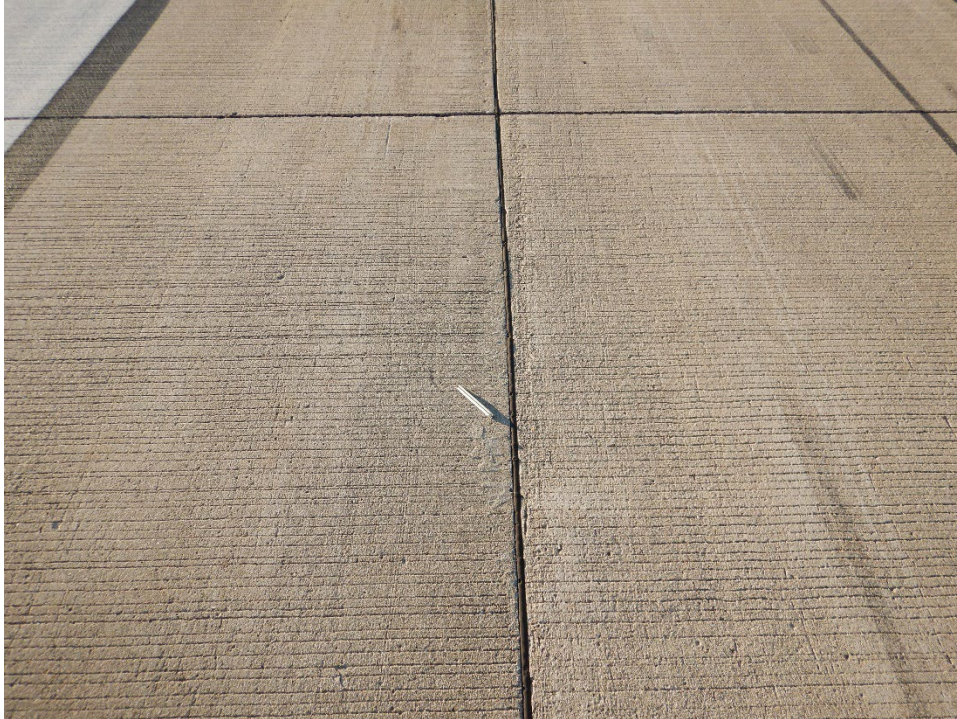
R18SP-01. Joint Seal Damage (Sample Unit No. 23).

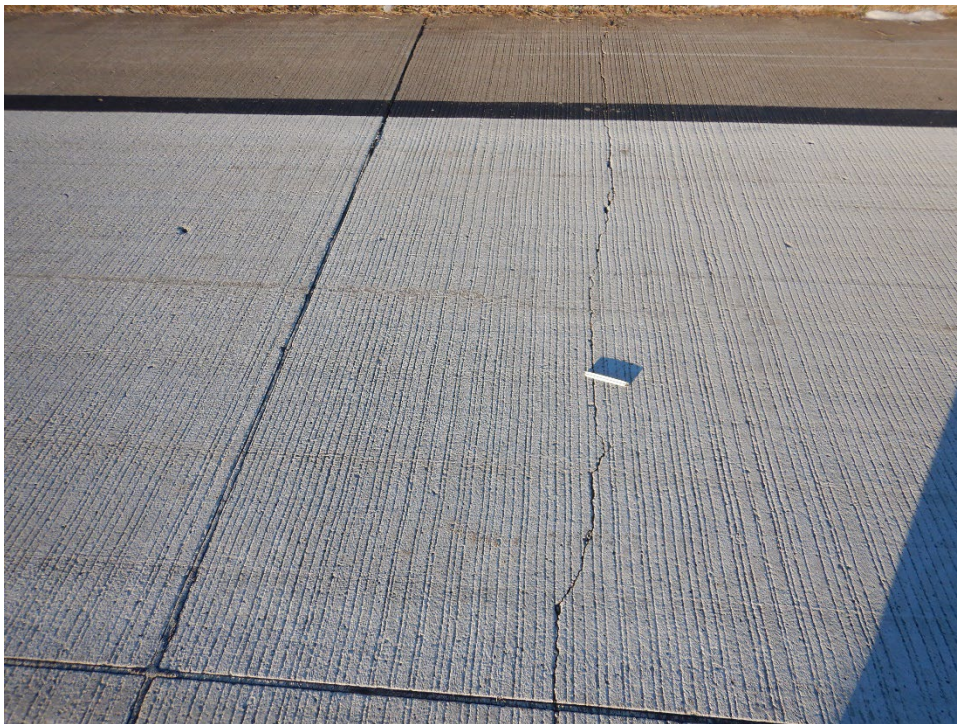
R18SP-01. LTD Cracking (Additional Sample Unit No. 22).

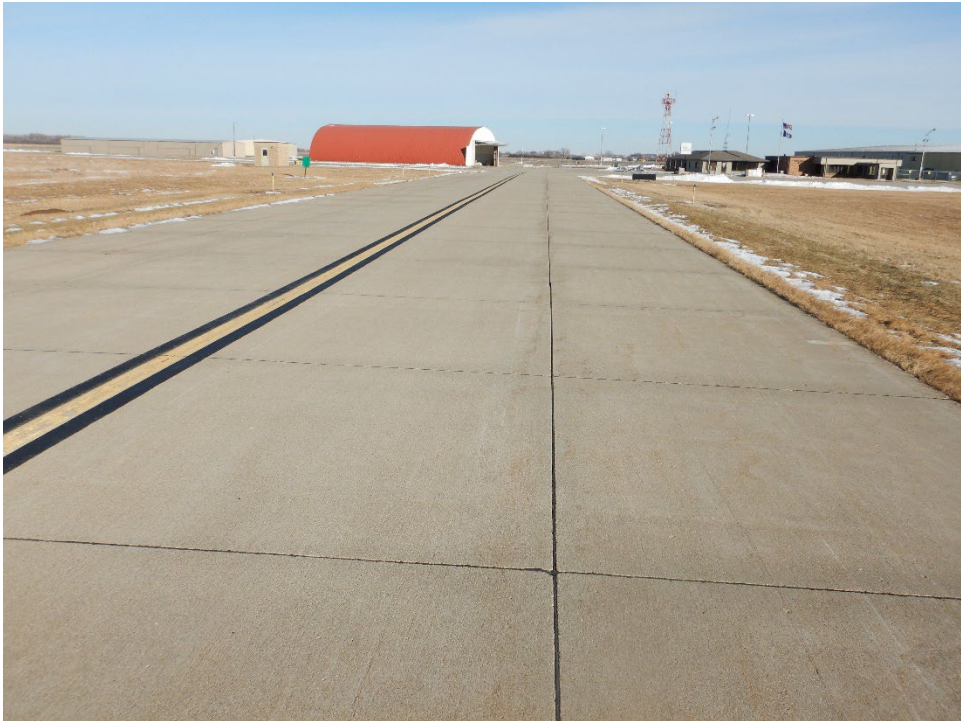
TASP-01. Overview.

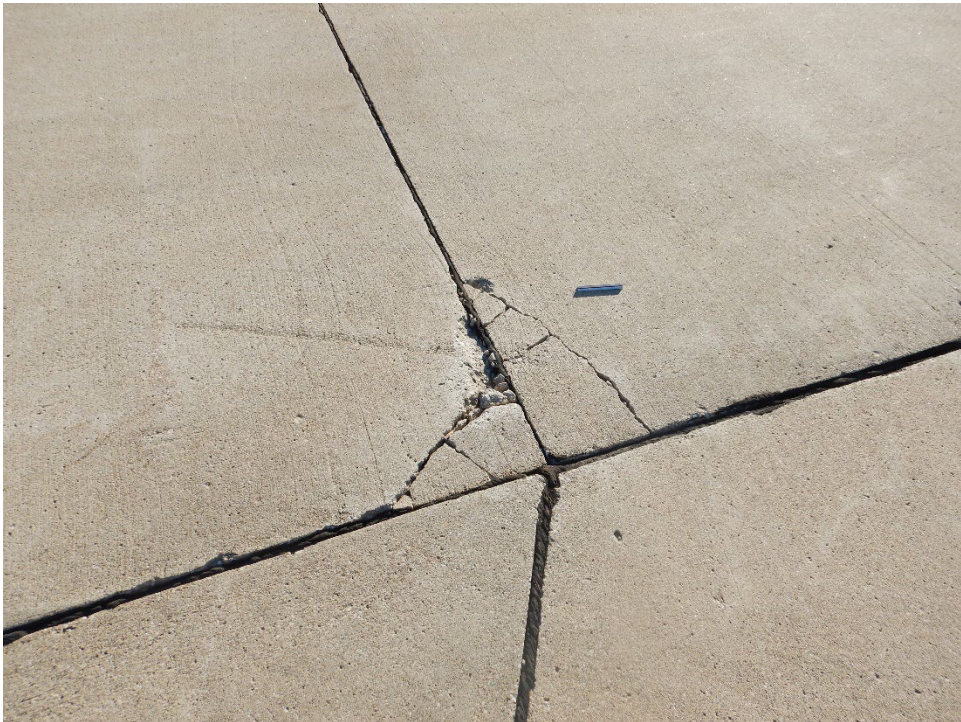
TASP-01. Corner Spalling (Sample Unit No. 02).

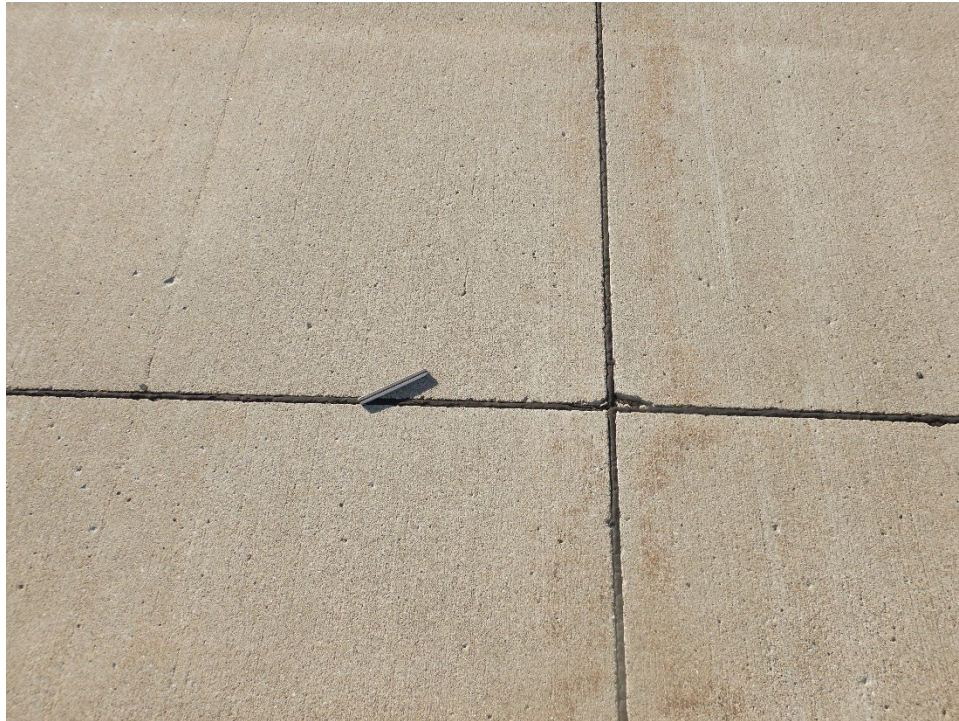
TASP-01. Joint Seal Damage (Sample Unit No. 16).

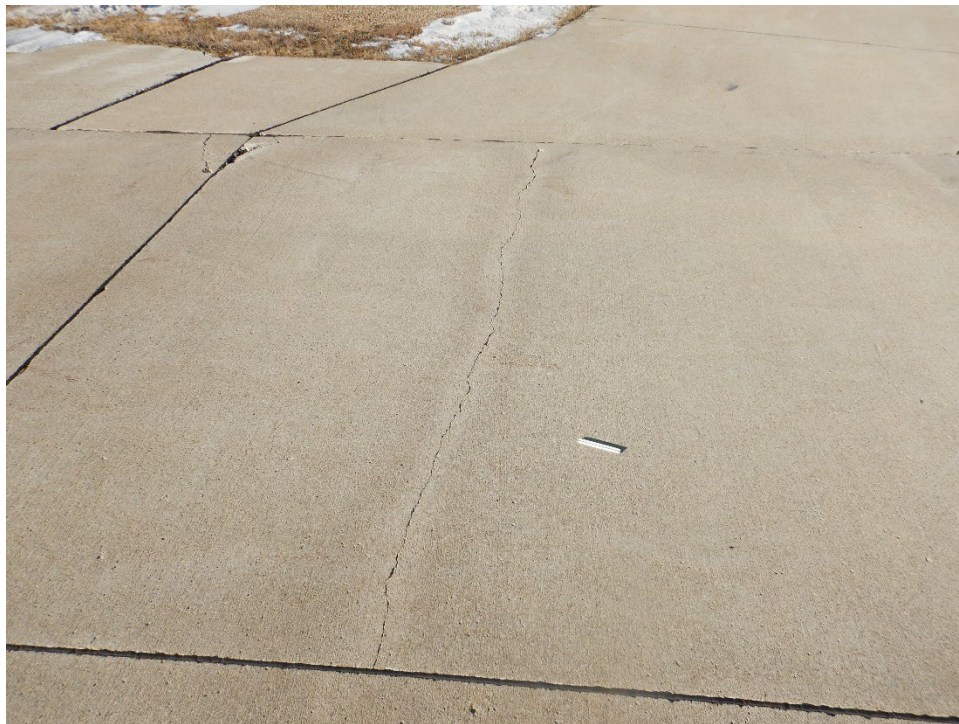
TASP-01. LTD Cracking (Additional Sample Unit No. 01).

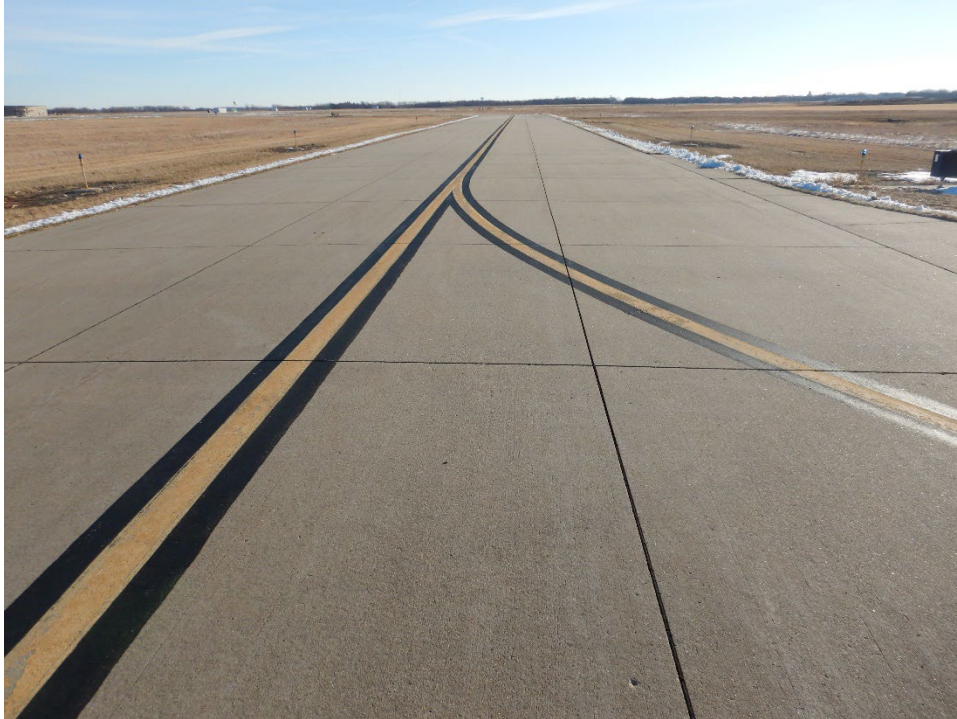
TASP-02. Overview.

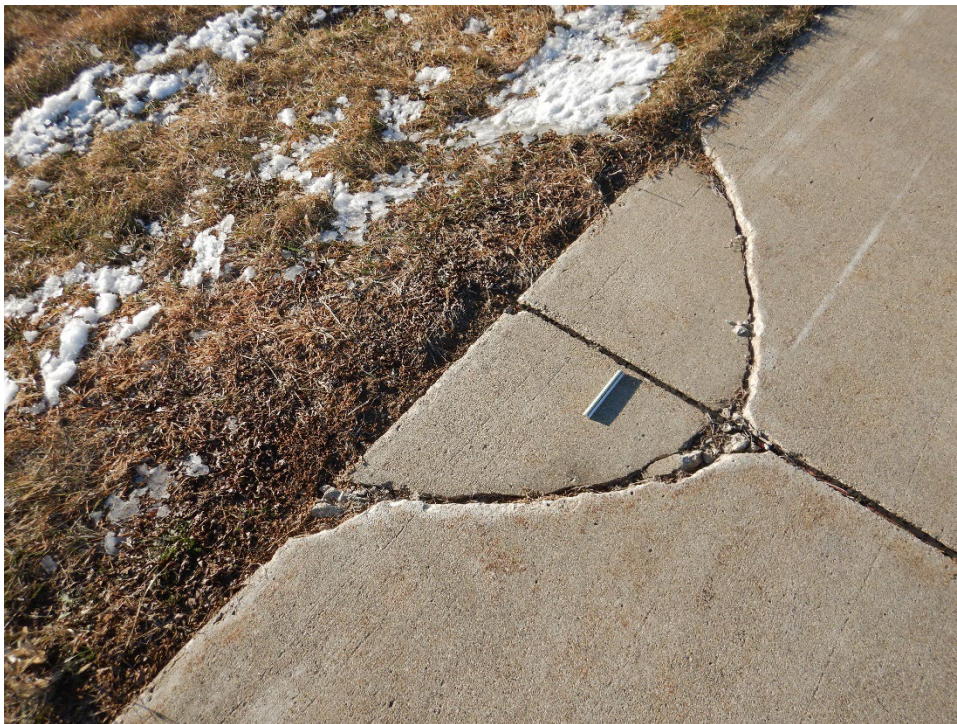
TASP-02. Corner Break (Additional Sample Unit No. 14).

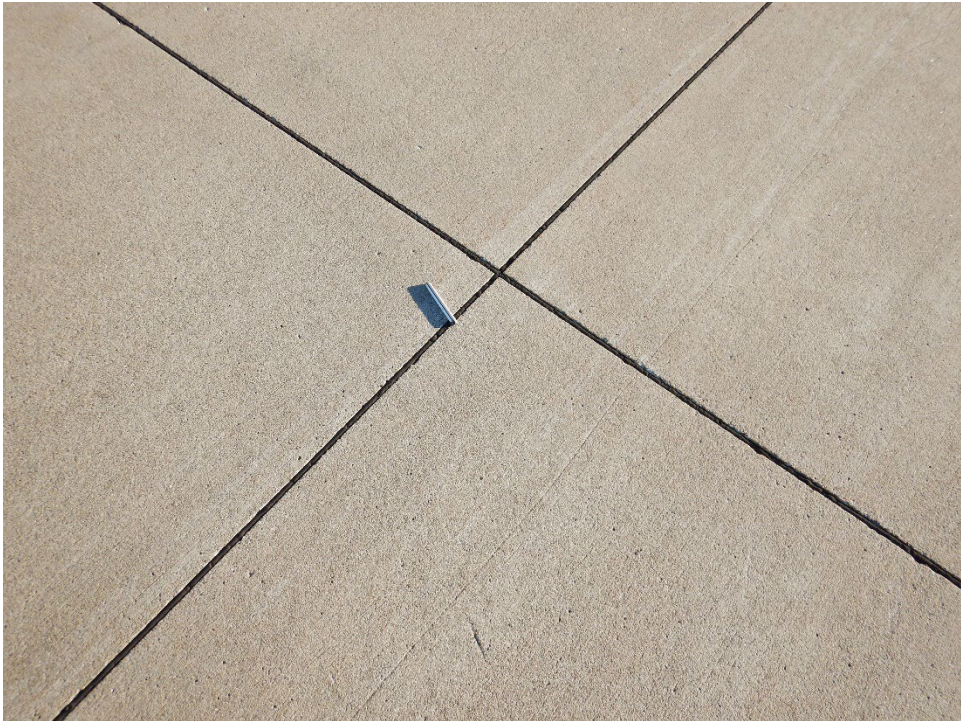
TASP-02. Joint Seal Damage (Sample Unit No. 08).

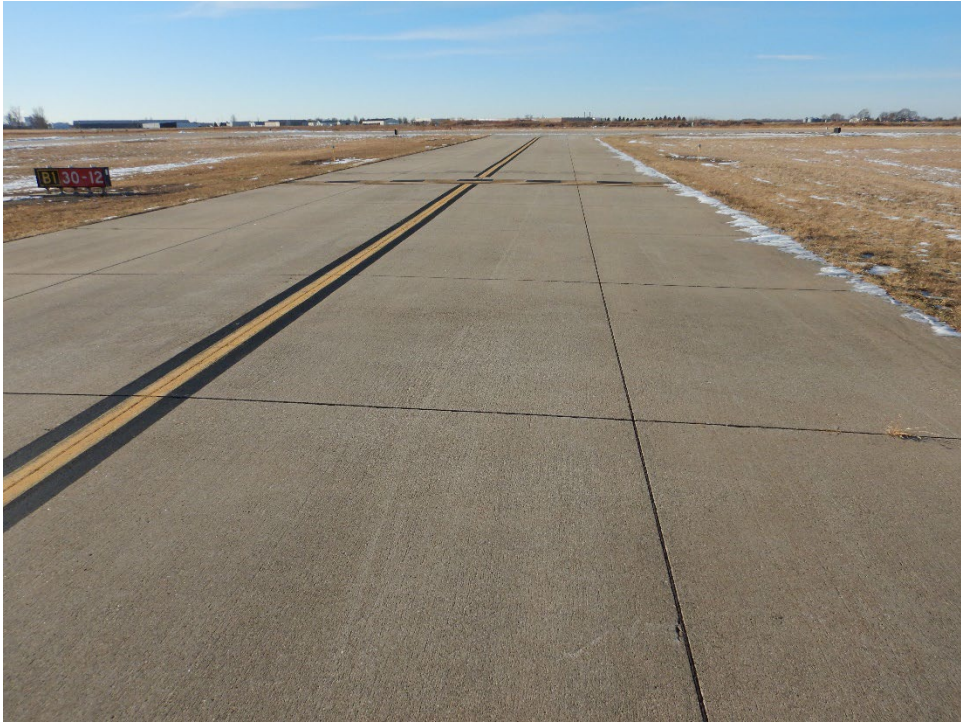
Taxiway B1 contained one section with only high-severity joint seal damage identified throughout.

TB1SP-01. Overview.

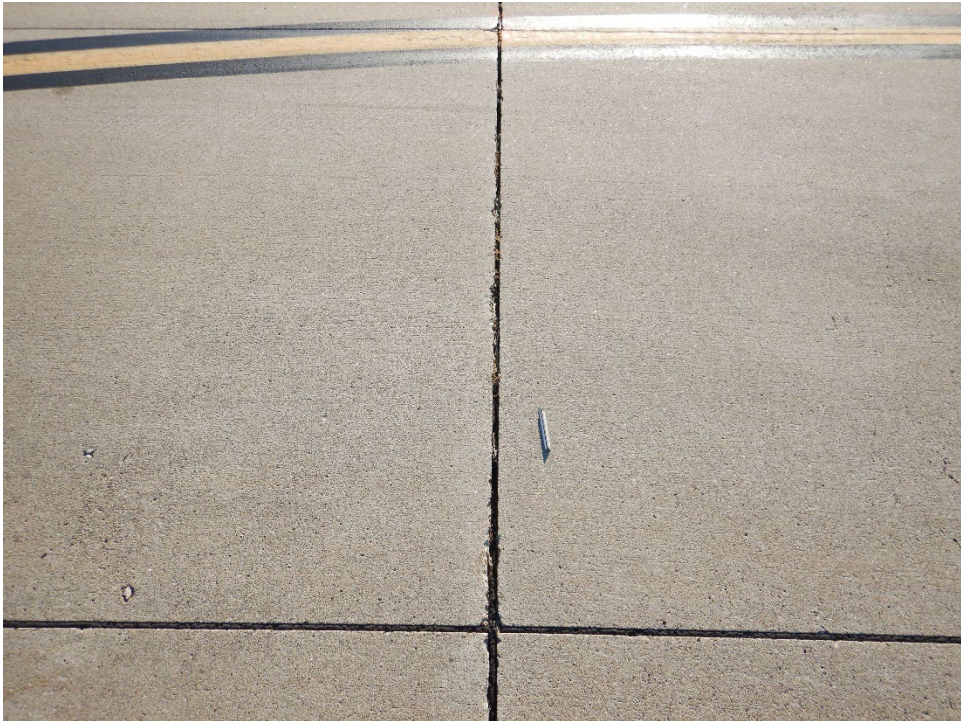
TB1SP-01. Joint Seal Damage (Sample Unit No. 05).

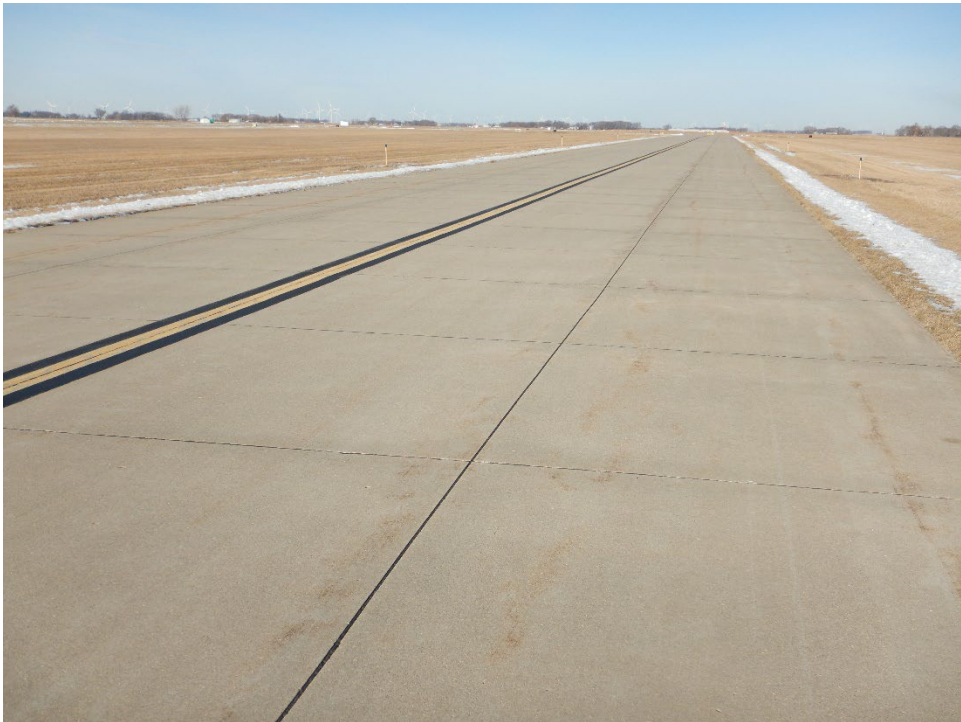
Taxiway B was defined by one section. Section 01 contained areas of low-severity corner spalling and medium- and high-severity joint seal damage.

TBSP-01. Overview.
