# Spencer Municipal Airport

## Pavement Management Report

**JULY 2023**

# SPENCER MUNICIPAL AIRPORT PAVEMENT MANAGEMENT REPORT

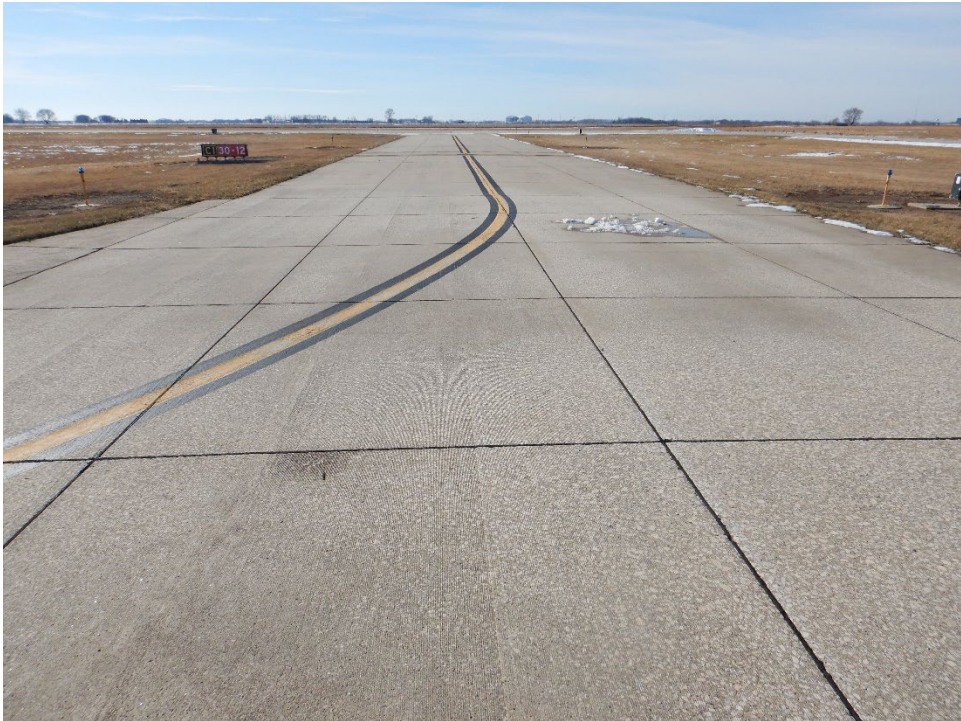
Taxiway C1 contained one section. Low- and medium-severity joint seal damage were identified throughout Section 01.

TC1SP-01. Overview.

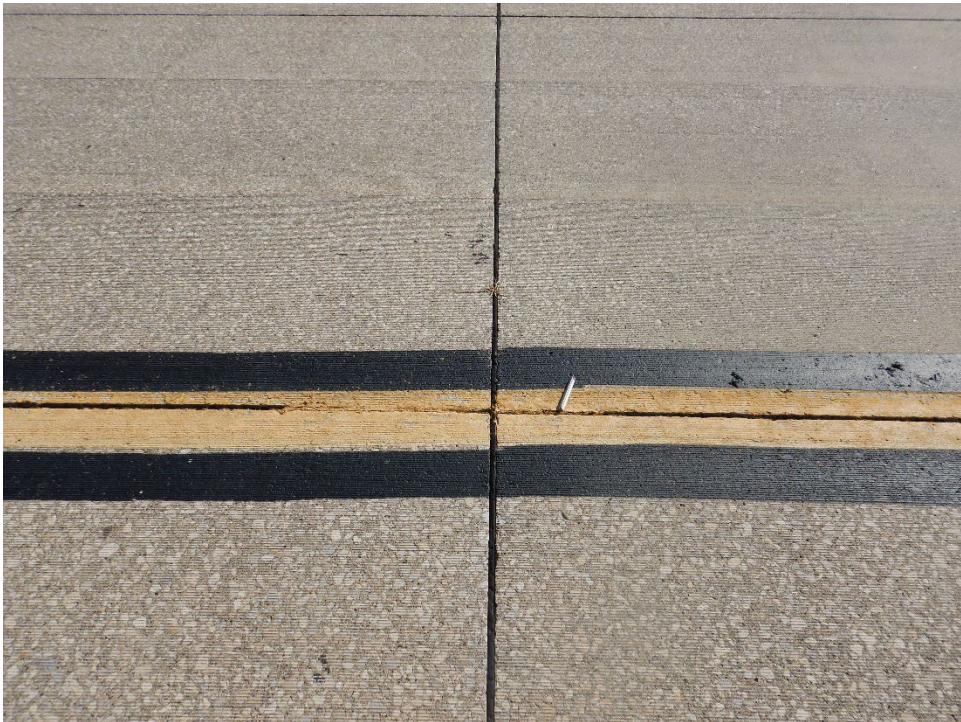
TC1SP-01. Joint Seal Damage (Sample Unit No. 03).

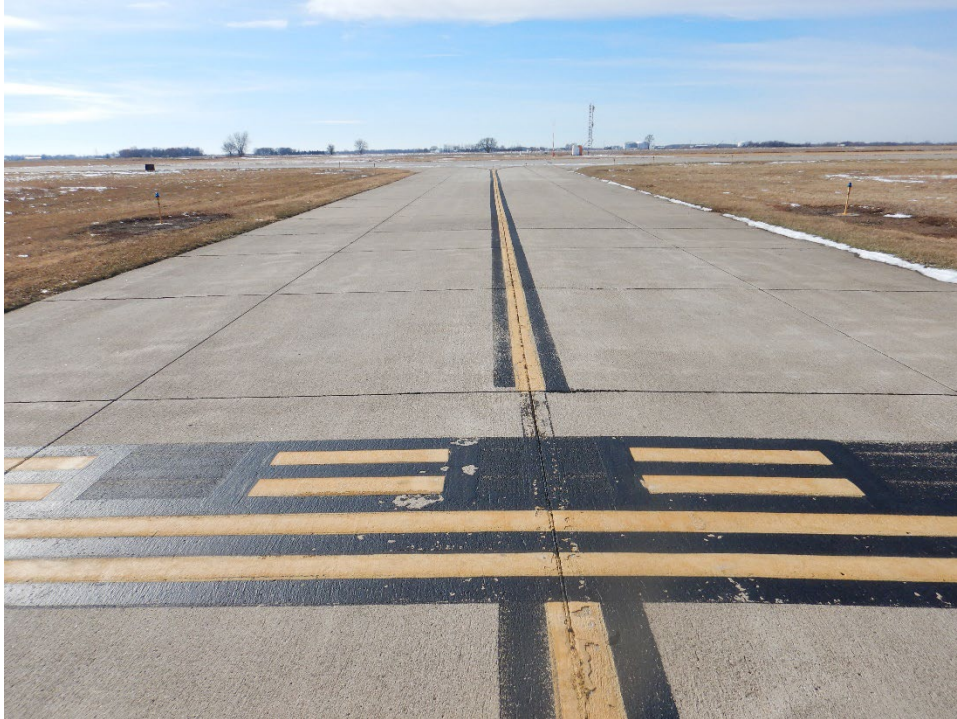
Taxiway C2 consisted of one section. Section 01 contained areas of medium-severity joint seal damage and joint spalling.

TC2SP-01. Overview.

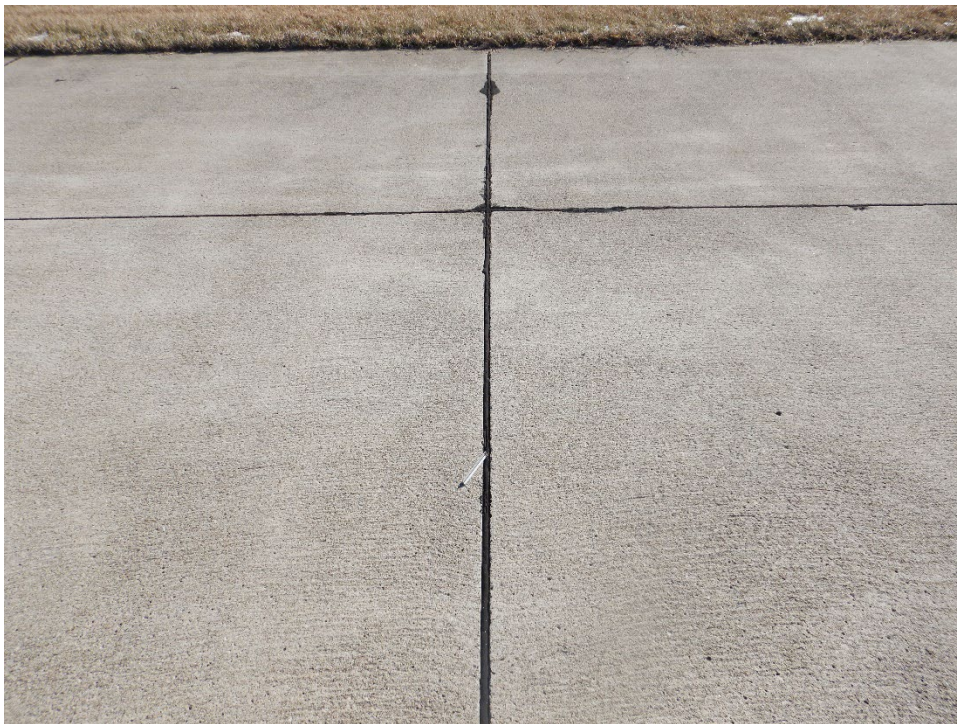
TC2SP-01. Joint Seal Damage (Sample Unit No. 03).

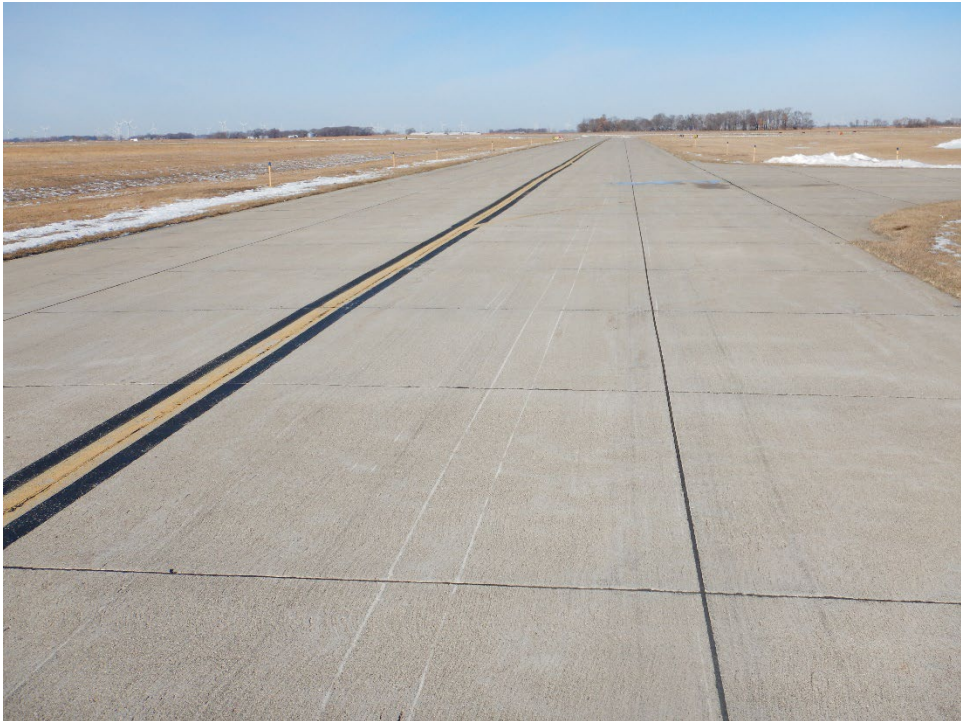
TCSP-01. Overview.

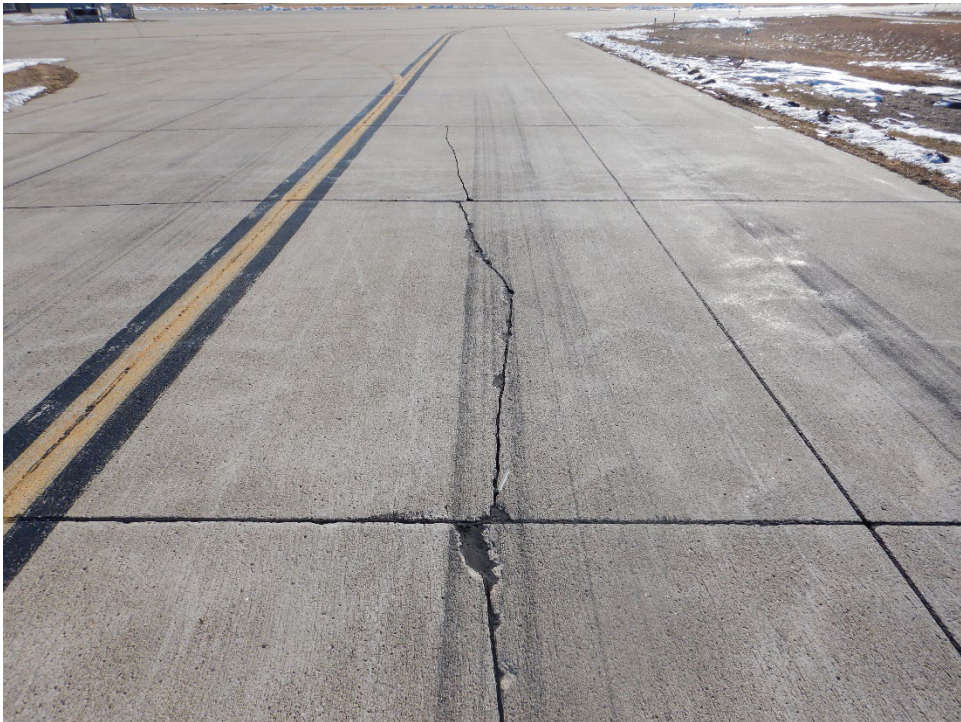
TCSP-01. LTD Cracking (Sample Unit No. 04).

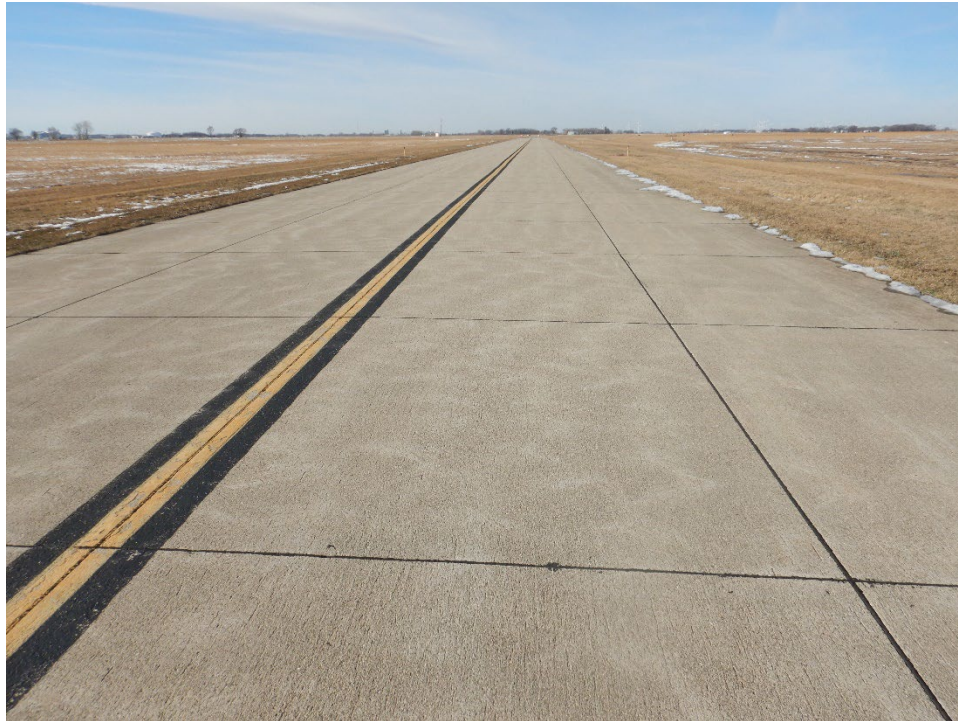
TCSP-02. Overview.

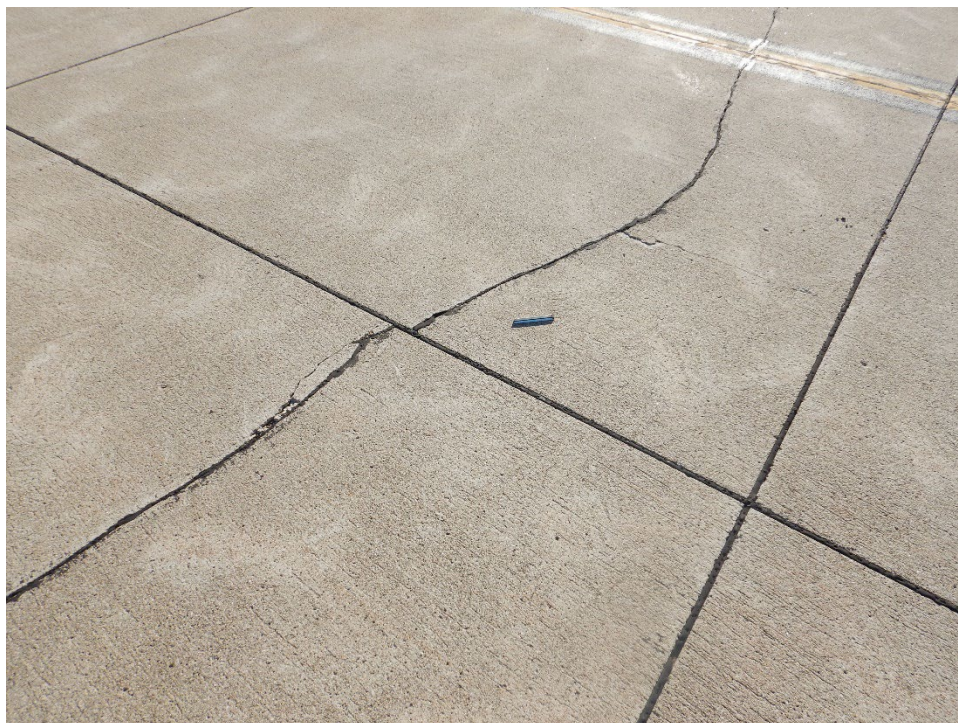
TCSP-02. LTD Cracking (Sample Unit No. 05).

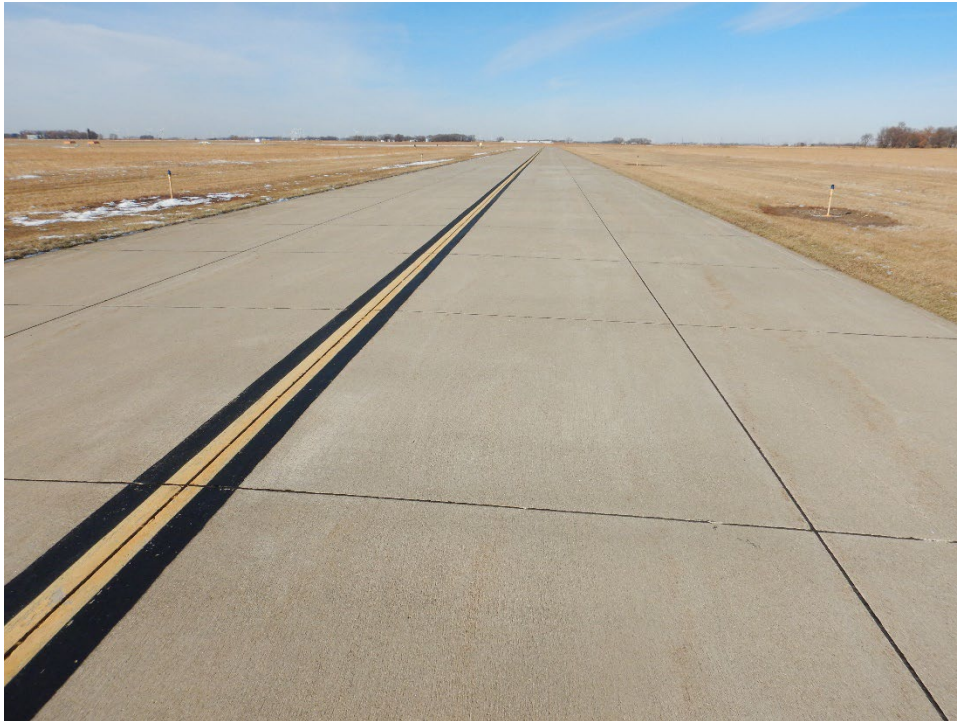
TCSP-03. Overview.

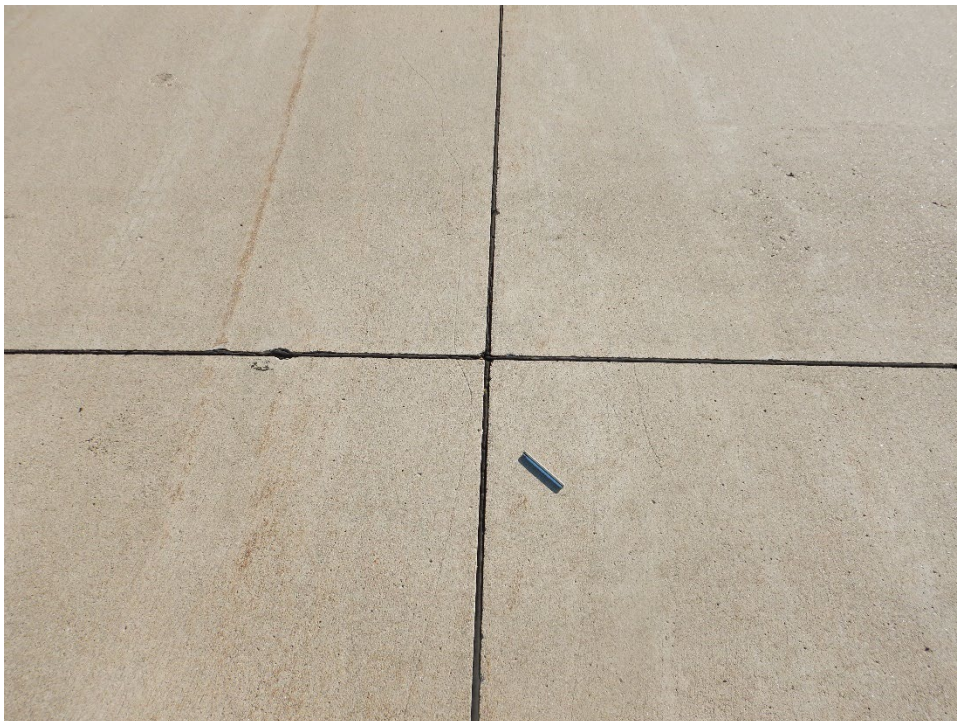
TCSP-03. Joint Seal Damage (Sample Unit No. 03).

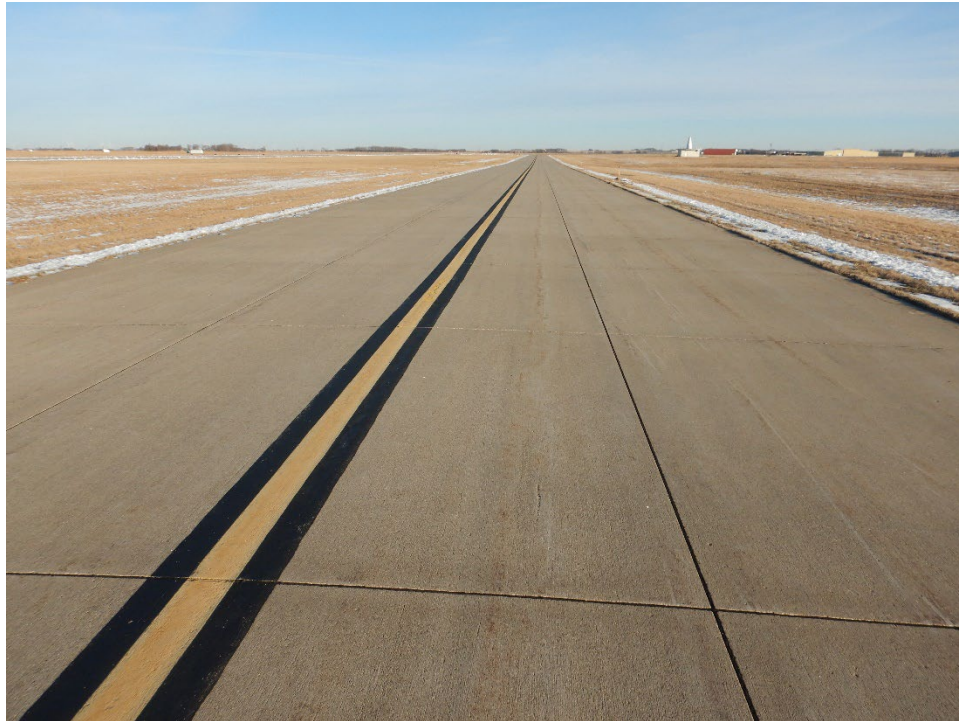
Taxiway D was defined by one section. Areas of medium-severity corner break, corner spalling, joint seal damage, joint spalling, and LTD cracking were observed in Section 01.

TDSP-01. Overview.

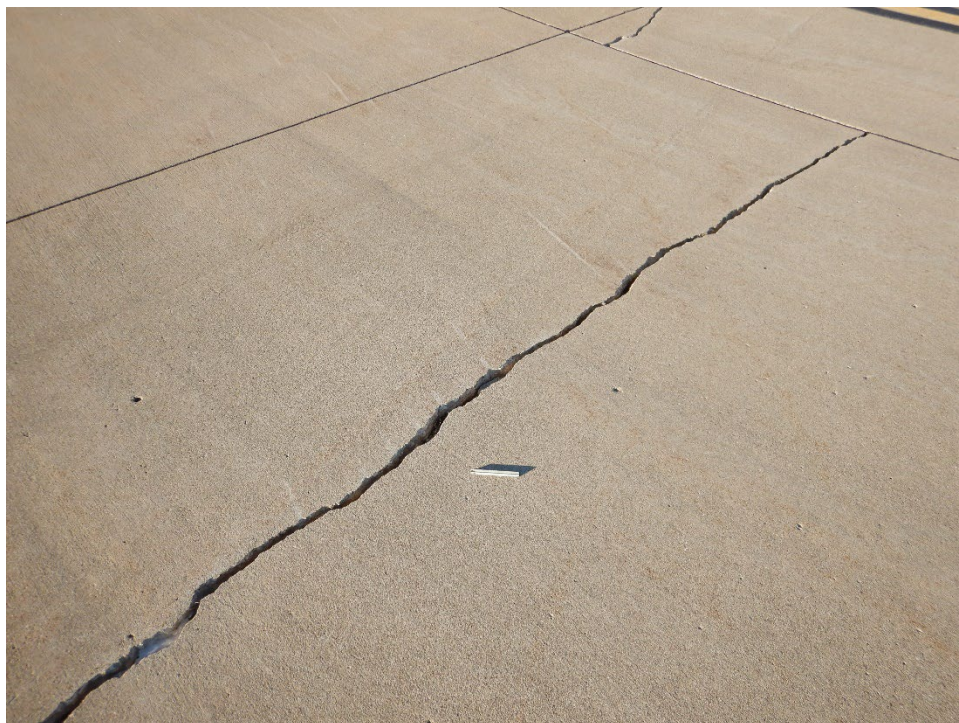
TDSP-01. LTD Cracking (Sample Unit No. 20).

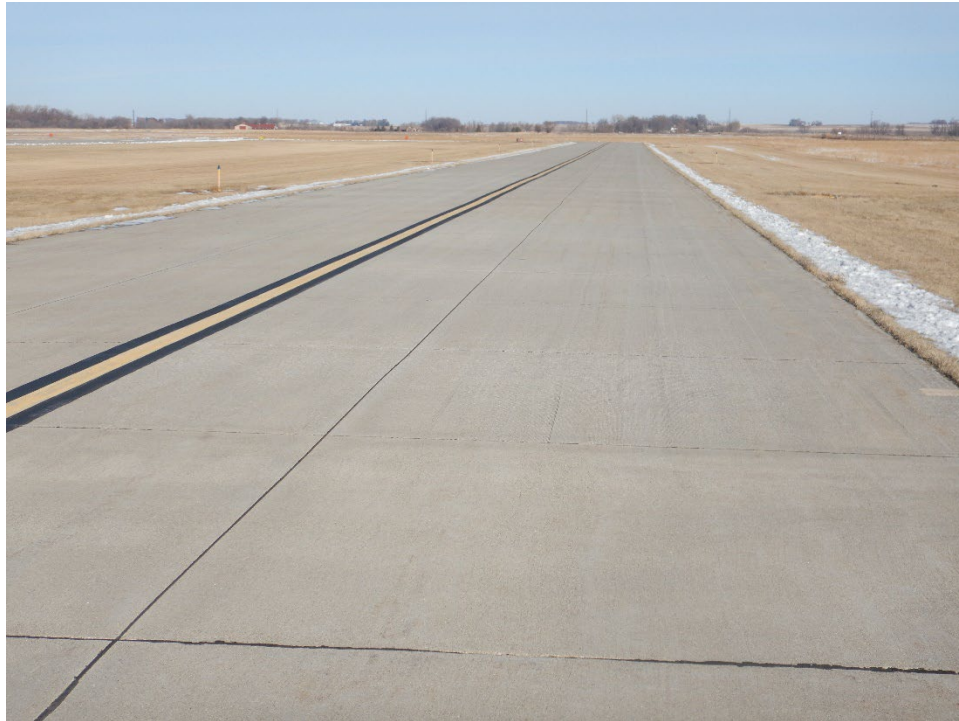
Taxiway E contained one section. Medium- and high-severity joint seal damage and low-severity joint spalling and LTD cracking were recorded in Section 01 during the inspection.

TESP-01. Overview.

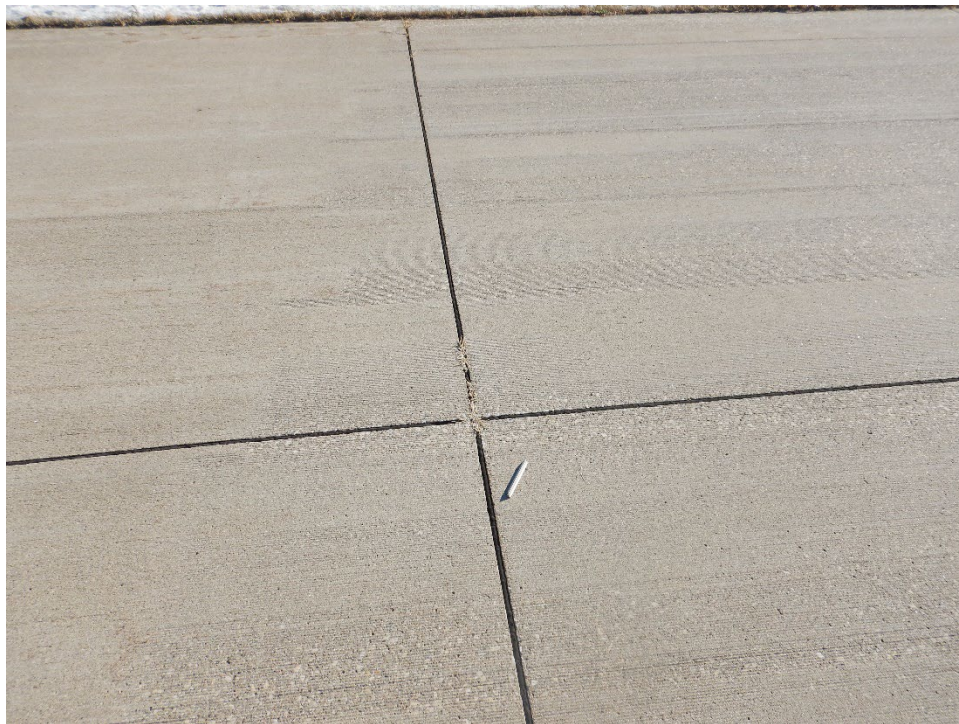
TESP-01. Joint Seal Damage (Sample Unit No. 02).

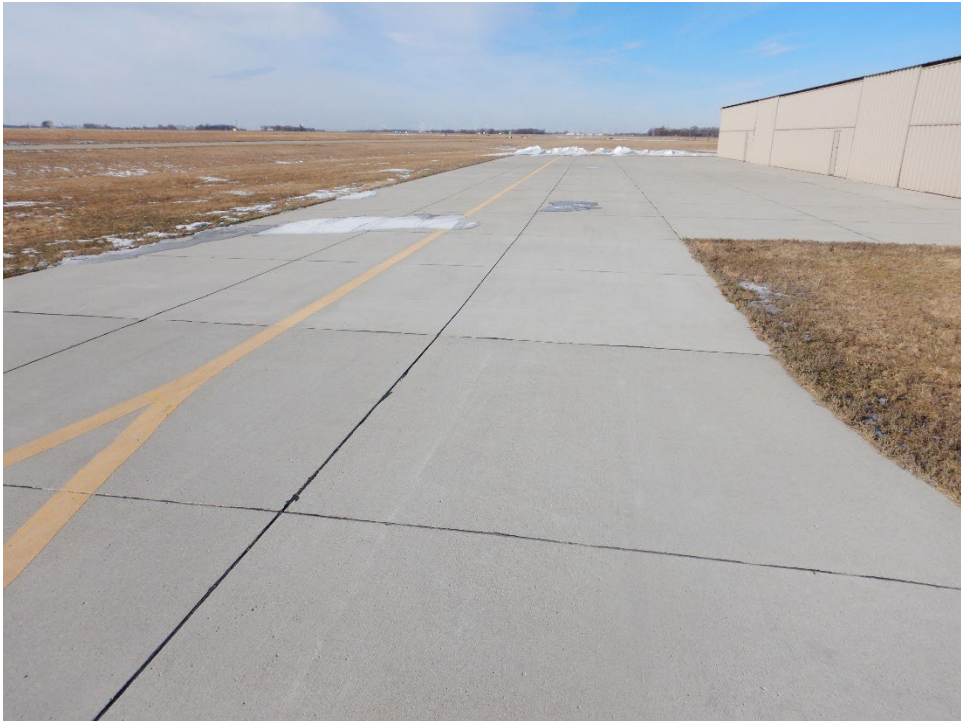
TH01SP-01. Overview.

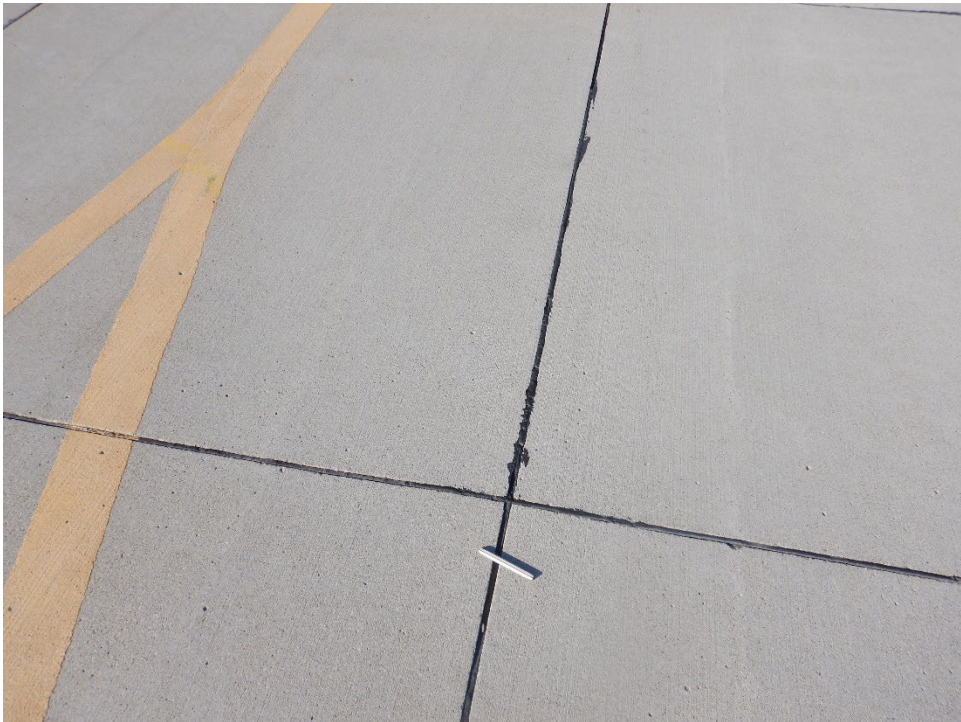
TH01SP-01. Joint Seal Damage (Sample Unit No. 01).

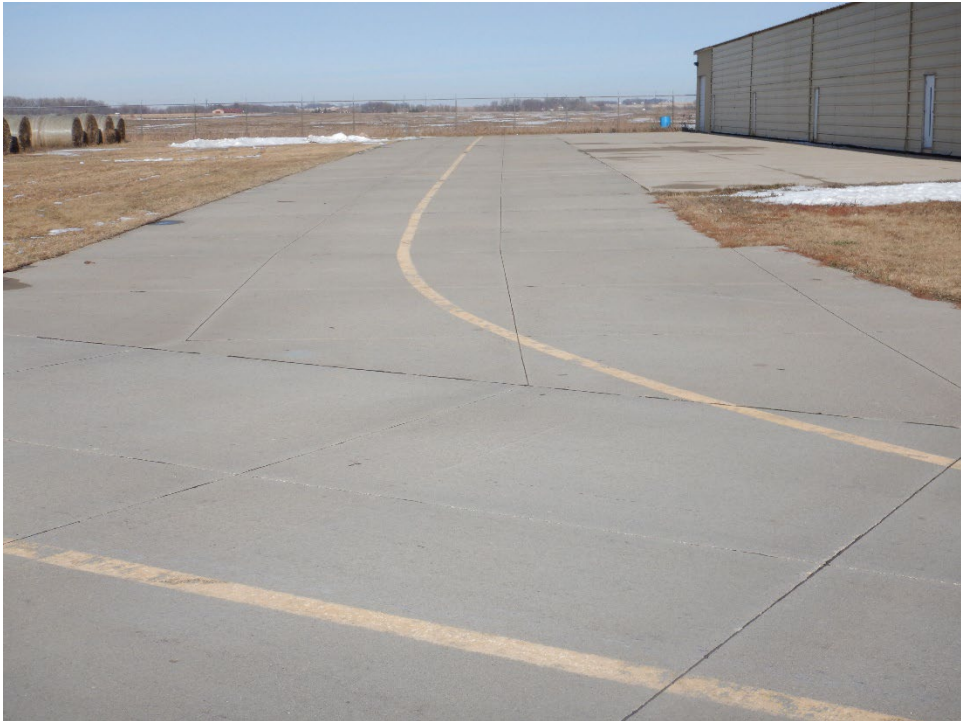
TH01SP-02. Overview.

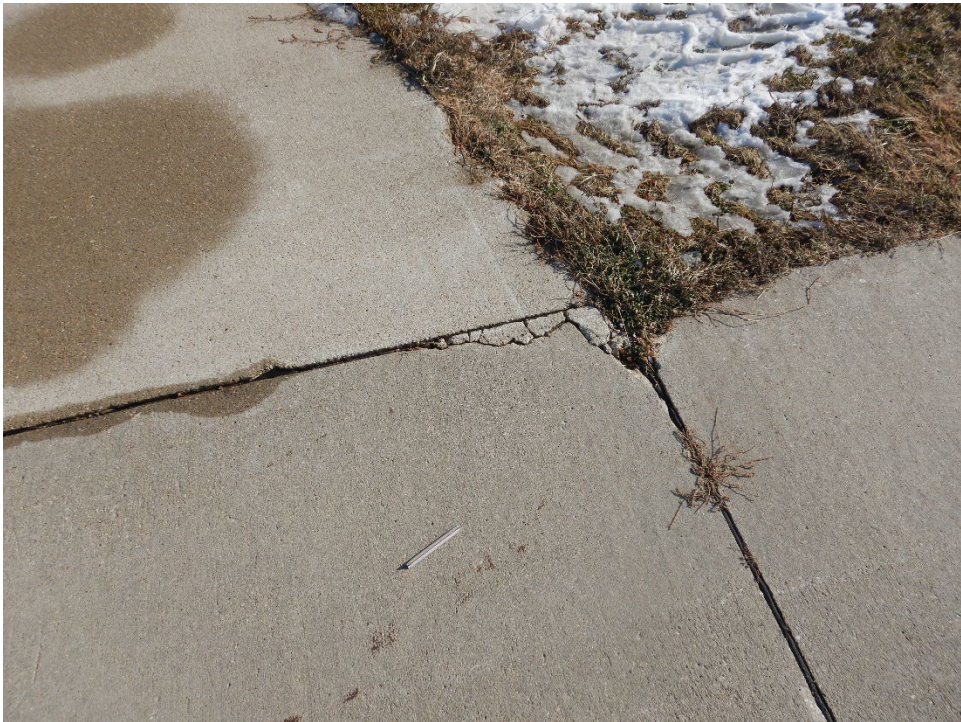
TH01SP-02. Corner Spalling (Sample Unit No. 04).

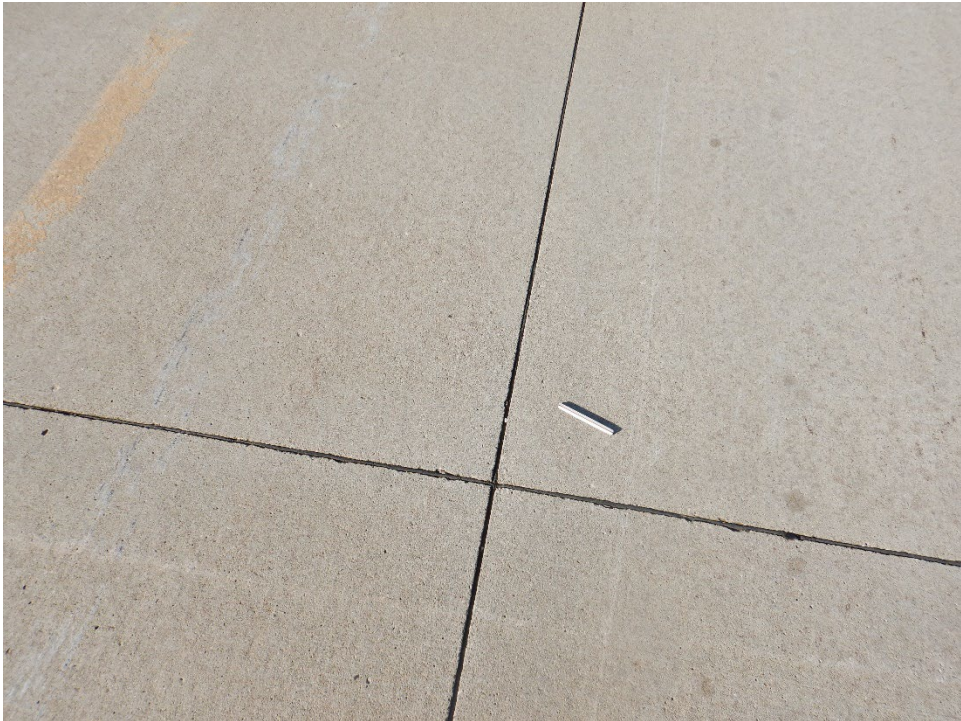
TH01SP-02. Joint Seal Damage (Sample Unit No. 02).

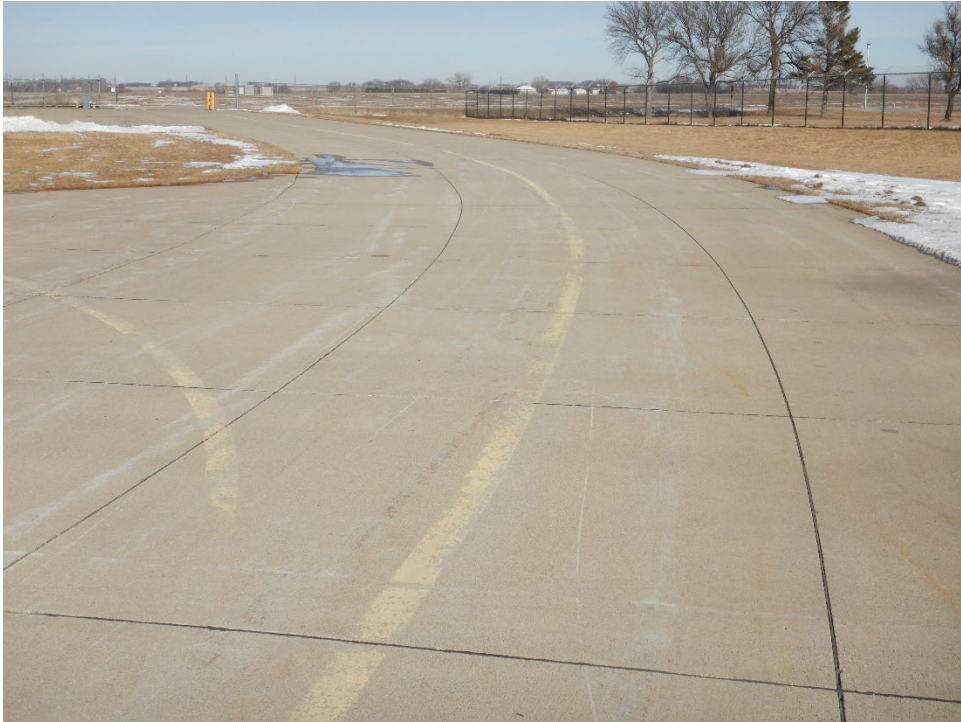
TH01SP-03. Overview.

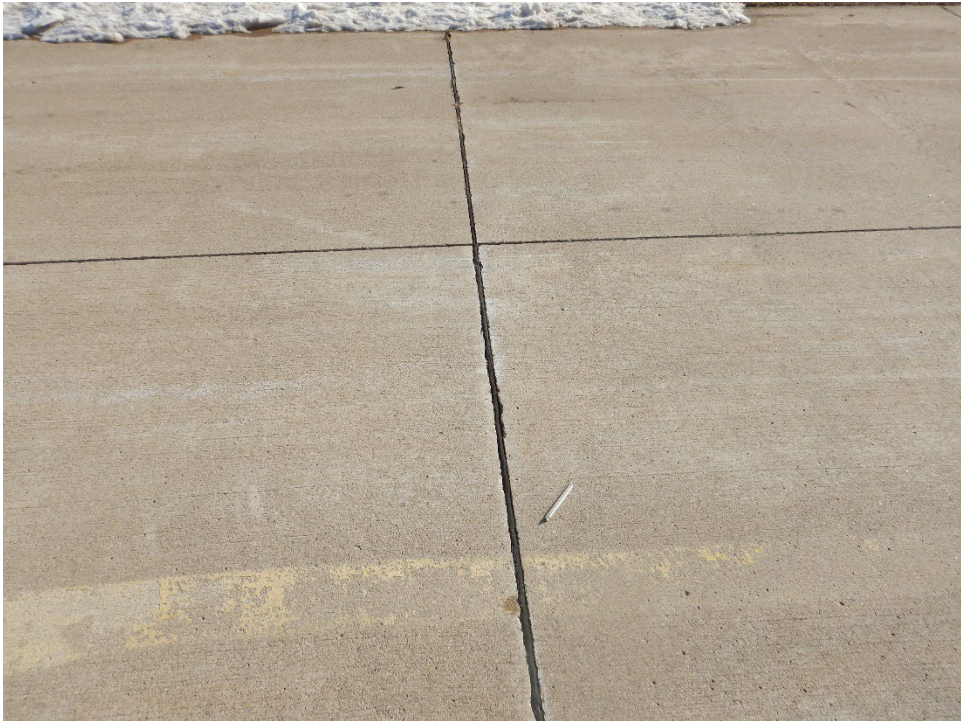
TH01SP-03. Joint Seal Damage (Sample Unit No. 02).

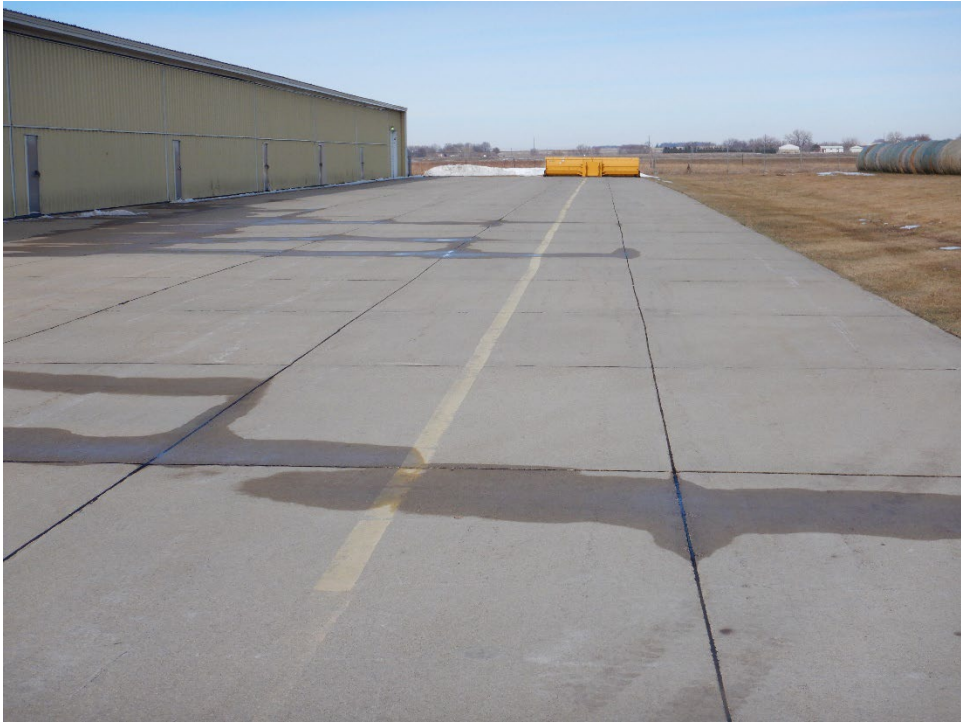
TH01SP-04. Overview.

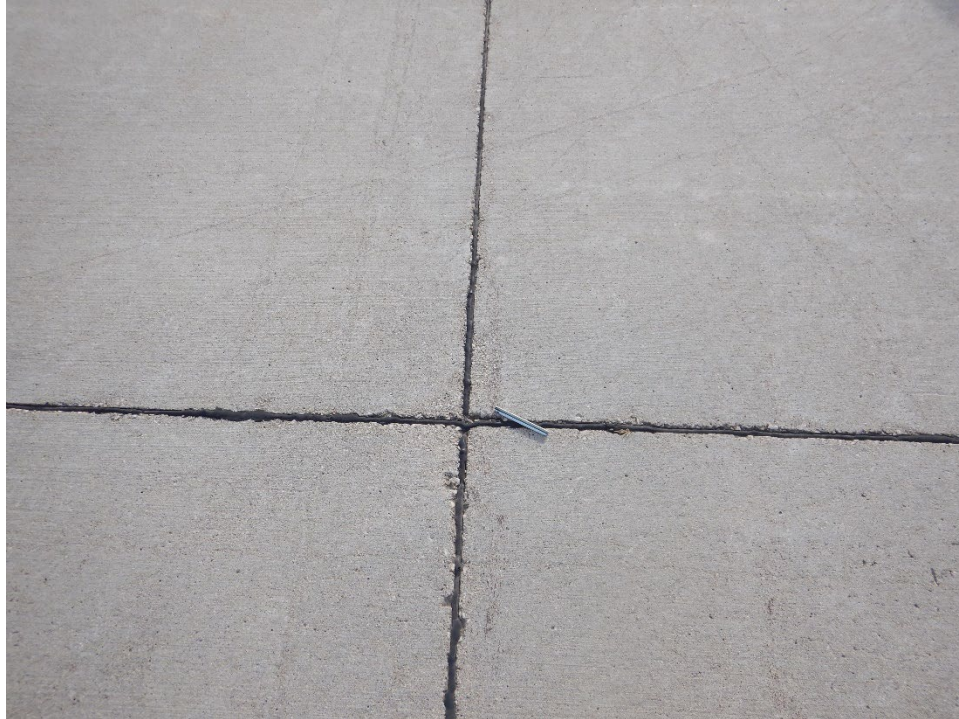
TH01SP-04. Joint Seal Damage (Sample Unit No. 02).
