# Spirit Lake Municipal Airport

**PAVEMENT MANAGEMENT REPORT**

**AUGUST 2019**

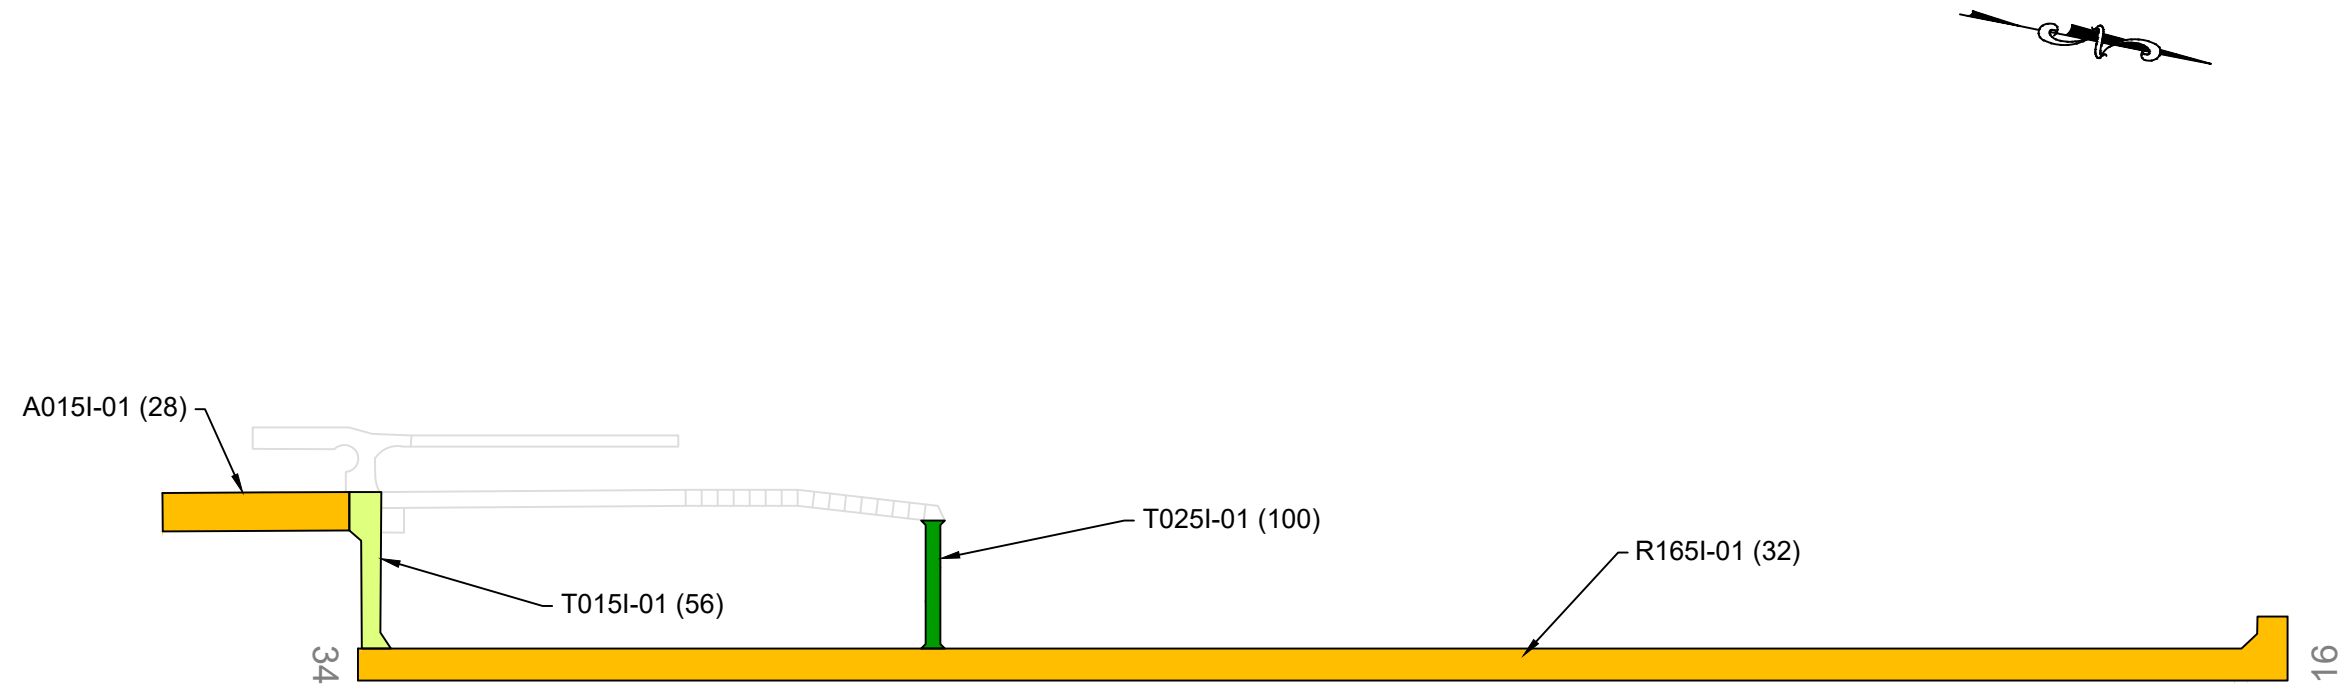
FIGURE 8. PCI MAP.

The pavements at Spirit Lake Municipal Airport were inspected on November 29, 2018. The 2018 area-weighted condition of Spirit Lake Municipal Airport is 34, with conditions ranging from 28 to 100 (on a scale of 0 [failed] to 100 [excellent]). During the previous pavement inspection in 2014, the area-weighted PCI of the airport was 80.

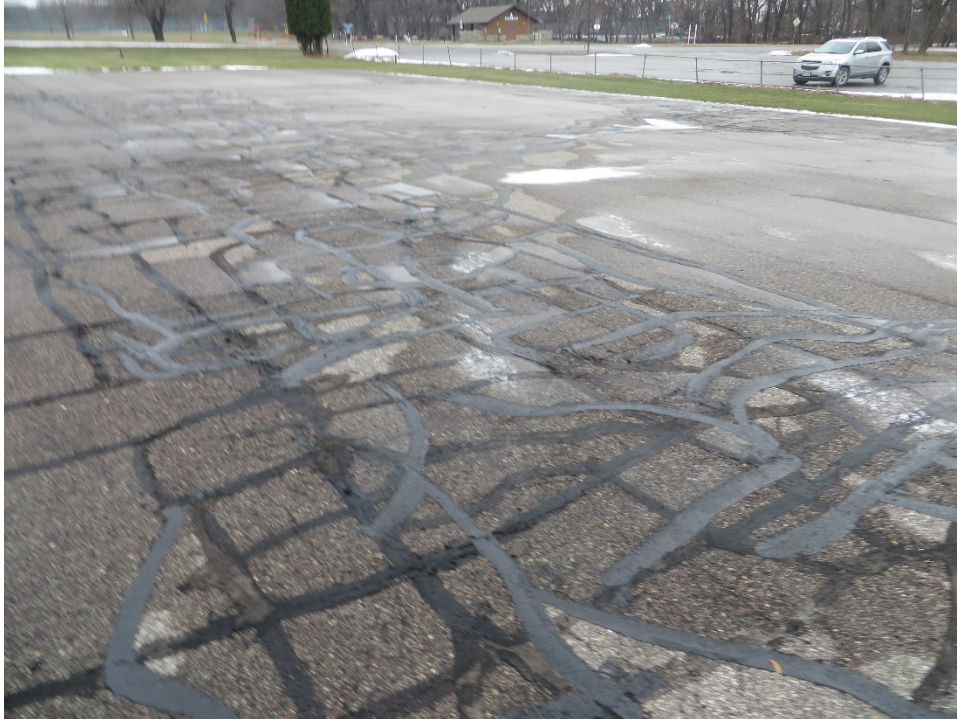
The apron area consisted of one section in poor condition. Medium-severity alligator cracking, low- and medium-severity weathering, and low-severity, sealed L&T cracking were recorded throughout Section 01.

A015I-01. Overview.

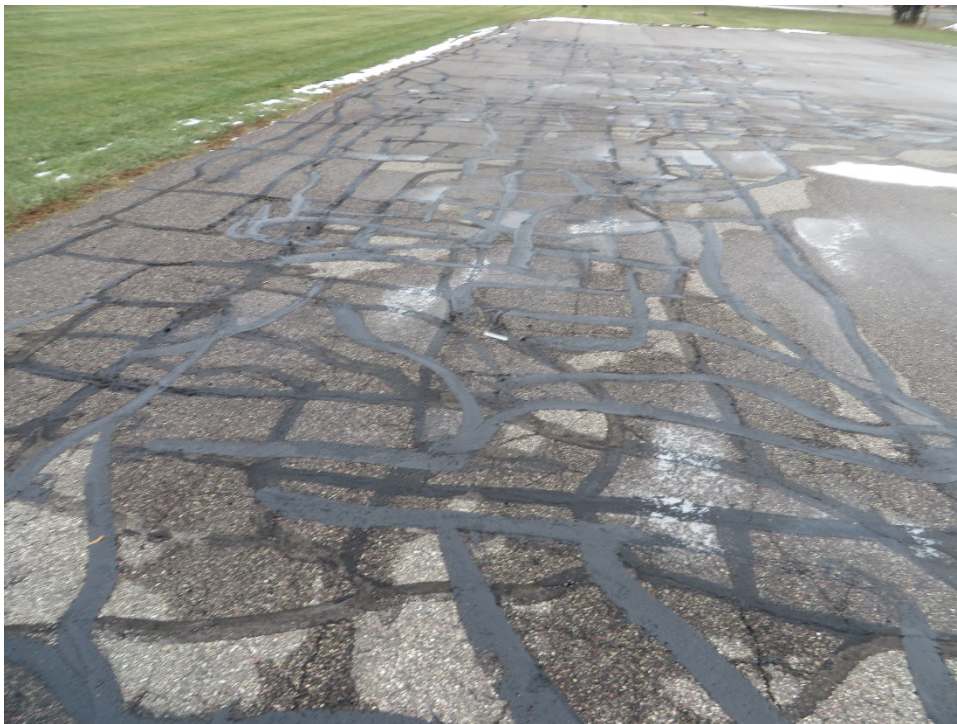
A015I-01. Alligator Cracking (Sample Unit No. 02).

| <b>Distress Type</b> | <b>Severity Level</b> | <b>Maintenance Action</b> |
|---|---|---|
| Alligator Cracking | Medium | Asphalt Patch |

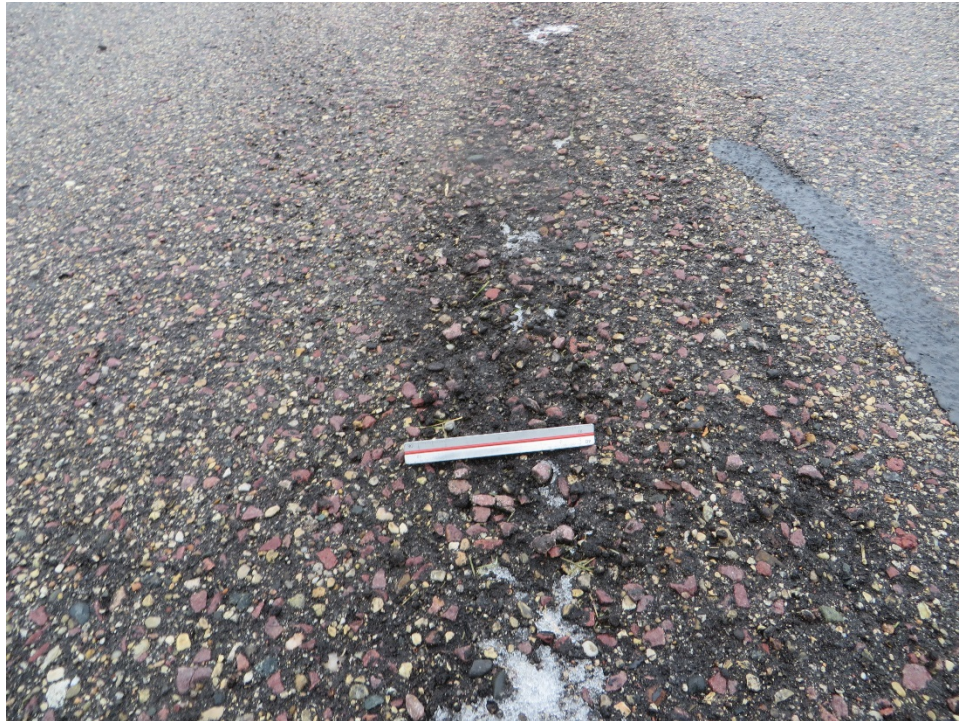
A015I-01. Weathering (Sample Unit No. 03).

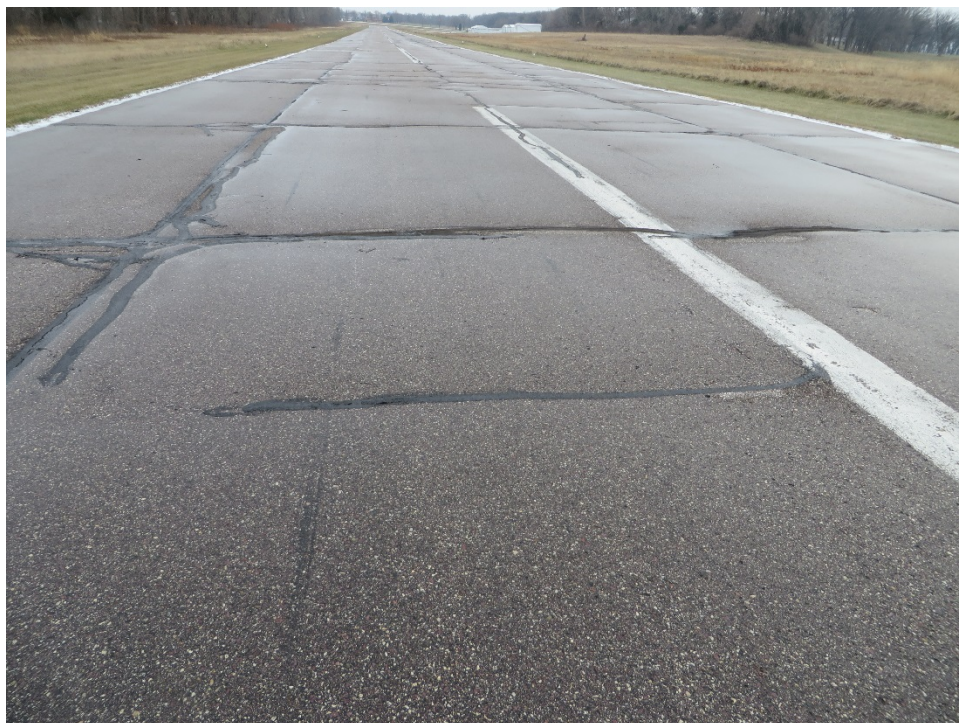
Runway 16/34 consisted of one section that was in poor condition. Medium-severity alligator cracking, low- and medium-severity longitudinal and transverse (L&T) cracking, and low-severity raveling and weathering were recorded throughout Section 01. The low-severity L&T cracking was sealed, and the medium-severity L&T cracking was due to either the development of secondary cracking, unsealed crack widths greater than 1/4 in, or crack sealant that was no longer performing satisfactorily.

R165I-01. Overview.

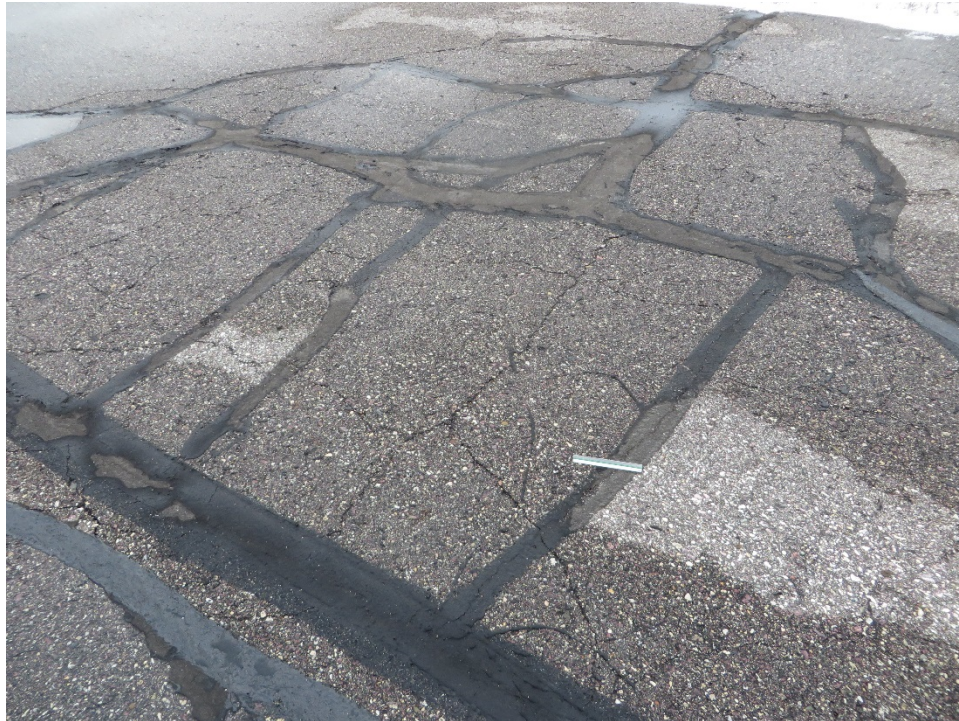
R165I-01. Alligator Cracking (Sample Unit No. 25).

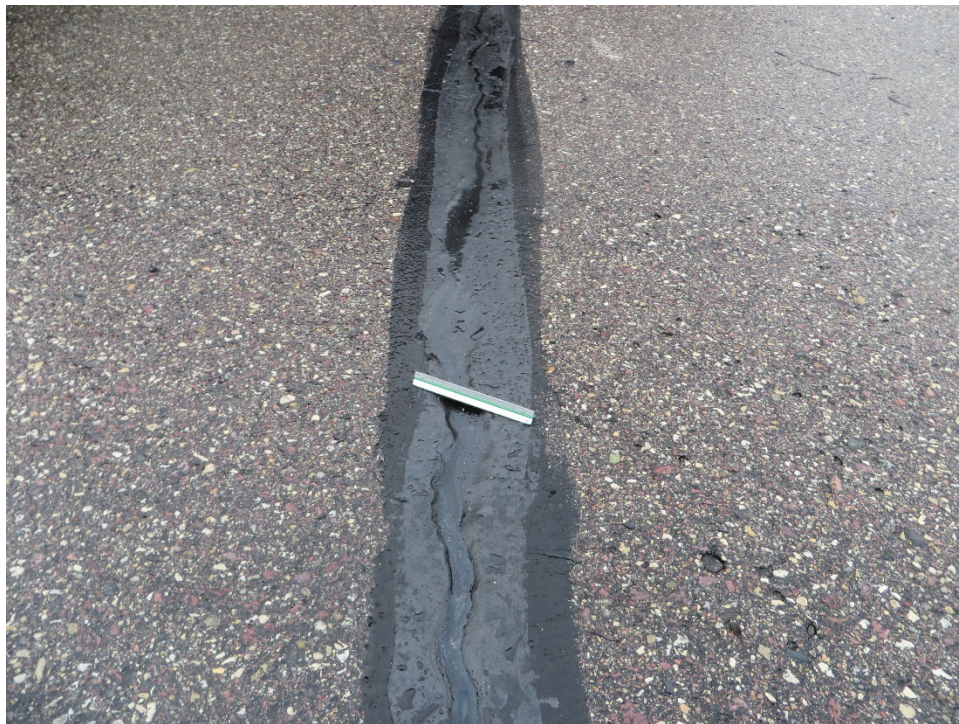
R165I-01. L&T Cracking (Sample Unit No. 02).

| <b>Distress Type</b> | <b>Severity Level</b> | <b>Maintenance Action</b> |
|---|---|---|
| L&T Cracking | Low | Monitor |
| L&T Cracking | Medium | Crack Seal—Asphalt |

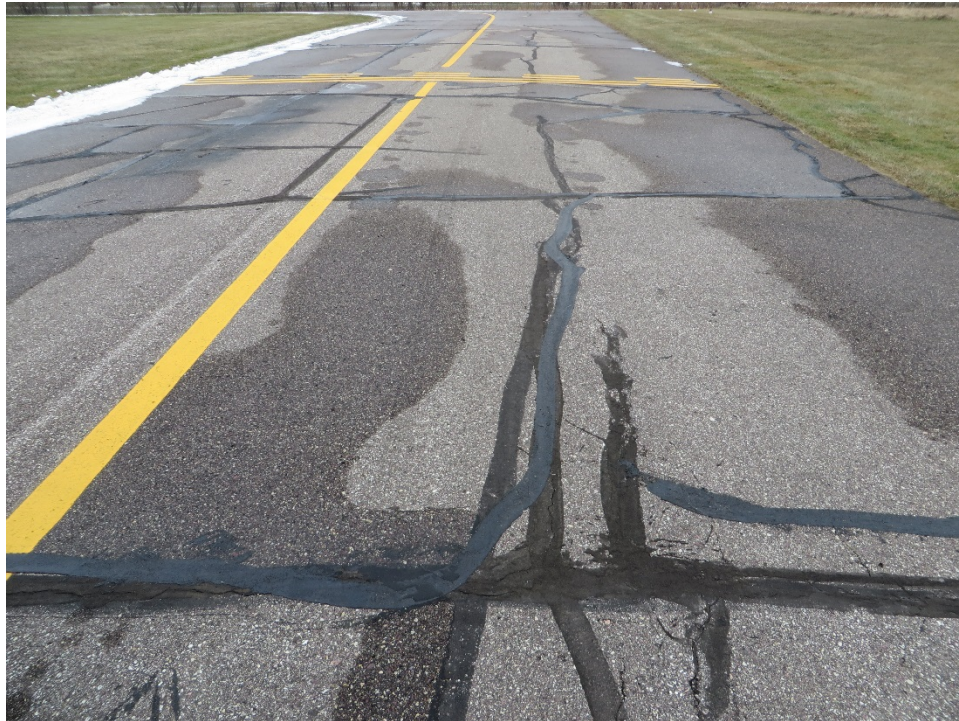
Taxiway 01 was defined by one section that connected the apron area with the Runway 34 approach. Medium-severity alligator cracking, low-severity block cracking, low- and medium-severity L&T cracking, and low-severity raveling and weathering were observed in Section 01. The low-severity cracking was sealed, while the medium-severity cracking was due to crack sealant that had failed.

T015I-01. Overview.

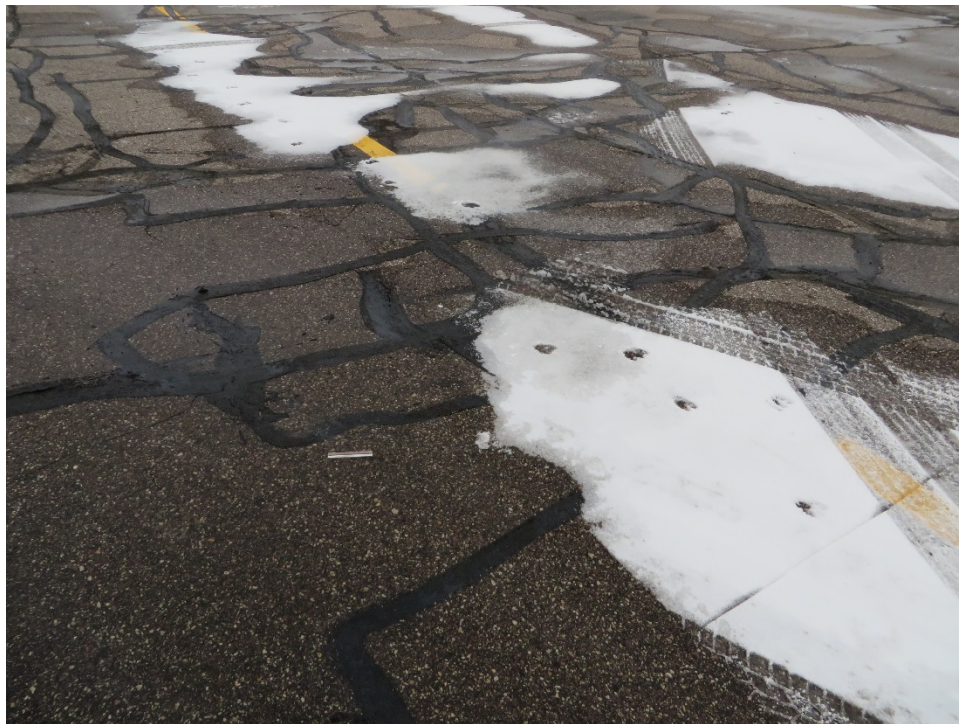
T015I-01. Block Cracking (Sample Unit No. 02).

| <b>Distress Type</b> | <b>Severity Level</b> | <b>Maintenance Action</b> |
|---|---|---|
| Block Cracking | Low | Monitor |

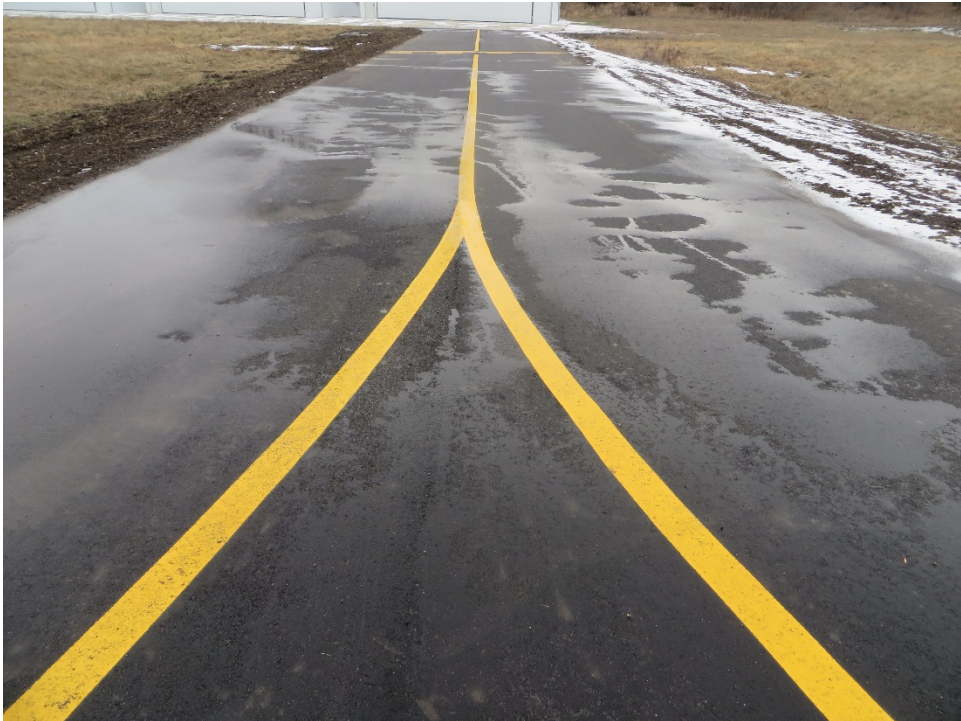
Taxiway 02 contained one, recently constructed section that was in excellent condition. No pavement distresses were identified during the inspection.

T025I-01. Overview.
