Storm Lake Municipal Airport

Pavement Management Report

JULY 2023

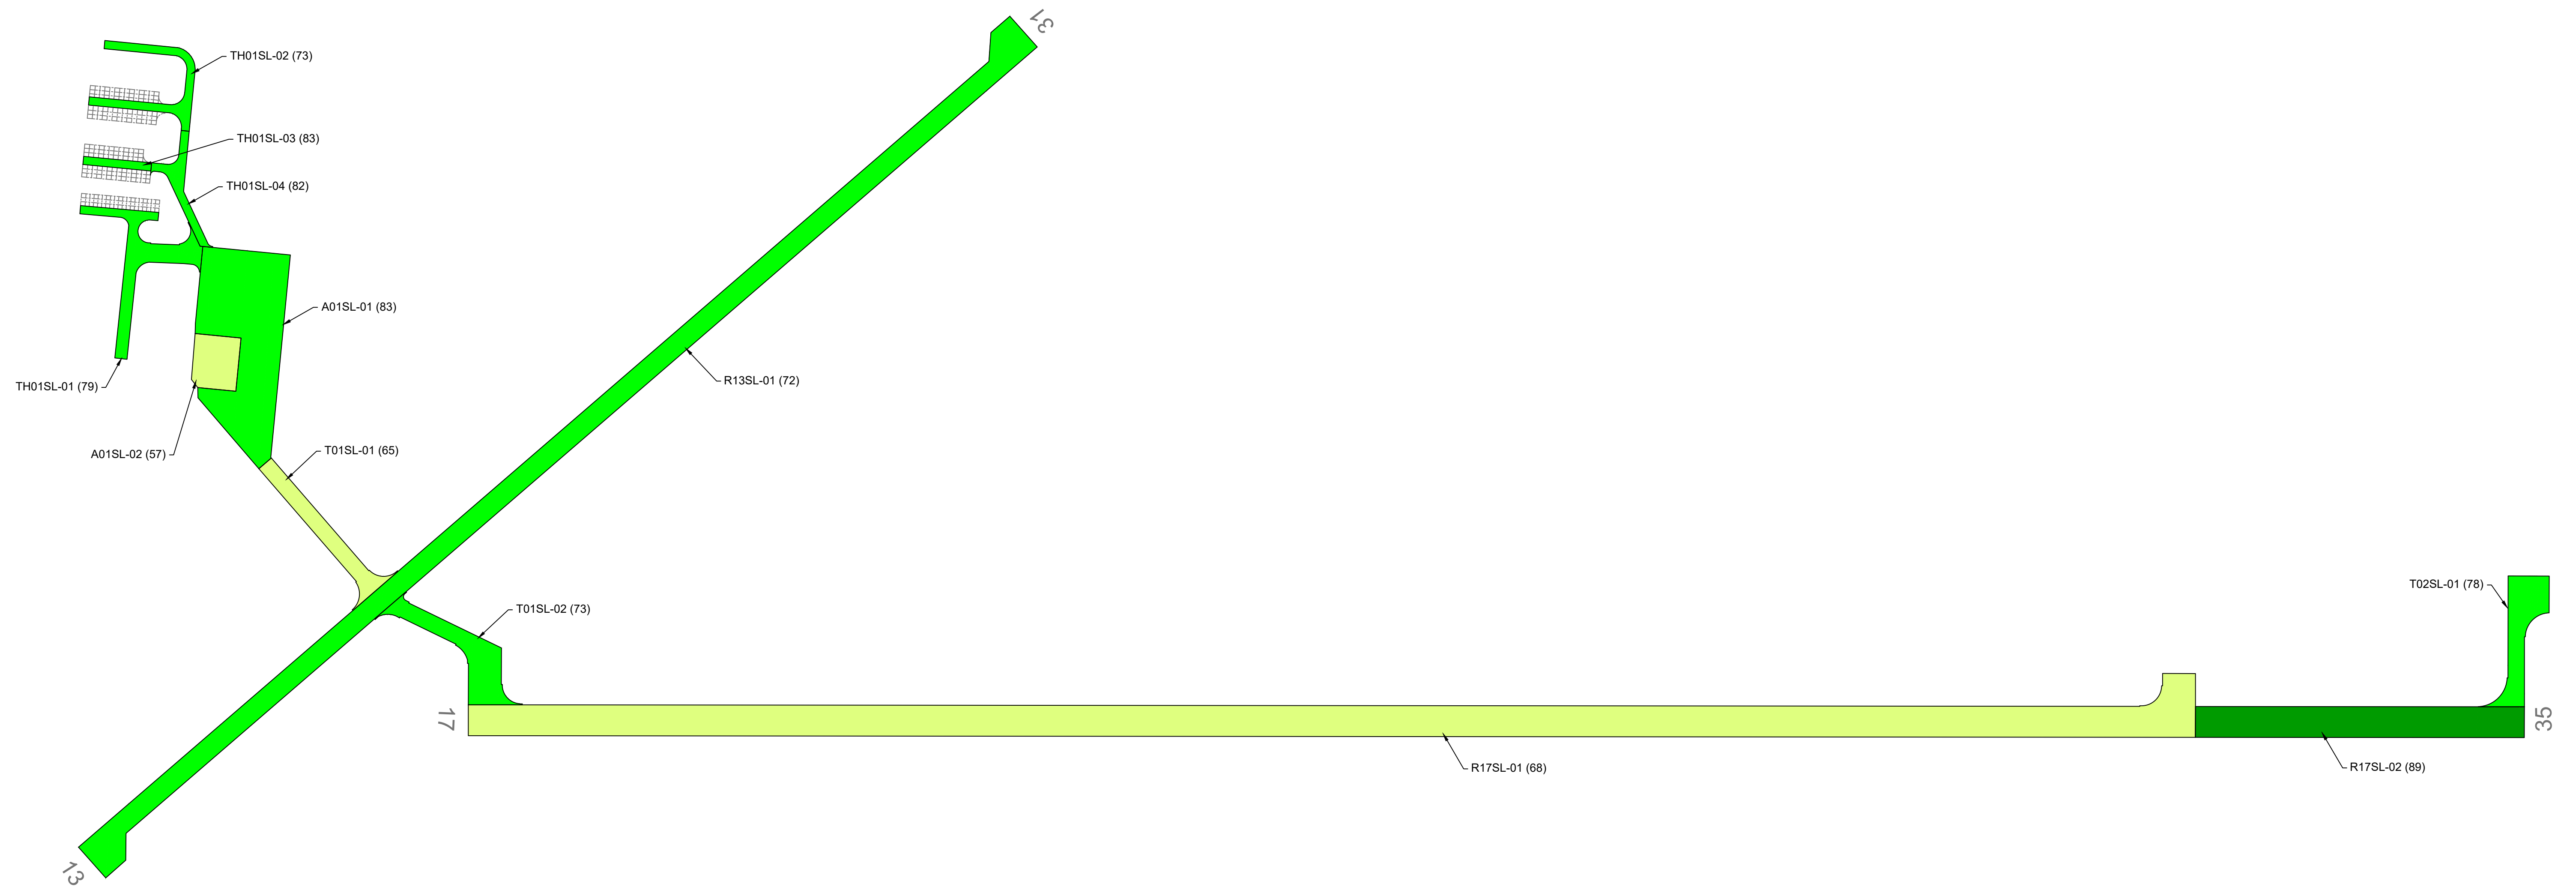
FIGURE 8. PCI MAP.

The pavements at Storm Lake Municipal Airport were inspected in November 2022. The 2022 area-weighted condition of Storm Lake Municipal Airport is 73, with conditions ranging from 57 to 89 (on a scale of 0 [failed] to 100 [excellent]). During the previous pavement inspection in 2019, the area-weighted PCI of the airport was 93.

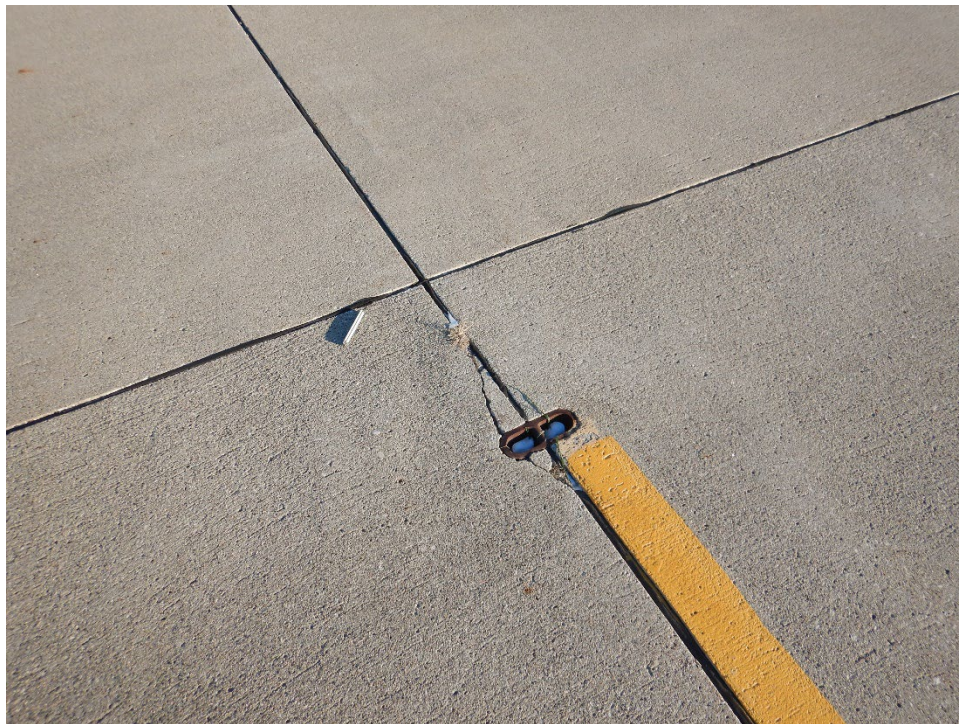
A01SL-01. Joint Spalling (Sample Unit No. 25).

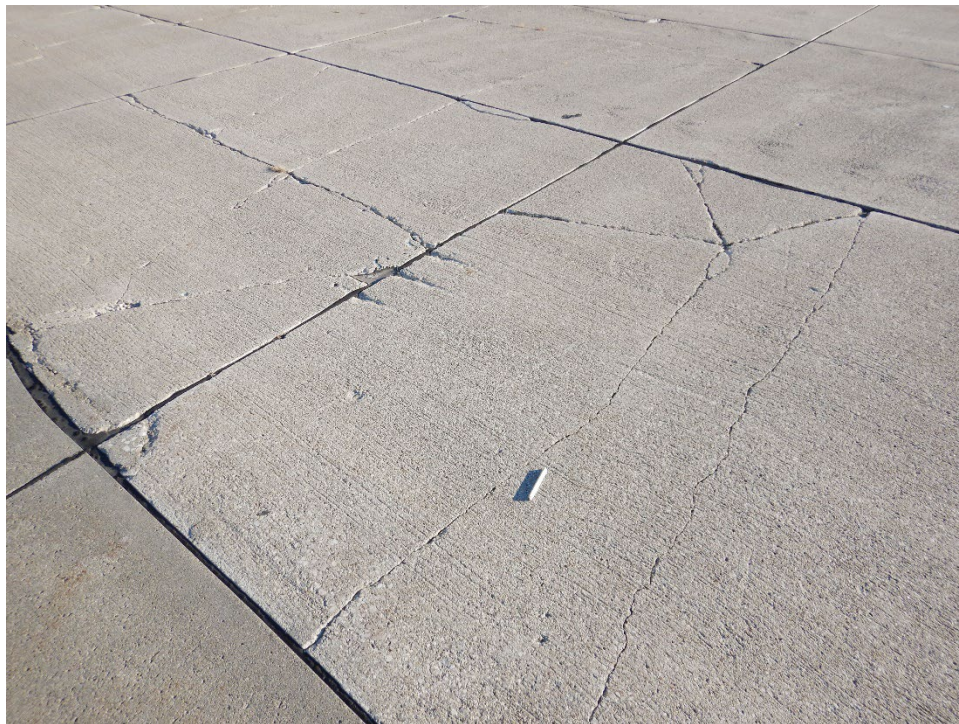
The apron area was defined by two sections. Areas of medium-severity corner break; low-severity corner spalling, faulting, and small patching; medium- and high-severity joint seal damage; and low- and medium-severity joint spalling and LTD cracking were observed in Section 01. Section 02 contained all severities of corner break and joint spalling; low-severity small patching, corner spalling, large patching, and faulting; medium-severity joint seal damage; low- and medium-severity LTD cracking; and medium- and high-severity shattered slab.

A01SL-02. Shattered Slab (Sample Unit No. 07).

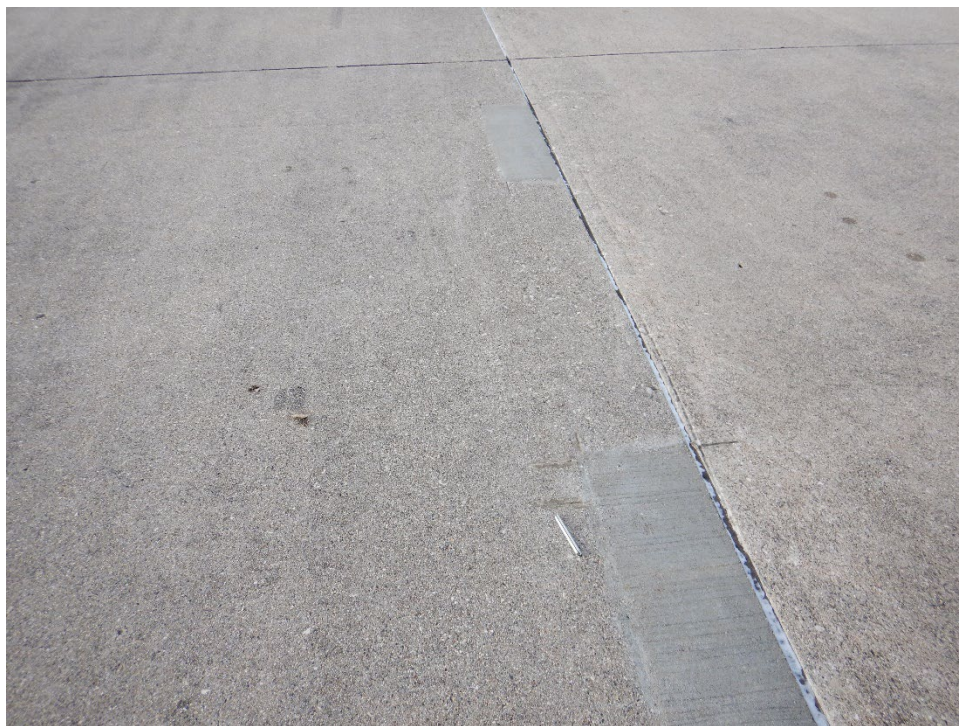
Runway 13/31 was defined by one section. Low- and medium-severity small patching, joint spalling, and corner spalling; medium- and high-severity joint seal damage; low-severity large patching; medium-severity longitudinal, transverse, and diagonal (LTD) cracking and shattered slab; and shrinkage cracking were observed in Section 01.

R13SL-01. Small Patching (Sample Unit No. 07).

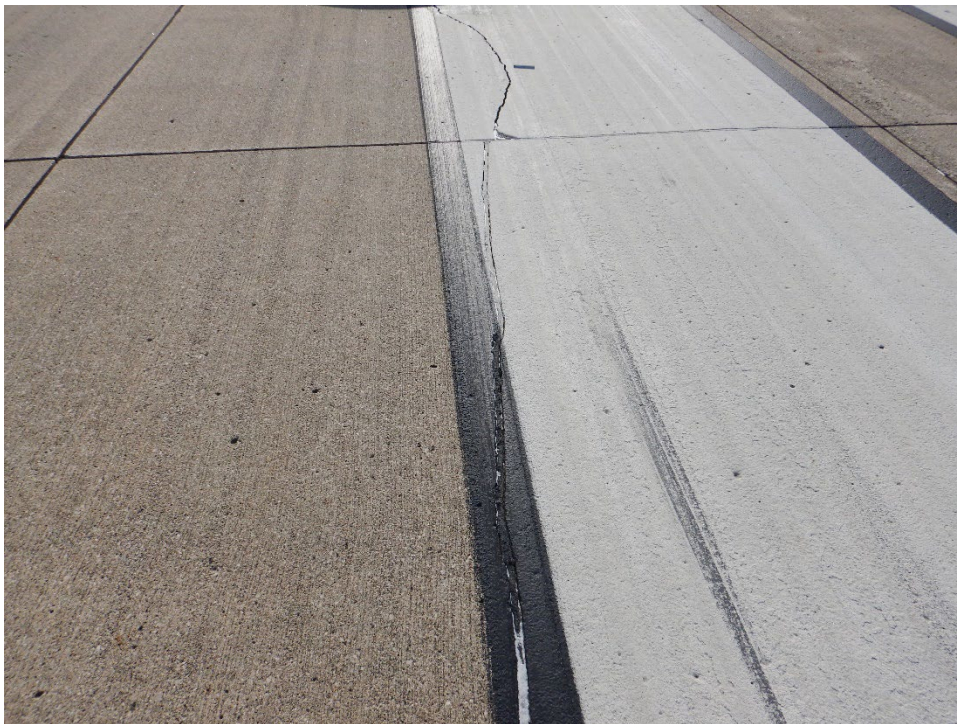
Runway 17/35 consisted of two sections. Medium-severity corner break, LTD cracking, and shattered slab; medium- and high-severity corner spalling; low-severity large patching and faulting; low- and medium-severity joint seal damage and joint spalling; and shrinkage cracking were recorded in Section 01. Areas of low-severity joint seal damage, low- and medium-severity joint spalling, medium-severity LTD cracking, and shrinkage cracking were observed in Section 02.

R17SL-01. LTD Cracking (Sample Unit No. 03).

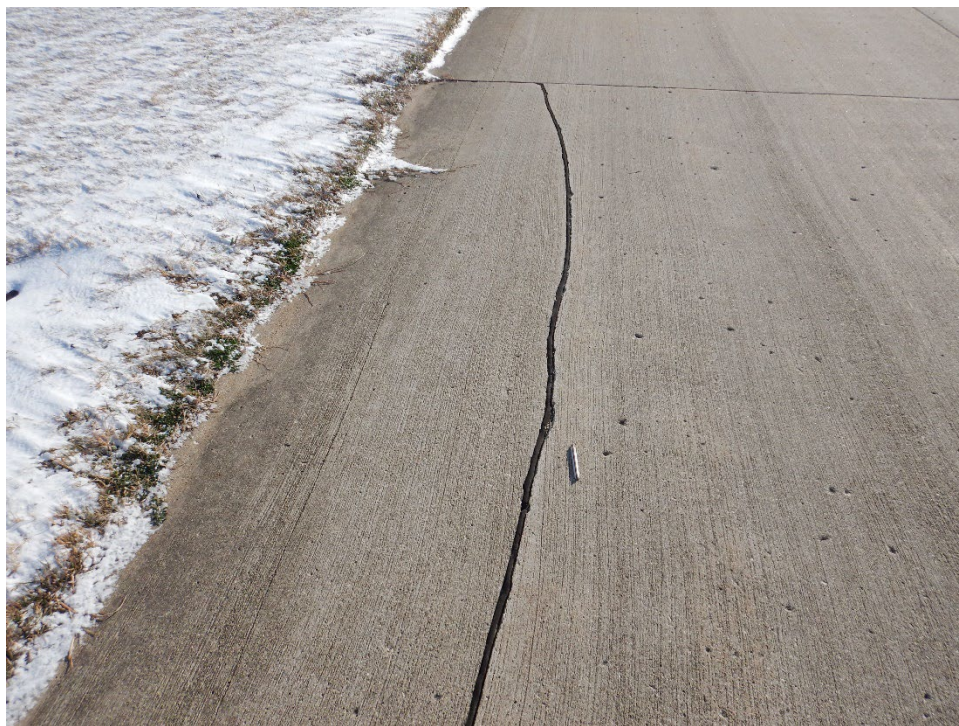
R17SL-02. LTD Cracking (Sample Unit No. 06).

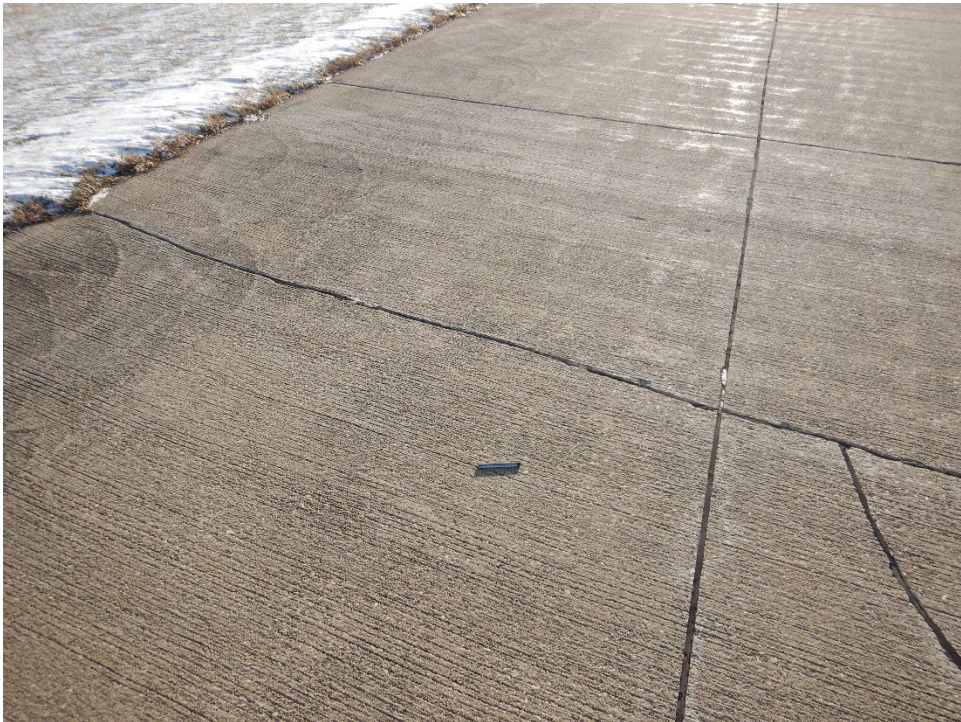
Taxiway 01 was defined by two sections. Section 01 contained areas of low-severity faulting, small patching, and large patching; medium-severity joint seal damage and corner break; high-severity corner spalling; low- and medium-severity joint spalling; all severities of LTD cracking; popouts; and shrinkage cracking. Medium-severity corner break, joint seal damage, and shattered slab; low- and medium-severity corner spalling, joint spalling, and LTD cracking; and shrinkage cracking were identified in Section 02.

T01SL-01. LTD Cracking (Sample Unit No. 05).

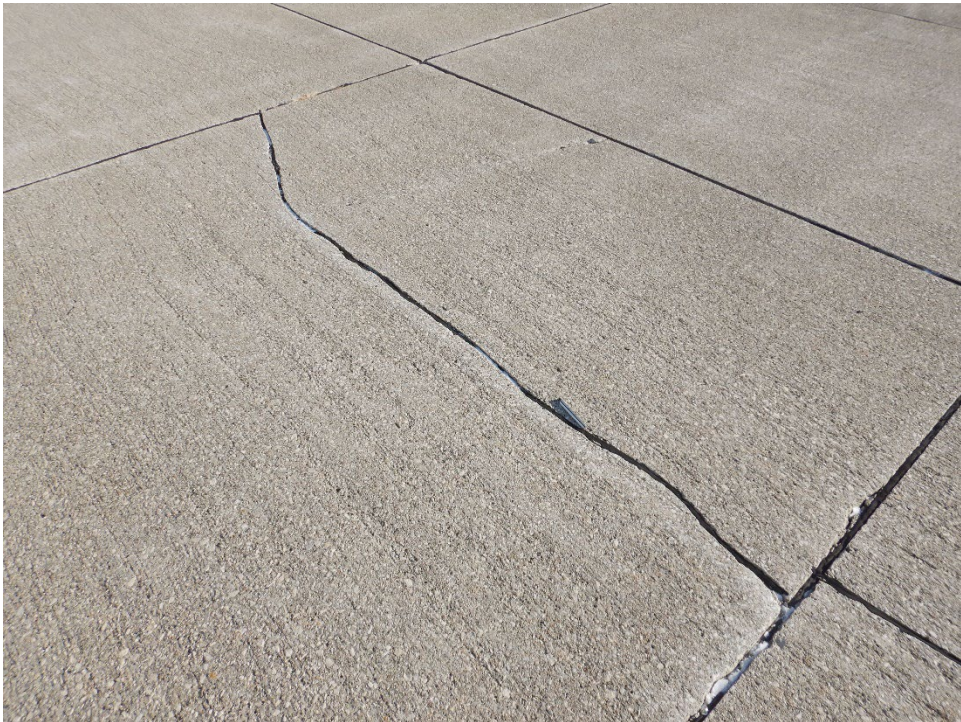
T01SL-02. LTD Cracking (Sample Unit No. 07).

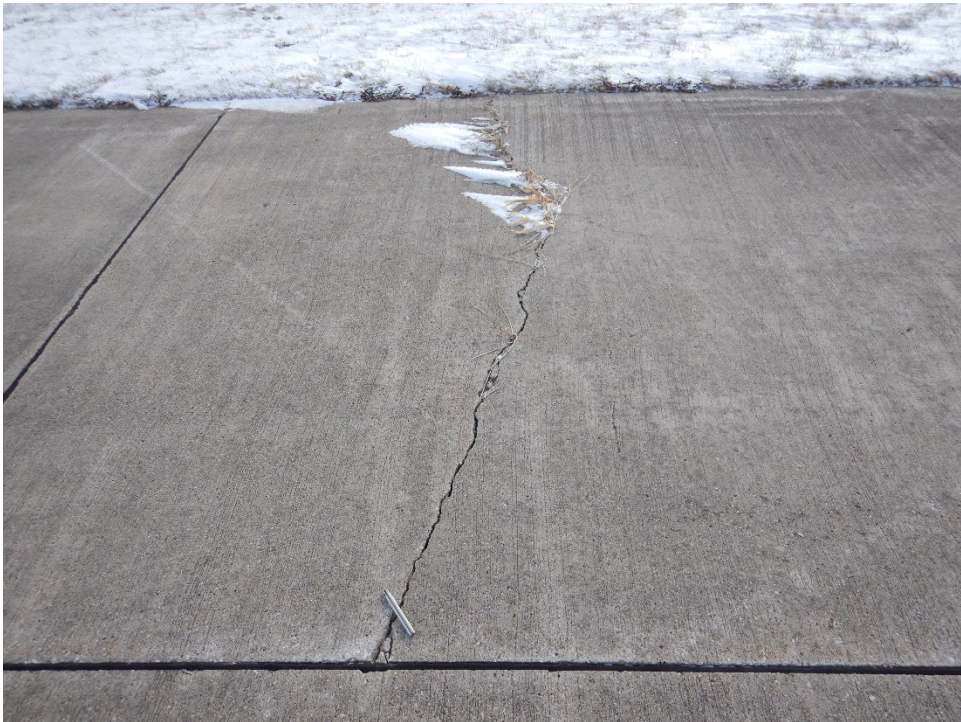
Taxiway 02 contained one section. Medium-severity joint spalling and corner break, high-severity corner spalling, low- and medium-severity LTD cracking and faulting, and medium- and high-severity joint seal damage were recorded in Section 01.

T02SL-01. LTD Cracking (Sample Unit No. 08).

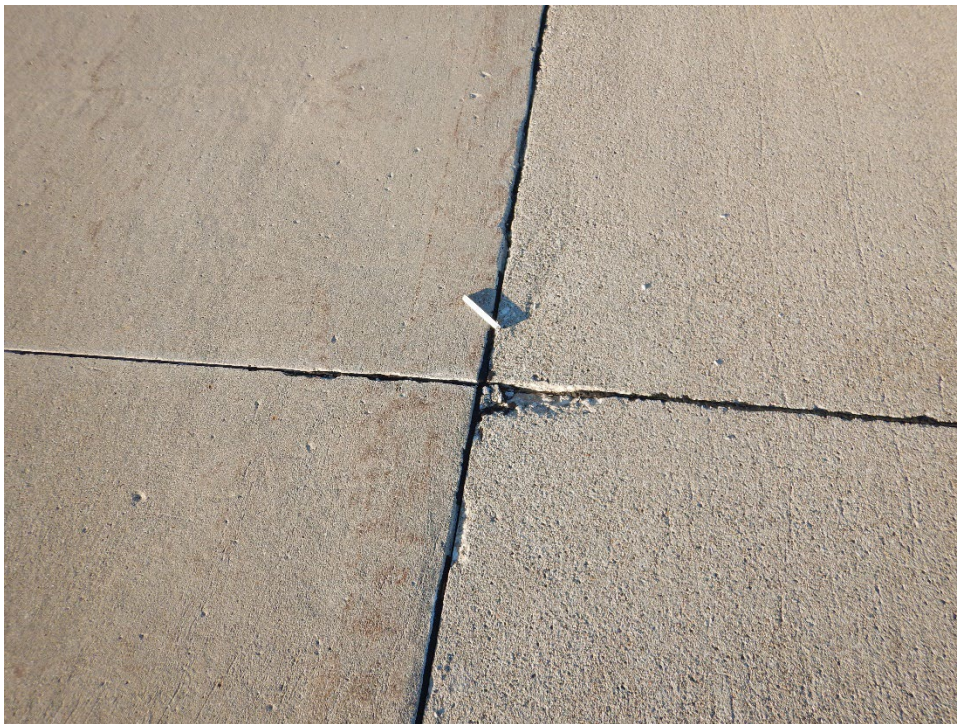
TH01SL-01. Joint Spalling (Sample Unit No. 10).

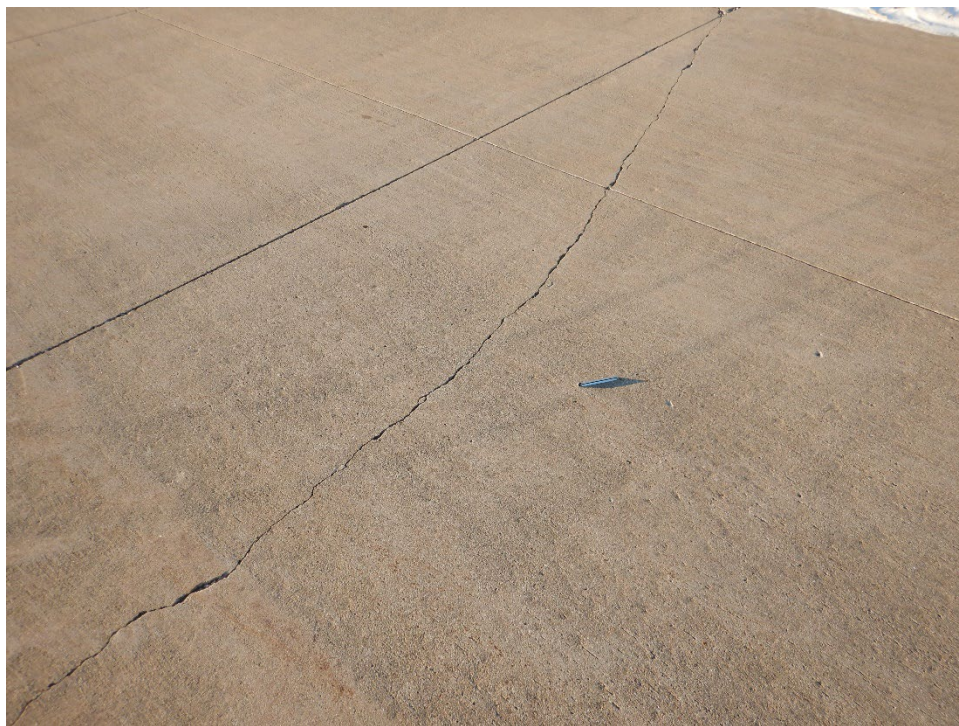
TH01SL-02. LTD Cracking (Sample Unit No. 01).

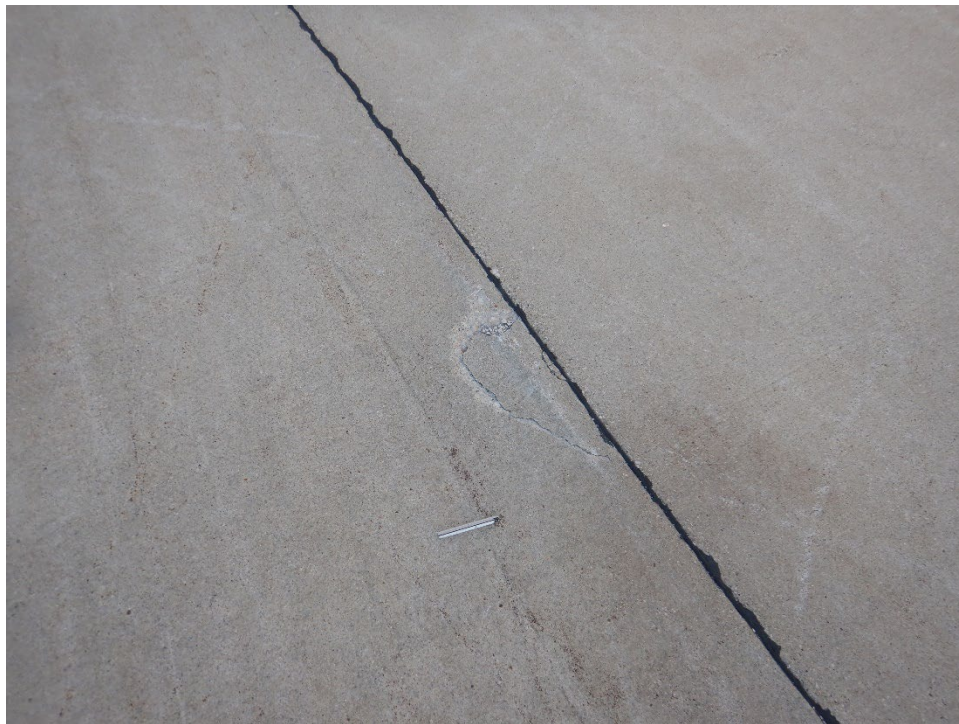
TH01SL-03. Joint Spalling (Sample Unit No. 01).

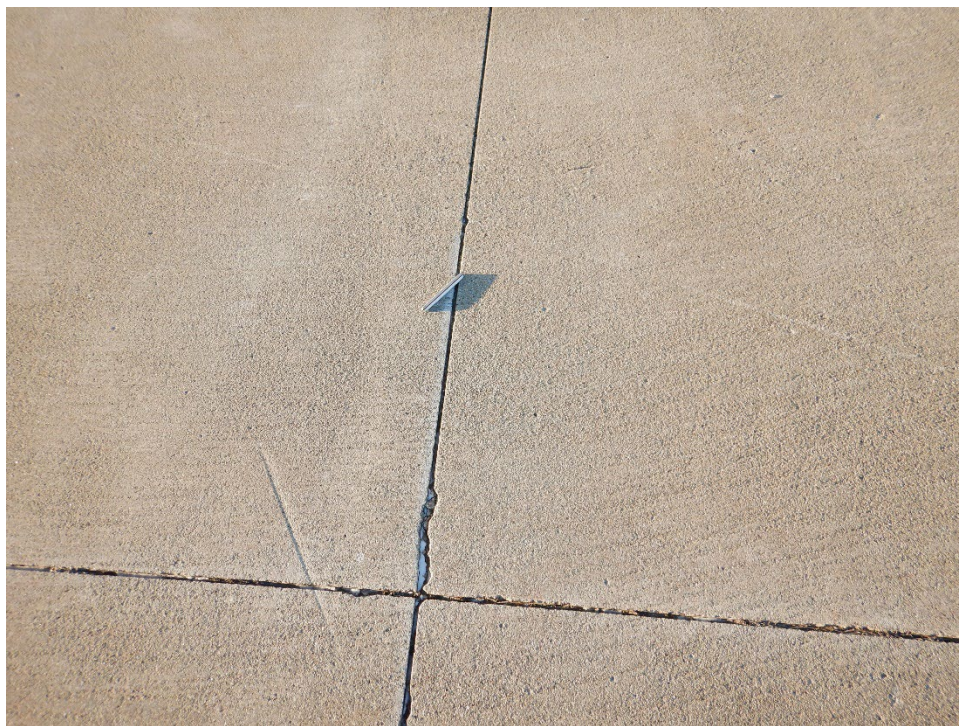
The T-hangar area consisted of four sections. Areas of low- and medium-severity corner spalling, low-severity LTD cracking and faulting, high-severity joint seal damage, medium- and high-severity joint spalling, shrinkage cracking, and medium-severity small patching were recorded in Section 01. Medium-severity corner spalling and shattered slab, high-severity joint seal damage, all severities of joint spalling, and low- and medium-severity LTD cracking were identified in Section 02. Section 03 contained areas of high-severity joint seal damage and medium-severity joint spalling at the time of inspection. Medium-severity corner spalling and LTD cracking, shrinkage cracking, high-severity joint seal damage, and low- and medium-severity joint spalling were recorded in Section 04.

TH01SL-04. Joint Seal Damage (Sample Unit No. 02).
