Tipton-Mathews Memorial Airport

Pavement Management Report

JULY 2024

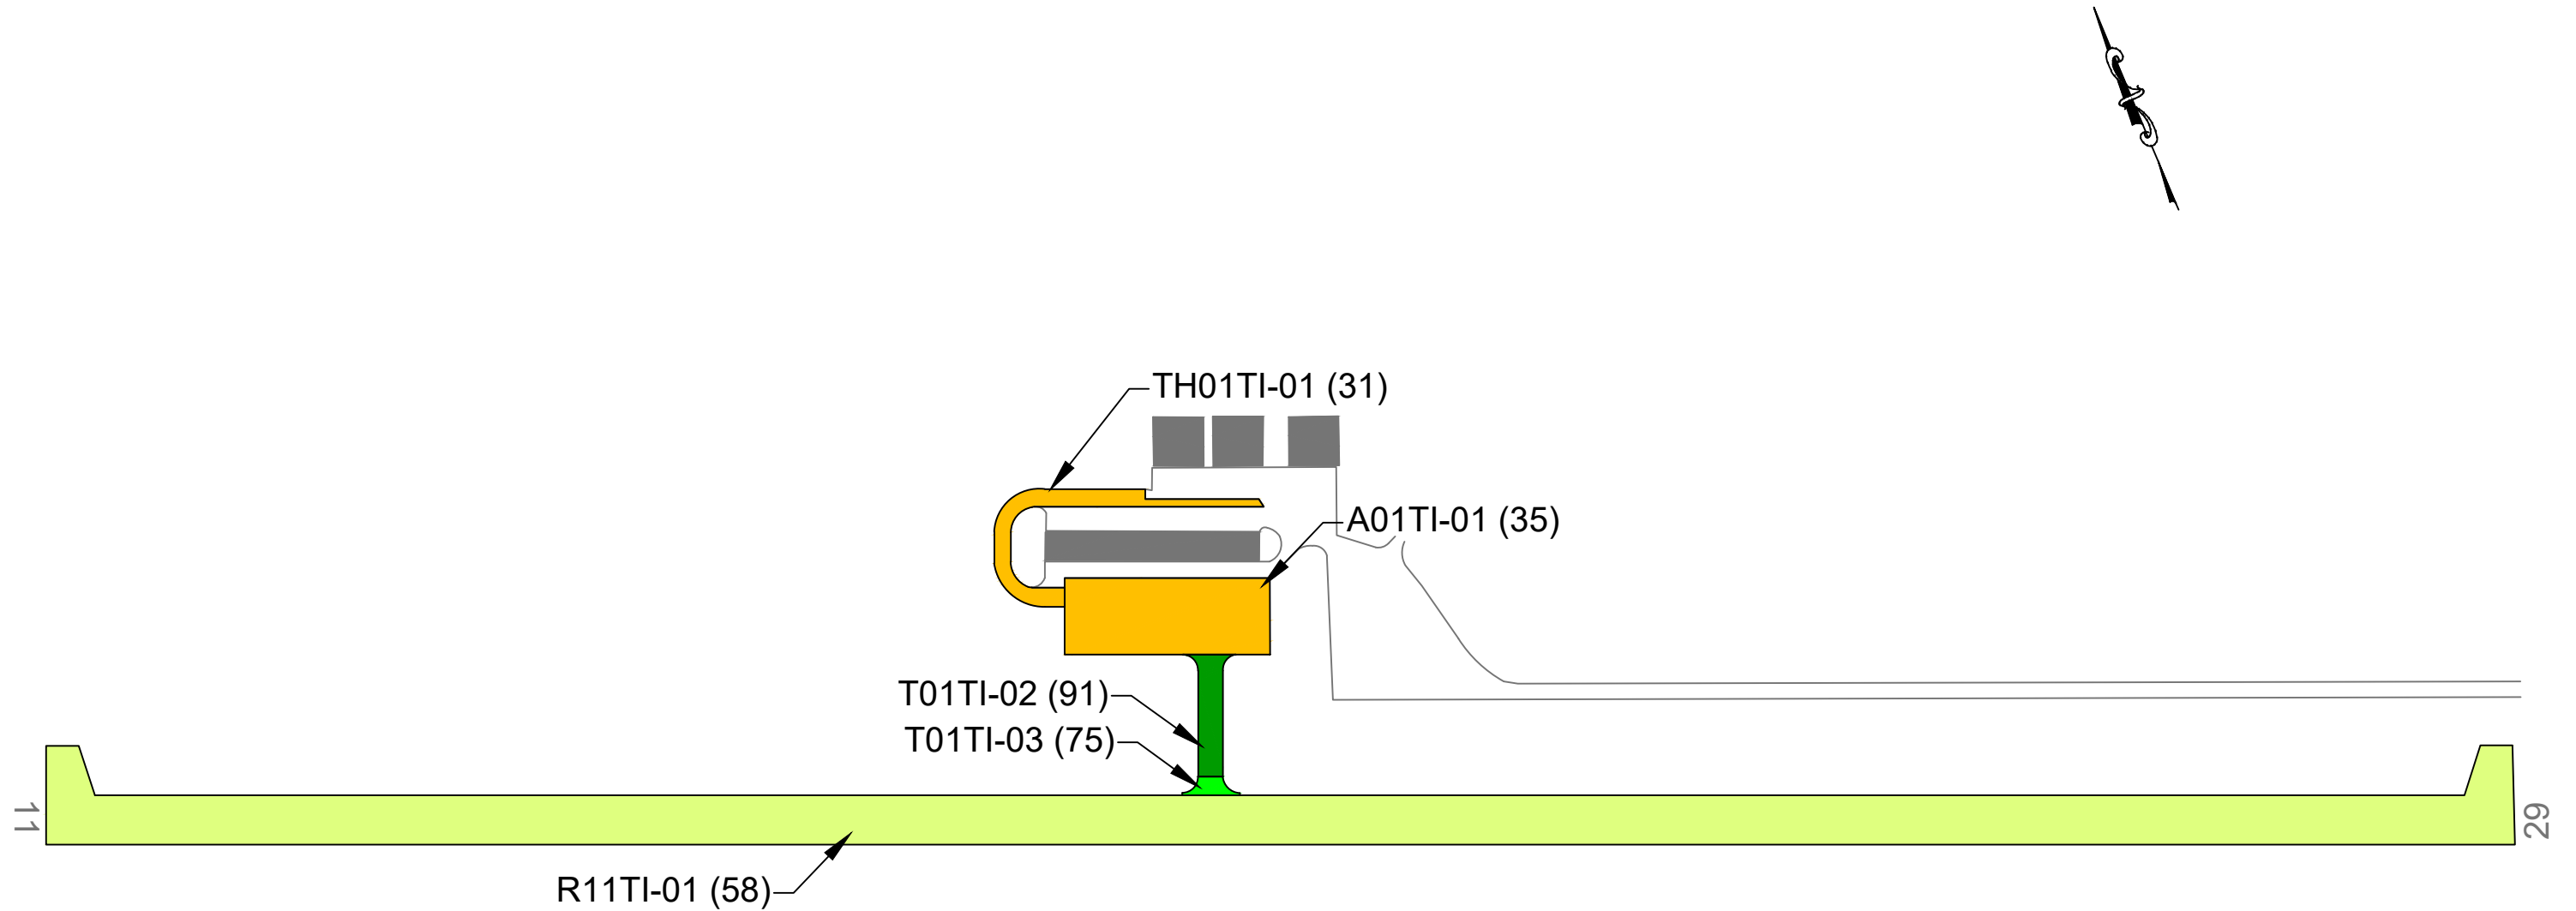
FIGURE 8. PCI MAP.

The pavements at Tipton-Mathews Memorial Airport were inspected in November 2023. The 2023 area-weighted condition of Tipton-Mathews Memorial Airport is 55, with conditions ranging from 31 to 91 (on a scale of 0 [failed] to 100 [excellent]). During the previous pavement inspection in 2020, the area-weighted PCI of the airport was 56.

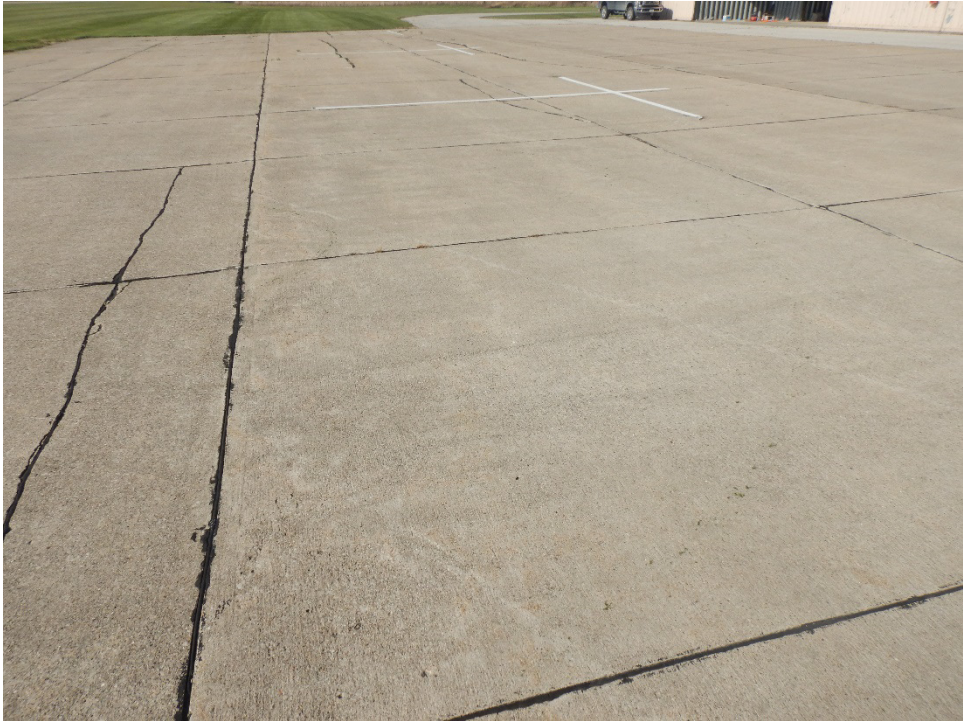
The apron area was defined by one section in poor condition. Section 01 contained areas of low-severity large patching and scaling; low- and medium-severity corner break, faulting, joint spalling, LTD cracking, and shattered slab; and medium-severity corner spalling and joint seal damage.

A01TI-01. Overview.

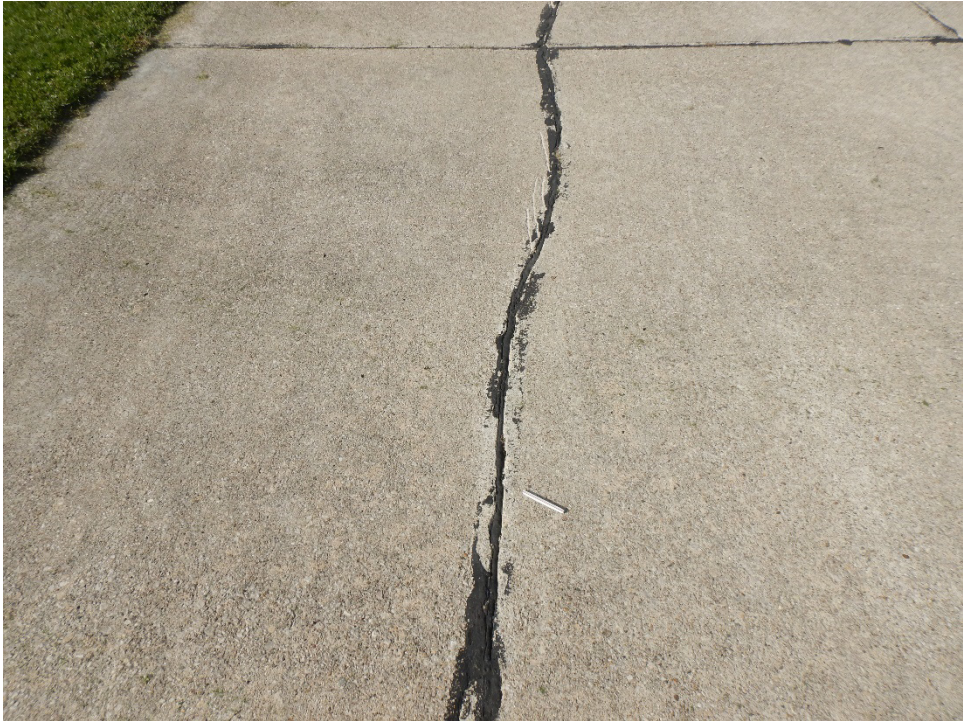
A01TI-01. LTD Cracking (Sample Unit No. 03).

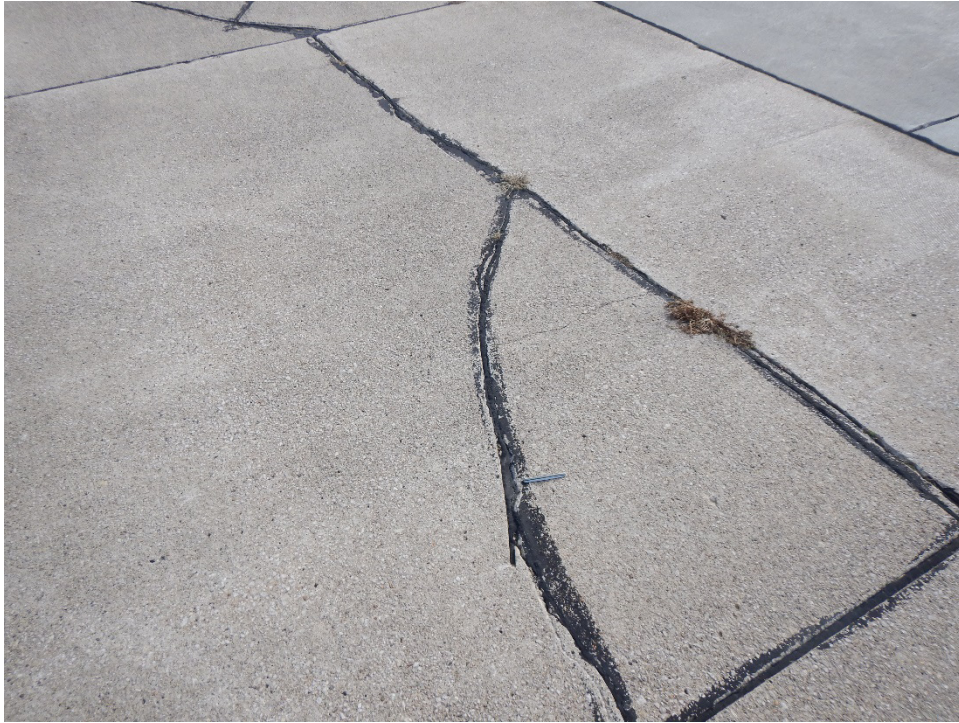
A01TI-01. Shattered Slab (Sample Unit No. 02).

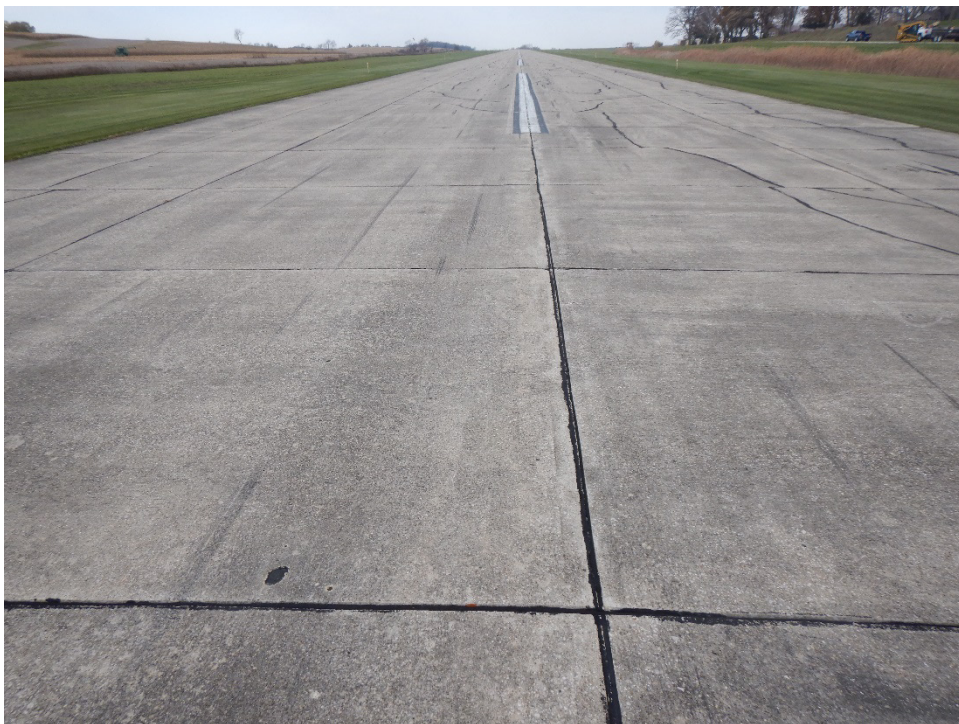
Runway 11/29 was defined by one section. Low-severity corner break and small patching; low- and medium-severity corner spalling, joint spalling, and longitudinal, transverse, and diagonal (LTD) cracking; medium-severity joint seal damage and large patching; and shrinkage cracking were recorded in Section 01.

R11TI-01. Overview.

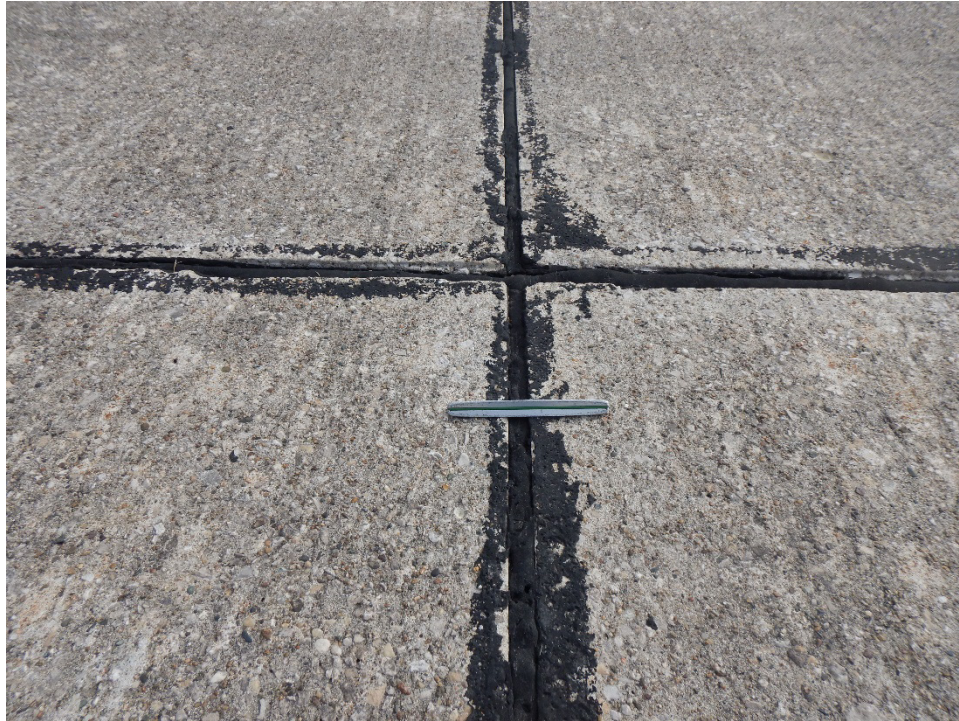
R11TI-01. Joint Seal Damage (Sample Unit No. 15).

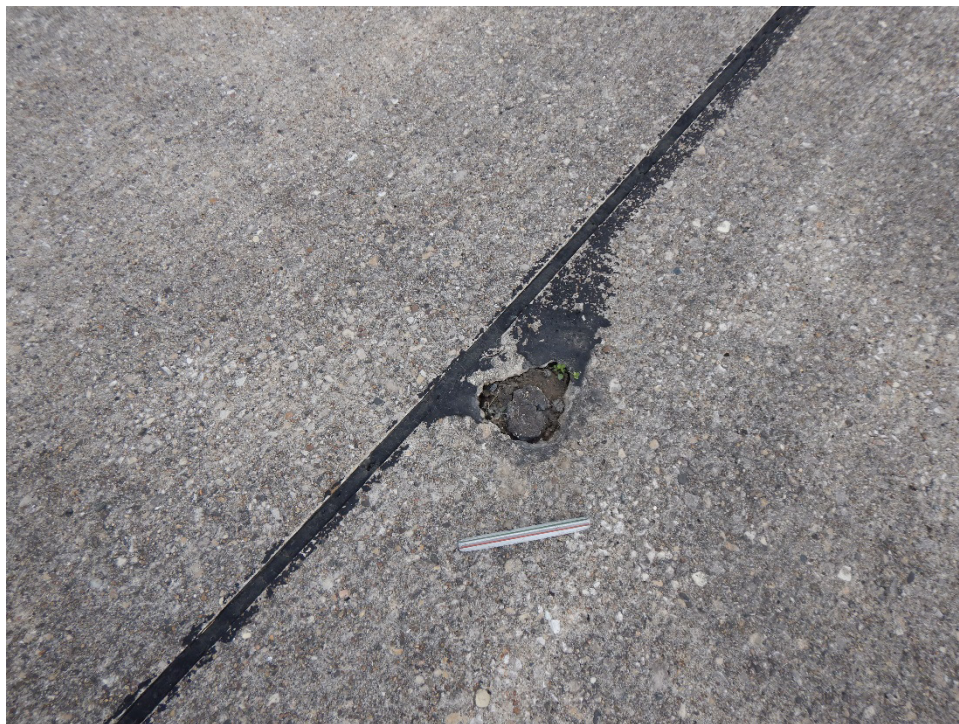
R11TI-01. Joint Spalling (Sample Unit No. 35).

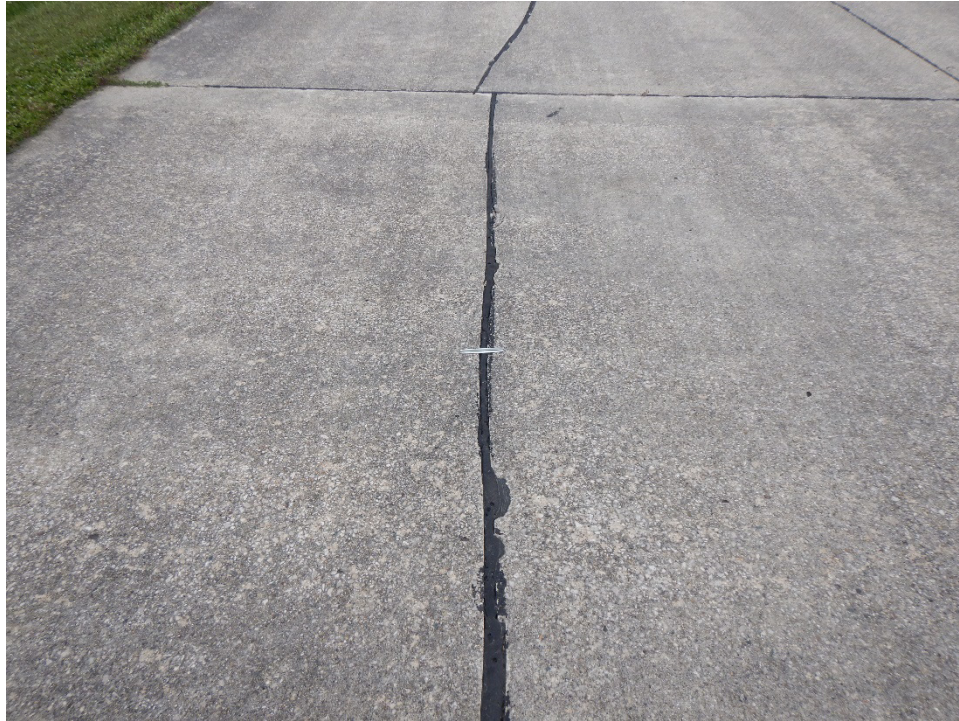
R11TI-01. LTD Cracking (Sample Unit No. 45).

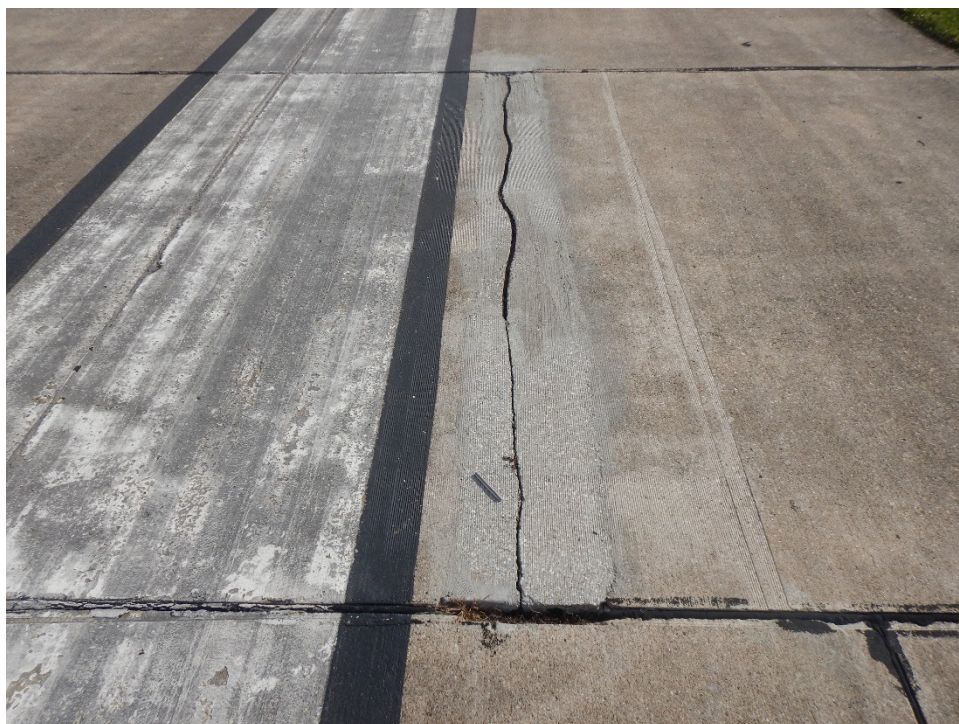
R11TI-01. Large Patching (Sample Unit No. 05).

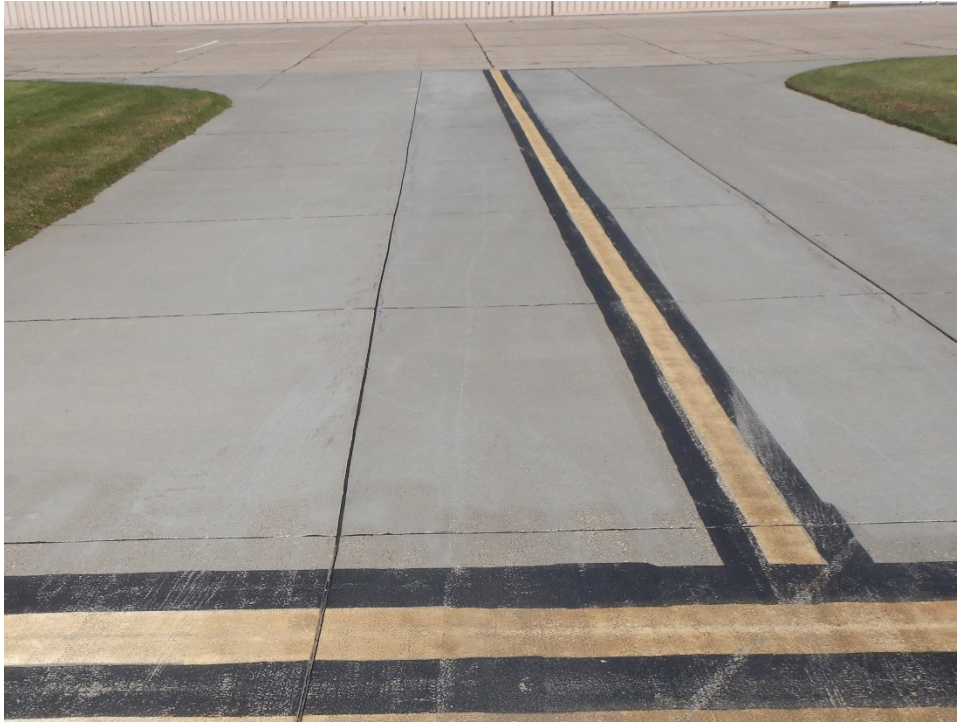
T01TI-02. Overview.

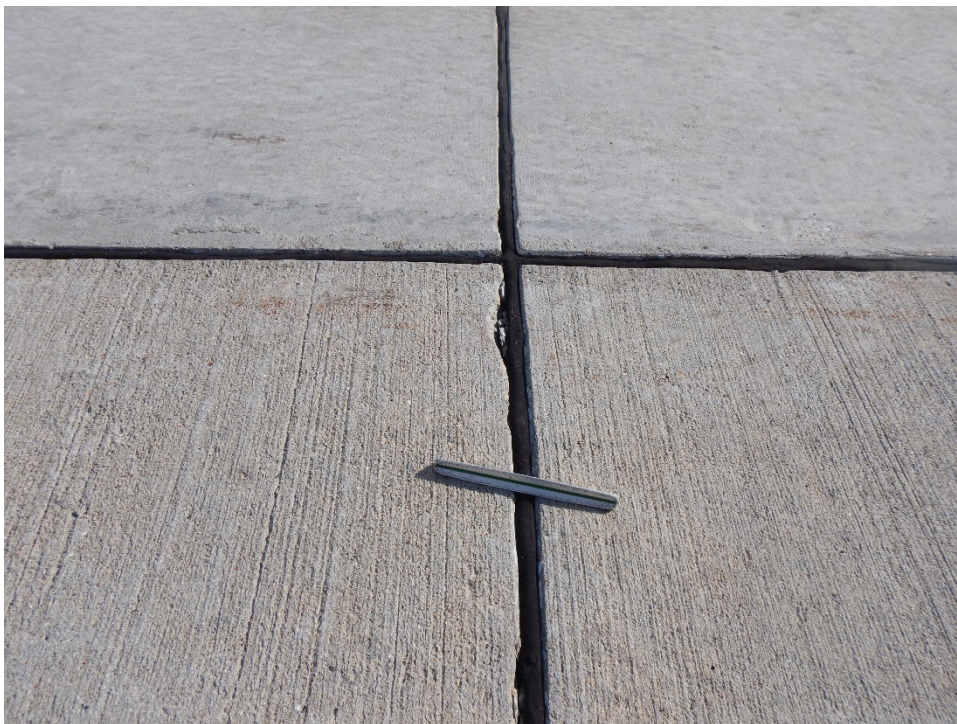
T01TI-02. Joint Seal Damage (Sample Unit No. 03).

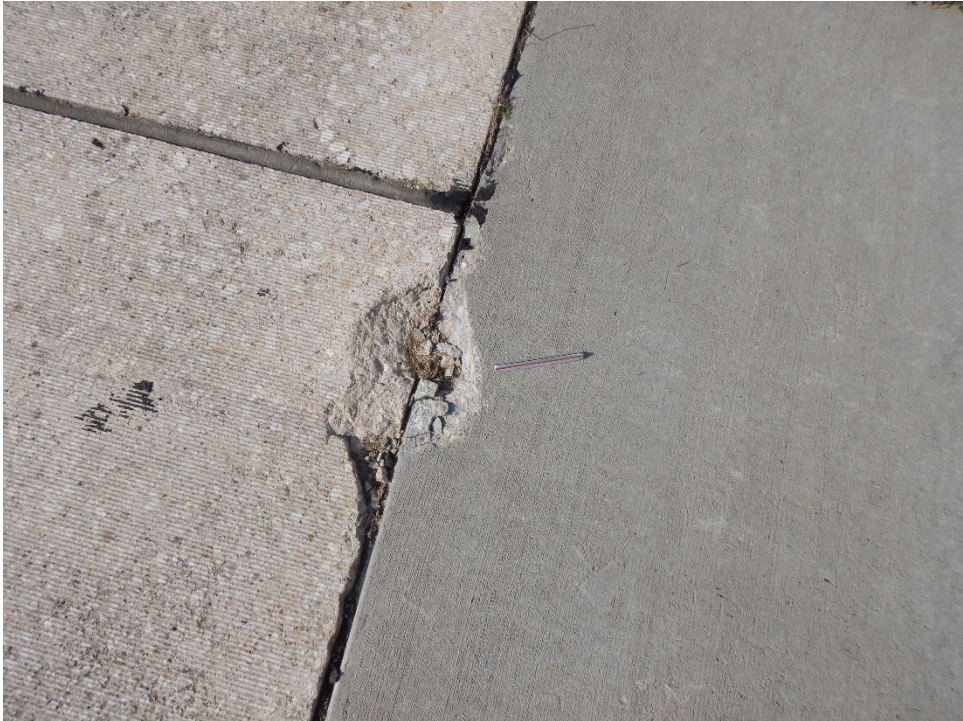
T01TI-02. Joint Spalling (Sample Unit No. 01).

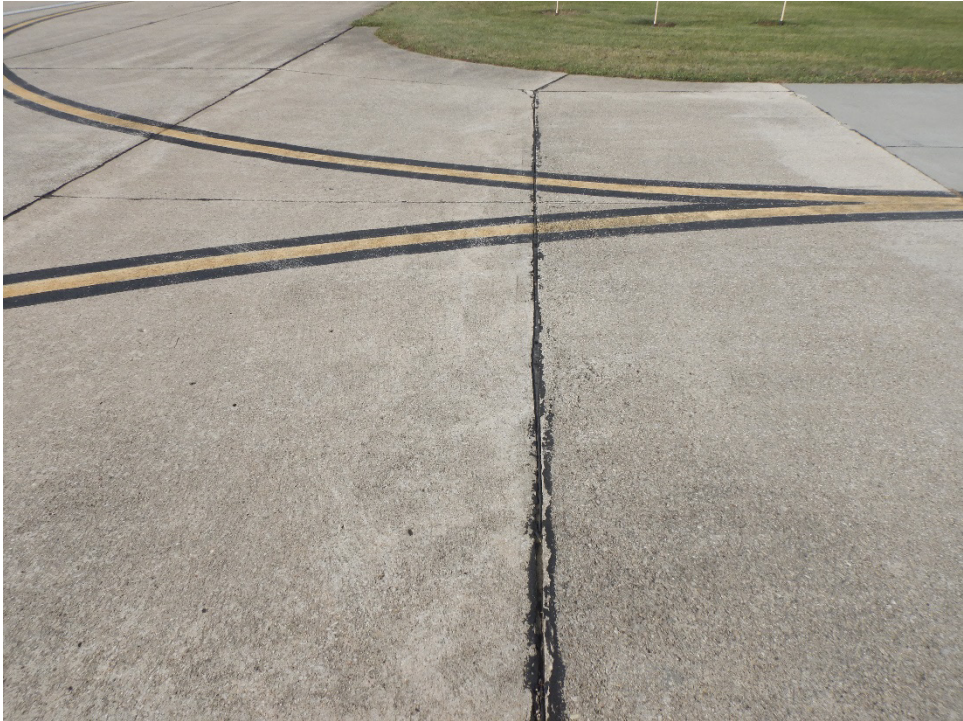
T01TI-03. Overview.

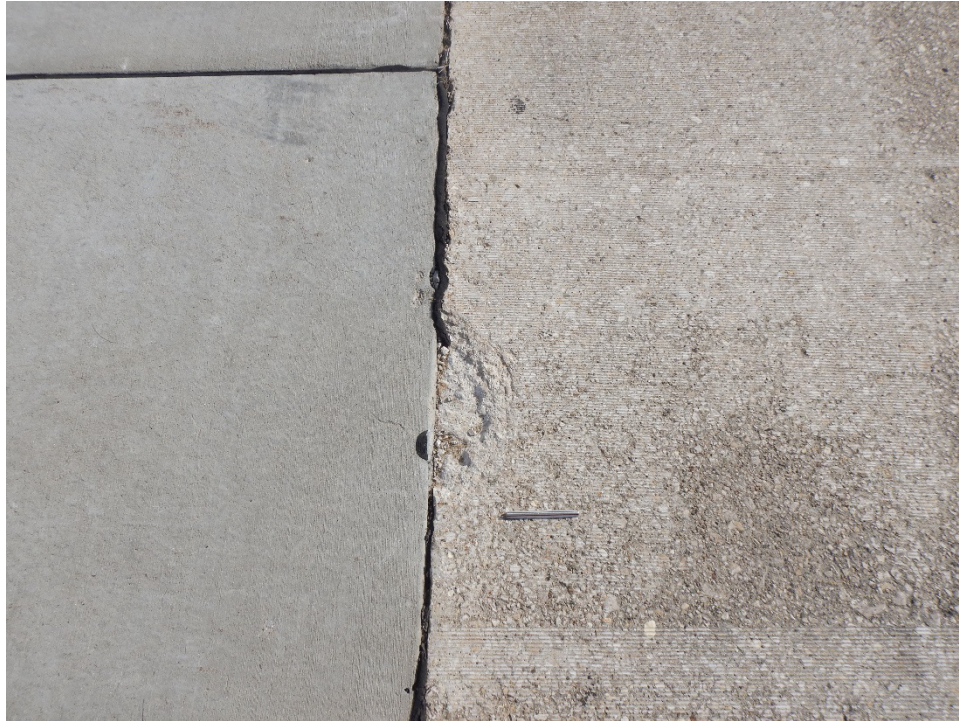
T01TI-03. Joint Spalling (Sample Unit No. 01).

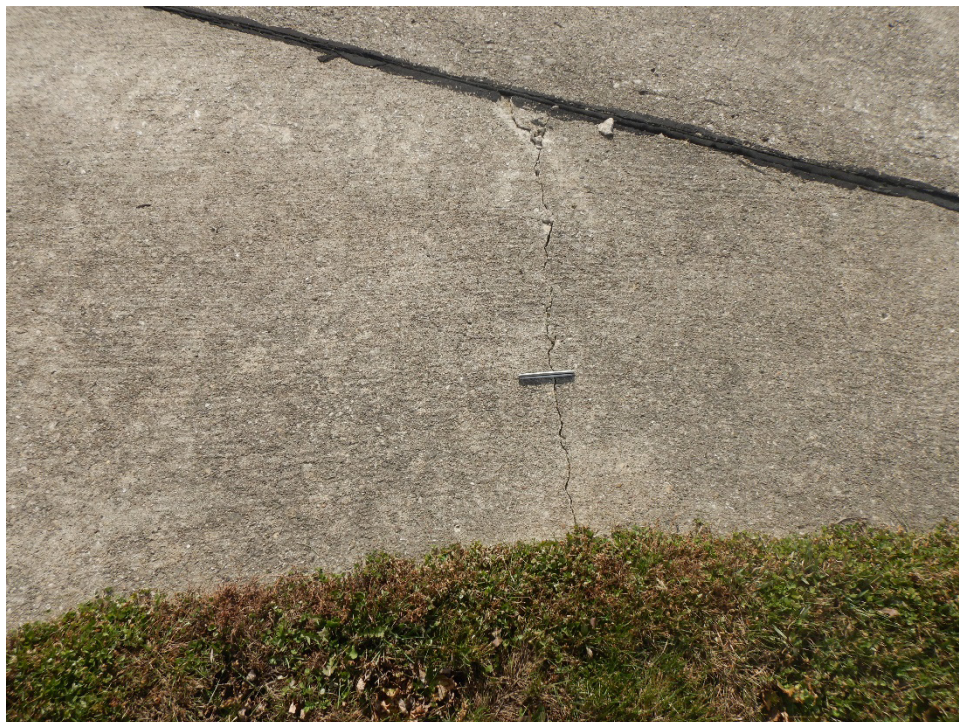
T01TI-03. LTD Cracking (Sample Unit No. 01).

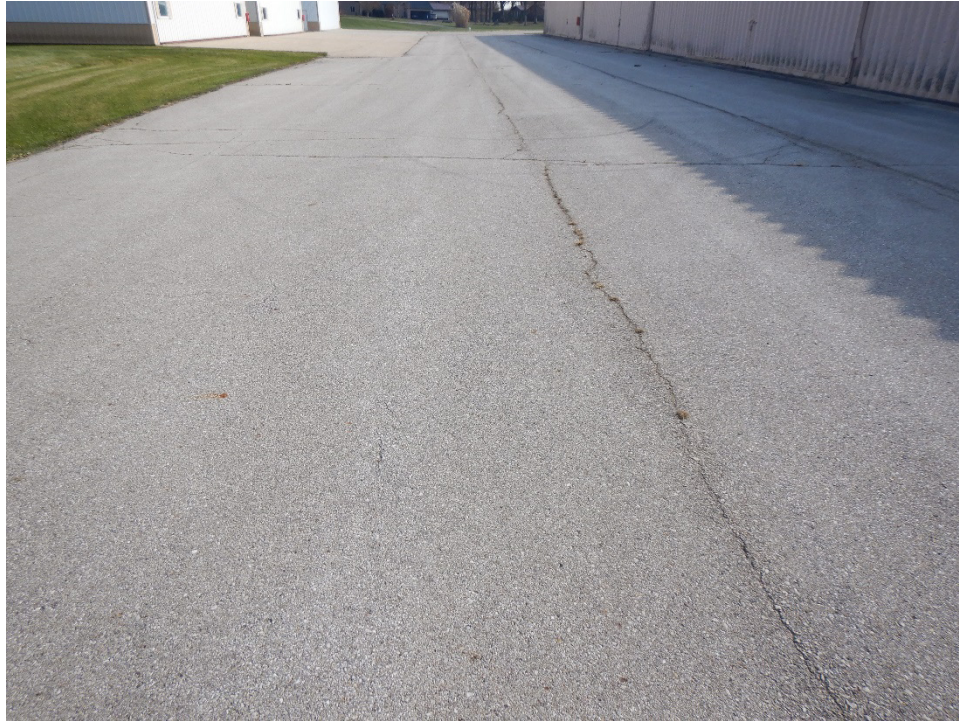
The T-hangar area contained one section in poor condition. Low-severity weathering, low- and medium-severity longitudinal and transverse (L&T) cracking, medium-severity patching, and medium- and high-severity alligator cracking were identified in Section 01. The low-severity L&T cracking was unsealed, and the medium-severity L&T cracking was recorded where either unsealed crack widths exceeded 1/4 inch or secondary cracking had developed.

TH01TI-01. Overview.

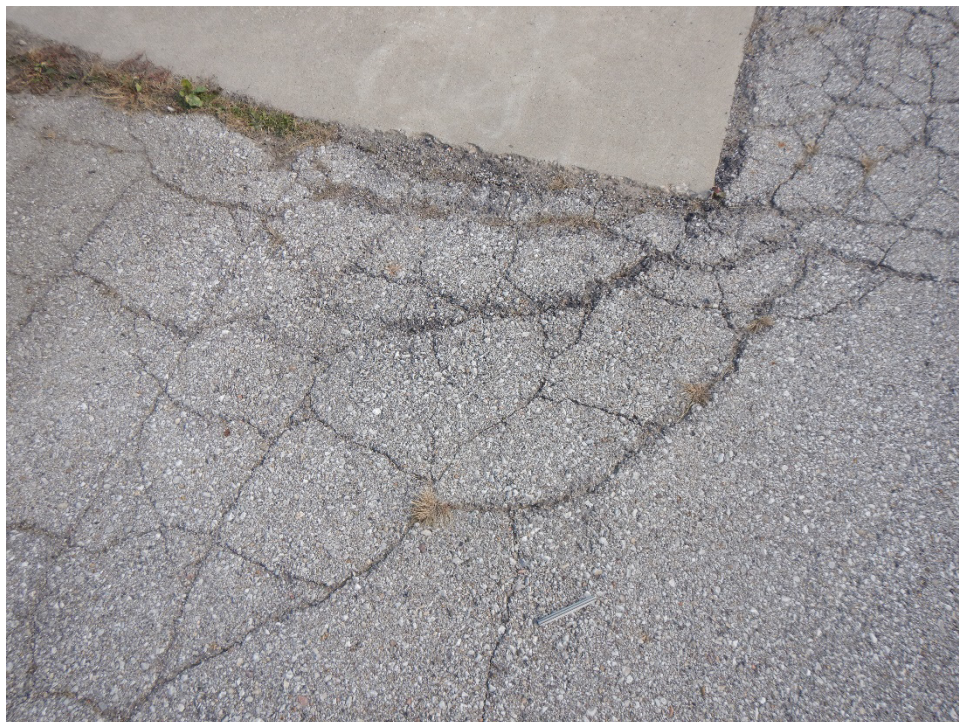
TH01TI-01. Alligator Cracking (Sample Unit No. 02).

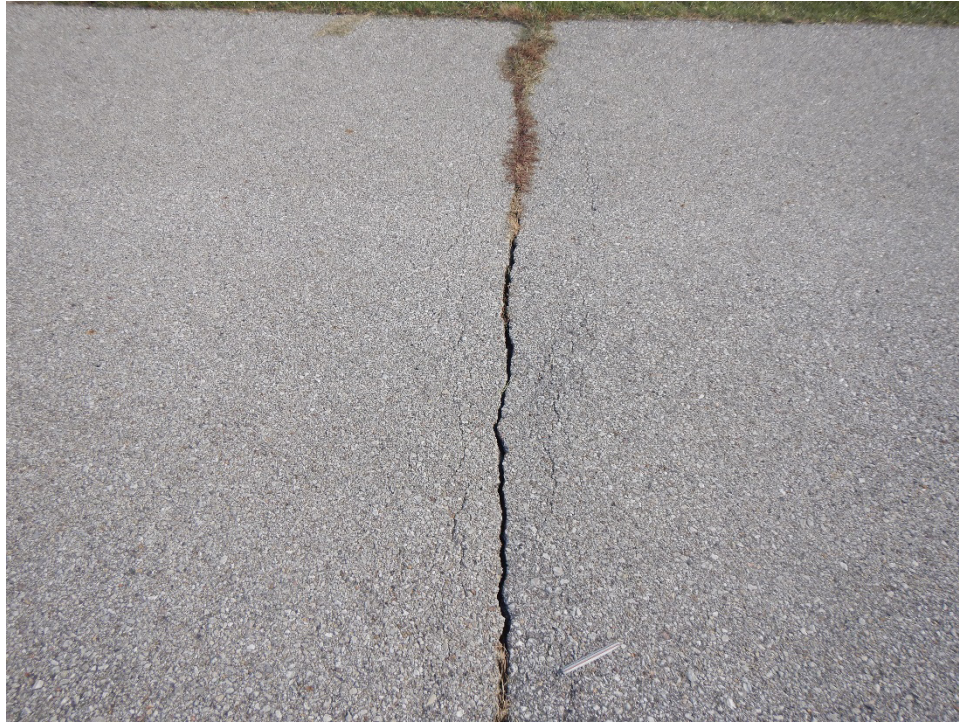
TH01TI-01. L&T Cracking (Sample Unit No. 01).
