Vinton Veterans Memorial Airpark

Pavement Management Report

JULY 2024

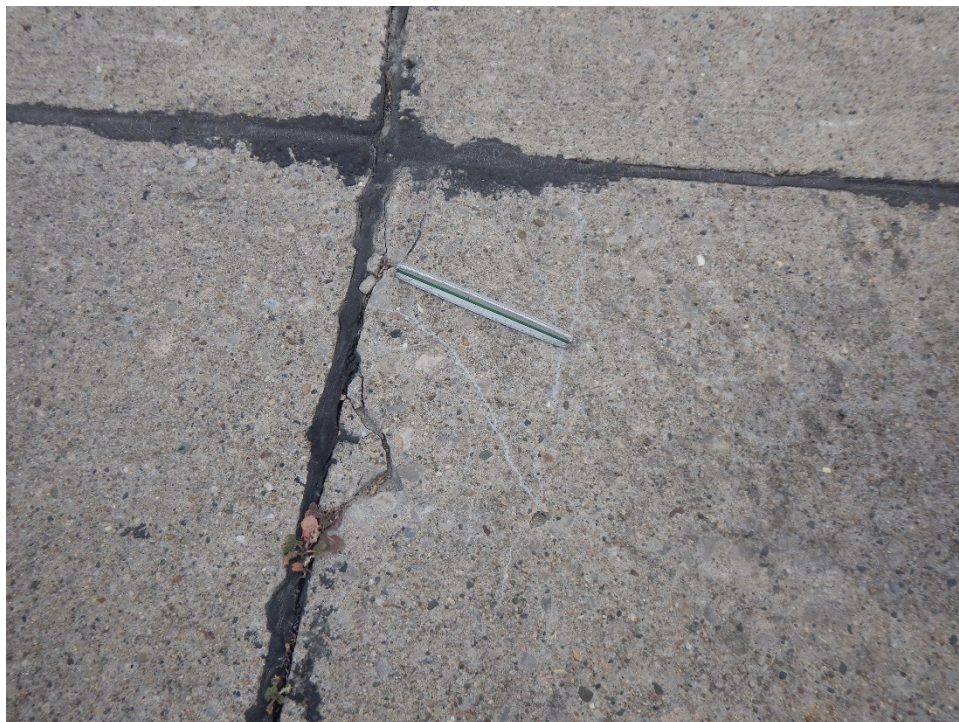
A01VI-01. ASR (Sample Unit No. 08).

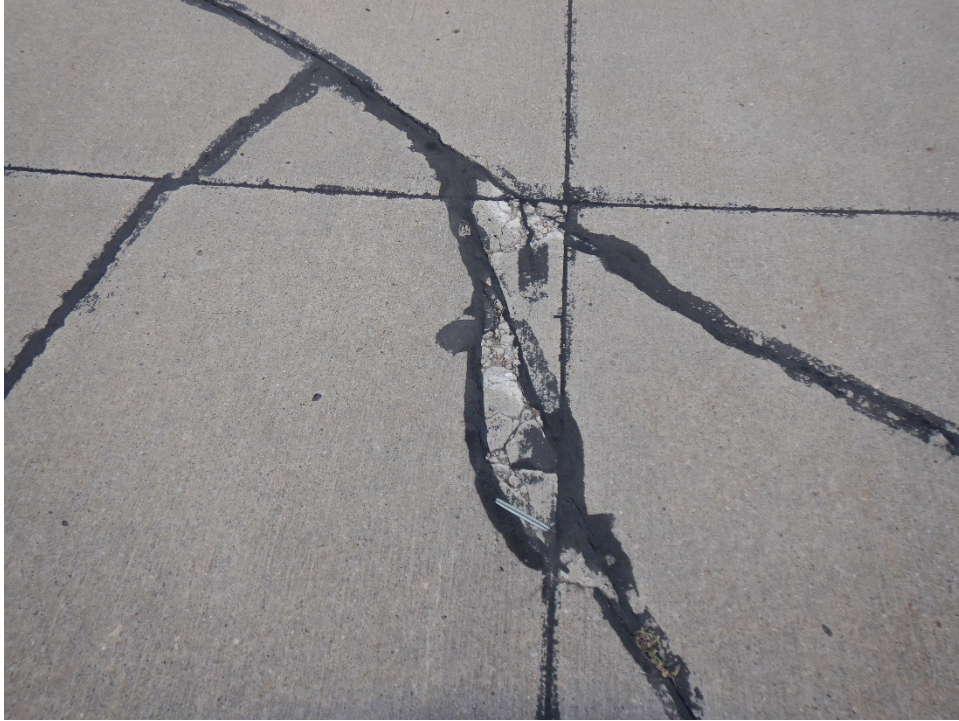
A01VI-01. Joint Spalling (Sample Unit No. 01).

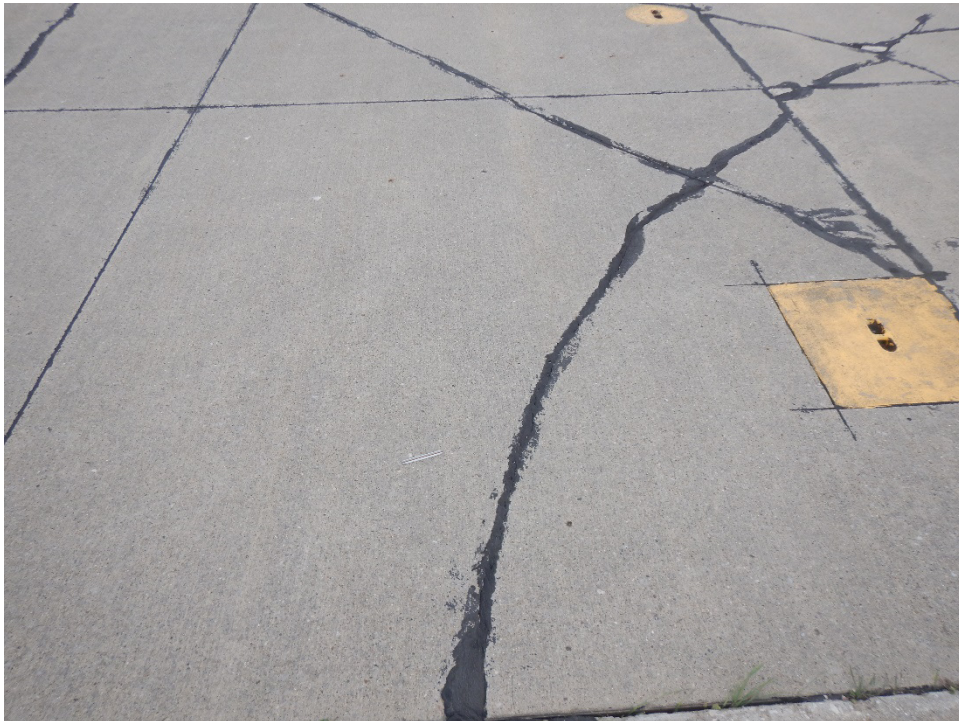
A01VI-01. Shattered Slab (Sample Unit No. 01).

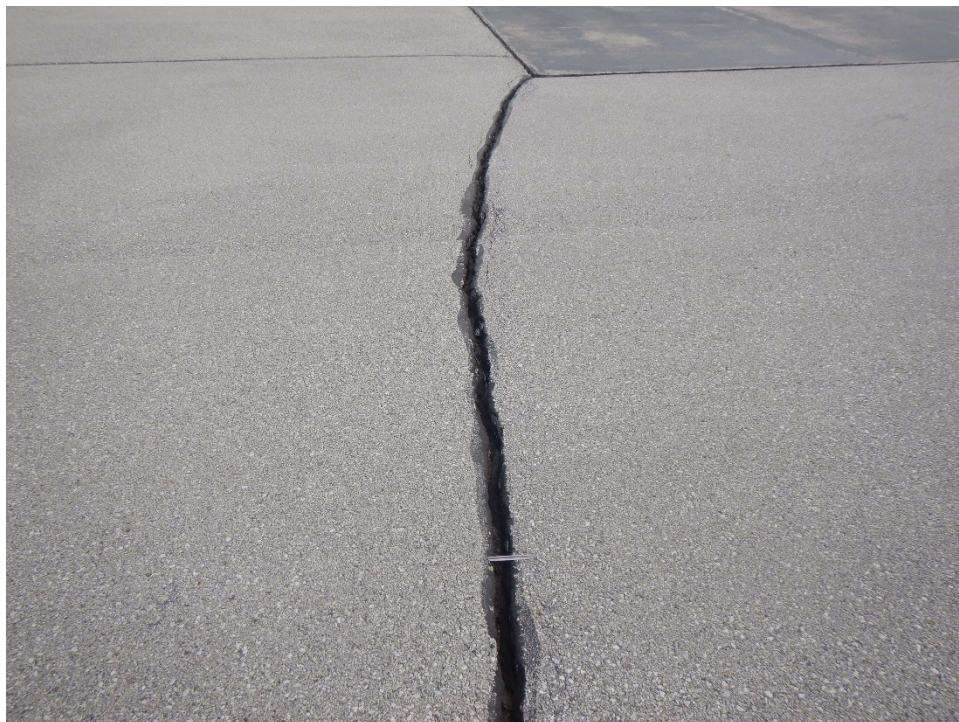
A01VI-02. L&T Cracking (Sample Unit No. 07).

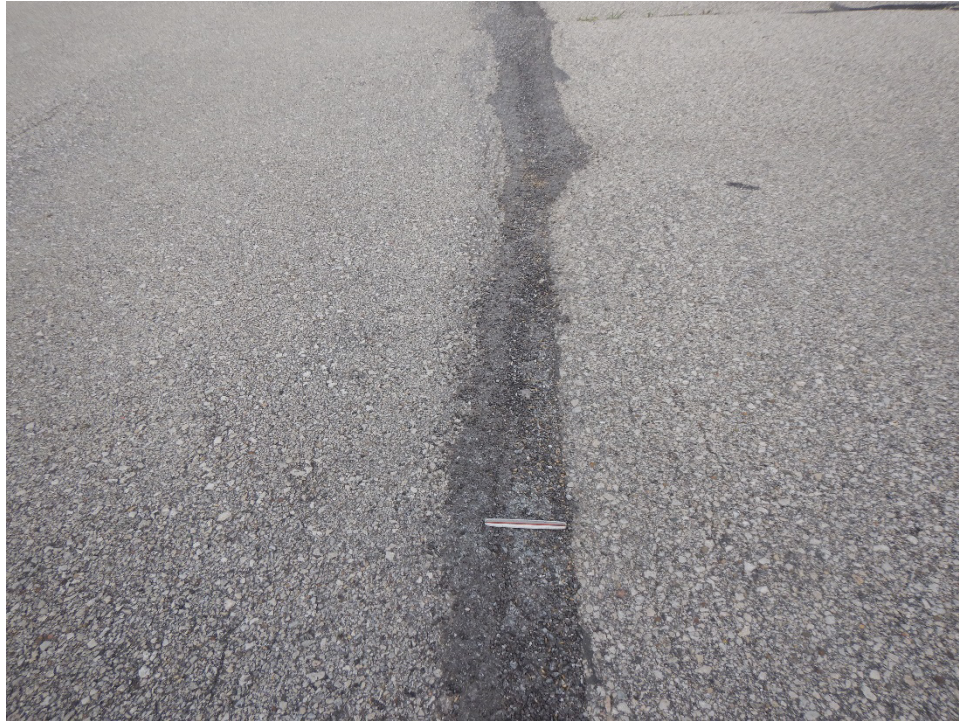
A01VI-02. Patching (Additional Sample Unit No. 01).

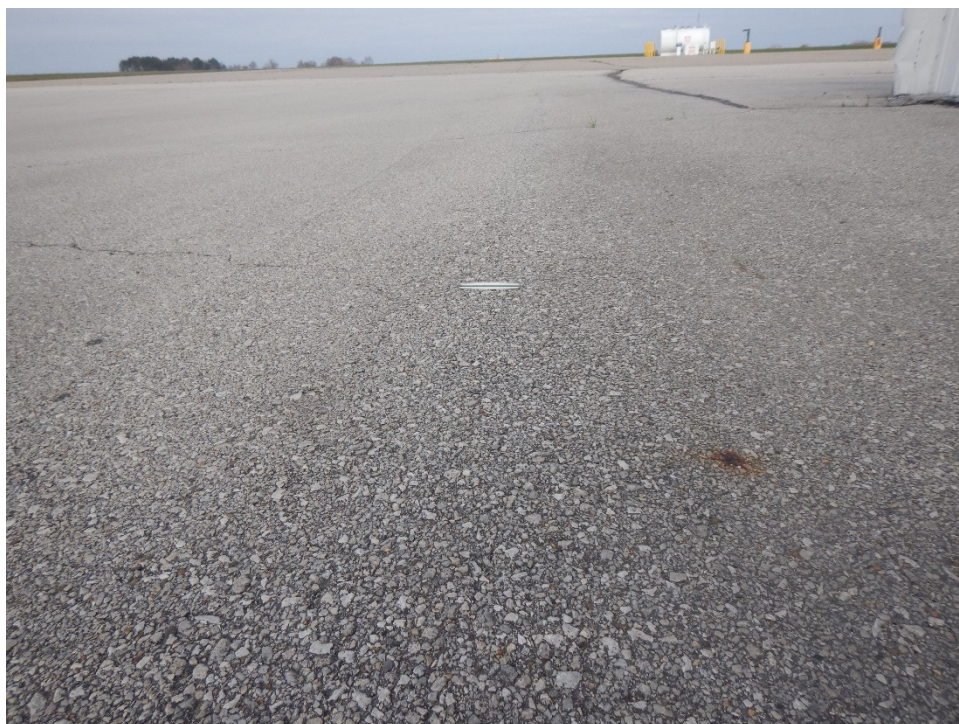
A01VI-02. Swelling (Sample Unit No. 02).

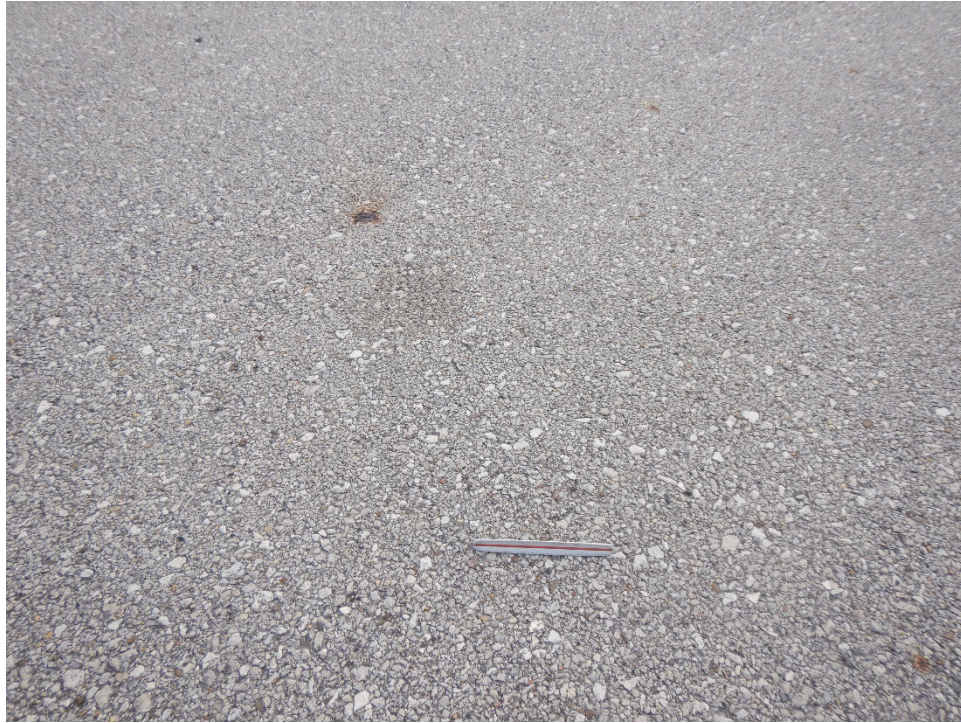
A01VI-02. Weathering (Sample Unit No. 08).

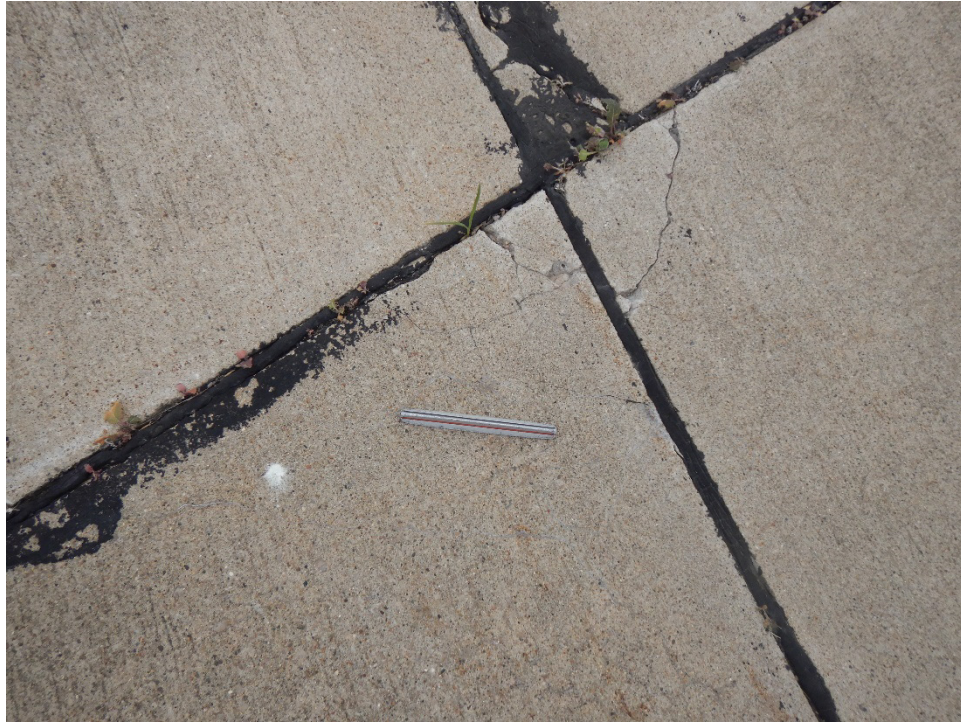
A01VI-03. ASR (Sample Unit No. 03).

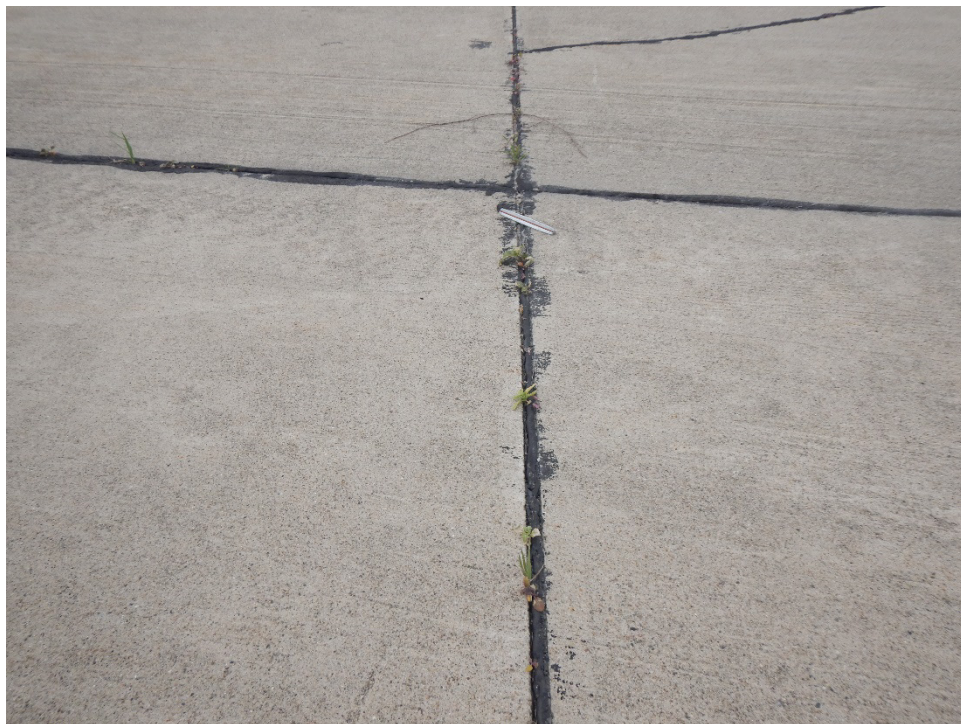
A01VI-03. Joint Seal Damage (Sample Unit No. 02).

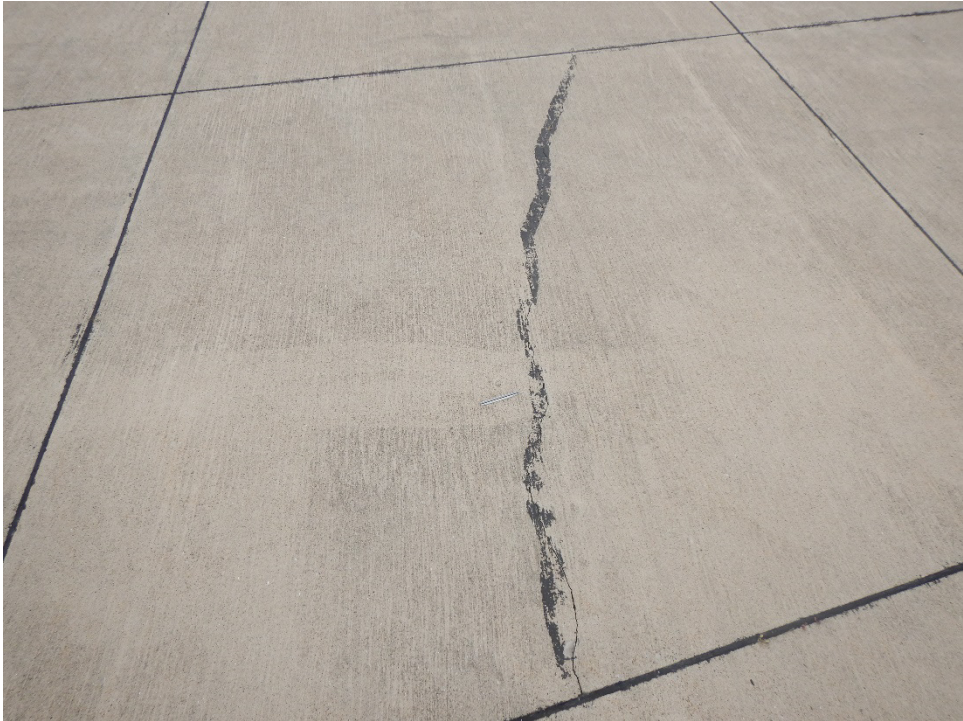
A01VI-03. LTD Cracking (Sample Unit No. 02).

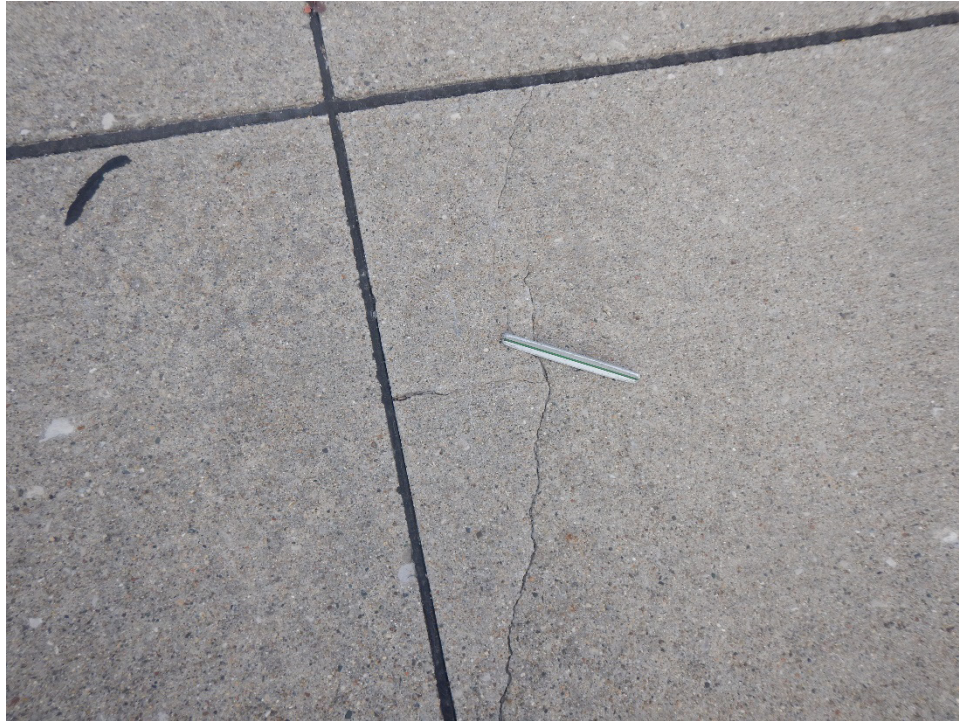
A01VI-04. ASR (Sample Unit No. 14).

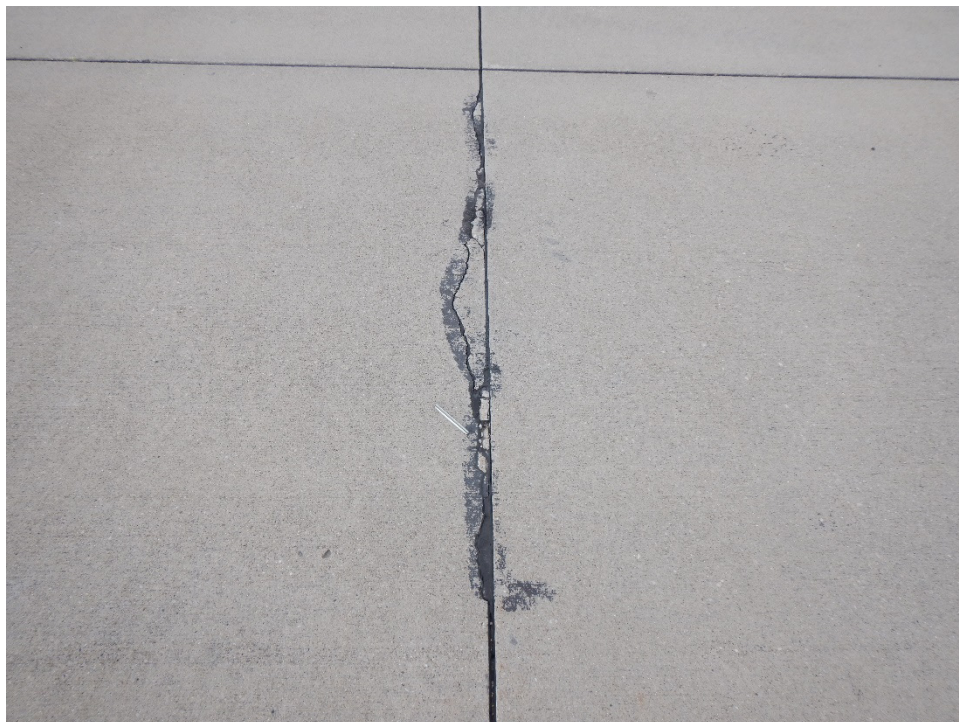
A01VI-04. Joint Spalling (Sample Unit No. 02).

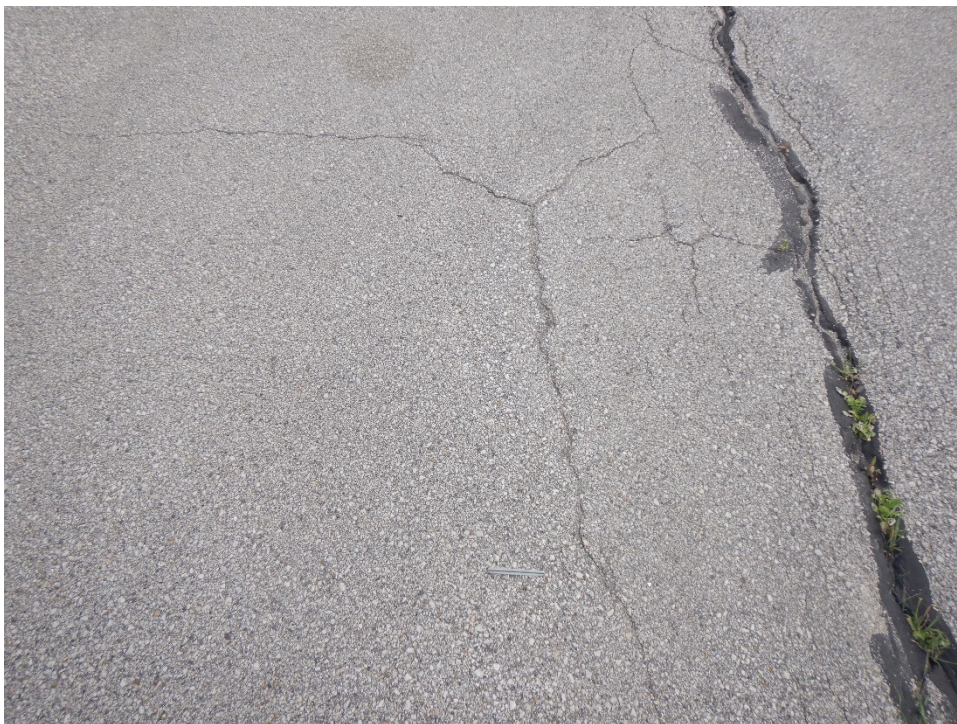
A01VI-05. L&T Cracking (Sample Unit No. 01).

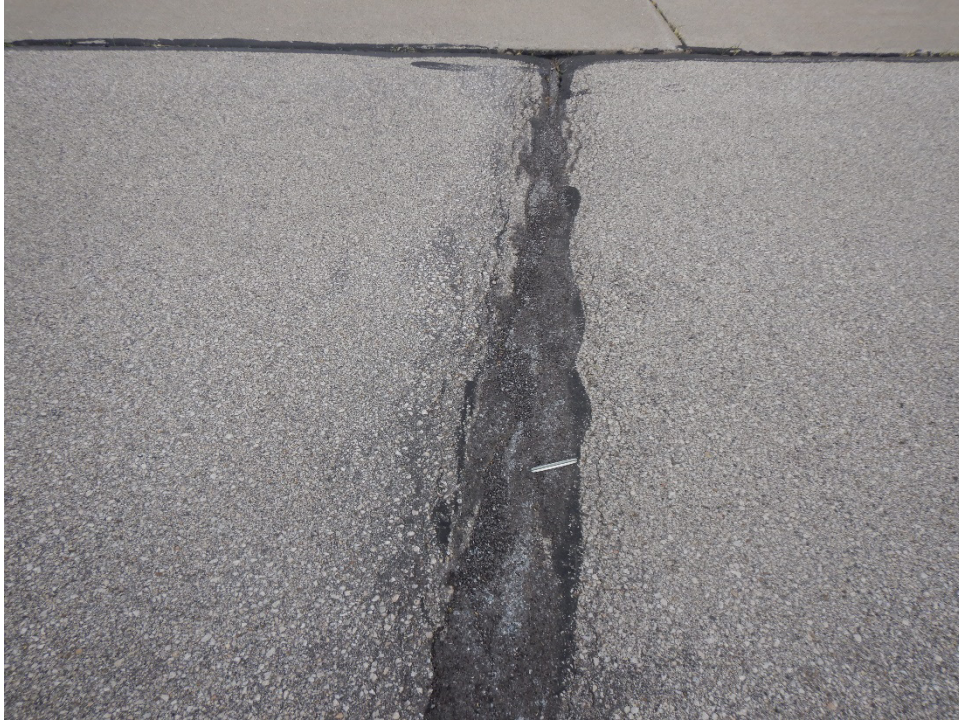
A01VI-05. Patching (Sample Unit No. 01).

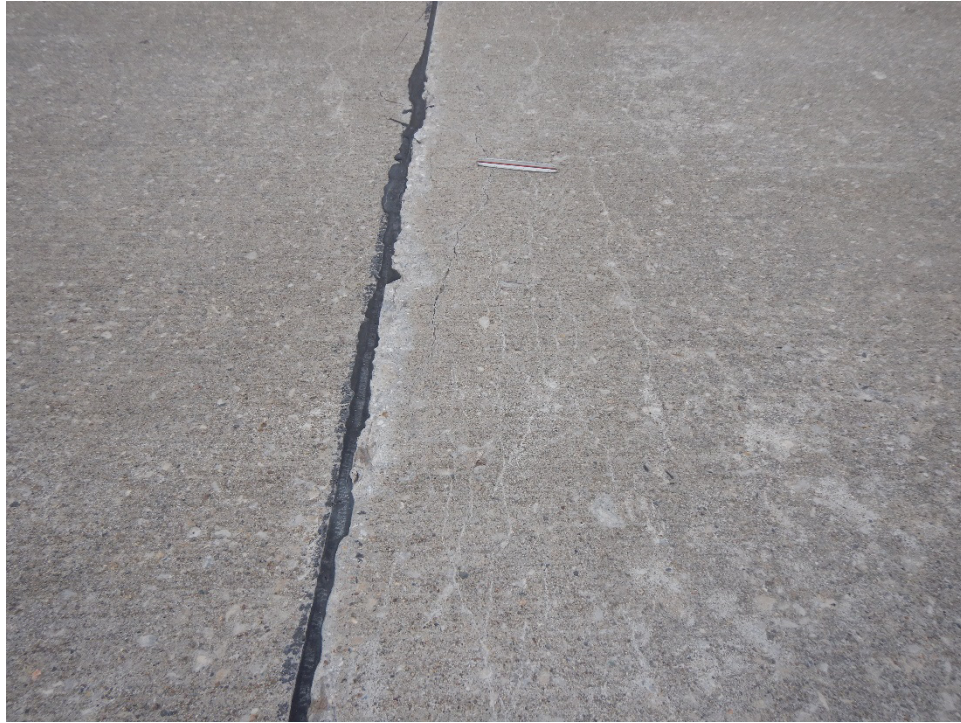
Runway 09/27 was defined by one section. Areas of low-severity corner break, faulting, large patching, small patching, and longitudinal, transverse, and diagonal (LTD) cracking; low- and medium-severity ASR, corner spalling, and joint spalling; and popouts were observed in Section 01 during the inspection.

R09VI-01. ASR (Sample Unit No. 012).

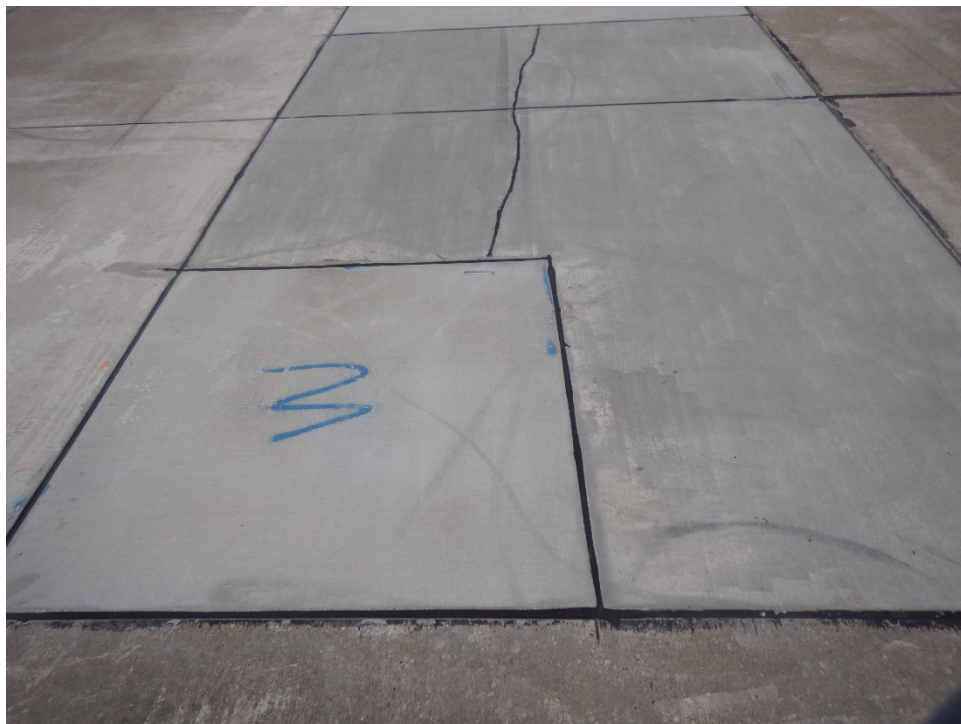
R09VI-01. LTD Cracking (Sample Unit No. 032).

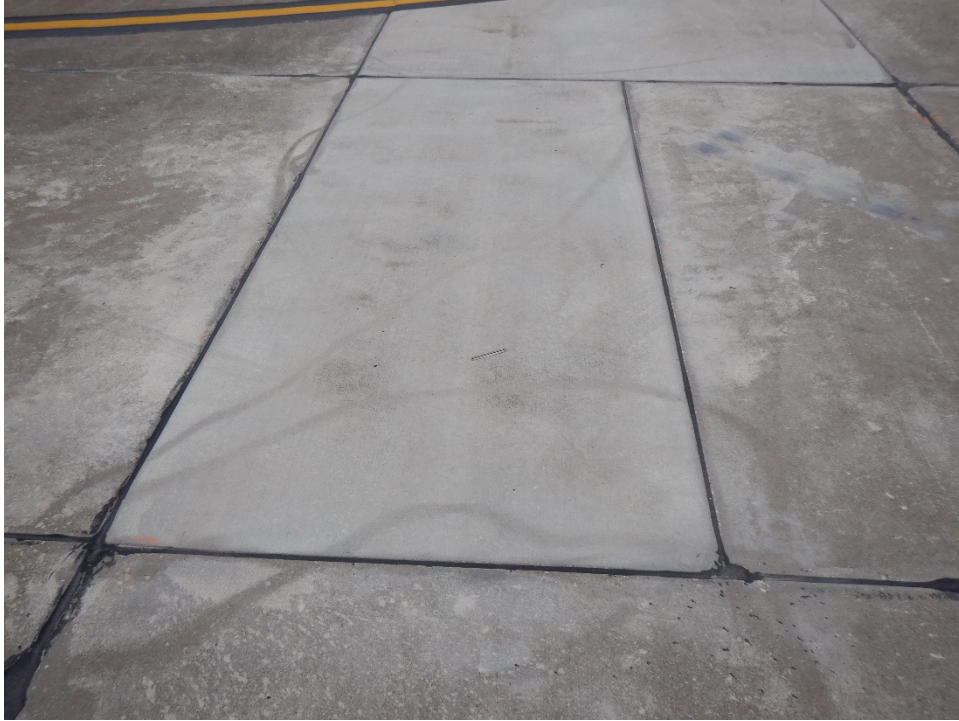
R09VI-01. Large Patching (Sample Unit No. 106).

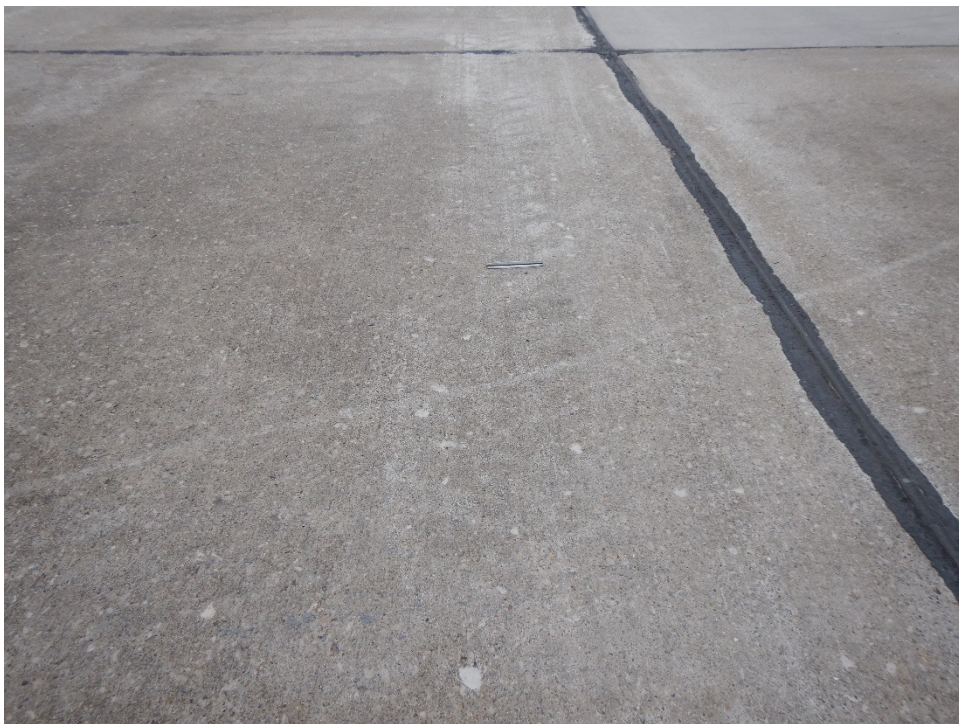
R09VI-01. Popouts (Sample Unit No. 052).

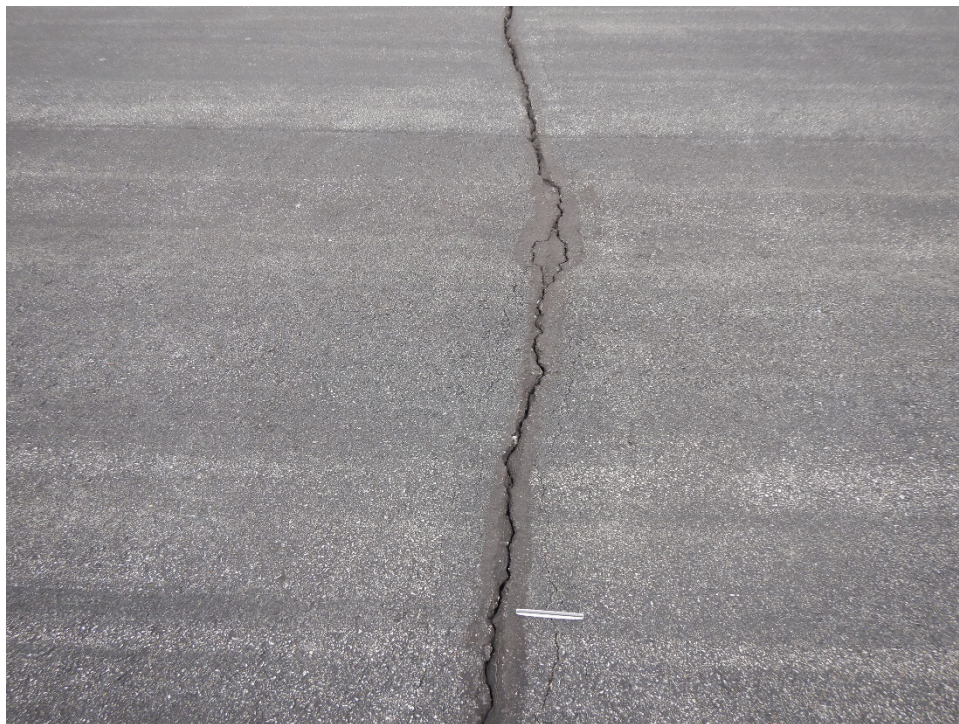
Runway 16/34 consisted of three sections. Section 01 was located at the Runway 34 approach with areas of low-severity patching and swelling and low- and medium-severity longitudinal and transverse (L&T) cracking recorded throughout. Section 02 comprised the majority of Runway 16/34. Areas of low-severity patching and low- and medium-severity L&T cracking were identified. In both Sections 01 and 02, the low-severity L&T cracking was unsealed, and the medium-severity L&T cracking was identified where either the crack sealant was unsatisfactory or unsealed crack widths were greater than 1/4 inch. Section 03 was located at the intersection of Runway 09/27 and contained only low-severity weathering.

R16VI-01. L&T Cracking (Sample Unit No. 02).

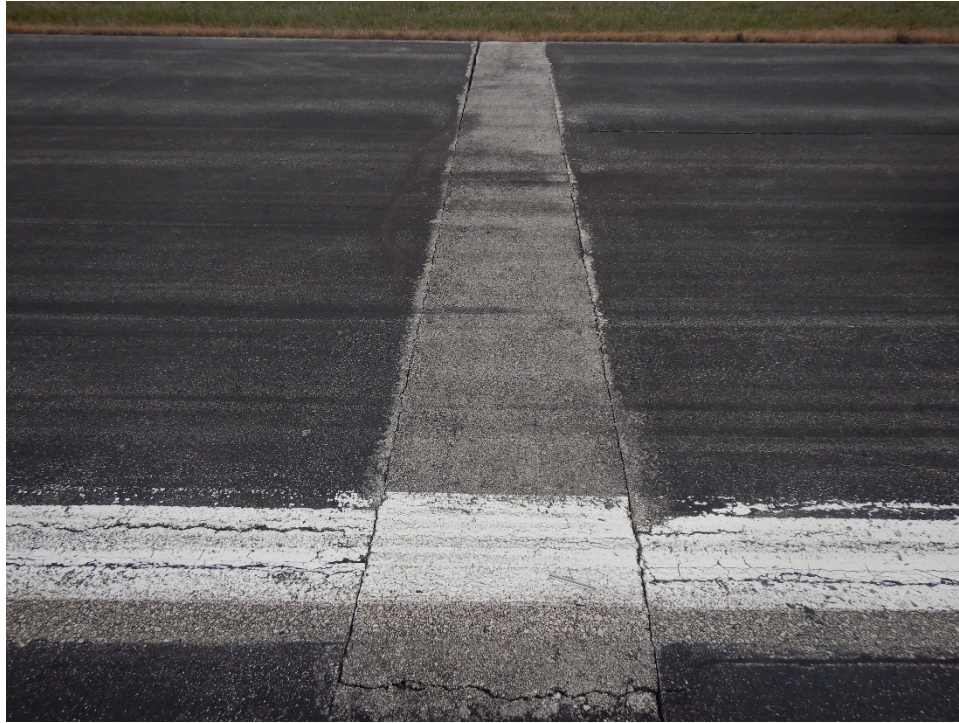
R16VI-01. Patching (Sample Unit No. 05).

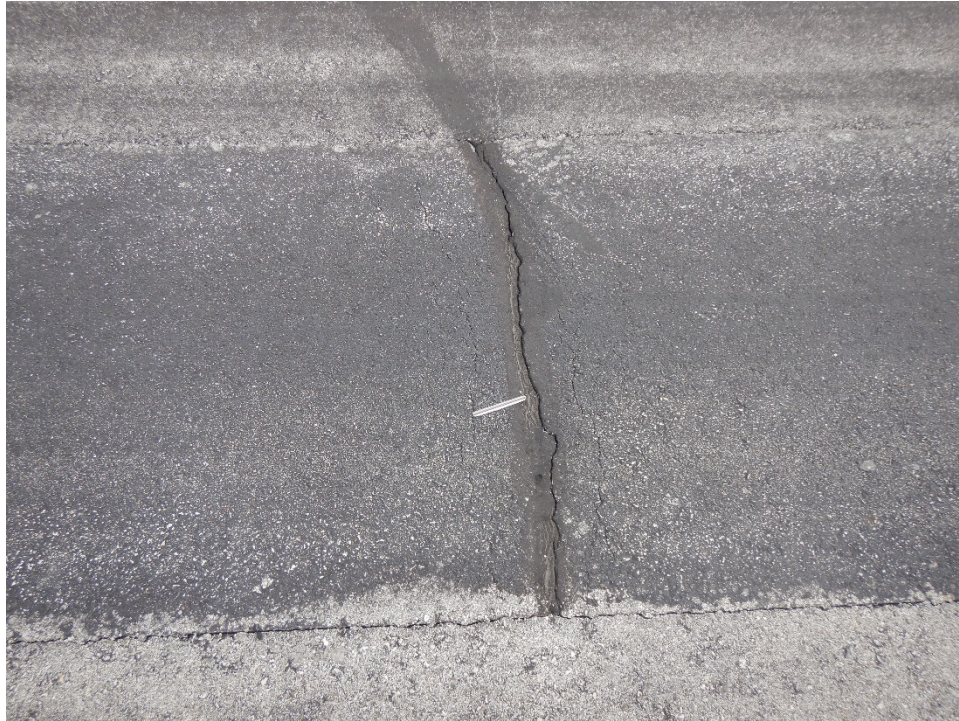
R16VI-02. L&T Cracking (Sample Unit No. 07).

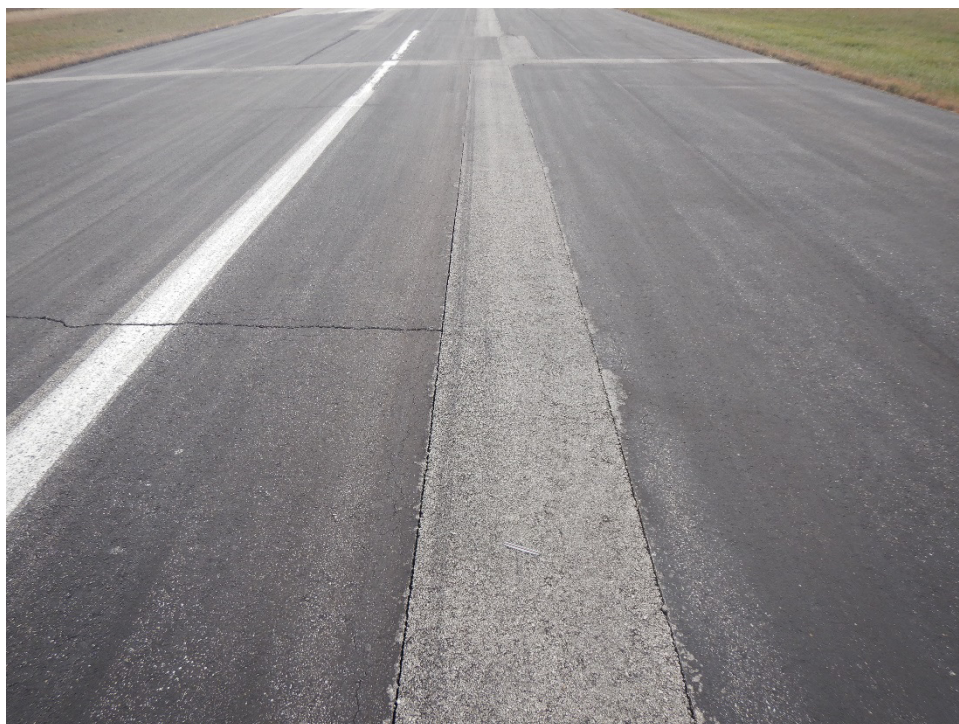
R16VI-02. Patching (Sample Unit No. 13).

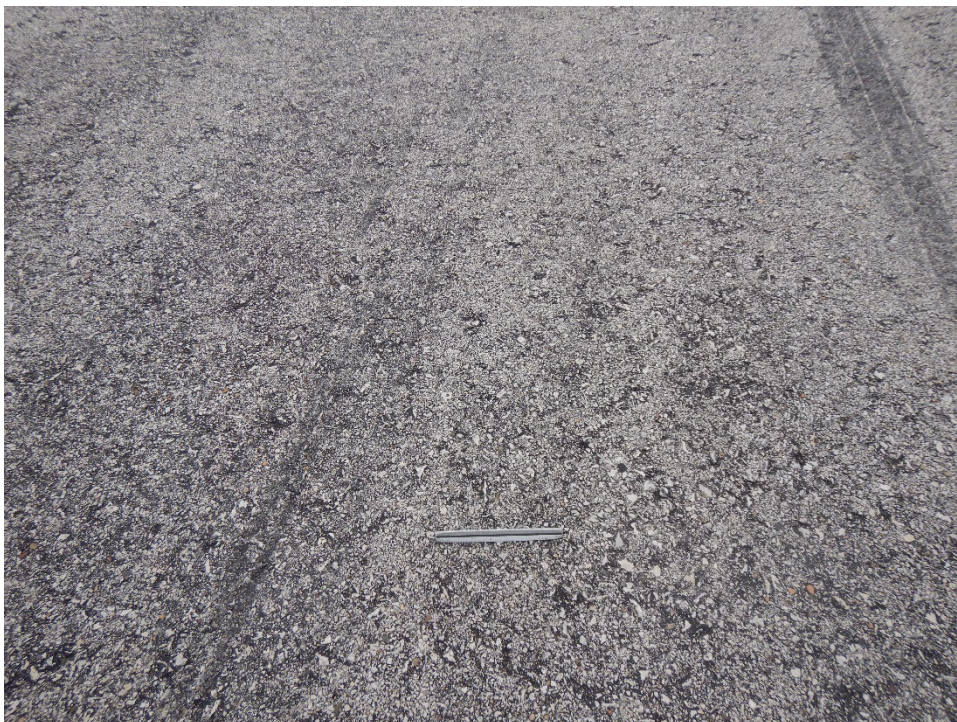
R16VI-03. Weathering (Sample Unit No. 01).

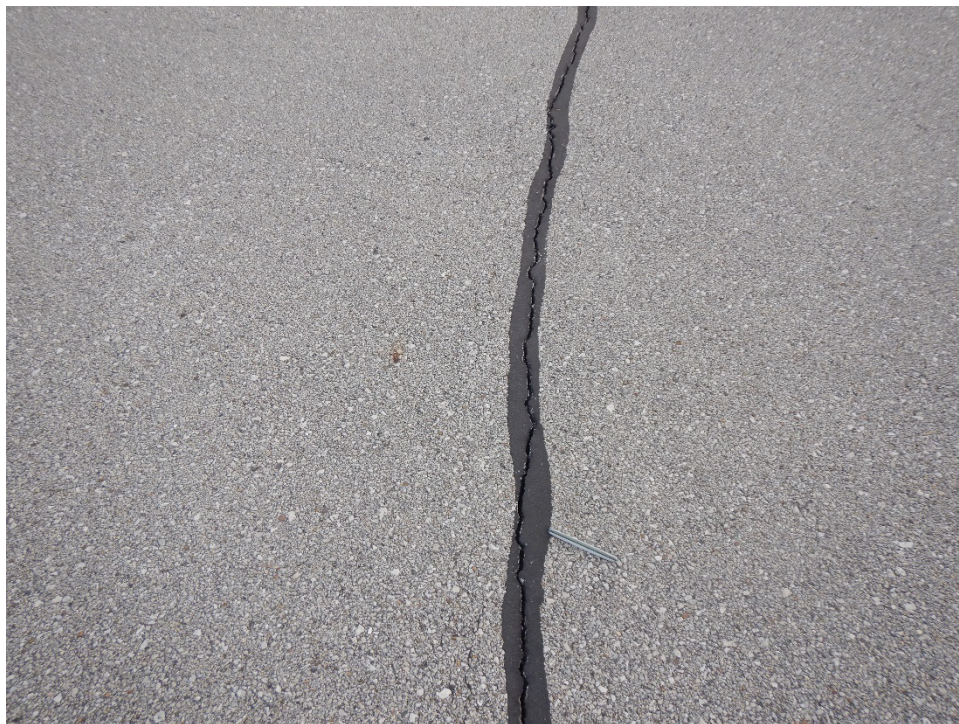
Taxiway 01 was defined by one section that connected Runway 16/34 to the apron area. Low-severity patching and low- and medium-severity L&T cracking and weathering were observed in Section 01. The low-severity L&T cracking was either sealed or unsealed, and the medium-severity L&T cracking was identified where the crack sealant was no longer satisfactory.

T01VI-01. L&T Cracking (Sample Unit No. 01).

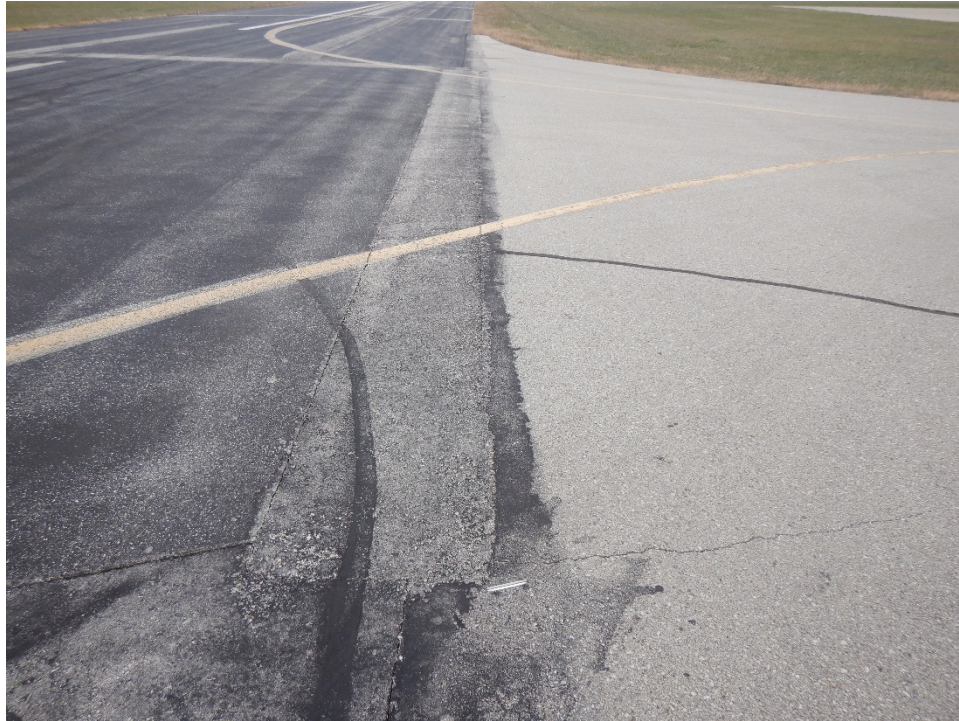
T01VI-01. Patching (Sample Unit No. 01).

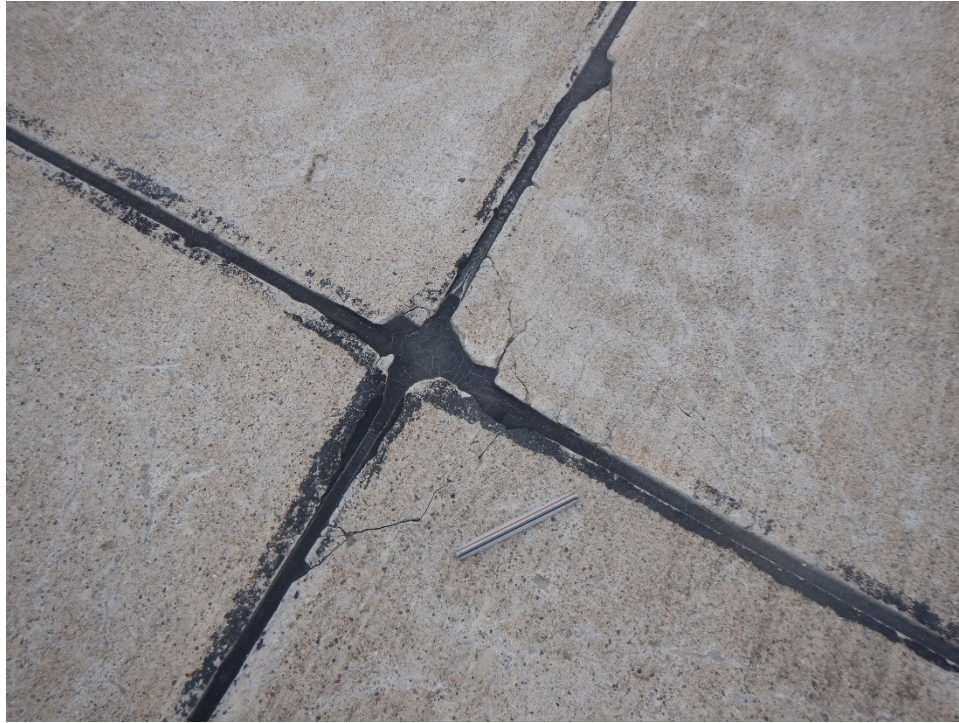
Taxiway 02 contained one section that connected Runway 09/27 to the apron area. Areas of low-severity large patching; low- and medium-severity ASR and LTD cracking; and medium-severity corner break, corner spalling, joint spalling, and joint seal damage were recorded in Section 01.

T02VI-01. ASR (Sample Unit No. 03).

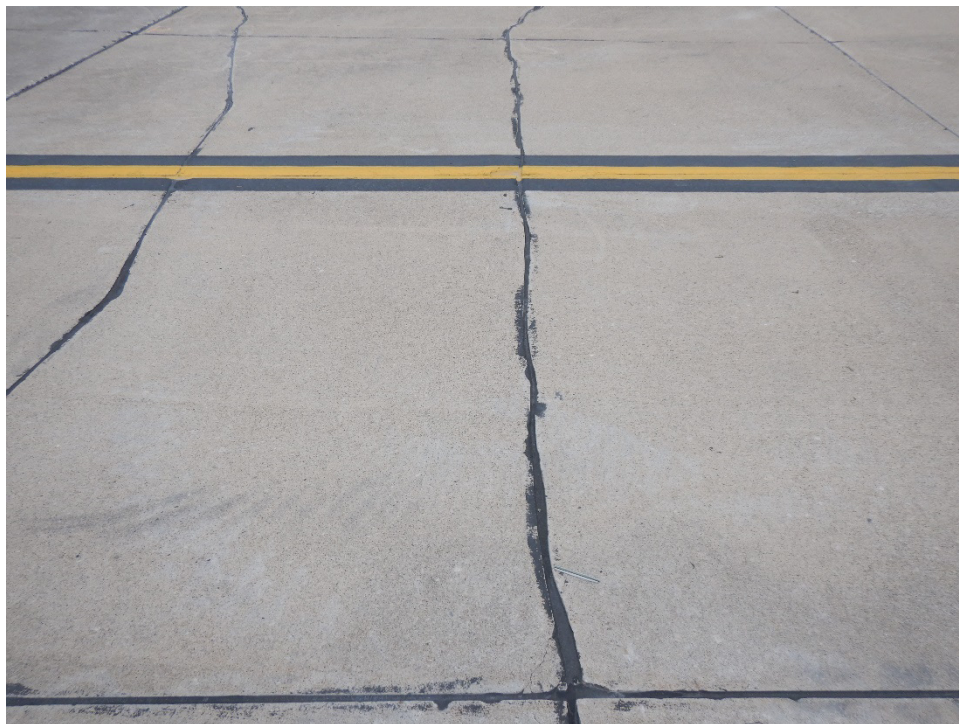
T02VI-01. LTD Cracking (Sample Unit No. 08).

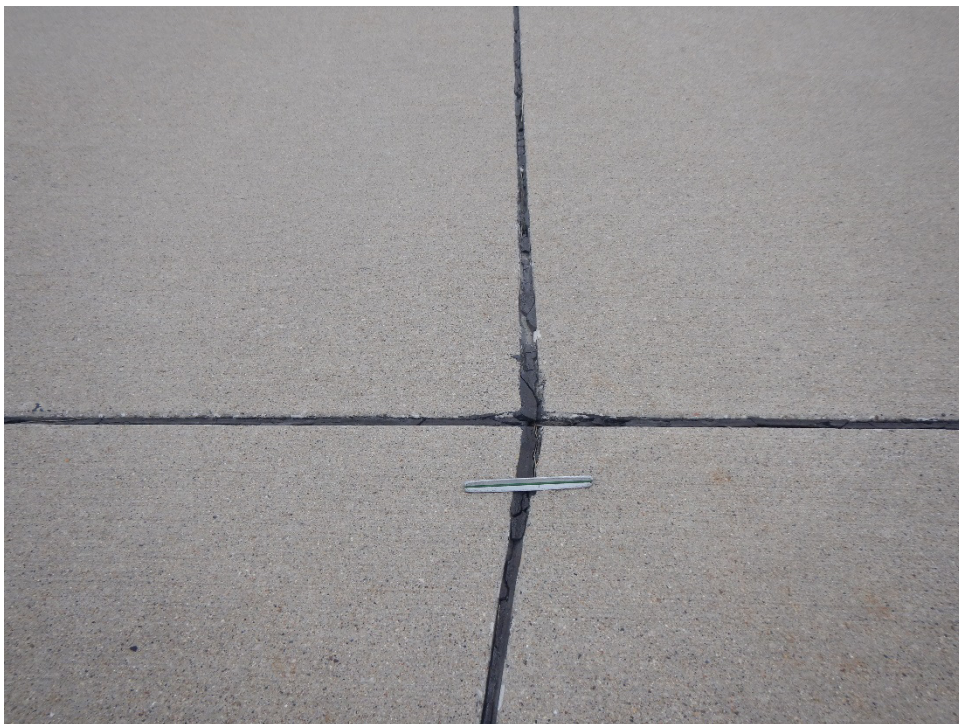
Taxiway 03 consisted of one section that was connected to the Runway 27 approach. Low-severity joint spalling and high-severity joint seal damage were identified in Section 01.

T03VI-01. Joint Seal Damage (Sample Unit No. 02).

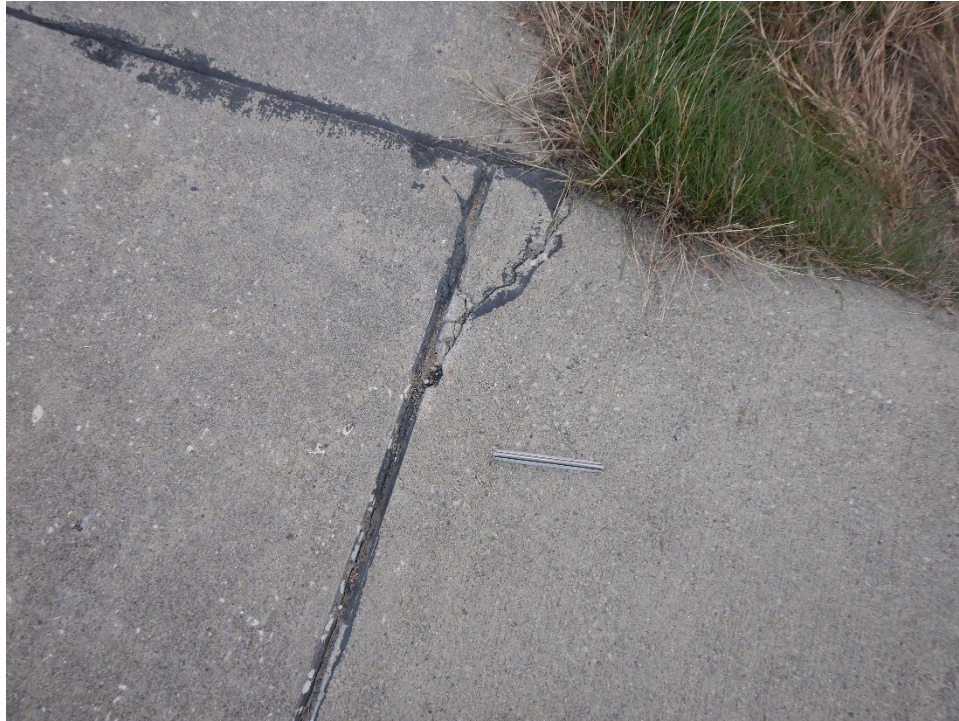
T03VI-01. Joint Spalling (Sample Unit No. 01).

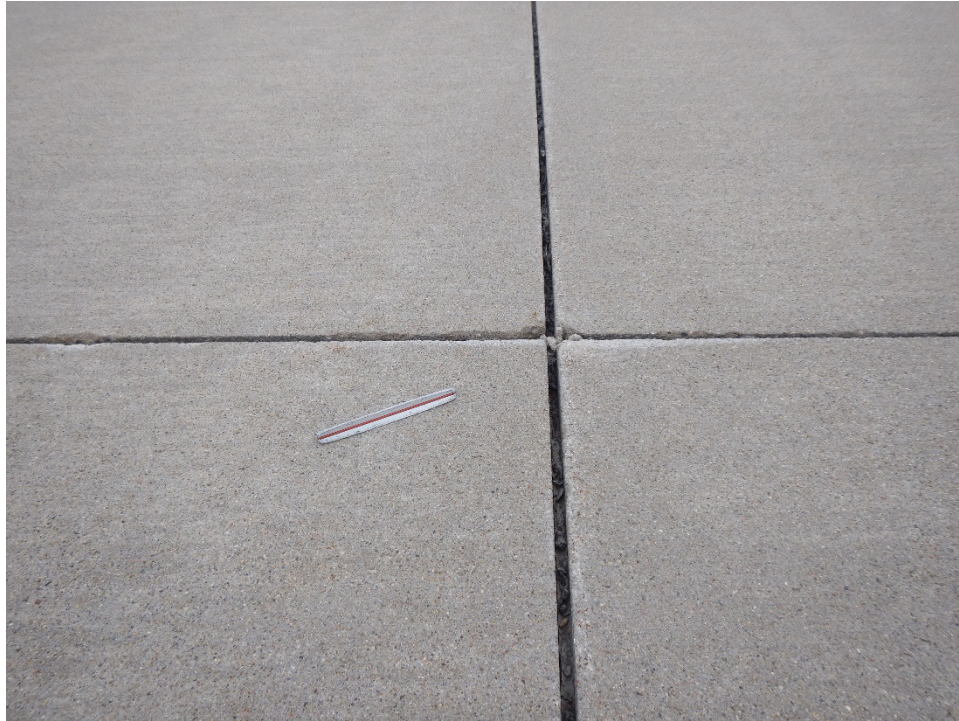
TH01VI-01. Joint Seal Damage (Sample Unit No. 02).

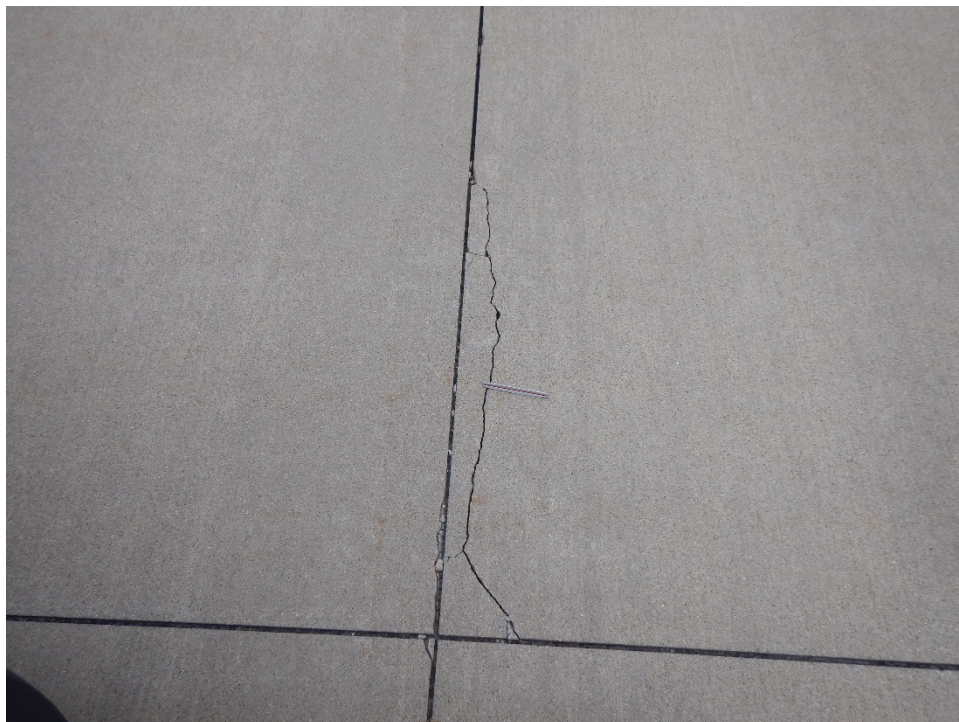
TH01VI-01. Joint Spalling (Sample Unit No. 02).

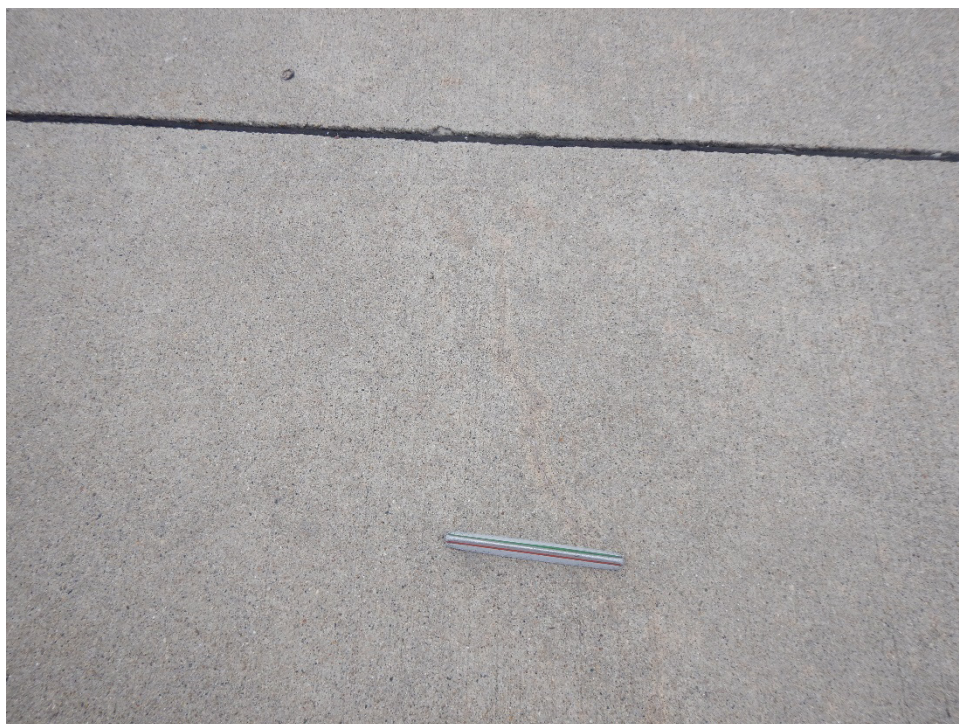
TH01VI-02. ASR (Sample Unit No. 04).
