Vinton Veterans Memorial Airpark

Pavement Management Report

JULY 2024

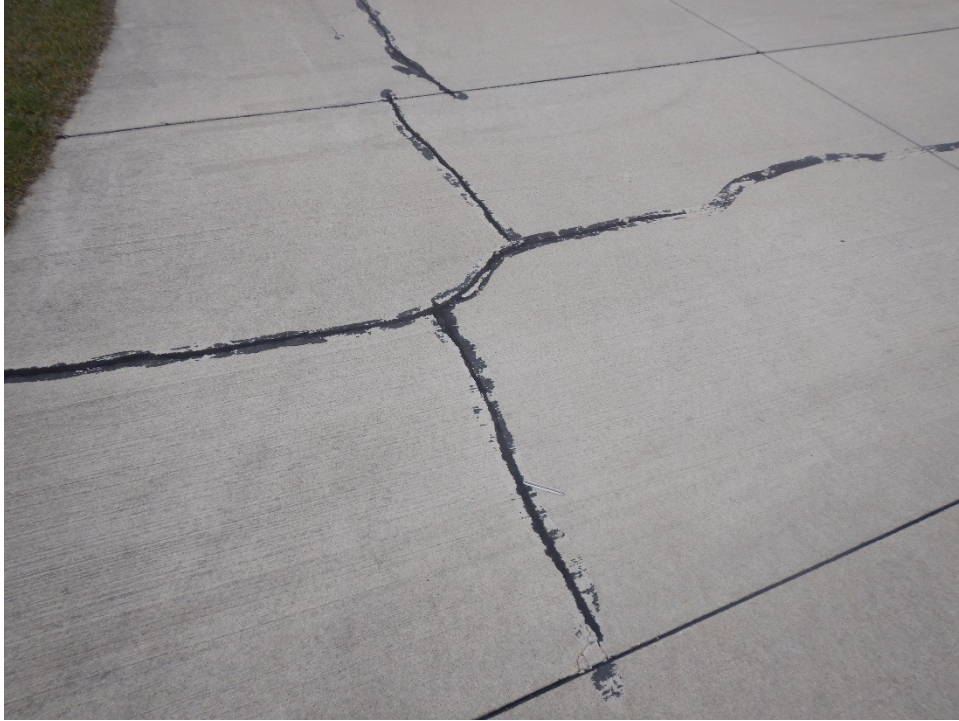
TH01VI-02. Shattered Slab (Sample Unit No. 04).

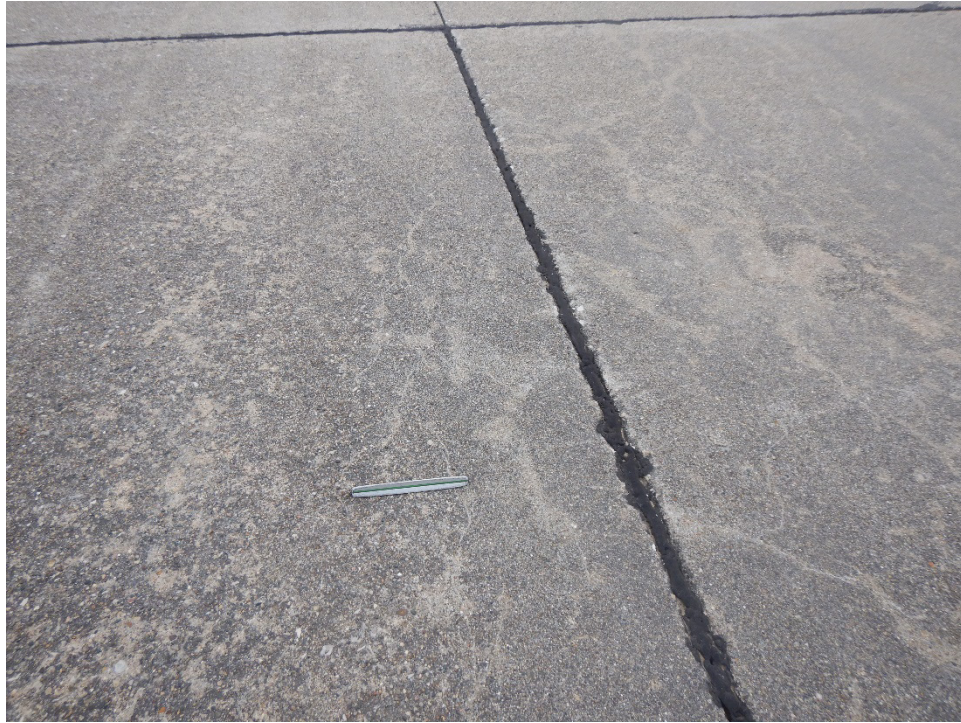
TH01VI-03. ASR (Sample Unit No. 01).

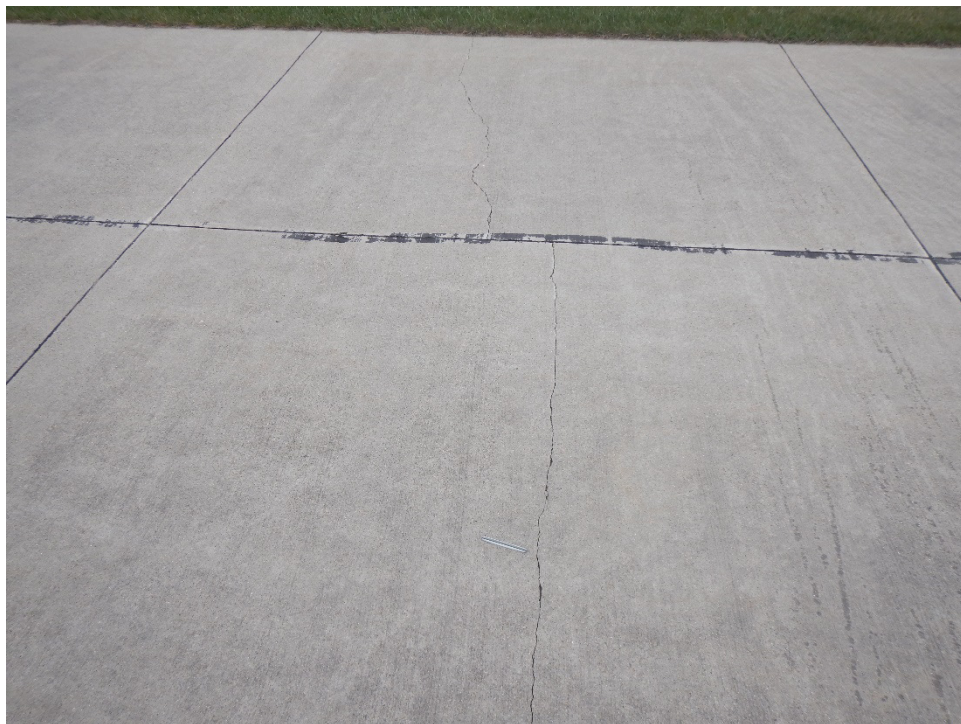
TH01VI-03. LTD Cracking (Sample Unit No. 02).

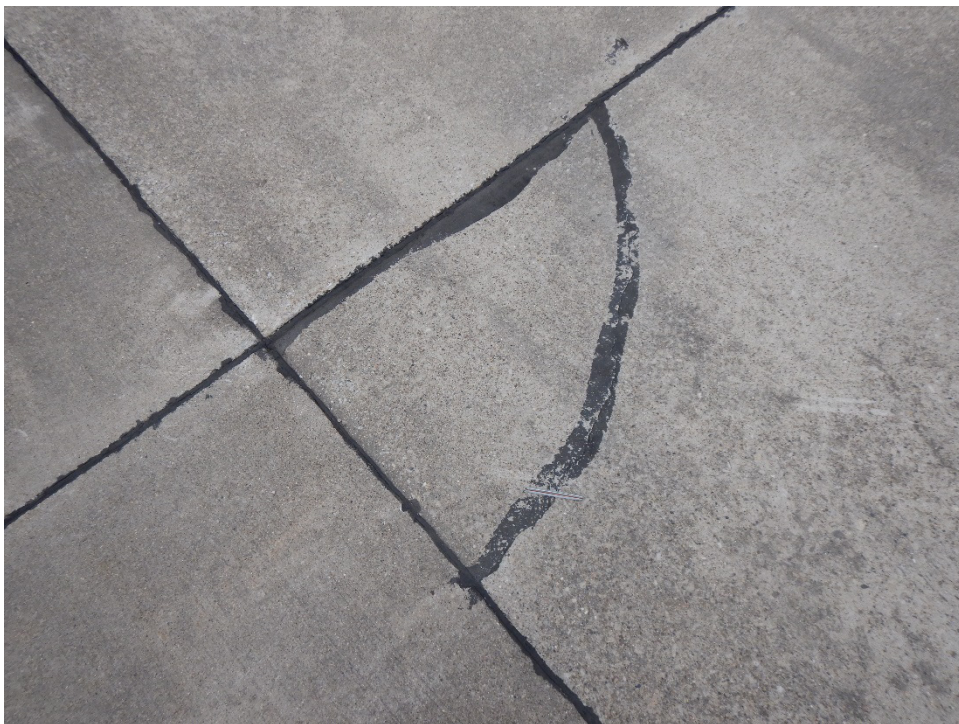
TH01VI-04. Corner Break (Sample Unit No. 01).

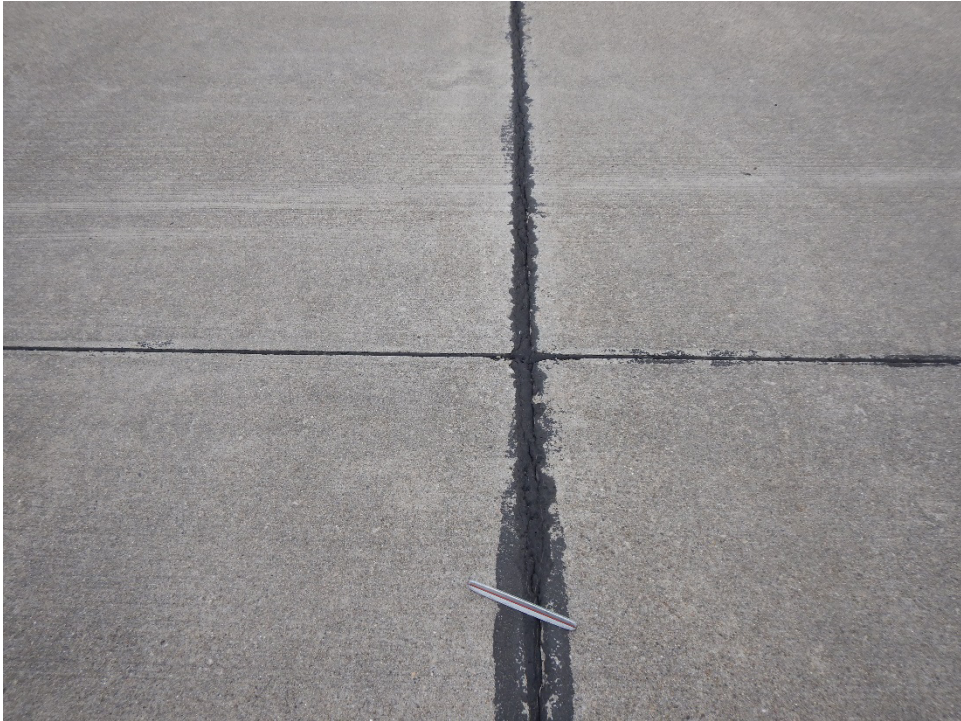
TH01VI-04. Joint Seal Damage (Sample Unit No. 02).
