Webster City Municipal Airport

Pavement Management Report

JULY 2023

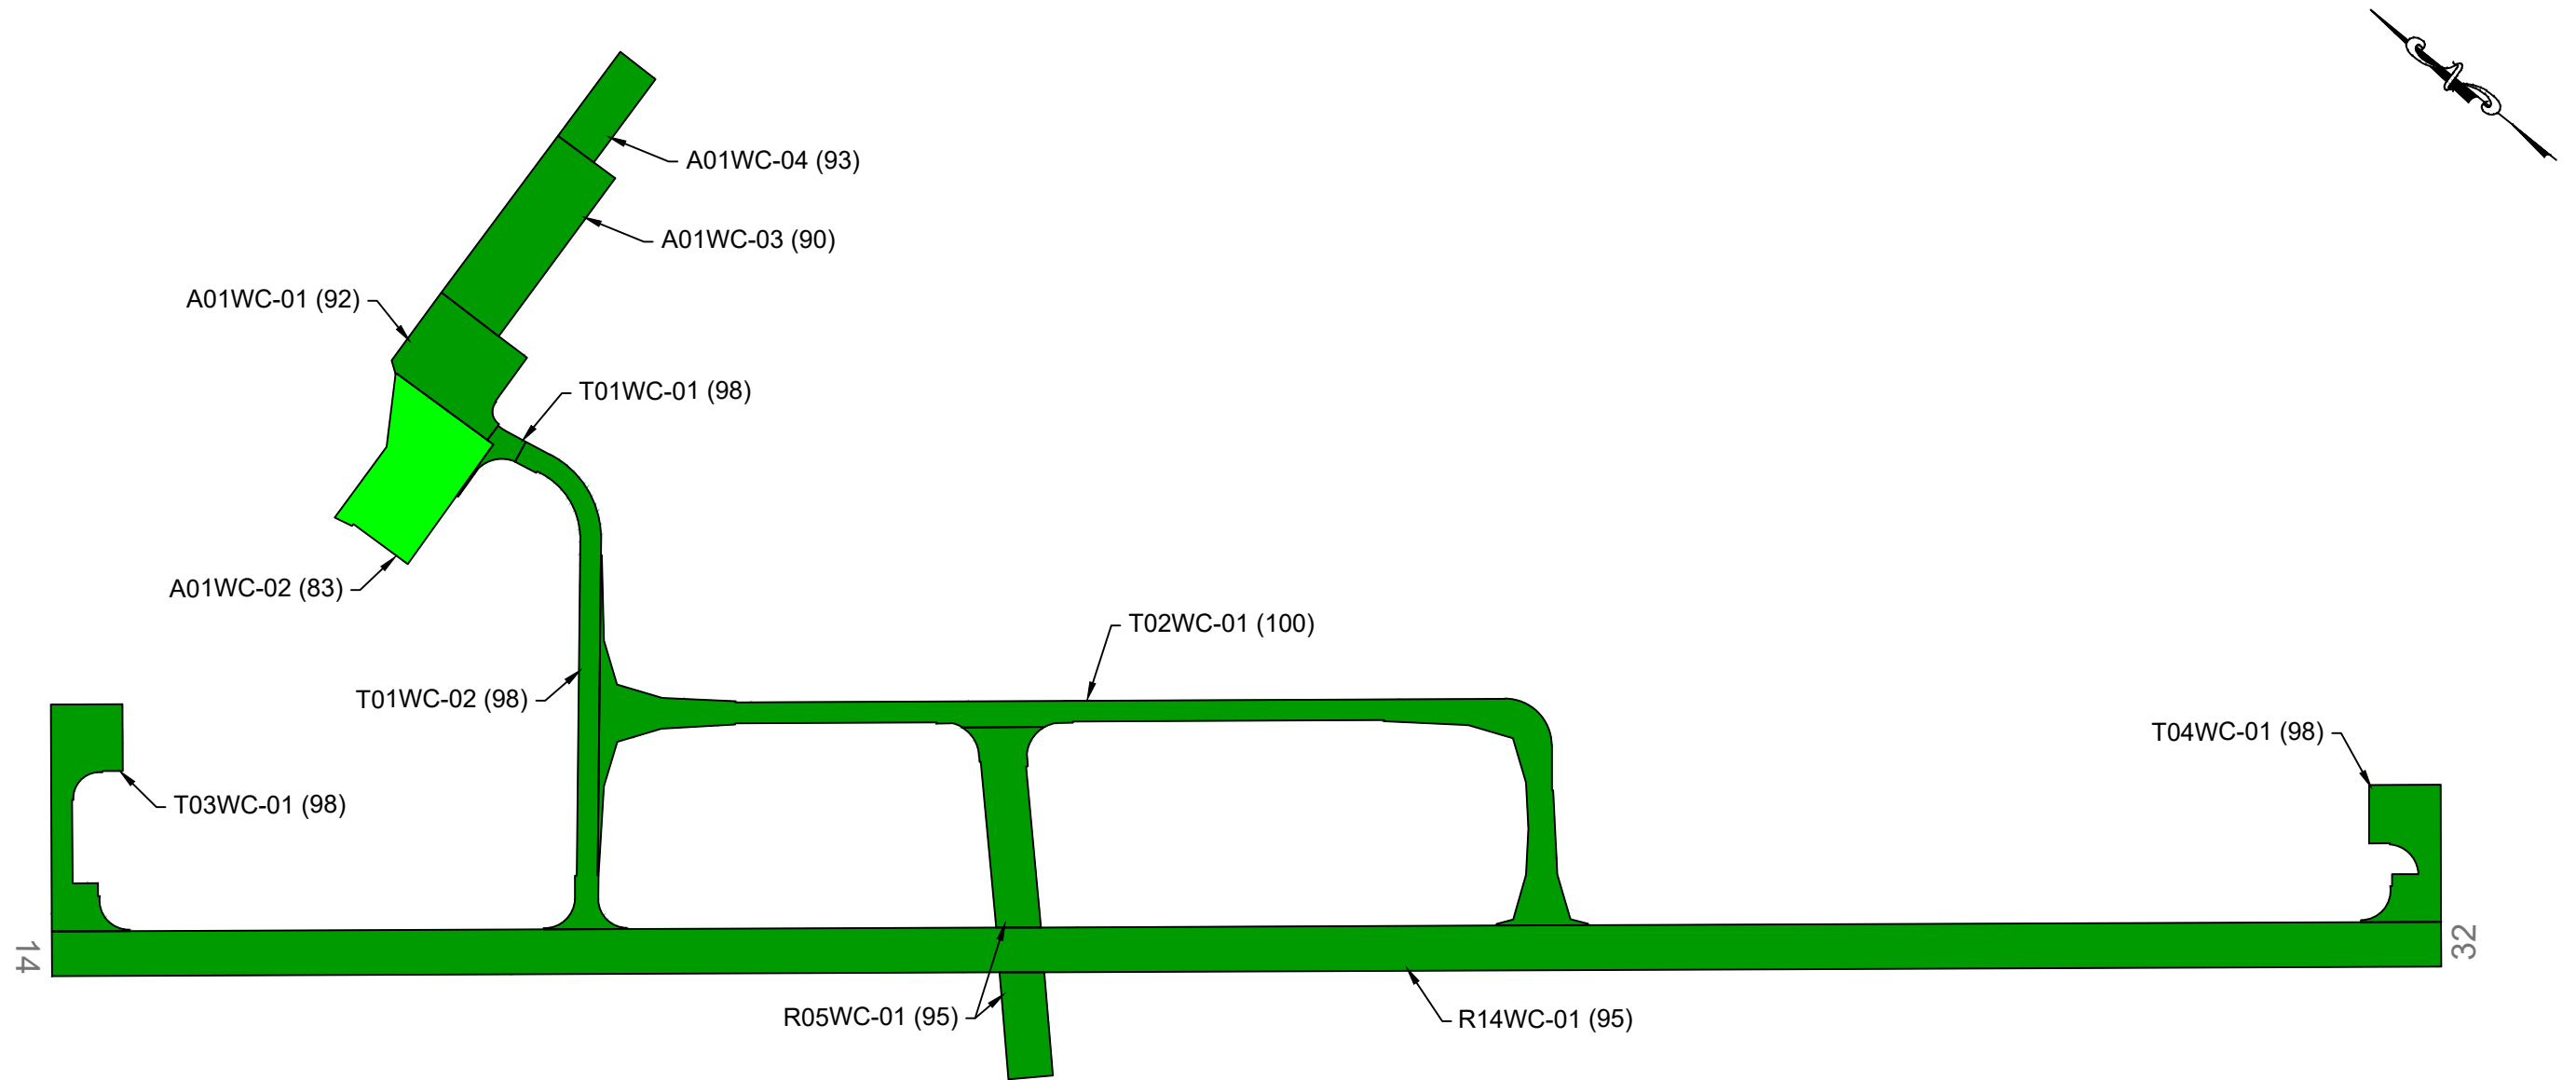
FIGURE 8. PCI MAP.

The pavements at Webster City Municipal Airport were inspected in November 2022. The 2022 area-weighted condition of Webster City Municipal Airport is 95, with conditions ranging from 83 to 100 (on a scale of 0 [failed] to 100 [excellent]). During the previous pavement inspection in 2019, the area-weighted PCI of the airport was 78.

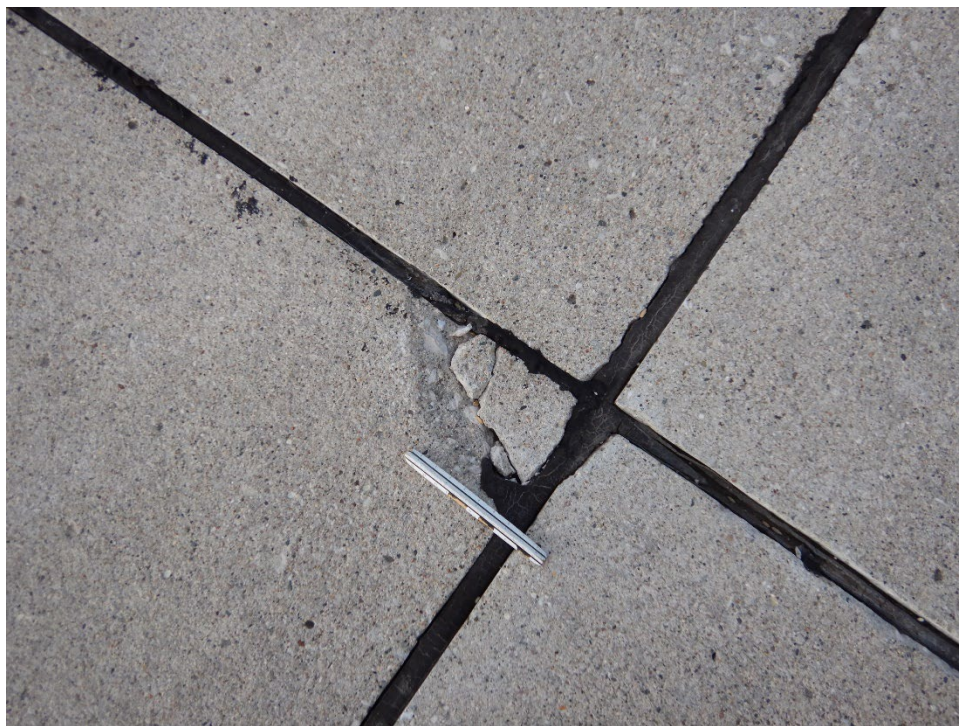
A01WC-01. Corner Spalling (Sample Unit No. 09).

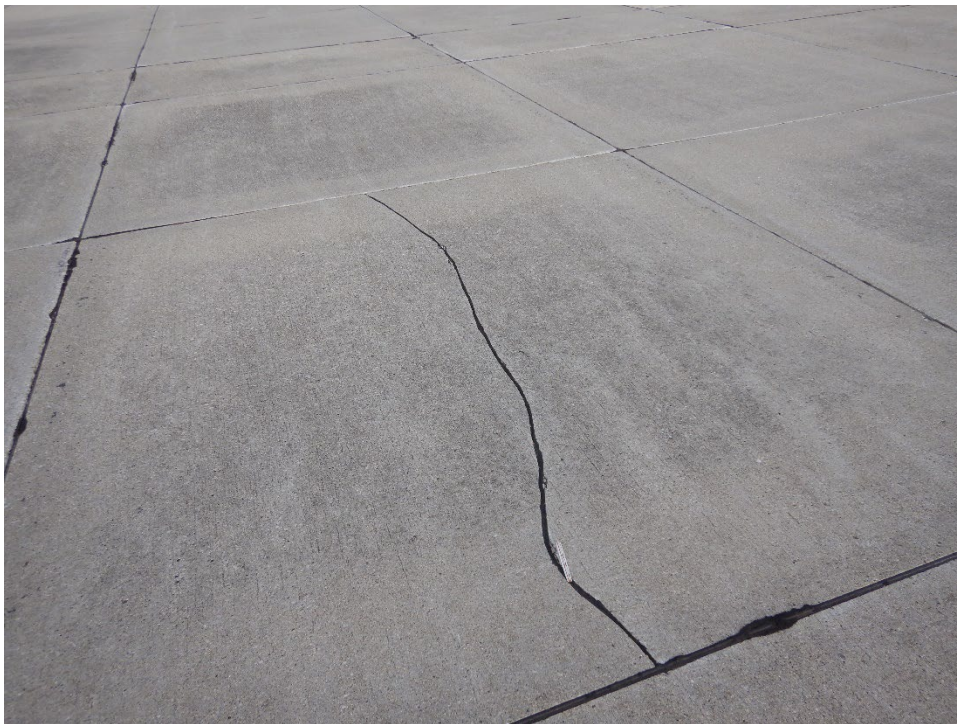
A01WC-02. LTD Cracking (Sample Unit No. 13).

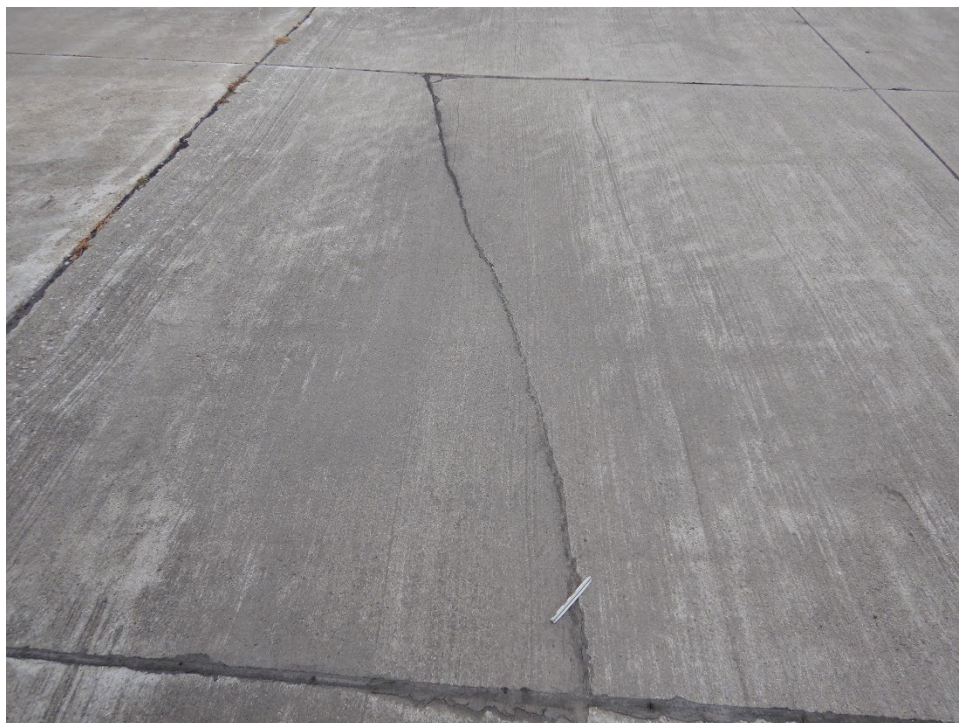
A01WC-03. LTD Cracking (Sample Unit No. 02).

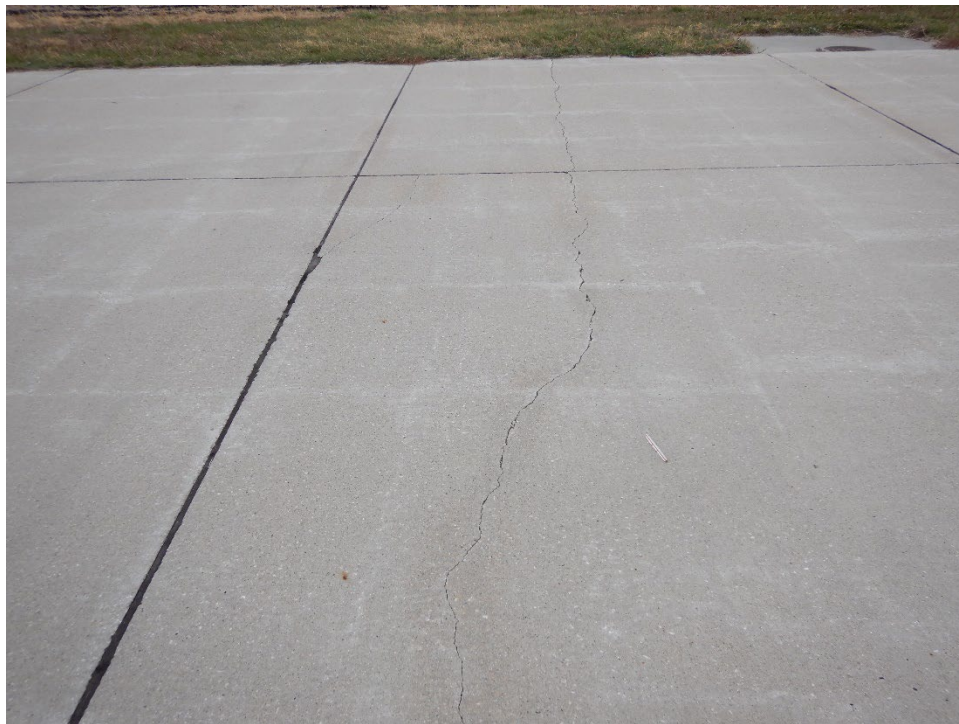
A01WC-04. LTD Cracking (Sample Unit No. 04).

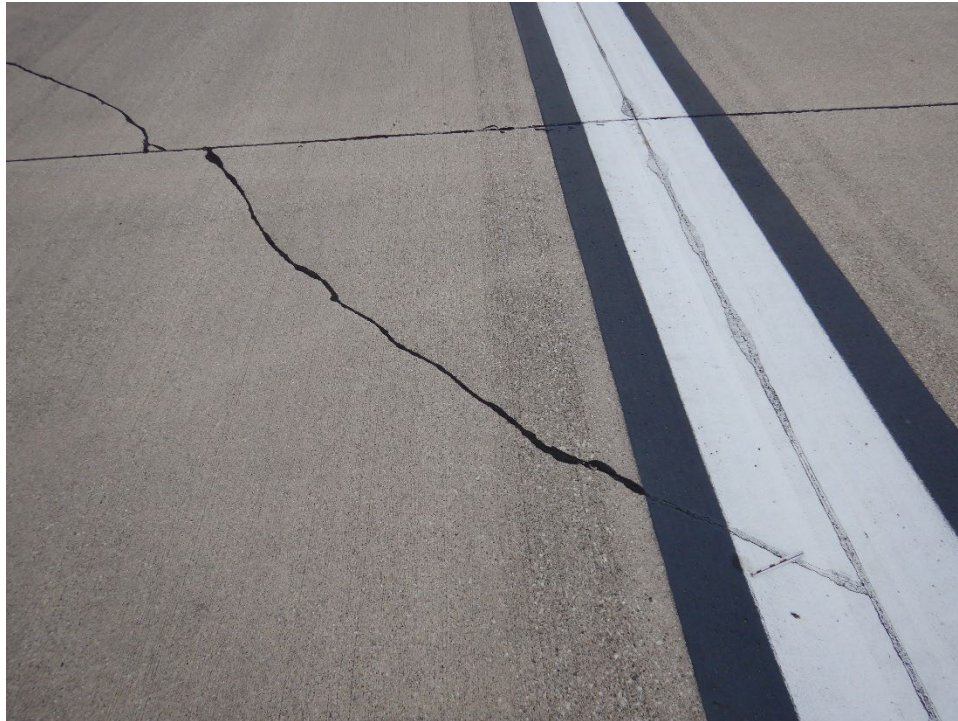
Runway 05/23 was defined by one section. Section 01 was in excellent condition with low-severity corner break, joint spalling, small patching, and LTD cracking recorded at the time of inspection.

R05WC-01. Corner Break (Sample Unit No. 08).

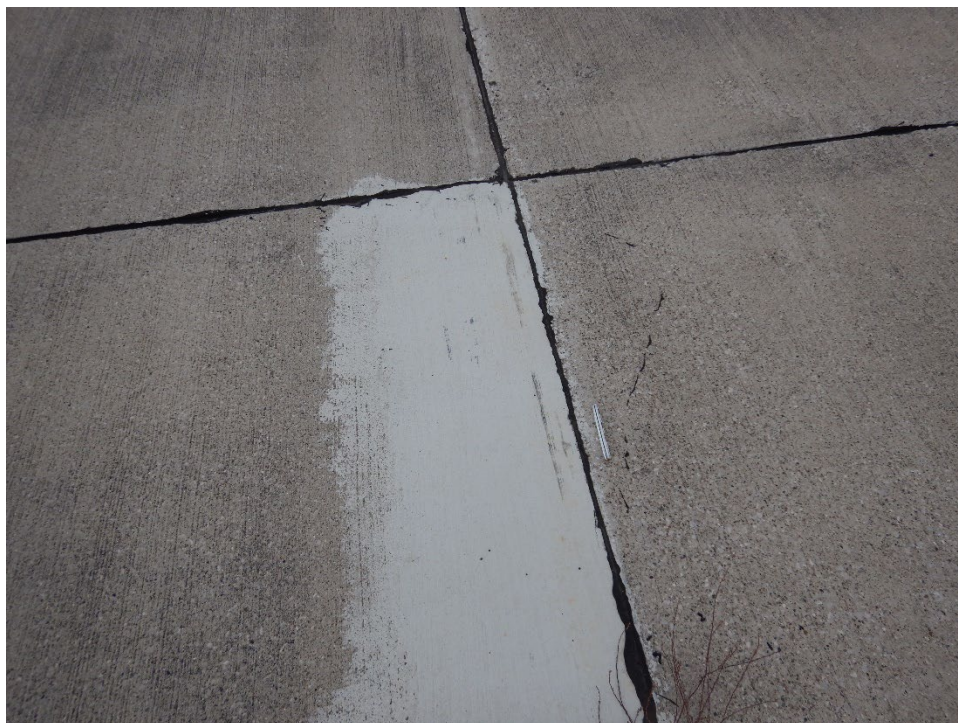
R05WC-01. Small Patching (Sample Unit No. 01).

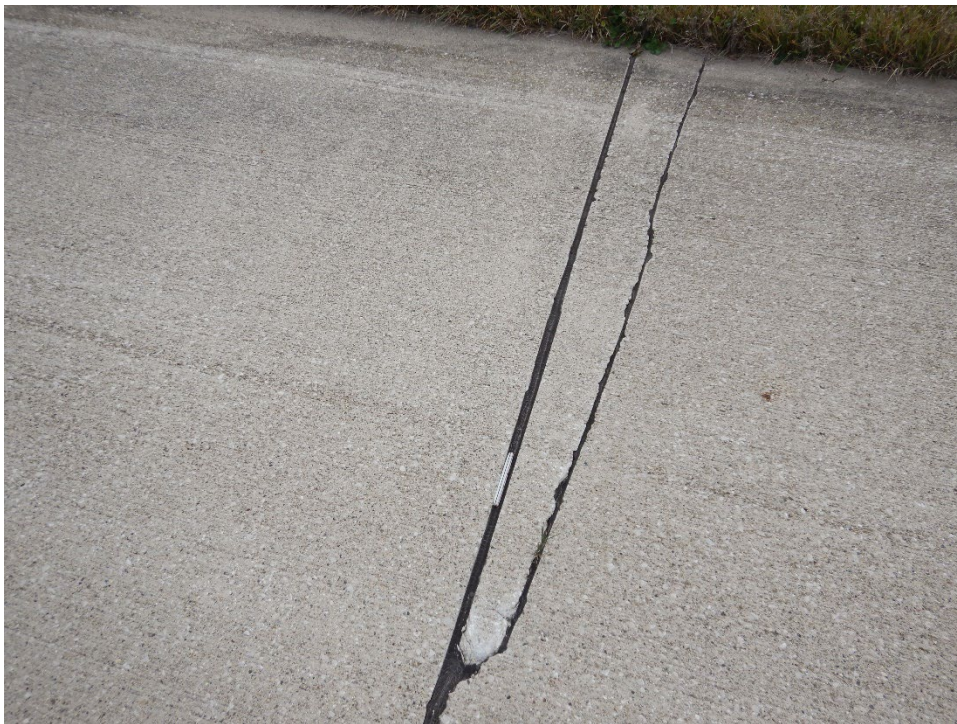
Runway 14/32 consisted of one section. Section 01 was in excellent condition with low-severity faulting; joint spalling; longitudinal, transverse, and diagonal (LTD) cracking; and small patching observed during the inspection.

R14WC-01. Joint Spalling (Sample Unit No. 61).

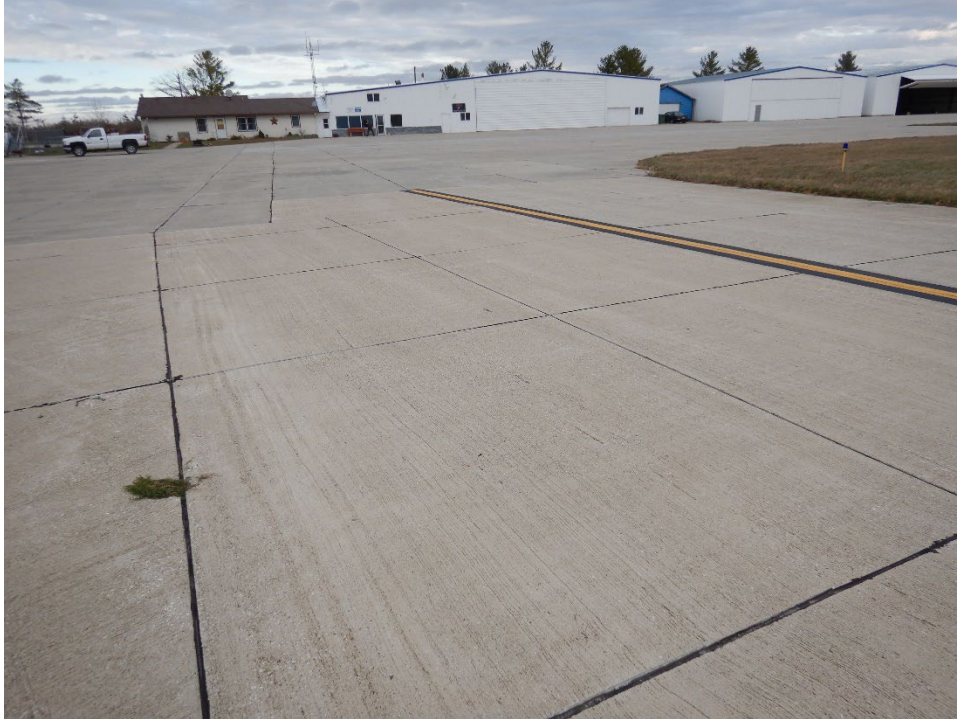
T01WC-01. Overview.

Taxiway 01 contained two sections. Section 01 was in excellent condition with only medium-severity corner spalling recorded. Section 02 was also in excellent condition with medium-severity LTD cracking and low-severity small patching and joint spalling observed at the time of inspection.

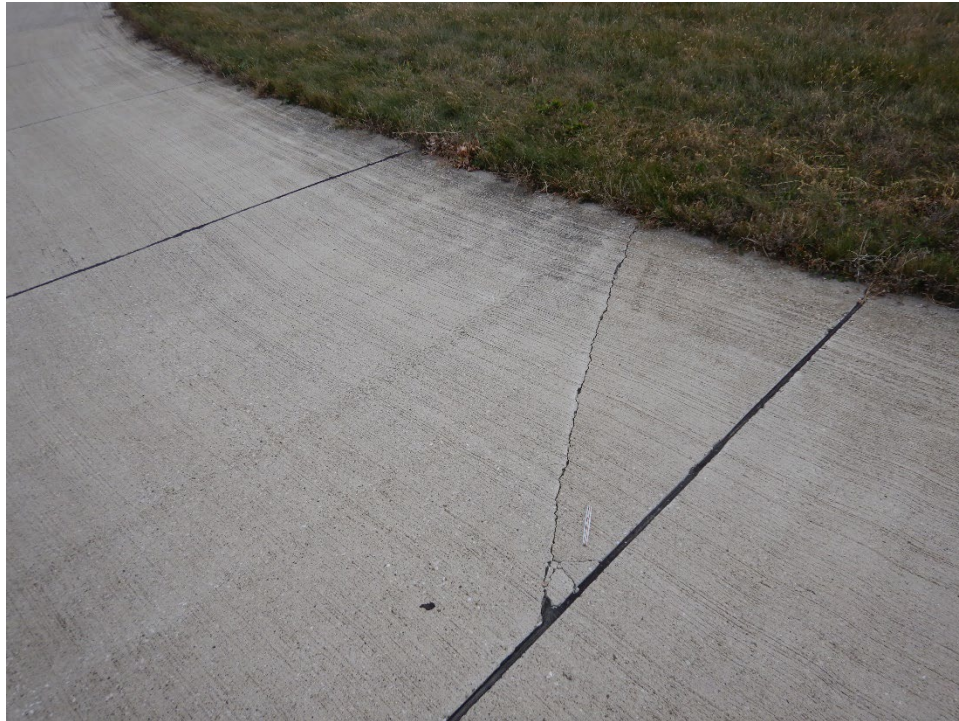
T01WC-02. LTD Cracking (Sample Unit No. 02).

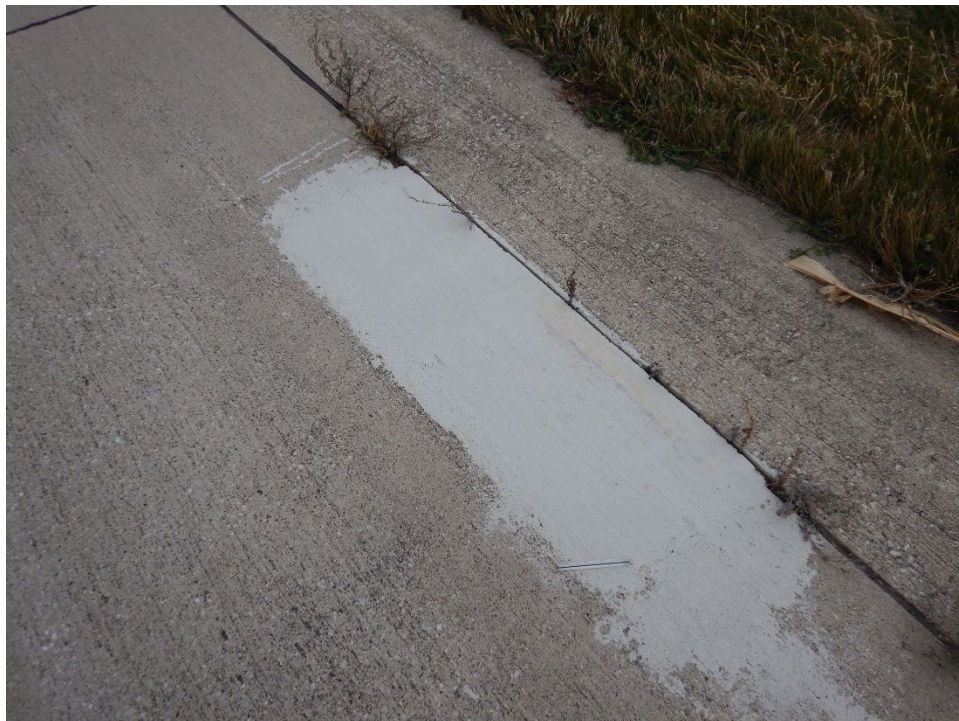
T01WC-02. Small Patching (Sample Unit No. 16).

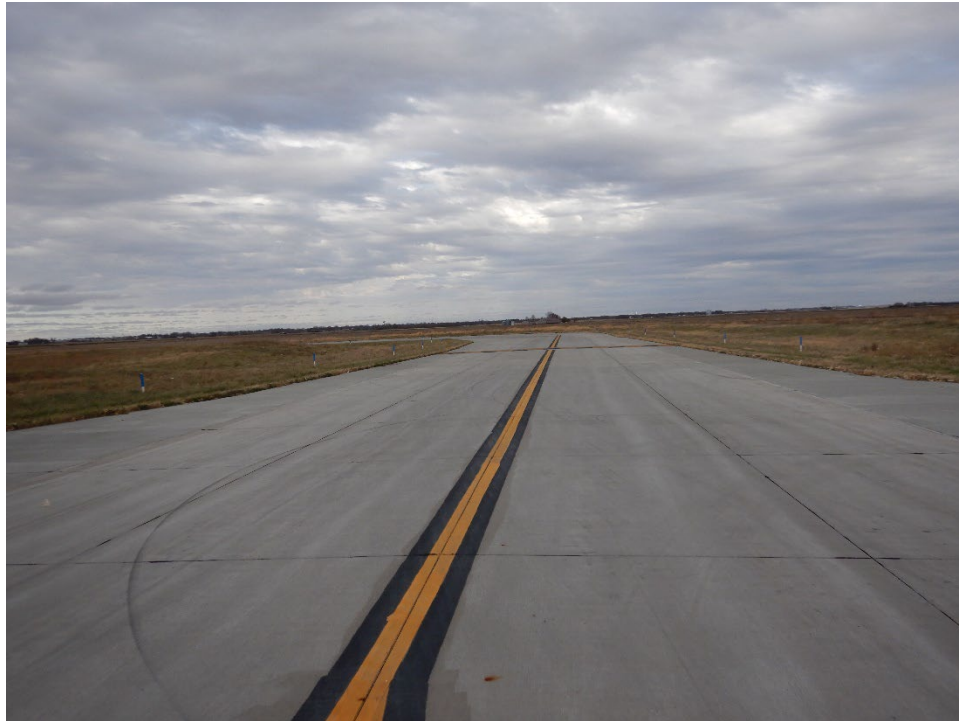
T02WC-01. Overview.

Taxiway 02 was defined by one section that was in excellent condition. No distresses were noted during the inspection.

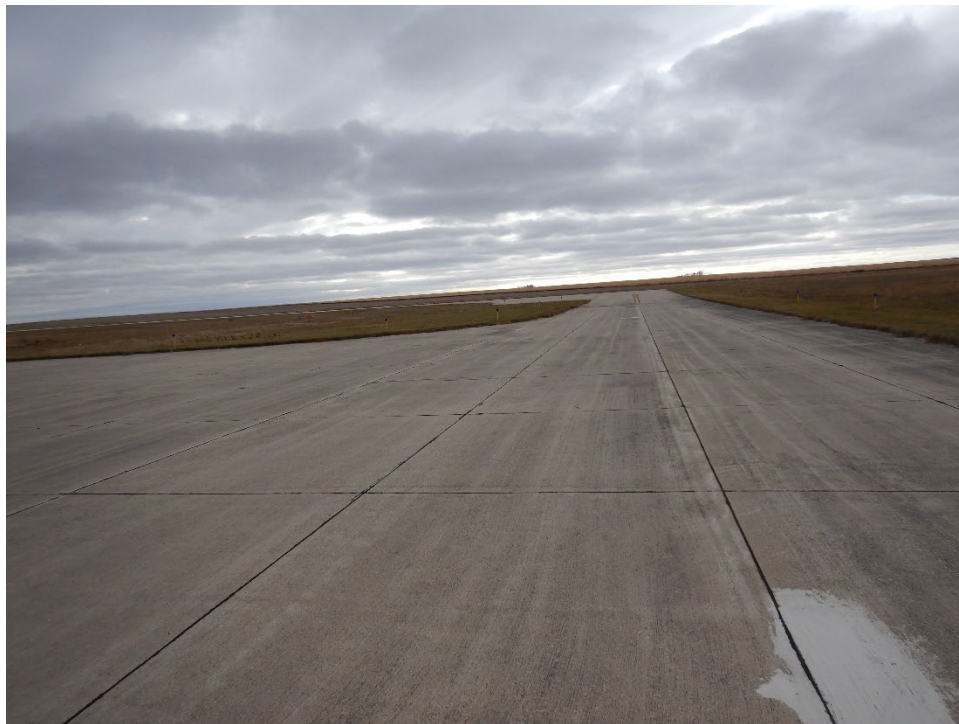
T03WC-01. Overview.

Taxiway 03 was located near the Runway 14 approach and consisted of one section. Section 01 was in excellent condition with medium-severity joint spalling and low-severity faulting, joint seal damage, and small patching recorded.

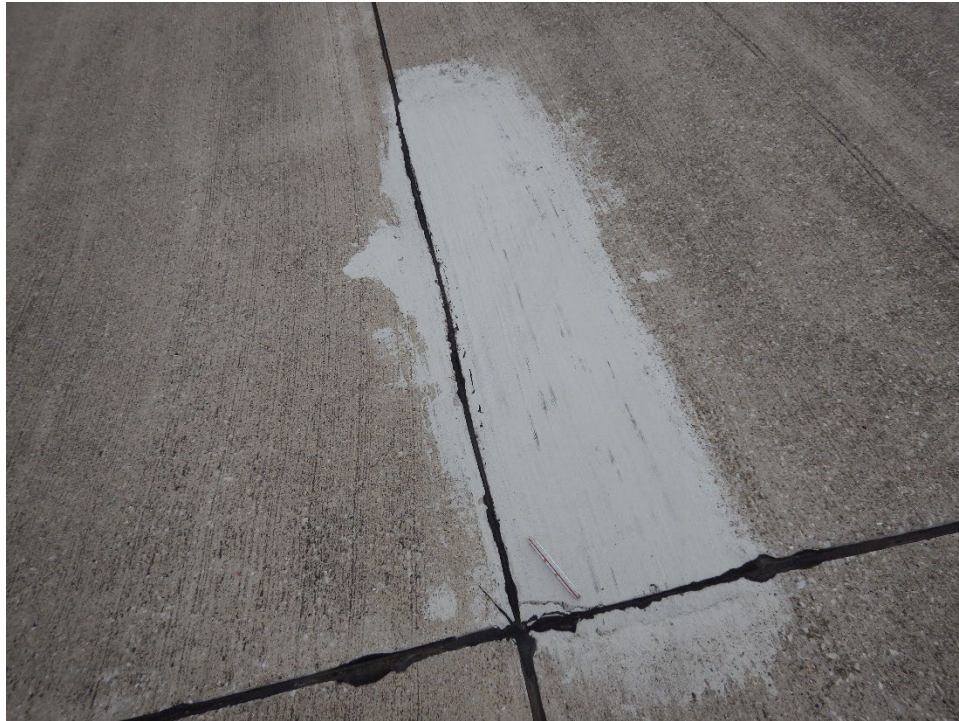
T03WC-01. Small Patching (Sample Unit No. 11).

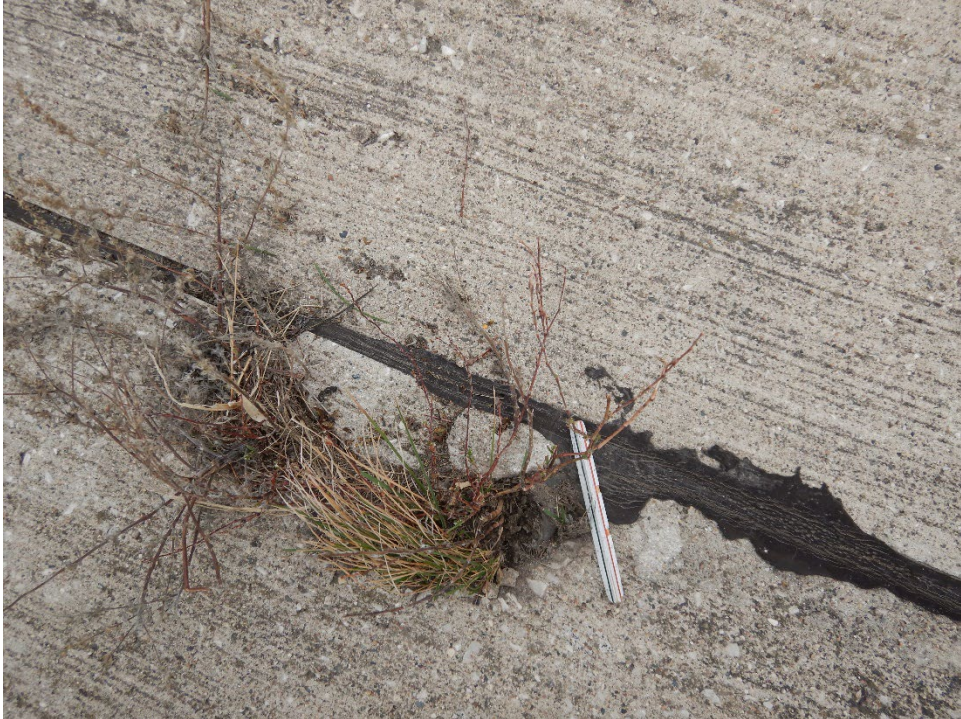
Taxiway 04 contained one section that was located near the Runway 32 approach. Section 01 was in excellent condition with low-severity faulting, low- and medium-severity joint spalling, and shrinkage cracking identified throughout.

T04WC-01. Joint Spalling (Sample Unit No. 10).
