EVALUATION OF THE BETTENDORF BRIDGE, IOWA

Final Report
July 2006

A report from
Center for Transportation Research and Education

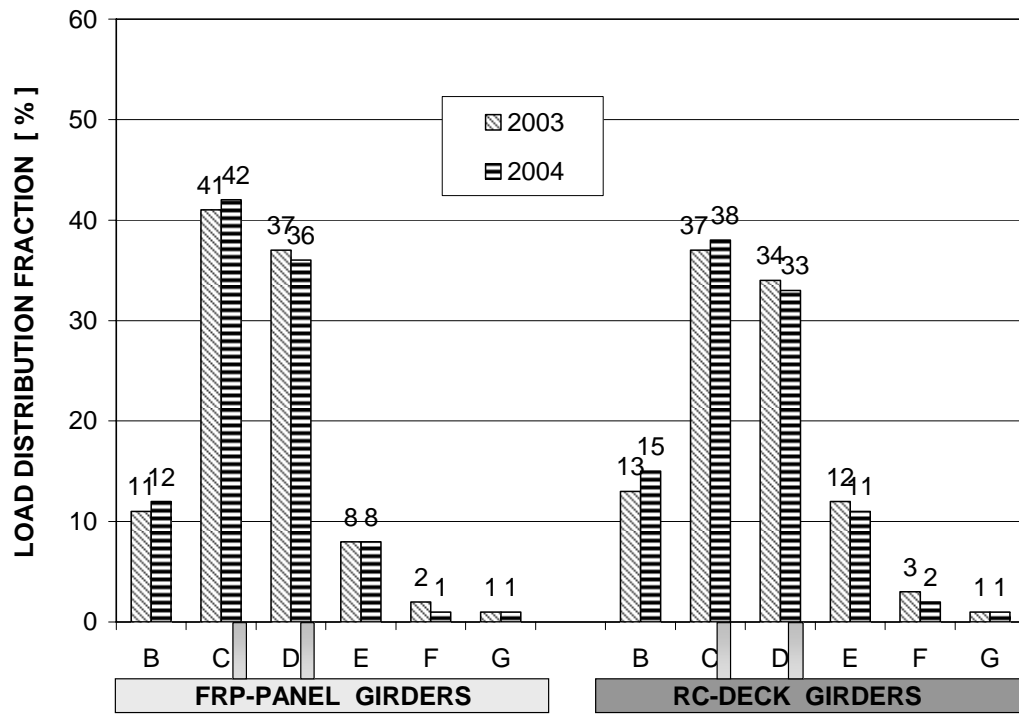
The Path Y2 LDF, shown in Figure 39, illustrates the same pattern between the two tests with only minimal differences. Although Path Y3 and Path Y4 were not coincident during the two-year study, it was observed that the LDFs for both were lower than 47% (Figure 40 and Figure 41).

Figure 39. Path Y2 LDF

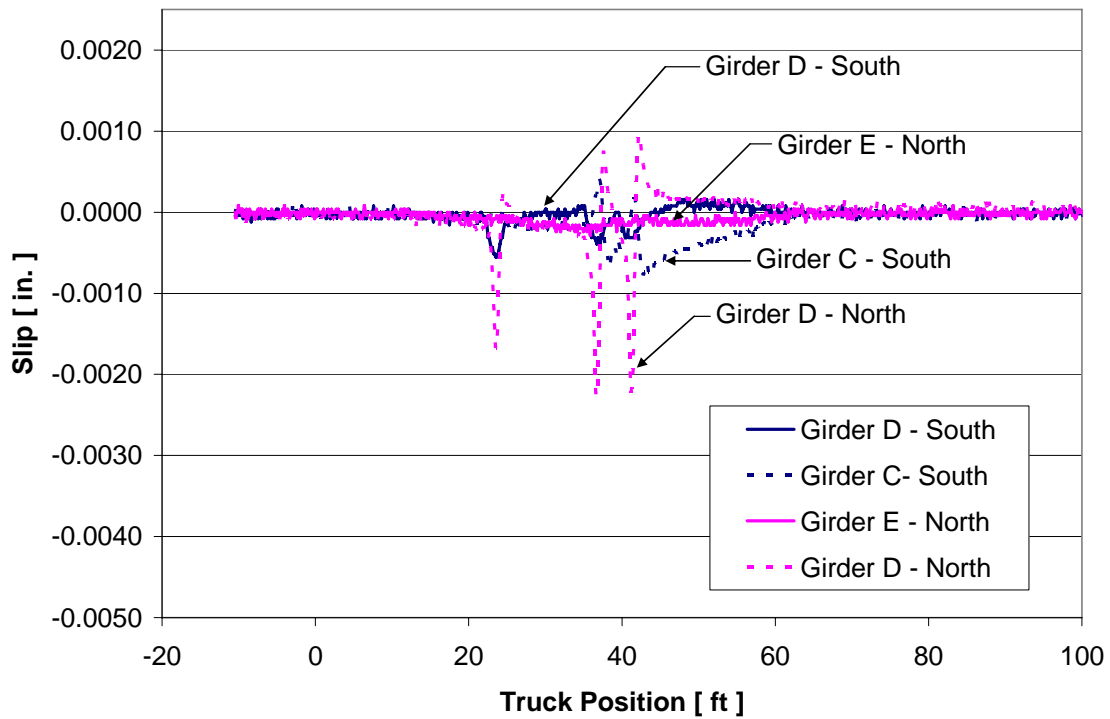
During the 2003 test, the peak measured slip, as shown in Figure 52, was 0.00226 in. and occurred when a truck tire was immediately over the instrumented section. Previous laboratory testing on the beam-to-slab connection (Wood et al, 2001) used in this bridge indicated that this level of slip (i.e., 0.00226 in.) corresponded to a horizontal shear force of approximately 9.8 kip or 26% of the connection’s measured ultimate strength. It should be pointed out that the testing by Wood et al (2001) was completed on simple push out samples which can vary significantly from flexural members. Likewise, during the 2004 test, the maximum slip found was 0.004501 in. on Girder D North. The associated horizontal shear force was 19.5 kip, about 52% of the measured ultimate strength (Figure 53). Table 2 summarizes the differential deflections (i.e. slip) measured during the two-year tests for Girders C and D for Path Y2 which was the most critical case.

**Figure 52. 2003 Path Y2 Deck-to-Girder Slip**
