APPENDIX A

Visual, Sounding, and Half-Cell Potential Plans

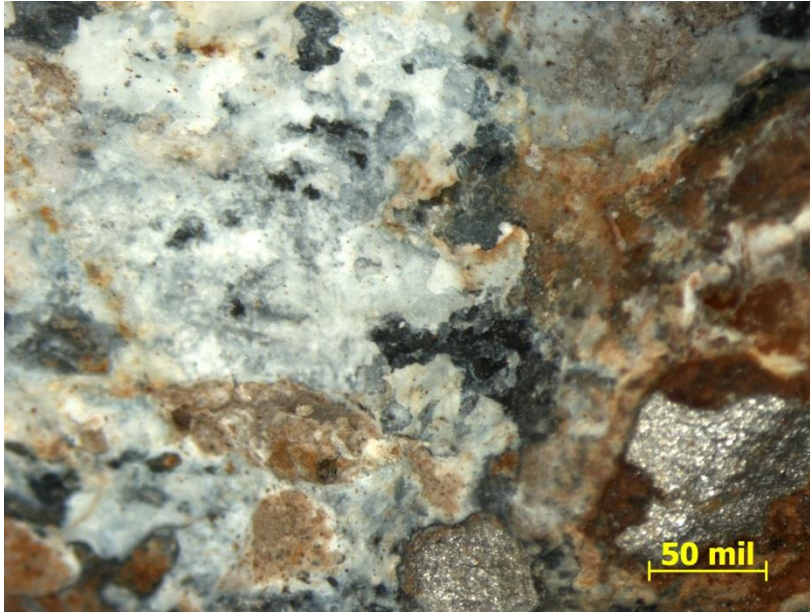
Figure 15. Micrograph of the bottom surface of Sample 9, showing white corrosion product.

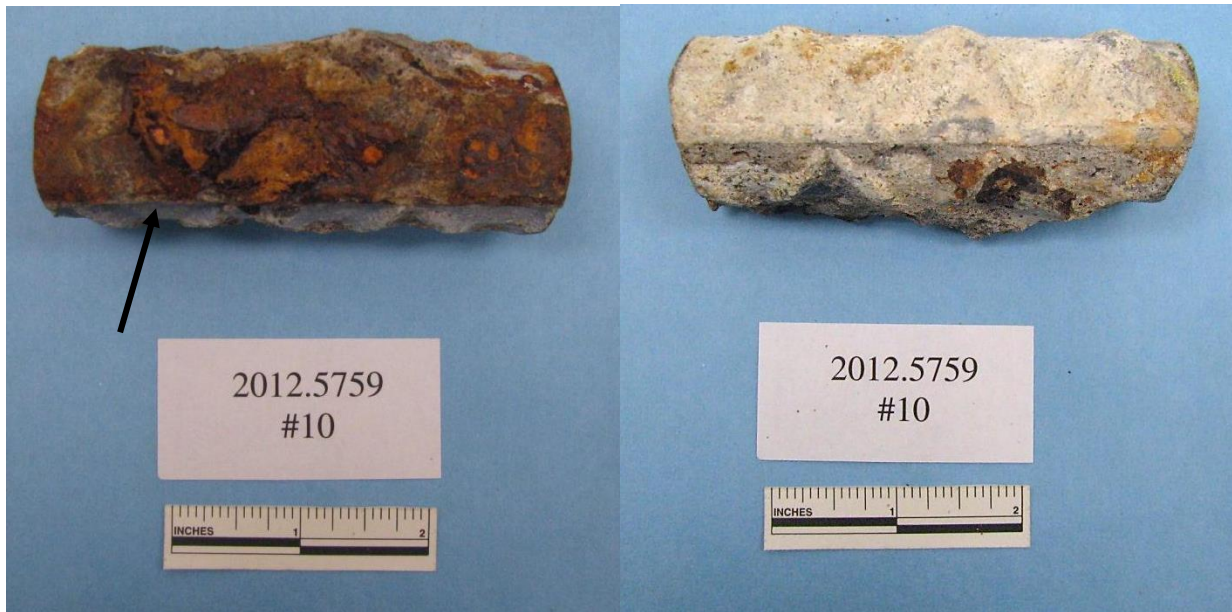
Figure 16. Sample 10. Top side (left) and bottom side (right). The stripe of blue-gray deposit is indicated with an arrow.

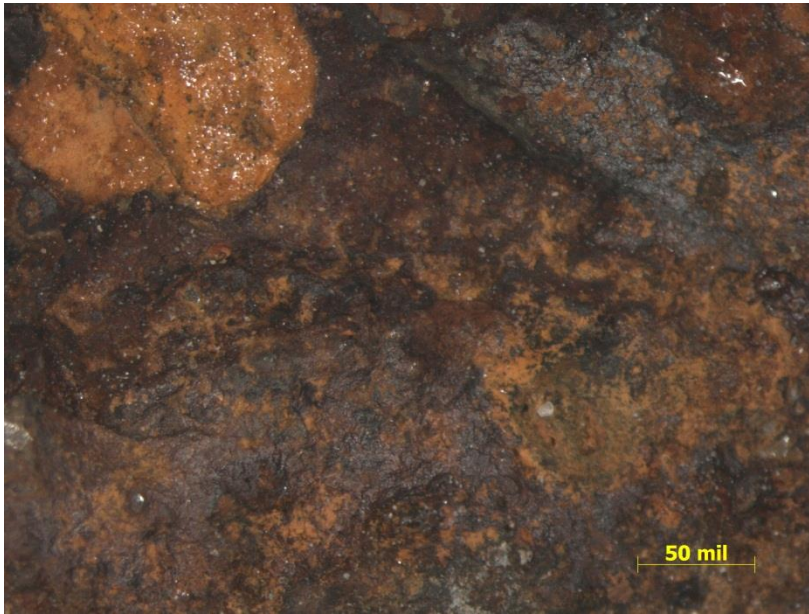
Figure 17. Micrograph of the top surface of Sample 10, showing red corrosion product from the steel.

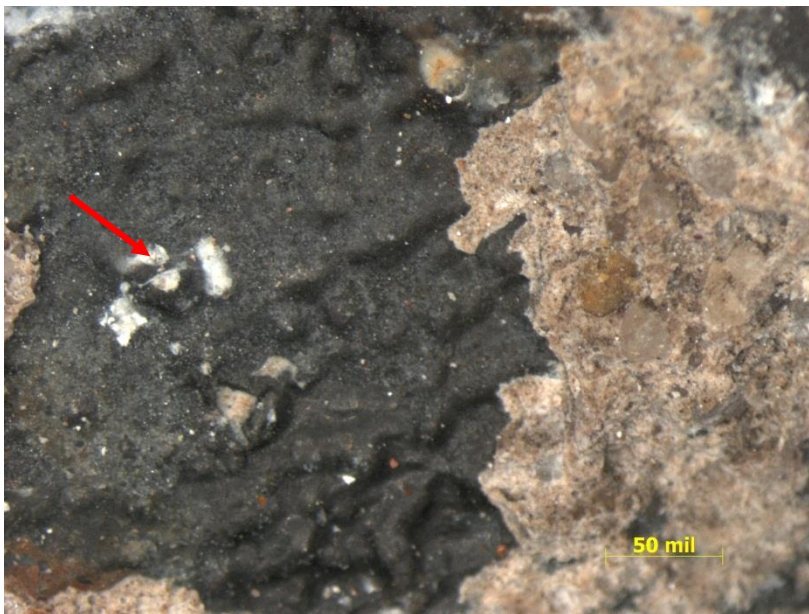
Figure 18. Micrograph of the side of Sample 10, showing concrete (indicated with an arrow) and a dark gray surface with only a small amount of white corrosion product.

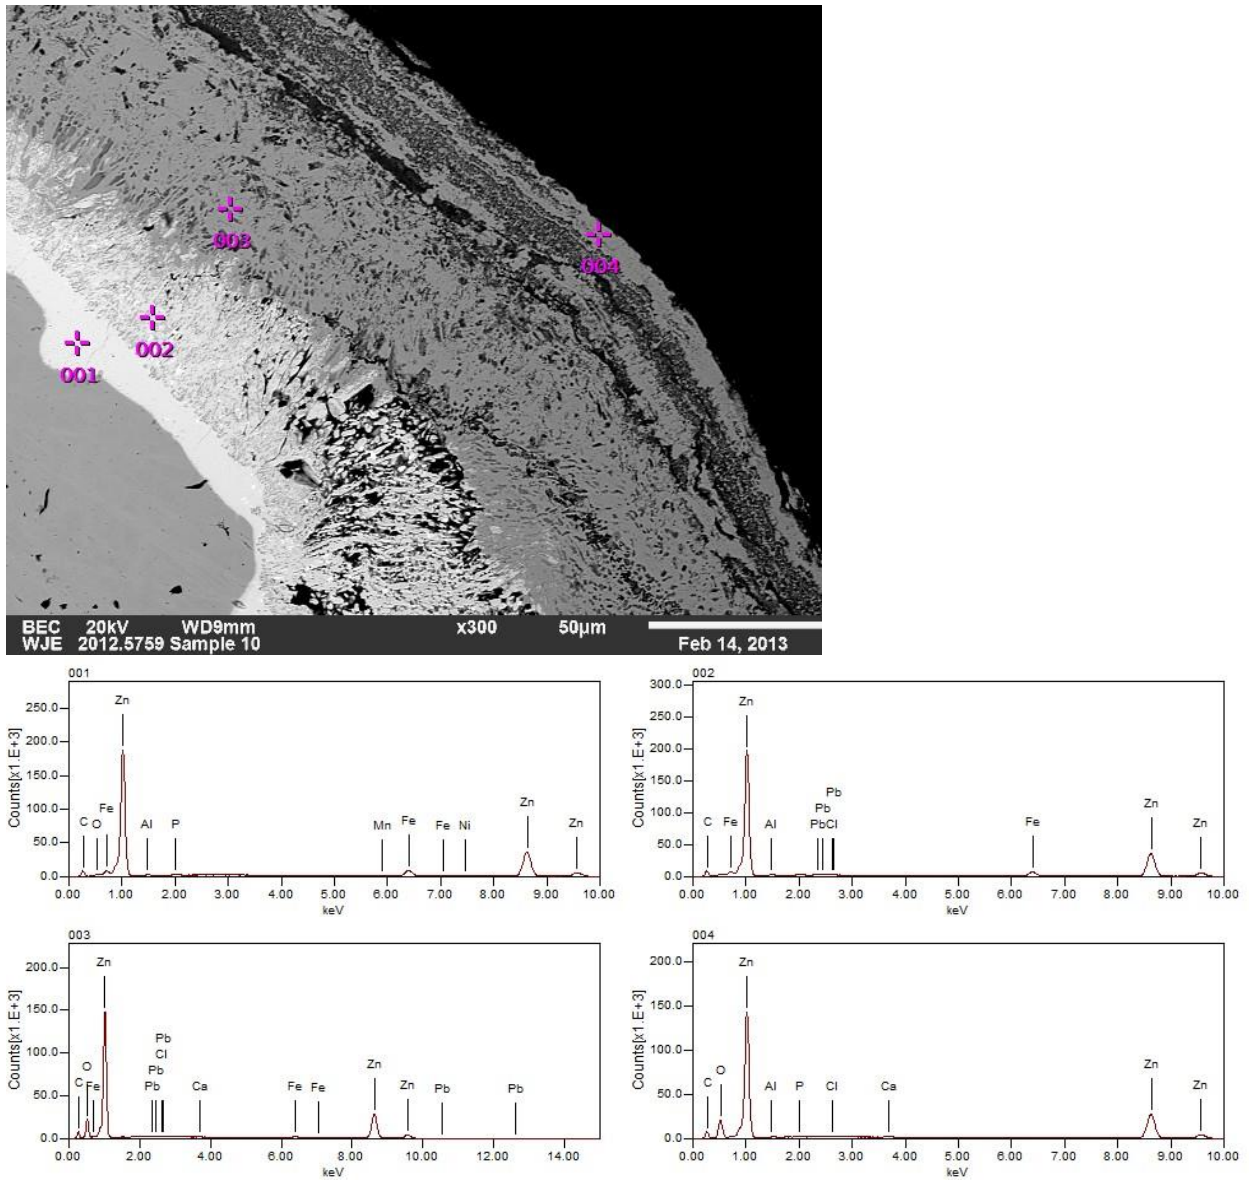
Figure 25. Cross-sectional BE image and point EDS spectra of the zinc layer Sample 10. Very little chlorine is incorporated into the zinc corrosion product (see EDS 004). Each EDS spectrum has a number above the upper left corner which corresponds to the location indicated on the micrograph. A minor amount of chlorine is present in the epoxy mounting medium.

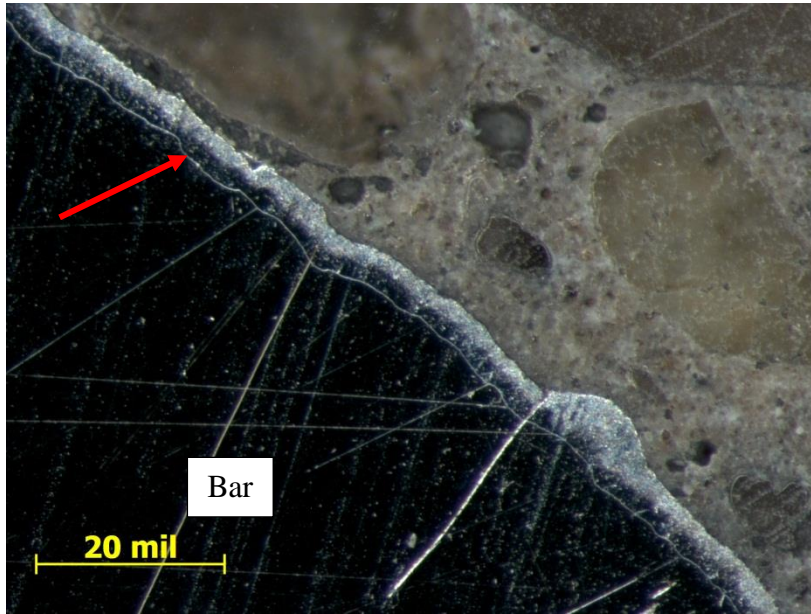
Figure 27. Cross-section of Sample 3, showing the bar, the zinc layer (arrow), and concrete adhered to the bar.

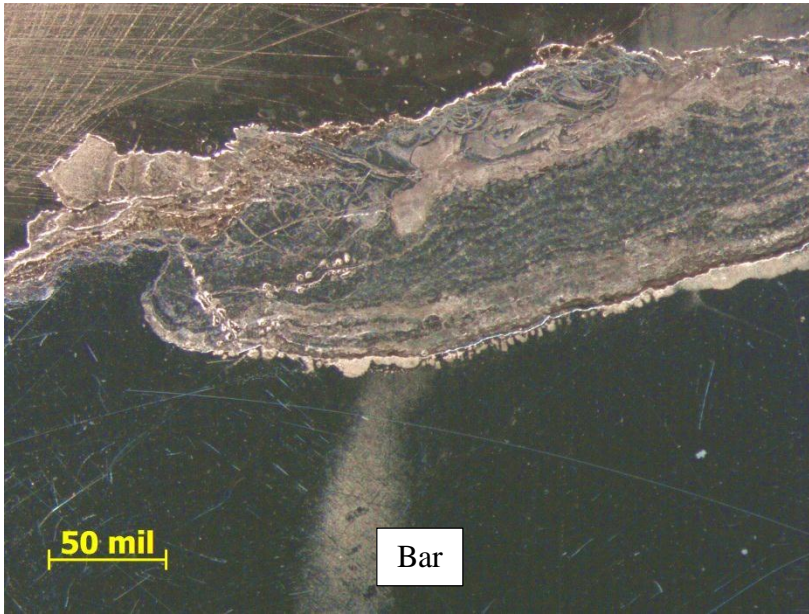
Figure 35. Cross-section of Sample 10, showing the corroded bar and pitting corrosion.

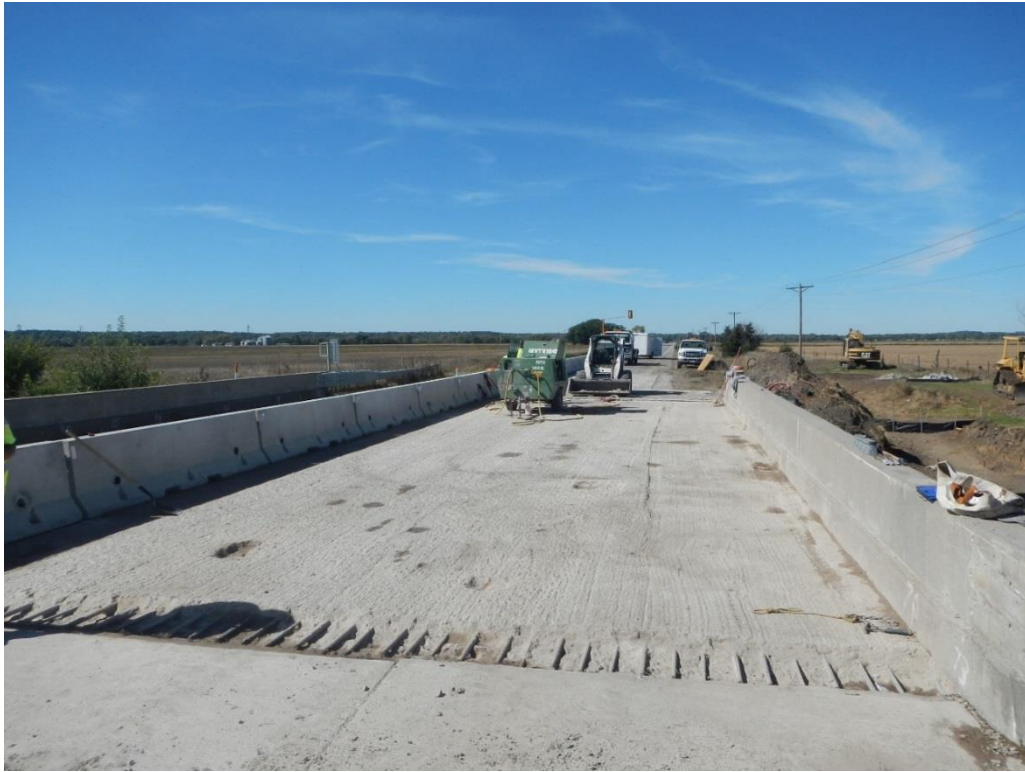
Figure E1. Overall view of IA92 deck, westbound lanes during Oct. 7, 2013 site visit.
