### **Load Test to Assess Fatigue Detail Performance on Westbound I-80 Bridge over the Cedar River**

February 8, 2010

**Iowa Department  
of Transportation**

**Bridge Engineering Center**  
2901 South Loop Dr.  
Suite 3100  
Ames, IA 50010  
(515) 294-8103

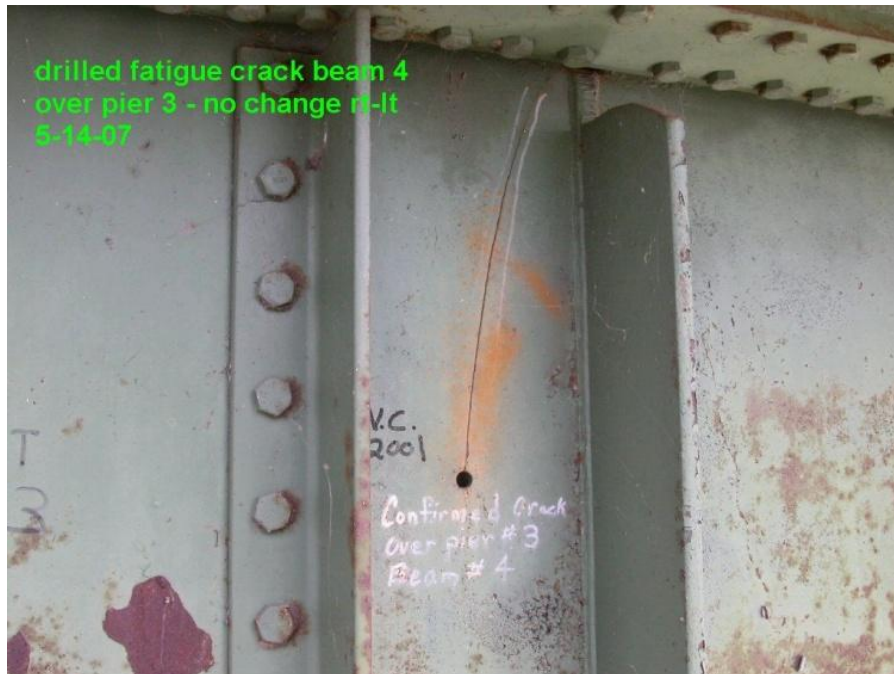
**Figure 6. Fracture of web on Girder 4 at Pier 3 of the eastbound I-80 Bridge over the Cedar River. In 1981, a 20" long fracture was found which was initiated at the top of the bearing stiffener at the pier**

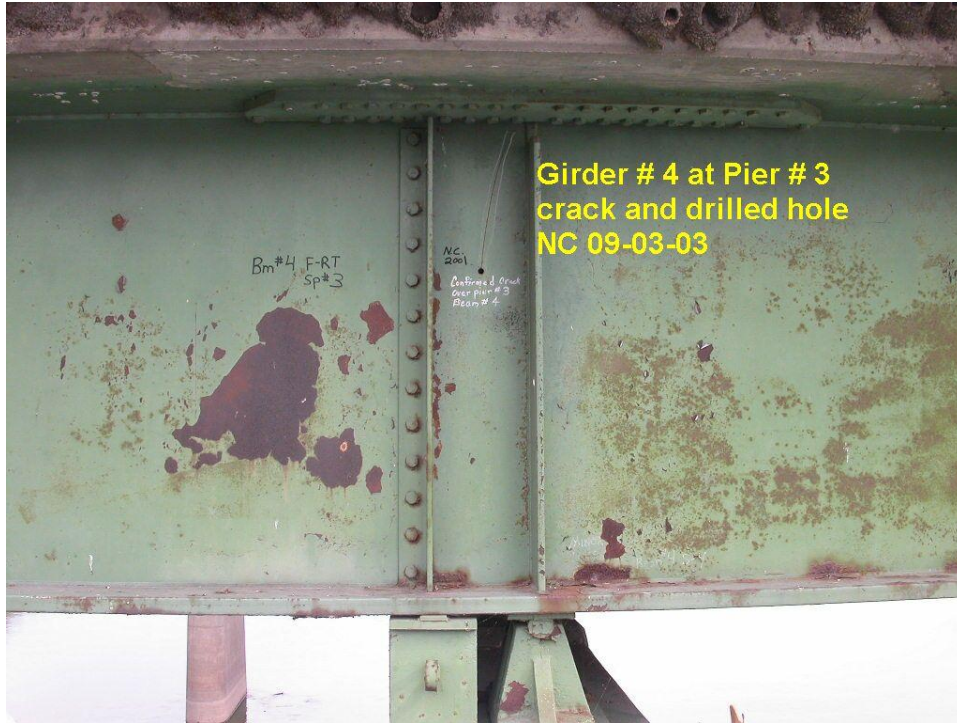
**Figure 7. Retrofit repair of Girder 4 at Pier 3 of the eastbound bridge, including installation of a bolster (bearing) between the bottom flange and the pier cap in line with the angles.**

The eastbound bridge was retrofitted as shown in Figure 7. It included drilling a  $\frac{3}{4}$  in. hole on each side of the stiffener and removing the web material between the holes. Additional plates were bolted to the top flange and two vertical angles were bolted to the web and a bolster (bearing) was installed between the bottom flange and the pier cap in line with the angles.

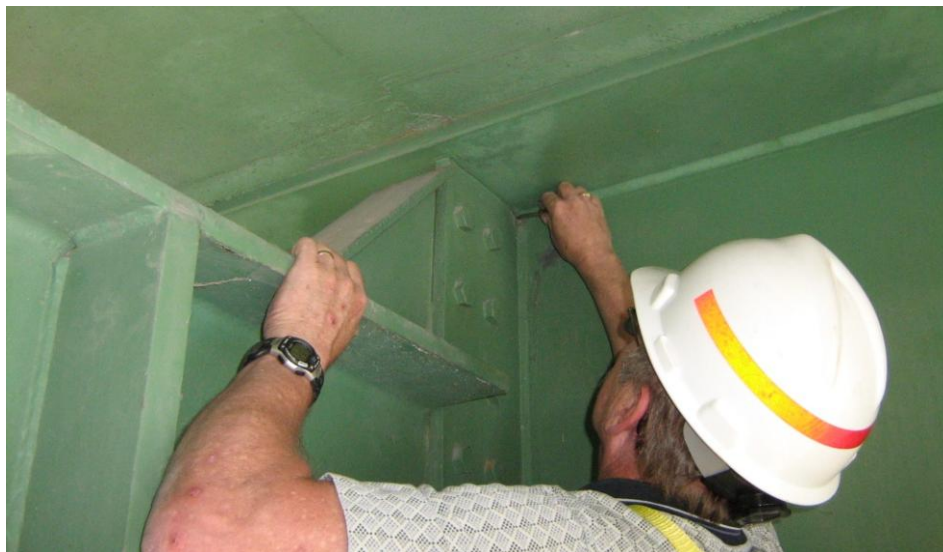
Prior to the placement of the instrumentation, feeler gages (minimum thickness was 0.008 in.) were used to assess the tightness of fit of the bearing stiffeners between the top of the stiffeners and the bottom of the top flange at all Pier 3 girders. The minimum thickness of the feeler gage could not be inserted at the top of stiffener/bottom of top flange interface at any of the Pier 3 bearing locations, and no visible evidence was noted of paint rust at the top of the stiffener region, indicating that the bearing condition was relatively tight (Figure 8). Subsequently, similar girder bearing stiffener locations were inspected, and feeler gages used, at Piers 4, 5 and 6. It should be noted that the girder bearing conditions at Piers 4 and 5 were similar to those at Pier 3 except for the following exceptions. At Pier 5 at an interior girder, the gap at the top of the stiffener/bottom of top flange interface was measured as 0.008 in. Paint rust at the top of the stiffener in the region was also visible at this location. Pier 6 is where the fatigue crack developed, and the fit at the top of the bearing stiffener is covered in a subsequent section later in this report.

**Figure 8. Inspection and measurement (with feeler gage) of pier bearing stiffener fit with top flange of girder.**

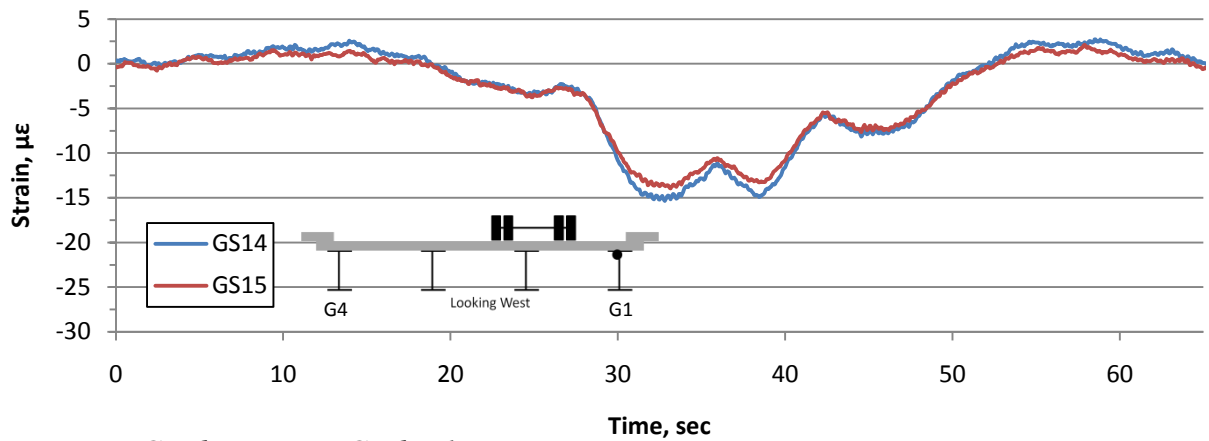
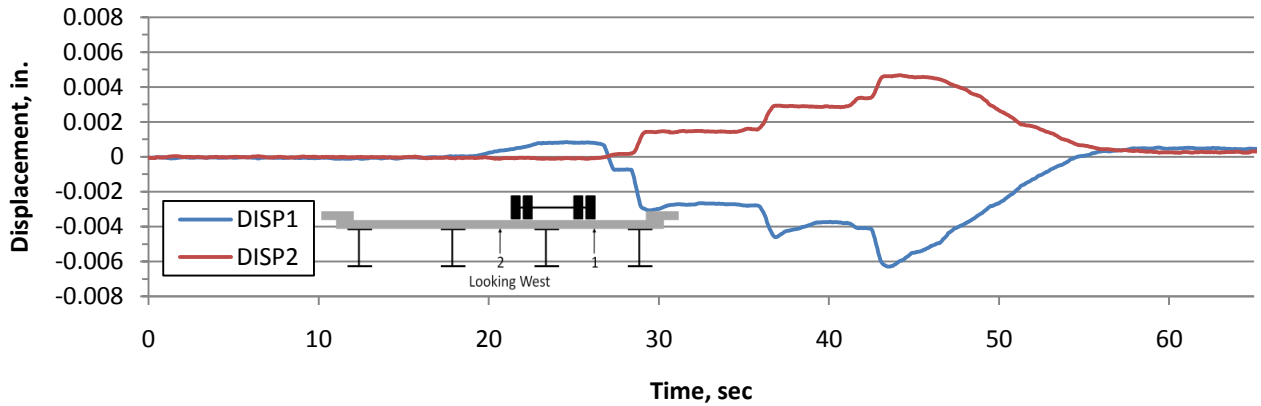
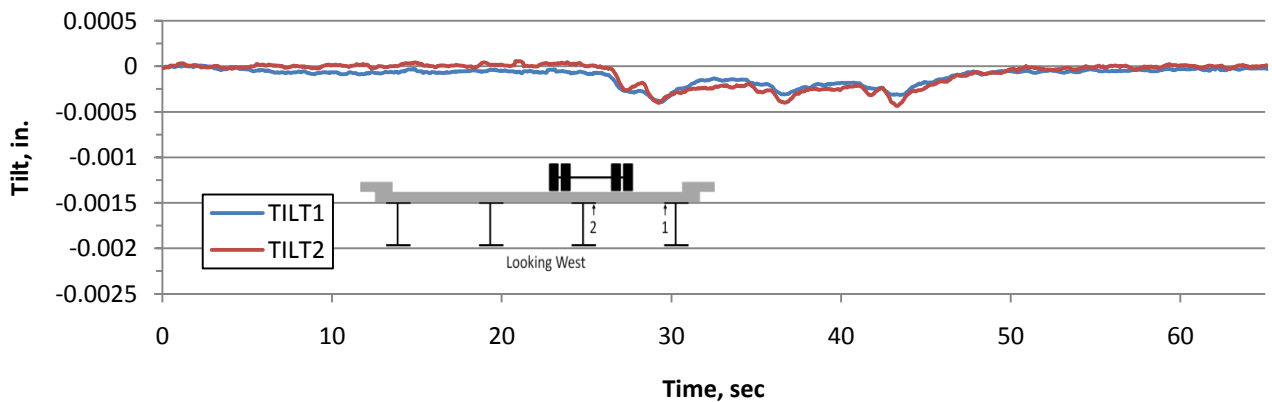
**Figure 16** shows plots of gradient strain in the web gap on Girder 1, deck displacements in two “girder bays” and top flange tipping displacements on Girders 1 and 2. The loading consisted of the Iowa DOT snooper, Truck 2 and Truck 1 (Load Case 1) crossing the bridge approximately 20 ft apart in the north lane.

The maximum recorded strain was approximately 15 micro strain (equivalent to 0.45 ksi). The stress range (i.e. change from positive to negative stress) for the complete time record would only be slightly larger as the positive strain values are less than 2 or 3 micro strain. The GS14 and GS15 gradient gages (Figure 16a) are the two farthest down on the web away from the web/flange fillet weld.

The qualitative displacements of the deck in girder Bays 1 and 2 (negative in Bay 1 and positive in Bay 2) are reasonable given the test truck transverse wheel positions. The top flange tipping displacement also seems reasonable given the test truck transverse positions, and in a qualitative sense correlate well with the gradient strain and deck displacement records.

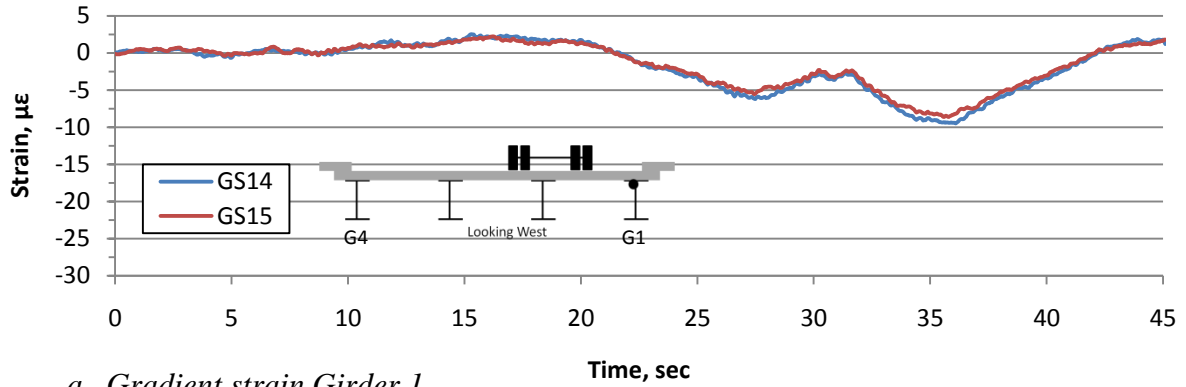
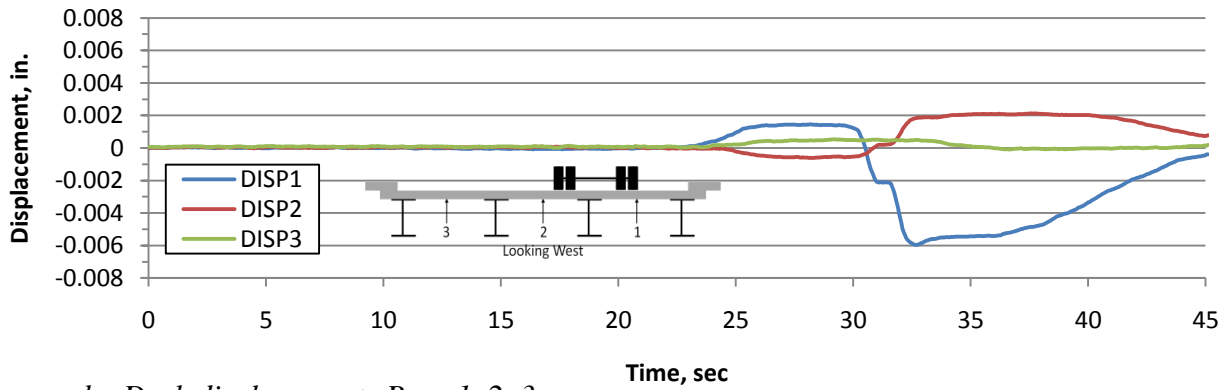
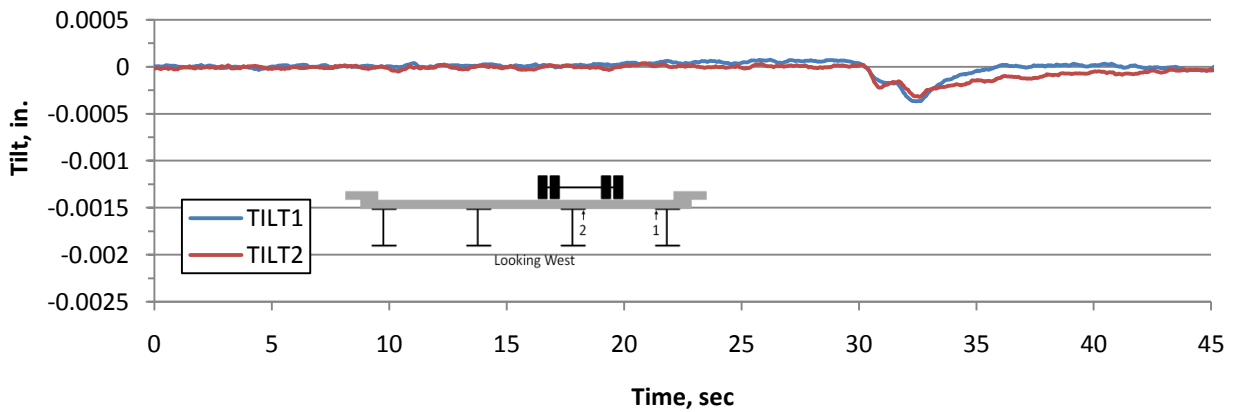
**Figure 17** shows plots of gradient strain in the web gap on Girder 1, deck displacements in all three “girder bays” and top flange tipping displacements on Girders 1 and 2. The loading consisted of only Truck 1 (Load Case 3) crossing the bridge in the north lane.

The maximum recorded strain was approximately 10 micro strain (equivalent to 0.3 ksi). The stress range (i.e. change from positive to negative stress) for the complete time record would only be slightly larger as the positive strain values are less than 2 or 3 micro strain.

The deck displacement in the girder bays 1 and 2 seem reasonable given the test truck transverse wheel positions. The top flange tipping displacements also seem reasonable given the test truck transverse positions. Qualitatively the top flange tipping and deck displacement correlate well. However, in a qualitative sense the correlation between the gradient strain and both the deck displacement and the flange tipping displacement are not as clear as in Figure 16.

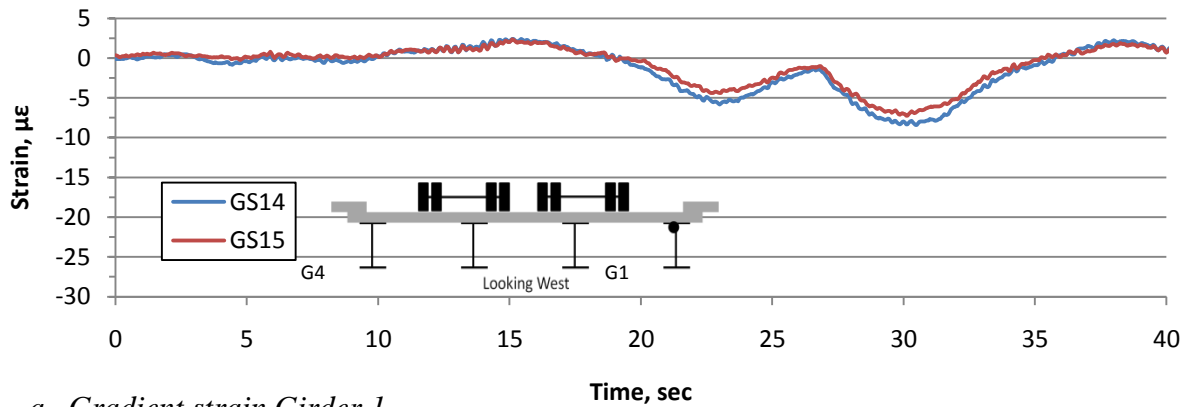
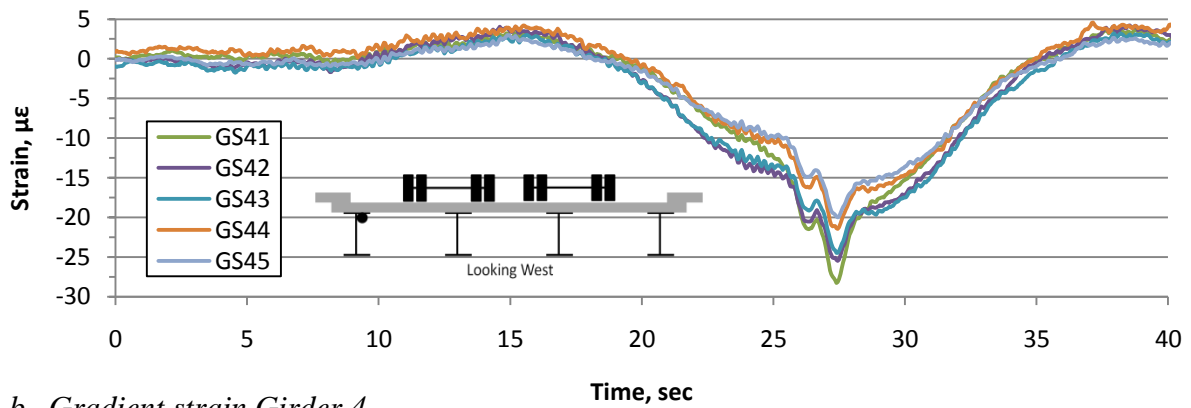
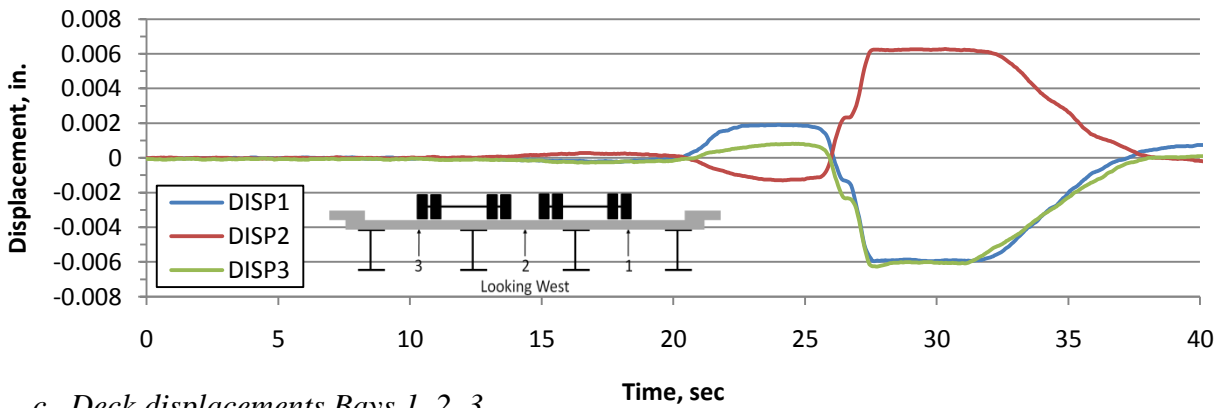
**Figure 18** shows plots of gradient strain in the web gap on Girders 1 and 4, and the associated deck displacements in all three “girder bays”. The loading consisted of Truck 1 in the south lane and Truck 2 in the north lane (side by side).

The maximum recorded strain in the web gap of Girders 1 and 4, respectively, was approximately 10 micro strain (equivalent to 0.3 ksi) and 28 micro strain (equivalent to 0.8 ksi). Note that at Girder 1, the two gradient strains should be correlated with GS 44 and GS 45 at Girder 4 since they are at similar positions in the web gaps. The stress range (i.e. change from positive to negative stress) for the complete time record would only be slightly larger as the positive strain values are less than 2 or 3 micro strain. It is interesting to note that the shape of the strain/time plot for web gap strain in Girder 1 and 4 are quite different, and certainly the maximum strain magnitudes differ as well. The displacements in girder Bays 1, 2 and 3 (negative in Bays 1 and 3 and positive in Bay 2) seem reasonable given the test truck transverse wheel positions.

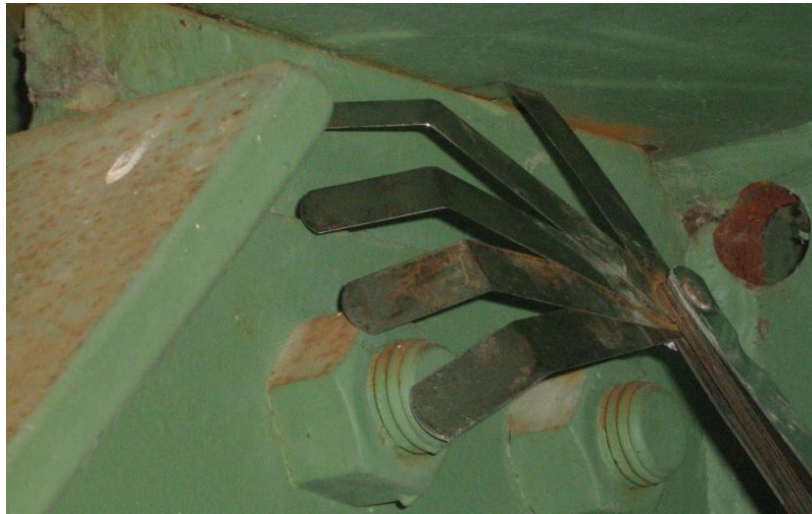
The same displacement transducer arrangement (described earlier in this report) at Pier 3 was used to measure girder top flange tipping at Girder 4 of Pier 6. Similar loading was applied on the bridge as for the data collection process at Pier 3. Prior to the placement of the instrumentation, feeler gages were used to assess the tightness of bearing stiffener fit at the girder top flange. At Girder 4, insertion of the feeler gage indicated a bearing stiffener fit that was not as tight as found at other piers (see Figure 20) on the bridge. The maximum measured gap was 0.014 in. Although the gap distance was minimally variable along the length of bearing, the feeler gage could be inserted all the way through the depth of the interface at every point along the length of bearing. Further, paint corrosion was visible at the stiffener/top flange interface.

**Figure 20. Feeler gage inserted between top of bearing stiffener and Girder 4 top flange at Pier 6. Note the corrosion between the interfaces and also note the retrofit hole that had been previously drilled to arrest a fatigue crack in the girder web.**

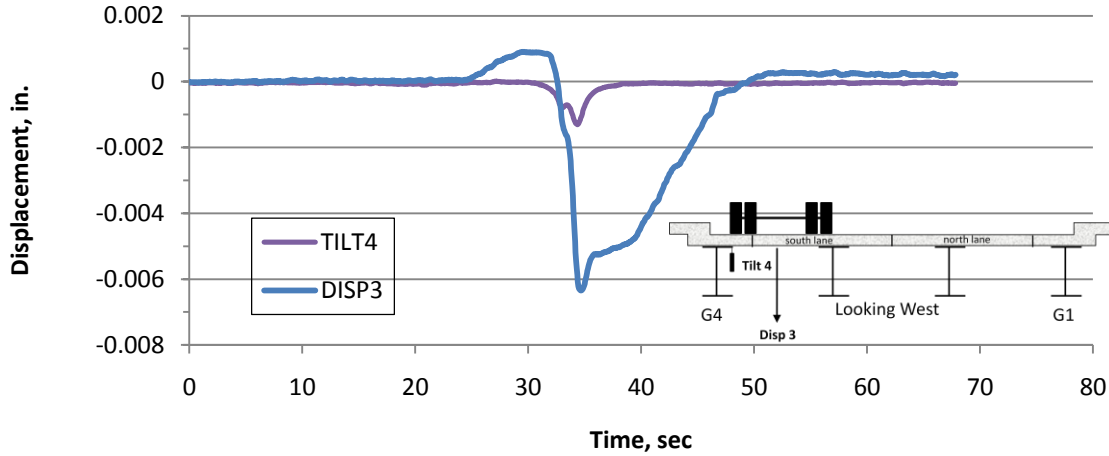
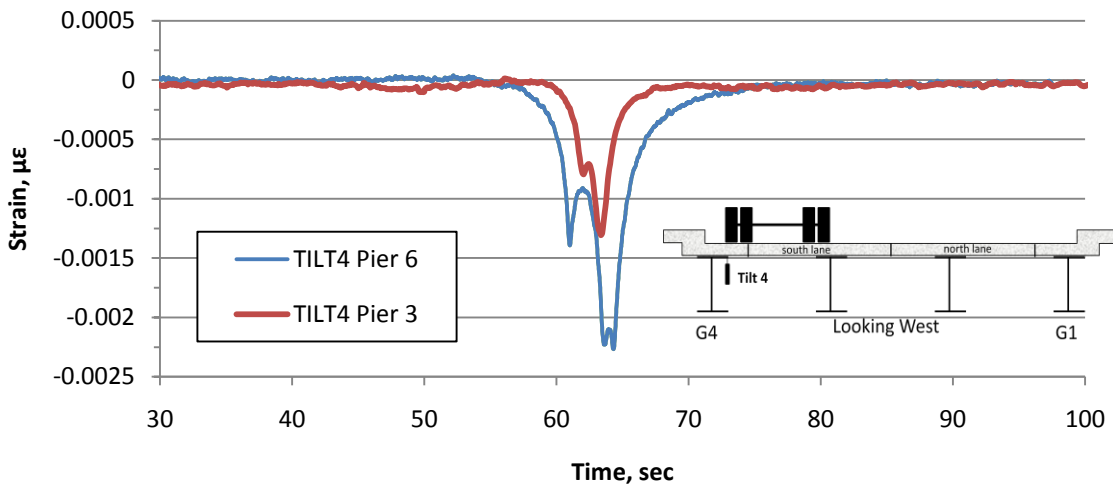
Figure 21 shows plots of top flange tilt displacement on Girder 4 at Pier 3 and Pier 6 for the same loading. The loading consisted of Truck 1 in the south lane. Note that the Pier 6 girder flange tipping displacement was significantly larger than that for Pier 3.

- The bearing stiffener fit at the top flange of Girder 4 was not as tight as at other observed and measured (with feeler gages) locations on the bridge.
- The tipping of the top flange at Girder 4 at Pier 6 is larger than at Pier 3 for the same loading condition.

- Analytical evaluation to simulate the flange tipping at pier locations would be useful to better understand the influence of bearing stiffener fit-up on web gap strains.
- The implementation of a combined experimental and analytical study on the eastbound I-80 Bridge over the Cedar River prior to demolition could provide useful information. The analytical study could be initiated prior the experimental portion of that study to better develop an effective test plan. Complementary laboratory testing of girders removed from the bridge would also be very useful.
