**Final Report on the  
I-129 Missouri River Bridge  
Deck Condition Assessment Using Non-Destructive  
Testing Methods**

**Bridge No. 9700.0S129, Sioux City, IA**

**Final Report  
I-129 Missouri River Bridge  
Deck Condition Assessment Using Non-Destructive Testing Methods  
Bridge No. 9700.0S129, Sioux City, IA**

**November 5, 2012**

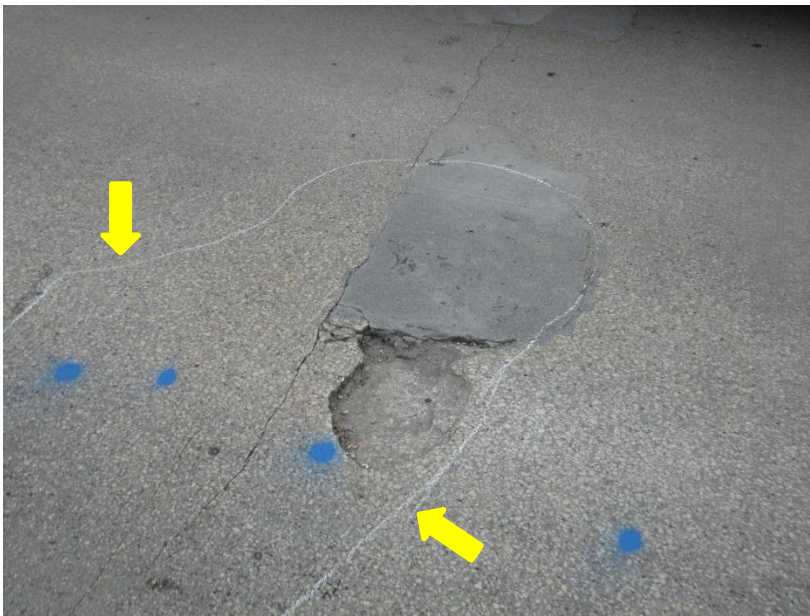
Several conventional patch repairs (see Figure 2.7) and the remains of multiple epoxy injection repairs (see Figure 2.8) were visible on the deck surface. It appears that the epoxy injection may have been used to treat cracks as well as to fill delaminations. In some cases, delamination continues to occur around the periphery of numerous delaminations injected previously with epoxy. However, it appears that the epoxy injection was reasonably successful at re-establishing bond at some locations where delaminations were present in 2008, and may also have reduced the quantity of delaminations that progressed to spalls.

*Figure 2.7. Existing concrete patch repair and cracking of deck. Note adjacent spall and new delamination (arrows) outlined in chalk.*

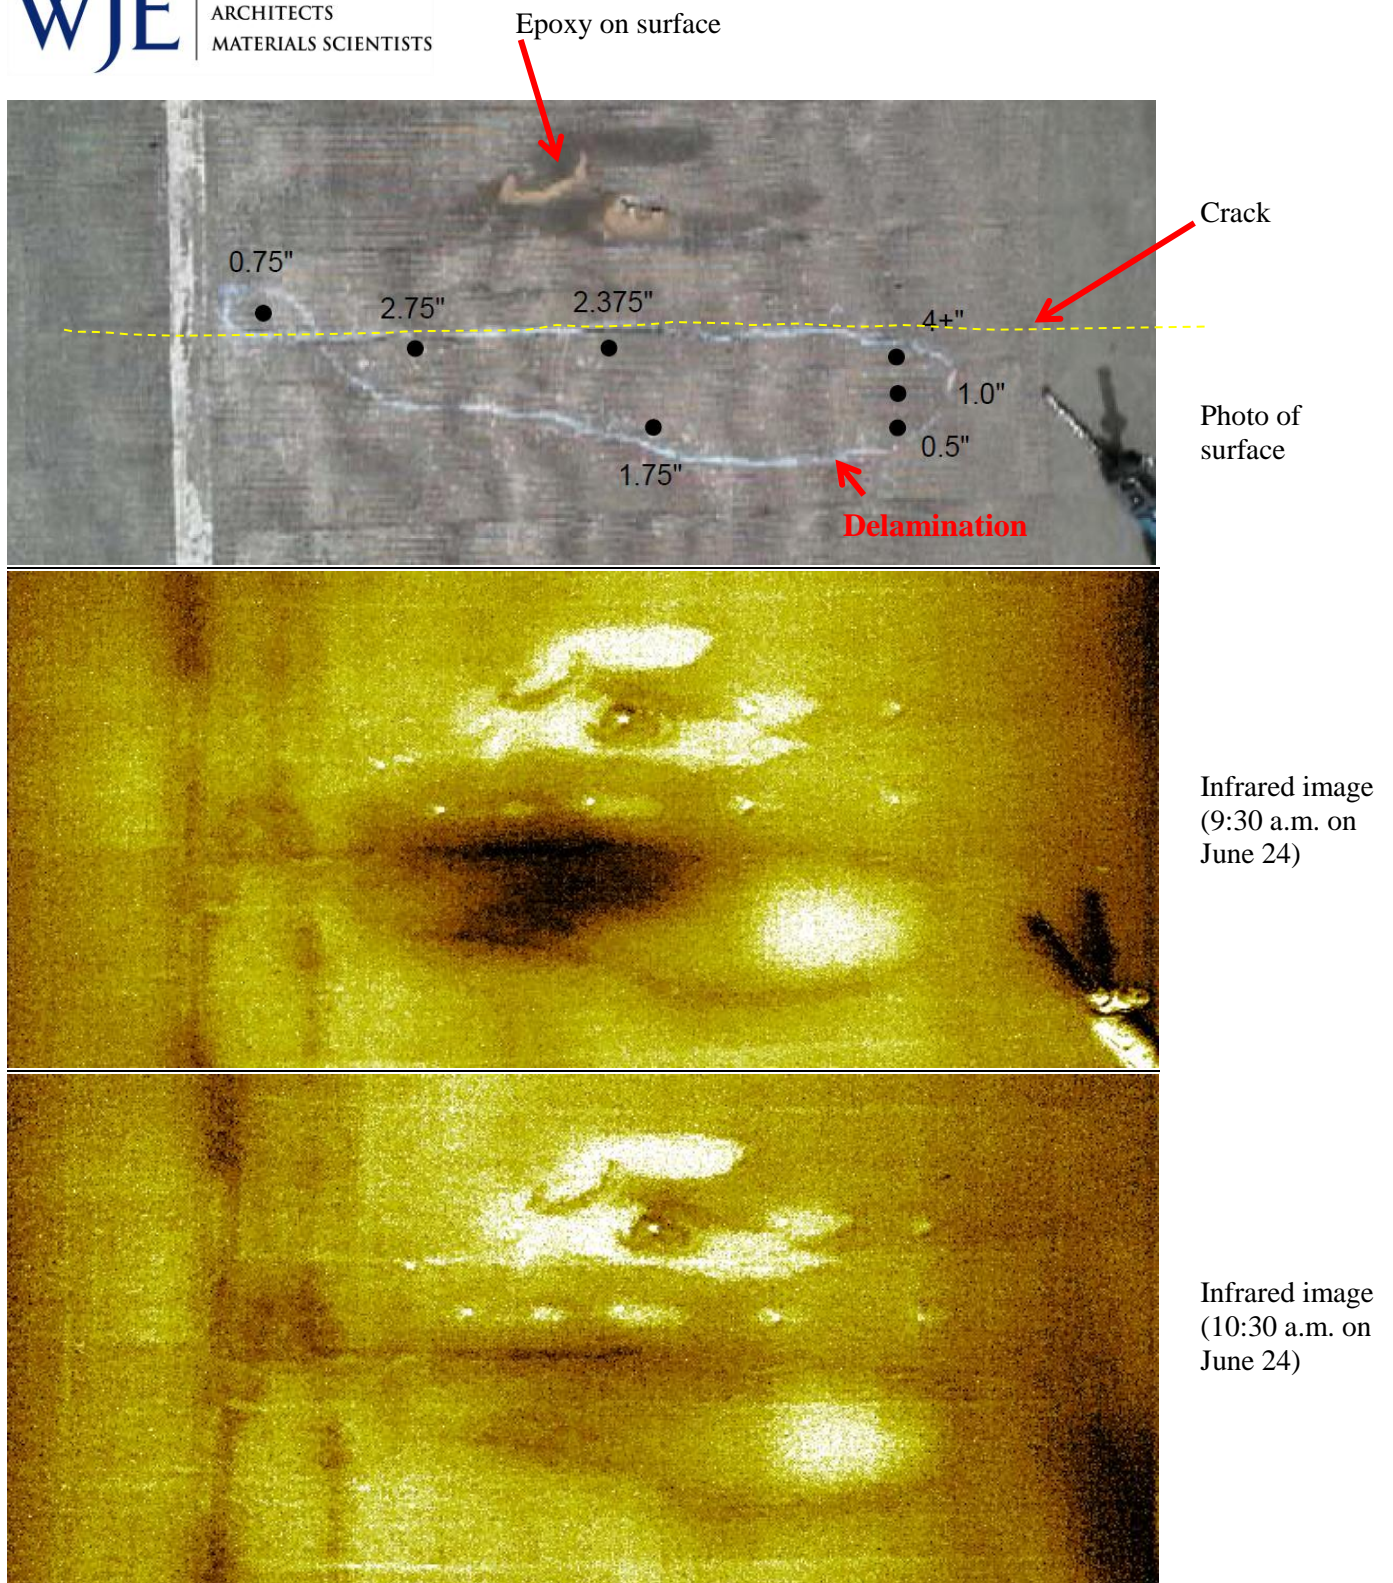
*Figure 3.11. Study of depth of delamination in westbound lanes: photo of marked delamination with results from drilling indicating depth of delamination and crack location (highlighted in yellow); infrared image taken at 9:30 am on June 24; infrared image taken at 10:30 am on June 24 (top to bottom).*

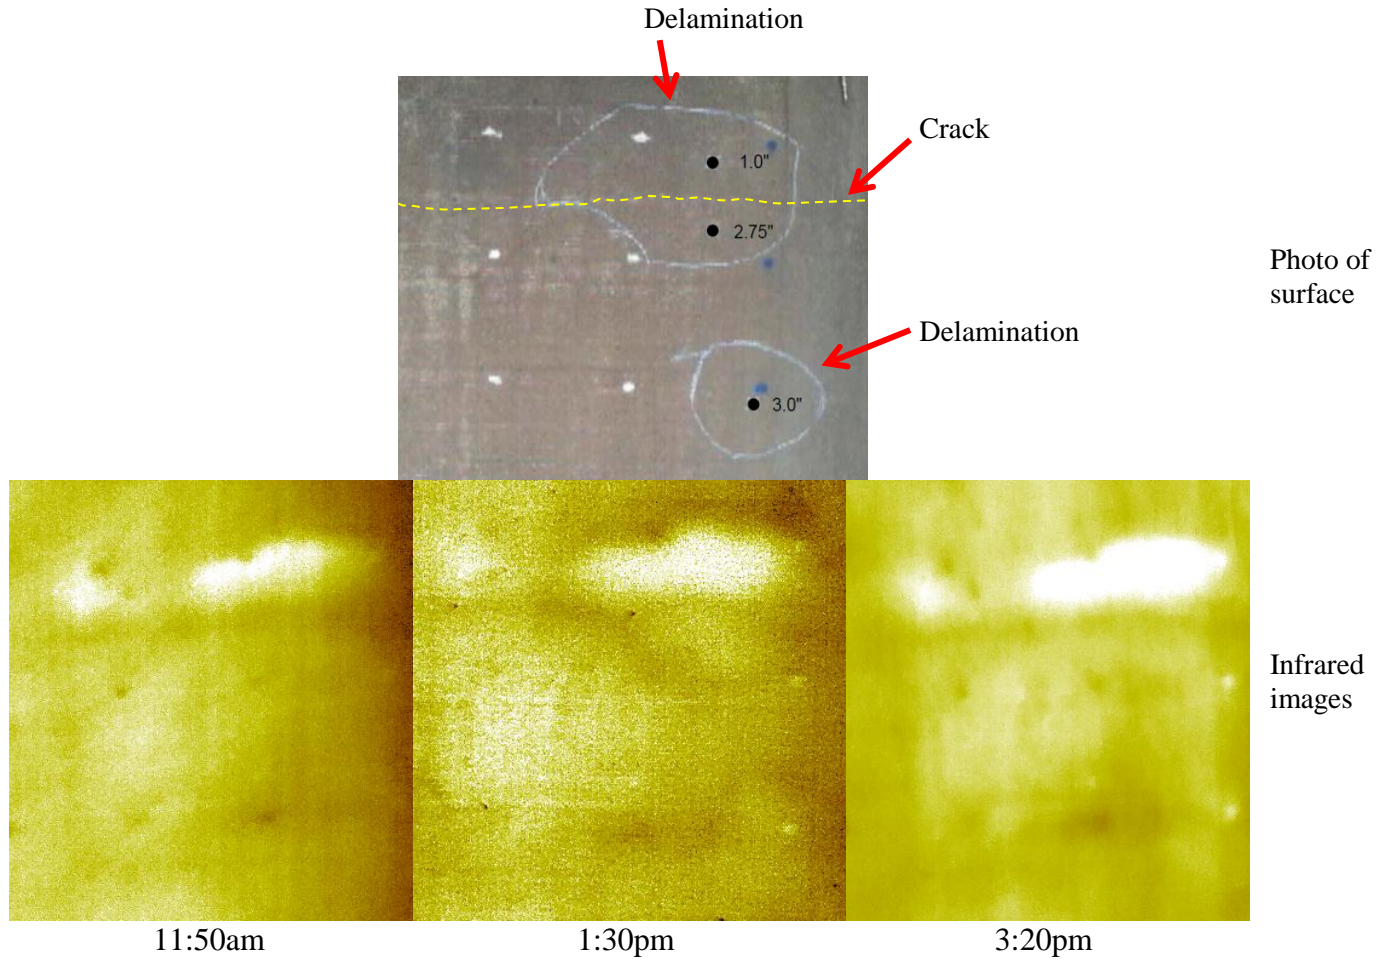
*Figure 3.12. Study of depth of delamination in eastbound lanes: photo of marked delamination with results from drilling indicating the depth of the delamination and crack location (highlighted in yellow, top); infrared images taken at the times shown (bottom). The bright spot observed in the top left of the infrared image is not associated with a delamination, but with a dark spot on the deck surface.*

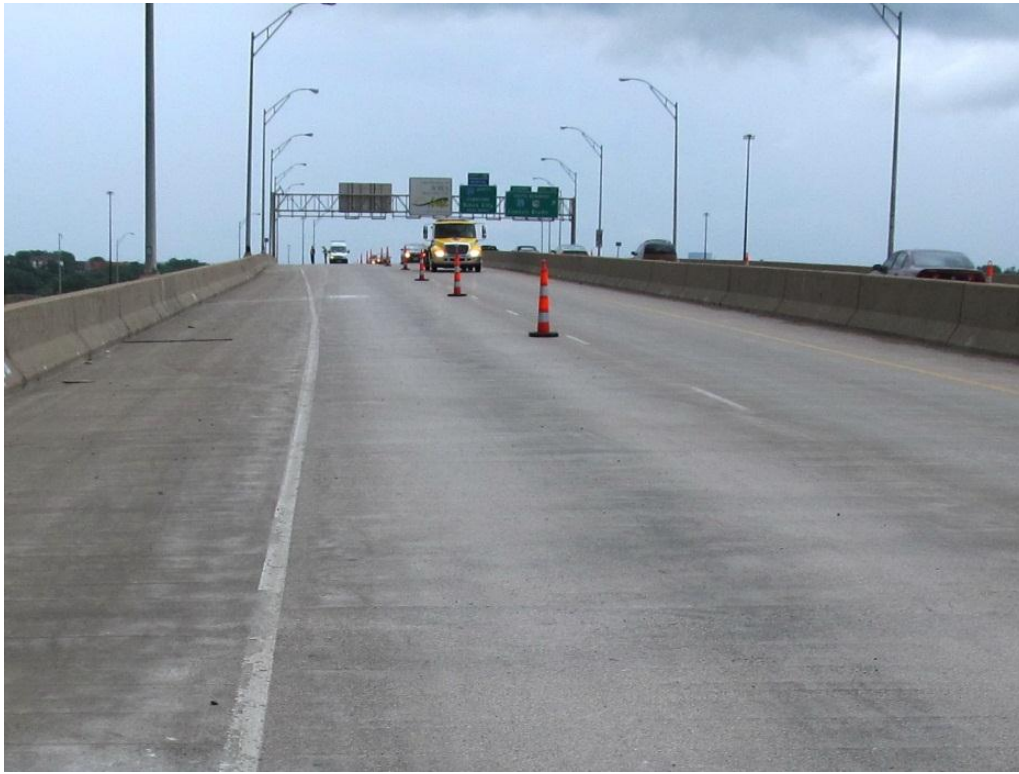
*Figure 3.13. Deck surface showing surface texture and color variation between wheelpaths and surrounding deck.*

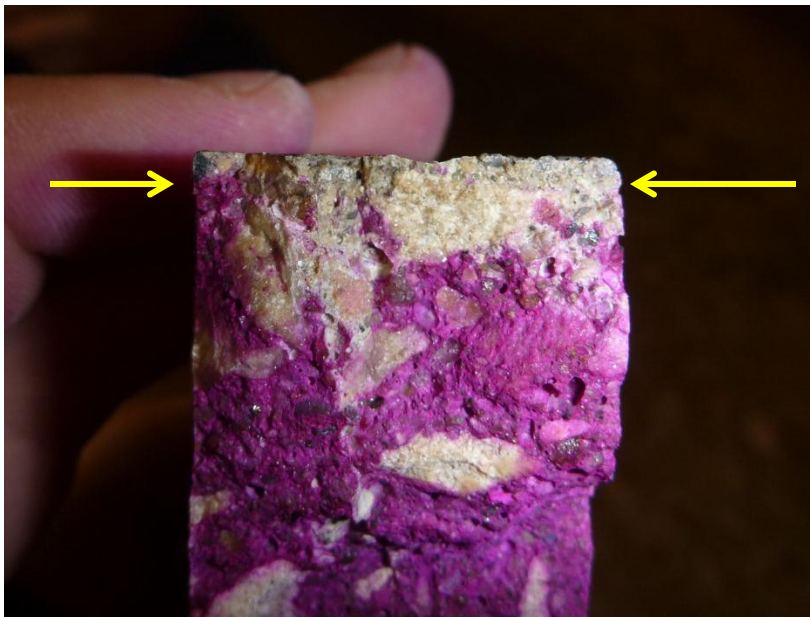
Figure 8.2. Phenolphthalein indicator on a freshly cracked surface of a core. The depth of carbonation is indicated by the arrow (pink color indicates  $pH > 9$ ).

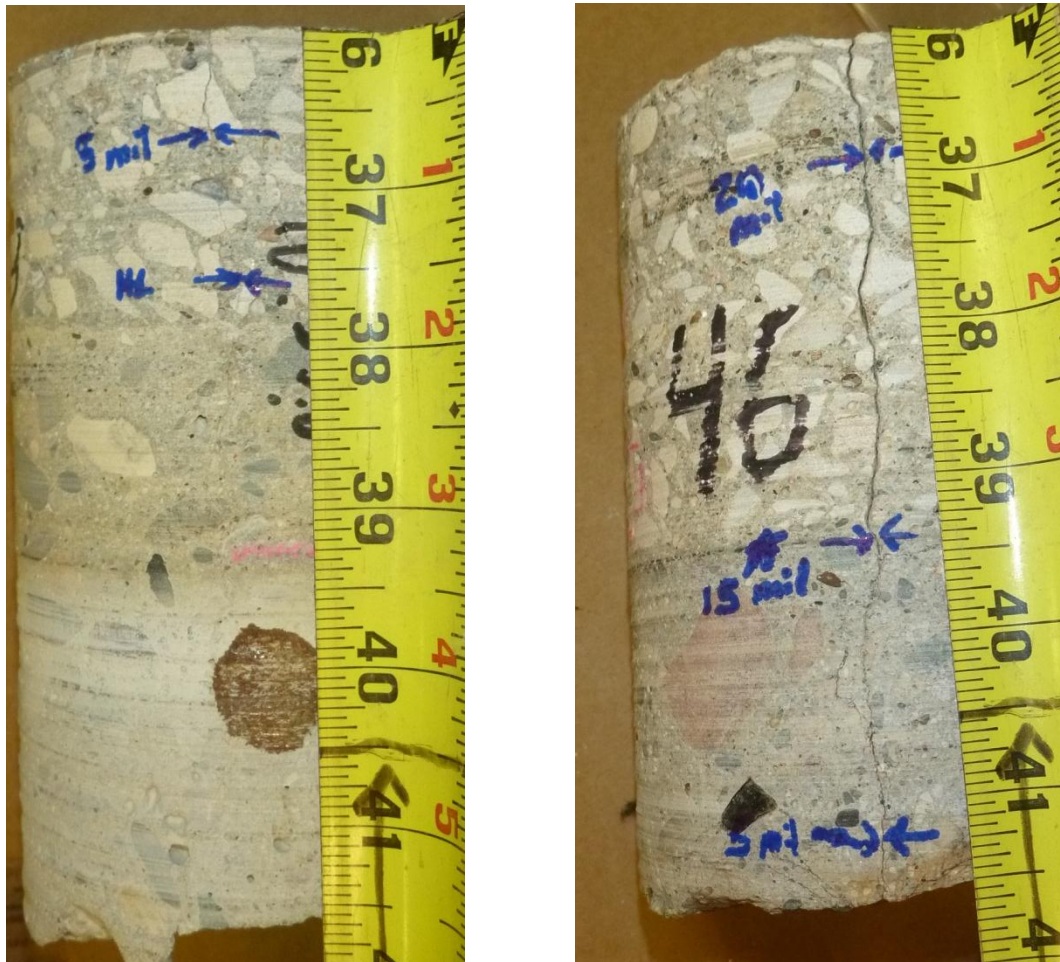
Figure 8.7. Comparison of crack width versus depth for Cores 33 and 46.

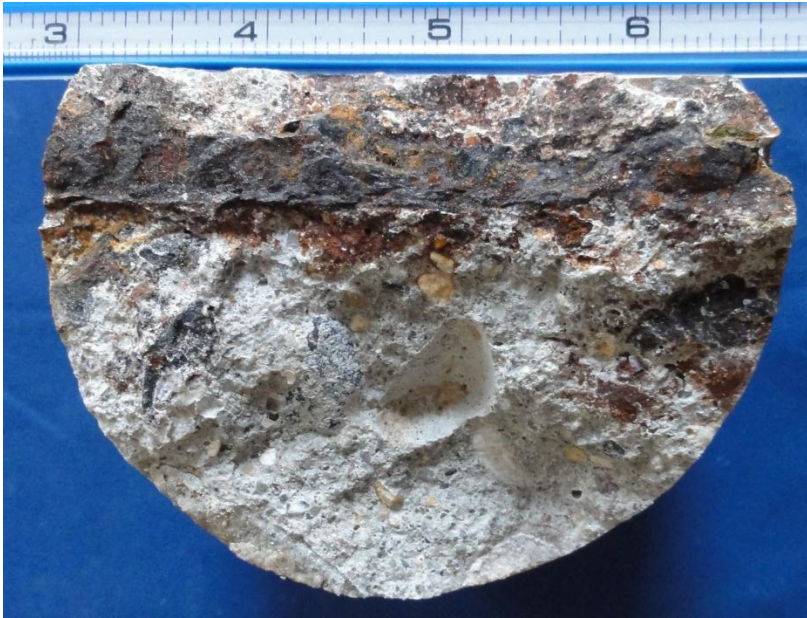
*Figure 8. Core 42; corroded rebar in base concrete at one of the transverse cracks.*

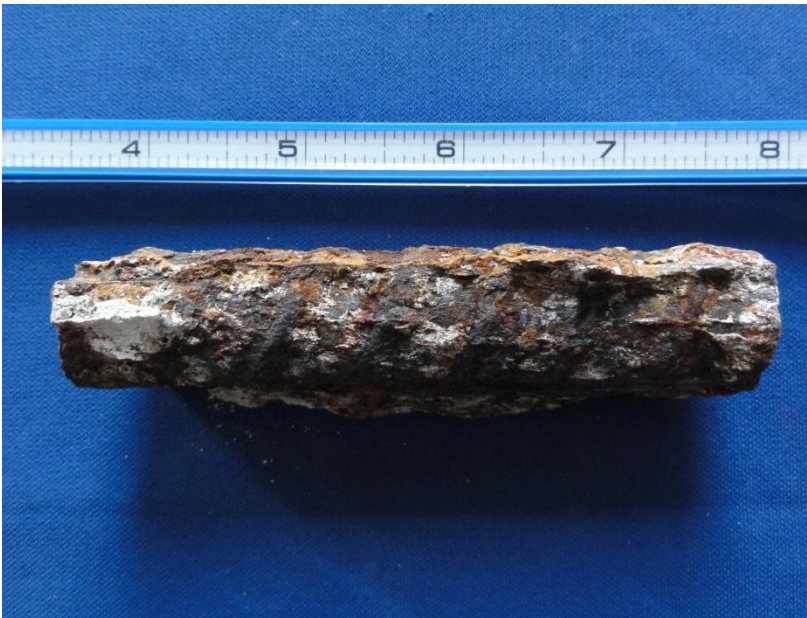
*Figure 9. Core 42: corroded rebar taken out of base concrete at one of the cracks.*
