# Field and Laboratory Studies on High-Mast Lighting Towers in Iowa

## ABSTRACT

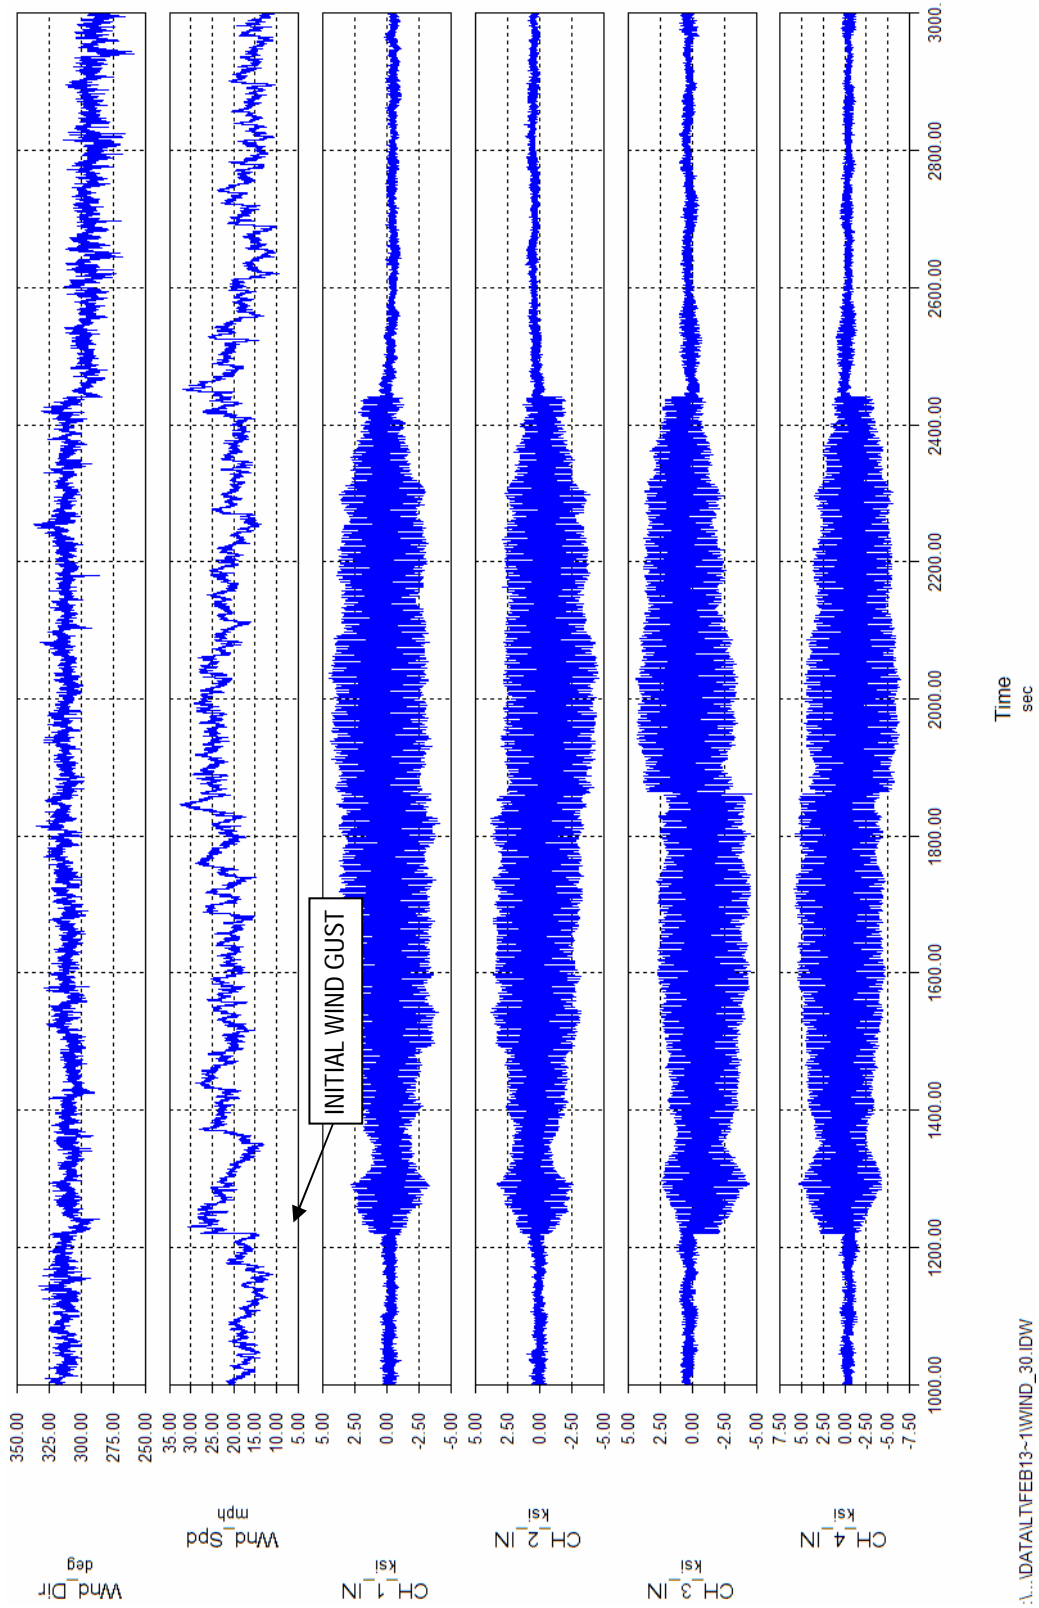
Figure 3. High-stress event, November 10, 2006, 7:10 a.m.

The highest stress cycles recorded during the monitoring period were the result of a wind storm that occurred on November 10, 2006, at approximately 7:10 a.m. The average wind speed at the time was only approximately 20 mph, with gusts up to 33 mph. The winds were from the north (note, the data in Figure 3 is an uncorrected wind direction; 58 degrees must be added to each measurement to correct to the compass directions). The stress cycles resulting from this wind event caused a second peak in the stress-range histograms at many locations where gages were installed.

At this time, the authors believe that the tower was excited by an initial gust (see Figure 3) that caused the tower to begin vibrating in its first mode. The first mode frequency for this pole is approximately 0.3 Hz (or a period of vibration of 3.3 seconds). This means that the time it takes for the pole to start at a positive peak stress, vibrate to peak negative stress, and return to peak positive stress is 3.3 seconds.

This observed vibration is most likely not vortex shedding, since the critical velocity for vortex shedding in the first mode is significantly less than the observed 20 mph present during the event. The wind gusts appear to have been in phase with the first-mode natural frequency of the tower, causing the magnitude of vibration to increase. This will be studied further as part of this project to fully assess the nature of this phenomena and its effect on the fatigue performance of the retrofitted and unretrofitted high-mast towers.

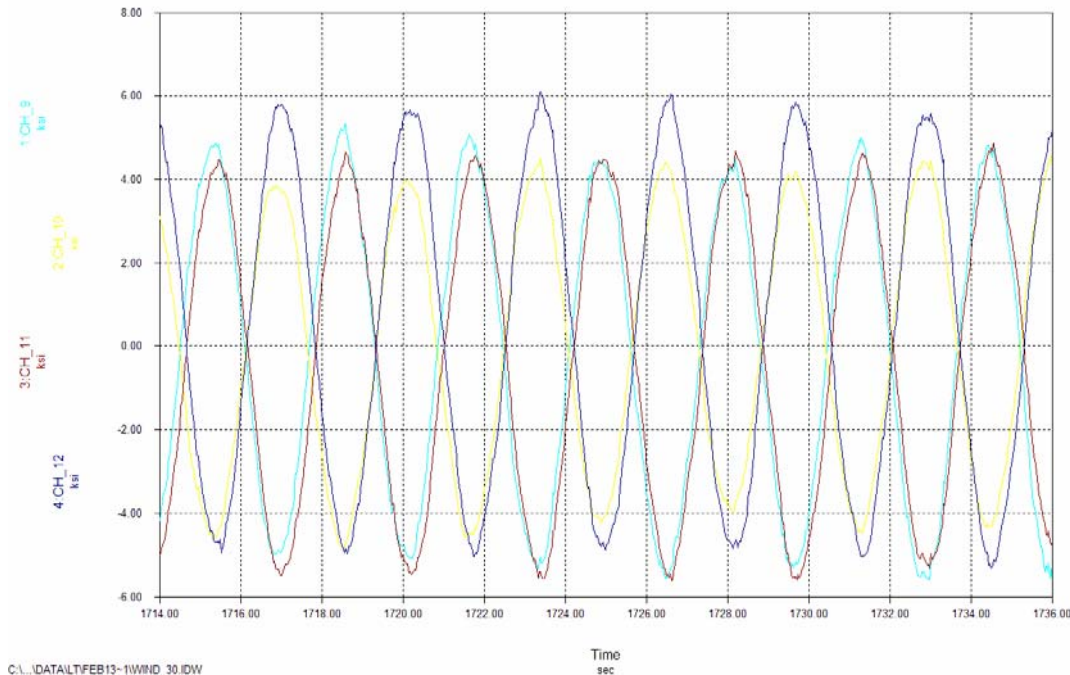
**Figure 4. High-stress event, November 10, 2006, 7:10 a.m.; strain gages six ft. above the baseplate**

Figure 4 contains a close-up stress time history for the four strain gages on the tower above the reinforcing jacket (6 ft. above the base plate). It can be seen that the time it takes the stress to vary from peak positive to peak negative and back to peak positive stress is approximately three seconds. Furthermore, strain gages CH\_9 and CH\_11 are in phase. Strain gages CH\_10 and CH\_12 are also in phase with each other, but collectively out of phase by 180 degrees with CH\_9 and CH\_11. Note that the magnitudes are roughly equal. This indicates that the neutral axis of bending lies on a 45 degree line running between CH\_9 and CH\_11 on one side and CH\_10 and CH\_12 on the other (i.e., running northeast-southwest). A similar plot for the four gages on the tower at the base weld (beneath the reinforcing jacket) is shown in Figure 5. It can be seen that the same direction of bending is causing the measured stresses.
