**SPECIAL PROVISIONS
FOR
BRIDGE DECK REMOVAL**

**Clayton County
BHM-CHBP-2315(607)--NA-22**

RE: Keystone Bridge Coring

Job Site Observations	Keystone Bridge
-----------------------	-----------------

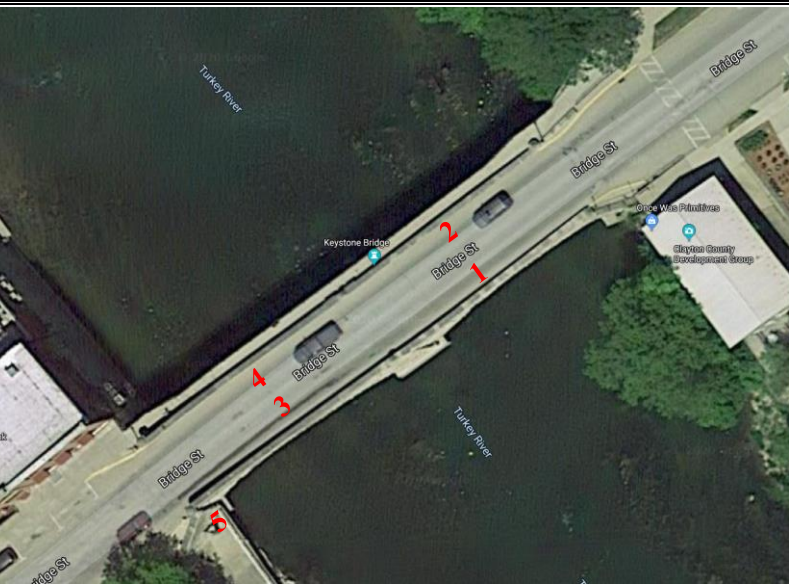
Picture #2	Remarks

<p>Location of core sampling by reference number.</p>

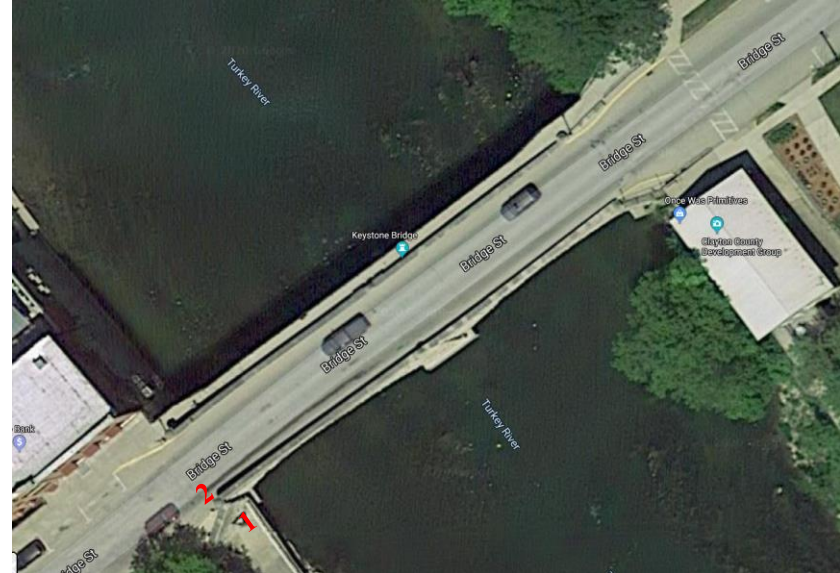
Picture #3	Remarks

Location of mortar sampling

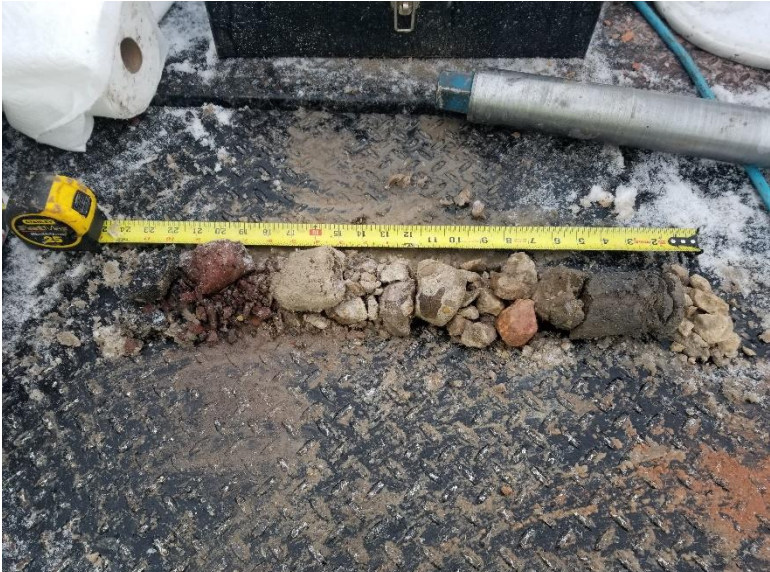
Picture #4	Remarks

Core #2 Description Top to Bottom: Asphalt, Brick, Sand Concrete, Rubble, Soil, Rubble (From Left to Right)

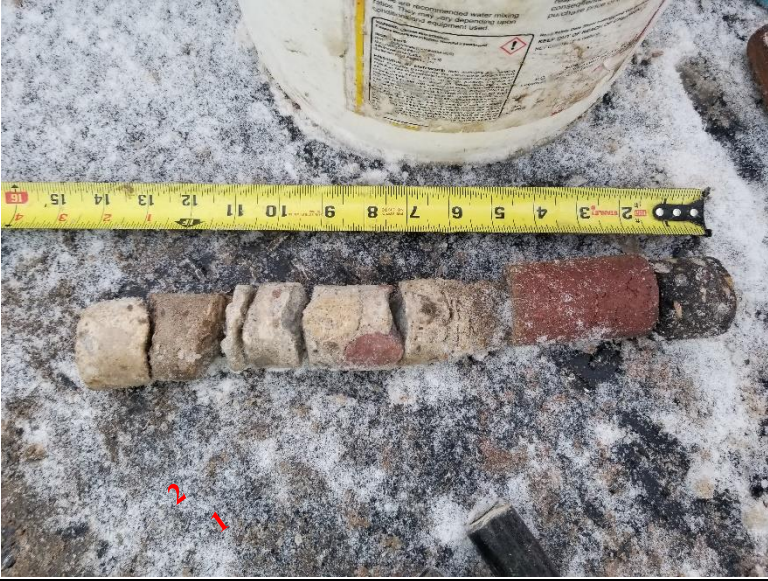
Picture #5	Remarks

<p>Core #3 – A eight inch piece of limestone was able to be extracted after this picture and is not shown.</p> <p>Description Top to Bottom:</p> <p>Asphalt, Brick, Sand, Concrete, Mortar / Grout, Sand, Limestone</p> <p>(From Right to Left)</p>

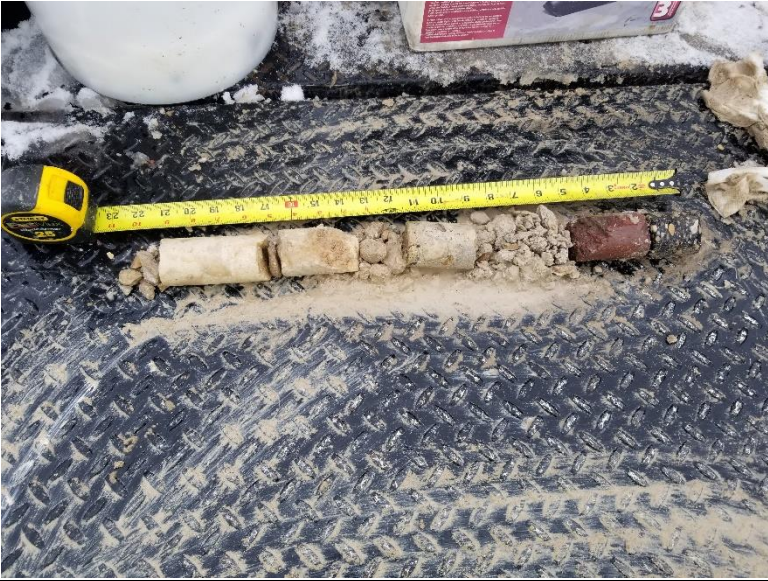
Picture #6	Remarks

<p>Core #4</p> <p>Description Top to Bottom:</p> <p>Asphalt, Brick, Sand, Concrete, Rubble, Limestone, Mortar, Limestone</p> <p>(From Right to Left)</p>

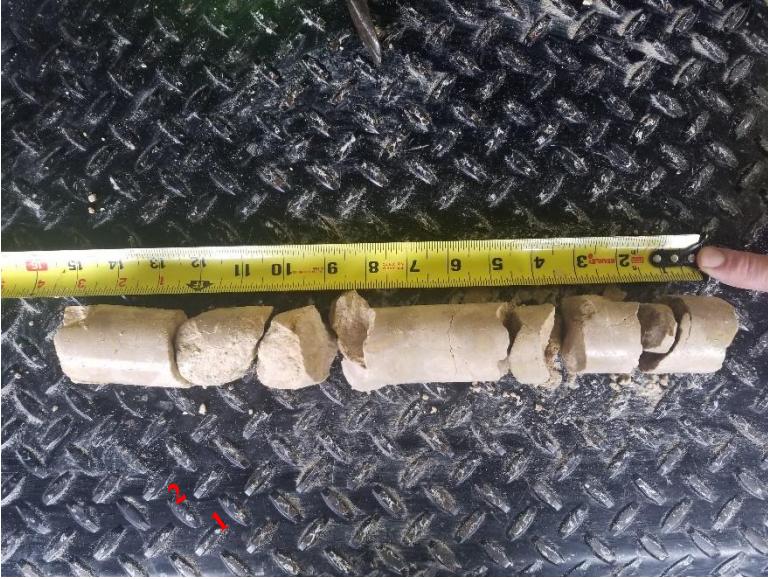
Picture #7	Remarks

<p>Core #5 – Limestone only</p>

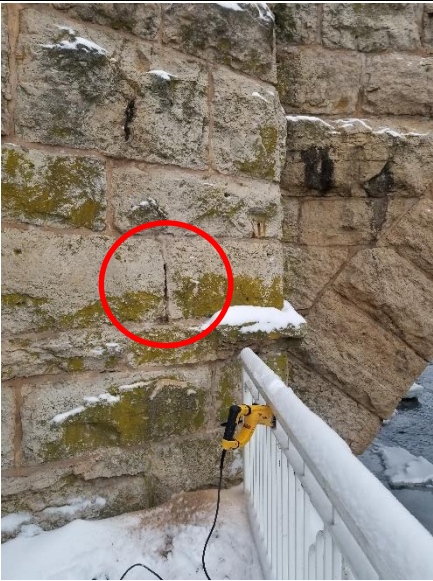
Picture #6	Remarks

<p>Mortar sample #1 Location</p> <p>Once the newer mortar was removed from the surface the original mortar was severely eroded and had been replaced by what appears to be frozen soil.</p>

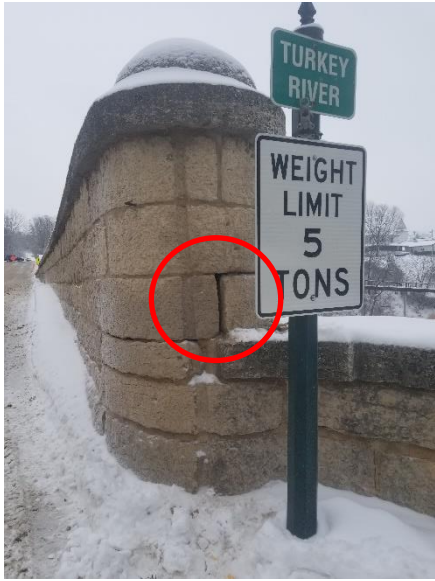
Picture #8	Remarks

Mortar sample #2 Location
