Strengthening Steel Girder Bridges with CFRP Plates

STRENGTHENING STEEL GIRDER BRIDGES WITH CFRP PLATES

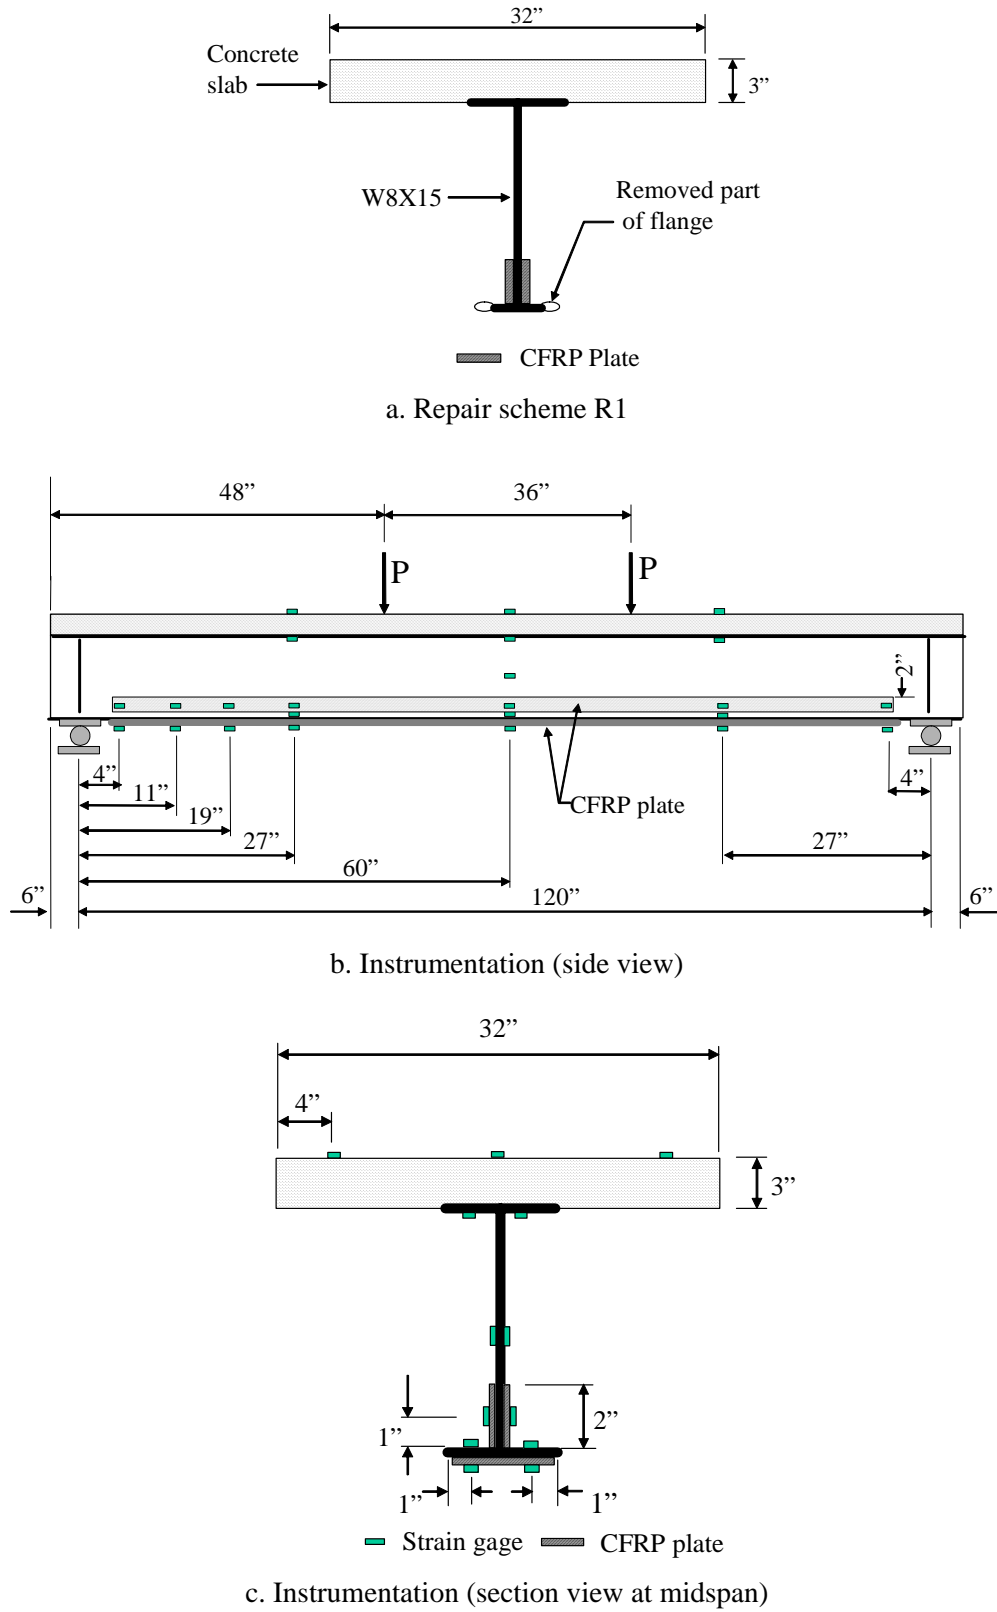
FIGURE 1. Repair scheme and instrumentation

The experimental program consisted of testing two undamaged (control) steel composite beams and four steel composite beams that were damaged by removing part of their bottom flange (i.e. a percentage of the bottom flange area) to simulate corrosion and then repaired by adding CFRP to restore their original strength.

The following notation is used herein to describe the specimens. Undamaged beams are designated with "U" while the designations for damaged beams start with the letter "D". In the case of the damaged control beam "D" was used alone to indicate that no repair was installed. In the case of the repaired beams, the letter "D" is followed by two numbers that indicate the percentage of damage to the bottom flange. For example, "50" means that 50% of the original bottom flange area was removed ("damaged"). This number is followed by a letter-number combination such as "R1" to reflect the repair scheme used. This combination is followed by a letter and two numbers such as "E22" to reflect the modulus of elasticity (MOE) in ksi of the CFRP plate being used. For example, "D50R1E29" describes a damaged beam with 50% of the bottom flange area removed that has been repaired using scheme 1 with a CFRP plate that has a MOE of 29,000 ksi. One of the repair schemes used (Repair 1) is shown in Fig. 1a. The second repair scheme employed (Repair 2) differs from Repair 1 in that CFRP plate is also bonded to the bottom flange.

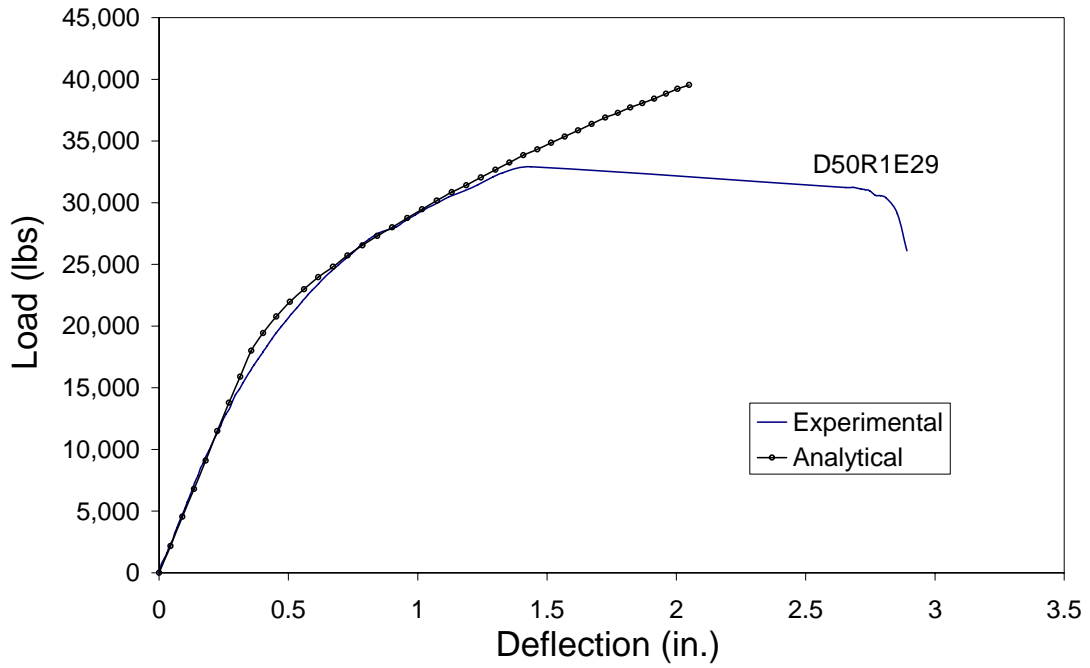
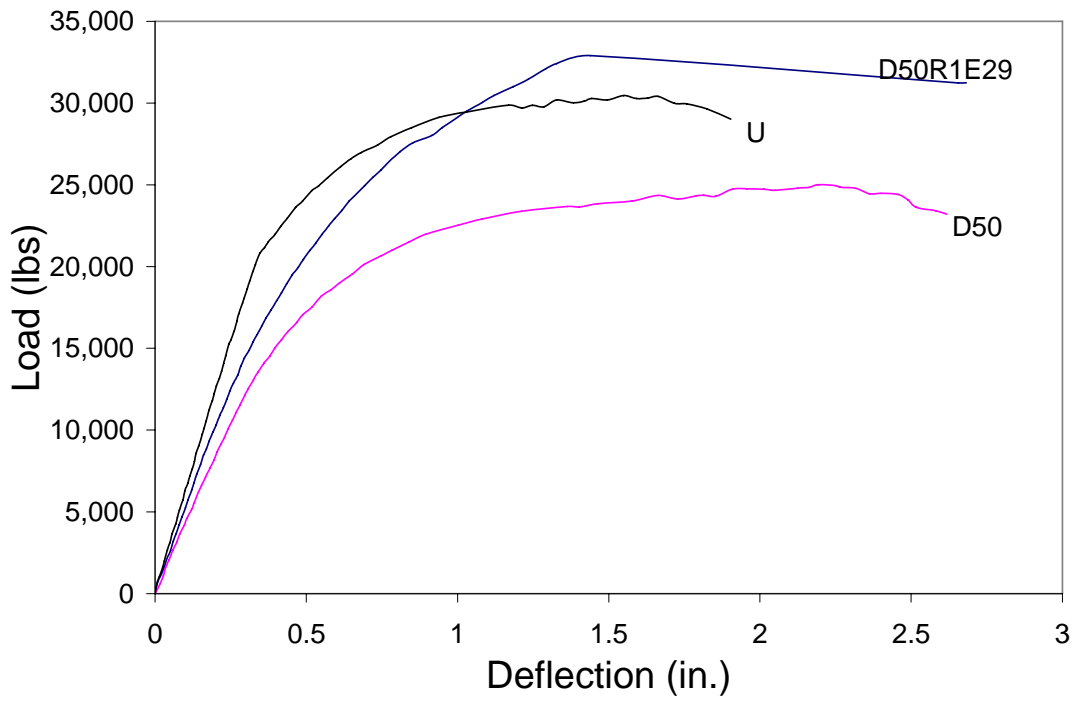
FIGURE 3 Behavior of Beam D50R1E29

Shown in Fig. 3a is a plot of the deflections of Beam D50R1E29 measured at the midspan; for comparison the analytically predicted deflection at midspan is also shown. This beam was damaged in a manner similar to Beam D50 and the repair consisted of attaching the 4 in. wide CFRP plates to both sides of the web. As seen in this figure, a very close agreement between the analytical and the measured midspan deflections existed until the applied load reached 33,000 lbs. Unfortunately, the beam did not reach the theoretical maximum load due to a

premature slip failure at the concrete-steel interface. The slip was initiated by the formation of longitudinal cracks on the top surface of the concrete slab along the lines of the shear studs. These cracks were formed as a result of high transverse tensile stresses induced by the shear studs. The fact that these specimens were scaled specimens required the use of thin concrete slabs; as a result, it was not possible to put double layers of reinforcement in the transverse direction. It appears that the internal transverse reinforcement was not sufficient to resist the tensile stresses in the transverse direction caused by the shear connectors. To overcome this problem in the remaining test specimens, external reinforcement was used to supplement the transverse reinforcement in the concrete slab. To accomplish this 4 in., wide uni-directional CFRP plates were bonded to the top of the concrete slab. The plates were cut in 20 in. lengths and placed on 14 in. centers, similar to the distribution of the transverse steel reinforcement. It should be mentioned that the addition of the CFRP plates to the top of the concrete slab will have negligible effect on the strength of the beam since the orientation of the plates is transverse to the length of the specimens.

Despite the fact that Beam D50R1E29 did not attain its ultimate predicted load (due to the reasons described above), reasonable results were achieved. This can be seen from the comparison of the responses of Beams D50, D50R1E29, and U illustrated in Fig. 3b, where it is obvious that both stiffness and strength were increased in the repaired beam (Beam D50R1E29). As a measure of elastic stiffness, deflections of the three beams were compared at the load that caused yielding in Beam D50 (15,000 lbs). The measured deflections of Beam D50, Beam D50R1E29, and Beam U at an applied load of 15,000 lbs were 0.396 in., 0.315 in., and 0.240 in., respectively. This indicates that approximately 50 percent of the lost stiffness in Beam D50 was restored in Beam D50R1E29. In the inelastic range, significant stiffness was gained as observed in Fig. 3b. In addition, the ultimate strength of the original beam (Beam U) was fully restored; in fact the ultimate load of Beam D50R1E29 reached 33,000 lbs, exceeding the failure load (31,000 lbs) of Beam U.

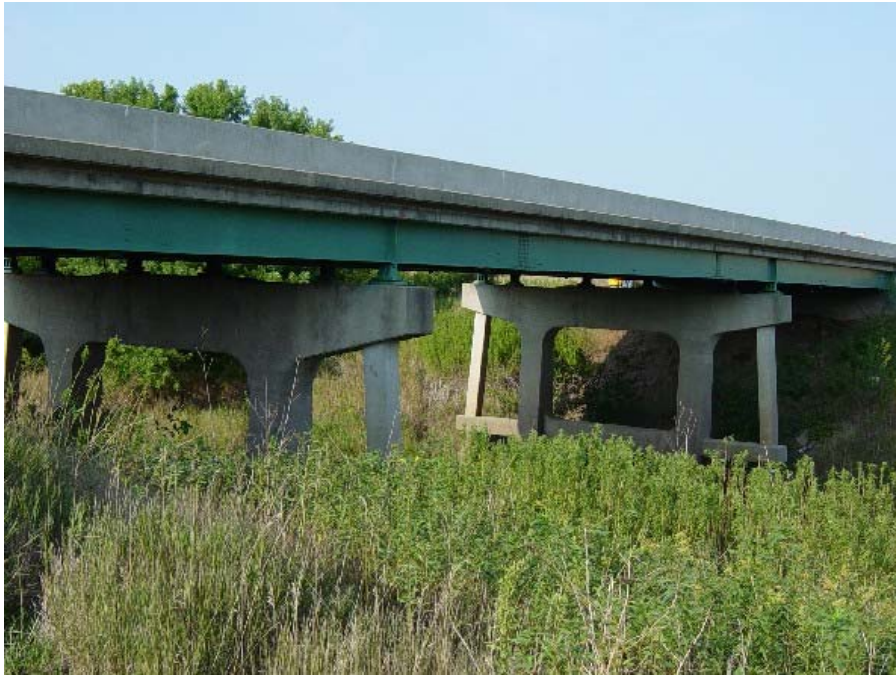
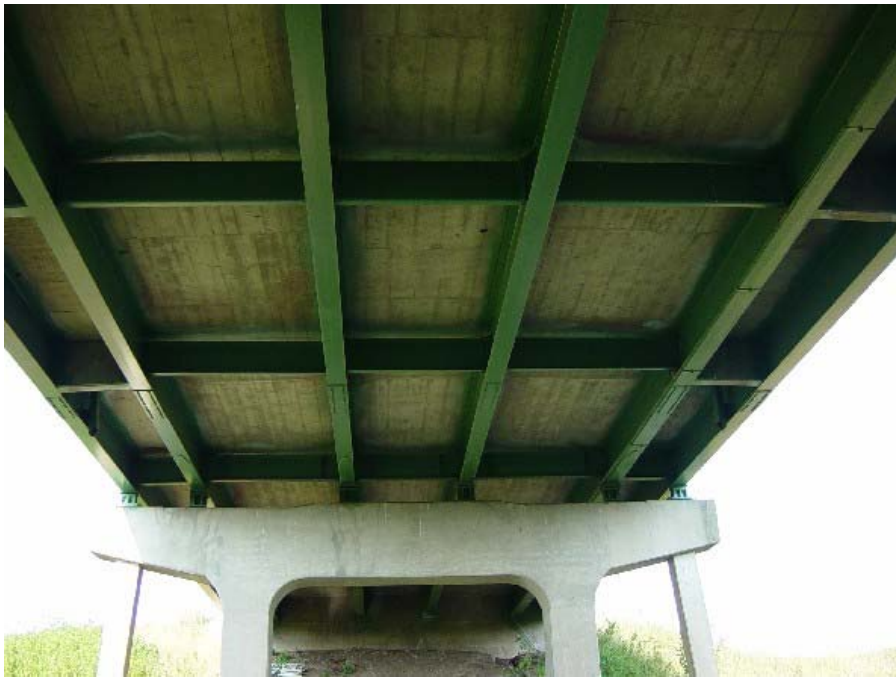
FIGURE 5 Photographs of Bridge 7838.5S092.

The bridge (Number 7838.5S092) selected for strengthening is the 150 ft x 30 ft three-span continuous I-beam bridge shown in Fig. 5. The bridge is located in southwest Iowa in Pottawattamie County on State Highway IA 92 over Walnut Creek. The bridge has two 45 ft - 6 in. end spans and a 59-ft center span. The original non-composite bridge was built in 1938 and was widened on both sides in 1967 by the addition of exterior girders that were constructed composite with the deck. The original bridge deck is a nominal 6.5-in. thick cast-in-place, reinforced concrete slab. The current average deck thickness is approximately 11 in. with 4 - 1/8 in. of crown from the edge of the roadway to the center of the roadway. The bridge deck is supported by two W27x84 exterior beams and four interior beams (two W27x91s and two W27x98s). As can be seen in Fig. 5, full depth 8-in. thick concrete diaphragms were cast between the W27x91 interior and W27x84 exterior beams when the bridge was widened in 1967. The bridge has no skew. Both abutments are integral concrete supported on treated wood friction piling, and the original piers are open-two-column concrete supported on untreated wood friction wood piling. The piers were also widened on both sides with the addition of a concrete pile at each end in 1967. The roadway width is 30 ft allowing for two traffic lanes and a shoulder on each side. The bridge has curbs integral with the deck with concrete guardrails connected to the curbs.

Both abutments have a few random vertical and horizontal hairline cracks with a small delaminated area at the top of one of the abutments. The top and bottom of the deck exhibit several hairline and narrow transverse cracks, and a few small delaminated areas. Both curbs have moderate hairline cracks through their length. The top of the deck has Portland Cement patches at several locations, and a few small spalls and delaminated areas along the construction joints.

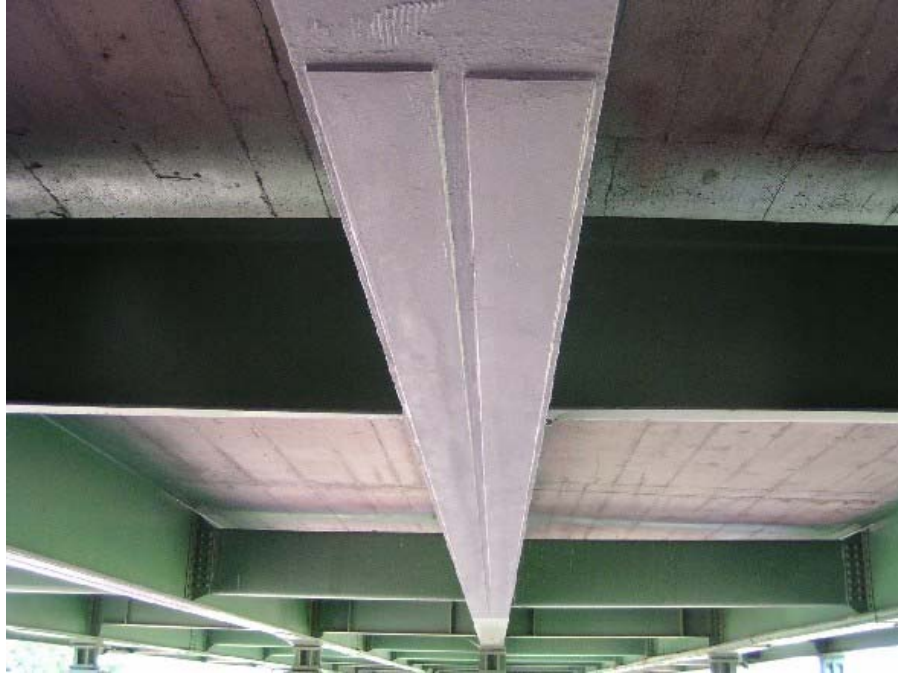
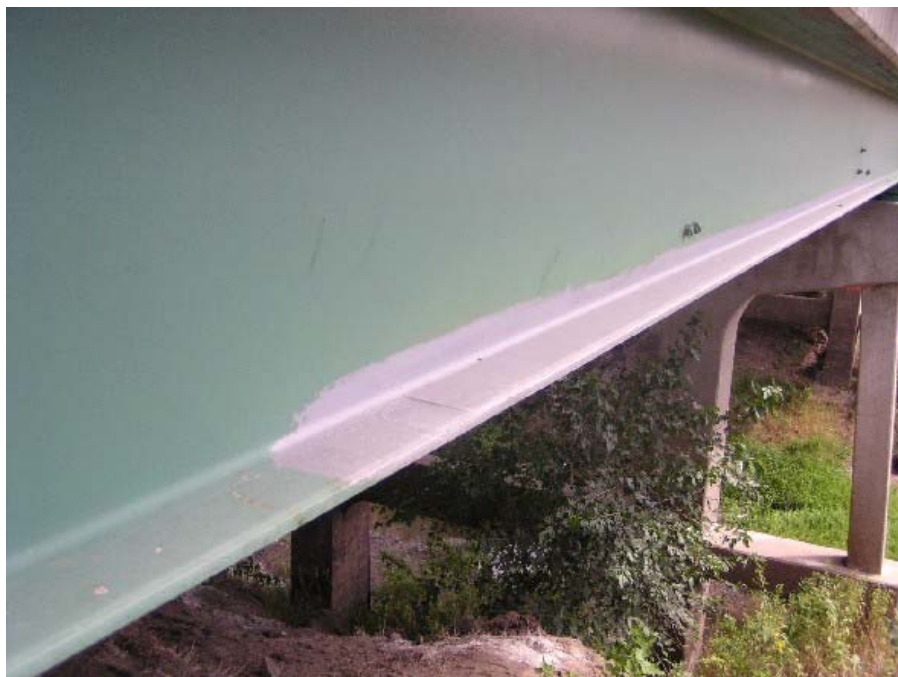
FIGURE 8 Photographs of installed CFRP strengthening system.

a. Beam 4 in the east end span

b. Top of bottom flange of Beam 6 in the west end span

Temporary scaffolding was constructed underneath the bridge in both end spans to provide easy access to the beams for installing the strengthening system. Access to the center span was provided through the use of a “snooper” truck. In the first step of the installation process the steel beam surfaces to which the CFRP plates were to be bonded were roughened to a coarse sandpaper texture by sandblasting to remove any lead free paint and unsound material. After sandblasting, the beam surface was cleaned with acetone. The bonding surfaces of the CFRP plates were also cleaned at that time with acetone. After the bonding surfaces were dry, the prepared beam surface was treated with a thin layer of FRS Primer to prevent corrosion induced by a galvanic reaction between the beam surface and carbon fibers. Once the primer had set, ECS 104 structural epoxy was applied to both the pre-cut CFRP plates and the beam surface using a 1/8 in. v-notched trowel. The plate was then carefully placed on the beam surface, starting at one end, taking special care to ensure a “straight” application. A smooth, hand roller was then used to apply pressure to the plate to evenly distribute the epoxy and to remove any trapped air. A smooth trowel was then used to remove any excess epoxy from the edges of the CFRP plates. After all plates were installed and the epoxy had cured, all surfaces were painted. Photographs of the completed installation are presented in Fig. 8.

The handling and installation of the CFRP plates was relatively labor intensive and required some training. At least a three-man crew was needed to install the system (one day per layer). It should, however, be pointed out that subsequent installations should be completed
