EXERCISE

NON-COMPLIANCE NOTICE AND CHANGE ORDER

Project Number: NHSX-032-1(41)—3H-31

Item Description: Bridge Approach, BR-203

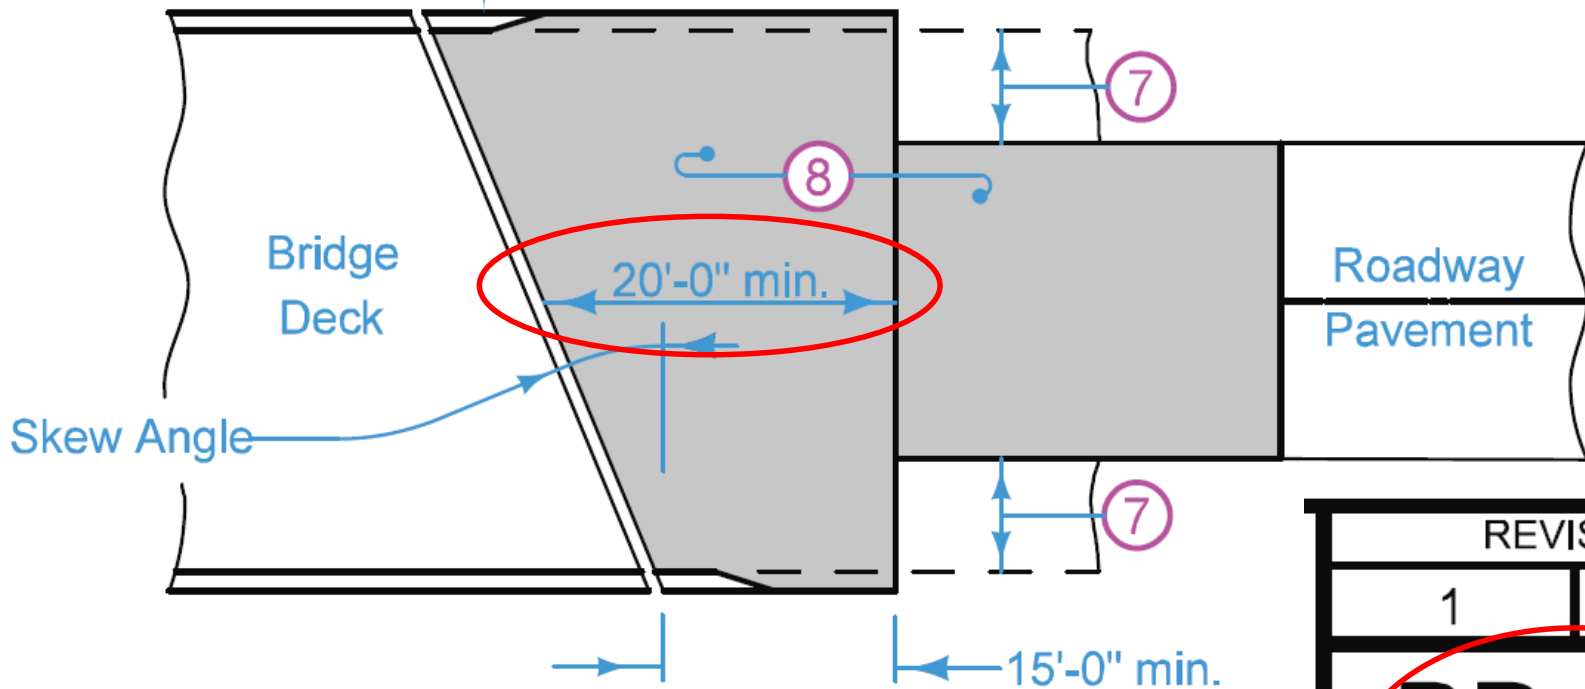
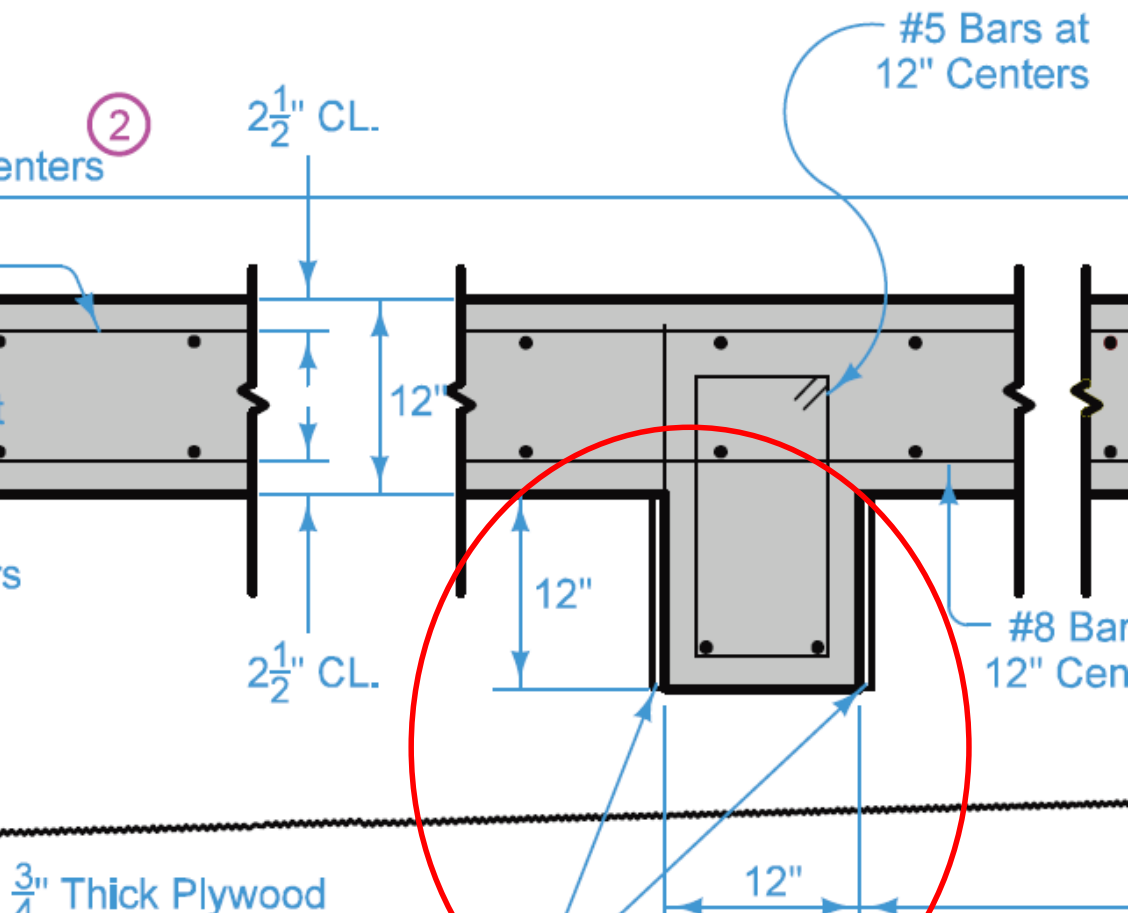
DOUBLE REINFORCED 12" APPROACH

3.5 CY of concrete with entrained air content exceeding the upper limit was placed in the west bridge approach.

9.2% Entrained Air

White pigmented liquid curing compound was placed on 80 SY of concrete was placed in the west bridge approach more than 30 minutes after finishing was completed.

White pigmented liquid curing compound was placed 45 minutes after finishing was completed.

8001 – Contractor elected to begin placement of concrete before entrained air test was completed and results of test (9.2% test result) were out of tolerance of 7.0% +/- 1.5% for 3.5 CY of concrete used for nonslip form paving in the double reinforced section of the west bridge approach.

8002 - Contractor placed white pigmented curing compound more than 30 minutes (actual placement 45 minutes) after finishing operation was completed on 80 SY of the double reinforced section of the west bridge approach.

A price adjustment on the 3-1/2 CY of concrete that was placed out of specification will be imposed.

A price adjustment on 80 SY of concrete will be imposed for the late curing compound application.
