Laboratory and Field Evaluation of the 24th Street Bridge

Terry Wipf, Iowa State University
Brent Phares, Iowa State University
Travis Hosteng, Iowa State University
Jake Bigelow, Iowa State University

August 20, 2009

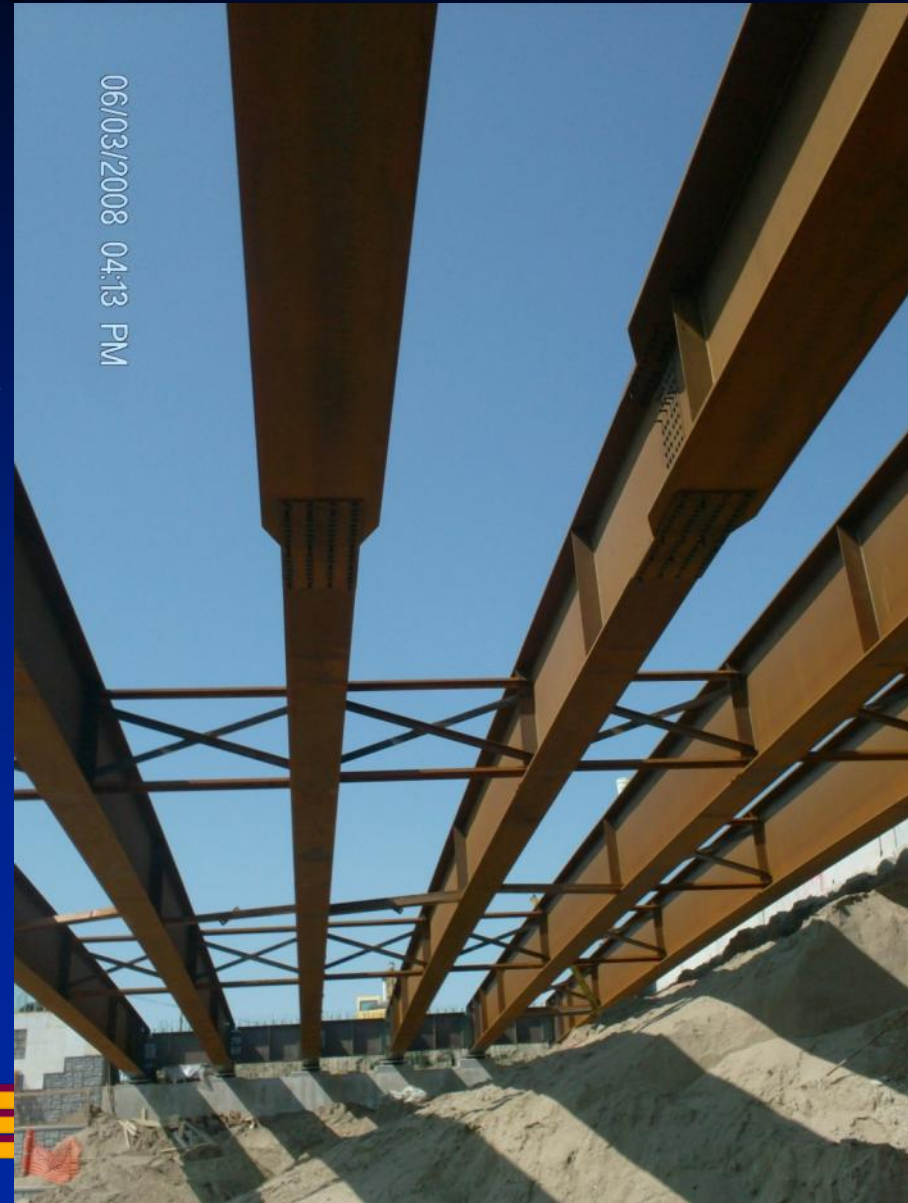
- Two spans
- 353.5 ft long
- 6 lanes plus sidewalks (99 ft wide)
- Precast deck panels (post tensioned)
- Composite steel girders

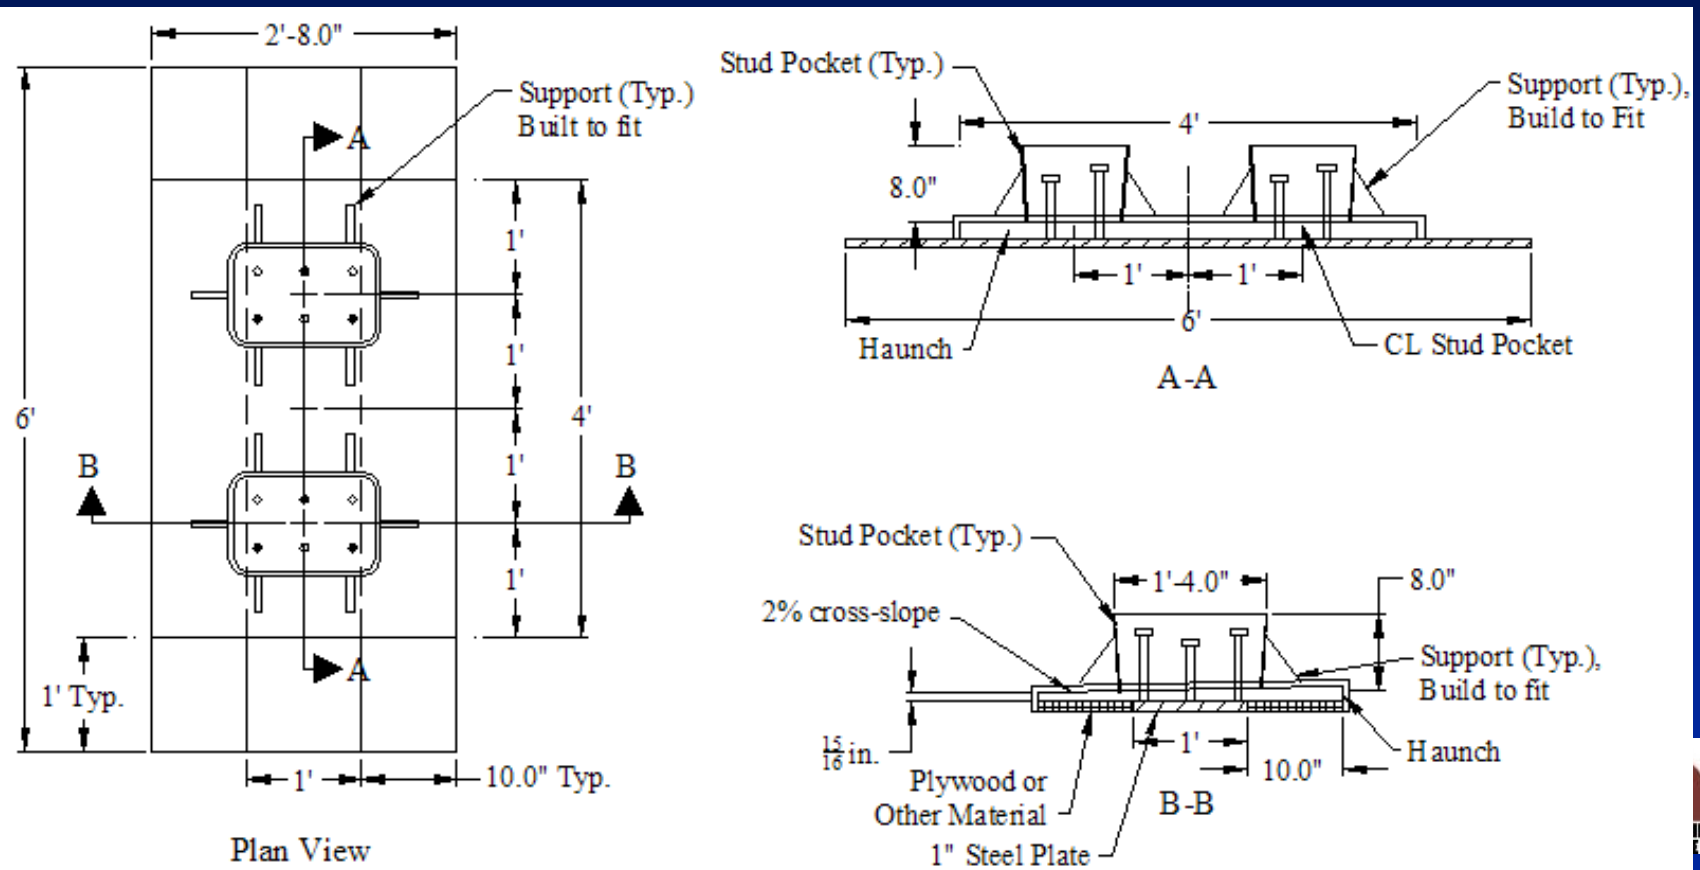
Cross-Section Views

- Stud pocket bend test
 - Confined space in pocket
 - Able to conduct bend test on all studs

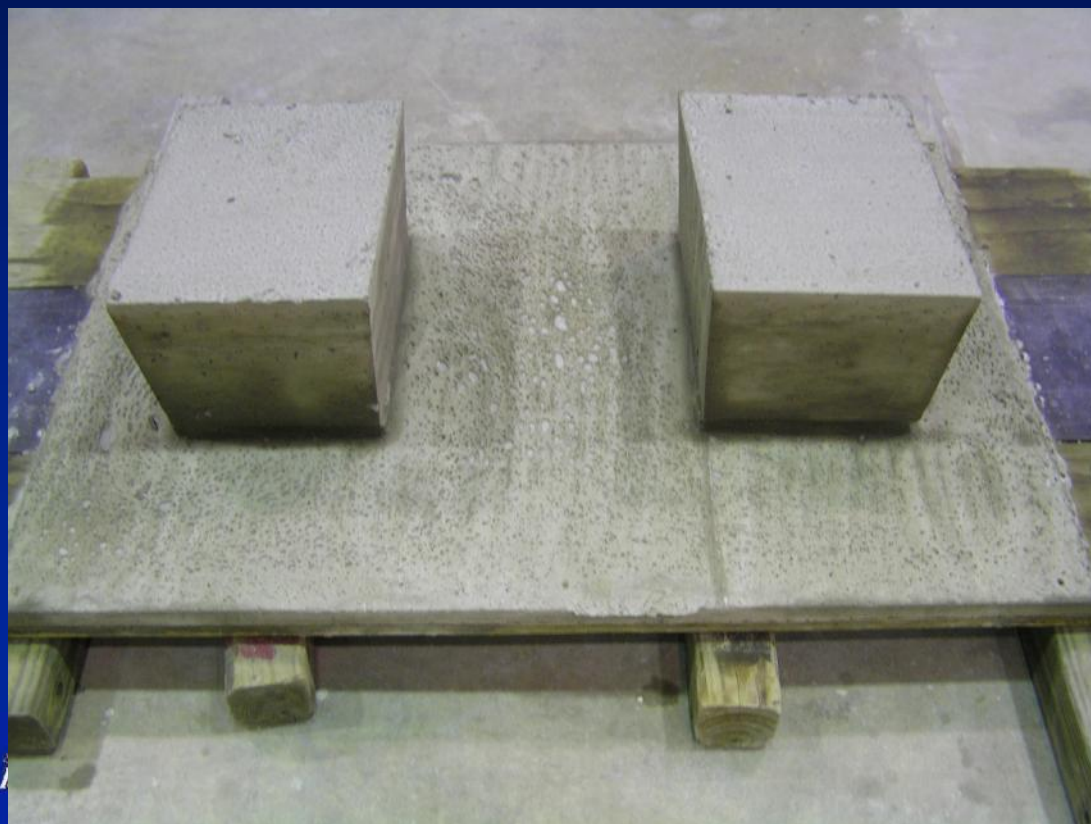
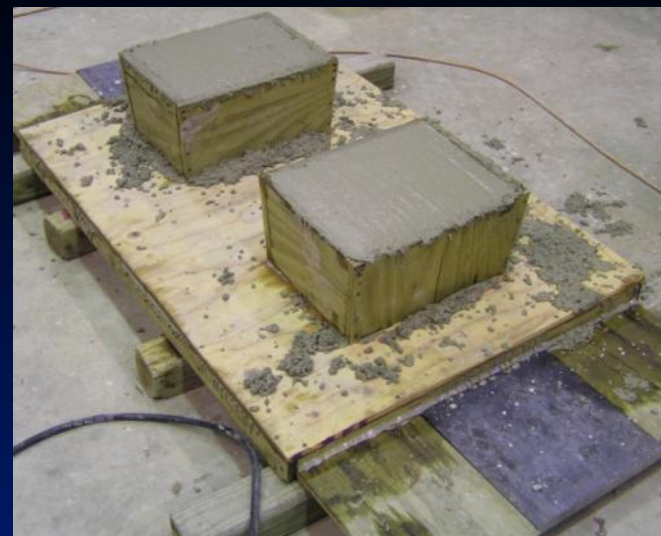
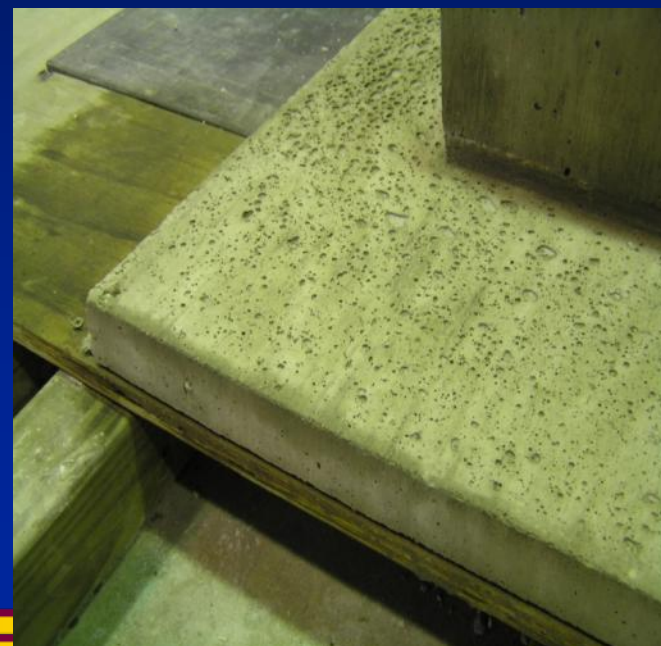
- Grout flowability
 - Sufficient grout flow from stud pockets to haunch

- Laboratory Testing
 - Stud pockets
 - » Installation
 - » Bend test
 - Grout can sufficiently flow from stud pocket into haunch
 - Waterproof duct tape is sufficient for sealing duct splices
 - Sandblasting surface of joint provide highest shear resistance

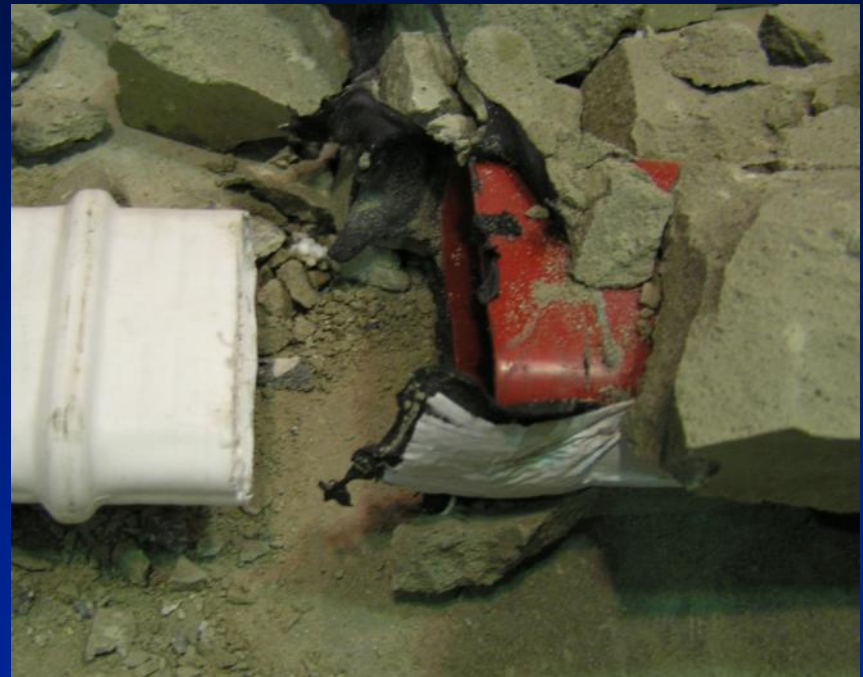
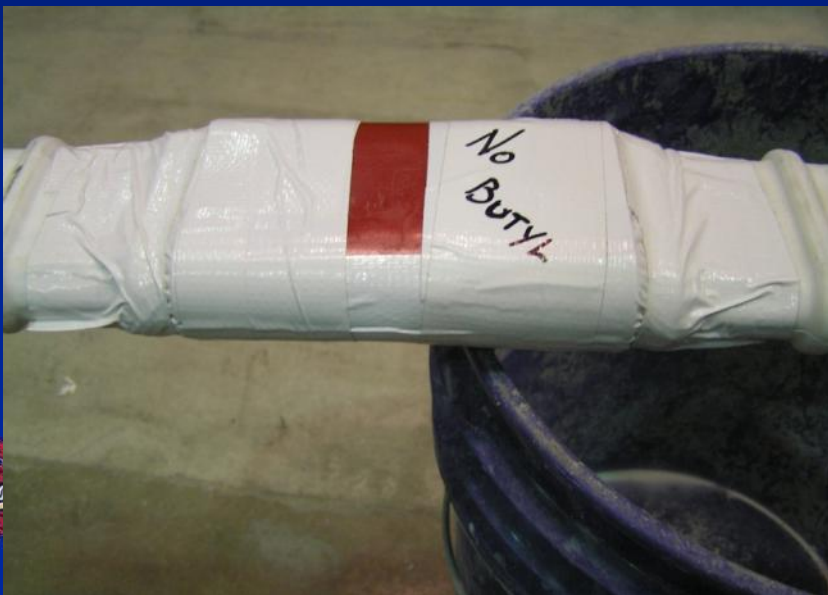
- Duct splicing performance
 - 1 in. x 3 in. duct splice checked for grout tightness
 - Waterproof duct tape
 - » Simple
 - » Works

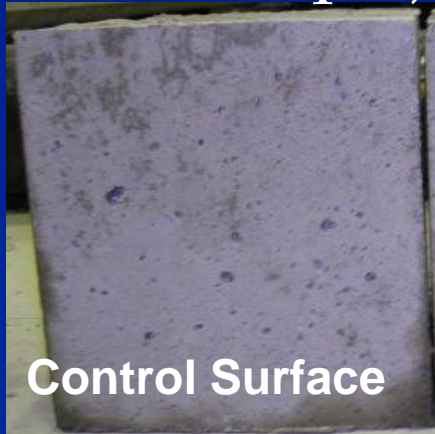
Control Surface

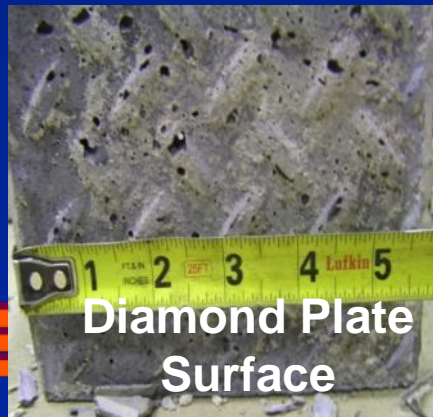
Diamond Plate Surface

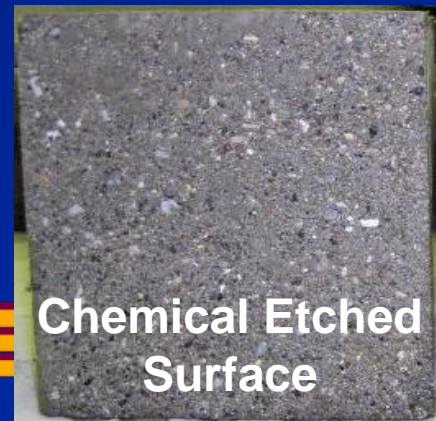
Chemical Etched Surface

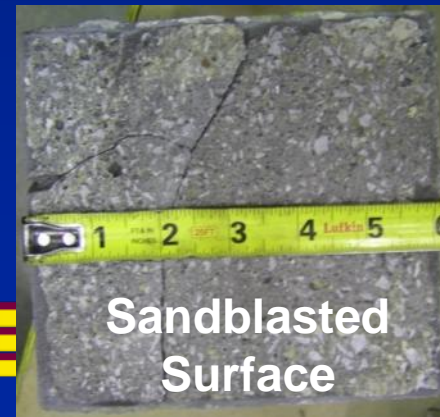
- Panel transverse joint shear
- Surface treatments
 - Control (no roughing)
 - Diamond plate forms
 - Chemical etching
 - Sandblasting (best performance 578 psi)

Sandblasted Surface

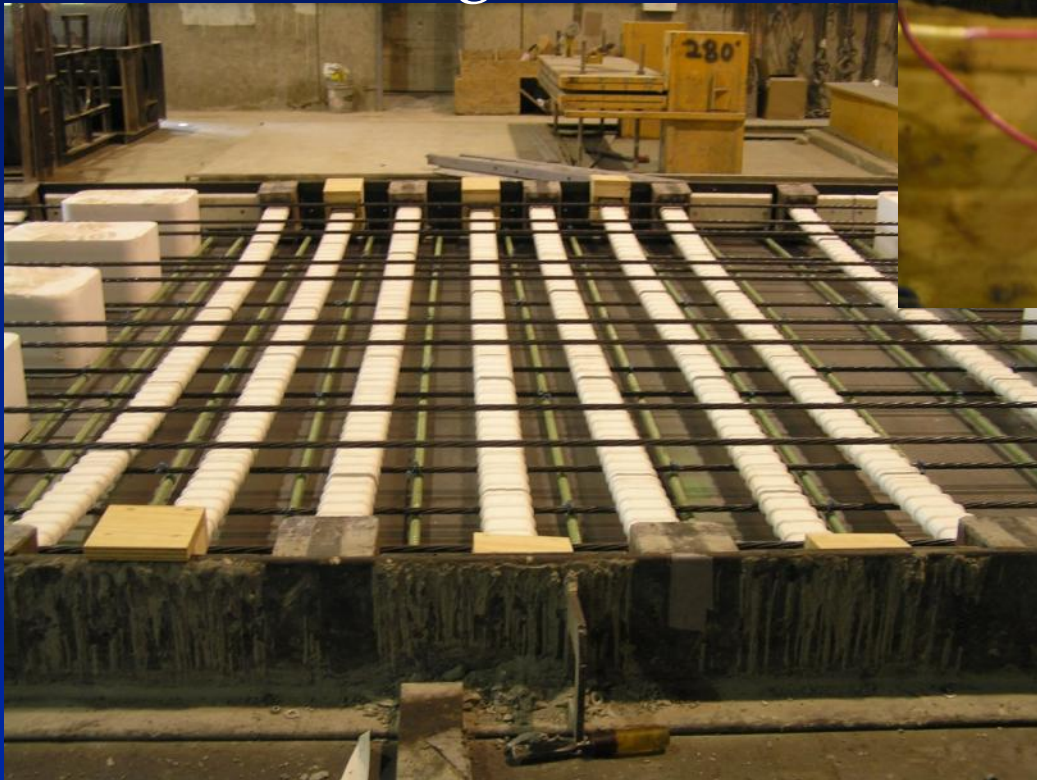
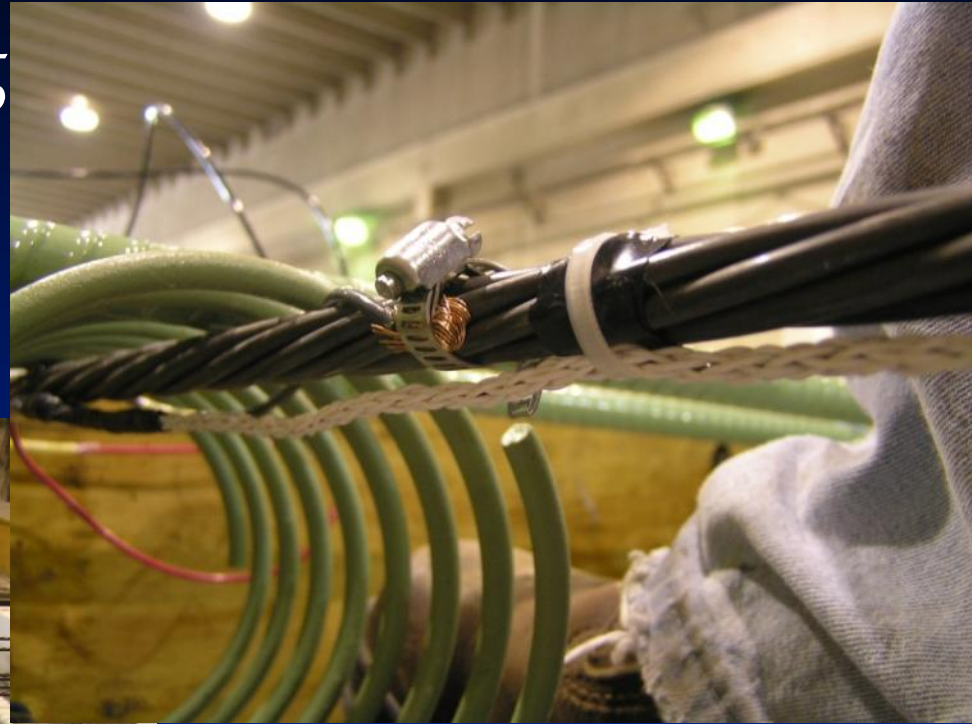
- Corrosion Monitoring
 - 6 pre-stress strands
 - 6 sacrificial post-tensioning strands

- No corrosion taking place as of June

- Field Testing
 - No corrosion indicated
 - Minimal pressure at mid-span joint during post-tensioning
 - Deflections were less than $L/6770$
 - Max and minimum strain occurred at bottom flange mid-span
 - » Max tension $66\mu\epsilon$
 - » Max compression $22\mu\epsilon$

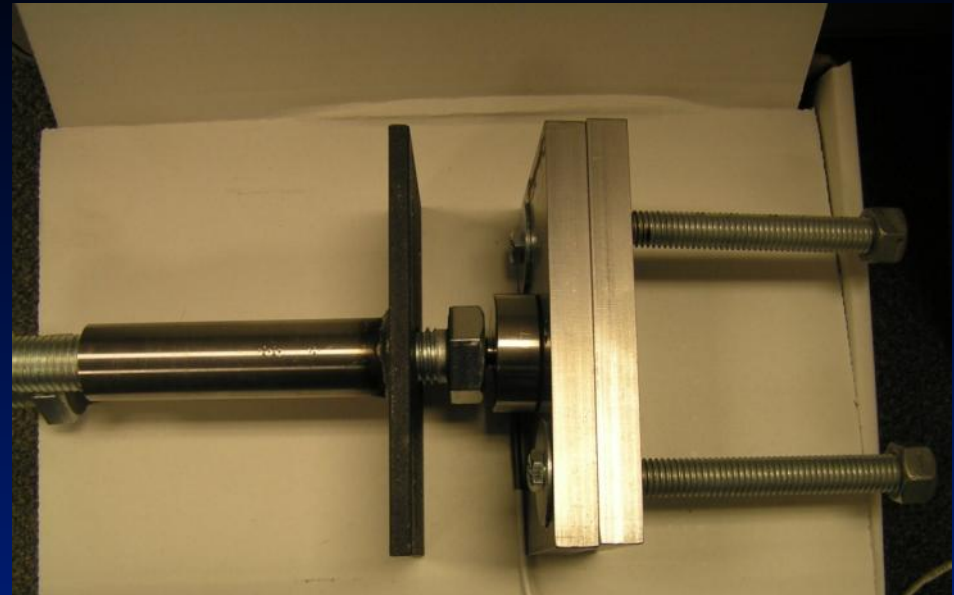
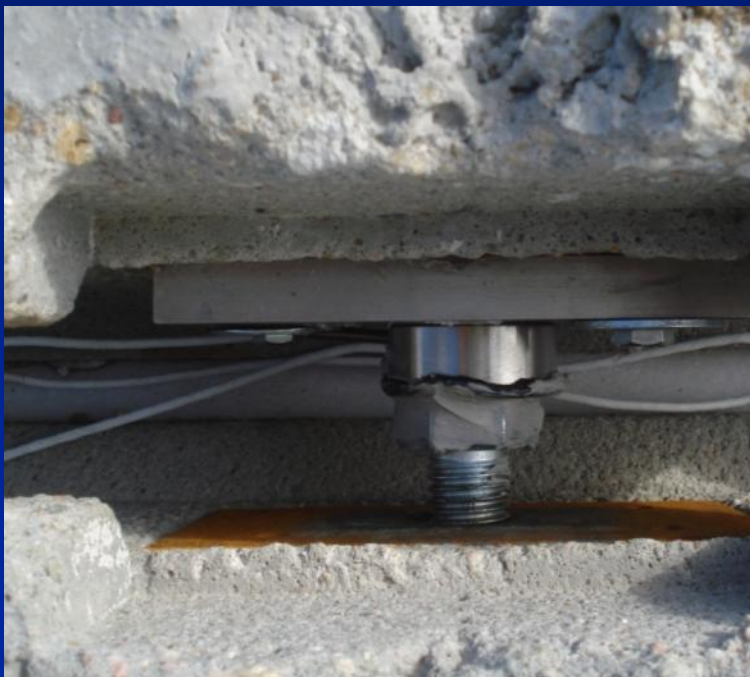
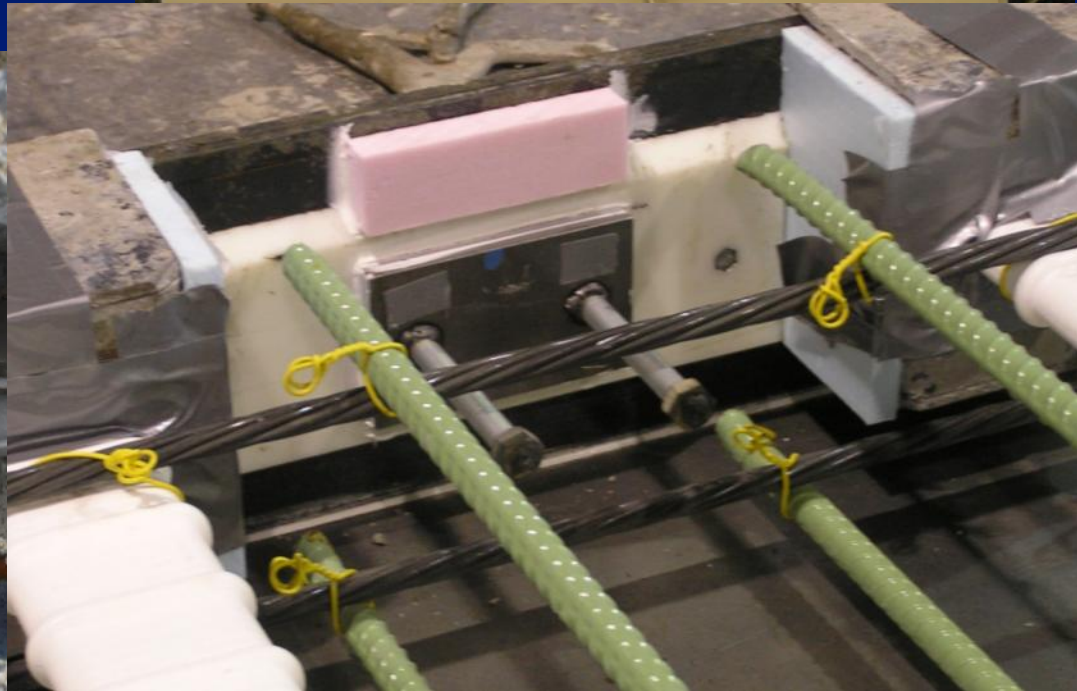
- Panel Joint Pressure
 - Monitored during post-tension

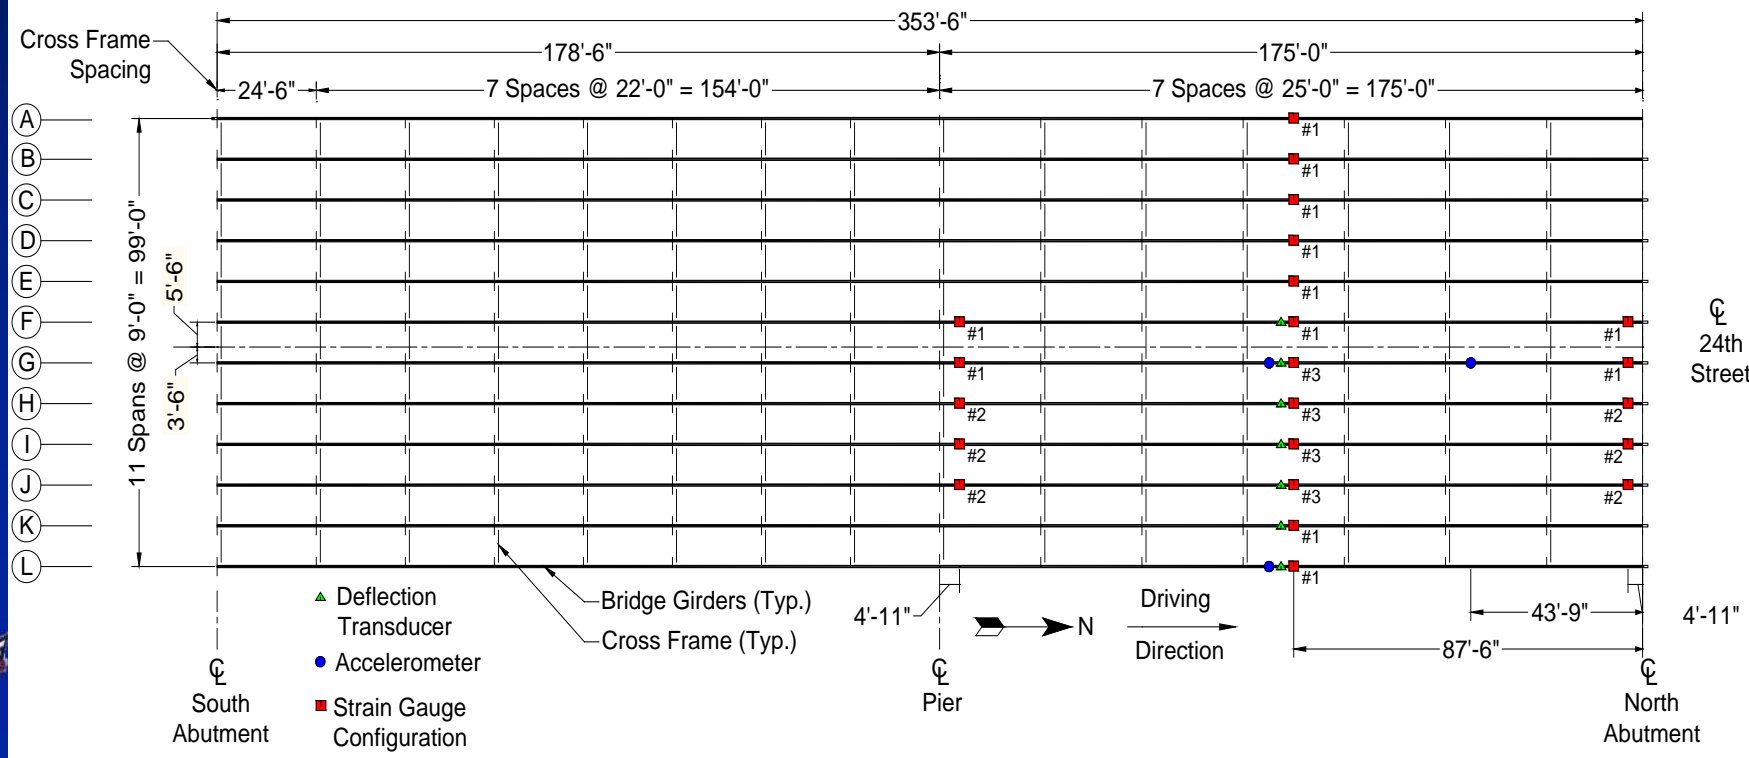
- Live load testing
 - Gauges located on north span
 - » Deflection, Strain, & Acceleration

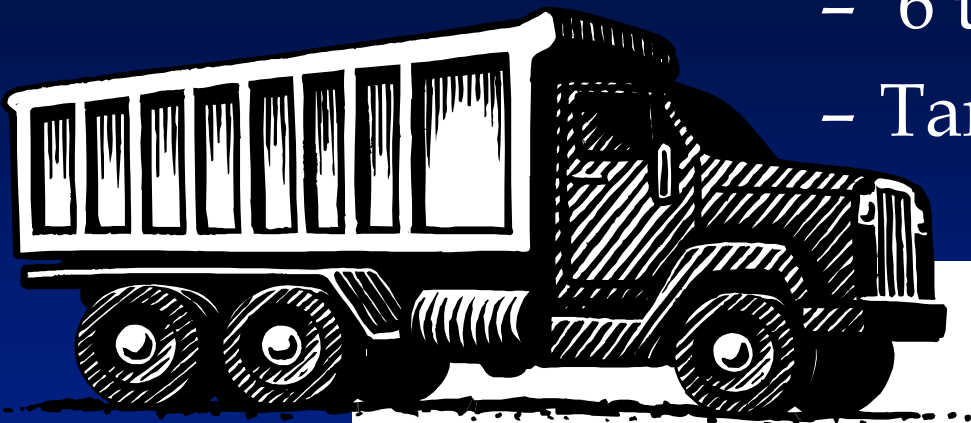
- Live load testing
 - 6 transverse load positions
 - Tandem axle dump truck

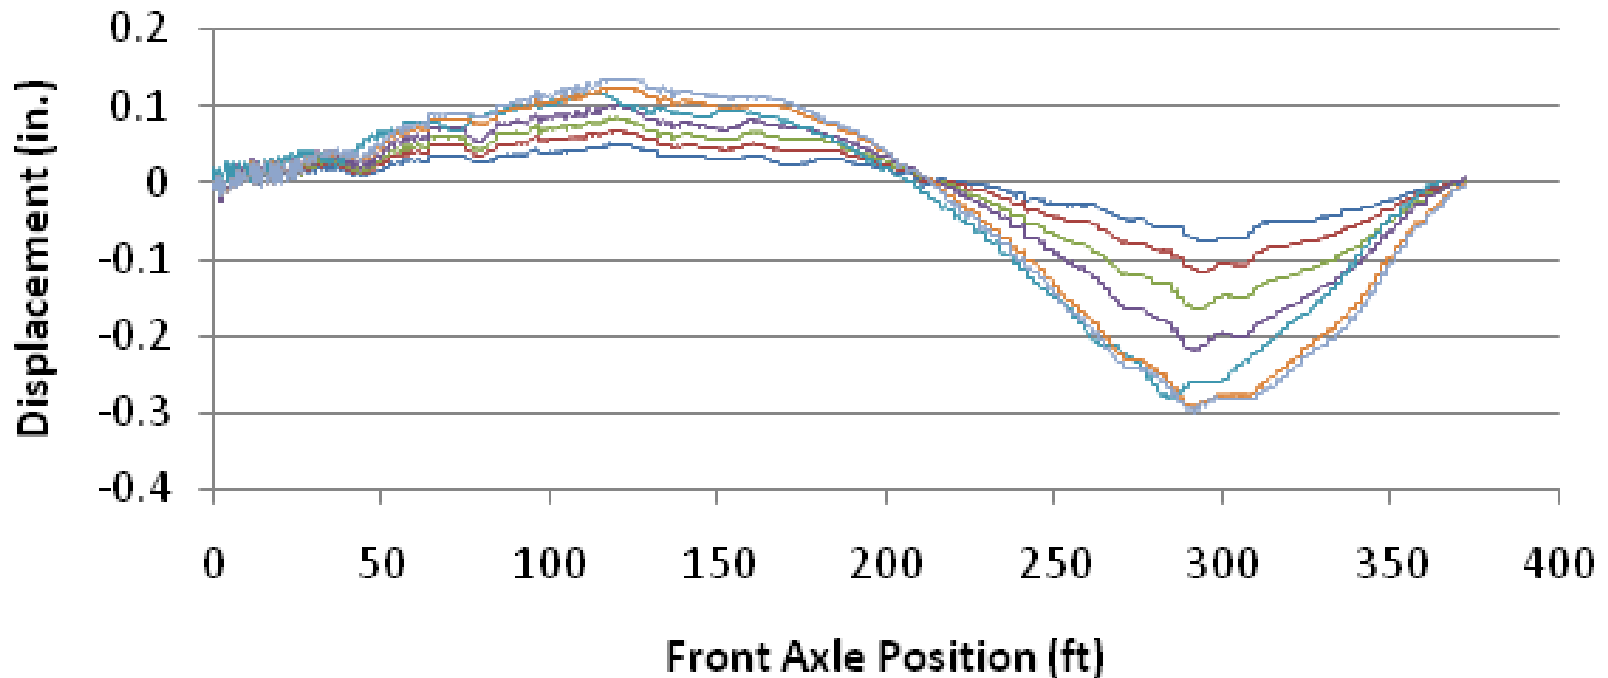
- Live load testing
 - Deflection @ midspan of north span
 - Truck on south span: max 0.15 in.
 - Truck on north span: min -0.31 in.

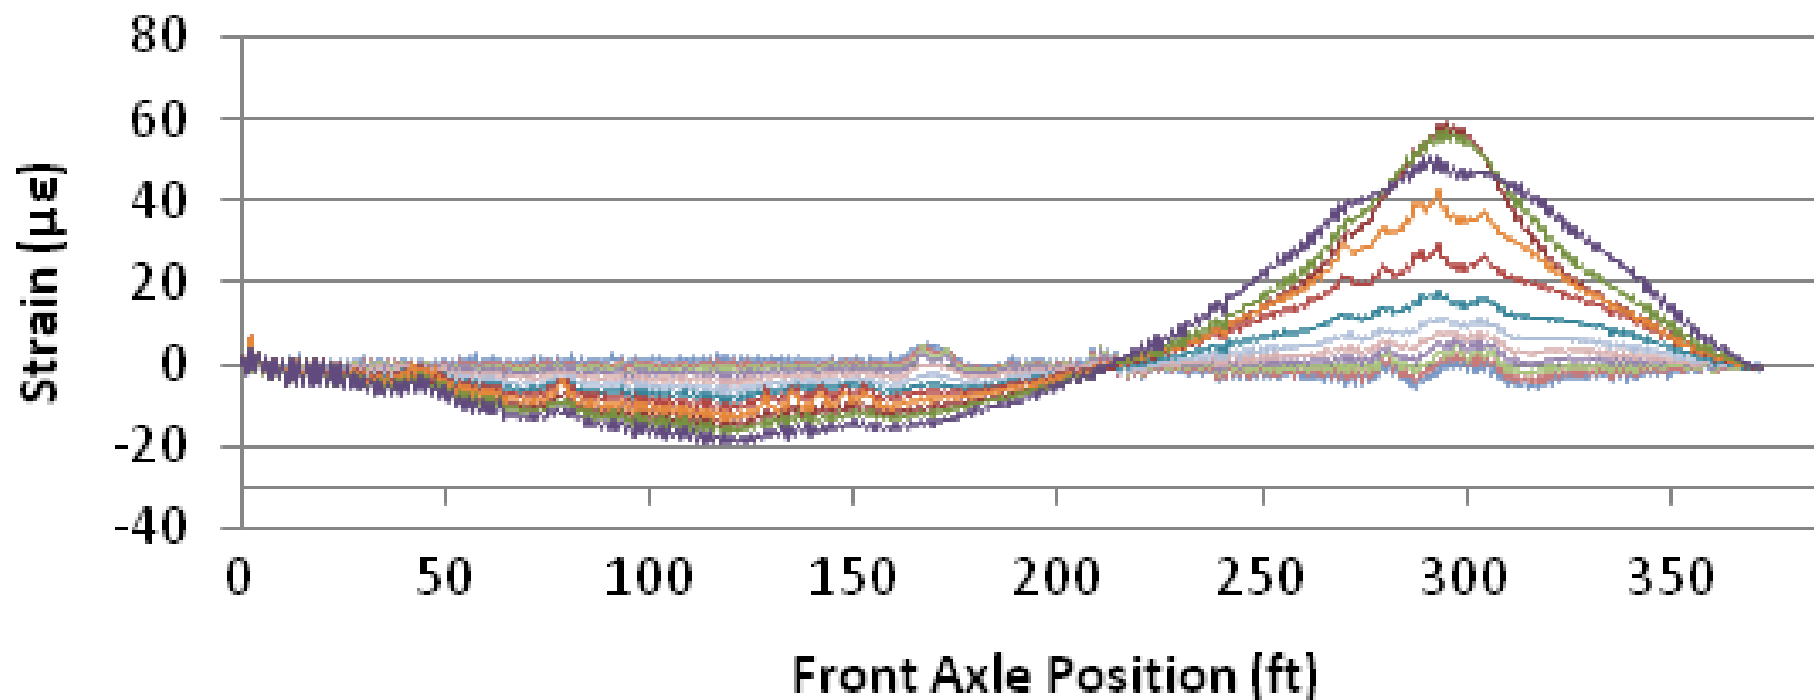
- Live load testing
 - Strain

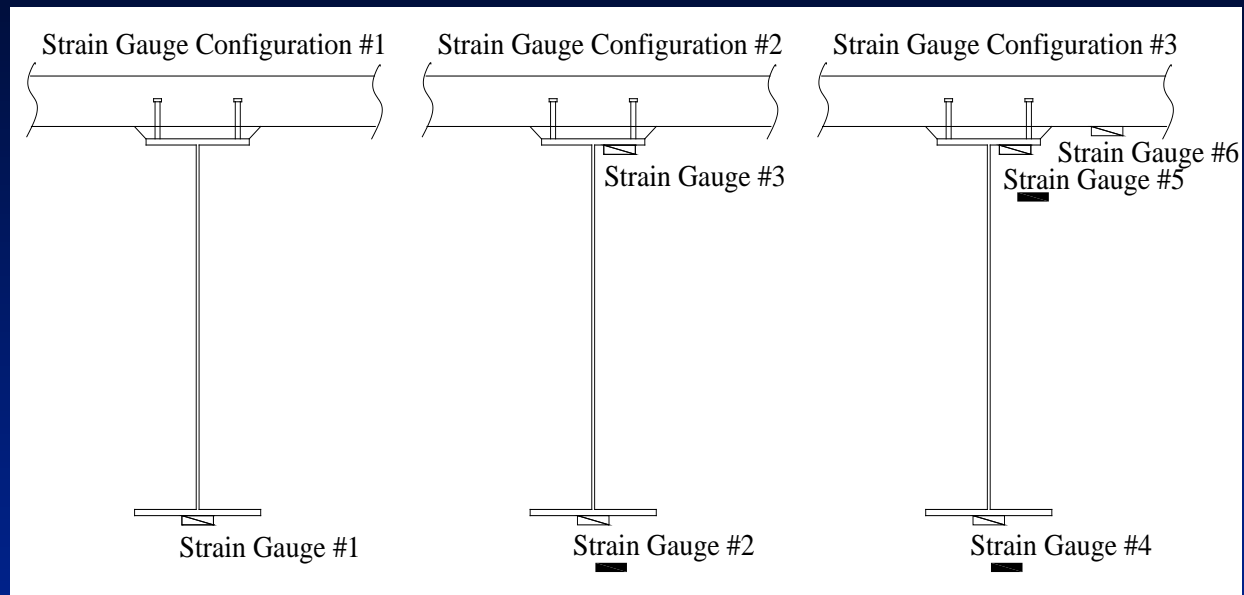
- Live load testing
 - Strain

Gauge Location	Bottom Flange	Top Flange	Bottom of Slab
Abutment	-4 to +14	-5 to +6	NS
Pier	-16 to +3	-1 to +5	NS
Mid-span	-22 to +66	-5 to +5	-2 to +6
