Strengthening Steel Girder Bridges with CFRP Plates

*Bridge Engineering Center
Iowa State University*

Description of Bridge:

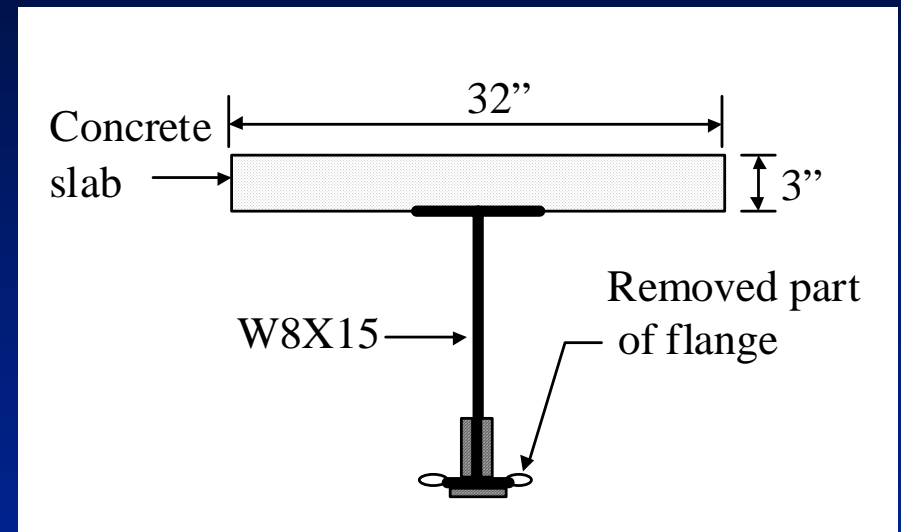
Damaged beam

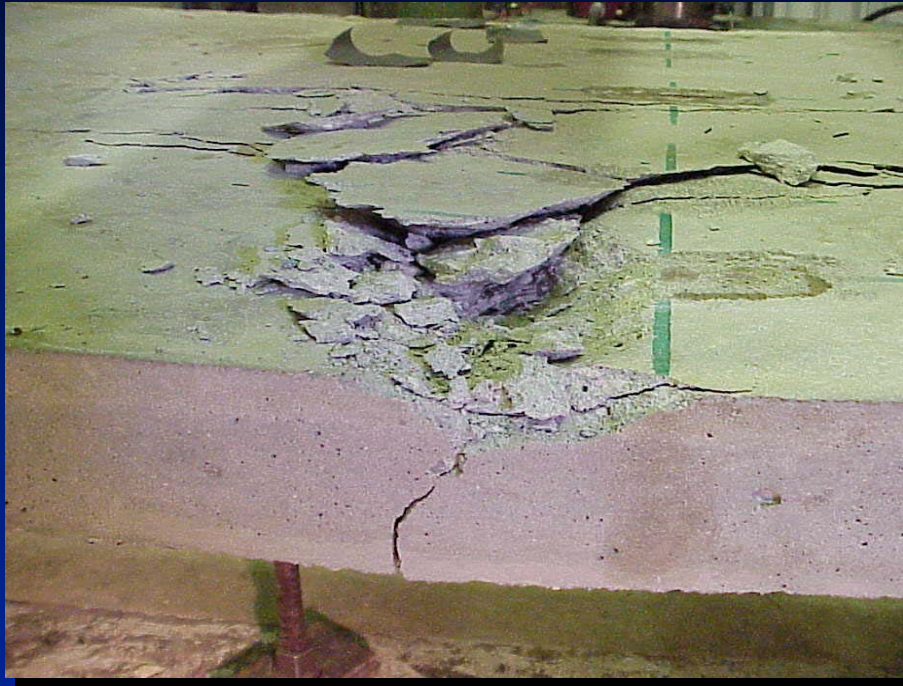
Concrete crushing

Failure Modes

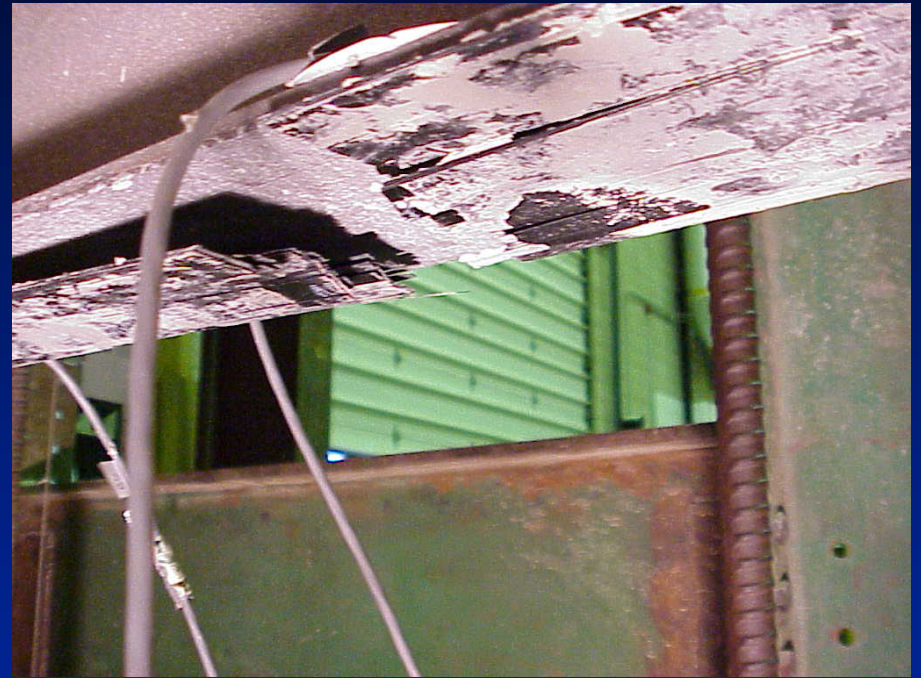
CFRP plate rupture

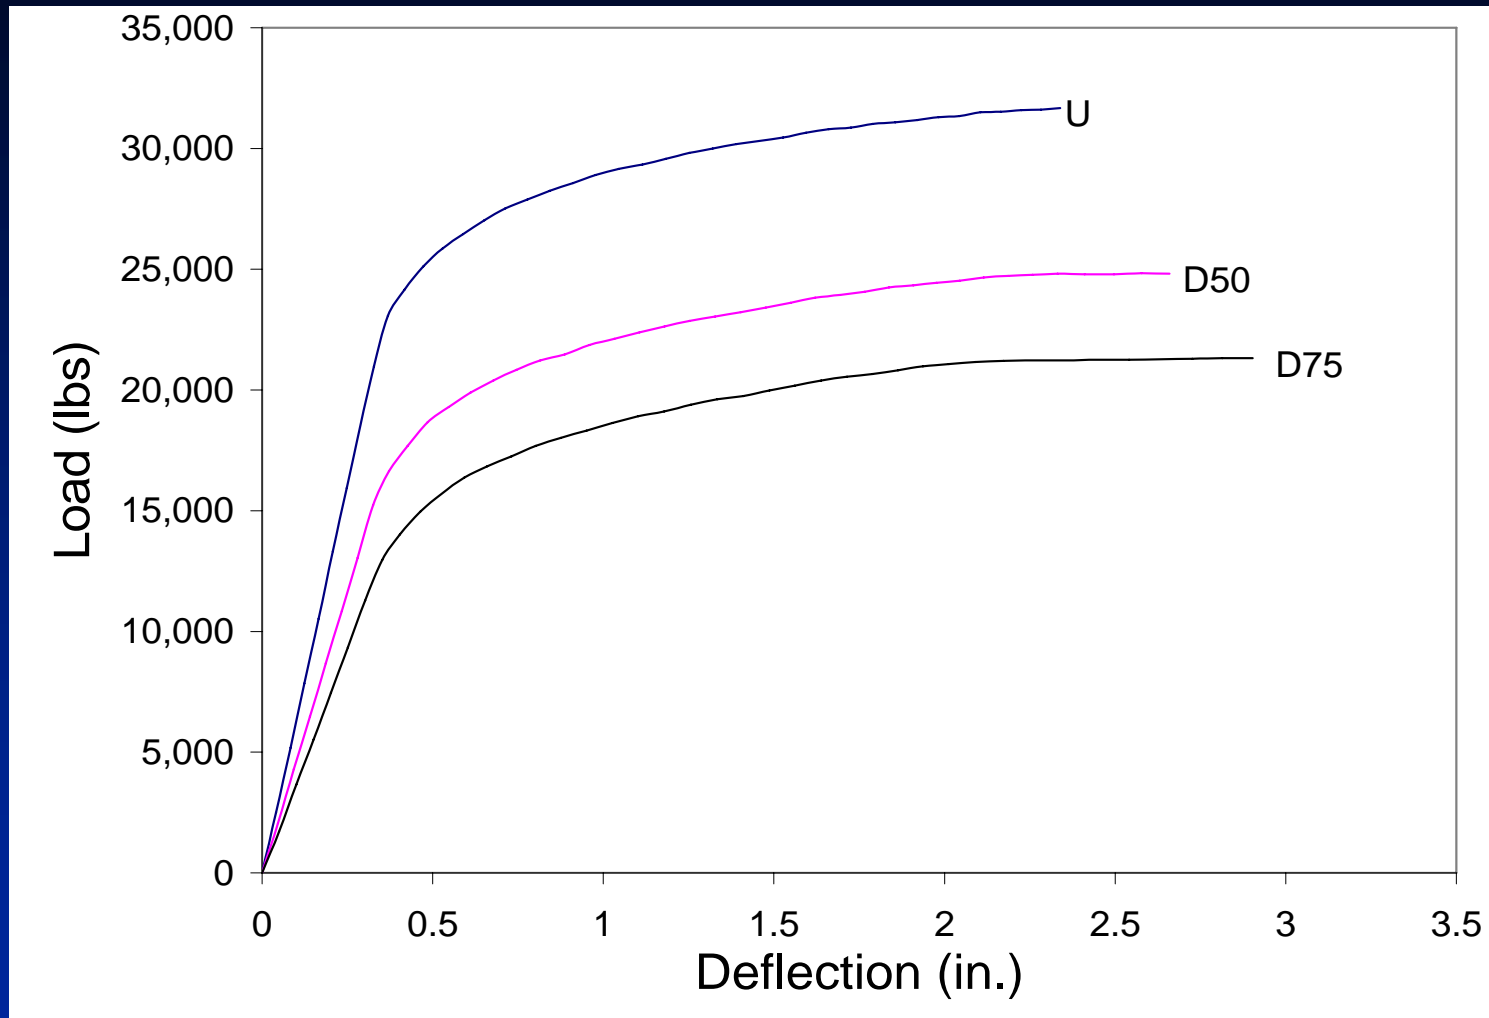
Analytical Midspan Deflection

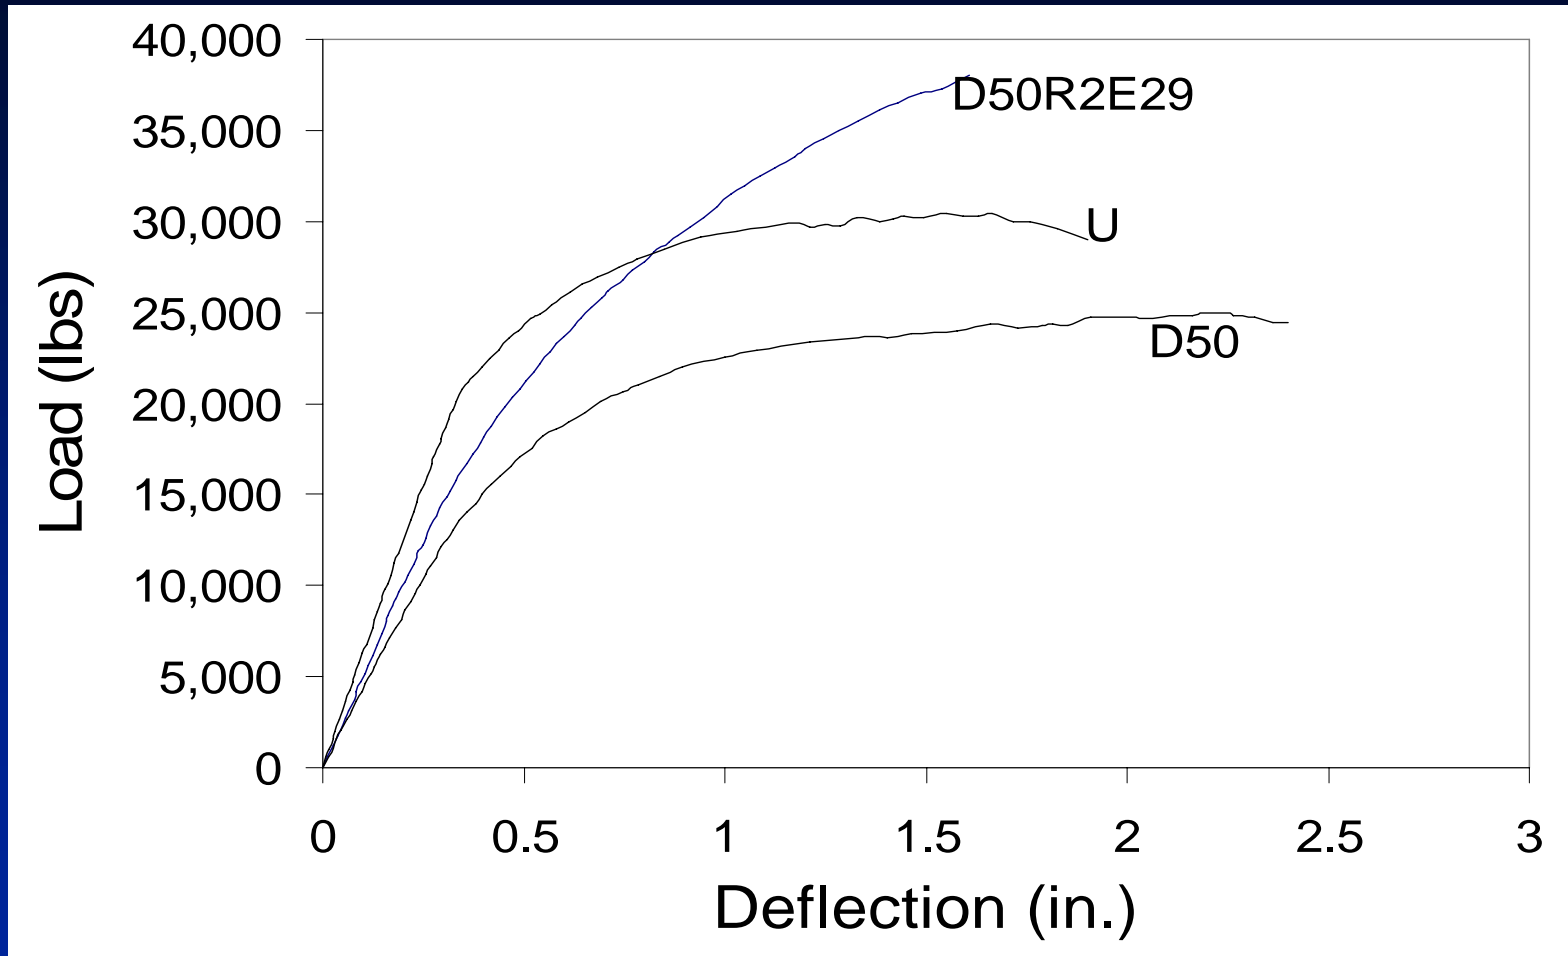
Impact of Repair Scheme 2

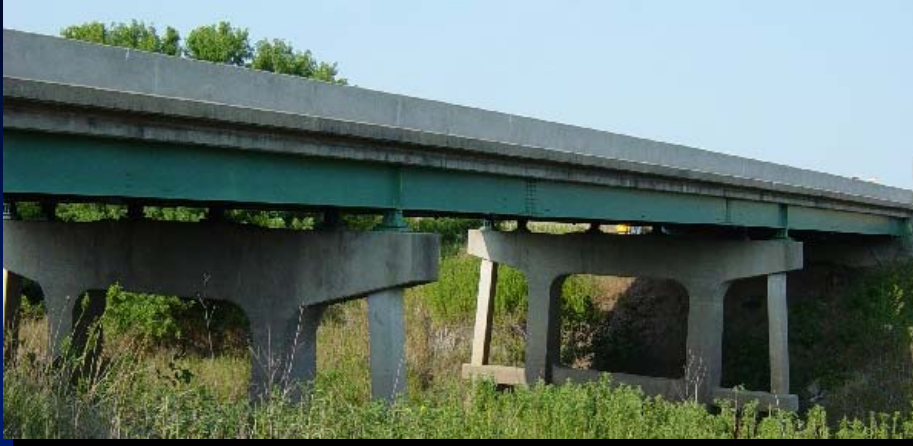
- Located in Pottawattamie County, IA on State Highway IA 92
- Three-span continuous steel girder bridge
- Roadway width = 30 ft [two traffic lanes]
- Total length = 150 ft
 - Two 45.5 ft end spans and a 59 ft center span

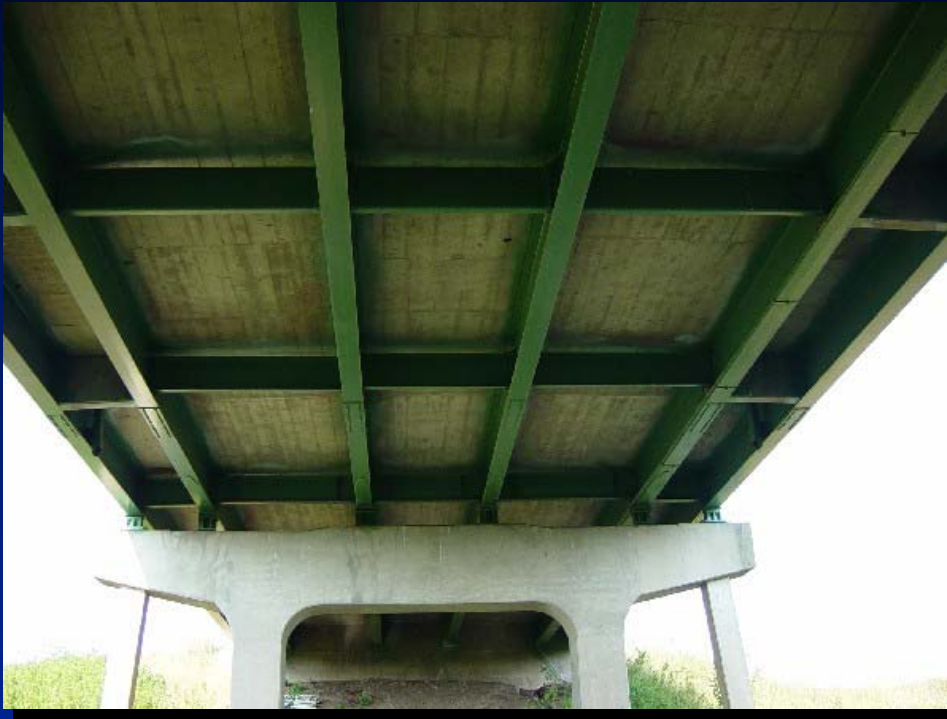
- Constructed in 1938, the bridge was originally non-composite
- In 1967, it was widened by adding two composite exterior girders

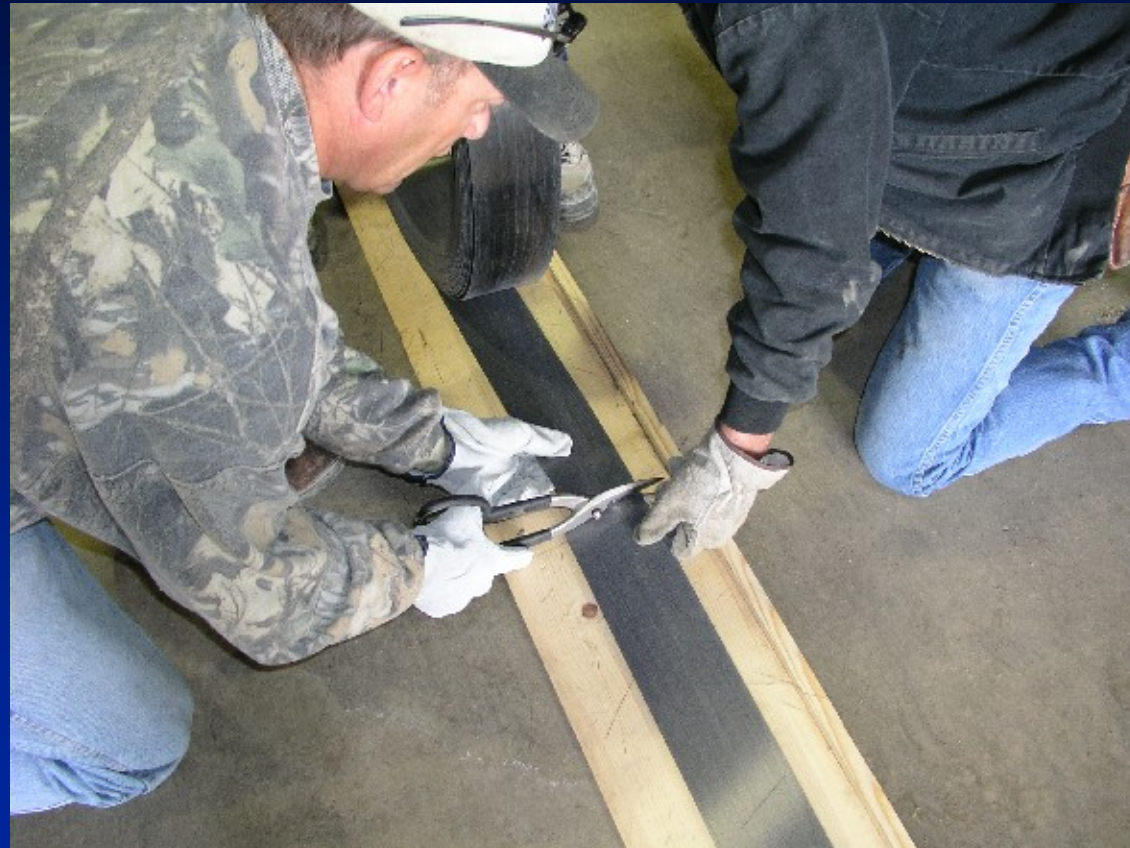
Removal of Paint from Beams - Stage 1

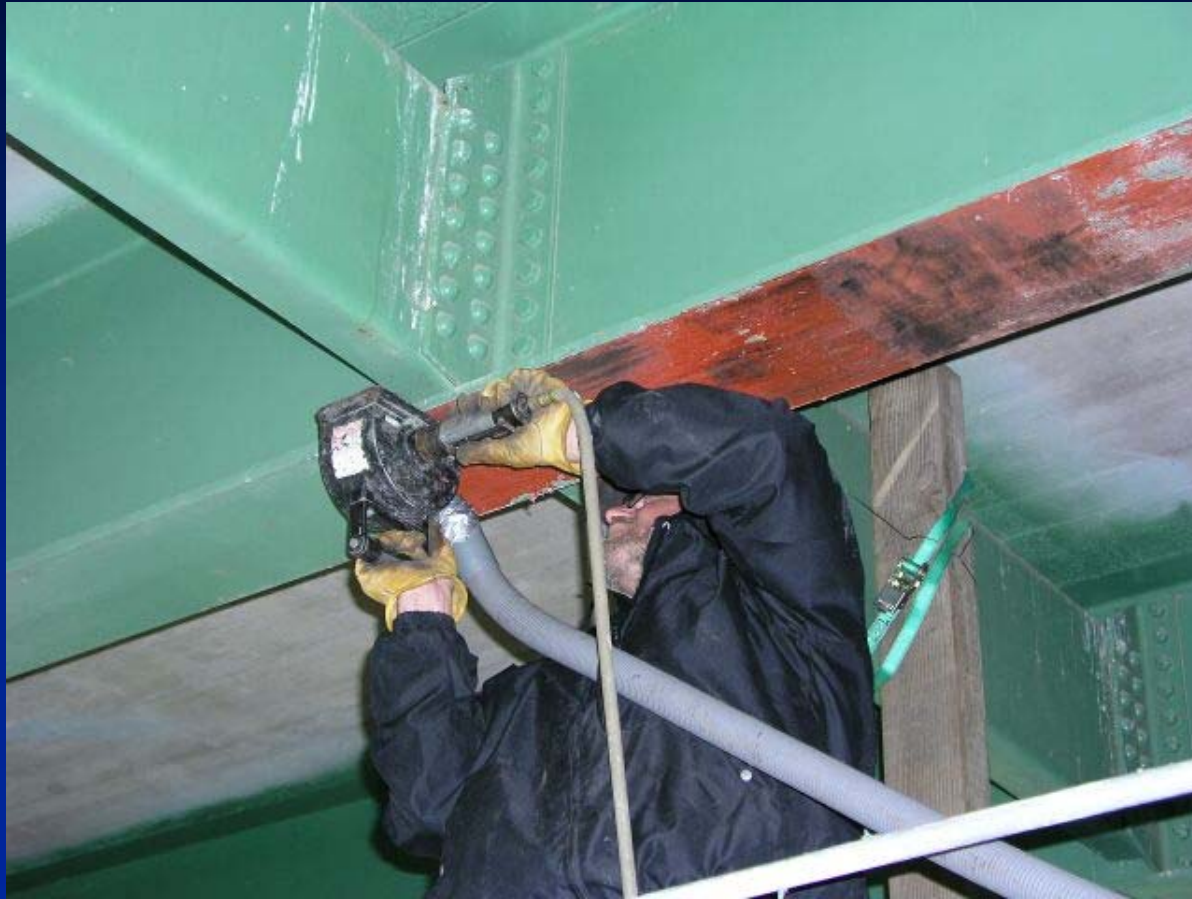
Removal of Paint from Beams - Stage 2

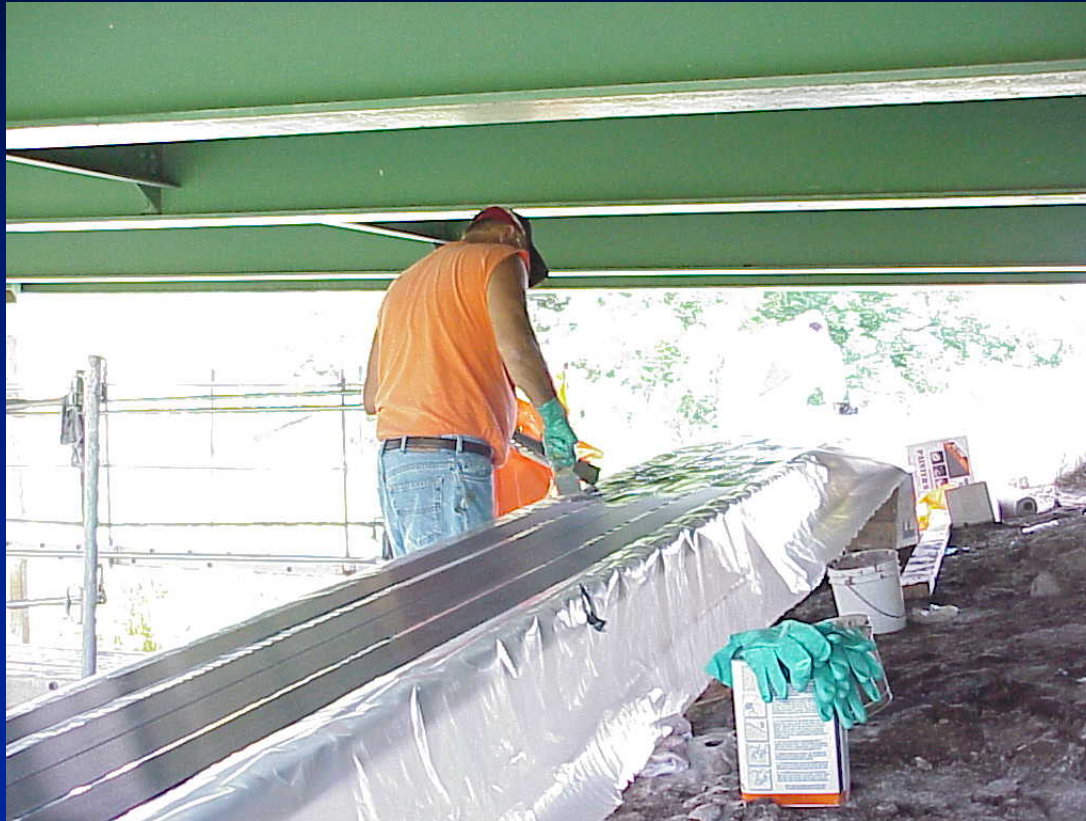
Obtaining Desired Thickness of Epoxy

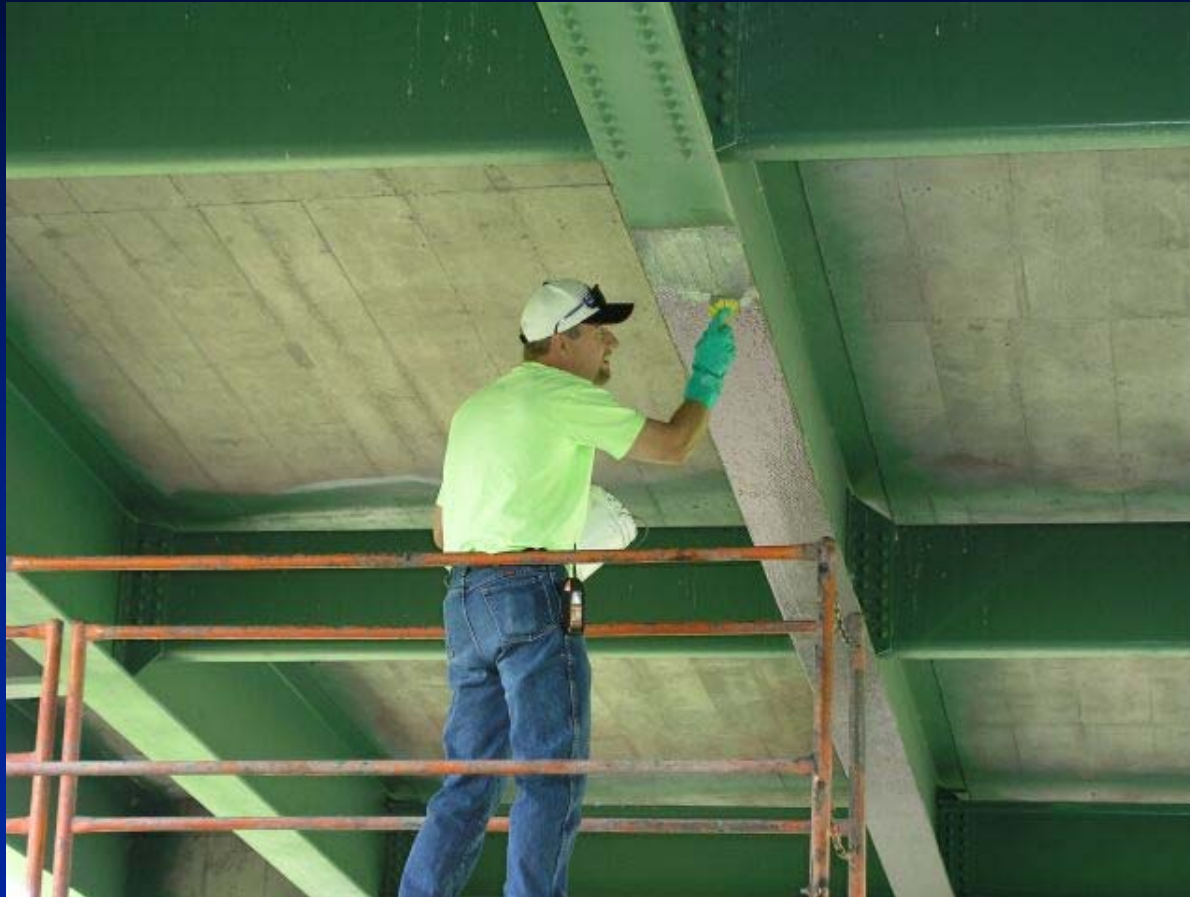
Installation of FRP Strips to End Span Beams

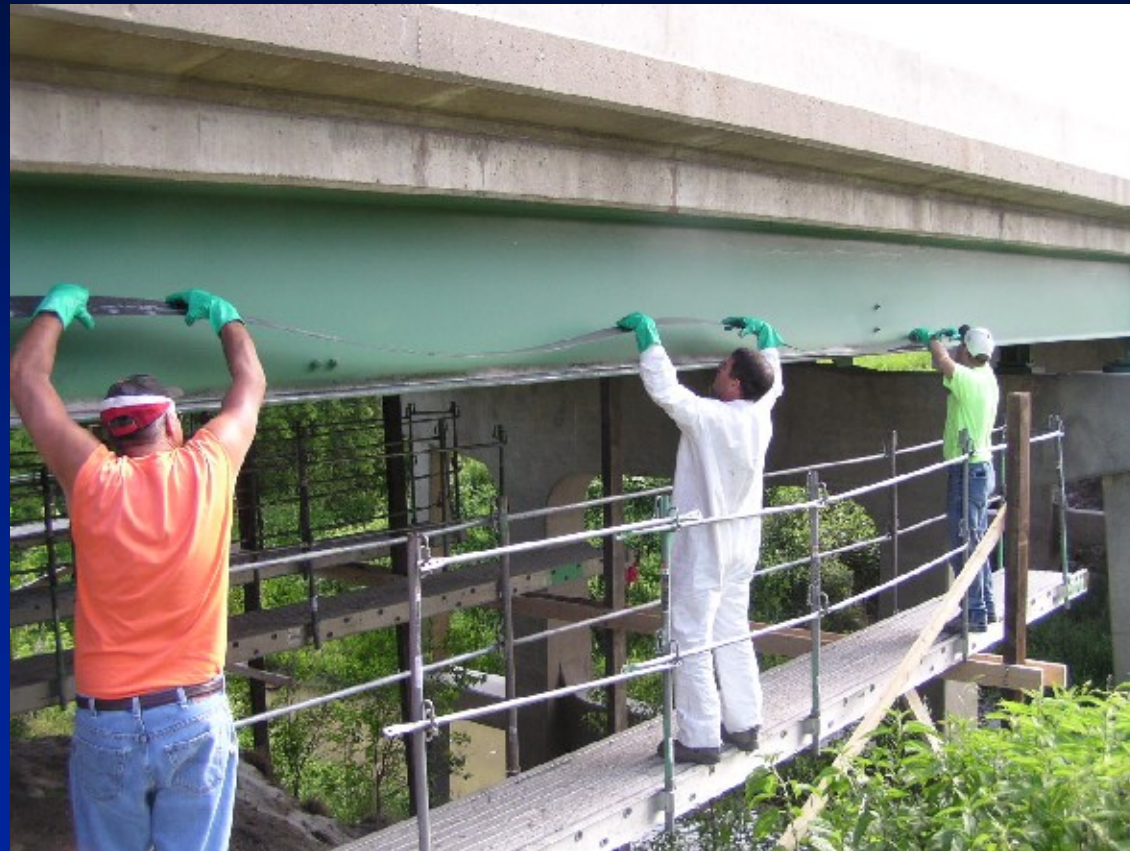
Installation of FRP Strips to Center Span Beams

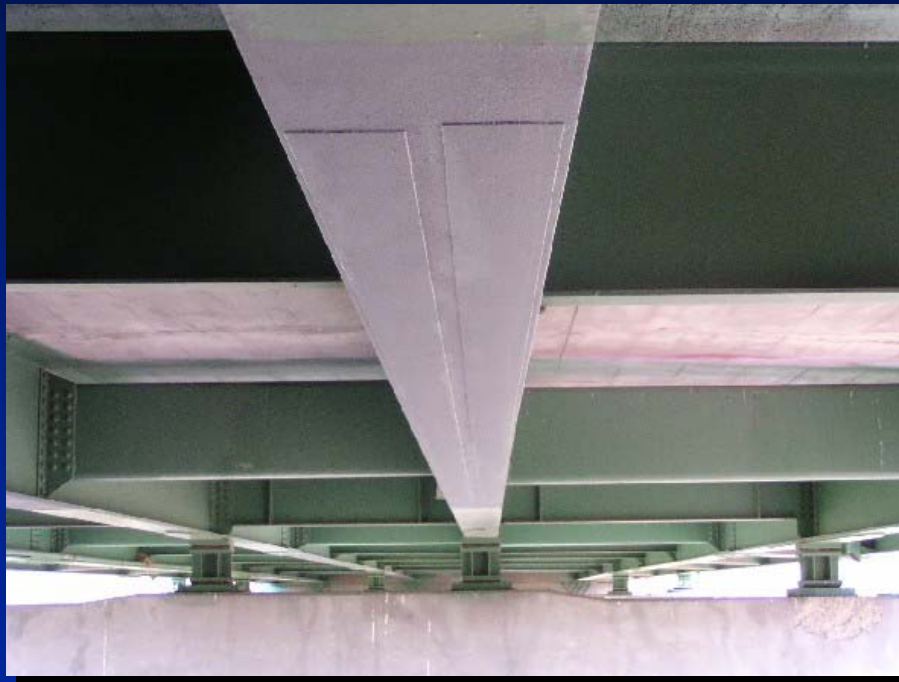
Three layers (East end span)
